**HISTORIC BUILDING SURVEY
OF
A NISSEN HUT,
HARTWELL LODGE,
MOOR LANE,
ROUGHTON,
LINCOLNSHIRE
(ROML09)**

Work Undertaken For
Oglesby and Limb
On behalf of
Pederson Properties Ltd

June 2009

Report Compiled by
Gary Taylor BA (Hons) MA MSc

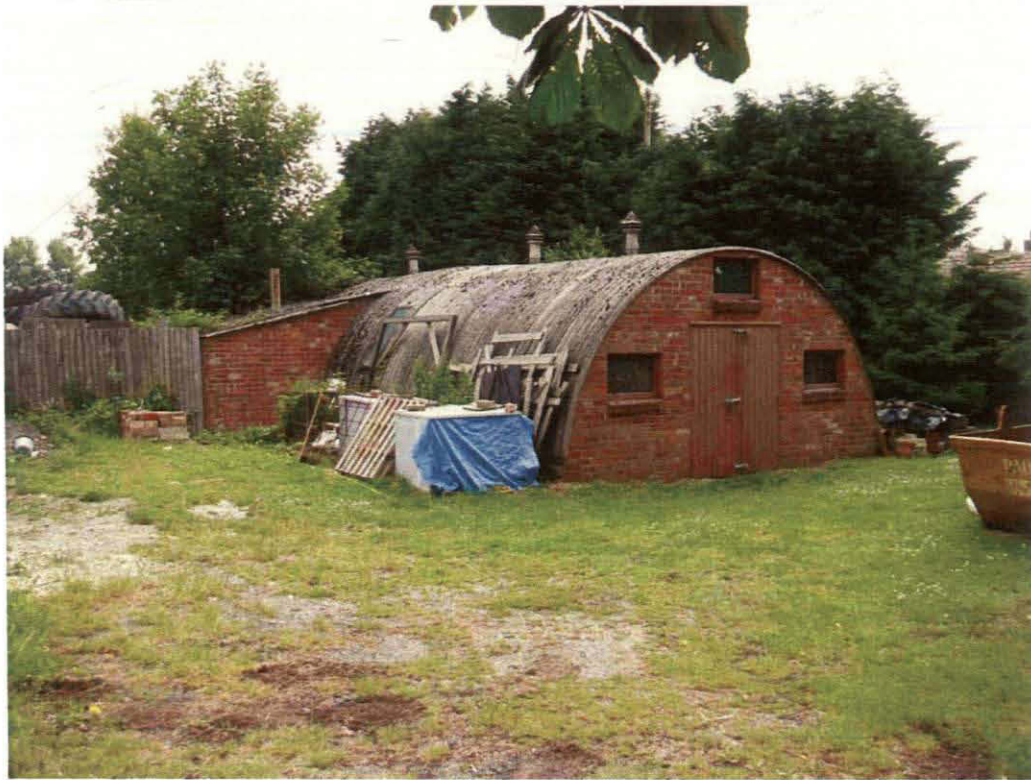
Of semi-circular form, the western elevation is of machine-made brick and contains three windows and a double door (Plates 1 and 2). Centrally-located, the double doors are planked and look to be replacements, perhaps of 1960s date. The doorway has a lintel of brick headers set on their narrow edge.

Plate 1 General view of Nissen hut, north and west sides, looking southeast

There are single-light windows on either side of, and above, the doors. All three windows are wooden-framed and have brick lintels and canted brick sills. These lintels and sills are of rows of header bricks and, with the exception of the top window lintel, have the headers set on their narrow edges. The top window lintel differs from the others in which the headers are set 3-2-3, with a pair of three bricks set on their wide edge flanking two bricks on their narrow side.

To north and south, the side walls are stub walls of machine-made brick, about 0.4m high. These have a series of buttresses along them. Four such buttresses were evident along the south wall, and two on the north wall, though that side was obscured by stacked materials. The walls and buttresses continue through to Room 2 at the eastern end (see below).

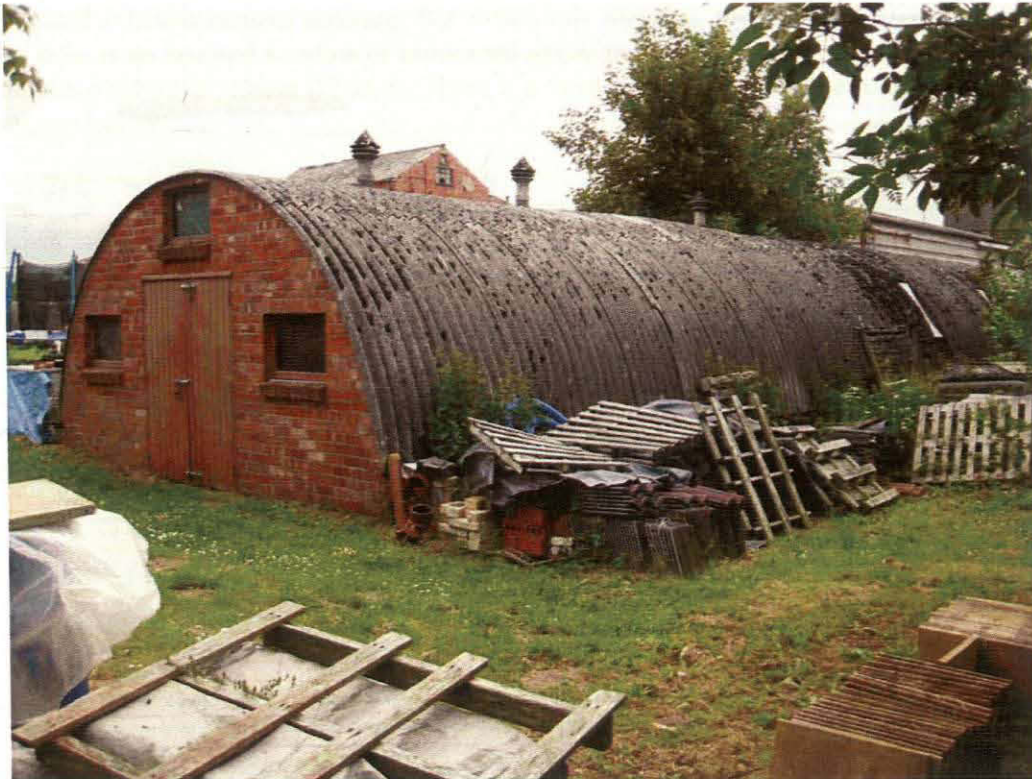
Plate 2 General view of Nissen hut, south and west sides, looking northeast

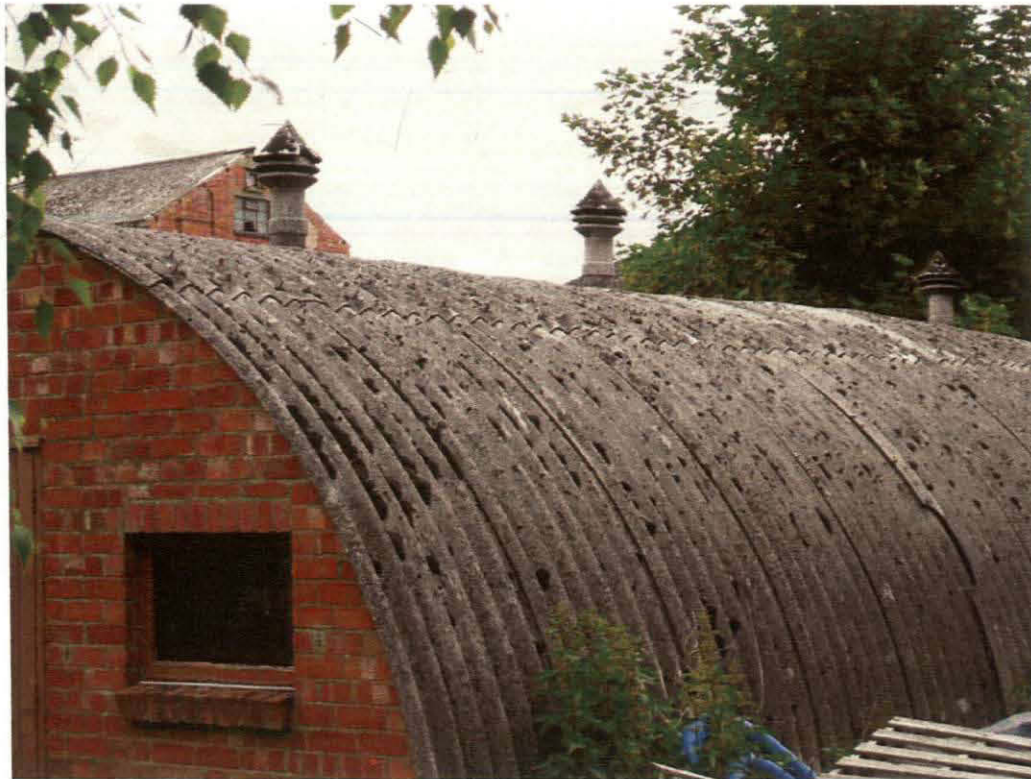
On top of the stub wall is the semi-circular upper section of the Nissen hut. This is of corrugated asbestos cement sheeting. Set within this sheeting, toward the eastern end of the north side, is an inserted window of reinforced glass. In the top of the roof are two chimneys of moulded asbestos cement (Plate 3). There is a third such chimney in the roof of the eastern room, see below.

Plate 3 Detail of chimneys in Nissen hut roof, looking northeast

There are three chimneys in the roof of the Nissen hut, two in the western room and one in the eastern. However, none of these connect to any remaining heating feature. It is possible that these chimneys were originally attached to pot-bellied stoves, the normal form of heating of Nissen huts used as military billets.

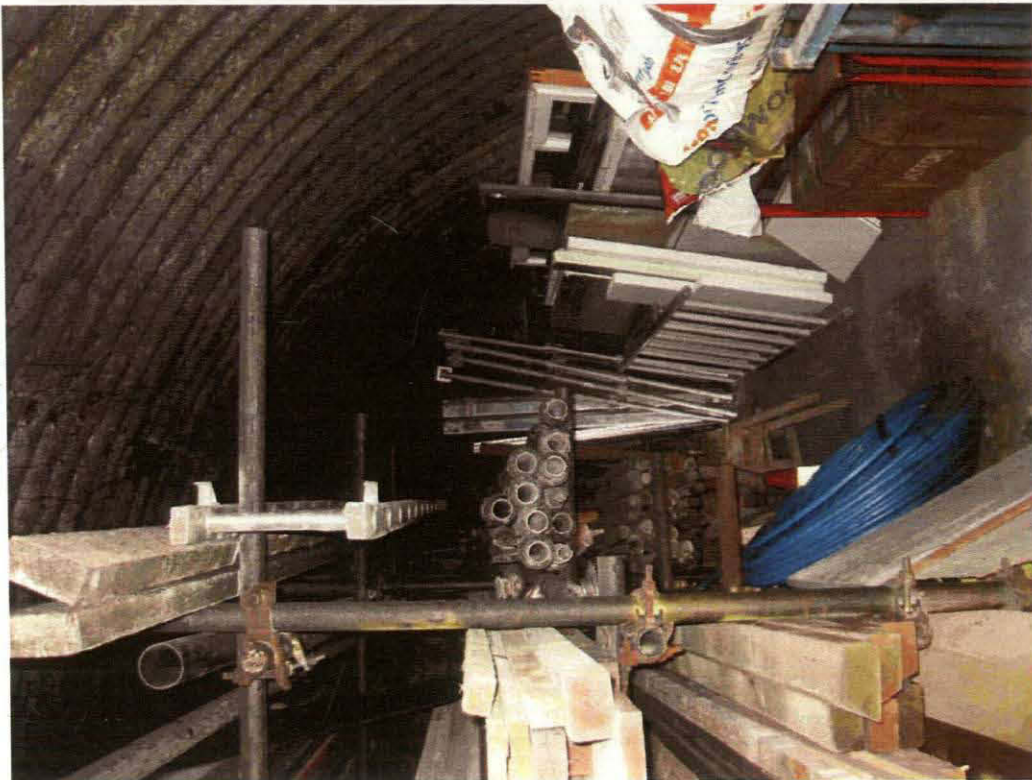
Plate 5 Interior of Room 1 of Nissen hut, south side, looking east

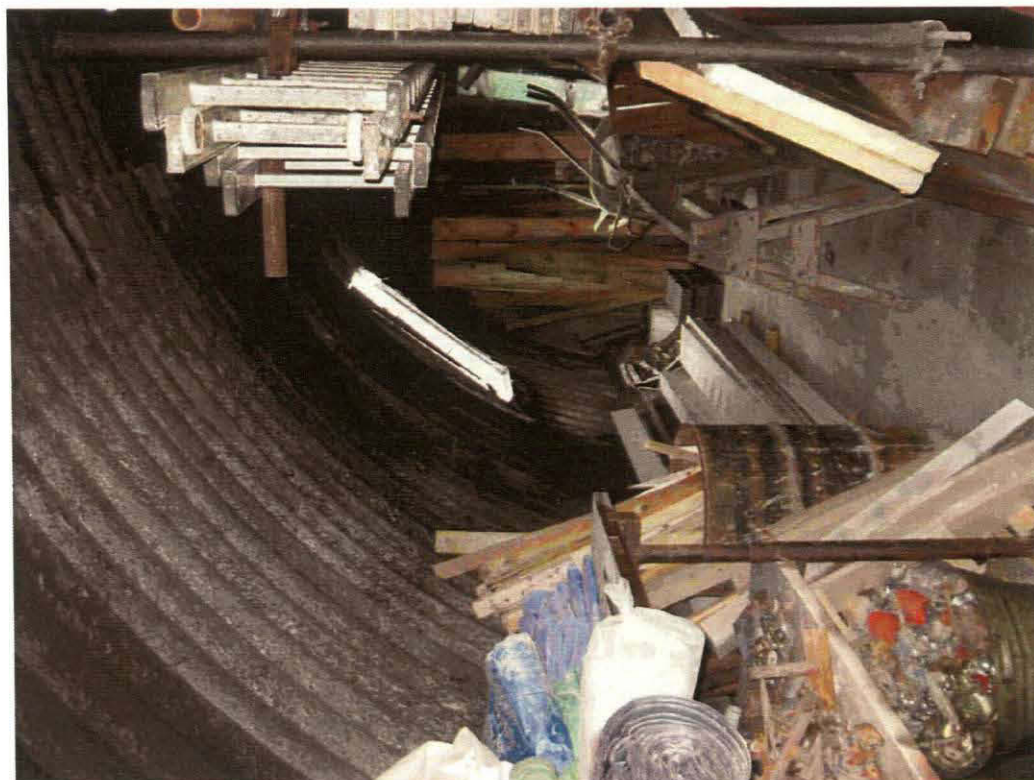
Plate 6 Interior of Room 1 of Nissen hut, north side, looking east

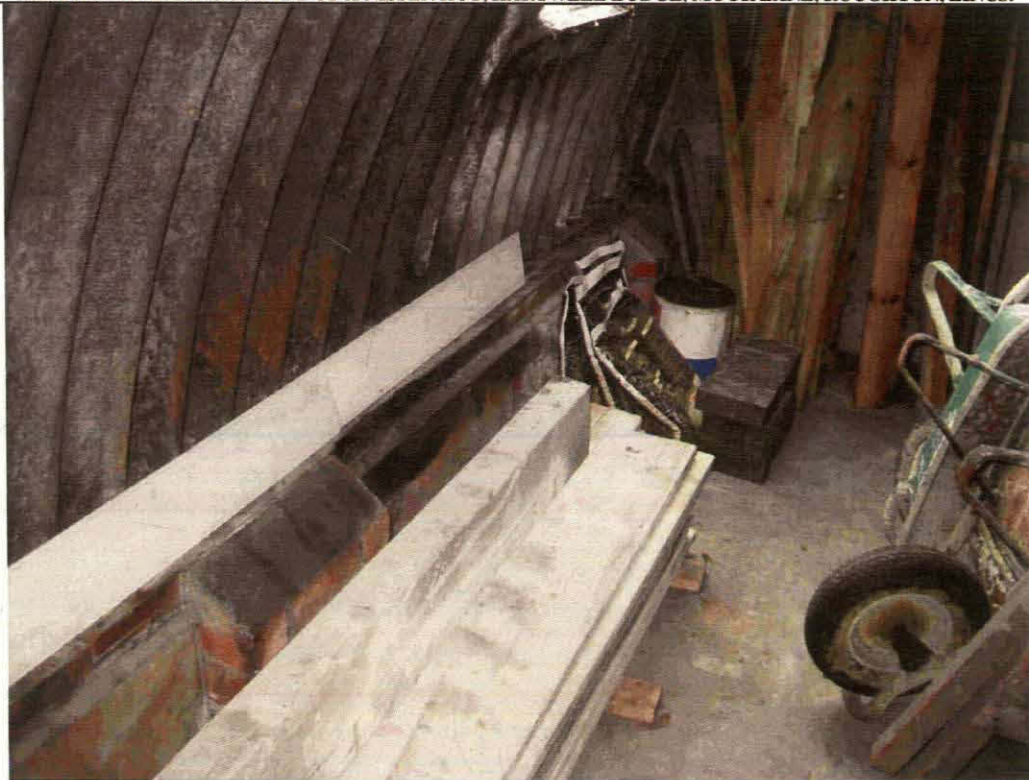
The room has a concrete floor. There are four plinths in both the north and south walls, set opposite each other (Plate 7). These plinths have canted tops that slope down slightly to the middle of the room. Within the roof are two holes, for the chimneys evident on the exterior (Plate 8). The western end wall is of breeze block.

Plate 7 Detail of plinths in Room 1 of Nissen hut, looking east

The recorded Nissen hut has a brick plinth wall with external buttresses and internal stanchions. On this plinth wall is the semi-circular arched upper walls and roof of curved corrugated asbestos cement sheet. In the original design for Nissen huts, these curved panels of corrugated sheeting were supported on arched ribs. However, such ribs are absent in the recorded building, though the internal stanchions appear to have been stands for such ribs.

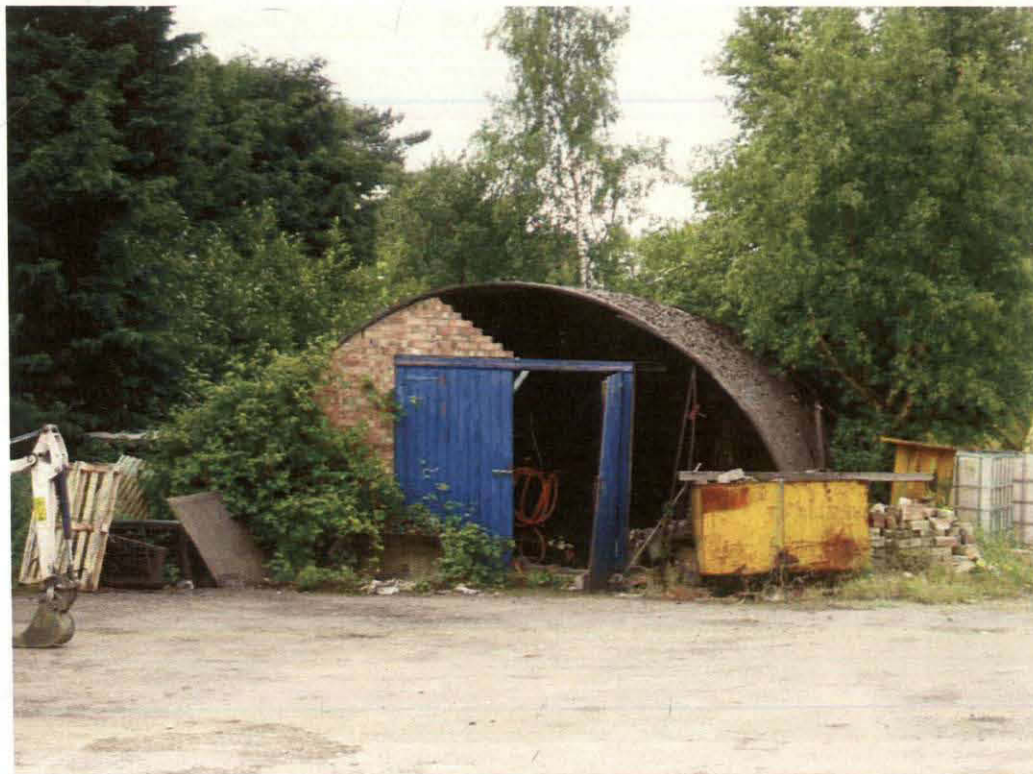
The eastern elevation is of the same semi-circular form as the western end of Room 1. Of machine-made brick, the eastern elevation contains a double door that is wider than the entry into Room 1. Centrally-located, the double doors in the eastern elevation are planked and may be original, possibly of 1940s date. There is no lintel to the doorway. About half (the northern part) of the wall has collapsed (Plate 9).

Plate 9 Eastern elevation of Room 2 of Nissen hut, looking west

In the western part of the roof is a hole for the chimney evident on the exterior. There is a modern strip light attached to the roof. The room has a concrete floor. About half of the eastern elevation has collapsed (Plate 9).

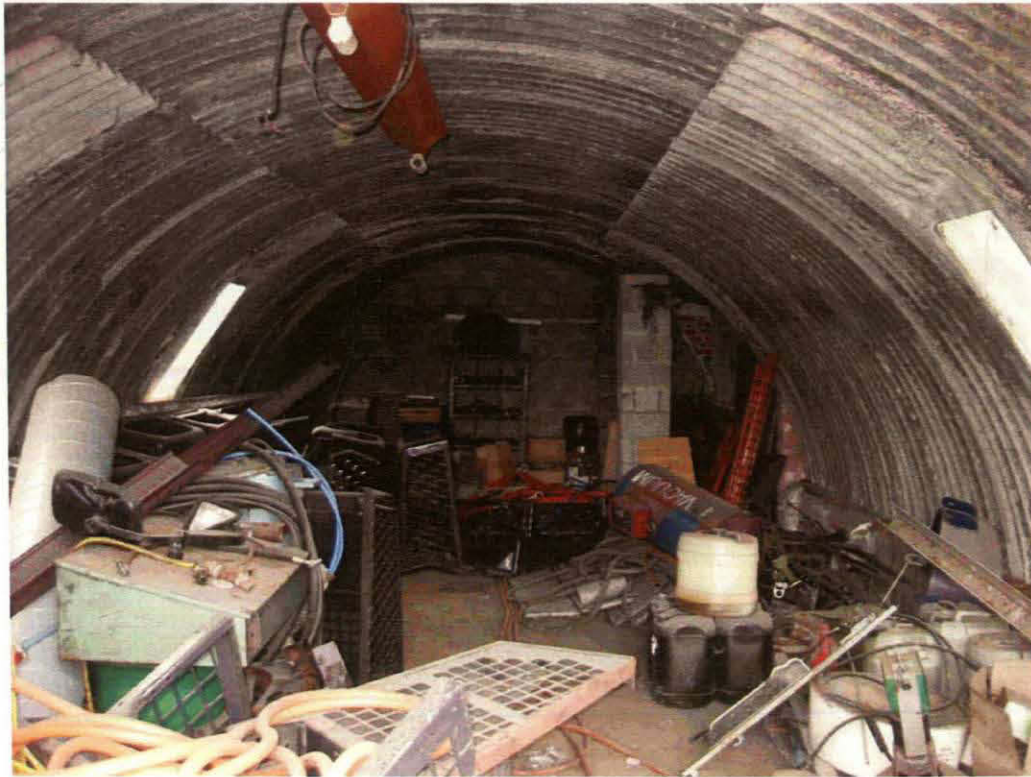
Within both the north and south stub walls are sets of plinths. There are six equally-spaced plinths on the south wall. On the north wall are four plinths, also equally-spaced and set opposite the four eastern-most plinths in the south wall.

Plate 10 Interior of Room 2 of Nissen hut, view toward dividing wall, looking west

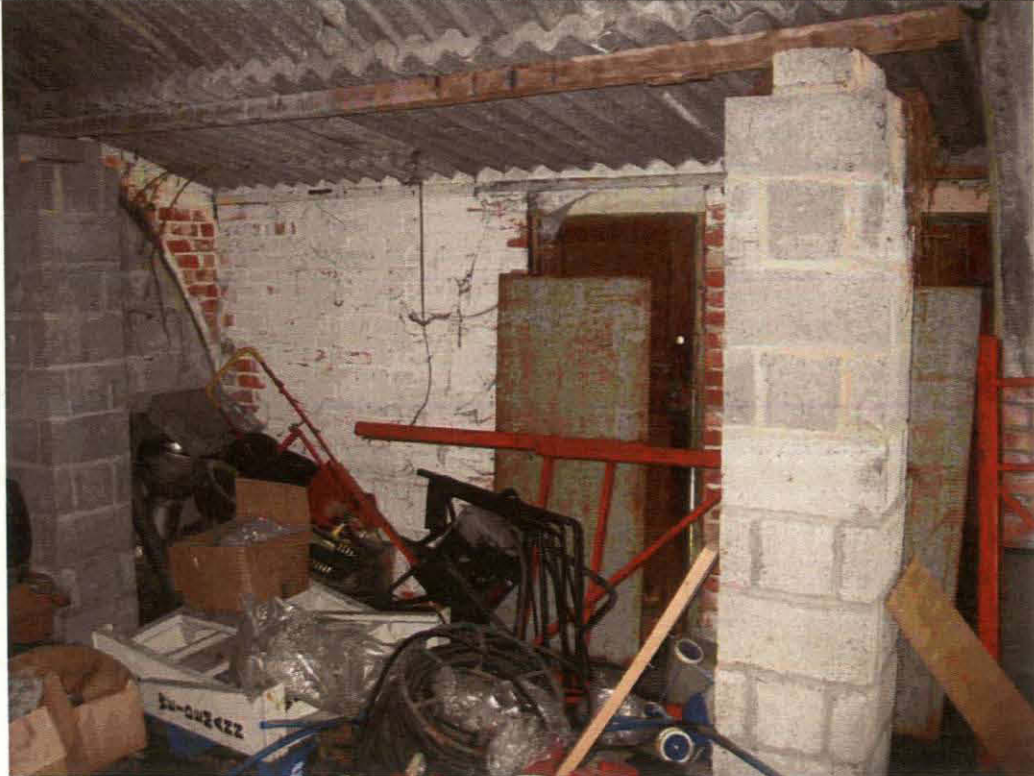
In the northwestern corner of the room are two breeze block stanchions each about 0.5m square (Plate 11). These stanchions are about 3m apart and 1m from the north wall of the room. They support a timber that carries a section of flat corrugated asbestos roofing that slopes down slightly to the north.

Plate 11 Detail of stanchions in Room 2 of Nissen hut, looking northwest

sloping roof of corrugated sheet, supported on two large breeze block stanchions located within the Nissen hut. The division of the Nissen hut into two rooms and addition of the extension came after the erection of the Nissen hut. However, the date of the alterations is uncertain, and they may have occurred immediately after the Nissen hut was erected.

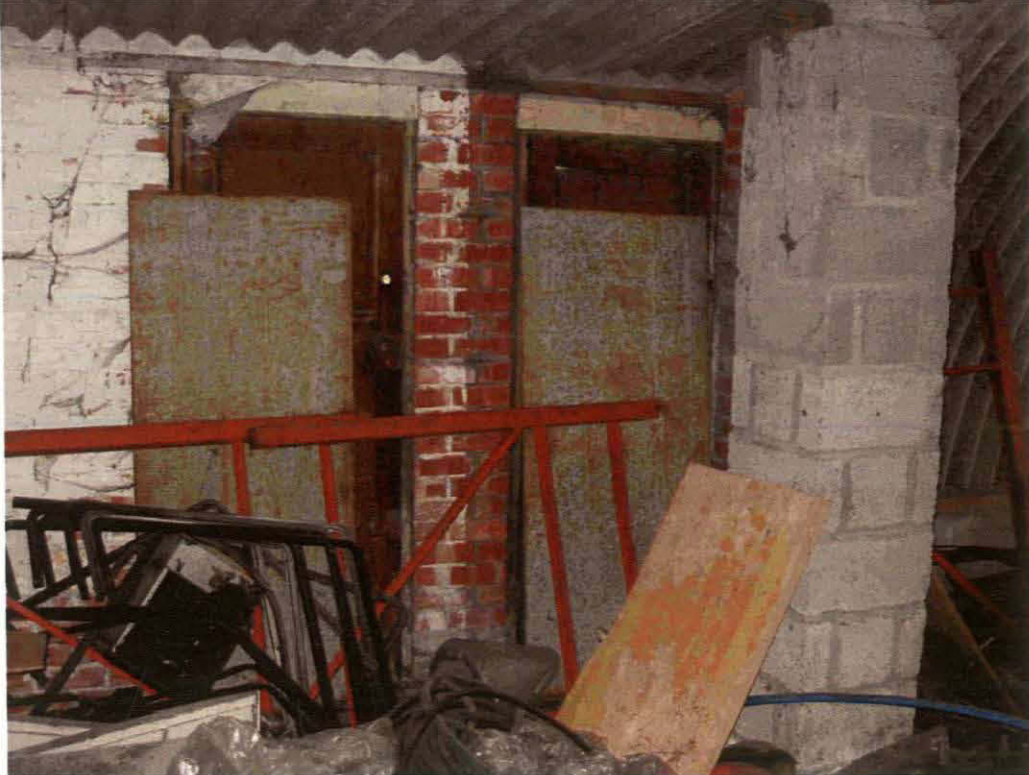
Set within the northern brick wall, toward its eastern end, are two panelled wooden doors that may be of the 1940s or earlier (Plate 12). These doors lead to the northern extension (Room 3, see below). However, both doors were blocked by thick sheets of steel and there was no access through them.

Plate 12 Interior of Room 2 of Nissen hut, view of doors to extension, looking north

Also of brick, the southern wall of the extension is constructed against Room 2 of the main Nissen hut. This wall contains the two panelled doors noted above (Plate 12; see Room 2, interior).

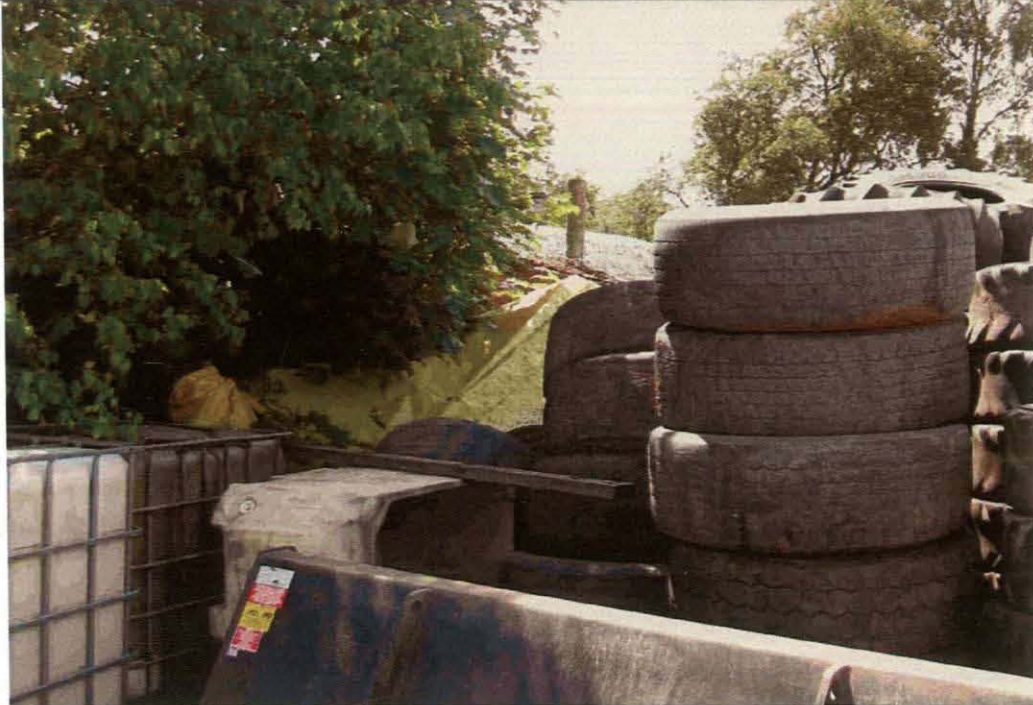
The west wall is of brick and is plain. There is a flat, slightly sloping roof of corrugated asbestos cement sheeting, through which passes a plain stove-pipe chimney (Plate 13).

Plate 13 View toward extension (Room 3), showing chimney and roof, and stacked materials preventing access, looking west

There was no access (internal or external) to the extension. However, a chimney in the roof implies some form of heating system within this annexe. Additionally, there are two doors from the Nissen hut to the annexe, perhaps suggesting the extension contains two rooms.

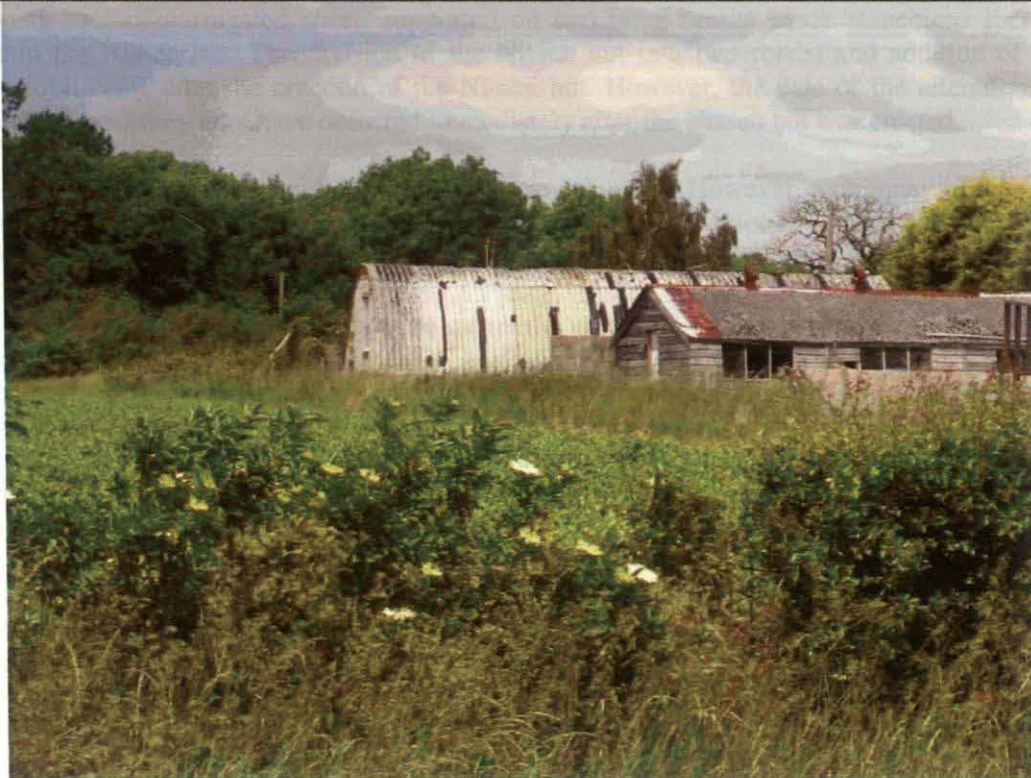
The recorded Nissen hut is one of two at Roughton, the second being located a few hundred metres to the north (Plate 14), and it is possible that these were part of an army camp associated with nearby RAF Woodhall Spa and used in the run-up to the Battle of Arnhem in 1944. However, neither of the Nissen huts appears on the 1950 and 1956 Ordnance Survey maps. Consequently, it seems more likely that the recorded Nissen hut was imported to the site in the 1950s, after the Second World War.

Plate 14 Other Nissen hut to north of Horncastle Road, looking north
