nps group
nau archaeology

**The Old Telephone Exchange, Spalding, Lincolnshire:
An Historic Building Record**

February 2009

In December 2008 a Level 3 Archaeological Building Survey was undertaken ahead of the demolition of the redundant telephone exchange on Gore Lane, Spalding, Lincolnshire (NGR: TF 2468 2265). The telephone exchange was constructed in the 1930s and represents a typical example of a purpose-built communications hub for that period.

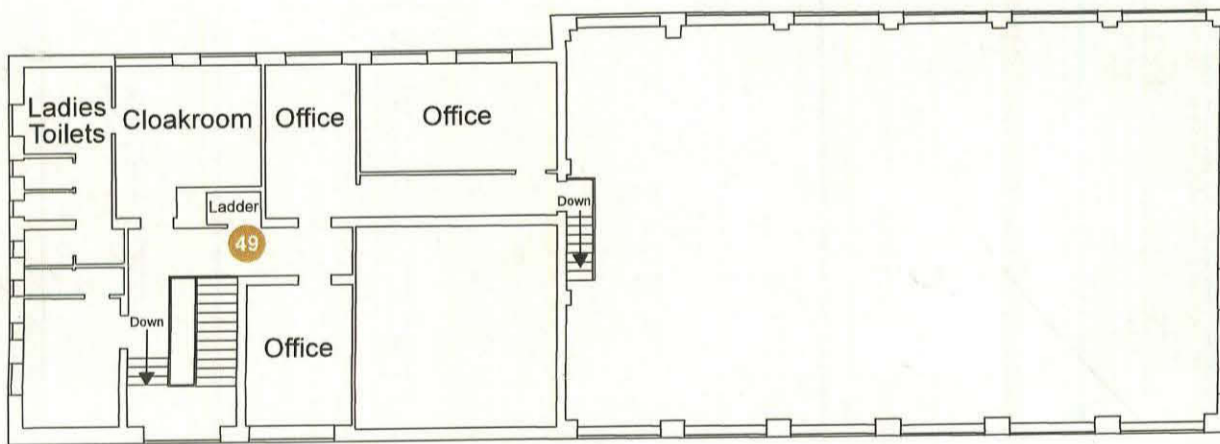
Figure 6 Plan of building

The Old Telephone Exchange is a three-storey building with flat roof, and is rectangular in plan with single-storey extensions to the north-west and south-west elevations (Fig. 6). The building is constructed of brick laid in alternating courses of headers (short side of the brick) and stretchers (long side of the brick), known as Flemish Bond.

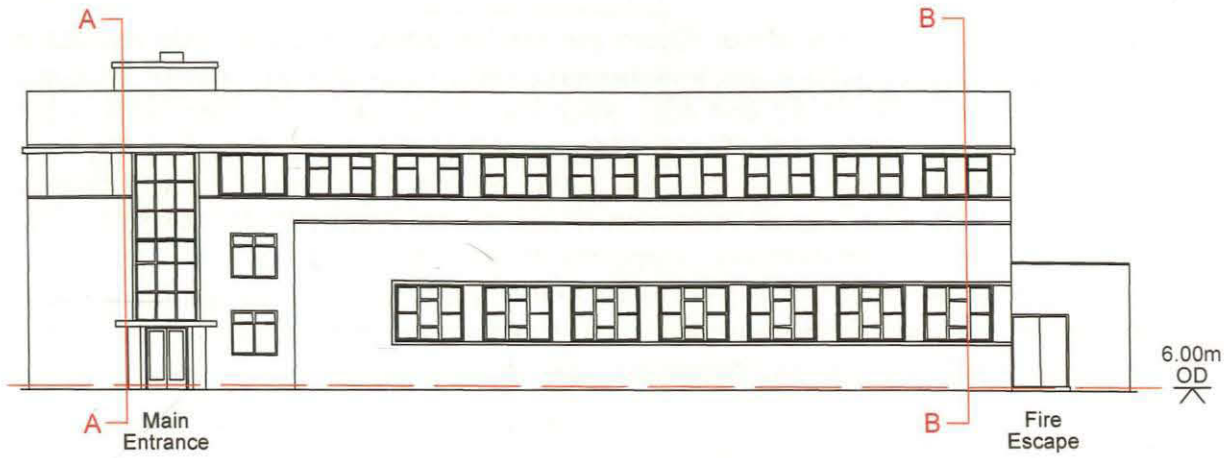
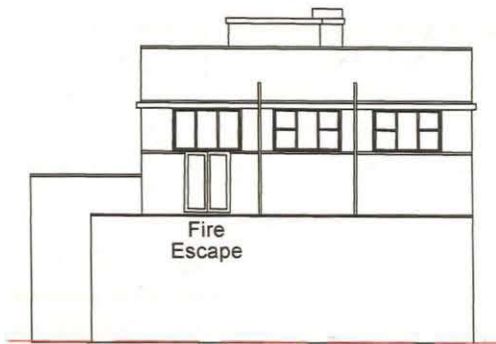
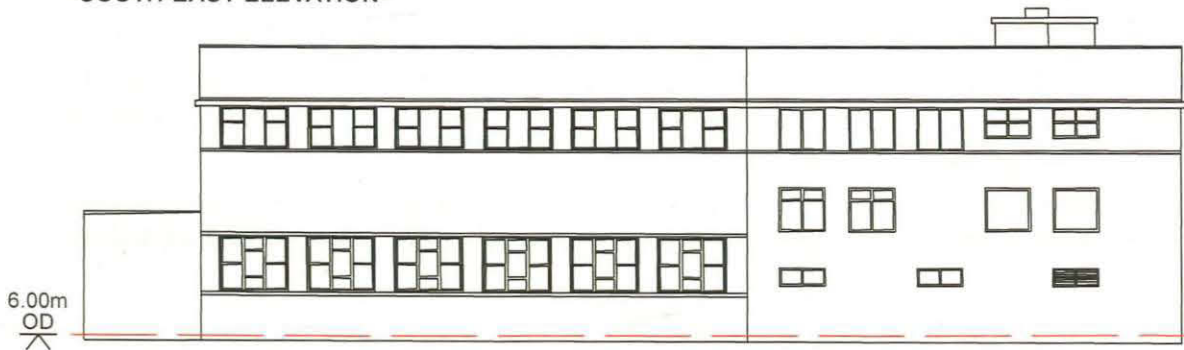
Figure 7 Elevations of building

The main elevation of the Old Telephone Exchange faces Gore Lane (Plates 2 and 3; Fig. 7). To the northern end of this elevation is a slightly recessed panel which contains the date '1938' (with a crown between the numbers) and the inscription 'E vi R, Telephone Exchange' (Plate 4). This date stone, along with the second floor windows, are set between two rows of string courses consisting of thin concrete blocks; this provides some architectural detail to the building. Fixed to the wall beneath the date panel is a notice from the Post Office which reads (Plate 5):

The north-east elevation of the telephone exchange was difficult to photograph due to the proximity of other buildings (Plate 10; Fig. 7). At ground level, this elevation has evidence for former apertures, which appear to have related to the former Tank Room (Fig. 6; Plate 11). At first floor level there are five windows, three of which have ventilators at the top; these light the gents' toilets (Plate 12). At second floor level, there are two similar windows which flank five thinner, three-pane windows; four of these light individual toilet cubicles (Fig. 6). As with the single-storey extension, this elevation contains two holes close to the top of the wall which allow water to drain from the flat roof into the hoppers and downpipes. The location of these holes and rain water hoppers provides an indication of the level of the roof behind the brickwork.

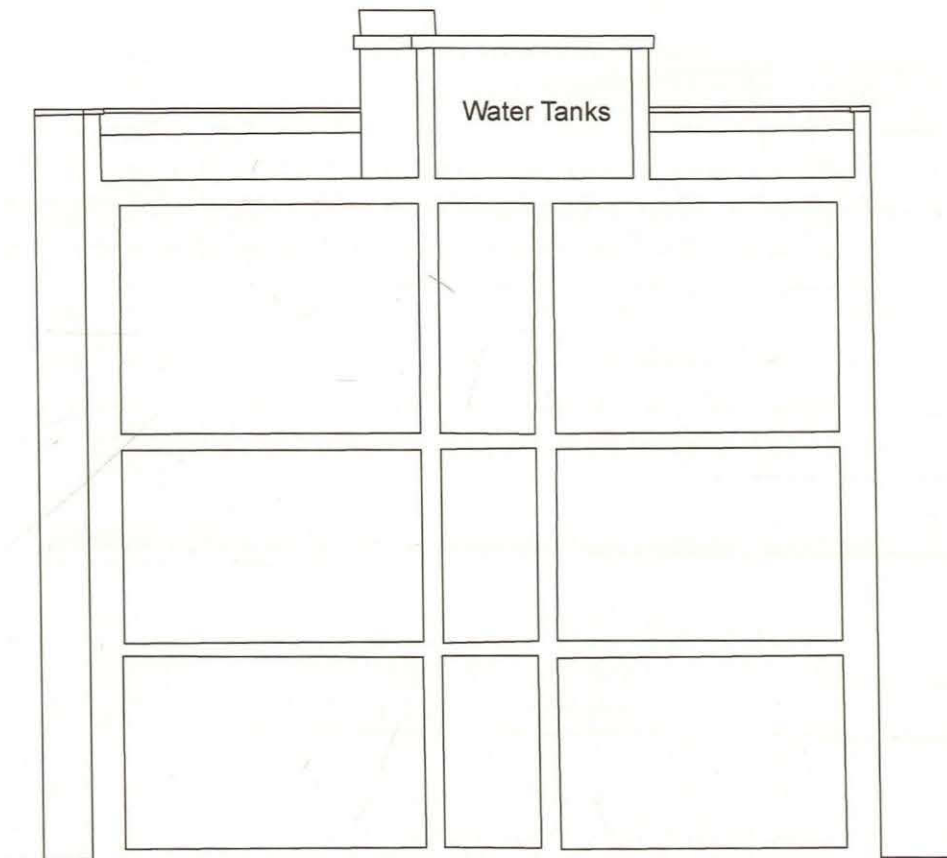
Figure 8 Section diagrams of Telephone Exchange

Section A-A through north-east end of Telephone Exchange

Section B-B through south-west end of Telephone Exchange

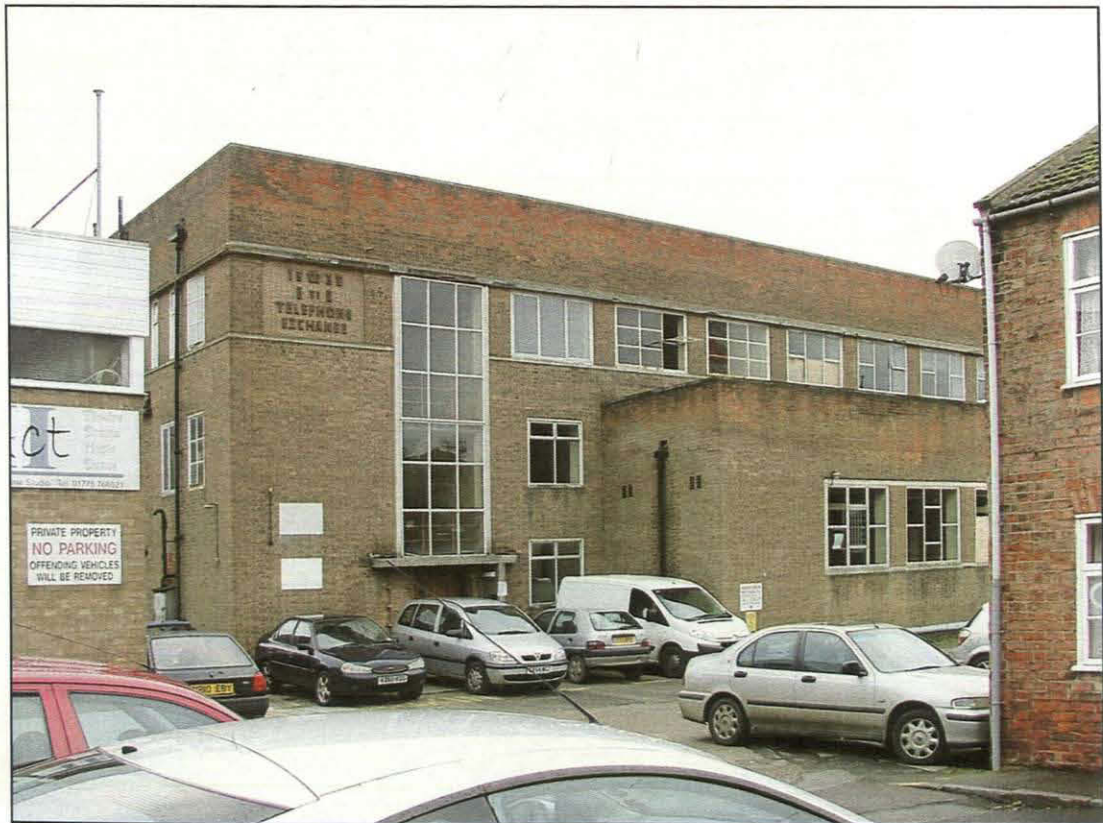
The main entrance into the building is located in the north-west elevation facing Gore Lane. The double-doorway is protected by a concrete lintel and a single concrete jamb to the right-hand side, and the brickwork surrounding the door is decorative. There is a letterbox to the left side of the door, which is now boarded over (Plate 6). Above the main entrance is a large window consisting of 18 panes set in a metal frame which lights the main staircase (Plate 2).

Plate 2. North-west (main) elevation as seen from Gore Lane

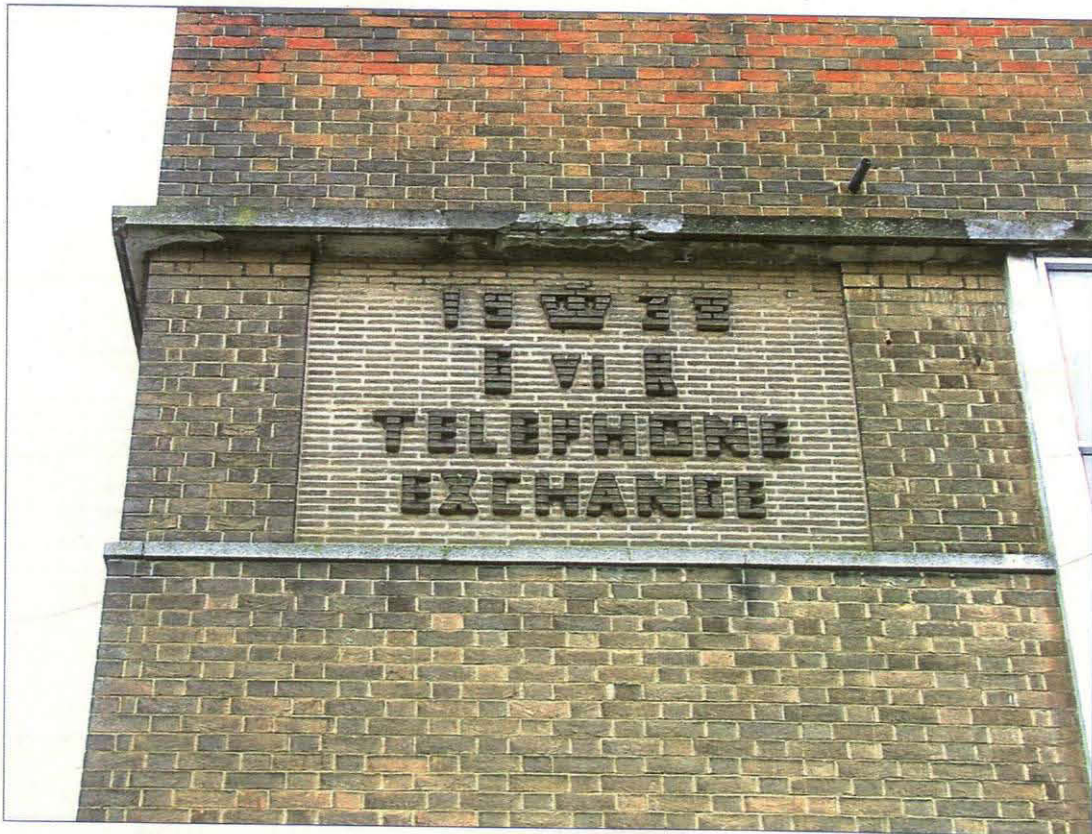
Plate 4. '1938 Telephone Exchange' in brickwork, north-west elevation

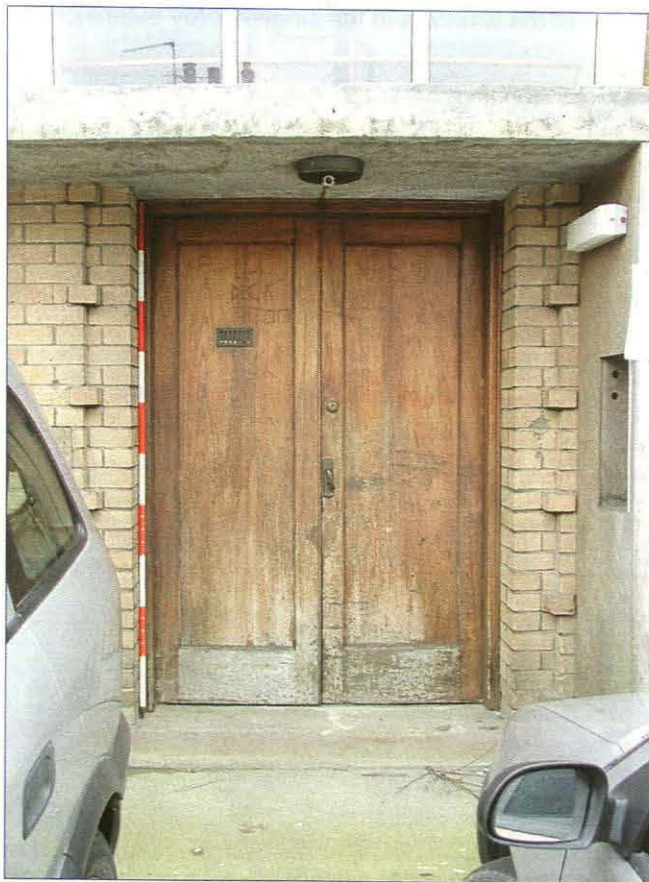
Access to the interior of the Old Telephone Exchange was possible via the double doors in the north-west elevation, as shown on Plate 6. The entrance opens into a small lobby which has to its left-hand side the former Meter Room, a sign on the door still displays the original lettering 'Meters', with a later sign above which says 'E.L & P Switch Room' (Plate 16; Fig. 6).

Plate 6. Main entrance into the telephone exchange (Scale = 2m)

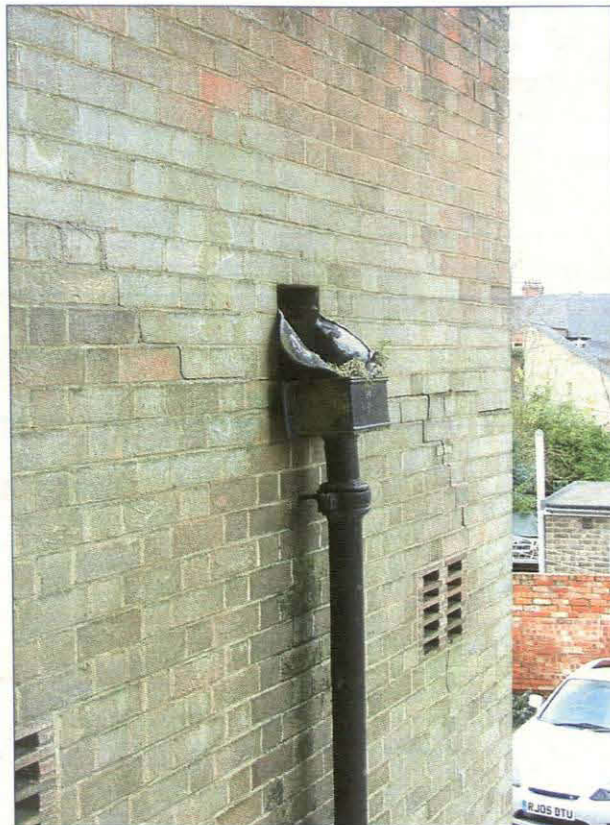
aluminium, although the originals may have been steel. Steel windows were inexpensive and readily available in a wide selection of sizes and styles. Their use in all forms of architecture became prolific following the First World War, in keeping with the new fashions and demands for low-cost, light, airy and well ventilated buildings (Clement 1997). As with the second floor windows along this elevation, those in the single-storey extension are also contained within two rows of string courses (Plate 7). Below the windows in the single-storey extension are two decorative ventilation holes constructed from thin bricks (Plate 8). In the north-east facing wall of the single-storey extension is a hole within the brickwork which allows water to drain into a hopper and downpipe from the flat roof hidden behind the brick wall (Plate 9).

Plate 9. Detail of the rain water hopper, north-east facing elevation of single-store extension, as seen from within the first floor office

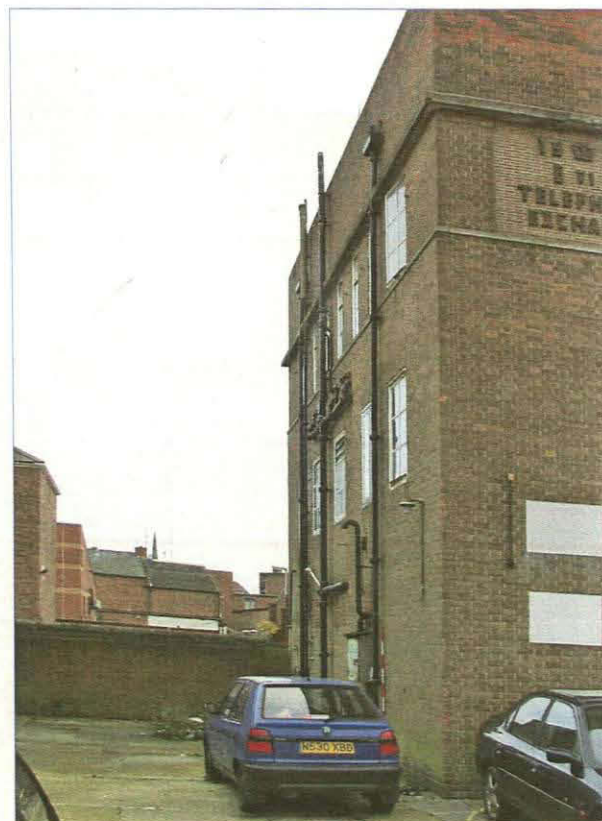
Plate 10. View looking south-east of the north-east elevation

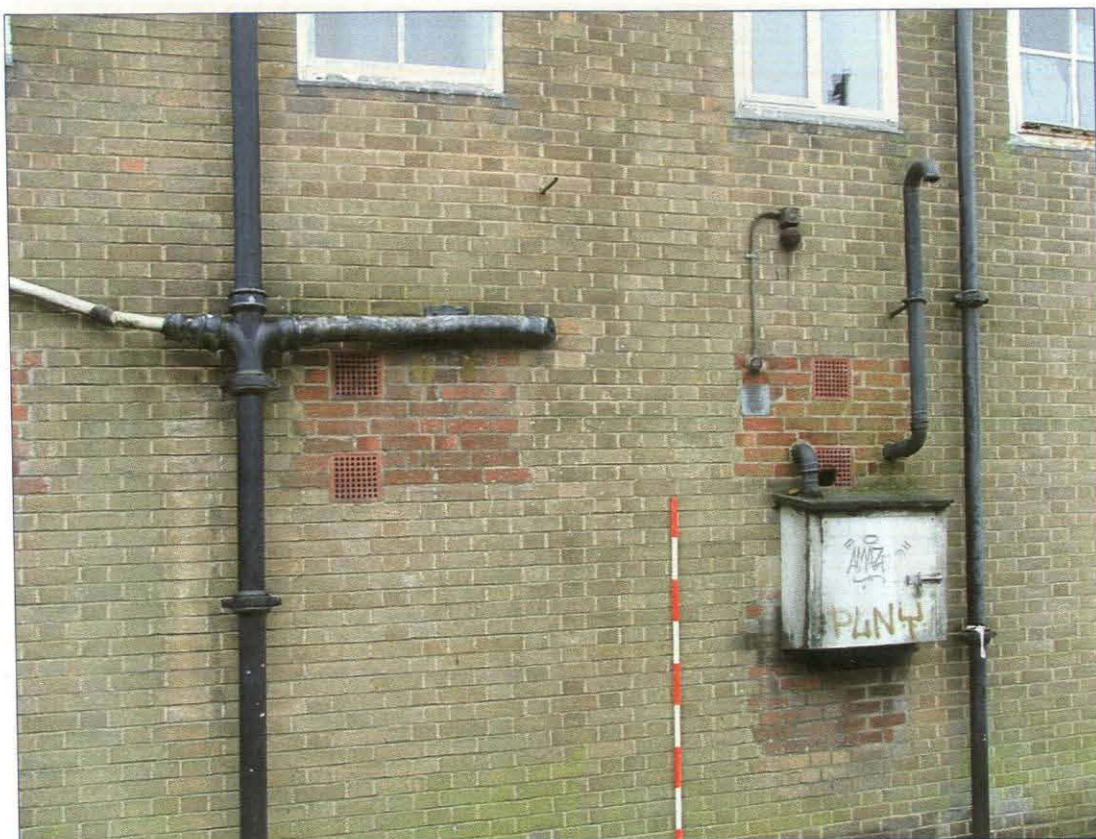
Plate 11. Detail of bricked-up holes in north-east elevation (Scale = 2m)

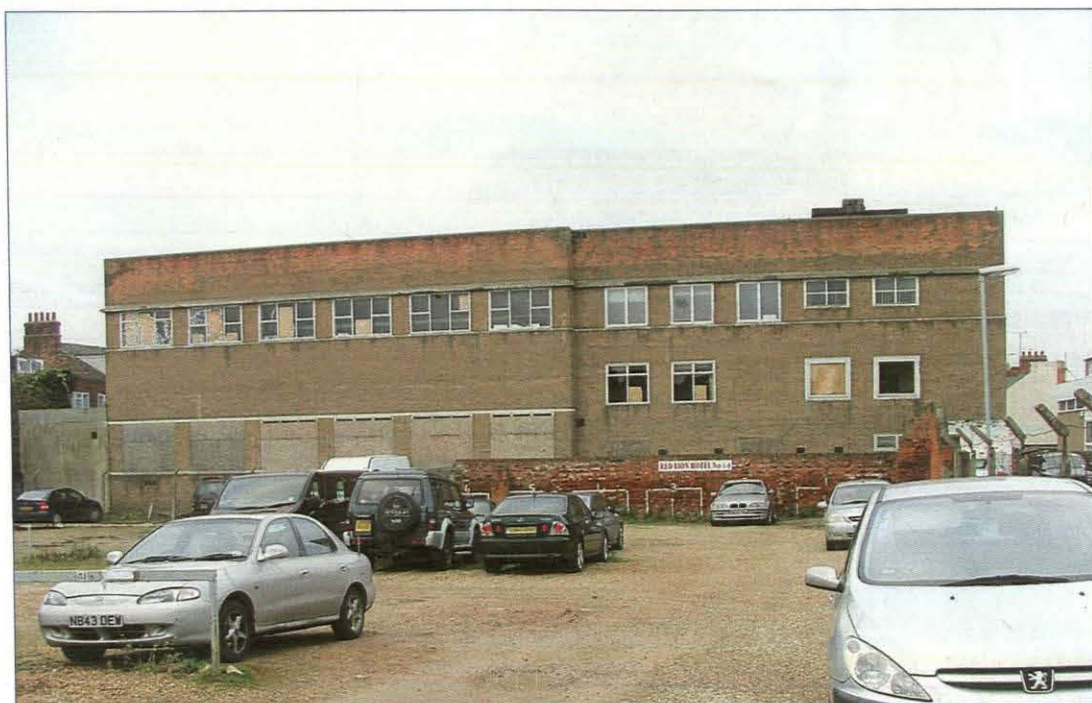
The south-east elevation faces the car park to the rear of the property (Plate 15). This elevation clearly shows a separation between the two sides of the building; the larger, south-west section has windows which light the ground floor large hall, and at the upper level the windows which, presumably, lit the original open-plan switchboard room, with no floor between. The north-eastern end, however, has three floors which housed the offices, toilets, kitchen, boiler room, and ancillary accommodation. The separation between the two ends is shown not only in the fenestration, but also by the fact that the southern end projects slightly from the rest of the building.

Plate 15. View looking north-west of the south-east elevation of the Old Telephone Exchange

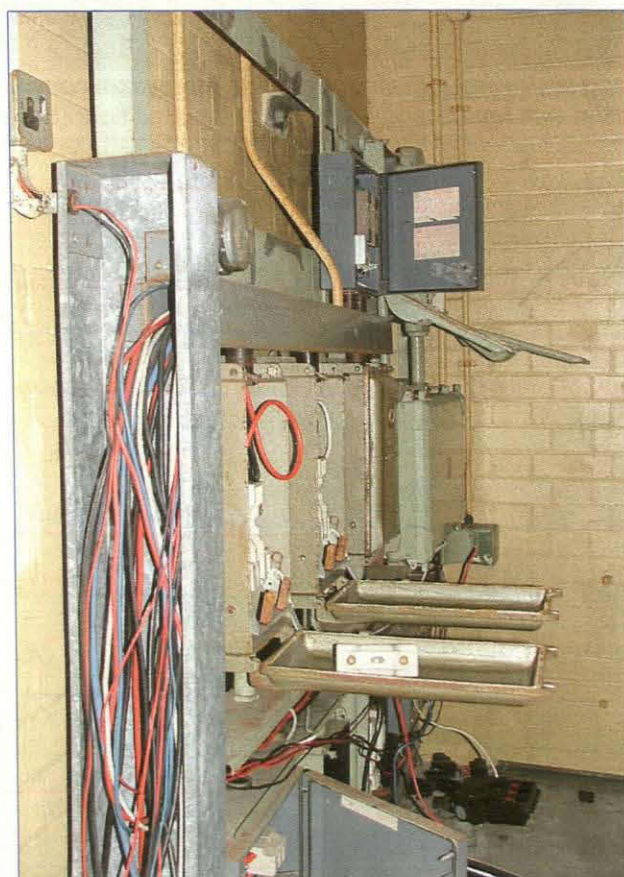
Plate 16. View of the remaining electrical equipment in the Electrical Intake Room, ground floor

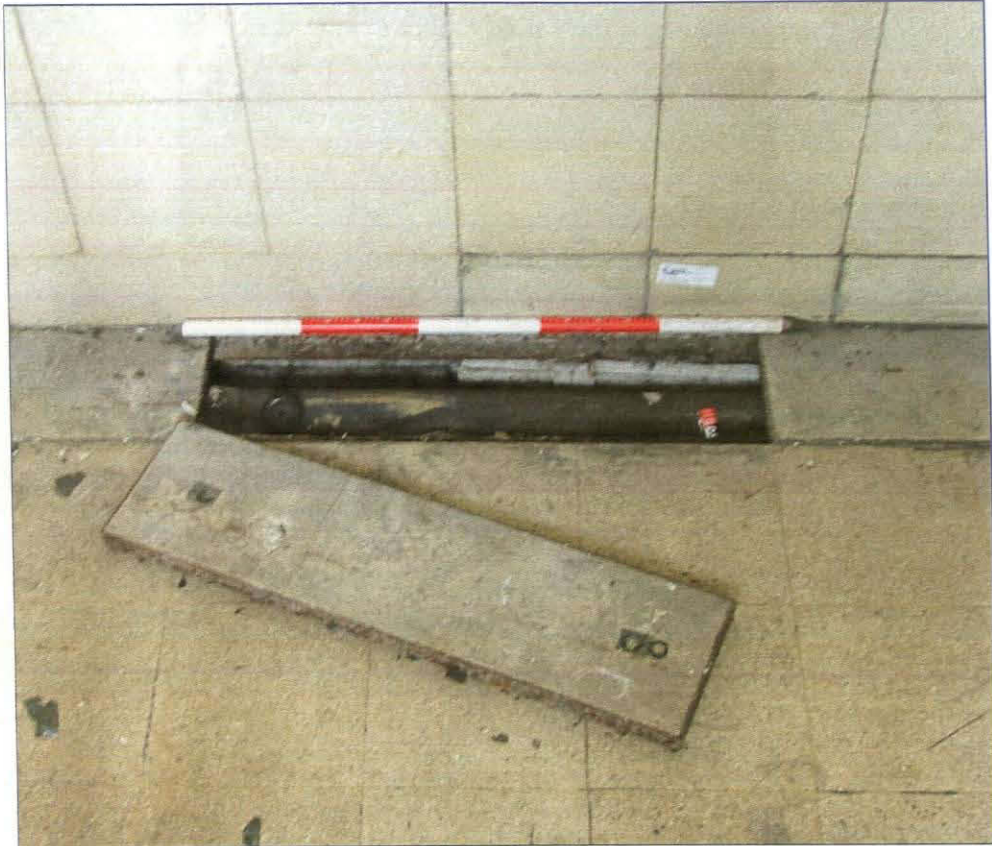
Upon entering the building, the small lobby leads into the base of the stairwell through a plain door with four horizontal glass panels (Plate 17). The floor of the entrance hall and the lower half of the walls are covered in square creamy brown tiles, which match the tiles of the staircase treads (Plate 18). Along the back wall of the stairwell, set beneath the floor, is a heating pipe which could be accessed by lifting up one of the sections of floor (Plate 19).

Plate 19. Heating pipe located beneath the floor of the entrance hall (Scale = 1m)

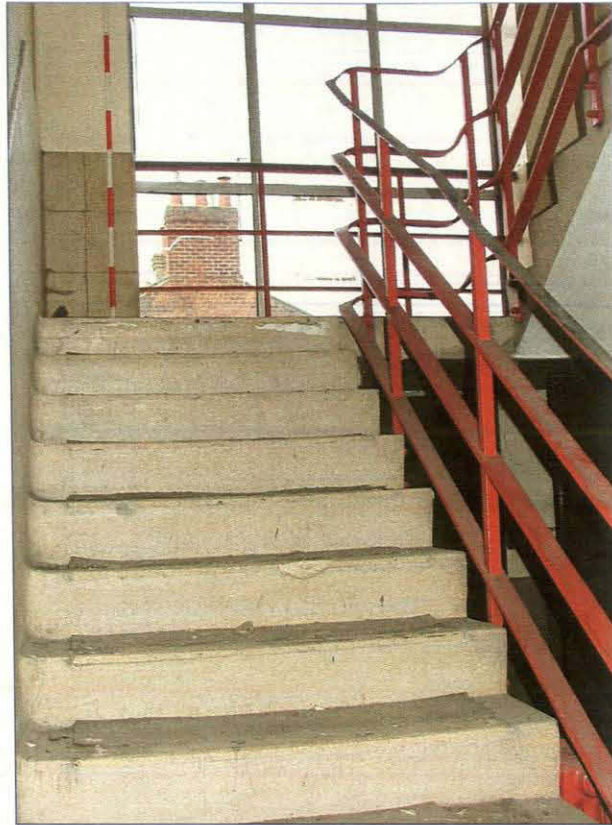
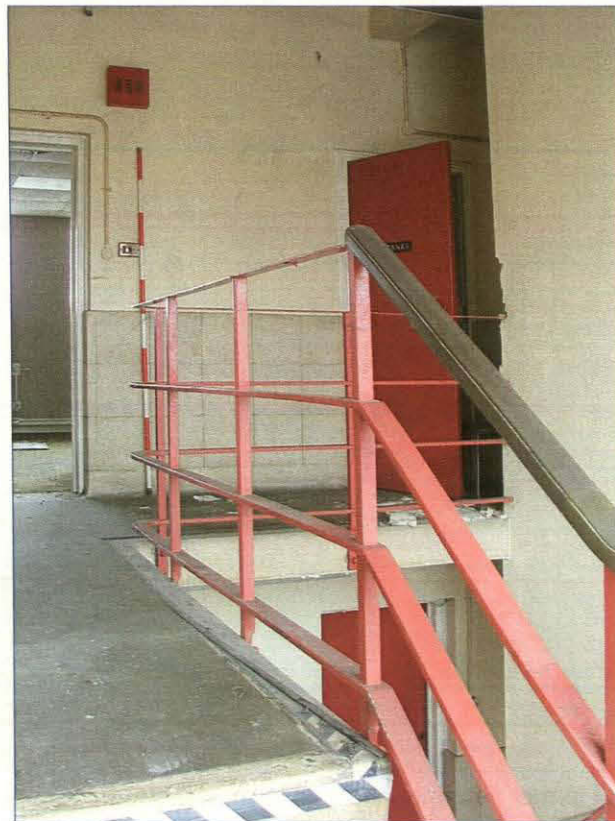
The staircase handrail and balusters are constructed from metal strips reflecting the Art Deco style of architecture of the period in which the building was erected. The handrails, where sections have not been stripped away, were of brass and when complete would have given a high quality finish to the stairwell (Plates 21 and 22).

Plate 21. Detail of metal handrail and balusters of staircase

Plate 22. Detail of staircase at second floor level showing surviving section of brass handrail (Scale = 2m)

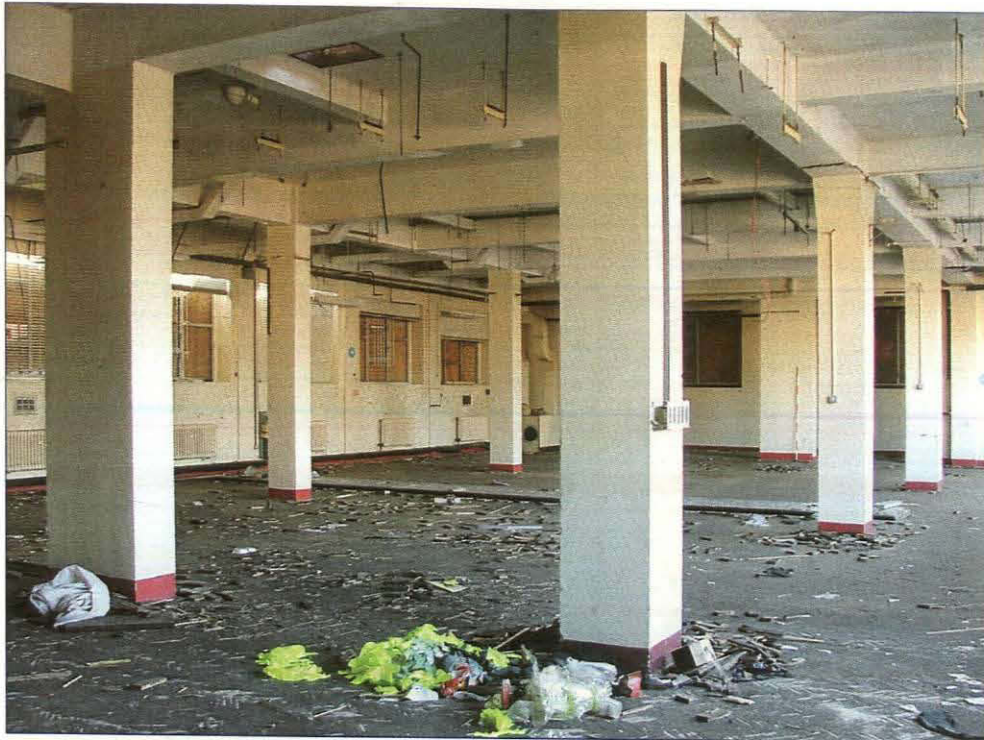
The main hall at ground level is a large open space with two rows of columns down its length, and is where the MDF (Main Distribution Frame) was presumably located (Plate 25). The flooring of the hall has been stripped away, with only sections remaining around the edges (Plate 26). This is unfortunate as the surviving remains indicate that it was a good quality parquet floor laid on top of concrete. Along part of the north-west wall is a concrete pit which retains its wooden hatches with 'ring pulls' (Plates 27 and 28). This pit, or cable channel, may have been the point where external cables came into the exchange and

Plate 25. View looking south-west of the interior of the ground floor hall (Scale = 2m)

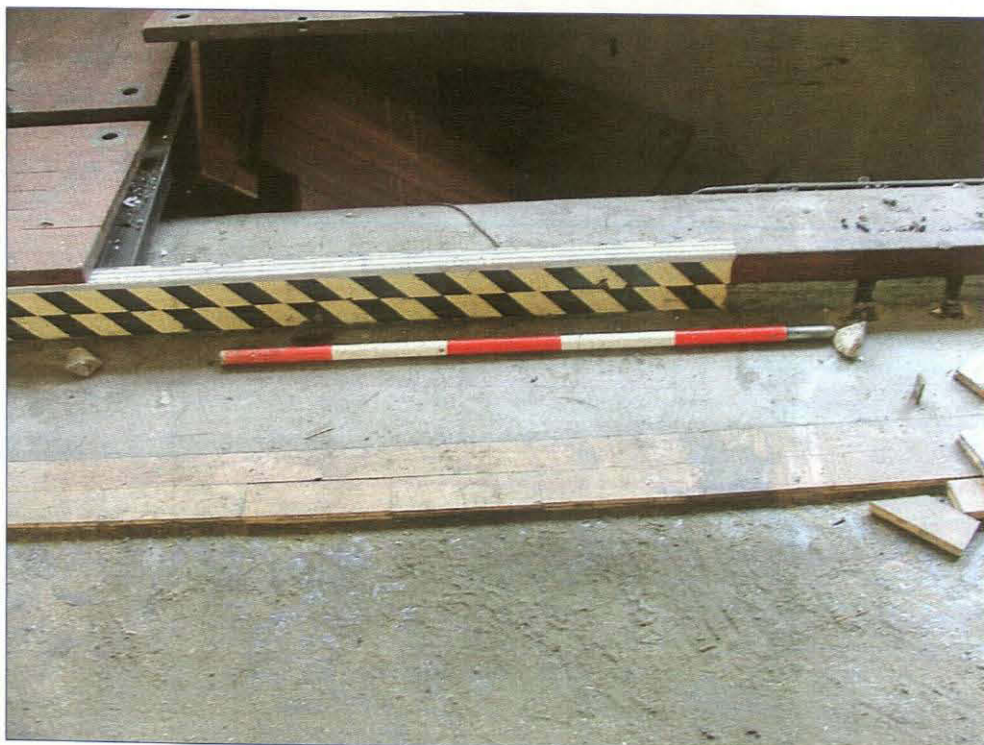
Plate 26. Surviving edges of a former parquet floor, ground floor large hall (Scale = 1m)

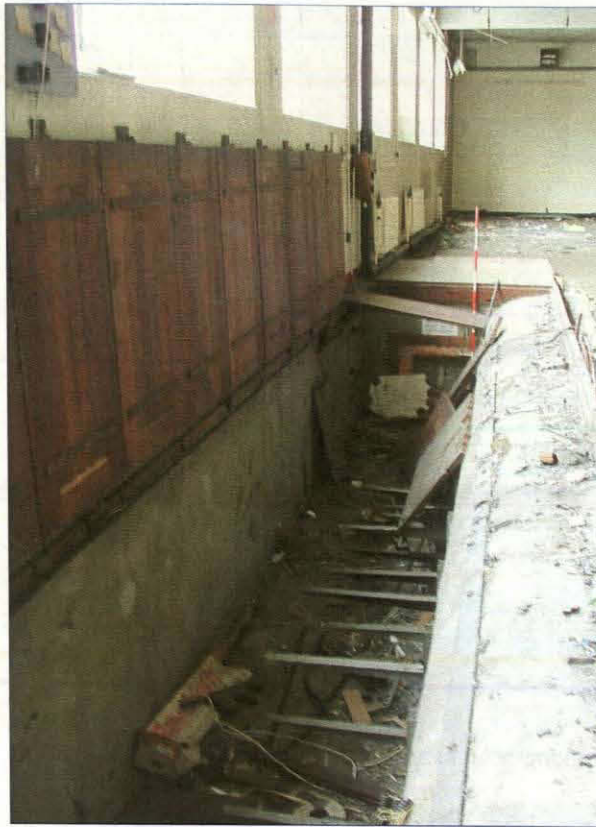
Plate 27. View looking north-east of the concrete pit in ground floor hall with wooden hatches
(Scale = 2m)

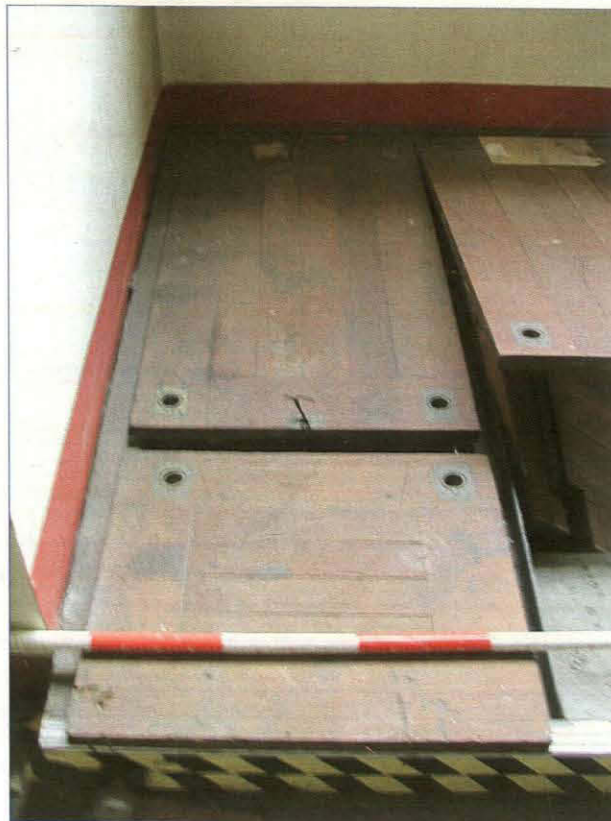
Plate 28. Detail of some of the wooden hatches over the pit, ground floor (Scale is in 20cm graduations)

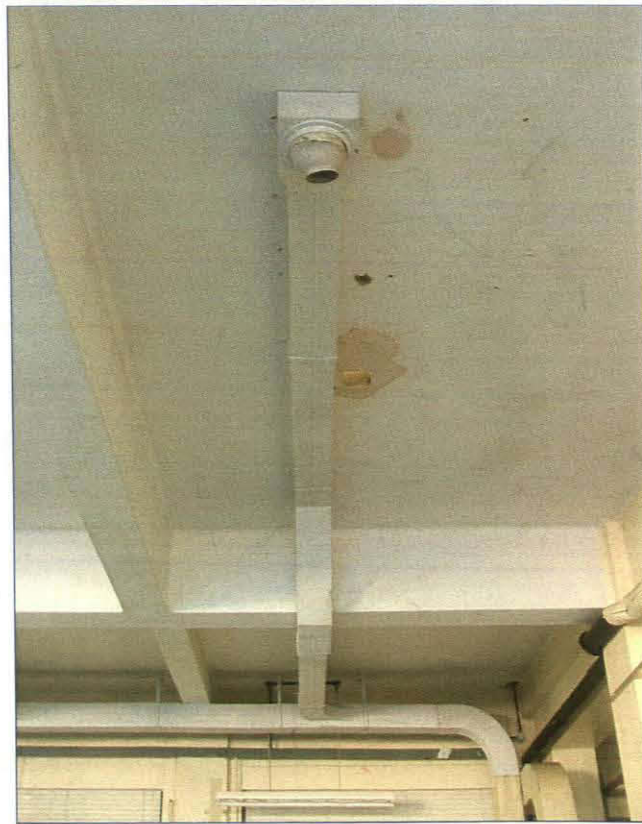
Plate 32. One of the lengths of ducting on the ceiling of the ground floor hall

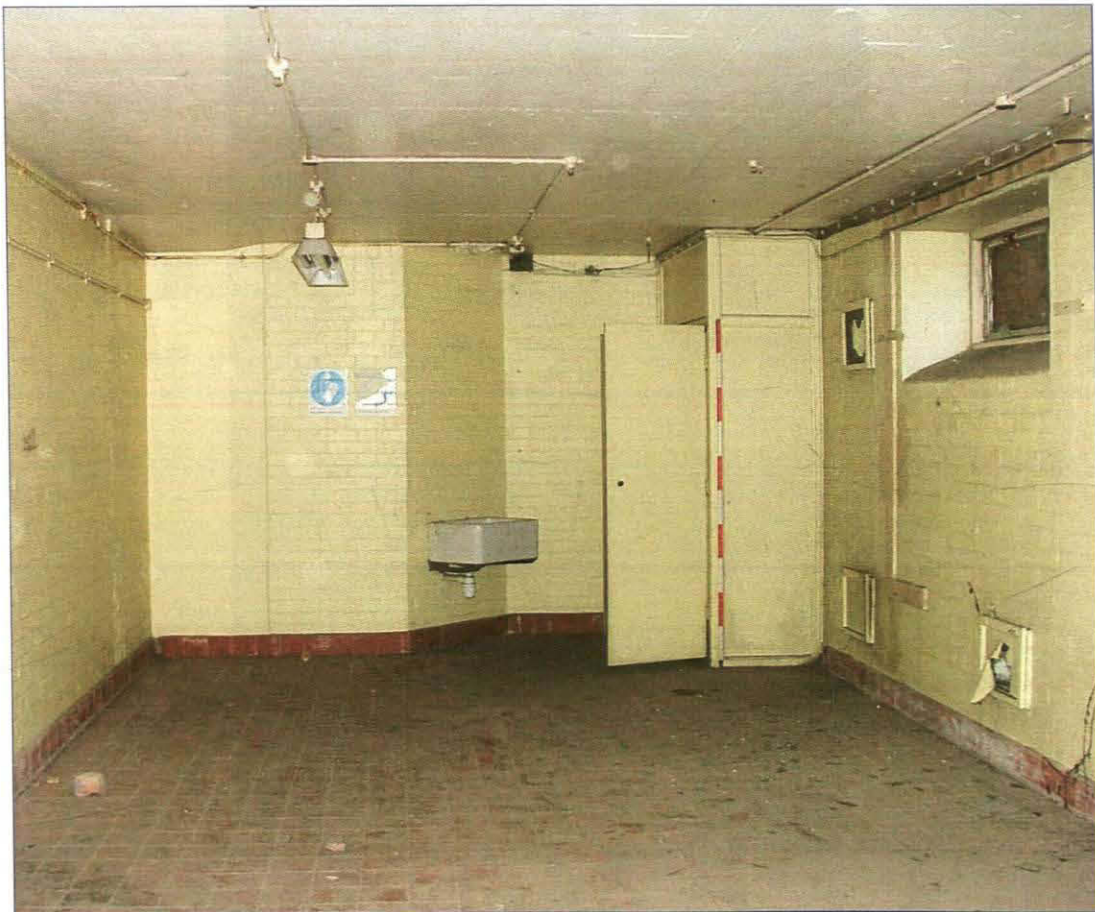
The Battery Room, as its name suggests, was where batteries were housed, possibly as a means of back-up should the electricity supply fail. This room at the time of survey was relatively featureless apart from a wash hand basin and cupboard at one end (Plate 36).

Plate 36. View looking north-east of the interior of the Battery Room (Scale = 2m)

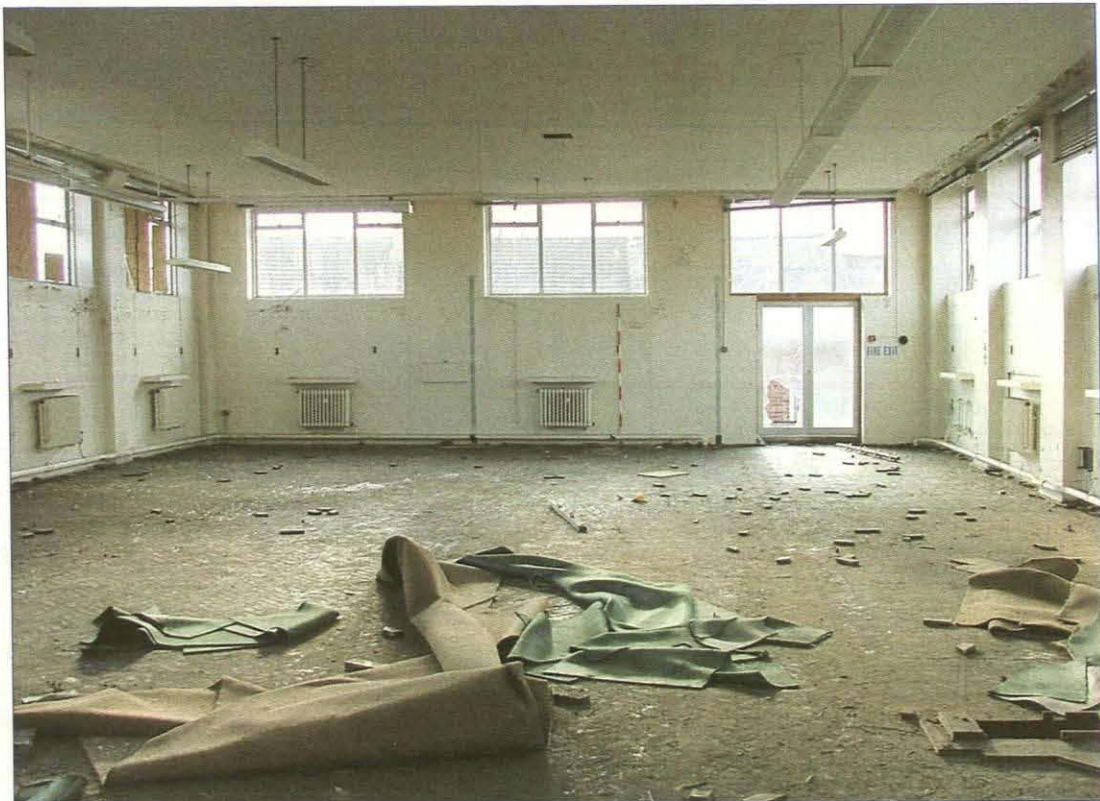
In the opposite wall to the Meter Room are double doors which provide access to the Operating Room, where the switchboards would have been located. This is a large open space (Plates 42 and 43), which has radiators along three sides, each with a ledge over (Plate 44). The presence of the radiators, if original features, would have presumably prevented the switchboards from being located against the walls, as was the case at Woolwich (Plate 1); consequently the switchboards may have been located centrally. Along the three external elevations of this large room, windows are located in the upper half of the walls; this would have made opening the windows rather awkward, and it is possible that this was done by the use of a pole with a hook, as sometimes seen in schools.

Plate 42. View looking south-west of the Operating Room (Scale = 2m)

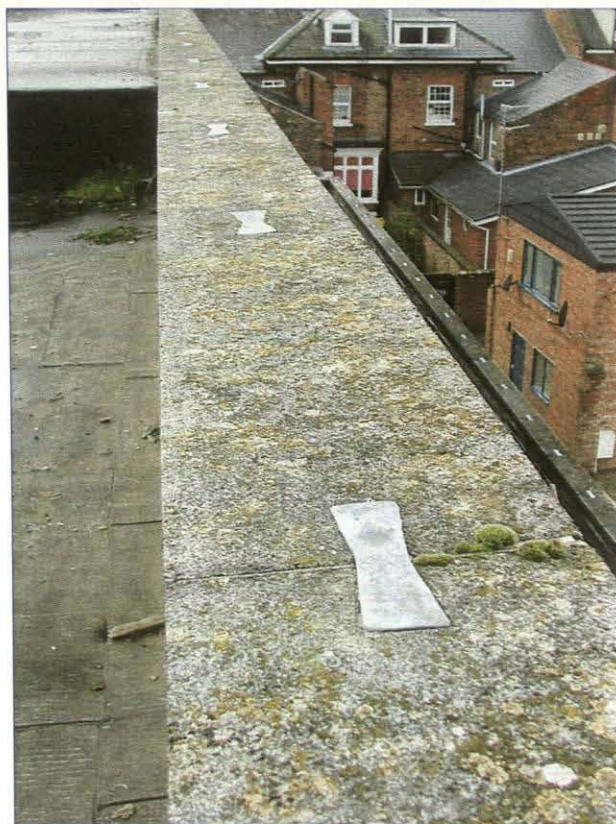
Plate 54. Detail of lead ties between the concrete capping stones of the parapet

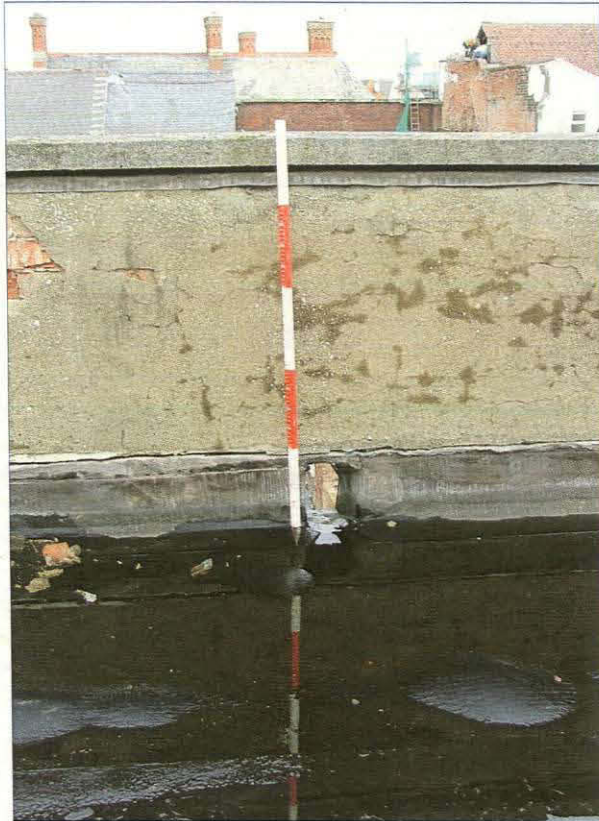
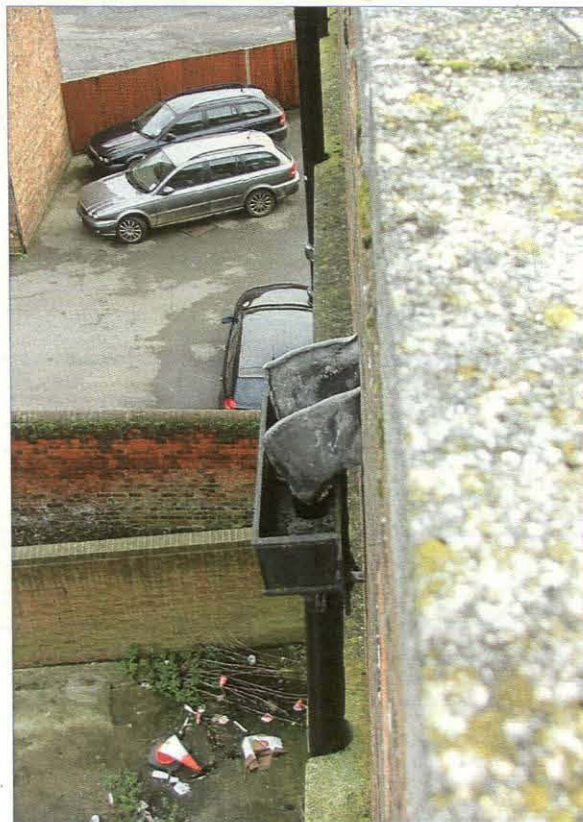
At the north-east end of the roof is a hole in the base of the parapet which allows water to drain from the roof into the rainwater hopper on the north-east elevation (Plates 55 and 56).

Plate 55. Detail of one of the drainage holes at the base of the parapet which allows water to drain into the hoppers

Plate 56. Detail of one of the rainwater hoppers as seen from the roof
