**BUILDING SURVEY OF
OUTBUILDING AT
MAIN ROAD/SCHOOL LANE
MAREHAM-LE-FEN
LINCOLNSHIRE
(MFMR05)**

Work Undertaken For
FieldView Homes

June 2005

A.P.S. Report No. **93/05**

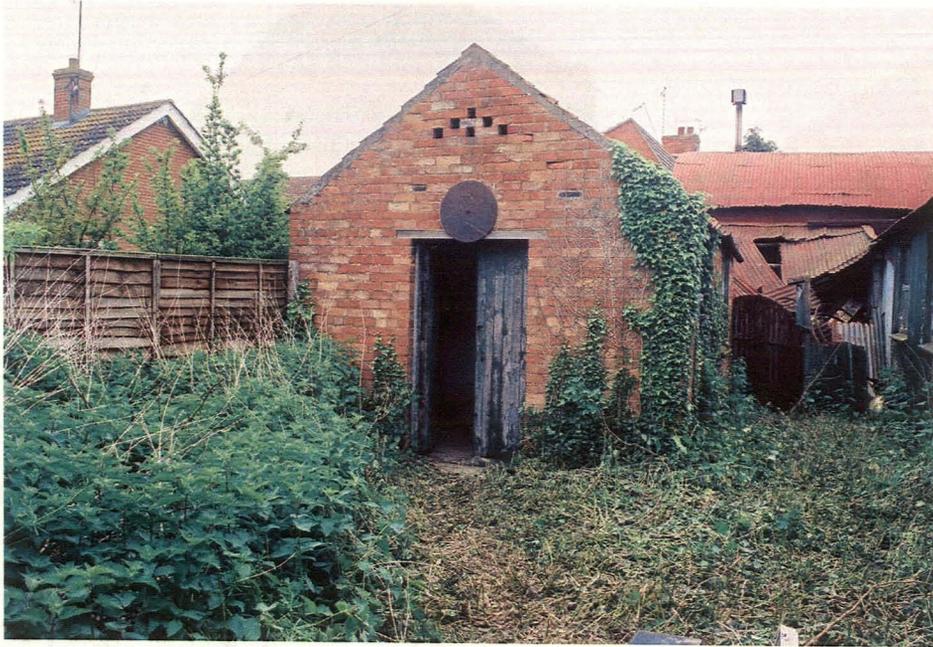
The recorded structure (Plates 1 and 2), lies within a complex of disused commercial units constructed of timber and corrugated iron (Plates 19 and 20).

Plate 1 WSW
elevation of recorded
structure, looking
ENE

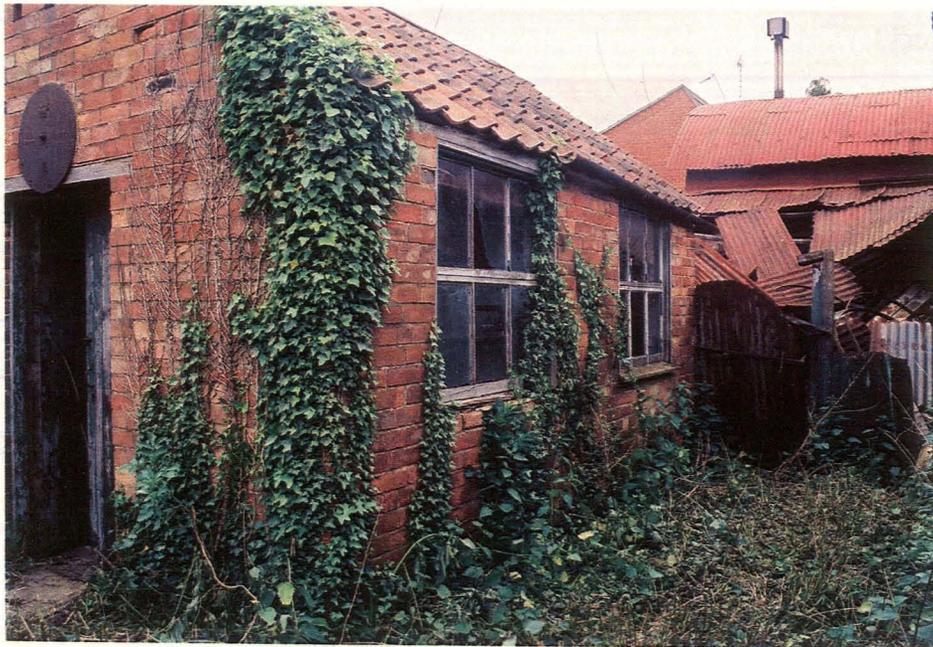
Seen in both the WSW and ENE gables is a triangular arrangement of missing bricks providing ventilation to the building (Plates 4 and 5). Natural light to the building is provided by two windows in the SSE elevation (Plate 2), fitted beneath the eaves line. The six light windows are encased in a timber frame split horizontally with the upper panels allowing for opening. Iron straps tie the window frames to the main brick structure. Faint signs of advertising etching 'AGENT FOR RALEIGH MOTORCYCLES' can be seen in the upper lights of both windows (Plate 7). Only one of the external wooden windowsills remains intact.

Plate 2 SSE elevation
of recorded structure,
looking ENE

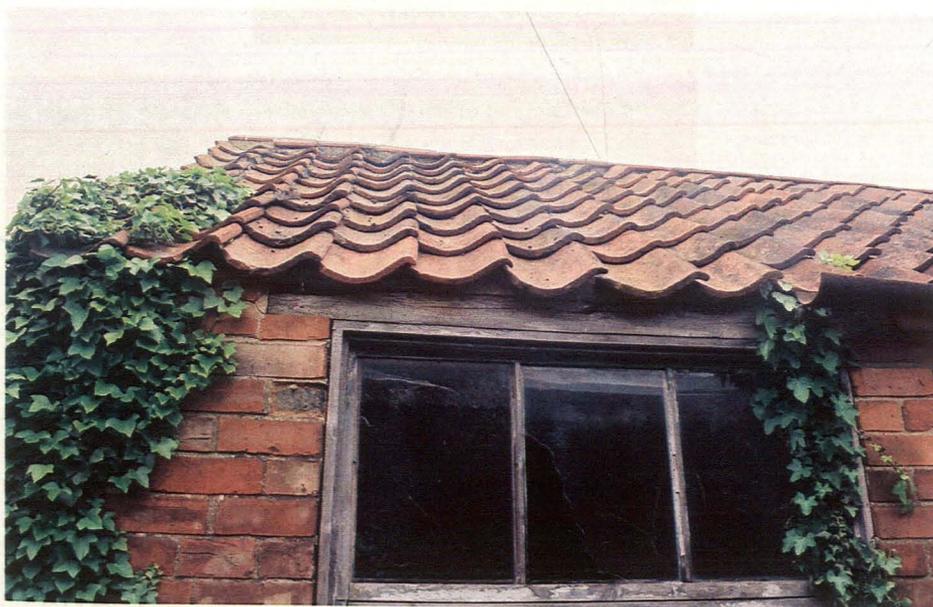
The building dated to the 1930s forms a small (4.77m x 3.89m) east northeast-west southwest aligned rectangular one-storey brick-built structure open to its pitched roof. The building is entirely constructed of machine made bricks in stretcher bond with a pantile roof (Plate 3). The building is tied and strengthened centrally through its longitudinal section by an iron tie bar, fitted with a circular iron plate seen in the WSW elevation (Plates 4 and 5). The pantile roof is supported by timber trusses with two main supporting beams (Plate 6).

Plate 3 Detail of
pantile roof, looking
NNW

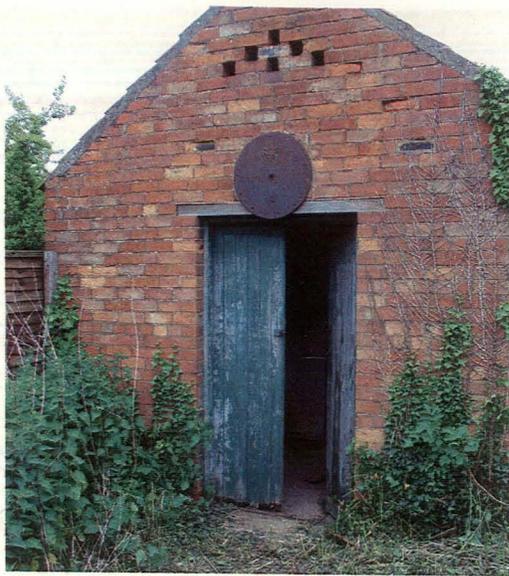
The building is provided with only one access, which is through the double timber barn door centrally placed in the WSW

elevation, with a wooden lintel (Plate 4). The door opens into what was originally constructed as a single celled building. A timber wall with a central open doorway has later been inserted to divide the structure into two small rooms.

Plate 4 WSW elevation showing wooden door, ventilation gaps and Tie Bar Plate, looking ENE

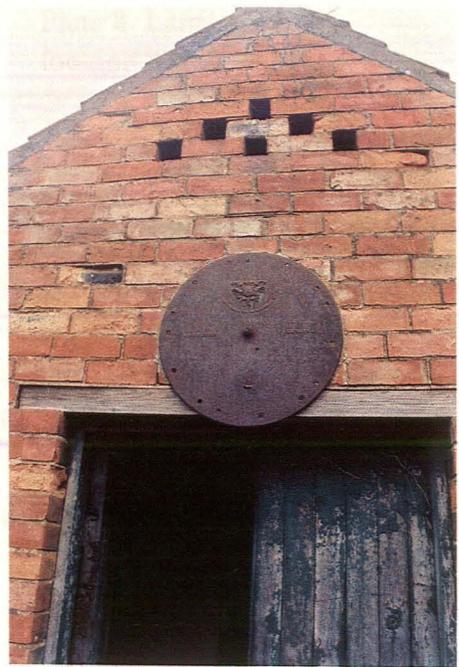
The small building, which no doubt would have produced much heat and fumes from the generators, is ventilated by gaps in the brickwork in both gable ends and the two windows in the SSE elevation.

Plate 5 Detail of ventilation gaps and Tie Bar Plate, looking ENE

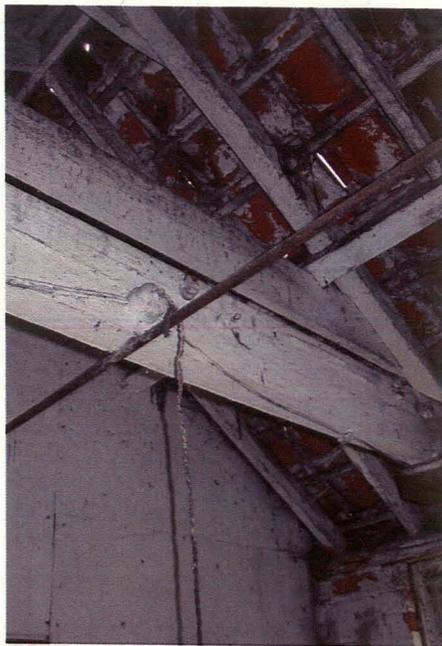
Plate 6 Roof trusses and the beam

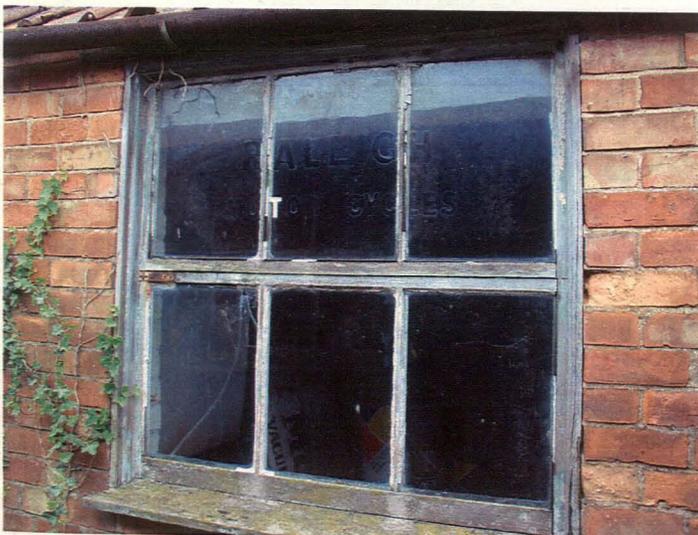
Plate 7 Detail of wooden framed windows, looking SSE

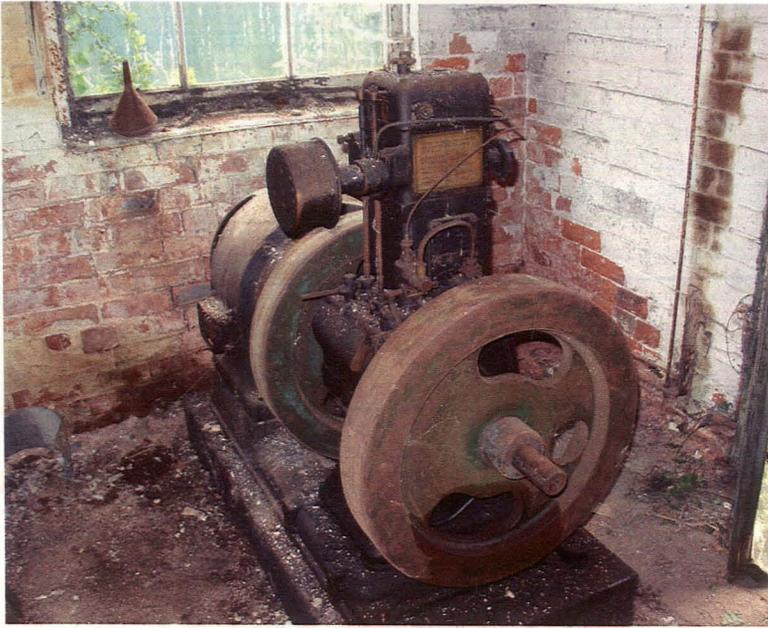
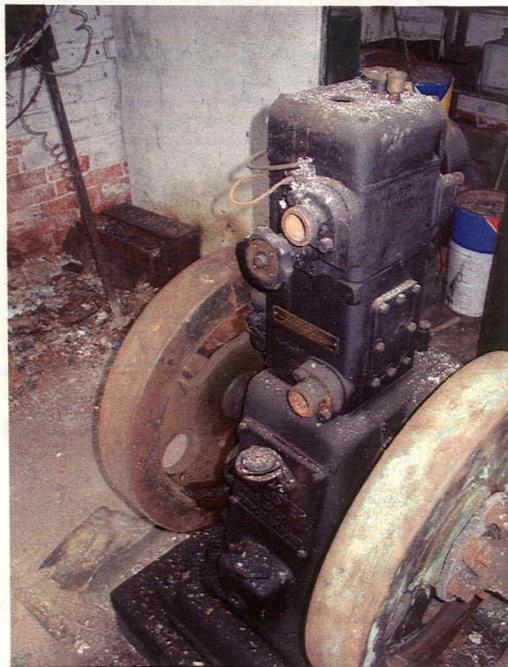
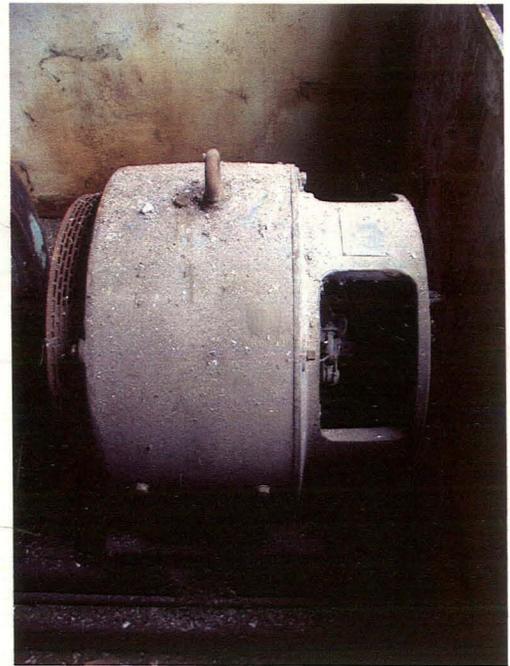
The WSW room is fitted with a number of industrial fixtures. A large fixed engine generator (Plates 8-10) bearing the trademark.

'P.A. LISTER & CO LTD DURSLEY
ENGLAND
BRITISH PATENT 322097'

was recorded situated on a concrete plinth in the southern half of the room. Overhead located in the southwestern corner of the room was a second smaller generator (Plate 12) supported by iron girders at eaves height (Plate 13). The drive belts are not present on either generator.

The larger generator is mounted on a concrete plinth and fills up a great deal of space in the front room. The generator bears the patent NO. 322097 and was made by P.A. LISTER & CO LTD DURSLEY ENGLAND. It appears to be in good condition although the drive belt are missing. Also, there are no indications as to what the drive belts would have powered. Prior to demolition the generator is to be removed from the site for restoration work, to repair it to full working order.

Plate 8 Large generator,
looking SW

Plate 9 Front
section of
large
generator,
looking NE

Plate 10 Rear section of
large generator, looking
ENE

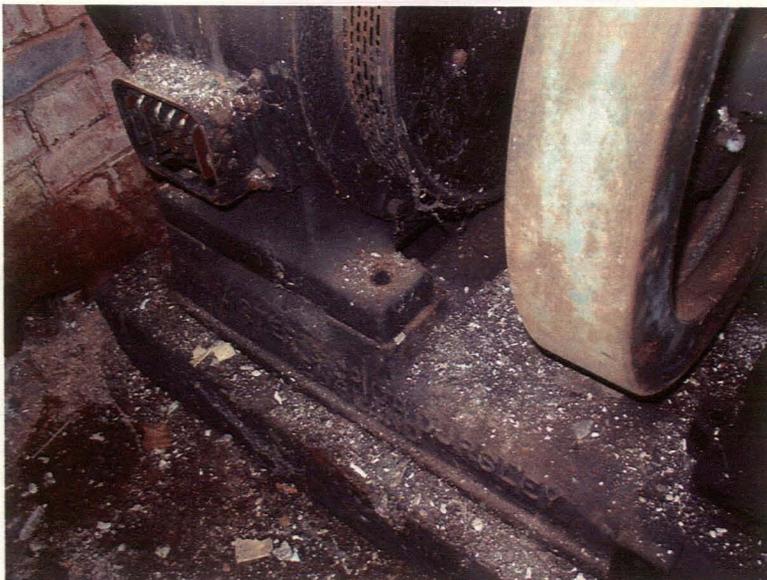
Plate 11 Embossed
trademark at base of large
generator, looking SW

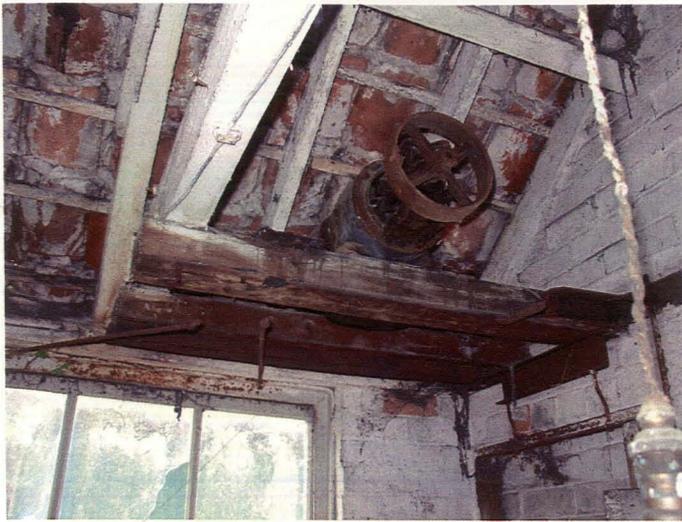
A smaller generator is positioned at eaves height on two girders, however, due to its inaccessible location no trademarks were noted. As with the two generators, the fuseboard and junction box is in a good state of repair, with all the ceramic fuses and gauges remaining intact. The disconnected wiring to the fuse board still remains wrapped around the board.

Plate 12 Overhead smaller generator supported by girders

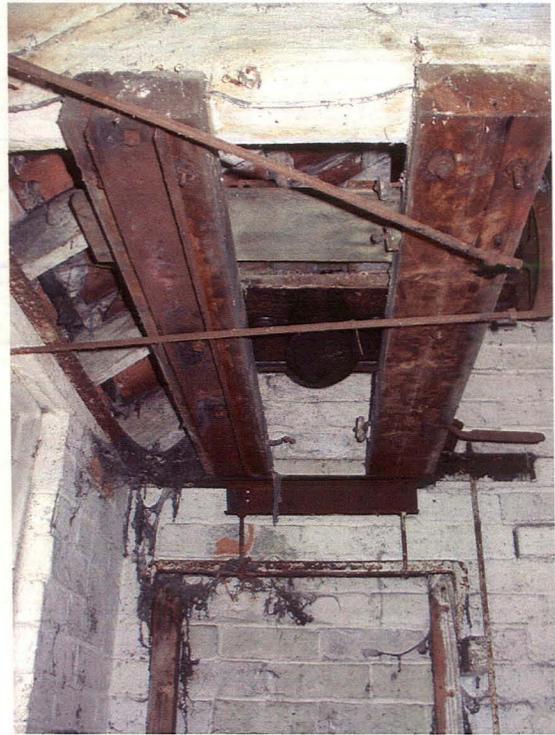
Plate 13 Girder supports for overhead generator, looking SW

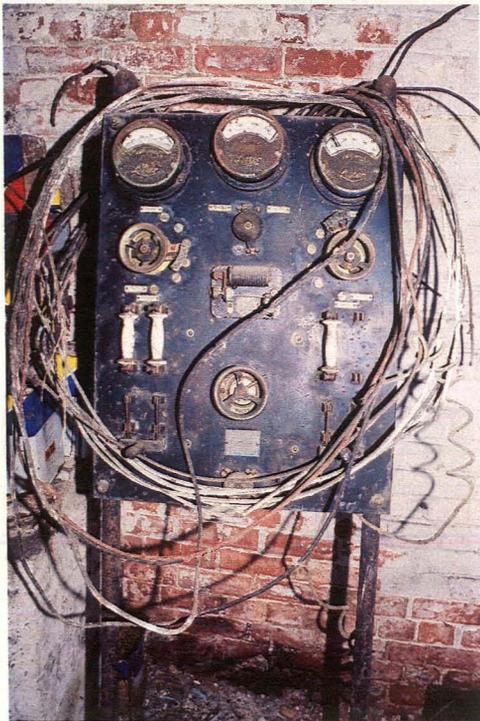
Fitted into the western corner of the room was a brick built plinth, standing 1.30m high (Plate 15). This would have originally supported a water-cooling tank. Adjacent to this and fitted both to the wall at its top and the concrete floor at its base was a fuse board/junction box (Plate 14). The board was fitted with three ceramic fuses along with various pressure gauges and dials.

Plate 14 Fuse board and Junction box, looking NNW

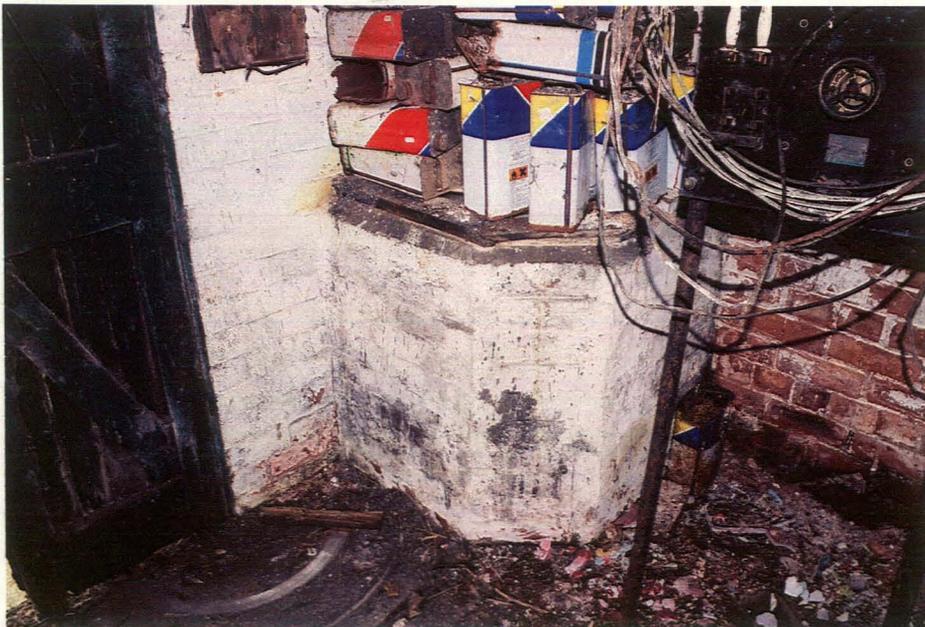
Plate 15 Brick plinth (water tank stand), looking SW

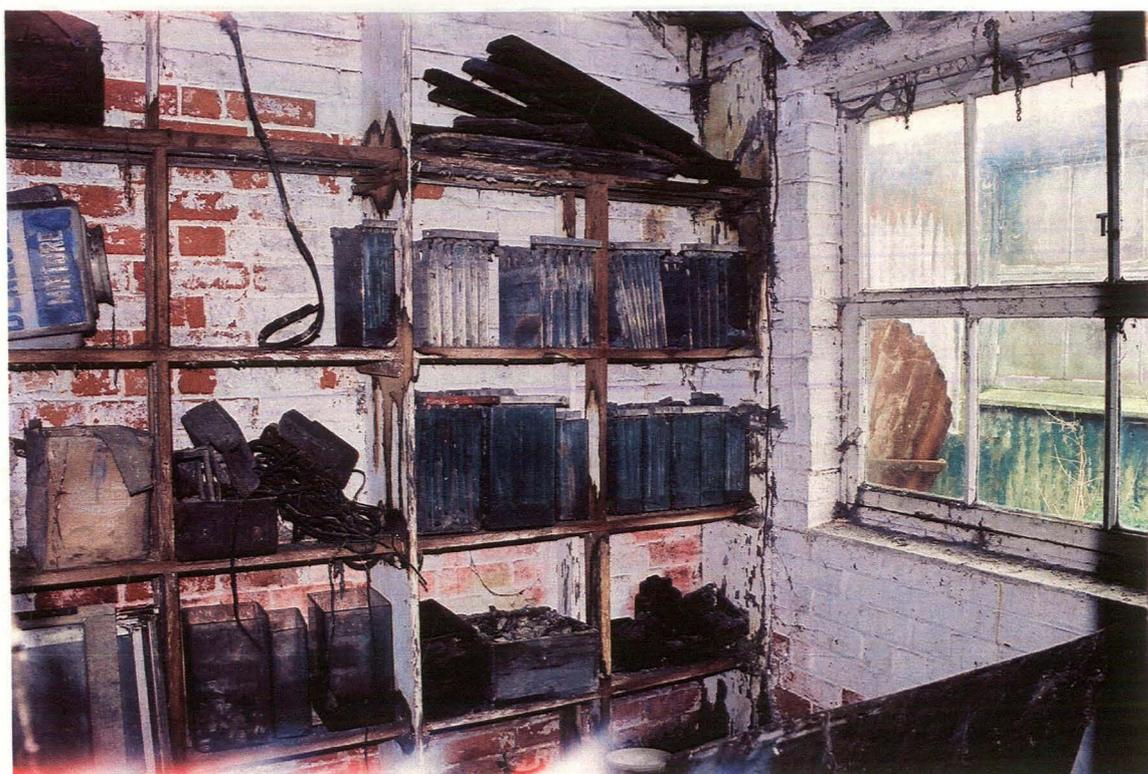
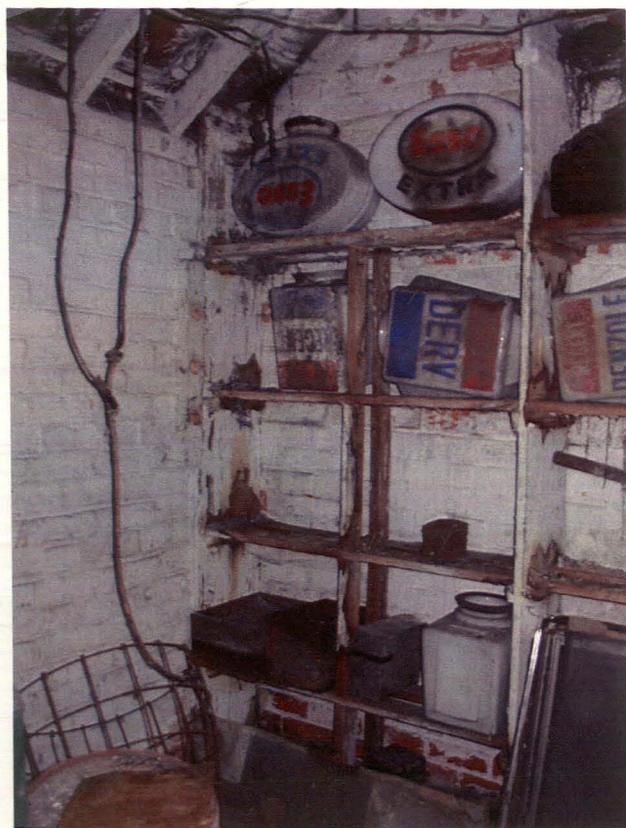
The second cell, to the rear of the structure was fitted with compartmental shelving (6 x 5 bays) across the back wall (Plates 16 and 17). These appear to have been used for the storage of batteries. The room at present forms a storage area for carboys, used oil drums and battery parts (Plate 18).

Plate 16 Shelving on back wall, looking East

Plate 17 Shelving on back wall,
looking NE

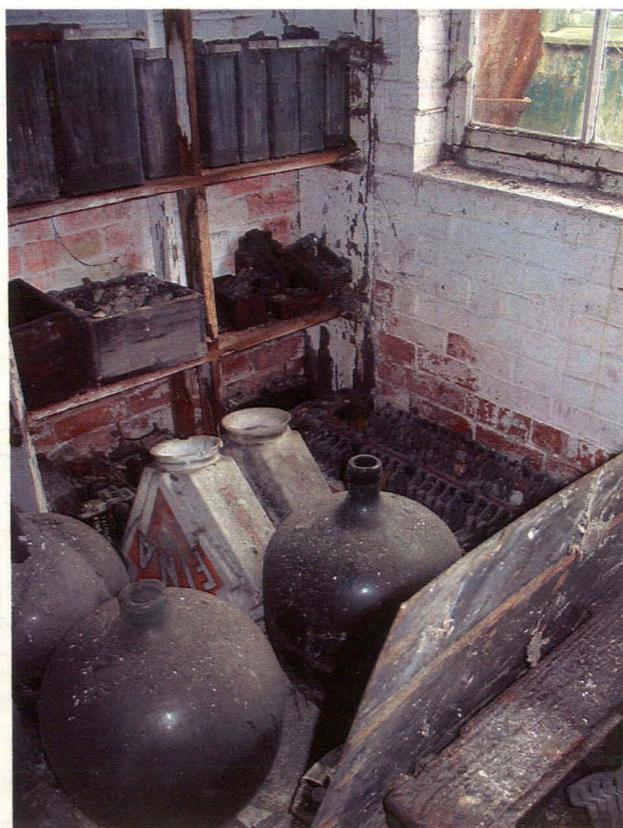
A large number of carboys and battery parts were identified in the rear room. It is likely that these carboys contained acid (for the batteries), given the site's former use as a garage. The shelving along the back wall no doubt formed a useful storage place for charged and uncharged batteries brought to the site.

Plate 18 Carboys stored in rear room,
looking East

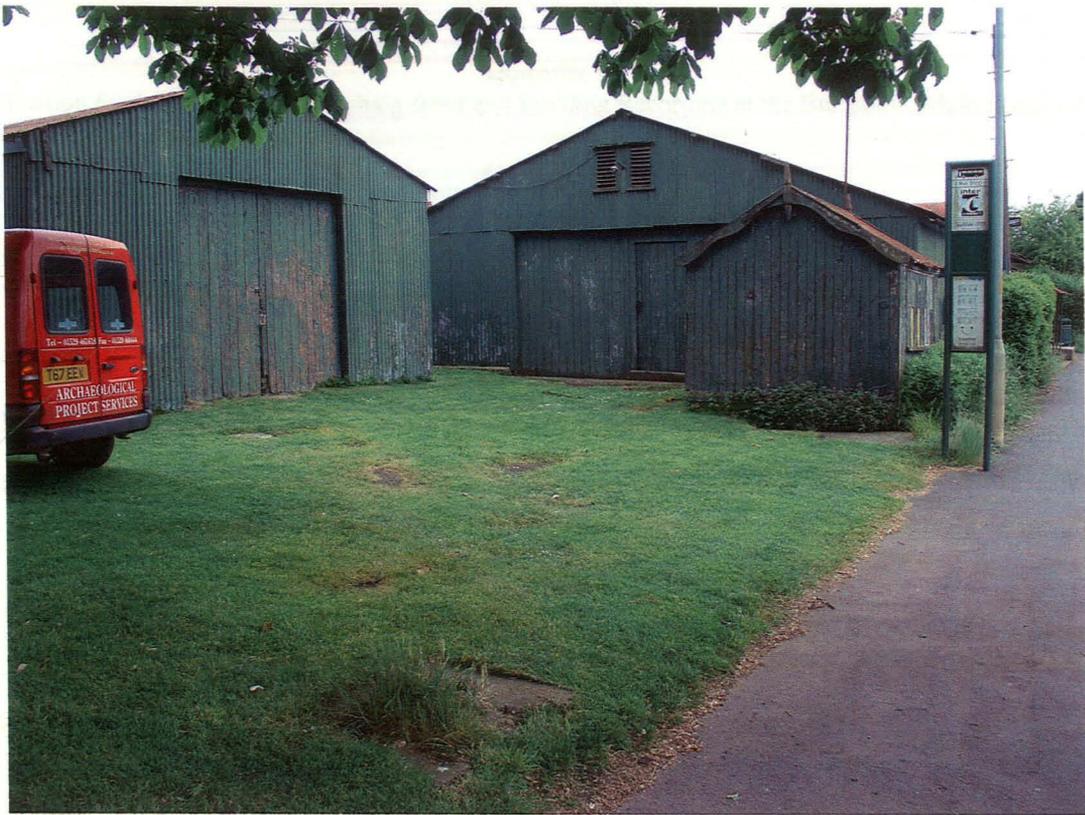
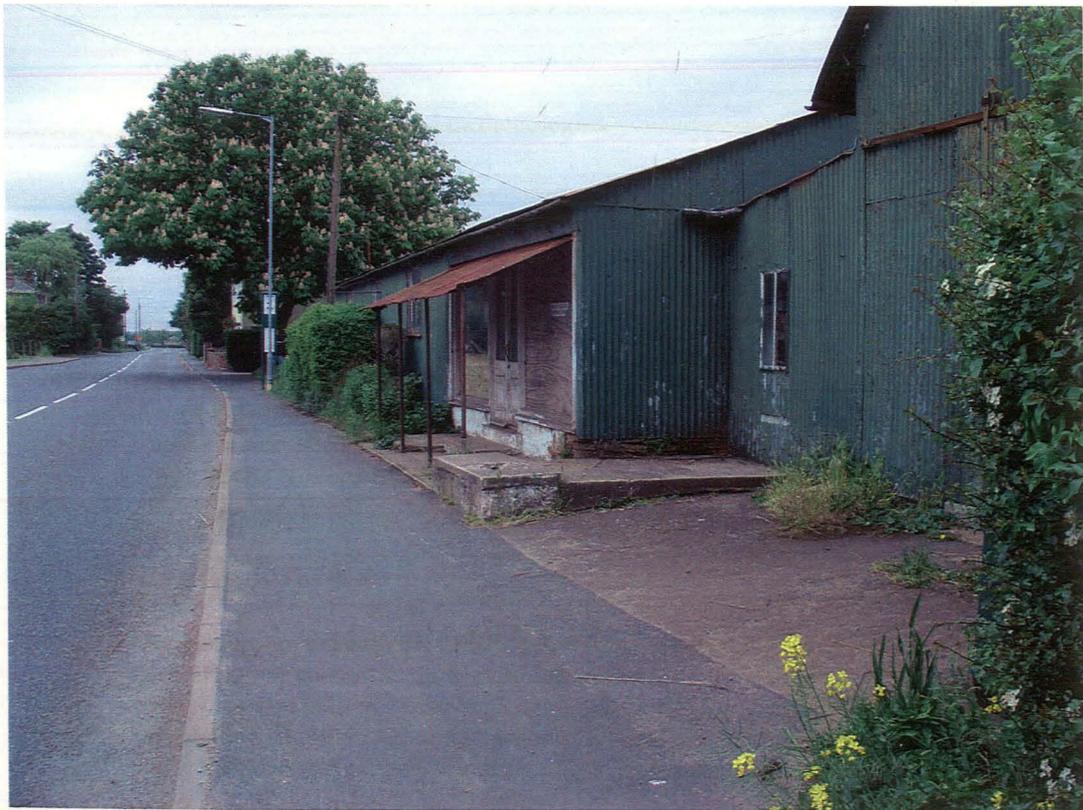
residential development at the site. The building is unique within the group being the only brick and pantile structure on the site, with the other structures being of timber and corrugated iron. The building, believed to date to the 1930s, is concealed by the later timber and corrugated iron structures (Plates 19 and 20) and is not visible from either School Lane or Main Road.

Plate 19 Garage buildings in front of recorded structure, looking NE

Plate 20 Street frontage of garage buildings in front of recorded structure, looking SW
