**STATION ROAD, DONINGTON,
LINCOLNSHIRE
STANDING BUILDING
PHOTOGRAPHIC SURVEY**

SITE CODE: SRD05
NGR: TF 20725 35550
ACC. NO. 2005.44

Report prepared for Chrysalis Homes

February 2005

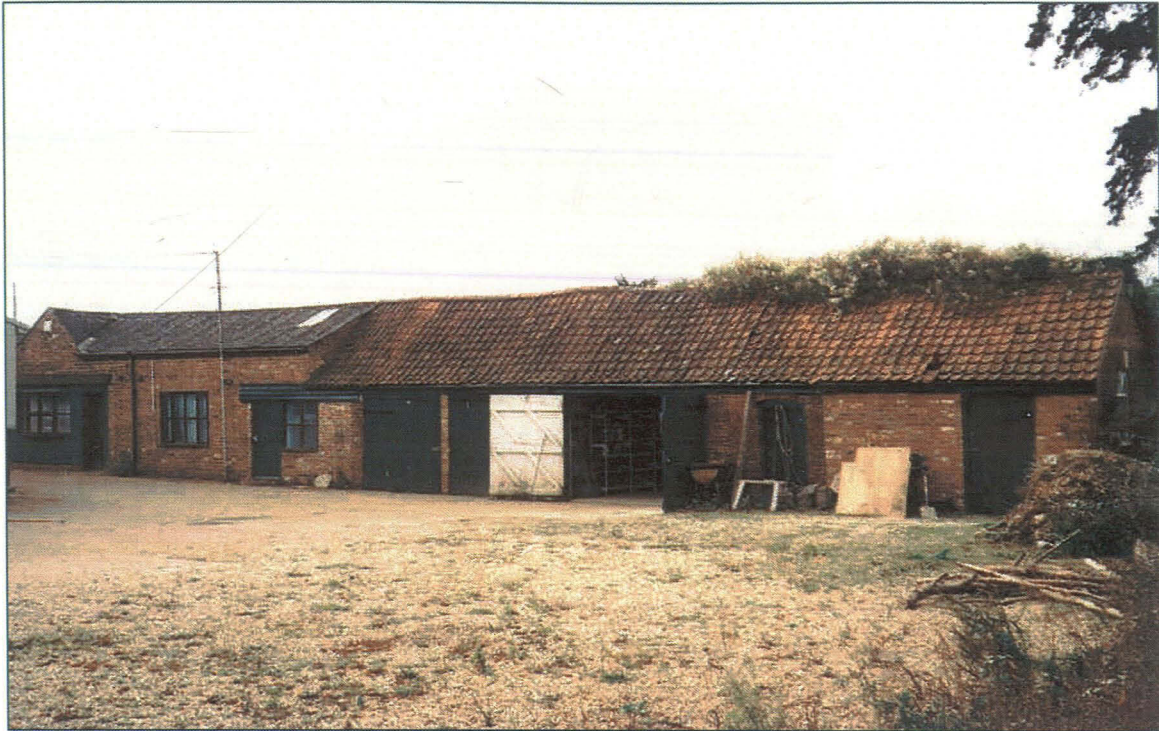
Pl. 1: General view of the buildings looking west-south-west. Taken prior to commencement of groundworks on the site (J. Bonnor, LCC)

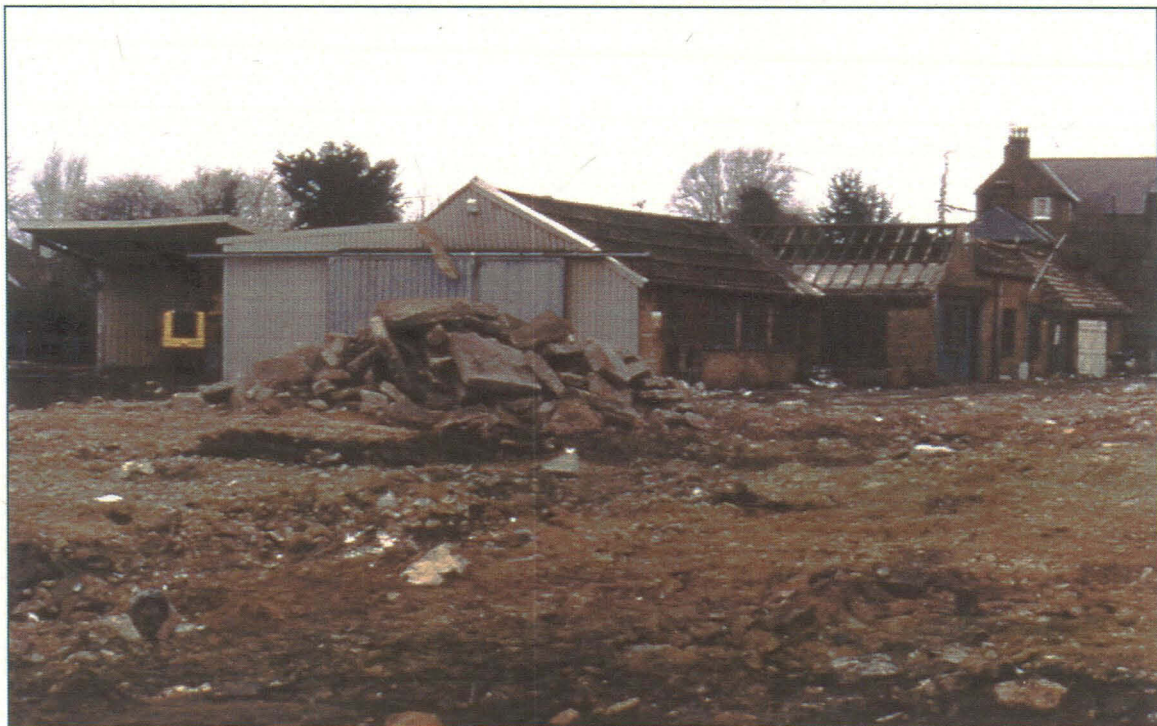
Pl. 2: General view of the south end of the buildings, looking north-west.

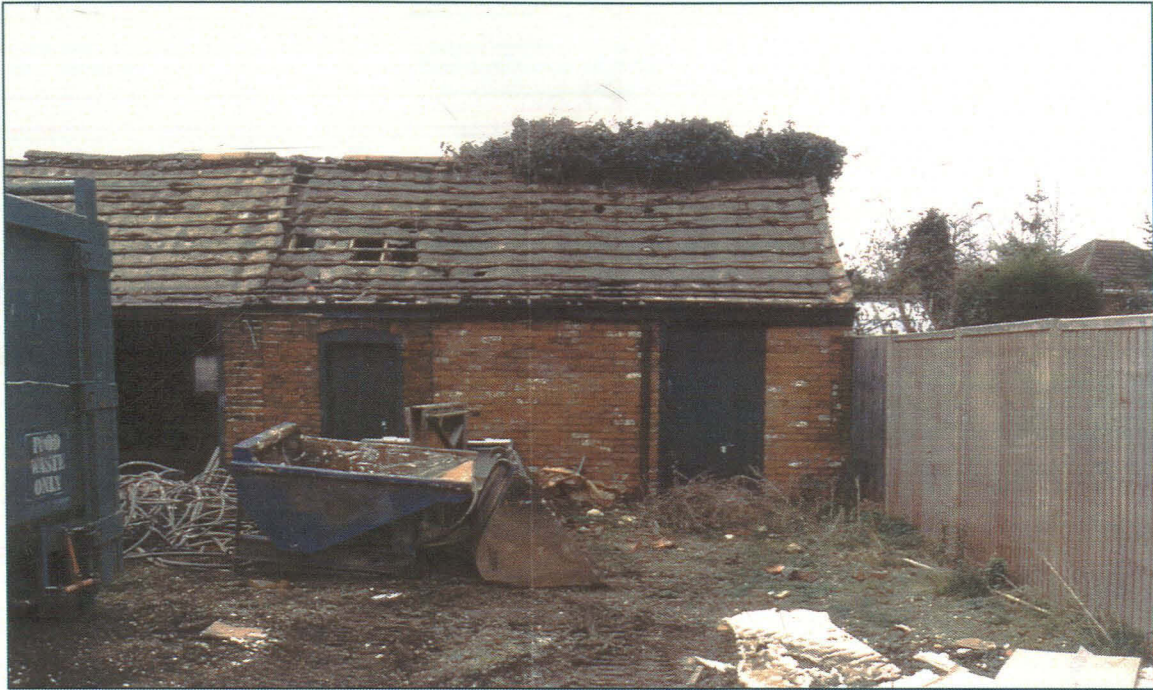
Room A: The room measures 3.6m east to west and 2.9m north to south and is whitewashed throughout (pl. 4). Access is by a wooden door on the east side (pl. 3). A single window illuminates the room from the north. Both the door and the window appear to be original features. The window is in a rounded arch with a decorative trefoil feature in the upper part of the window (pl. 5). This window may have been decorated as such given that it looks northwards towards Holmfield House and Station Road. It may also suggest that this room was originally used by the works foreman/manager as an office. The south wall of the room was a recent timber and plywood partition wall, with a doorway into Room B. The flooring consists of dark grey engineering bricks, which continued beyond the wooden partition.

Room B: This room measures 3.1m north to south, with a maximum dimension of 5m east to west. Access is by a door on the east side of the room (pl. 3). The west wall of the room exhibits a dog-leg to the west. At this point, it could be observed that the original wall running east to west between Rooms A & B had been demolished (pl. 7). To the south of this, the ground surface steps down by c.150mm, with dark grey engineering bricks to the north and a concrete floor to the south. Externally, it is possible to observe a phase of rebuilding of the eastern wall, extending southwards from the point at which it was formerly abutted by the demolished wall, to the south-west corner of the room (pl. 3). This phase of rebuilding and the demolition of the internal wall may have been contemporary, although the reasoning is unclear. Map evidence suggests that several additional structures which abutted this end of the building have since been demolished (see 7.0 below).

Pl. 3: Exterior view of Rooms A & B, looking west. Note area of rebuilding around the door of Room B. Note also that the roof tiles have been removed (compare to fig. 1)

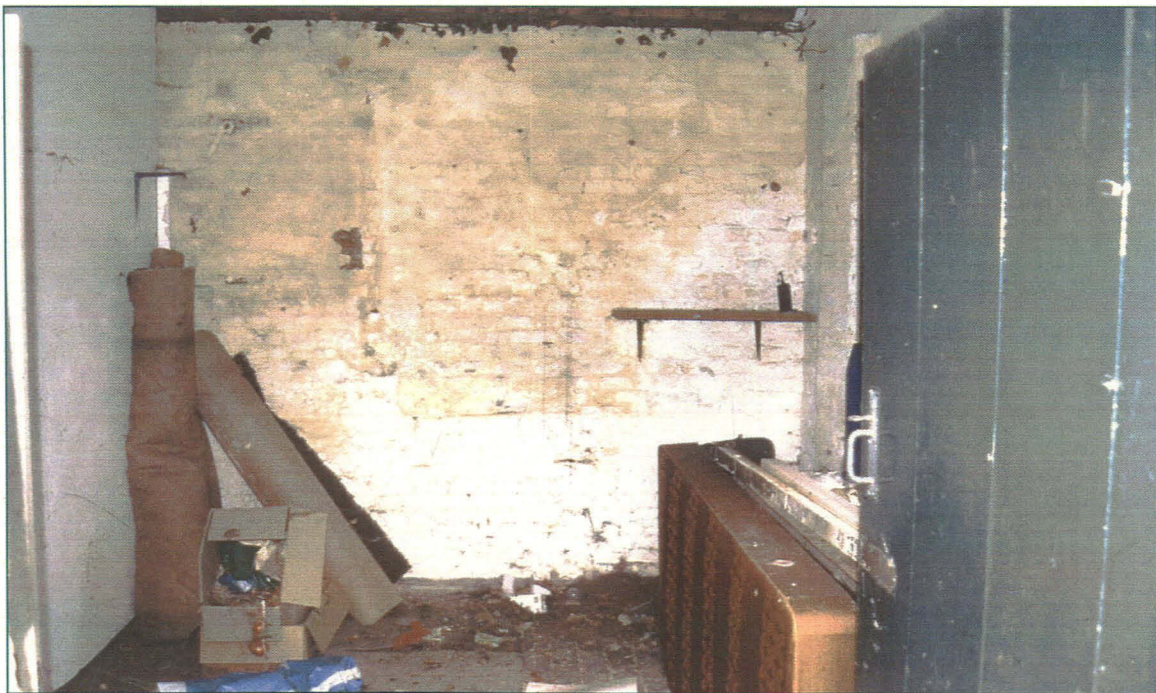
Pl. 4: Interior view of Room A, looking west

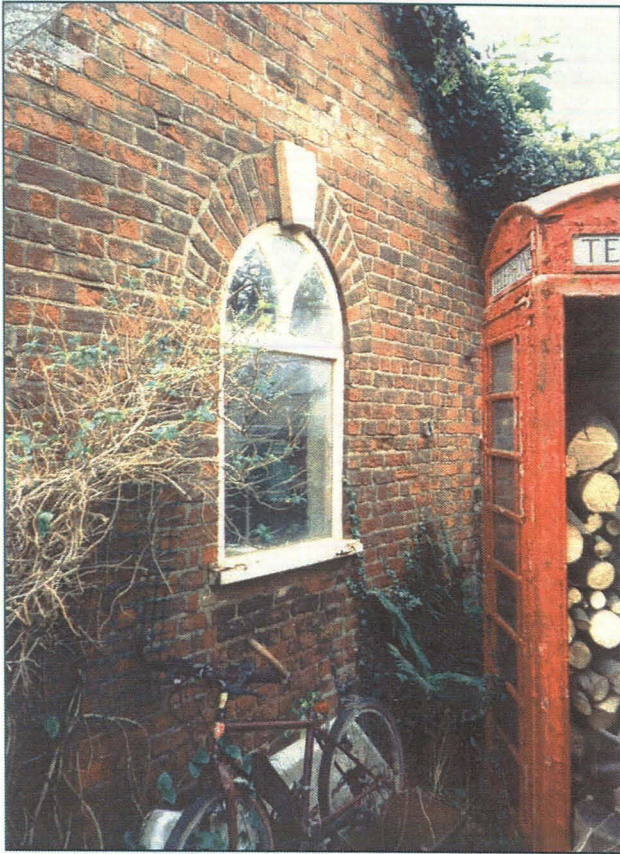
Pl. 5: External view of decorative window in north wall of Room A, looking south-west (J. Bonnor, LCC).

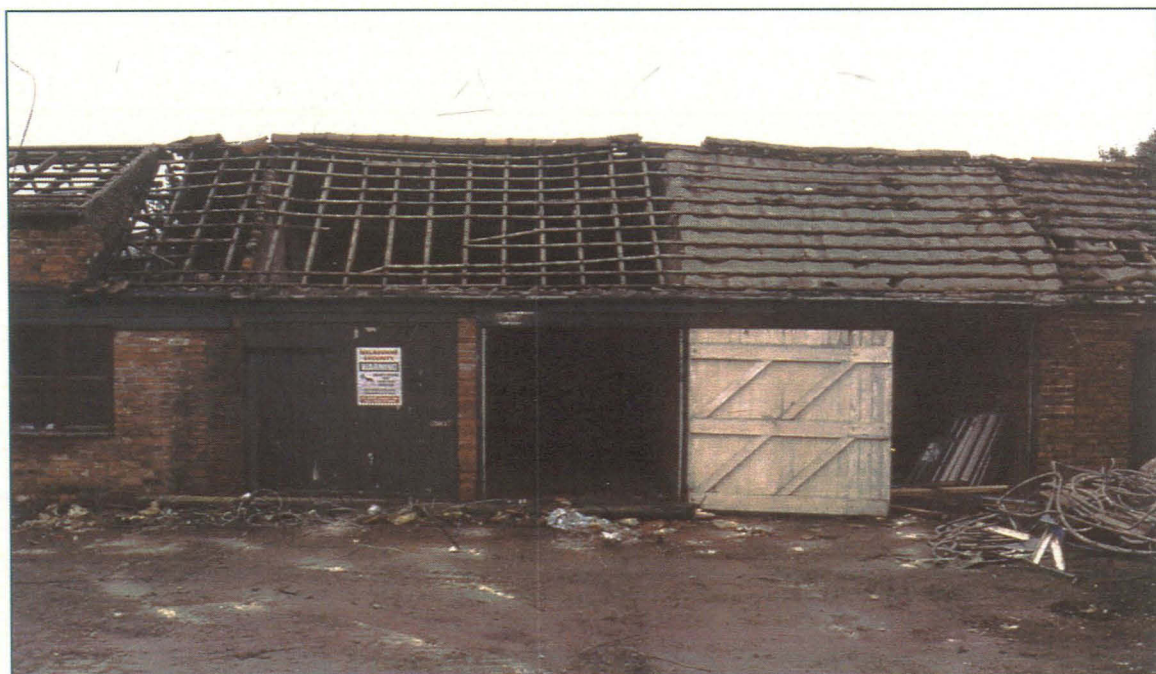
Room C: The room measures 3.7m north to south and 4.7m east to west, and is accessed by a large barn door on its east side (**pl. 8**). A small arched recess was observed near the door in the north wall of the room (**pl. 9**). This appears to be an original feature, but its function is unclear. The whitewashing of the brickwork made it unclear whether the original feature allowed access to Room B or it was originally blocked up. It is possible that it was a hatch allowing the passage of materials between the two rooms.

Room D: Room D measures 4.9m north to south by 3.8m east to west. Two large barn doors take up almost the entire east frontage of the room (**pl. 8**). They are separated by a modern brick pillar, which suggests that the room may originally have been divided into two. However, a concrete floor has replaced the original, and no evidence of a former wall was observed in the west wall of the room (so this hypothesis is far from certain).

Pl. 8: Exterior view of Rooms C & D, looking west. Note the modern window and brickwork of Room E to the left of the shot

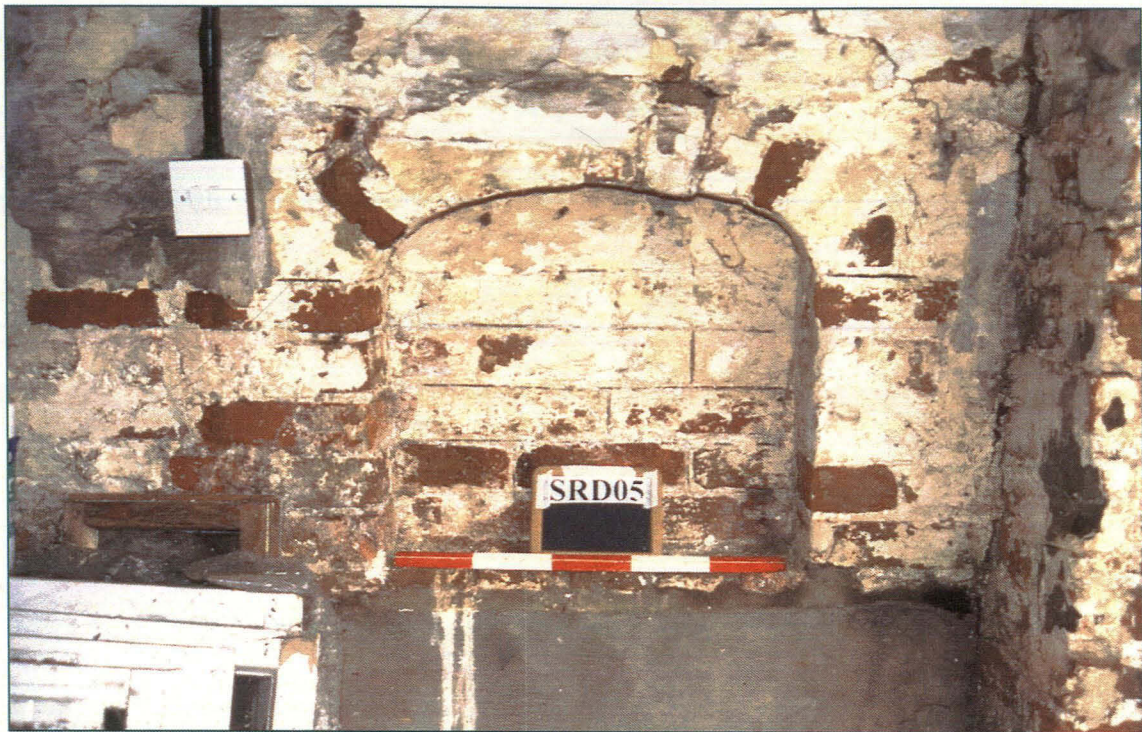
Pl. 9: Arched recess in north wall of Room C. Looking north.

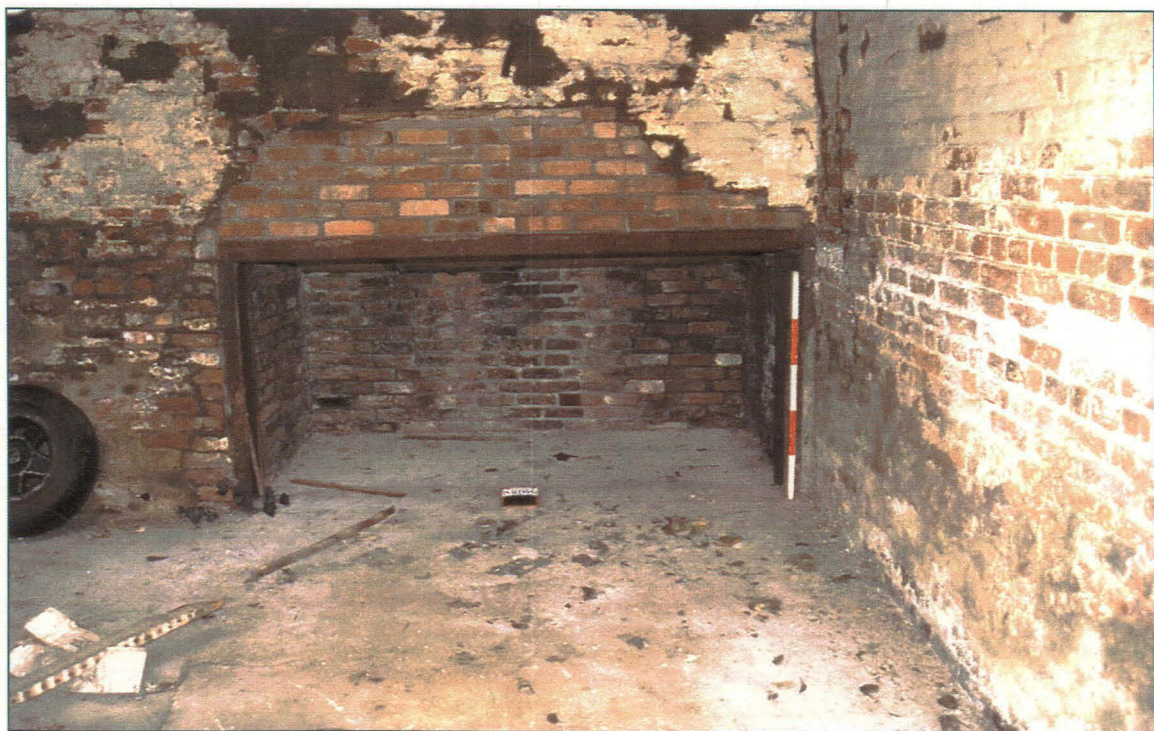
In the north-west corner of the room, an apparently original recess was observed, measuring approximately 2.5m wide by 1m high and 1m deep (**pl. 10**). It is not clear what function this feature served in the original building. It may have been used for loading goods into the room, although it backs onto the gardens of Holmfield House. Whether the owner of these buildings and Holmfield House was the same is unknown, but there is no boundary between the two properties depicted on early maps (figs. 4 & 5), which would suggest that this may be the case.

Pl. 10: Possible loading bay in west wall of Room D, looking west

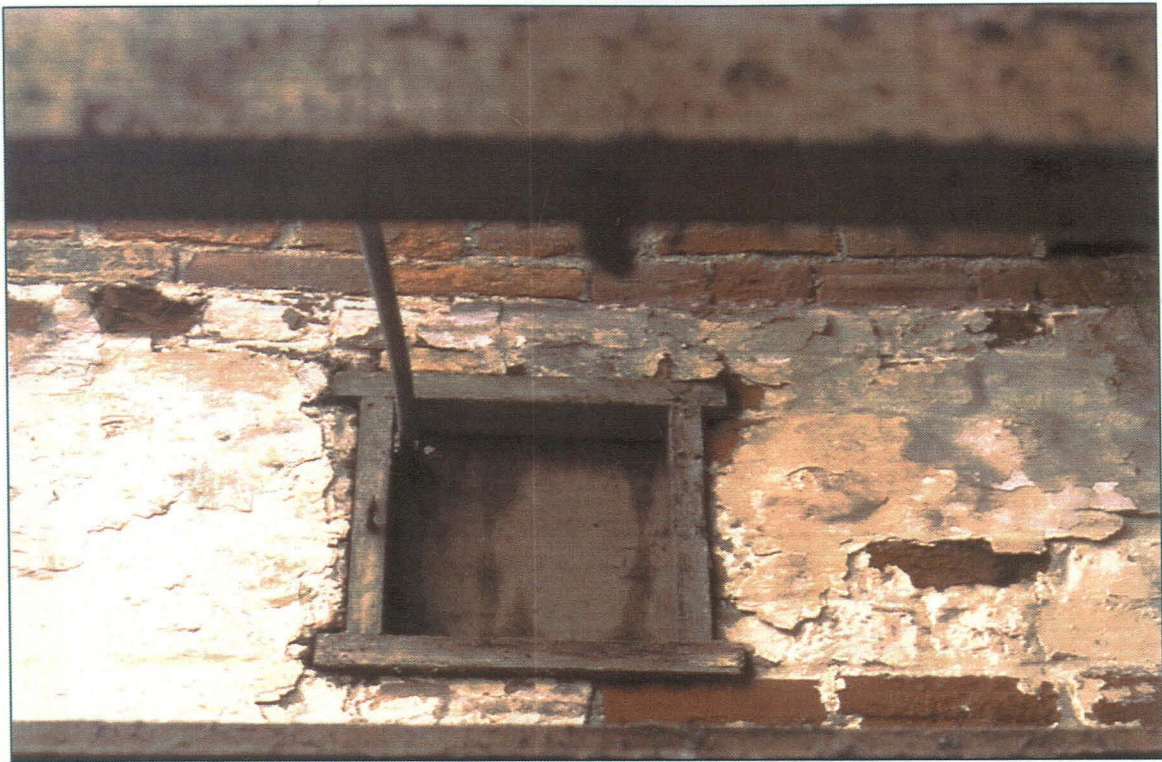
In the gable of the south wall, a small wooden hatch was observed (**pl. 11**). It is possible that this was used as a ventilation hatch to allow air into the loft area, to prevent spoiling of stored perishable goods.

Pl. 11: Possible ventilation hatch in upper south wall of Room D. Looking south

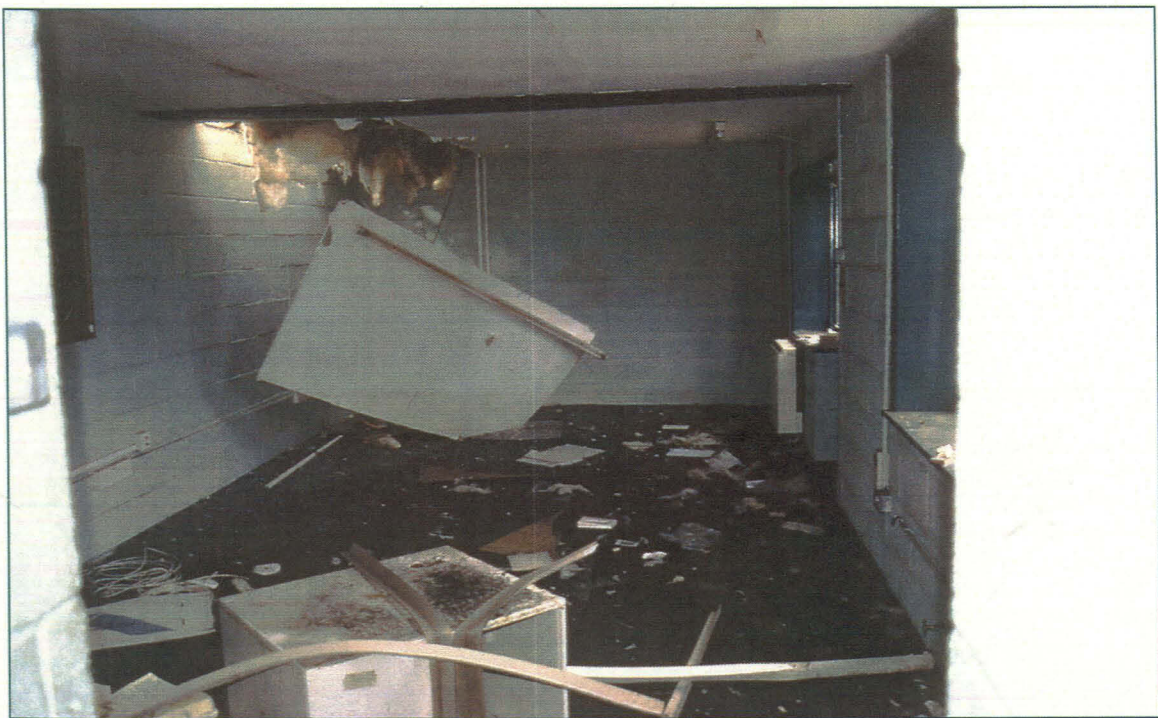
Room E: The interior of the room measures 7.5m north to south and 3.5m east to west. The original brickwork has been maintained on the exterior, although an internal breezeblock wall has been built on all four sides of the room, and a suspended ceiling has been built, with overlying asbestos insulation (**pl. 12**). Probably associated with this redevelopment, two windows and a door were built into the east wall of the room. This redevelopment was undoubtedly for the use of the room as offices of the Grundy Engineering Works, which until recently occupied the site.

Pl. 12: Room E, showing breeze block rebuilding and suspended ceiling. Looking north.

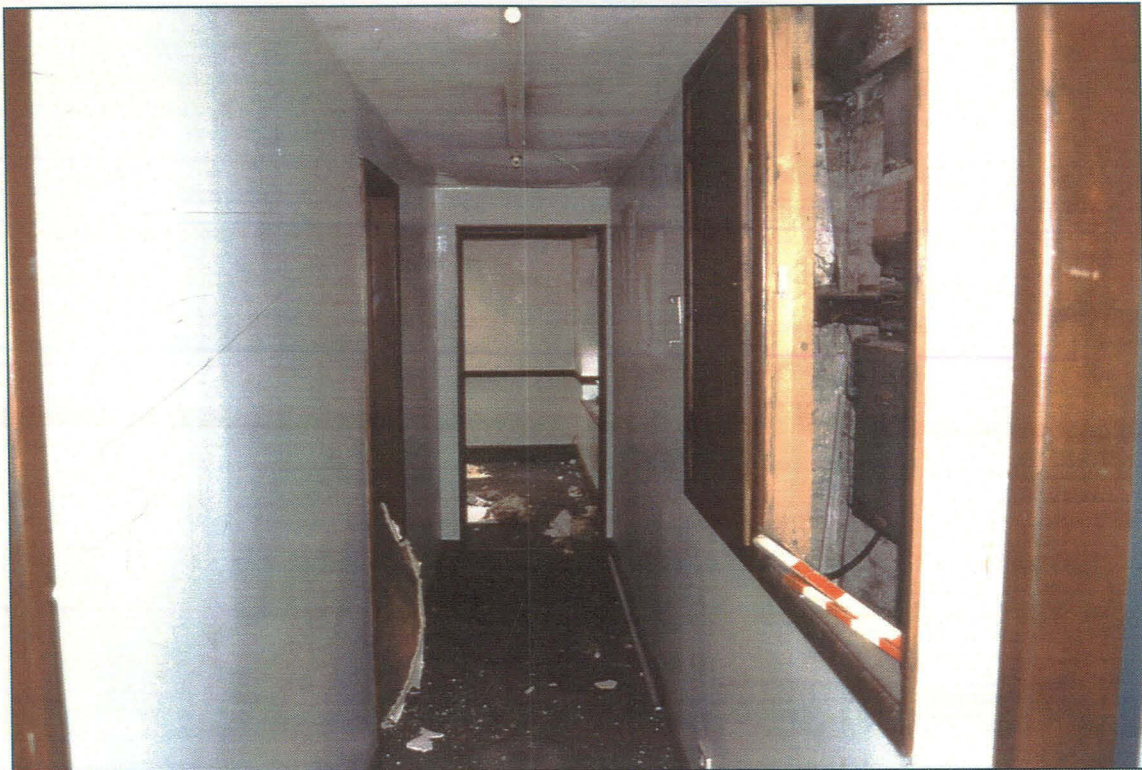
To the immediate south of Room E, a corridor extends east to west, with a door at its east end. In the north side of the corridor, a recess has been built to house fuse boxes and

electricity meters for the offices. In this recess it was possible to observe the line of the east – west and north – south walls of the original building (**pl. 13**).

Pl. 13: Corridor to Room H, looking west. The original wall is visible in the fuse box to the right.

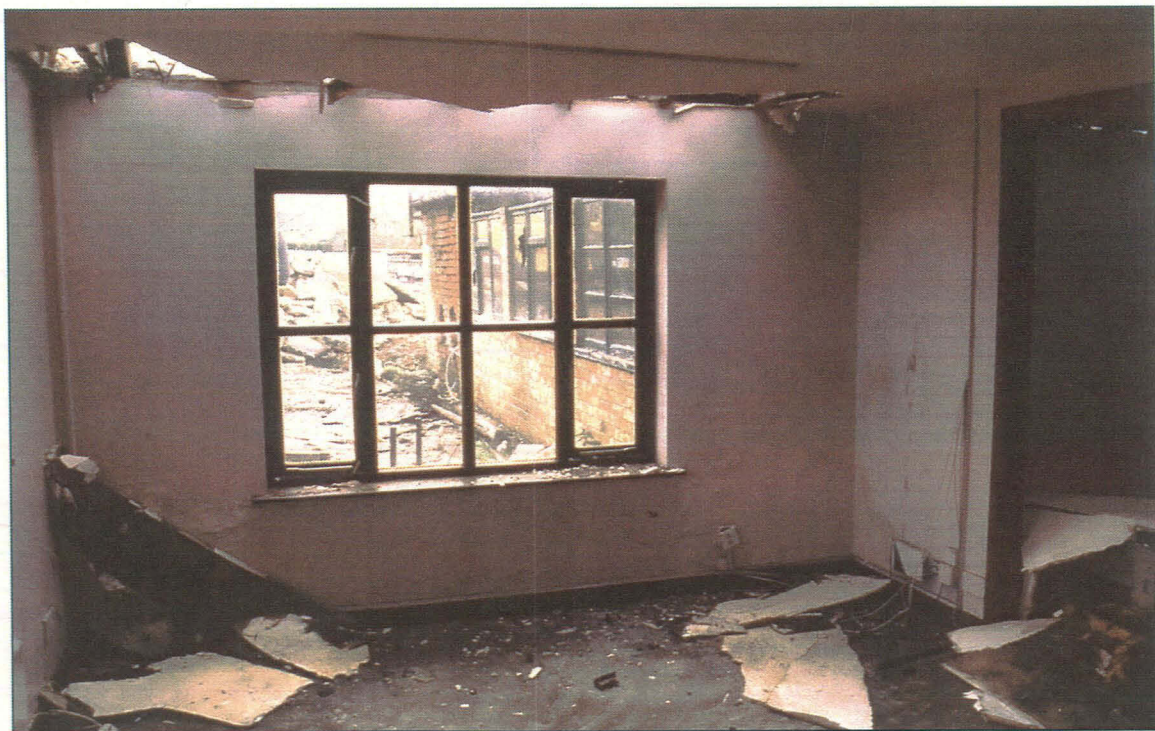
Room F: This room is accessed via a doorway extending off the east – west corridor. It has two modern windows; an east facing bay window and a second window facing south (**pl. 14**). The room is 3.3m square. The east and south external walls are also a modern rebuild, while the north and west walls are dry-lined. A large door in the west wall allows access to Room G (**pl. 15**).

Pl. 14: Room F, looking east-south-east

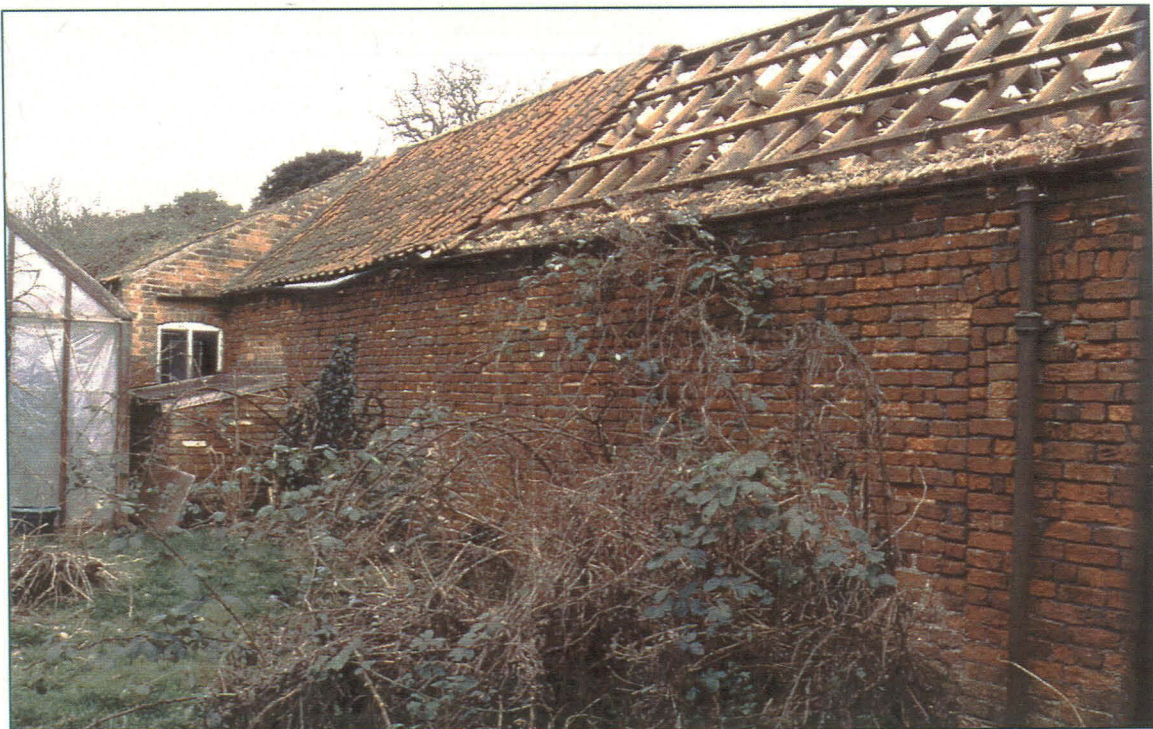
A breezeblock wall extends along the west side of the room, although the original brickwork survives on the exterior of this wall. A window has been inserted into the centre of this wall. Another small window was observed in the south-west corner of the room, looking south (**pl. 16**). This also appears to be a later insertion.

Examination of the west external wall of Room E revealed an original doorway with a blocked segmental arch. The brickwork used to block this door was identical to the surrounding brickwork, and in the same bond, suggesting that it may have been blocked relatively soon after its construction (**pls. 16, 17**).

Room H: Room H is accessed by a door at the west end of the corridor. The room is 4.6m north to south by 3.1m east to west. Again, all four walls are dry-lined, within the framework of the original brick walls on the west and north, with a breezeblock replacement to the south. A window looks north along the west wall of the building (**pl. 16**).

Pl. 16: View along western exterior wall, looking north. Note the hatch in Room D, and the blocked doorway at the extreme right of the shot

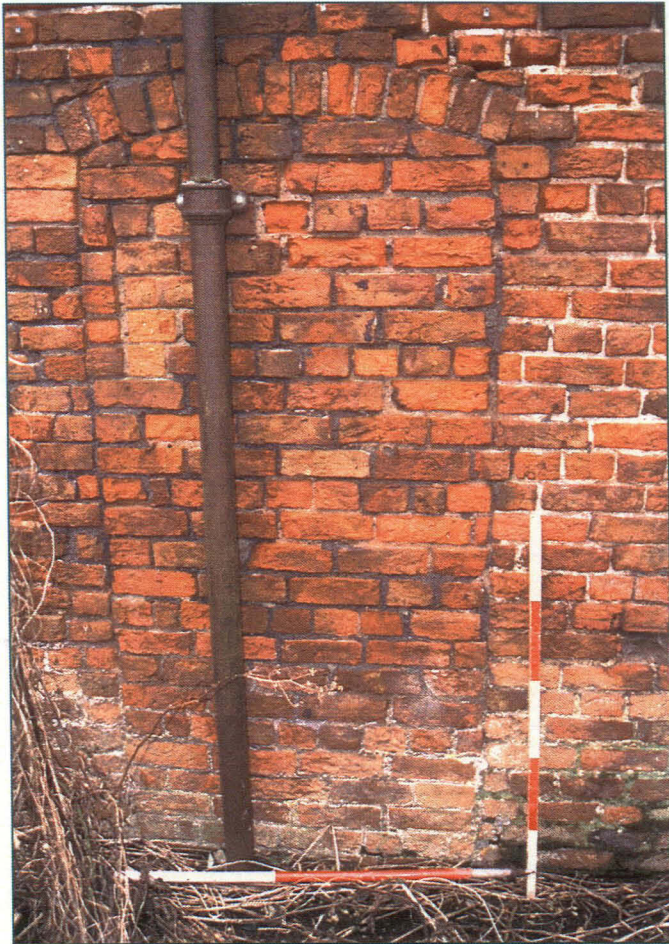
Pl. 17: Detailed view of blocked doorway in exterior of Room E. Looking east.

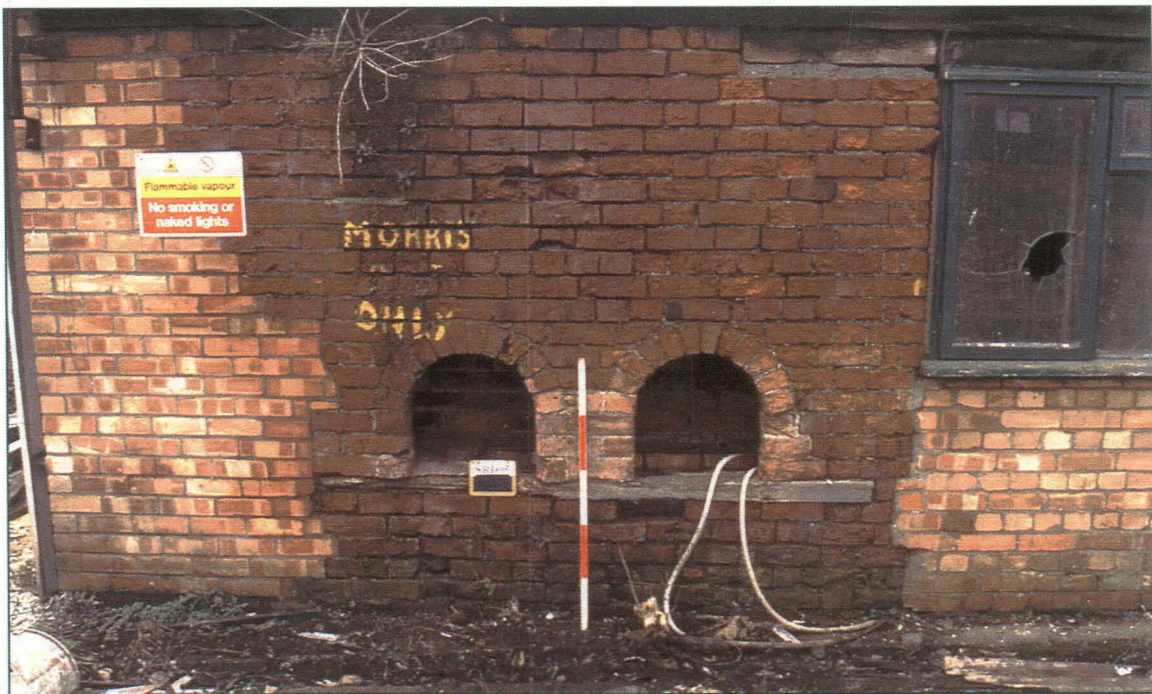
The east face of the room reveals one area of probable original brickwork, exhibiting two small arched features, with brickwork to their rear and a wooden sill (**pl. 18, 19**). Inside the arches, the recess is blocked to the left and right, with a corbelled roof, three courses high over the top of the aperture. The function of these features is unclear. However, a shallow drain ran along the frontage of Room I, suggesting that the arches were not originally blocked up and were used to expel waste from inside the room.

Pl. 18: Arched recesses in exterior wall of Room I. Looking west.

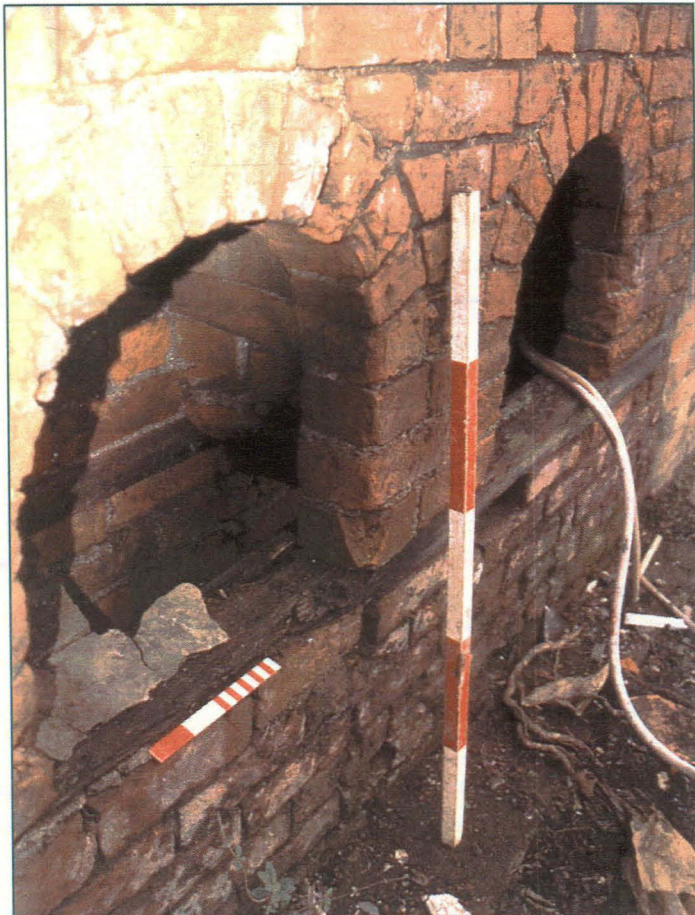
Pl. 19: Detailed view of arches. Note the interior corbelling of the structures and the gap allowing access between the two arches. Looking north-west

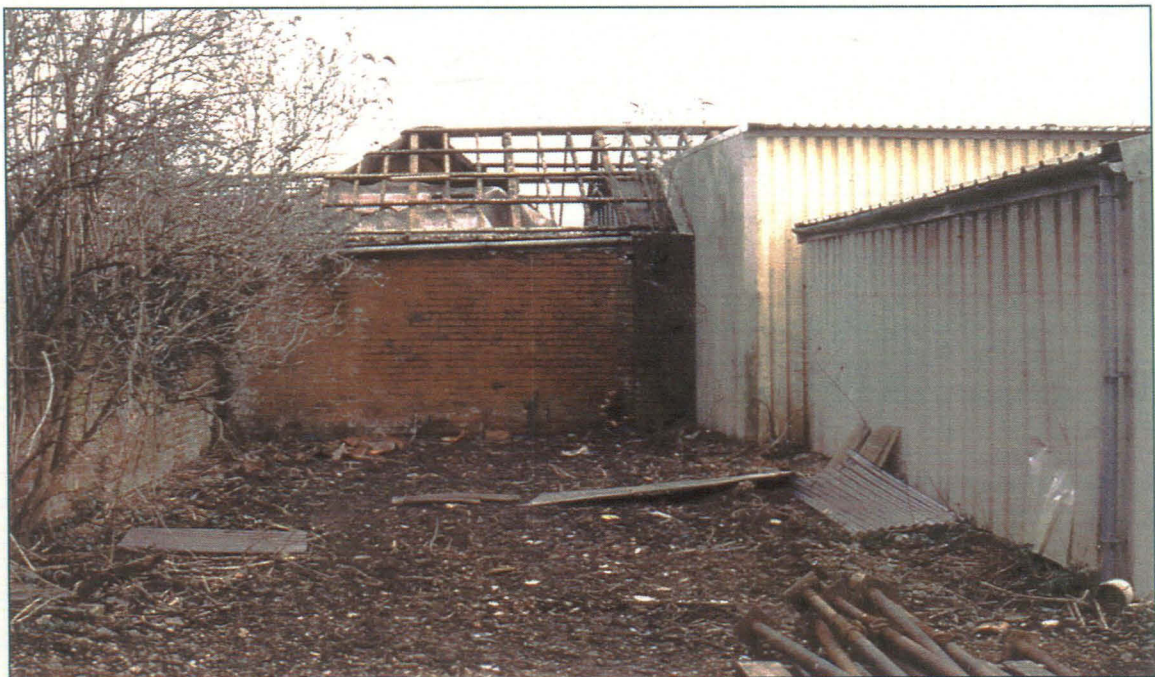
The external west wall of Room H shows a clear vertical scar, suggesting that the southern portion of the buildings represents a later extension, the east – west dividing wall running along the line of the breezeblock south wall of Rooms G and H (**pl. 20**, fig. 3).

A garden wall extends to the west from the external west wall of Room H, delineating the property of Holmfield House to the north (**pl. 20**). One foundation course of a southwards return was observed at the west end of the garden wall.

Pl. 20: Western exterior wall of Room H, looking east, with metal sheds to the south.
