**HISTORIC BUILDING SURVEY AT
WALNUT TREE FARM
MILL LANE,
BRANT BROUGHTON,
LINCOLNSHIRE
(WFBB07)**

Work Undertaken For
Tony Sharpe Building Design Consultants
On behalf of Mrs A. Askew

March 2007

A.P.S. Report No. 27/07

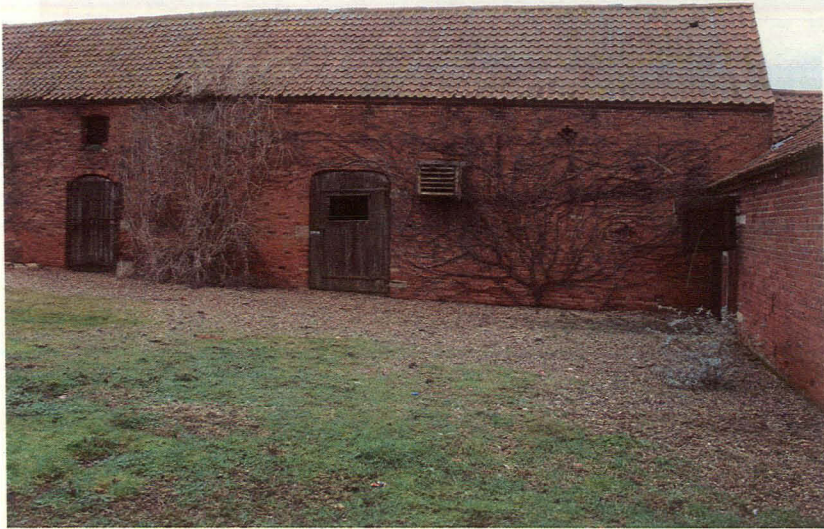
The south facing elevation (Plate 1) is the principal elevation of the barn and contains two doors located fairly centrally along it. Both doors have segmental brick arches. A third doorway lies at the western end and is now blocked, although the lintel remains. All doors have limestone blocks within the brick where the hinges and bolts fittings were attached (Plate 2).

Plate 1 - The south facing elevation of the north range

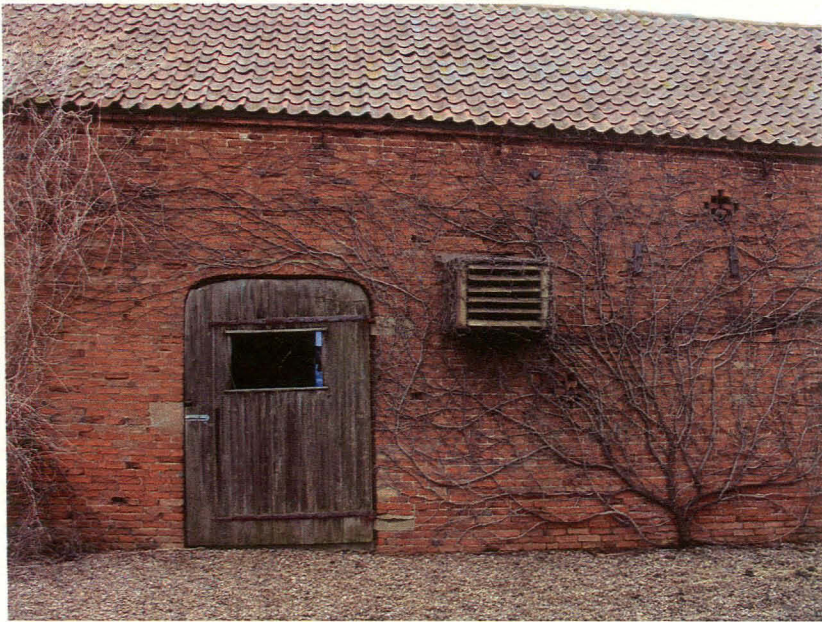
Plate 2 - South elevation of the north range showing doorway with stone fittings

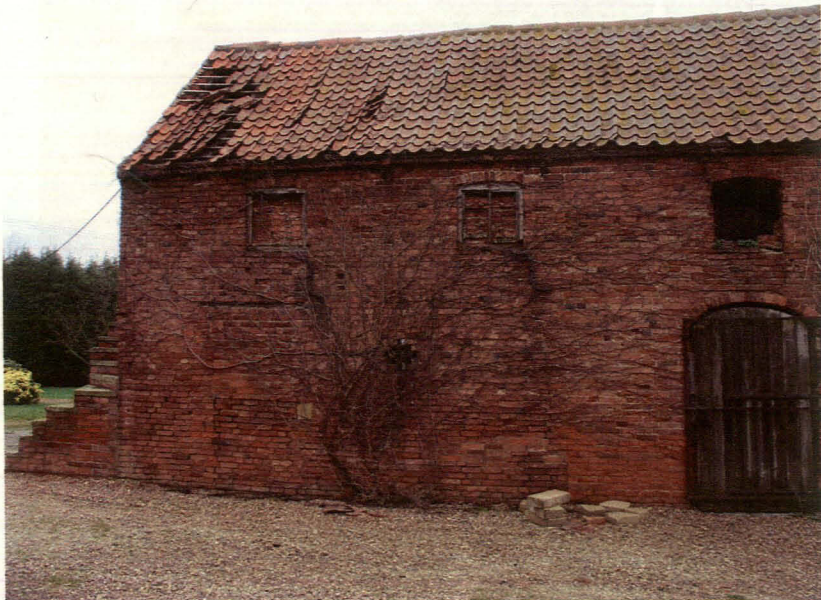
Three windows in the first floor are visible towards the west of the building (Plate 3) of which two are blocked, though still retain their wooden frames. Each window has a segmental arch over.

Plate 3 - South elevation of the north range showing blocked door and window openings for the first floor

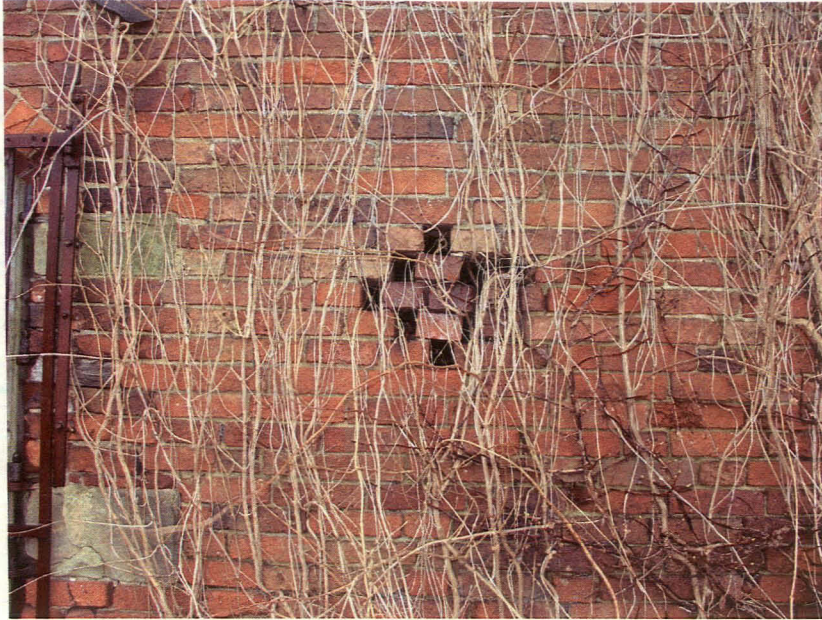
Honeycombed brickwork (Plate 4), to provide ventilation to the interior of the barn, occurs in five locations in the elevation, all apart from one on the ground floor.

Plate 4 - View showing honey-combed brickwork ventilation

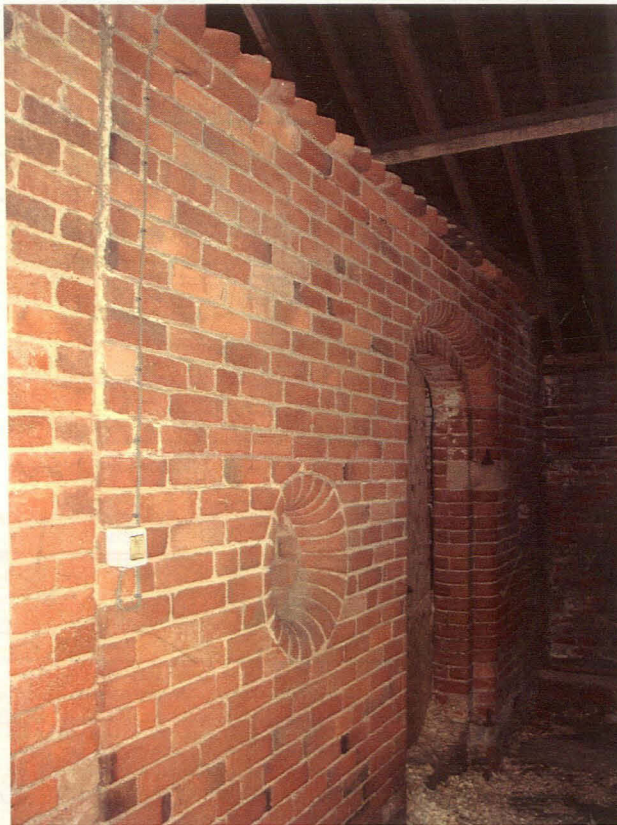
At the eastern end of the south elevation is a single storey construction which has a straight join with the remainder of the barn. This has a central door with a brick arch and two circular recesses (these are matched on the interior of the room) using bullnose bricks (Plate 5). Above this at eaves level is a course of cogging bricks.

Plate 5 - View of the north range at the eastern end showing decorative brickwork and straight join to barn

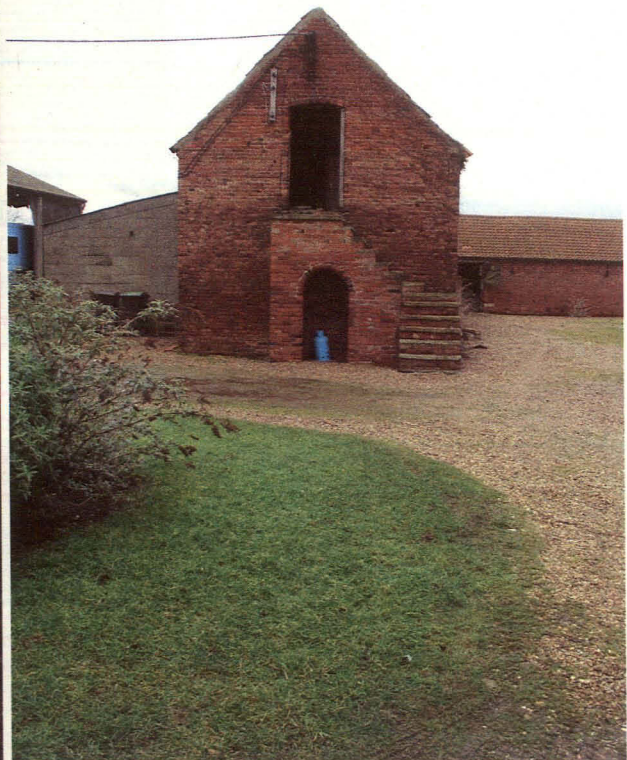
The west elevation has a gable end with attached stairway leading to a first floor door set centrally within the gable. The door has a segmental arch (Plate 6). The staircase has a single turn and overlies a small room or store which has a simple

Plate 6 - West facing elevation of the north range showing staircase to first floor

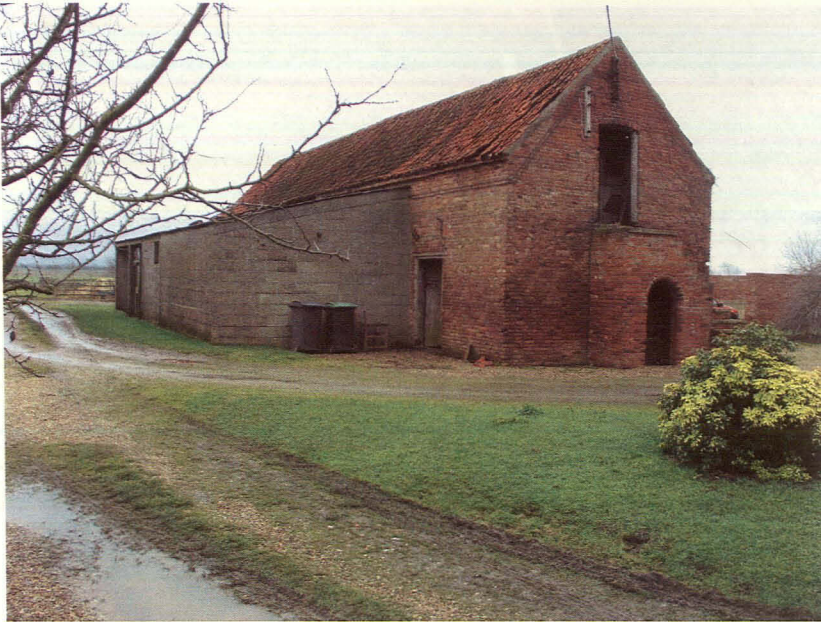
The north elevation is partially obscured by the concrete block lean-to (Plate 7). However, a door is located at the west end, which is off-line with the blocked doorway recorded on the south elevation. It has a similar wooden lintel above. Two doorways are evident within the lean-to which extend to eaves height (Plate 8). One is wide enough for a cart and presumably was its function. There are no stone fittings for hinges which may suggest it was permanently open. The second doorway is much narrower and has a single stone with an attached hinge towards the base on its east side, no upper equivalent is visible. Within the doorway is a timber frame for a door with a possible window above. Similar honeycomb brickwork for ventilation is also evident.

Plate 7 - View showing the concrete lean to on the north side of the north range

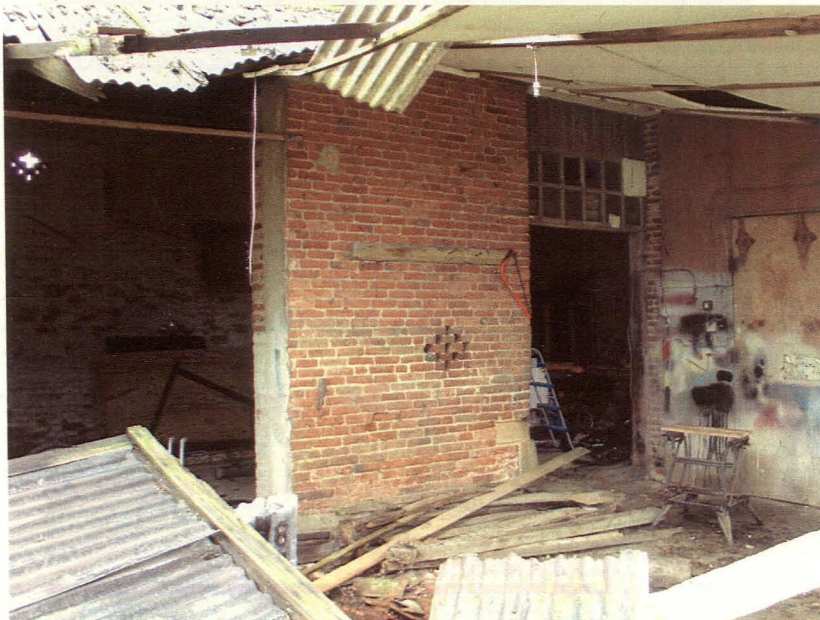
Plate 8 - View showing the principal doors to the barn in the north range

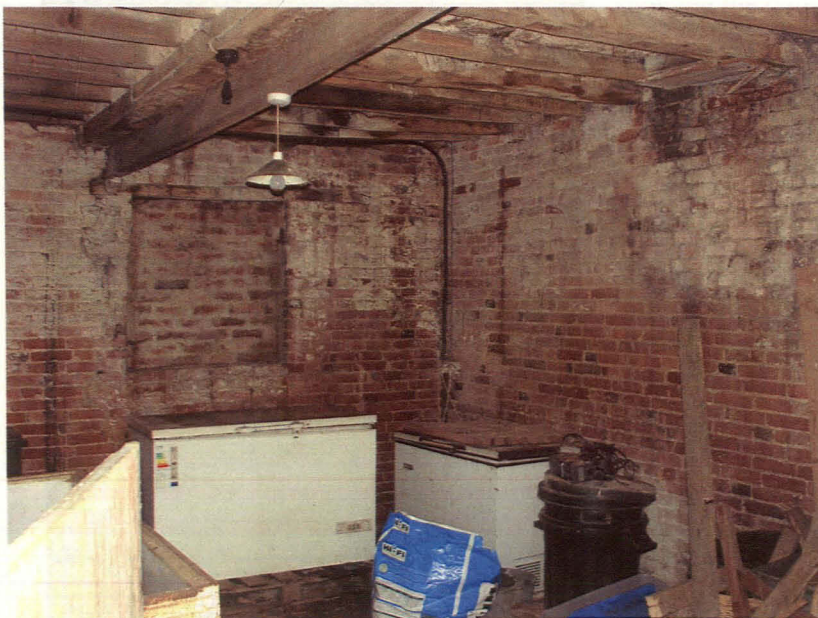
The westernmost room is of single storey height with a single beam. Two doors, one now blocked (Plate 9), give access to the outside and another door is present giving access to the room to the east. It has a brick and stone floor.

Plate 9 - Interior view of the western ground floor room with blocked doorway

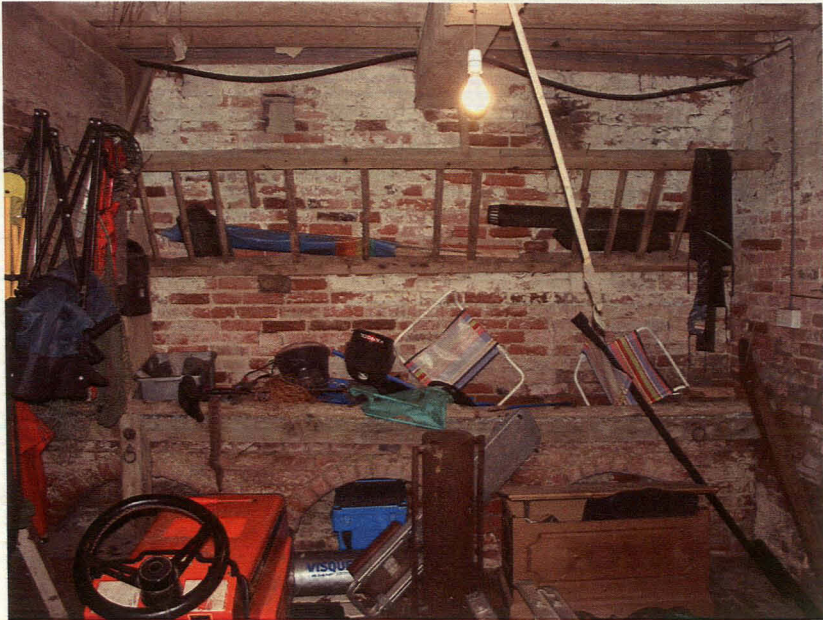
The next room to the east was a stable and was divided into two bays with a central kicking post with a wooden partition (Plates 10 and 11). It retains its manger and hay rack. The manger is of brick over three arches in each bay with a wooden lip. The floor is of brick. A door gives access into the main barn area to the east.

Plate 10 - Eastern stable bay showing manger and hay rack

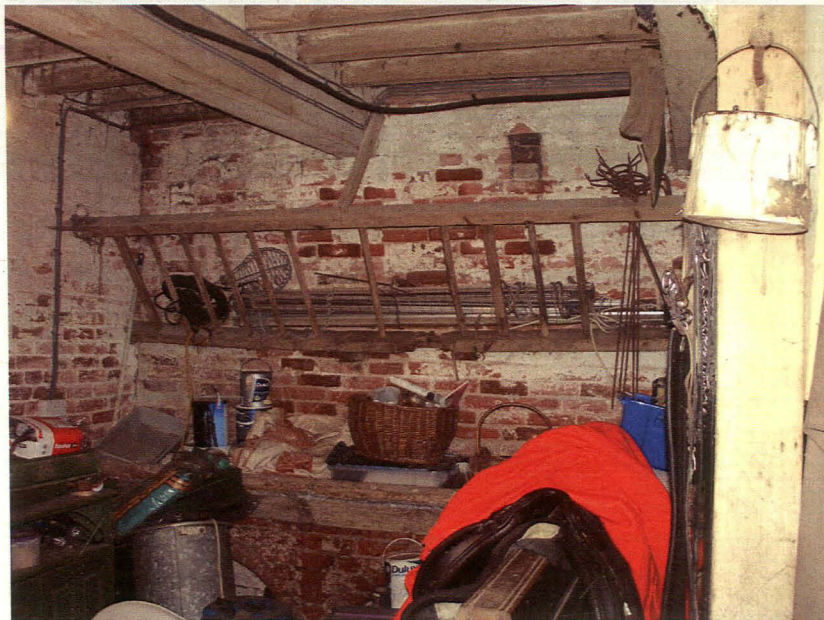
Plate 11 - Western stable bay

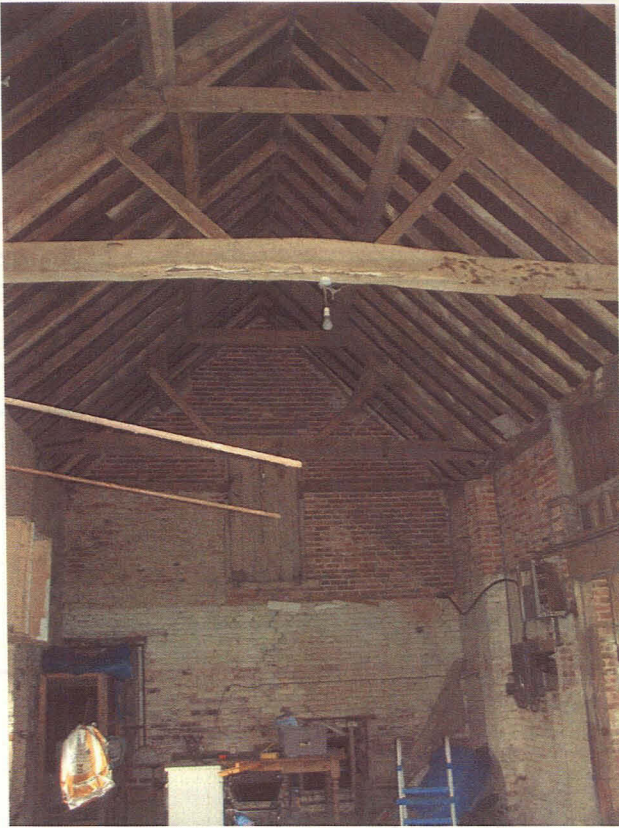
The main barn (Plates 12 and 13) is of two-storey height and has a concrete floor throughout. There are seven internal buttresses within the barn area, of which some support tie-beams. On the west wall

Plate 13 - Interior view of the barn showing doorways to the stable and granary

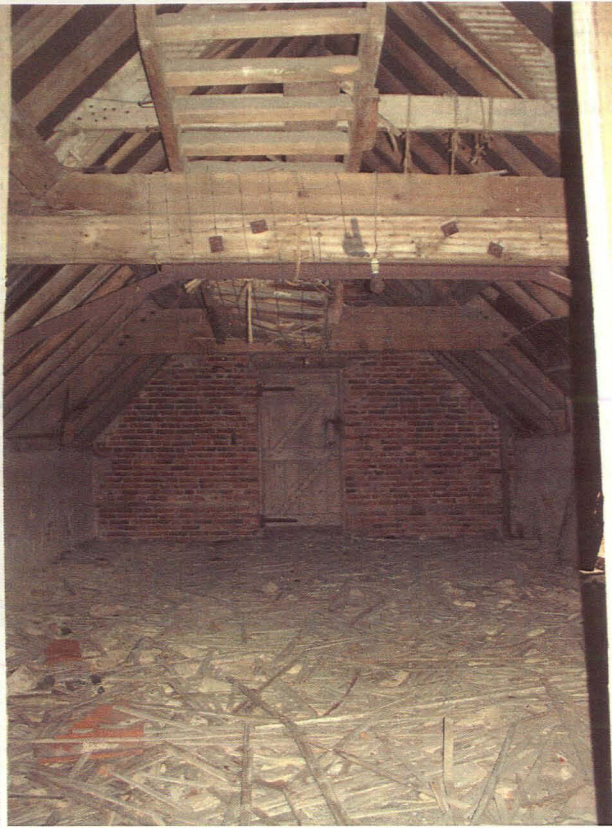
Access to the first floor is via the external staircase on the west side of the structure. The first floor room extends 9.85m across this range of buildings and is partly portioned by a wood divide towards the west end. Two of the windows visible on the south elevation are bricked in with the most easterly still open. There is a door at the east end of the room which gives access to the main barn space on the ground floor (Plates 14 and 15). The roof is an extension of that recorded within the barn (see above).

Plate 14 - Interior view of the first floor granary looking east

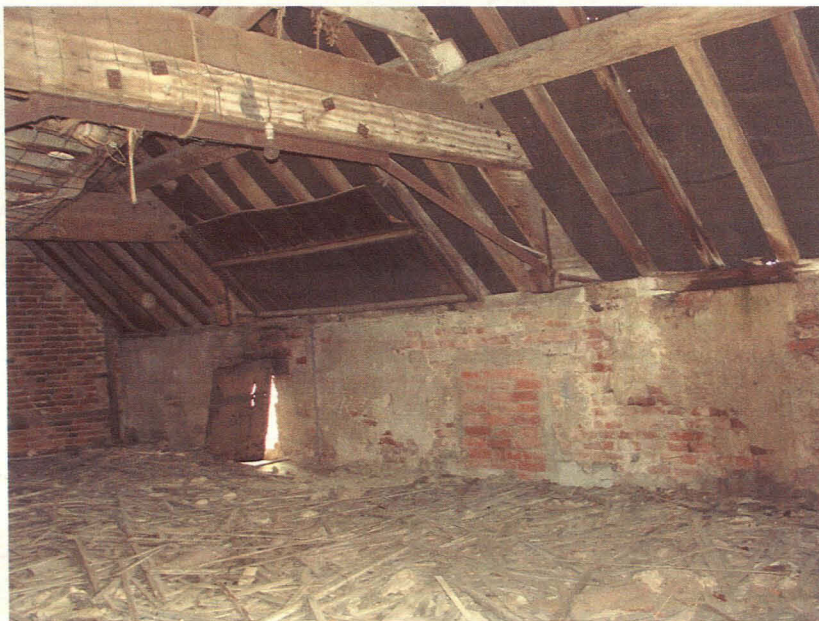
Plate 15 - The granary interior showing the blocked window openings

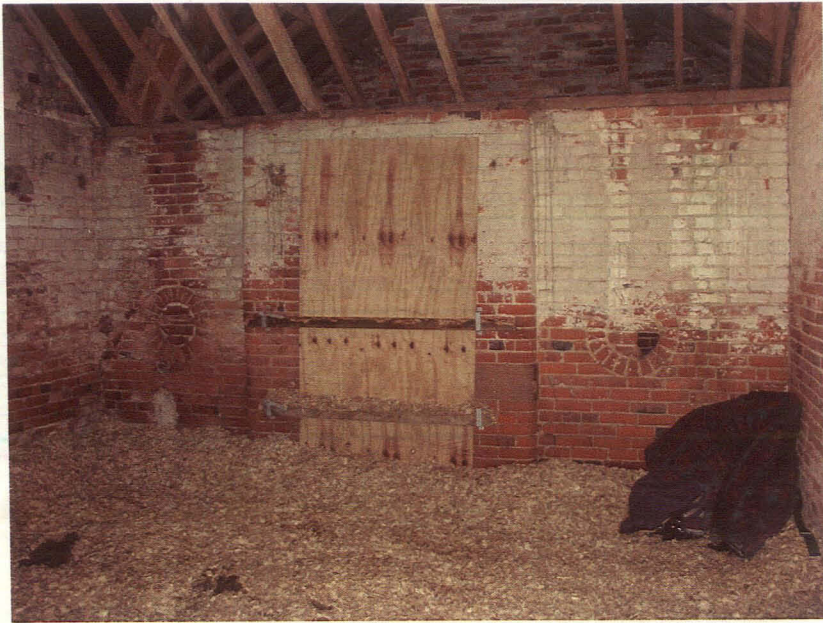
The easternmost room has the door from the south intruding into the room with rounded corners using bullnose bricks (Plate 16). The two circular recesses visible in the external elevation are repeated within the room and would appear to be blocked. The floor is covered in litter.

have functioned as a tack room or stable. The purposes of the circular recesses are also not clear, but when considered with the dentilation of the brickwork, may be nothing more than decorative. However, there is a possibility that they have been blocked and could have been a small cupboard for storing curry combs and brushes.

Plate 16 - View of the interior of the east room of the north range, showing the circular brick recesses

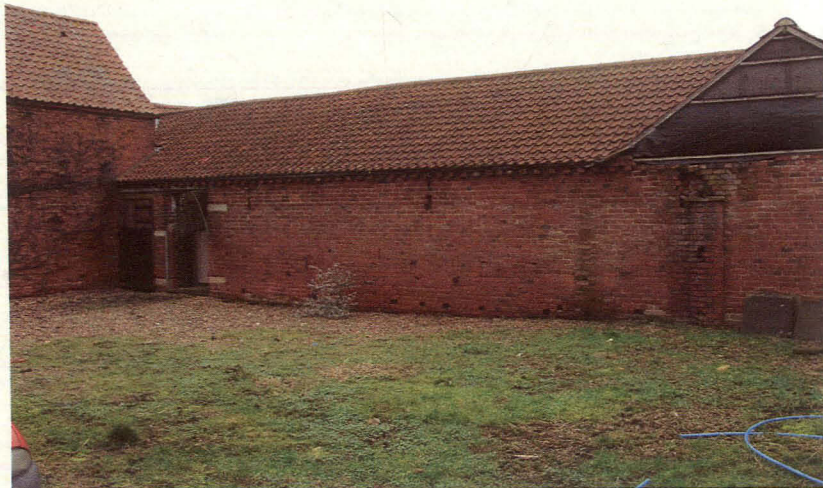
The west facing elevation is plain with two doors located towards the northern end (Plate 17). There is a decorative course of dentilation at the eaves. Towards the south are the remnants of the gable end to a former south range where a buttress is also apparent.

Plate 17 - West facing elevation of the east range

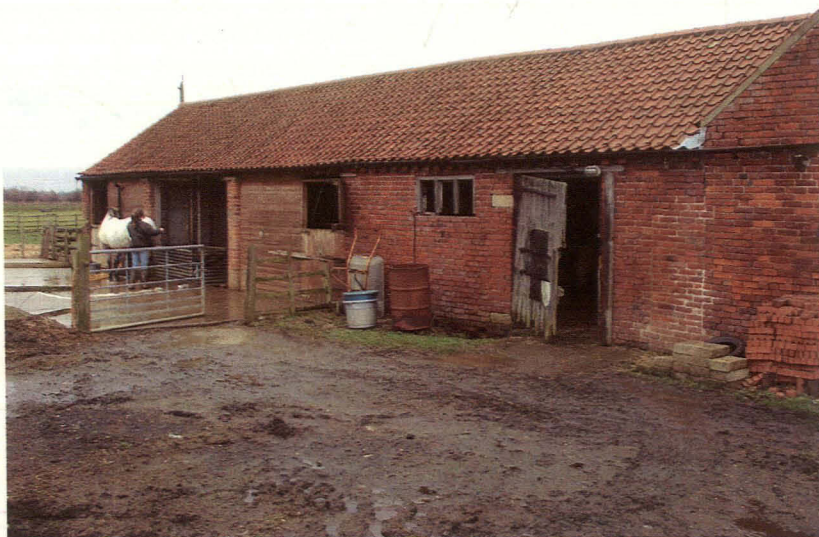
The east facing elevation has three open access sheds which are now partly infilled with wooden stable doors (Plate 18). A

door and window are located towards the north end and there is a blocked doorway to the north of this which would have given access to between the two ranges. A straight join is visible with the east elevation of the north range. The eaves are dentilated.

Plate 18 - East facing elevation of the east range with former cart shed to the left
