**BUILDING ASSESSMENT OF
20 ST. MARY'S STREET,
STAMFORD,
LINCOLNSHIRE
(STSM03)**

**Work Undertaken For
G. R. Merchant and
Mr S. Laxton**

April 2003

APS Report No. 89/03

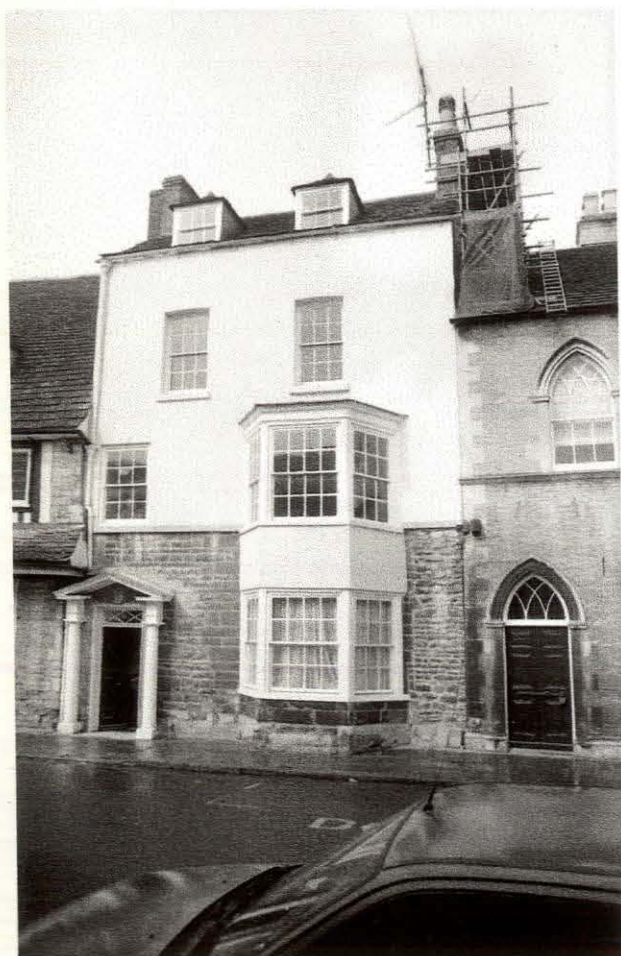
The ground floor frontage is of coursed stone and rubble and the upper two storeys are stuccoed. It has a slate roof with two gabled dormer windows (Plate 2).

Plate 2 Detailed view of frontage of 20 St. Mary's Street, looking north

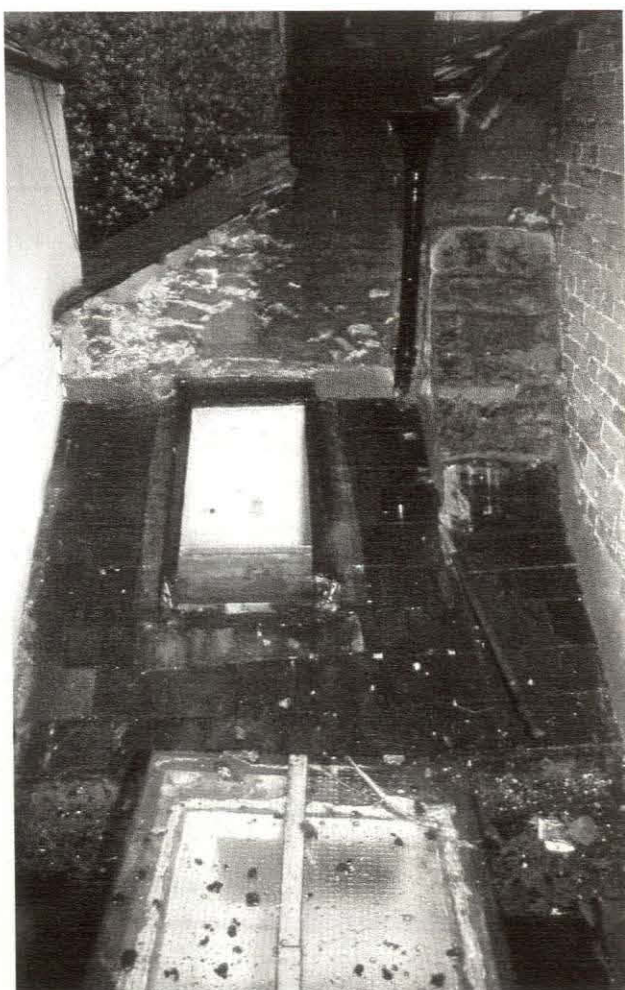
The existing roof over the utility area comprises two sections sloping down toward each other to form a small channel, and is sunken and surrounded by existing

structures. As such, it is not overlooked by any adjacent building. The roof is covered with slate, probably Welsh, and butts against a wall of late handmade, probably 19th century, brick to the east. In the northern section of the roof is a flat, glass skylight of probable mid 20th century date. In the southern section of roof is a dormer-type window, topped with wire-reinforced glass. This light is also likely to be mid 20th century or perhaps a little later (Plate 3).

Plate 3 View looking down on existing roof over utility area, looking north

The roof of the utility area appears to be conclusively of 20th century date. It butts against a wall of late handmade brick of 19th century date and is thus clearly later than this. The use of non-local, probably Welsh, slate also indicates a 19th century or later date for this roof. Use of wire-reinforced glass in the dormer-type skylight may be a late alteration and is likely to date from the second half of the 20th century.

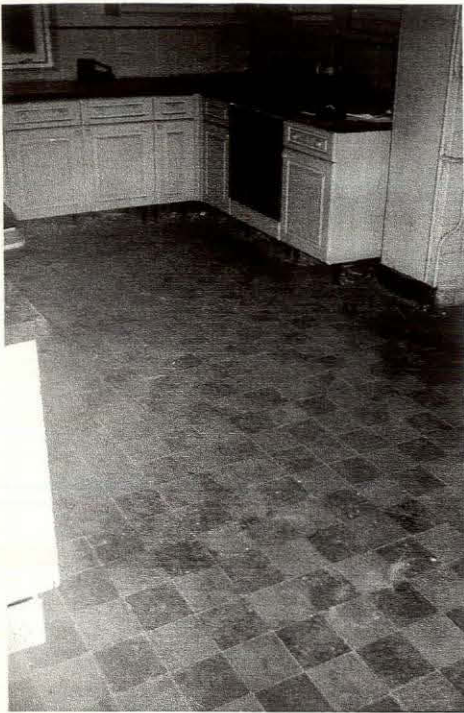
Located on the north, rear, side of the building, the kitchen is about half the width of the property. It has a recent chequerboard pattern tiled floor in red and pale yellow (Plate 4). All the windows are single-pane lights of recent date (Fig. 5). The various storage units and fittings within the kitchen are also modern (Plate 5).

Plate 4 Kitchen,
tiled floor, looking
north

Virtually every aspect of the kitchen suggests it is a 20th century extension to the property. The quarry tiled floor and straight sawn roof timbers are both no earlier than the later 19th century and, overall, the general appearance of the kitchen suggests that it probably dates to the first half of the 20th century. Its external door to the yard is of four panels, rarely seen before 1830 but the commonest type after 1850 (Wedd 2002, 119). However, this door has a bakelite handle

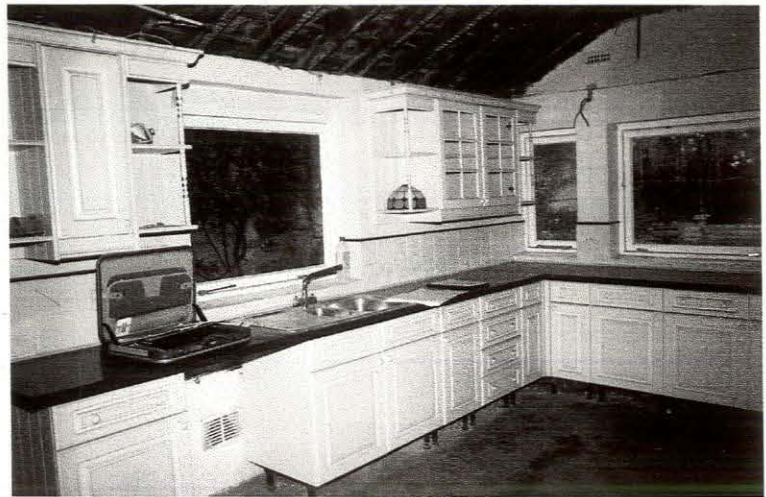
Plate 5 Kitchen, showing recent fittings
and windows, looking northwest

which suggests a 20th century date. The windows and fittings are all late 20th century.

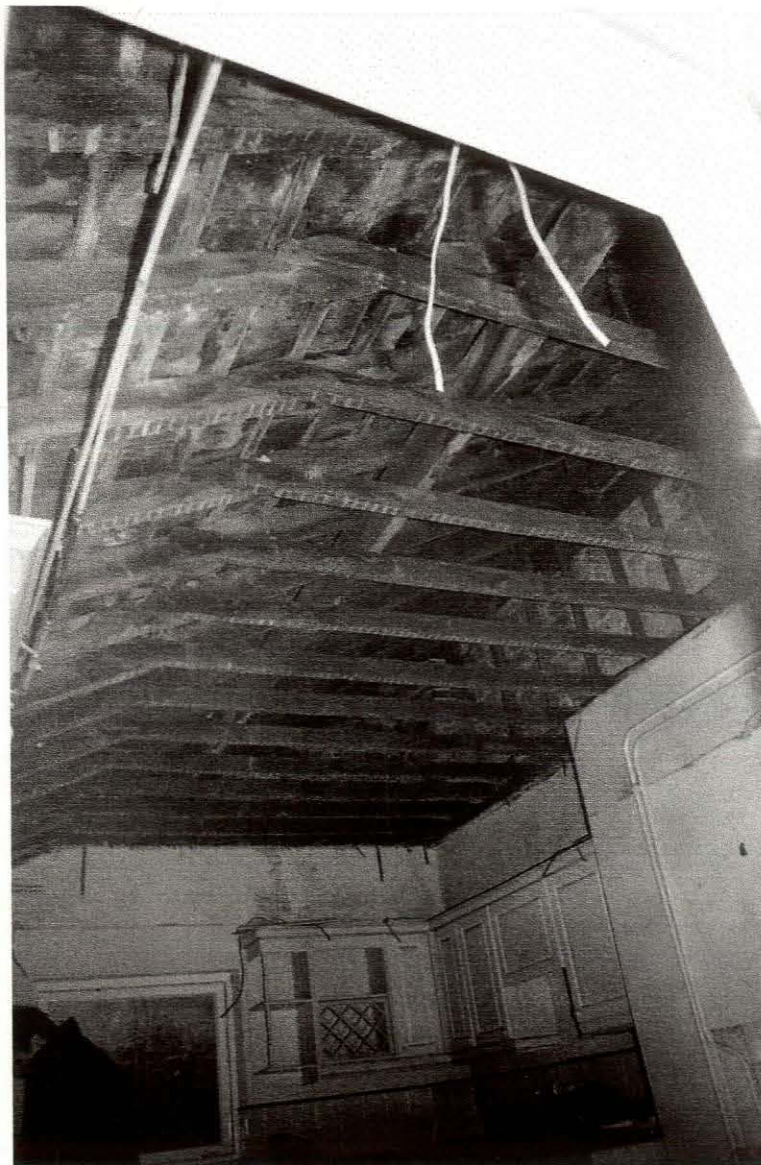
The kitchen has a plain, sloping roof rising against the adjacent property to the east (21 St. Mary's Street). Slate, probably Welsh, clads the roof and the ceiling has been removed to reveal the timbering, which is all straight-sawn and clearly recent, perhaps dating from the first half of the 20th century (Plate 6). A four-panel door (Plate 7), probably also dating to the first half of the 20th century, provides access from the kitchen to the exterior yard. On its exterior the door has a spherical doorknob with a bakelite handle.

Plate 6
Kitchen,
showing roof
timbering,
looking north

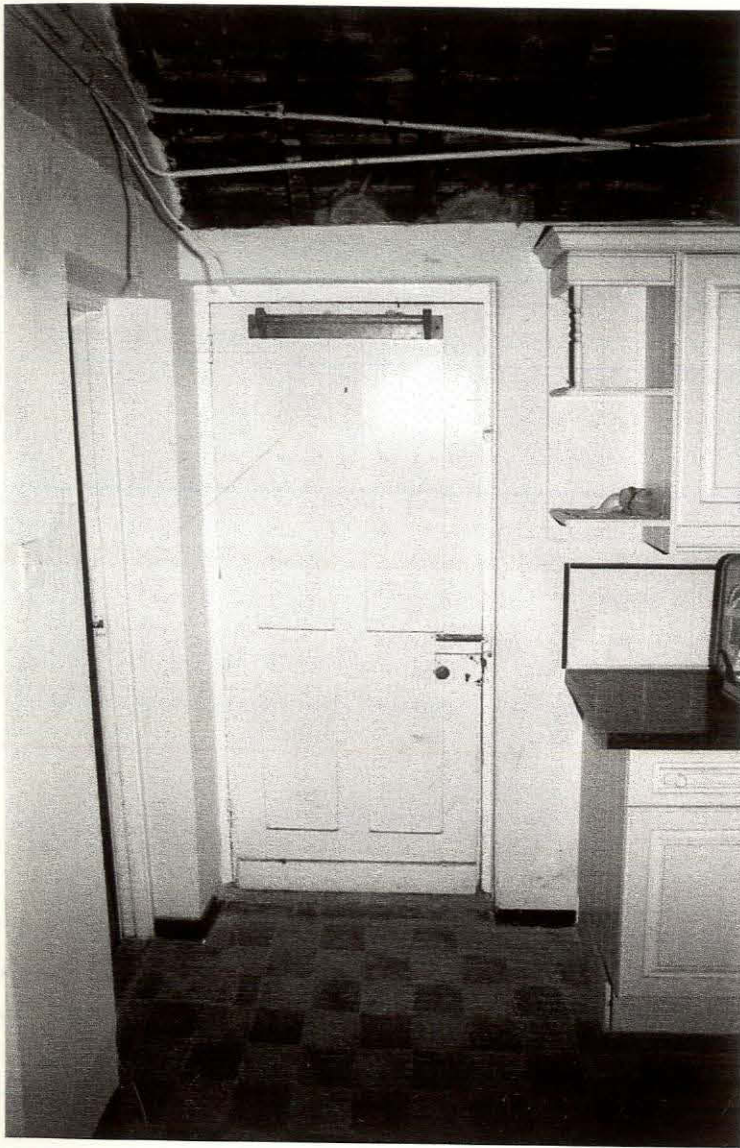
Plate 7 Kitchen door,
interior view, looking
west

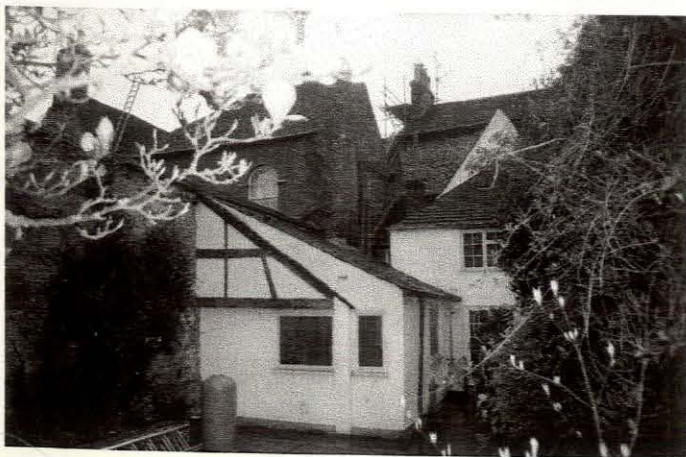
On its exterior, the north wall of the kitchen appears to embody an earlier structure, with exposed timbering (Plate 8). This apparently earlier structure has a steeper roofline than the kitchen and this is capped with ceramic nib tiles (Fig. 5). These are, however, totally uniform in size and thus apparently machine-made. Moreover, none of this tiling appears in any way disturbed by the raising of the kitchen wall.

The exposed timbering is entirely sawn with straight edges and there are no pegs

or peg holes evident, even where separate timbers meet.

Plate 8 Kitchen, showing
exposed mock-timbering,
looking southeast

The kitchen exterior north wall appears to incorporate a wall of an earlier structure. However, the visible aspects of this suggest it is entirely mock. The nib tiles on the stretch of apparent earlier roofline appear to be machine-made and are undisturbed by the apparent raising of the kitchen wall. The timbering is only exposed on the exterior of the wall and does not carry through to the interior. Moreover, the timbers exposed here, and in the kitchen roof, are all cut with straight edges, whereas medieval timbers are irregular and have curves. Such rigid straightness of timbers is a characteristic of Victorian and later copying or replacement of medieval timber framing (Rackham 2001, 67). Moreover, the half-timbering exposed in the kitchen wall lacks any pegs or pegholes, which absences further indicate the mock nature of this facade. Thus, this half-timbered wall, evident only from the yard/garden, appears to be a conceit of probable early 20th century date.

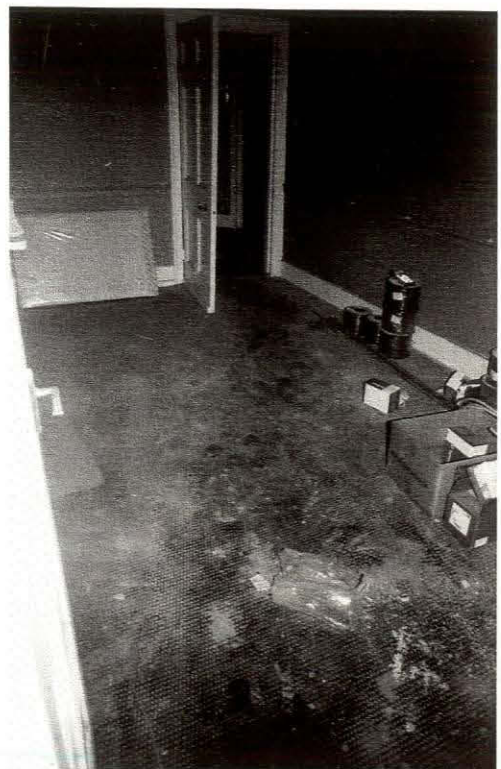
Floors of both the main utility room (Plate 9), off the kitchen, and the bay-windowed front room (Plates 10 and 11), were also examined. Both are of concrete and clearly recent.

Plate 9 Concrete floor of
utility room, looking south

The concrete floors of the main utility room and the bay-fronted room are both clearly recent, probably mid 20th century.

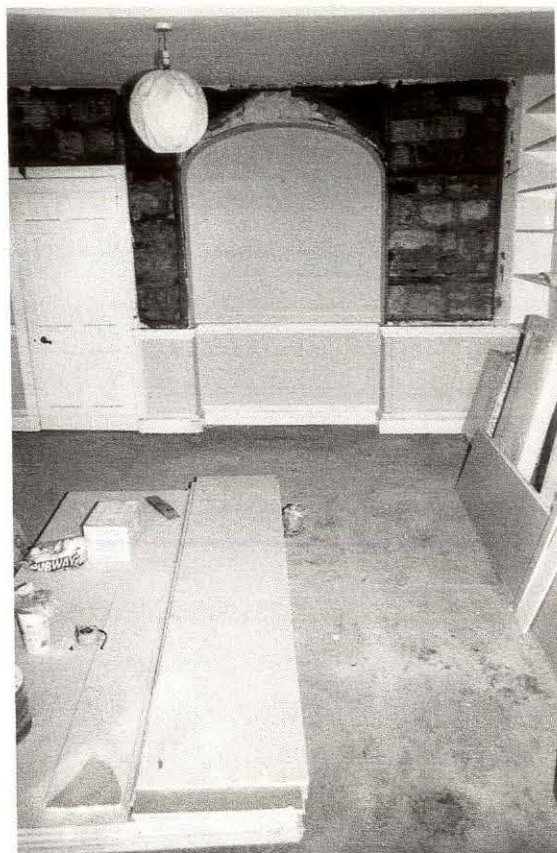
Plate 10 Concrete floor of bay-fronted room, looking south

Plate 11 Concrete floor of bay-fronted room, looking north
