**HISTORIC BUILDING RECORDING
AT THE
ANGEL AND ROYAL HOTEL,
HIGH STREET,
GRANTHAM,
LINCOLNSHIRE
(GAR03)**

**Work Undertaken For
JEFFERSON SHEARD ARCHITECTS**

November 2003

APS Report No. 168/03

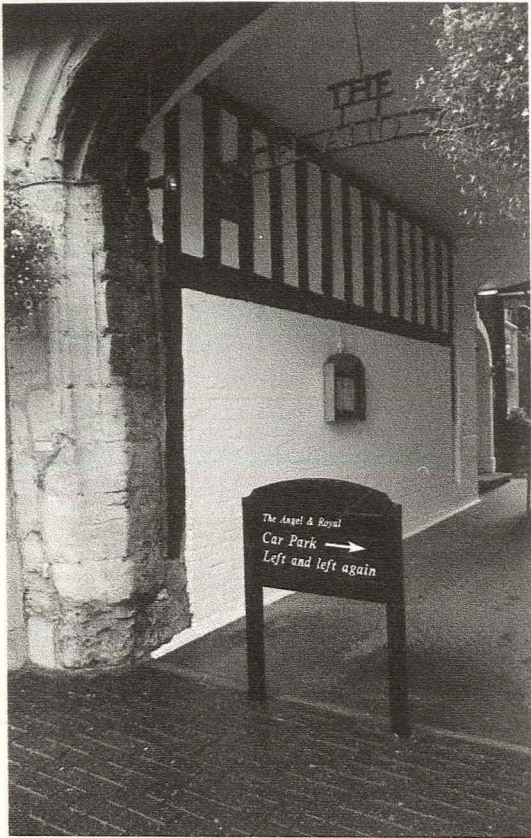
Plate 5 Exposed Timberwork in Archway Passage, looking northeast

a series of wide vertical studs between (Plate 5). Wooden pegs are evident in the lower horizontal and there are also joiner's marks on this and the studs. These joiner's marks consist of incised Roman numerals of the form I, II, III *etc.*, and are found in matching pairs on the studs and the adjacent part of the horizontal (Plate 6). The numerals commence at the right, east, side and increase in value westward.

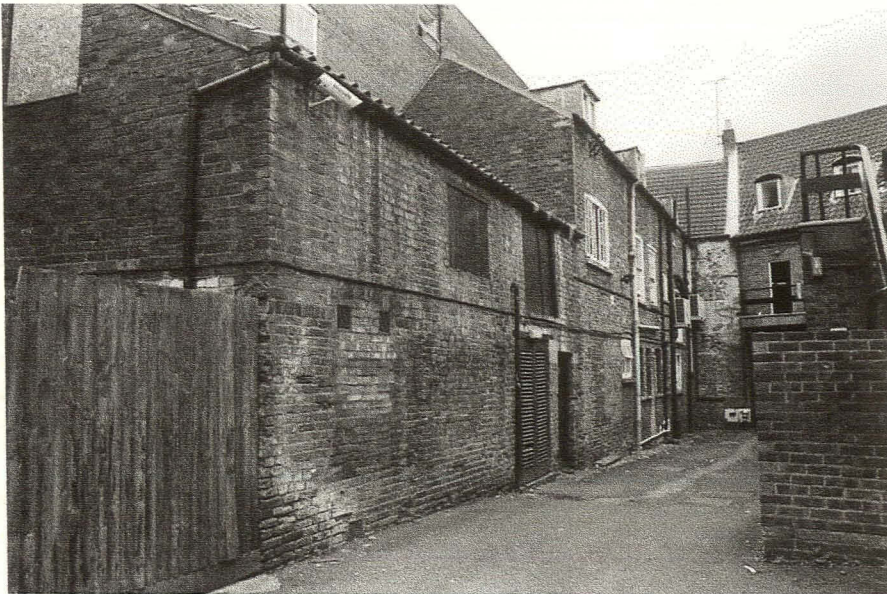
Plate 29 Centre and Western Part of North Side of North Wing, looking southwest

West of and alongside the door and blocked window noted above is a lean-to building, 2-storeys high, of brick with a pantile roof and a chimney of machine-made brick (Plate 29). This lean-to has two blocked ground floor windows both with segmental arches and two planked entries with timber lintels on the first floor. Handmade brick blocks the western window while machine-made bricks and two bricks vents infill the easterly window. West of the blocked windows there is a wide double door of wooden grills with a timber lintel and, west of this, a planked door with a large stone lintel. Machine-made brick surrounds the slatted door. Across this elevation, in line with the top of the door and ground floor window lintels, is a row of header bricks.

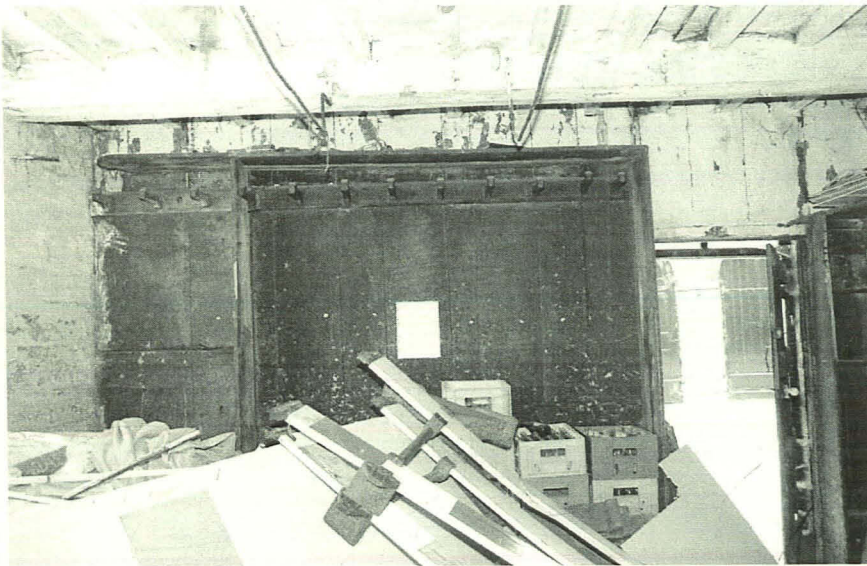
Plate 38 Panelling and Open Cupboard, Ground Floor, East End Store Room, North Wing, looking south

On the ground floor there are wooden pegs within a sort of open cupboard. These pegs may be harness hooks, though could have been for coats. Larger triangular pegs on both the ground and upper floor walls may also be harness pegs though this is doubtful, particularly those on the upper storey. If the pegs are harness hooks this indicates the building was a tack room and similar structures are found in associations with stables in farm complexes elsewhere (Barnwell and Giles 1997, 55).
