SURVEY OF BUILDINGS AT CAISTOR HOSPITAL, NORTH KELSEY ROAD, CAISTOR, LINCOLNSHIRE (CACH 07)

> Work undertaken for Pick Everard on behalf of Cannon Kirk

> > September 2007

A.P.S. Report No: 124/07

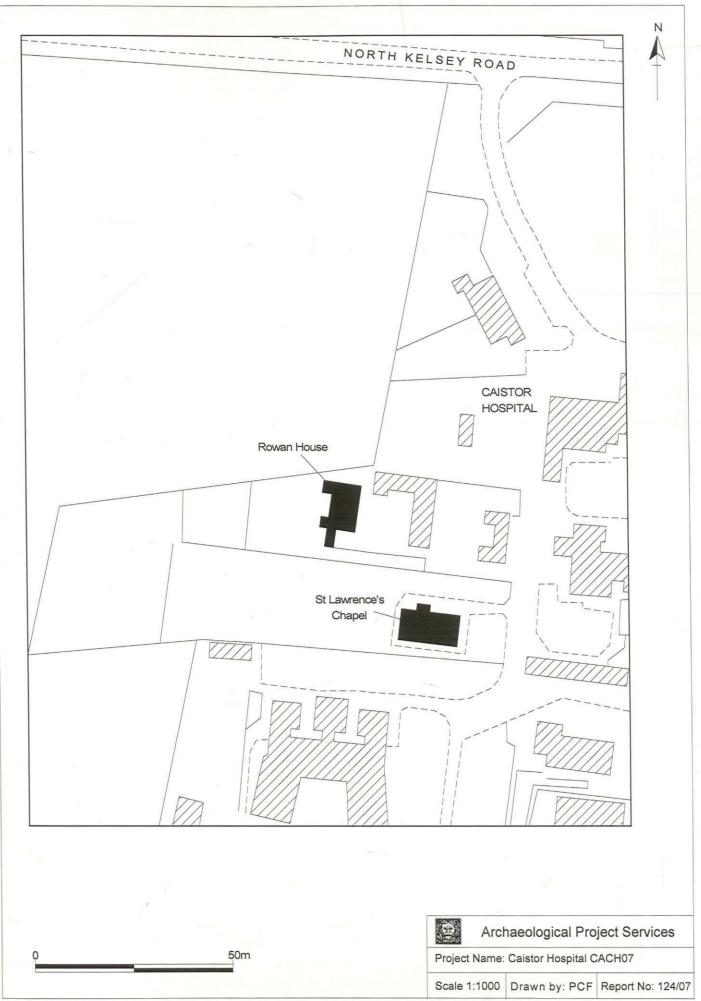
Figure 3 - Plan showing location of recorded buildings

St Lawrence's Chapel and Rowan House lie southwest of the main complex of workhouse and hospital structures (Fig. 3). Both are heavily overgrown and have been subjected to vandalism.

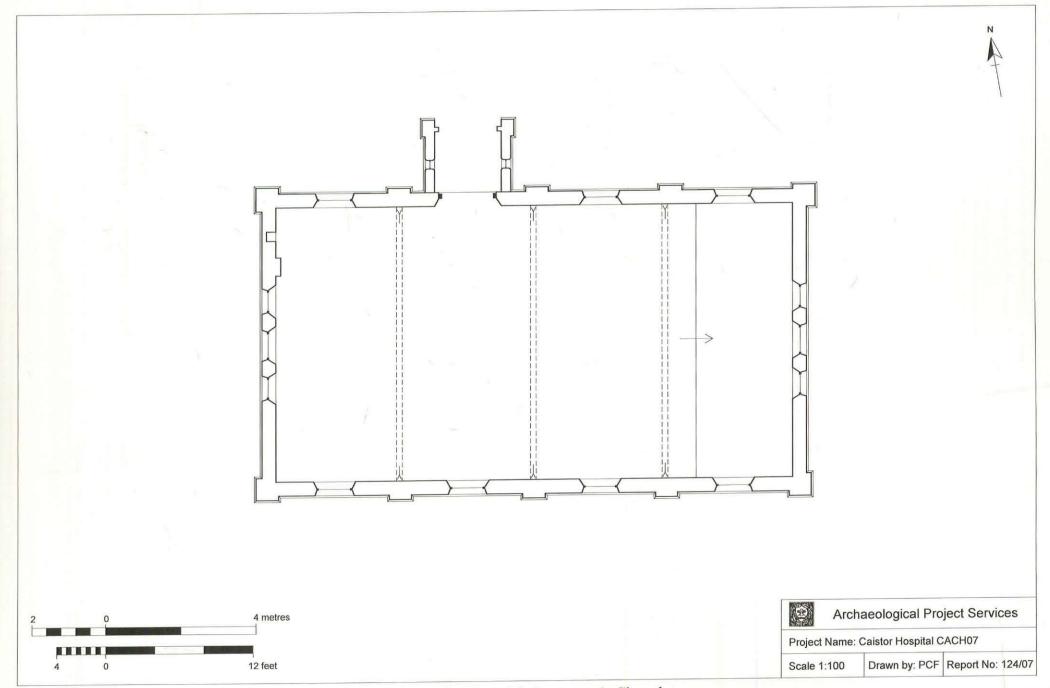
Figure 4 - Plan of St Lawrence's Chapel

St Lawrence's Chapel (Fig. 4)

The chapel is a simple 4-bay rectangular structure measuring 14.4m long by 8m wide. It is constructed of yellow gault hand-made bricks in English garden wall bond and has a slate roof. All windows are tall lancets with plain or frosted glass where this survives.

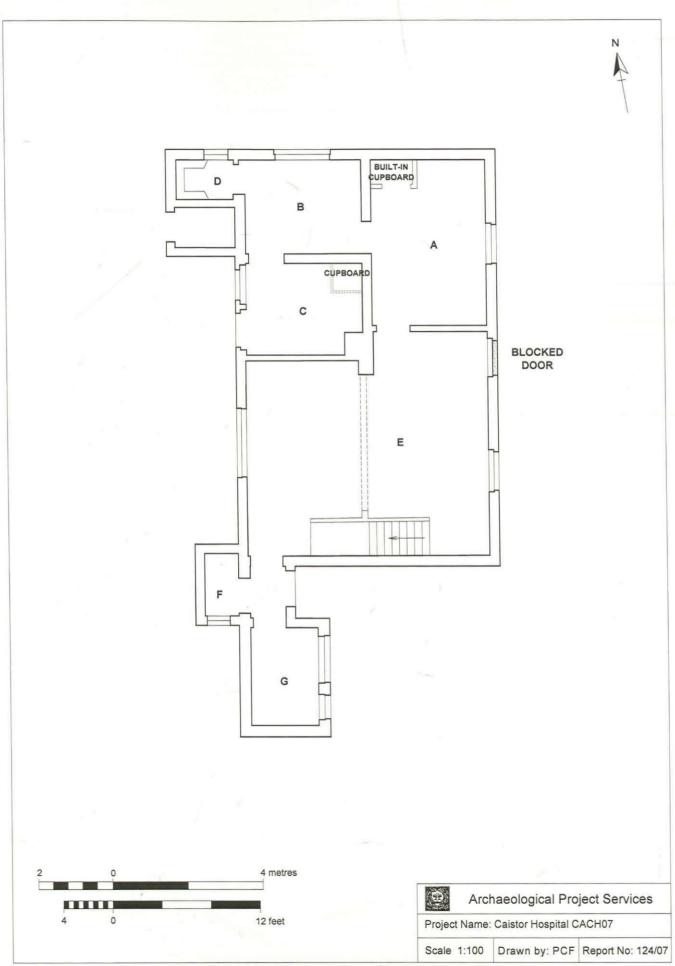
Figure 5 - Ground plan of Rowan House

Rowan House (Figs. 5 and 6)

The house is a 3-bay structure constructed of red machine made brick in stretcher bond with a slate roof. The core of the

building comprises a rectangular block of 11m by 7m to which later additions are apparent.

For ease of reference, letters have been assigned to each of the rooms on the ground floor.

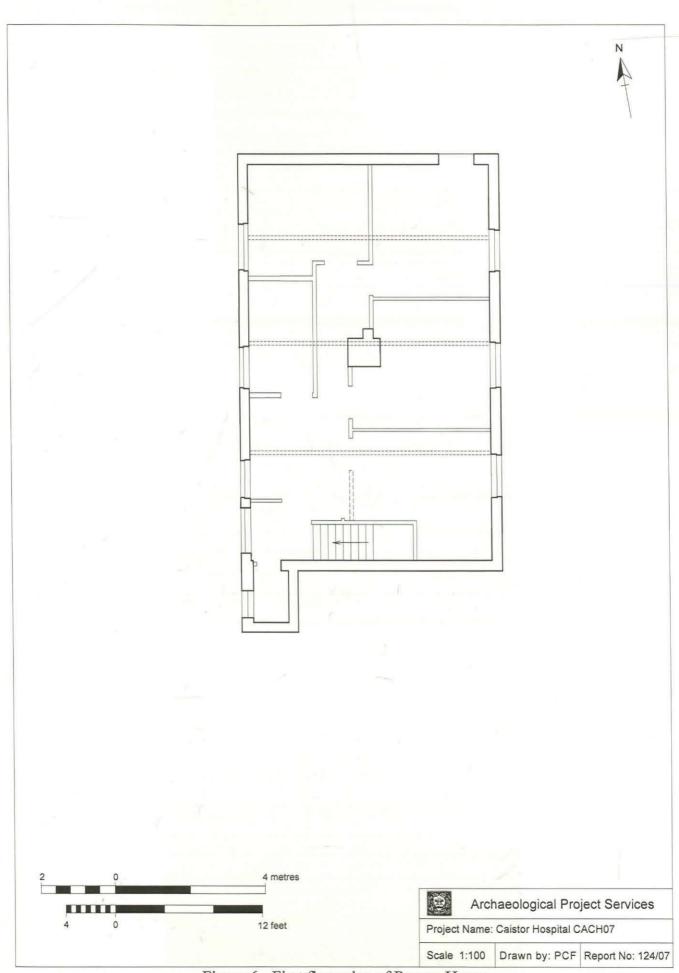
Figure 6 - First floor plan of Rowan House

On the first floor level, all original walls have been removed apart from those associated with the central chimney and a small area above room F on the ground floor. Apart from the sash windows there are no original features apparent. A crittall window has been inserted at the top of the stairwell.

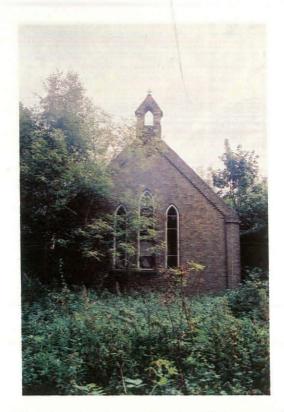
The chapel has clasping buttresses at each corner with three buttresses on the north and south sides which surround the windows. There is a sloping plinth which surrounds the structure and decorative brickwork is evident at eaves height. At the apex of the roof towards the east is a stone cross which is mirrored by a bellcote at the west end (Plate 1).

Plate 1 - View showing the west façade of St Lawrence's Chapel

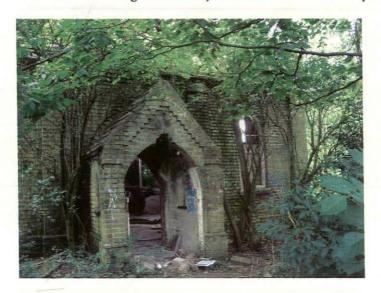
On the northern side of the chapel is a later porch (Plate 2). It is bonded to the chapel with a straight join but otherwise matches the chapel in most respects. Two small lancets are located on each side of the porch and the entrance is a simple two-centred arch.

Plate 2 – The north porch of St Lawrence's Chapel

St Lawrence's Chapel clearly shows no alteration from its original purpose, except for a later north porch which judging by its style was probably constructed soon after the chapel.

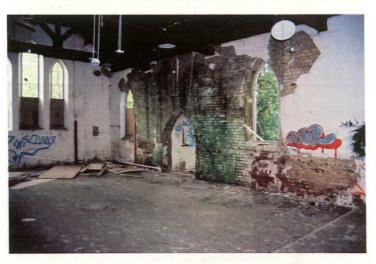
The interior is a plain rectangle. A raised area at the east end indicates the location of the altar. At the west end is an internal buttress, of unknown function, adjacent to which is a small niche, perhaps for vestments (Plate 3).

Plate 3 – Interior view of the chapel, looking northwest

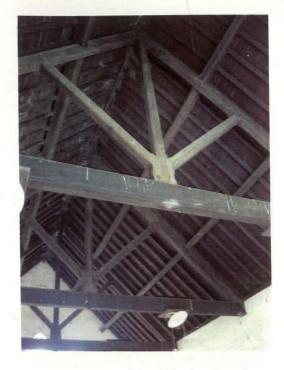
The roof comprises King post trusses on tie-beams (Plate 4). The tie-beams are chamfered and have straight-cut stops.

Plate 4 - Roof detail in the chapel

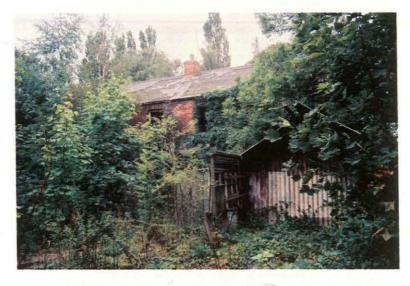
The front façade (Plate 5) of the house faces to the east and has a central, now blocked, door flanked by two sash windows on the ground floor and three windows on the first floor, all with brick flattish arches. A chimney is placed centrally to the structure.

Plate 5 – The east façade of Rowan House

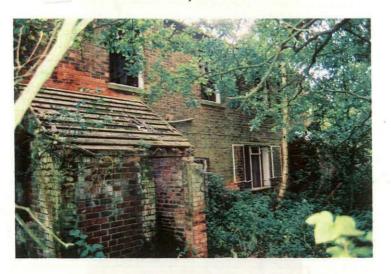
The west façade retains three original sash windows at first floor level and a single window and door are original on the ground floor (Plate 6). South of the door a large rectangular crittall window has been inserted.

Plate 6 – The west façade of Rowan House

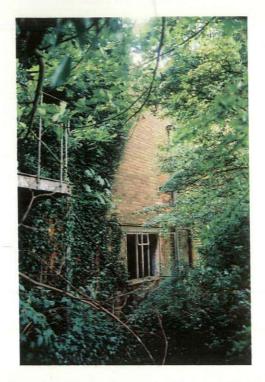
On the south side of the building is a later addition of c. 1950s. The southern façade is otherwise plain. The northern façade has an inserted fire exit at first floor level and two original windows on the ground floor (Plate 7), one for a pantry which extends west beyond the building.

Plate 7 – The north façade of Rowan House

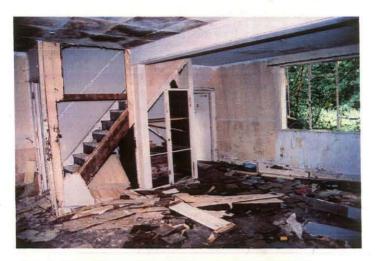
had access to the outside by a now blocked door. This may have once been sub-divided into two as a joist spans the room from north to south (Plates 11 and 12). Access to the first floor is provided by a staircase located along the southern wall.

Plate 11 – Room E, looking south

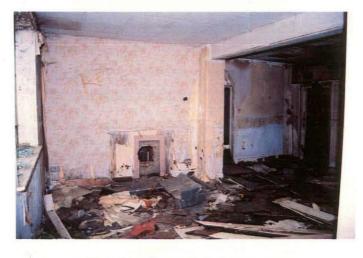
Plate 12 – Room E, looking north

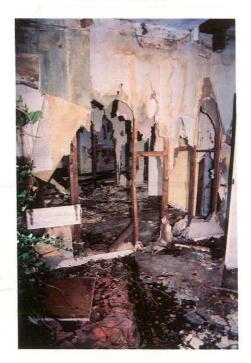
Plate 14 – View of the first floor, looking southwest
