**BUILDING ASSESSMENT OF  
THE CO-OPERATIVE STORE  
AND ADJACENT STRUCTURES,  
ALBION STREET/WEST STREET,  
CROWLAND,  
LINCOLNSHIRE  
(CAS03)**

**Work Undertaken For  
Sherramore Ltd and LCS Property Ltd**

January 2004

APS Report No. 183/03

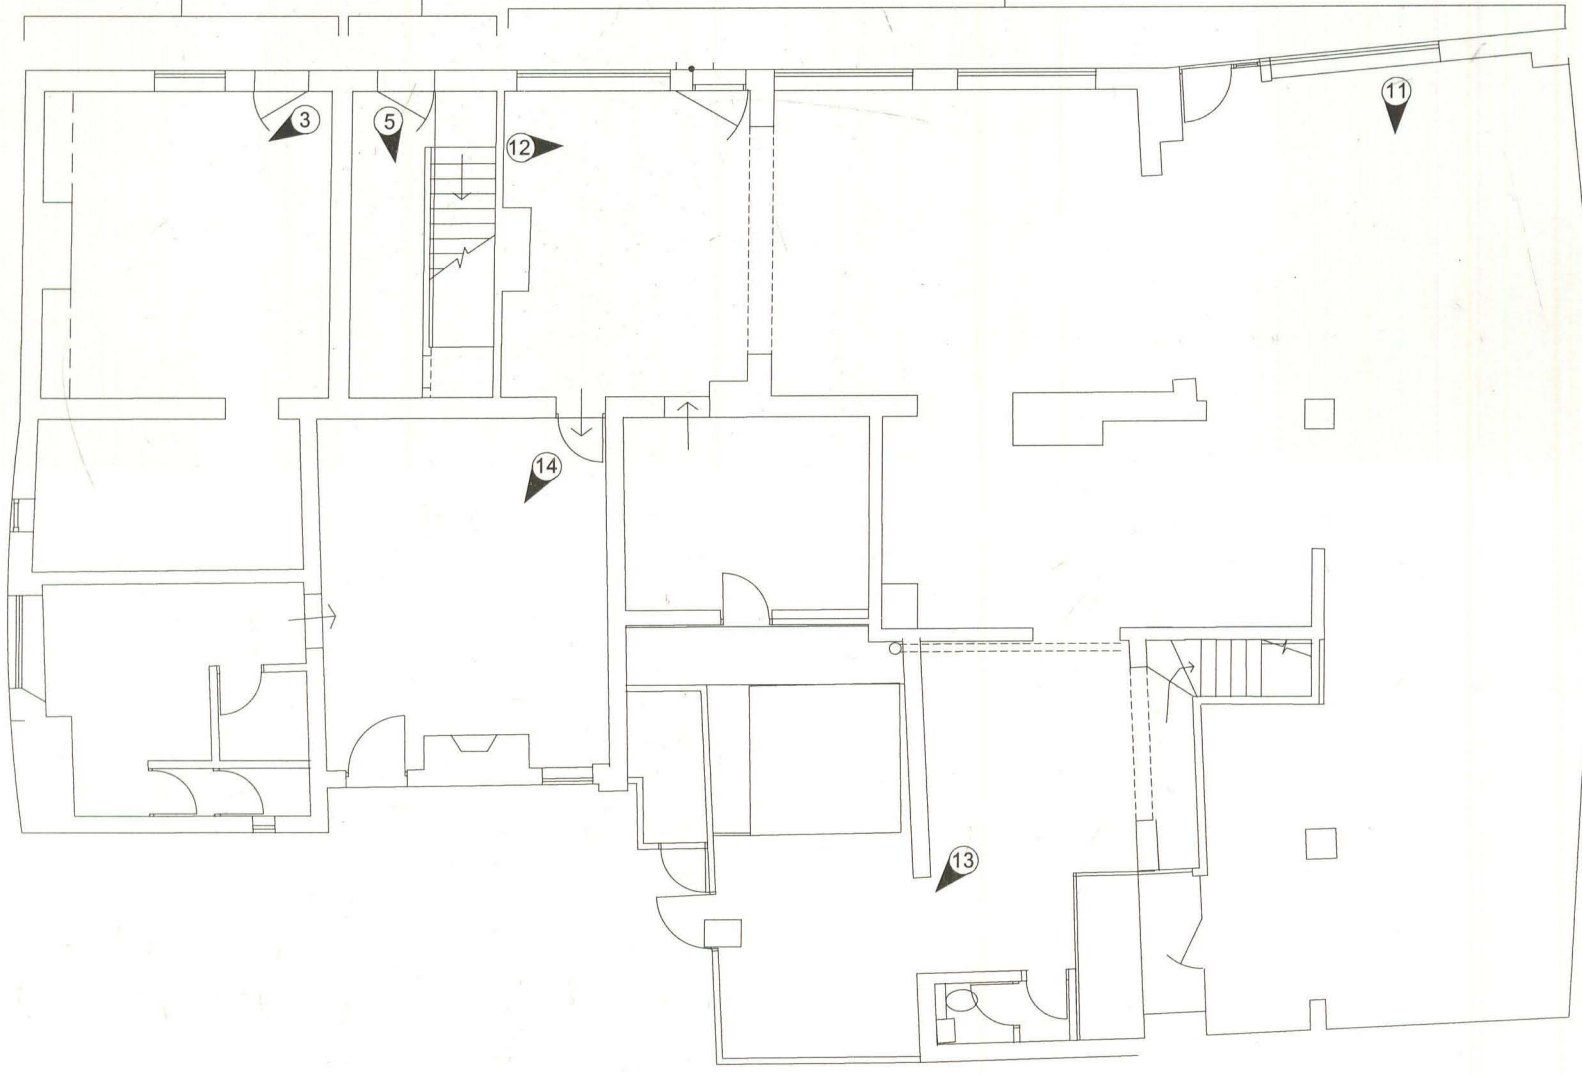
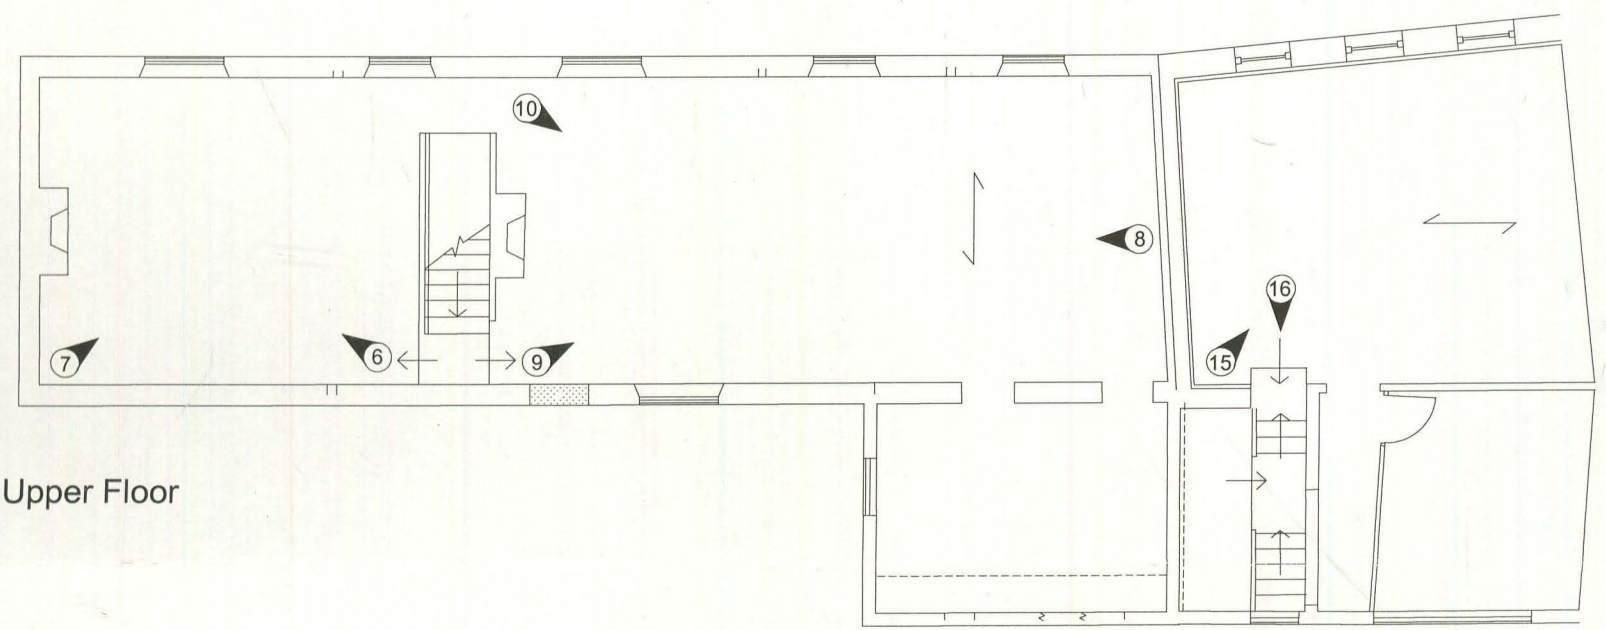
Figure 5 Plan of Ground and Upper Floors of Buildings, with key to plates and indicative original and present arrangement of stuctures

The Co-operative store and associated structures comprises three units that, currently, are separate at ground floor level. All three units and their upper storeys were recorded. These units comprise the existing Co-Op store with connecting storage rooms, staff and welfare facilities, a stairwell to the upper floor and a two-room shop.

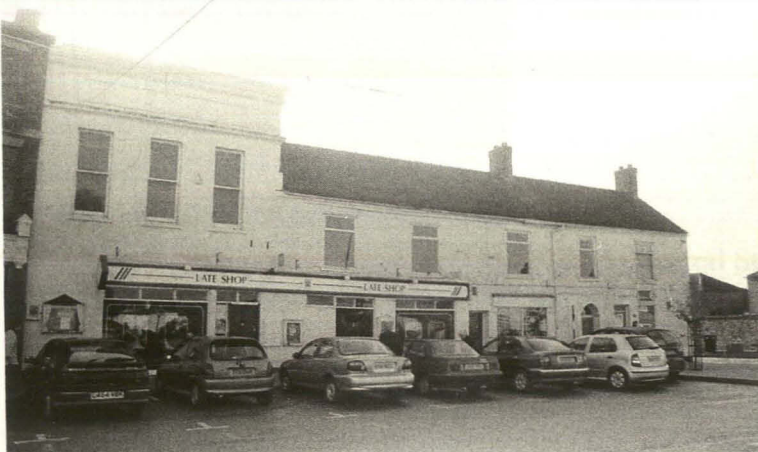
Architecturally, the street frontage of the buildings still retains much of its original form, though on the ground floor large store windows of perhaps the 1970s-80s significantly impact the appearance of the 19<sup>th</sup> century façade. However, despite this early modern disruption to the façade, the frontage of the buildings do have some limited local significance as part of the general streetscape.

Plate 2 Frontage of Recorded Buildings, looking south

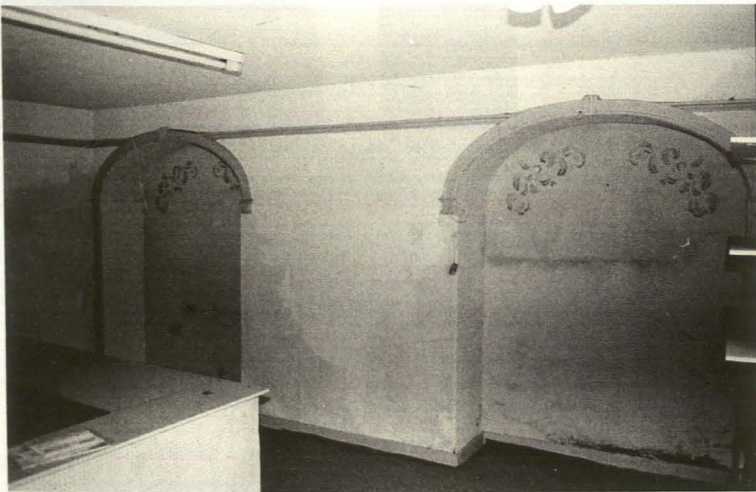
Plate 3 Detailed Interior View of West End Shop, showing arched alcoves and shop counter, looking southwest

There are indications of alterations to these houses prior to their conversion to the Co-Op complex. The building at the western end of the range had its ground floor fireplace blocked and was converted to a shop with the installation of a shop counter. Additionally, the central house also had its fireplace blocked and its doorway was infilled, though this may have occurred when the Co-Op store was created.

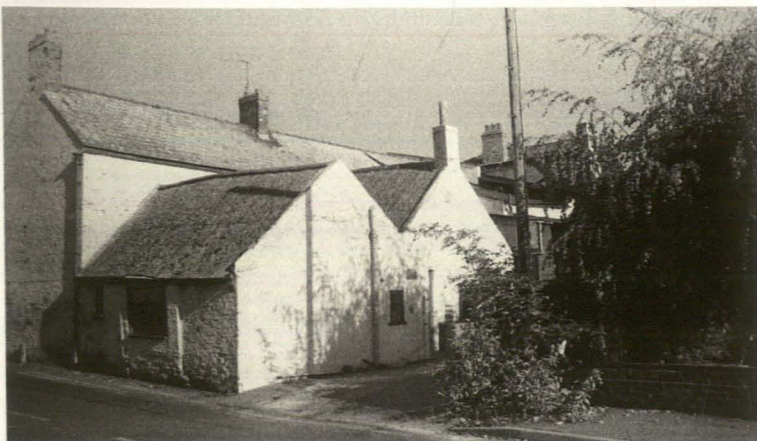
Plate 4 Single Storey Buildings to rear of West End Shop and Stairwell, looking northeast

The partially stone-walled building noted above forms a single storey extension to the rear of the western house and,

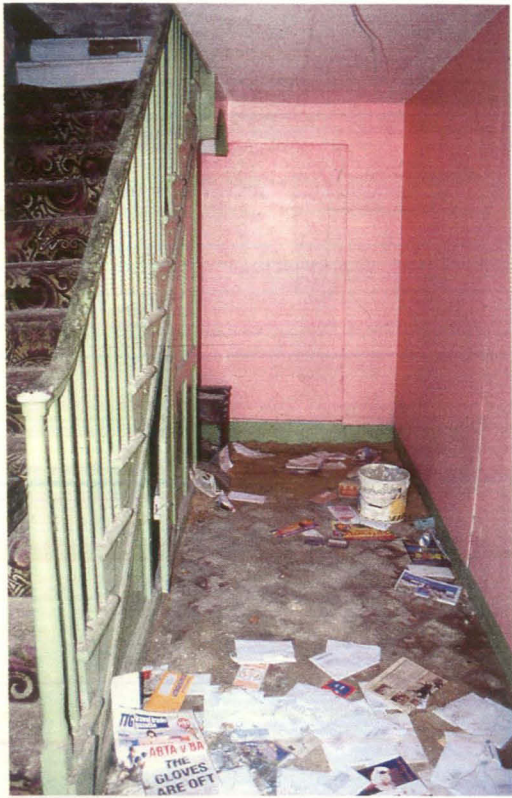
Entry to the stairwell compartment is through a doorway on West Street. This has a single centre arch and semi-circular fanlight. Within are the stairs up to the top floor and a quarry tiled passage running alongside the stairs (Plate 5). At its south end this passage gives access through an arch to a small storage area beneath the stairs.

Plate 5 Central Stairwell,  
looking south

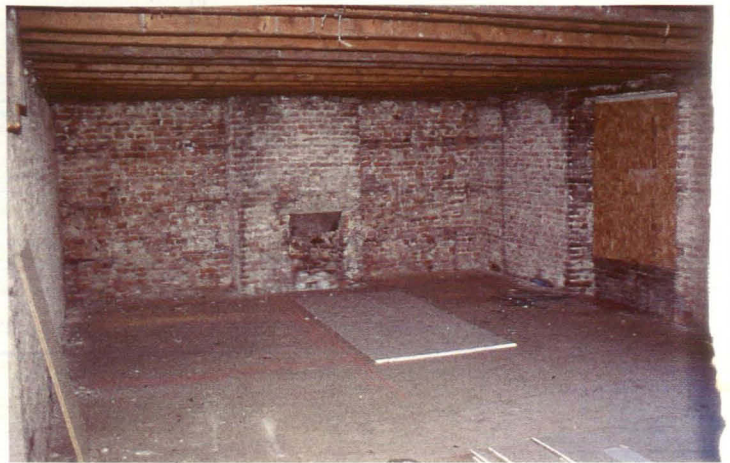
Above the western shop and stairwell, the upper storey comprises a modern boarded floor with an empty fireplace in the middle of the western wall. Either side of this fireplace are scars of removed shelving (Plate 6). To the west, but about 1.5m before the stairs are reached, there are scars of removed walls on both the north and south interior elevations.

Plate 6 Upper Floor, area of West  
End Shop and Stairwell, showing  
fireplace and scars of removed  
shelving, looking west

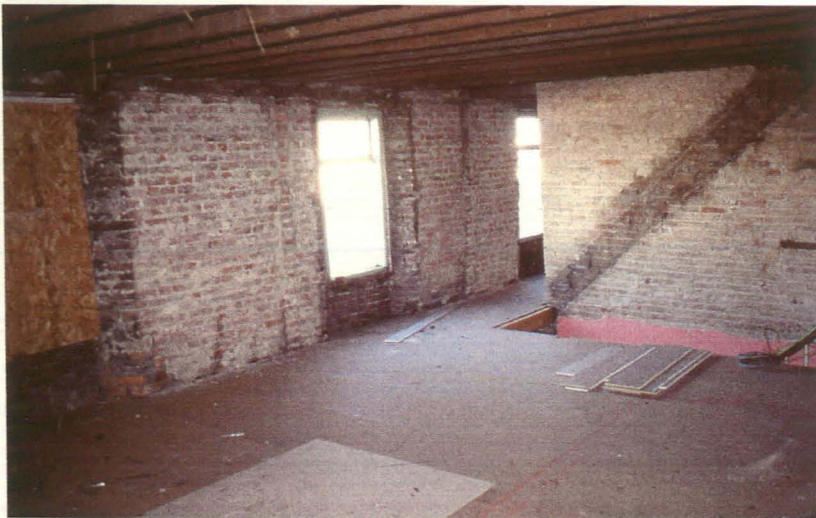
On the wall above the east side of the stairway there is a scar of a removed flight of stairs up to the attic (Plate 7). On the other, east, side of this wall is an open fireplace (Plate 8).

Plate 7 Upper Floor, area of West  
End Shop and Stairwell, showing  
scar of removed stairs, looking  
northeast

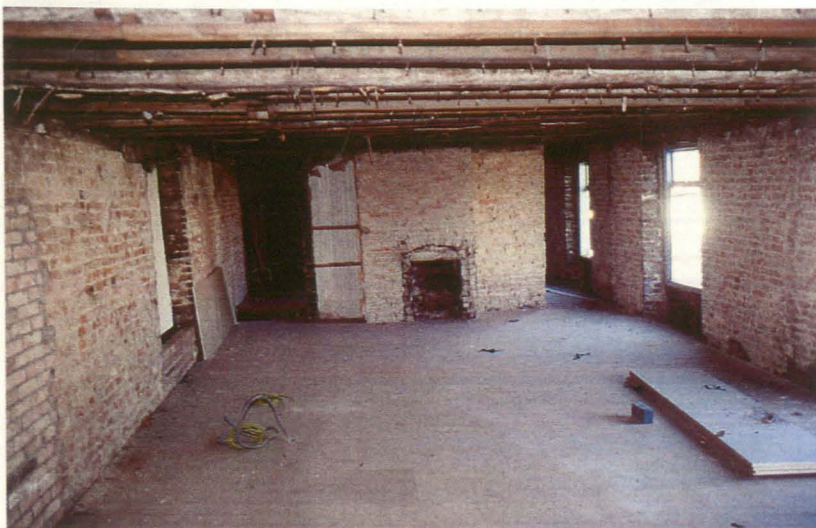
Plate 8 Upper Floor, area of  
eastern section of housing terrace,  
looking west

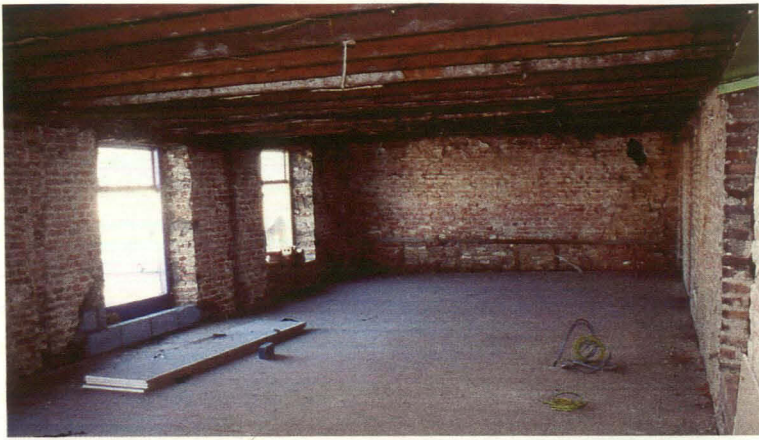
In the lower part of the east end wall of this upper storey is an area of timber lacing, employing apparently machine-sawn timbers (Plate 9).

Plate 9 Upper Floor, area of eastern section of housing terrace, showing timber lacing in east wall, looking northeast

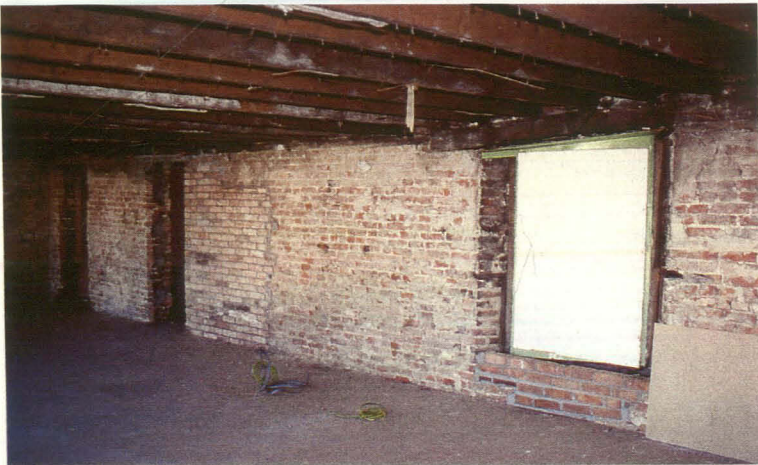
At the southeast corner of this top floor range are two entries to a small room to the south (Plate 10). There is brick blocking on the west side of the western entry. Within this small room there is a window in the west wall and several (five) straight or ragged joins in the south wall.

Plate 10 Upper Floor, area of eastern section of housing terrace, showing boarded window and entries to room to south, looking southeast

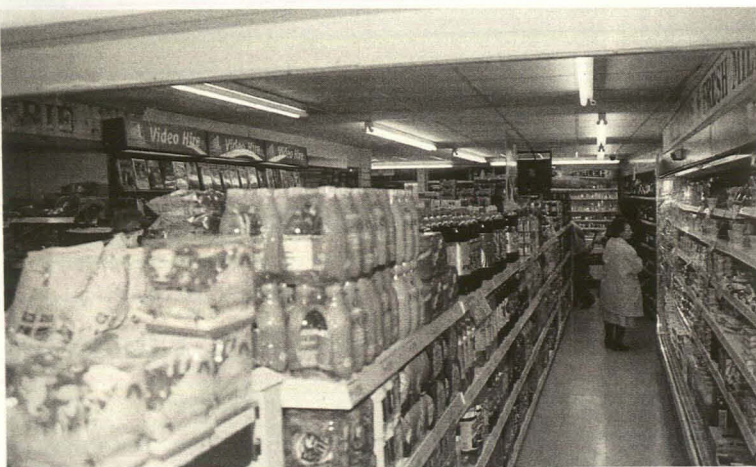
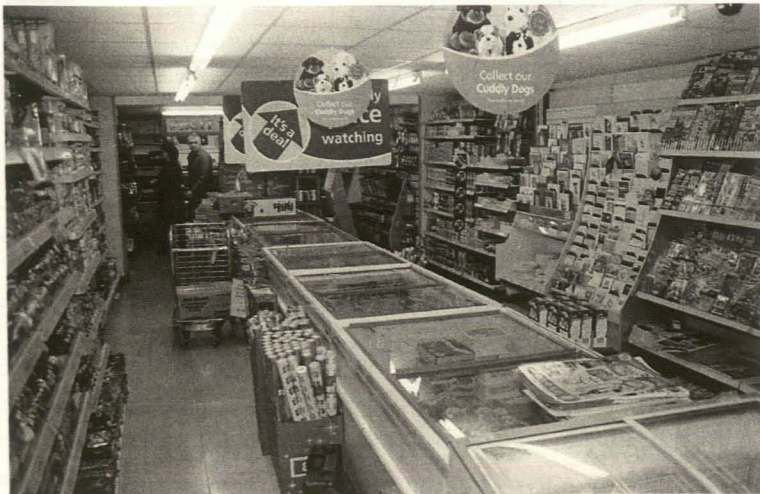
store is mostly open-plan with some supporting piers and short lengths of walling or wide openings between compartments (Plates 11 and 12). There is a rectangular projection in the west end wall of the shop that probably marks the location of a blocked fireplace. A second rectangular projection in a length of wall in the centre of the store may be another blocked fireplace.

Plate 11 Co-Operative Store Ground Floor Interior, looking south

Plate 12 Co-Operative Store Ground Floor Interior, looking east

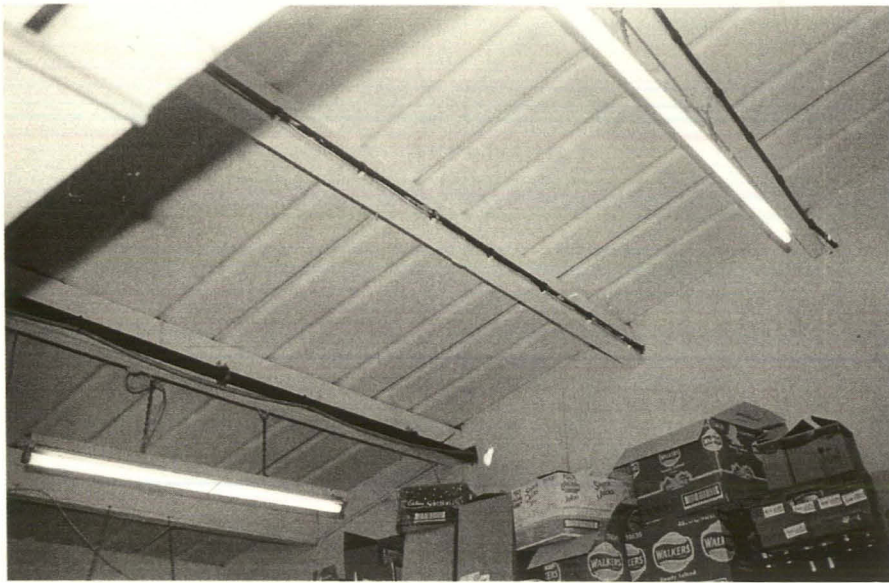
To the rear, and immediately west, of the retailing area are store rooms with concrete floors and concrete, or rendered, walls and a sheet steel roof (Plate 13). West of these are further stores and staff rooms. These single storey structures wrap around the south side of the central stairwell and west end shop discussed above. The store area south of the stairwell (Plate 14) has a fireplace with a glazed tile surround of probable early-mid 20<sup>th</sup> century date in the south wall. West of this store area is a staff room that lies to the rear of the west end shop. The room is mostly clad or rendered. There is a window in the west wall with the southern reveal being splayed. Although this wall is rendered internally, the exterior is of stone. Alongside this to the south is a much thicker section of walling, identified as brick on the exterior.

Plate 13 Sheet Steel Roof of Recent Extension to Store, ground floor, looking southwest

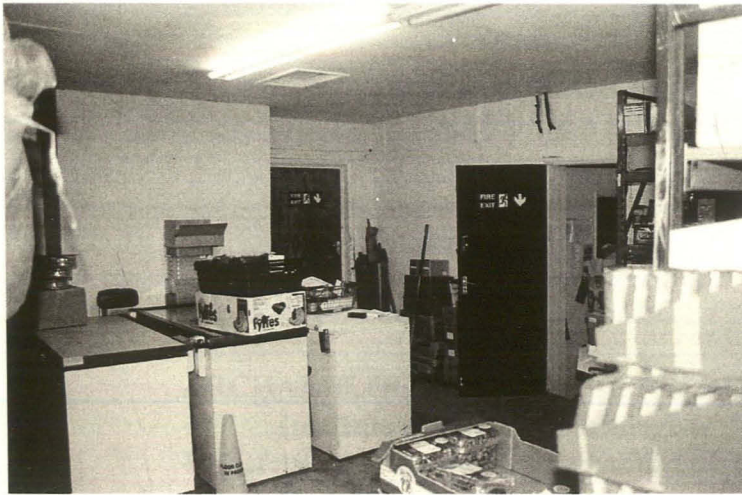
Plate 14 Store Area in Rear of Co-Op Store, ground floor, looking southwest

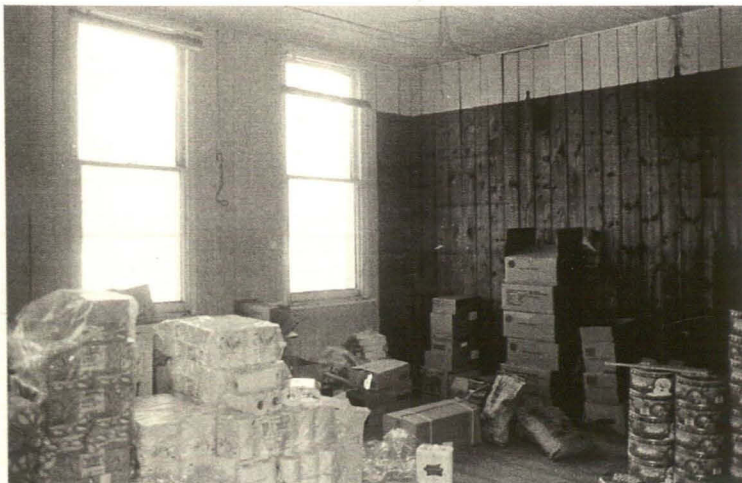
Toward the southeastern part of the store are stairs up to the top floor. This upper storey storage area is restricted in extent to the eastern part of the Co-Op store. This upper storey comprises a full width room on the north side, a small square room at the southeast corner with a blind corridor alongside, and the stairwell in the southwest corner. All the rooms are covered with planking, this panelling probably being early-mid 20<sup>th</sup> century (Plate 15). There are three recent sash windows in the north wall of the main room and a modern wide window in the south wall of the southeastern room. In the south wall overlooking the stairs there is a single centre arched window with red stained glass, probably of late 19<sup>th</sup>-early

Plate 15 Co-Operative Store, Upper Floor, main storeroom showing panelling, looking northeast

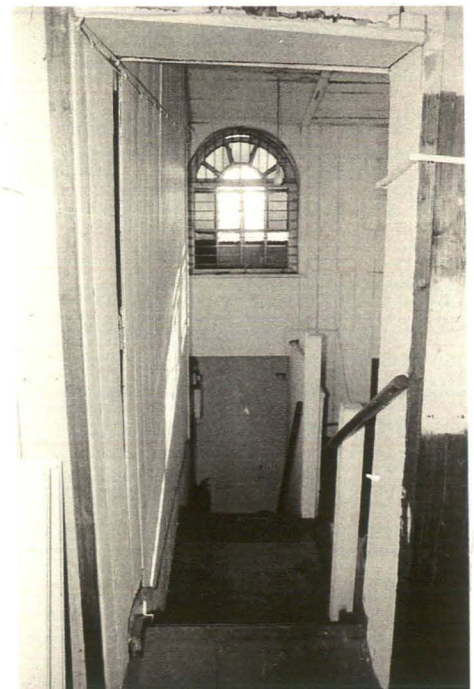
20<sup>th</sup> century date (Plate 16).

Plate 16 Co-Op Store Stairwell from Upper Storey, showing stained glass window, looking south
