**BUILDING SURVEY OF
FARM BUILDINGS AT
THE ELMS,
HUBBERT'S BRIDGE,
LINCOLNSHIRE
(HBE03)**

FRAMPTON PARISH

September 2003

A.P.S. Report No. 154/03

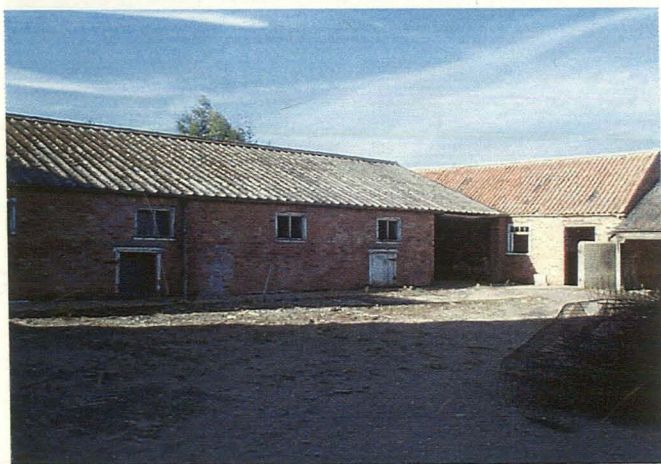
Set around a yard with the detached farmhouse to the east, the U-shape arrangement of barns comprises a southern and a northern wing linked by a north-south range on the western side (Plates 3-5).

Plate 3 General view of recorded barns from the northeast corner of courtyard, looking southwest

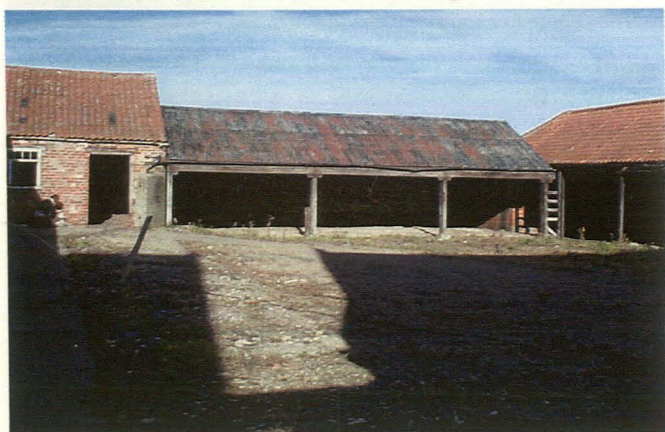
Adjoining the southern wing is a later north-south orientated machine made brick built structure, comprising four cells. This forms part of the western range (Plates 4, 14). All the rooms are open to the roof which is pitched and pantiled. All the rooms are floored with handmade bricks, with the exception of the northern stable which is floored with rough mosaic tiles.

Plate 4 North-south range, showing open barn, looking northwest

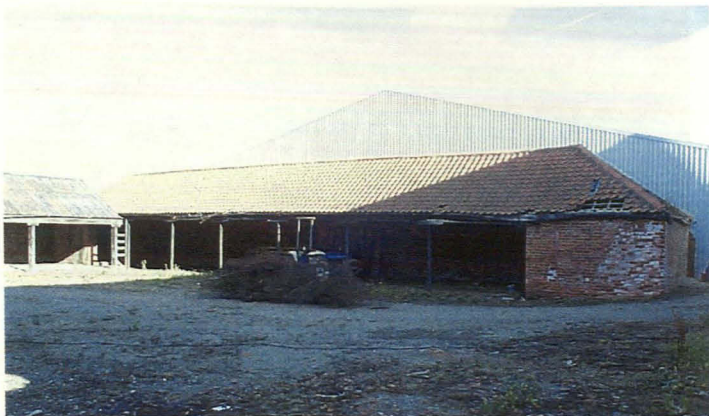
Plate 5 Northern east-west wing
showing open barn, looking
north

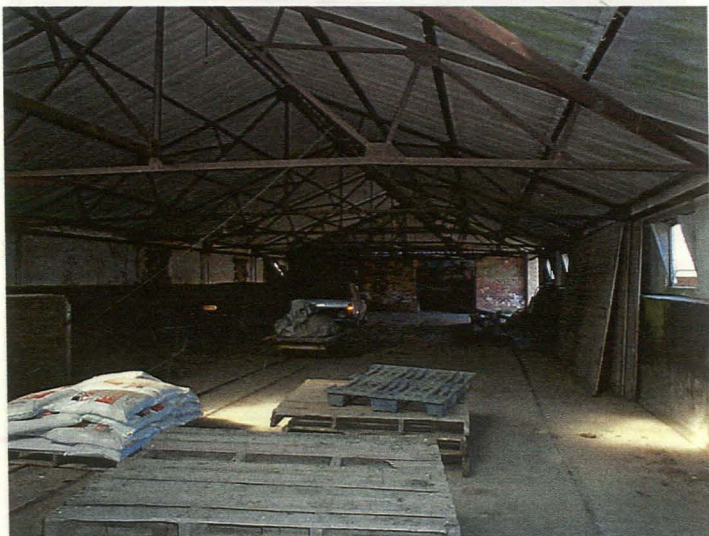
The buildings form a one-storey brick structure opened to its pitched roofs. The earliest phase was identified at the point where the southern wing joins the extension of the listed granary. The back, western, wall of the extension to the listed barn has previously been removed and replaced with two iron stanchions to support the roof. This removal of the back wall has enabled direct access to the main barn, and allowed the wheel tracks centrally inlaid into the main barn floor to form a continuous route into the listed granary (Plate 6).

drain immediately parallel to the southern elevation cut into the concrete. The barn is roofed with corrugated steel sheeting supported by five iron frames and cross bars (Plates 6, 7).

Plate 6 Interior of southern wing,
showing iron roof trusses in
main barn

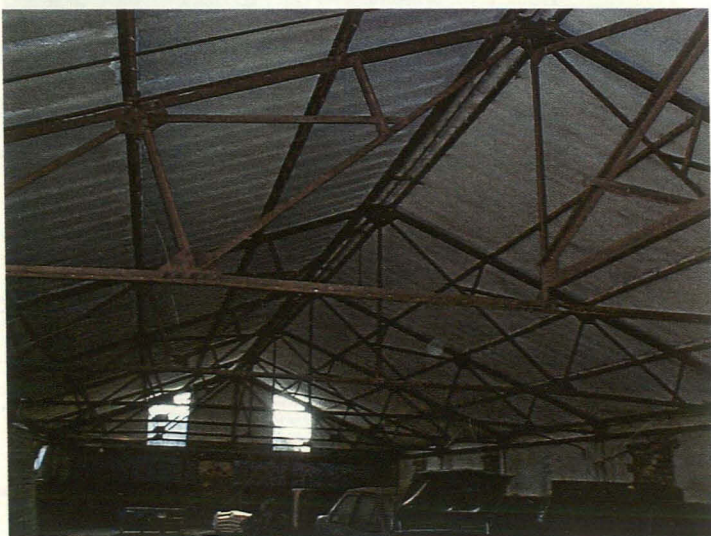
Plate 7 Detailed view of iron roof
trusses

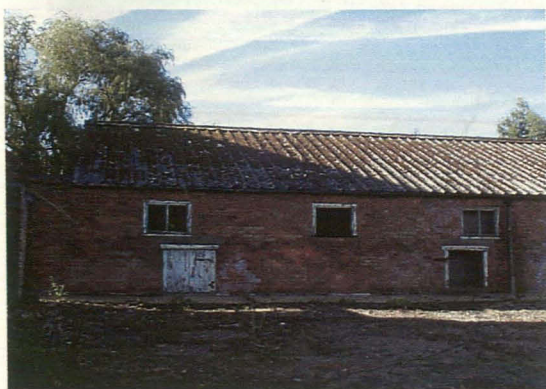
Plate 8 Window and lower hatch
door arrangement, northern
elevation of southern wing,
looking south

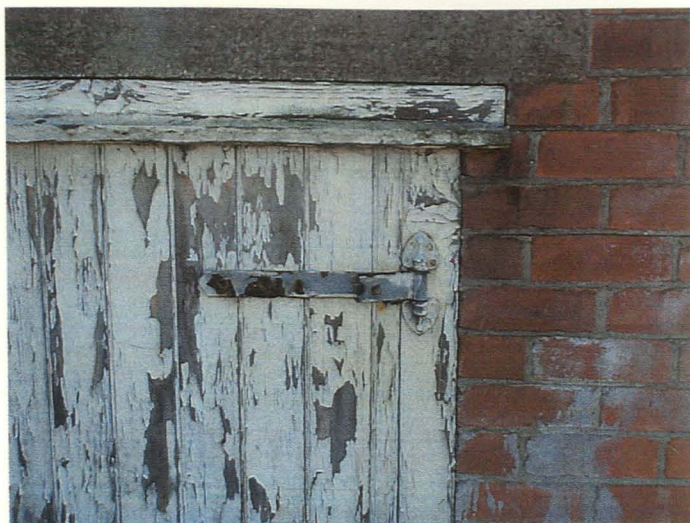
Plate 9 Hinge detail on lower hatch door of northern elevation of southern wing, looking south

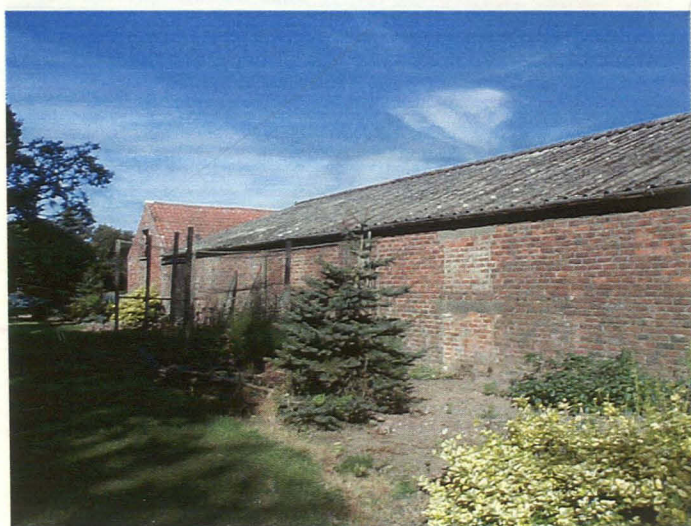
Forming the southern wing of the complex, the main barn shows several construction phases. The southern elevation (Plate 10) is constructed of handmade bricks with five windows and two lower half stable doors infilled with modern machine made bricks (dated to the second half of the 19th century or later). Located at the westernmost end of the main barn in the southern elevation is a timber hung sliding door (Plate 12).

Throughout the buildings there is considerable evidence of renovation having taken place, with many of the walls showing brick patching where windows have been infilled or where walls have been strengthened as a result of wear and tear.

Plate 10 Brick patching in southern elevation of southern wing, looking northwest

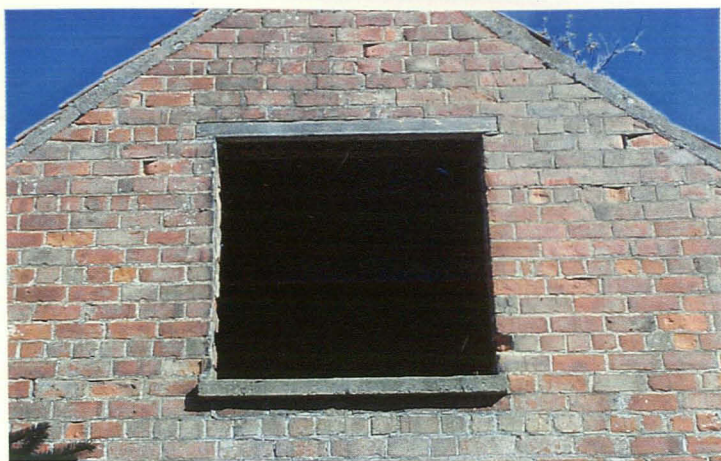
An opening with concrete sills where a possible window has been removed is present in the apex of the southern gable located in the southernmost cell (Plate 13). This cell is likely to have functioned as a store/chaff room as, unlike many of the other cells, there is no evidence of any cattle feeding troughs or tethering rings having been removed. An internal wooden door located in the northern wall provides access to the adjacent cell (Plate 15).

Plate 13 Removed window in
southern elevation of
western range, looking
north

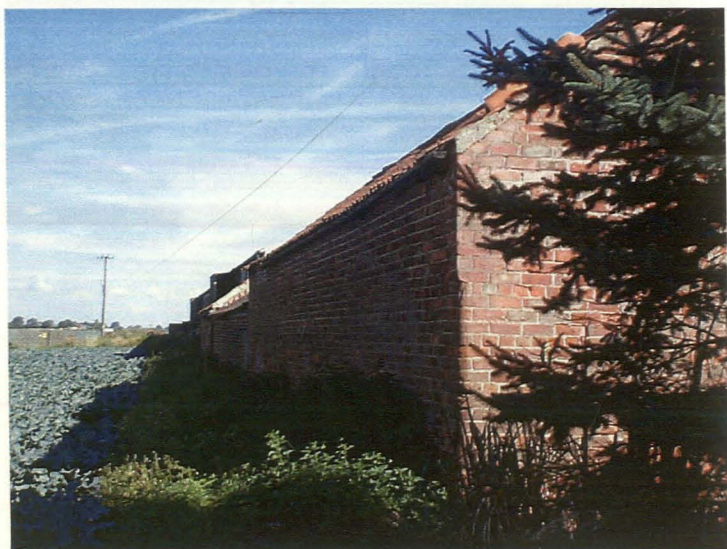
Plate 14 Western elevation of western
range, looking north-northeast

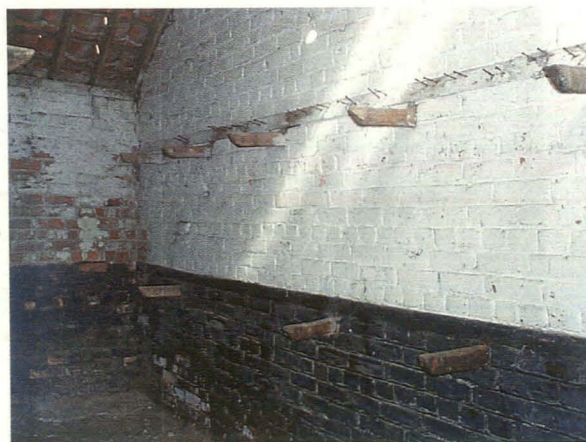
Like the previous two rooms, the next cell (the saddlery) can only be entered by internal doorways. A wooden stable door is located in the cell's south internal wall. A wooden framed window located in the eastern external wall faces out over the courtyard. Two rows of wooden pegs set into the brickwork on both the southern and northern internal walls form saddle racks, above which are bridle hooks (Plate 16).

Plate 16 Saddlery, showing saddle
rack and bridle hooks,
looking north-northwest

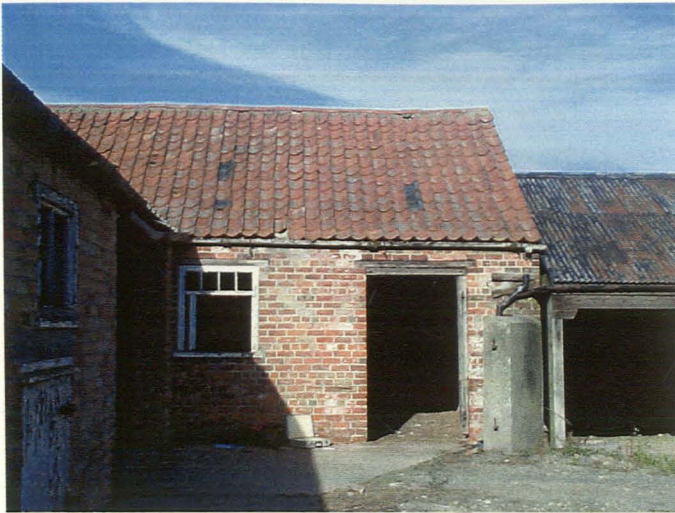
The final cell within the brick structure can only be accessed via the courtyard. The door has been removed and only part of the wooden frame remains (Plate 17). Rough mosaic tiles form the flooring material, with drains cut into the floor along the southern and northern edges. Along the back wall/western elevation, recesses cut into the wall indicate that a trough and a feeding rack have been removed. This cell would have functioned as a stable.

Plate 17 Western range, stable entrance and remains of wooden framed window, looking west

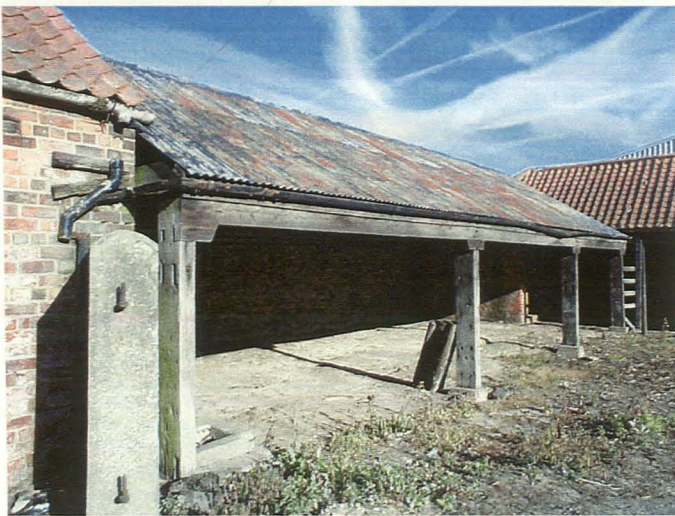
Abutting the brick structure to the north is a barn with an open side facing the farmyard (Plate 18). A straight join was identified between the southern brick structure and the back wall/western elevation of this open barn. The western wall shows evidence of a trough and hayrack having been removed in the form of recesses and scarring of the brickwork. Timber beams carried on timber posts support a corrugate steel roof (Plate 18). The timber posts have been reused from elsewhere and show a considerable number of peg holes and beam slots (Plate 19).

Plate 18 Western open barn/carhouse, showing roofing detail, looking northwest

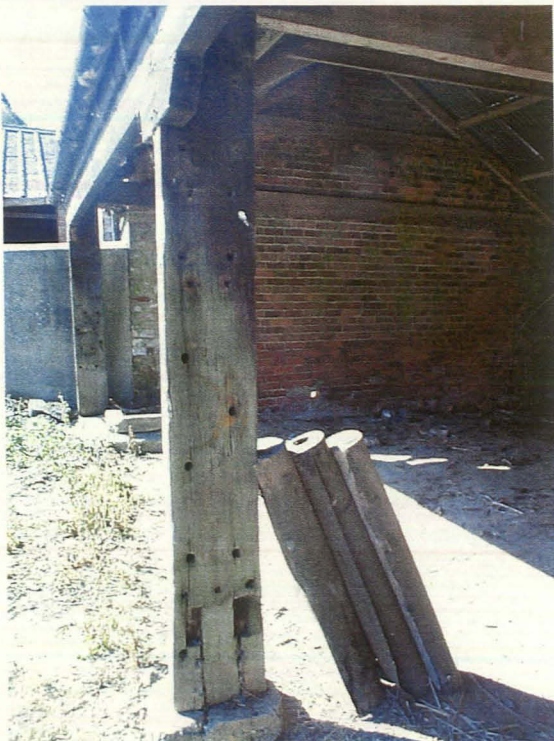
The reused beams supporting the roof at the frontage of the north-south range open barn are all marked by a large number of peg holes and beam slots. It is very likely that these beams have been reused from elsewhere in the farm buildings and have perhaps derived from the demolition/re-roofing of the barn.

Plate 19 Detailed view of reused timber beams, looking south-southwest

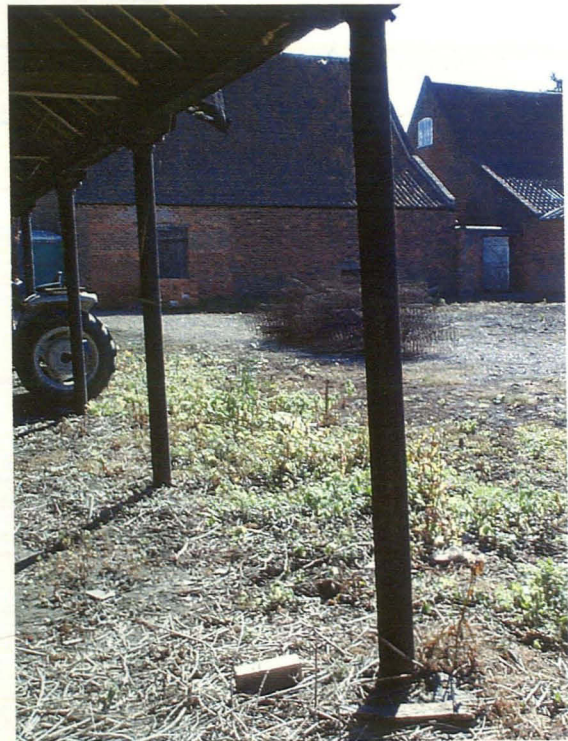
Plate 20 Iron stanchions supporting timber beam in the northern wing

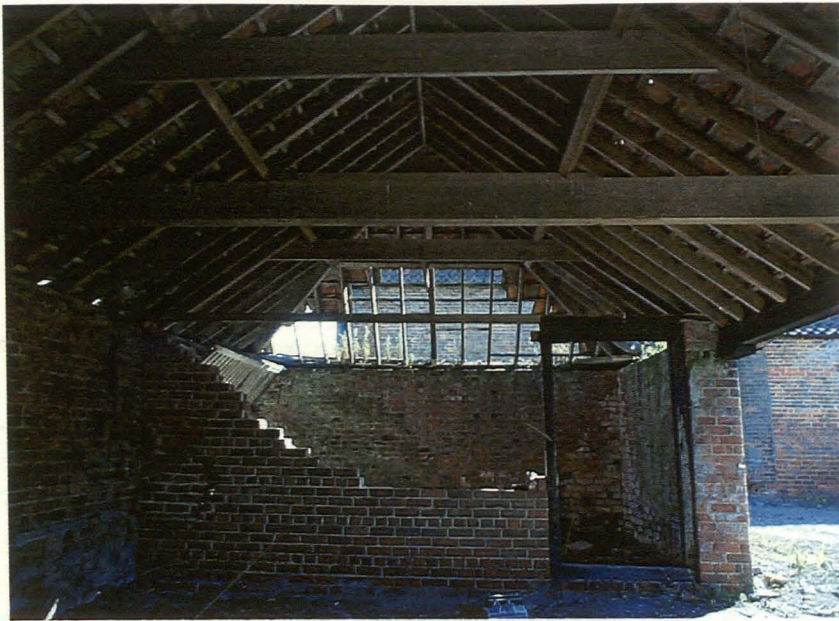
The eastern stable is in a poorer state of repair than the rest of the farm buildings, with part of the internal western wall has collapsed (Plate 21). The roof having suffered deterioration and part of the eastern wall and all of the southern wall have been rebuilt. The collapsed internal wall of machine made brick has been built up against an earlier handmade short brick wall (built to half room height). A wooden feeding trough and a hayrack remain attached to the northern wall (Plate 22).

Plate 21 Northern wing eastern stable, showing collapsed wall and detail of roofing, looking east

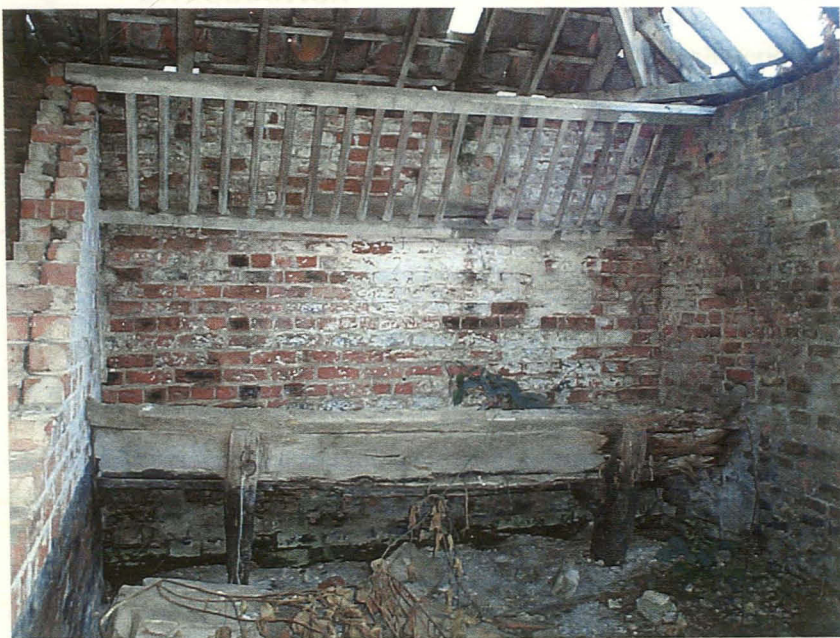
Plate 22 Feeding trough and hay rack in eastern stable, looking north

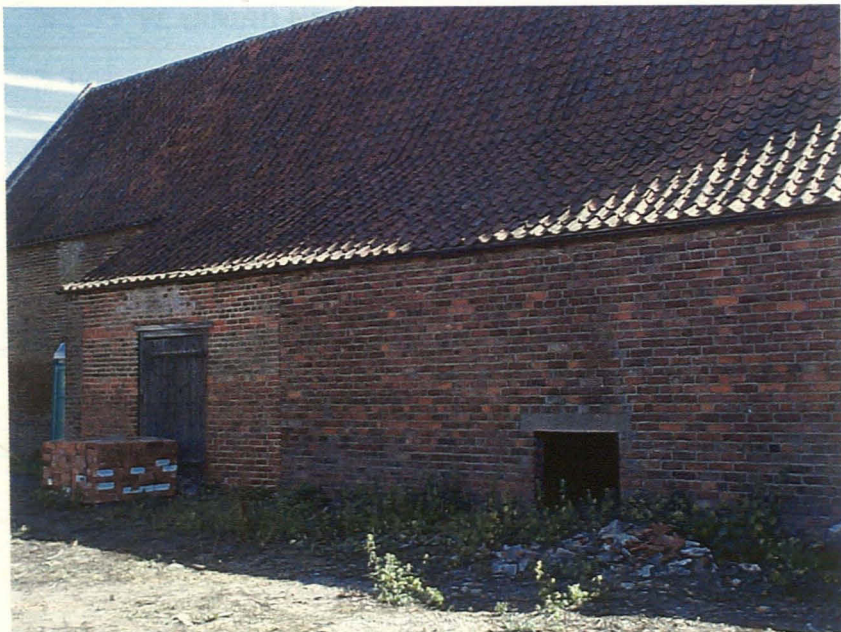
A note has been made of the half entrance in the rear extension of the northern listed granary. At present the opening consists of a half door (hatch) with a concrete lintel (Plate 23). This is to be heightened to allow for the addition of a full sized doorway, though no other structural work is to be undertaken at present to this building. A little to the north of this hatchway is a straight join in the brickwork and north of this junction is a narrow projecting bay containing a timber door.

The listed buildings are not included in the present scheme of conversion works and so have not been examined as part of this scheme of building recording. However, reference has been made to the small entrance hatch in the rear extension of the northern building which is to be heightened to form access to the cell (Fig. 4). To the north of this hatchway is a straight join in the brickwork that defines the northern limit of the extension and the south side of the original advanced entry bay of the barn (Plate 23). This hatch door,

which has a concrete lintel, is therefore located in the 20th century extension to the barn.

Plate 23 Entrance to rear extension of northern listed barn
