**SURVEY OF  
FARM BUILDINGS,  
130 WOOLRAM WYGATE,  
SPALDING,  
LINCOLNSHIRE  
(SWWY04)**

Work Undertaken For  
Holgate Maintenance Ltd

A.P.S. Report No. 178/04

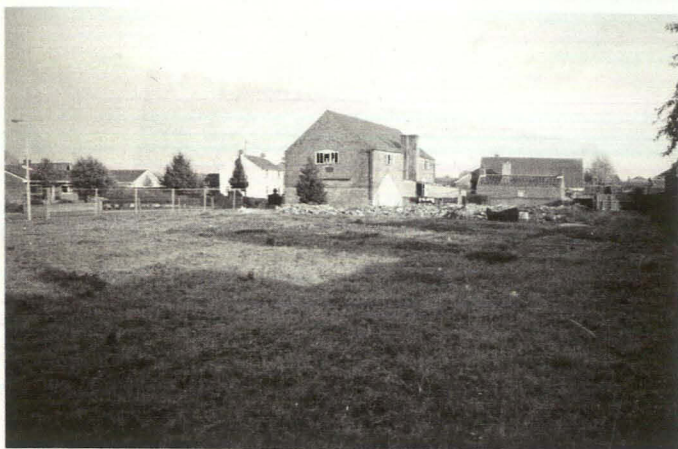
The main agricultural building still surviving at the site is a two-storey structure of machine-made brick with a slate roof (Plate 1). Glasshouses that were formerly alongside this building have been demolished down to ground level, leaving only their footings evident. A single storey

Plate 1 General site view, looking northeast

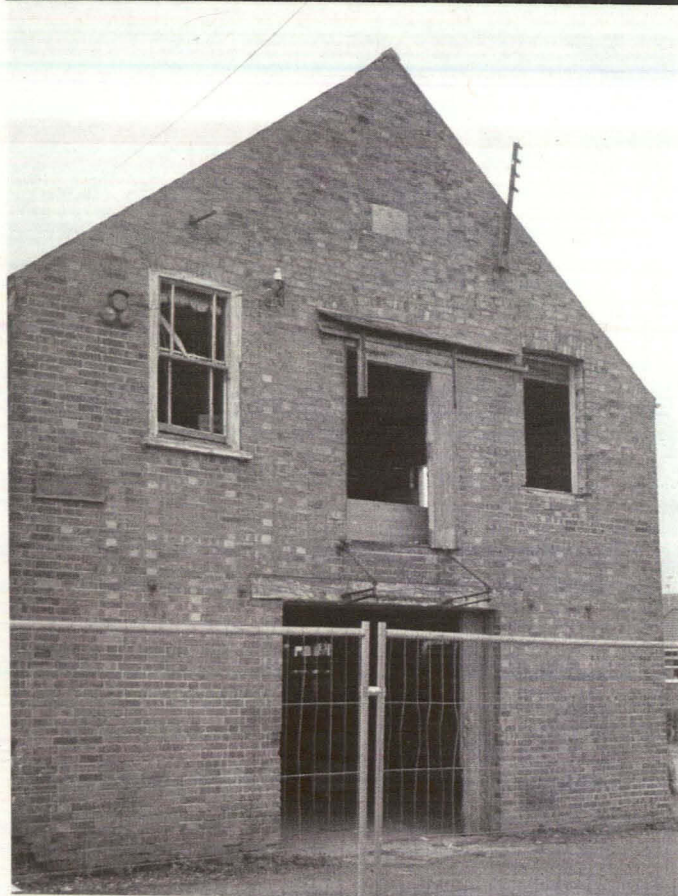
Elongated east-west, the main building is three windows wide with the entry at the eastern end. Double hung sliding timber doors fill this entry, which has a timber lintel to the opening (Plate 2). Over this is a metal framework that probably originally carried a weatherhood. In the upper storey of this eastern gable are two windows with brick segmental heads, with an entry (door) between them. This entry has an external hung sliding timber door and a brick segmental arch over. Above this entry, set high in the gable, is a worn sandstone datestone (Plate 3), inscribed:

Plate 2 Eastern elevation of main building, looking northwest

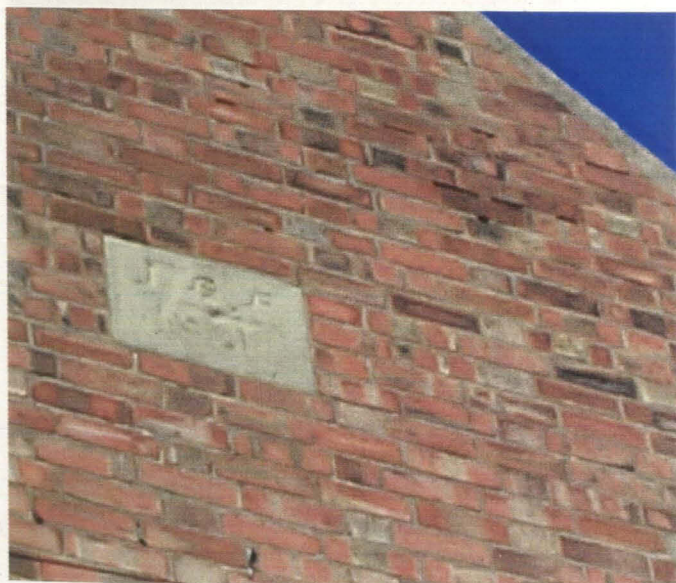
JGB

1931

Plate 3 Datestone in eastern gable, looking northwest

Examination of the buildings at 130 Woolram Wygate has shown that the main building has retained much of its external style and features as originally built. Moreover, the identification of a datestone above the entry confirms the building was constructed in 1931 and the initials relate to the Baxters, the owners of the site prior to its recent sale. The initials on the datestone refer to John George Baxter, who was recorded as a market gardener of Pinchbeck Road, Spalding, in trade directories of 1930 and 1933, but not in 1937 (Kelly's Directories Ltd).

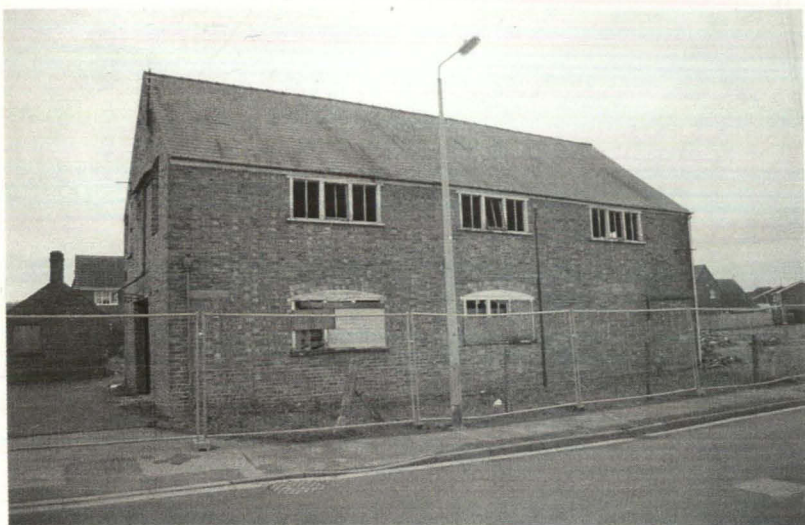
On the ground floor of the northern elevation are three wide windows with segmental brick arches (Plate 4). The most westerly of these windows is blocked with brick (Plate 5), while the other two are three-light windows, the central lights being pivoting sashes. There are three similar windows on the upper storey, their tops just below the gutter (Plate 4).

Plate 4 Northern elevation,  
looking southwest

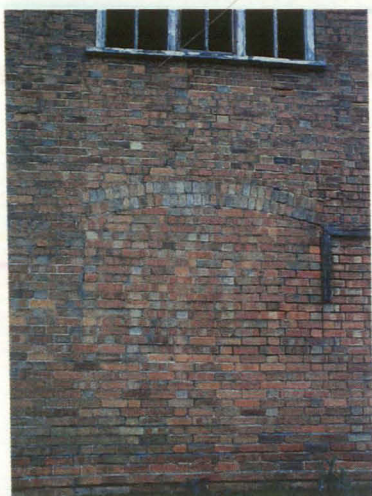
Plate 5 Northern elevation,  
blocked ground floor  
window, looking south

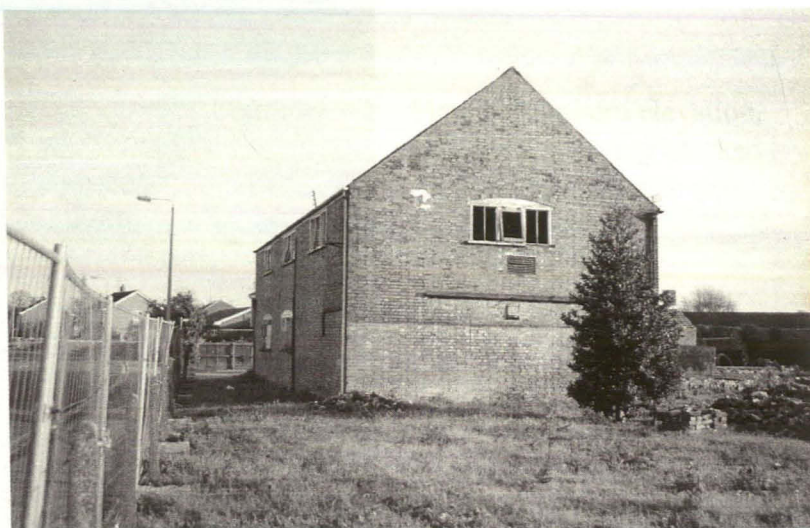
The western gable has two wide windows, one on each floor and both with segmental brick arches (Plate 6). Brick blocking infills the ground floor window, with a small ventilator fan set in the upper part of this blocking (Plate 7). The upper storey window is of three lights, the central being a top-pivoting sash. Between the two windows is a large ventilator grill.

Plate 6 Western elevation,  
looking southeast

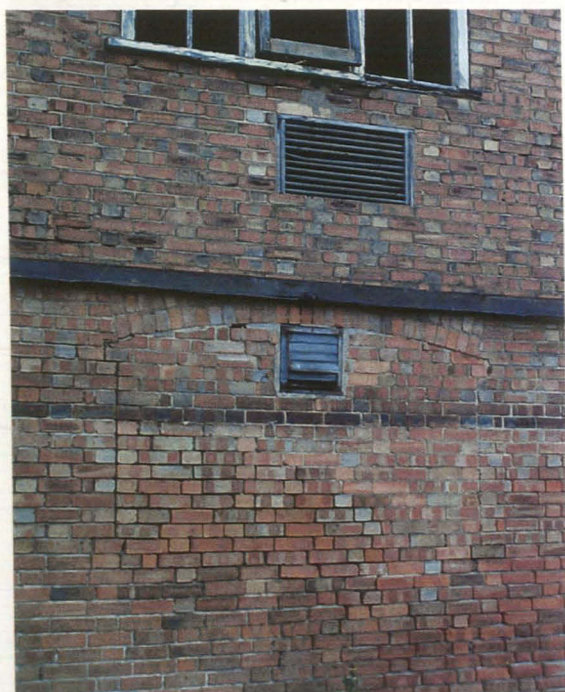
Plate 7 Western  
elevation, blocked  
window, looking east

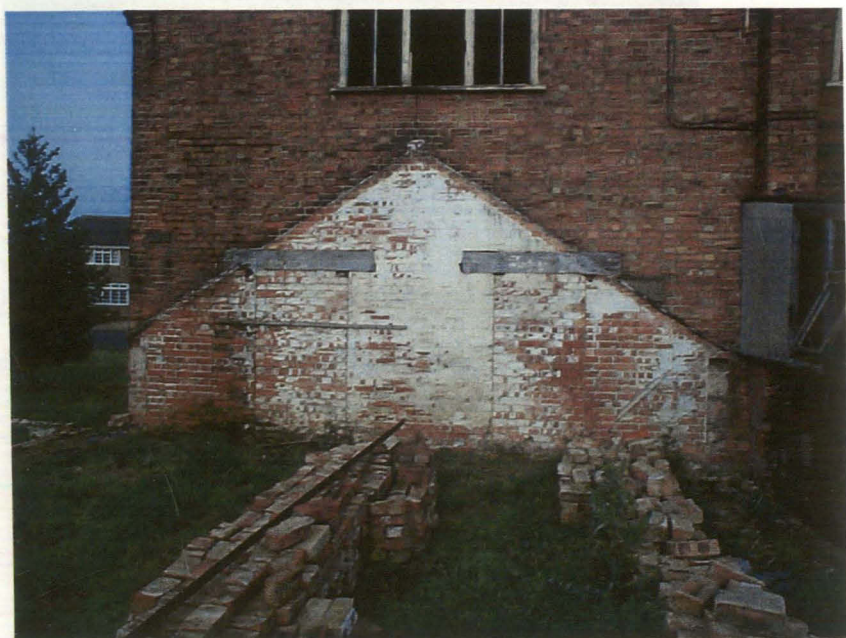
doorways, both blocked with brick and having substantial timber lintels (Plate 9). There is also the scar of a single storey extension that butted against the main building and projected to the south. In the upper storey is a wide, three-light window, as on the northern elevation. Beyond the chimneys, the eastern side of the elevation is virtually identical to the western part, except that the ground floor doors are still in place and the lintels to these are smaller (Plate 10). Additionally, here the single storey extension to the south, which now survives as a scar, was bonded into the main range. There is also another three-light window located centrally on the upper floor, but partially obscured by the eastern chimney (Plate 8).

Plate 9 Southern elevation, west side, showing blocked doors and glasshouse scar, looking north

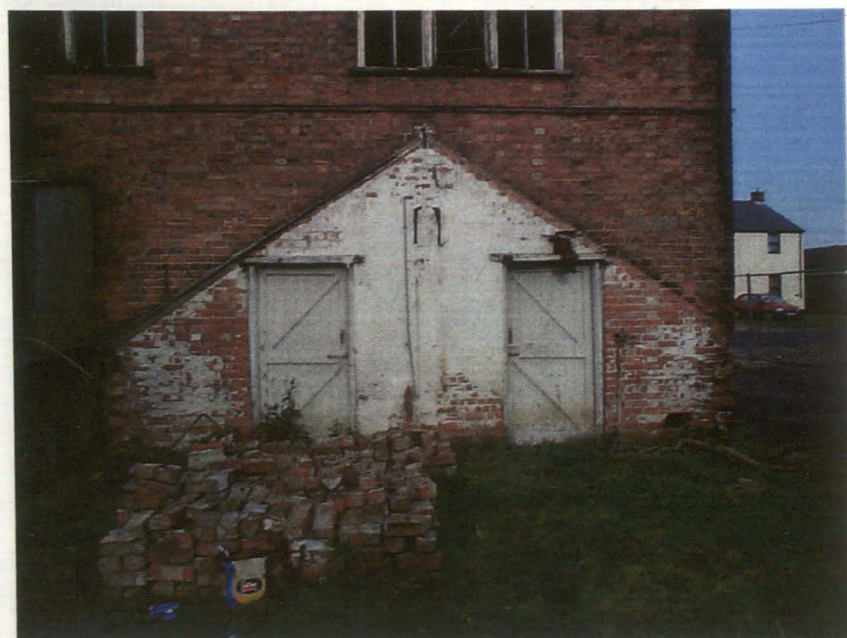
Plate 10 Southern elevation, east side, showing doors and glasshouse scar, looking north

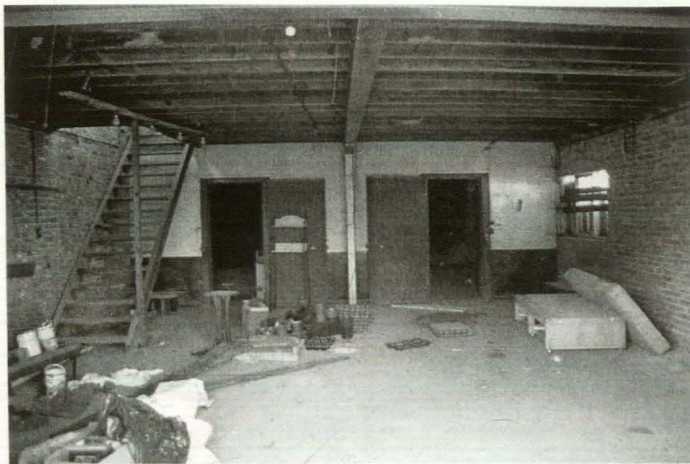
At ground level, the interior of the building is divided into two compartments. The eastern half (Plate 11) has a concrete floor and two rolled steel joists (RSJs) set in a T-pattern support the floor of the upper storey. One of the beam joists is supported by a further, vertical, RSJ. Sections of pipes survive in various areas, including alongside the joists supporting the ceiling (Plate 12). Additionally, a row of hooks alongside the north wall probably originally carried a pipe (Plate 13). Access to the upper floor is via a stairway of timber steps in the southwest corner of the room (Plate 11).

Plate 11 Interior, east room, looking west

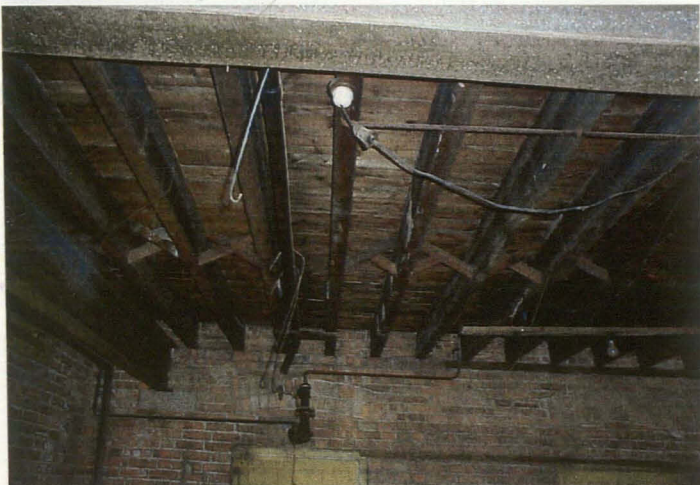
Plate 12 Interior, east room, showing joists to upper floor and hanging pipes, looking south

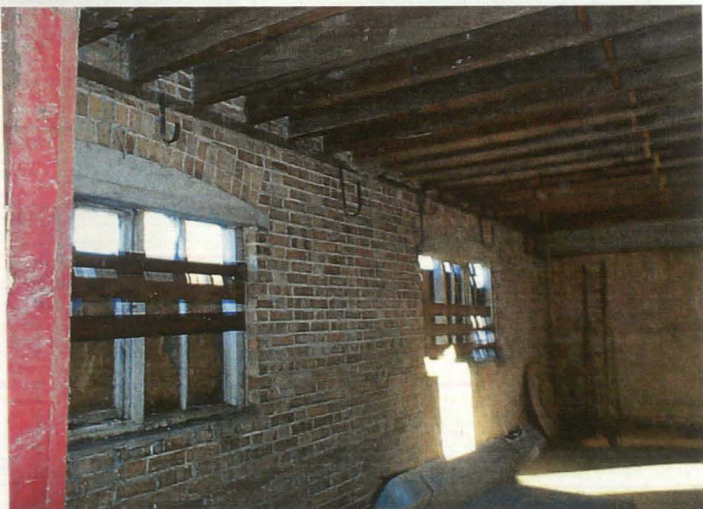
Plate 13 Interior, east room, north side, showing pipe suspension hooks, looking east

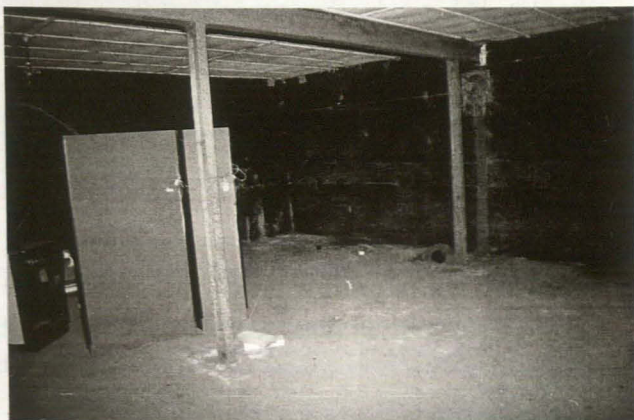
A north-south wall containing two doors separates the east room from that to the west. This wall slightly overlaps the edge of the middle ground floor window in the north elevation. There is a concrete floor to the western room and a single RSJ crossing the room east-west to support the floor of the upper storey. Two vertical RSJs hold up this beam (Plate 14). The interior of this room has been clad internally with concrete and no features are evident, other than a ventilator fan in the west wall.

Plate 14 Interior, west room, showing RSJ beam and supports, looking southwest

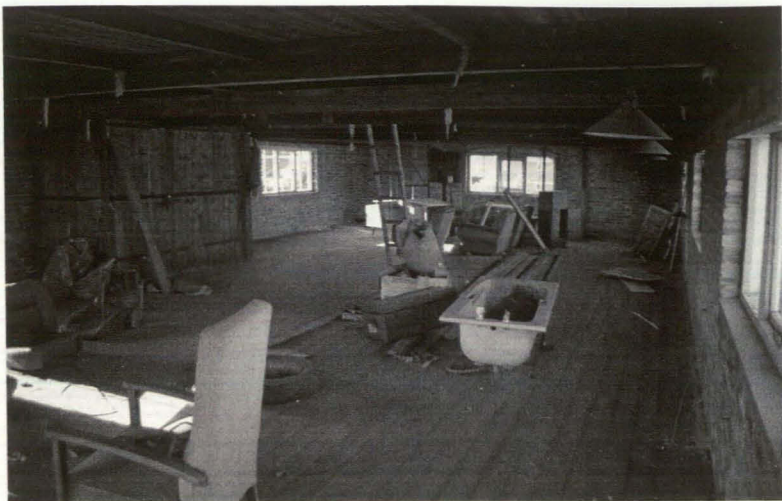
The upper storey is a fully open plan room except for the stairwell compartment (Plate 15) and a small, fenced housing for an electrical engine at the west end (Plate 16), alongside the large ventilator grill (which is visible from the outside). Much wood has been used in this upper floor and there are some vertical timbers in the southeast corner that indicate the former presence of an office compartment (Plate 17). There are also two separate attic spaces, to each end of the building and both accessed through small doors in their vertical faces (Plates 18 and 19). Between the two attics the upper floor is open to the rafters.

Plate 15 Interior, upper floor, showing staircase housing on left, looking southwest

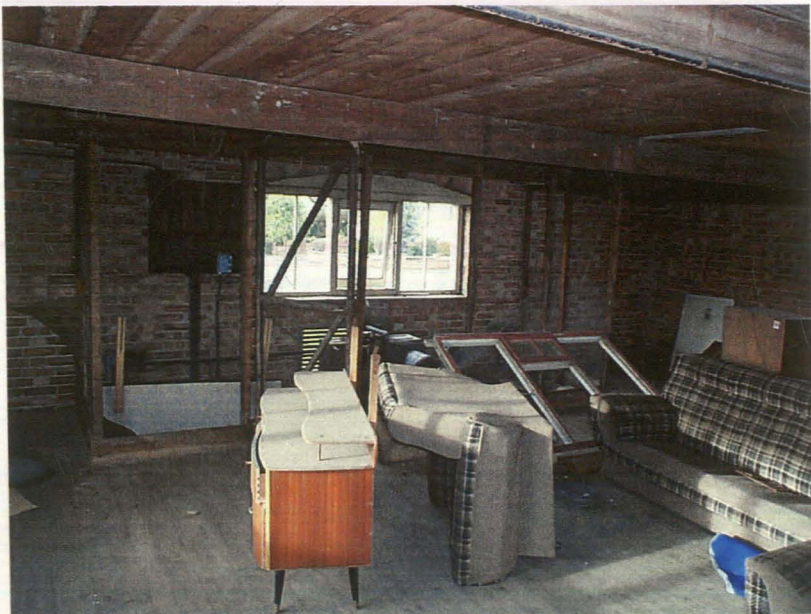
Plate 16 Interior, upper floor, west end, showing cage around mechanical equipment, looking southwest

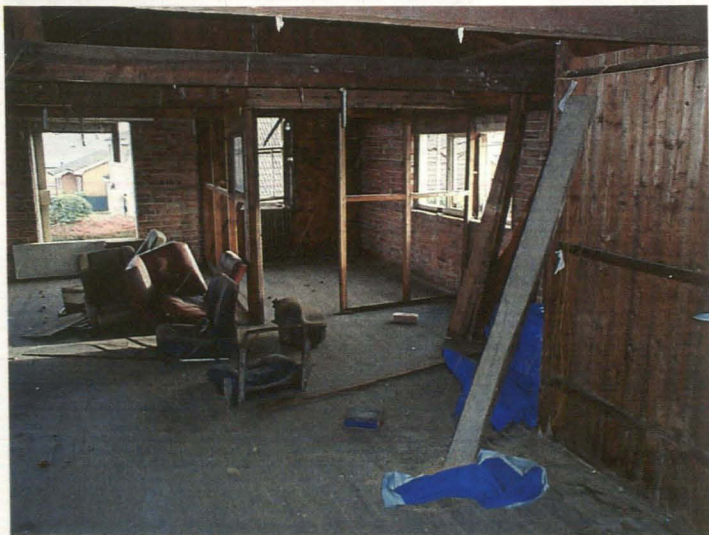
Plate 17 Interior, upper floor, east end, showing timber uprights from office compartment in far corner, looking southeast

Stairs led to an upper storey that perhaps served as a further storage area, though it also had a small compartment installed as an office. This upper storey was well lit by large windows on each elevation. Additionally, a doorway in the eastern wall suggests that there was a facility for loading and unloading directly between the exterior and upper storey. However, there is no sign of a jib for this and the presence of a projecting weather shield, indicated by a metal framework over the main entry, would probably provide an obstruction to such loading operations. Above the wooden ceiling of the first storey is an attic that may have been used as a further darkened storage area.

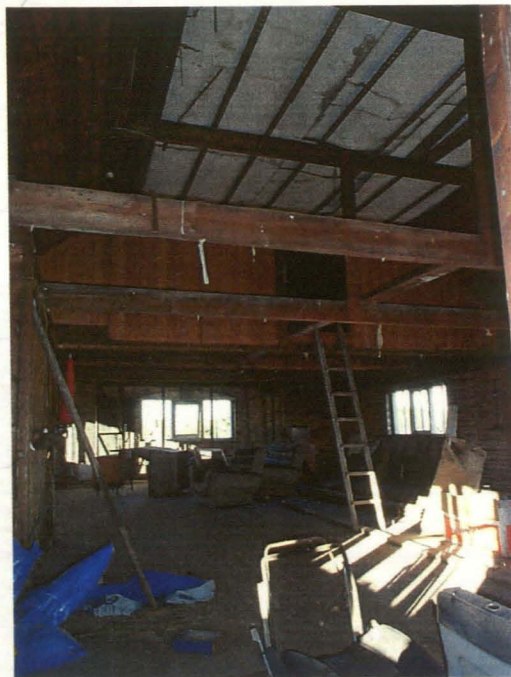
Plate 18 Interior, upper floor, showing western attic, looking northwest

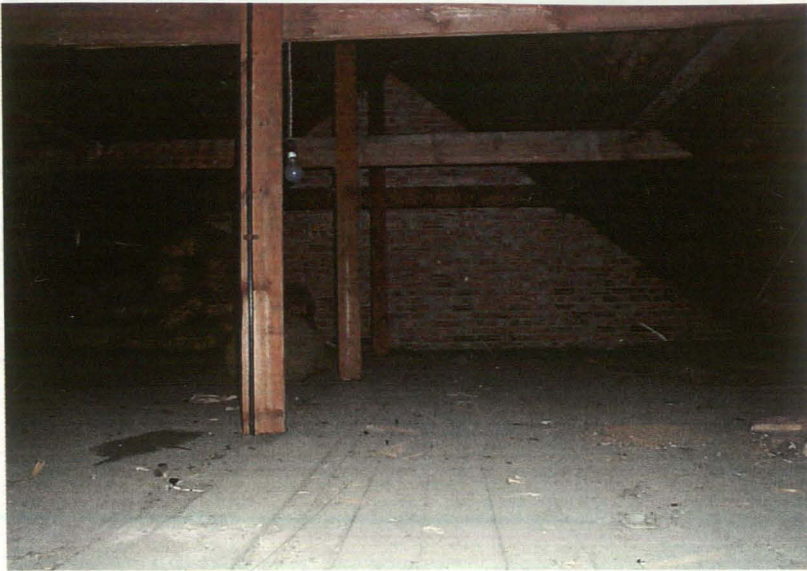
Plate 19 Interior, western attic, looking west

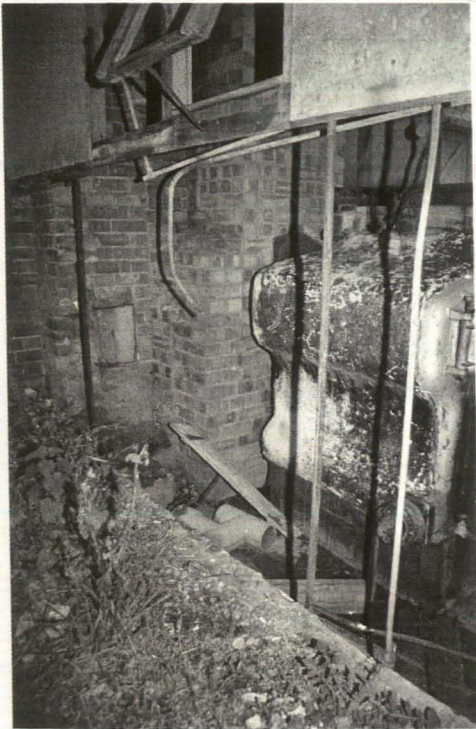
In the middle of the south side of the main building are the two chimneys, mentioned above. The western chimney is the smaller of the two and straight joins, together with the nature of construction, show this to be the earlier, with the eastern chimney later built against and around it (Plate 20). The heater is still plumbed into the eastern chimney (Plate 21).

Plate 20 Chimneys, showing straight joins, looking northeast

Between the sites of the two glasshouses on the south side of the main building is a boiler house containing a heating unit and two chimneys. This boiler would have provided heat to the two adjacent glasshouses and, via pipes, the main building. Straight join relationships, together with other aspects of the construction, show the larger, eastern chimney to be the later of the two. This eastern chimney replaced the western and allowed a larger heating system to be installed. Although the western chimney

was made redundant it was not taken down, probably due to the risk of damage to the glasshouses. The eastern chimney, which partially blocks one of the upper floor windows, still has the boiler/heating unit plumbed into it.

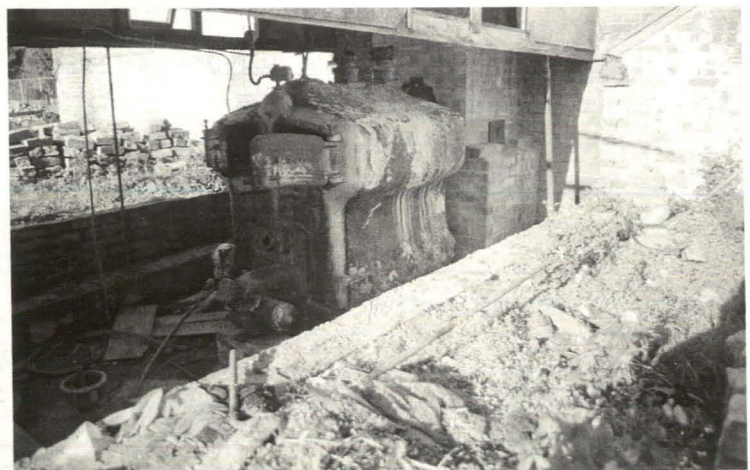
Plate 21 Boiler house, showing heating unit plumbing into eastern chimney, looking northwest

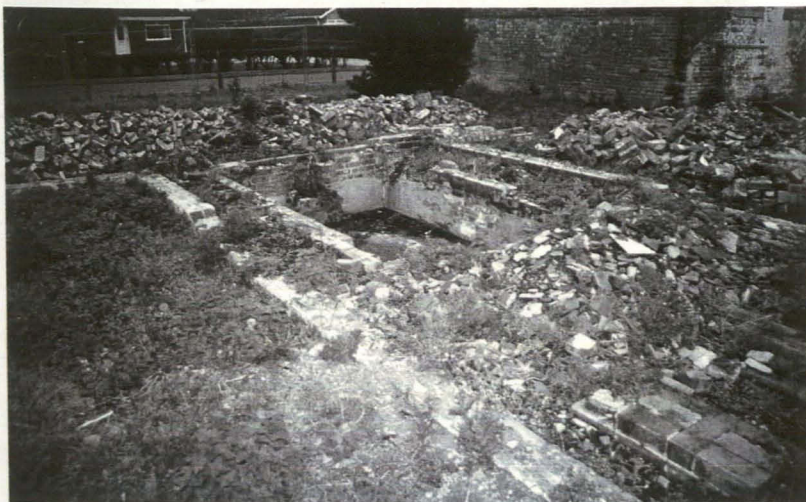
most westerly sets of glasshouse footings, at their northern end, is a sunken boiler/heater house with remnants of the chimney base on the north side (Plates 22 and 23).

Plate 22 Area of western glasshouses, showing remnant walls and boiler house, looking northeast

Two further glasshouses had been located immediately to the west. Between this pair is another sunken boiler house with the remnants of a chimney base. However, all the greenhouses were demolished some time ago and all that remains are their foundation walls.

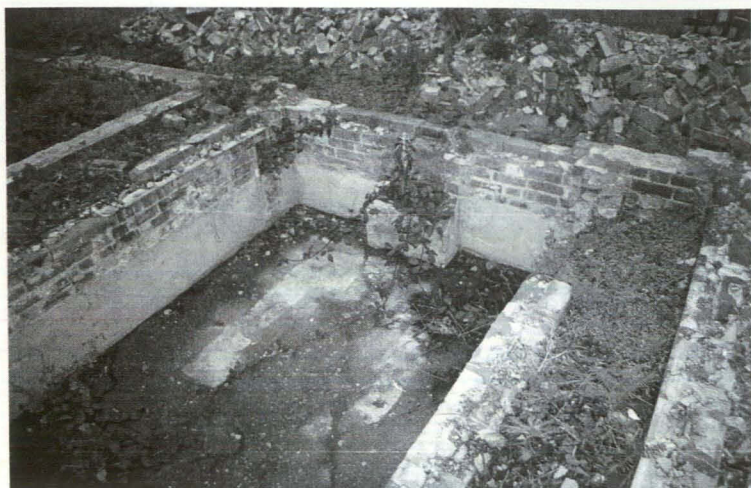
Plate 23 Boilerhouse between western glasshouses, showing chimney base, looking northwest

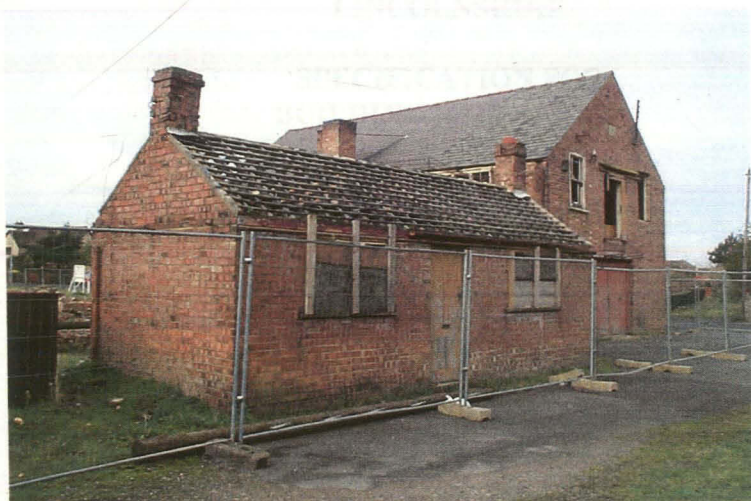
On the east side of the most easterly glasshouse footing is a single storey north-south building. There was no internal access to this structure. Entry to the building is notionally through a centrally placed timber door in the eastern elevation (Plate 24). There are windows to either side of this door but both are blocked. There is a further, small, blocked window in the western elevation (Plate 25), and a normal-sized window, also blocked, in the eastern part of the north gable, this latter window having a flat arch of brick (Plate 26). Chimney stacks are evident in both the north and south gables, the southern gable being otherwise plain.

Plate 24 Single storey building, east and south sides, looking northwest

Alongside the most easterly glasshouse is a single storey building. There was no internal access to this structure and, consequently, it is of uncertain function. However, chimneys are located in each gable and imply the presence of fireplaces, or perhaps heating systems, within.

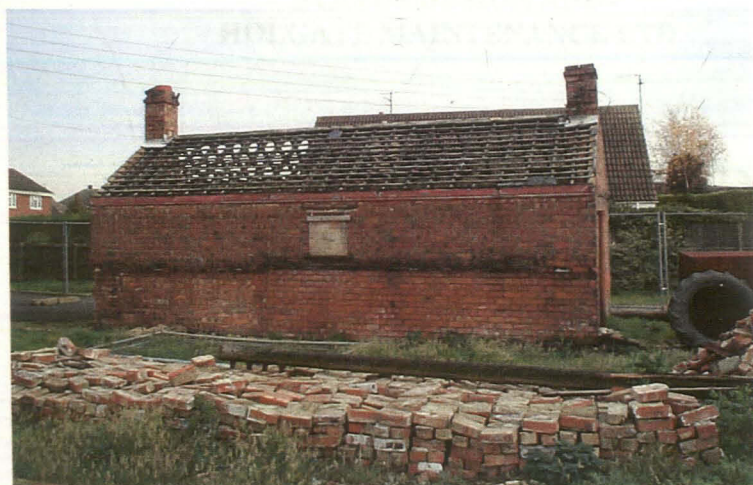
Plate 25 Single storey building, west side, looking east

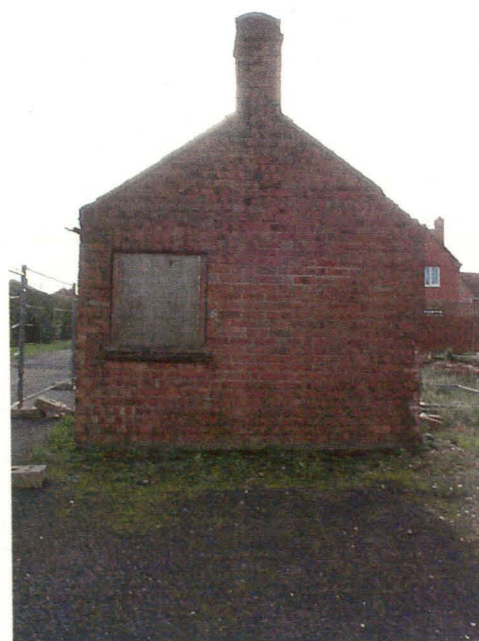
Plate 26 Single storey building, north side, looking south
