**BUILDING SURVEY OF
FORMER JOHNSONS' SEED WAREHOUSES,
LONDON ROAD,
BOSTON,
LINCOLNSHIRE
(BLR02)**

Work Undertaken For
Quadrant Chartered Surveyors

January 2003

APS Report No. 15/03

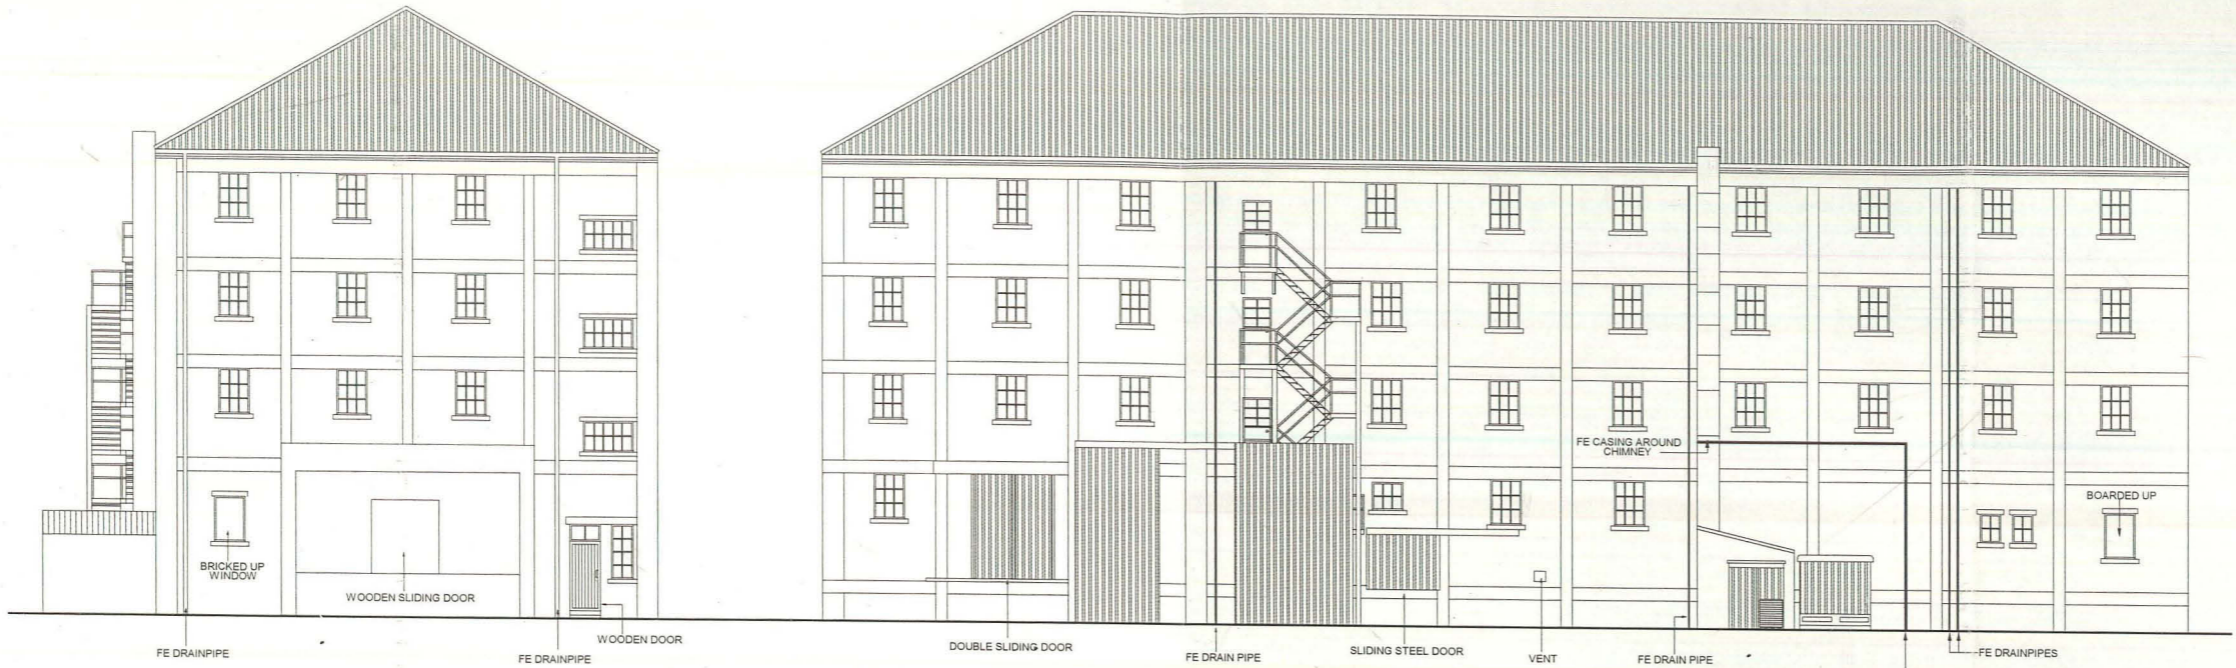
Figure 3: Warehouse 1, the external elevations

The warehouse is a 4-storey brick-built structure in a concrete frame, with a corrugated pitched roof (Plate 1 and 8). It is elongated north-south, 11 window bays long and 4 window bays wide. The

In the east elevation, the fourth bay has a sequence of doors at each storey (Plate 3 and 7). An external steel staircase provides access to these doors. The base of the staircase is encased in a steel surround (Plate 6). Further access into the lower level of the building is provided through three sliding steel double doors at ground floor level.

Between the 7th and 8th bays is an external chimney encased in a steel frame (Plate 3). At the base of this chimney an additional small brick-built shed provides access to the chimney and further storage. Immediately adjacent to this is an electricity sub-station (Plate 5). Prior to the construction of the former two structures an earlier building abutted bay 8 and 9 of the warehouse, to the level mid-way in the first floor. The purpose of this structure, which is now only represented by a scar on the warehouse wall, is unknown. Three vertical iron drainpipes were noted along the elevation (Plate 8).

The western elevation is very similar to the eastern elevation, with the windows being almost identical with the exception of the 1st bay, which is vacant of any windows. There is also no window in the ground floor of the 2nd bay. A major difference in this elevation is that there are no access points into the warehouse, via doors or external stairways.

The northern elevation is divided into four bays. Large wooden sliding doors extend across the central two bays of the ground floor, providing loading access to the interior. The windows contained within the first three bays are identical to those in the other elevations. The fourth bay has its windows offset lower from the rest and laid horizontally. A wooden door with a two-panel window opens from the ground floor of the fourth bay (Plate 2).

The southern elevation differs from the northern in that it is divided into three larger bays (Plate 4). Each has a nine panel window. An additional small wooden door is present in the area beneath the ground floor.

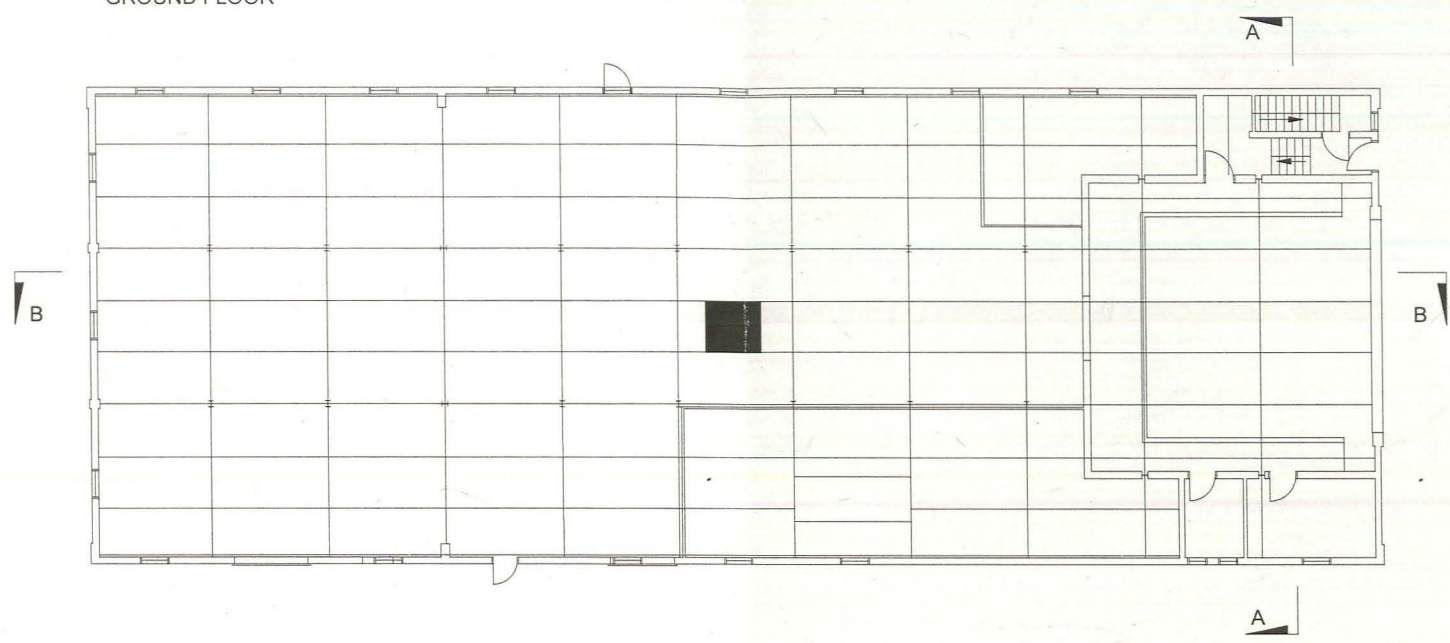
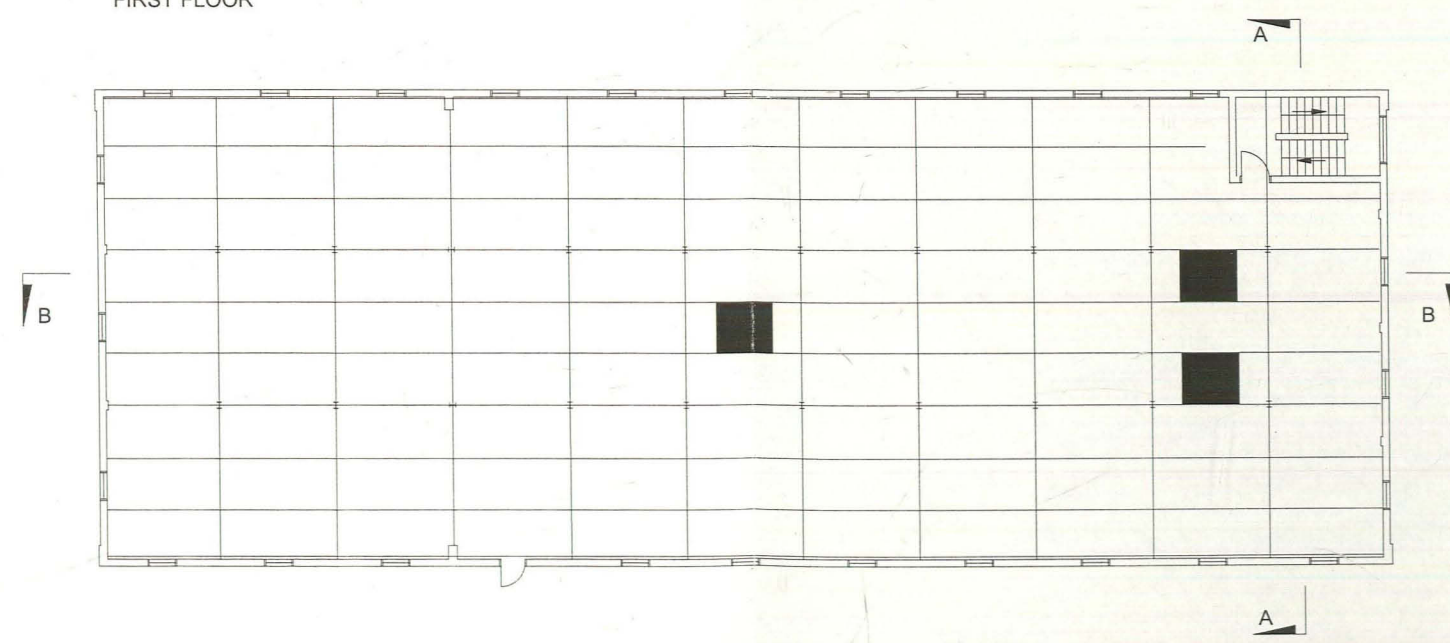
Figure 4: Warehouse 1, ground and first floor plans

The warehouse has four floors. The interiors have been part gutted, removing any evidence of former function. The ground floor is based with concrete; all other storeys are timber floored. The central aisle of each floor has 20 parallel upright I-section RSJ's, supporting the ceiling and the floor above (Plates 9-11).

A sack hoist was centrally located and extends through all the floors. Two further sack hoists were located at the southern end of the building within the central aisle from the first floor upwards. Each sack hoist's set of trap doors was partly enclosed by a case of planking. The sack hoists were operated by a crane mechanism (Plate 10).

A concrete stairwell, located in the southeastern corner of the warehouse, provides access to all floors. The ground floor displayed the remains of two recent internal timber partitions, which created an additional two rooms.

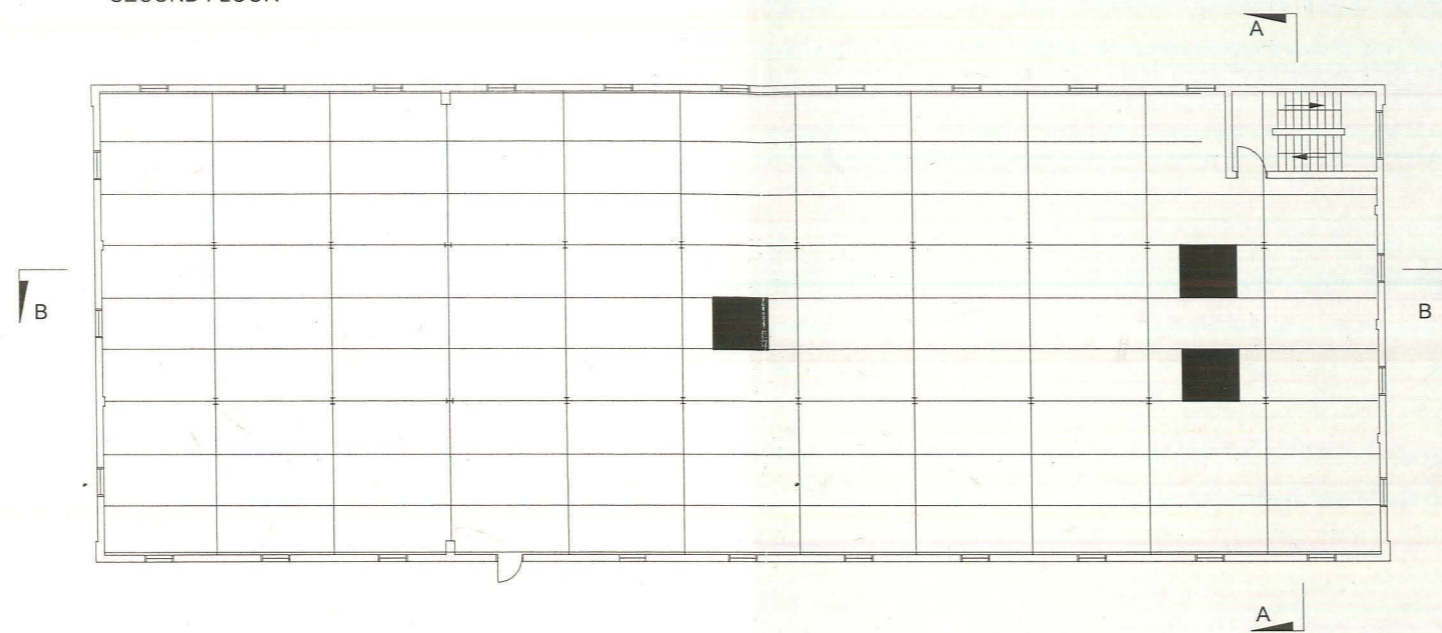
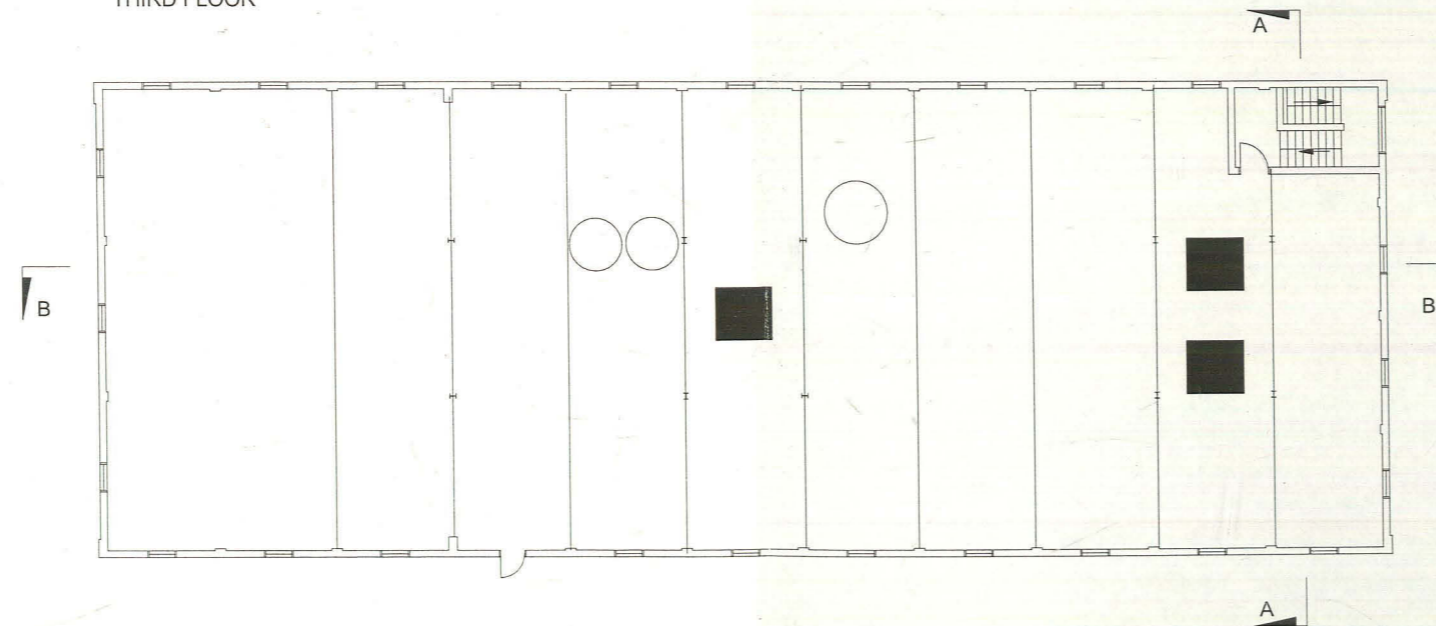
Figure 5: Warehouse 1, second and third floor plans

Three steel silos are located in the roof space on the third floor. Along with these

are larger steel uprights supporting 12 steel roof trusses (Plate 12).

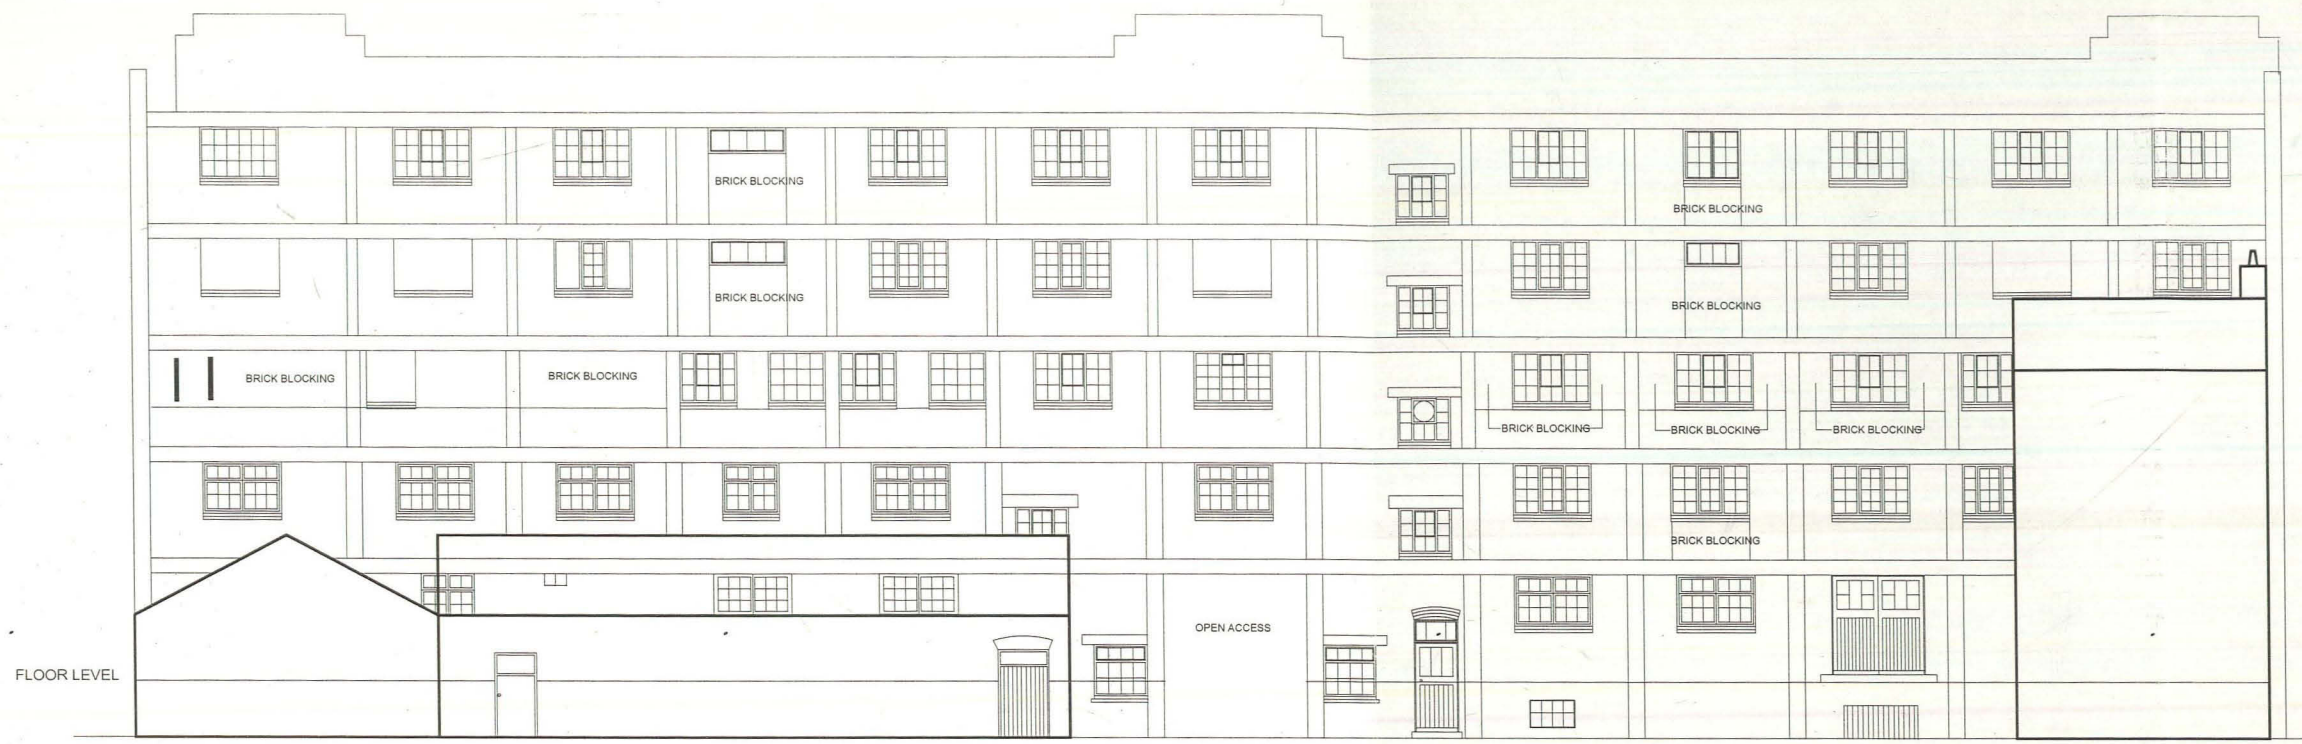
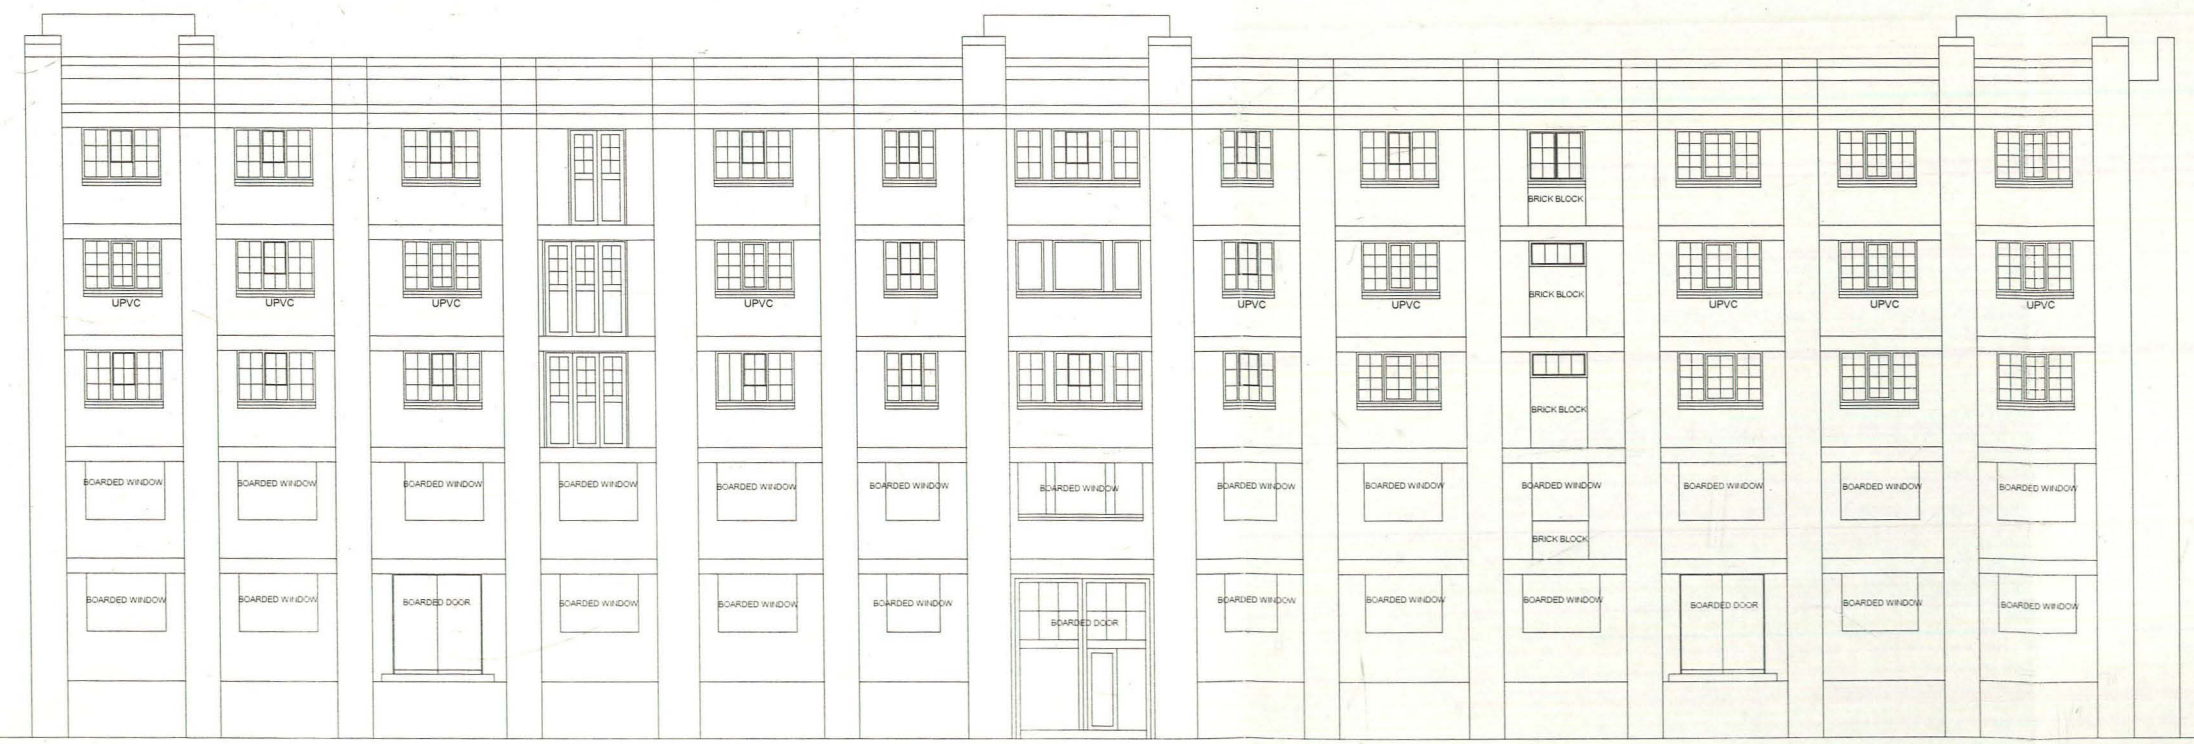
Figure 7: Warehouse 2/Stells Lane, north and south elevations

The second warehouse is a five storey brick built structure in a concrete frame with a basement. The warehouse is elongated east-west where it is divided into 13 bays. The east and west elevations are divided into three bays. Unlike Warehouse 1 the roof is flat with an upstanding architrave along the top of the northern elevation, and metal railings along the top of the other elevations. Located centrally on the flat roof is a wooden shed, that houses the sack hoist mechanism (Plate 21).

The northern elevation is the only elevation with a road approach, from Stells Lane, this is reflected in the more impressive façade with the additional architrave along the top and the imposing central bay (Plate 20). The windows in the ground and first floor are boarded up. However, from internal examination, these windows are of the same character/design as those present on the second-fifth floors. Two boarded doors are also present on the ground floor in the 3rd and 11th bays. Generally the windows are 16 or 18 panes and are a mix of wooden and UPVC frames with the third floor frames being entirely replaced by UPVC. The central bay is more ornate than the rest, with the windows being 24 panes. The fourth bay has a sequence of wooden doors with glass panelling in the top half. There is however no external staircase present providing exterior access to these doors. A large boarded up central door provides drive-in

access to the warehouse. Windows on the first to fourth floors of the 10th bay are set in blocked doorways, to which there is no surviving external stairway.

The southern elevation is in the main a mirror image of the northern (Plate 13), though in general is less impressive without the large windows of the central bays. There are also additional structures at ground floor level.

The second floor appears to have had considerable external alteration, with several of the bays having had brick blocking and bays 1 and 3 having no windows at all (Plate 19).

The symmetry seen in the northern elevation does not exist in the less impressive southern elevation with the windows of bay eight being completely offset lower and smaller.

Two sets of doorways on the upper floors of both the northern and southern elevations (in the 4th and 10th bays) would

clearly originally have had access to external stairways that have since been removed. Following their disuse as means of external access, the doors in the 10th bay of the northern elevation and both bays in the south face were mostly blocked up and replaced by windows.

Two doors in the north elevation (3rd and 11th bays) gave access to the ground floor of the warehouse but are set well above the exterior ground level. These doors must have been provided with external stairs that have since been removed.

Numerous window spaces in the southern elevation have been partially or completely blocked since original construction (as have those on the upper floors of the western side of the buildings).

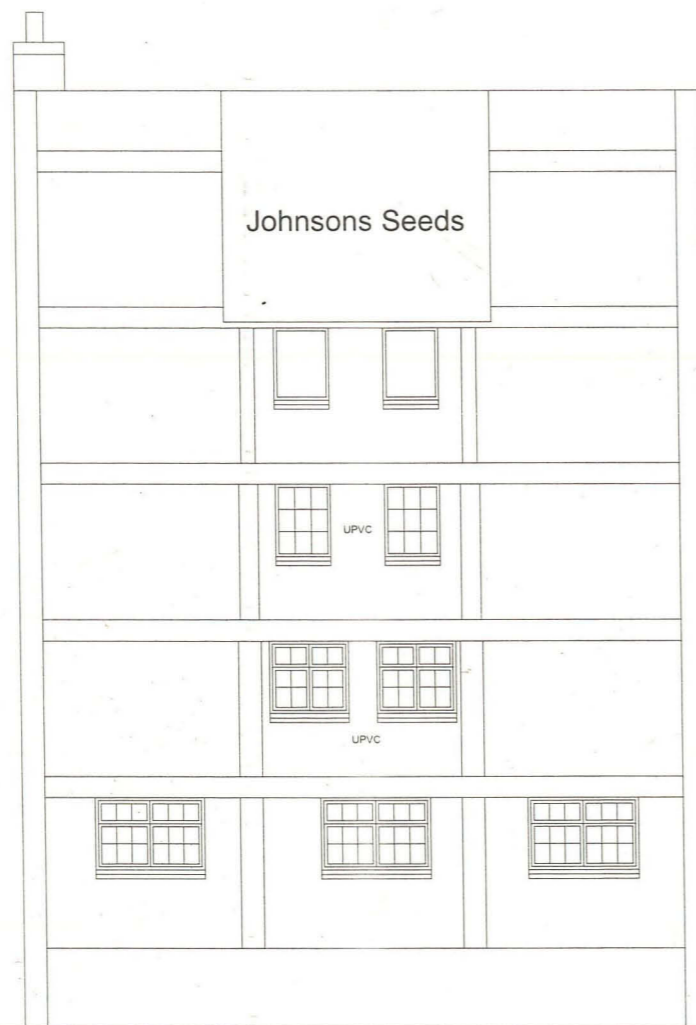
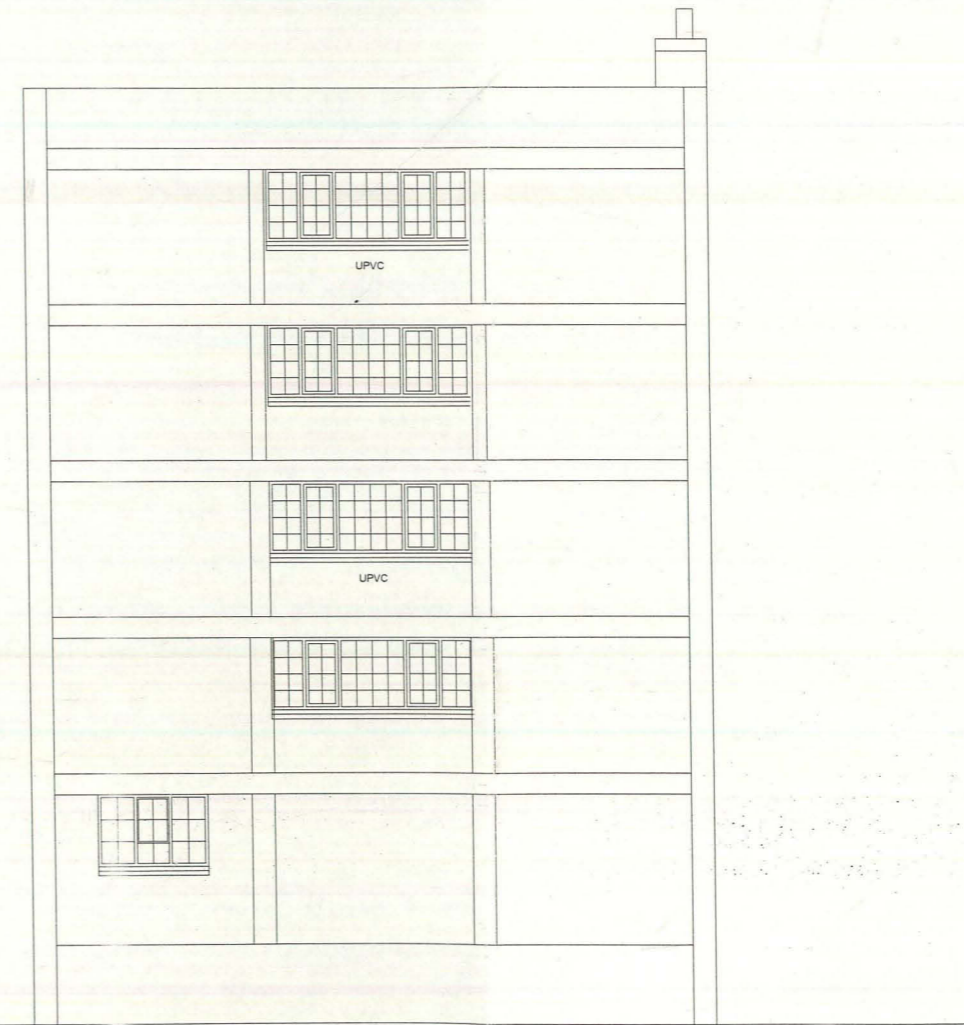
Figure 8: Workhouse 2/Stells Lane, west and east elevations

Both the west and east gables are divided into three bays. The western gable has a painted sign centrally located at the top of the building displaying the name 'Johnsons Seeds' (Plate 14). Beneath this sign are two parallel sets of windows set within the central bay. The ground floor

has larger windows set within all three bays.

The windows of the eastern gable are all, with the exception of the ground floor, set within the central bay and extend across the full width of the bay. The ground floor window is smaller and offset in the first bay (Plate 15).

The eastern elevation displays a large painted sign with 'Johnsons Seeds'. This would have been a form advertising from the former rail-yard and line which ran to the east of the warehouse.

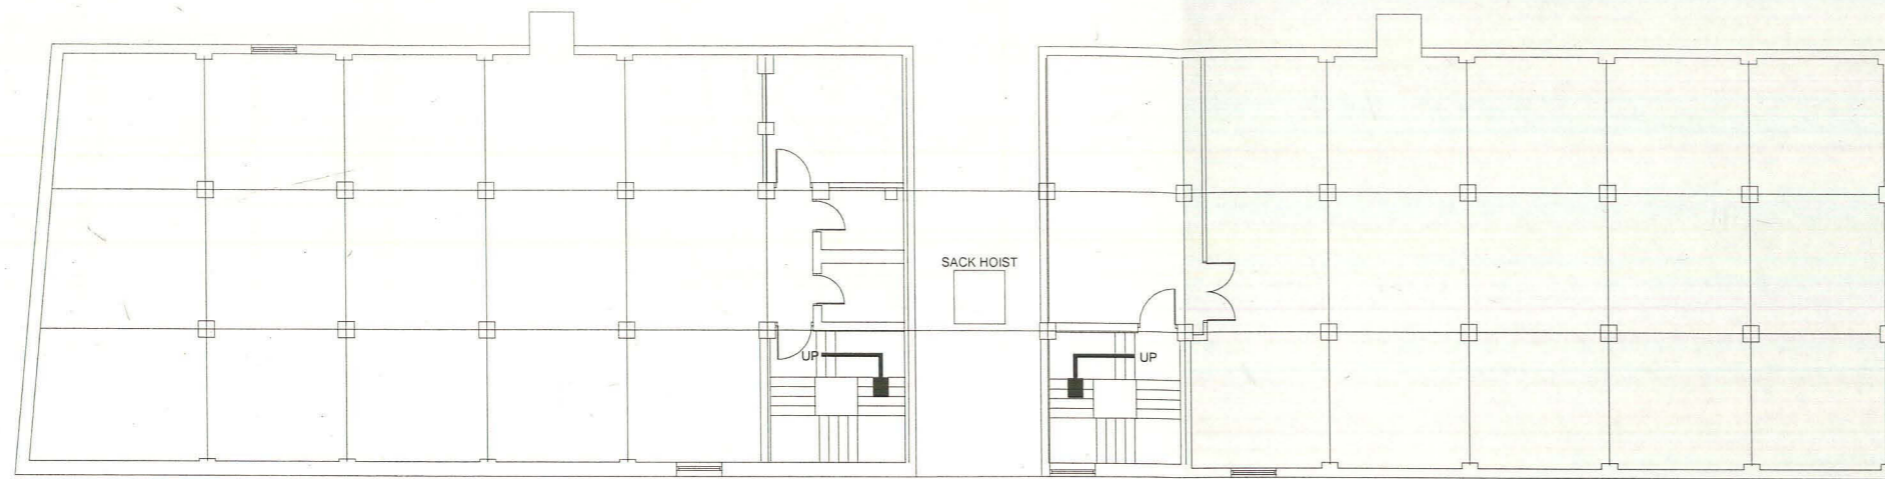
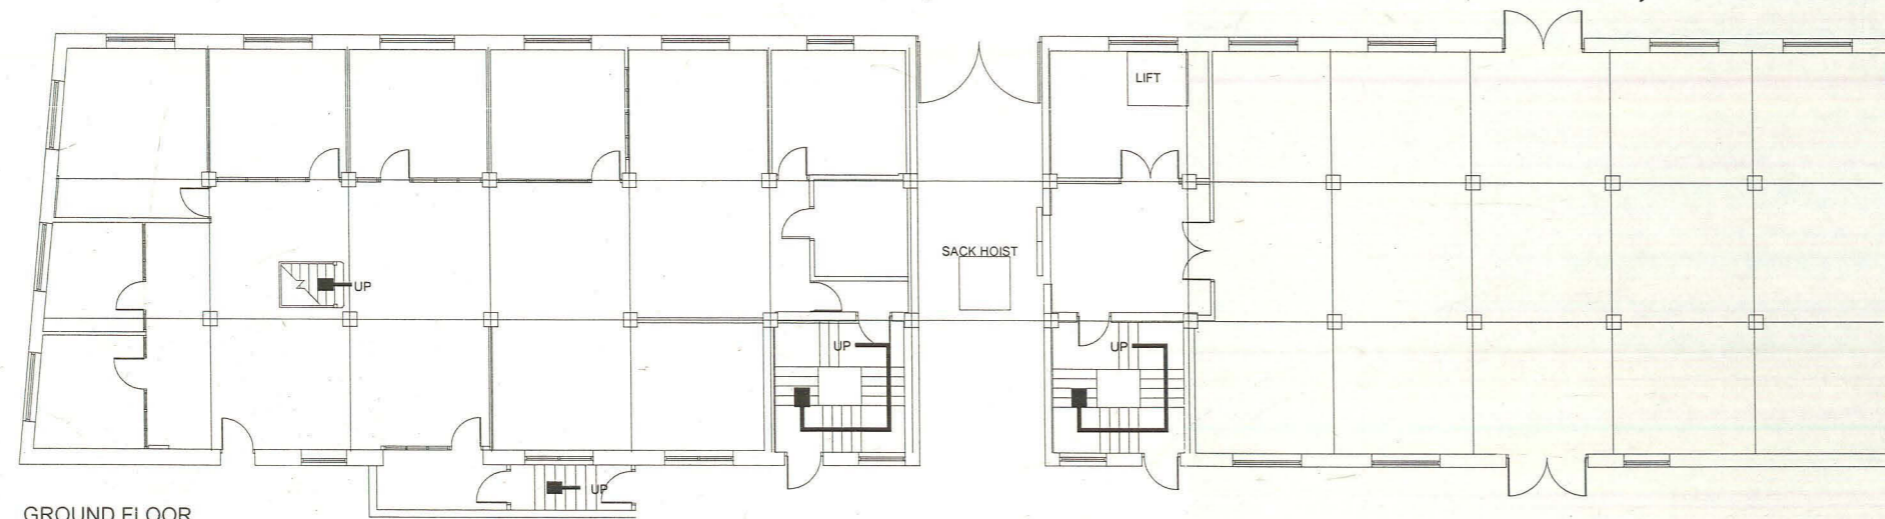
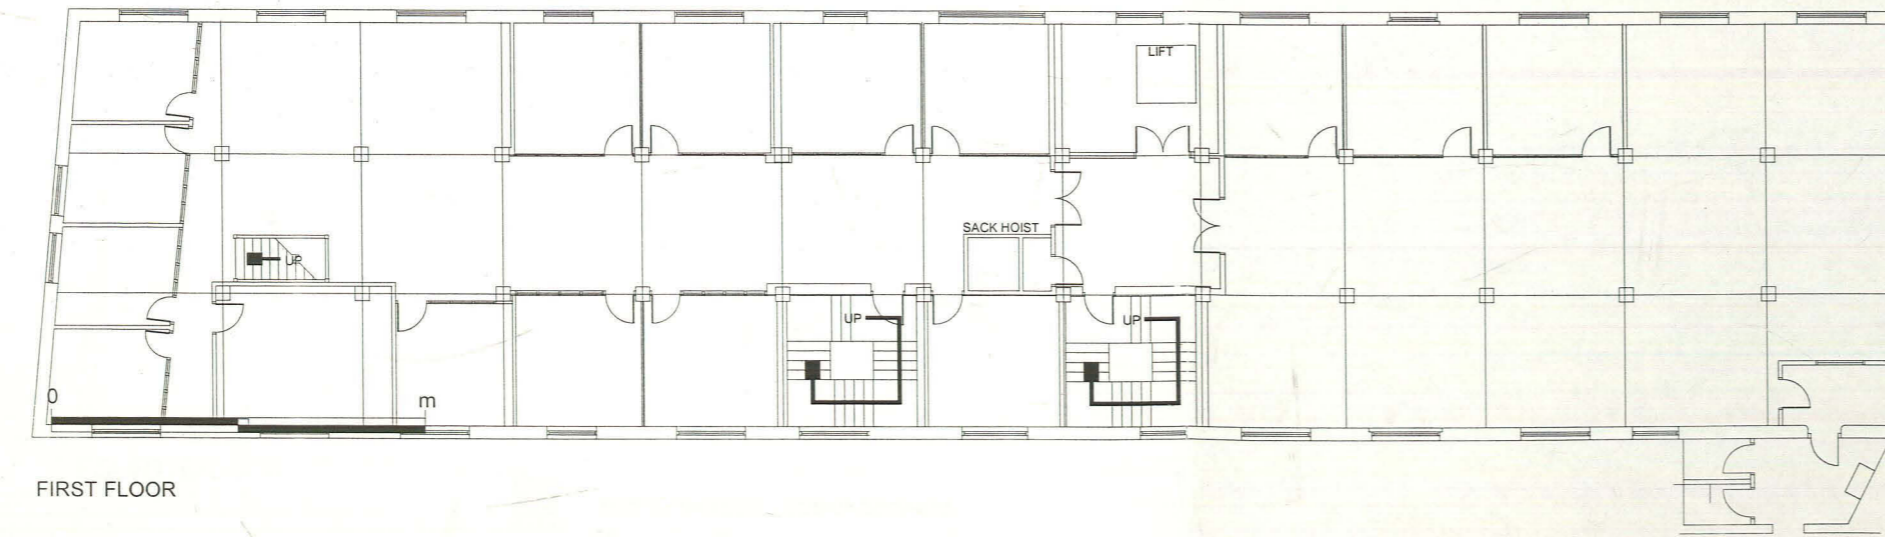
Figure 9: Warehouse 2/Stells Lane, basement, ground floor and first floor plans

Due to flooding access to the basement was limited. The interior is divided into two wings with all the floors being timber. From the first floor upwards this divide is off centre, with the eastern wing containing the dividing corridor. A lift providing access to all floors is present in the eastern wing adjacent to the drive-thru access. Two concrete internal staircases again providing access to all floors are located on either side of the central bay of the warehouse. The staircase in the western wing terminates at the second floor. A third staircase is present at the west end of the western wing between the first and second floor.

A square, double-panel trapdoor is present in all the floors, allowing sack hoist access through these floors, and loading in the ground floor loading bay. The sack hoist mechanism is stored in the wooden shed on the roof and displays a metal plate with 'PICKERING LTD GLOBE ELEVATOR WORKS STOCKTON-ON-TEES' (Plates 22 and 23)

The ground and first floors of the warehouse have internal plasterboard divides, creating individual office spaces, with the second-fourth floors remaining open plan. Stanchions, of timber and concrete are present throughout the elongated central aisle of the building

The warehouse is divided into two wings, with the ground floor wings being entirely separated by loading bay access. Elsewhere the wings were divided by a corridor space offset from the central bay to the east.

A sequence of trapdoors runs centrally through the building in a vertical direction. These allowed the sack hoist mechanism located within a wooden structure built in the centre of the flat roof to provide lifting power between the floors, and loading access at the ground floor.

The two wings could operate separately up until the third floor, as each has its own stair access. Reasons for this divide may be that different stages or type of seed processing were taking part in each of the wings, and this divide would aid in ensuring the seed types did not get mixed up.

The ground and first floors had been compartmentalised, with timber/plasterboard partition walls, to form a series of offices. The extent of this conversion suggests that the primary functions of the warehouse, that is, seed storage, processing and packaging, had either reduced, changed in nature or was relocated to other premises on site or elsewhere. Their place had been taken by functions of an administrative nature.

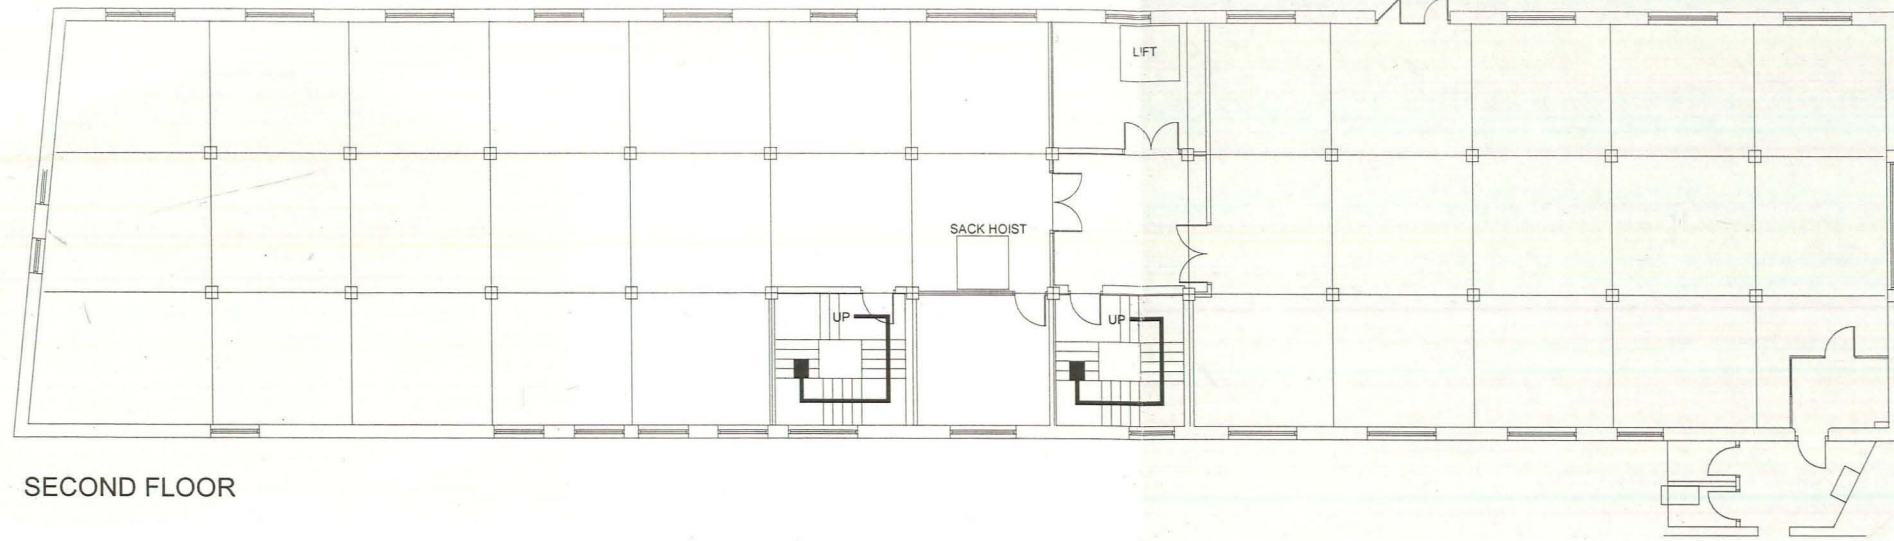
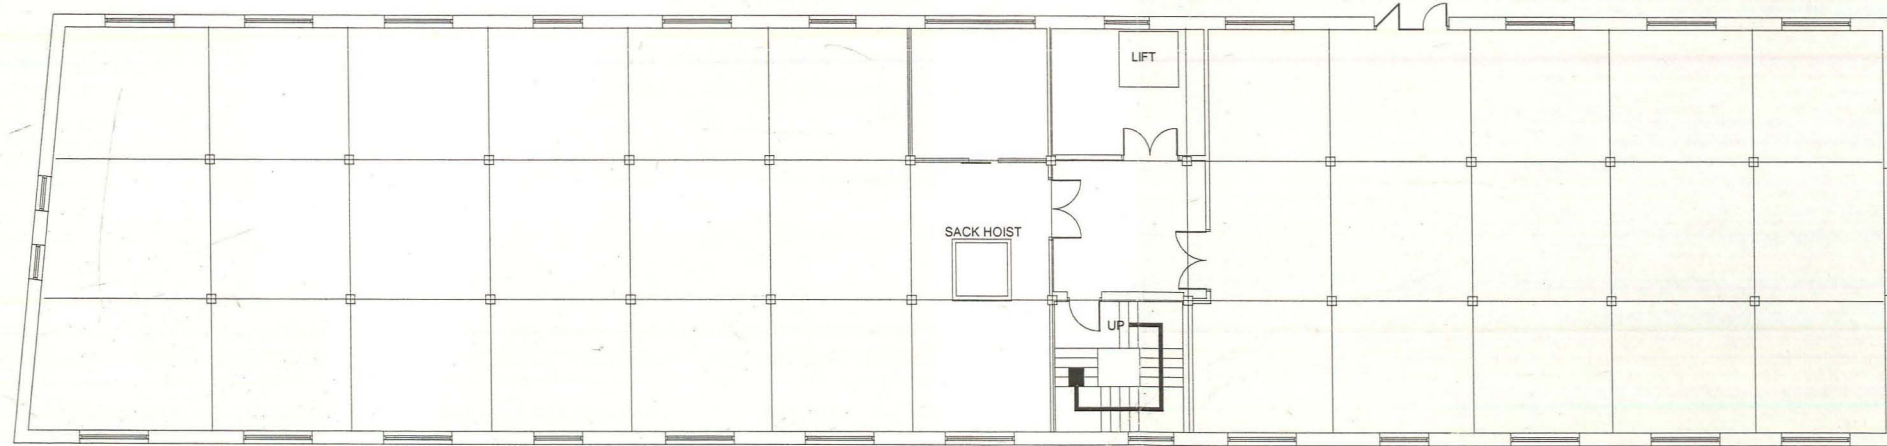
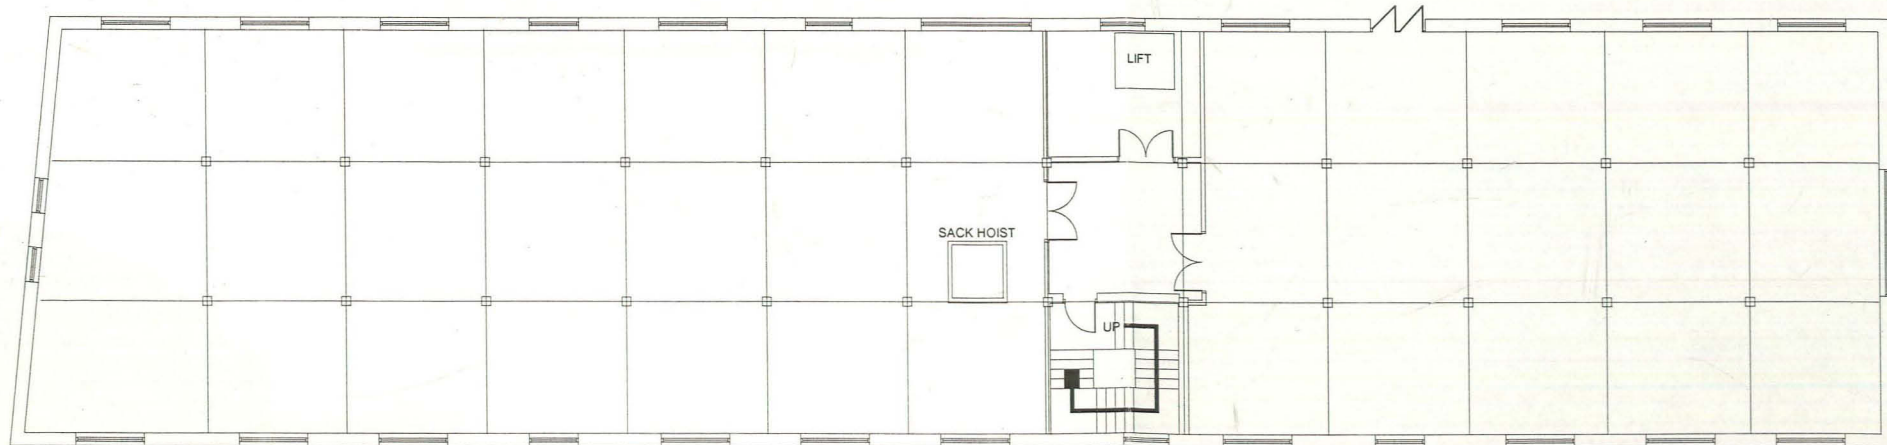
Figure 10: Warehouse 2/Stells Lane, second-fourth floor plans

supporting the floors and ceilings (Plates 24 and 25).

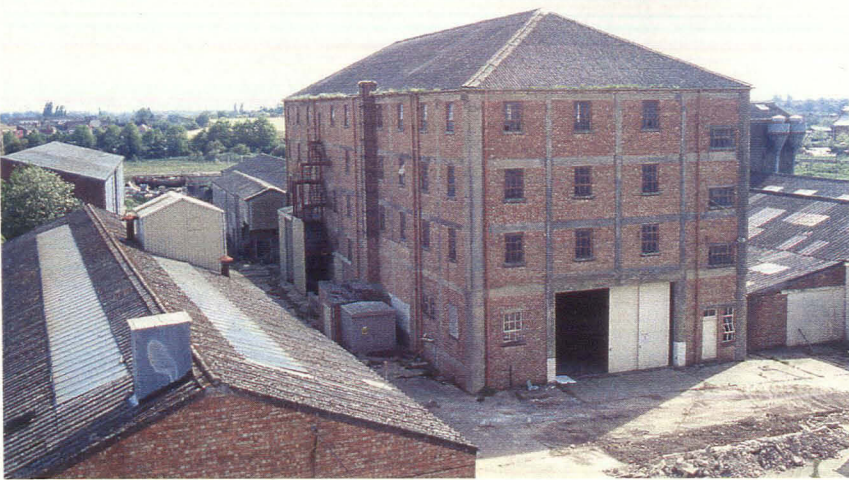
Plate 1 North and east elevation of Warehouse 1

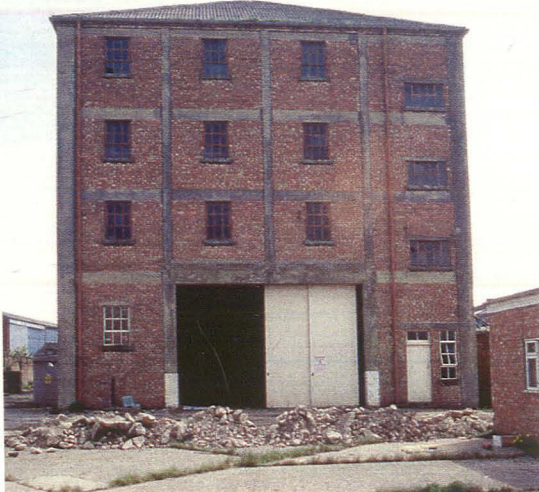
Plate 2 North elevation of Warehouse 1, showing loading access

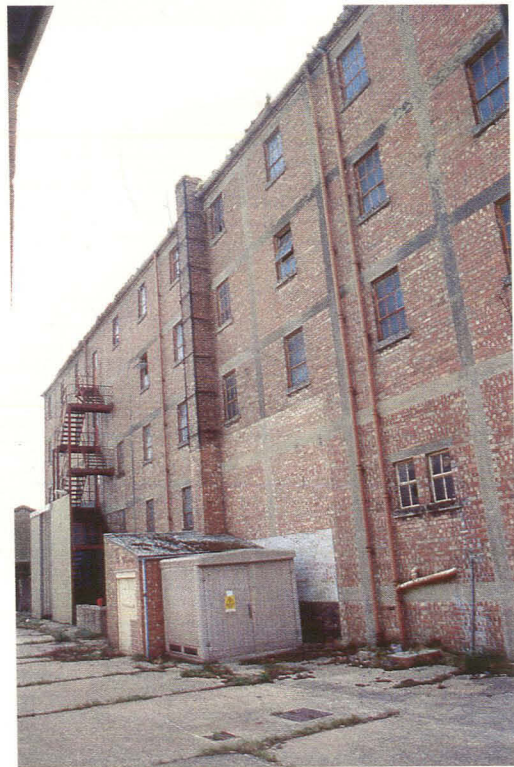
Plate 3 East elevation of Warehouse 1, showing electric sub-station, chimney with steel frame

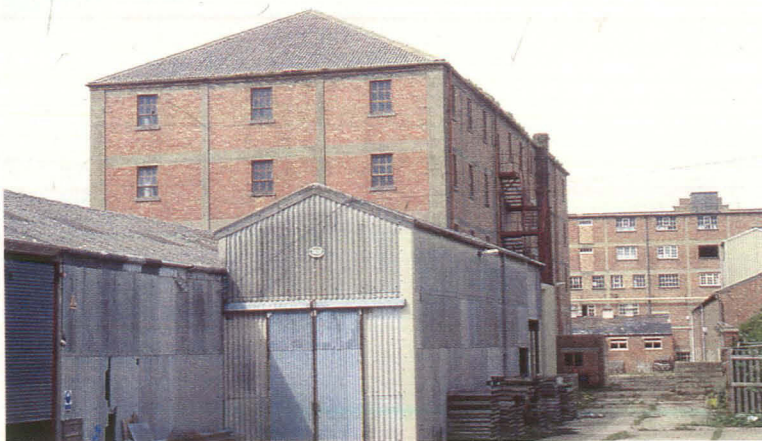
Plate 4 South elevation of Warehouse 1

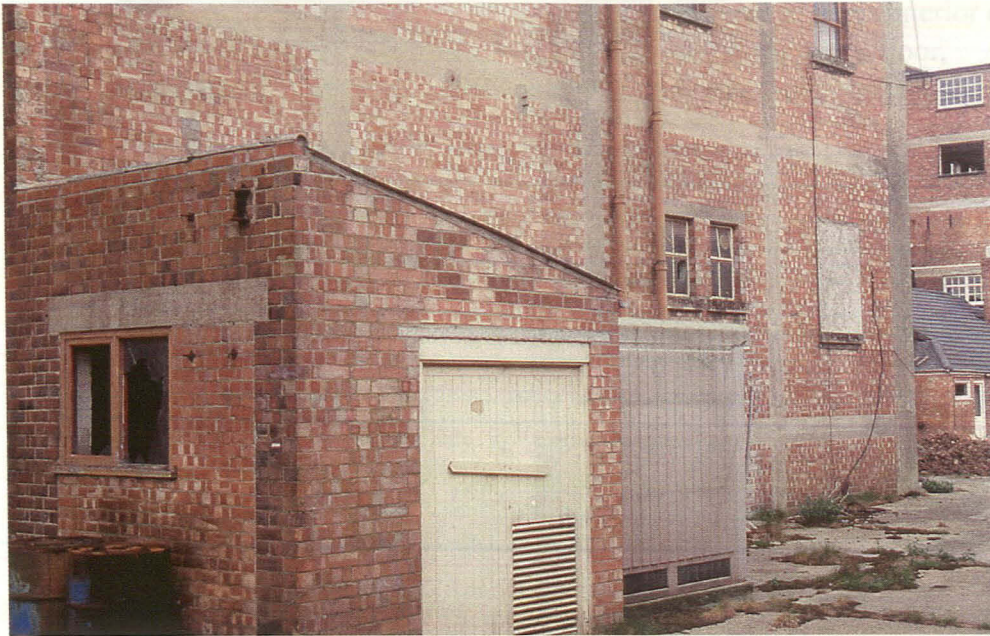
Plate 5 Detailed view of the additional structure and electric substation on east elevation of Warehouse 1.

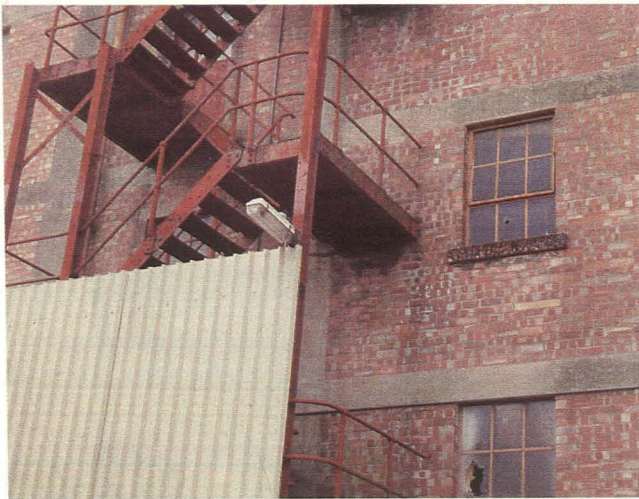
Plate 6 Detailed view of corrugated steel around base of external staircase, Warehouse 1

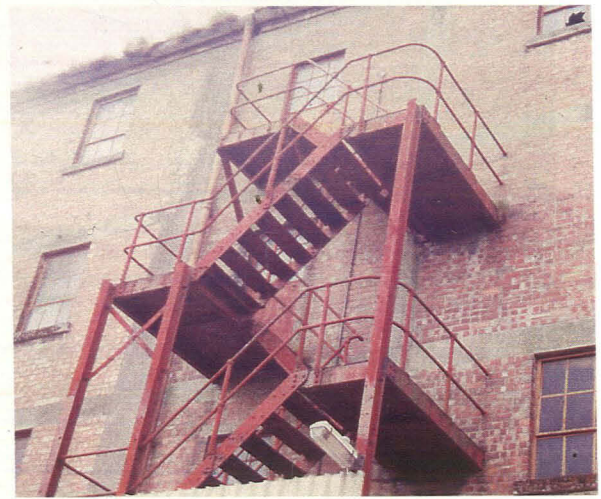
Plate 7 External stairway providing access to Upper floors of Warehouse 1

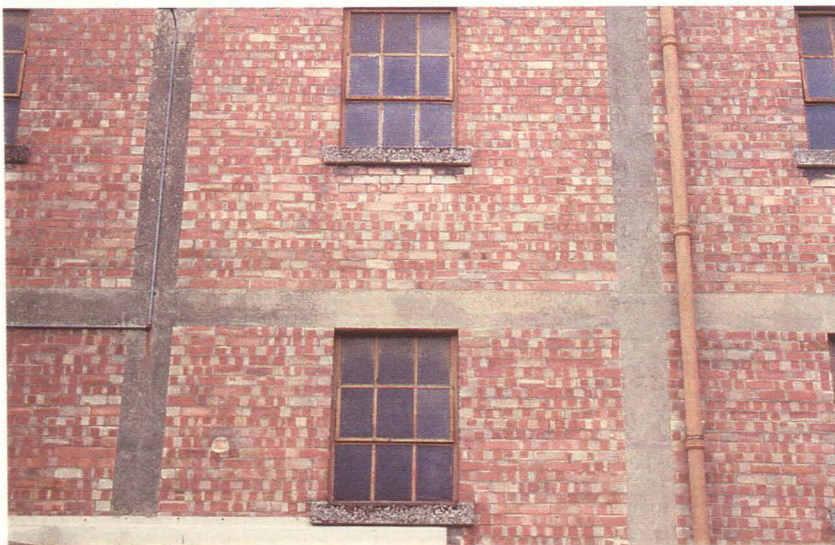
Plate 8 Detailed view of concrete frame, brick work, windows and iron drainpipe

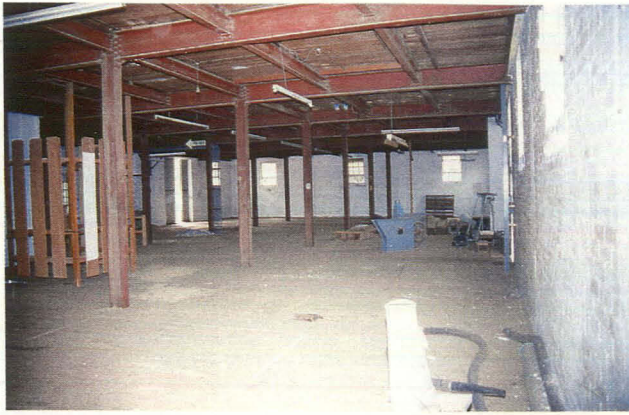
Plate 9 Interior of
ground floor,
Warehouse 1

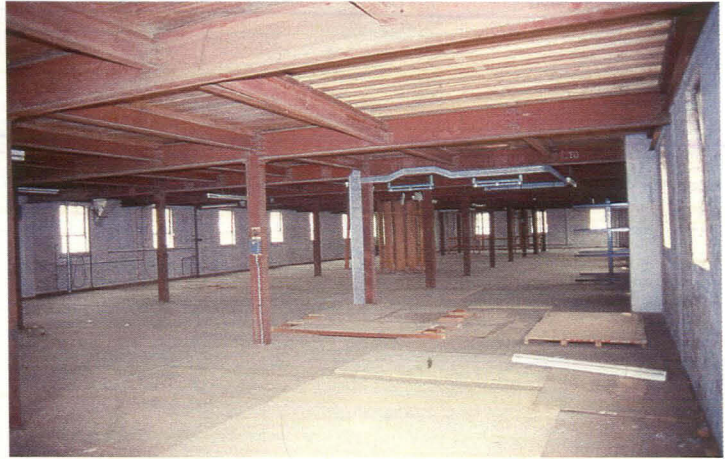
Plate 10 Interior of first
floor, showing sack hoist,
Warehouse 1

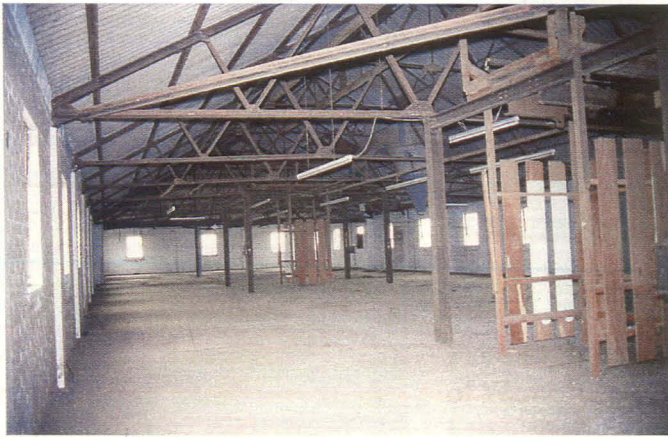
Plate 11 Interior of third
floor, showing sack hoists,
Warehouse 1
