**BUILDING SURVEY OF
FORMER JOHNSONS' SEED WAREHOUSES,
LONDON ROAD,
BOSTON,
LINCOLNSHIRE
(BLR02)**

Work Undertaken For
Quadrant Chartered Surveyors

January 2003

APS Report No. 15/03

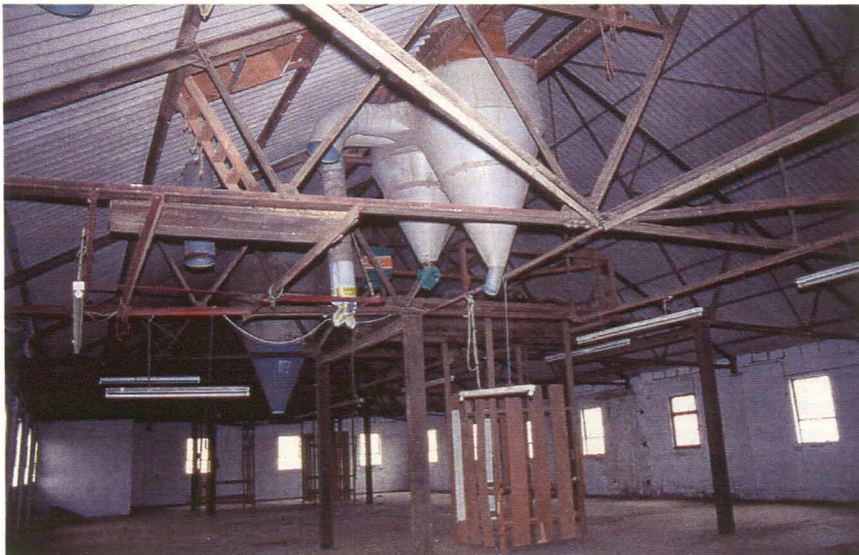
Three steel silos are located in the roof space on the third floor. Along with these

are larger steel uprights supporting 12 steel roof trusses (Plate 12).

Plate 12 Third floor,
showing silos and
metal roof trusses,
Warehouse 1

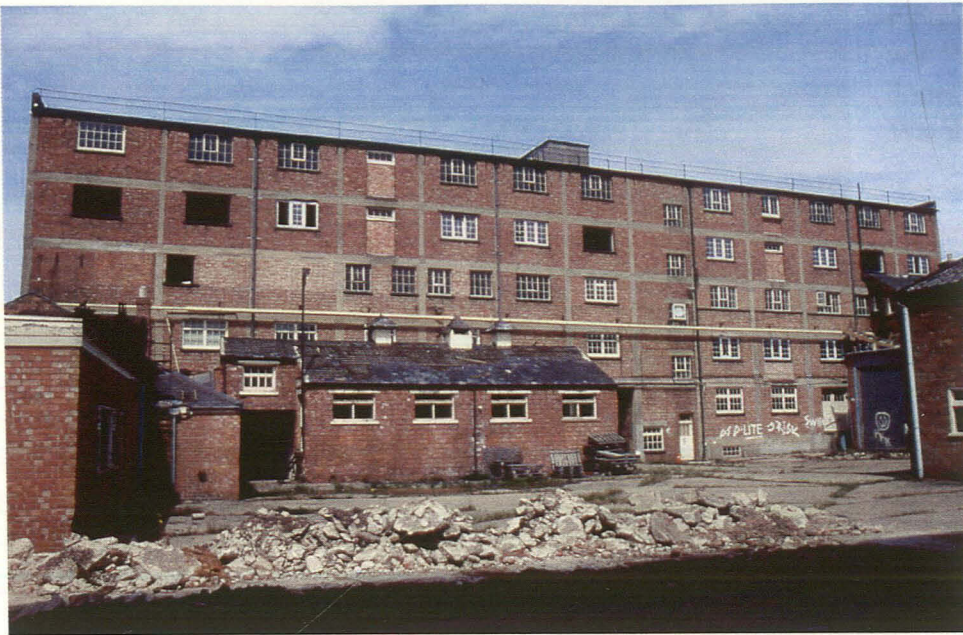
The southern elevation is in the main a mirror image of the northern (Plate 13), though in general is less impressive without the large windows of the central bays. There are also additional structures at ground floor level.

Plate 13 South elevation of Warehouse 2/Stells Lane

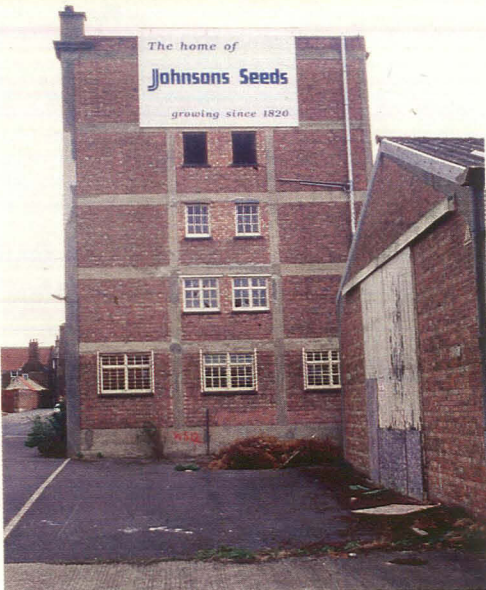
Both the west and east gables are divided into three bays. The western gable has a painted sign centrally located at the top of the building displaying the name 'Johnsons Seeds' (Plate 14). Beneath this sign are two parallel sets of windows set within the central bay. The ground floor

Plate 14 Western elevation of Warehouse 2/Stells Lane, showing warehouse sign

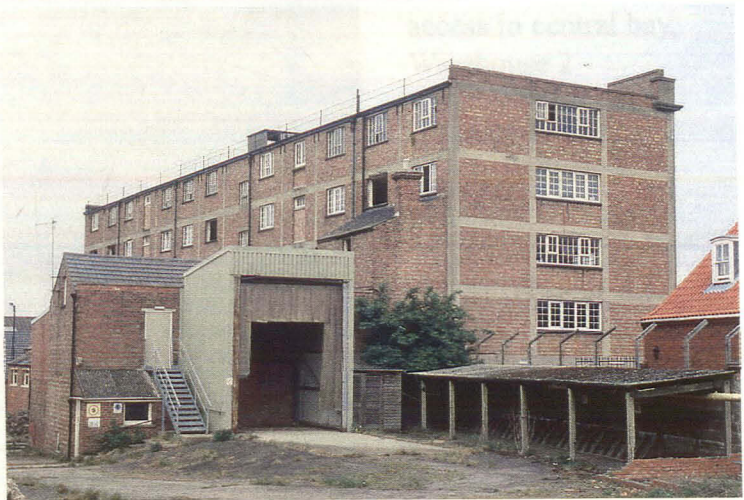
The windows of the eastern gable are all, with the exception of the ground floor, set within the central bay and extend across the full width of the bay. The ground floor window is smaller and offset in the first bay (Plate 15).

Plate 15 Eastern elevation of Warehouse 2/Stells Lane

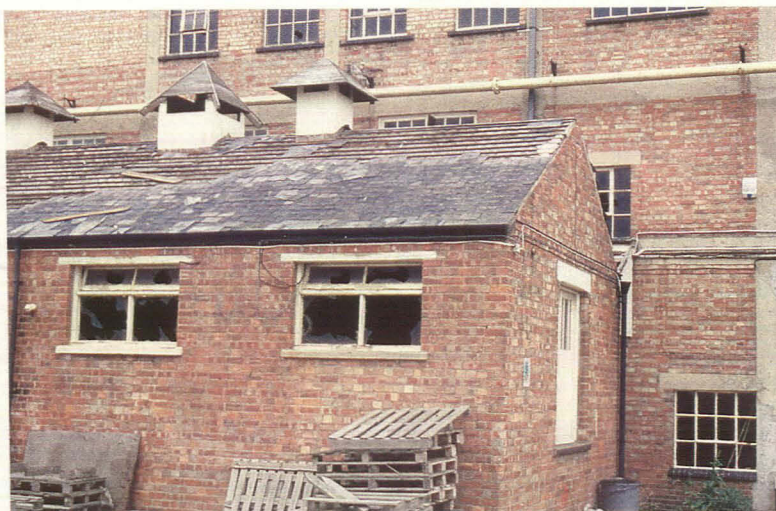
A three-storey brick structure has been added on to the western end of the building. At the eastern end a single storey building had been added. This building had 3 louvered chimneys, which may indicate the building functioned as a boiler room for the adjacent warehouse.

Plate 16 Additional structure at western end of south elevation, Warehouse 2

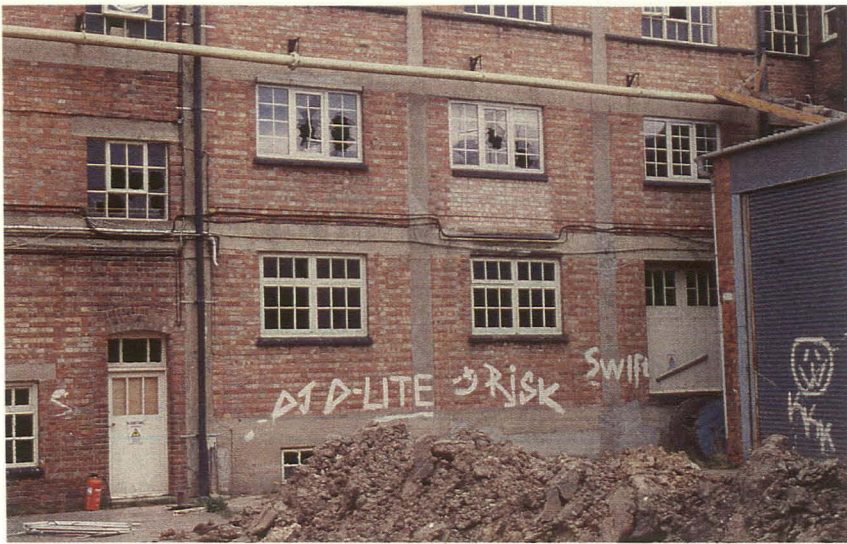
Access to the ground floor is through one of three wooden doors set at actual ground level, or through the raised wooden double door at the western end (Plate 17).

Plate 17 Detail of windows and wooden doors in south elevation, Warehouse 2

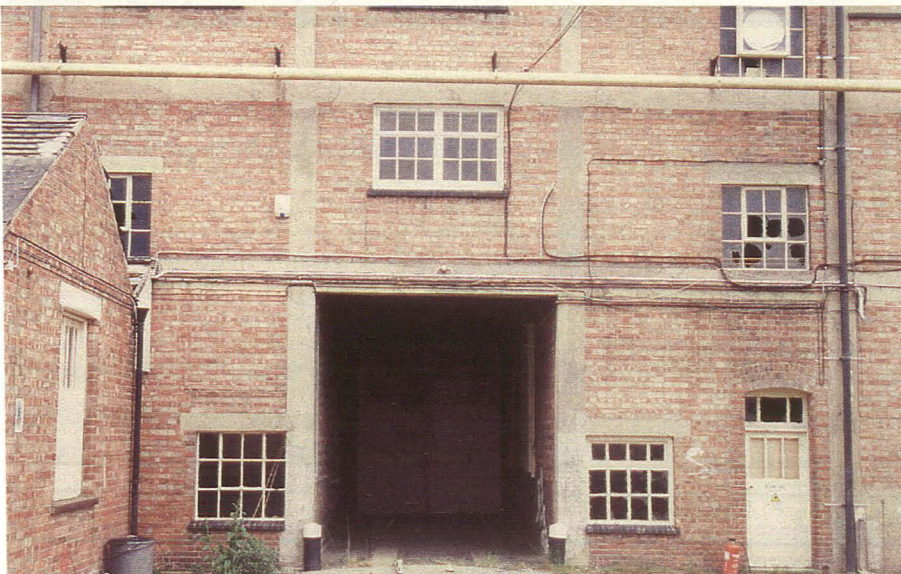
The central bay had been left open at ground level providing loading access from the warehouse floors and the internal lift, which was immediately adjacent (Plate 18).

Plate 18 Drive-in access in central bay, Warehouse 2

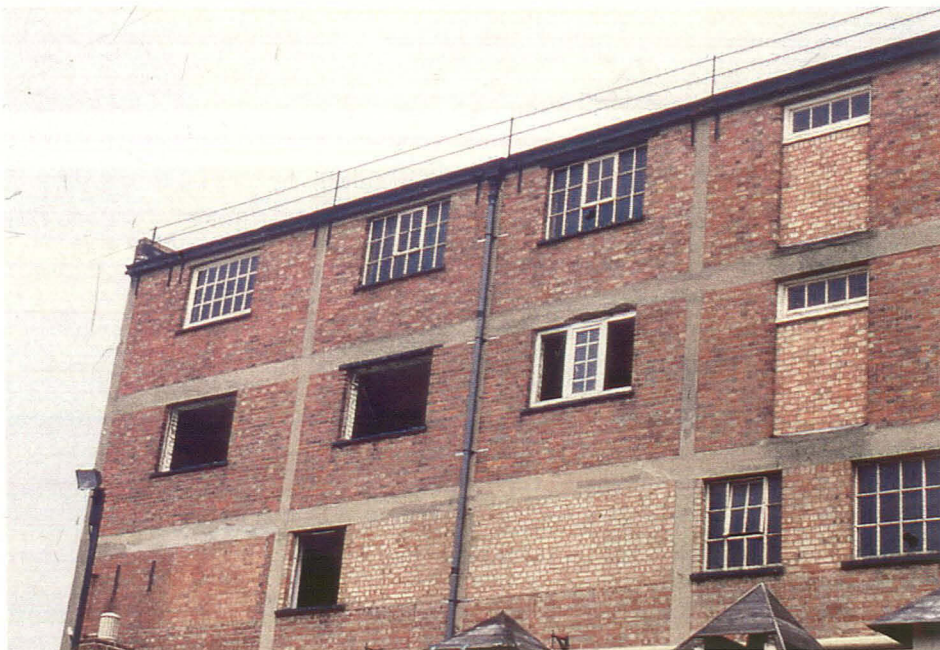
The second floor appears to have had considerable external alteration, with several of the bays having had brick blocking and bays 1 and 3 having no windows at all (Plate 19).

Plate 19 Brick blocking on third storey and metal railing around roof, Warehouse 2

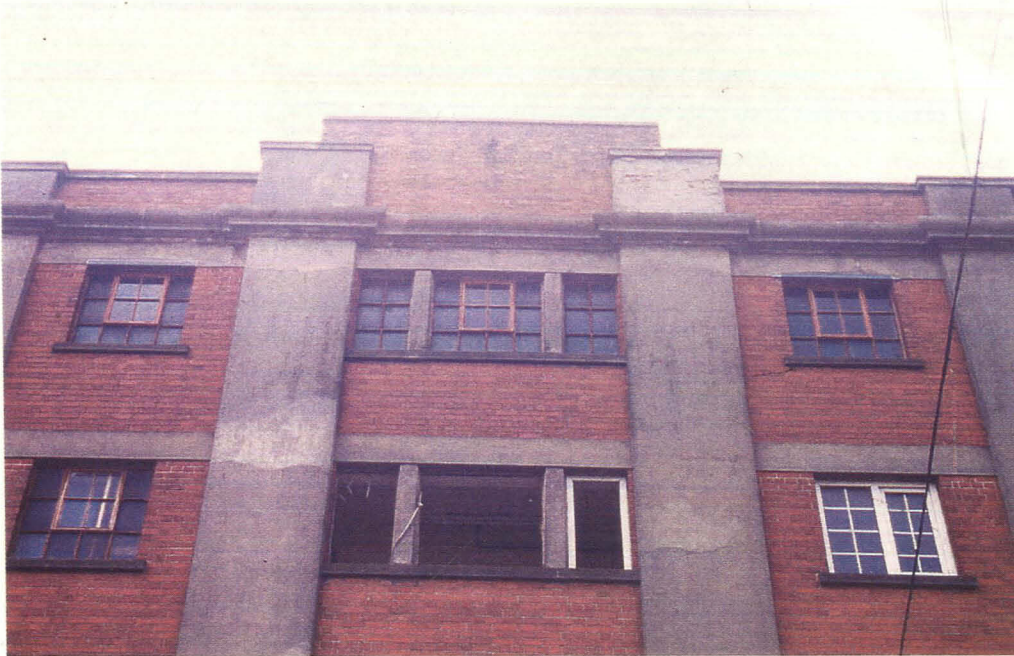
The northern elevation is the only elevation with a road approach, from Stells Lane, this is reflected in the more impressive façade with the additional architrave along the top and the imposing central bay (Plate 20). The windows in the ground and first floor are boarded up. However, from internal examination, these windows are of the same character/design as those present on the second-fifth floors. Two boarded doors are also present on the ground floor in the 3rd and 11th bays. Generally the windows are 16 or 18 panes and are a mix of wooden and UPVC frames with the third floor frames being entirely replaced by UPVC. The central bay is more ornate than the rest, with the windows being 24 panes. The fourth bay has a sequence of wooden doors with glass panelling in the top half. There is however no external staircase present providing exterior access to these doors. A large boarded up central door provides drive-in

Plate 20 Brick
architrave, and
top of central
bay in northern
elevation,
Warehouse 2

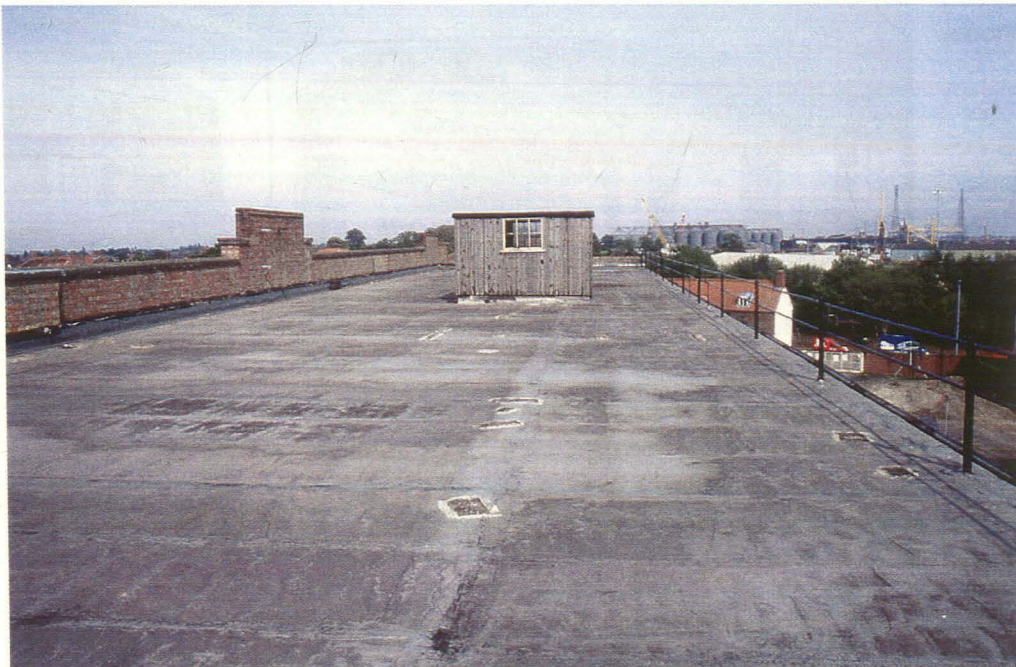
The second warehouse is a five storey brick built structure in a concrete frame with a basement. The warehouse is elongated east-west where it is divided into 13 bays. The east and west elevations are divided into three bays. Unlike Warehouse 1 the roof is flat with an upstanding architrave along the top of the northern elevation, and metal railings along the top of the other elevations. Located centrally on the flat roof is a wooden shed, that houses the sack hoist mechanism (Plate 21).

Plate 21 Flat
roof with central
wooden
structure
housing sack
hoist,
Warehouse 2

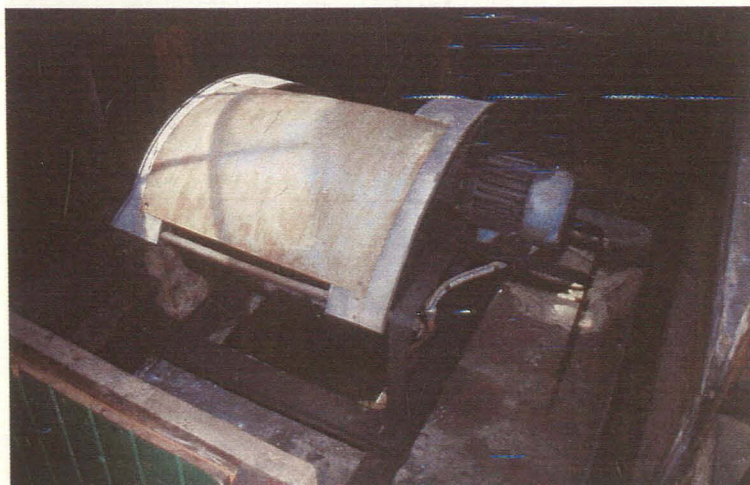
A square, double-panel trapdoor is present in all the floors, allowing sack hoist access through these floors, and loading in the ground floor loading bay. The sack hoist mechanism is stored in the wooden shed on the roof and displays a metal plate with 'PICKERING LTD GLOBE ELEVATOR WORKS STOCKTON-ON-TEES' (Plates 22 and 23)

Plate 22 Sack hoist
machinery,
Warehouse 2

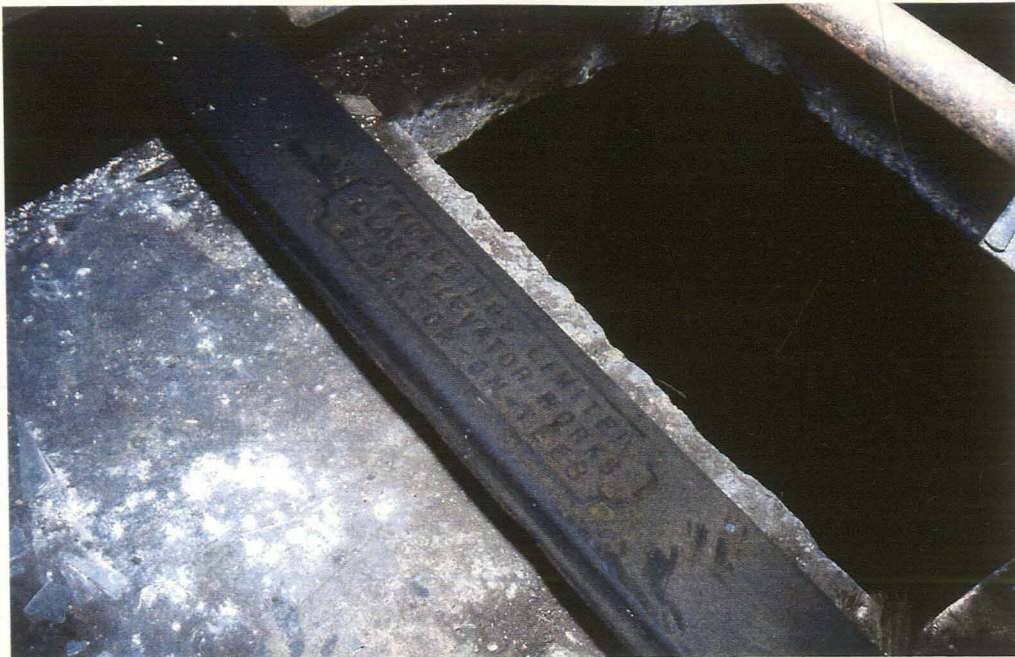
Plate 23 Metal plate of sack hoist with 'PICKERING LTD GLOBE ELEVATOR WORKS STOCKTON-ON-TEES embossed, Warehouse 2

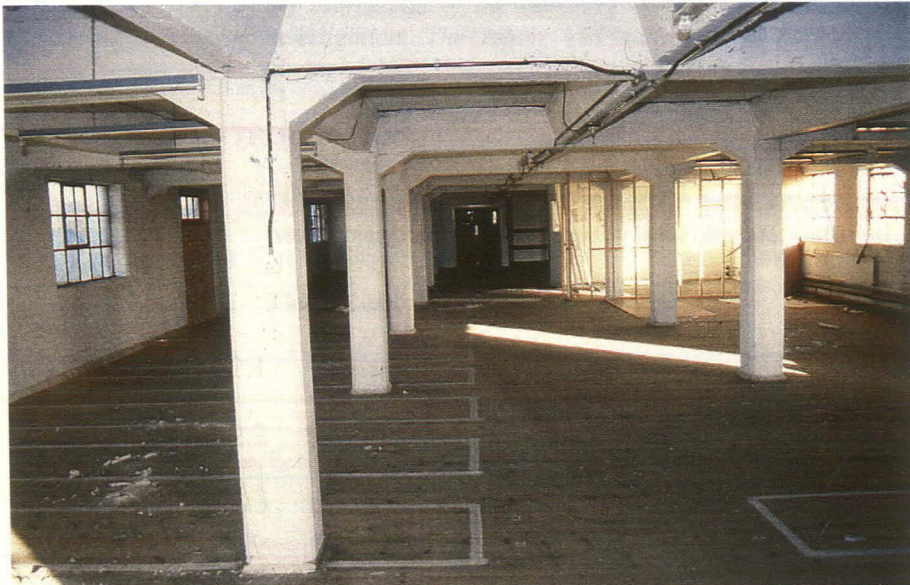
The ground and first floors of the warehouse have internal plasterboard divides, creating individual office spaces, with the second-fourth floors remaining open plan. Stanchions, of timber and concrete are present throughout the elongated central aisle of the building

supporting the floors and ceilings (Plates 24 and 25).

Plate 24 General view of second floor, Warehouse 2

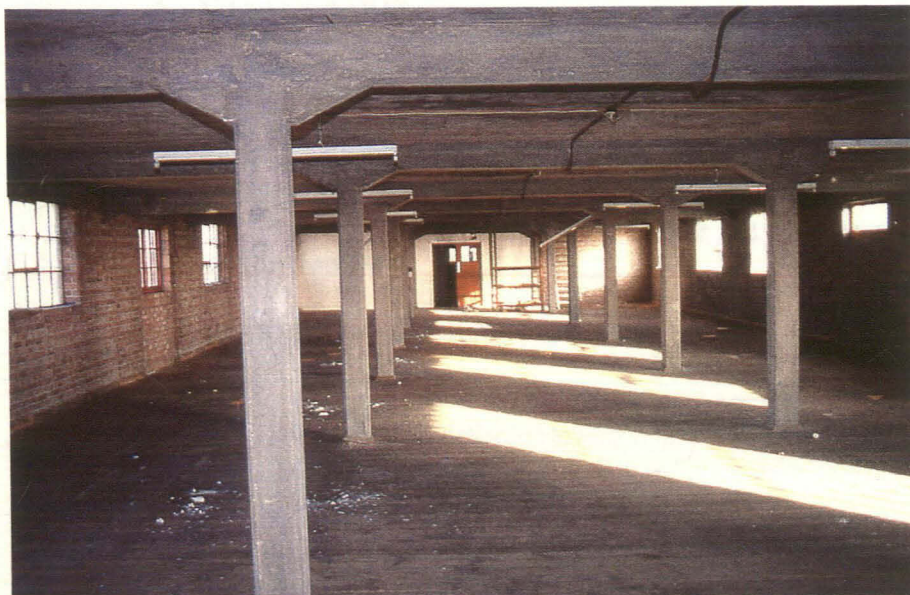
Plate 25 General view of third floor, Warehouse 2
