**BUILDING SURVEY REPORT
THE GREYHOUND INN, FOLKINGHAM
LINCOLNSHIRE**

Planning Reference: S07/0792/32 and S07/LB/6796/32

Allen Archaeological Associates
Report Number 2008/016

April 2008

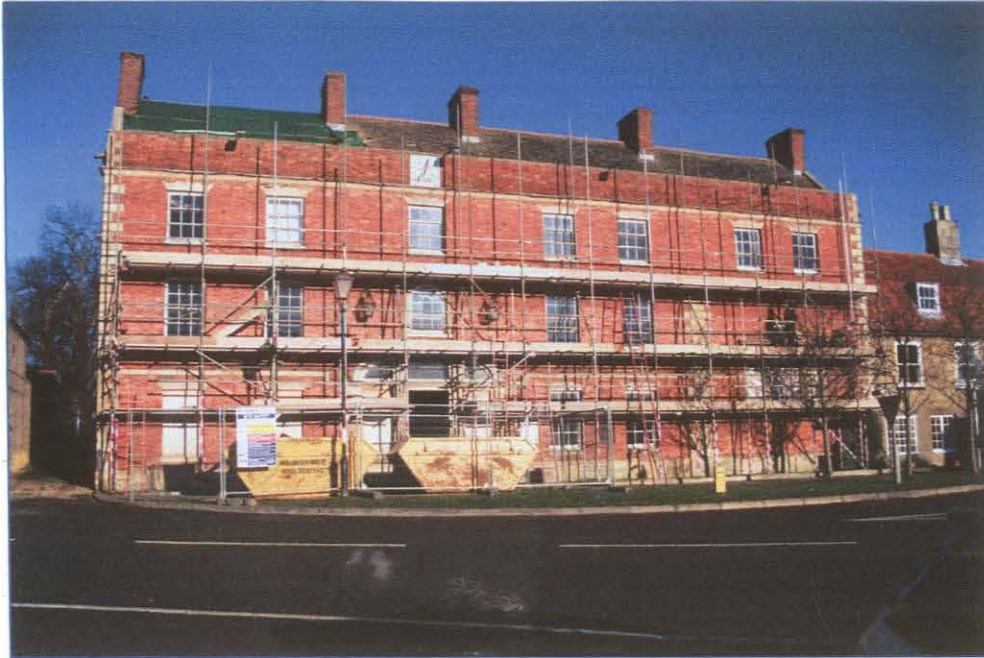
Plate 1: (001) Southern façade of the Greyhound Inn demonstrating the limitations upon photographic recording. Looking north.

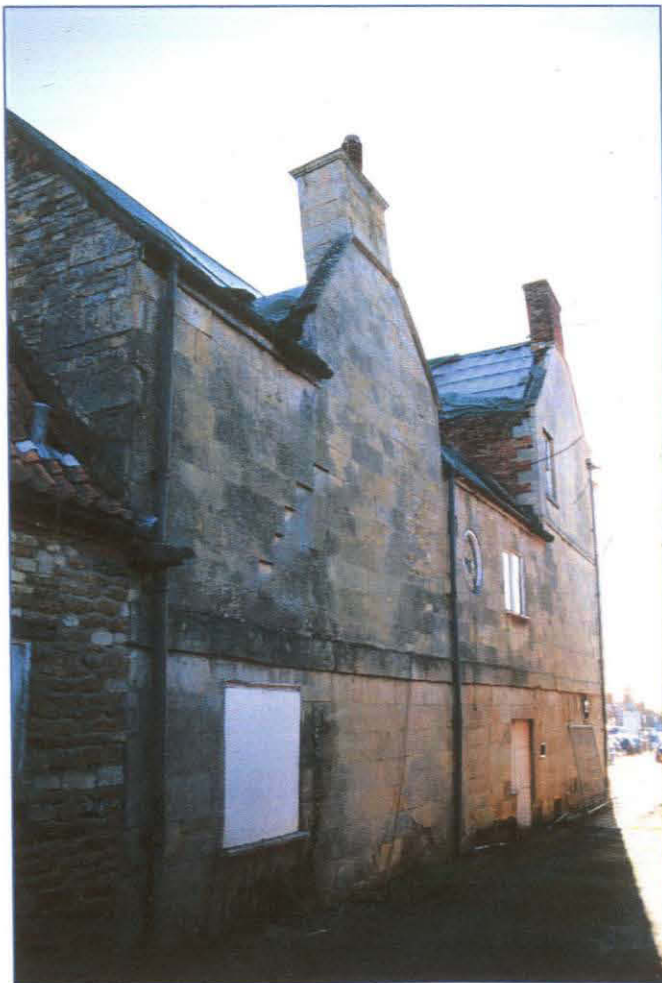
Plate 2: (009) The Western Elevation showing the ashlar cladding. Note the location of the Western Range stack behind the gable coping. The tarpaulin covers fire damage to the second floor. Looking south-east.

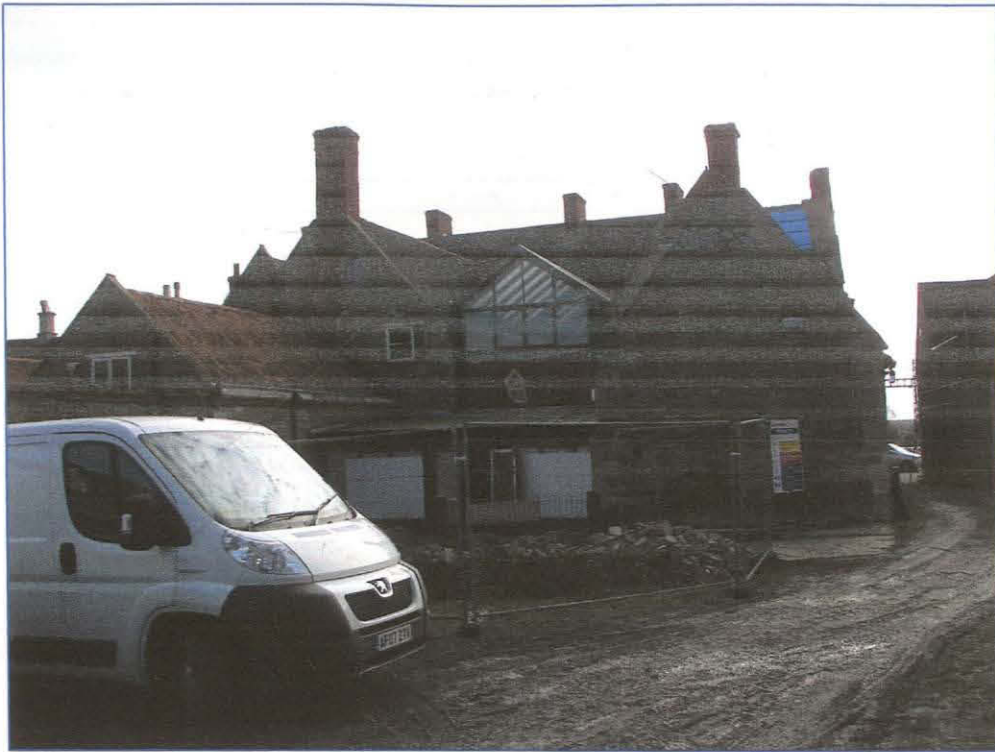
Plate 3: (178) Northern elevations showing the false garret bullseye window in the Eastern Range and the visually intrusive lean to abutting the atrium frame. Looking south-east.

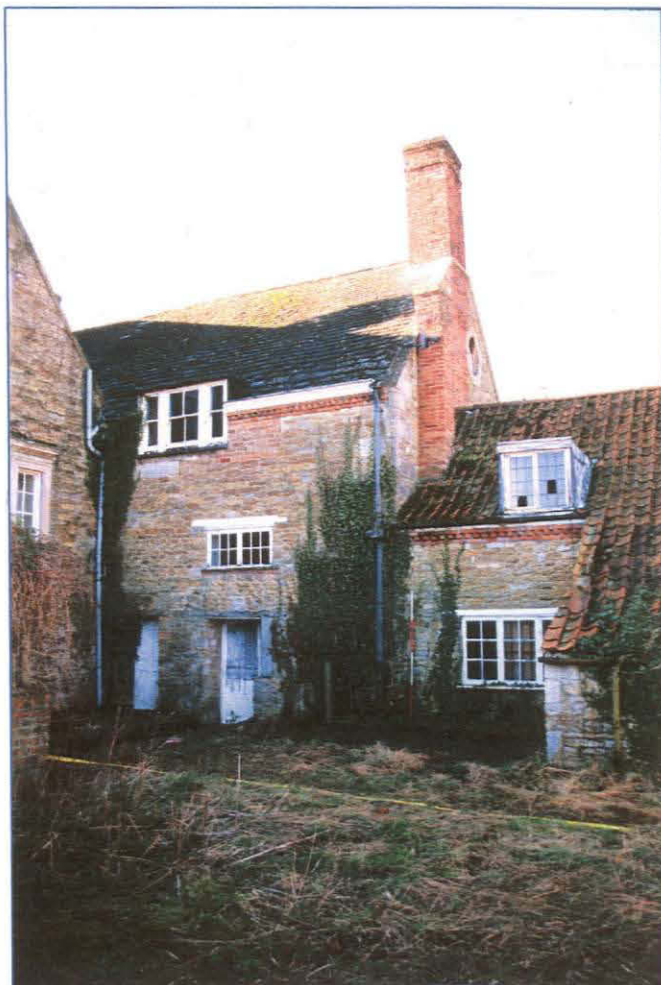
Plate 4: (013) The eastern elevations of the Eastern Range, detailing remodelling at the eaves and the insertion of dormers into the roof. Looking south-west.

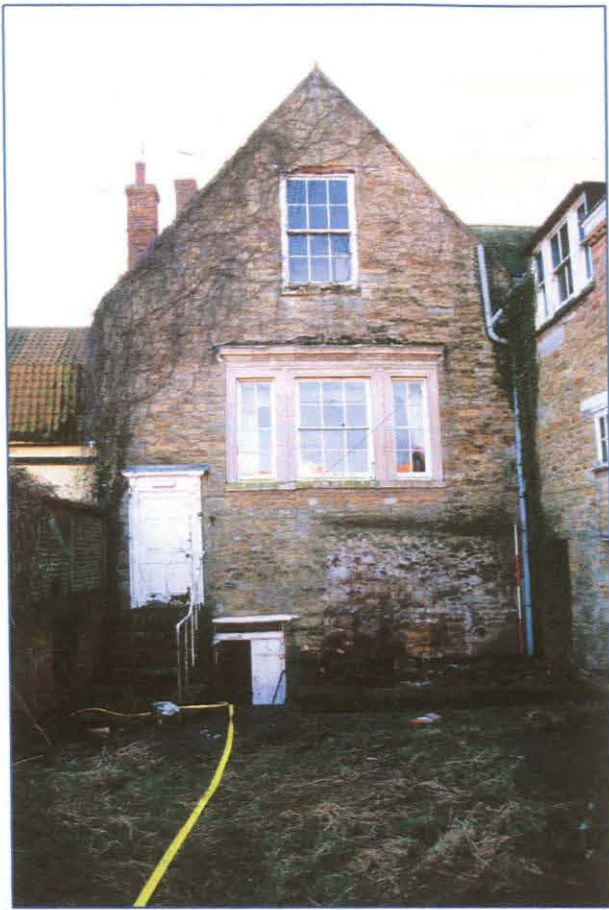
Plate 5: (014) North elevation of the courtroom showing the high level moulded stone window and rear access steps with steps down to the cellar doorway. Looking south

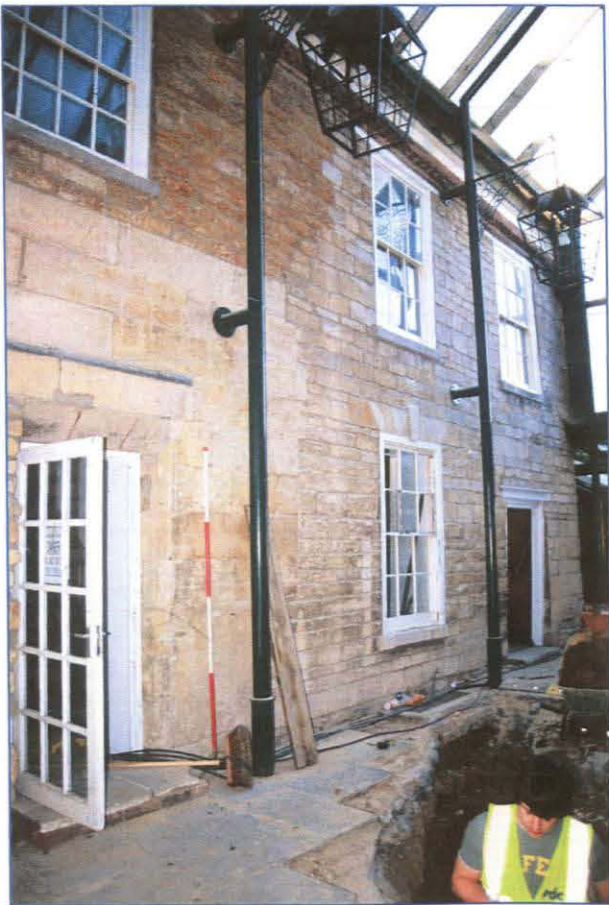
Plate 6: (026) Eastern elevation of the Western Range (South Block) illustrating the changes in wall fabric associated with phases of development. Looking north-west

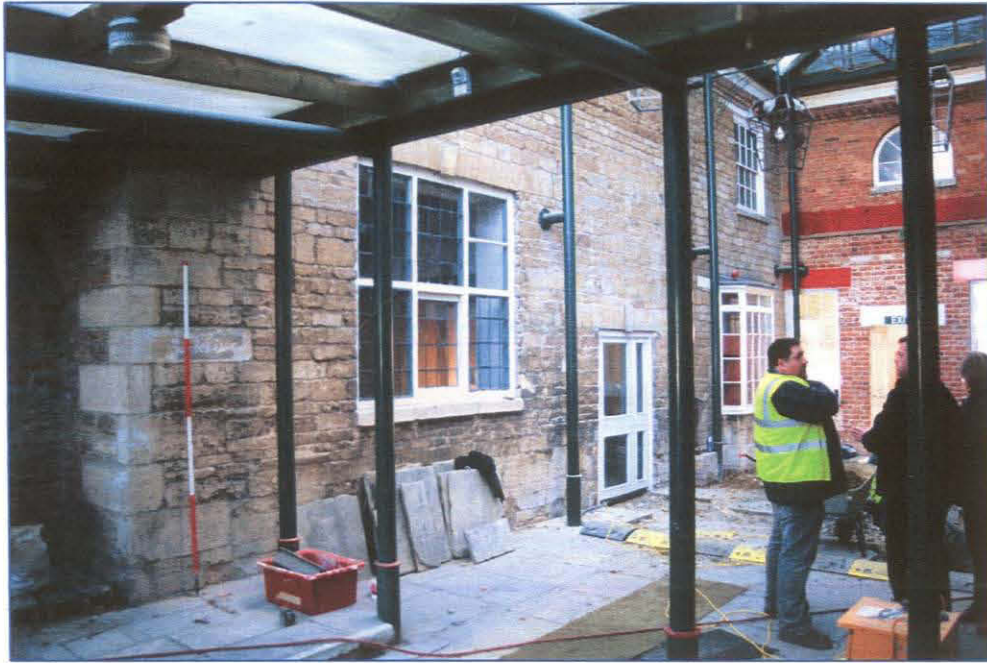
Plate 7: (021) Western (internal) elevation of the East Range (South Block). Looking east.

- 6.18.2 The western (internal) elevation is divided into three bays, with a projecting keystone within a flat arch over the central (modern replacement) doorway. To the right of this door, on the ground floor, is a late 18th century splayed bay window consisting of a sixteen light window flanked by four light casements below a three light header. This window partially covers the timber lintel of an existing opening having been added to the original façade in the 19th century, on a projecting bay constructed with an ashlar plinth.

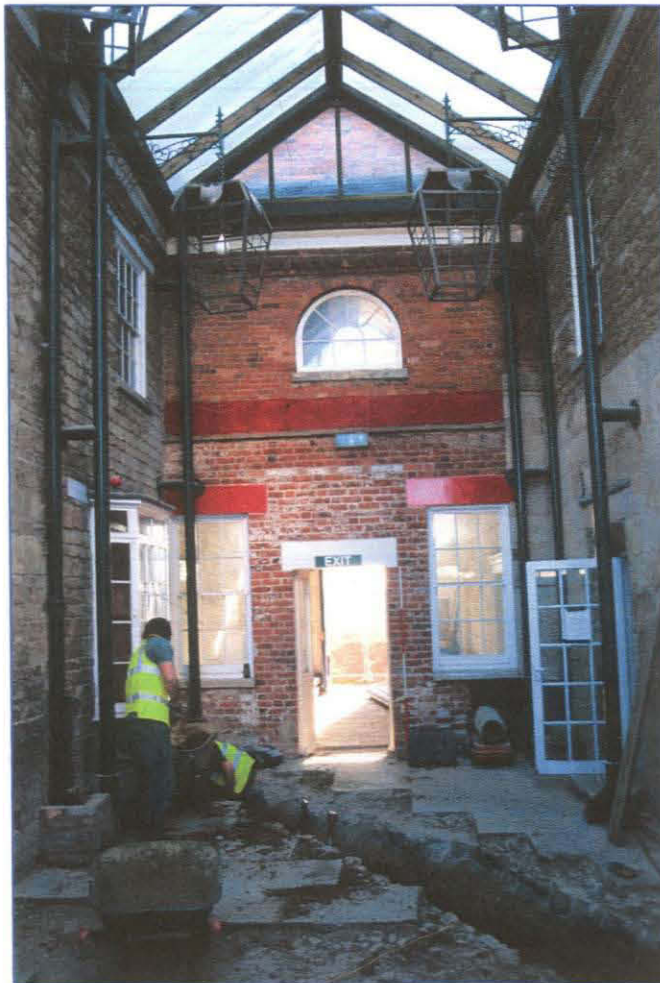
Plate 8: (027) Northern elevation of the carriageway arch with 19th century infilling on the ground floor. Note the offset of the ashlar blockwork facia, in the right hand corner, necessary to correct the alignment between the Southern and Western Ranges. Looking south.

- 6.3.3 The lower part is formed by the in-filled carriageway arch. This is constructed in three inch 19th century hard faced bricks laid in Flemish bond topped by a stringer course of ashlar. There is a central doorway of two halves with raised and fielded panels below two light transom glazing that are flanked by 6/6 vertical sash windows.

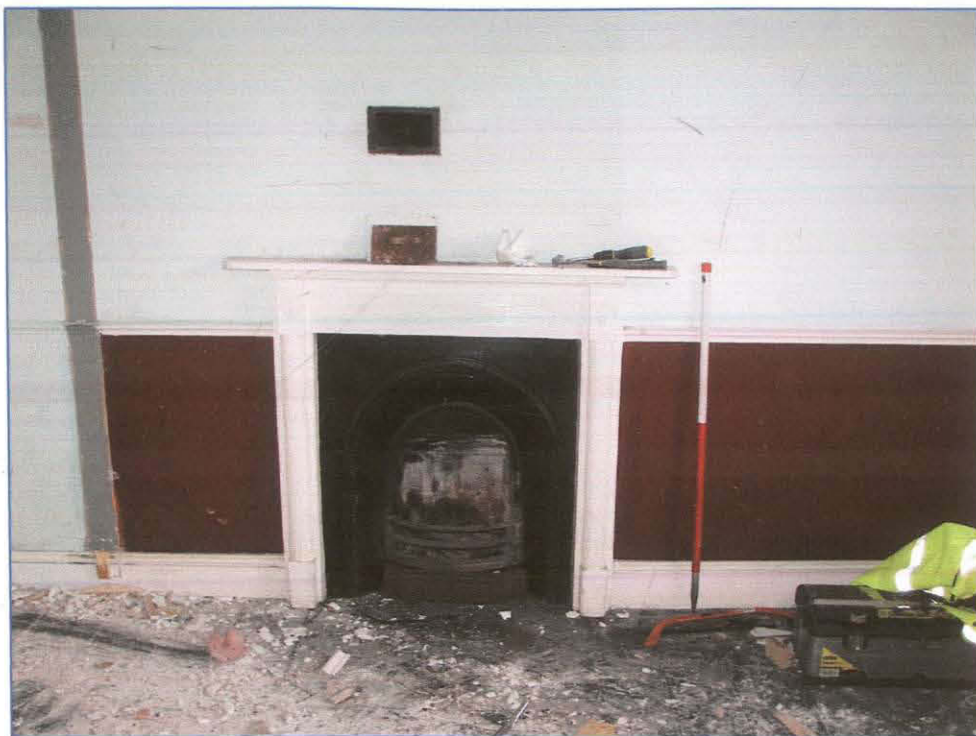
Plate 9: (shot 113) Room 16 retains a mid 19th century cast iron arched register grate that has a Regency style fire surround with concentric bosses and reeded moulding. Looking east.

- 6.6.3 Room 16 retains a mid 19th century cast iron arched register grate with a Regency style fire surround with concentric bosses and reeded moulding. It has a timber plank floor that is likely to have replaced a lime ash predecessor.

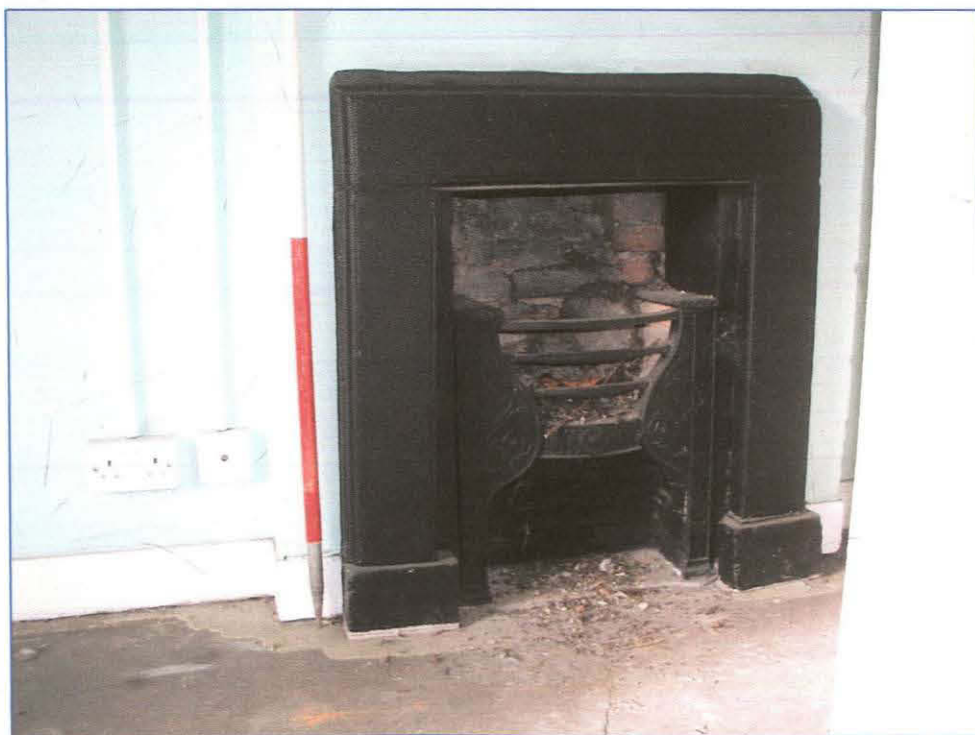
Plate 10: (123) Room 18 retains a late 18th early 19th century cast iron hob grate with a plain stone surround. The same style of fireplace has been retained in rooms 19, 20 and 21. Looking north-north-west.

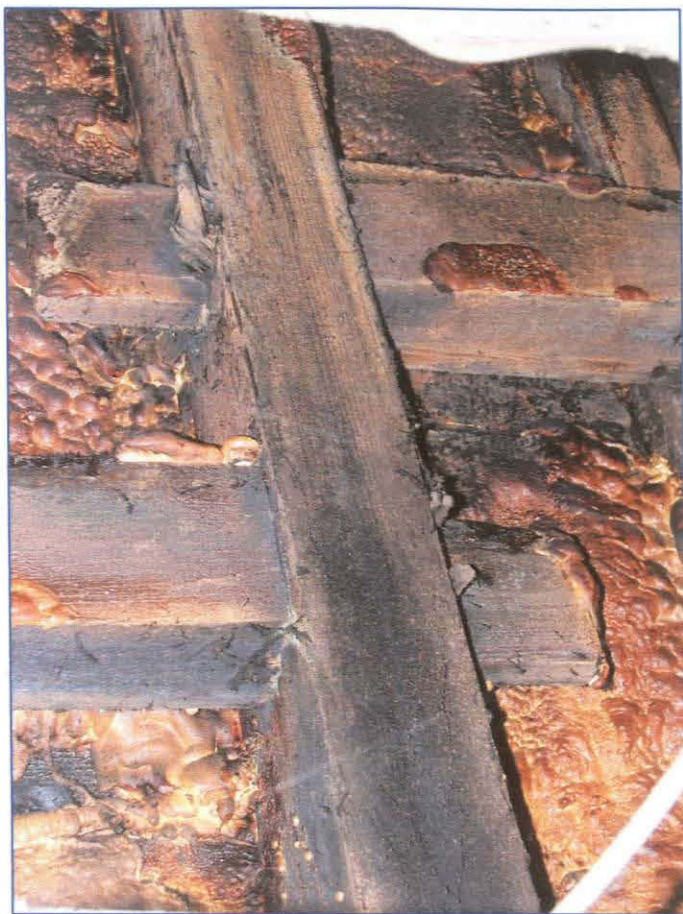
Plate 11: (shot 138) Staggered butt purlins morticed with tenons pegged behind the principal rafters and supporting common rafters. Observed in the fire damaged part of the Southern Range. Shot taken vertically.

6.2.2 Detail of the roof construction (where visible due to fire damage) includes staggered butt purlins morticed and pegged through principal rafters and supporting common rafters. The joists consist of both squared and round wood timbers, morticed into bridging beams between the wall plates.

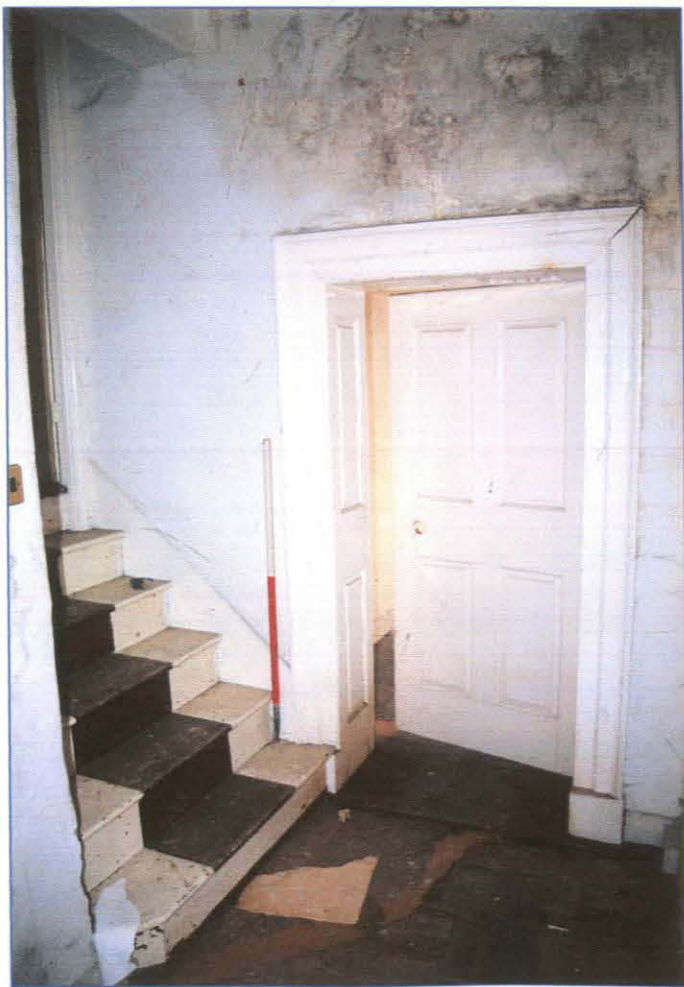
Plate 12: (074) On the first floor, rooms have doors that are four panel raised and fielded within a boxed, paneled frame with architrave. Shot depicts the door of Room 10 taken from the western half landing facing south.

- 6.7.1 Although Room 10 was water damaged, it still retains egg and dart cornice, square section skirting and has a reproduction antique fireplace in the western wall. The windows are 6/6 sashes over 18th century panelling with contemporary shutters and architrave, the floor is planked.

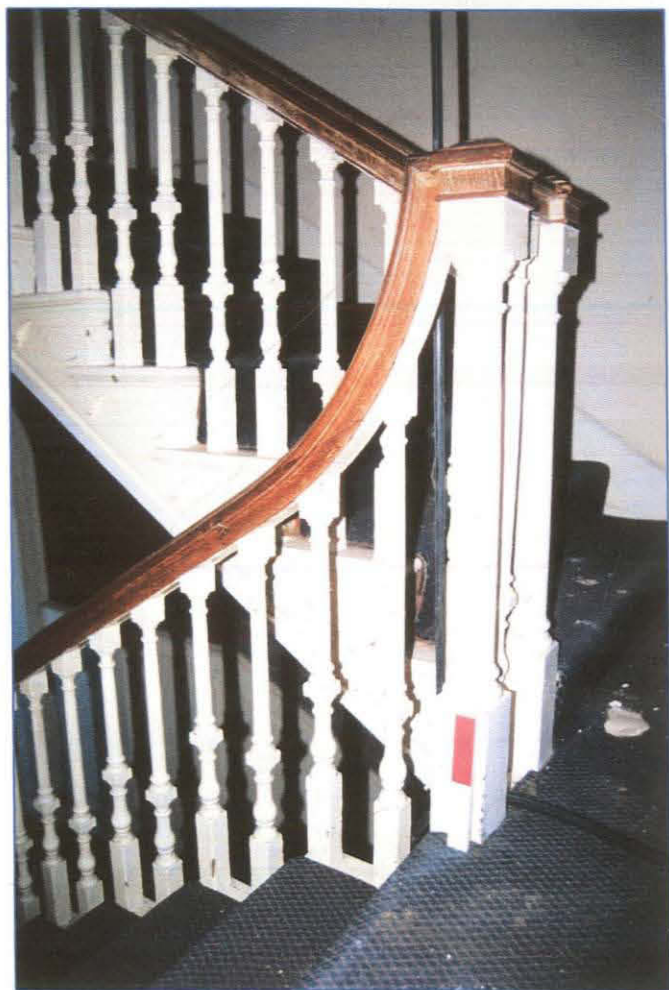
Plate 13: (097) Constructed in an open strung mid Georgian style, the eastern staircase has slender turned balusters standing on the treads with columnar newel posts and ramped handrail. Looking south-west.

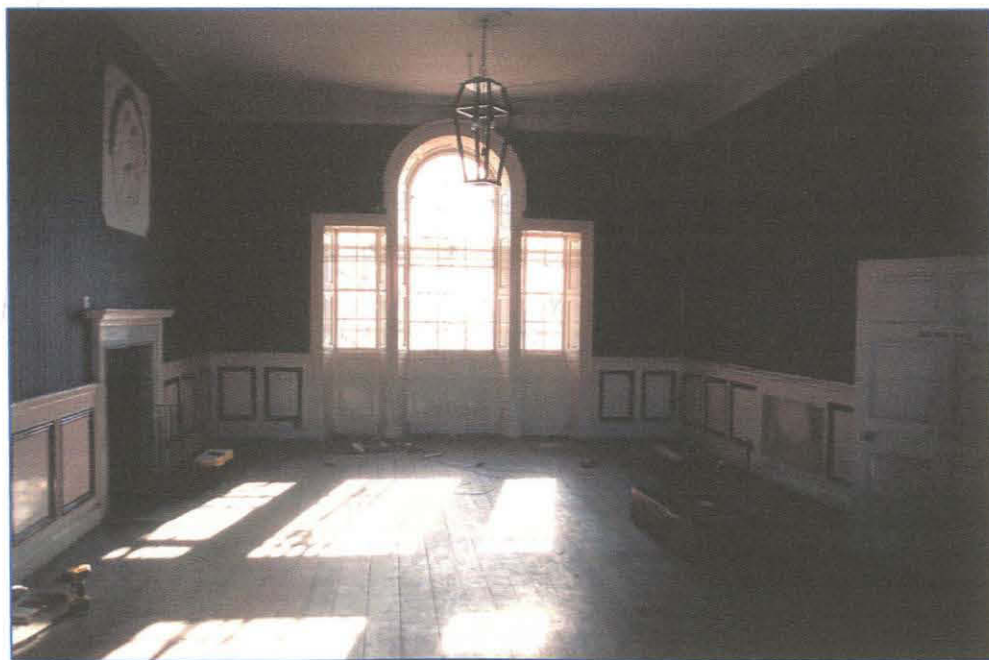
Plate 14: (033) general shot of the courtroom, its panelling and Venetian window. Looking south.

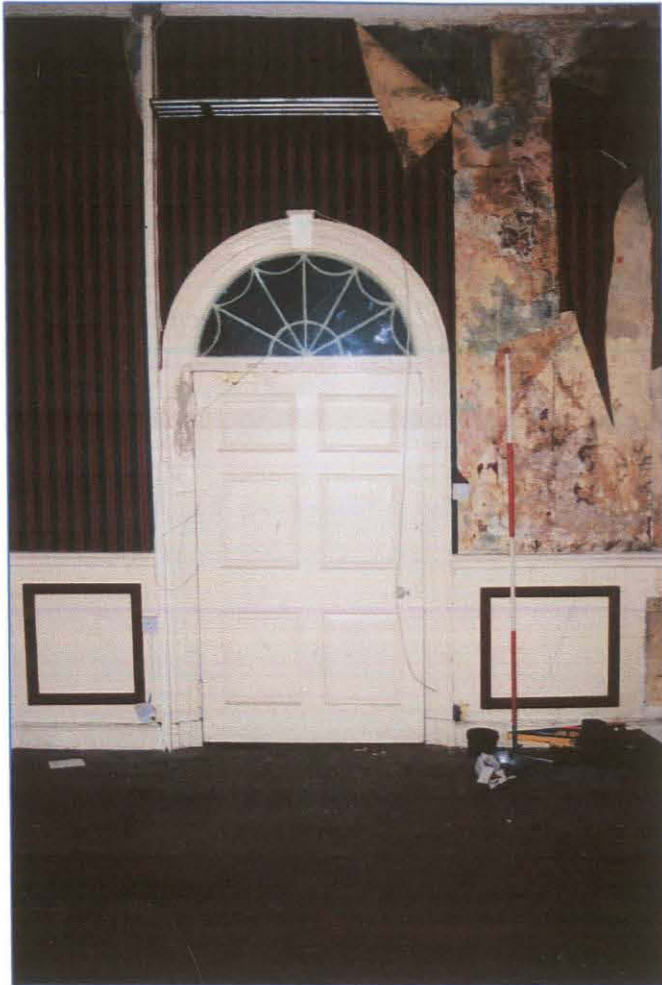
Plate 15: (036) The courtroom is accessed via a six panel door with an Adam Style fanlight header, framed by architrave with keystone detail on both sides of the door frame. This shot also demonstrates the level of water damage to the interior of the building. Looking east.

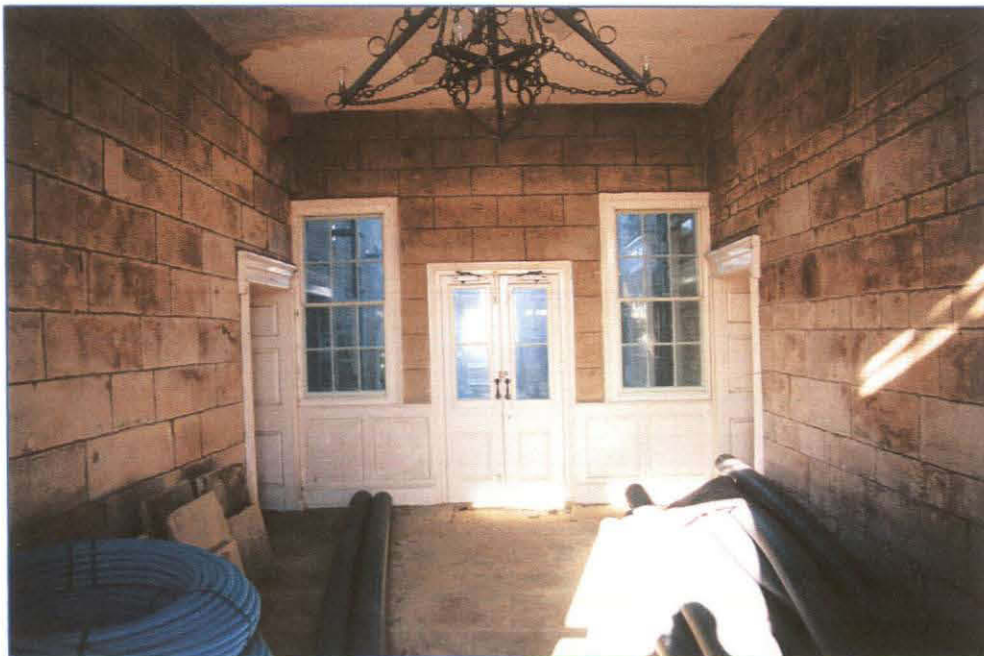
Plate 16: (030) The ashlar lining applied to the carriageway arch in 1789. The northern end is filled by a 19th century brick wall, door and windows, with imitation stone dressing over panelling applied the interior wall. Looking south.

- 7.15 The main entrance was created by the insertion of a moulded stone doorway into the carriageway arch of the southern façade during the 19th century. This comprised a three light basket arched head, ashlar moulded frame with squared flat columns, and ovolo capitol and cornice and ashlar rustication of the outer architrave. The northern elevation of the carriageway arch was also infilled with brickwork around a doorway flanked by two sash windows that created the carriageway hall.

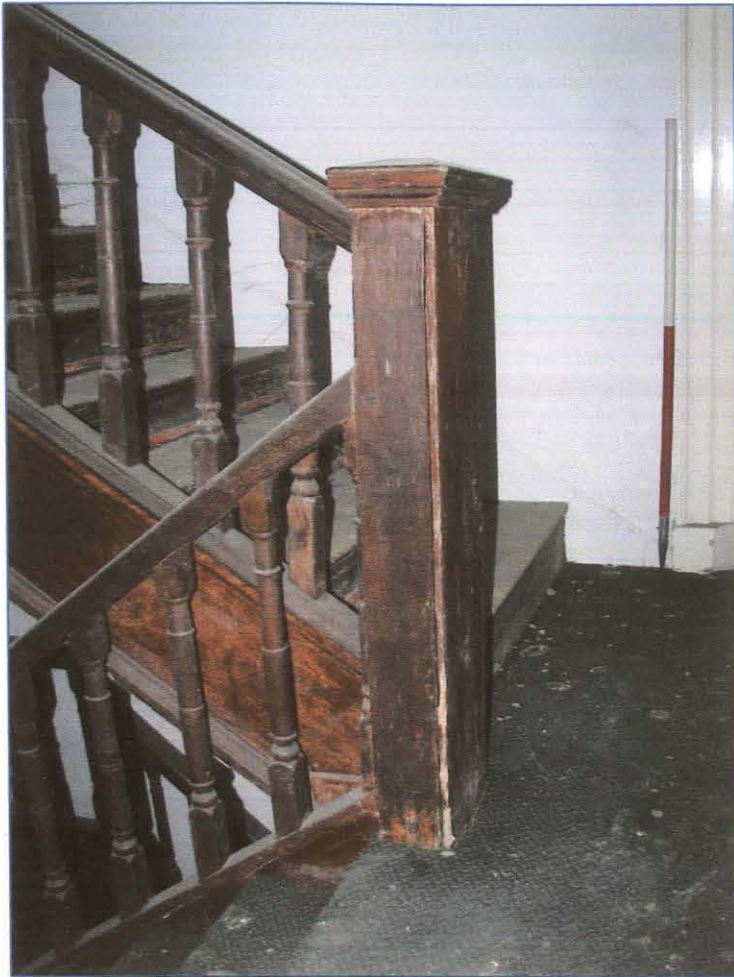
Plate 17: (167) The Western Range staircase, later 17th/early 18th century style, closed string construction with simple turned balusters, heavy plain handrail and balusters. Looking north.

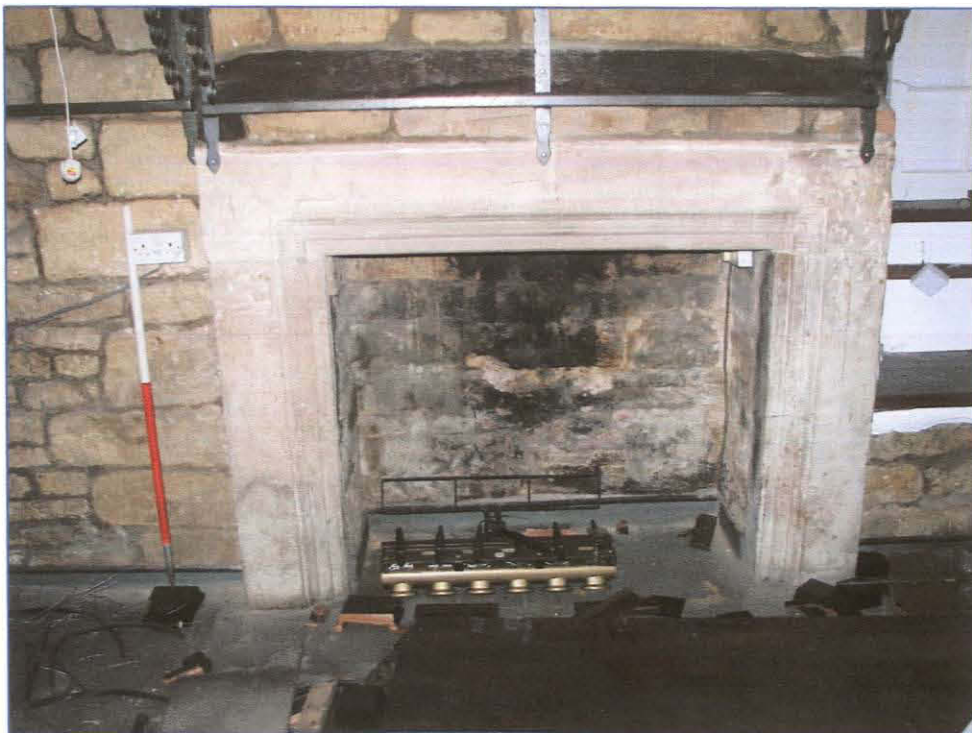
Plate 18: (056) Room 6 in the Western Range, 17th century open fireplace with a stone surround. Looking west.

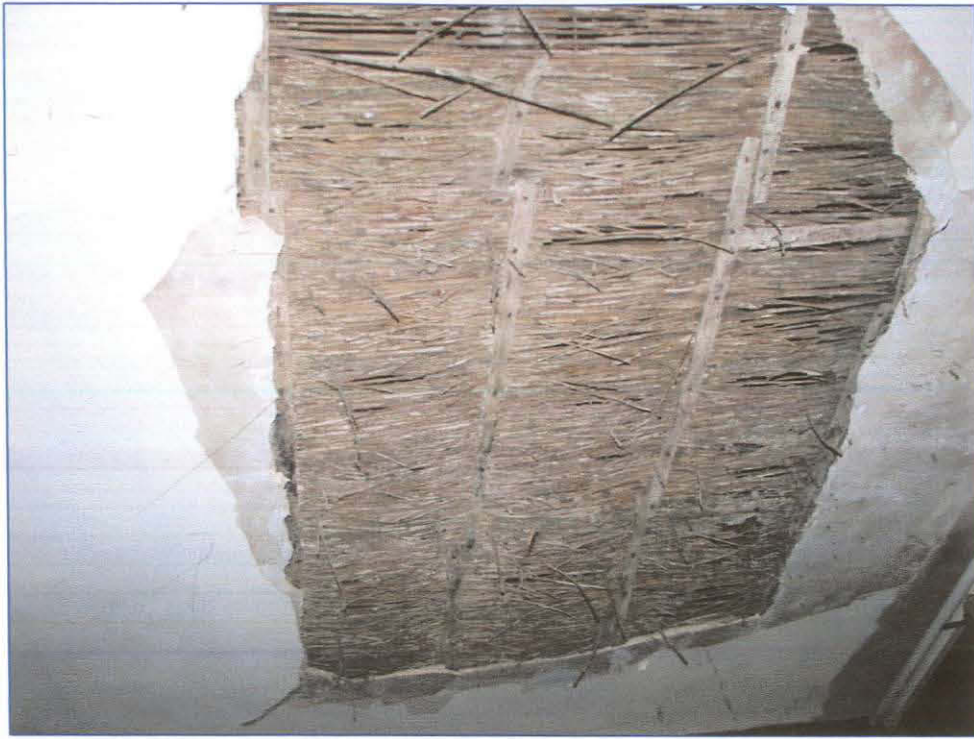
Plate 19: (057) The reed base, for lime ash flooring in Room 9, exposed in the ceiling of Room 6.

- 6.13.7 To the right of the chimney is a blocked 16 light casement window. A damaged patch of the ceiling has exposed the reeded base for the lime ash flooring in Room 9 above.

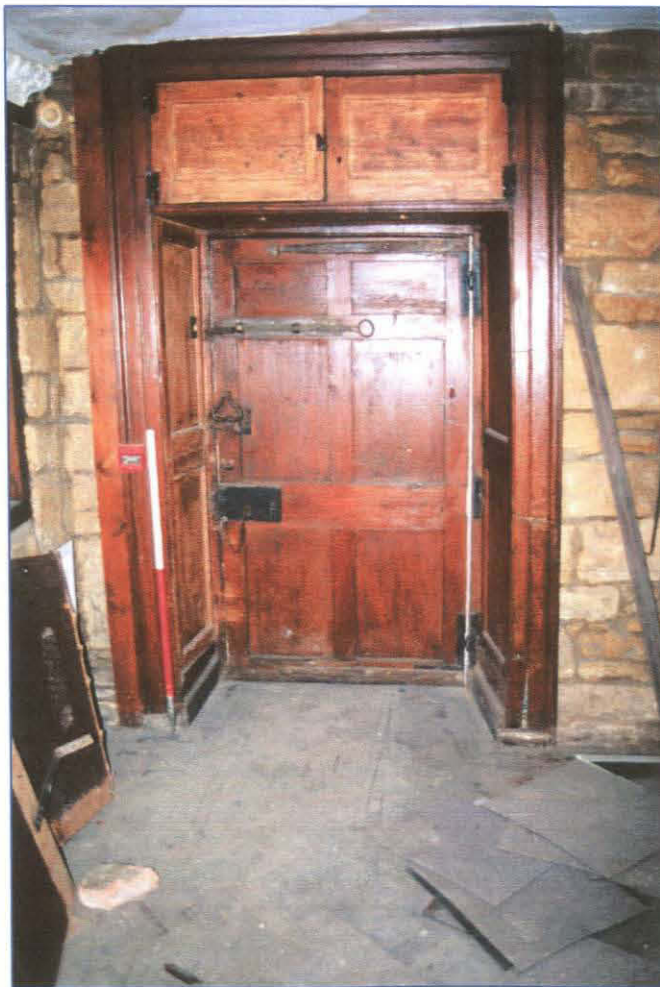
Plate 20: (055) Room 6, mid 18th century style six panelled door with L shaped hinge and contemporary iron work. The door is set within panelled jambs below a built in cupboard. Looking east.

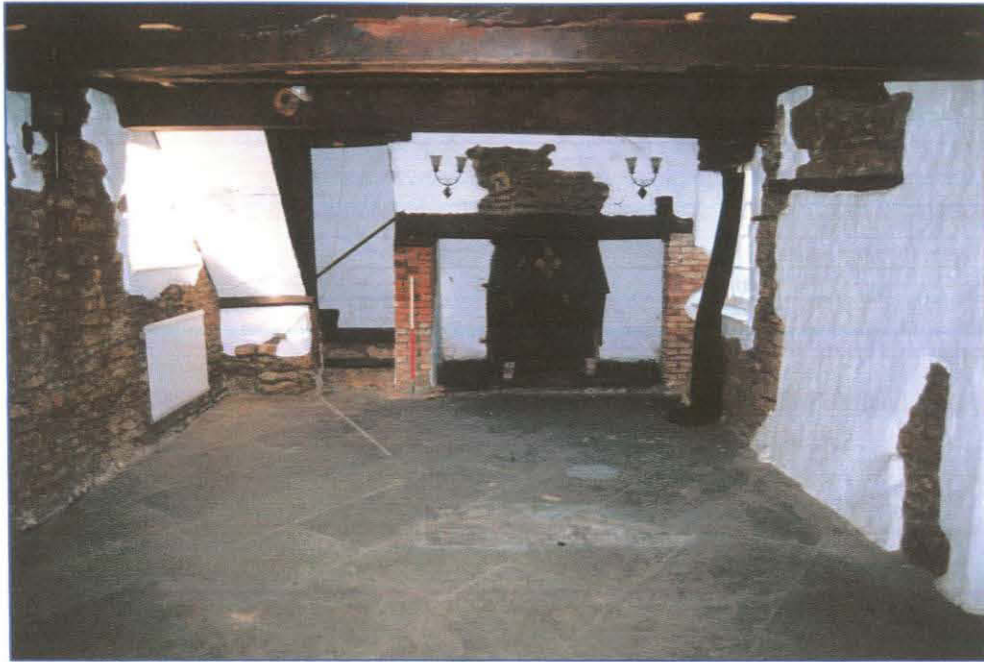
Plate 21: (047) Room 8, in the Western Range. At the northern end of the room is a broad 17th century style fireplace with a heavy timber bressumer supported on 2^{1/4} inch brick piers. Adjacent to the fireplace is the staircase to the garret room above. Large timber cross beams support the joists for the garret floor. Looking north.

- 6.16.5 A modern replacement plank door occupies the blocked doorway in the western wall with only the lintel visible behind the blocked in 17th century door in the south corner of the eastern wall.
- 6.16.6 At the northern end of the room is a broad 17th century style fireplace with a heavy timber bressumer supported on 2 ¼ inch brick piers.

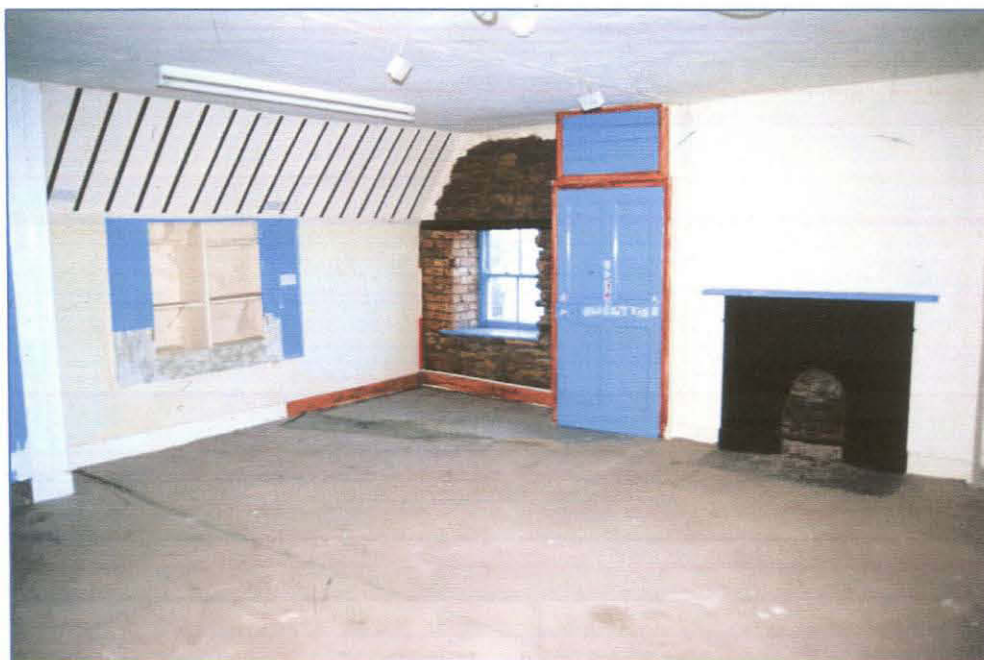
Plate 22: (079) Room 13, on the first floor of the Eastern Range. Set into the chimney breast on the northern wall is a 19th century cast iron arched bath grate with a plain stone mantel and pillars. The door leads to Room 14 down a short flight of stairs. Looking north-west.

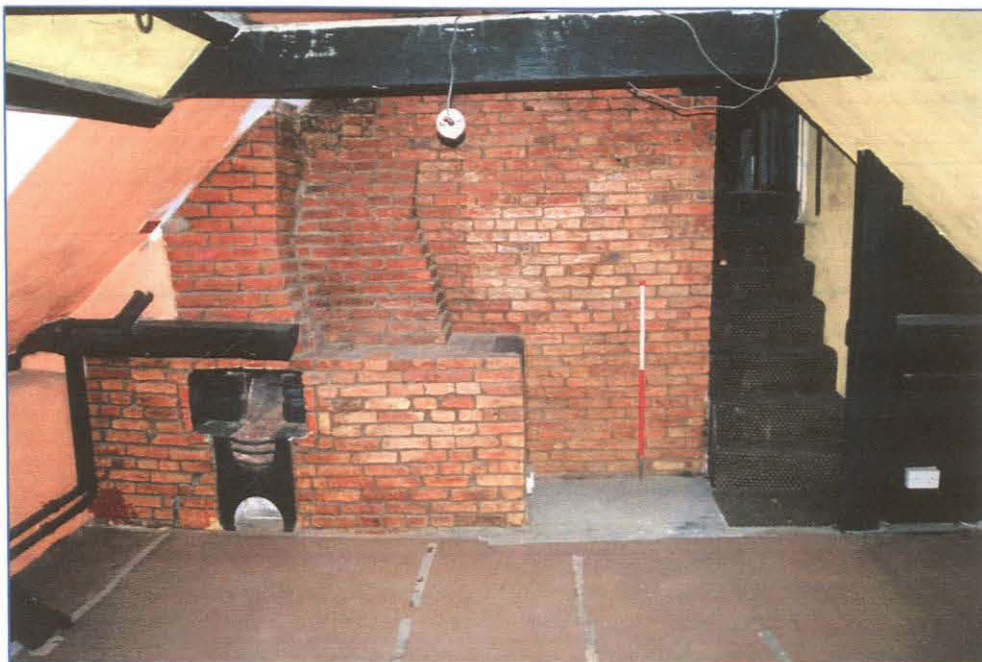
Plate 23: (083) Room 14. The southern wall is dominated by a large brick chimney breast that has a small hob grate built onto its eastern side. This structure also supports the stub end of a cross beam that has been cut to accommodate the insertion of stairs from Room 13. A timber stanchion at the foot of the stairs supports the opposing beam stub. Looking south.

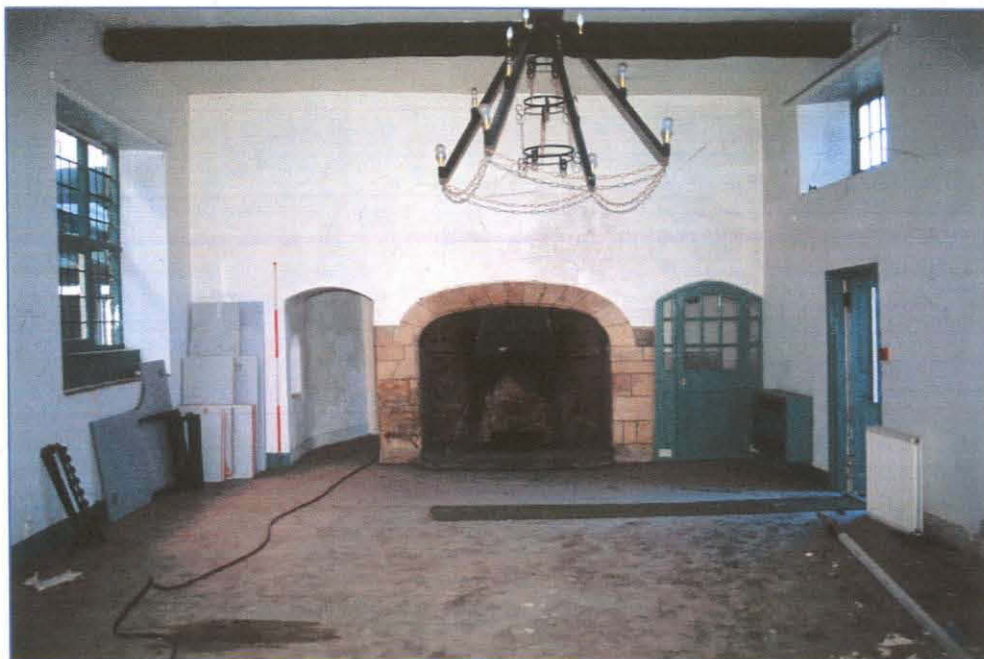
Plate 24: (038) Room 2. In the north wall is a large 18th century basket arched fireplace with integral moulded stone surround and buttresses over an integral stone slab. There is an arched recess to the east of the fireplace with a half glazed nine pane door flanked by narrow three light sashes. The arch to the west passes through a former oven set into the corner of the building with an external curved wall. Looking north.

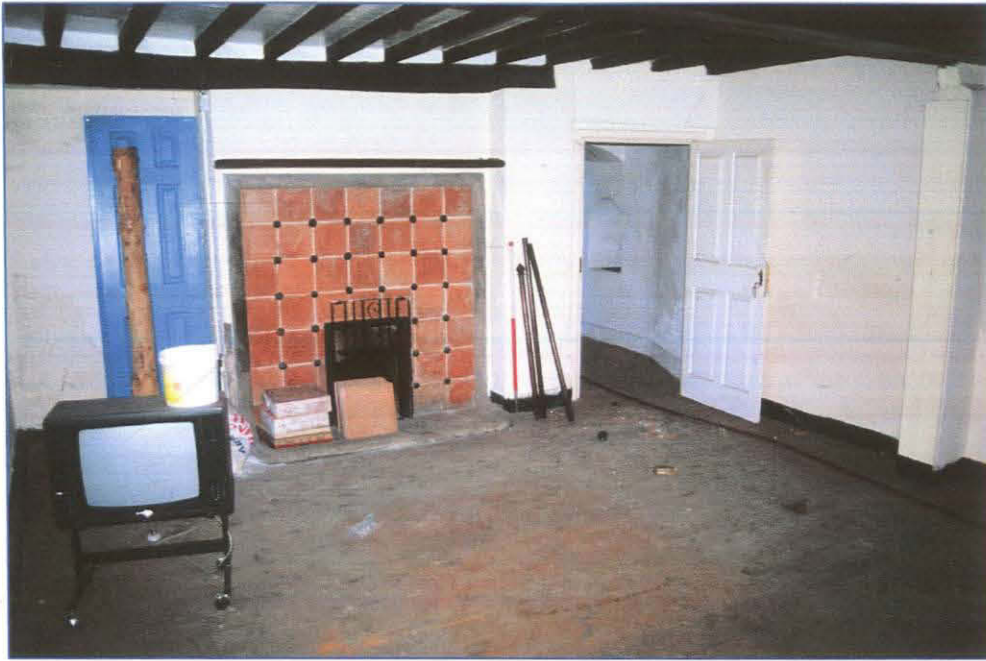
Plate 25: (041) Room 3 has a beamed ceiling with a large cross beam supporting squared timber joists, with a further beam set into the chimney breast crossing a recess on its eastern side. There is a tile backed modern retro fireplace incorporating iron studs and a small grate fitted to the chimney breast on the south wall. The floorboards are also a relatively recent addition to the building and the internal doors are modern replacements. Looking south-east.

- 6.20.10 There is a tile-backed modern retro fireplace incorporating iron studs and a small grate fitted to the chimney breast on the south wall. The floorboards are also a relatively recent addition to the building and the internal doors are modern replacements.

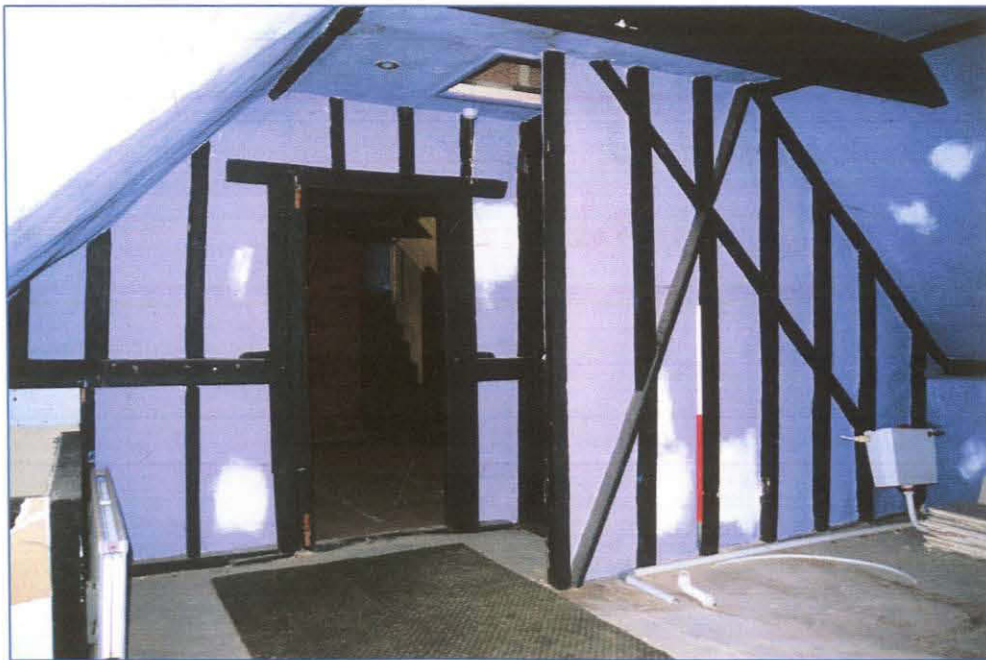
Plate 26: (085) Room 15. The 18th century type doorframe in the southern wall of this room is constructed in heavy timbers that form part of the roof superstructure. It has an expanded lintel that is secured to the jambs with pegged mortice and tenon joints supporting timber studding to the apex of the roof. An original latch hoop is still attached to the north side of the frame. A partition wall of timber uprights with cross bracing may have enclosed what may have been the original internal staircase access. Looking south-east.
