**ARCHAEOLOGICAL WATCHING BRIEF
AND BUILDING RECORDING
AT THE RIVER EDGE AND
FORMER FLOSS LAUNDRY,
MORTON CORNER,
GAINSBOROUGH,
LINCOLNSHIRE
(GMC03)**

**Work Undertaken For
Black and Veatch**

August 2004

APS Report No. 108/04

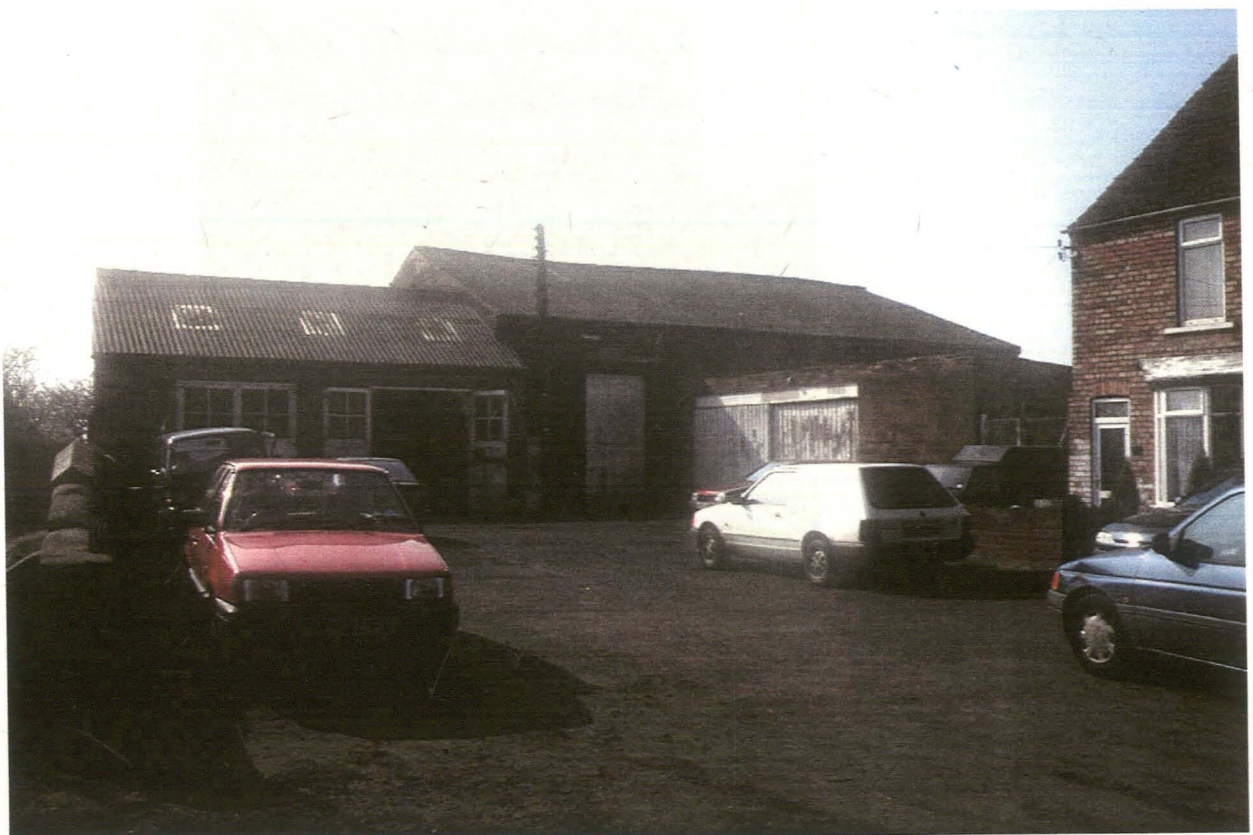
Plate 2 General View, north side of former mill, looking southwest

Constructed of brick with a concrete floor and pressed, corrugated asbestos roof, the main mill building is approximately 19m by 13m in area, elongated east-west (Plates 2 and 3). The building is trapezoidal in shape, with the northern side slightly, about 2m, longer than the southern. The western side of the building faces the river.

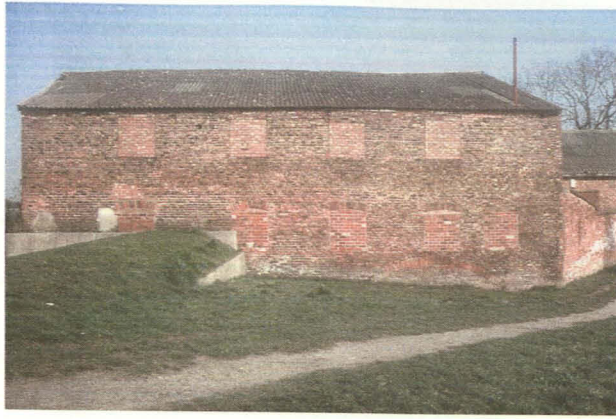
Plate 3 South Side of Former Mill, showing blocked windows, looking north

The south wall has a sequence of five windows at ground floor level and a further row of four on the second storey (Plate 3). The windows in the upper row are generally set above those on the ground floor, except for the fifth, east end, ground level window. With the exception

of this most easterly window, the ground floor windows have segmental arches of brick rubbers; the tops of the second storey windows are at eaves level. All the windows are blocked with brick. Beneath the ground floor windows are two infilled brick arches (Plate 8).

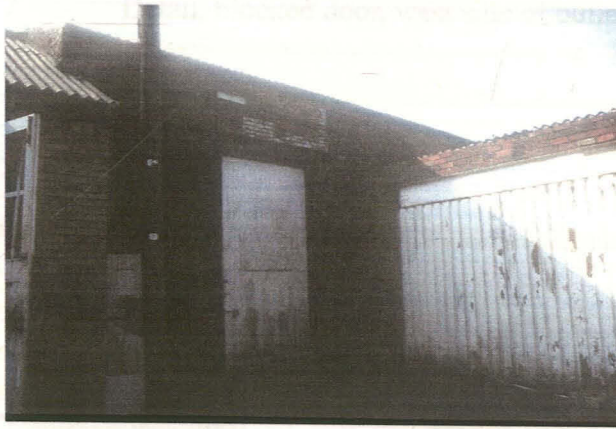
Plate 4 North Side of Former Mill, showing main entry and extension, looking southwest

Entry to the main building is by tall, planked double doors toward the eastern end of the north elevation. This entry employs a rolled steel joist (RSJ) as a lintel. Immediately west of this entry is an extension to the north, described below (Plate 4).

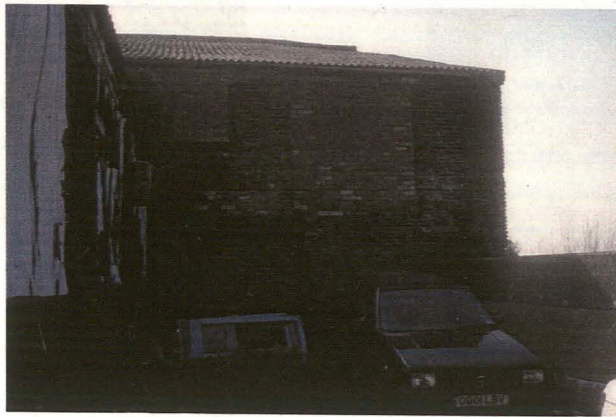
Plate 5 North Side of Former Mill, western end showing blocked entries, looking south

elevation continues (Plate 5). There is a brick-filled entry with a rolled steel joist over. Above and at either end of this RSJ is cleaner brick. At the upper storey level are two blocked openings. Above the entry is a tall, narrow former opening. The lower half of this is filled with handmade brick, while the upper part is blocked with machine-made brick. Above this, extending to the eaves, is an area of machine-made brick. Alongside this to the west is a high and wide opening blocked with machine-made brick. Moreover, within this blocking a smaller rectangle of window-dimensions blocked with a different kind of machine-made brick.

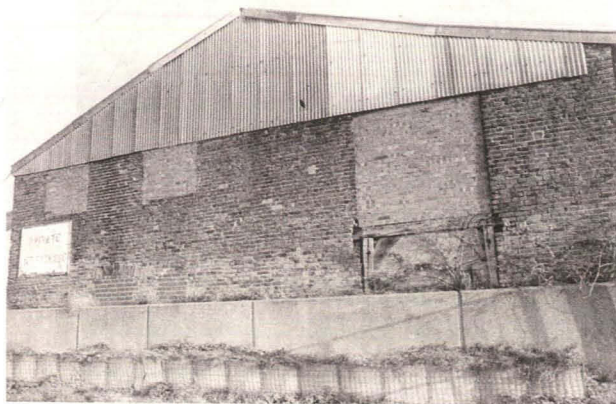
Plate 6 West Side of Former Mill, showing blocked entries, looking northeast

In the southern half of the western gable is an opening that extended at least two storeys high, to the current eaves line (Plate 6). The lower part of this appears to be a doorway with timber framing that includes sub-triangular spandrels that provide an archway-like appearance to the entry (Plate 7). Breeze blocks infill this doorway. Above the timber lintel of the door the remainder of the two-storey opening is blocked with machine-made brick.

At first storey level are two further openings, both blocked with machine-made brick. The upper parts of these are obscured by corrugated plastic sheeting that covers over the full angle of the gable (Plate 6).

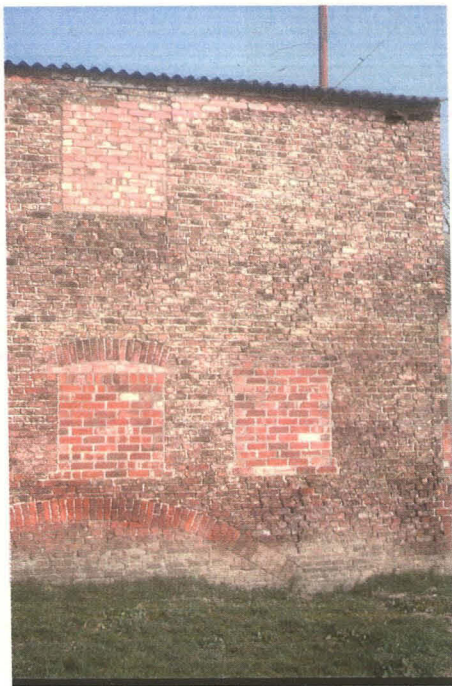
Plate 8 Detail, blocked windows toward eastern end of south side of mill, looking north

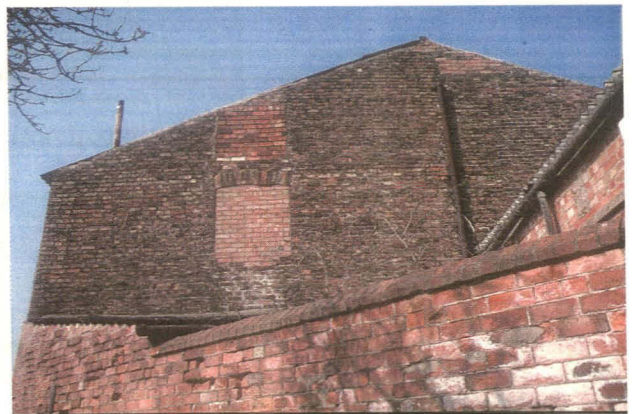
Plate 9 East Side of Former Mill, showing blocked and truncated windows, looking west

The eastern gable is partially obscured by an extension (see below). However, there is a blocked window with a segmental brick arch at second storey height, and a further blocked window on the third storey. This latter window is truncated by the eaves line (Plate 9).

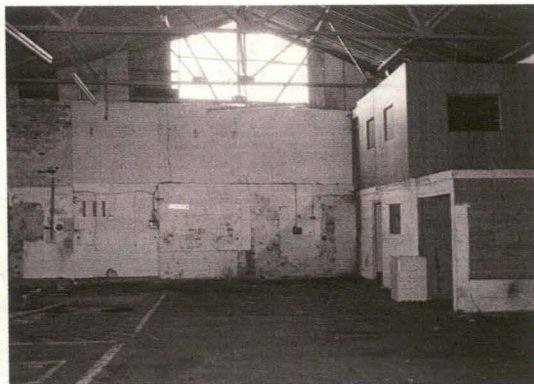
Plate 10 Interior Main Mill Building, west end, showing offices and blocked entries, looking west

The southern interior elevation contains blocked windows, as seen on the exterior. Similarly, the internal face of the western wall reveals evidence of the blocked entry noted on the exterior (Plate 10). Additionally, the internal elevation establishes that one of the blocked entries is a door, the other a window. Two blocked windows are also evident in the interior of the northern wall. These windows are also visible in the extension to the north (see below).

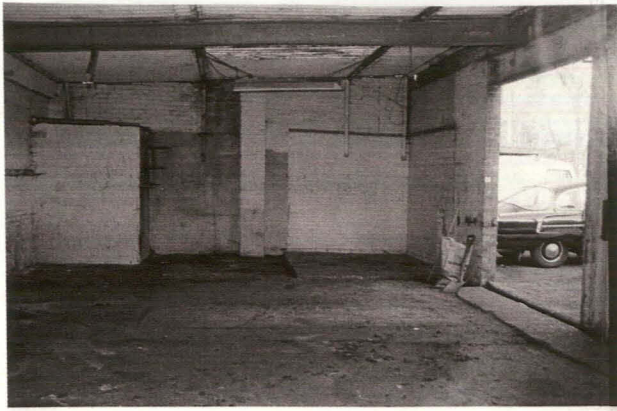
Plate 11 Interior Main Mill Building, east end, showing blocked entries, looking east

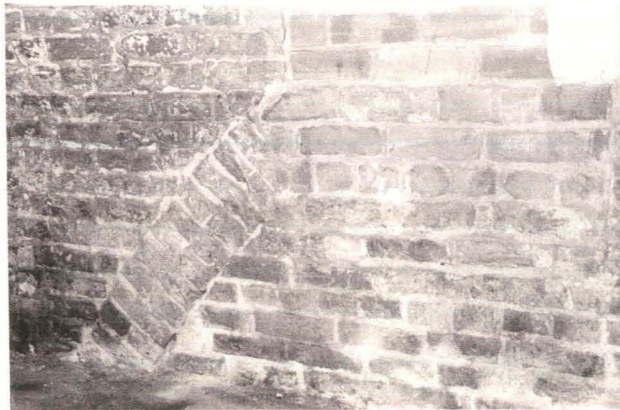
Plate 12 Detail, truncated brick arch, looking northwest

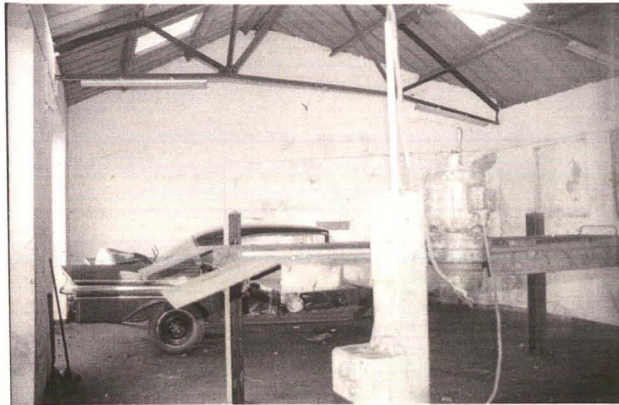
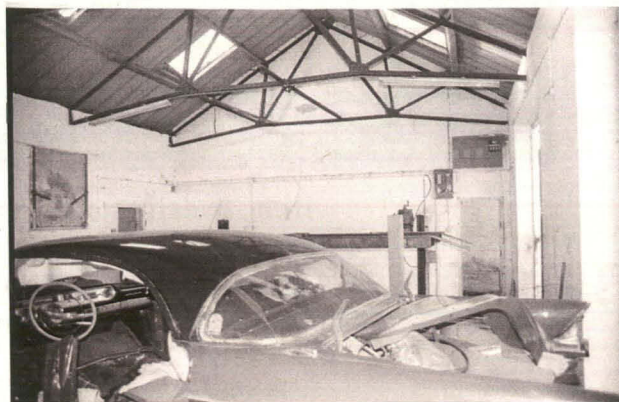
Plate 13 Interior of Eastern Extension, looking east

Plate 14 Interior of Eastern Extension, looking west

The northern half of the triangular extension is a single room (Plates 13-14). There is an infilled circular ventilation opening in the northern wall, and another in the west wall.

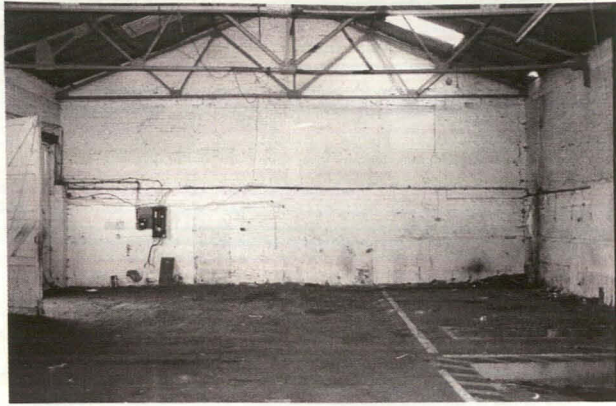
Plate 15 Interior of Northern Extension, looking north

sliding door in the east wall. Above this entry is a rolled steel joist lintel. The north wall is plain and the west wall contains three large windows and, at the northern end, a door to a toilet. The toilet compartment is located internally at the northwest corner of the building and is defined by breeze block walls (Plate 15).

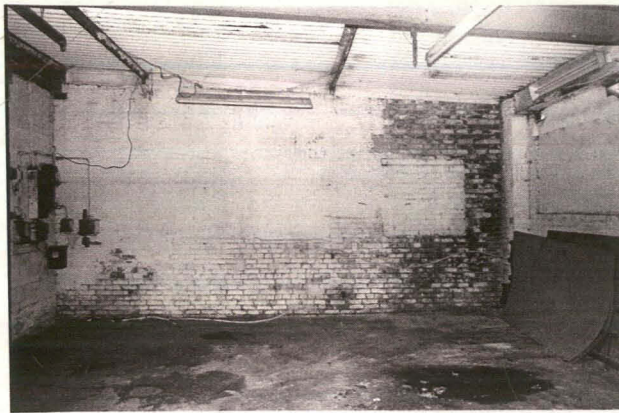
Plate 16 Interior of Northern Extension, showing blocked windows, looking south

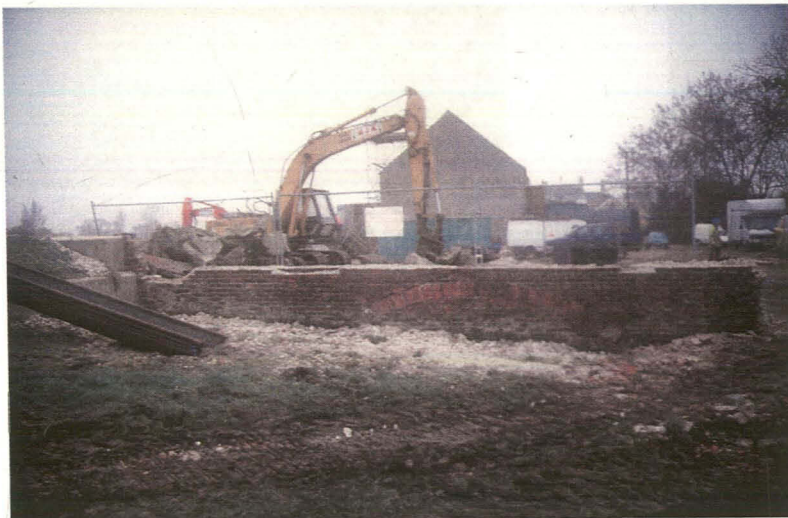
Plate 17 Partially demolished mill building, showing retained brick arch, looking northwest

When the mill was demolished, a section of the lower walls containing the brick arches was retained (Plate 17).

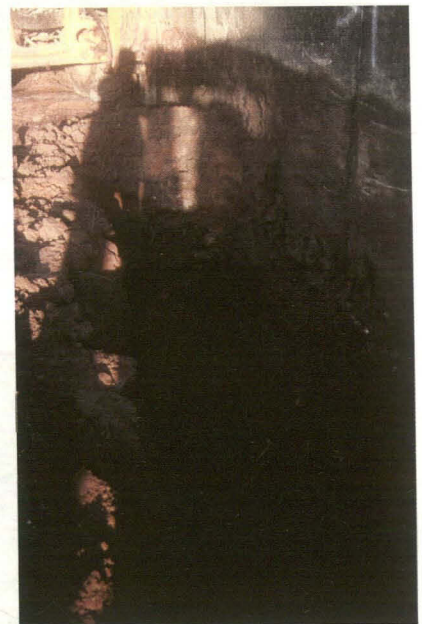
Plate 18 Timbers, Possible River Revetment, Revealed in Trench, looking north

Overlying the natural river silts (012) was a deposit of black organic silt (011) containing brick, stone and wood, including possible poles (Plate 18). This deposit yielded 19th century pottery, a large iron retaining spike of late post-medieval date and a wooden peg. This deposit and materials is thought to be river margin with possible revetment or flood defences. Above this was a 1.6m thick layer of grey-brown silt with rubble, brick, mortar, stone and metal (010), explained as dumped material.

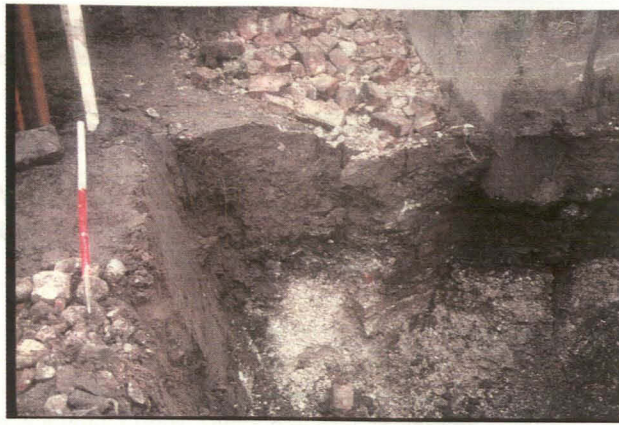
Plate 19 Possible Millrace, looking east

Just outside the western side of the mill building part of a brick arch, over 1m high was revealed (022). This is thought to be part of a millrace (Plate 19).

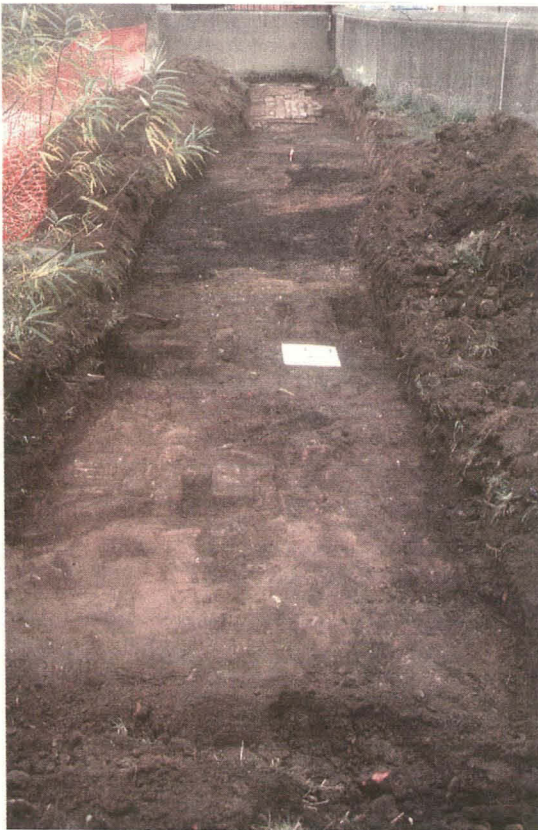
Plate 20 Stripped Area, northern end of site, looking north

At the northern end of the monitored route (Plate 20), an area of structural remains about 3.5m long by 1.5m wide was exposed (Plate 21). The earliest element of this was a mortared brick wall, aligned east-west (004). This wall formed the southern limit of a layer of brown gravelly silt with crushed brick (003) that contained pottery of 19th century date. This layer provided bedding for a mixed stone and brick surface (002). Partially overlying this floor was a concrete surface (001). Built up against the south side of wall (004) was an area of mixed grey and brown silt with crushed coal, brick rubble, slate and glass (005). This is a dumped deposit.

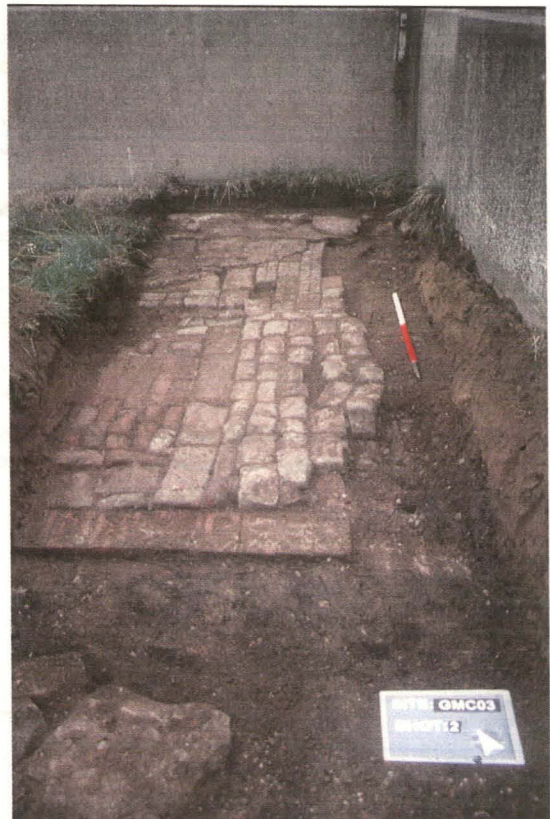
Plate 21 Floor and Wall, northern end of site, looking north

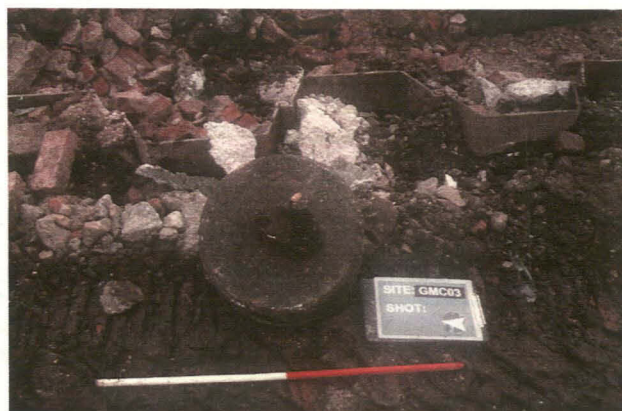
Plate 22 Millstone found in demolition rubble

Within the mill building, overlying the post-medieval brick surface (016), was a 0.3m thick deposit of red-brown rubble (015) that provided a bedding layer for the present concrete floor of the building (014). Additionally, above the possible post-medieval millrace was the concrete flood defence bank (021). During demolition of the mill building a small millstone was revealed but not retained (Plate 22).
