BUNKERS FARM, WELTON LE WOLD, LINCOLNSHIRE

PHOTOGRAPHIC BUILDING SURVEY

Site Code: BFWW 08
LCCM acc. no: 2008.91
Planning ref: N/200/03059/06
NGR: TF 2840 8696
PCA job no: 08-441

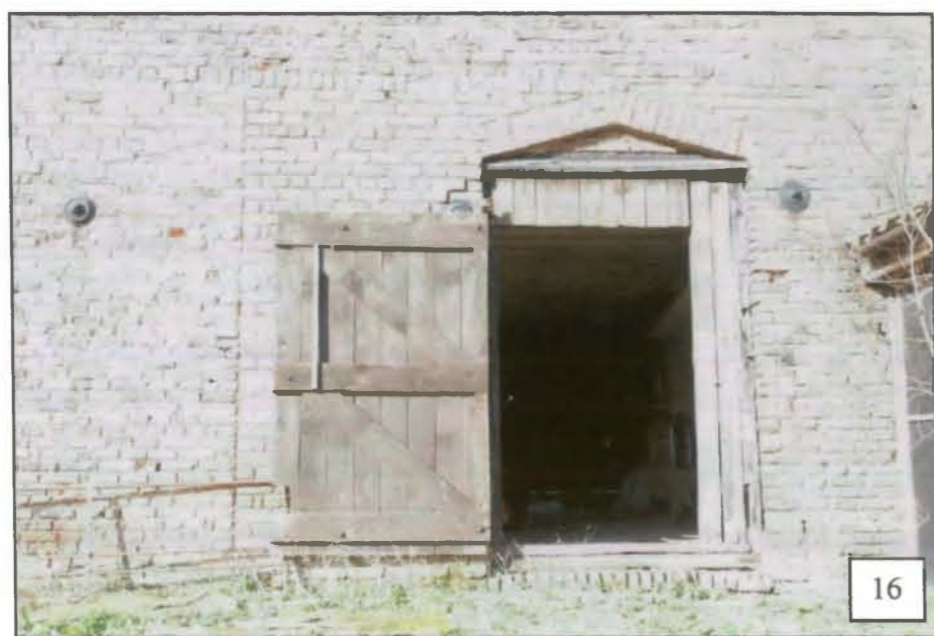
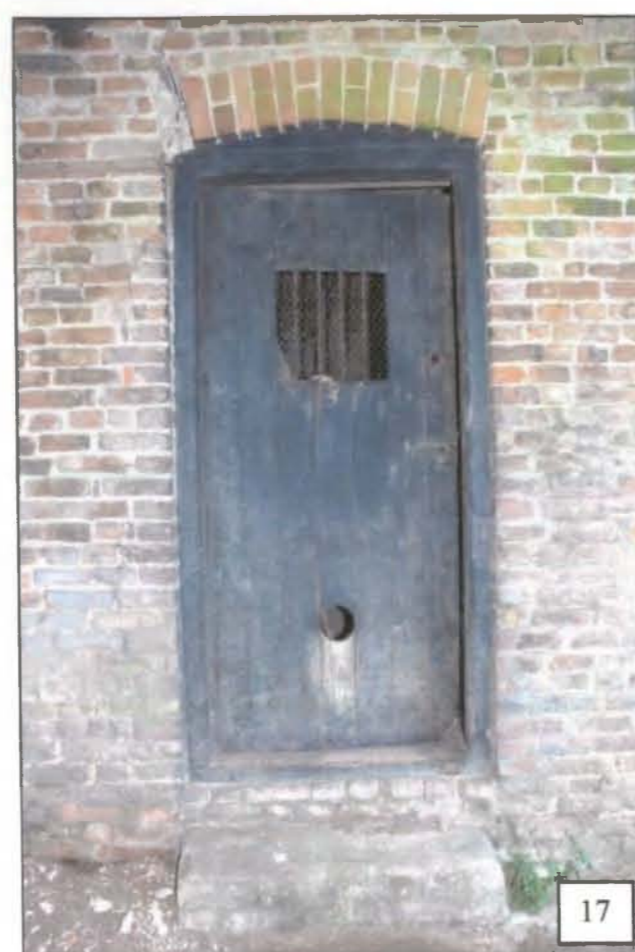
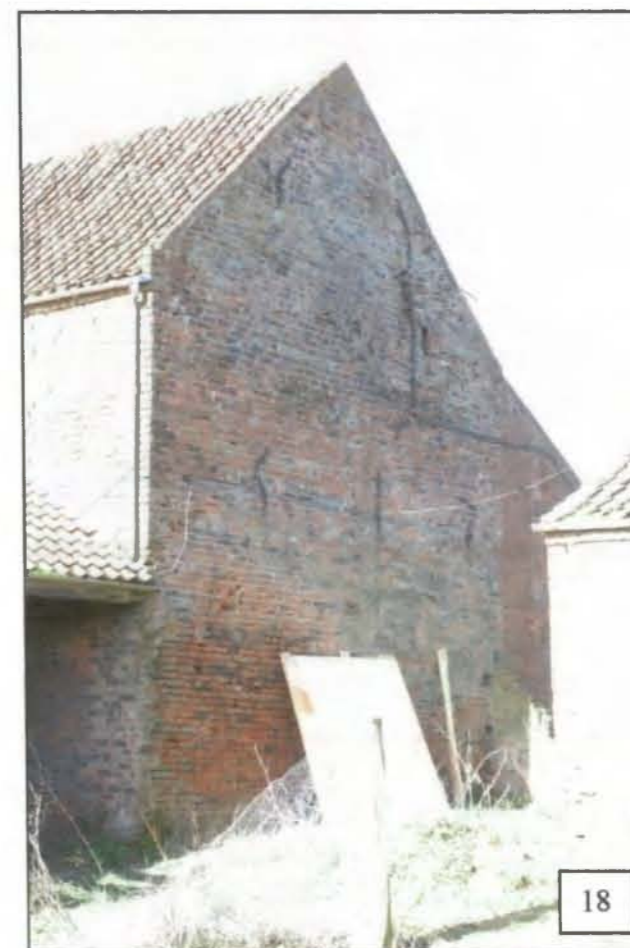
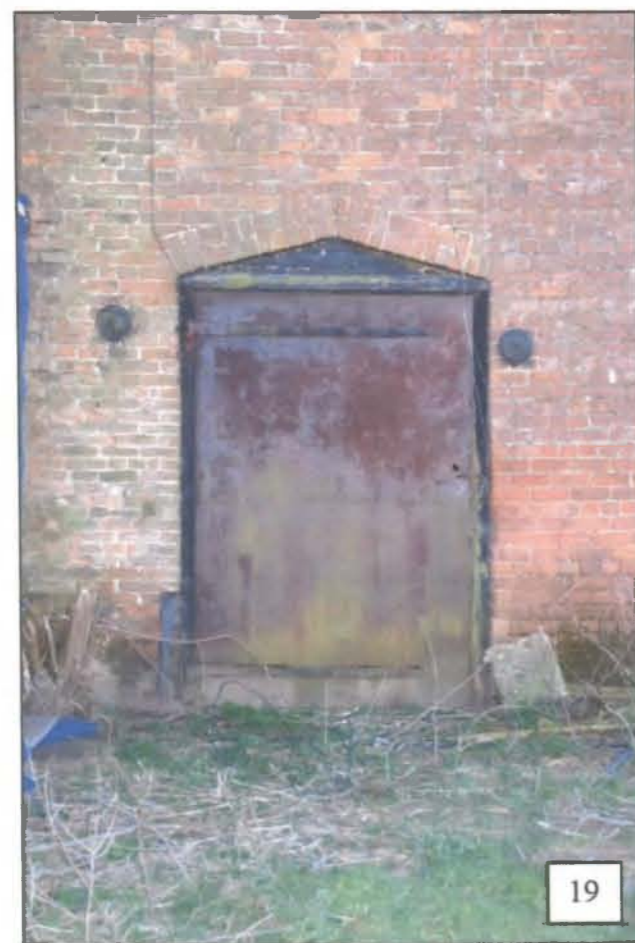
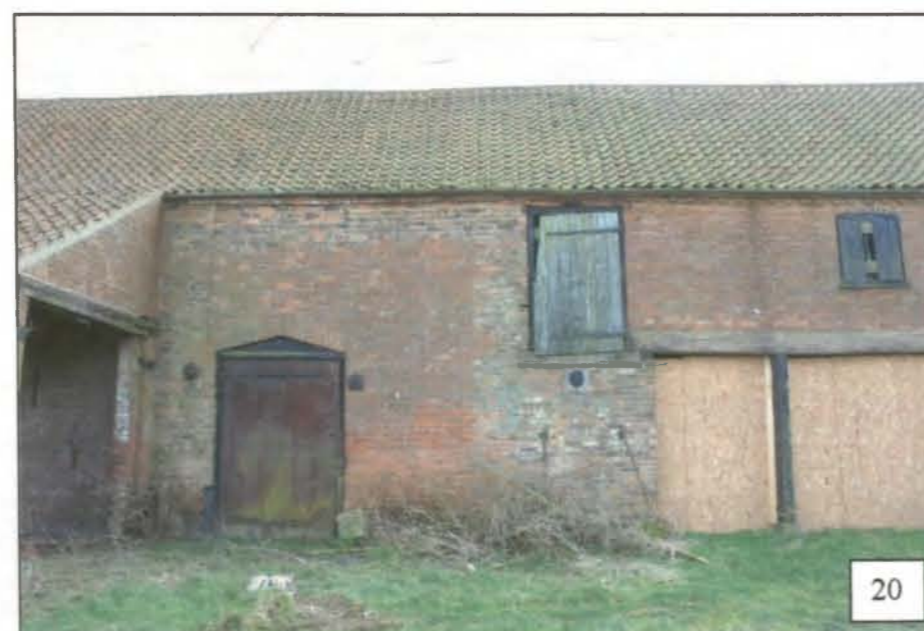
The original building was constructed in a mixture of red and yellow brick (brick dimensions 9" x 4¼" x 2¼", 3 courses rise 8¼"), 13½" in thickness and in a 5-course English Garden Wall (EGW) bond (i.e. 5 courses of stretchers to one of headers). The gable walls differed, ranging from 3- to 7-course EGW. The building was aligned east-west and had a pitched pantile roof. It had a plain eaves cornice comprising a single row of projecting stretchers.

The main door openings on the north and south sides of the original building were nearly the full height of the walls: these have been blocked in the same brickwork as the western extension to the structure, and the present door openings match that in the south side of the extension.

The east gable clearly displayed the scar of a pitched roof, presumably where Building A was originally joined. A blocked door opening with a shallow-arched lintel of edge-set headers was also centrally placed in this wall.

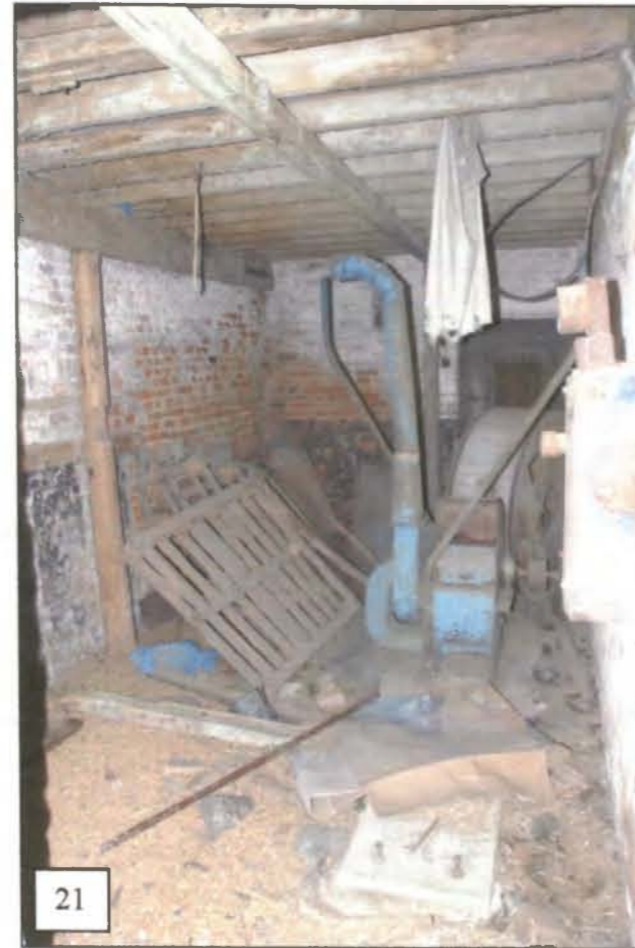
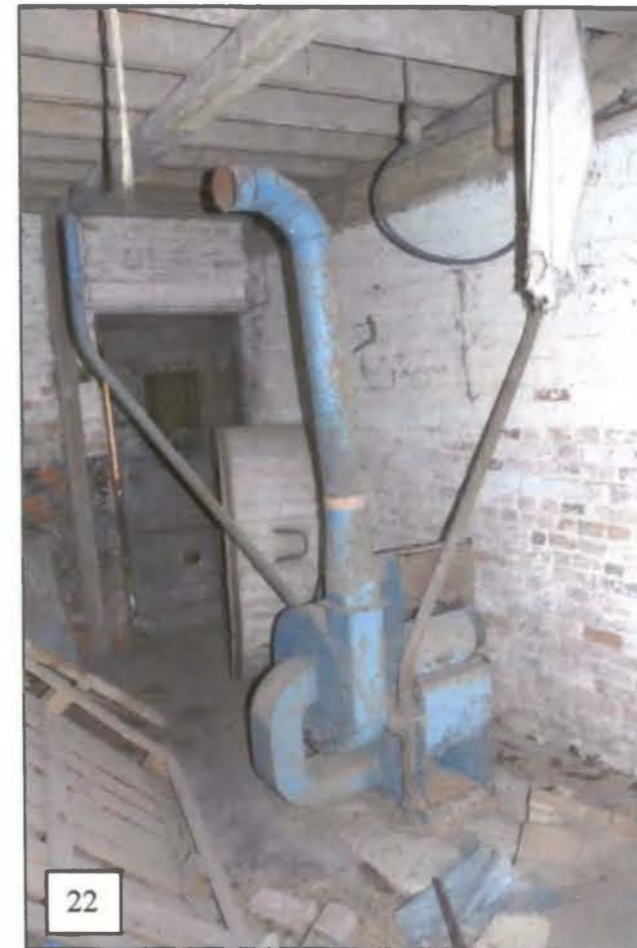
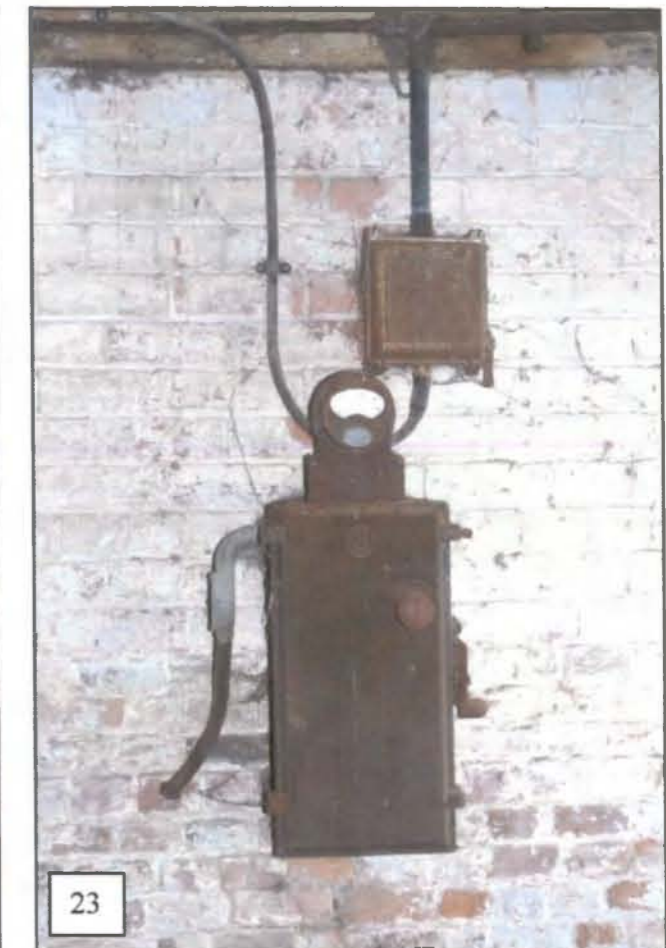
This room had two entrances. The southern door was a ledged, 5" beaded plank door, with a small barred window, thumb-latch and a cat hole, in a 5" x 3" chamfered frame with a timber lintel. No door was present in the opening to the north, but the 5" x 3" chamfered frame, with timber lintel and doorsill, remained. The walls were whitewashed; the north, south and east walls were painted black to a height of 4' 1".

The room was roofed by the exposed beams, joists and floorboards of Room 12 above. The beams were 11" x 3": the eastern beam was centrally braced by a 6" diameter timber post. The joists were 7" x 2" at c. 15" centres.

The floor was a mixture of asphalt and concrete, including concrete pads with bolts for machinery. A slit vent was present in the south wall, probably blocked on the north side. A belt-driven grain blower remained *in situ*: its electric control box was located on the west wall.

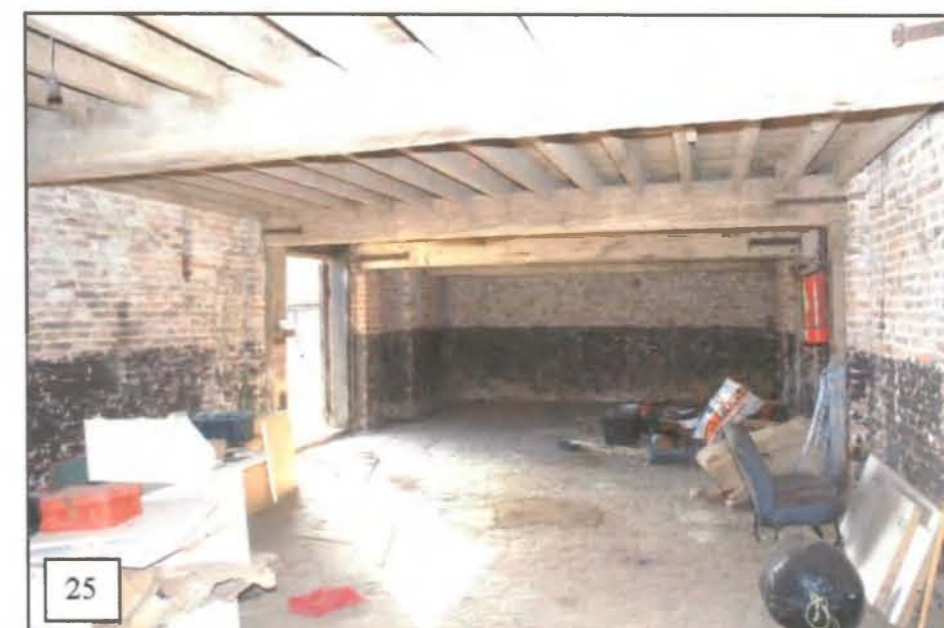
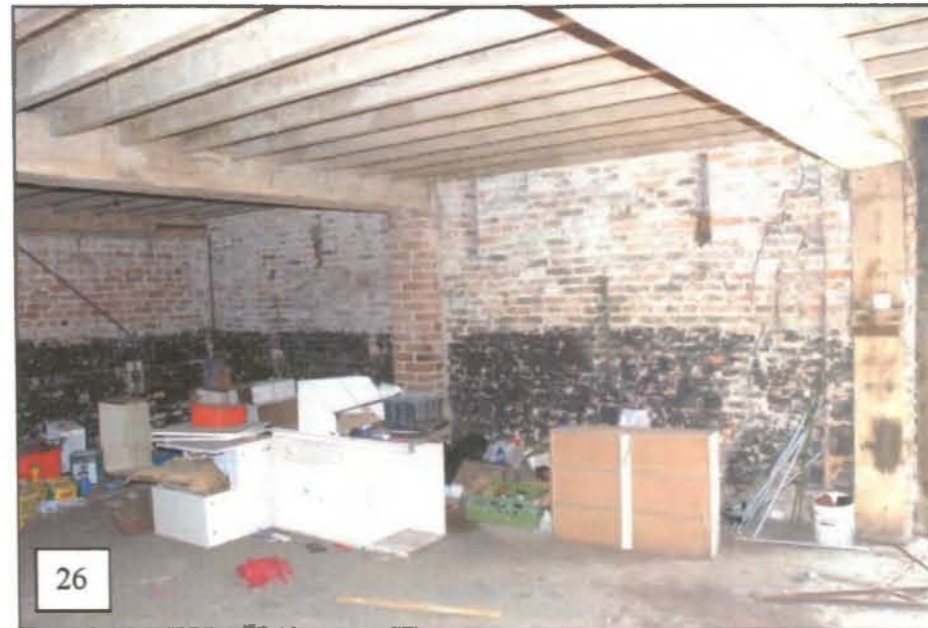
Room 8 was again roofed by the exposed beams, joists and floorboards of Room 12 above. The beams were 13" square, with hewn faces; the joists were 7" x 2½" at 14" centres. The beams were generally supported by brick buttresses on the north and south walls – some of these were of modern brick, and some beams had additional timber supports.

No windows were present here; the north and south walls had slit vents, 25" high and 3" wide. There were six vents in the south wall, of which four were blocked, and four in the north wall, of which two were blocked.

The floor was chiefly of a smooth asphalt, or possibly poured pitch, which had extensively cracked: it retained the impressions of machinery and other installed features. At the east end there was a continuous concrete repair, 4' wide; various other cement and concrete repairs were present, one of which had the date 1957 inscribed into it.

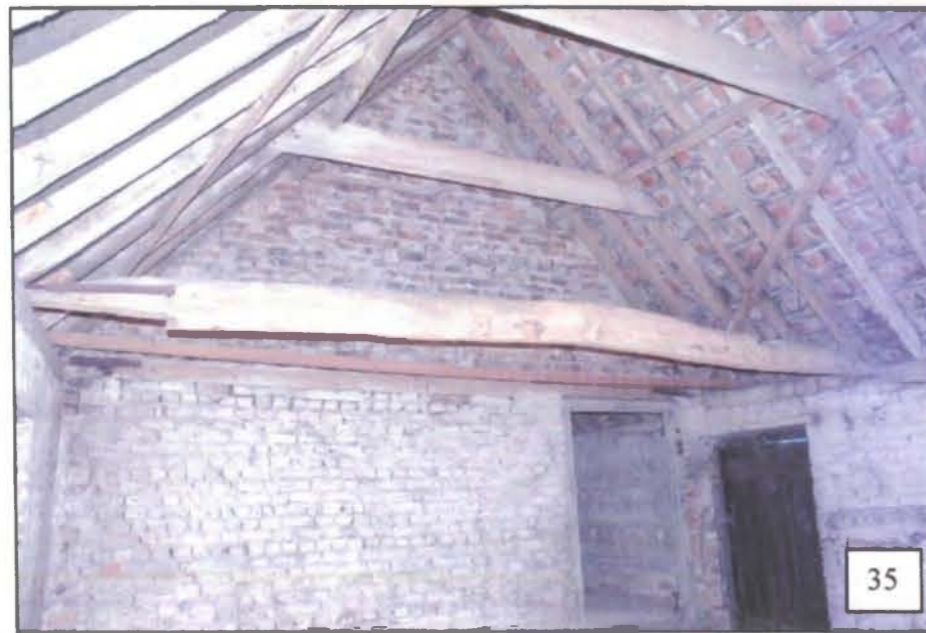
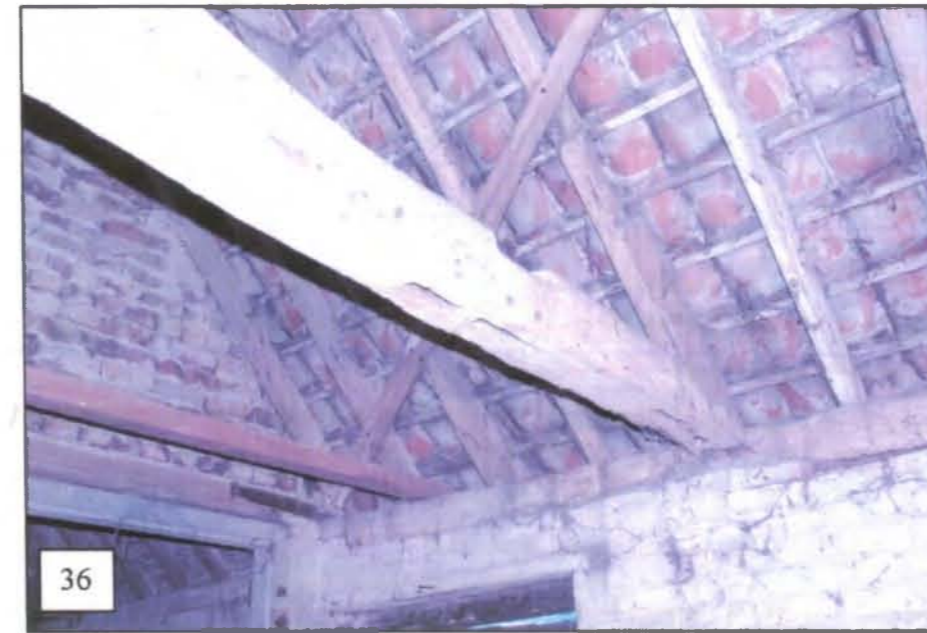
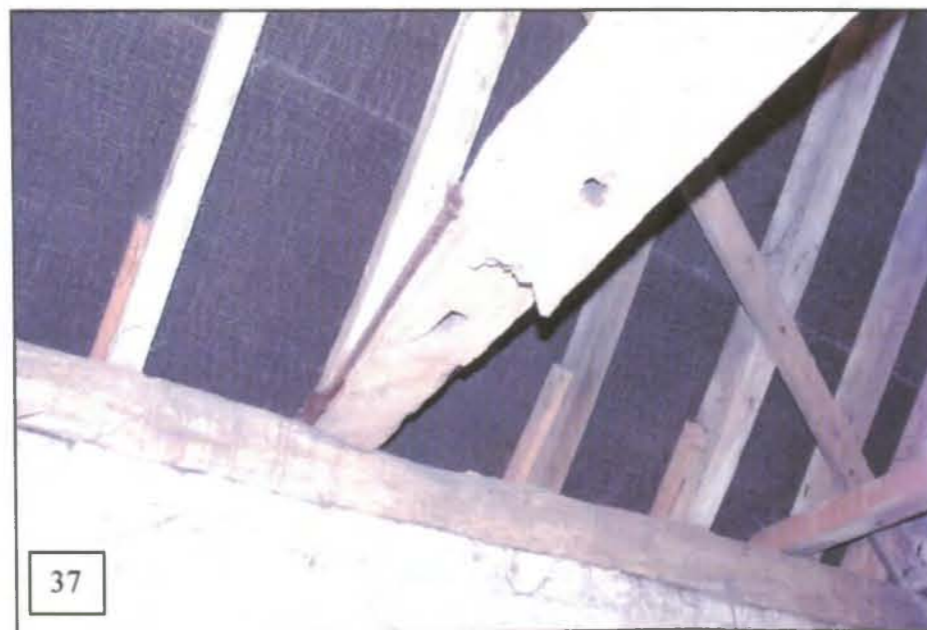
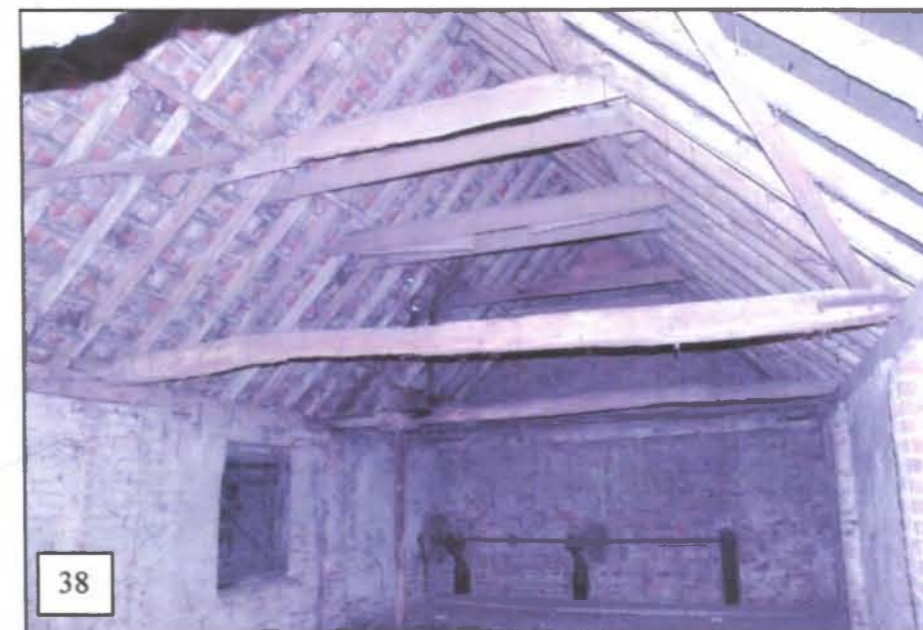
The exposed roof was of principal rafter construction with clasped pegged through purlins, felted on the south side. Every third rafter was heavier, and had a collar. Four main tie beams were present, with a smaller subsidiary tie beam at the eastern end. The tie beams measured $9\frac{1}{2}$ " x 8"; the rafters 4" x $2\frac{1}{2}$ ", and the main rafters $3\frac{1}{2}$ " x $4\frac{1}{2}$ ". Some diagonal bracing was also present. The westernmost tie beam was clearly re-used, having several mortices on its lower surface, and a large chamfered notch on its upper face.

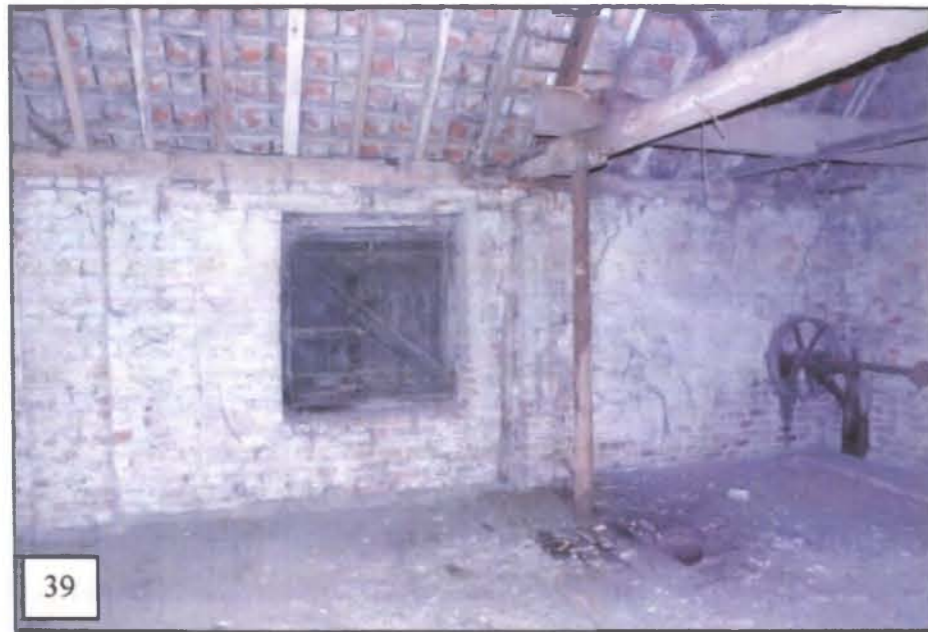
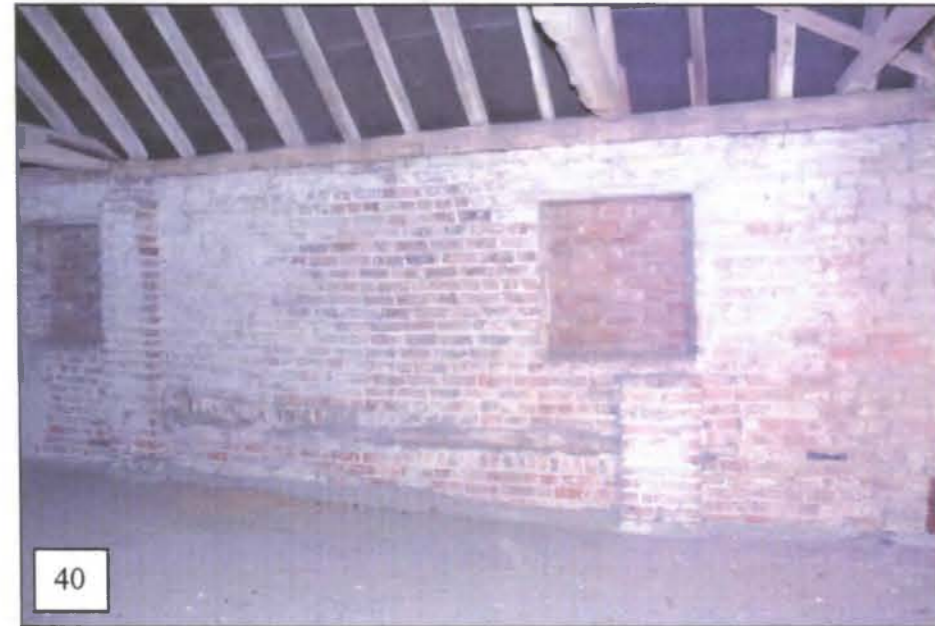
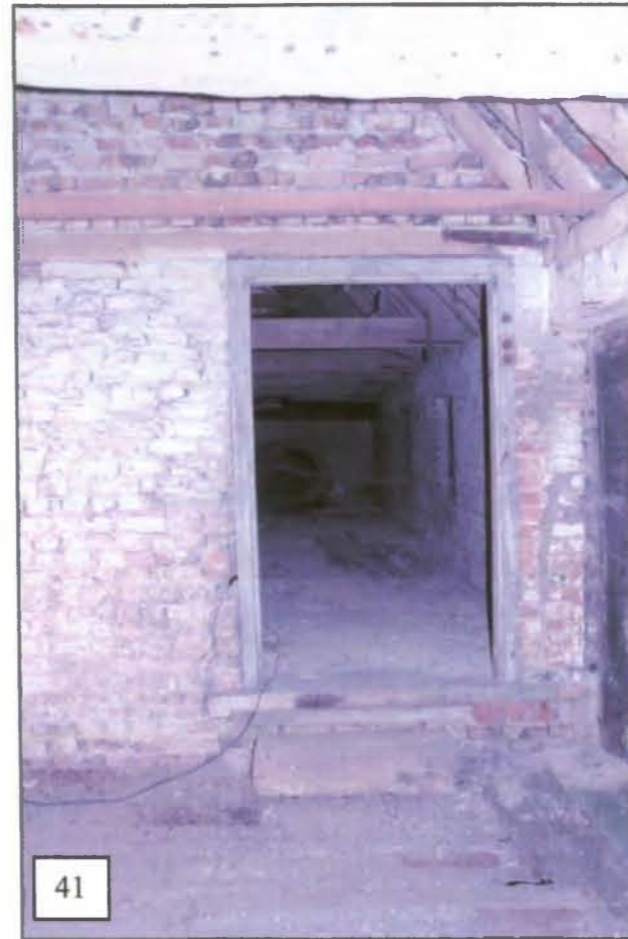
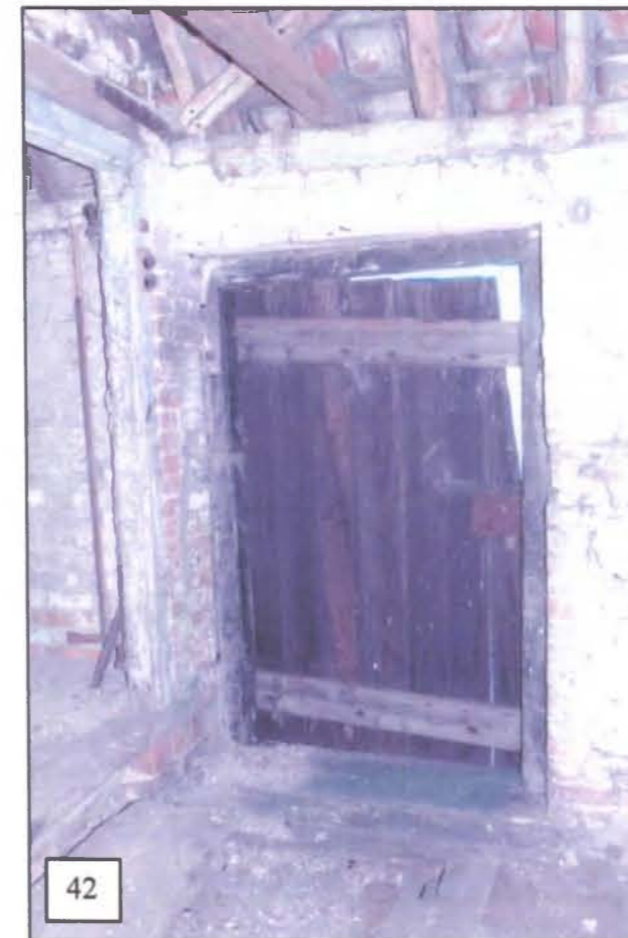
A window was present at the east end of the north wall. It was 46" square and had been converted into a heavy framed loading door with shutters (ledged and diagonally braced beaded-edge 5" planks) in a 5½" x 3" frame. The roof collars were paired up on either side of this window.

A heavy timber beam was present in the northeast corner of the room, running east-west, supported at its western end on the eastern tie beam, itself braced here with a 4½" diameter roundwood post. Further support was provided by the subsidiary tie beam at its centre.

A drive shaft from Building F, with pulleys for a belt-drive, was mounted on cast-iron brackets on the east wall, but could not be closely approached as the floor was unsafe.

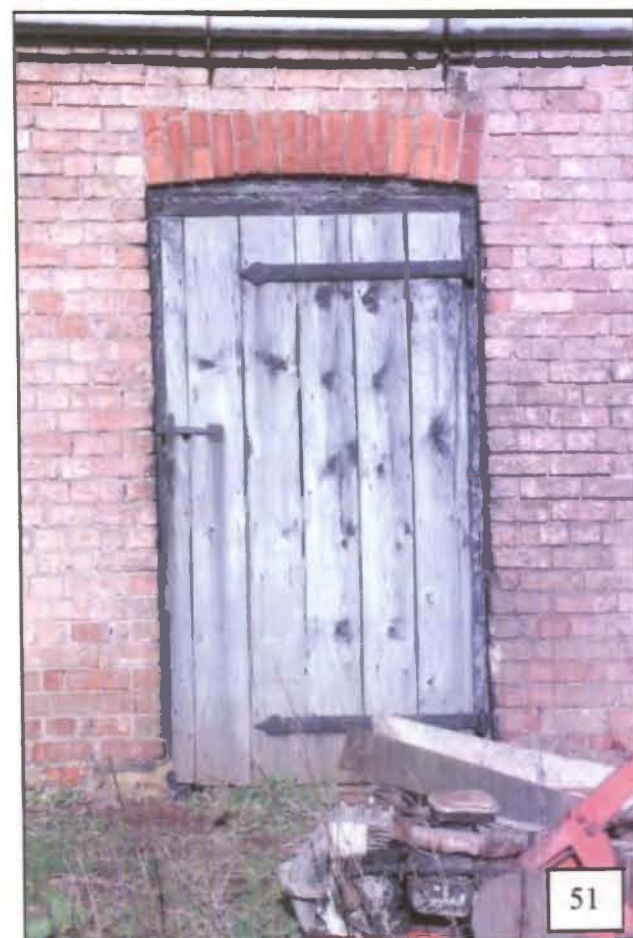
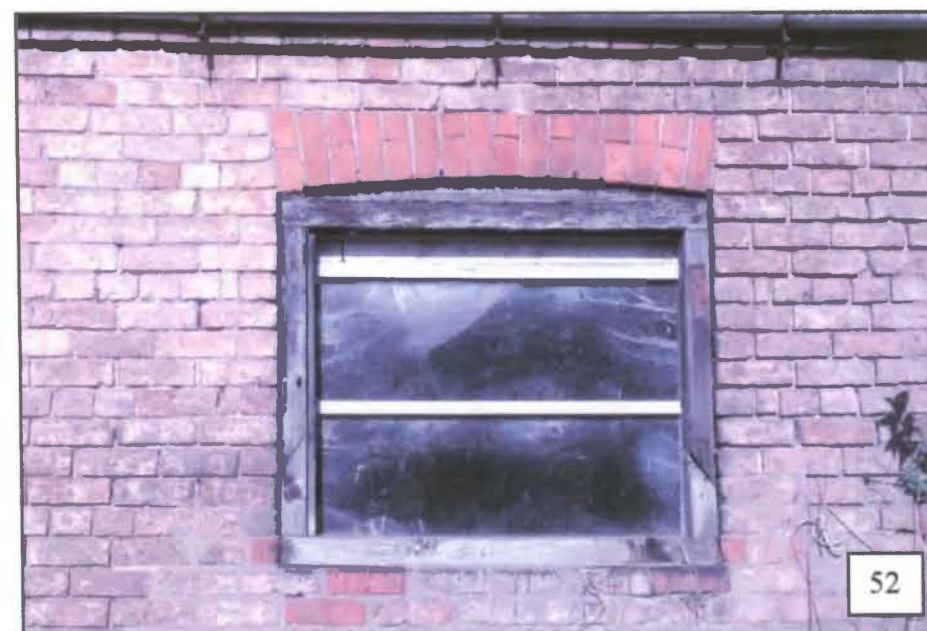
Building A was L-shaped in plan, constructed of a mixture of brick, all in 3-course EGW bond, with a pitched pantile roof, hipped at the southern end. It has a complex constructional history, of which the northern, east-west aligned, part appears to be the earliest with the north-south aligned part added later. Later still, the yard frontage was reclad in yellow brick with red axed-brick door and window heads to produce a uniform appearance. A later brick-built lean-to structure with a pantile roof was present on the south side of this building, but this could not be accessed as the entrance was on neighbouring property. On the east wall, the remains of a whitewashed area (to the north of the east door of Room 4) attest to the position of a further lean-to structure; this is visible on the Ordnance Survey maps of 1886 and 1907, but no longer extant.

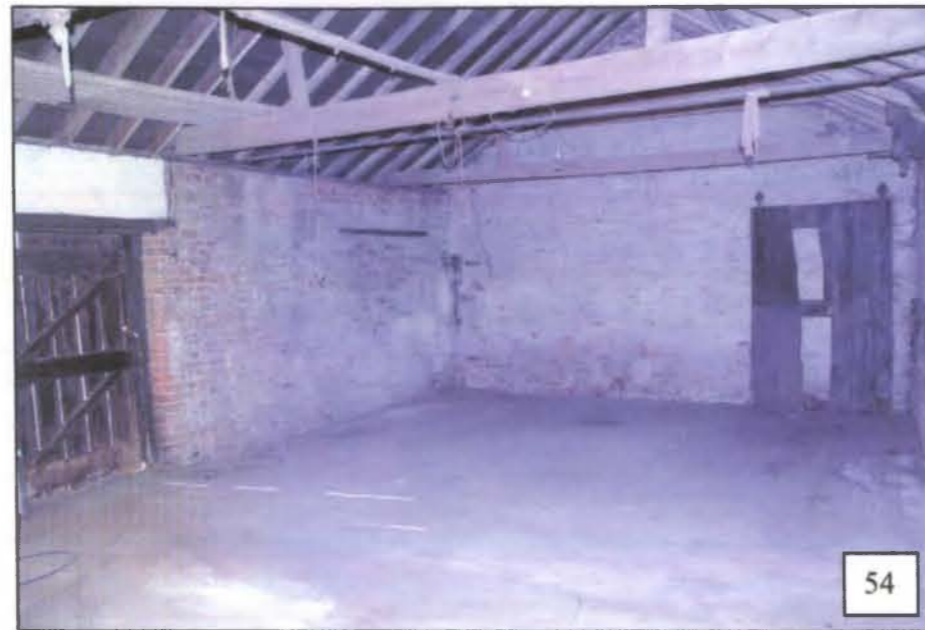
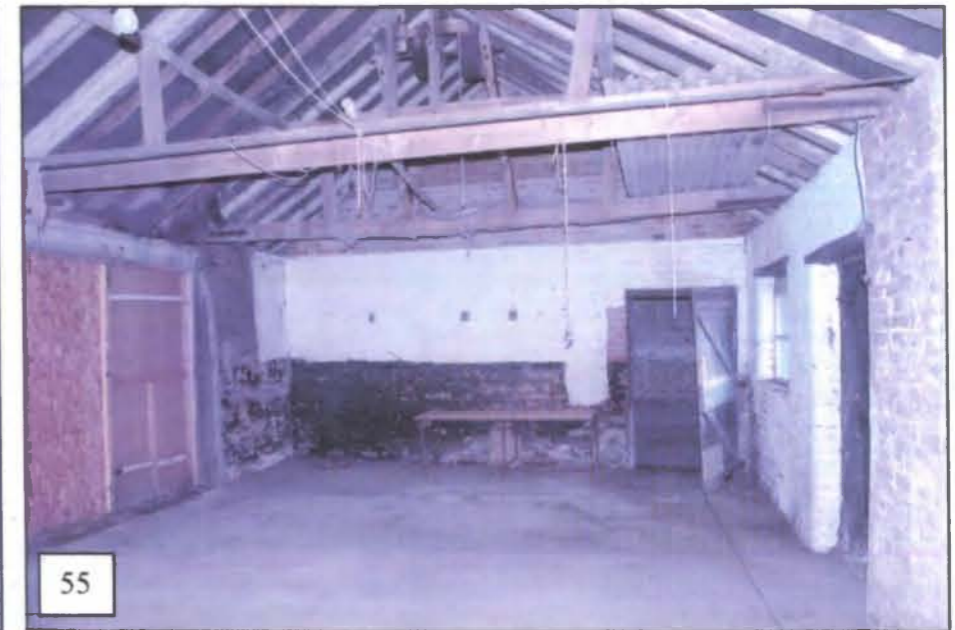
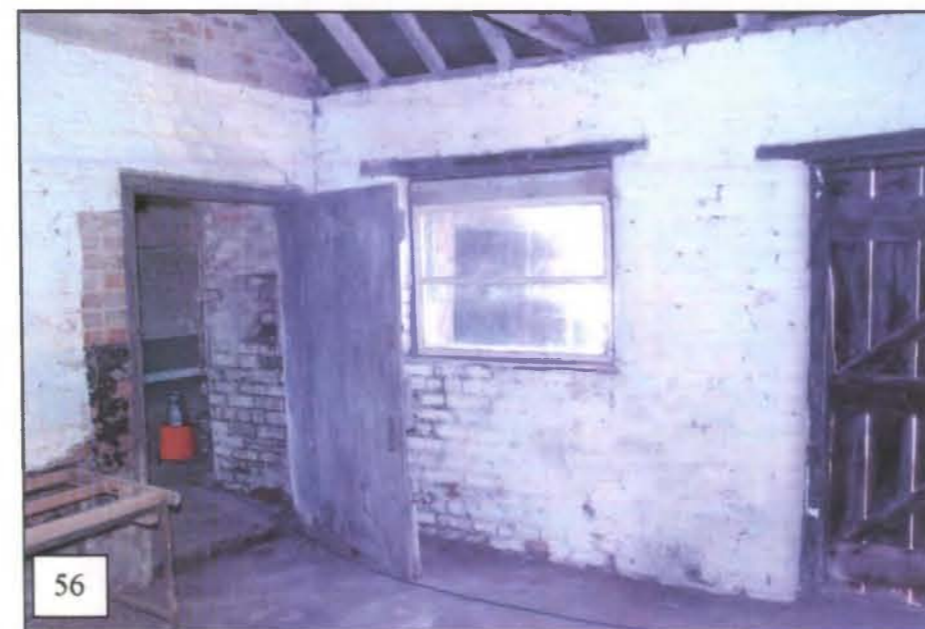
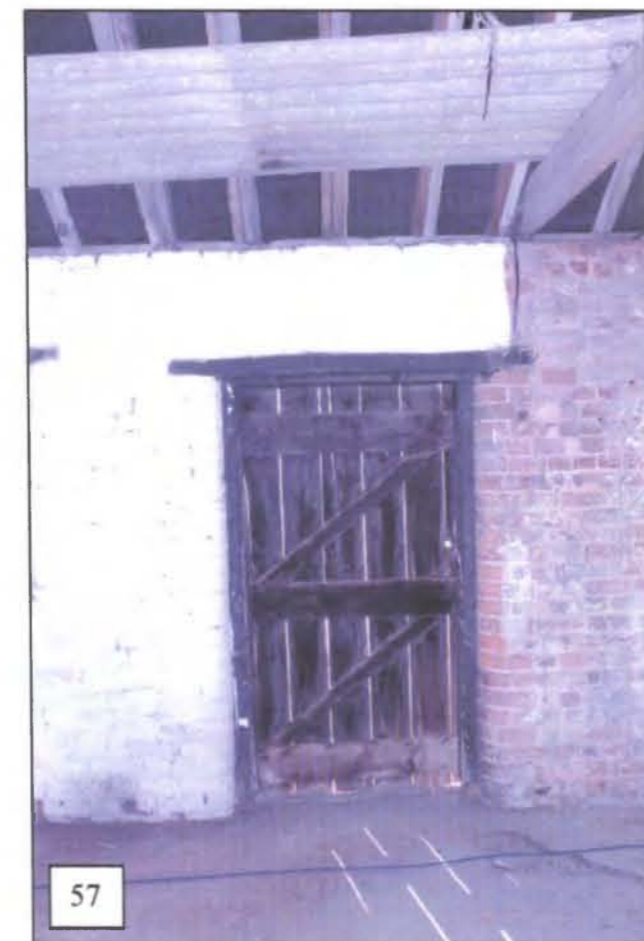
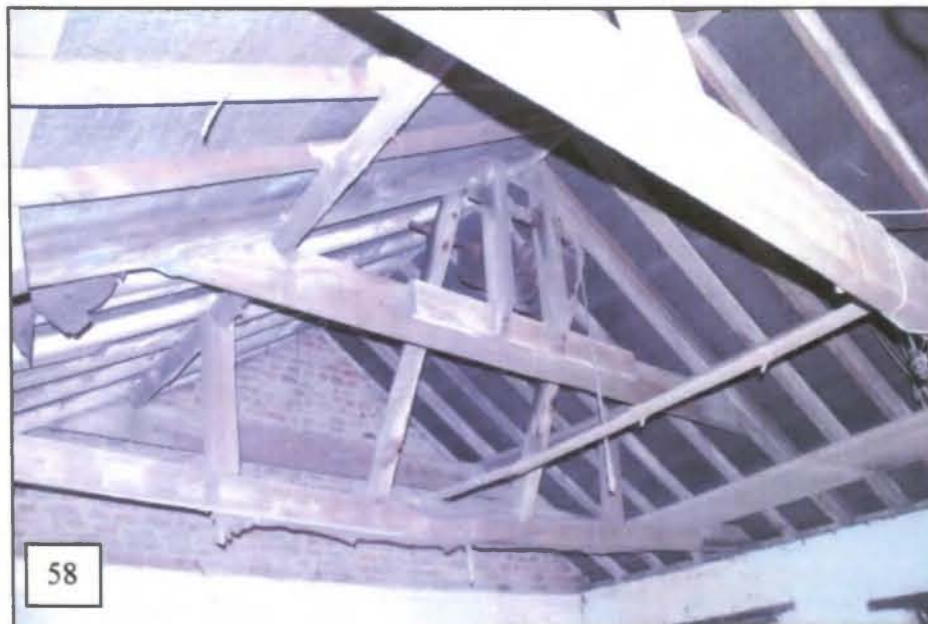
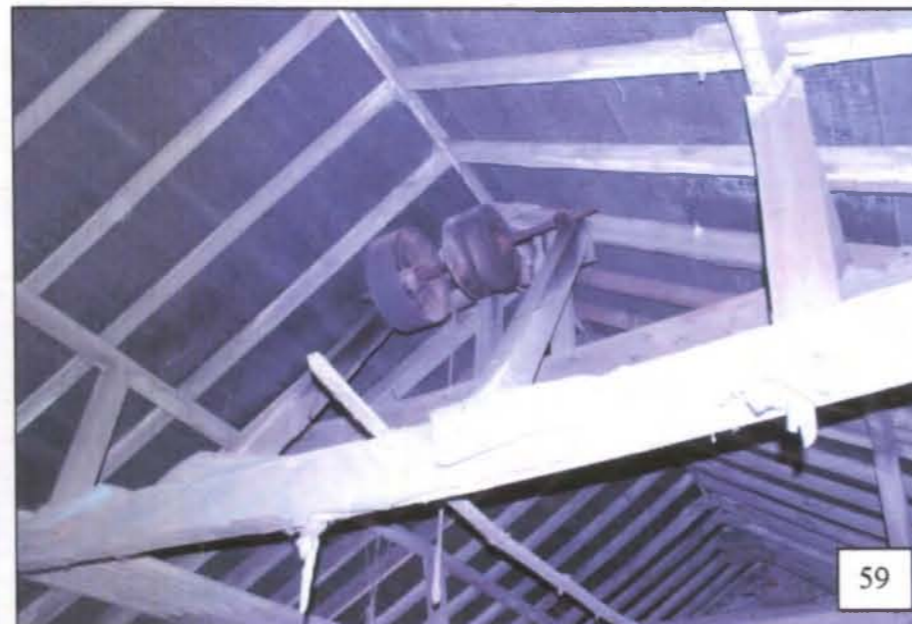
Interior - Room I

The walls were of exposed whitewashed brick, the north and east walls painted black to a height of 50".

The roof was of common collar rafter construction, three 6½" x 4" tie beams were present, and the clasped through purlins were supported on struts to the tie beams, occasional separate collars were present and also occasional ridge collars. At the eastern end two large pulleys for belt-driven machinery were supported on two diagonal struts from the eastern tie beam to the rafters. It is unclear exactly how these were driven.

The room had one window of two horizontal lights, probably converted, in a heavy timber frame. The window had a timber lintel, a cement skim internal sill, and bullnose edges. The floor was of asphalt, repaired in concrete, with impressions left by machinery.

In the north side was a large opening, converted with bullnose brick edges inserted. This probably originally had a sliding door, but had been blocked in modern plywood. In the south side a ledged and diagonally braced 8" plank door was present, with a timber lintel and bullnose edges, while the east side had a ledged and diagonally braced 5" beaded plank door in a 3" x 5" frame.

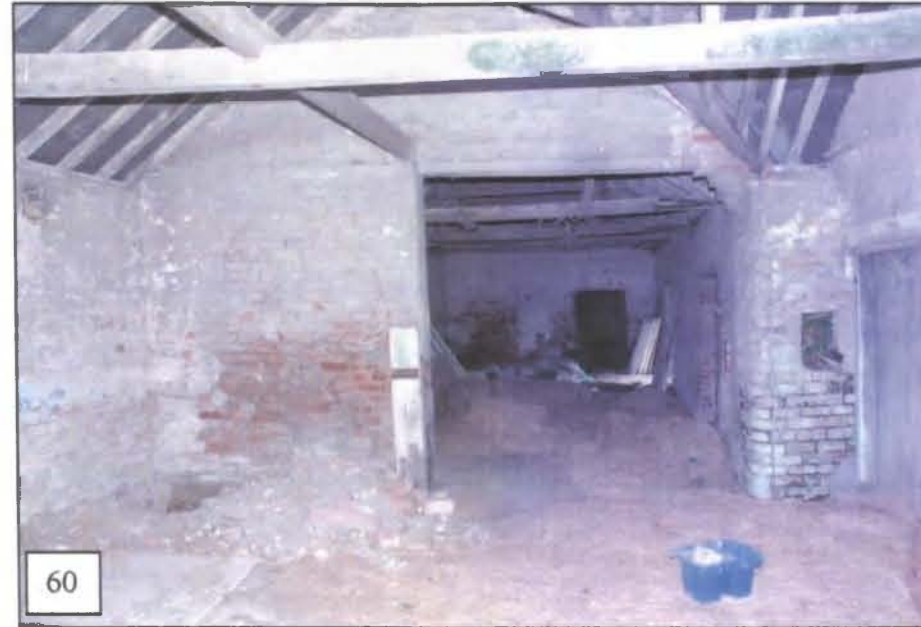
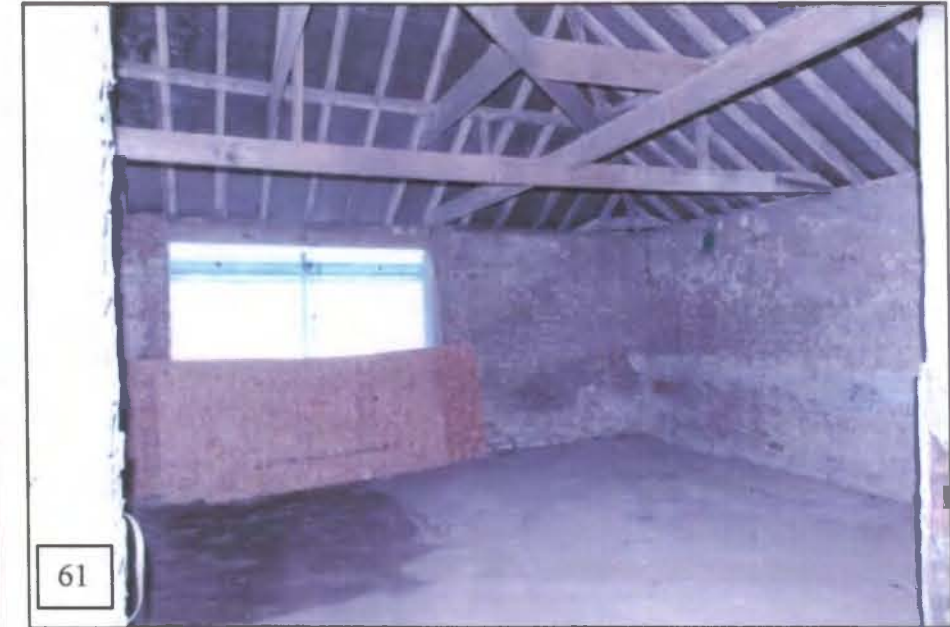
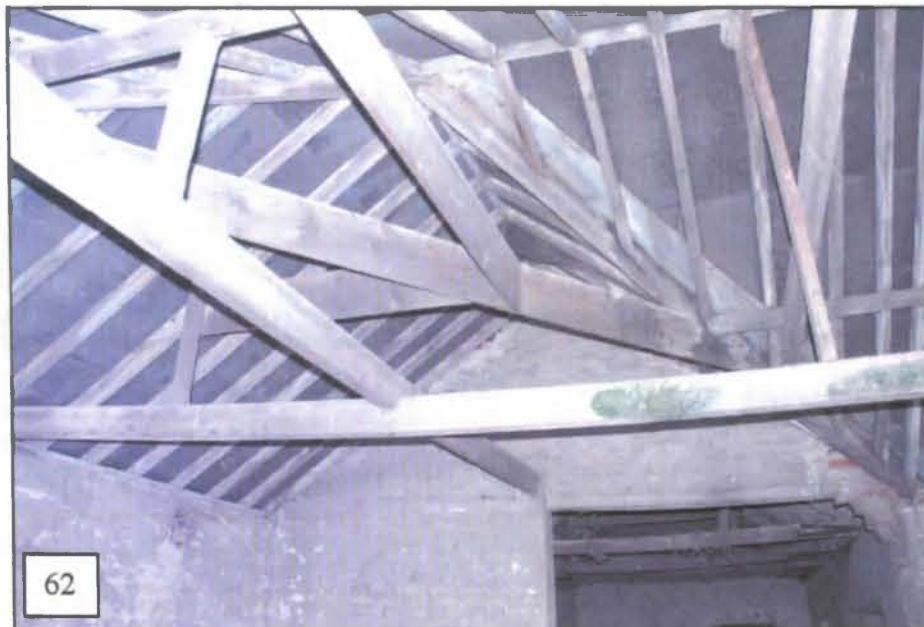
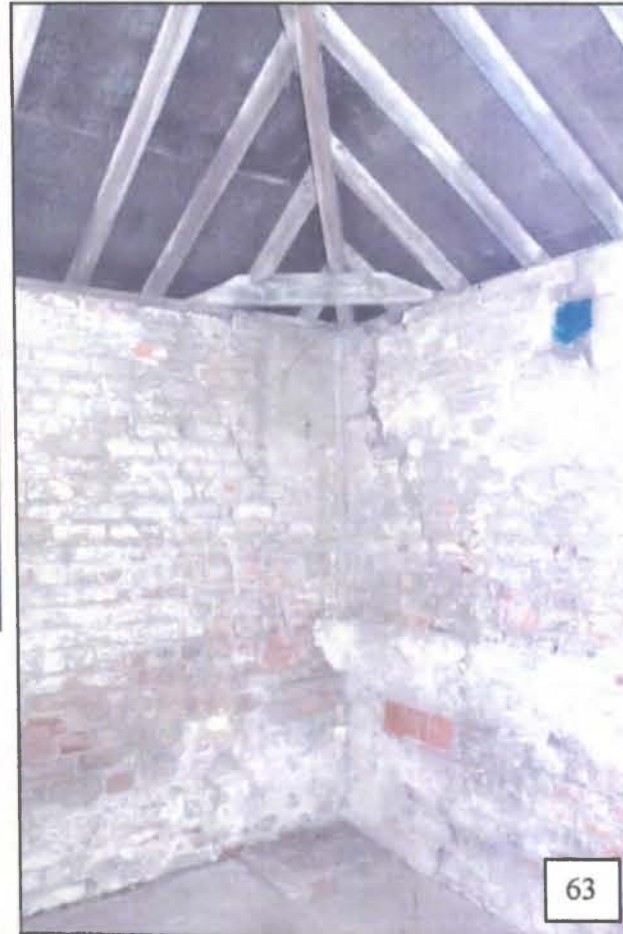
Room 2

The exposed roof resembled that of Room 1 in construction, but had corner collars jointed to a collar on the diagonal, with a dragon beam supporting the sloping ridge board in the northeast corner. Crossed 6½" x 3" tie beams supported the collars, purlins and ridgeboard on 4" x 2" struts.

The room had no windows, but two rectangular vents were present in the east wall, two courses below the wall plate. The floor was of poured concrete, with a N-S running drainage channel at the north end; in the northwest corner part of the original floor survived. This was of bricks, 8½" x 4¾" x 2¼", laid on edge in E-W half-abutting rows. In the south-west corner of the room there was a small alcove, 0.44m high, 0.32m wide and 0.36m deep, with a 2½" timber lintel and a bullnose corner was present in the angle of the wall on the south-western side.

The room had three entrances: a large opening in the north side, with a timber lintel and interior bullnose edges, and another to Room 3, which appears to have been enlarged with a timber lintel and 'buffers'. A further door (described above) gave access to Room 1.
