BUNKERS FARM, WELTON LE WOLD, LINCOLNSHIRE

PHOTOGRAPHIC BUILDING SURVEY

Site Code: BFWW 08
LCCM acc. no: 2008.91
Planning ref: N/200/03059/06
NGR: TF 2840 8696
PCA job no: 08-441

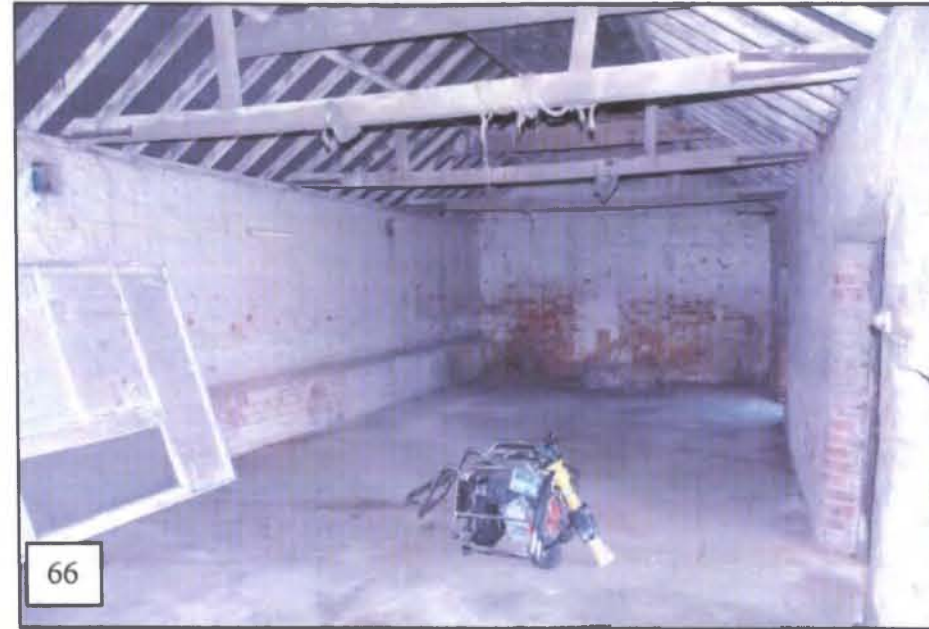
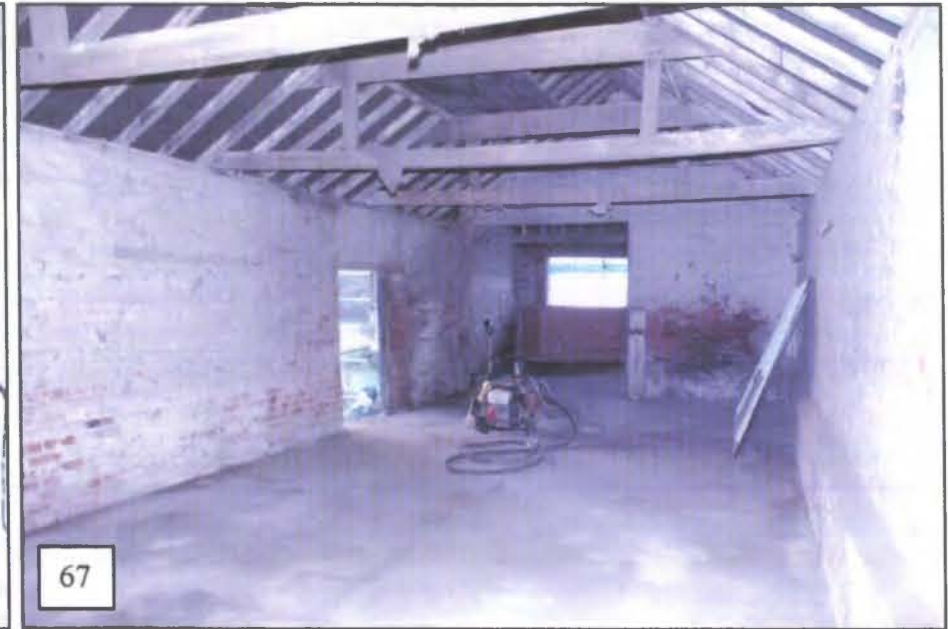
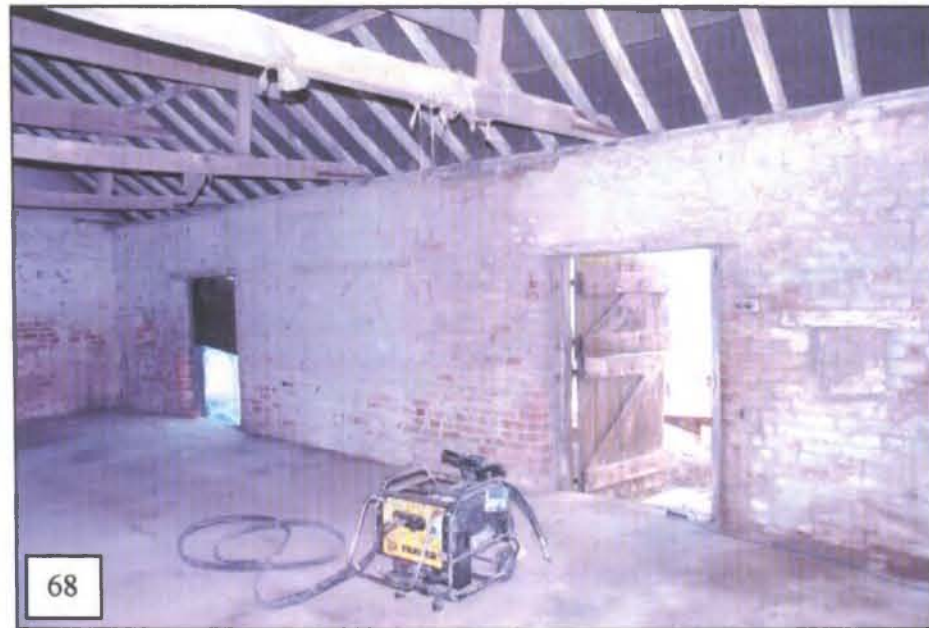
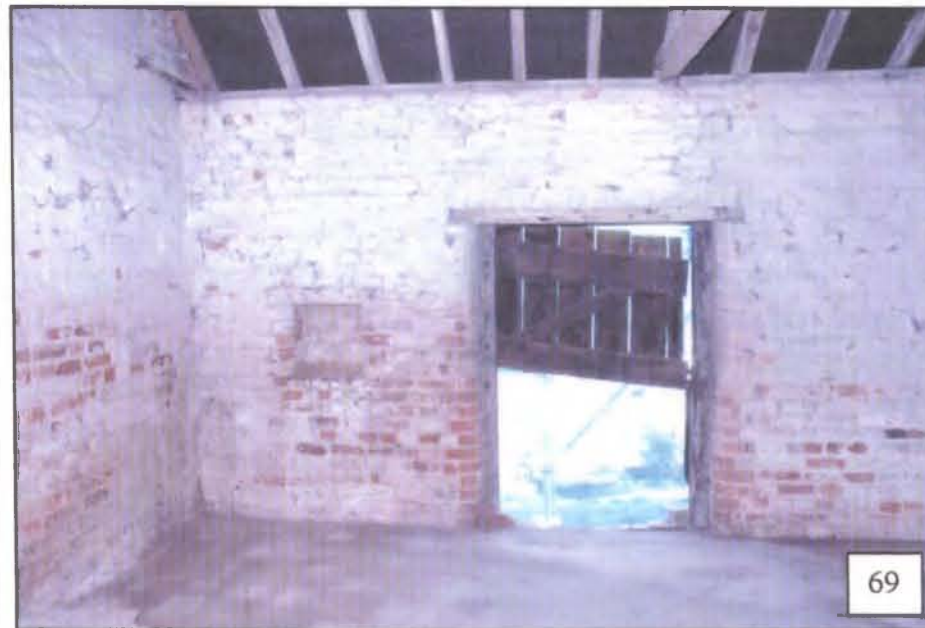
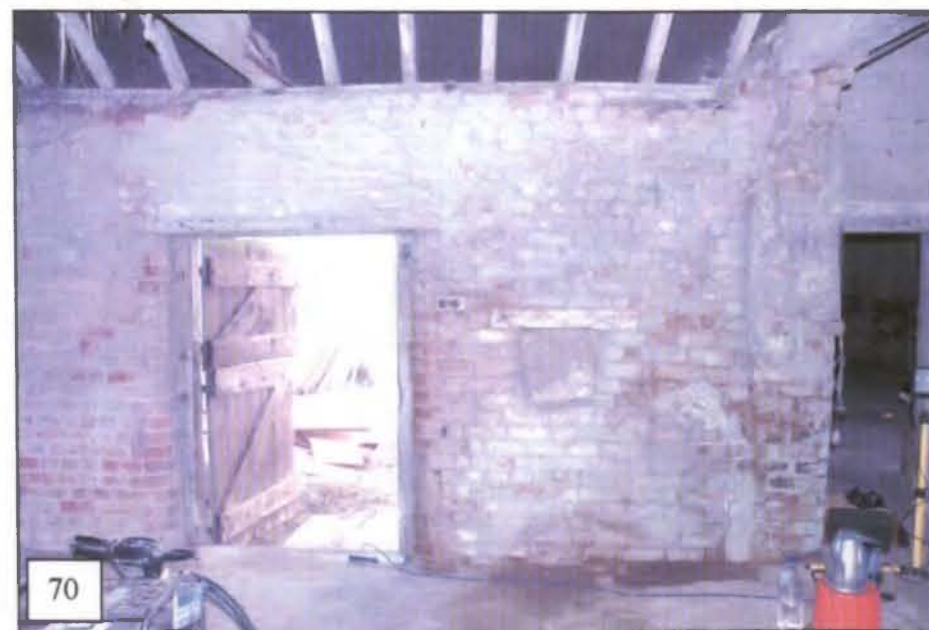
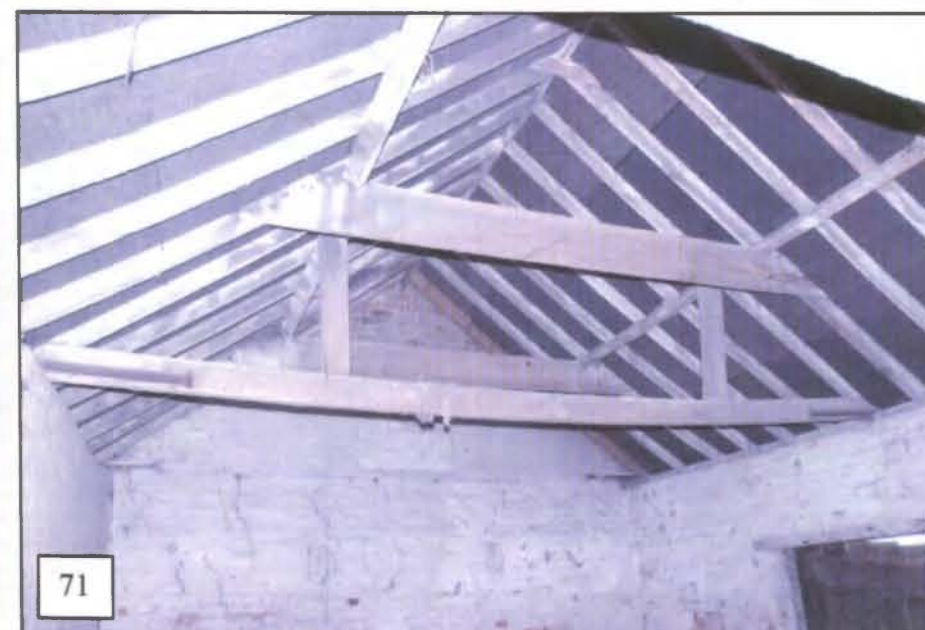
Room 3

The exposed roof was of principal rafter construction with clasped through-purlins, similar to the roof of Room 1. Three tie-beams were present, but the collars and ridge-collars occurred at every fifth rafter (all occurring together above the central tie beam to produce a rudimentary truss). There were no windows in this room, but two bullnose brick alcoves were present in the west wall, 43" x 43" x 9" deep, with timber lintels.

The floor consisted of two north-south oriented poured concrete panels. The walls were of variously whitewashed brick; the lowest 2' of the east wall was thickened by 5" (an extra leaf), and this section had a chamfered cement coping.

The doors in the west wall comprised two diagonally braced and ledged 8½" plank stable doors in 4" x 4" frames, with timber lintels and sills. A third doorway between these two had been blocked, and a further door opening had been bricked-up below the apex of the south gable.

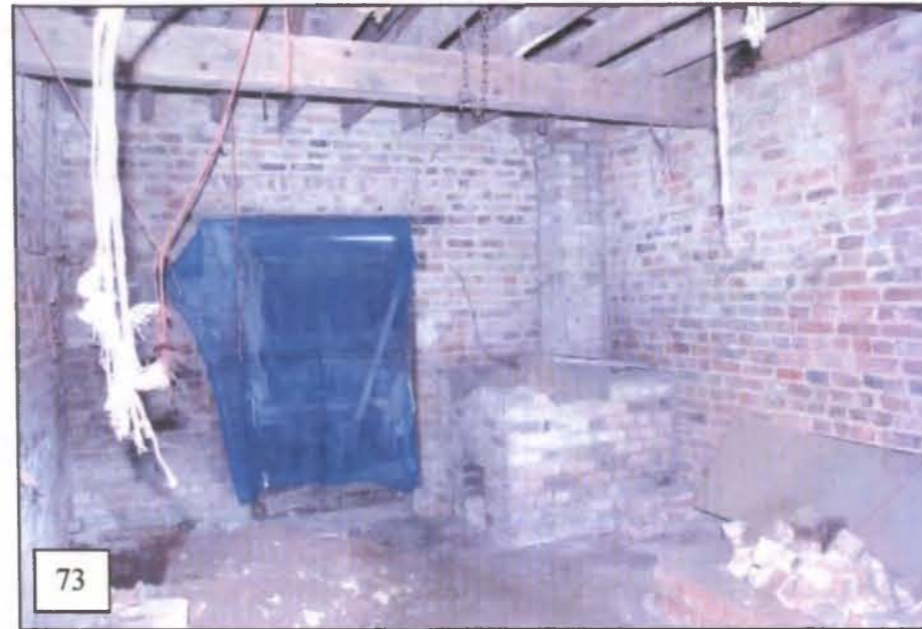
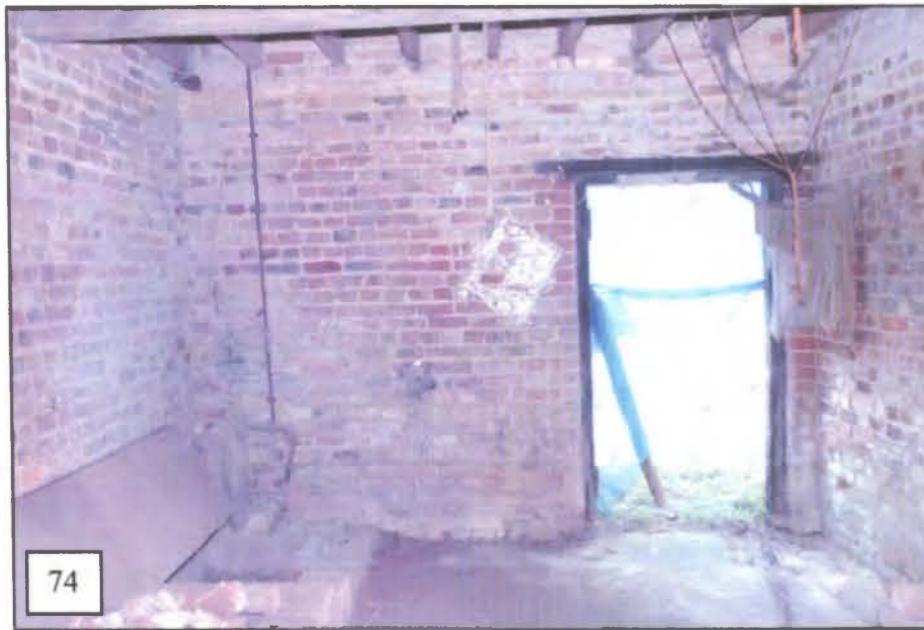
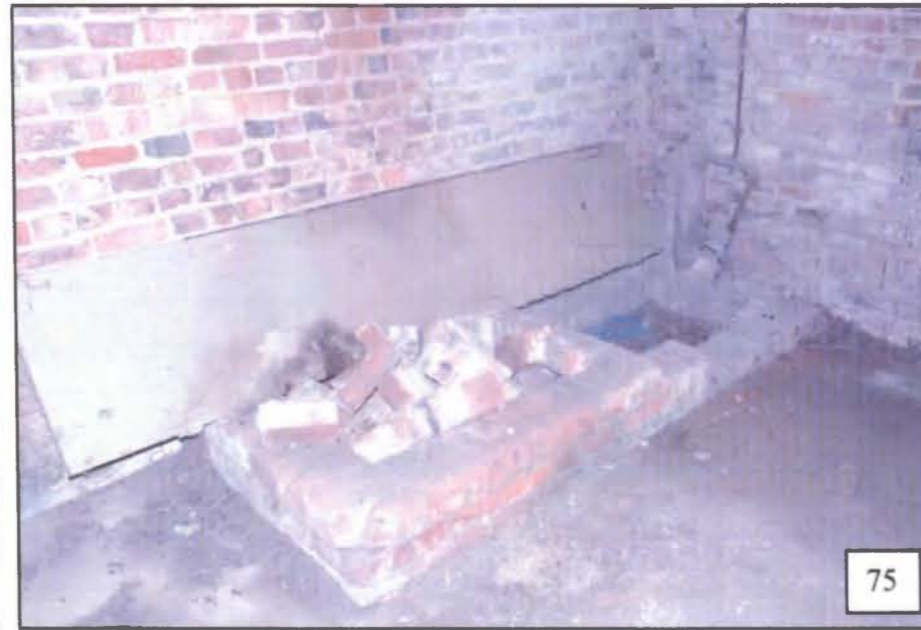
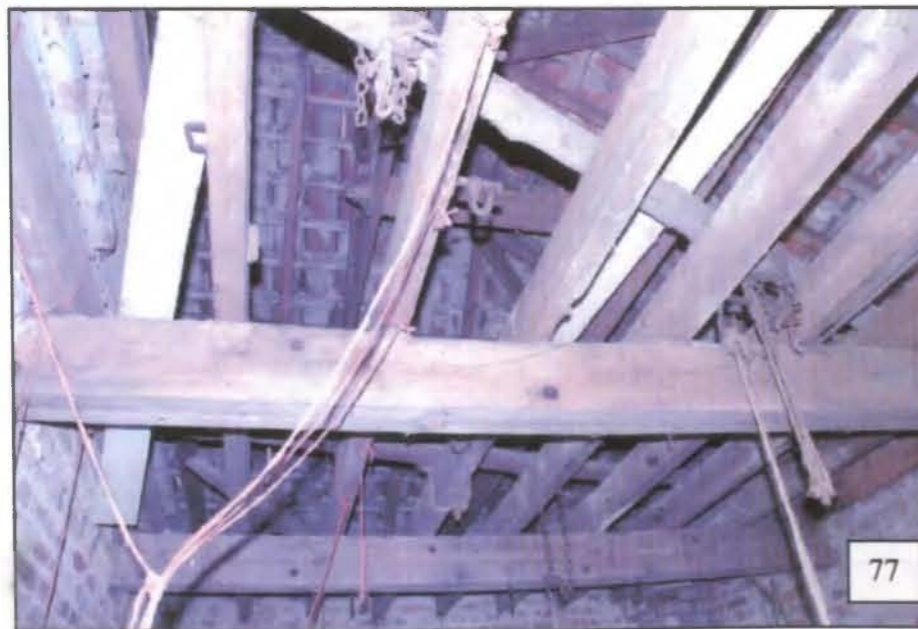
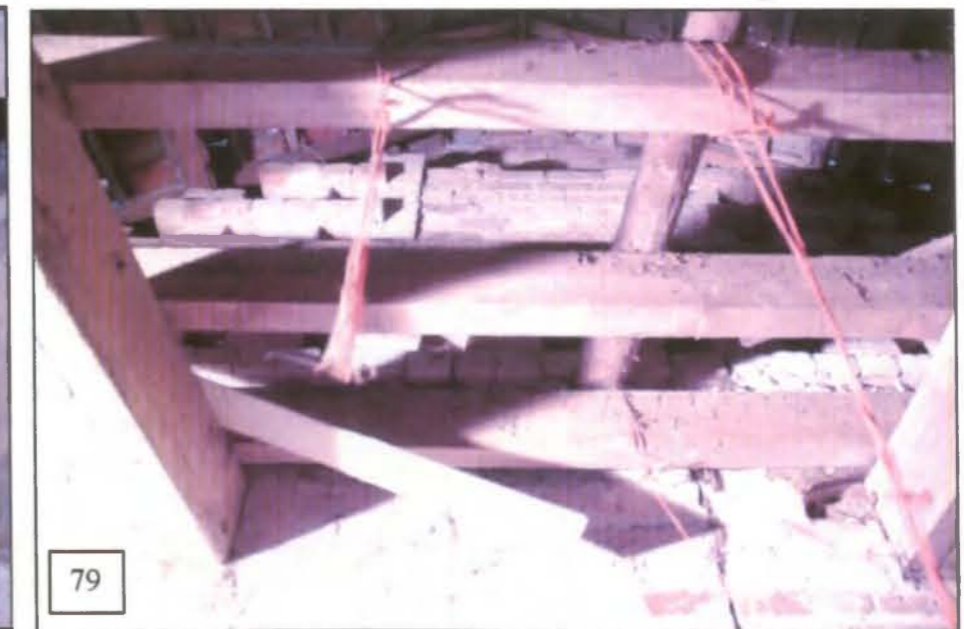
The exposed roof resembled that of Room 3, but the hipped south end had a north-south collar morticed into the southernmost east-west collar. The beams and joists of a first floor were present: there were two beams, each comprising two parallel 9" x 3" elements, supporting 6¾" x 3" joists at 17" centres. This structure represented the remains of a floor of the pigeon loft on the north wall. The floor was of poured concrete, with a shallow east-west running channel on the north side.

The south-east corner of Room 4 was occupied by a brick-built 'copper', measuring 1.14m x 1.24m x 0.95m, with a chimney 0.36m x 0.39m, built in yellow 9" x 4½" x 3" bricks, which stepped into the room as it passed through the first floor. In the south-west side were two water tanks or troughs in red 9" x 4½" x 3" brick, with heavily worn edges: their overall dimensions were 2.82m x 1.04m x 0.50m, and they protruded from the floor by 0.25m. A lagged lead and steel pipe supplied water to one of the tanks, with a tap. The eastern door was no longer present, but the 5" x 3" frame remained; the doorway has a timber lintel but no sill, and bullnose edges to the interior brickwork. Judging by the hinges, the door here was not of the 'stable' type.

A ledged, 5" beaded plank door was present in a 5" x 3" frame, with 3" timber lintel, no sill, in the eastern opening that had bullnose edges on the north side, but had been rebuilt square on the south side, possibly because of the nearby copper. In the north wall, above the floor, a pigeon loft was present, with four rows of nest holes flanking a now blocked access door. The lowest row of holes ran continuously below this door; above, the rows on each side comprised 2, 3 and 4 holes. Continuous brick ledges were present below the nest-holes, projecting c. 3" from the wall.

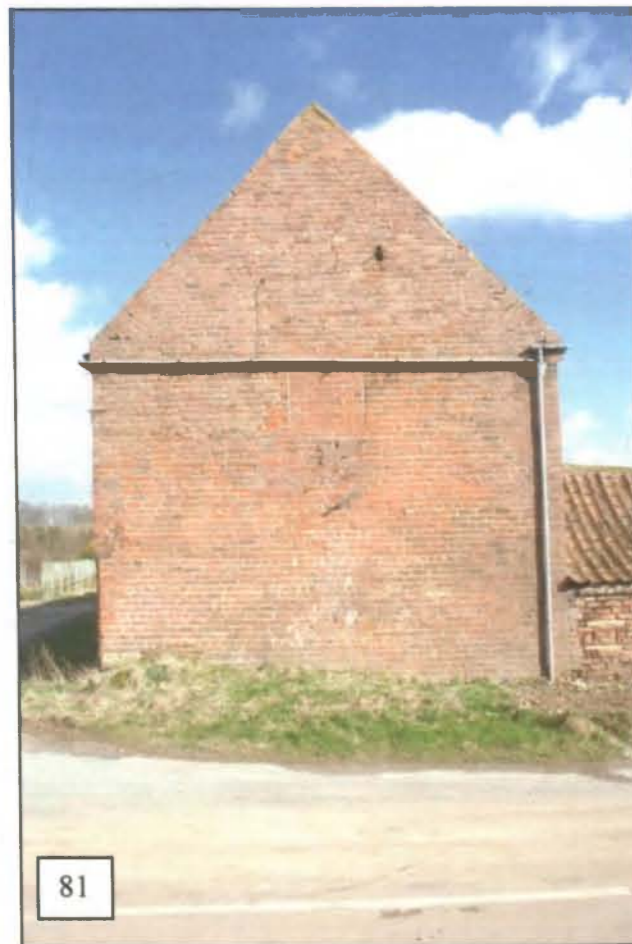
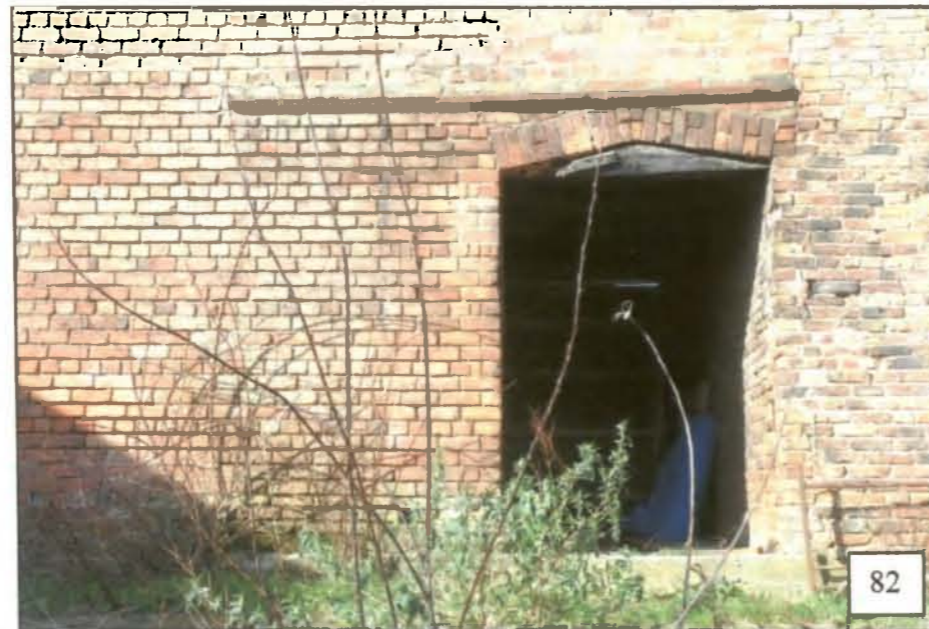
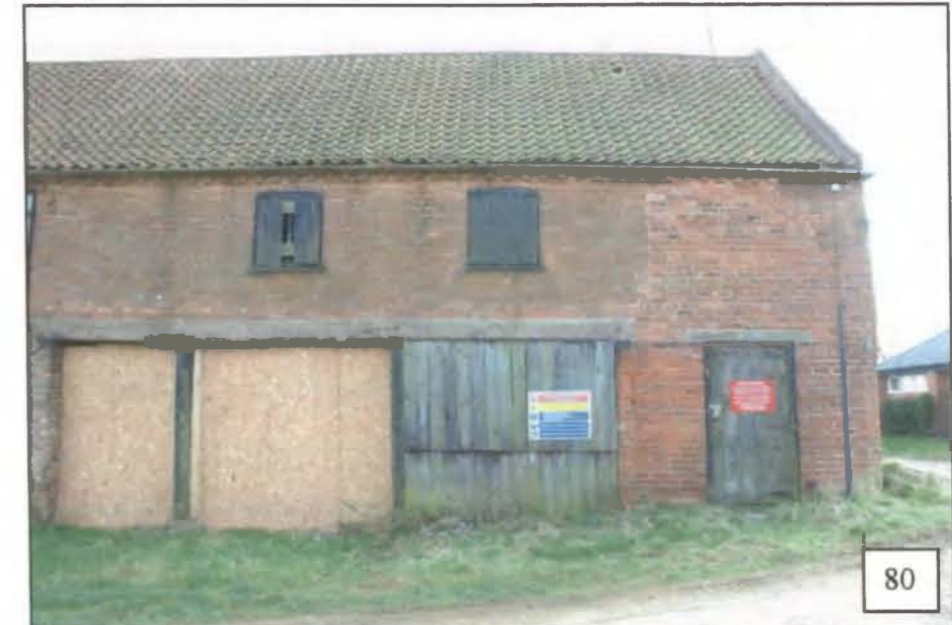
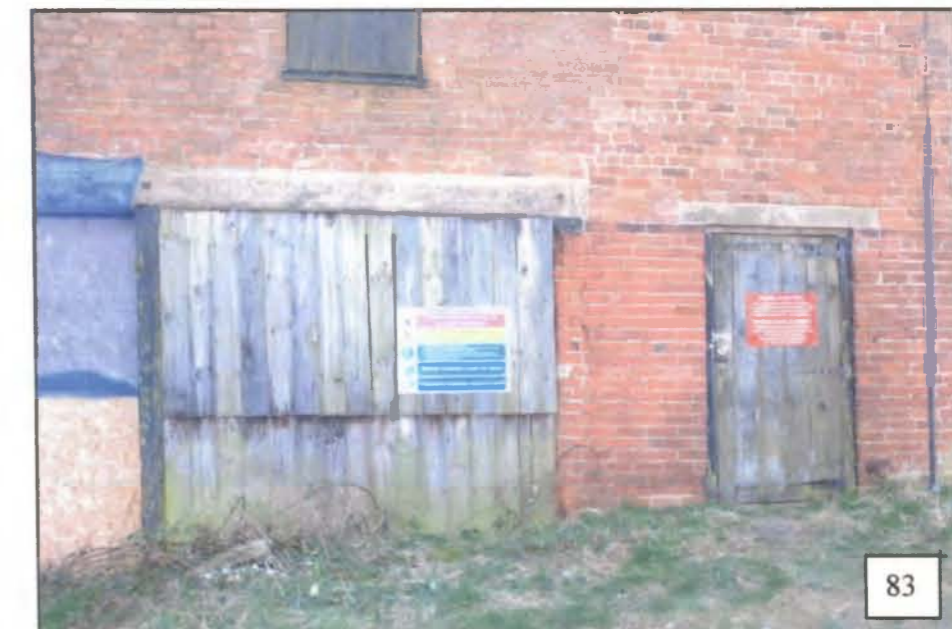
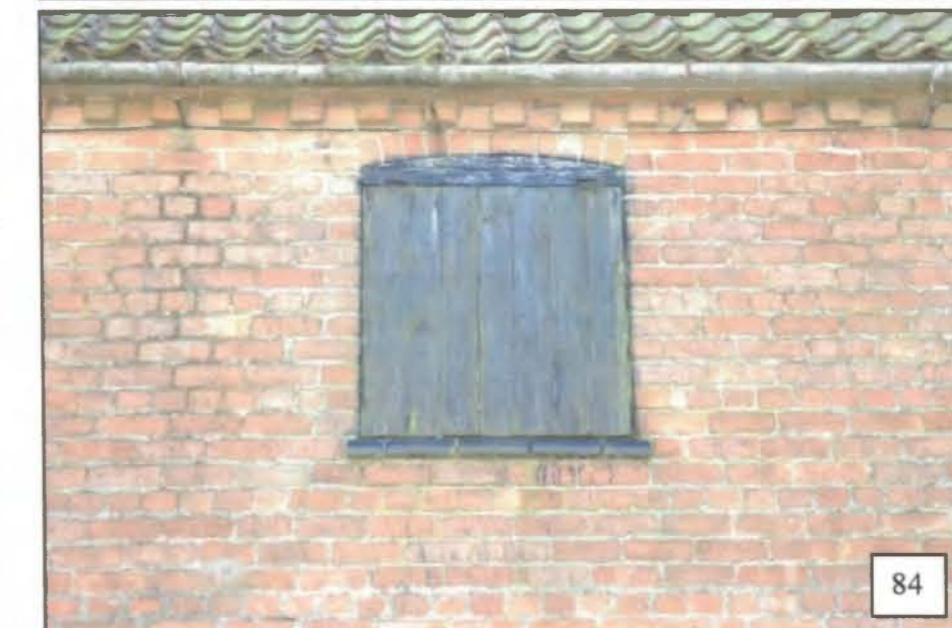
Extension to Building D

Building D was extended by almost its own length to the west. The ground floor of this new structure functioned as an open-fronted north facing wagon shed, while the first floor expanded the grain storage capacity of the farm. Alterations carried out to the original building included the reduction of the size of the doors, and may have involved the re-arrangement of the first floor beams.

The extension to Building D was constructed in red brick (brick dimensions 9" x 4 1/4" x 2 3/4", 3 courses=10 1/4"), in 3-course English Garden Wall Bond. It extended the pitched pantile roof of the original structure, but had a dentil eaves cornice. The main door opening had a shallow pointed-arched lintel of alternating stretchers and pairs of headers, (similar door openings were constructed in the brick blocking of the large openings of the original barn), while the windows had shallow-arched lintels of edge-set headers and chamfered brick sills.

On the north side, the large openings of the cart shed were of timber construction, with a heavy lintel beam supported on 8" x 6" chamfered timber posts, while the door to a smaller store room at the west end (Room 10) had a timber lintel. Above this door, a panel of more modern brickwork attests to the wall having been more recently rebuilt.

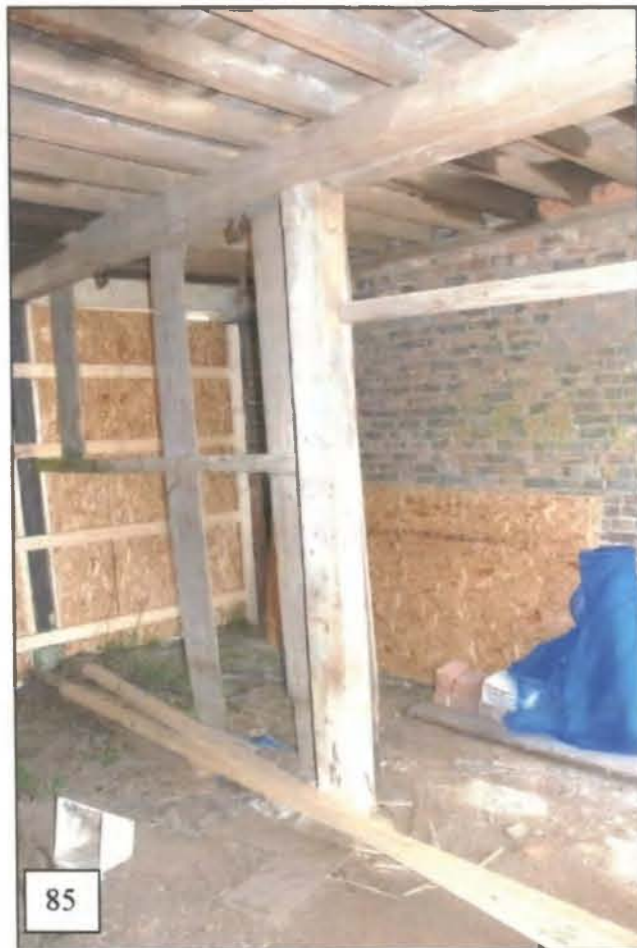
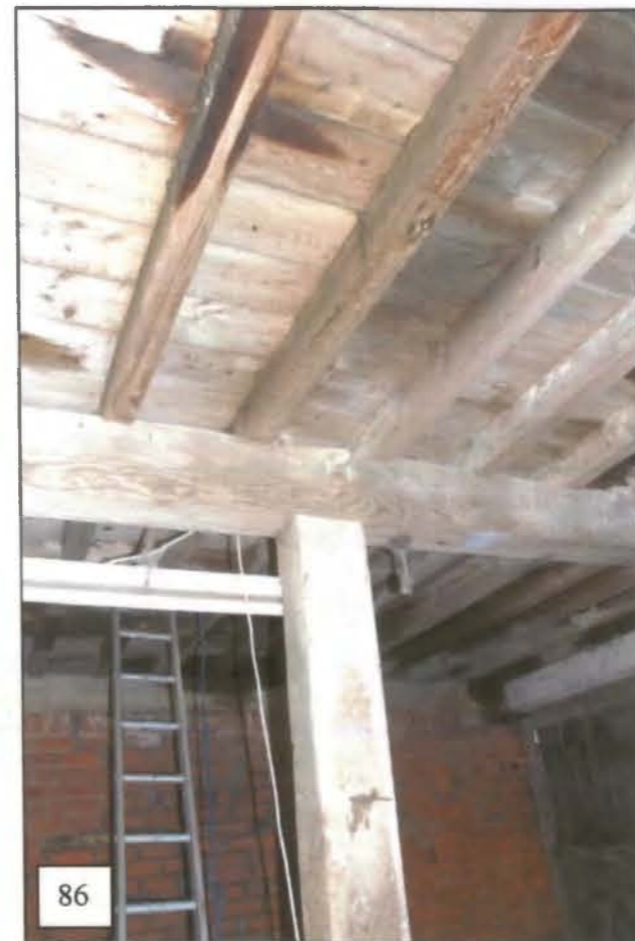
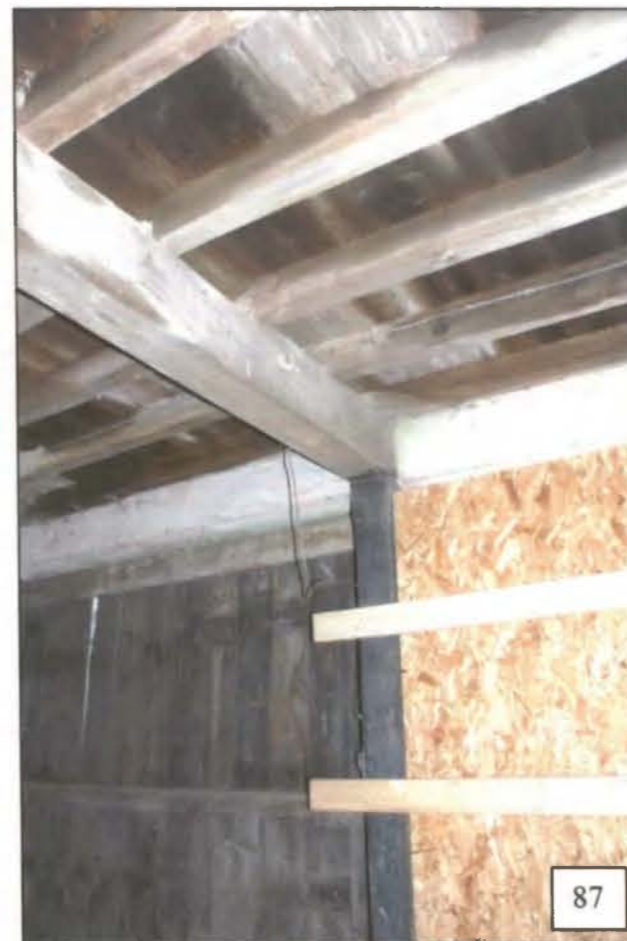
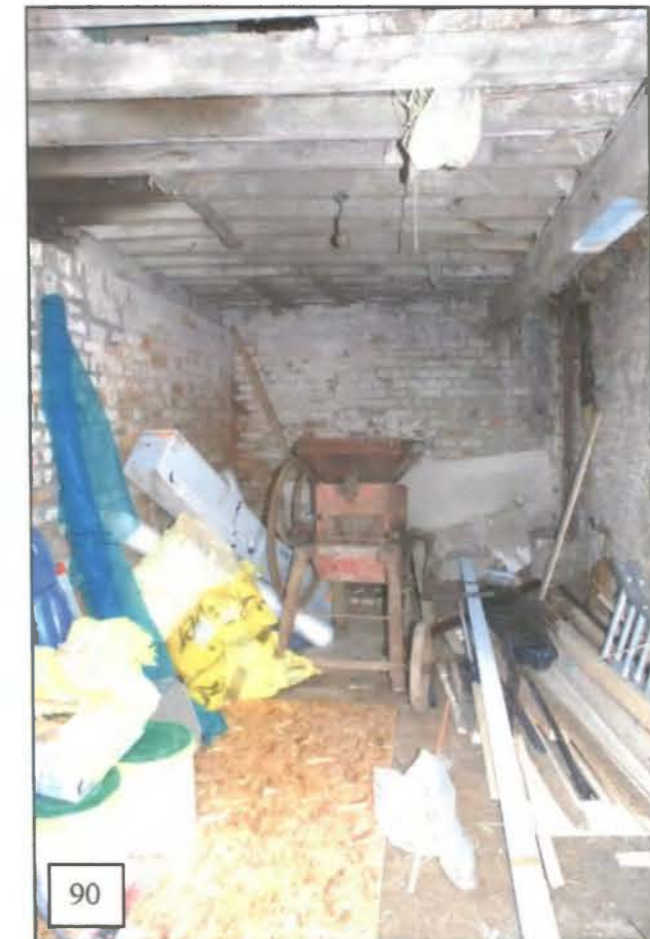
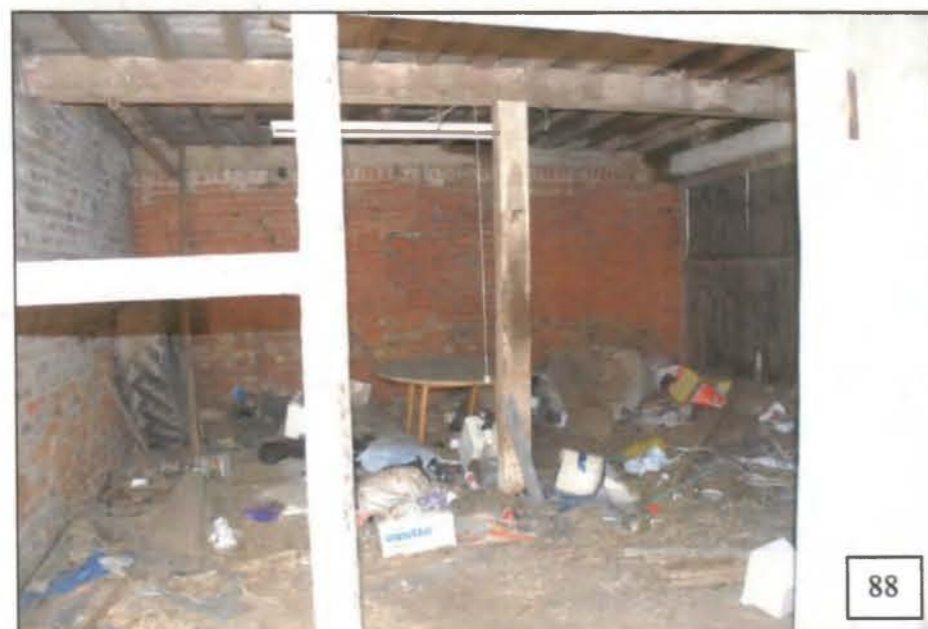
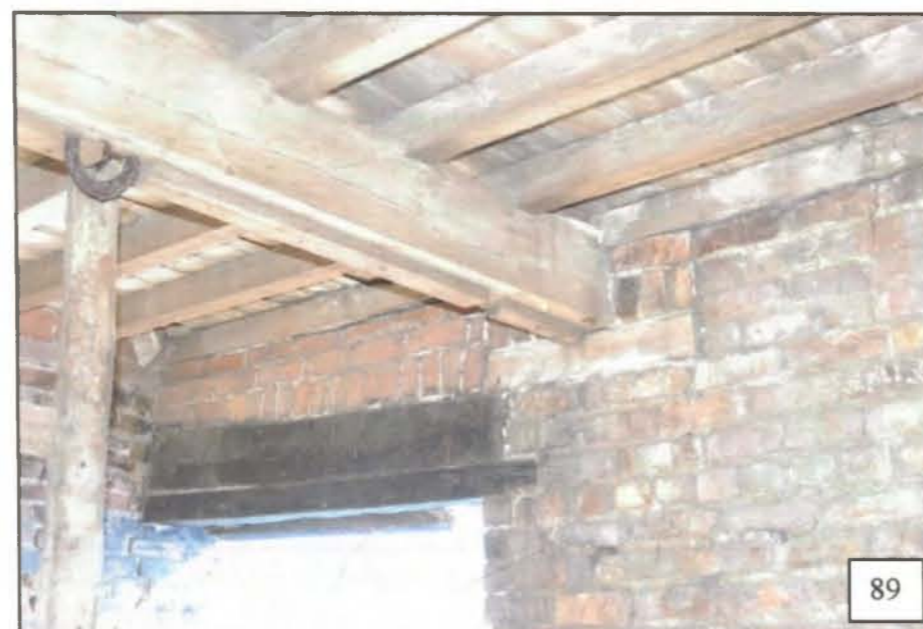
Room 9 represented the open fronted cart-shed. It was roofed by the exposed beams, joists and floorboards of Room 11 above. The floor was of packed earth, with some traces of mortar. Two rectangular timber posts, 8" x 6" with chamfered edges, supported beams of similar size in the centre of the room; the eastern post stood on a stone pad. On the line of the eastern beam, a 10½" plank partition on 3" x 2" studwork attests to a more recent division of the area. The room had a doorway in the south wall: on the interior, it had a heavy timber lintel and a concrete sill, but the door and frame were no longer present. The northern side was originally open: it has been blocked on the western side with 7" vertical planks. The lintel beams on the interior here have been renewed in concrete. Where the beams on the southern side meet the south wall, they were supported on timber pads. The walls were of bare untreated brick, but the posts on the northern side were painted black.

Room 10 was a small storeroom at the west end of the building. It was roofed by the exposed beams, joists and floorboards of Room 11 above, and had no windows. The floor was of heavily worn 9" x 4" bricks, laid on flat in half-abutting east-west rows. A water supply was present, with taps, in the southwest corner.

The room was accessed through a ledged and diagonally braced 8" plank door in a 5" x 3" frame with uprights chamfered on the interior side, a timber sill, and a 6" x 6" I-beam lintel, with 3" timber on the exterior. The walls were whitewashed, though the whitewash had largely worn off.

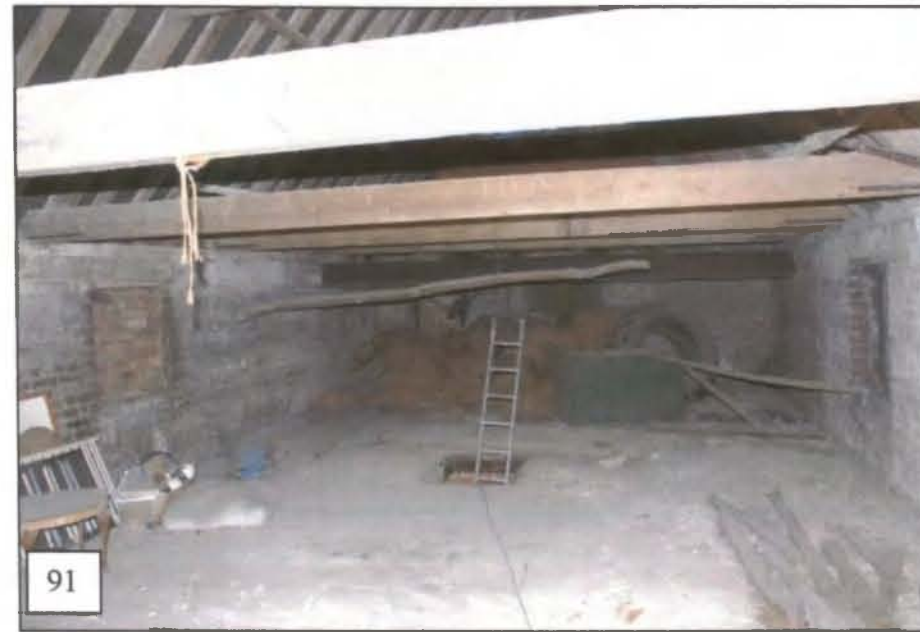
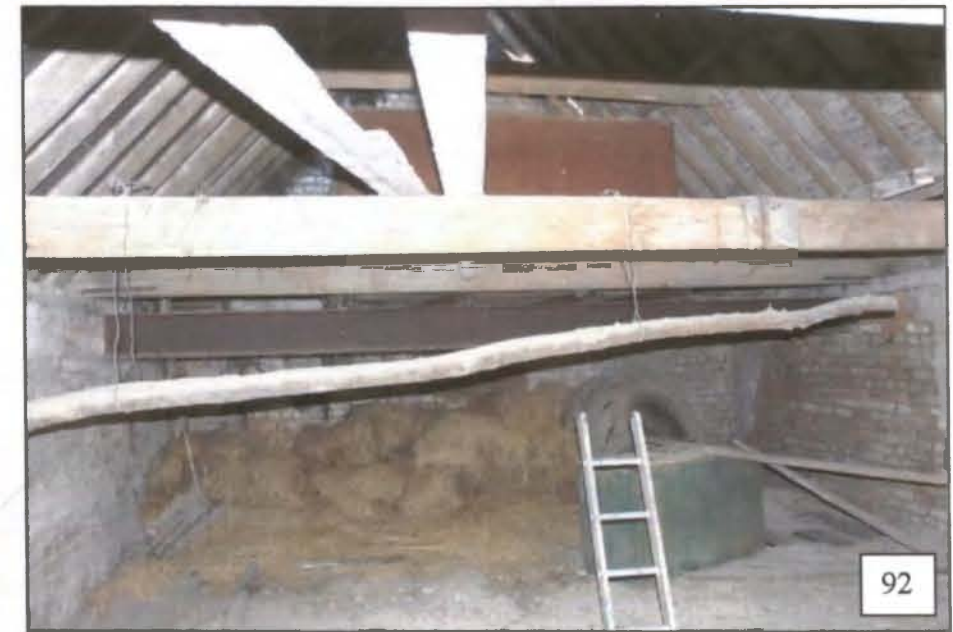
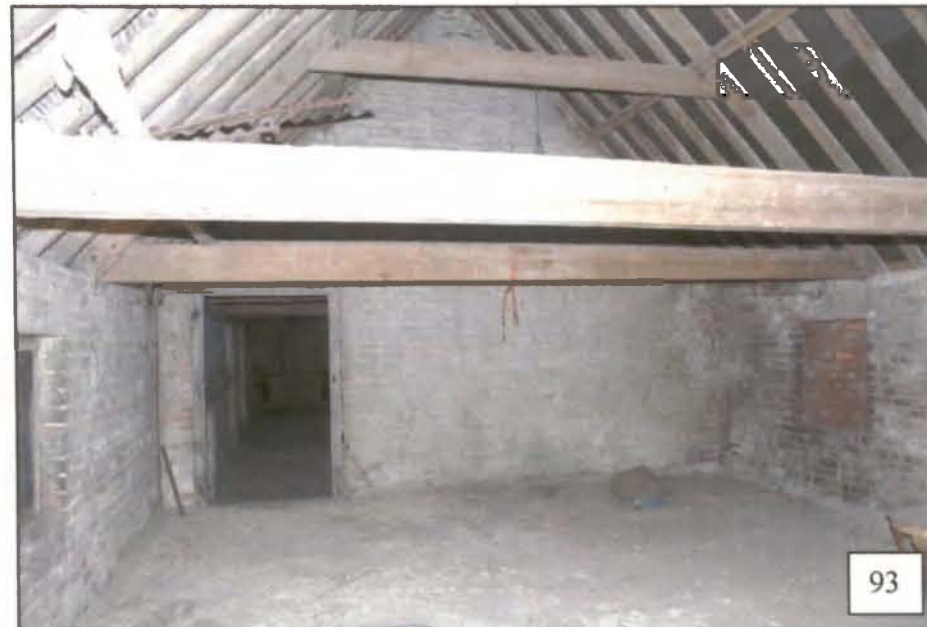
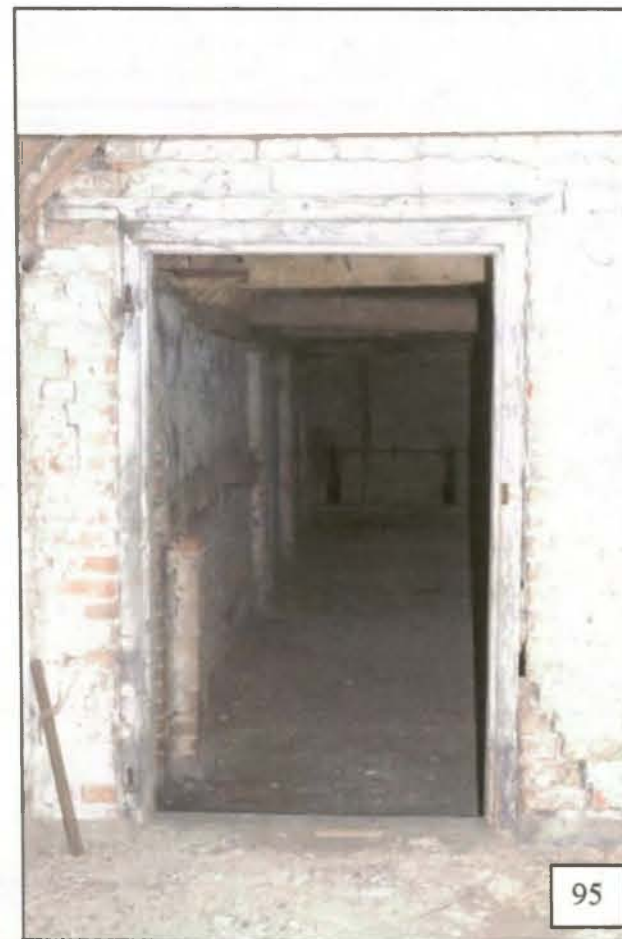
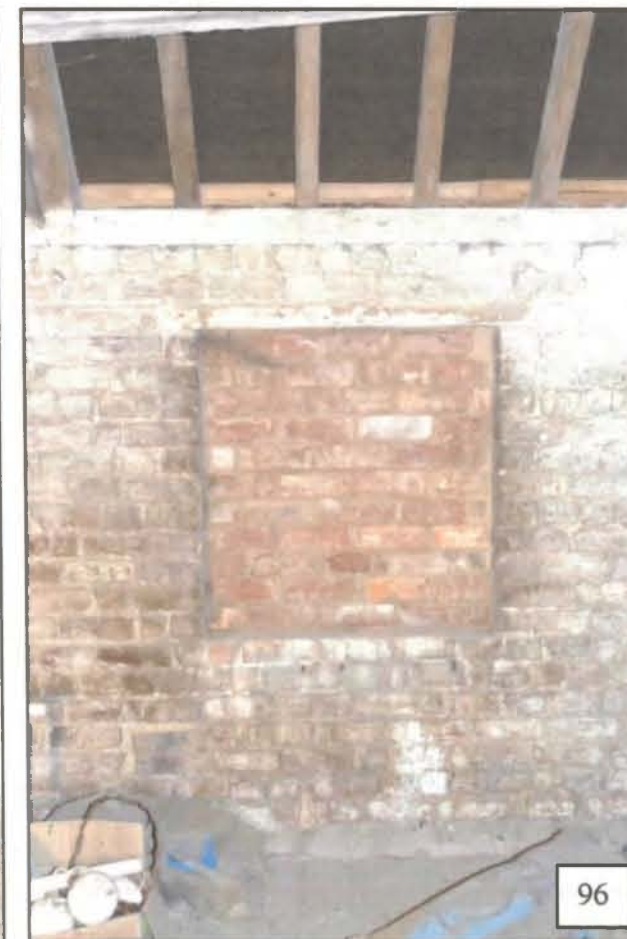
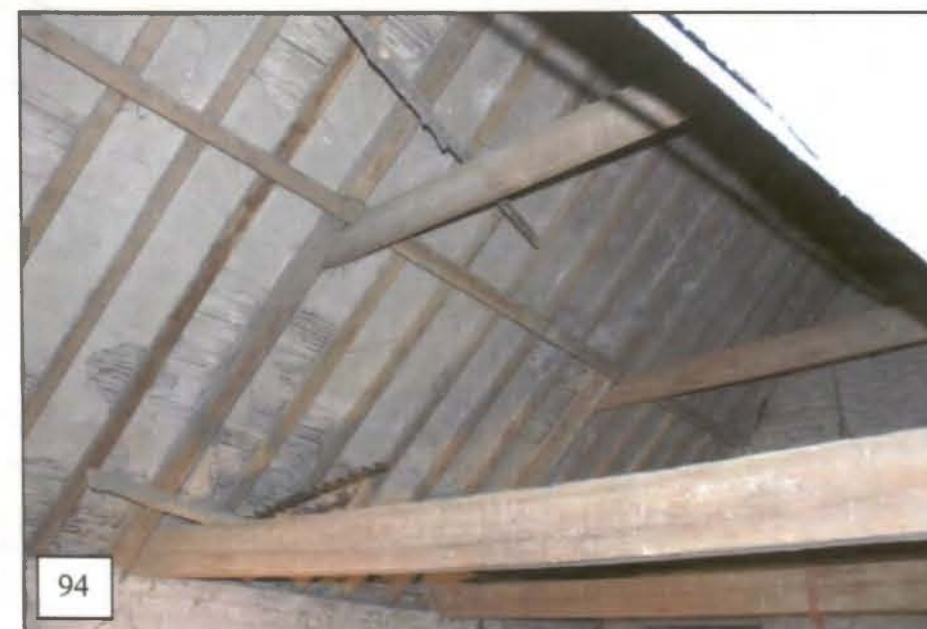
The roof was of principal rafter construction with clasped through-purlins, every sixth rafter being heavier. Three collars were present, and four tie beams. The tie beams were sawn, measuring 9" x 4"; the collars measured 9" x 1½", the rafters 3" x 2½", and the principal rafters 6" x 4". A layer of roofing felt was present below the tiles of the southern pitch, while the north side retained most of a plaster and lath ceiling between the rafters.

Two windows were present in the north wall, each 3' wide and 3' 2" high, with two lights and a beaded frame; they had vertical iron bars, but had been boarded up. There were also two windows in the south wall, blocked with modern 9" x 4½" x 3" bricks and cement. No door was present in the opening to Room 12, but a 6" x 3" frame survived here with a 2¾" lintel and a 7" x 3" sill.

At the western side of the room, a heavy north-south I-section steel beam was present, 12" x 5" in size, supporting a large water tank; this beam was inserted into the south wall, and rested on a timber corbel. The western side of the north wall has been reconstructed in modern brick in the area of the northern end of the I-beam, probably occasioned by the mounting of the water tank. Access to the west part of the room was difficult, and it remains unclear how the west side of the water tank was supported.

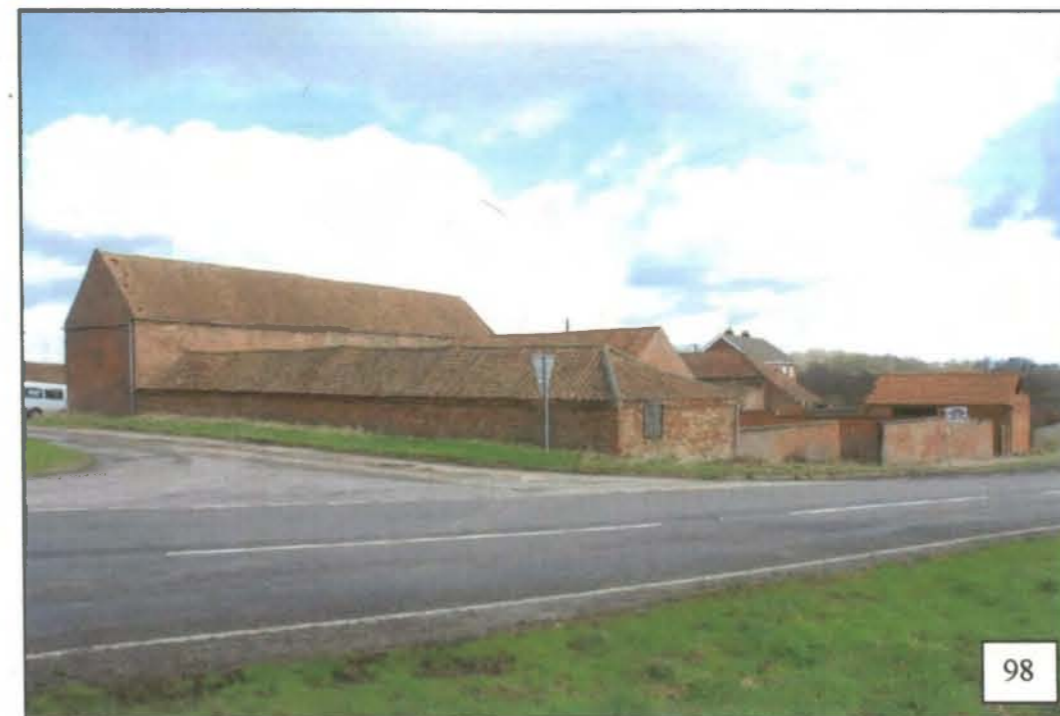
98

Building G was constructed in a mixture of varying shades of red and yellow brick (brick dimensions 9" x 4¼" x 2¼", 3 courses=8¼"), 9" in thickness and in a 5-course English Garden Wall bond. The coursing was not absolutely regular: the west wall had a continuous 3-course EGW bond part.

The building was aligned north south with a pitched pantile roof, hipped at the south end. It had a plain eaves cornice comprising a row of projecting headers with a row of stretchers above.

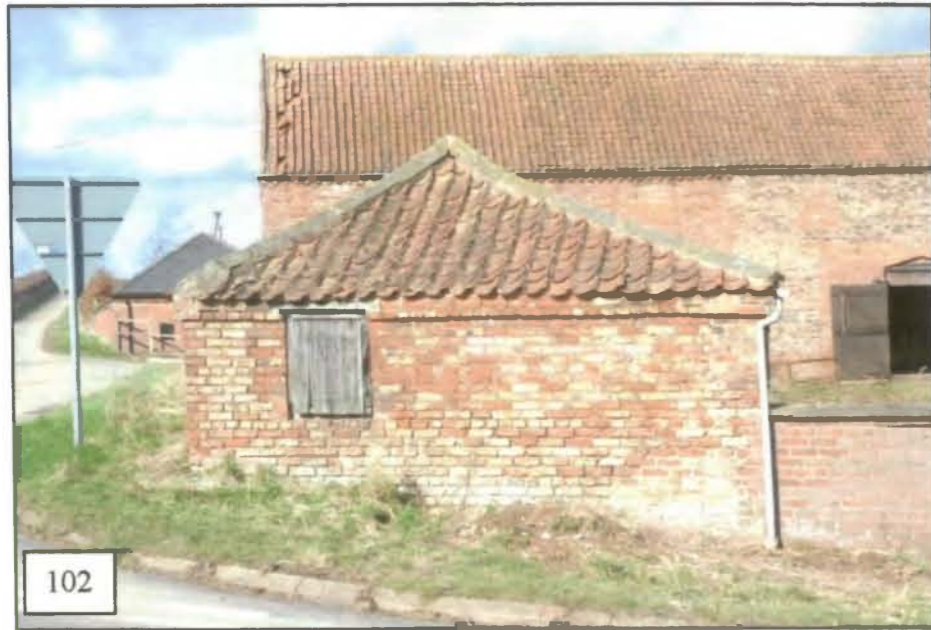
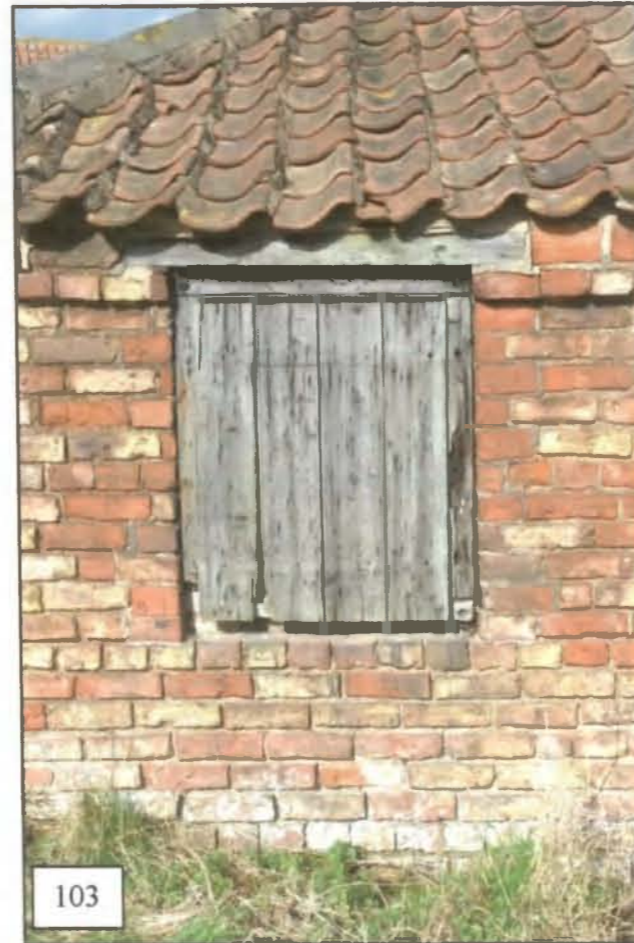
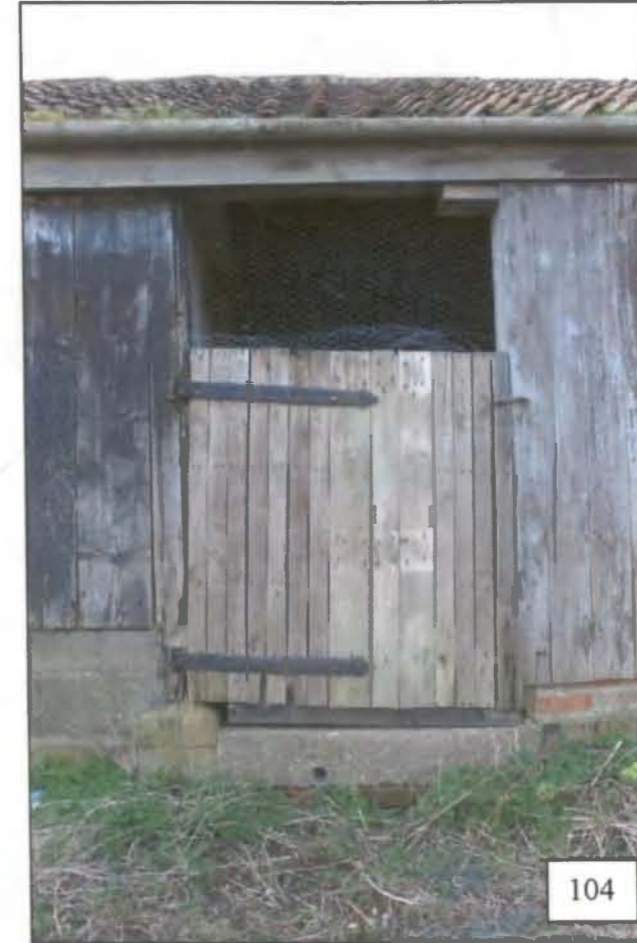
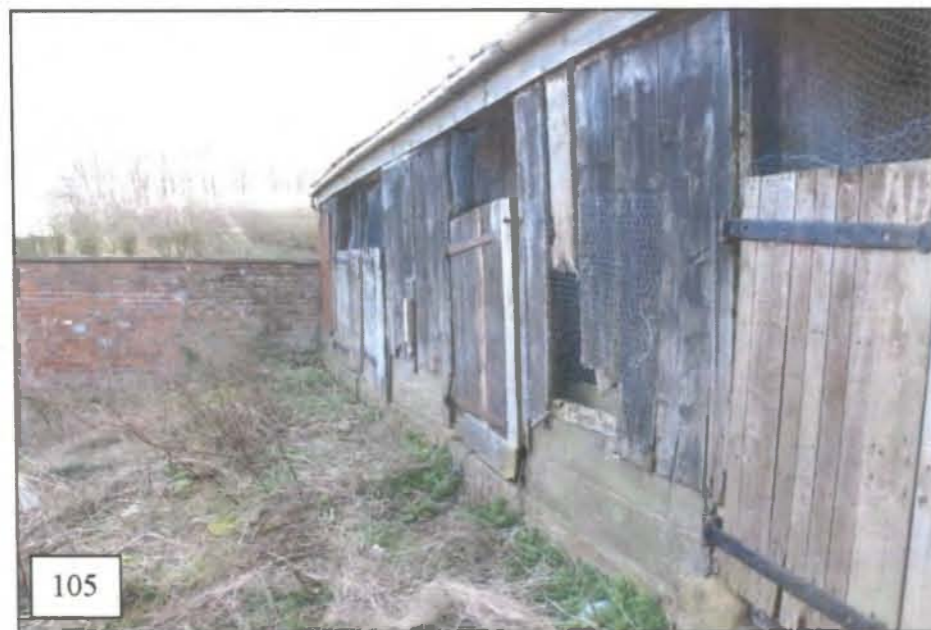
Building G comprised an effectively open fronted structure, with its eastern side carried on a series of timber posts, infilled with vertical plank panels and the doors to the various stalls and loose boxes. A small window was present, let in below the wall plate on the west side of the south wall; this had a timber lintel and a framed plank shutter.

On the east side, the doors of the stalls and loose-boxes were ledged and diagonally braced half-doors, of planks that varied in width from 2½" to 8" hung on long external strap hinges (although many have been replaced with more modern, shorter equivalents). The exterior timber and the doors had all been creosoted.
