BUNKERS FARM, WELTON LE WOLD, LINCOLNSHIRE

PHOTOGRAPHIC BUILDING SURVEY

Site Code: BFWW 08
LCCM acc. no: 2008.91
Planning ref: N/200/03059/06
NGR: TF 2840 8696
PCA job no: 08-441

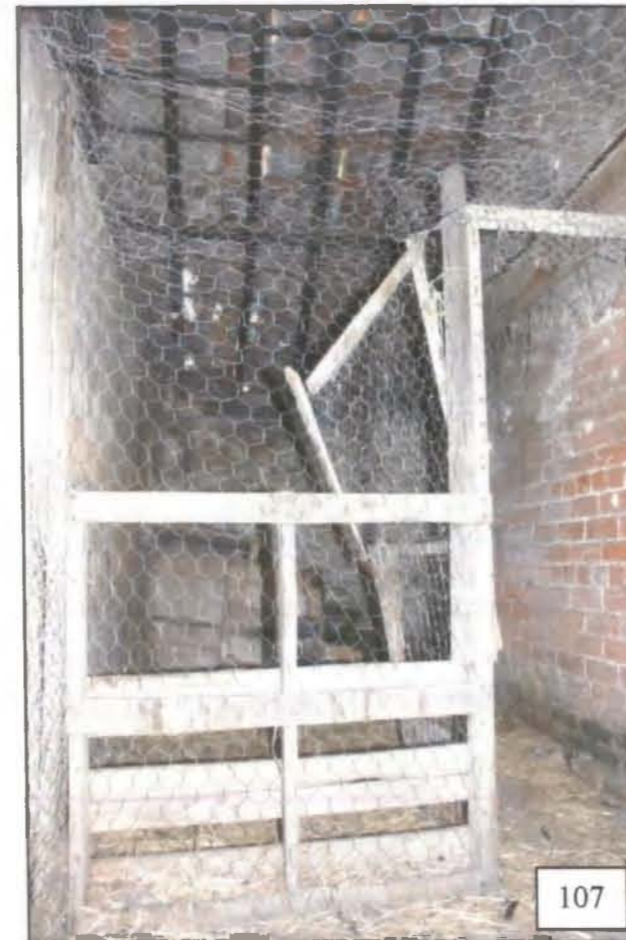
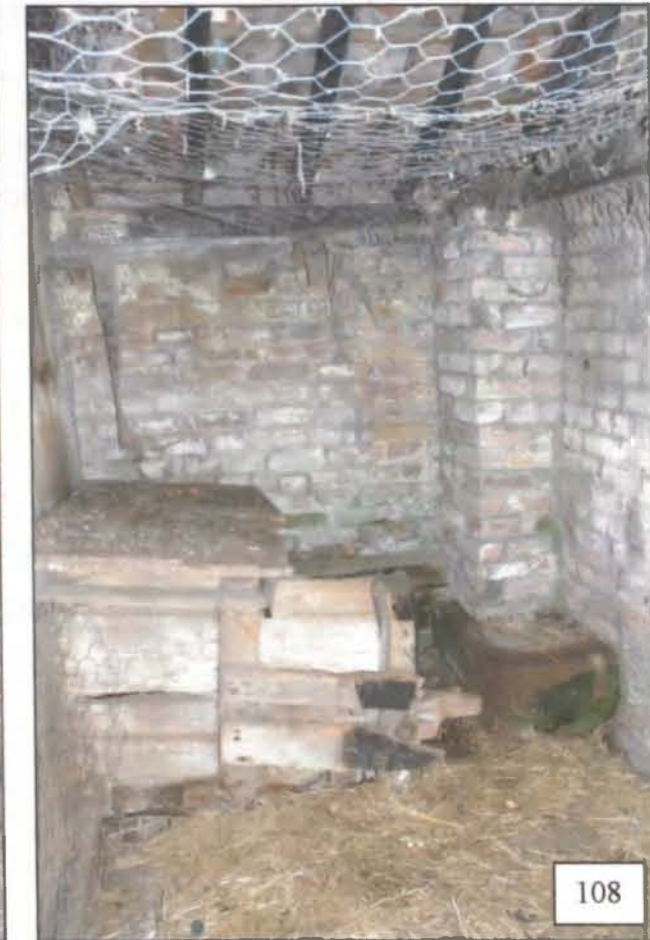
Room 17 was a small room at the north end of Building G. The exposed timbers of its pantiled roof included rafters, a tie beam, purlins and a strut (see Room 18 for construction). The room had no windows. The floor was of packed earth and hay.

Room 17 was divided from Room 18 by a partition of 10-12" planks on 3-4" studwork. A feeding trough was present on the west wall, with a heavy timber coping. In the north-west corner, the tie beam was carried by a brick pilaster on a worn stone base or plinth.

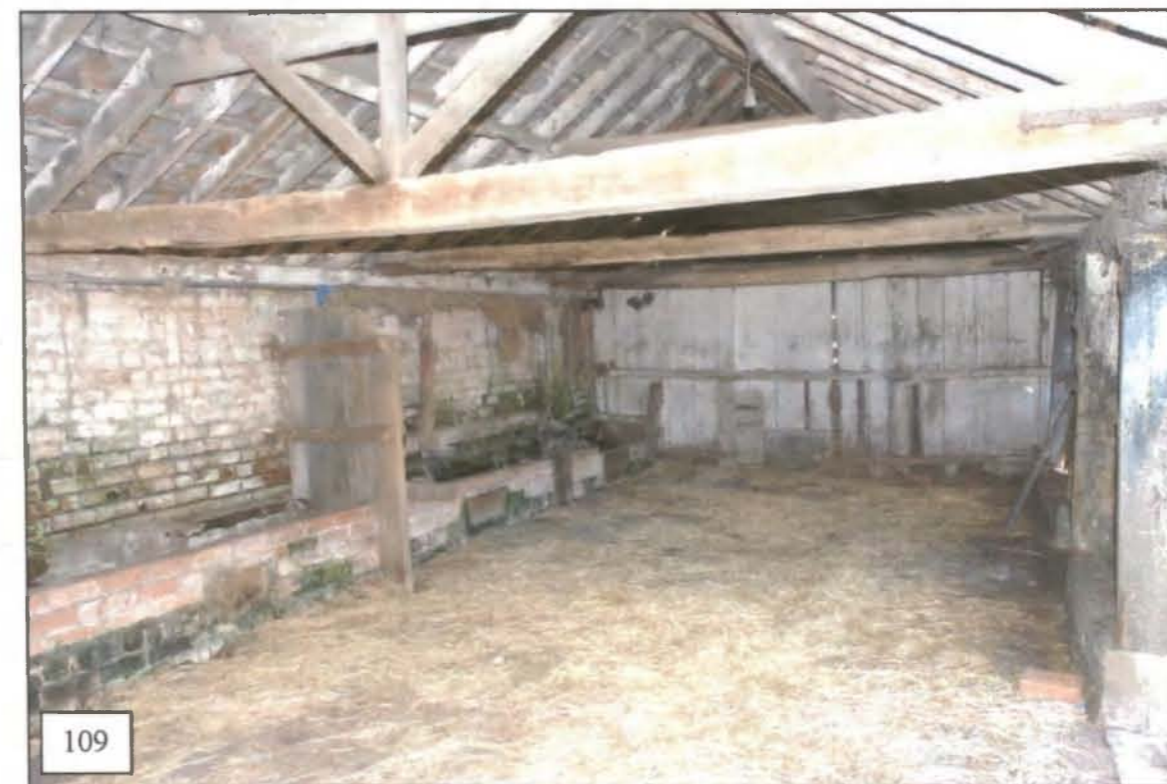
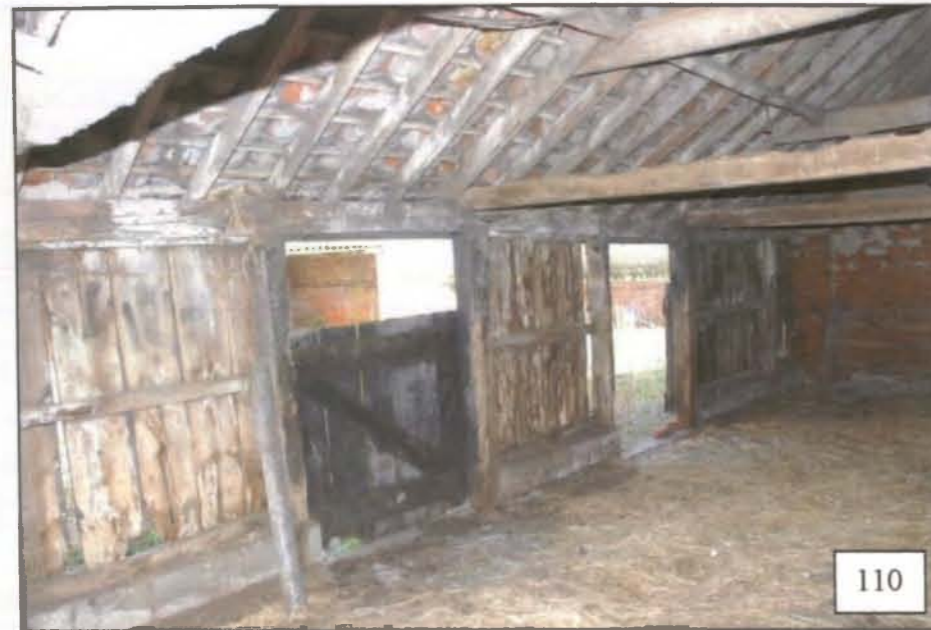
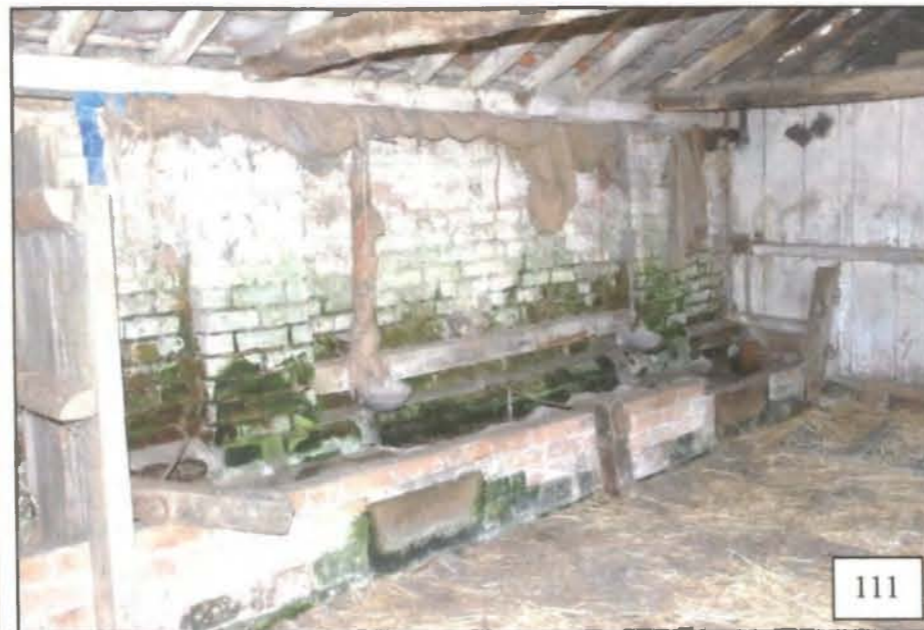
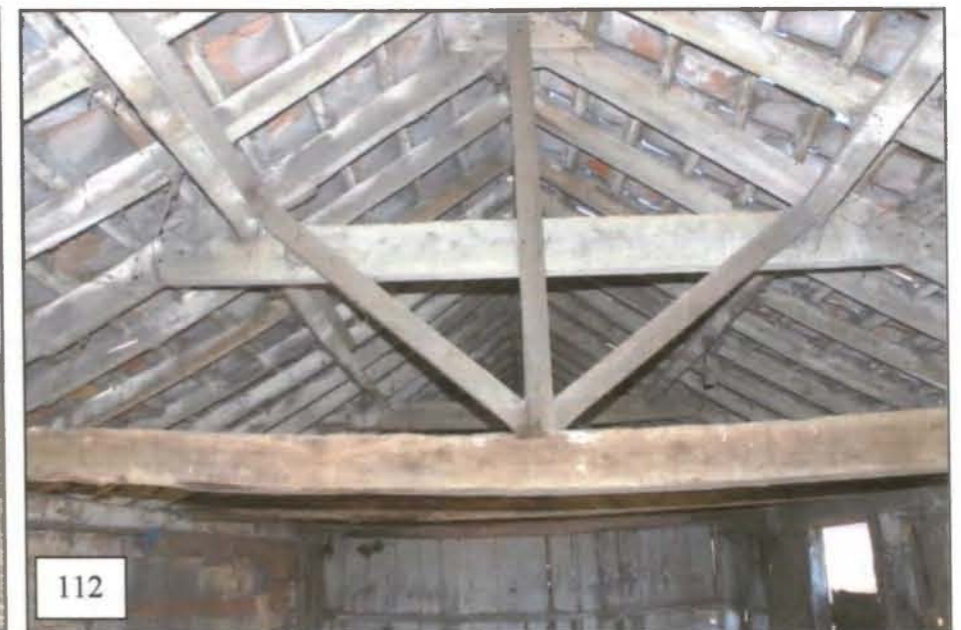
Room 18 was much larger and afforded shelter for several animals. The construction of the roof was more visible here, and was of principal rafter construction with clasped through-purlins. The tie beams measured 6" x 5", and the rafters 3½" x 2½"; the principal rafters were 4½" x 3" in size with collars 8" x 2" and ridge collars. The tie beam in the centre of the room had extra struts, forming a rudimentary king-post truss.

The room had no windows, and was lit by two transparent pantiles. The floor was of edge-set 9" x 2¼" bricks, laid in E-W half-abutting rows. On the western side, the brick feeding trough with timber fittings continued (brick dimensions 9" x 4½" x 3") and had a central plank partition.

As mentioned above, the eastern side of the building was originally open: it had 8" x 6" upright chamfered posts, blocked in with a concrete dwarf wall with 11" wide vertical planks above on 2-3" square horizontal studwork. Two doors were present on the east side, as described above.

As it was larger than the other rooms, Room 18 afforded several insights into the construction of the building. The west wall, of 9" brickwork, was strengthened by a series of evenly spaced brick pilasters on a chamfered brick-topped plinth. The building also has a central east-west dividing wall, which forms the south wall of Room 18, to provide further strength to the structure. The dividing wall ended on the east side in a 18" square brick pillar. All of the brick walls had been whitewashed.

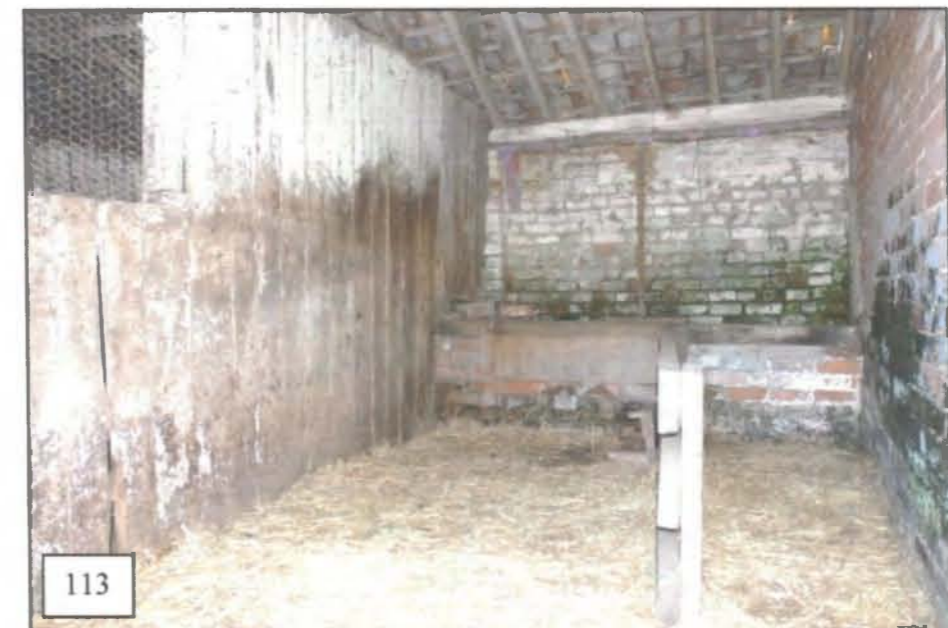
This room was a loose-box, providing accommodation for a single animal. The exposed timber of the pantile roof continued through this room (of similar construction to that described in Room 18). The floor was again of edge-set bricks, laid in east-west half-abutting rows: three courses run north-south on the eastern side, possibly indicating the course of a drainage channel. The door opening had a modern concrete sill.

The room is divided from Room 20 to the south by a plank partition below a tie beam: the planks range in size from 7" to 11", on a variety of studwork. On the western side, the brick feeding trough with timber coping continued.

It is likely that this room provided accommodation for a large animal, perhaps a bull, judging by the timber buffers at a slight diagonal which divided this room. The brick pillar on the eastern side of the north dividing wall had a chamfered internal edge.

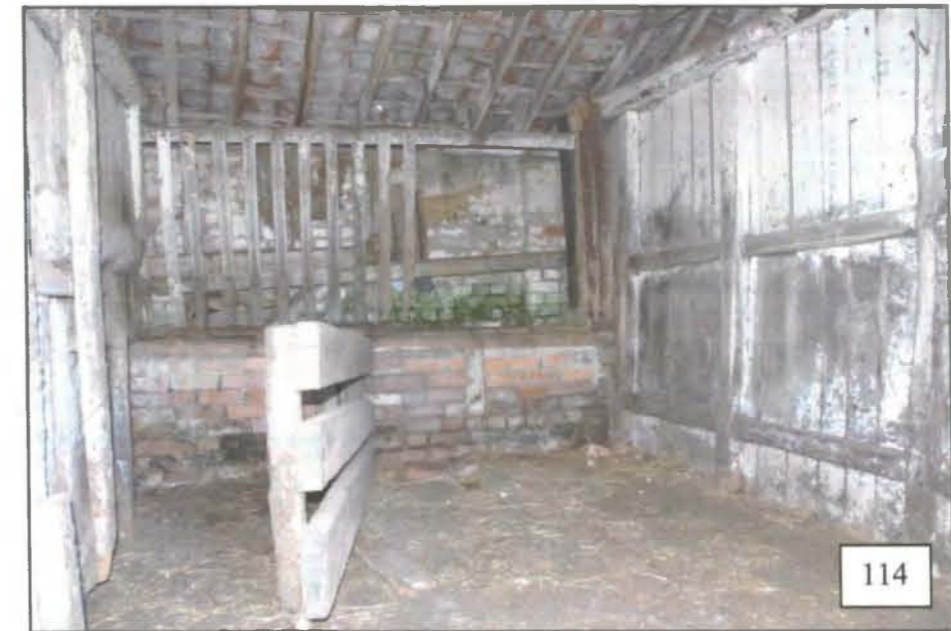
This room was also a loose-box, providing accommodation for a single animal, perhaps a bull, as more timber buffers at a diagonal opposite to that of Room 19 also divided this room.

The exposed timber of the pantile roof continued through this room (of similar construction to that described in Room 18). The floor was again of edge-set bricks, laid in east-west half-abutting rows with the same three-course drainage channel running north-south on the eastern side. The door opening had a modern concrete sill.

The room was divided from its neighbours by plank partitions below the tie beams: the planks range in size from 7" to 11", on a variety of studwork. On the western side, the brick feeding trough with timber coping continued. A hayrack was mounted on the west wall of Room 20, above the animal trough.

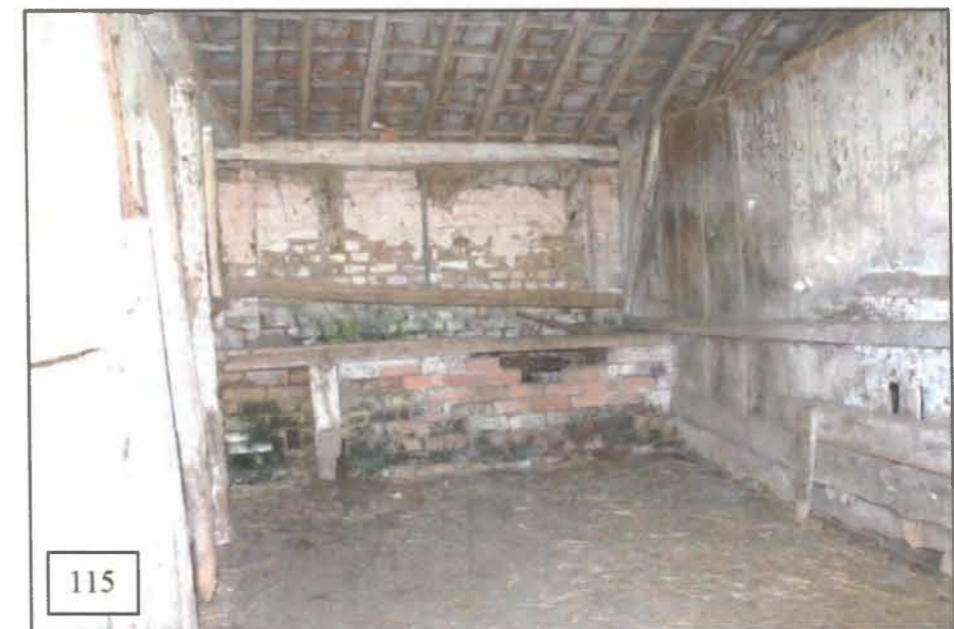
Like Rooms 19 and 20, this room was also a loose-box, providing accommodation for a single animal.

The exposed timber of the pantile roof continued through this room (of similar construction to that described above). The floor was again of edge-set bricks, laid in east-west half-abutting rows with the same three-course drainage channel running north-south on the eastern side. The door opening had a modern concrete sill.

The room was divided from its neighbours by plank partitions below the tie beams: the planks range in size from 7" to 11", on a variety of studwork. On the western side, the brick feeding trough with timber coping continued. The remains of a hayrack were also present on the west wall above the animal trough.

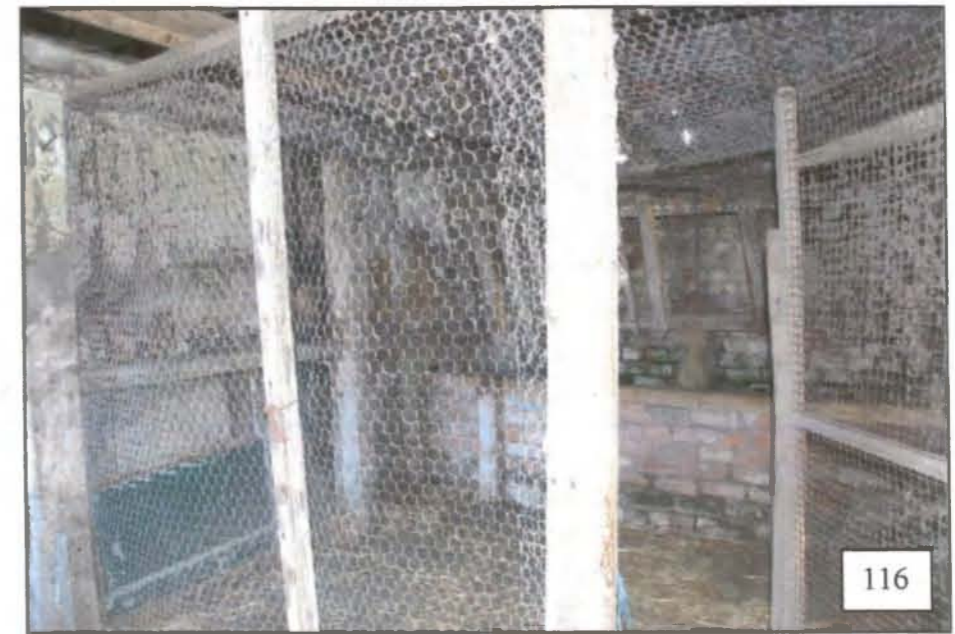
This room was originally a loose-box, similar to the others.

The roof was of similar construction to that described in Room 18. The floor was again of edge-set bricks, laid in east-west half-abutting rows with the same three-course drainage channel running north-south on the eastern side. The door opening had again been renewed with a modern concrete sill.

The room was divided from its neighbours by similar plank partitions to those described above below the tie beams. On the western side, the brick feeding trough with timber coping continued, and the remains of a hayrack above this were also present. Most recently the room had been further divided with chicken wire on a light timber frame to accommodate birds.

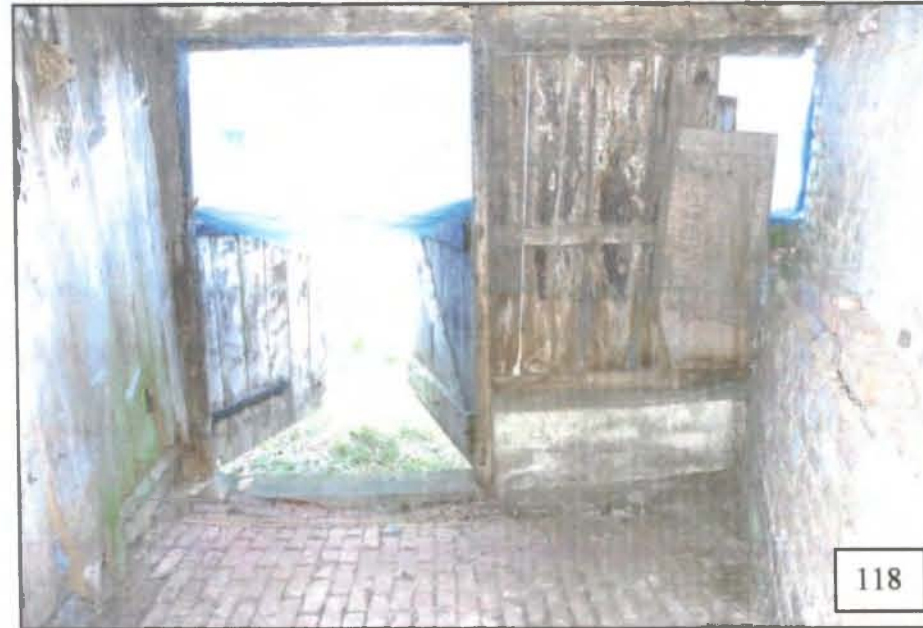
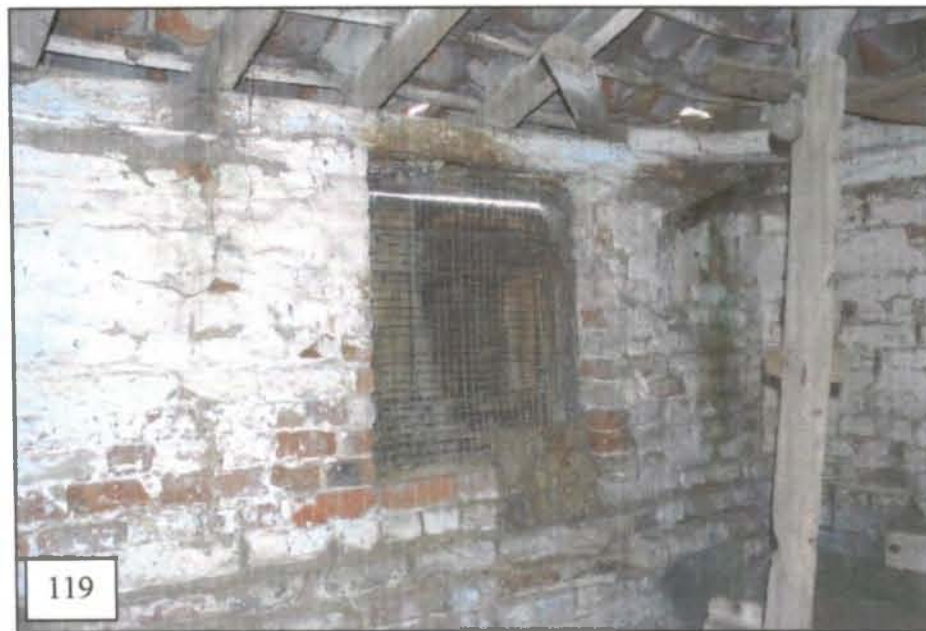
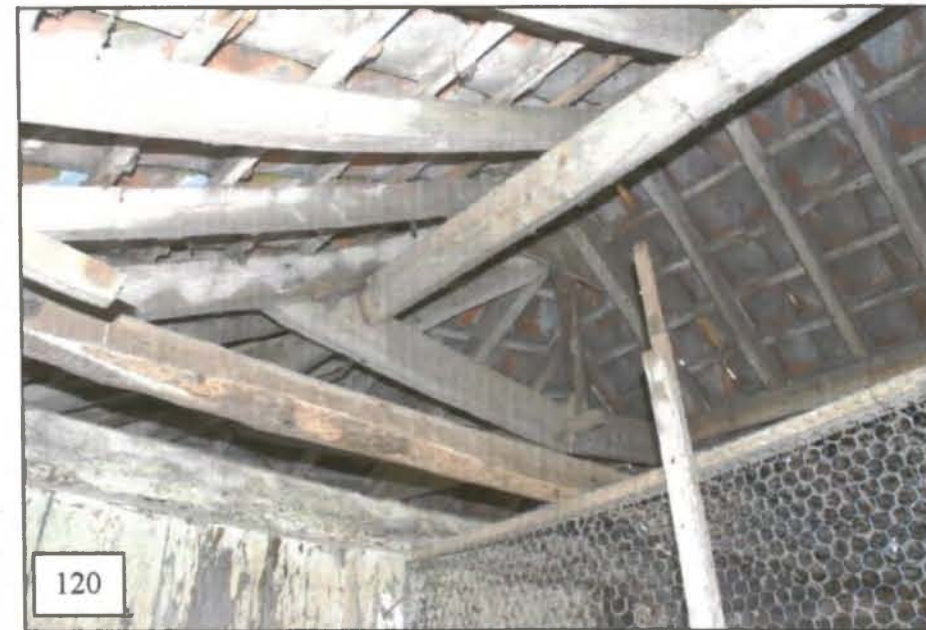
Room 23 was a smaller room, again probably a loose-box, which narrowed to the west as the southern end of Building G was not square.

The hipped end of the roof was visible here, the rafters being supported on a wider (deeper) ridge collar above the southernmost tie beam. Dragon beams at the corners supported the diagonal ridge boards, while a north-south collar was pegged at the centre of the southernmost conventional collar. The southwest corner of the roof had been additionally braced with a rectangular post, itself braced to the northern partition.

The window had a 3" x 3" timber frame, with a ledged 6" plank shutter. The floor was again of edge-set bricks, laid in parallel E-W half-abutting rows: it sloped down to a N-S running three-brick drainage channel on the eastern side. The brick-built feeding trough recorded in Rooms 19-22 continued into Room 23. The south wall was constructed on a 3' high plinth, with its upper two courses stepping back to the upper wall thickness.

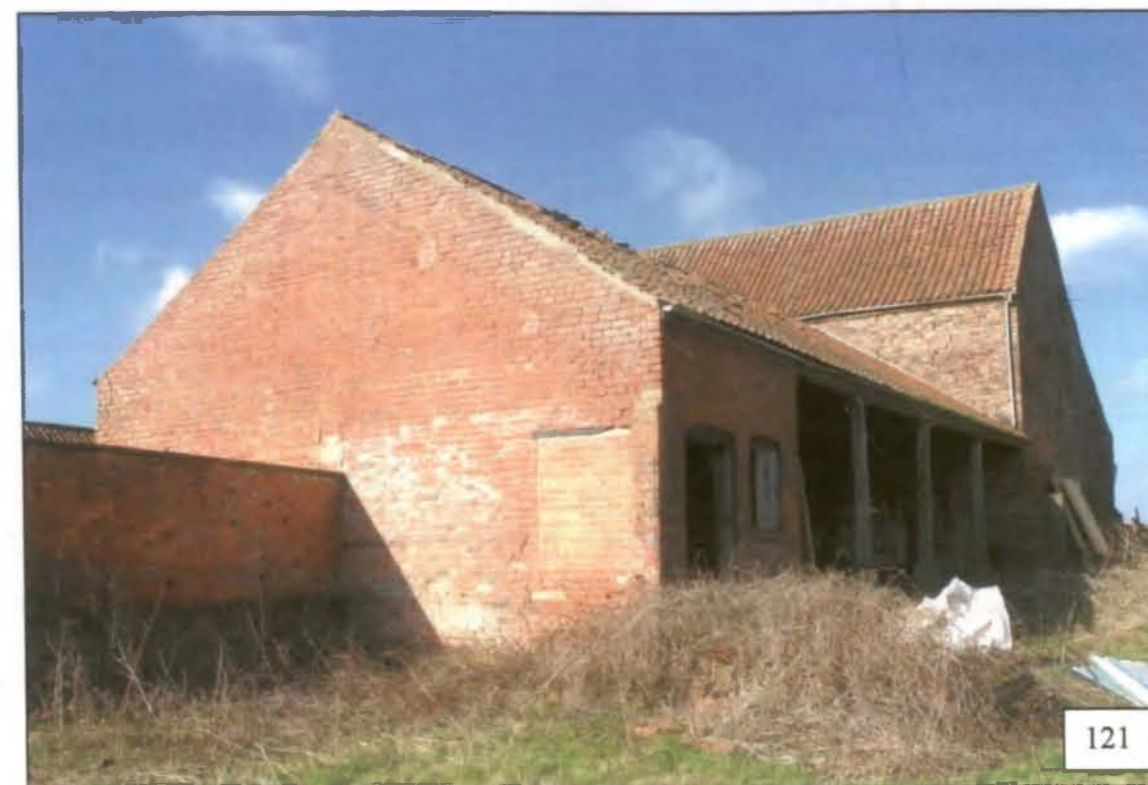
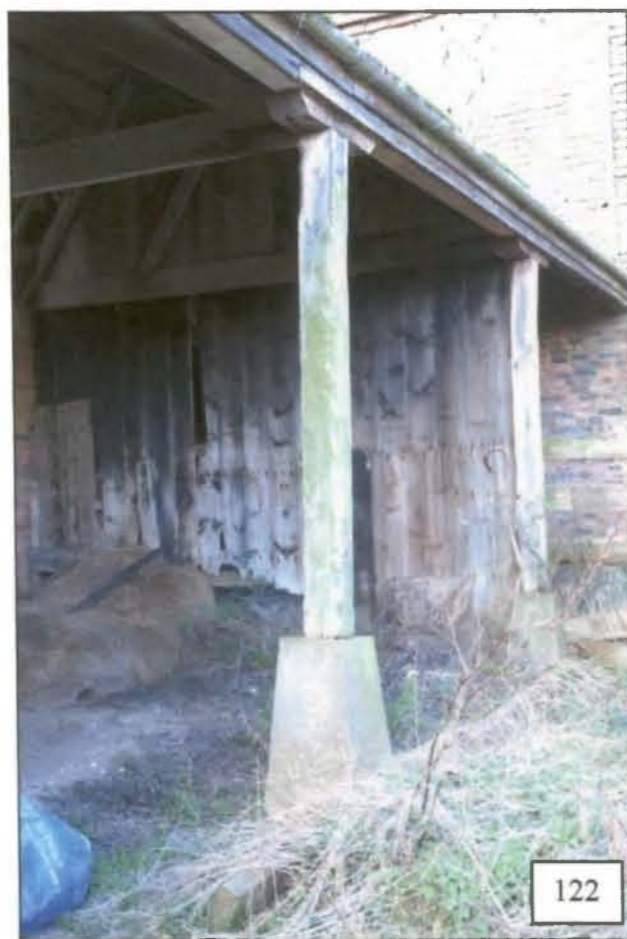
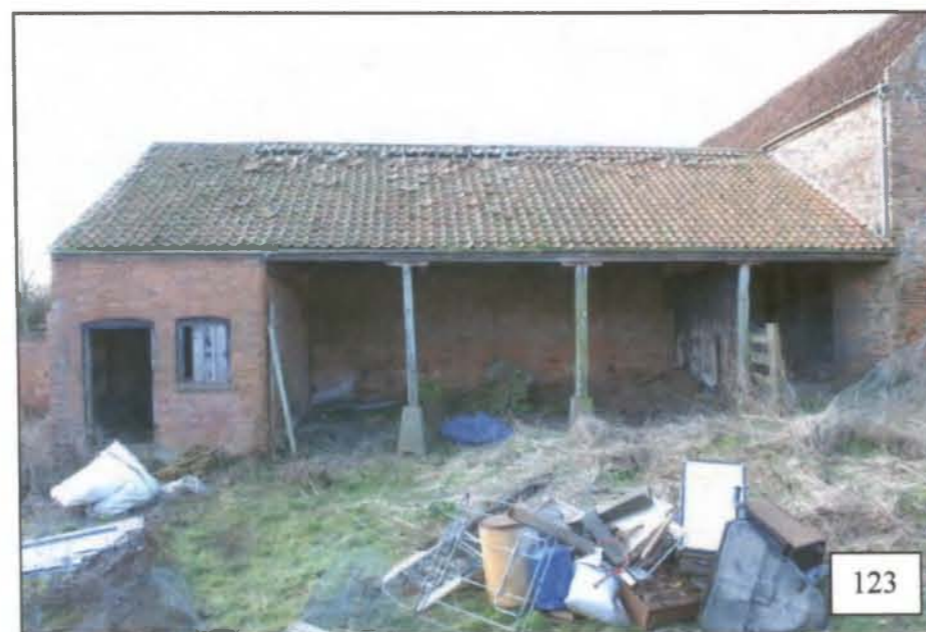
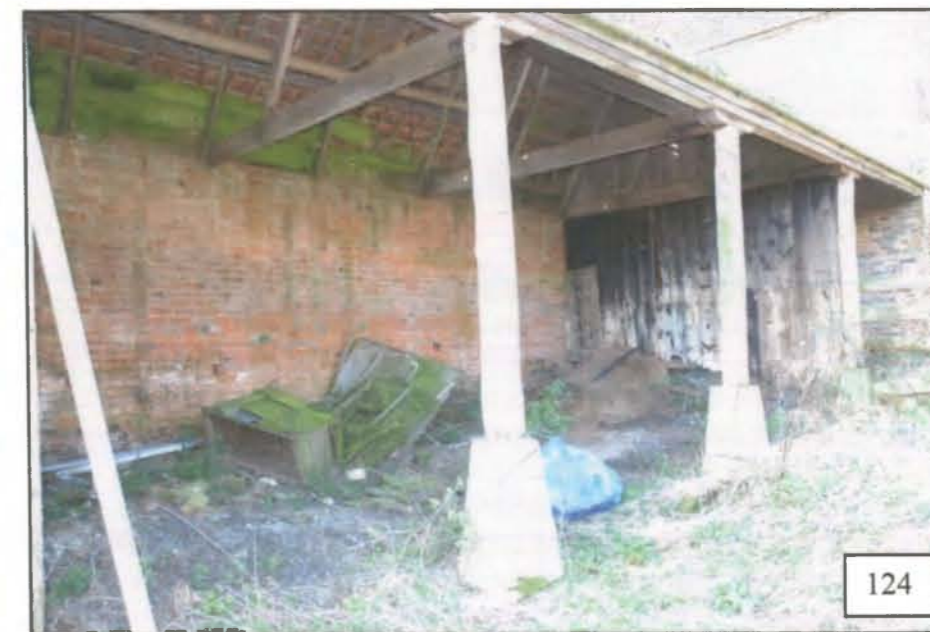
This building formed the central arm of the E-shaped farm complex. It was constructed against the south wall of the original part of building D. On the 1st and 2nd edition OS maps, this formed a structure that reached to the road frontage. The southern part of this structure is no longer extant. It is recorded on the 1910 Land Tax survey as 'crew sheds and 3 loose-boxes'. In the Turnor farms of the same period such a building was used as fodder storage; its central position facilitated the supply of fodder to either of the crew yards through a centrally placed door in the spine wall. If the construction of Building G was not the cause, then the construction of this building definitely necessitated the breaking through of the entrance to the crew yard between Buildings A and D.

Building E was constructed of reddish-orange brick (brick dimensions 9" x 4 1/4" x 3", 3 courses=10"), generally of 3-course English Garden Wall Bond, 14 1/2" in thickness, except for the gable, which had 5 and 7 courses of stretchers to a single header course. It was on a north-south alignment, with a pitched pantile roof. It was open fronted to the yards on its east and west sides.

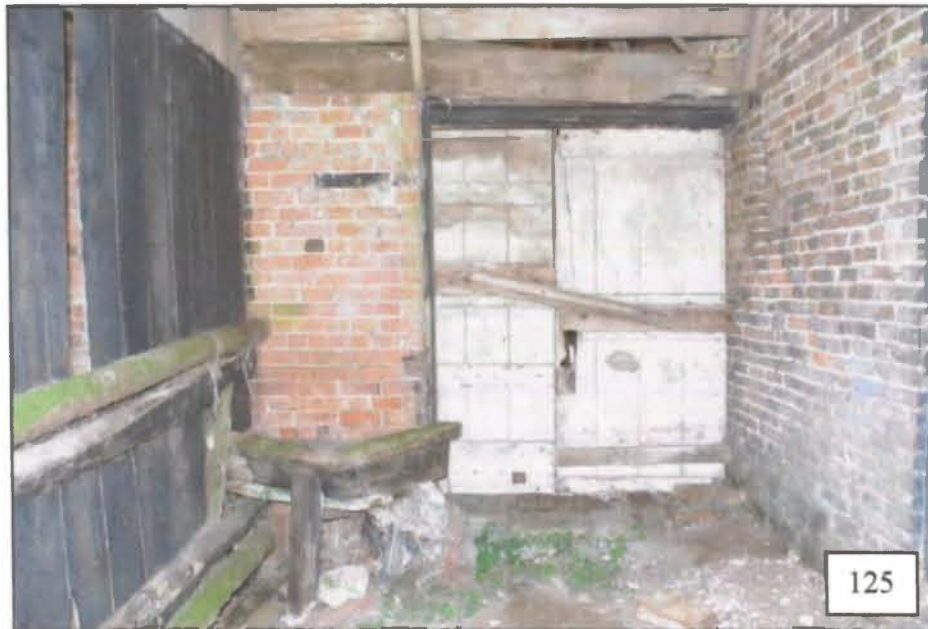
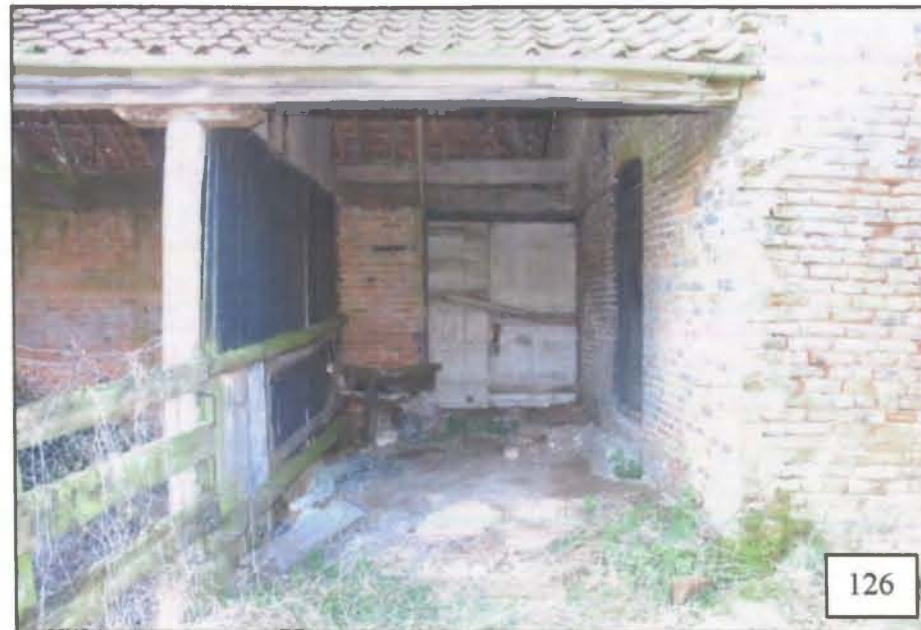
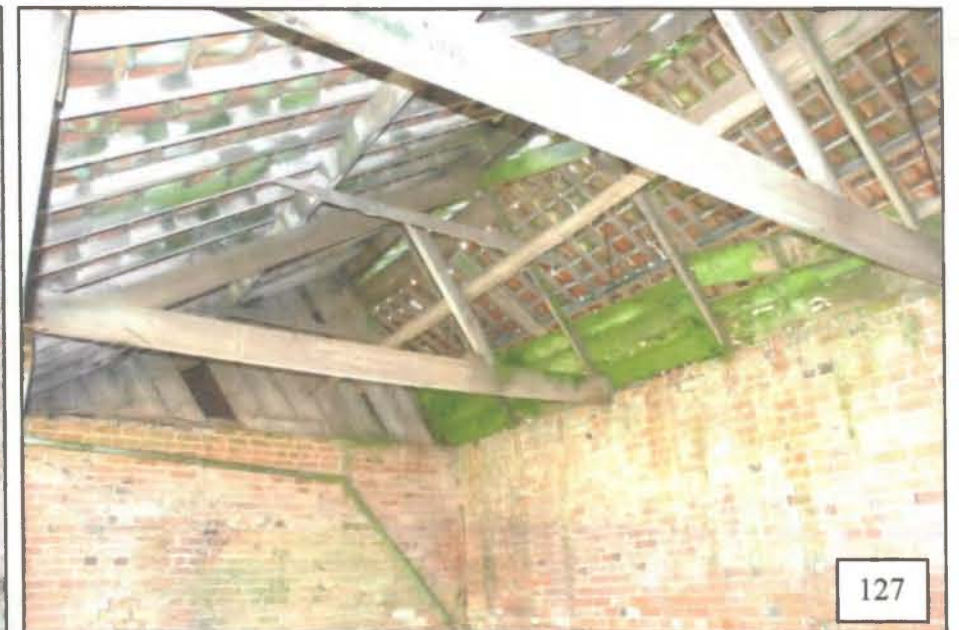
This represented the open fronted area on the east side of the structure, the open side having a heavy through-lintel supported on three 7" square posts on concrete bases. The trusses and rafters of the pantile roof were exposed; the remains of a plank ceiling were also present, spanning the area between the central dividing wall, or spine wall, to the upper purlin. The floor was of packed earth.

On the north side, a timber partition of 9" wide vertical planks on horizontal roundwood rails was present, separating the main part of the structure from the access to the neighbouring yard; the partition was creosoted. Next to the doors from Room 13, a timber feed trough was present. The north wall (actually the south wall of Building D) had four slit vents of which three had been bricked up.

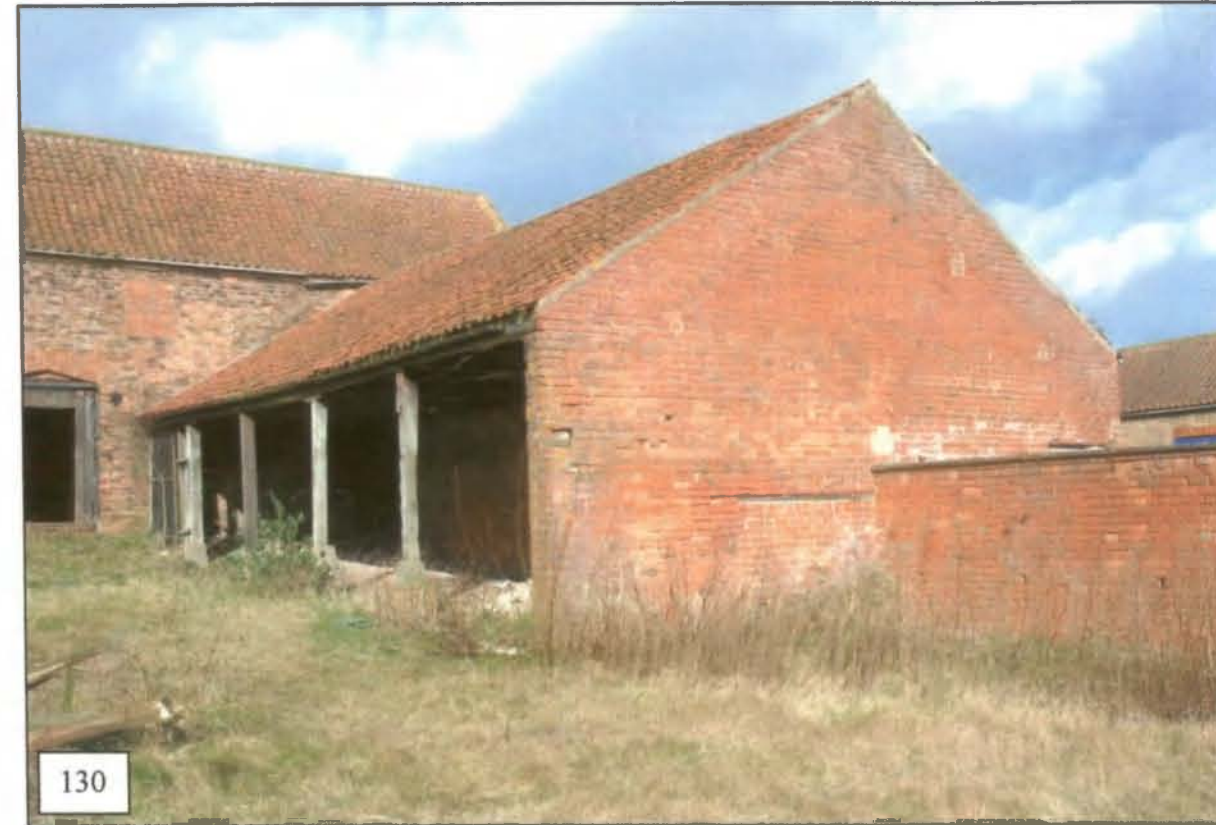
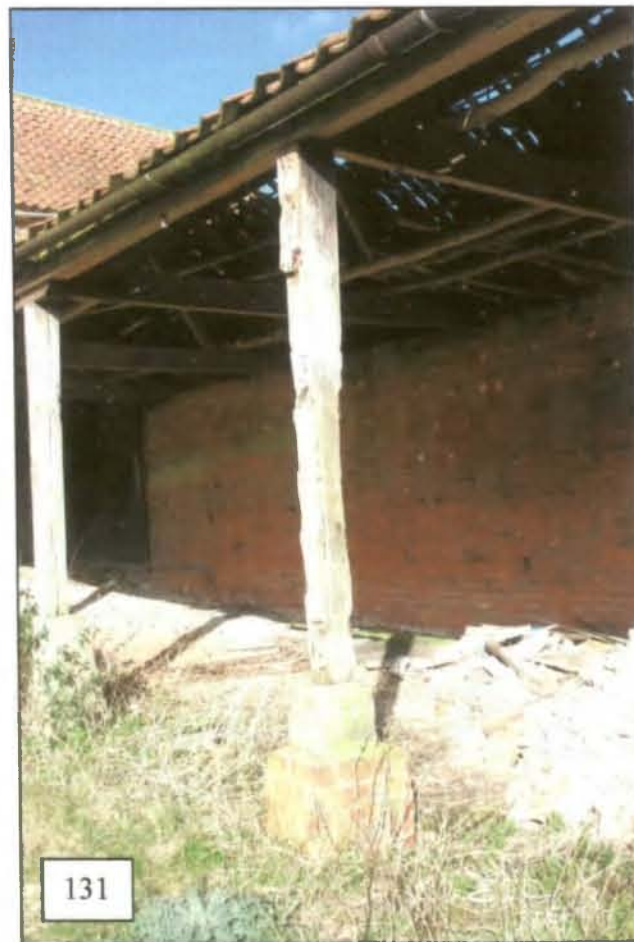
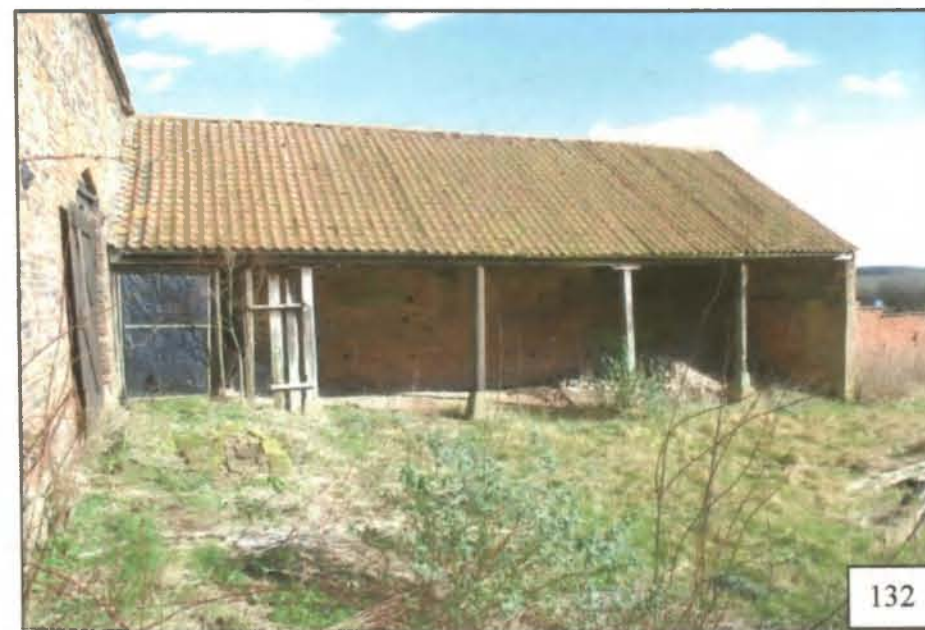
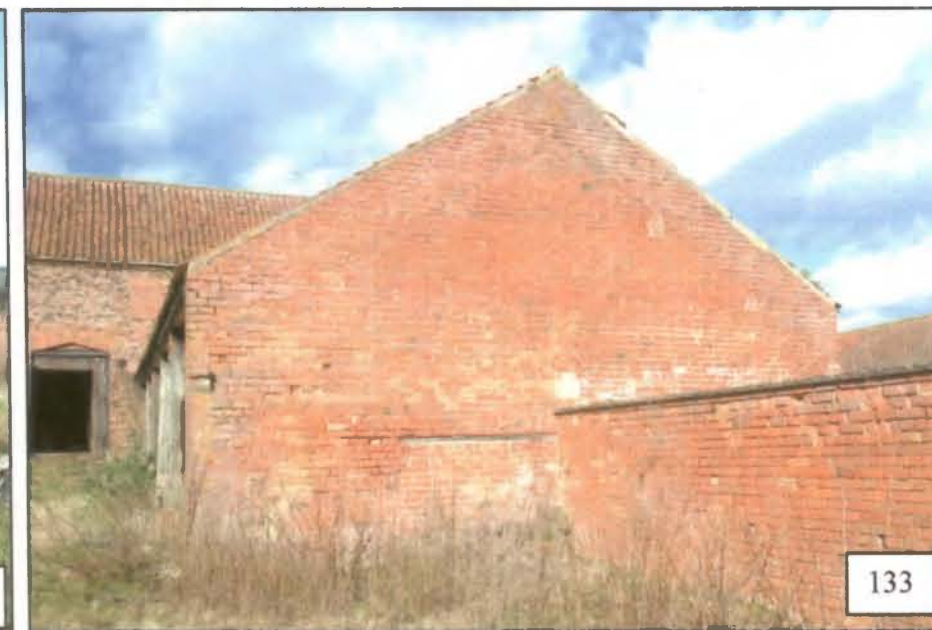
The west side was open: here, its trusses were supported on a lintel beam and a variety of timber posts, probably different because of later replacement rather than original design. The southernmost of these posts measured 7" x 4½", and stood on a stone and brick plinth; the next was 5½" x 6½", on a concrete plinth; the third was a re-used telegraph pole, on a concrete plinth, and the northernmost was 7" square and also stood on a concrete plinth. Room 13 was open to Room 14 above the spine wall. The south gable stepped back to 9" thick brickwork above the 22nd course.

A bricked-up opening with a timber lintel, at the base of the south gable wall of Building E, allowed for the mucking out of this structure. The scars of the roofline of the building once present to the south of Building E were clearly visible in this wall; it was probably of the same date and of a similar configuration to Building E, as a scar is also visible here, where the central spine wall of the structure has been reduced in height to that of the other boundary walls and given a similar concrete coping.

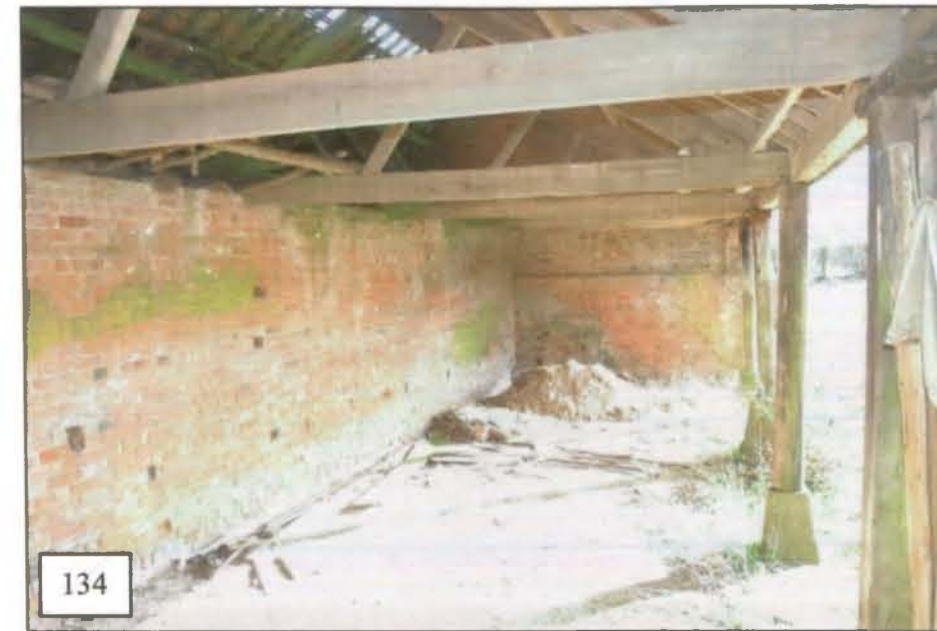
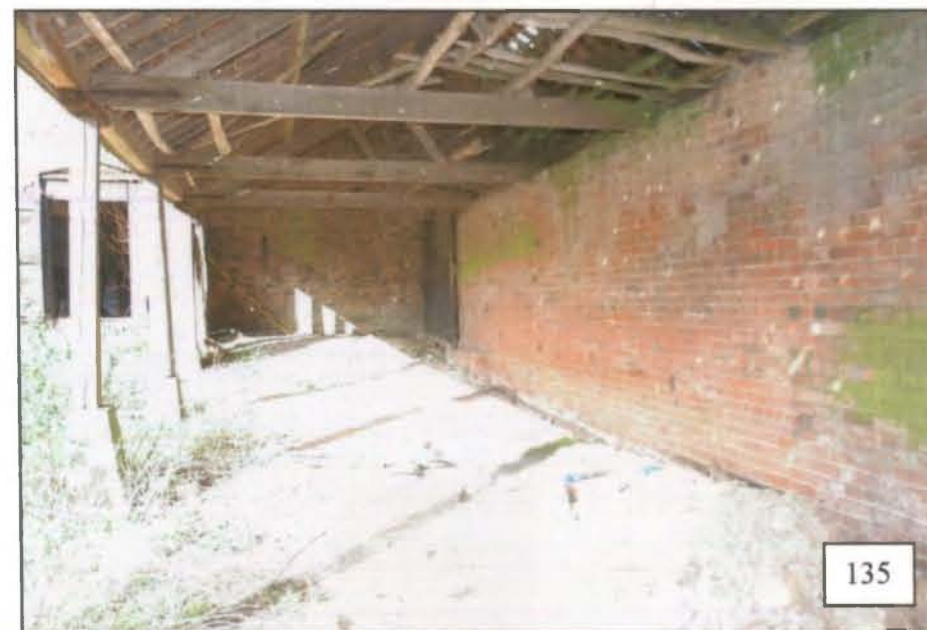
The trusses, purlins and rafters of the pantile roof were exposed throughout the structure. The trusses were of timber, with diagonal braces and iron tie bars, resting on the central spine wall; the purlins were bolted to the trusses.

The trusses in this building were of a king-post type, but with the king post itself replaced by an iron rod. This practice appeared in Staffordshire from c. 1865 and an account, written in 1850, noted iron king posts as being a recent introduction (Peters, 1988 pp.24-31).

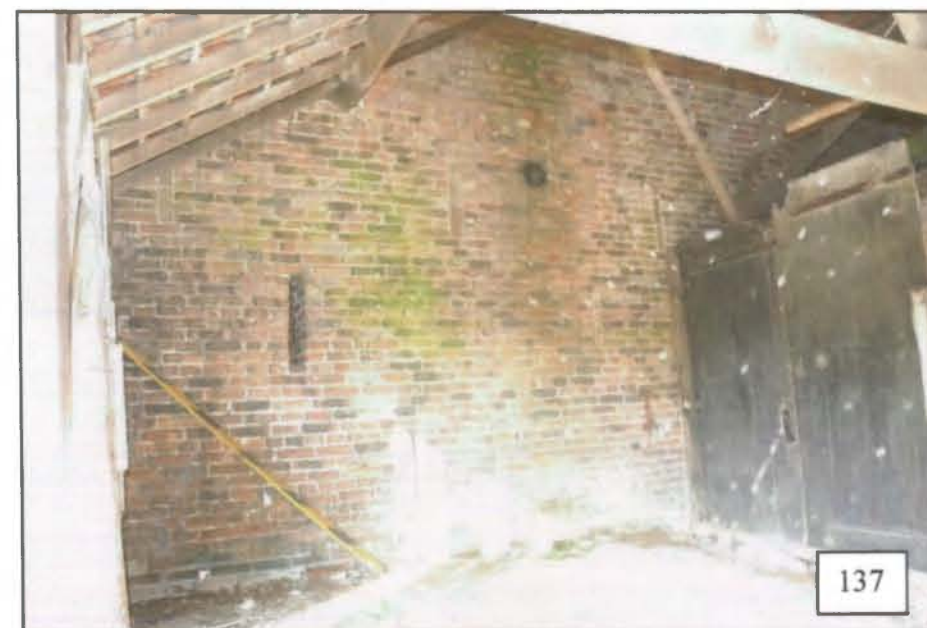
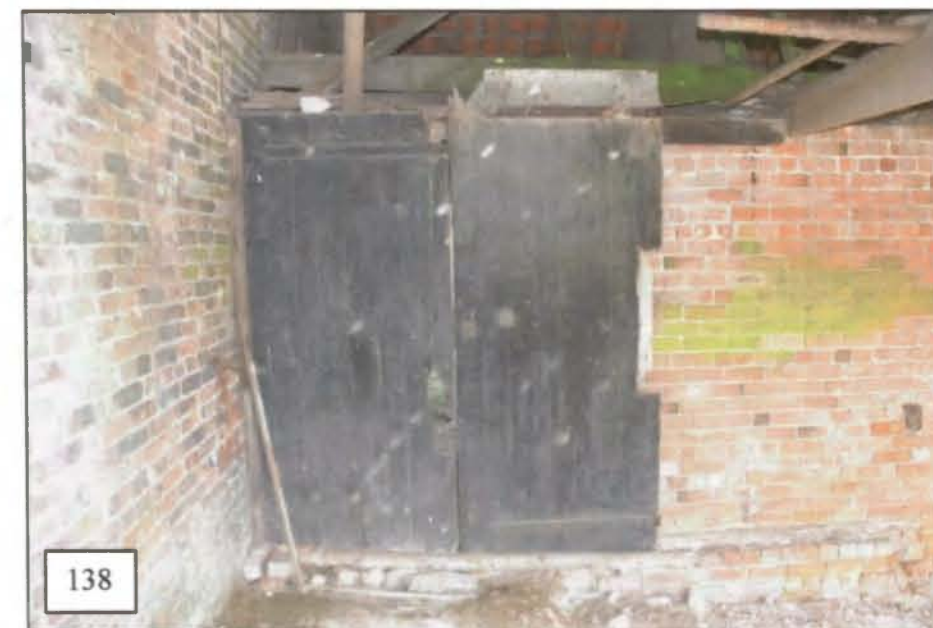
Six slit vents were visible in the north wall, this being the south wall of the original part of Building D; four of these were bricked up. This wall also had a bullseye tie-bar endplate.

At the northern end of the east wall a mismatched pair of plank doors afforded access to the other side of the building, and between the crew yards. The northern of the double doors was of 5" plain planks with three ledges, and the other was of 10½" beaded planks with four ledges.

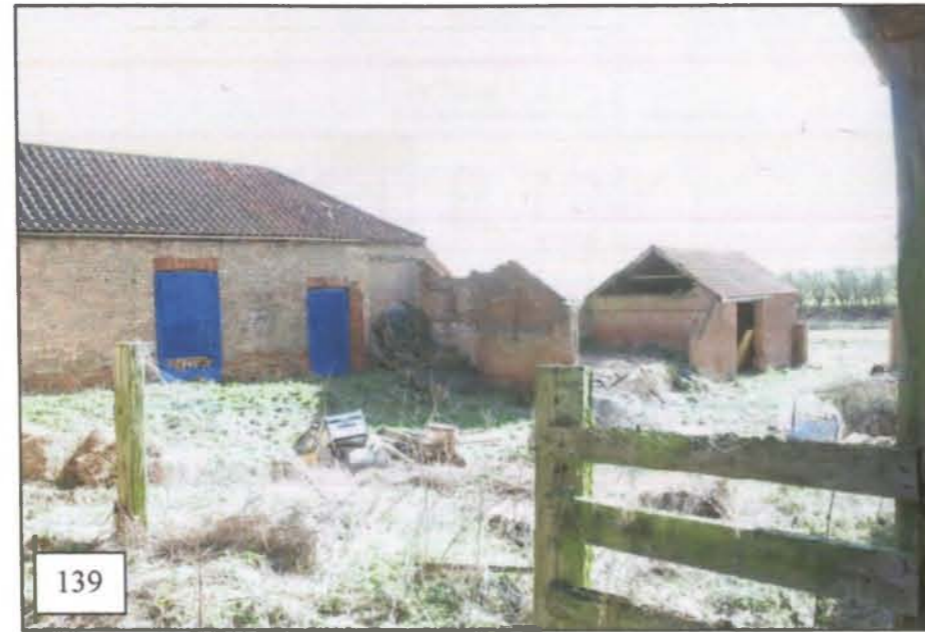
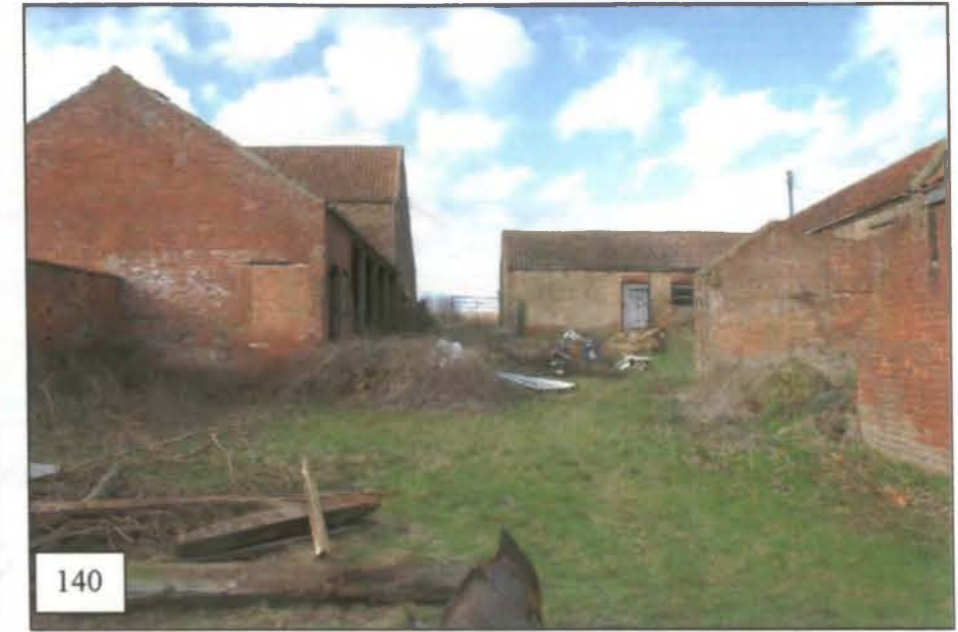
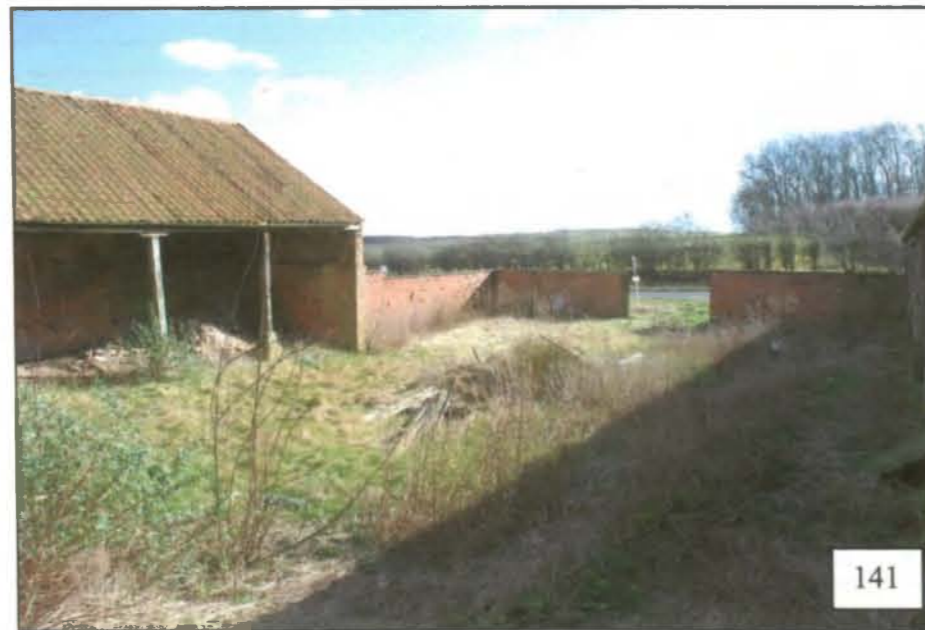
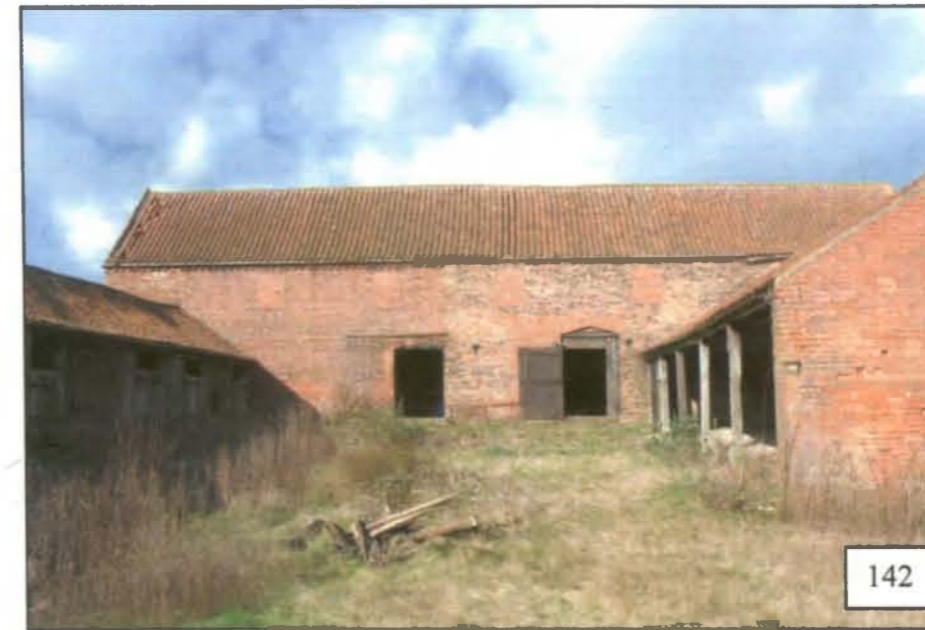
It is not the buildings themselves, or their function, which shows their origin in the 'High Farming' period of local agricultural development. It is their arrangement around two open areas, called crew yards, which demonstrates this heritage. This arrangement, open to the south and delimited by brick walls, maximised the amount of sun received by the animals penned in the area.

The crewyard boundary walls were of a reddish-orange brick (brick dimensions 9" x 4¼" x 3", 3 courses = 10"), generally in 3-course English Garden Wall Bond, with a modern concrete coping.
