BUNKERS FARM, WELTON LE WOLD, LINCOLNSHIRE

PHOTOGRAPHIC BUILDING SURVEY

Site Code: BFWW 08
LCCM acc. no: 2008.91
Planning ref: N/200/03059/06
NGR: TF 2840 8696
PCA job no: 08-441

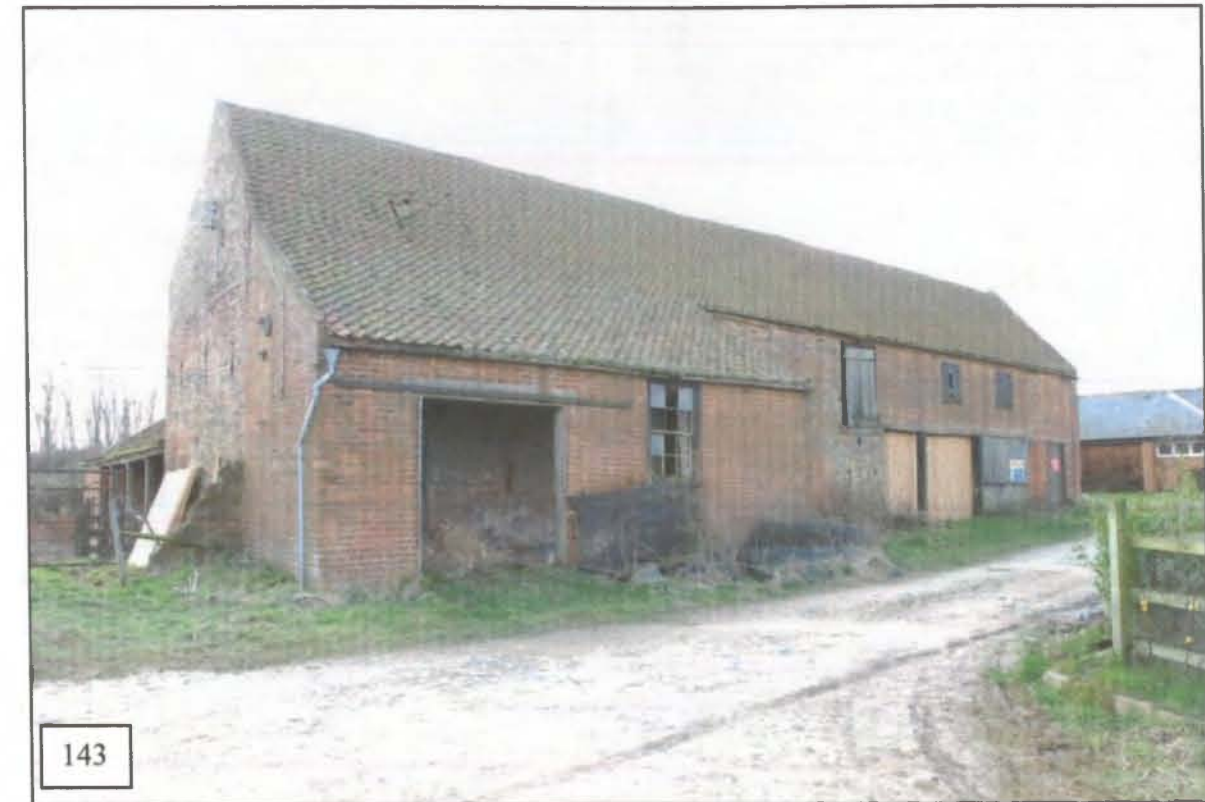
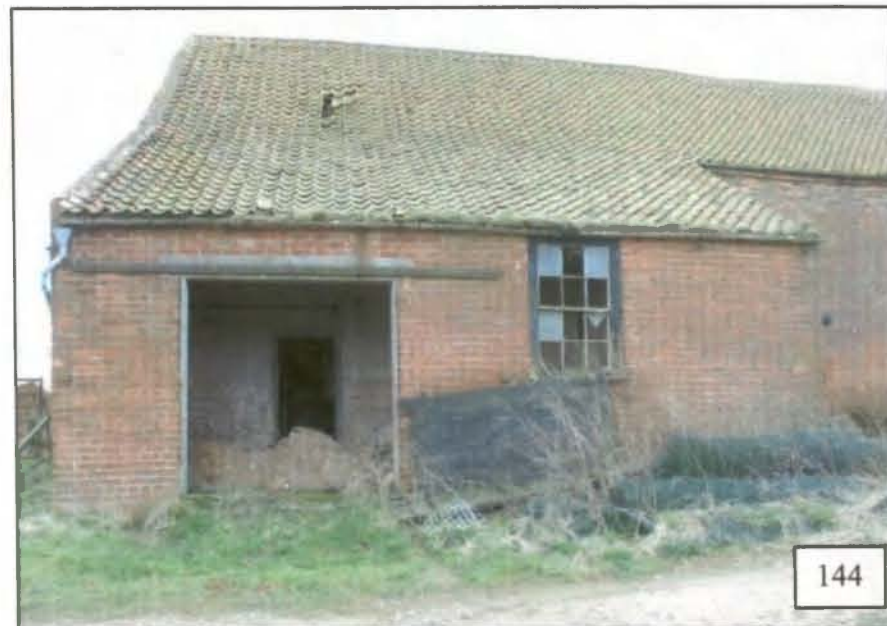
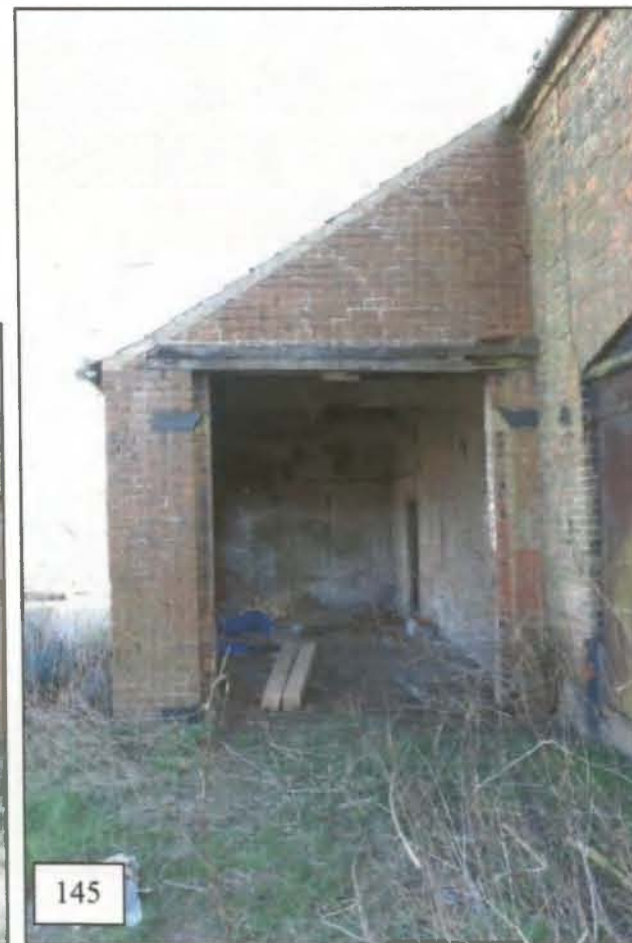
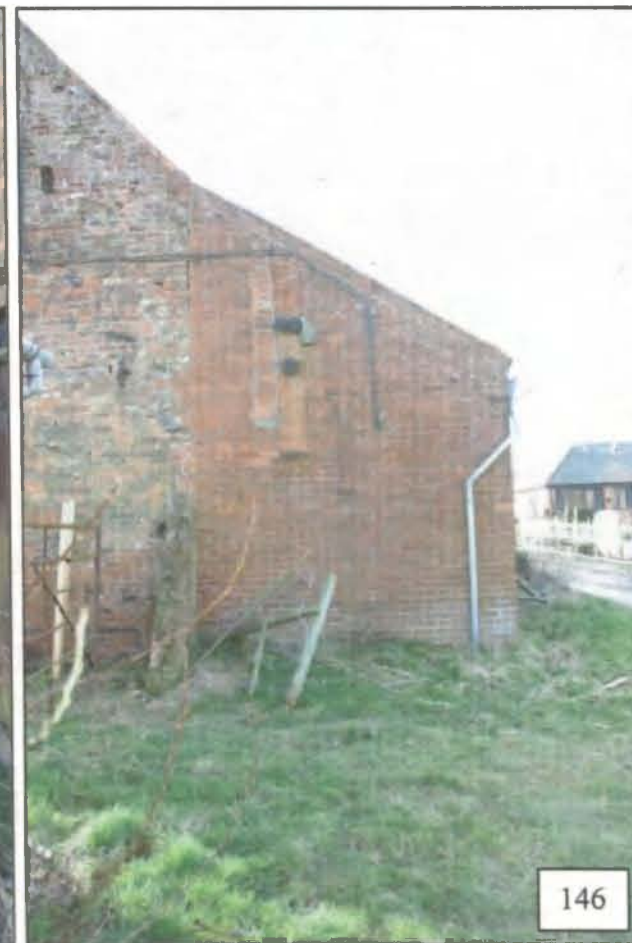
Building F was constructed in a uniform dark red brick (brick dimensions 9" x 4¼" x 3", 3 courses=10"), in 3-course English Garden Wall Bond. It was a lean-to structure, with a single-pitched pantile roof, joined to Building D at the eaves, at a shallower pitch to the roof of that structure.

The east gable wall of Building F clearly displayed the 9" wide bricked-up vertical slot where a drive belt had passed through the wall.

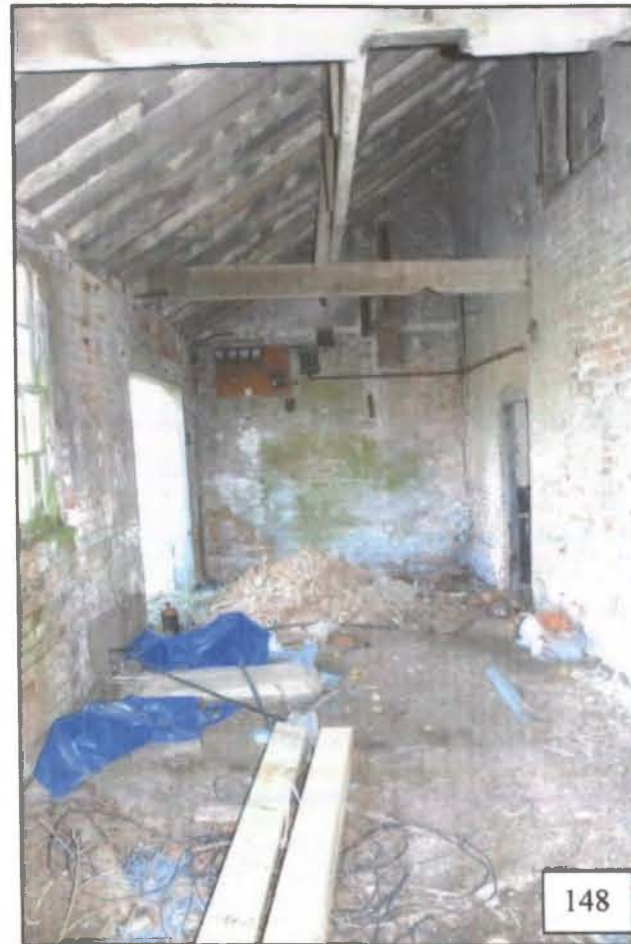
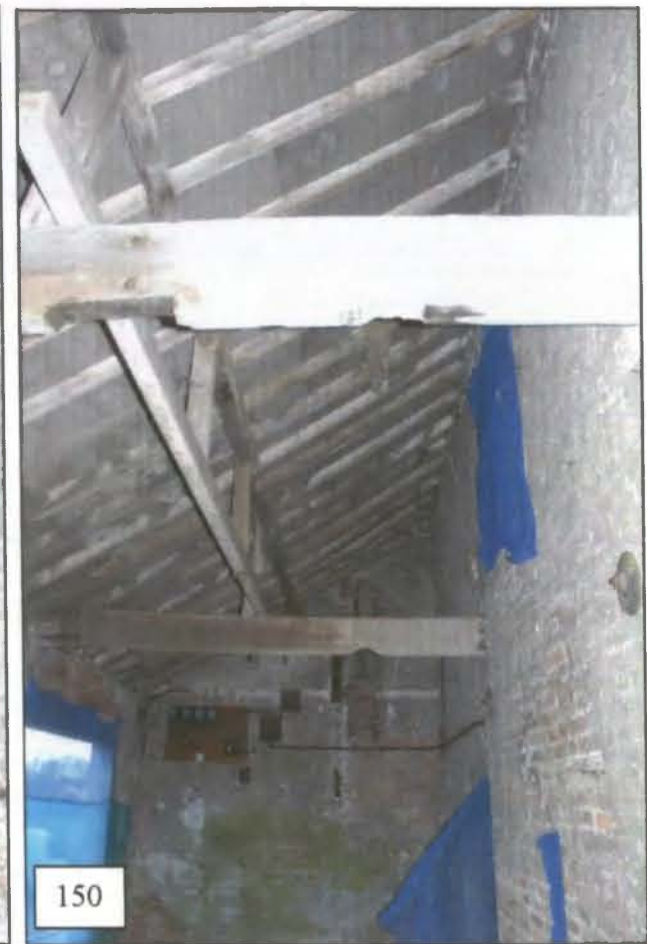
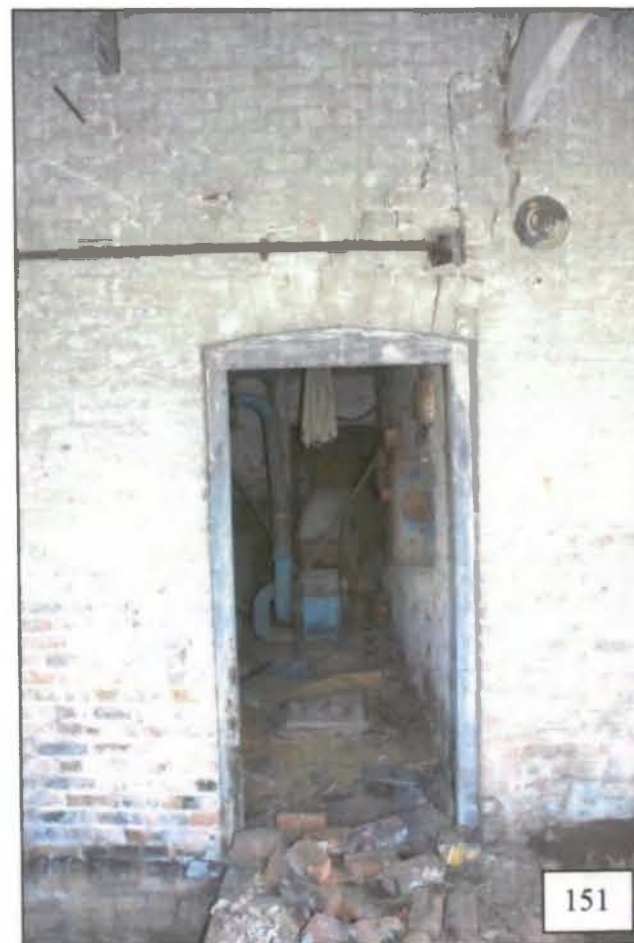
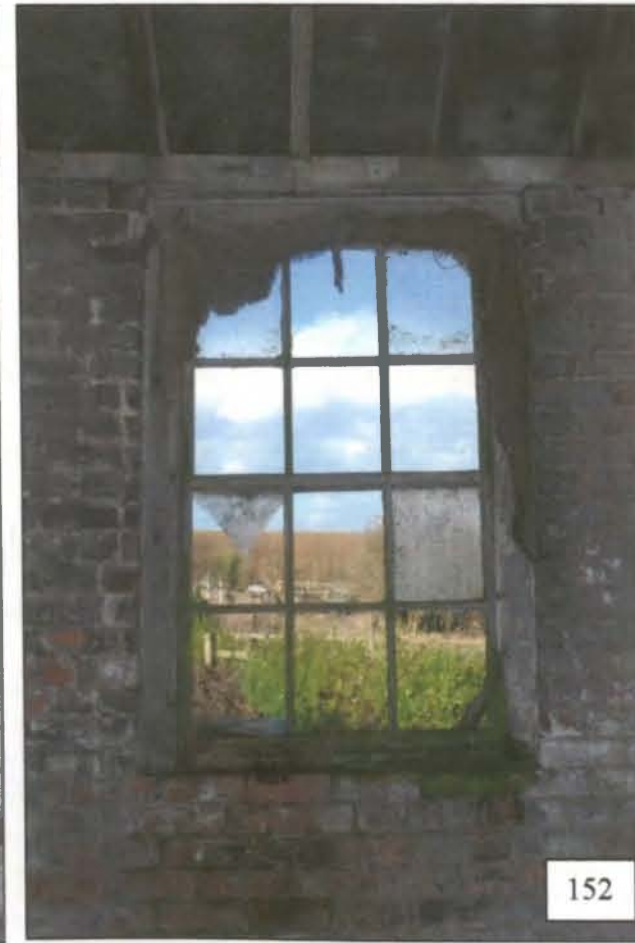
Room 16 was east-west aligned. The beams and rafters of the pantile roof were exposed; the roof was felted below the tiles. The single-pitch roof ran from the eaves of Building D, and had a single through purlin supported on a trestle arrangement from two large north-south tie beams let into the south wall. The floor was of edge-set 8½" x 2¾" bricks, laid in north-south half-abutting rows.

The room showed traces of belt-driven agricultural machinery: there were electric boxes on the east wall, and high up on the same wall was the pulley for a belt-drive. This had curved spokes and a timber rim, and was mounted on a cast-iron bracket, in a slot in the wall, now bricked up on the exterior. The tie beams were worn thinner on their undersides in the line that the belt would have taken from this pulley.

A window was present in the north wall, of two 6-pane sashes, and was probably re-used in this position; no lintel was present as it was set immediately below the wall plate, but it had a timber sill.

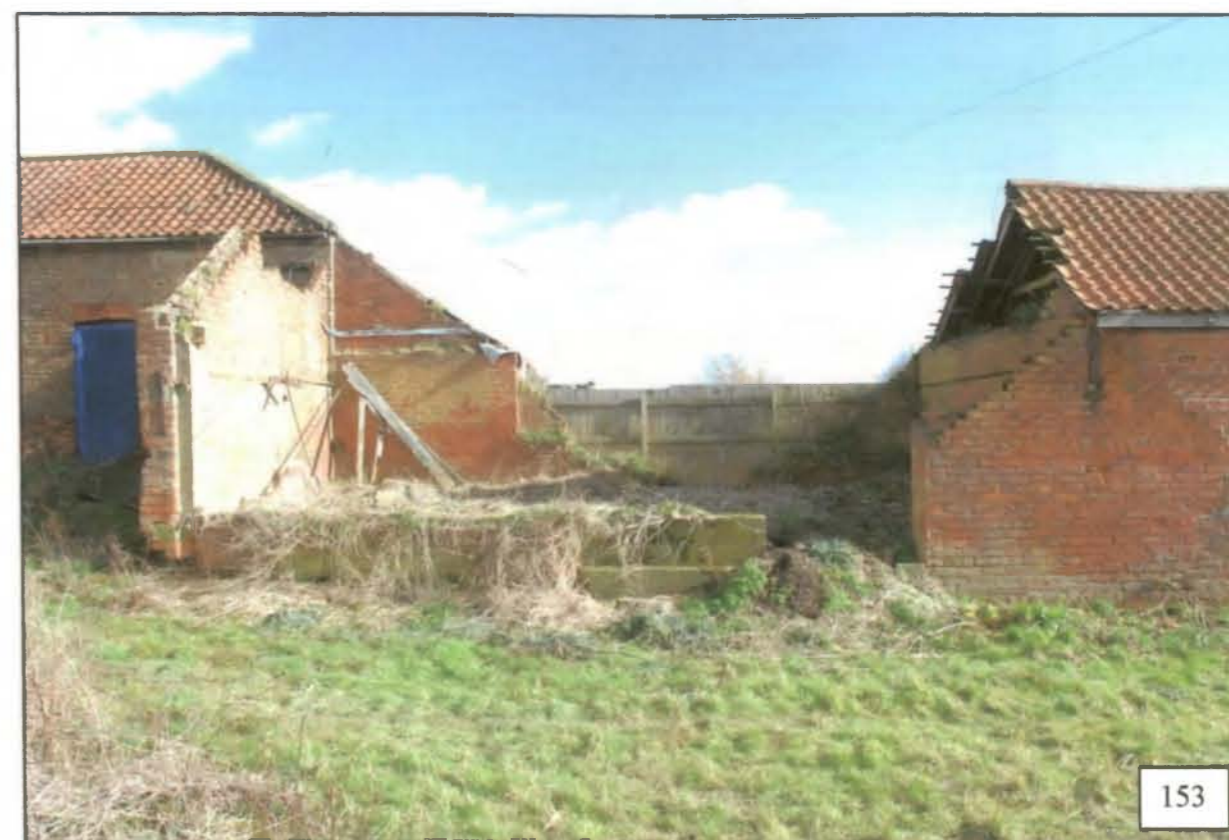
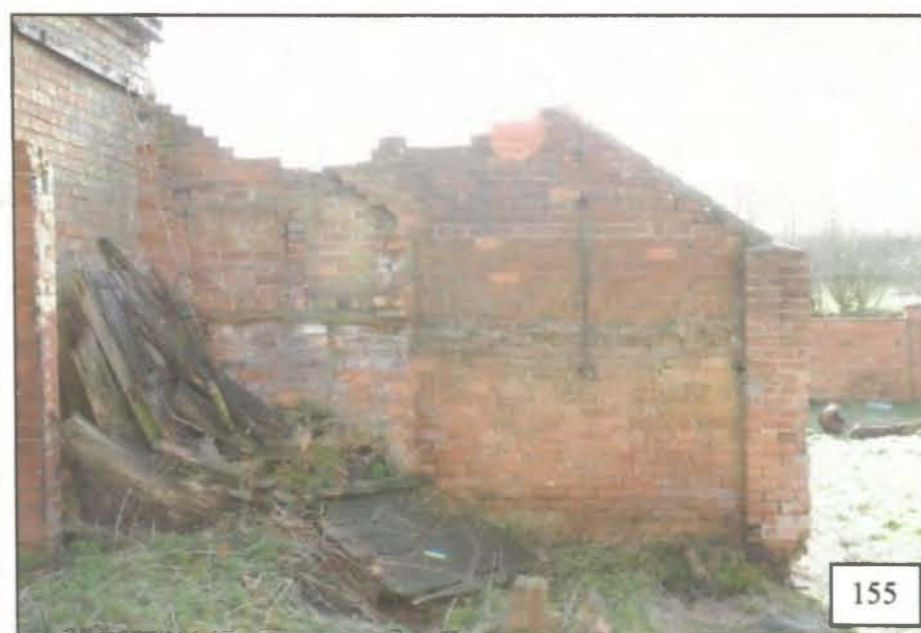
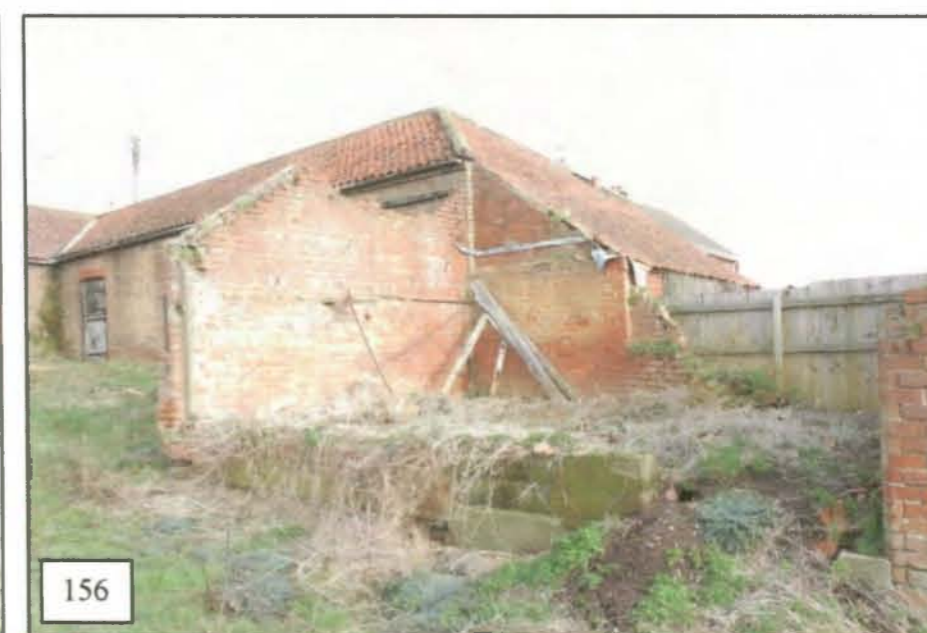
Buildings B and C were added at the southern end of the east range of the main farm complex between 1891 and 1907, as they are not shown on the first edition Ordnance Survey map, but do appear on the second edition. On the 25" OS map of 1907, whoever annotated this plan whilst undertaking the Land Tax survey around 1910 described them as brick crew sheds. They clearly employed the former eastern boundary wall as part of their structures.

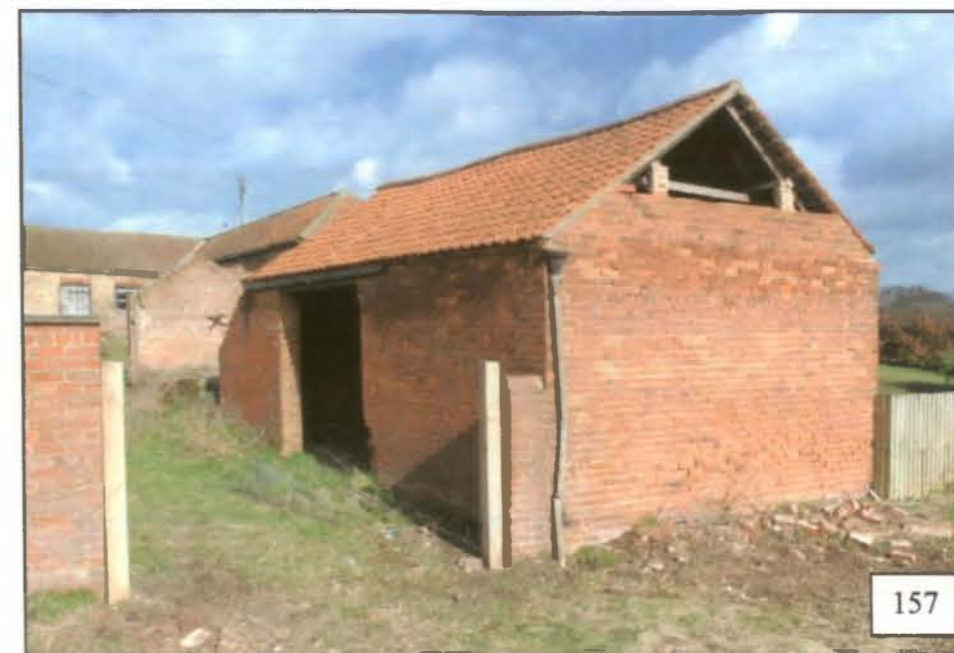
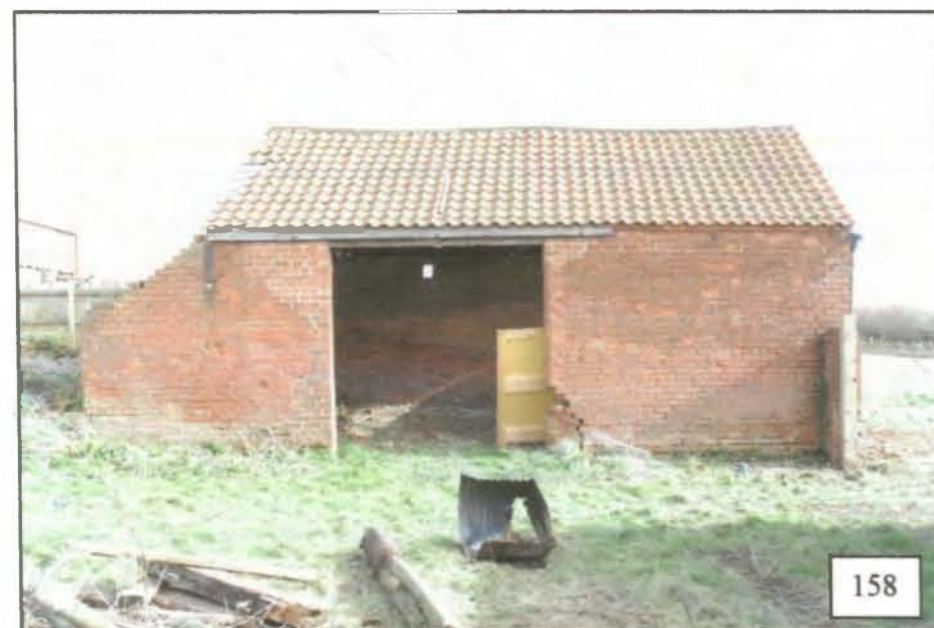
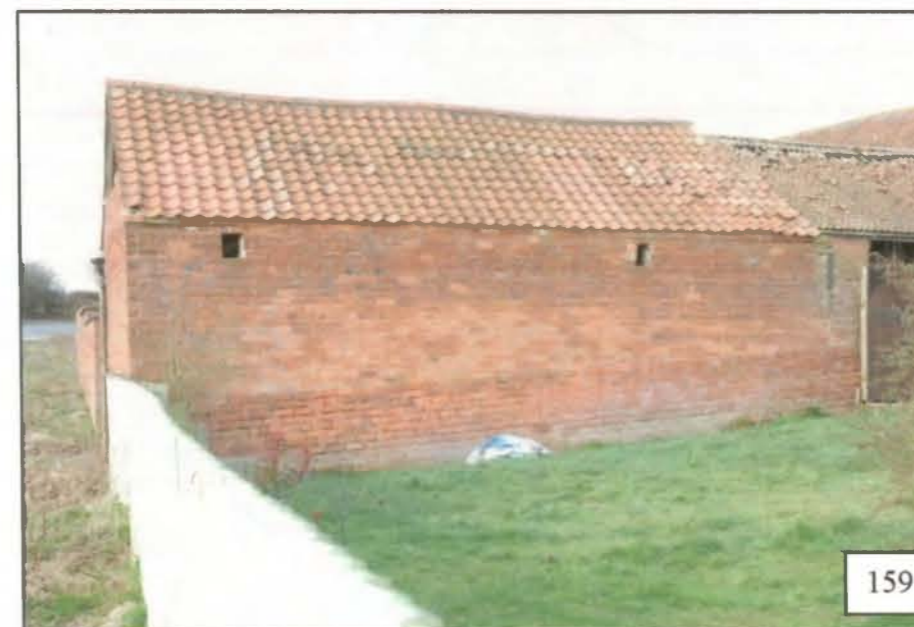
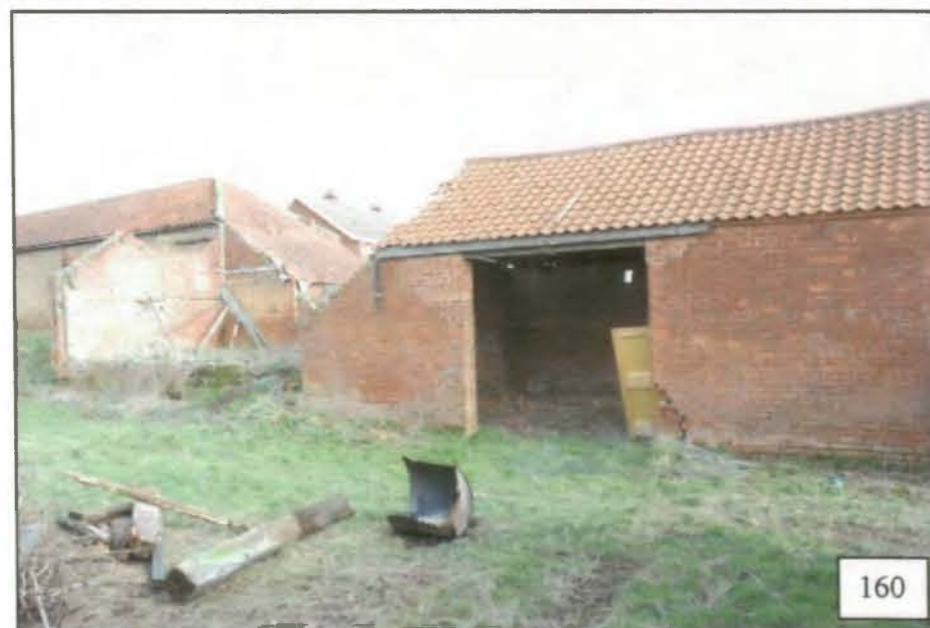
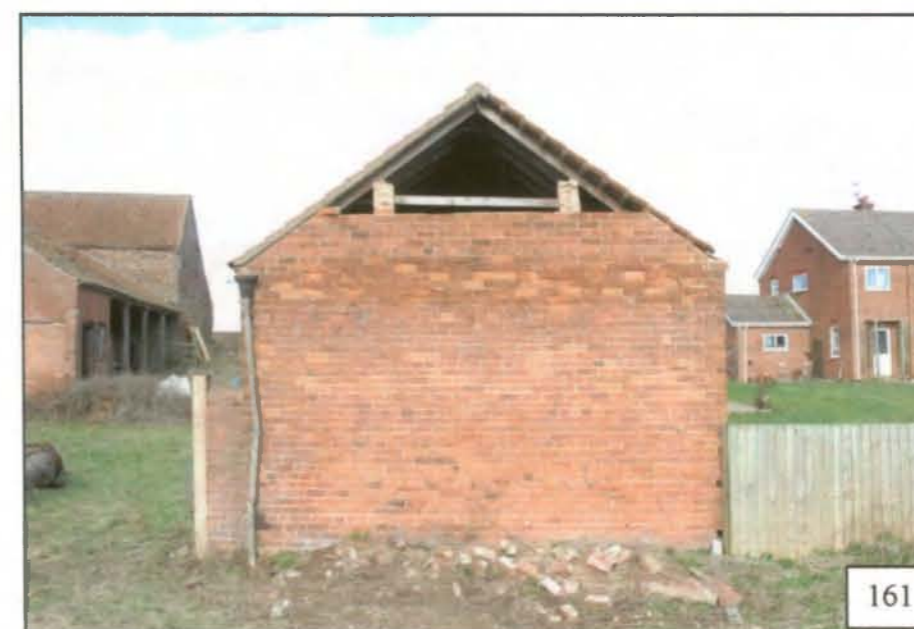
This building occupied the southeastern corner of the eastern crew yard. Like Building B, with which it was contemporary, its walls were in red brick (brick dimensions 9¼" x 4½" x 3", 3 courses=10½"), 9" thick in 5-course English Garden Wall Bond. It had a pitched pantile roof, with an eaves cornice of a single row of slightly projecting stretchers.

A large door opening was present in the west wall, which appears to have been enlarged, and two small rectangular vents were present just below the eaves in the east wall. Although the roof was intact, the brickwork at the apex of the southern gable had collapsed.

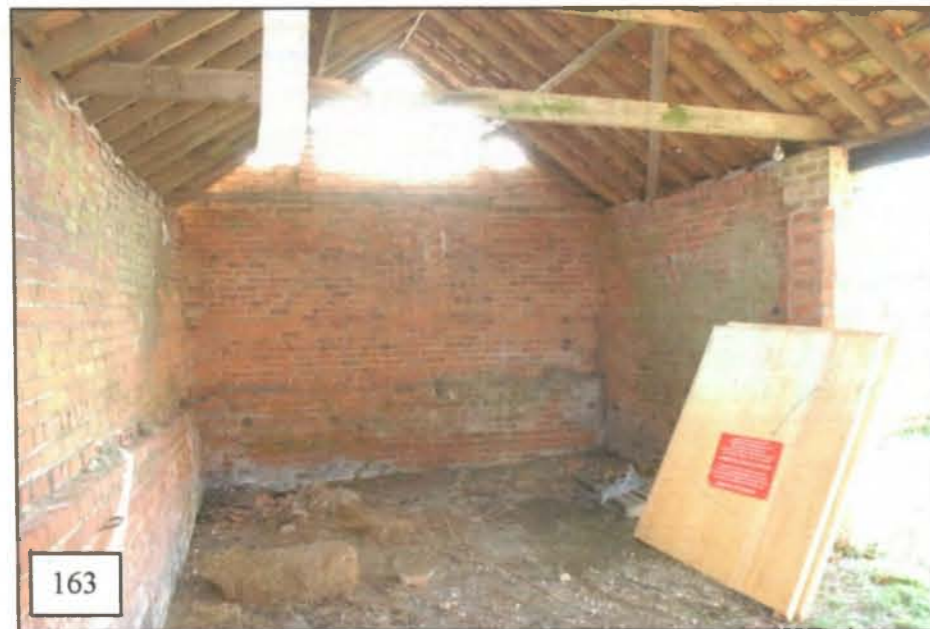
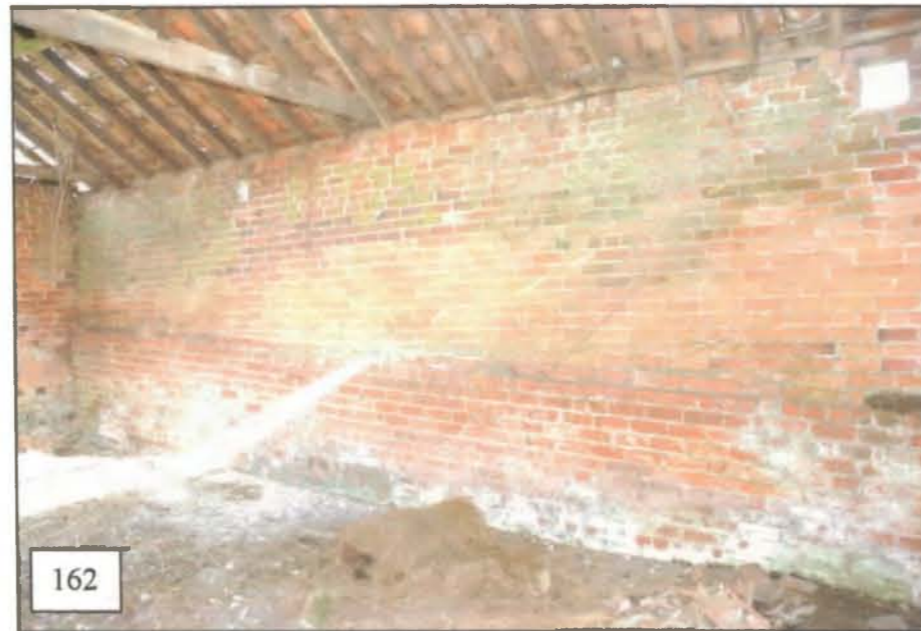
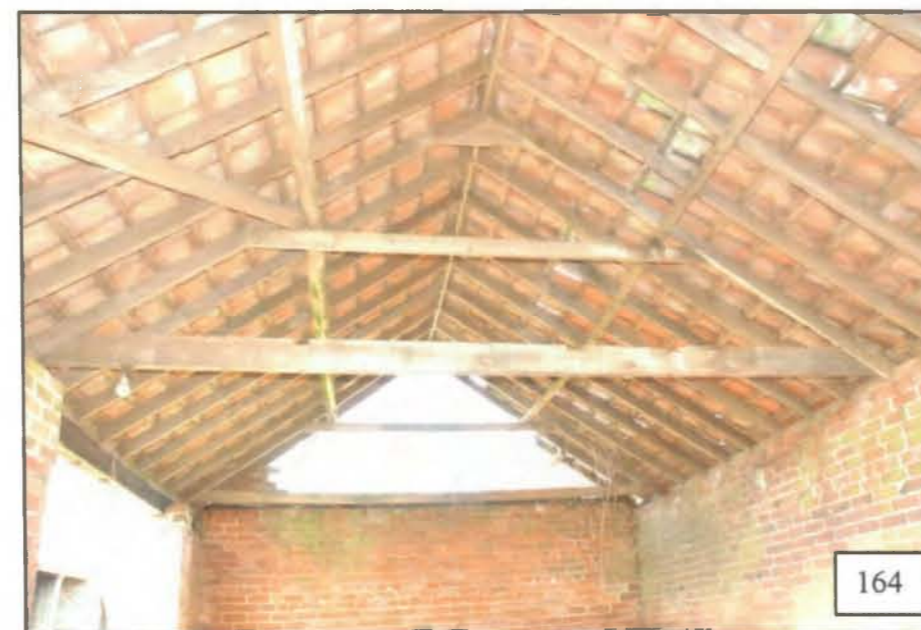
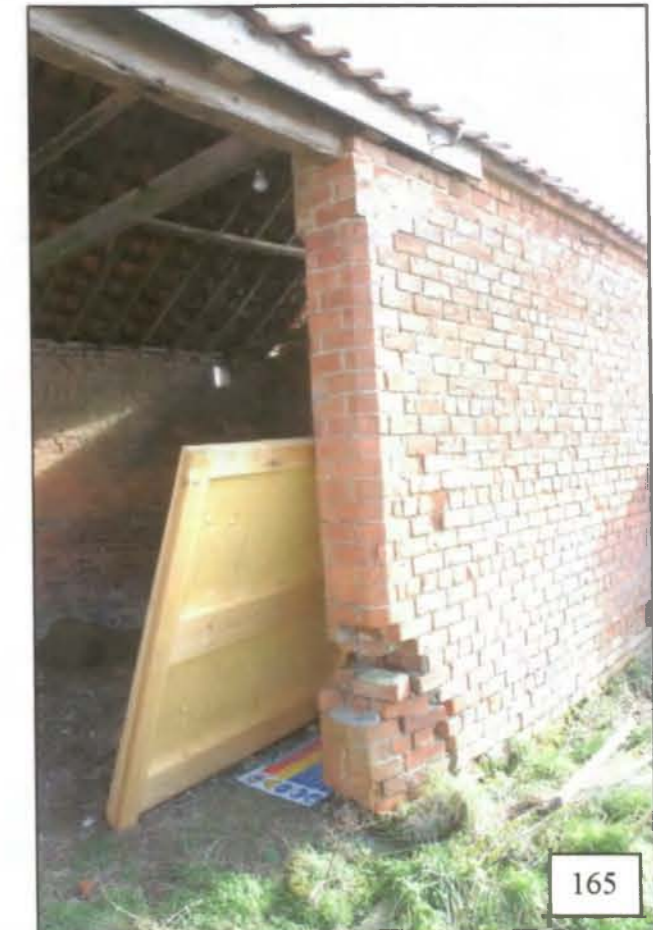
The exposed roof timbers were generally lighter than those of the other buildings on the site. The roof was of collar rafter construction with clasped through-purlins; three tie beams were present in total (c. 6-7" x 2"), positioned below the collars and ridge collars all occurring at the same pair of rafters.

The room had no windows, but two rectangular vents were present in the east wall, one course below the wall plate, c. 10" high and 9" wide.

The floor was of packed earth. The north wall appeared to be later, suggesting that Building B was constructed later. The south (gable) wall was of only 4" thickness above the wall plate, with two 9" pillars supporting the purlins –this part had partially collapsed.

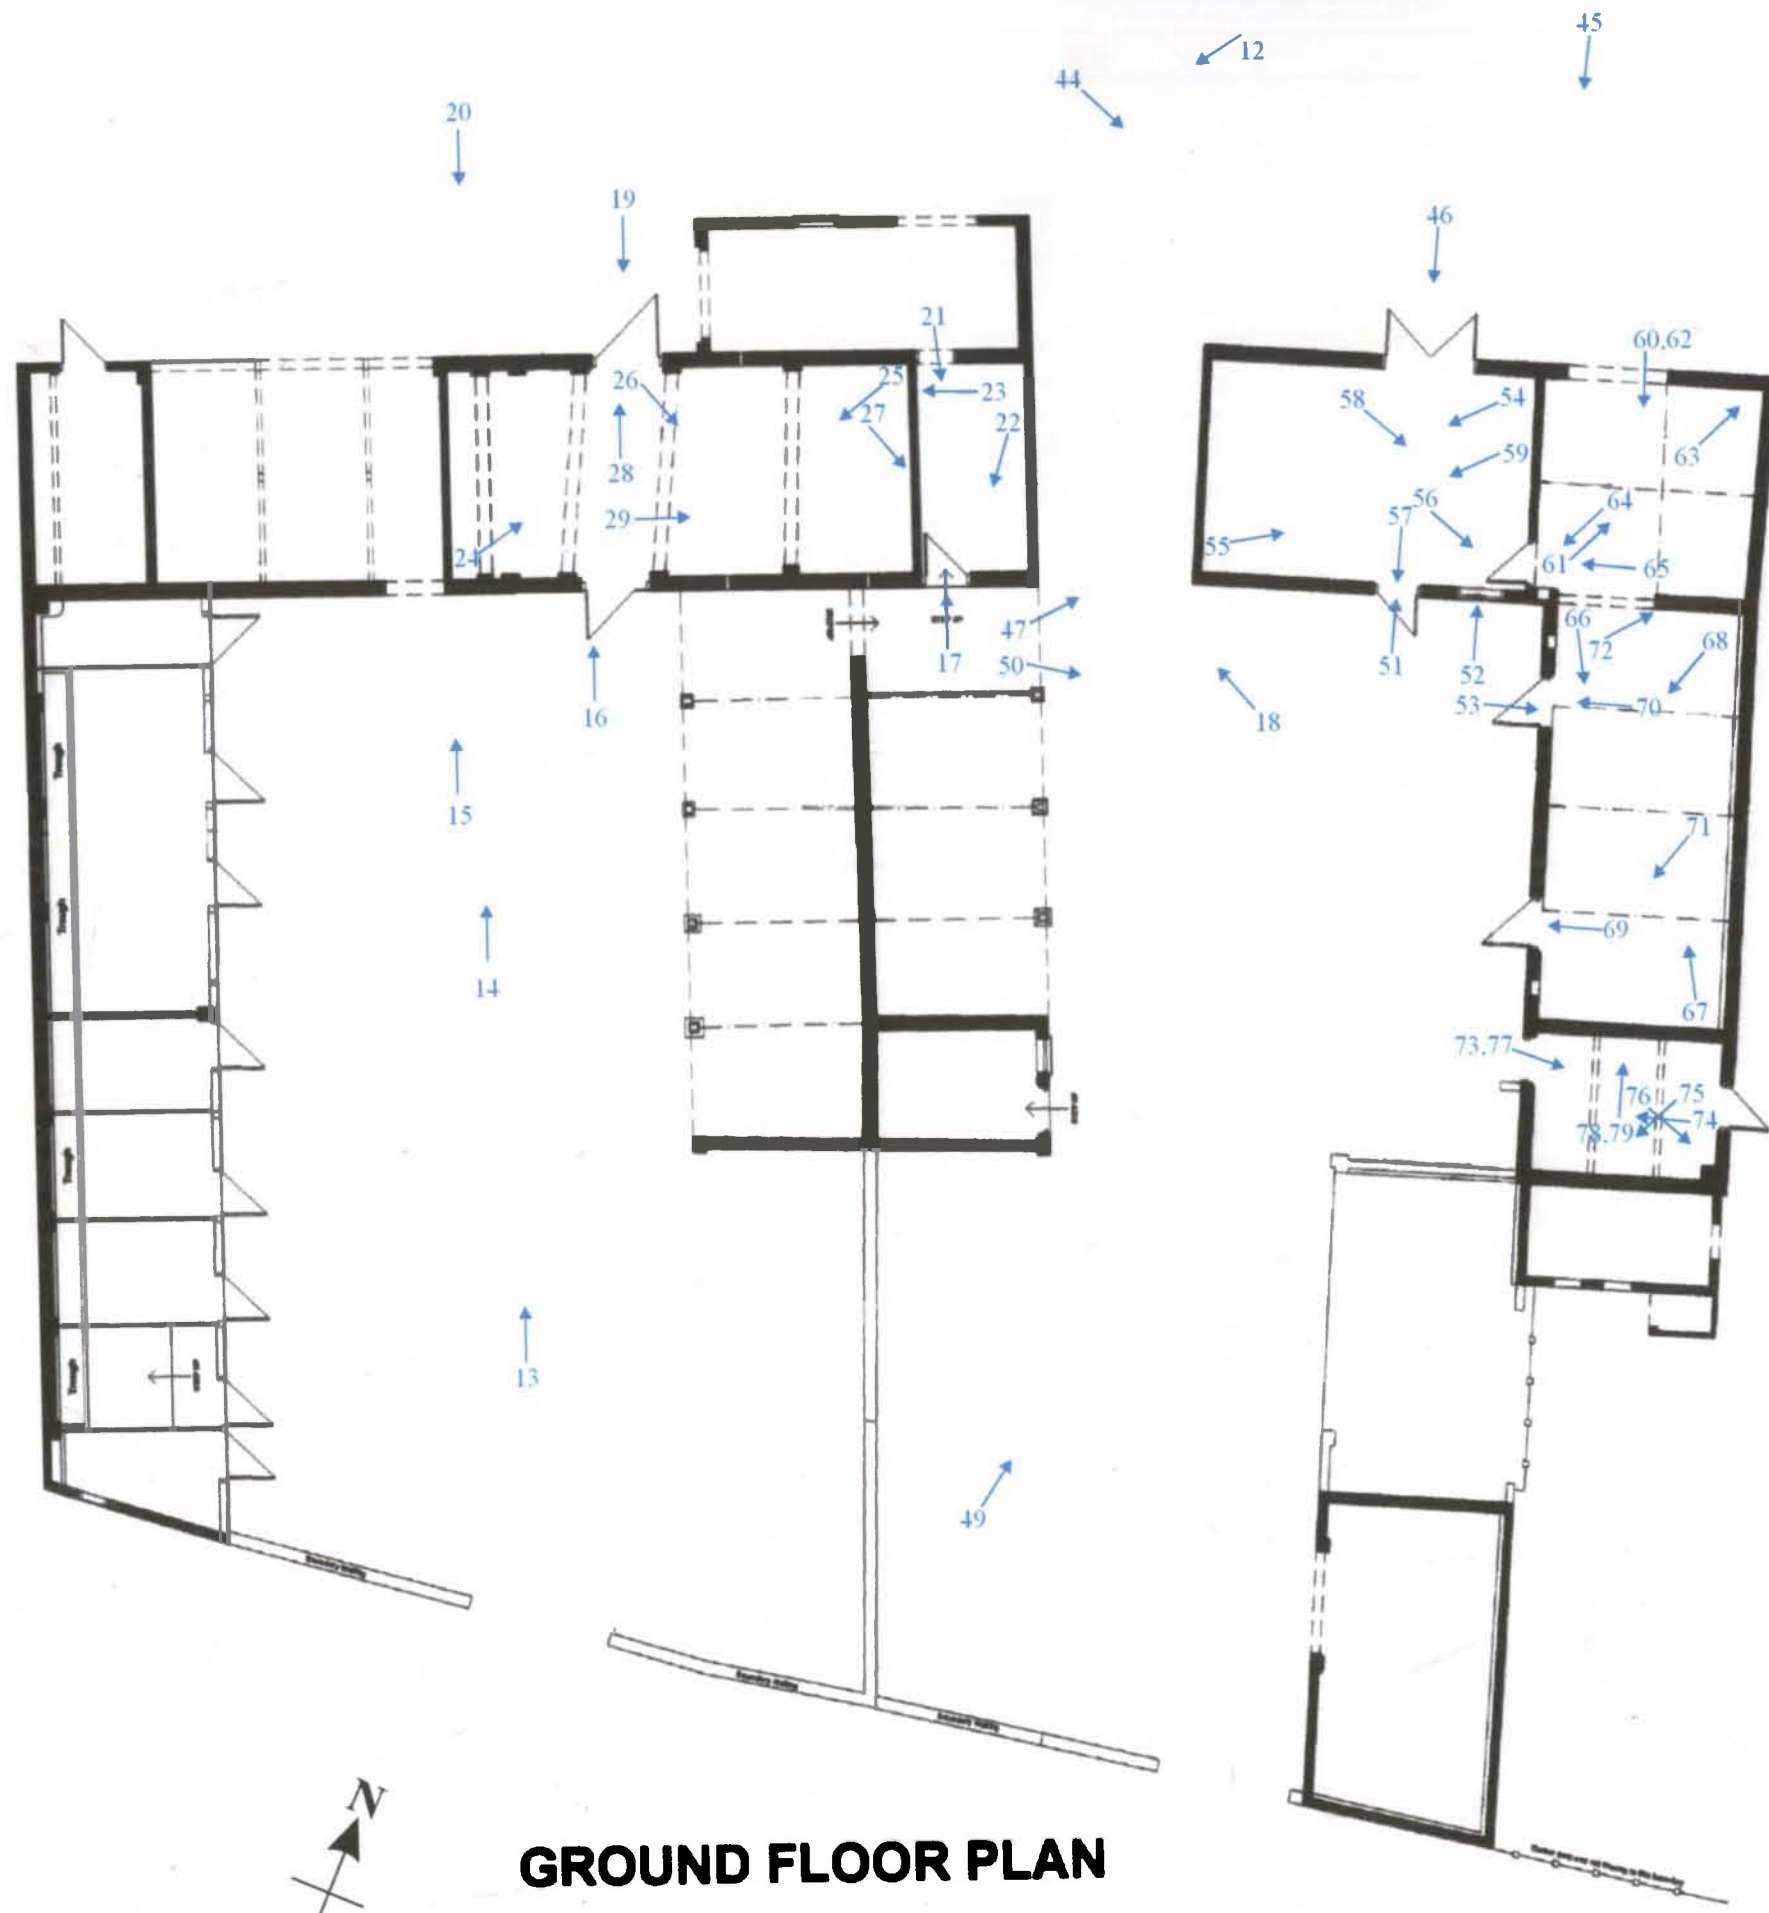
Plan showing the locations and directions of photographs in the General and Site Setting sections of the report. The buildings of Bunkers Farm are shaded; those subject to redevelopment are highlighted in red. Scale 1:1250.

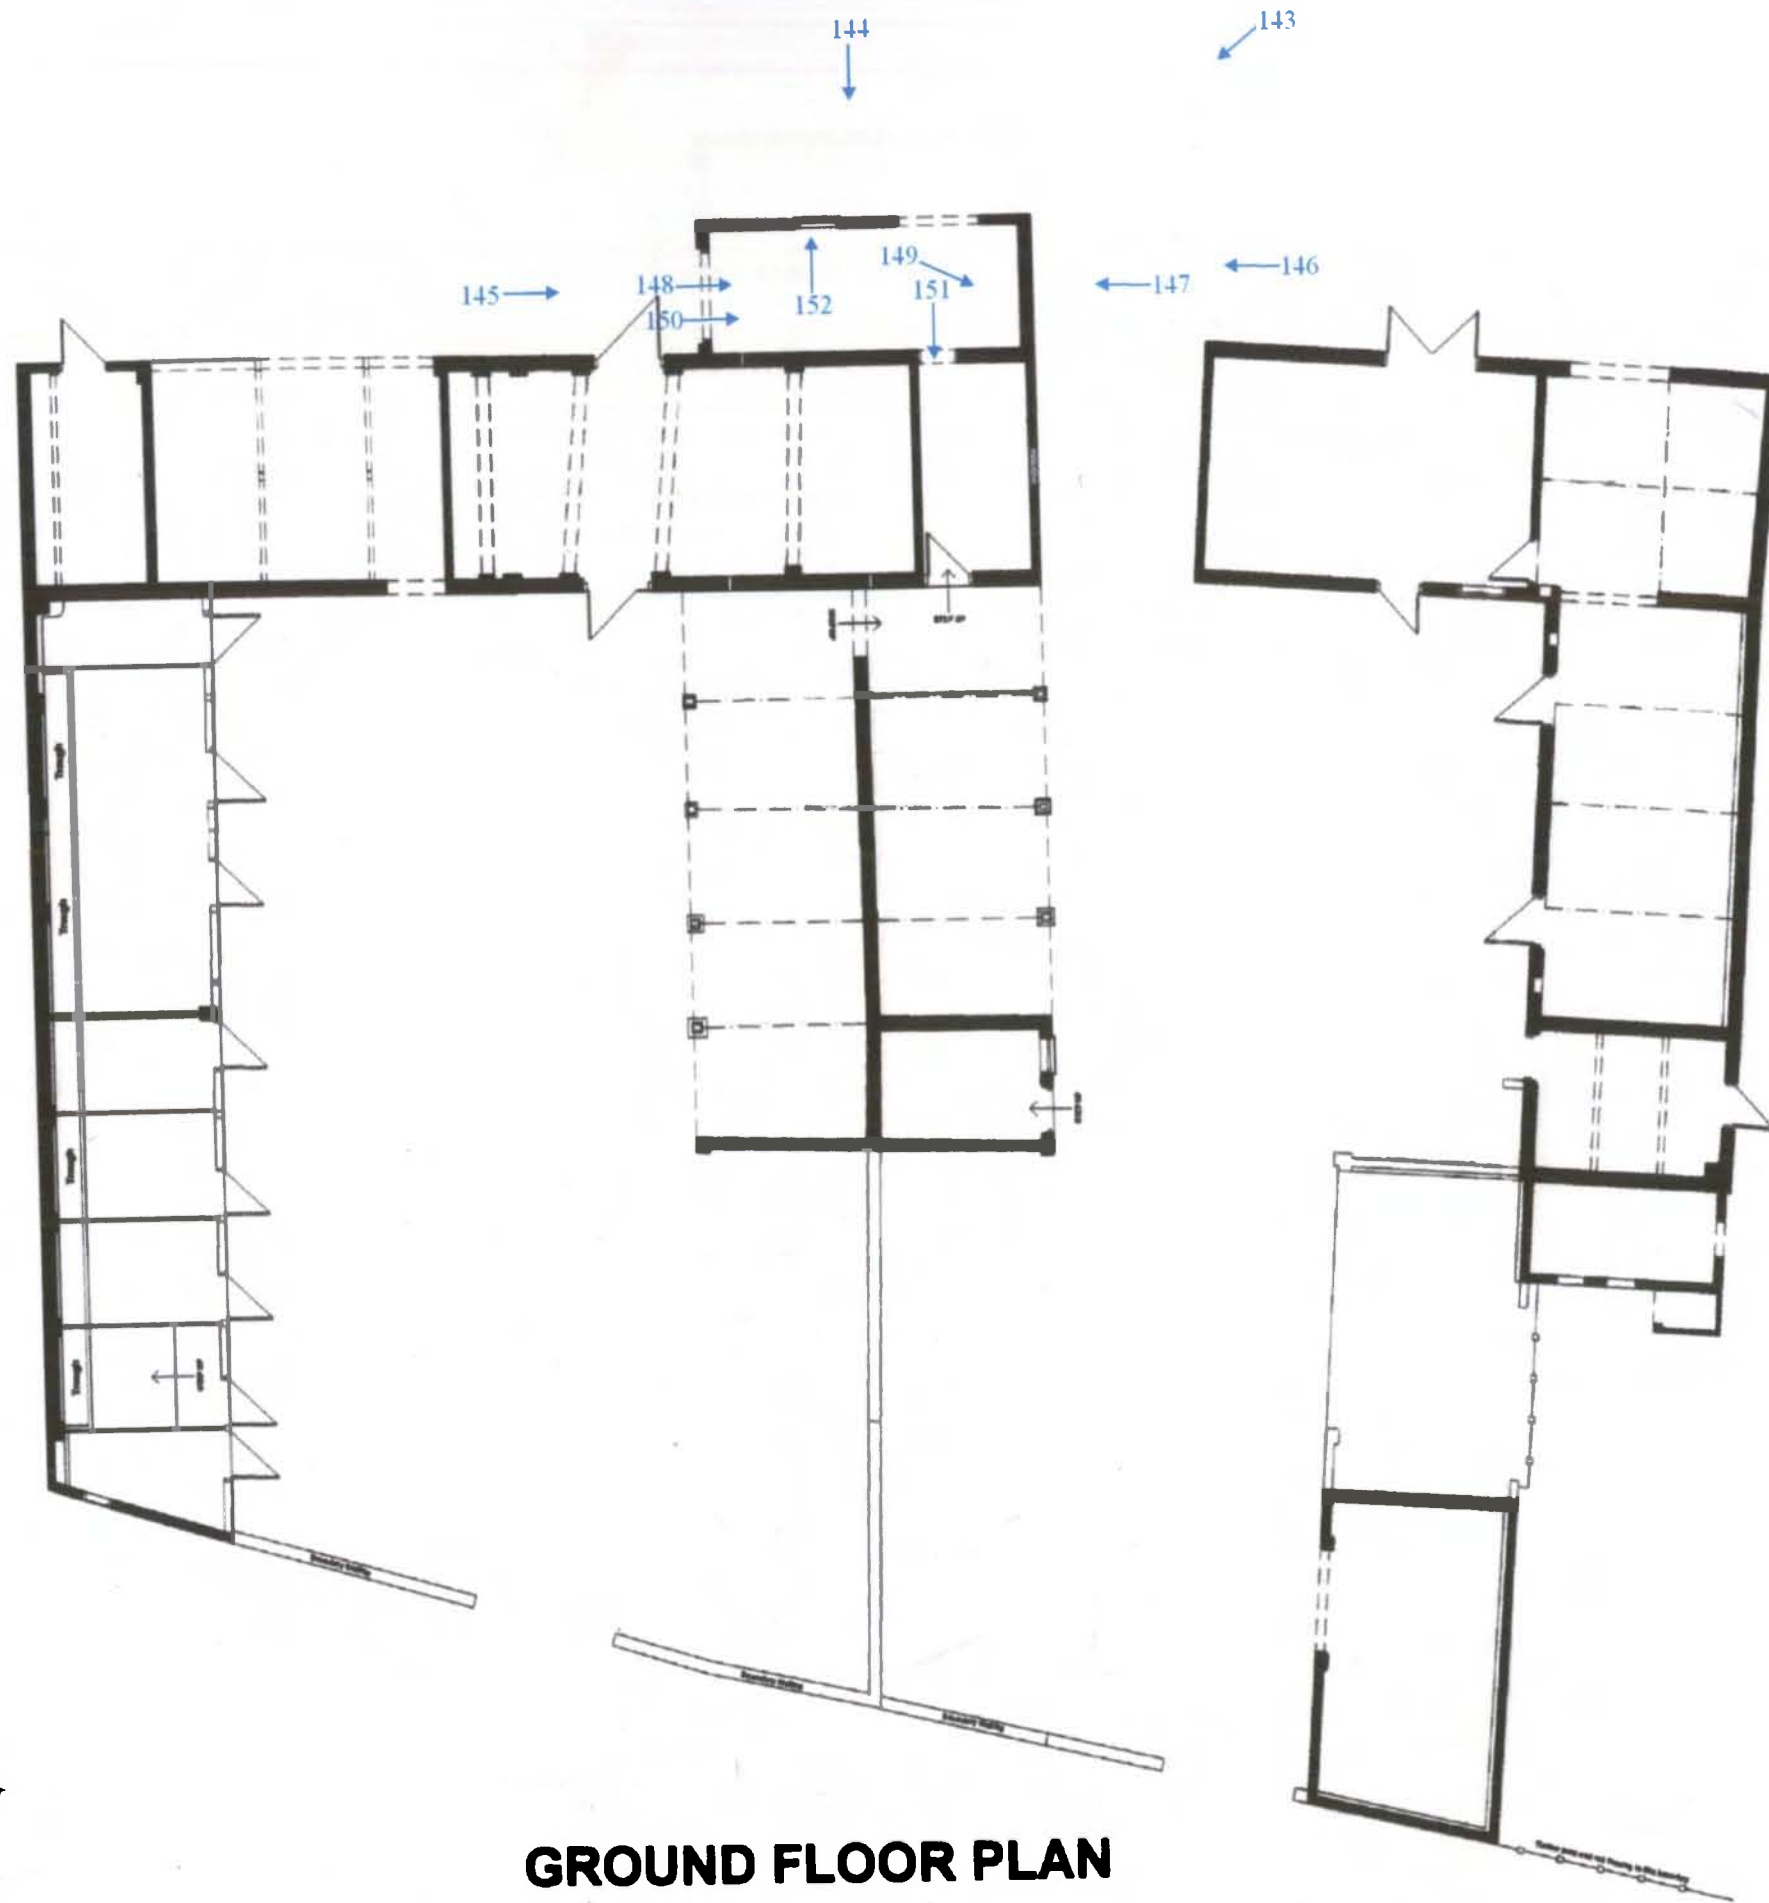
FIRST FLOOR PLAN

Plan showing the locations and directions of photographs in the Phase II section of the report. Scale 1:200.
