BUNKERS FARM, WELTON LE WOLD, LINCOLNSHIRE

PHOTOGRAPHIC BUILDING SURVEY

Site Code: BFWW 08
LCCM acc. no: 2008.91
Planning ref: N/200/03059/06
NGR: TF 2840 8696
PCA job no: 08-441

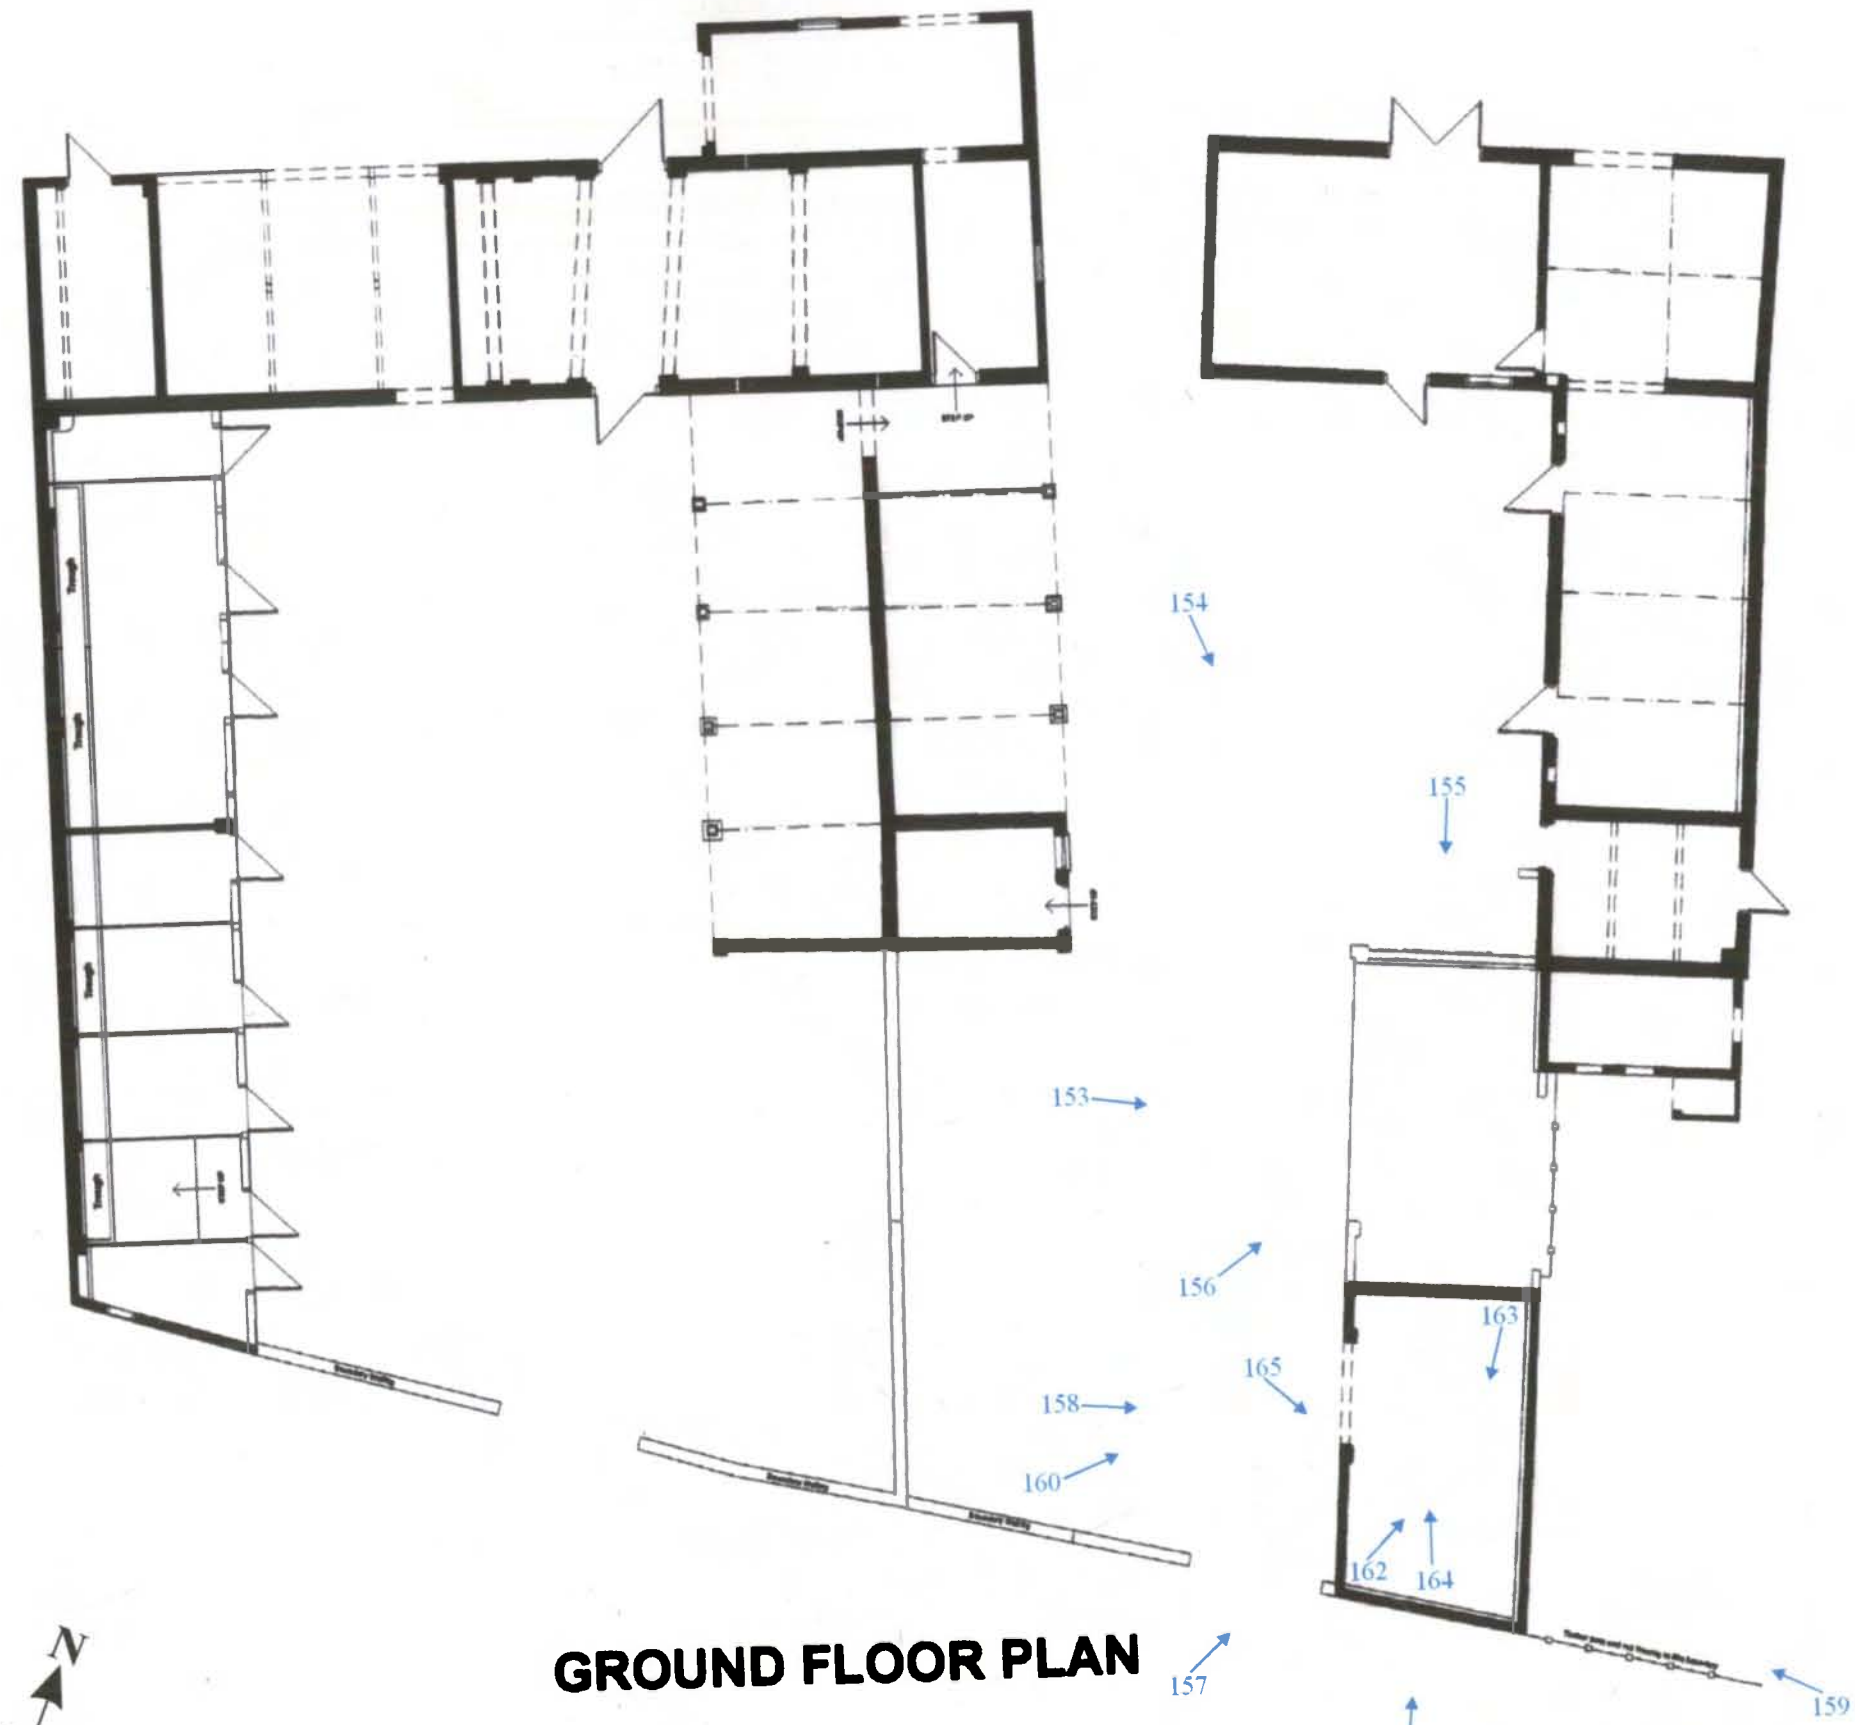
GROUND FLOOR PLAN

Plan showing the locations and directions of photographs in the Phase III section of the report. Scale 1:200.

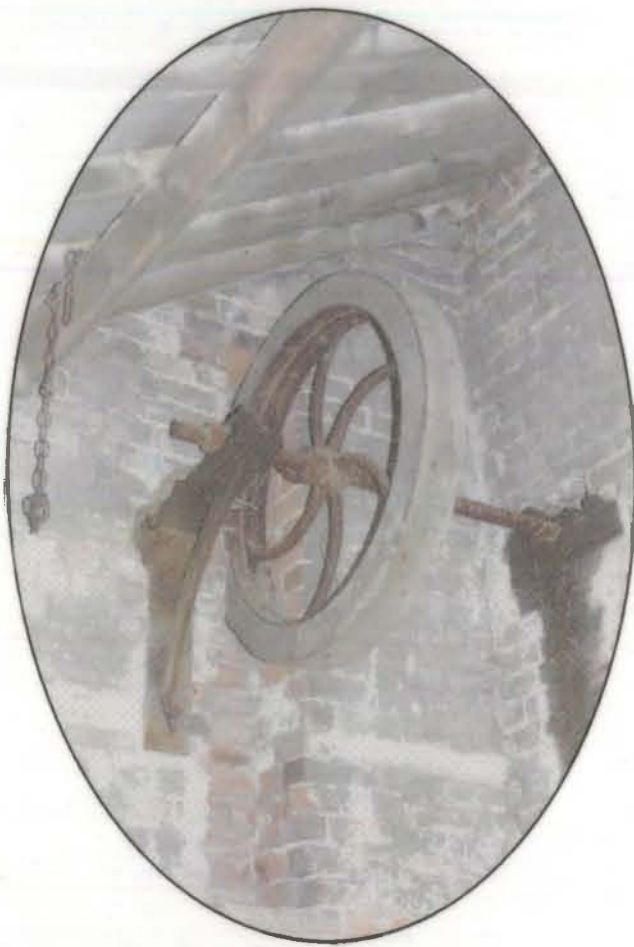
Back Cover Photograph: Pulley in Building F that transferred power from a steam engine via a belt-drive, looking southeast.

The room showed traces of belt-driven agricultural machinery: there were electric boxes on the east wall, and high up on the same wall was the pulley for a belt-drive. This had curved spokes and a timber rim, and was mounted on a cast-iron bracket, in a slot in the wall, now bricked up on the exterior. The tie beams were worn thinner on their undersides in the line that the belt would have taken from this pulley.
