# GRANGE FARM, WEST TORRINGTON, LINCOLNSHIRE

## PHOTOGRAPHIC BUILDING SURVEY

Site Code: GFWT 08  
LCM acc. no.: 2008.68  
Planning refs.: S/205/00678/08  
NGR: TF 1430 8132  
PCA job no.: 08-457

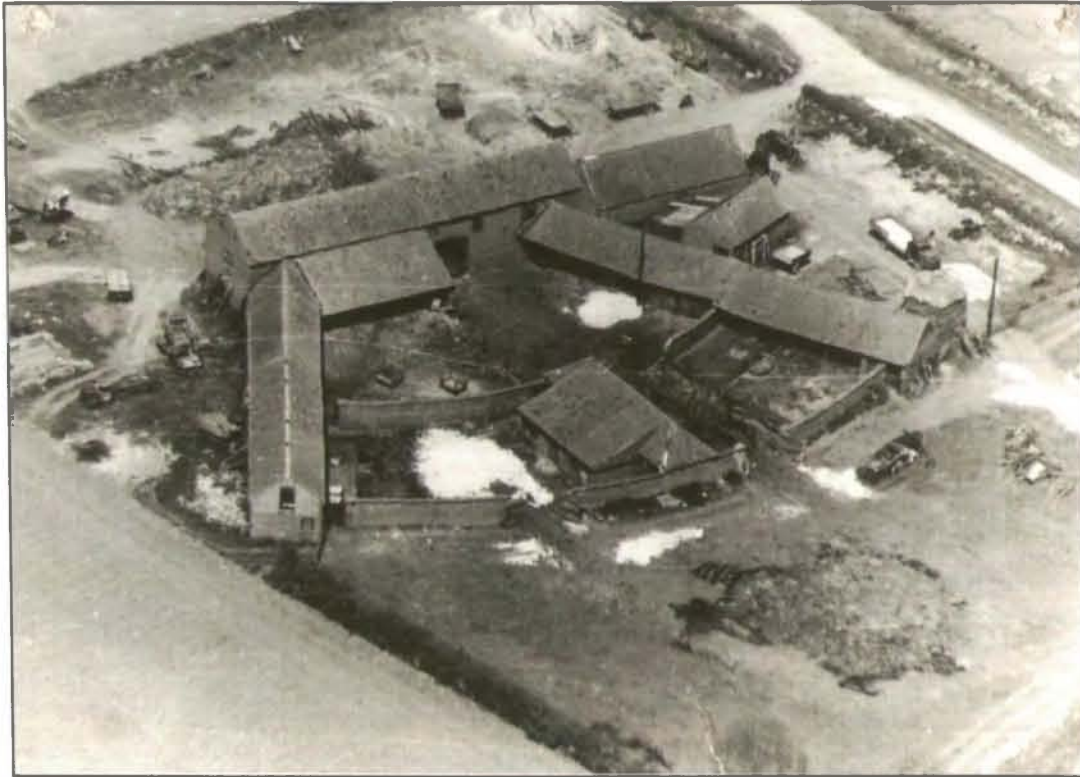
**Fig. 6a:** Aerial photograph taken of Grange Farm in the early to mid 1950s (Mary Hoban, *pers. Comm.*). At this time the barn/granary had its original pantile roof. A building is present on the eastern side of the east range, which is no longer extant on the site.  
(Reproduced by kind permission of Mrs Mary Hoban)

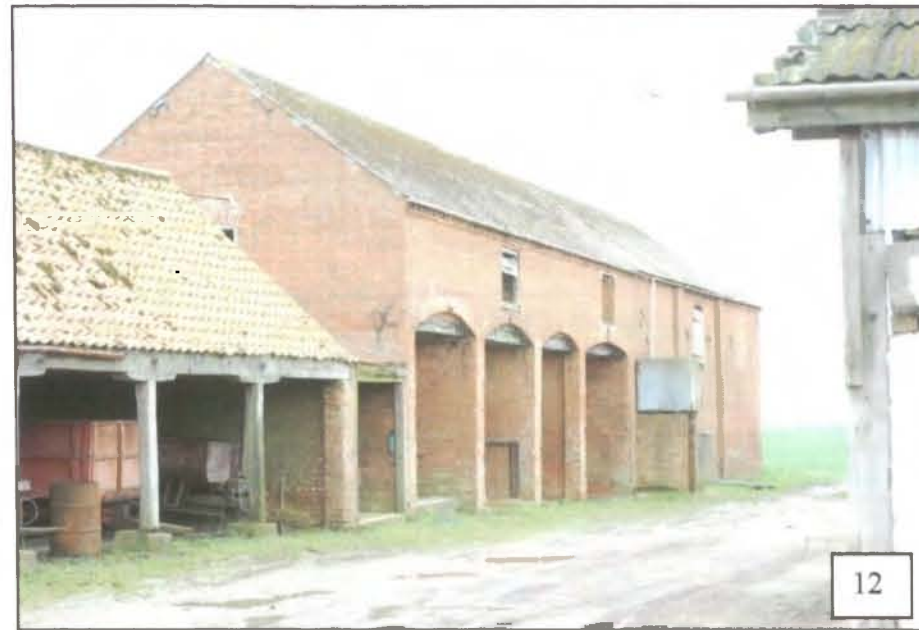
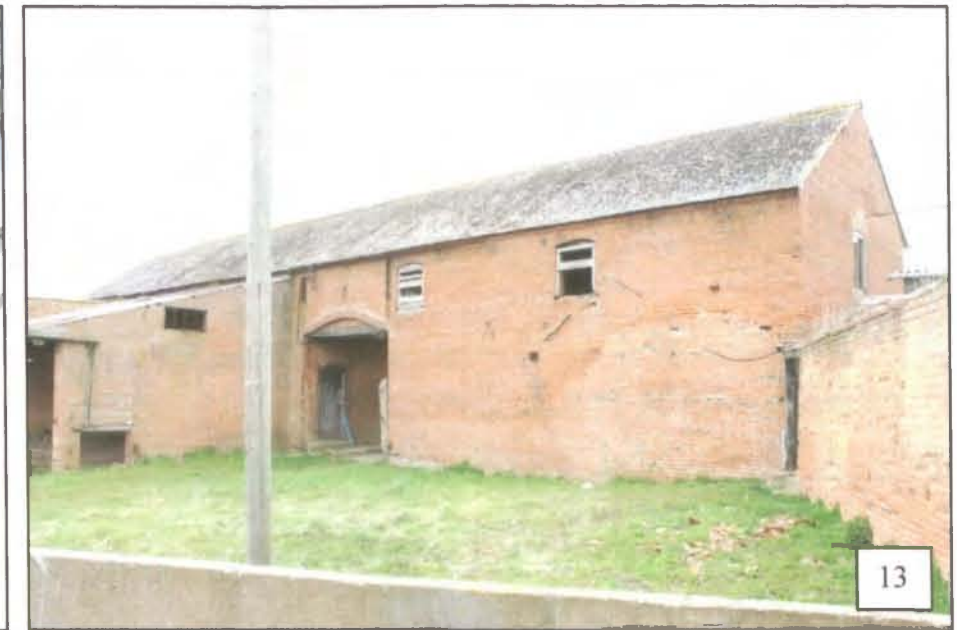
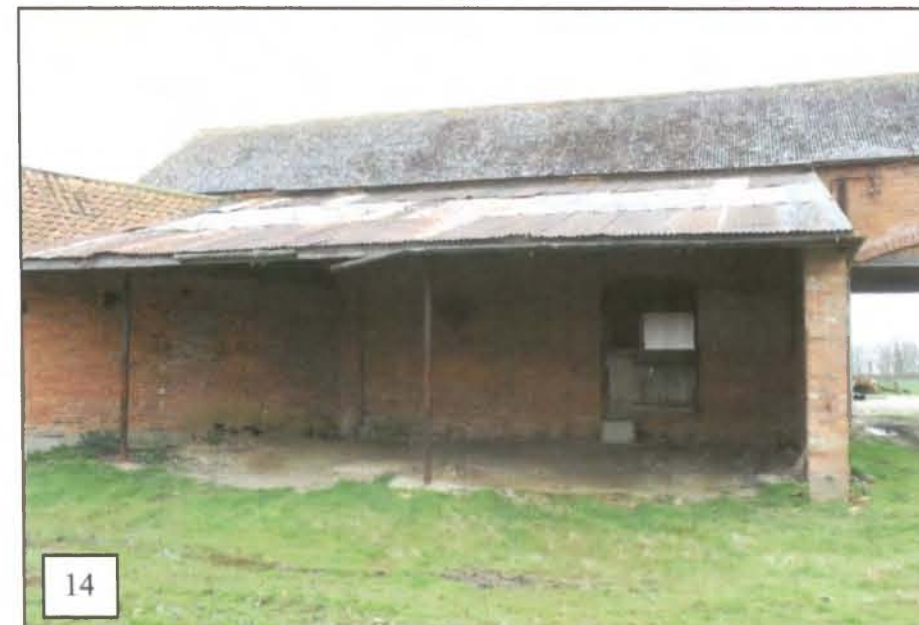
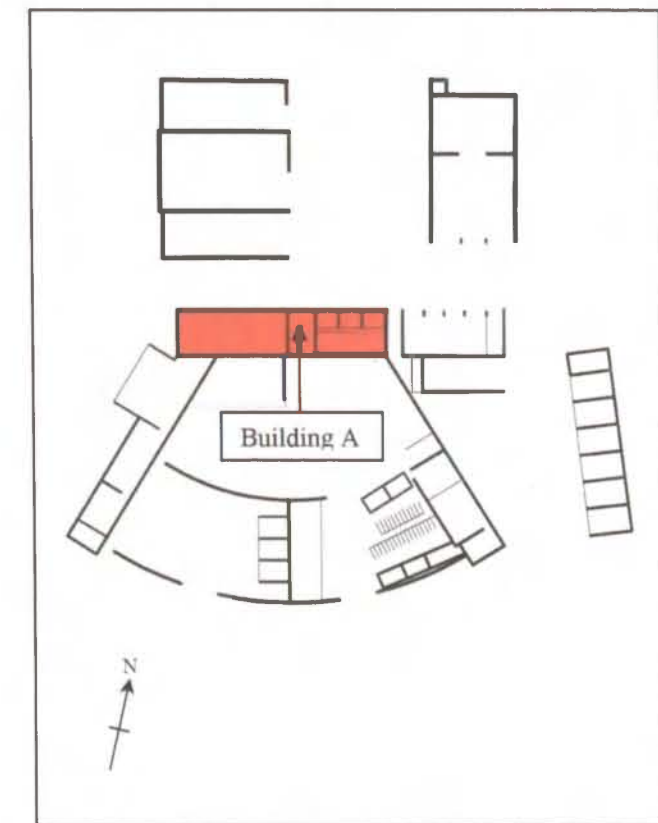
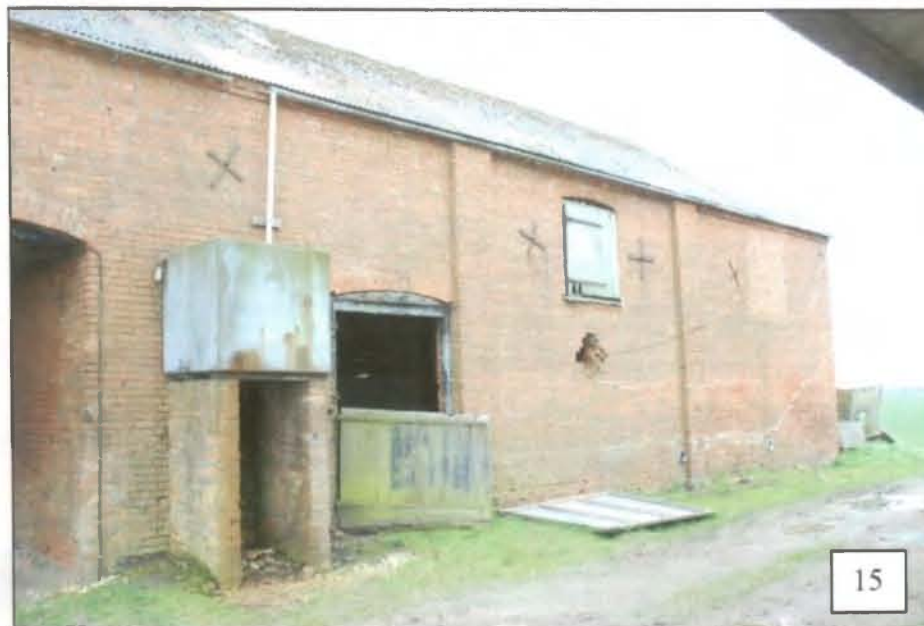
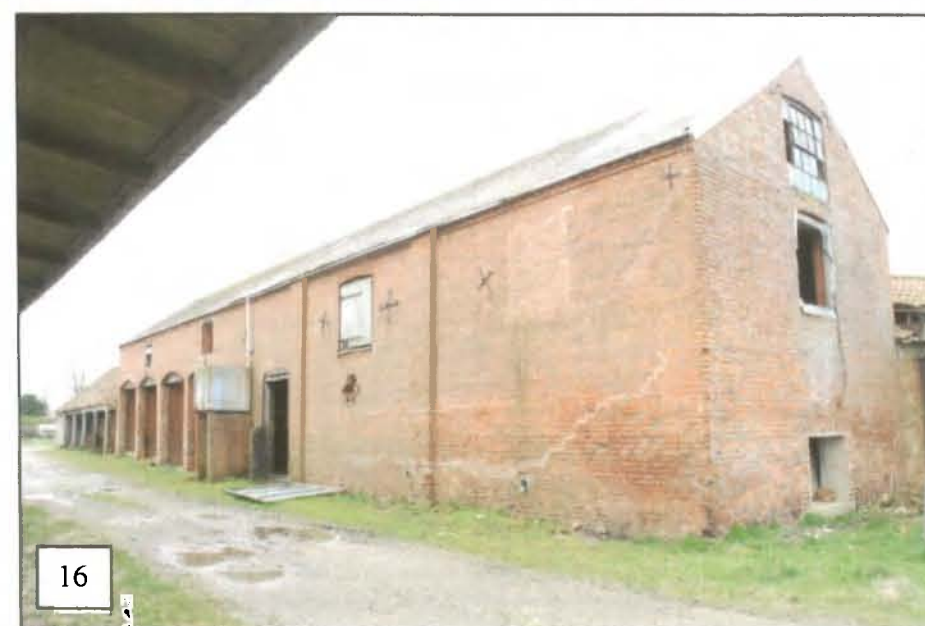
This building formed the north range of the farm: it is the only two-storey structure, and in Phase I functioned as a threshing barn and cart shed, with a granary above. Later extensive alterations have masked much of its original internal arrangement, and few original fixtures and fittings survive.

The threshing barn, with a granary/hayloft above, occupied the western part of the structure. It had only a large door at ground floor level, and two large openings at first floor level, one of which has been bricked up, while the west elevation had a similarly sized window opening on the first floor.

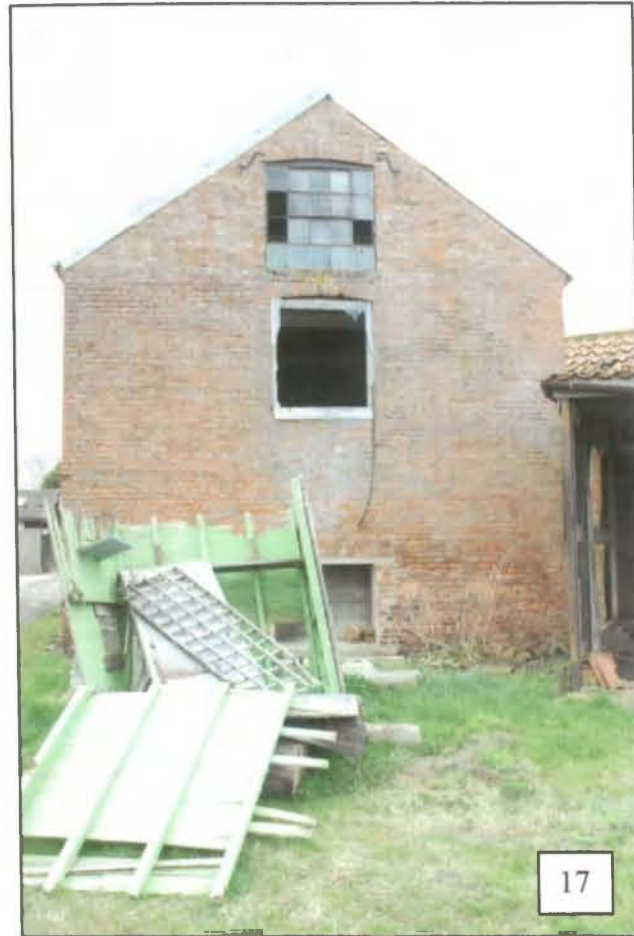
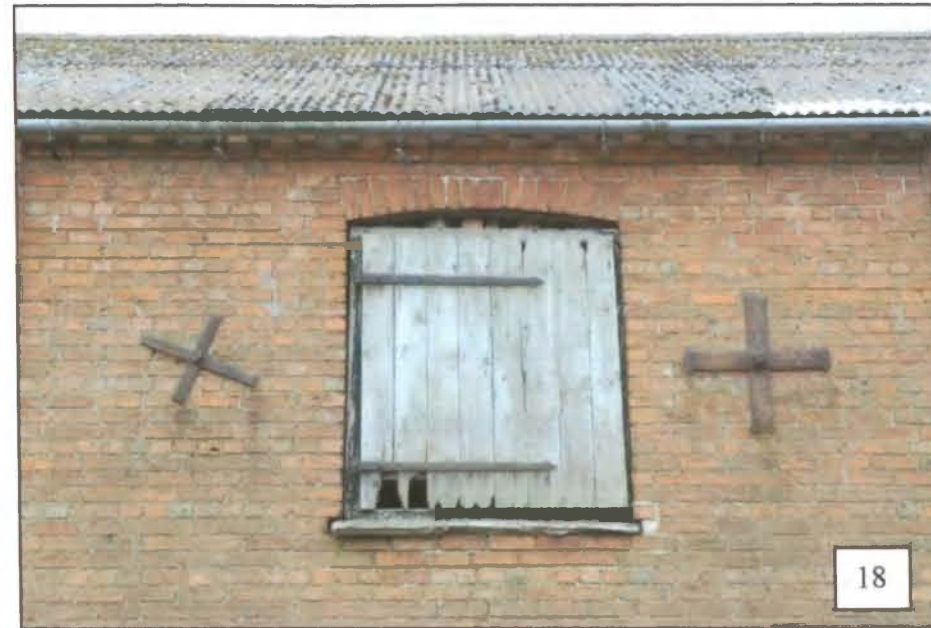
The western part of Building A does retain some original features: on the north side, the large stable-type door at ground level is of ledged and diagonally braced beaded plank construction, with long strap hinges. The first-floor ledged and diagonally braced plank loading door is in an original position, but may itself be a replacement.

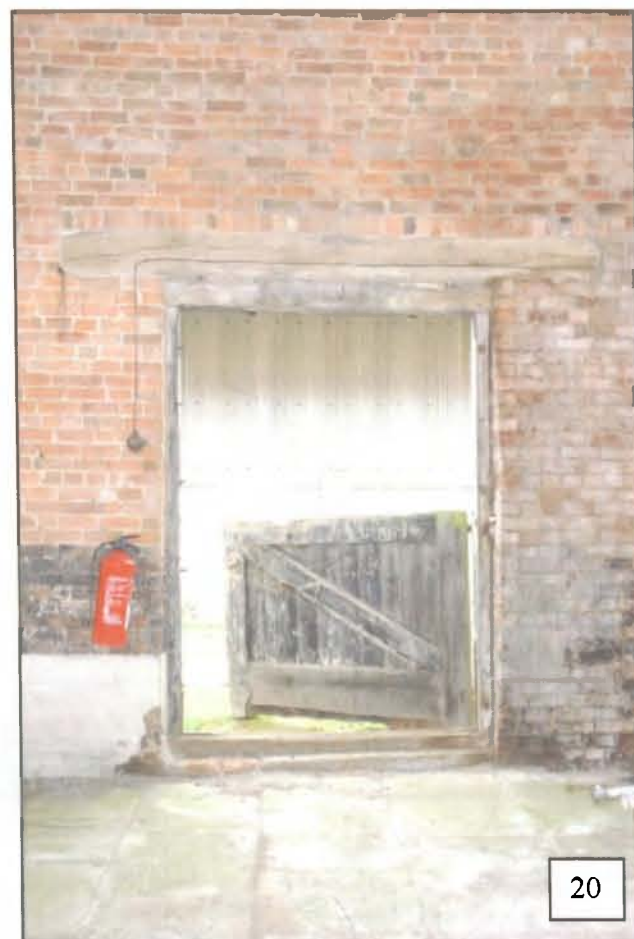
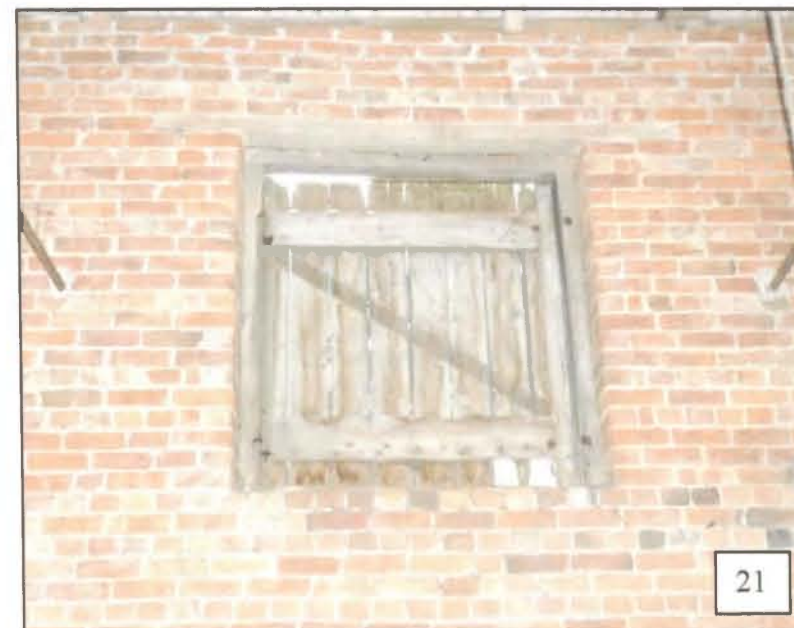
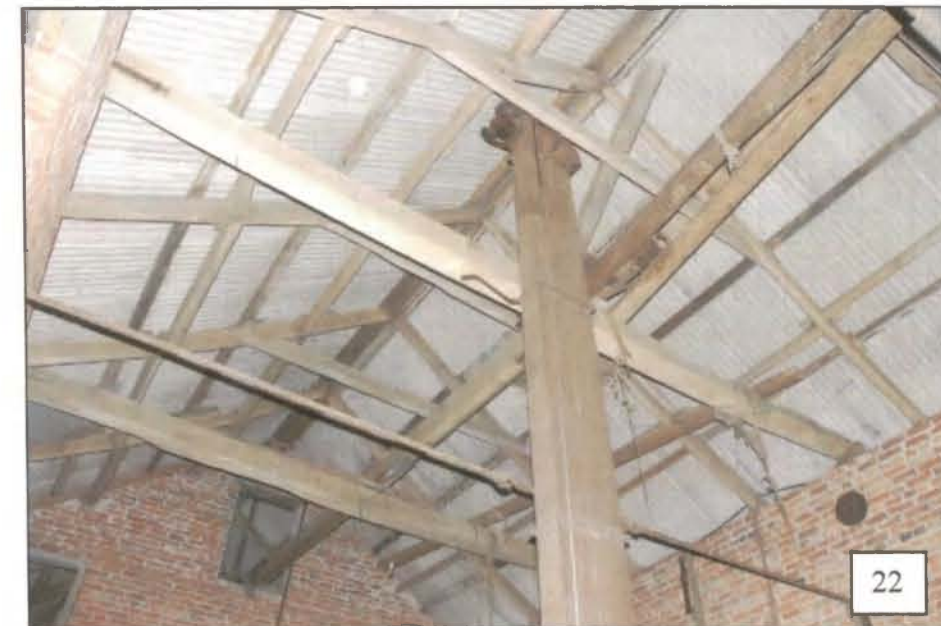
The roof, although now reclad in corrugated asbestos cement panels, retains the heavy timbers of its original construction. It is of collar rafter construction with chamfered collars, a ridgeboard and staggered butt-purlins, their pegged tenons projecting through the rafters. In the western part, which has lost the stiffening effect of its first floor, four three-part iron tie-rods span the structure, centrally suspended from the nearest tie-beam or collar.

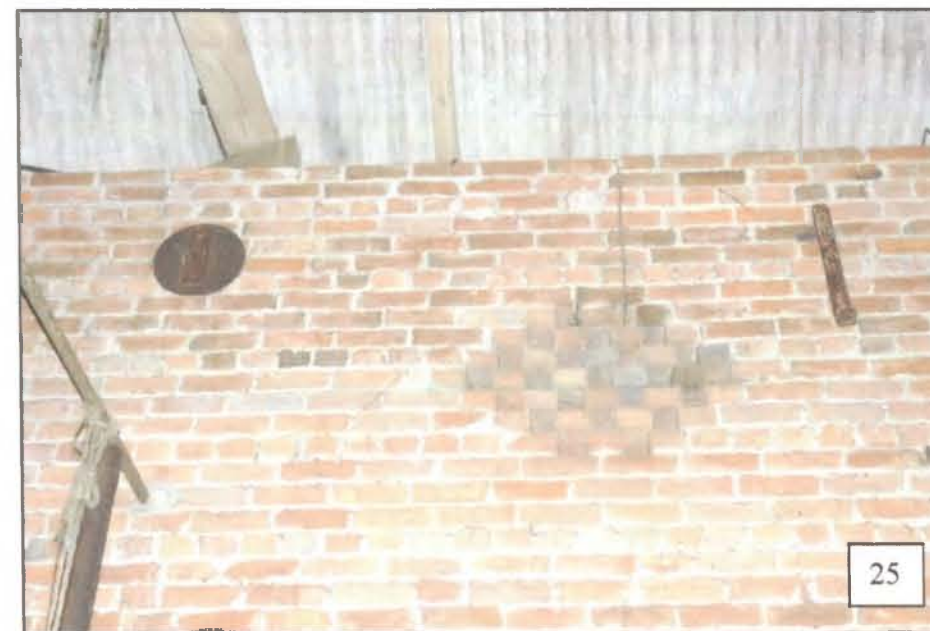
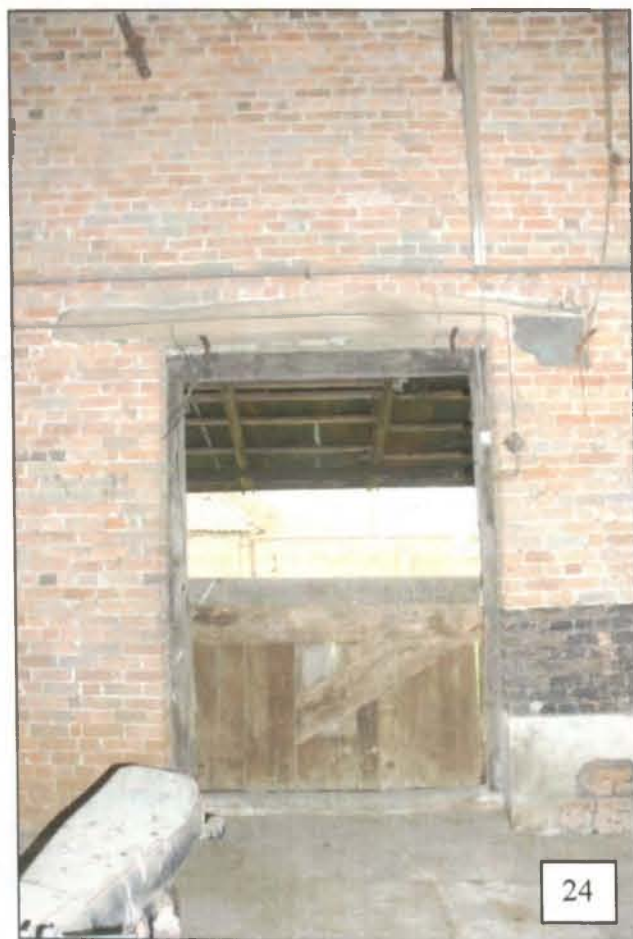
Directly opposite the ground floor doorway in the north wall, a similar door was present on the south side. This comprised a pair of ledged and diagonally braced plank stable-type doors, which originally gave access to the northern crewyard.

On the south side a diamond pattern brick ventilator was also present: this was centrally placed at first floor level.

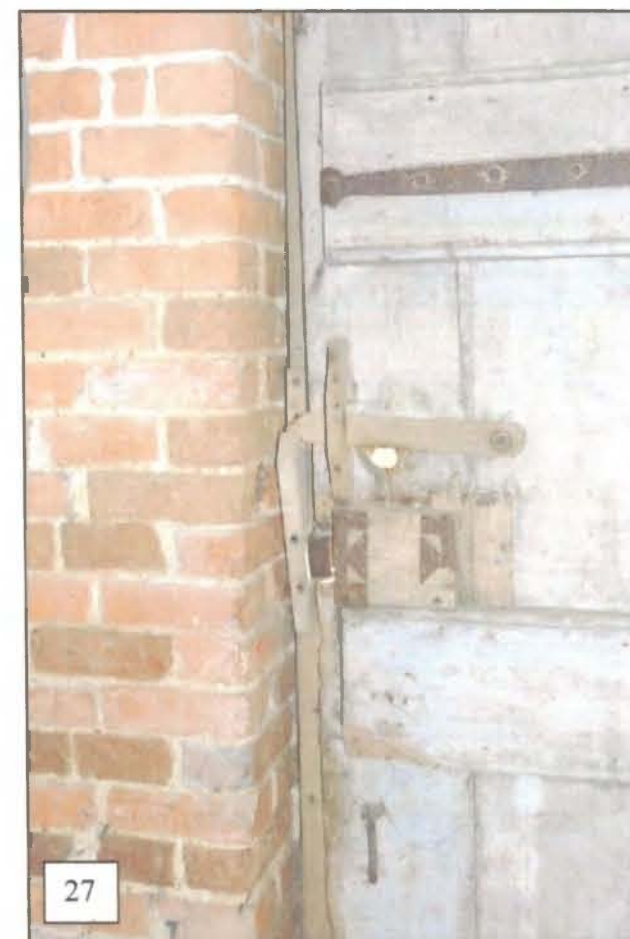
At the eastern side of the barn, a smaller doorway gave access to the through-passage from the stackyard to the crewyards. This door was of ledged beaded plank construction, with long strap-hinges and a wooden latch and lock.

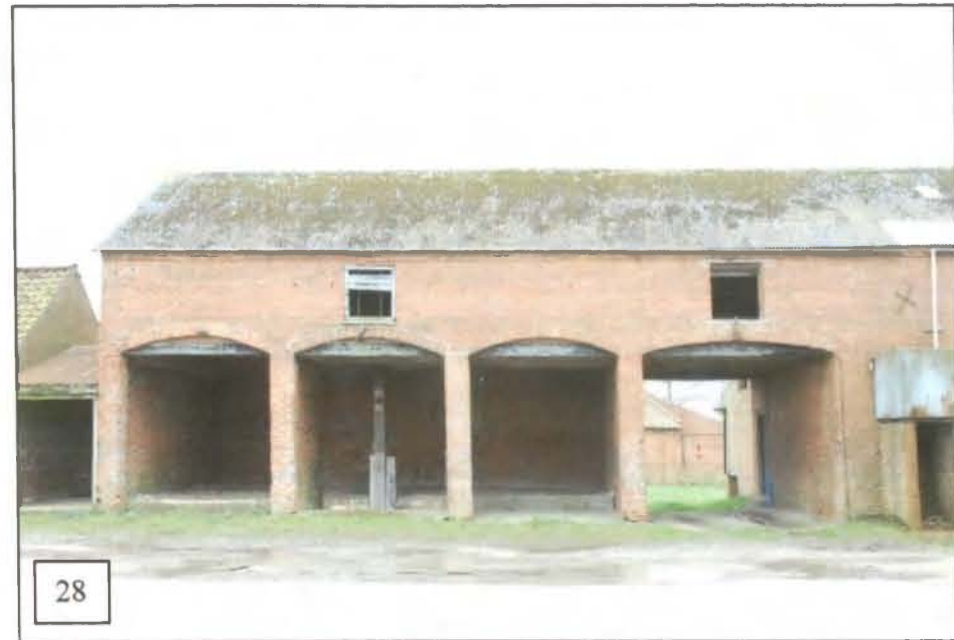
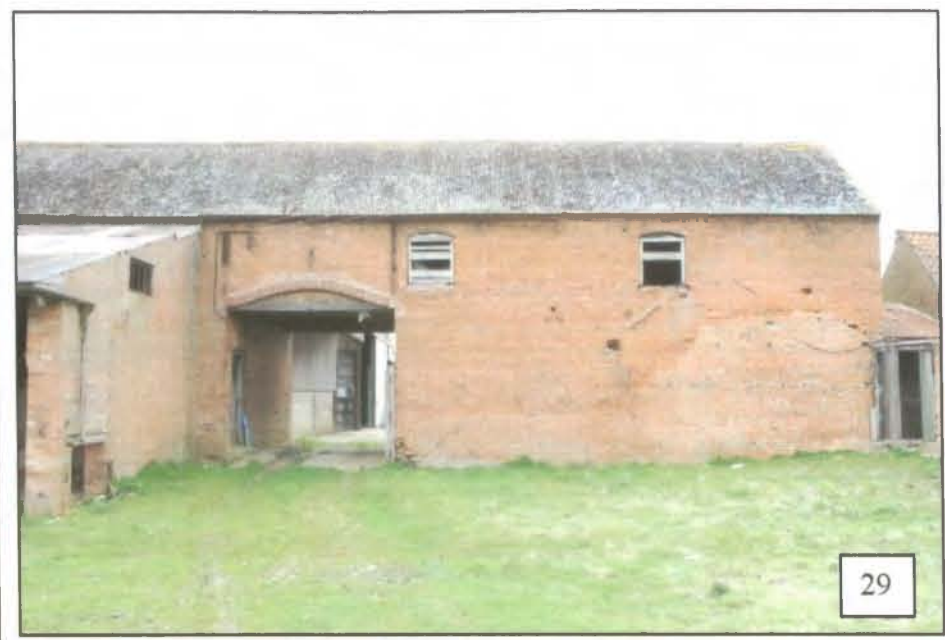
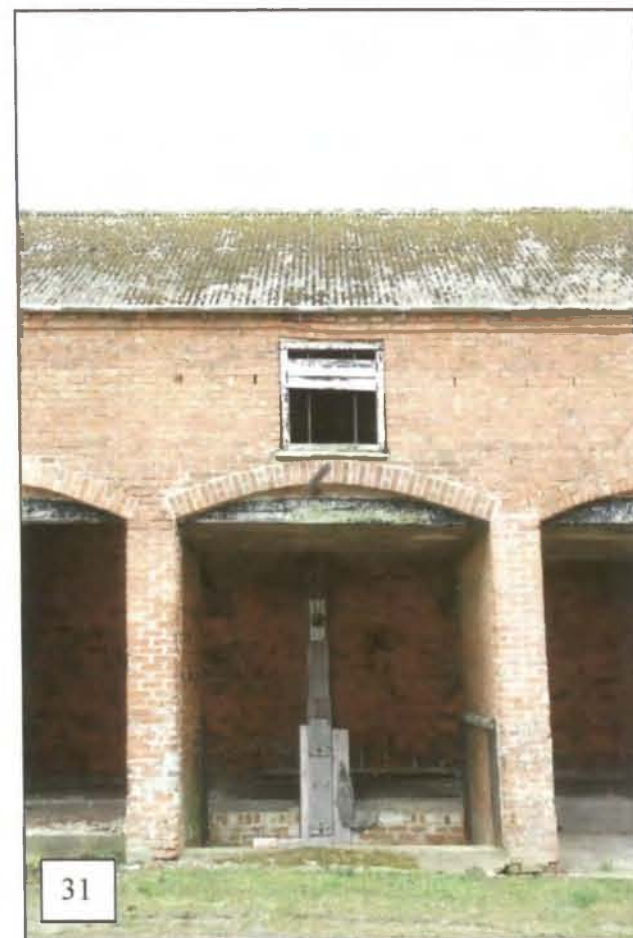
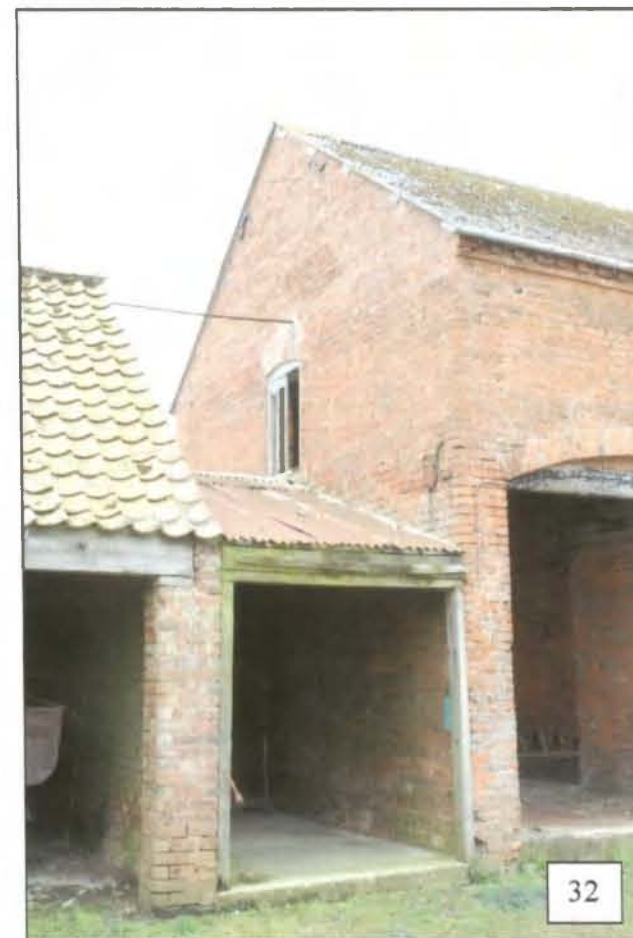
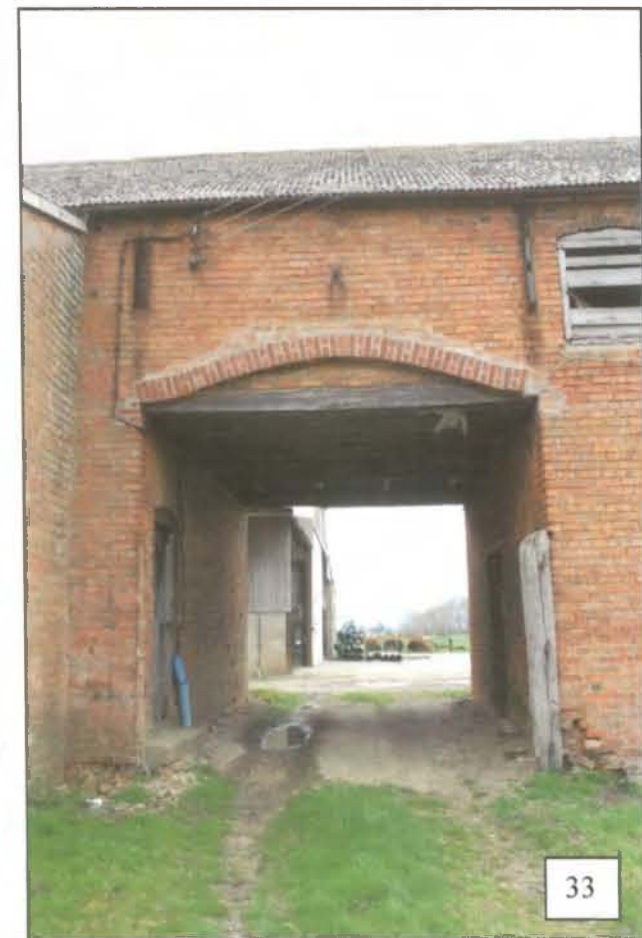
The eastern part of Building A was built as a 3-bay cartshed, with a granary on the first floor. To the west of these bays, but centrally placed in the building, a wider shallow-arched opening gave access to the yards.

The north elevation is dominated by these openings, and has two smaller windows at first floor level. The south elevation is blind at ground floor level, although it retains the scars of building E, which has now disappeared. This side too has two windows at first floor level, while a further window, present in the east gable wall, is in a partially bricked up larger opening, suggesting that there was originally a hayloft door here.

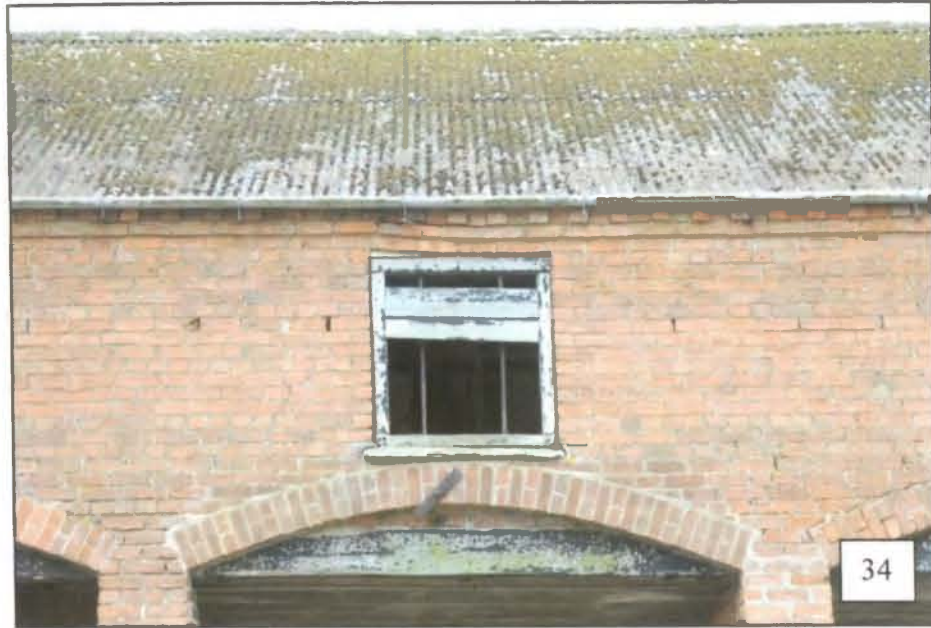
A joint in the brickwork can be seen running diagonally up the wall to the west of the arched through-passage opening, the header courses of the EGW bond are not continuous across this joint. Rather than being indicative of a change in the phase of construction, this joint attests to the brickwork of the western part of the structure being finished before the eastern (cartshed) brickwork was completed.

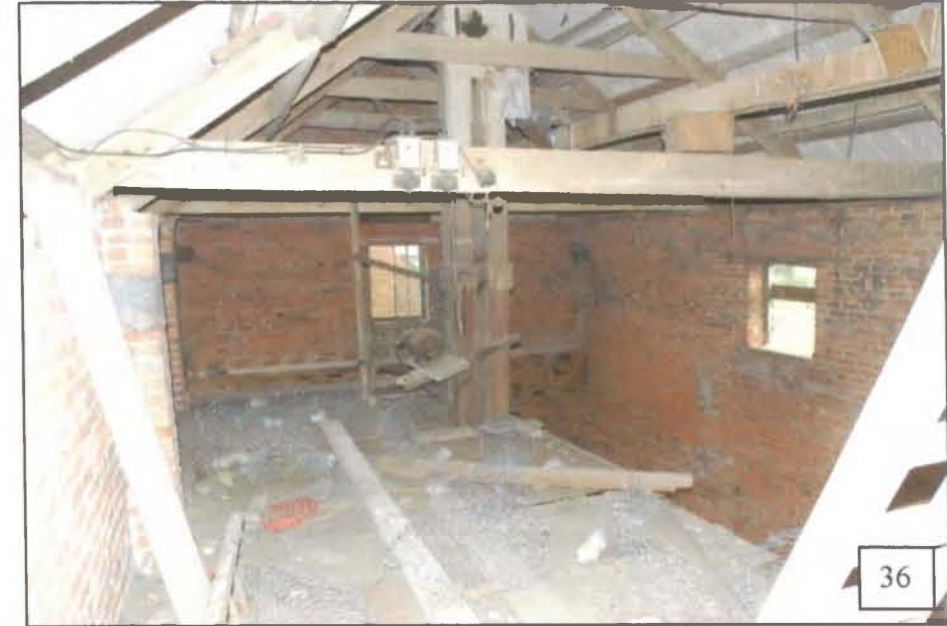
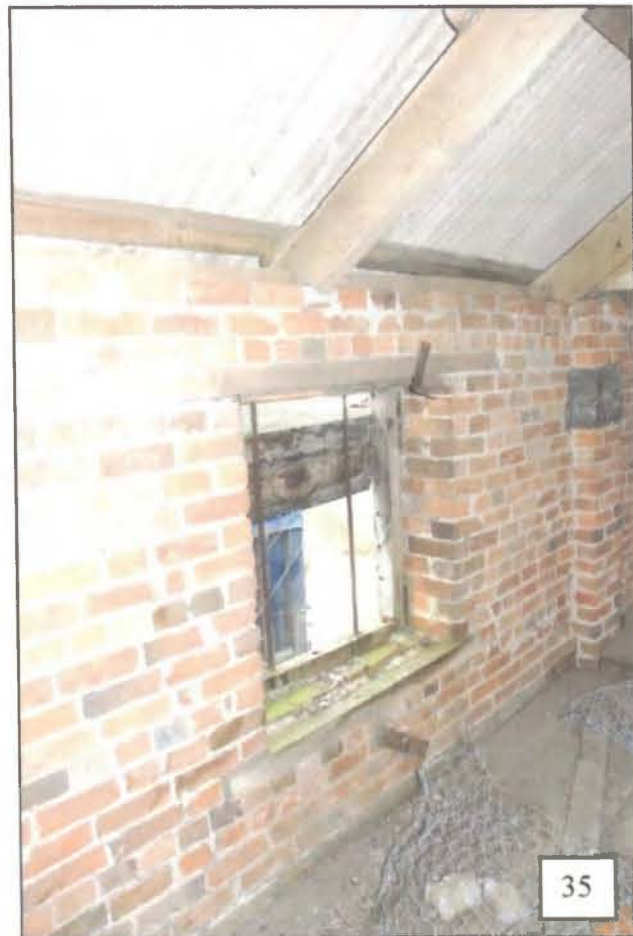
The granary windows, now in a poor state of repair, had vertical iron bars and horizontal timber louvres, retained in the frames with pegs, allowing them to be opened or closed.

The original first floor of the building was only present in the northwestern part of the structure: it comprised 9" wide tongue and grooved floorboards running north-south.

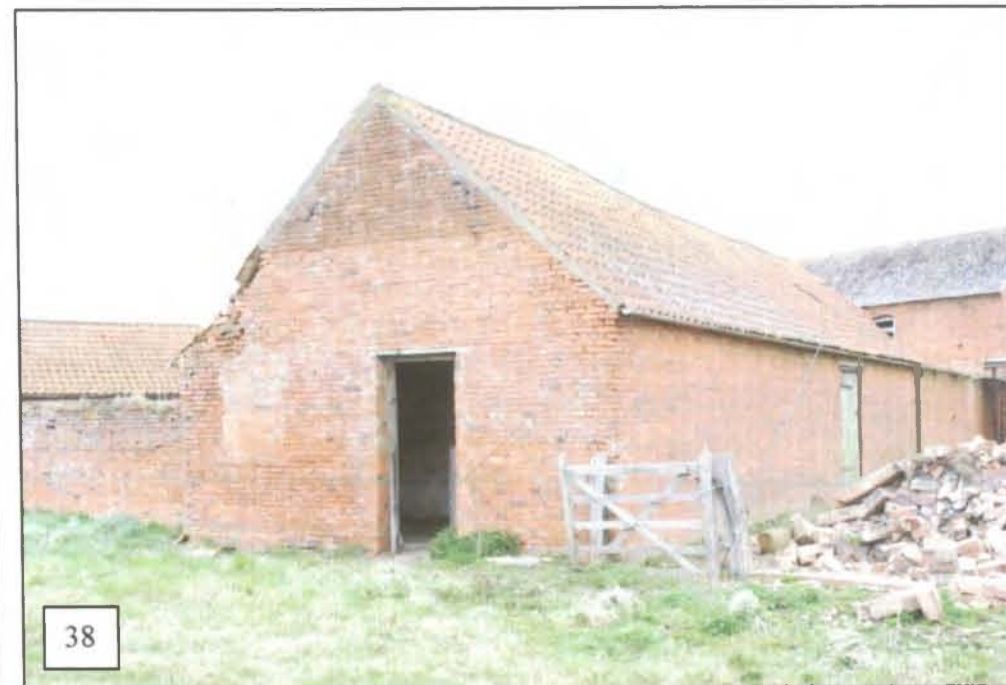
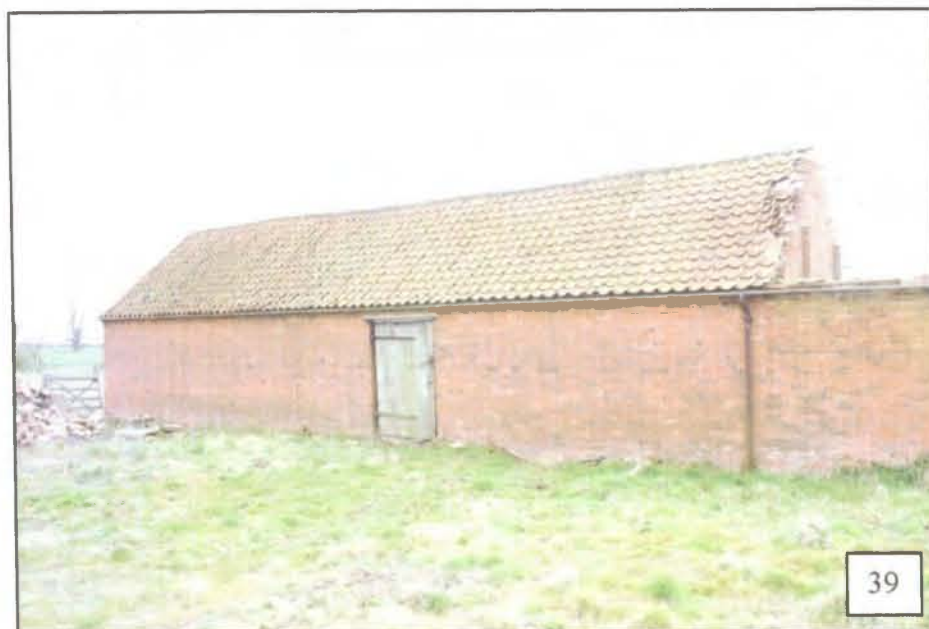
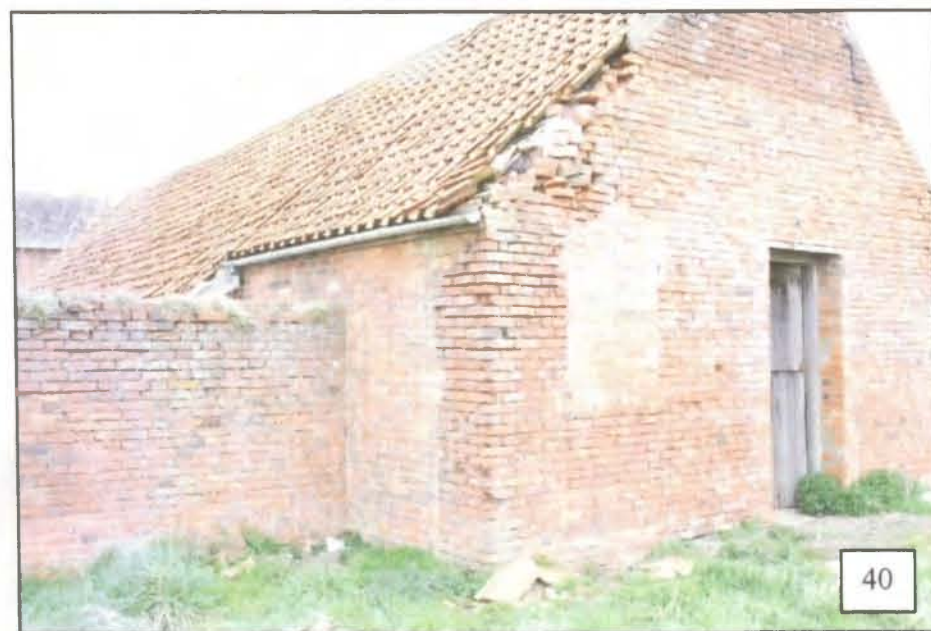
Like the other buildings of this phase, this building was constructed in 13" thick brickwork in 3-course EGW bond, with a similar dentil eaves cornice. It had a pitched pantile roof. The doorway in the south wall appears original, but a window here has been bricked up. A further door has been bricked up to the south of the boundary wall on the west side.

The door in the south wall is of ledged plank construction, and is of a stable-door type, it is probably not original.

The upper part of the south gable is of a dark red brick, it is unclear if this represents a rebuilding of the wall, or a variation in the brick originally used in the construction as this wall was not visible from the inside.

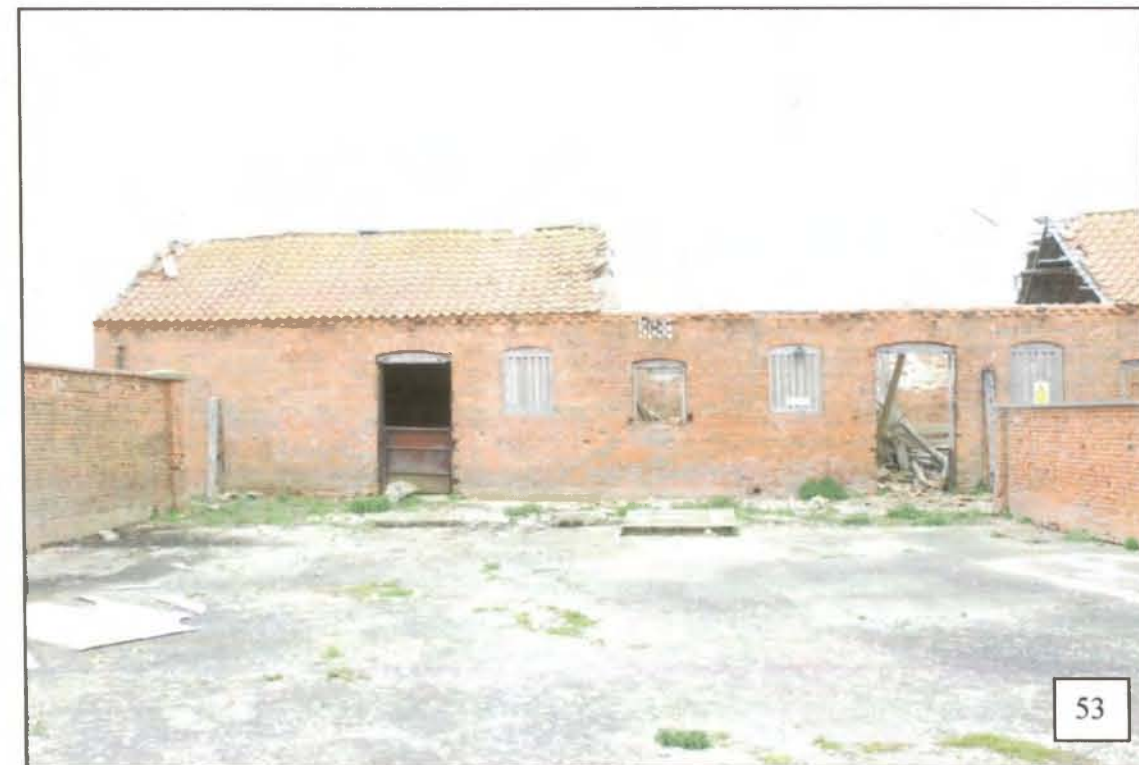
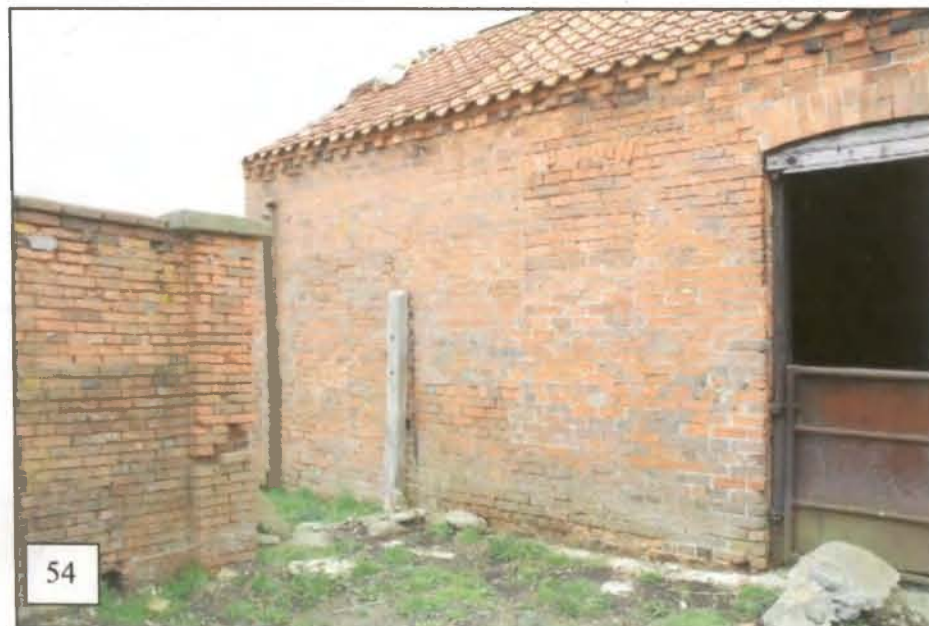
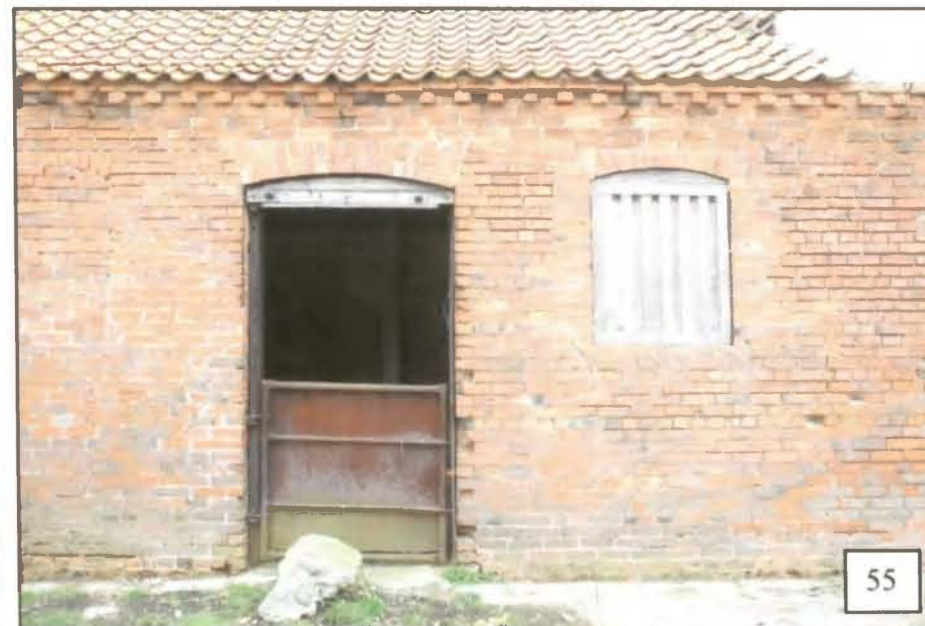
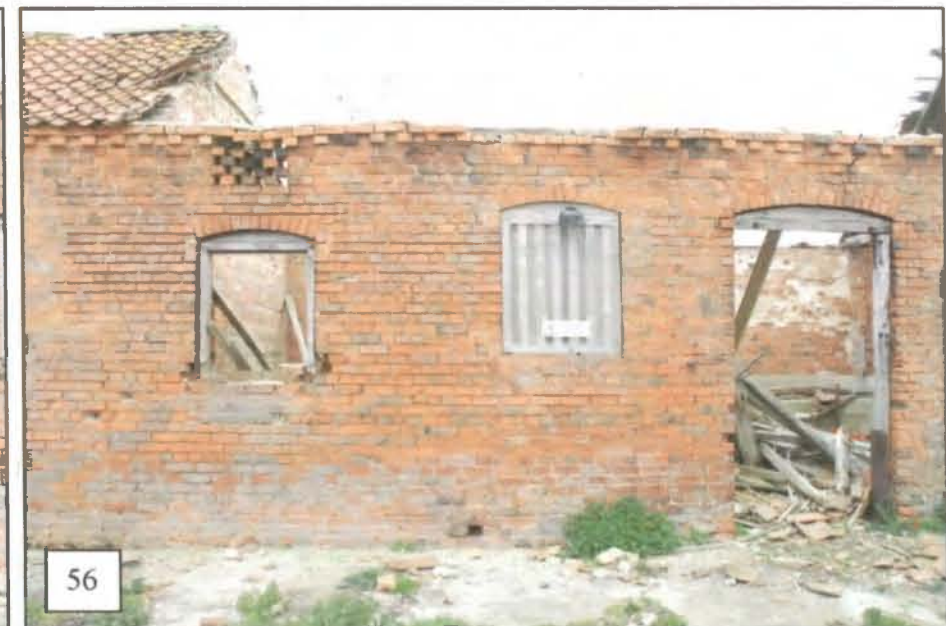
The southern part of Building F remains much as it must have been at the time of its construction (at least in arrangement, if not in detail). In the northern part of the structure the roof has collapsed following the failure of the tie-beams.

These buildings conform both in construction and style to the scheme already established in the other buildings of this phase: they are constructed in orange/red brick in 3-course EGW bond, with a wall thickness of 13½". They have pitched pantile roofs, with a projecting dentil eaves cornice.

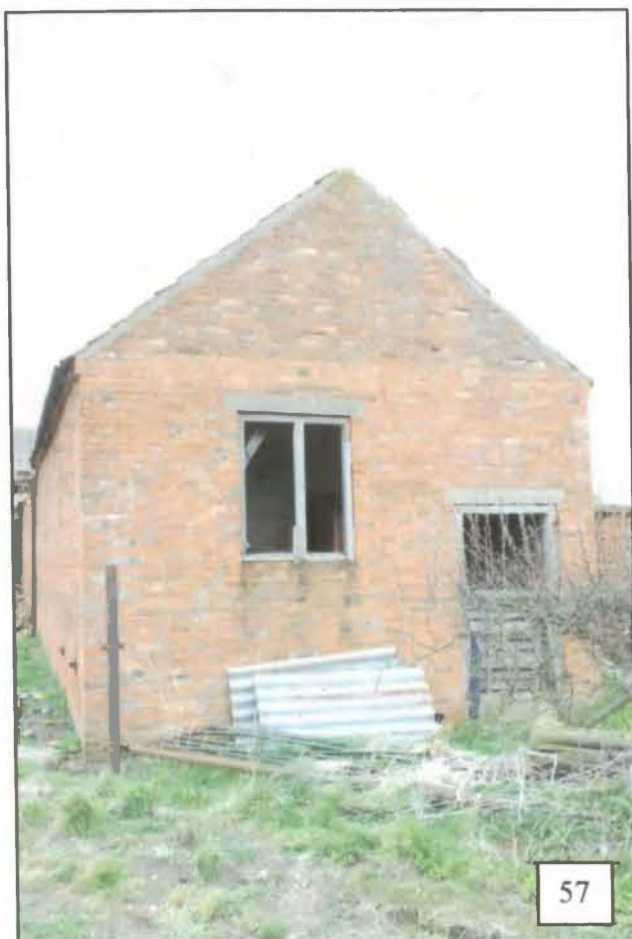
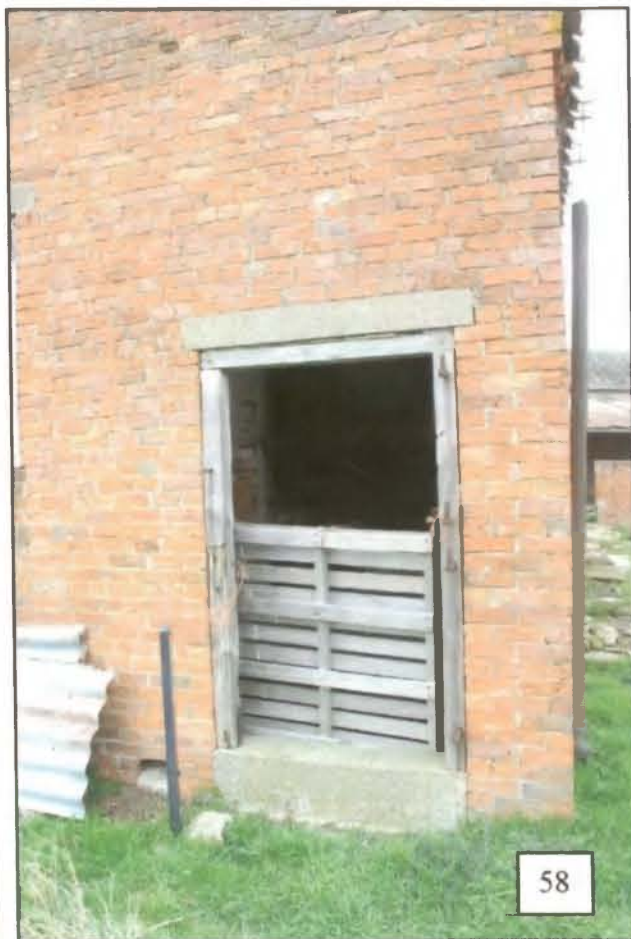
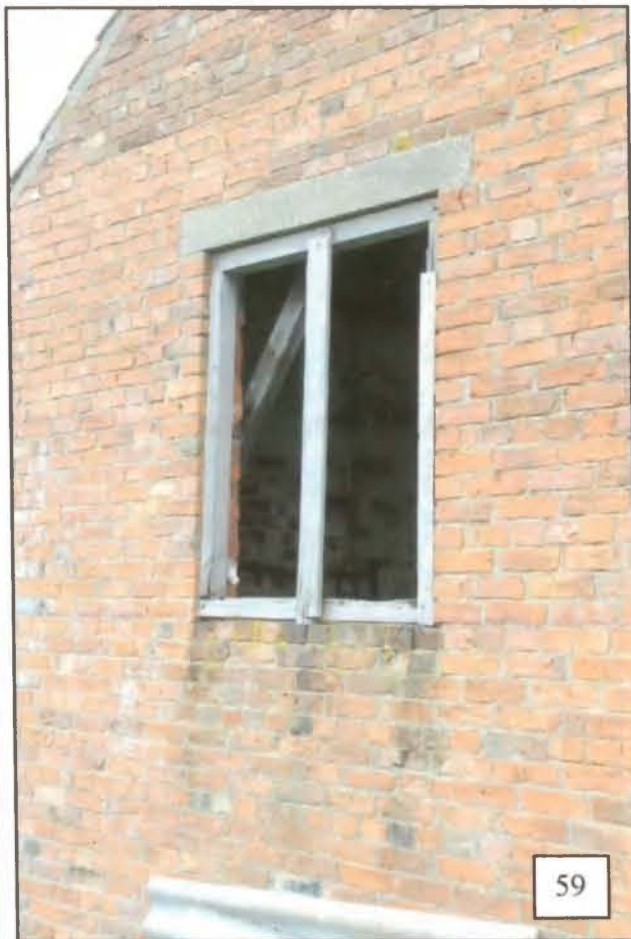
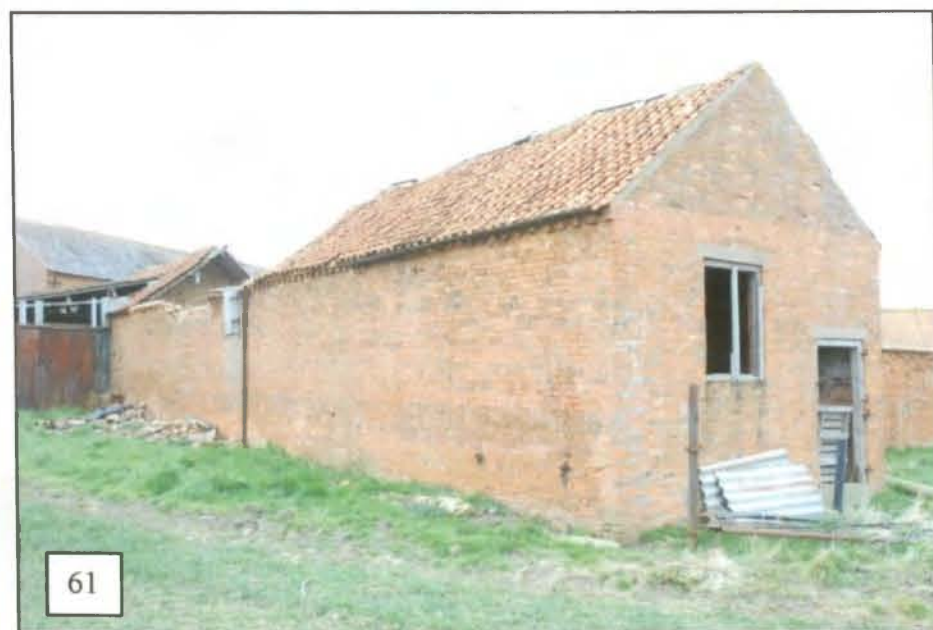
The southern part of Building F has retained its roof, and is divided into a smaller southern room, probably originally a loose box, with a larger room to the north. At the south side, the eastern (crewyard) elevation has a bricked-up door and window. The present entrance to this room is through the south gable wall, where a two-light window is also present; these are modern openings with concrete lintels.

A small loading door is present immediately below the eaves in the middle of the western elevation, while at the north end, a door with a half-round brick lintel has been bricked up. The remains of cast-iron guttering, downpipe and a collector box are also evident here.
