# GRANGE FARM, WEST TORRINGTON, LINCOLNSHIRE

## PHOTOGRAPHIC BUILDING SURVEY

Site Code: GFWT 08  
LCM acc. no.: 2008.68  
Planning refs.: S/205/00678/08  
NGR: TF 1430 8132  
PCA job no.: 08-457

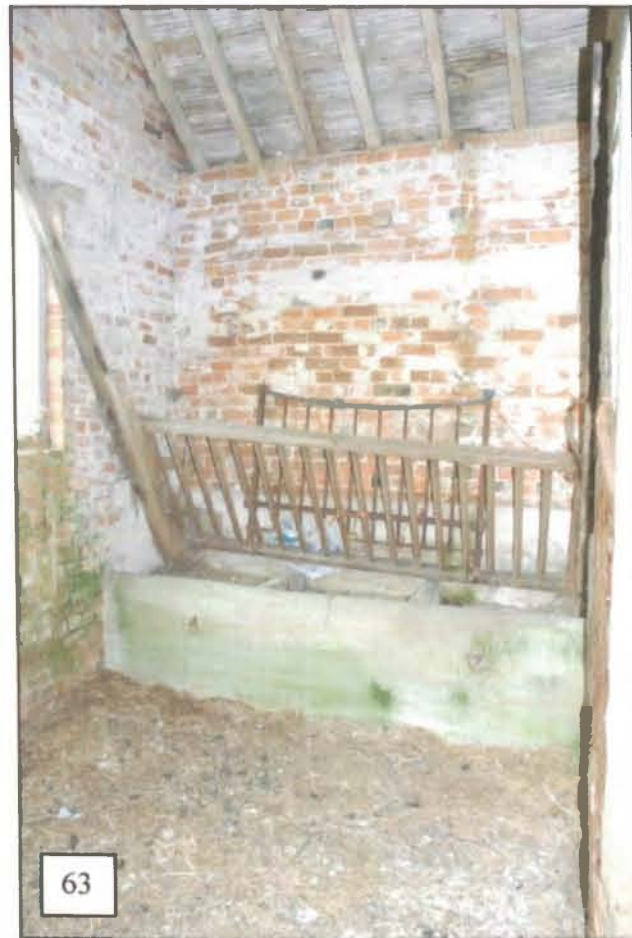
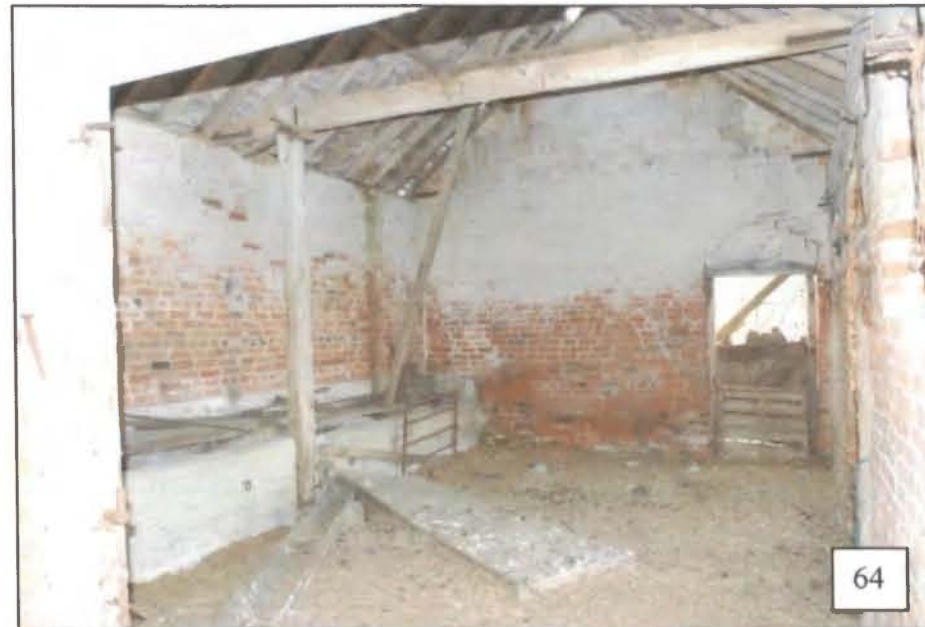
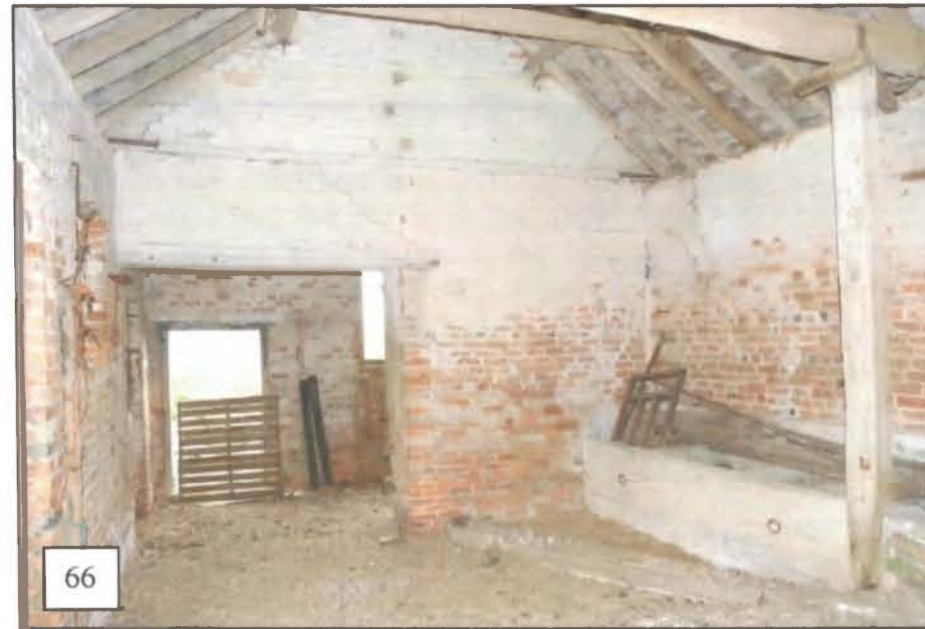
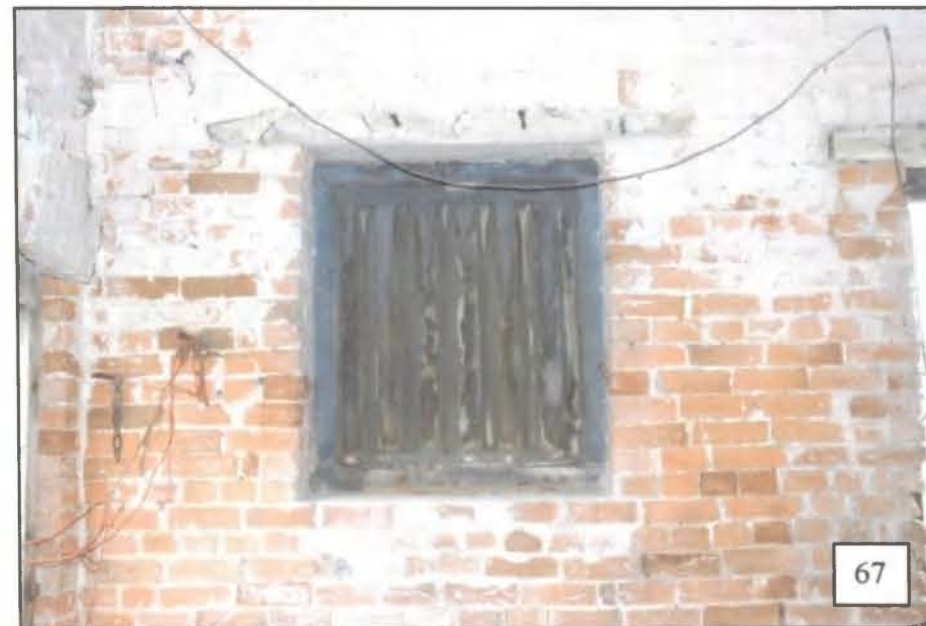
Internally, this part of the building has changed little since its inception. The smaller room to the south appears to have functioned as a loose box. Both this room and the rooms to the north have a concrete feeding trough running along the western wall. In the loose box, this retains a timber hayrack above. These rooms have been whitewashed, but this has been worn off on the lower parts of the walls. Below the remains of straw, the floors are of poured concrete. The roof structure is identical to that of Building B: a clasped through-purlin collar-rafter roof, with occasional chamfered collars; however, there are laths present above the rafters – although no sign that this was ever plastered. The original windows have been replaced by horizontally sliding slatted timber ventilators. A communicating doorway to the derelict northern room retains the lower half of a ledged and diagonally braced stable door.

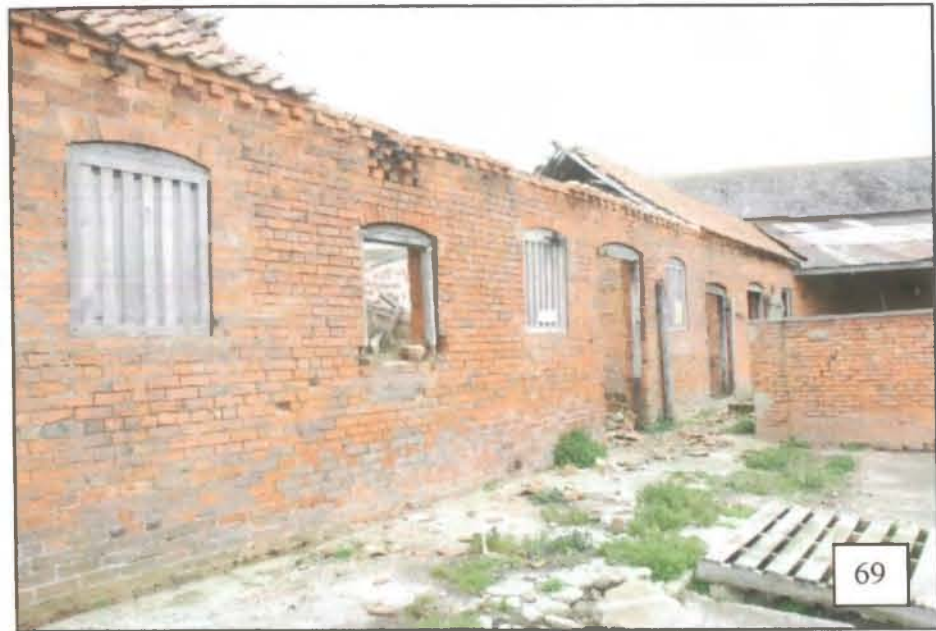
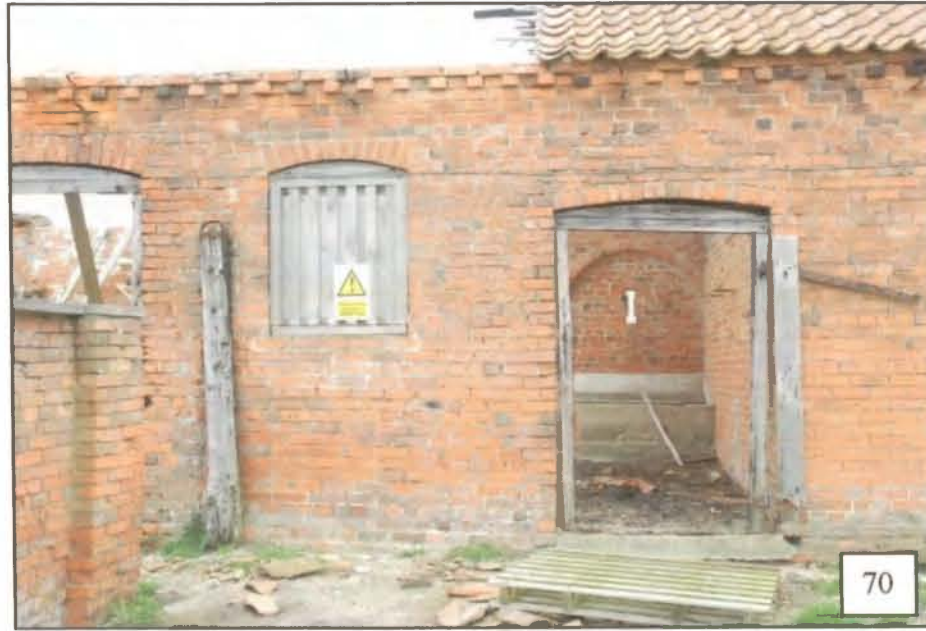
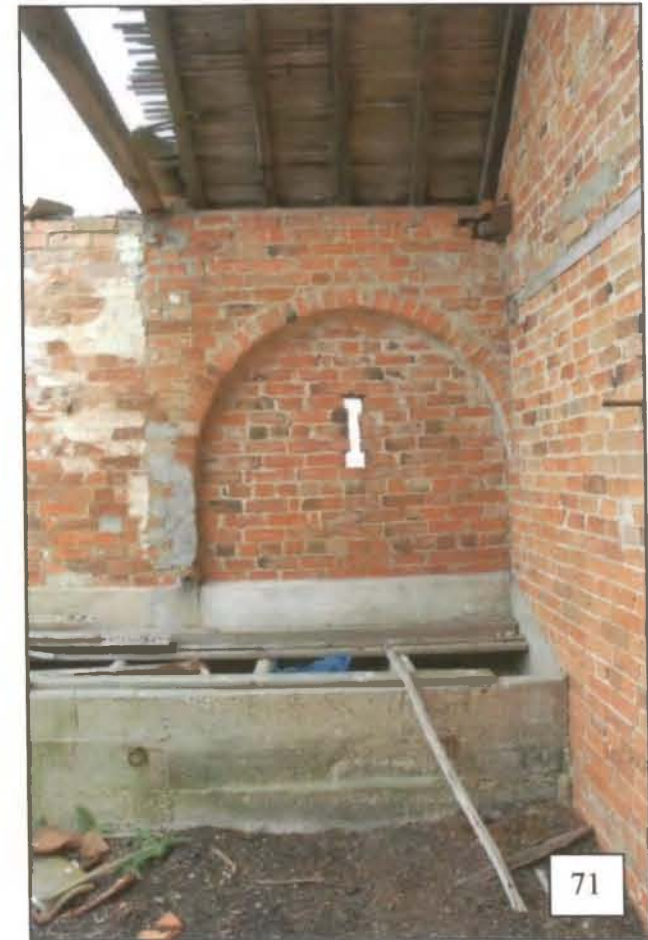
The roof has collapsed into the northern room of Building F, obscuring most of the internal detail. Of note, however, is the bricked-up door on the west side with a half-round brick lintel. This has been bricked up, and a slot vent built in the centre. The doorway on the eastern side has a similar half-round lintel on the inside, but the exterior has a shallow-arched lintel. This appears to represent an alteration in the function of this area and suggests that a passage giving access from the field was originally present here. A rectangular brick 'honeycomb' ventilator is also present above the southern window on the eastern side of this room.

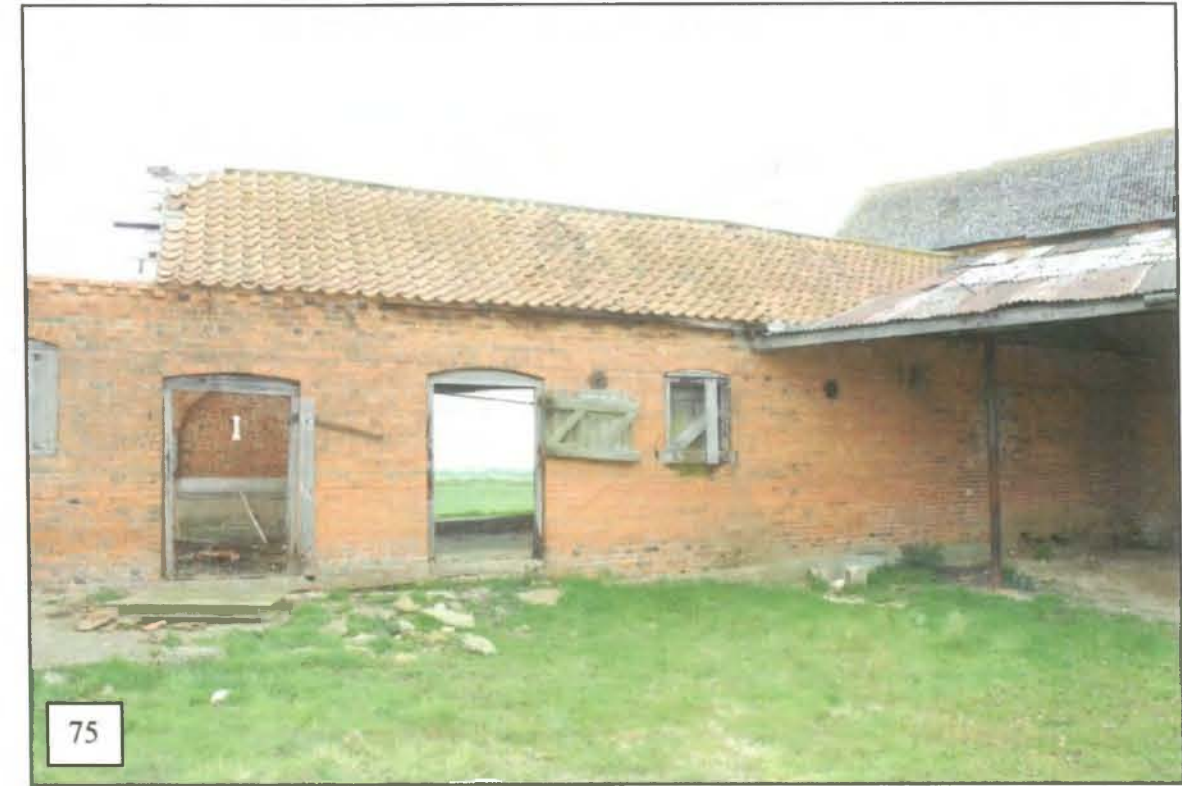
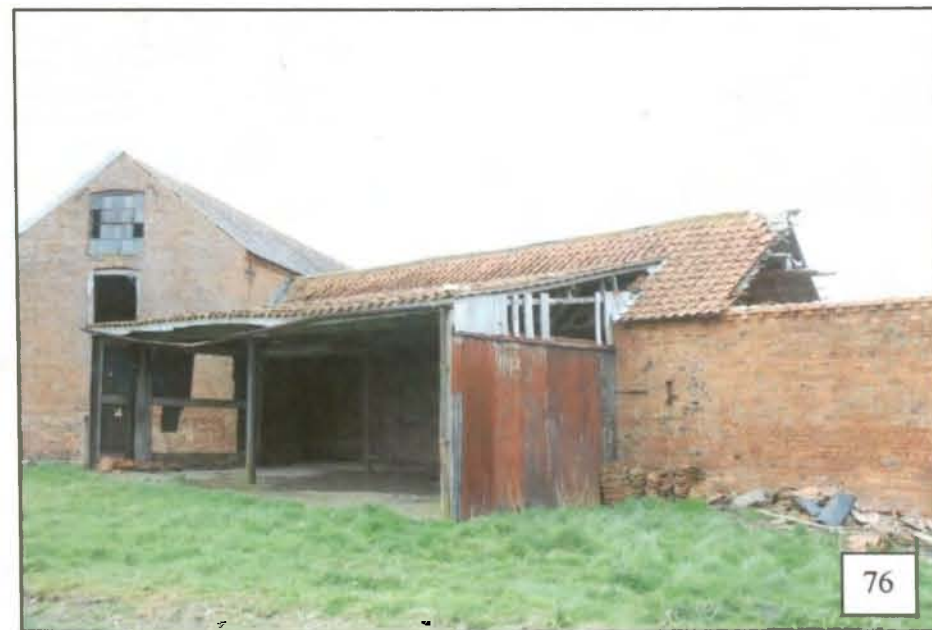
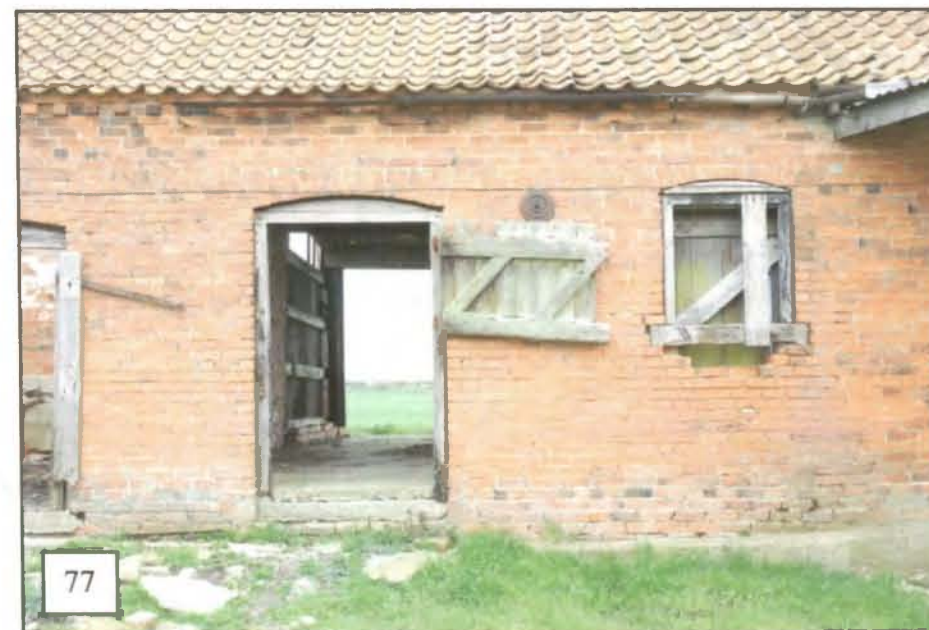
Building H occupies the northern part of the west range of the model farm. It is similar in construction and style to the other buildings of this range, but the east (crewyard) wall differs somewhat in construction. The thickness of this wall, the only surviving wall here of Phase I date, is of only 9", with an extra leaf of 13½" brickwork around the door openings.

A window and a door have been bricked up in this elevation, both in the area now covered by the roof of the neighbouring lean-to shelter (Building G).

Building H has been recently altered, the west wall being removed and the roof extended to provide a larger, open-fronted covered area to the west.

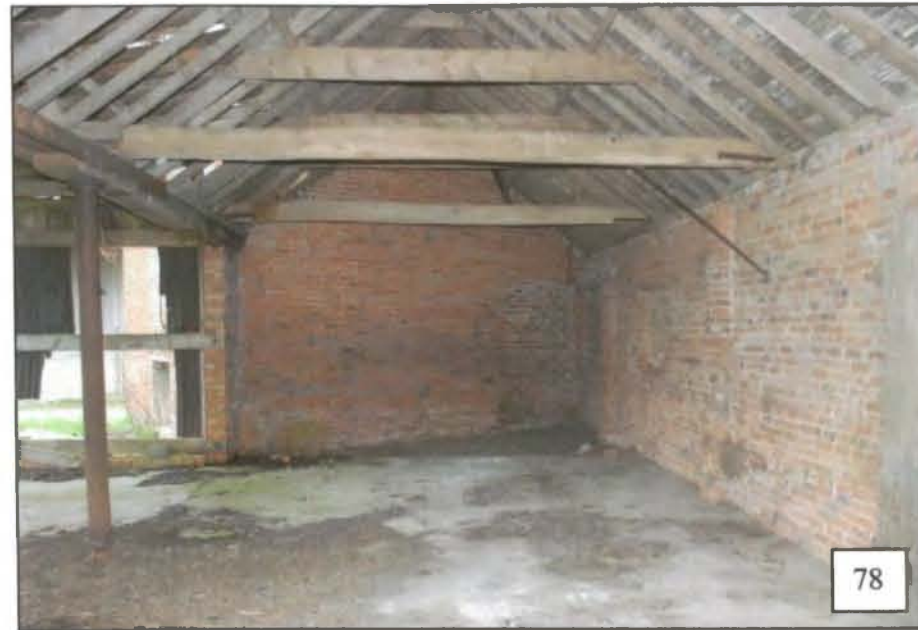
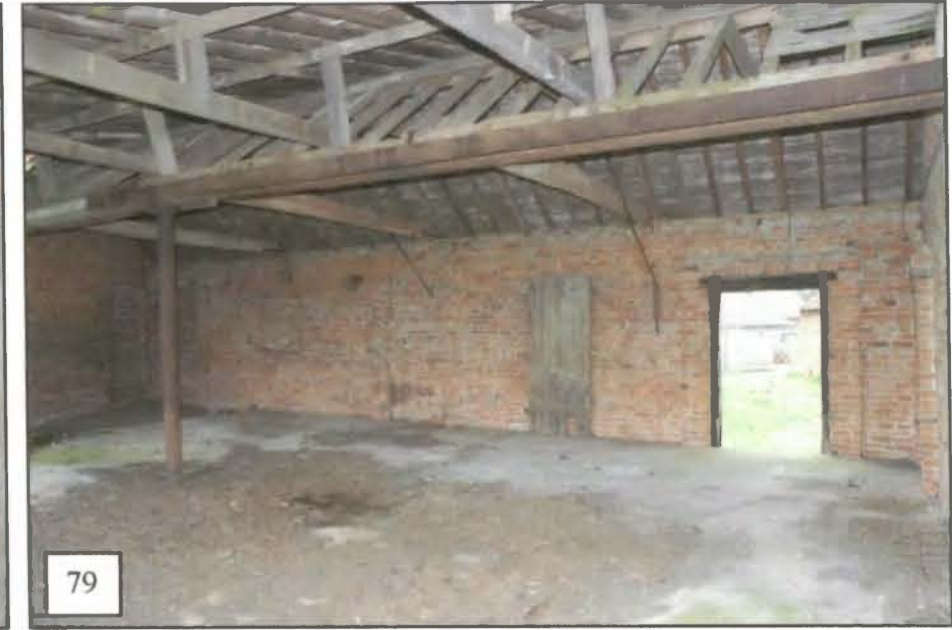
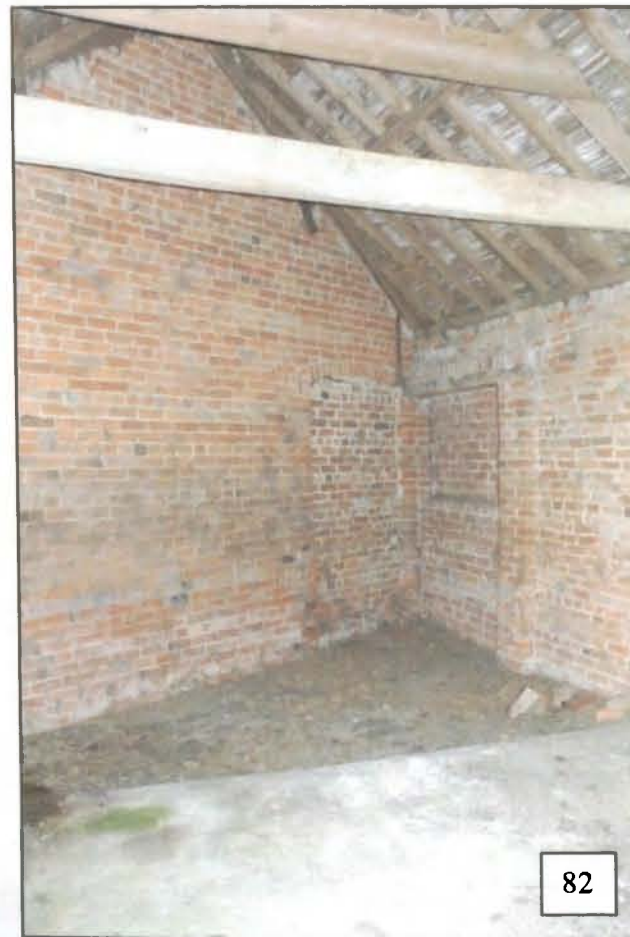
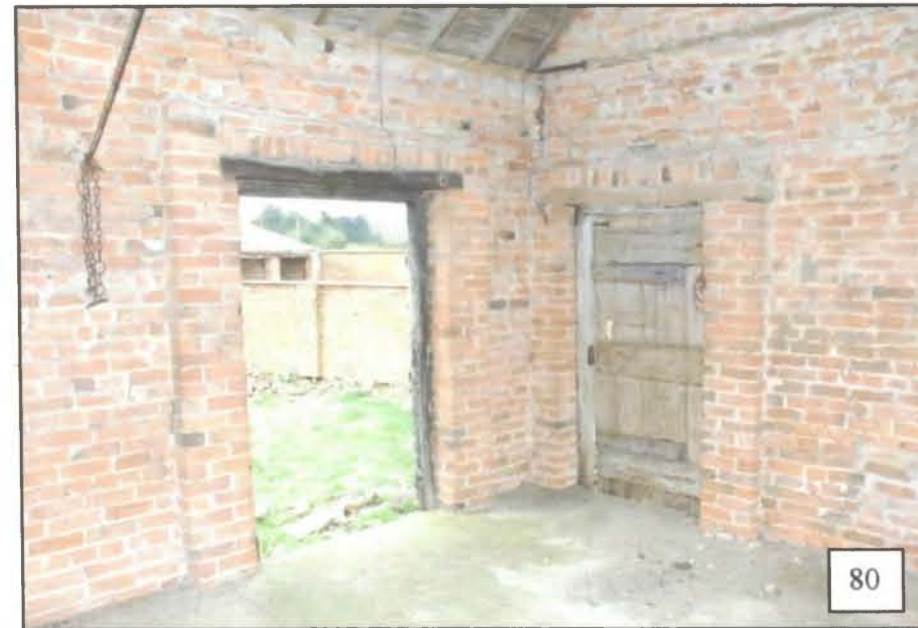
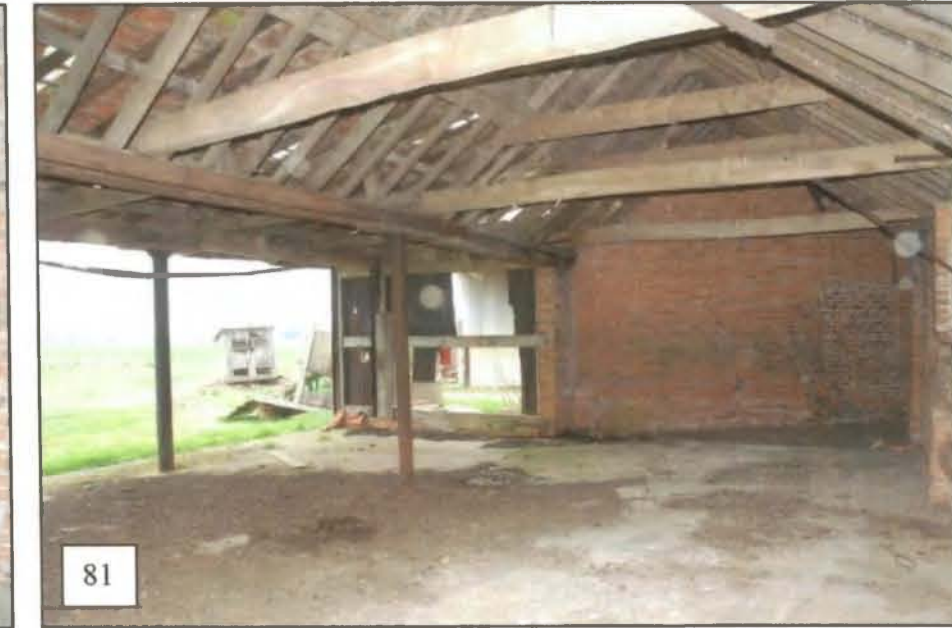
The roof is similar to that of the other buildings of the model farm, of collar-rafter construction with chamfered collars and clasped through-purlins; three tie beams were present here.

A communicating door from Building A on the east side of the north wall has been bricked up, while a door on the east side of the south wall retains its pair of ledged plank stable doors and leads to Building F.

The floor is of large poured concrete panels.

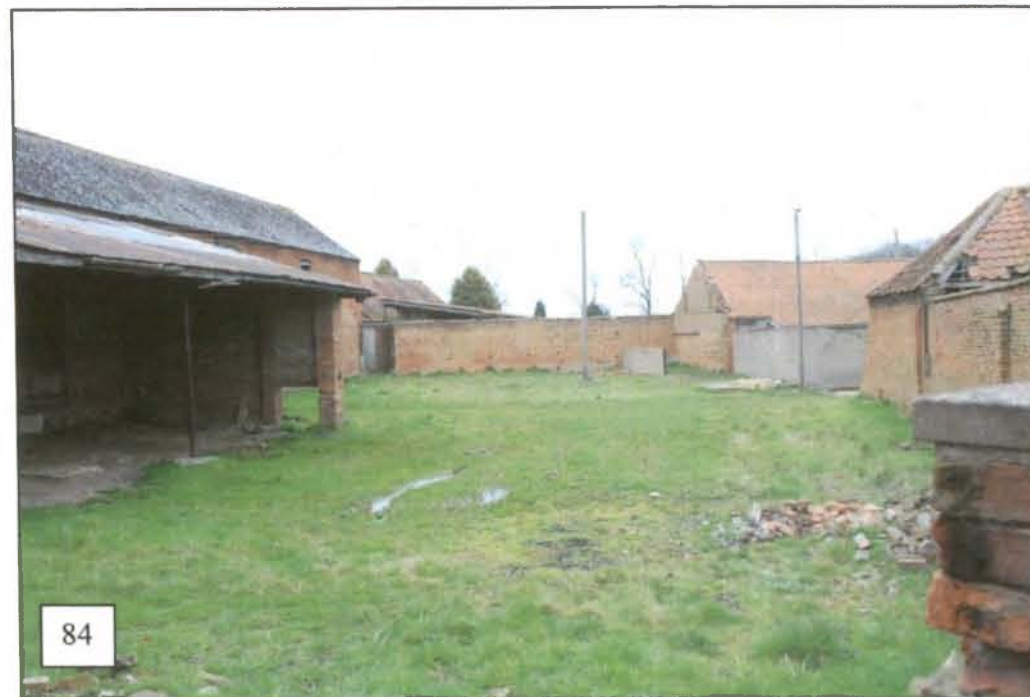
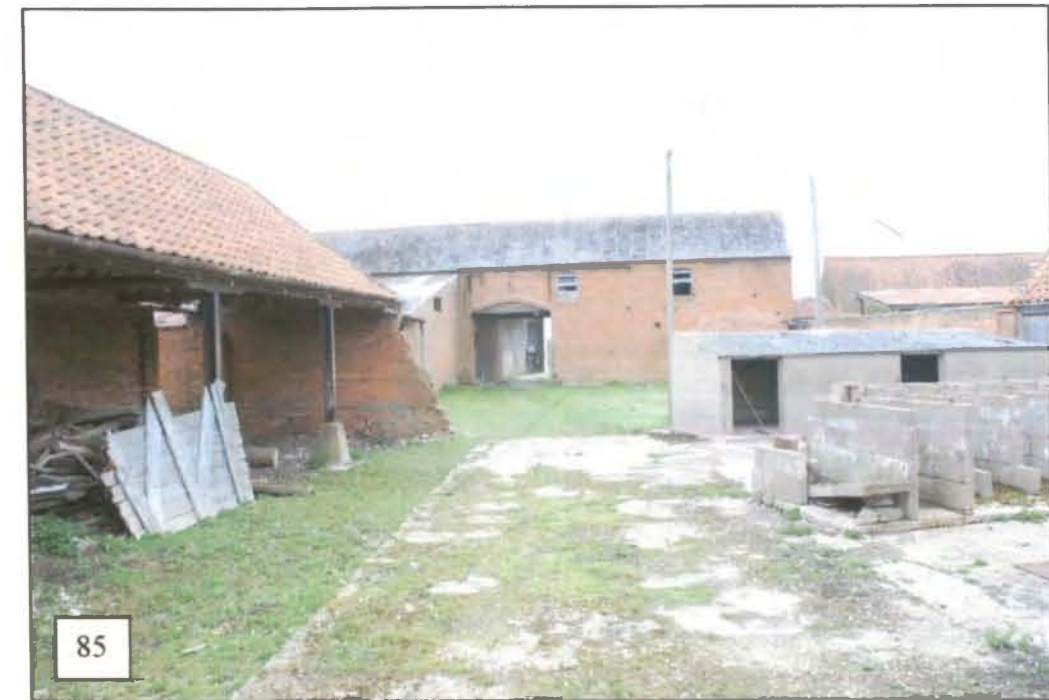
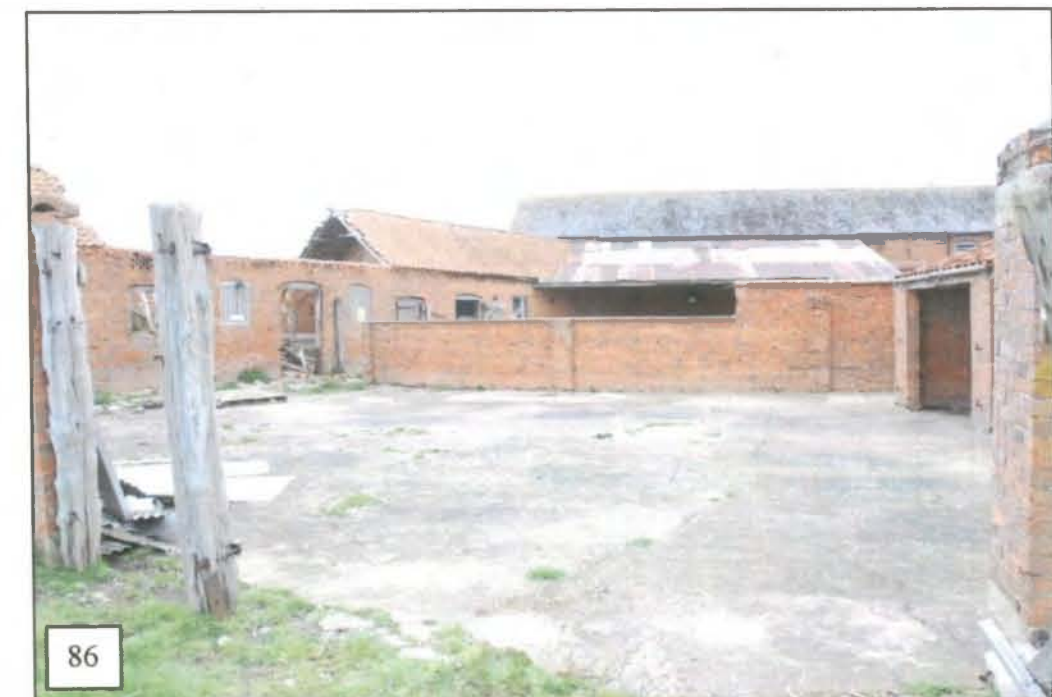
As first designed, the model farm had three crewyards. The unique layout of the buildings meant that, for little extra expense in construction materials, space and sunlight was maximised for both the crewyards and the surrounding buildings.

Judging by the layout of the surviving walls, there was a single northern crewyard, while the area to the south was divided by a central wall into two further crewyards.

Modern concrete aprons and later buildings now occupy the southern crewyards, but the northern area is less cluttered and retains the feeling of space envisioned by the initial design.

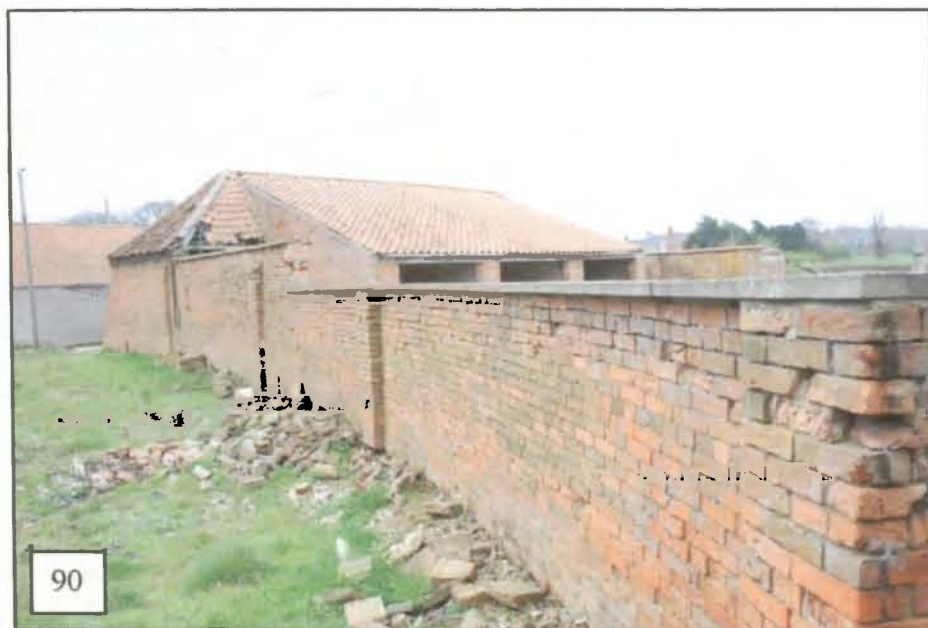
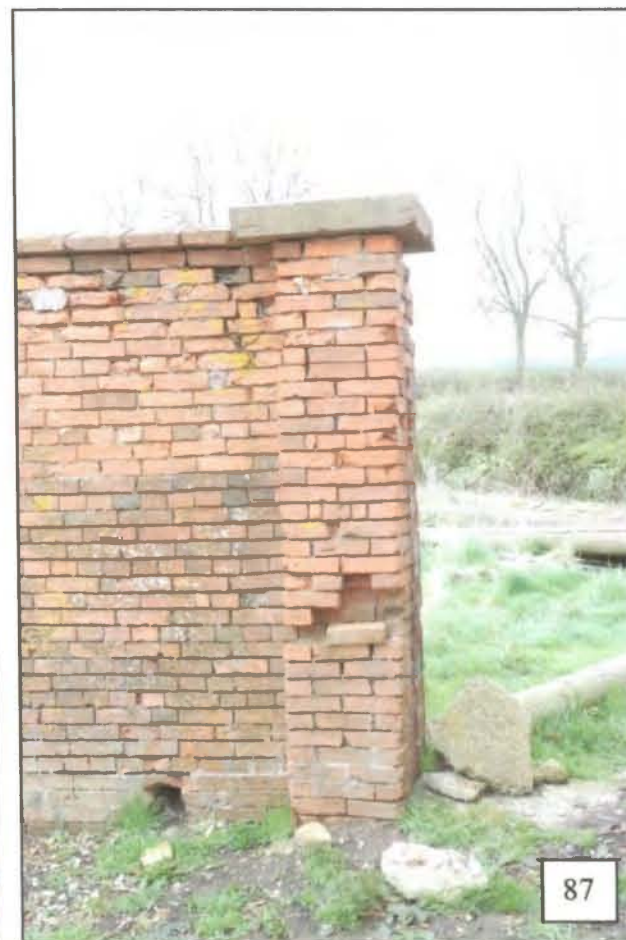
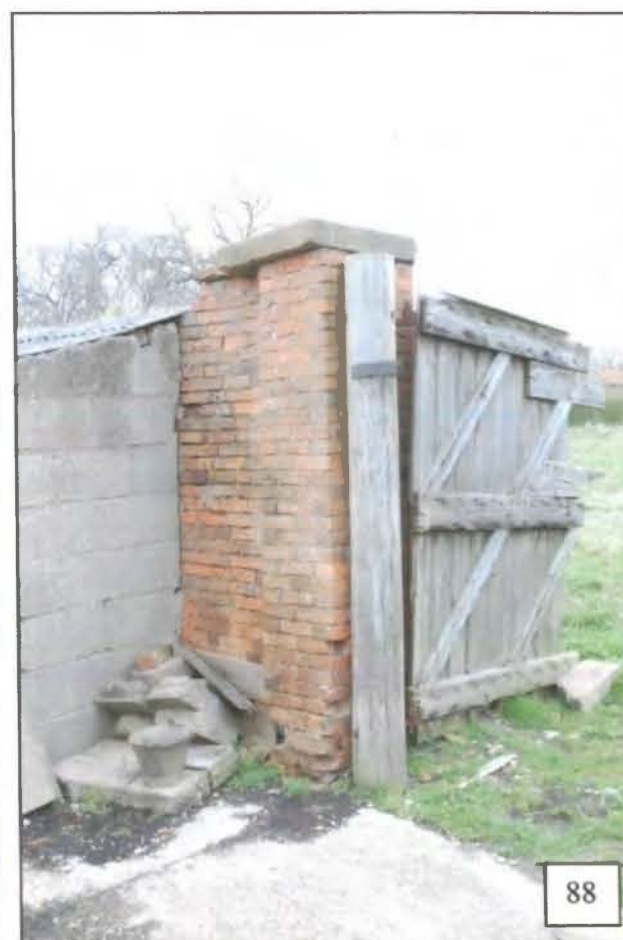
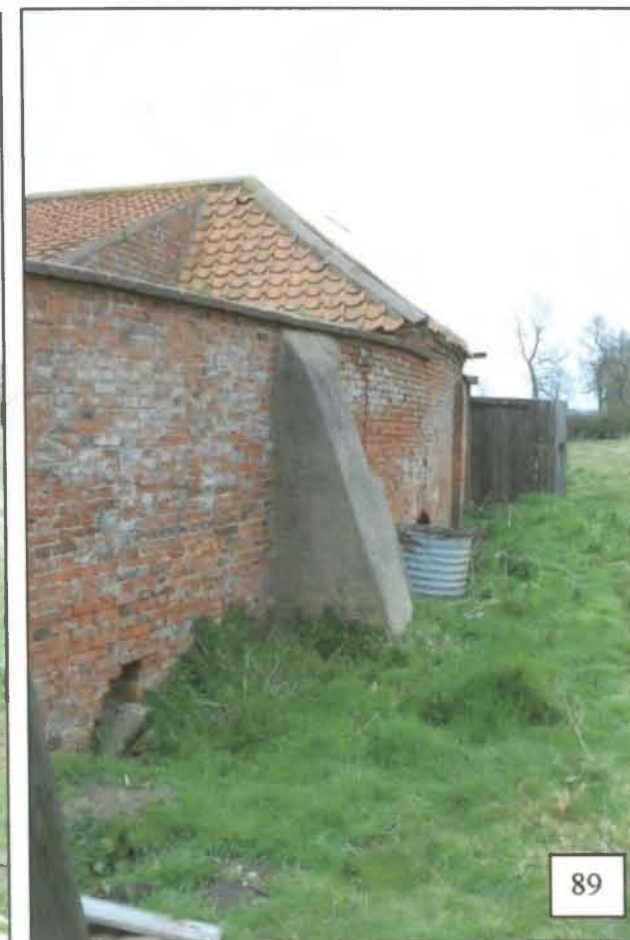
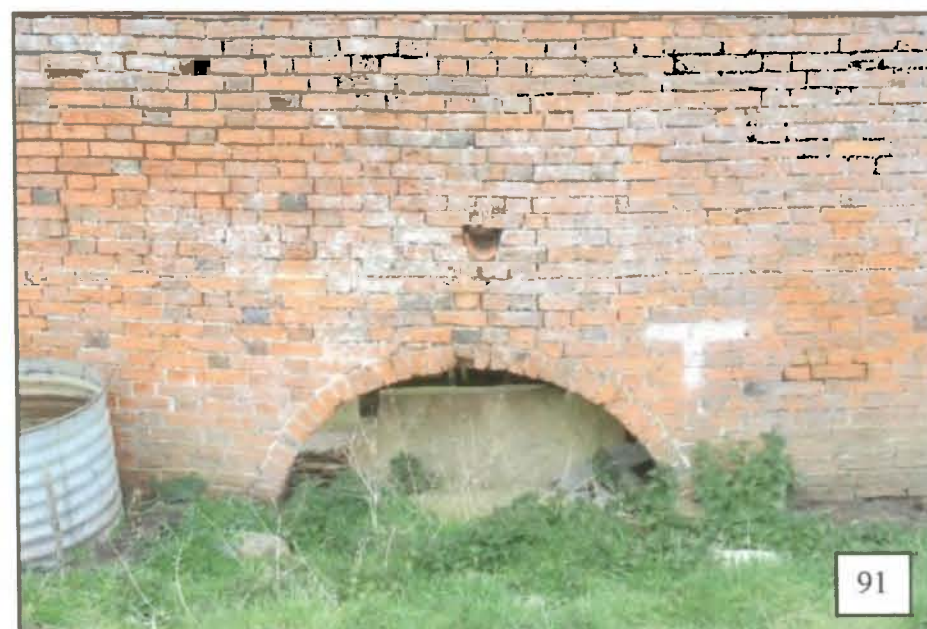
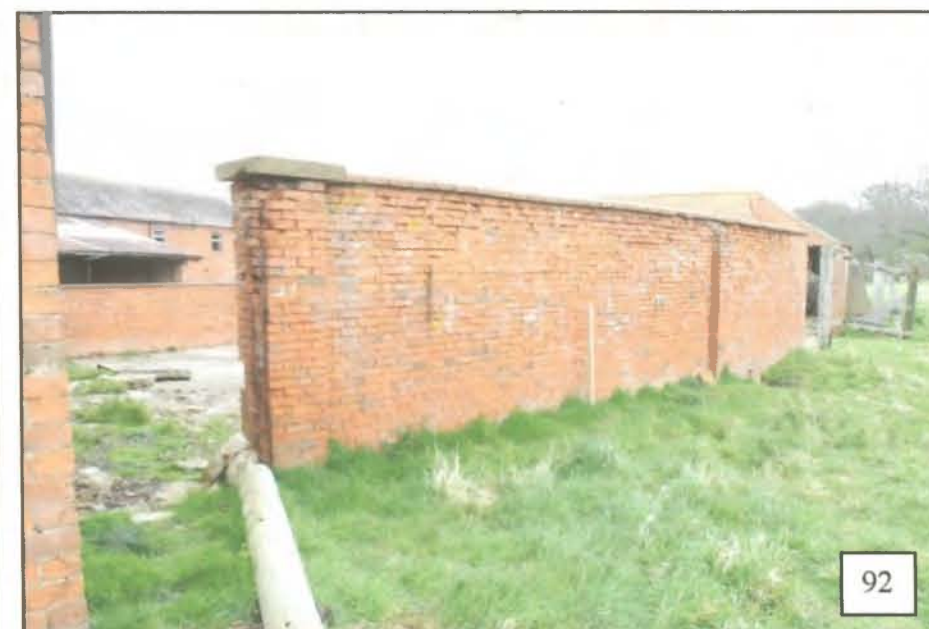
The crewyards were delimited by two east-west aligned curving brick boundary walls around 8ft in height, with regularly placed buttresses and pyramidal terracotta coping. The walls were 13½" in thickness, with 18" x 21" gate piers and buttresses, the buttresses having a chamfered top, while the gate piers had a pyramidal stone coping.

In the centre of the south boundary wall, a half-round brick arch provides evidence of a central drainage system.

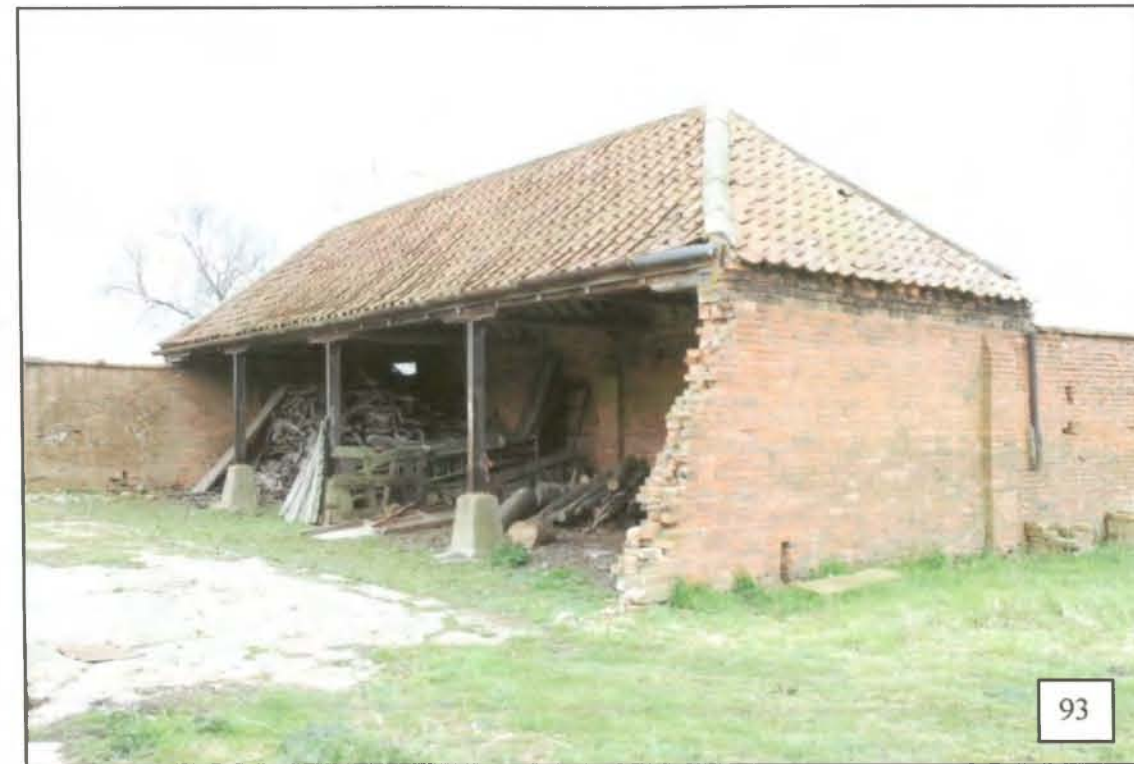
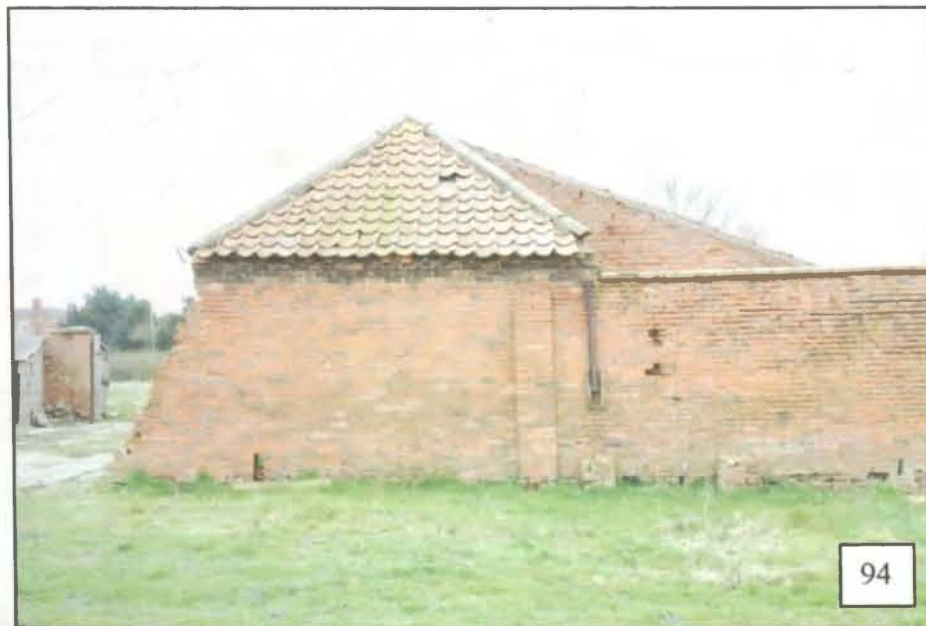
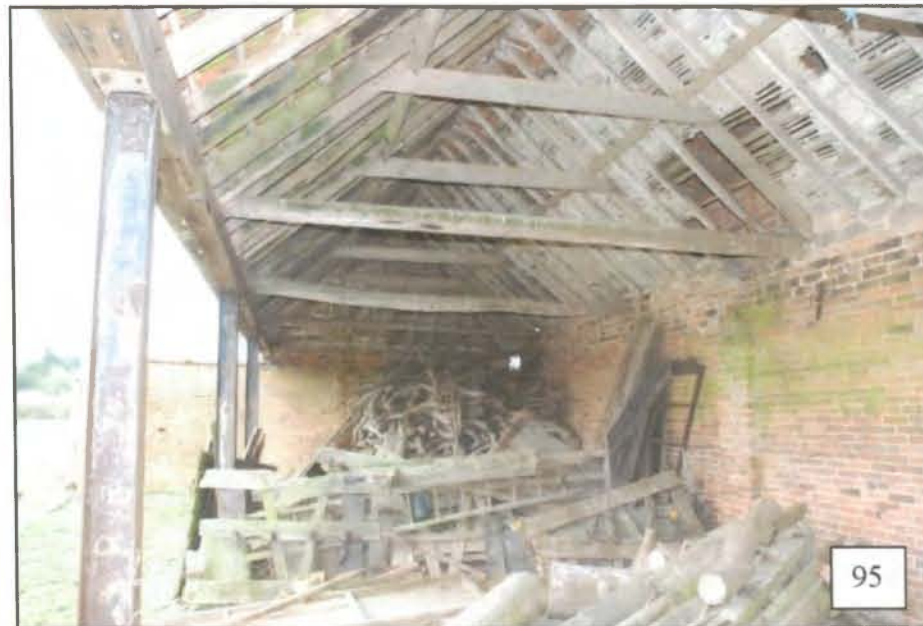
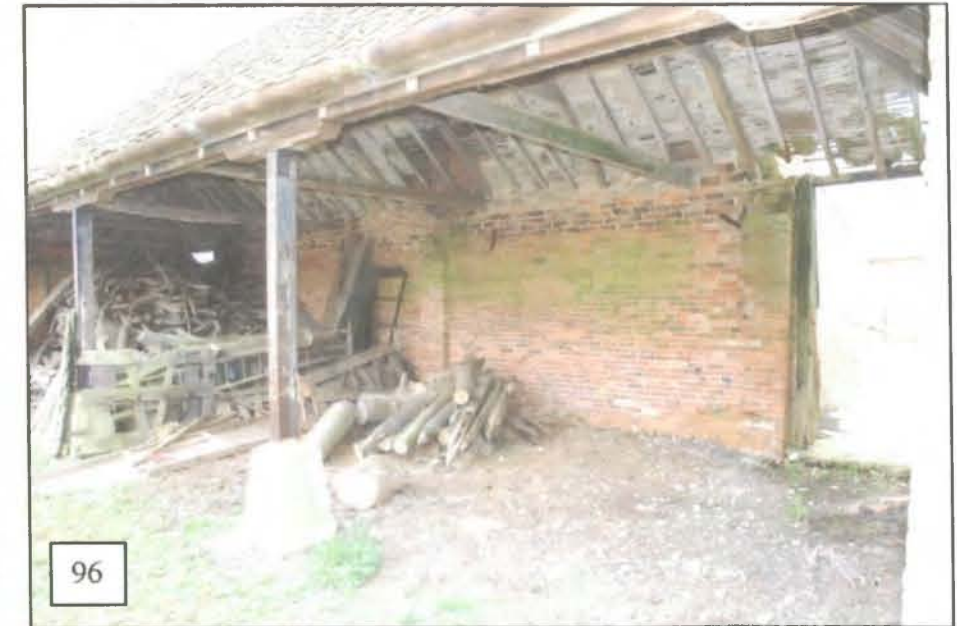
This building was clearly constructed after the original crewyard, as it employs the brick dividing walls of the original arrangement as the north, south and west walls of its structure. As built, it was open-fronted to the eastern yard and would have been used for the storage of animal fodder (probably straw). Although primarily supplying material to the eastern yard, access was provided at the north and south sides to the western yard. Such structures are common in the design of the Turnor farms, which were predominantly E-shaped in plan, incorporating a double crew-yard arrangement with the central spine occupied with the storage of straw/fodder which could be easily distributed to either yard.

Building I comprised an open fronted structure, with its eastern side carried on three I-profile steel uprights set into concrete bases. This represents a renewal of an original timber structure here. The building is carried predominantly on the pre-existing walls of the crewyard boundary walls; their coping having been removed, only three courses of brickwork were added to reach eaves height. The newer brickwork was carried out in a much darker red brick, 2 3/4" in thickness.

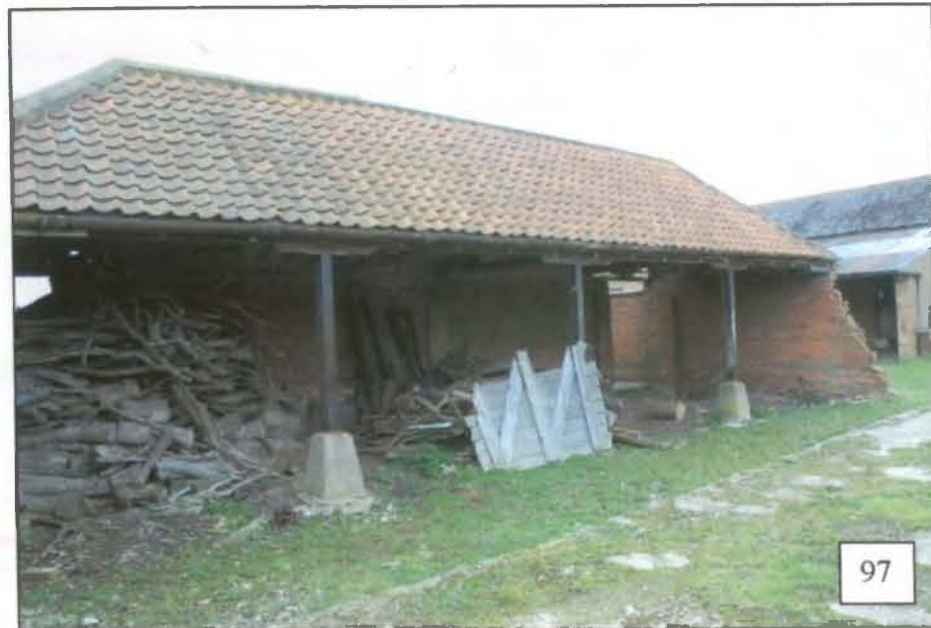
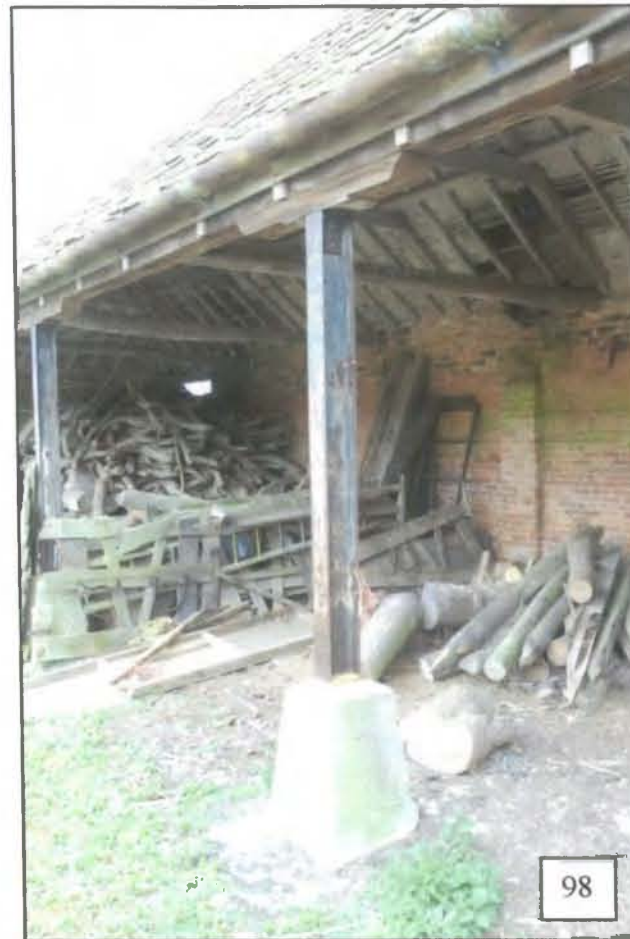
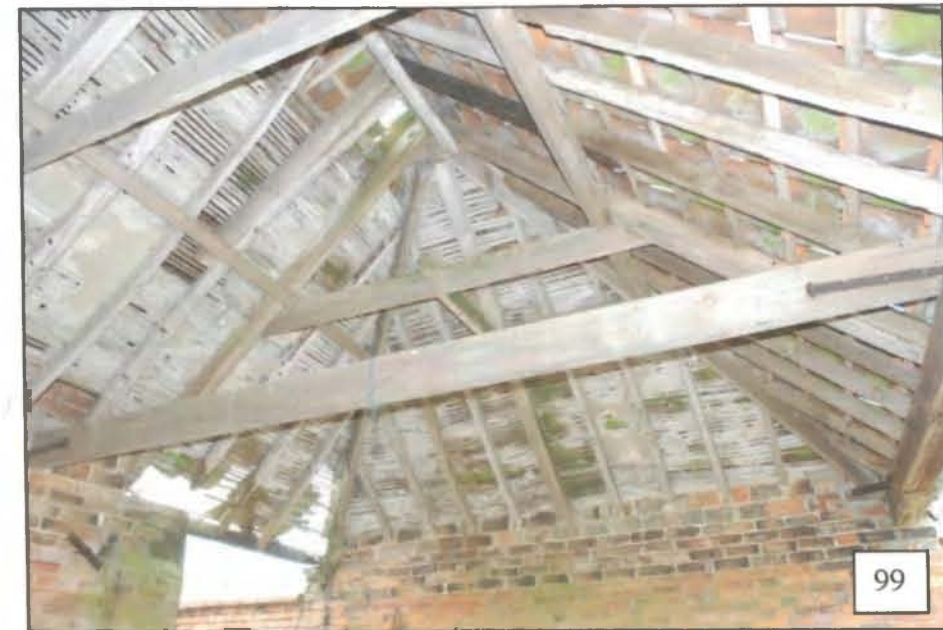
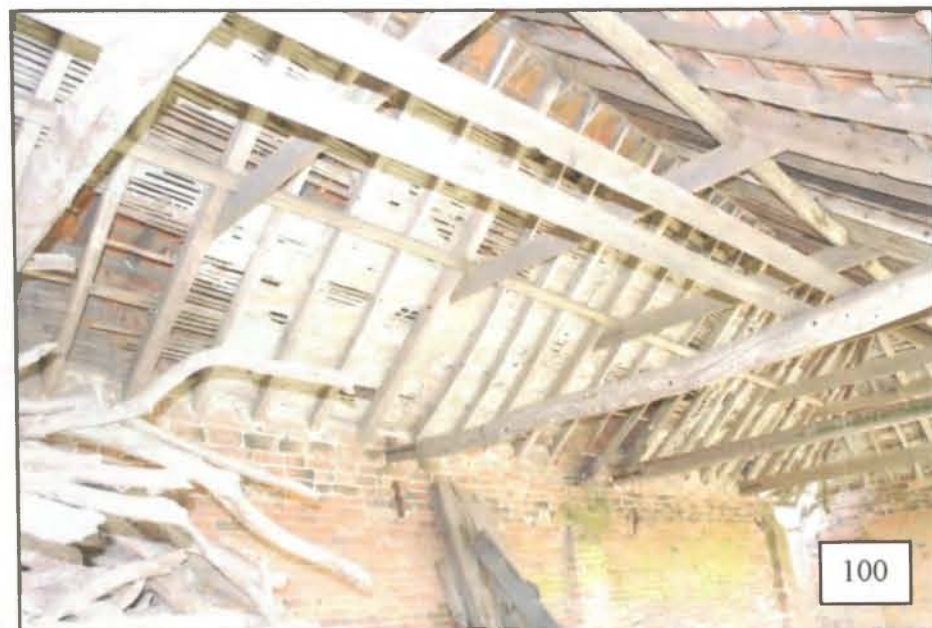
Building I has a hipped pantile roof, of collar rafter construction with clenched through-purlins and chamfered collars. Interestingly, extensive traces of plaster remain adhering to the lath below the pantiles here. Four tie beams are present, but the southern three are of roundwood and may have been replaced when the timber of the open eastern front was renewed.

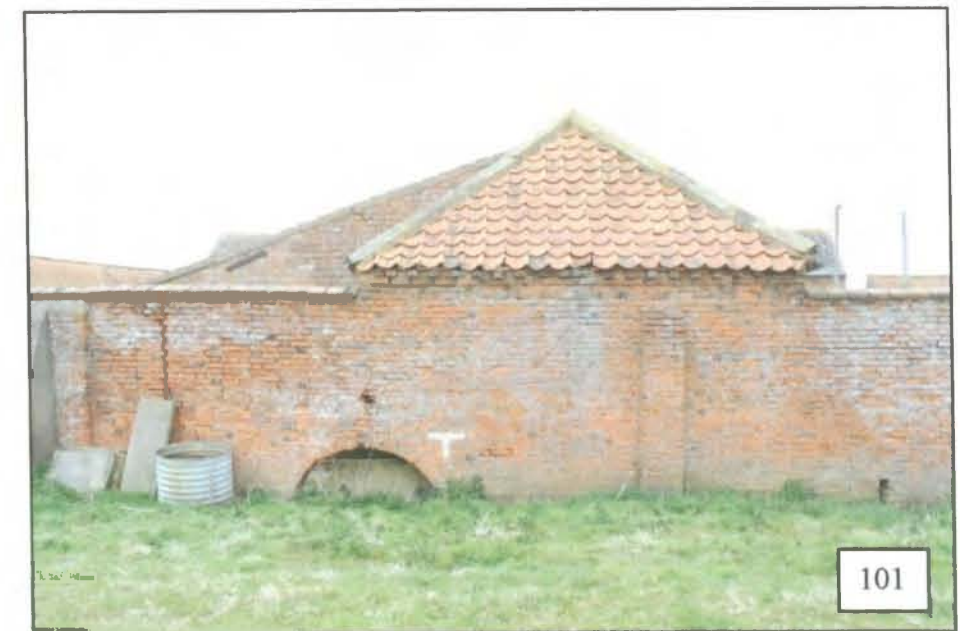
This building was later extended to the west to provide more animal accommodation here.
