# GRANGE FARM, WEST TORRINGTON, LINCOLNSHIRE

## PHOTOGRAPHIC BUILDING SURVEY

Site Code: GFWT 08  
LCM acc. no.: 2008.68  
Planning refs.: S/205/00678/08  
NGR: TF 1430 8132  
PCA job no.: 08-457

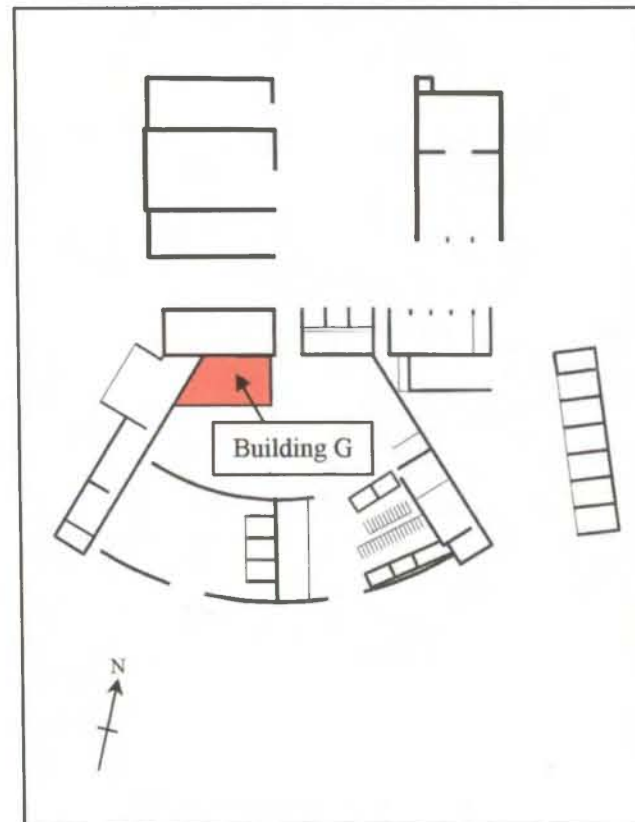
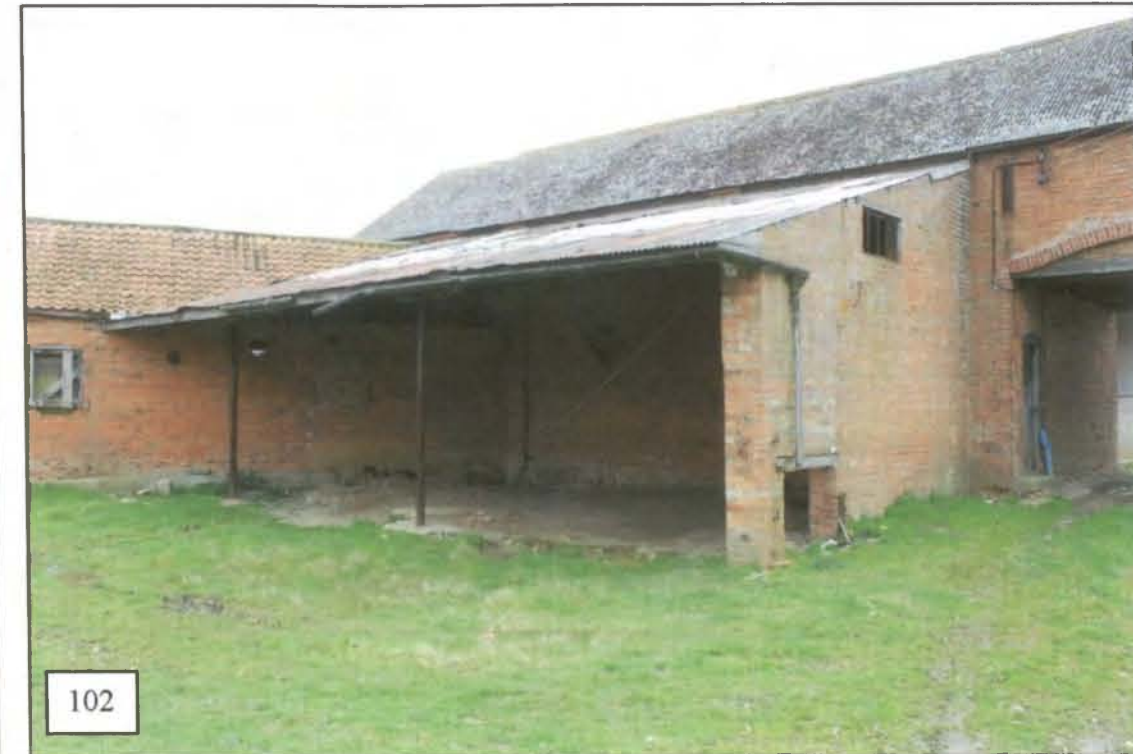
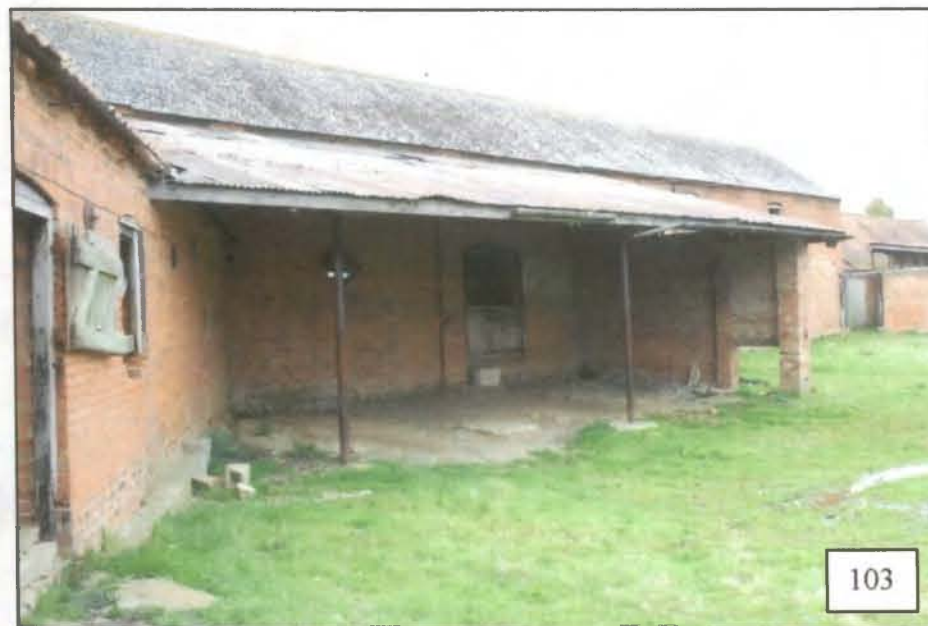
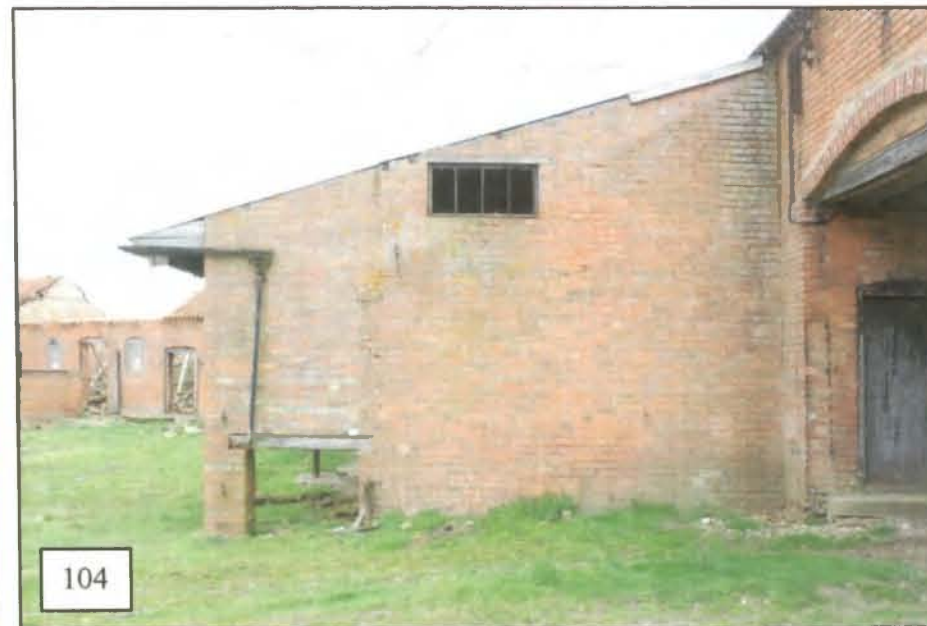
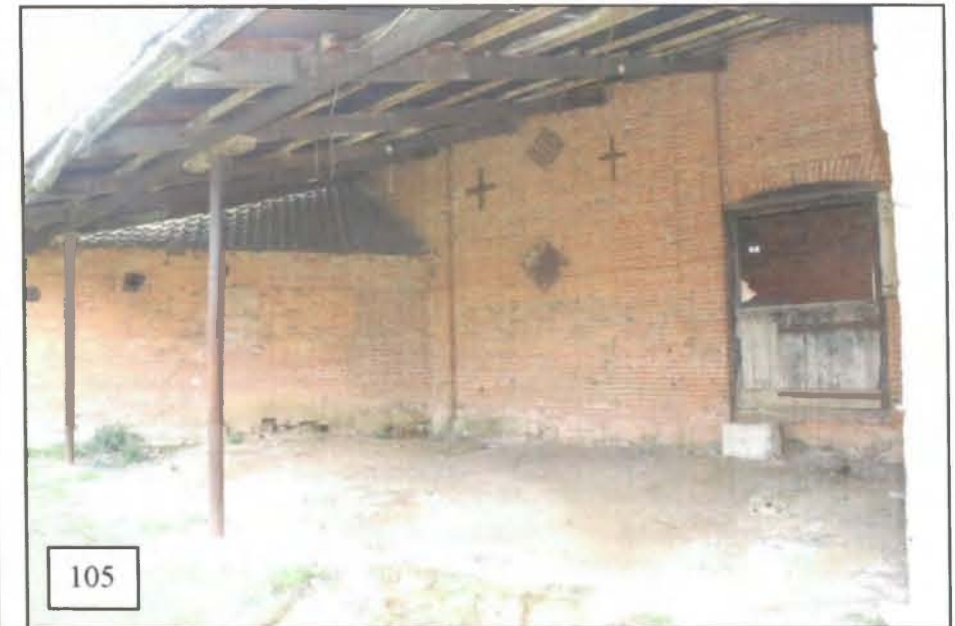
Building G is a lean-to structure utilising the south wall of Building A as its main structural support. It is unclear now how the roof of the original building was supported on the west side, but an east gable wall is present in which two clear building phases are evident. It seems likely that the earlier structure represented in this wall is part of that seen on the OS map of 1886.

The original structure was constructed in 3" brick, in 5-course EGW bond. The east wall was 9" in thickness, with a 14" thick buttress at the south side.

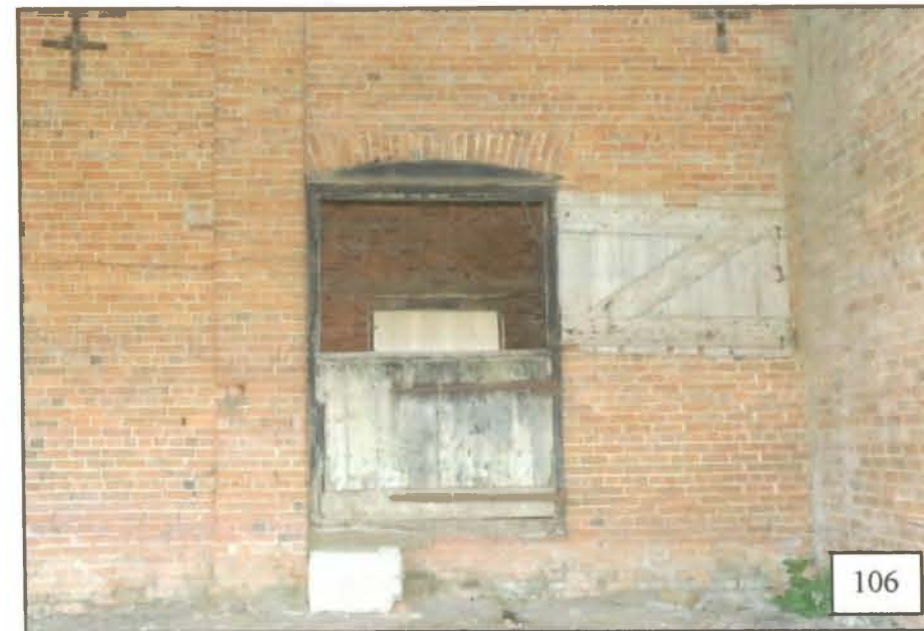
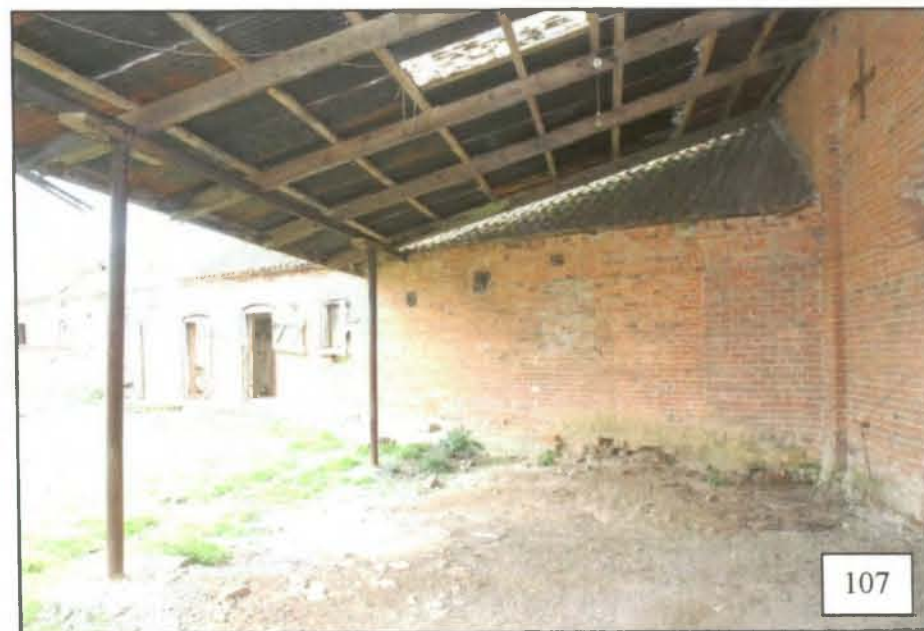
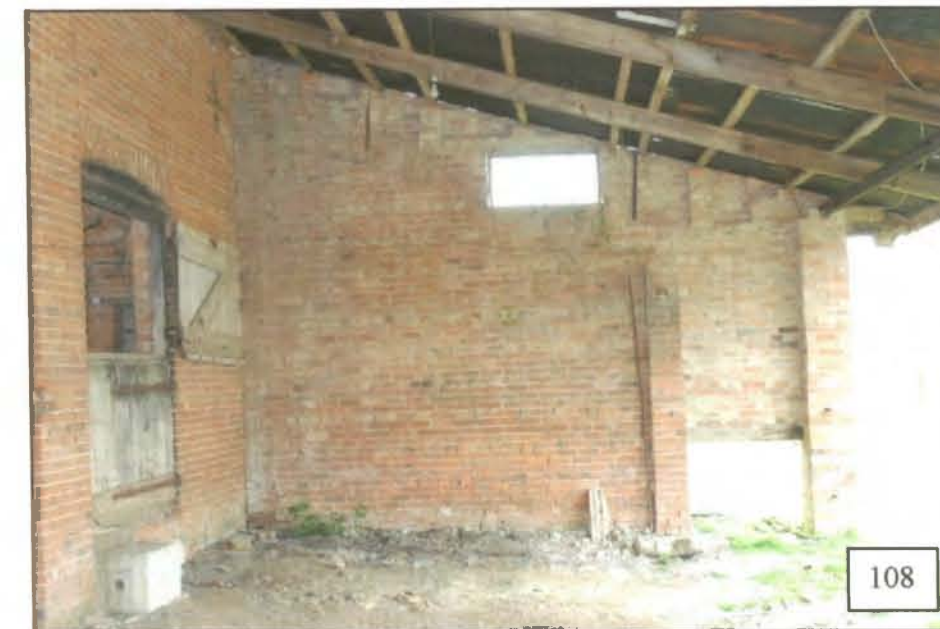
The modern structure appears to be a direct replacement of the earlier one, extending it to the south, and raising the height of the eaves. This was carried out in a lighter 3" brick. A top-hung metal-framed four light window is also present in this wall. The roof is of corrugated metal sheets and is carried across the open front on 6" steel channel, supported on two 4½" diameter steel pipe uprights.

It is likely that Building G was constructed as cattle accommodation or as fodder/straw storage for the northern yard. As extended, the building served as a cattle shelter for overwintering stock, when the northern crewyard was divided in two by a temporary north-south fence (Mary Hoban, *pers. comm.*)

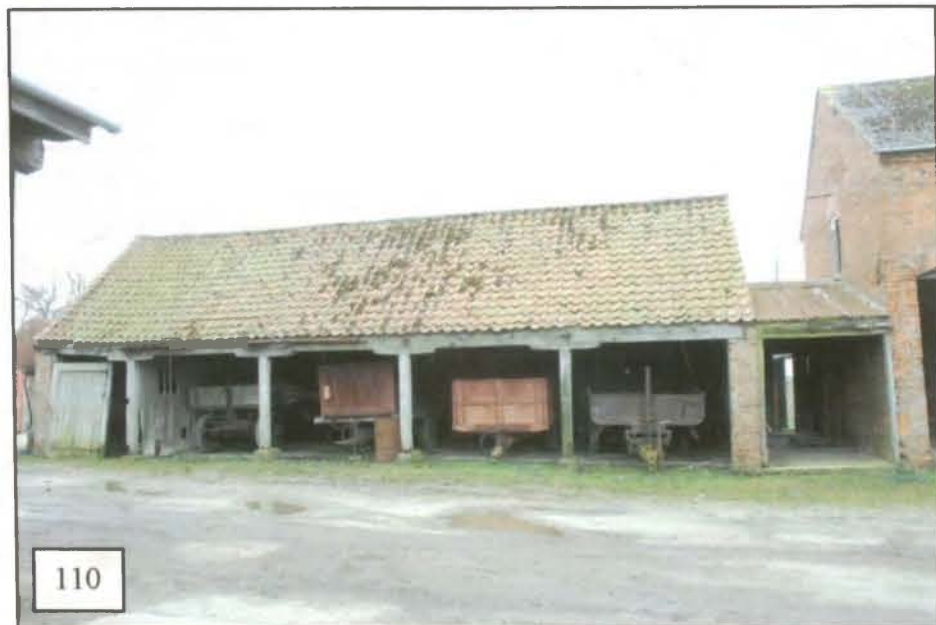
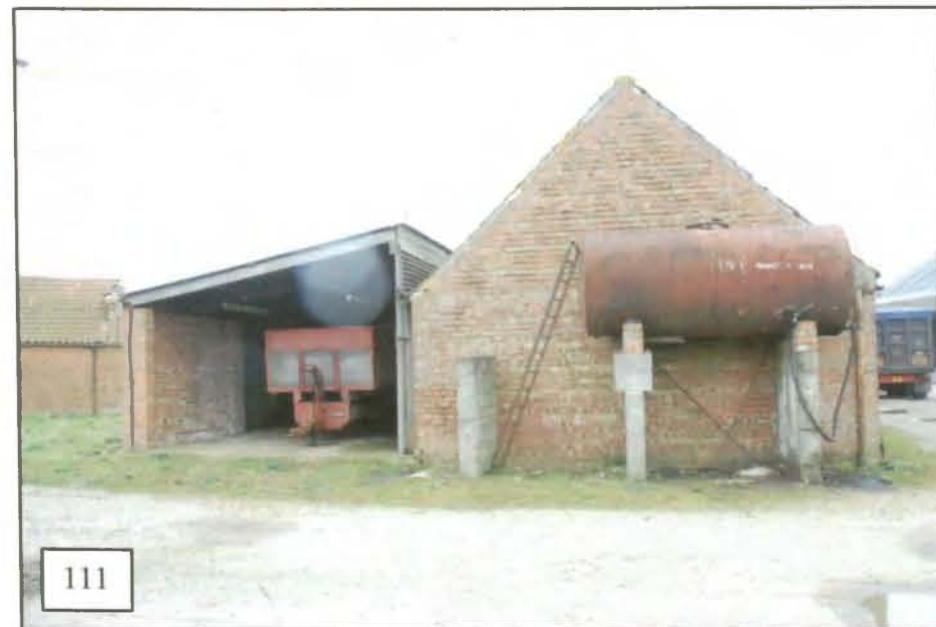
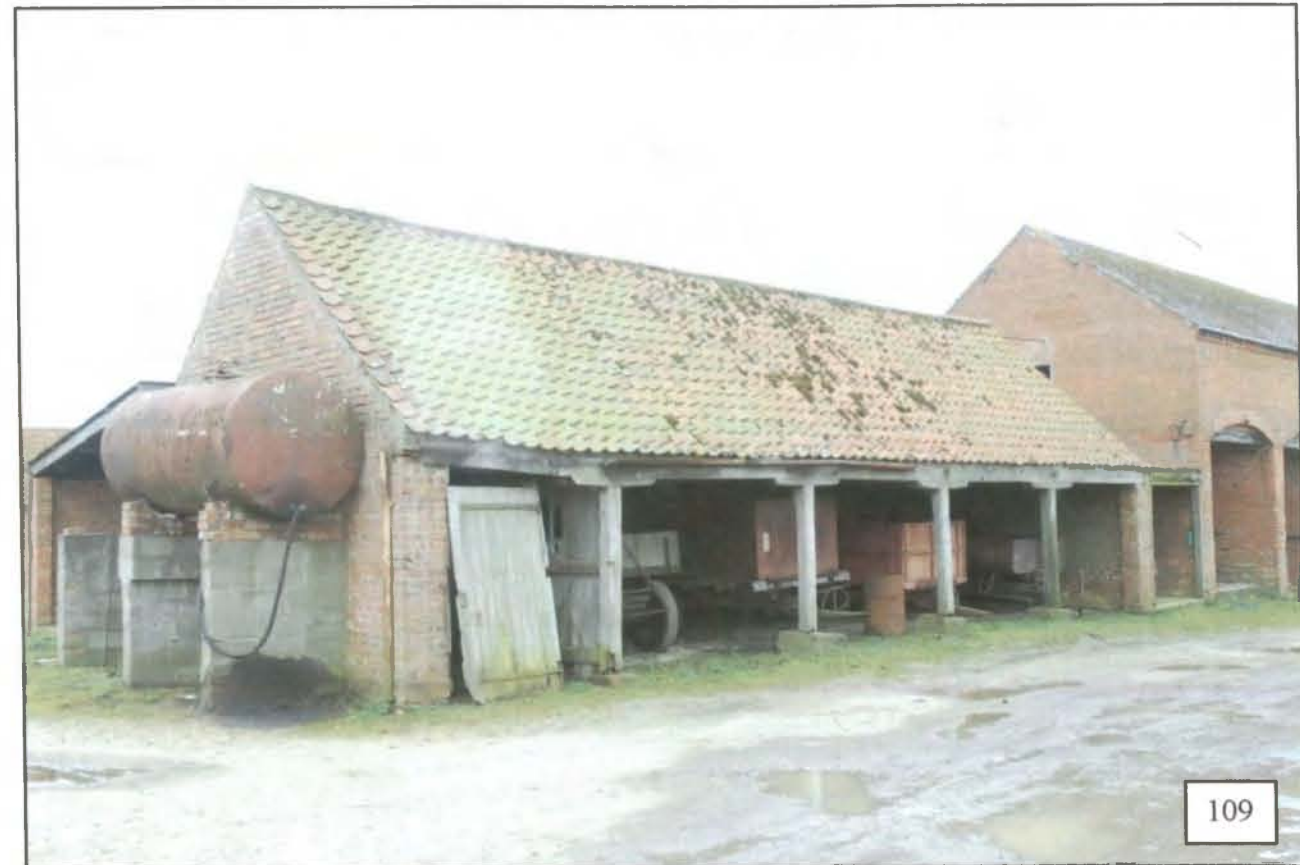
Building B was added to the east of the north range of the model farm, continuing the northern building line established by this range. It does not appear on the second edition 6" or 25" OS maps of 1907, however, the valuer who annotated this plan whilst undertaking the Land Tax survey around 1910 has added its outline and described it as a brick and tile wagon shed. The timber partition present between the eastern bays of this structure had graffiti suggesting it was built in 1909 – the cartographic evidence supports such a date. The building itself is indicative of the increased mechanisation of local farming practice that had occurred since the farm's original construction, which required more accommodation for increasingly expensive implements and equipment.

Building B is a five-bay open-fronted structure, constructed of 9" thick brickwork in 3-course EGW bond in a reddish orange 3" brick, with a pitched pantile roof.

The four western bays are open, while the eastern bay has a ledged plank door, complete with doorpost, leant in the gap. The northern side of the building is supported on four chamfered 7" square posts on concrete plinths.

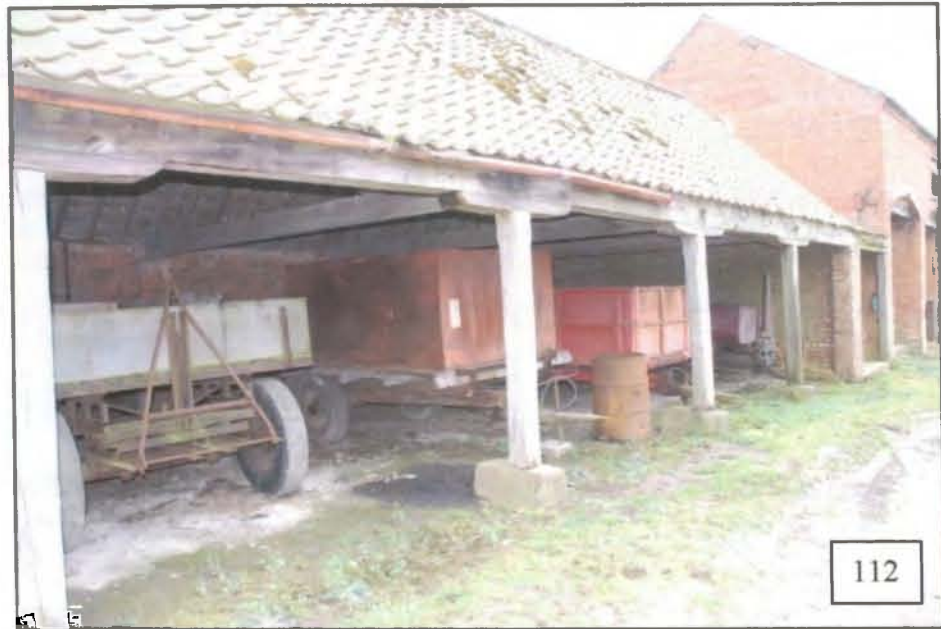
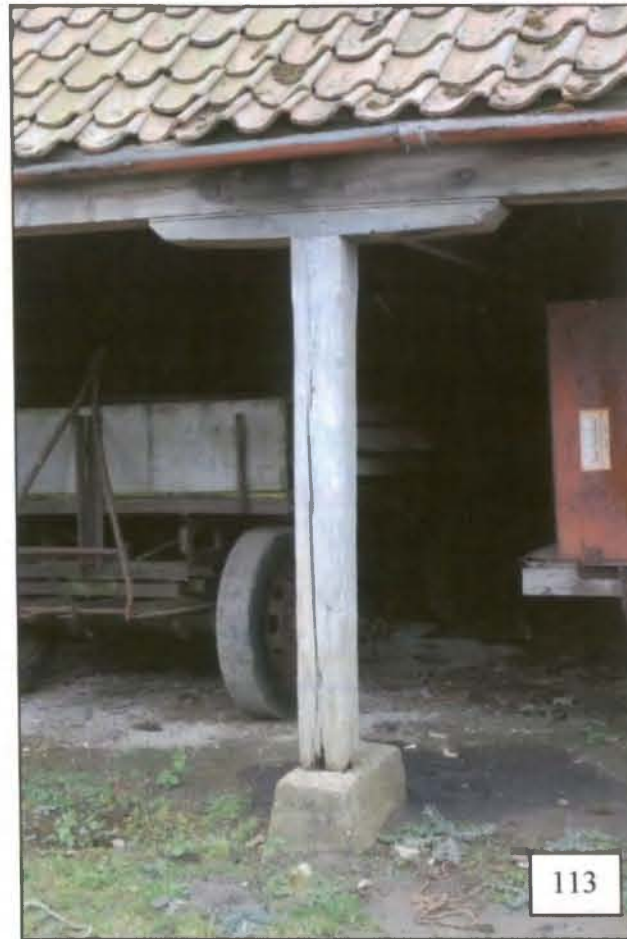
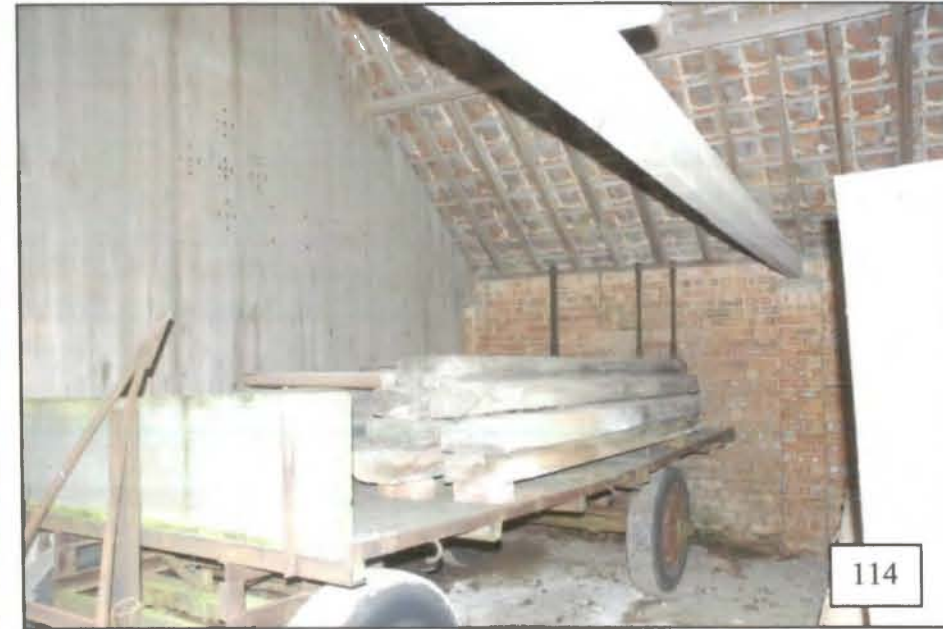
The floor is of packed earth: in the westernmost two bays, the rear half of the floor comprises a series of north-south laid railway sleepers covering a rectangular concrete-lined pit, which may have been an inspection pit, but is more likely to have been part of the grain transport system.

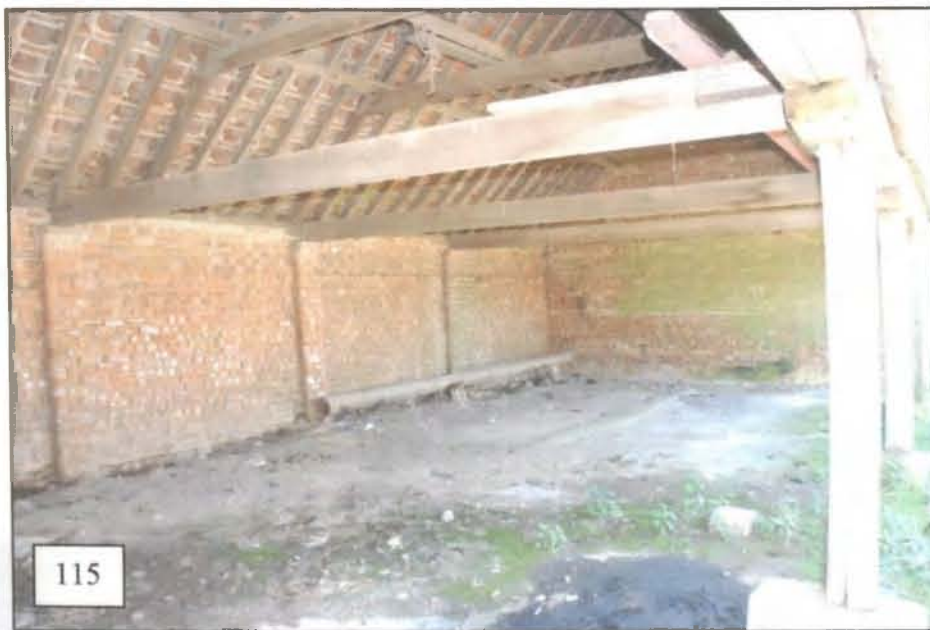
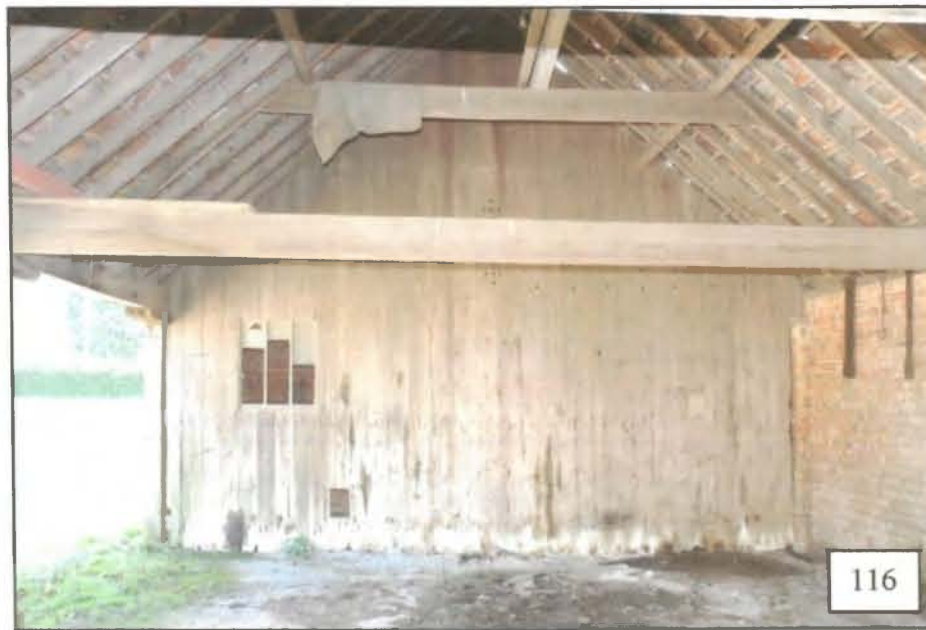
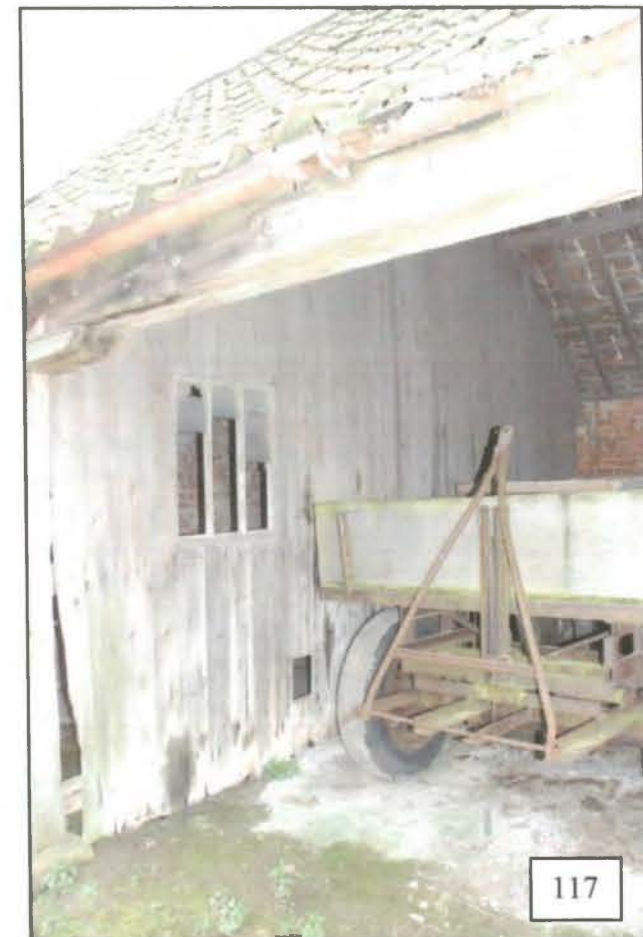
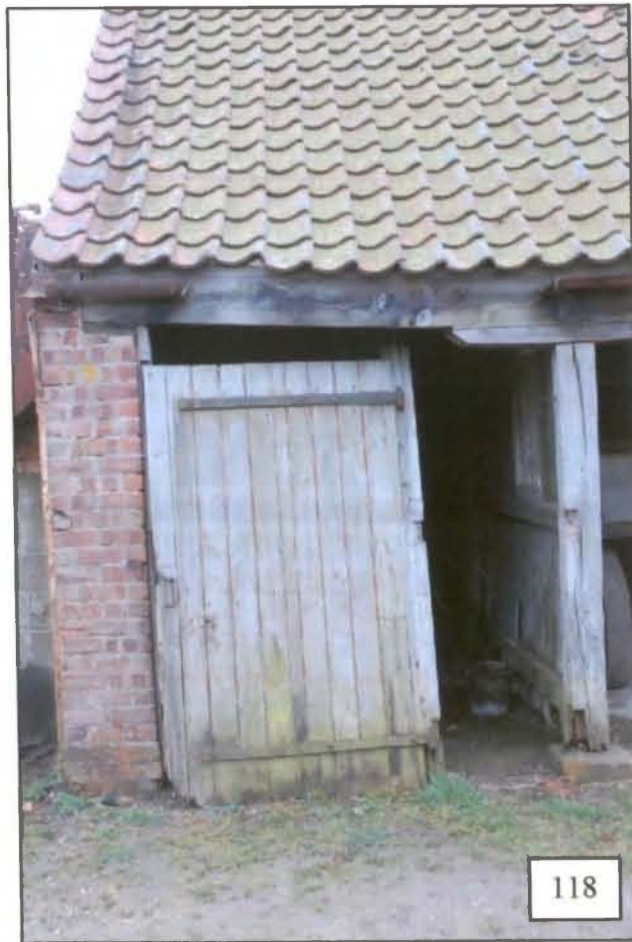
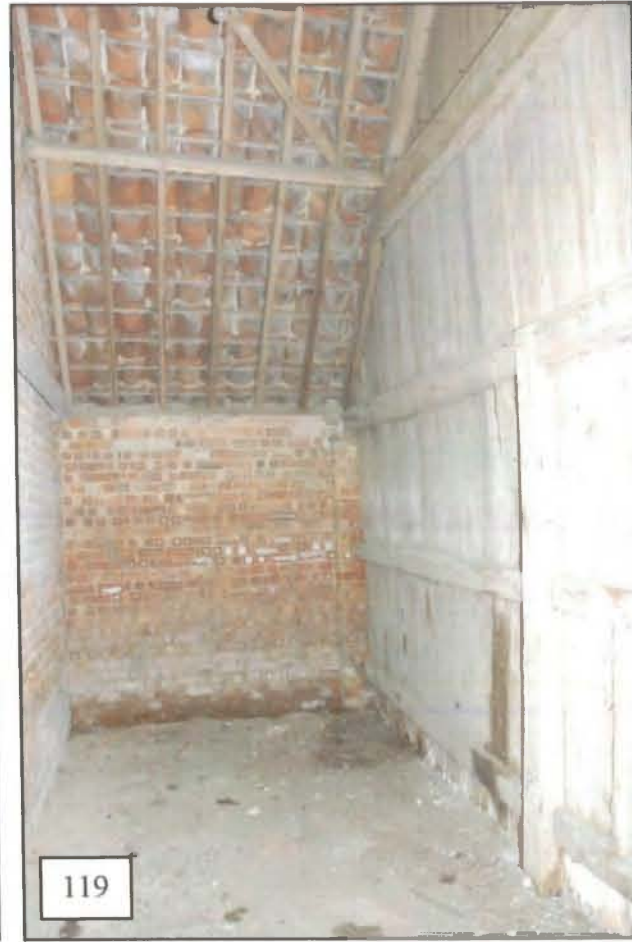
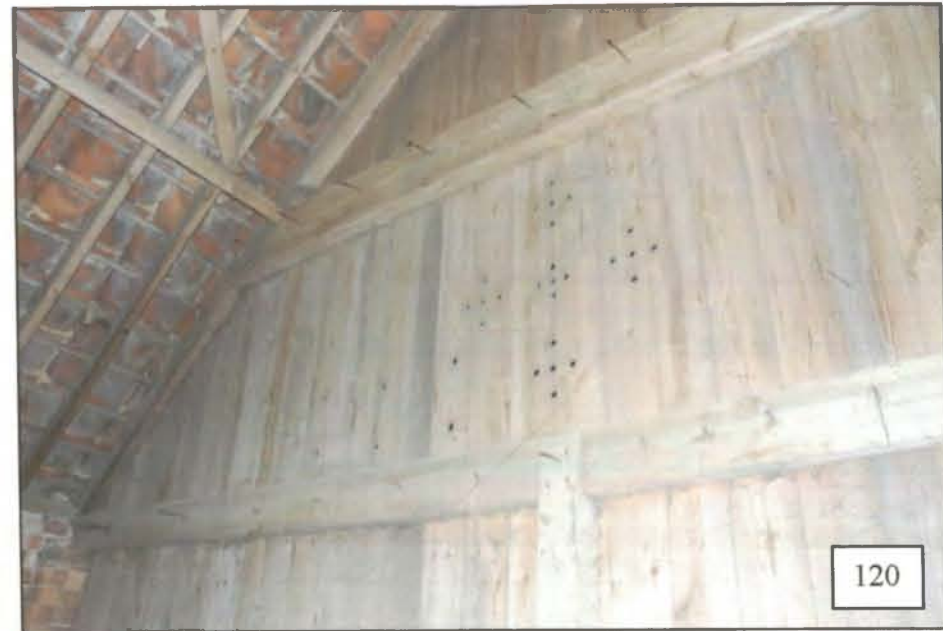
The roof is similar in construction to those of the single-storey model farm buildings, of collar-rafter construction with clasped through-purlins. The underside of the pantiles is clearly visible above the rafters. At the east and west ends of the building, the roof has diagonal timber braces between the ridge-board and purlins. The chamfered heavy timber tie-beams are supported on the south side on brick buttresses, and morticed to the horizontal timber lintel-beams above the posts with wrought-iron angled brackets.

A timber partition, of vertical 7" tongue and grooved planks, separates the eastern bay from the rest of the building. The partition is fixed to the west side of a collar above and a tie-beam lower down, the tie beam being braced with a central 5" square vertical post, which has further horizontal braces both to the wall and to the post of the open-frontage. A three-light window of overlapping panes is present towards the north end of this partition.

The partition has a series of drilled ventilation holes in a nested diamond pattern, centrally placed between the supporting collar and tie-beam, with a series of further drilled holes arranged in vertical pairs to the south.

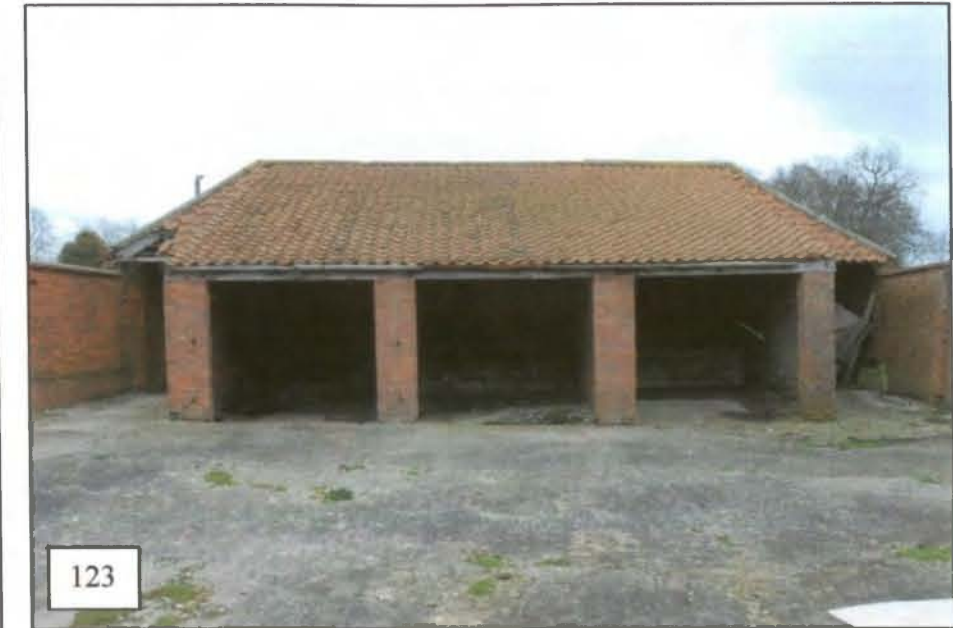
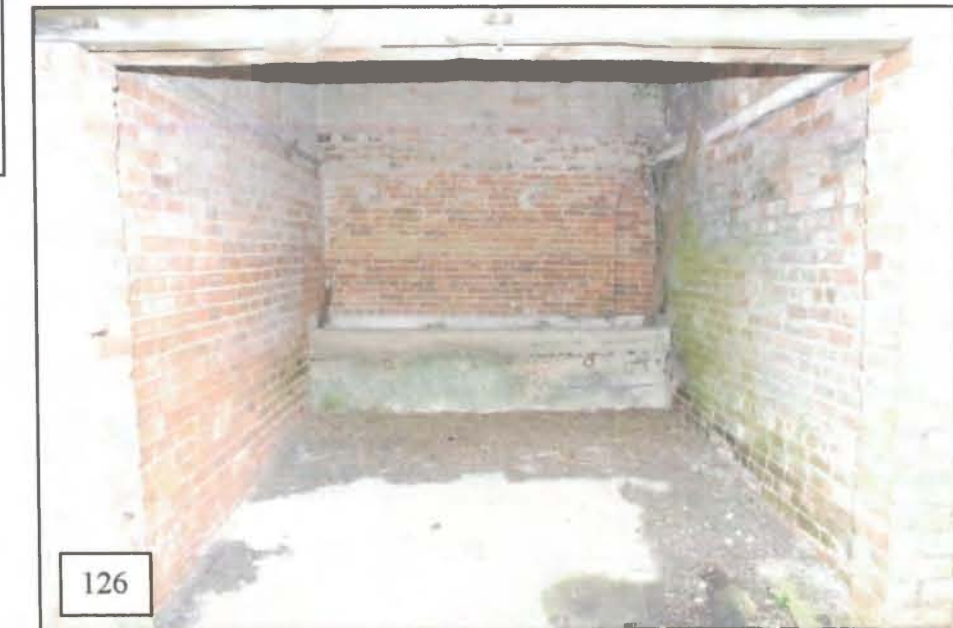
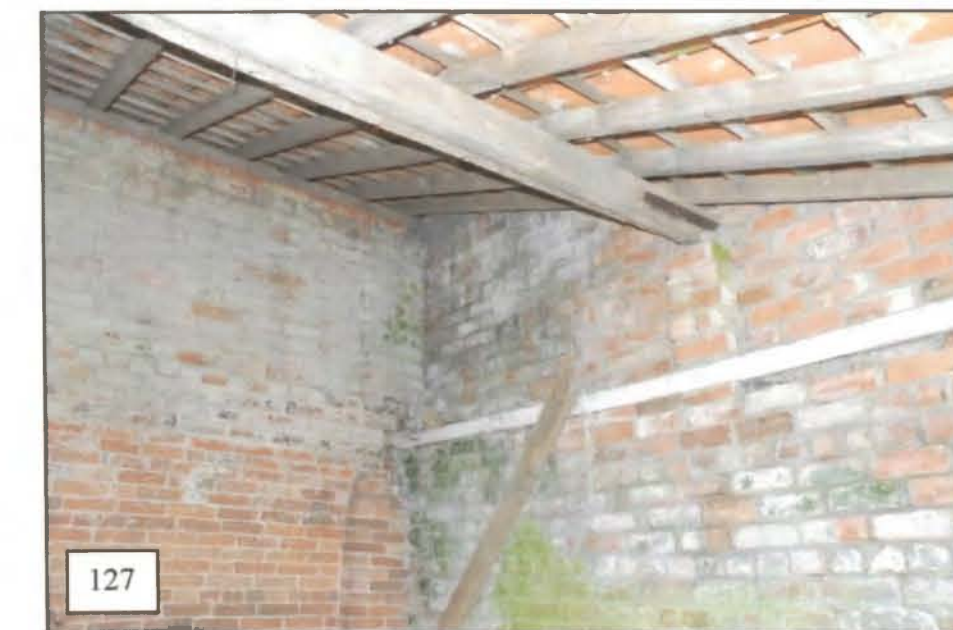
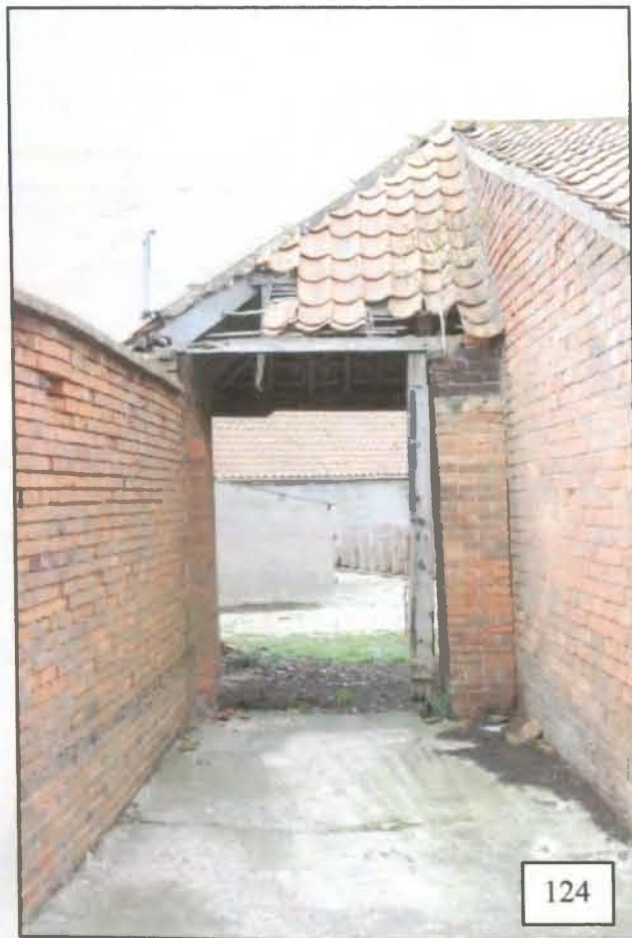
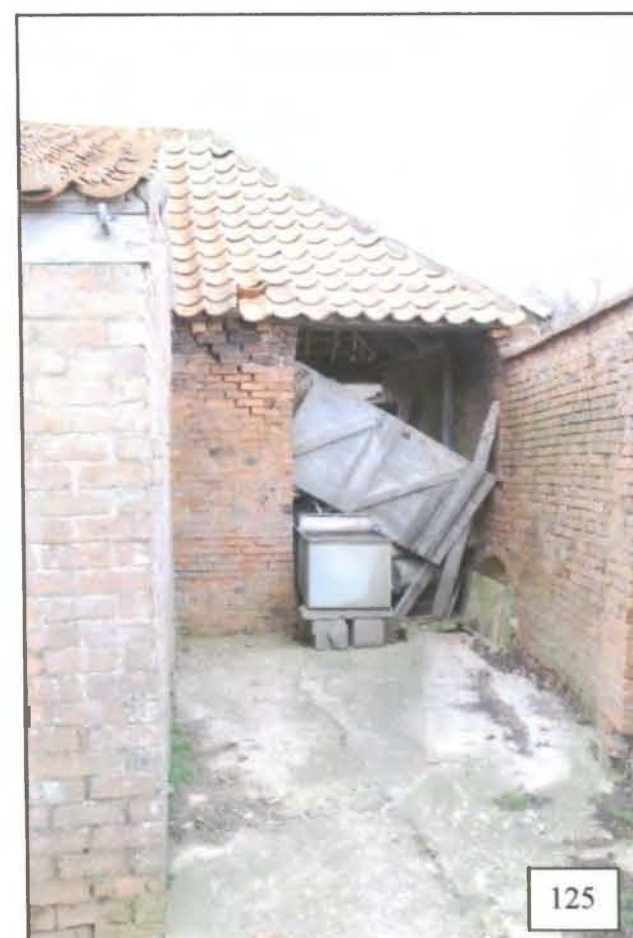
In this phase, an extension was also built on to the west side of Building I. This is a three-bay structure, open-fronted to the west; the bays divided from each other with 9" brick partition walls. It was constructed in a red/orange 3" brick in 3-course EGW bond. It had a single-pitched pantile roof, its rafters supported on the timbers of the western pitch of Building I, and by 9" thick brickwork built above its west wall.

Unlike Building I itself, this extension did not reach the crewyard boundary walls, but has its own gables, allowing a wide, open passage between the crewyards to its north and south. Although its most recent use was as a cattle shelter, Mary Hoban remembers that this is probably the building in which horses were stabled, before the farm became fully mechanised. Each bay has a concrete feeding trough at its eastern end (although this is heavily damaged in the northern bay) and a concrete floor, inscribed with lines at 6 1/2" intervals to mimic tiles.

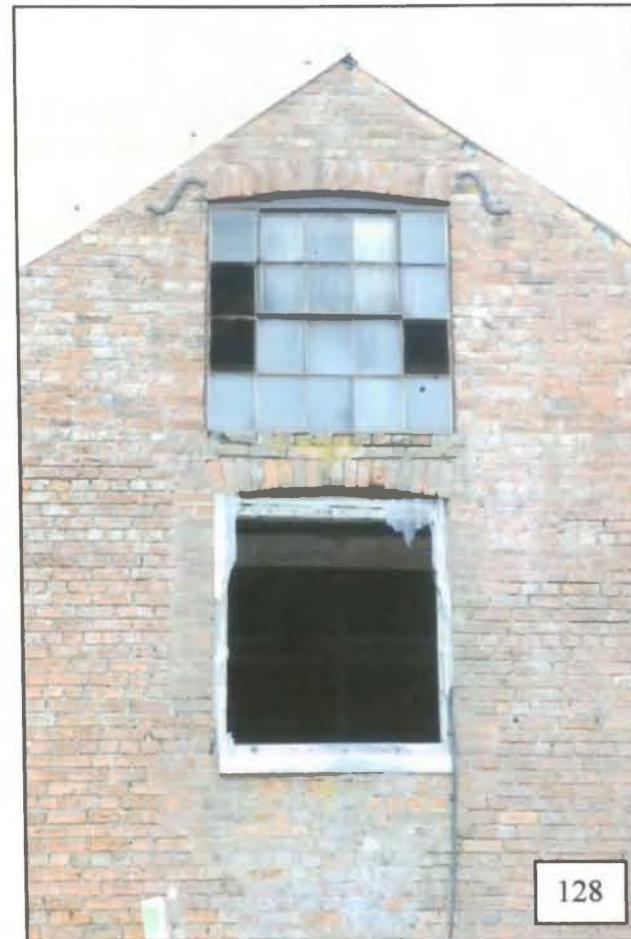
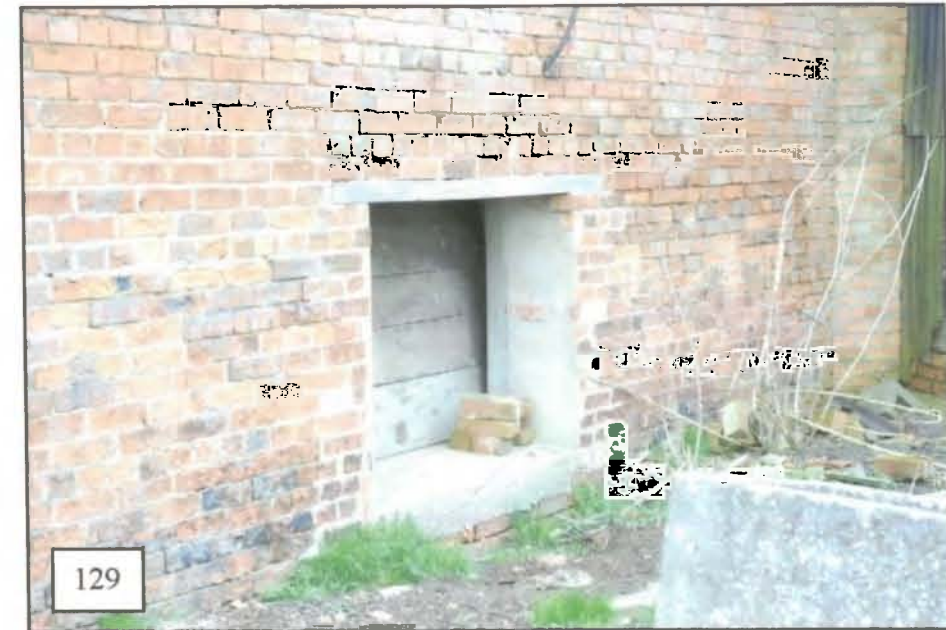
The original barn/granary arrangement was no longer capable of handling the ever-increasing grain yield, and extensive alterations were undertaken to this building. Firstly, the original pantile roof was replaced with corrugated asbestos concrete sheets. The cartshed was converted into several large grain hoppers with reception in the central bay.

The west half fared differently: the upper floor was removed and the resulting room was tanked out in rendered blockwork. An underground system for transferring grain from wagons to hoppers was inserted, and an overhead system was also in evidence.

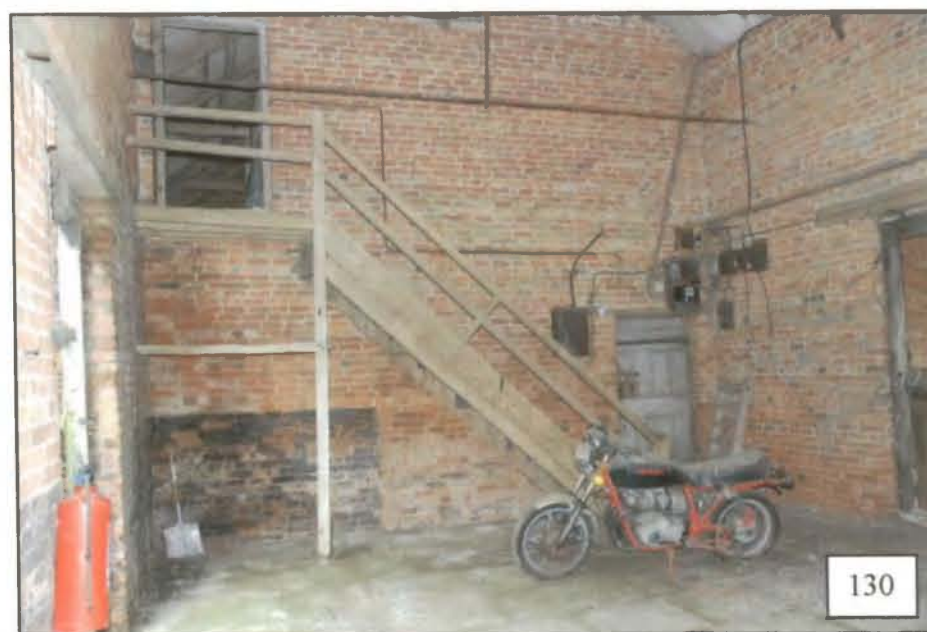
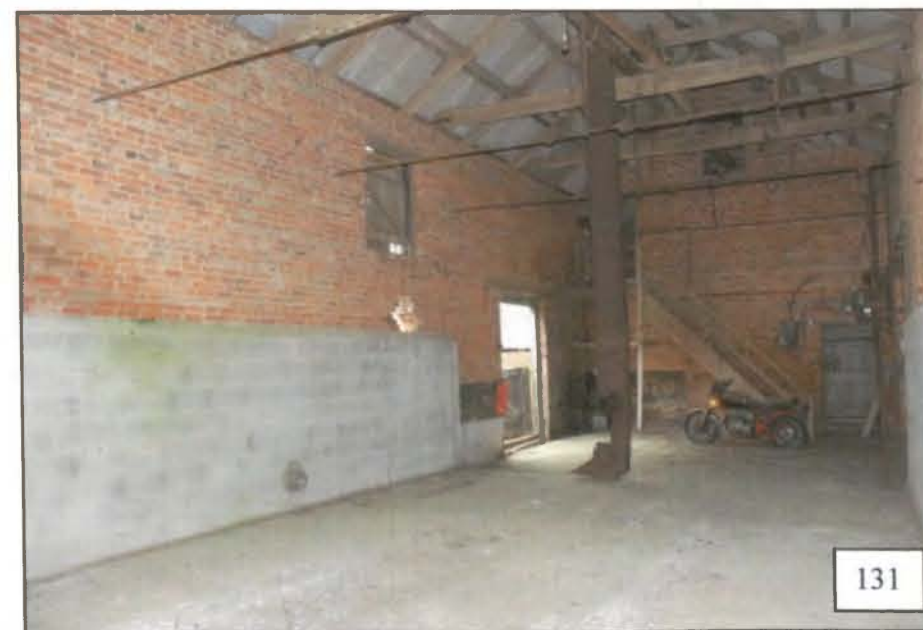
In the western gable, a large metal-framed window of 20 panes, with a centrally pivoting 6-pane casement in the upper half, was inserted above the original first floor window. At ground level, a new opening was forced through, with a concrete lintel to allow transport of grain into and out of the building.

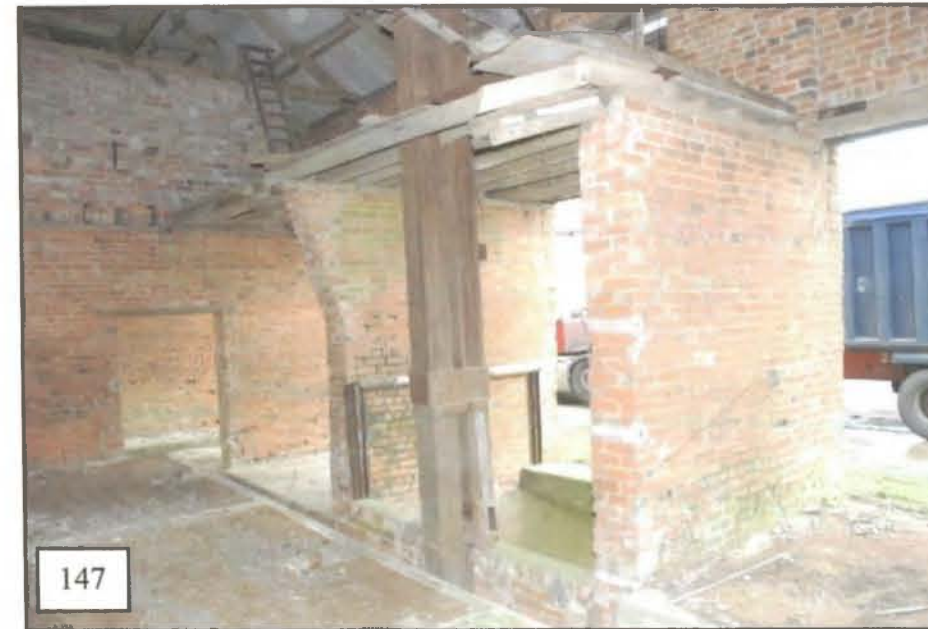
In the eastern part of the building, the rear halves of the cartshed bay dividing walls were removed along with the first floor in this area, to provide room for large mesh-floored grain bins (now removed). A central passage was excavated and concrete-lined to provide a grain transport system, while the central cart shed bay was excavated to provide a reception hopper for offloading grain from wagons.

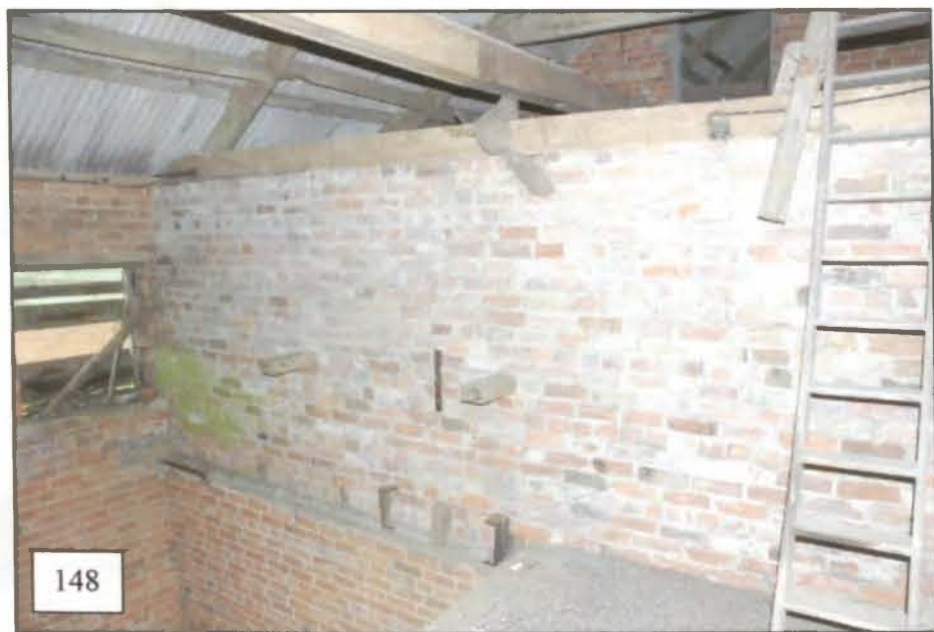
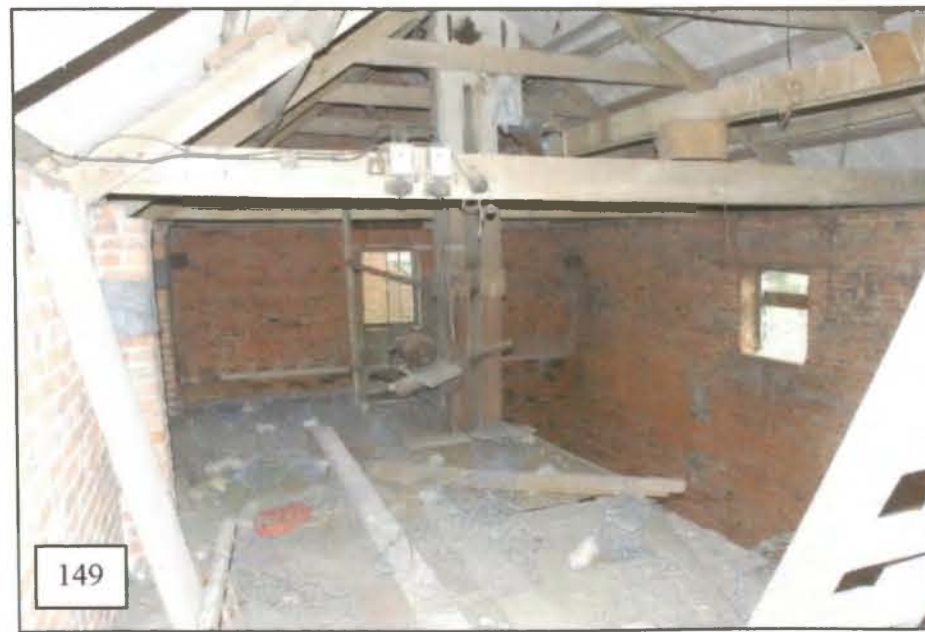
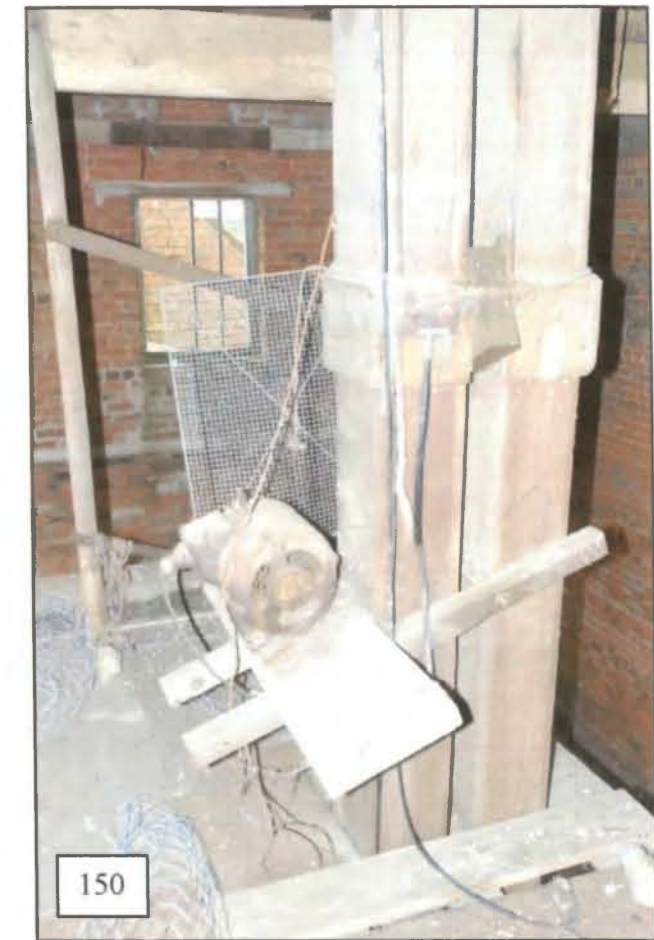
At first floor level, a large grain hopper was constructed over the passage from the yard, with chutes to allow loading of wagons. An overhead grain transport system was also present to transfer the grain from here to the tanked-out area in the western part of the building.
