# GRANGE FARM, WEST TORRINGTON, LINCOLNSHIRE

## PHOTOGRAPHIC BUILDING SURVEY

Site Code: GFWT 08  
LCM acc. no.: 2008.68  
Planning refs.: S/205/00678/08  
NGR: TF 1430 8132  
PCA job no.: 08-457

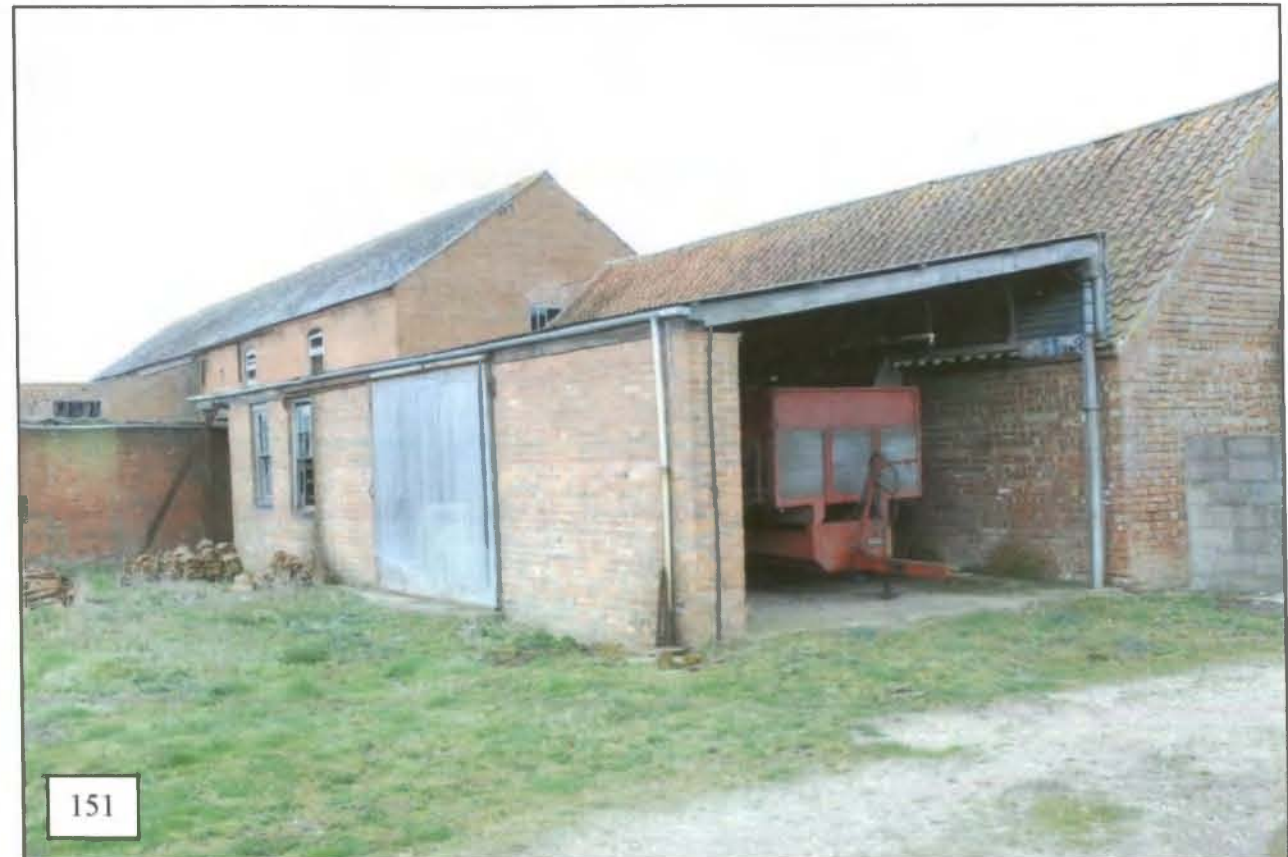
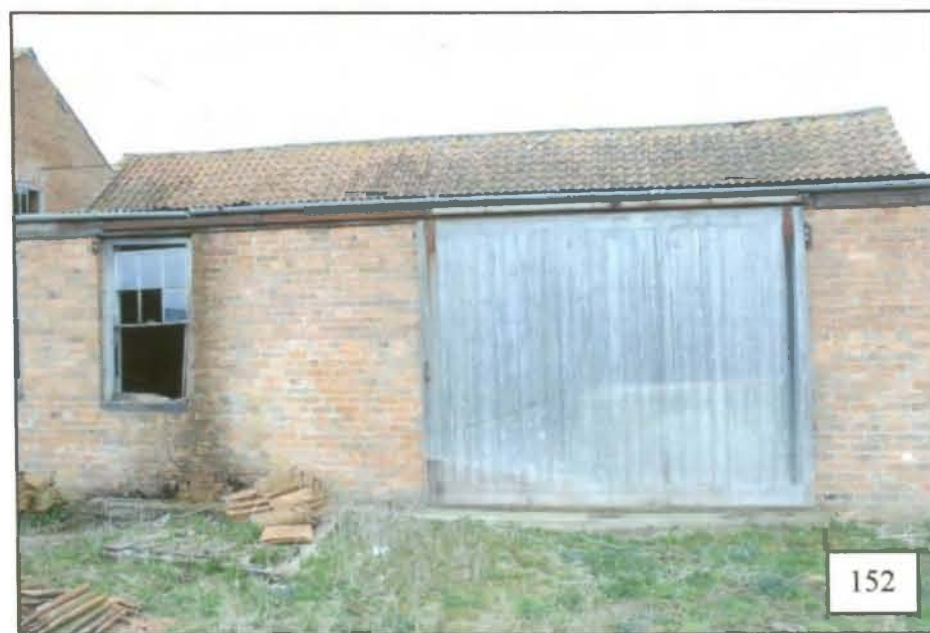
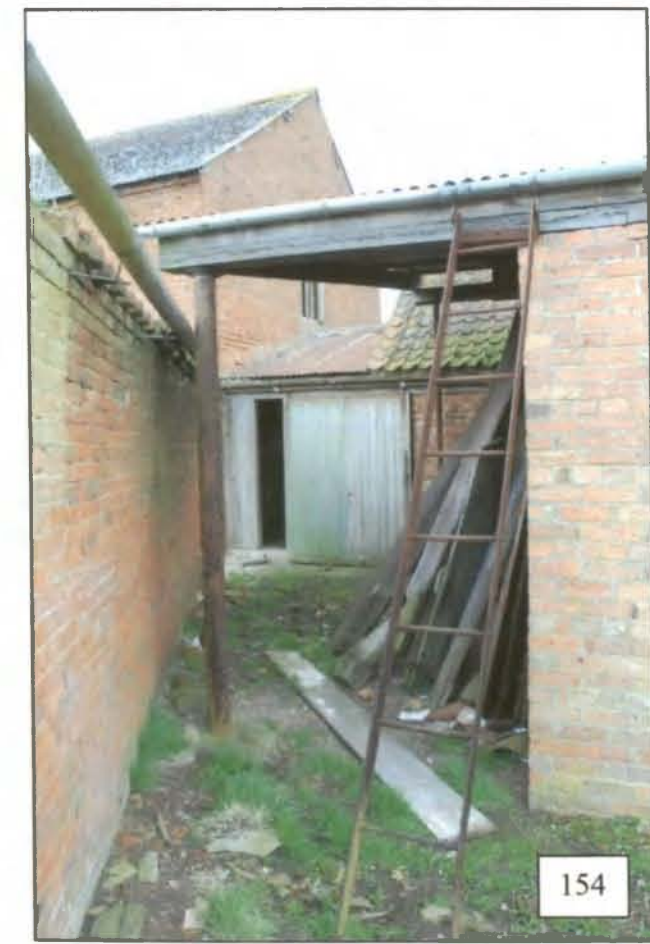
Building C utilises the south wall of Building B as its northern side, and is open-fronted to the east. The remaining brickwork is 9" in thickness, and of a mixture of re-used 2 1/4" - 2 3/4" brick (probably derived from the demolition of the building shown in the aerial photographs to the immediate south of the position of this structure) in a 3-course EGW bond. It has a single pitched roof of corrugated iron sheets, which is supported on the north side by a row of four 3 1/2" diameter steel pipe uprights, with corrugated plastic sheets in the intervening space between this roof and the eaves of Building B.

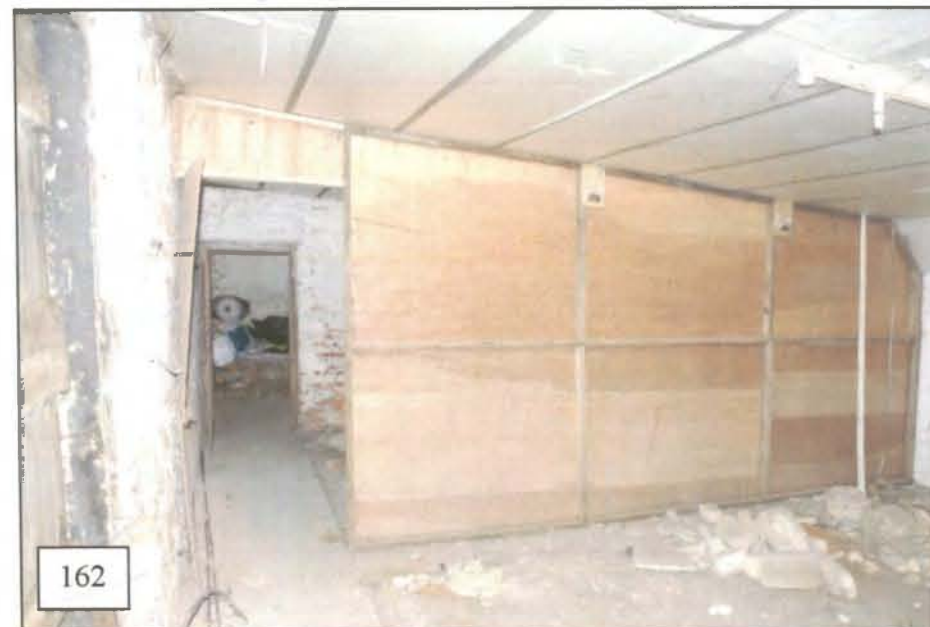
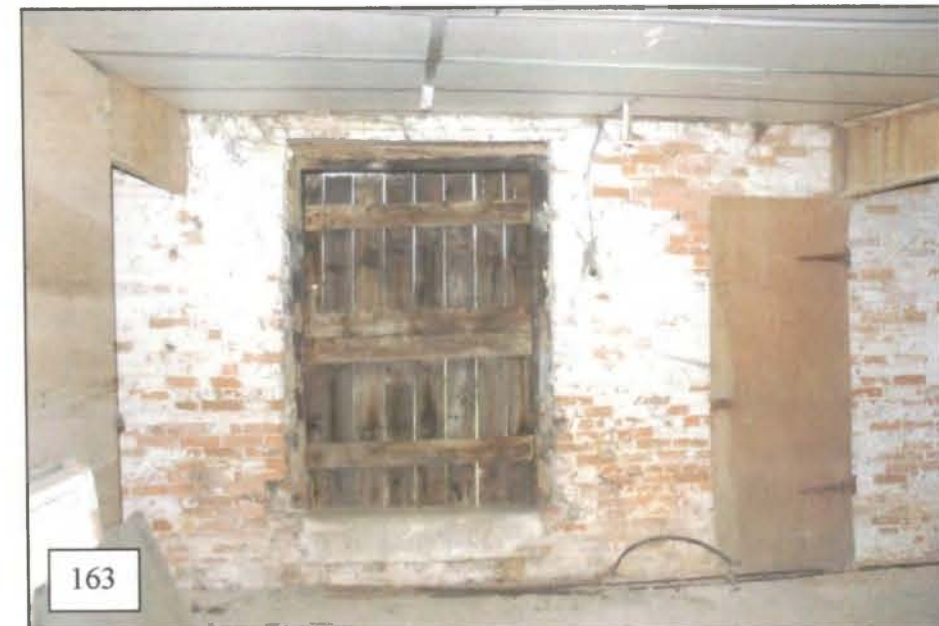
The interior of Building D, which until now had been an open-fronted four-bay cattle shelter, was completely altered. The open west side was blocked in 9" concrete blockwork, and the interior was divided into three rooms with stud partitions, modern doors and a plasterboard ceiling. A modern stable door was inserted in the middle of the east wall of the building, and further access was created at the northwest corner.

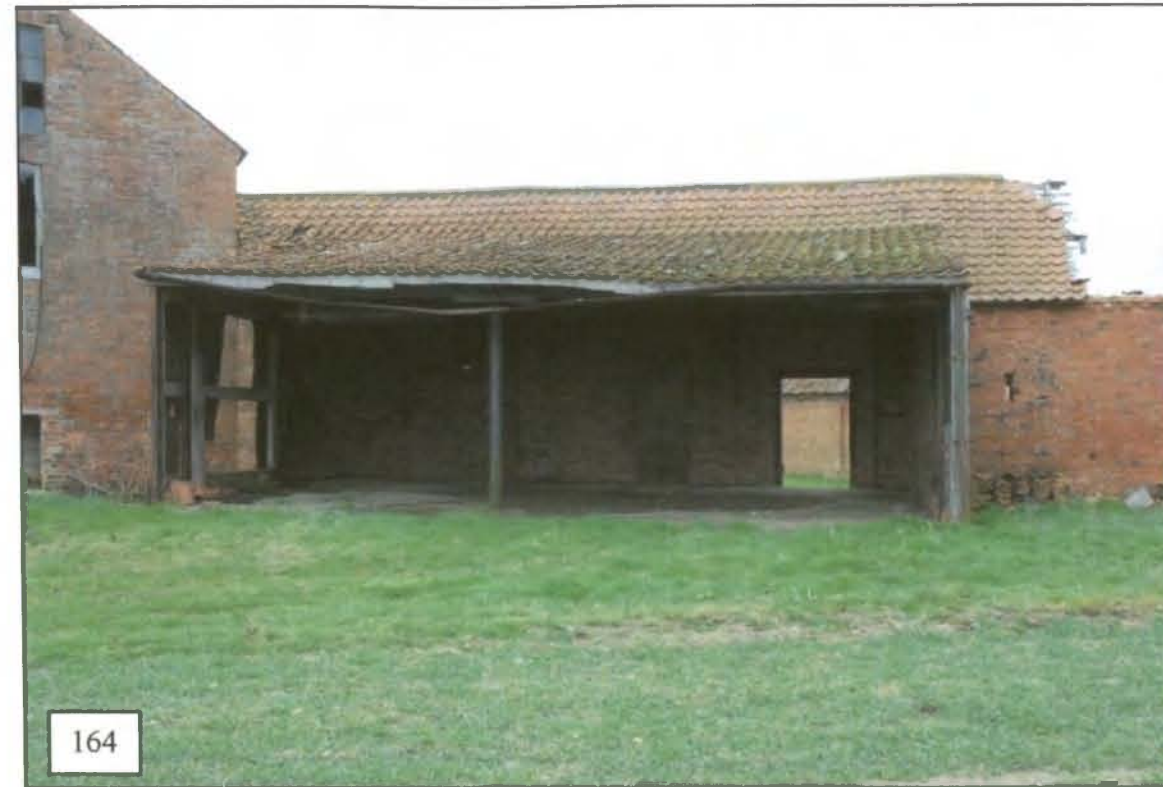
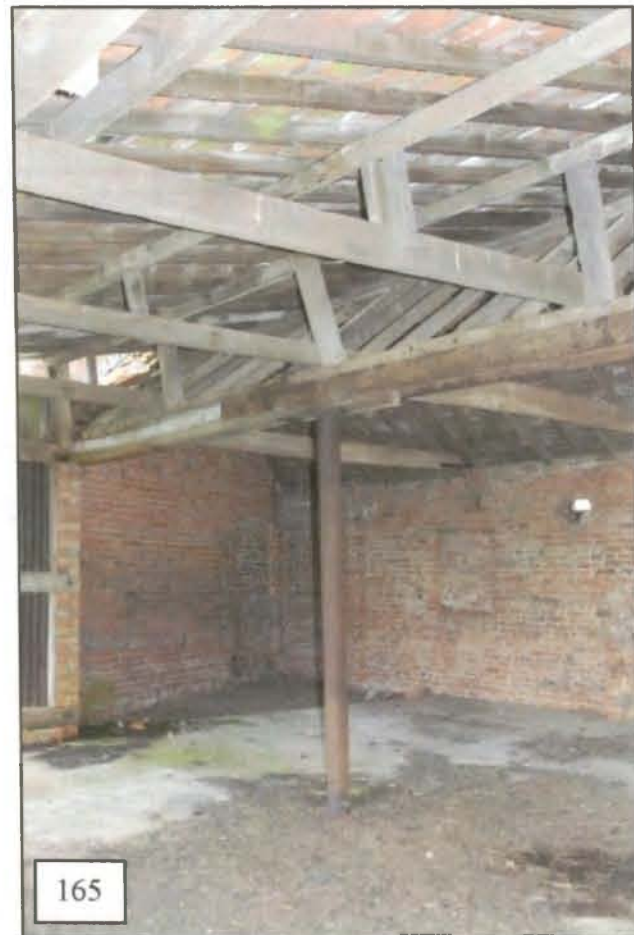
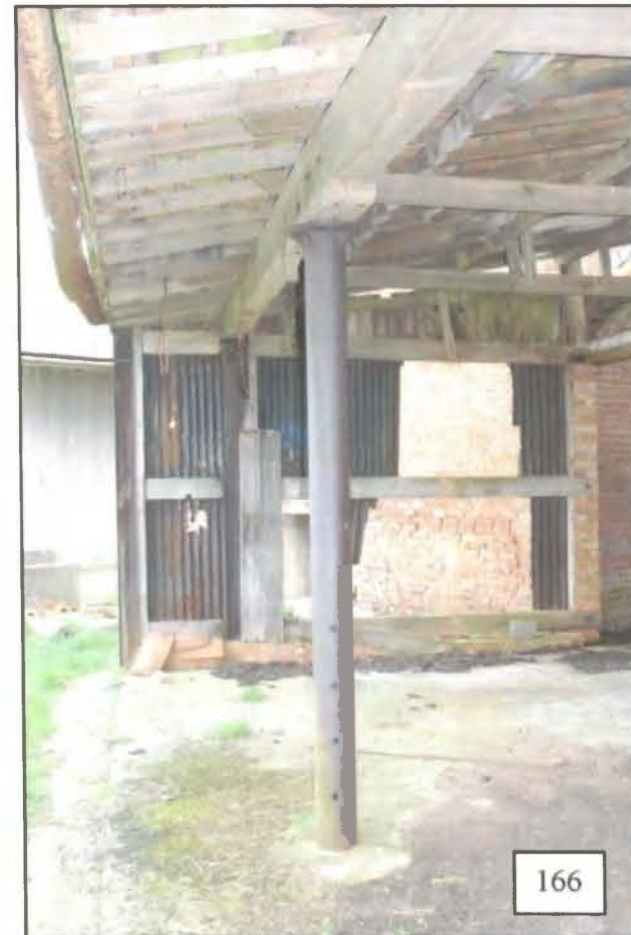
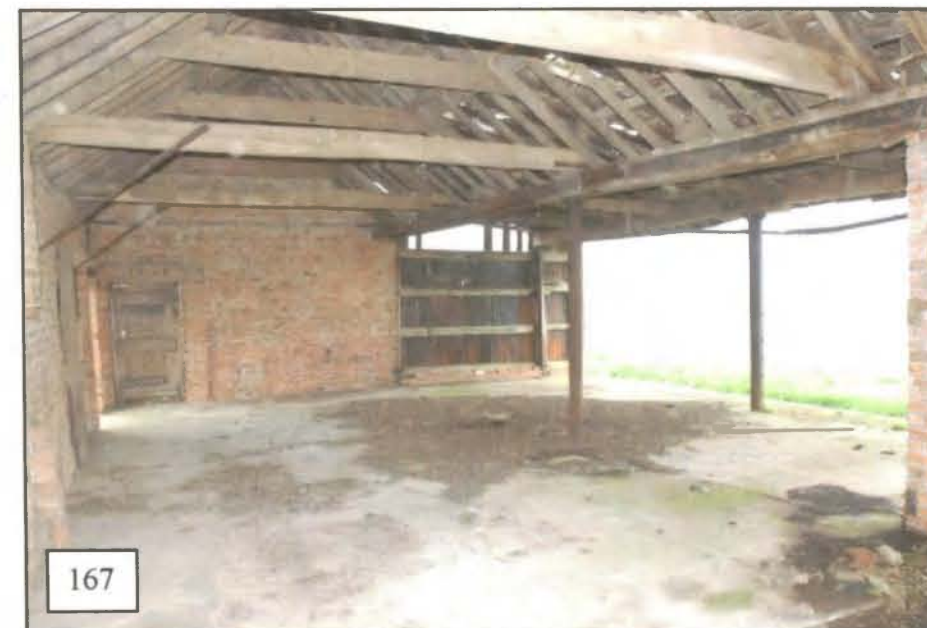
The building was extended by demolishing the west wall and carrying the wall plate of the original structure on a single centrally placed 5" diameter steel pipe upright. The new structure had a single pitched roof of re-used pantiles supported on short struts from the original western wall plate. It was open-fronted to the west and the extended roof was supported on each side on I-section steel uprights and a central 6" diameter cast-iron stanchion. On the north and south sides the remaining space was enclosed with corrugated iron sheeting on timber studwork attached to the steel uprights. The floor comprises eight poured concrete panels, contemporary with the extension.

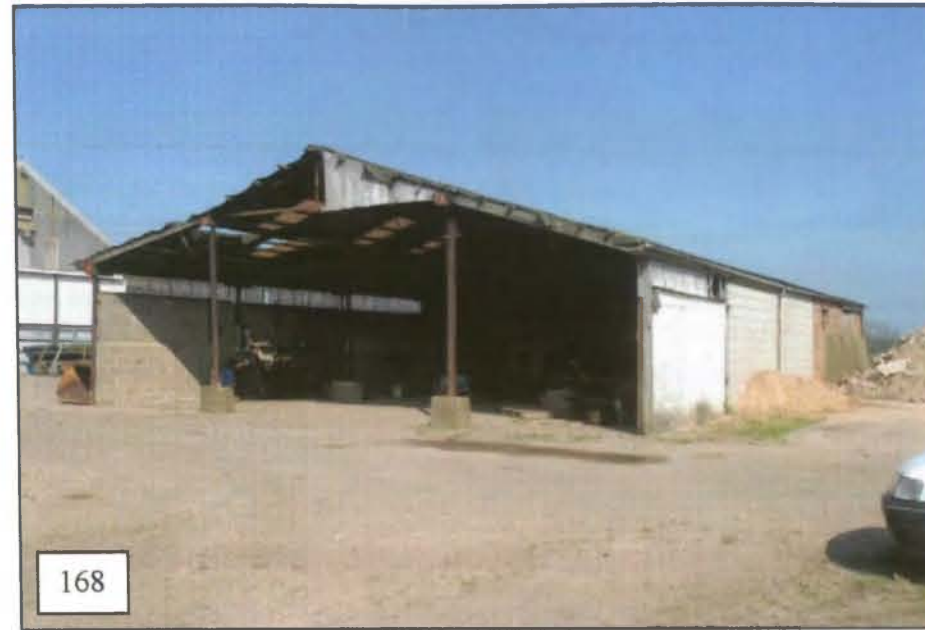
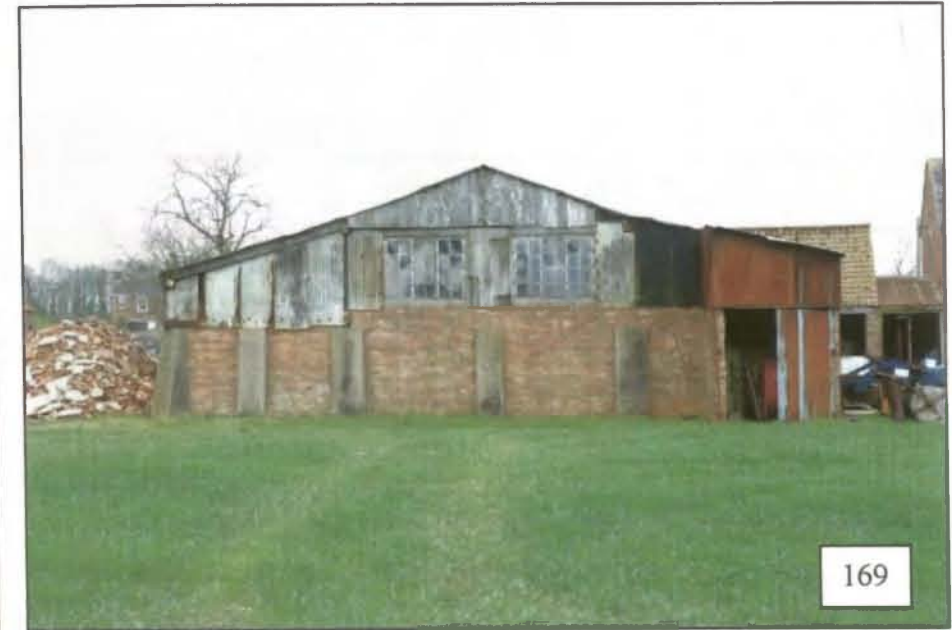
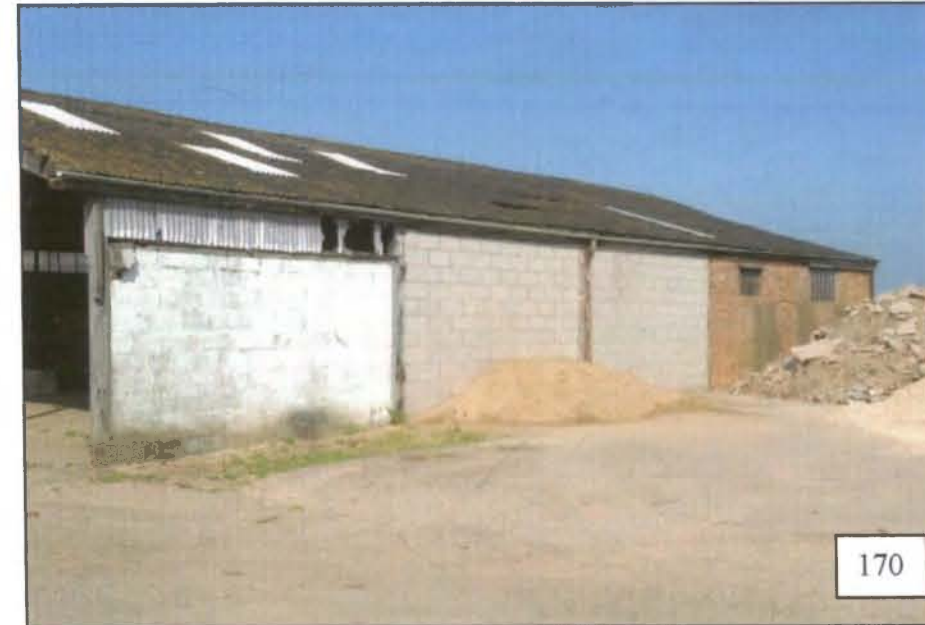
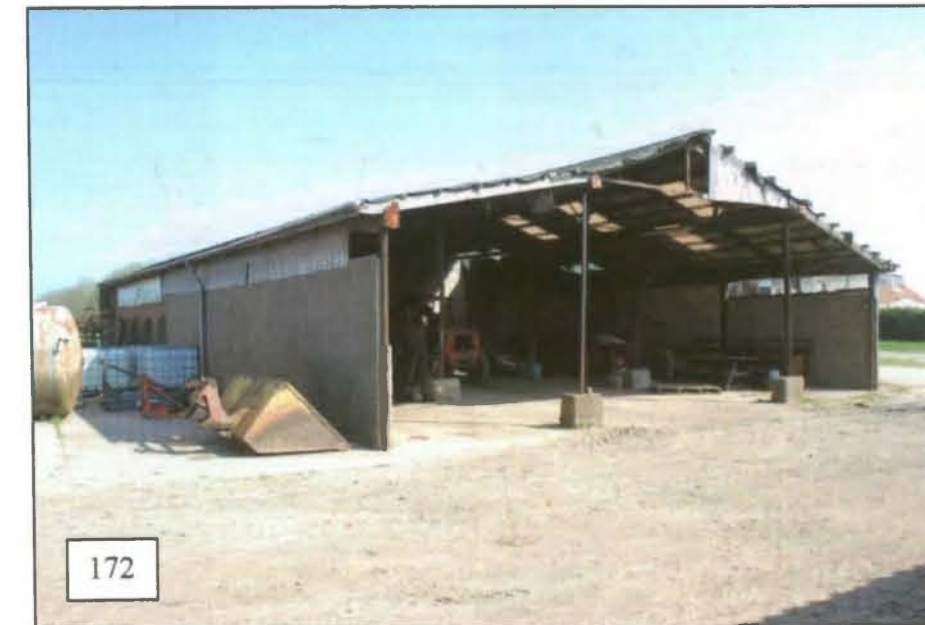
Building L comprises a large steel framed building, with a shallow pitched roof of corrugated asbestos cement sheets, the central part of which is carried on steel trusses supported on vertically set re-used tramway rails as uprights. The roofs flanking the central section are effectively lean-to structures carried on the central uprights and external rows of a mixture of re-used full-sized rails and I-beam uprights. It has a floor of poured concrete panels.

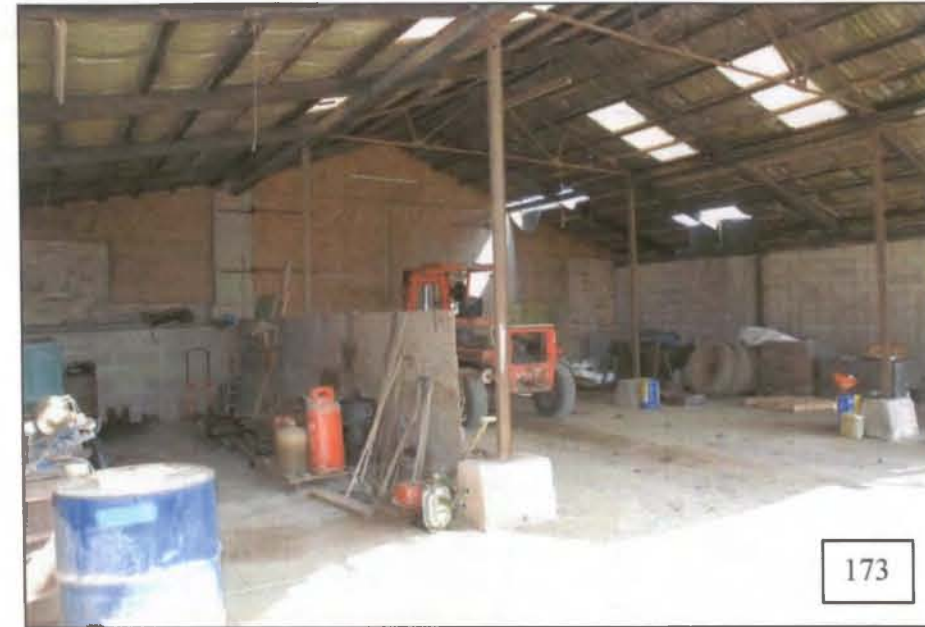
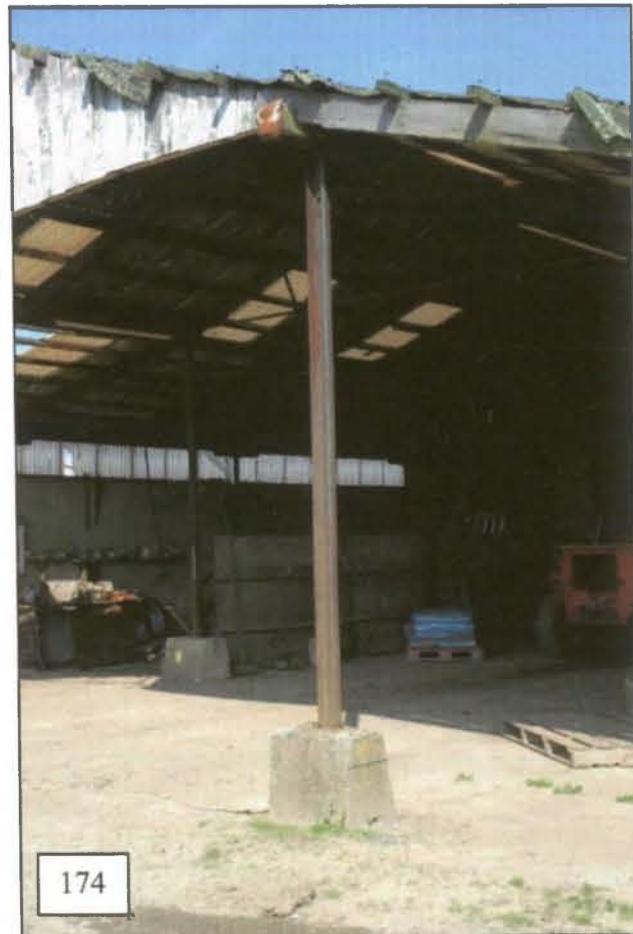
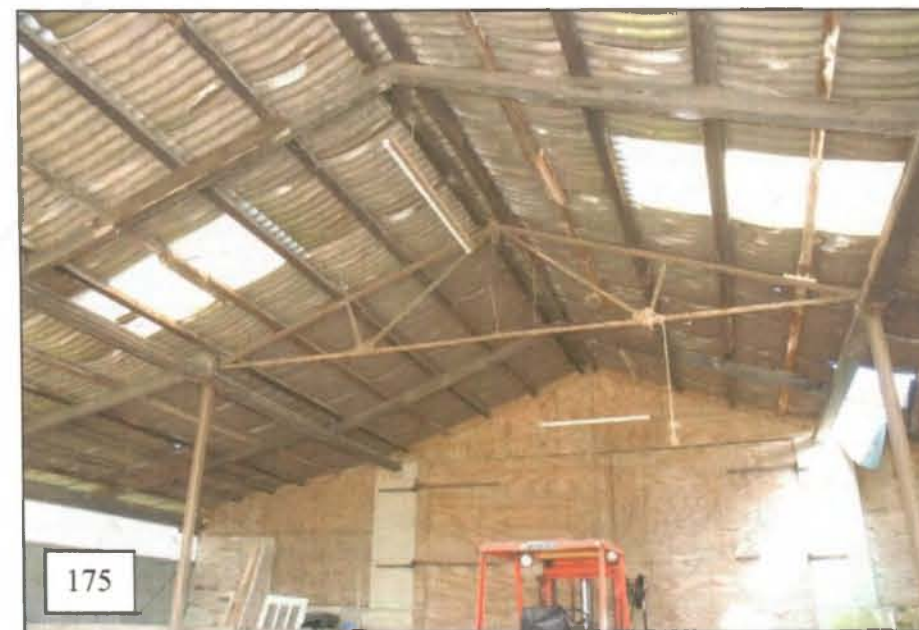
More recently, the building has been enclosed. This appears to have happened in two distinct phases, the northern part of the structure being enclosed first, in modern 3" brick with a mixture of re-used steel-framed windows. The southern half of the building was then enclosed with concrete blocks, the lower part of 9" thick blockwork with 4" blockwork above and transparent corrugated plastic panels below the eaves, leaving the southern end open. There is a redundant fan-house on the north side of Building L, attesting to its history as a grain store, but the structure was most recently used as a workshop and storage area for farm machinery.

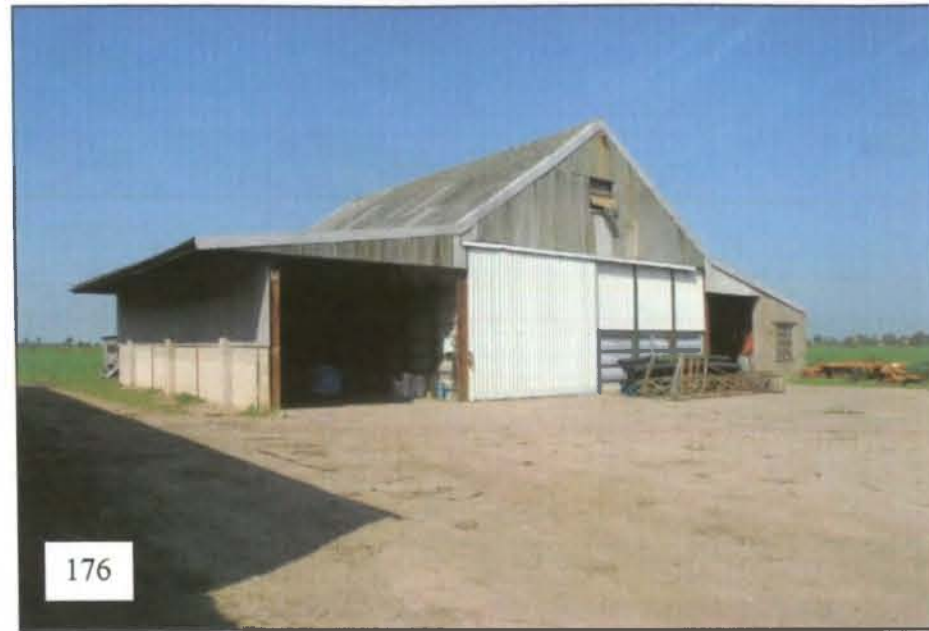
176

Constructed since the aerial photograph of 1964: Mary remembers this as having been built in the late 1960s. She remembers that, when built, only the central part was walled, the north and south bays being completely open-sided. The structure, although clad in modern materials (profiled panels etc), has a timber structural core, and the roof trusses are more typical of Victorian industrial building elements than anything available in the 1960s: Mary remembers that the structure for this building was reclaimed from the demolition of a foundry in Market Rasen by a local builder. Several other elements present around the farm may also have had a similar origin. The upper window in the west gable of Building A is very similar to those in the northern bay of this building, while some of the sliding doors may also be from the same source.

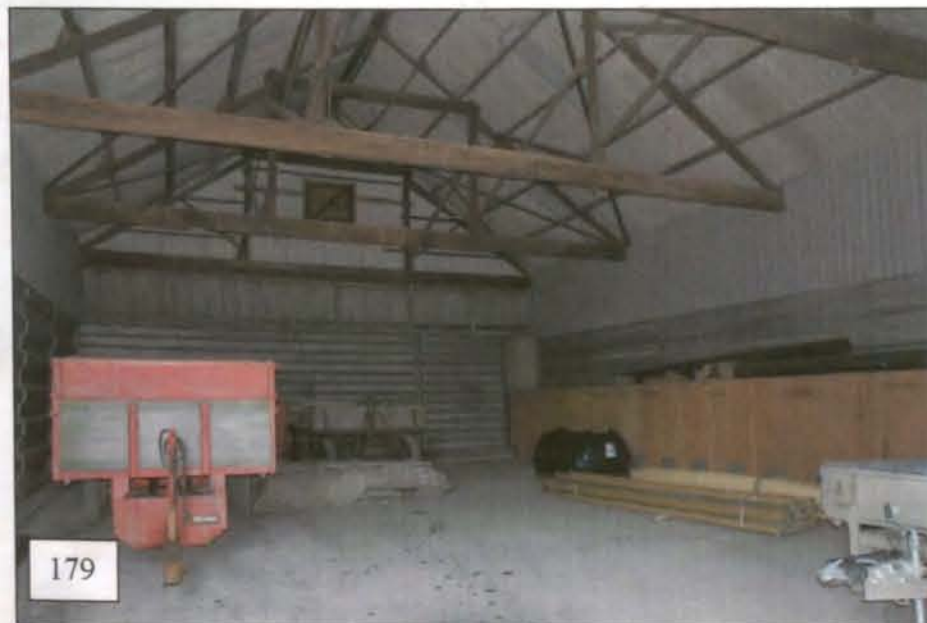
179

Building M is entirely clad in modern profiled sheets. It has no openings, apart from a large horizontally sliding door on the east (yard) side and window-like ventilation openings below the apex of the east and west gables. Inside, the roof construction is clearly evident. Five large re-used queen post trusses are present: all are reinforced by vertical steel tie-rods within the queen posts, and carry chocked through-purlins on their backs. Some of the trusses have lost their diagonal struts, probably because they interfered with the rather *ad hoc* longitudinal scissor bracing employed when they were erected here.

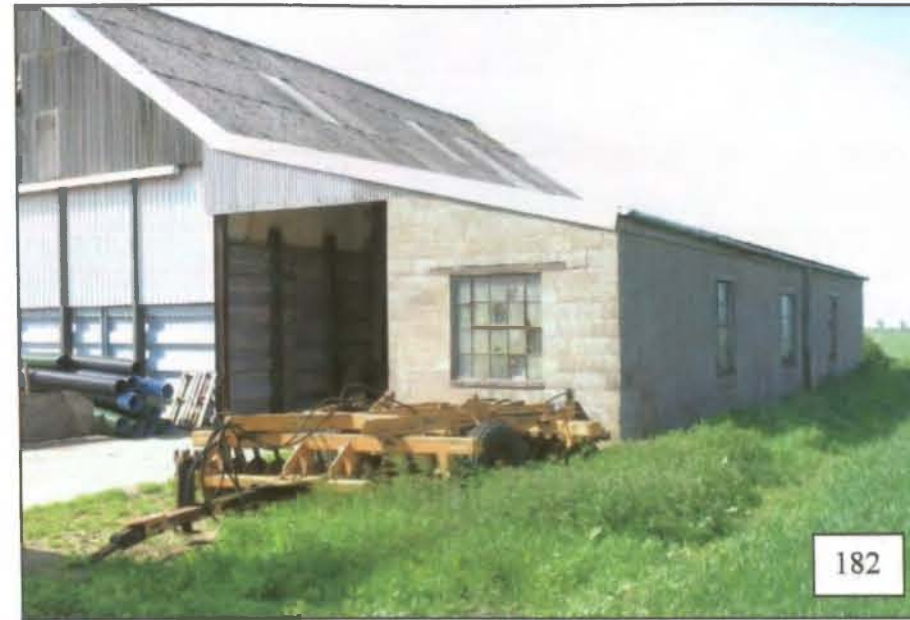
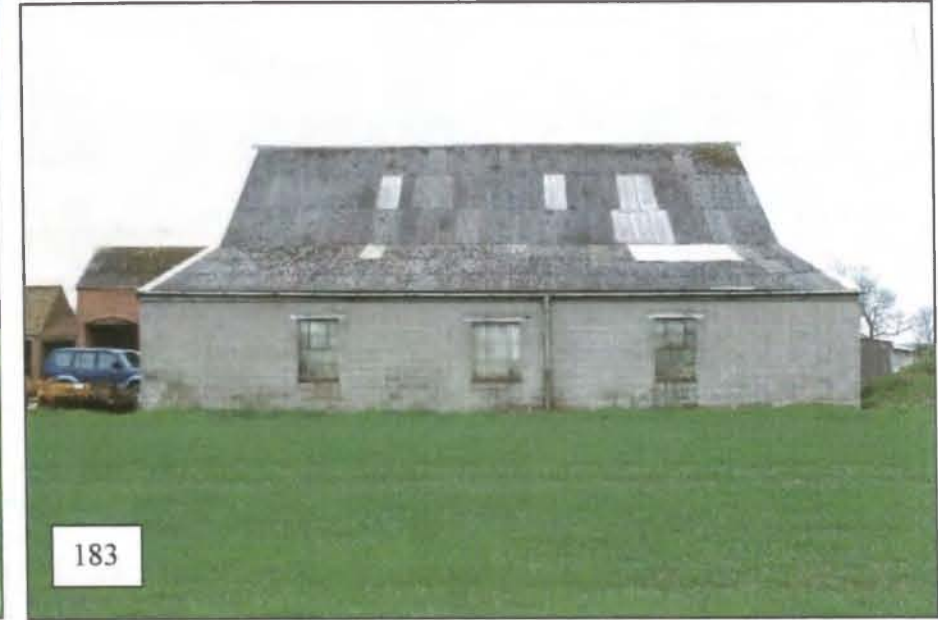
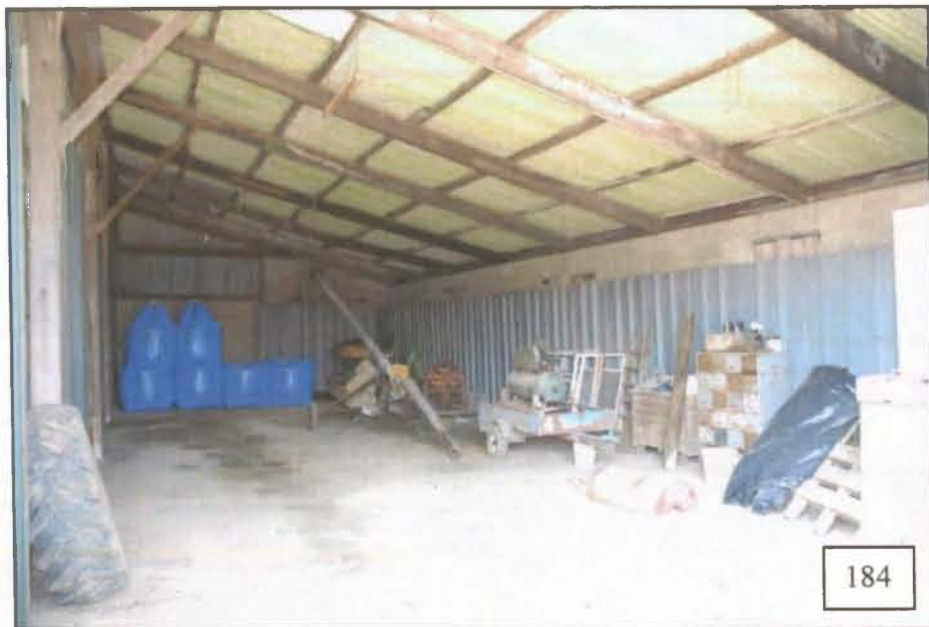
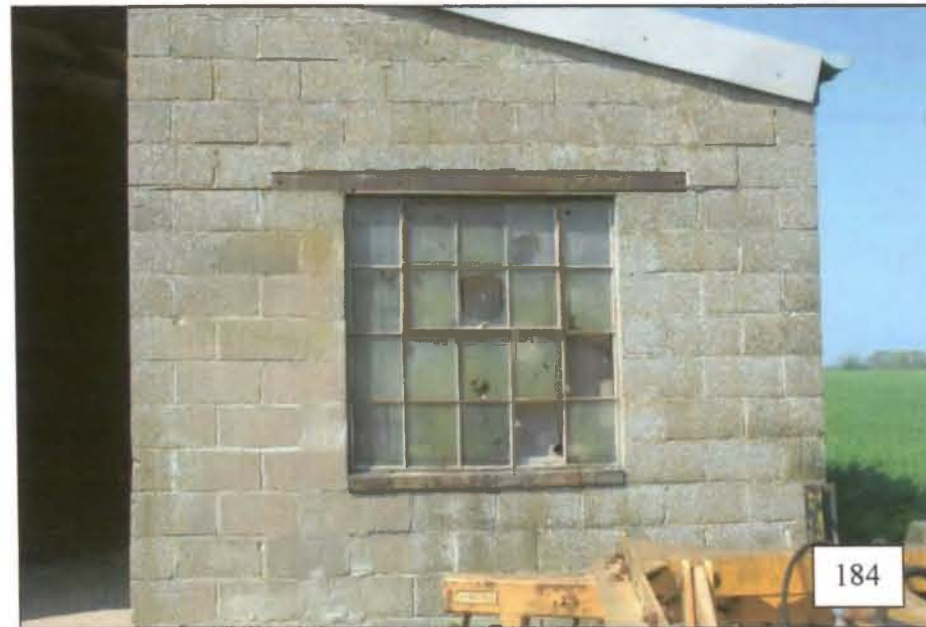
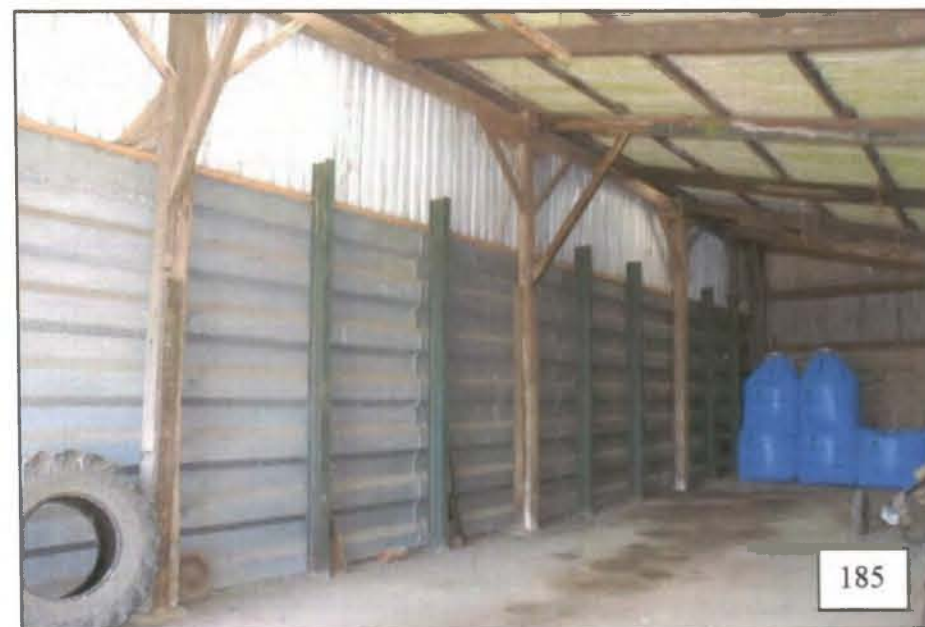
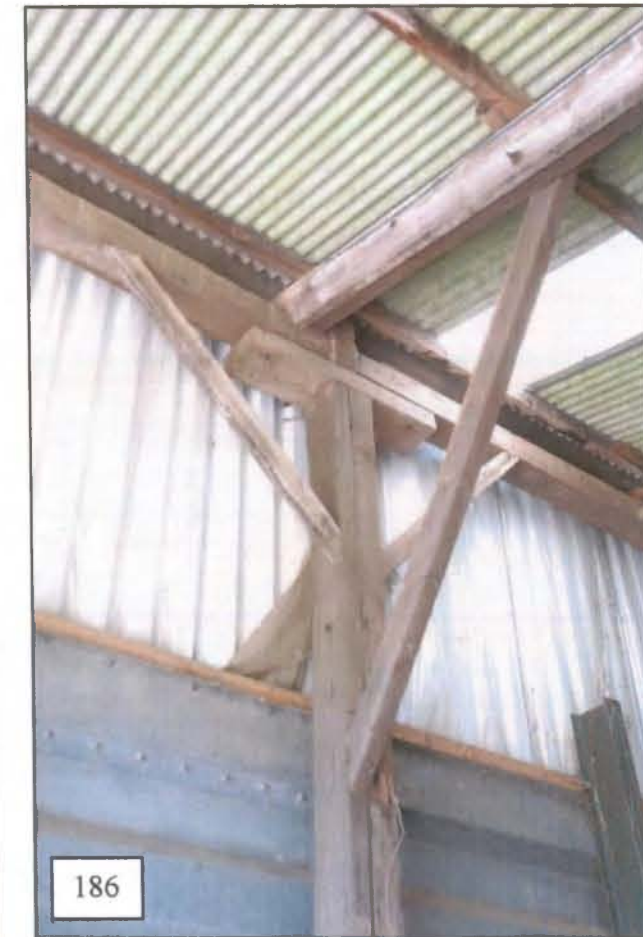
The northern bay of building M is clad in 9" concrete blocks, with a total of five large metal-framed windows of 20 panes, with a centrally pivoting 6-pane casement in the upper half, three of which are present in the north wall, with a further one in each of the gables. It has a floor of poured concrete panels. The south wall is the profiled metal sheeting of the neighbouring grain storage area, supported on large vertical I-section posts.

Heavy timber uprights (7" x 8") support the trusses of the central part of the building, reinforced by steel channels set against them. This part of the building was most recently used as a storage area.

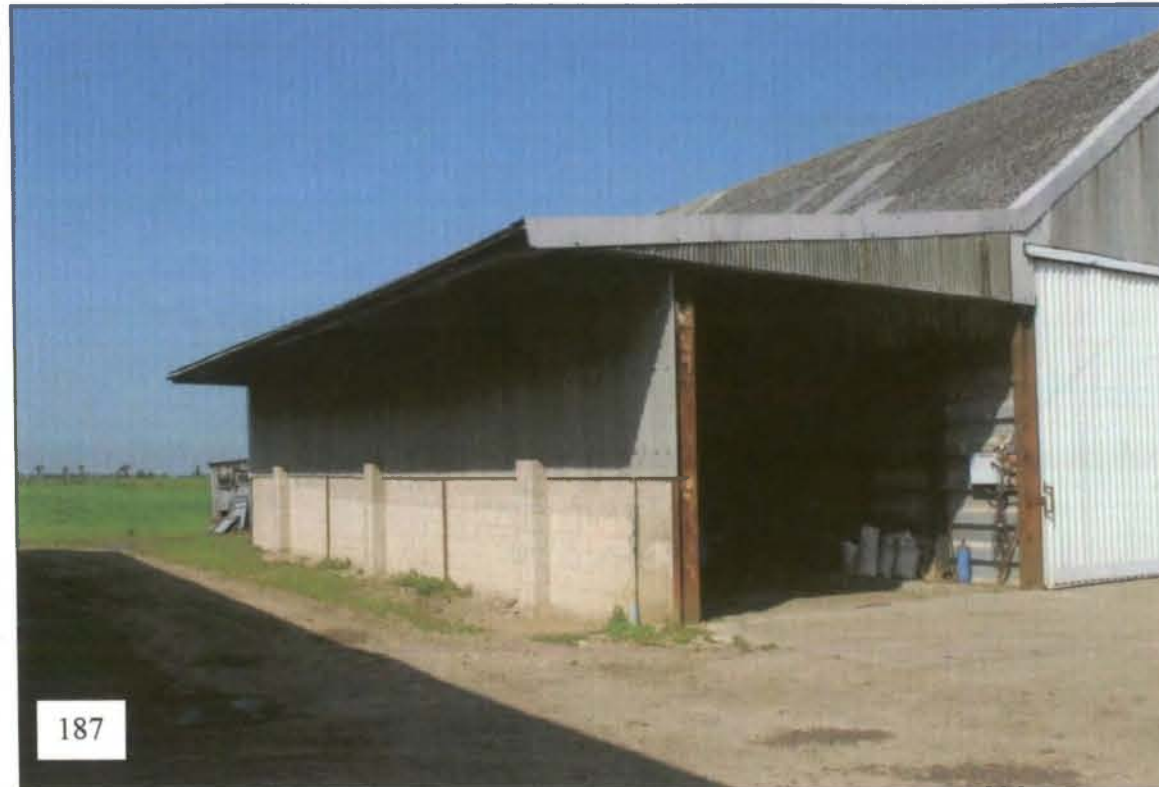
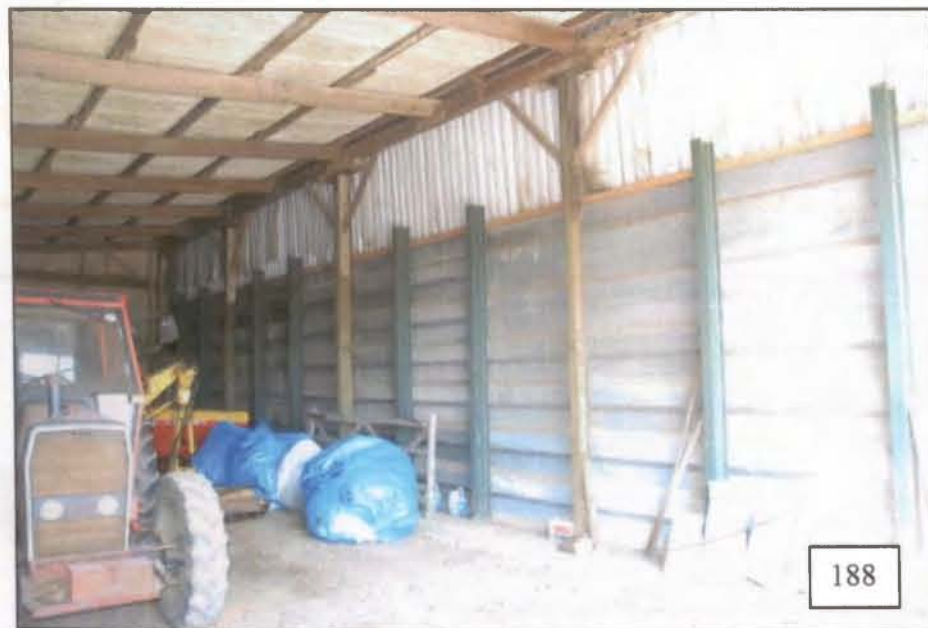
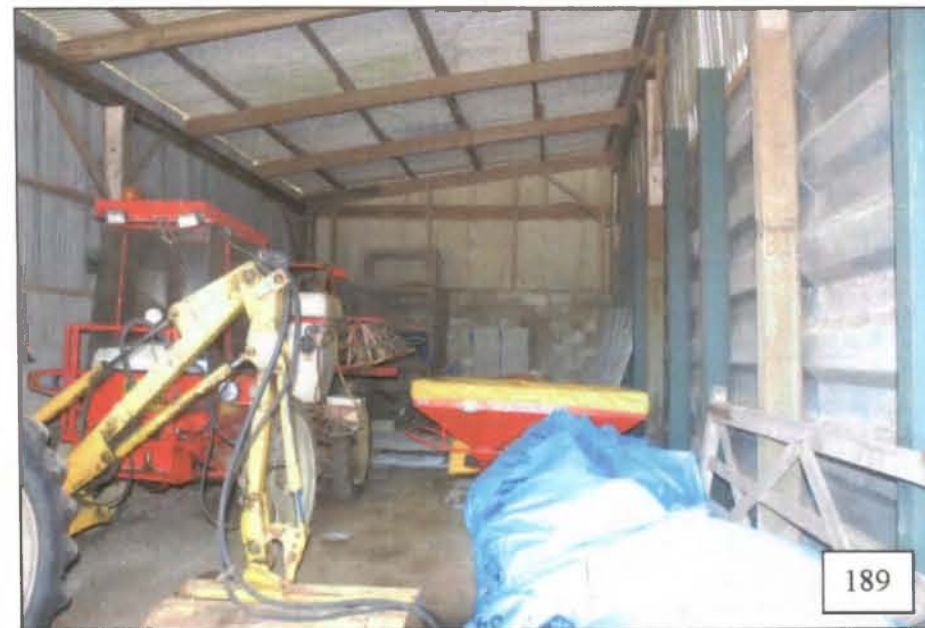
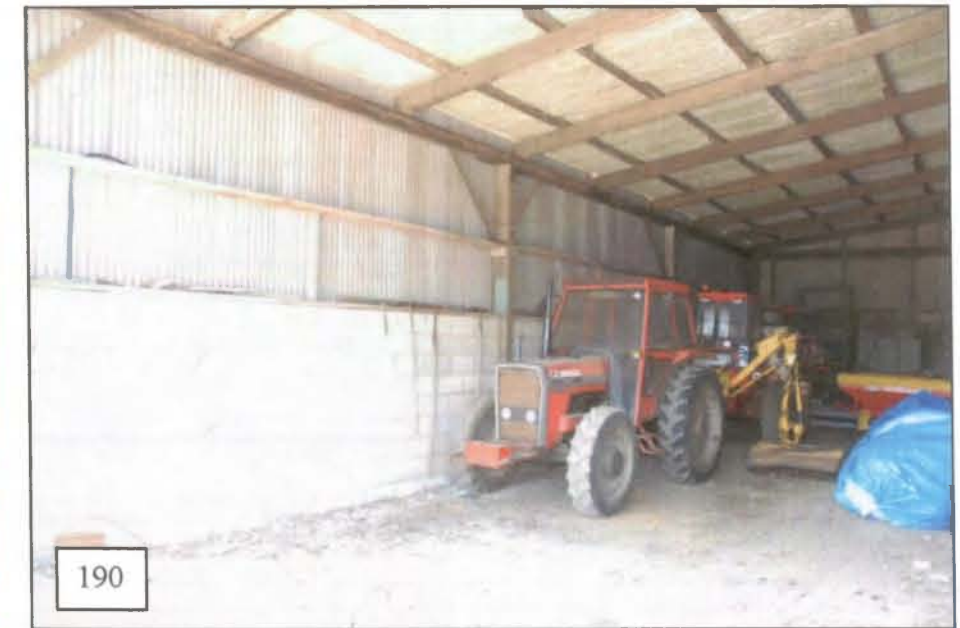
The southern bay of building M has been enclosed most recently and the lower part of the structure is clad in modern 9" concrete blockwork to a height of 6', with modern profiled sheet cladding above. It has a floor of poured concrete panels. The north wall is the profiled metal sheeting of the neighbouring grain storage area, supported on large vertical I-section posts.

Here, the support for the trusses of the central part of the building and the roof of this building is all provided by heavy I-section steel beams and diagonal bracing. This part of the building was still in use as a machinery shed and storage area at the time of the survey.

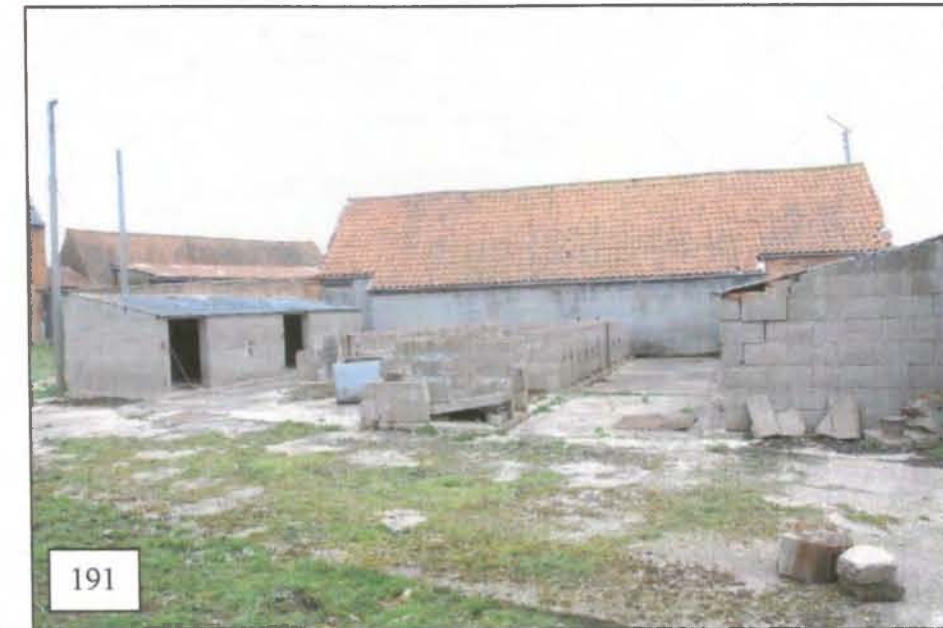
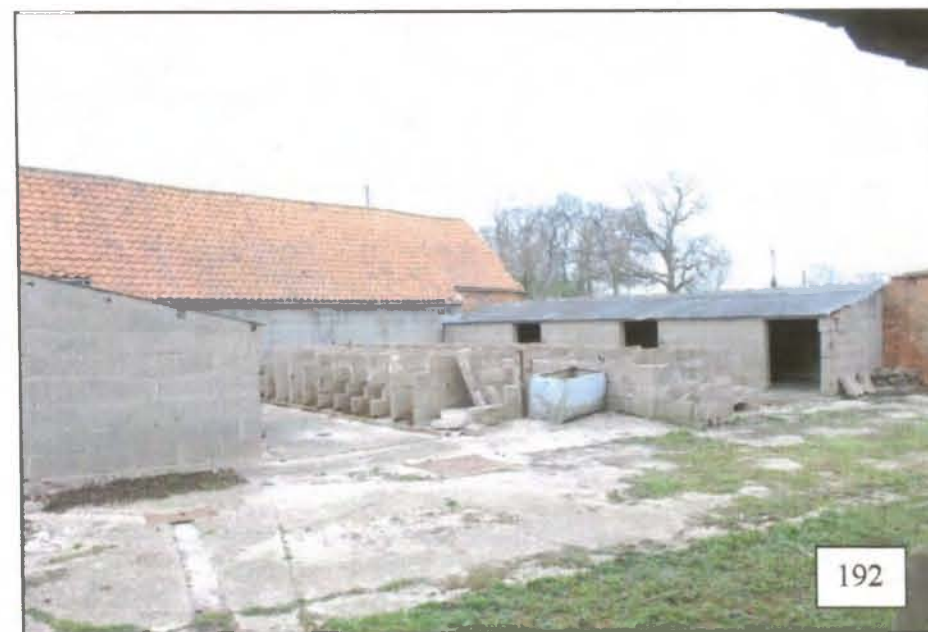
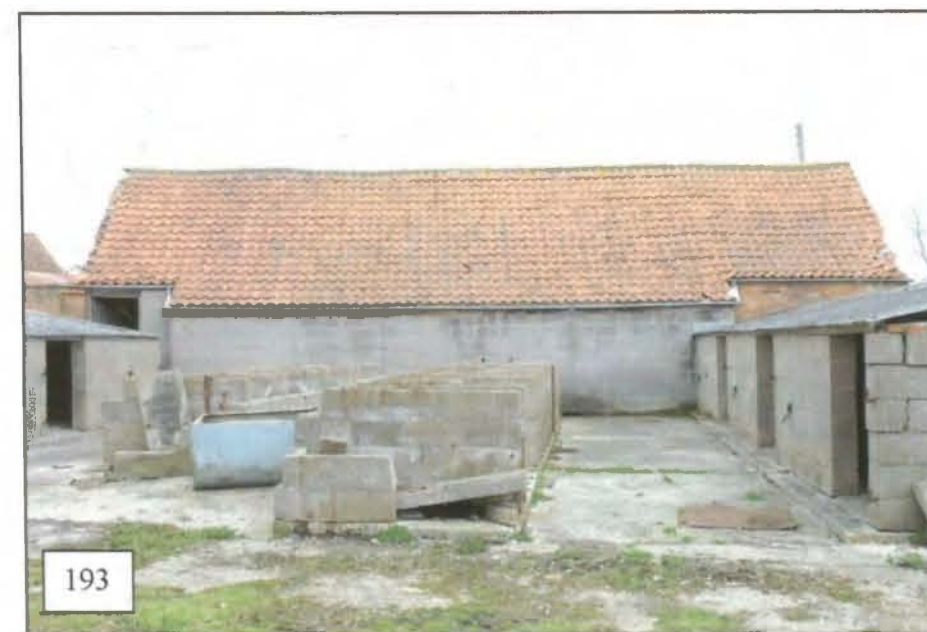
The shelter sheds, two on the north side and three against the southern boundary wall, were constructed of 9" thick concrete blocks, with corrugated asbestos cement sheet roofs. It appears that the curved northern crewyard dividing wall was demolished to make room for the northern pig shelters.

The feeding pens were constructed in 4" thick concrete blocks, with 12 pens on the north side of the central passage, and 17 to the south. All of these structures were constructed on a poured concrete apron.
