# GRANGE FARM, WEST TORRINGTON, LINCOLNSHIRE

## PHOTOGRAPHIC BUILDING SURVEY

Site Code: GFWT 08  
LCM acc. no.: 2008.68  
Planning refs.: S/205/00678/08  
NGR: TF 1430 8132  
PCA job no.: 08-457

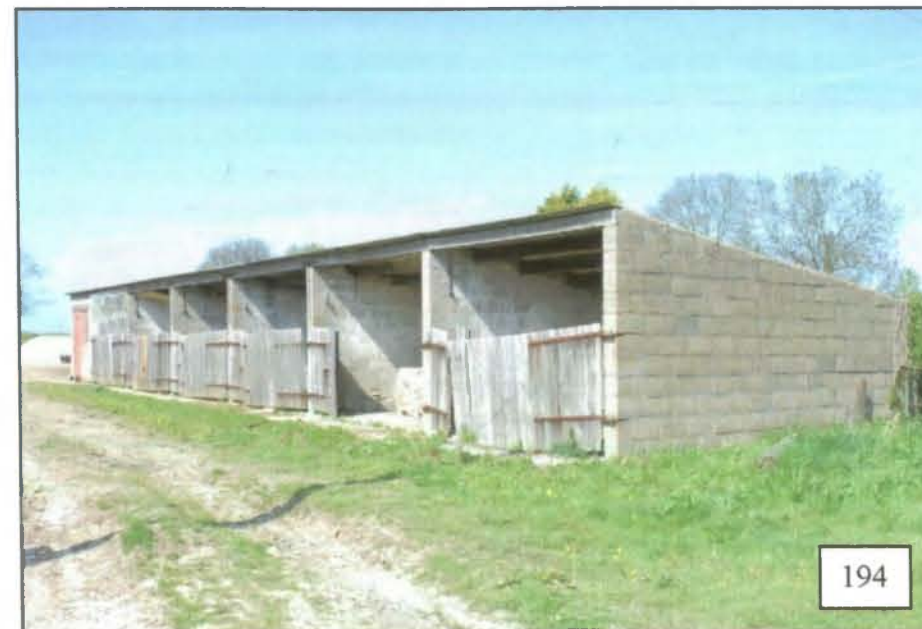
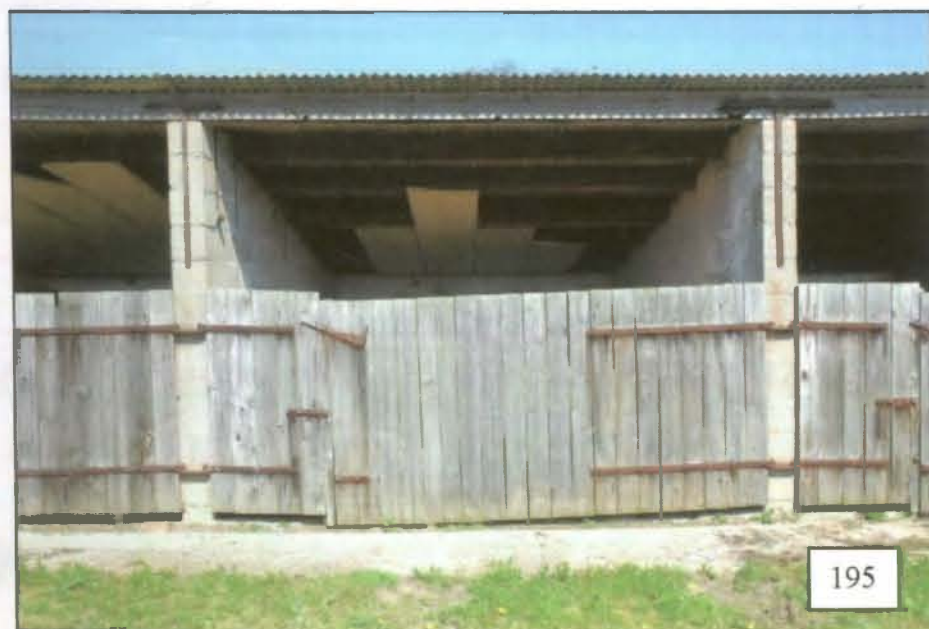
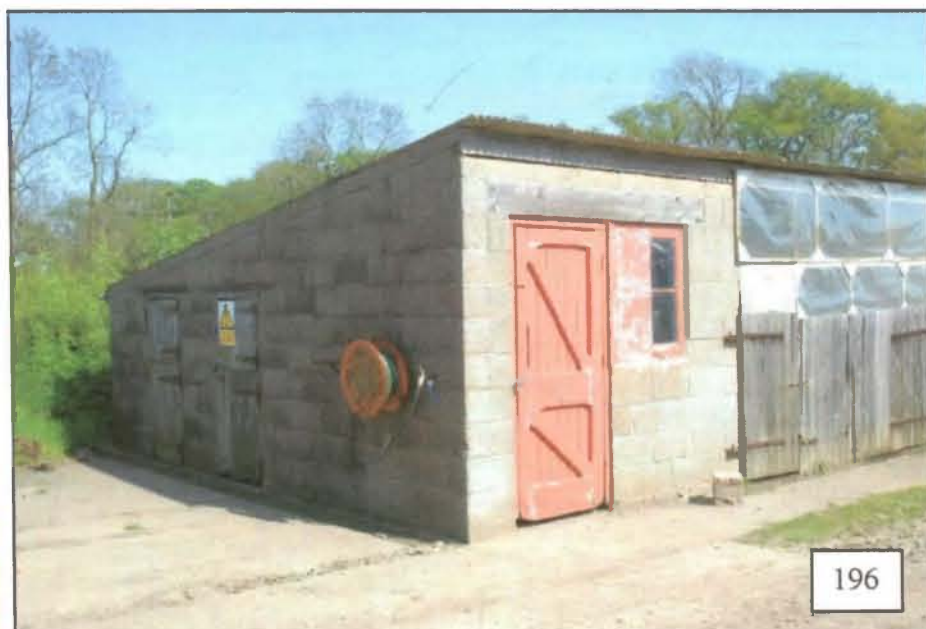
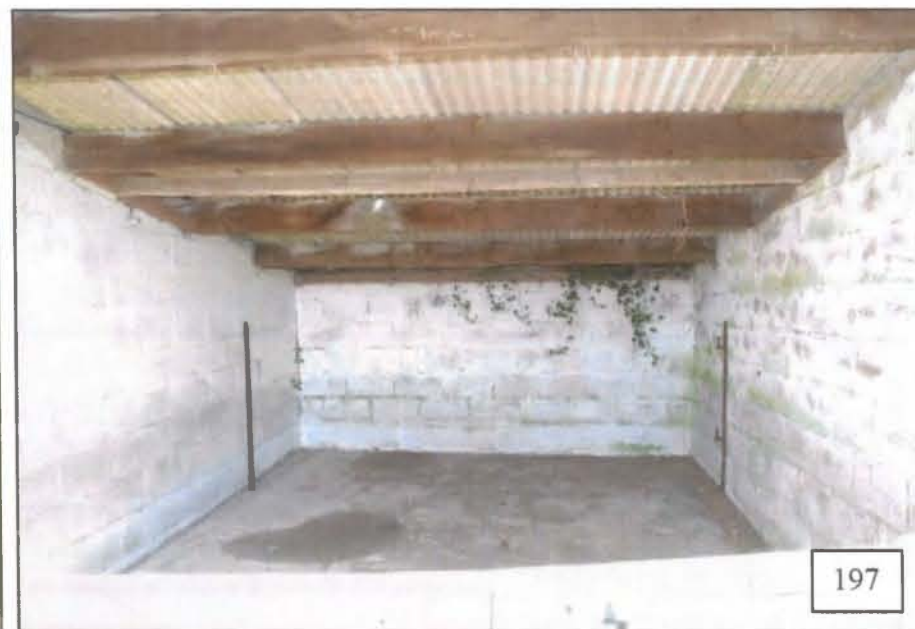
At the eastern side of the site, a row of open-fronted sheds provided further accommodation for pigs. This comprised a seven-bay structure, the northern bay being enclosed to provide secure storage (it was locked at the time of the survey). Building K was completely constructed of 9" thick concrete blocks, with a single-pitched corrugated asbestos cement sheet roof.

The animal pens were identical, each with a two-part ledged and diagonally braced plank gate on the west side, divided so that a smaller gate on the north side gave access for farmhands, while the larger gate could be opened for the animals or to allow for mechanical mucking out.

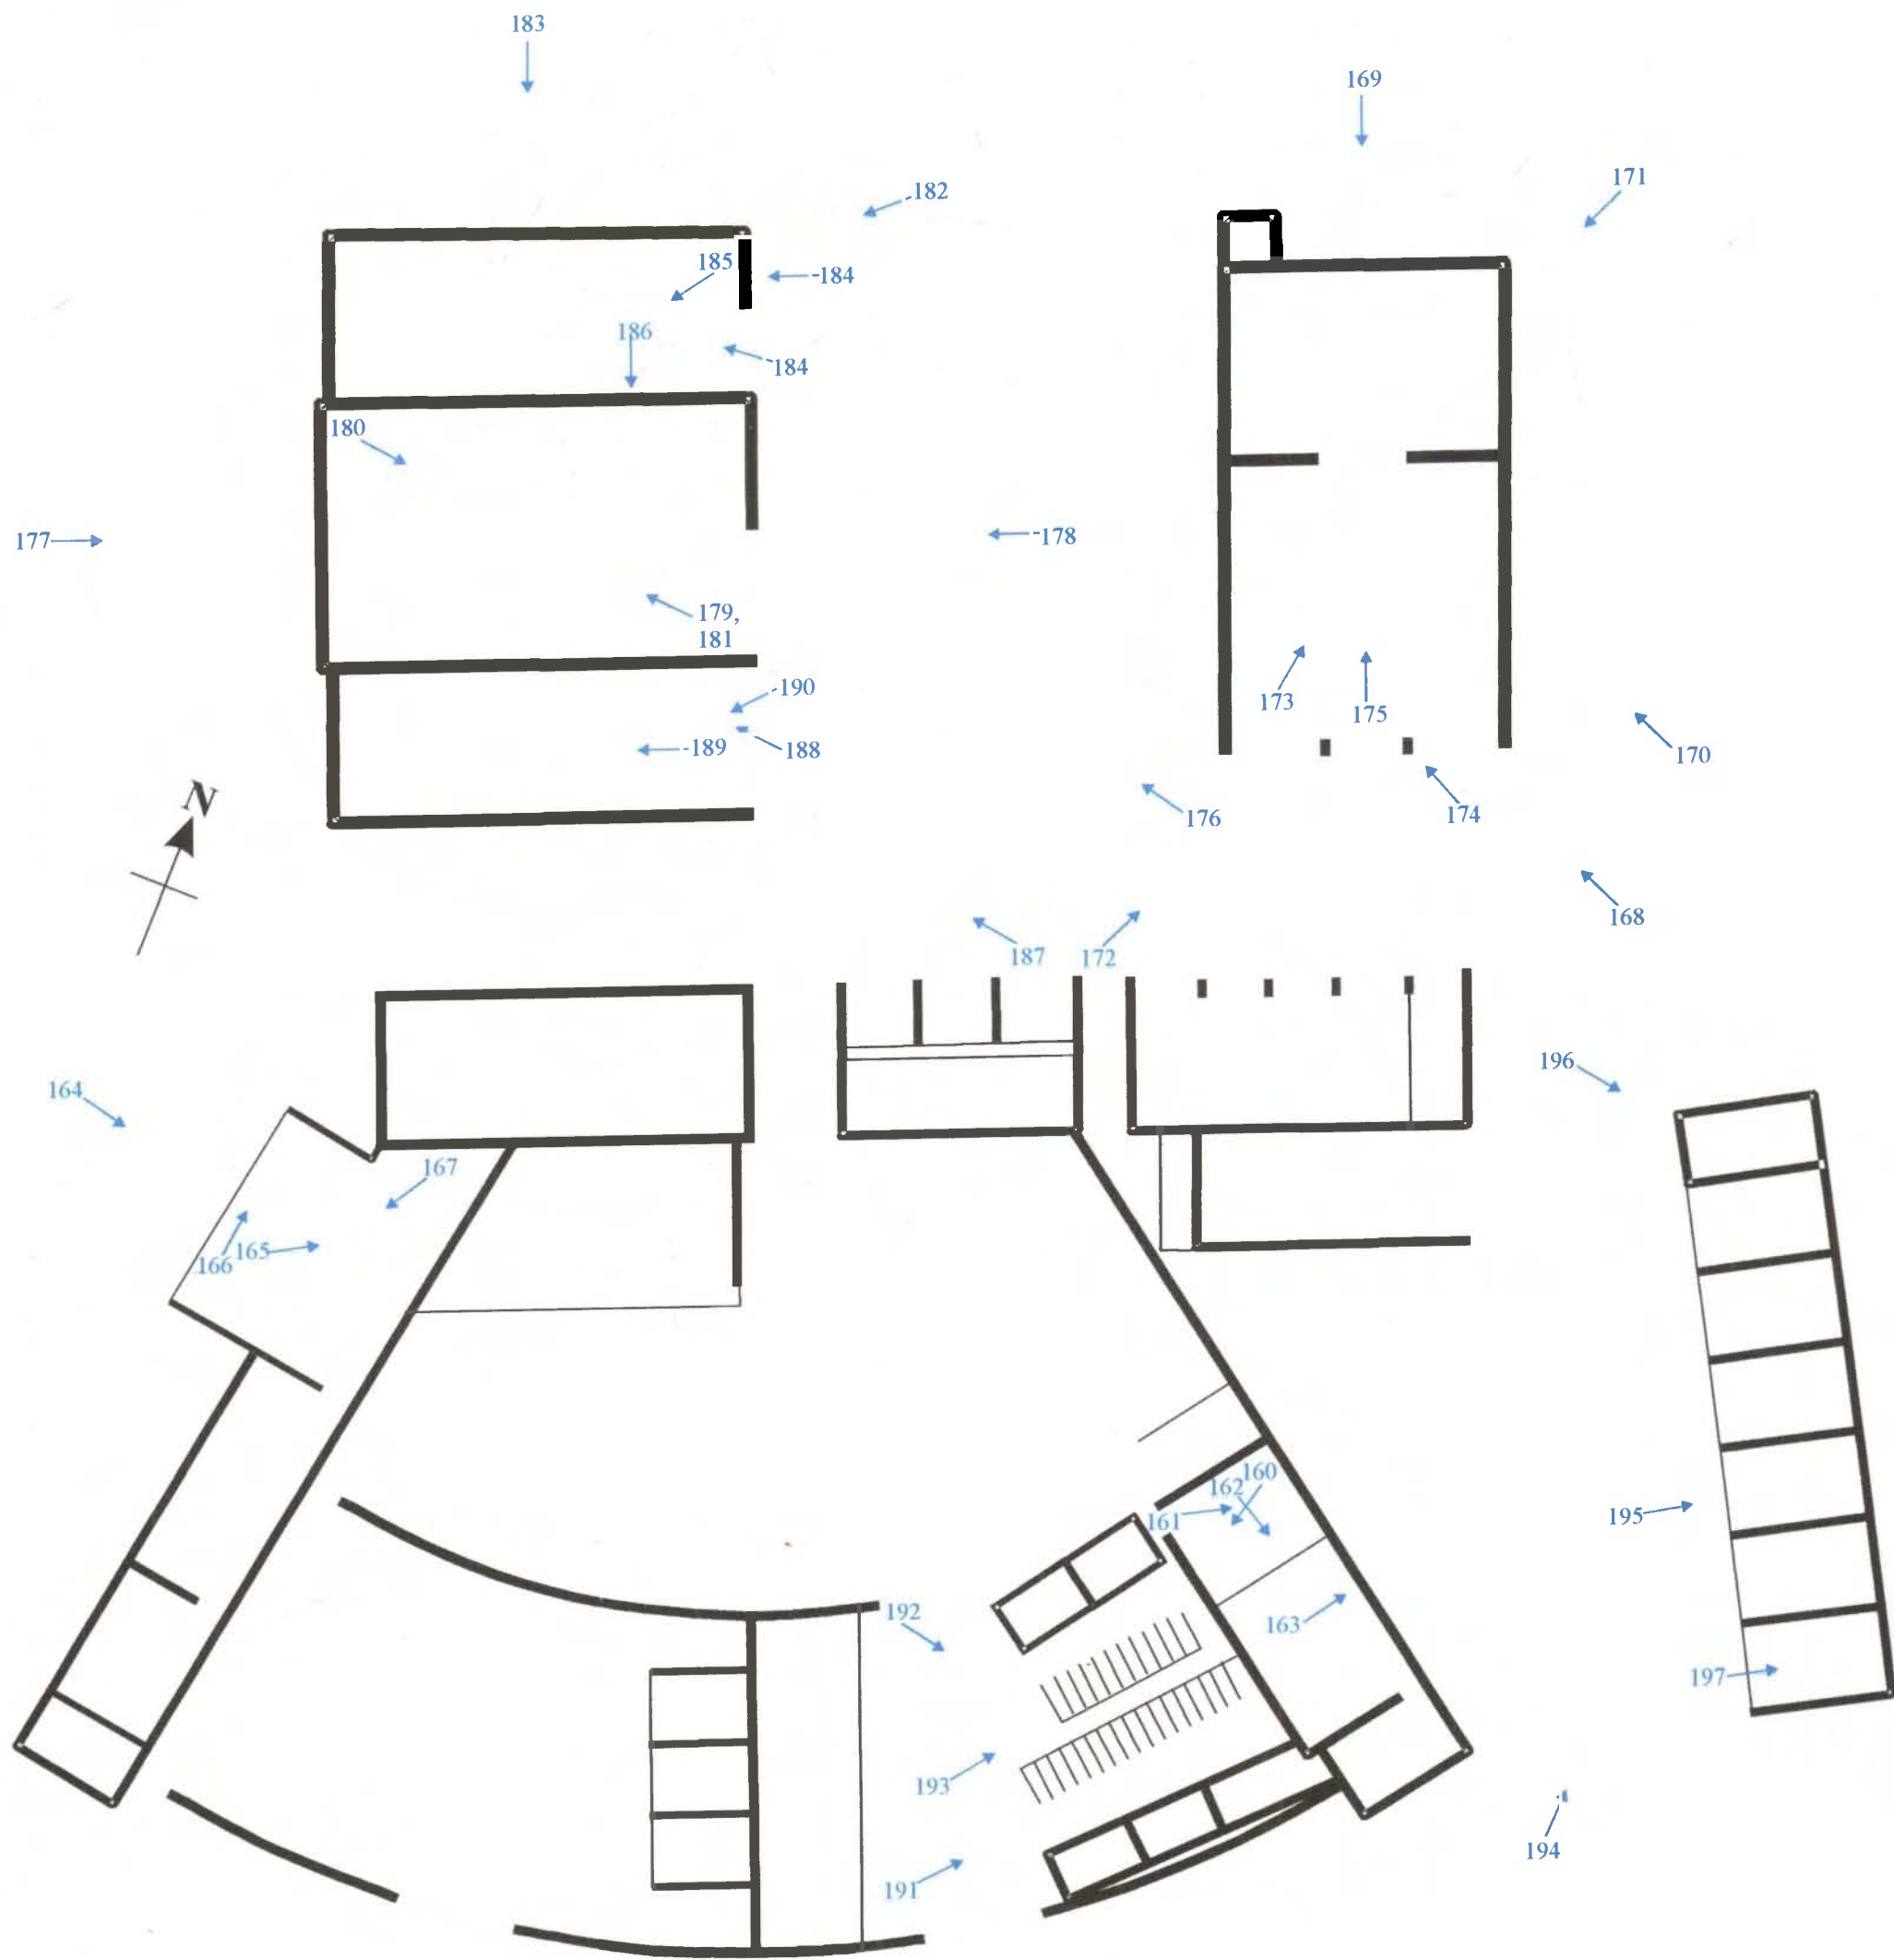
Plan showing the locations and directions of photographs in the Phase V section of the report. Not to Scale.
