# OUTBUILDING AT MANOR HOUSE, NORTON DISNEY, LINCOLNSHIRE

## PHOTOGRAPHIC BUILDING SURVEY

Report prepared for Heronswood Design Limited  
by

May 2008

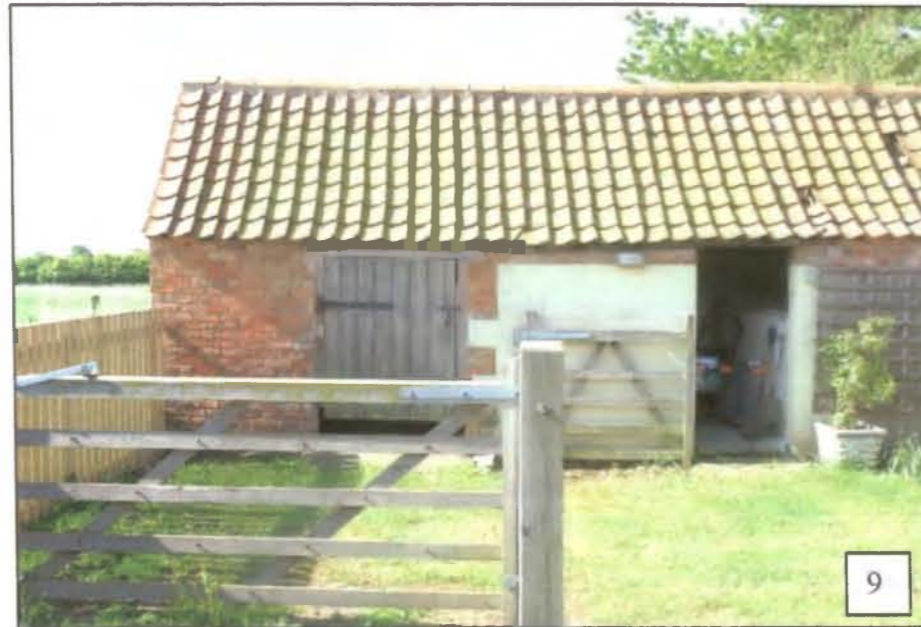
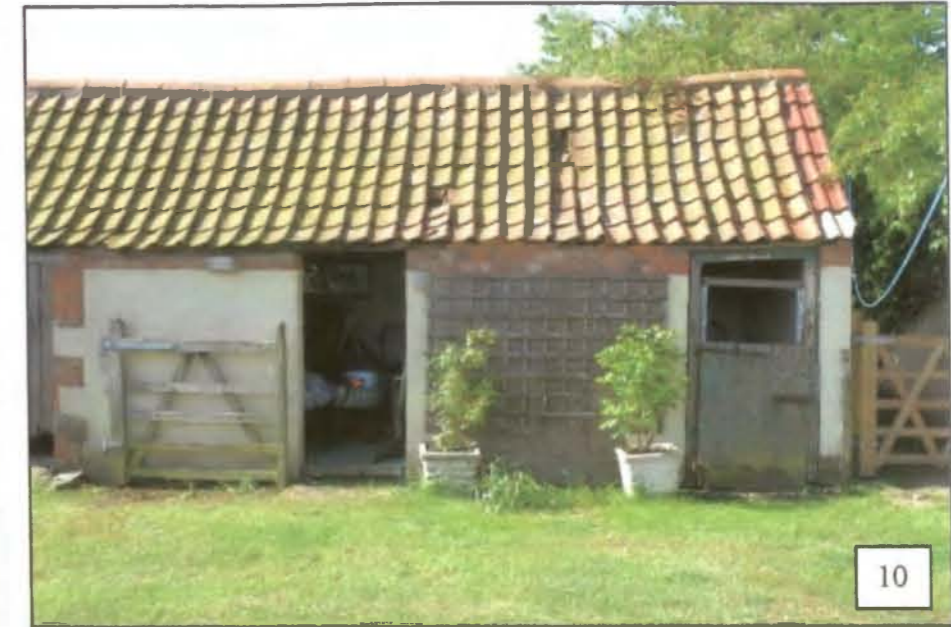
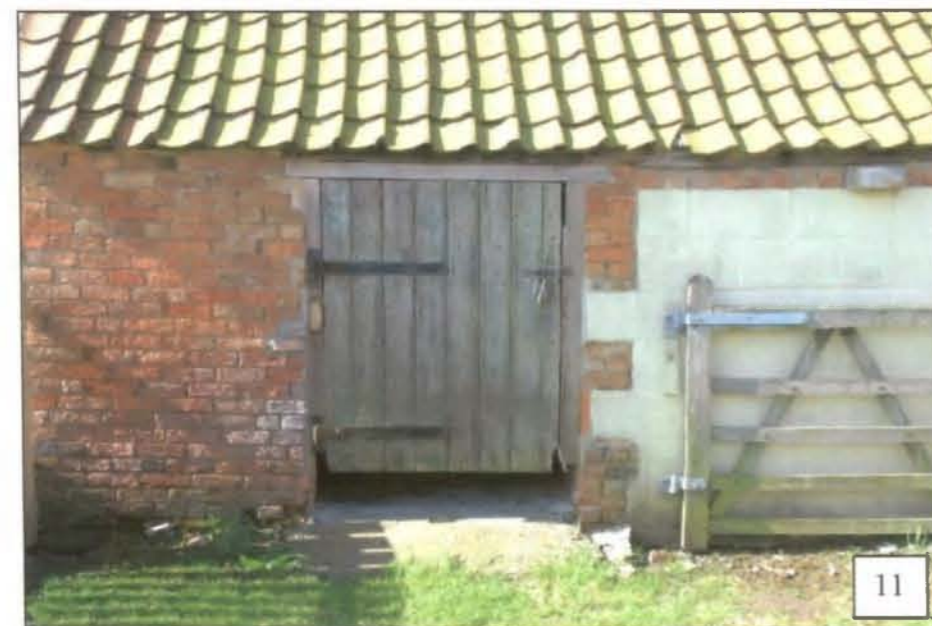
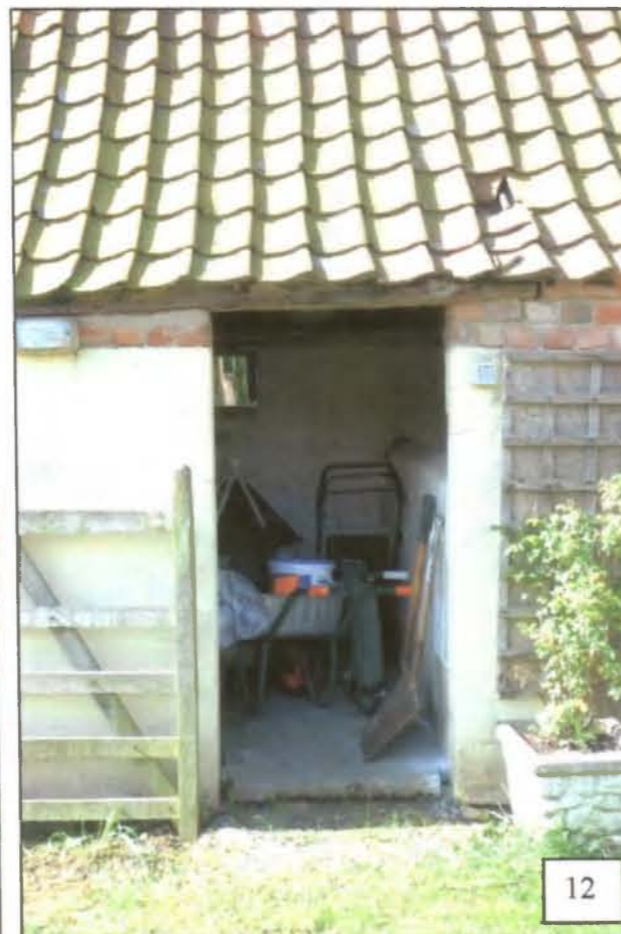
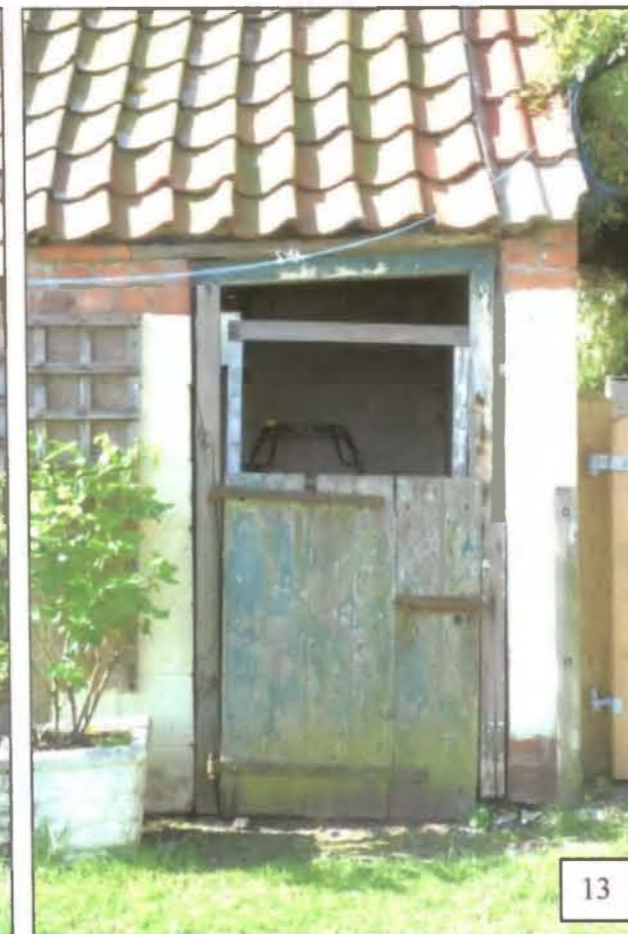
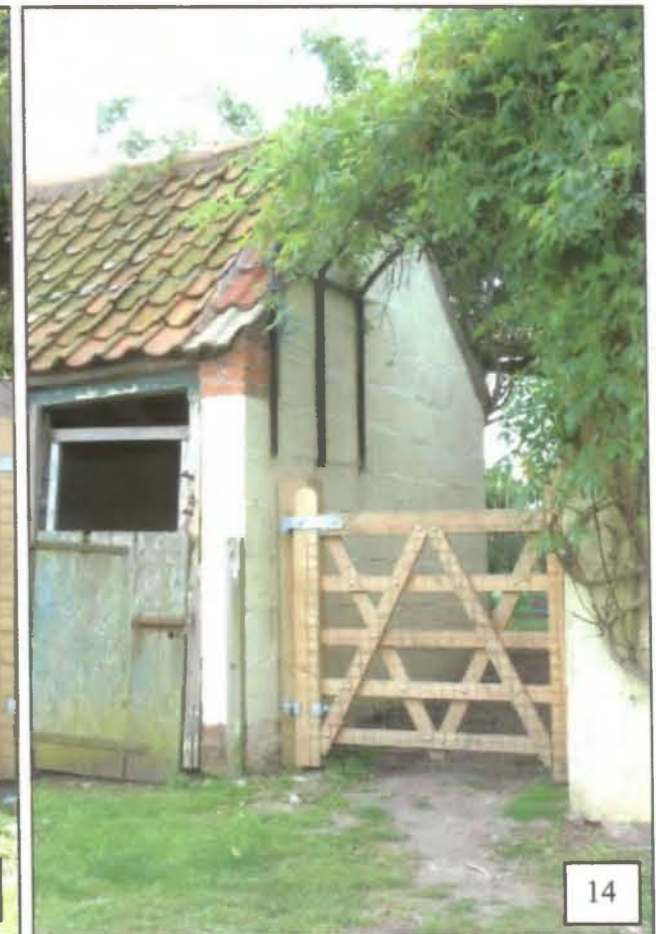
**North Elevation**

On the north side, the eastern third of the building was constructed of brick in 3-course English Garden Wall Bond (EGW) – having three courses of stretchers to each course of headers (brick size:  $8\frac{5}{8}$  - 9" x  $4\frac{1}{4}$ " x  $2\frac{3}{8}$  -  $2\frac{1}{2}$ ", 3 courses =  $8\frac{1}{2}$ "). The brick coursing was irregular in two ways: the number of stretcher courses to header courses was not always three, and the header courses were often not continuous, sometimes comprising pairs of headers alternating with pairs of stretchers.

The western two-thirds of the north elevation were constructed of concrete blocks (block size:  $17\frac{3}{4}$ " x  $8\frac{3}{4}$ " x  $8\frac{1}{2}$ ", 3 courses =  $27\frac{1}{4}$ "), in stretcher bond. This had a modern brick foundation, of which one course was visible, and the space between the blockwork and the wall plate was made up with brick: a single stretcher course in the central panel and two header courses on the west side. Three door openings were present here, approximately evenly spaced; they differed in size, with the eastern opening wider than the others. The eastern and western door openings had doors; no door or doorframe was present in the central opening. All three openings had a timber lintel, let in immediately below the wall-plate.

The height of the eaves on the north side was between 1.45m and 1.52m.

The western gable was constructed of the same concrete blocks as the north side with a modern cement verge. All of the blockwork on the north and west sides of the building was painted cream.

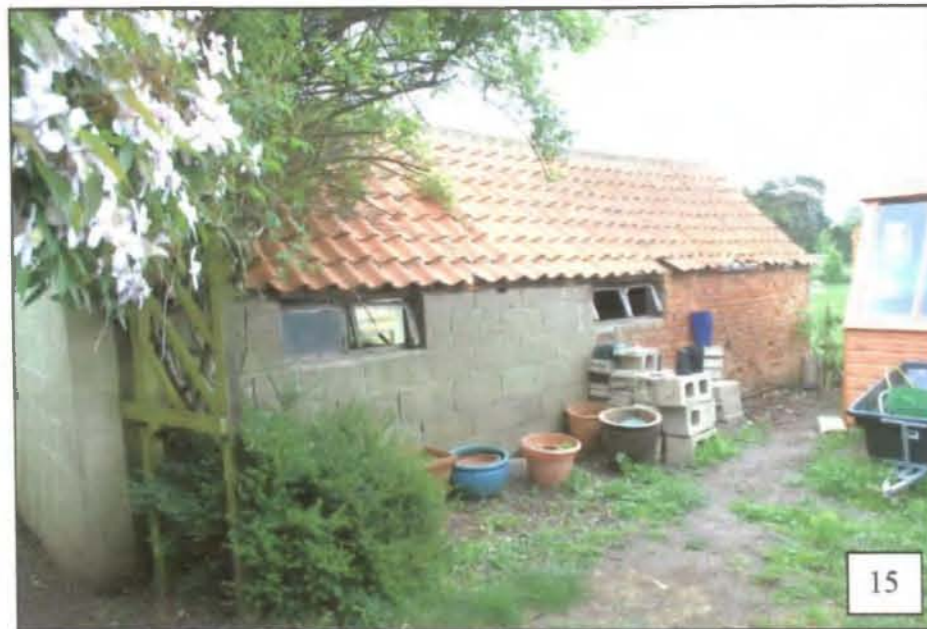
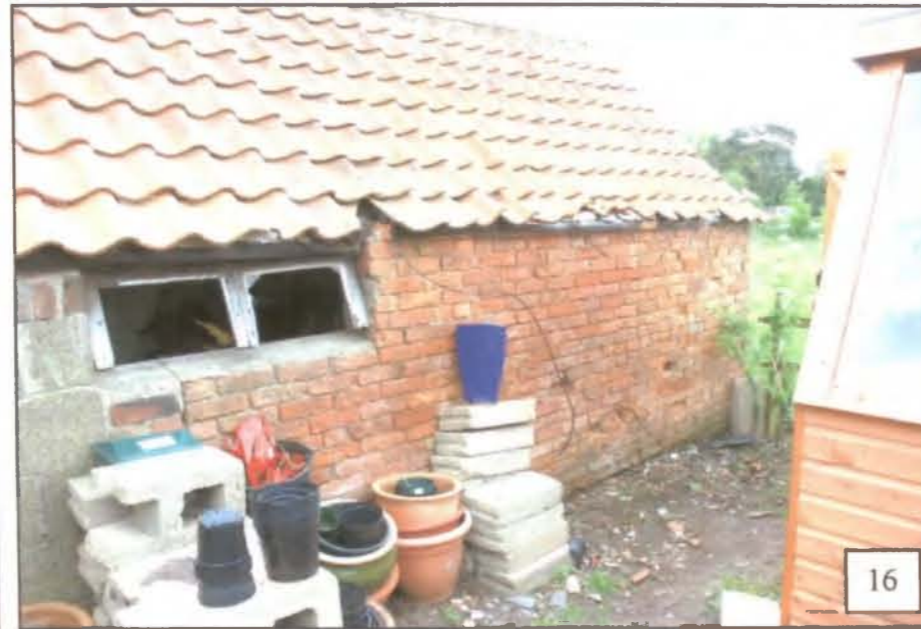
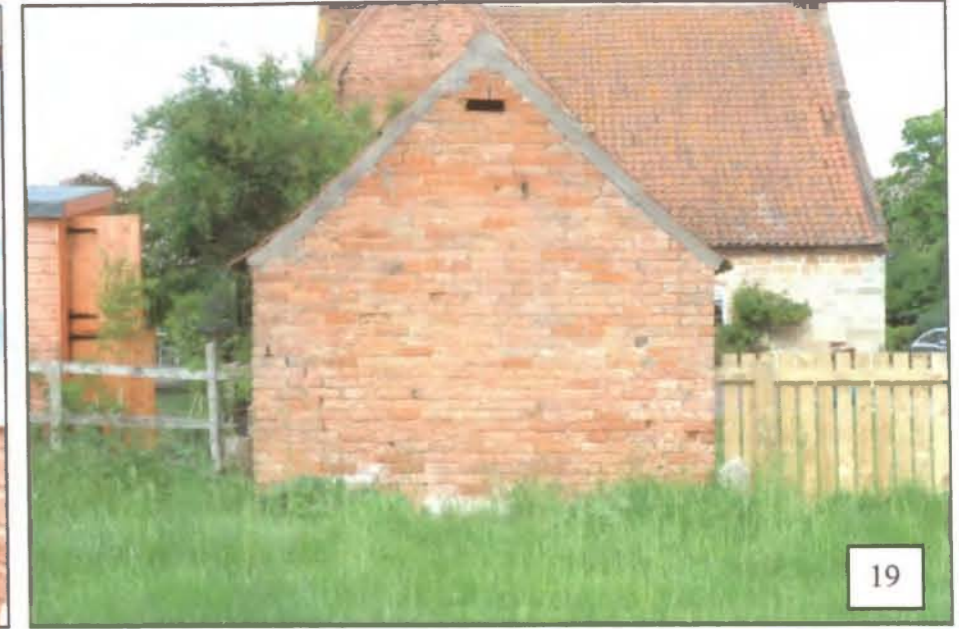
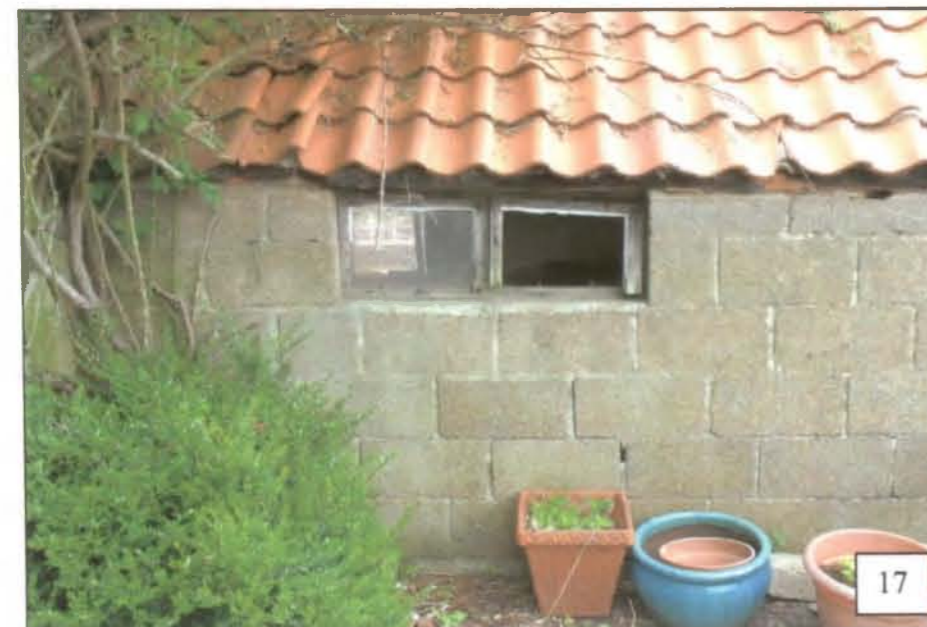
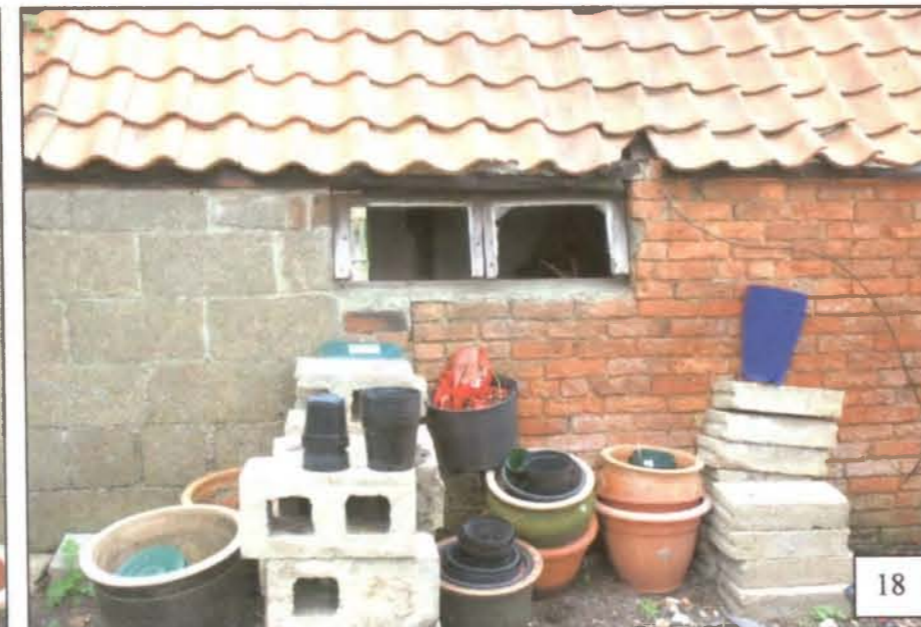
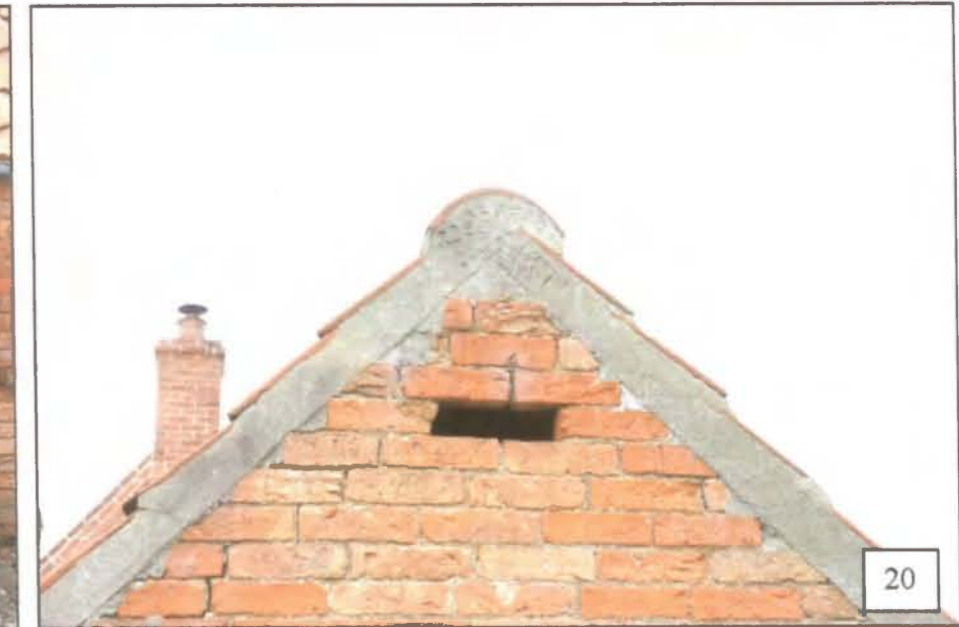
### South Elevation

The south elevation of the building was of the same two building phases as the north. The eastern part of this wall was constructed of the same 9" thick brickwork as that discussed above on the north side, in a similar irregular 3-course EGW bond. This part of the south wall had an eaves cornice comprising a single course of projecting stretchers. The western part of this wall was of modern concrete blocks, the same as those discussed above, here unpainted. The two building phases met below the eastern window, where the blocks were roughly keyed into the brickwork, using 3" bricks and brick fragments to make up for the irregularities in the coursing (see also plate 40). The windows clearly belong to the more modern building phase.

### East Elevation

The eastern gable wall was constructed in brick, and was of the earlier building phase. No joints were present within the brick-built phase of the building, making all of this phase contiguous. It has, however, been re-pointed with a cement mortar, and a date - 1971- inscribed into the cement of the east gable verge appears to indicate when the roof was re-covered, if not the date of the block-built alterations to the building.

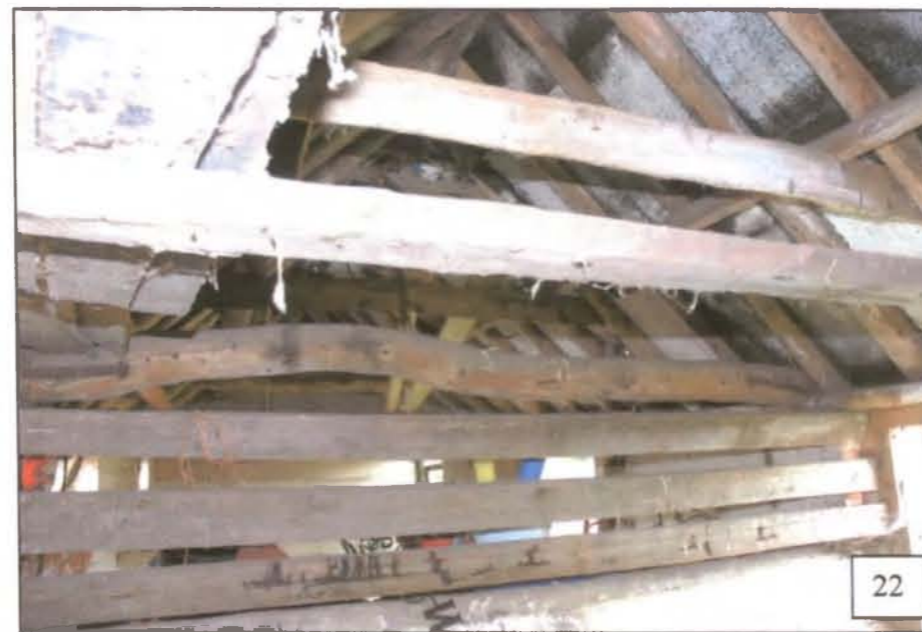
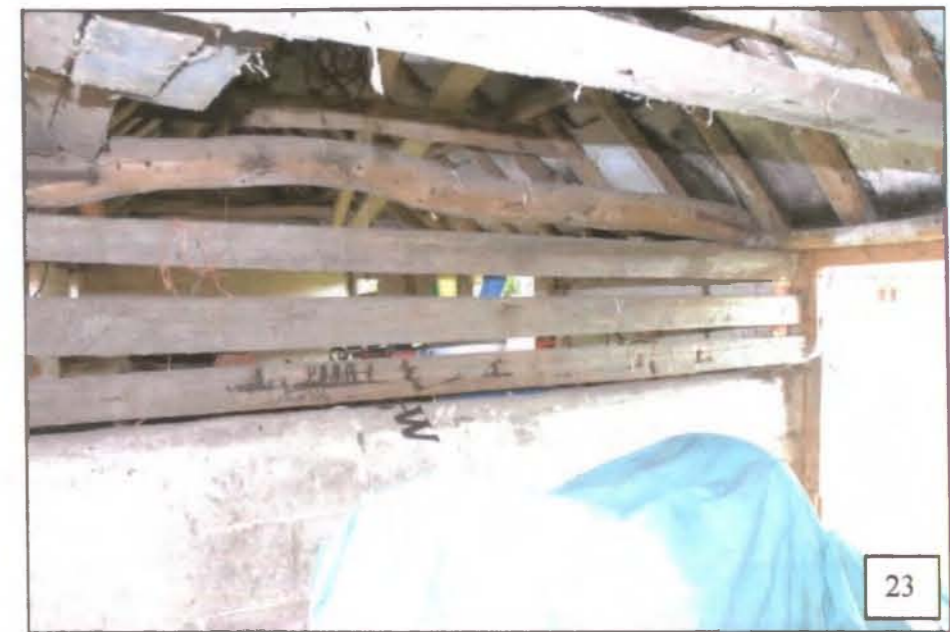
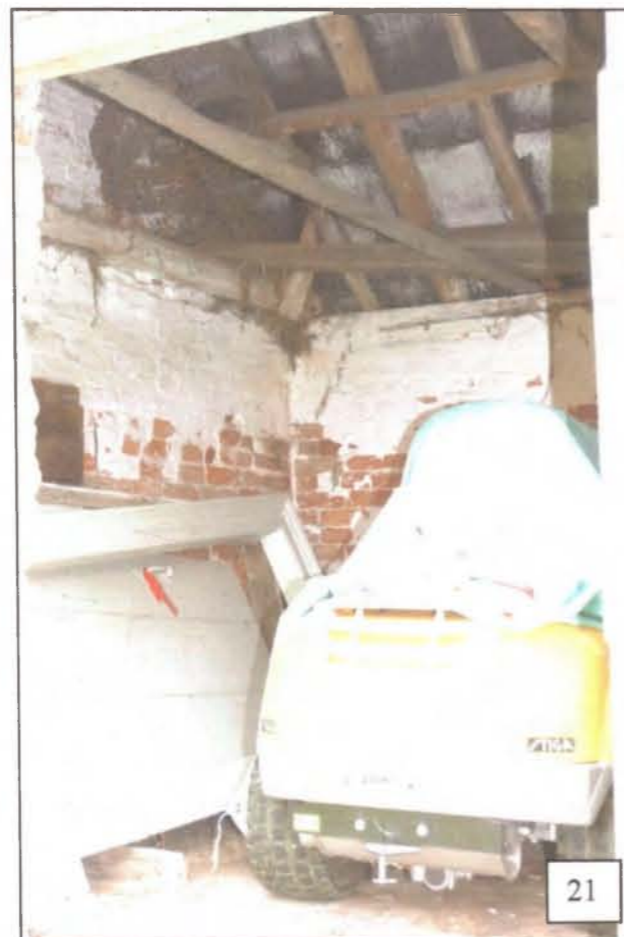
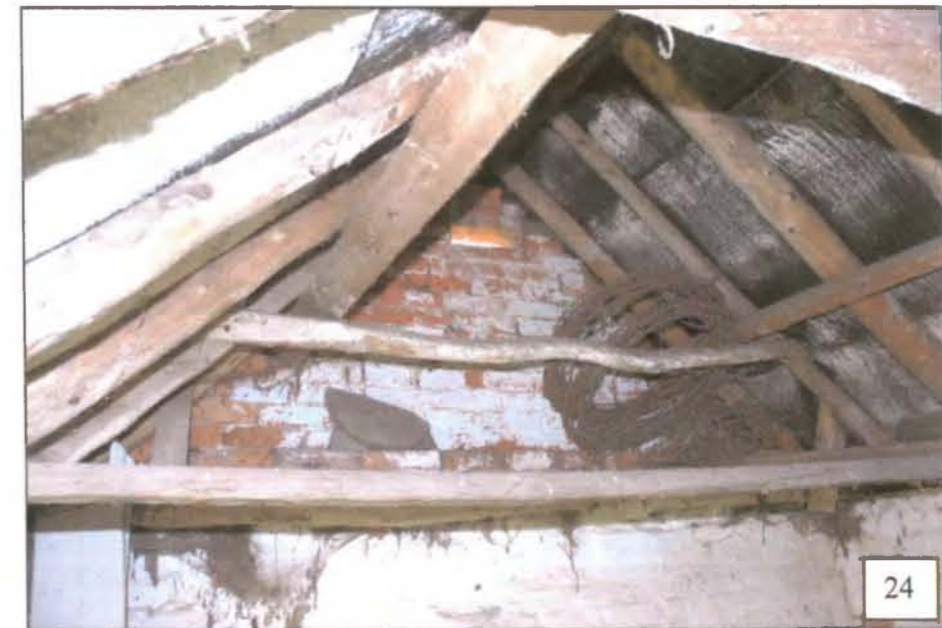
**Room 1**

Apart from the concrete block western partition, the other walls of Room 1 walls were of 9" thick brickwork, reflecting the bond seen outside. All of the walls were whitewashed, the lower 4ft of which was heavily worn.

From four courses above the wall plate, the east gable wall was of 4½" thick brickwork, in stretcher bond. A brick was left out (or removed) at the apex of the gable for ventilation.

The roof was of collar rafter construction: the wall plates and collars were all of pit-sawn half or quarter-roundwood lengths; the tie-beams were mostly roundwood, one or two of which were axe-trimmed, probably when felled. The rafters were of pit-sawn ½ or ¼ -roundwood, 2½" - 5" in size, while the heavier timbers were 5-6" in size. The wall plates were employed flat side up. The roof had clenched through purlins, of a similar size, and these overlapped, rather than being jointed. At the apex of the roof, a ridgeboard ran the length of the building, which was again converted from roundwood, sawn on two sides to make a plank. There were five later ridge collars, of sawn 5" planks.

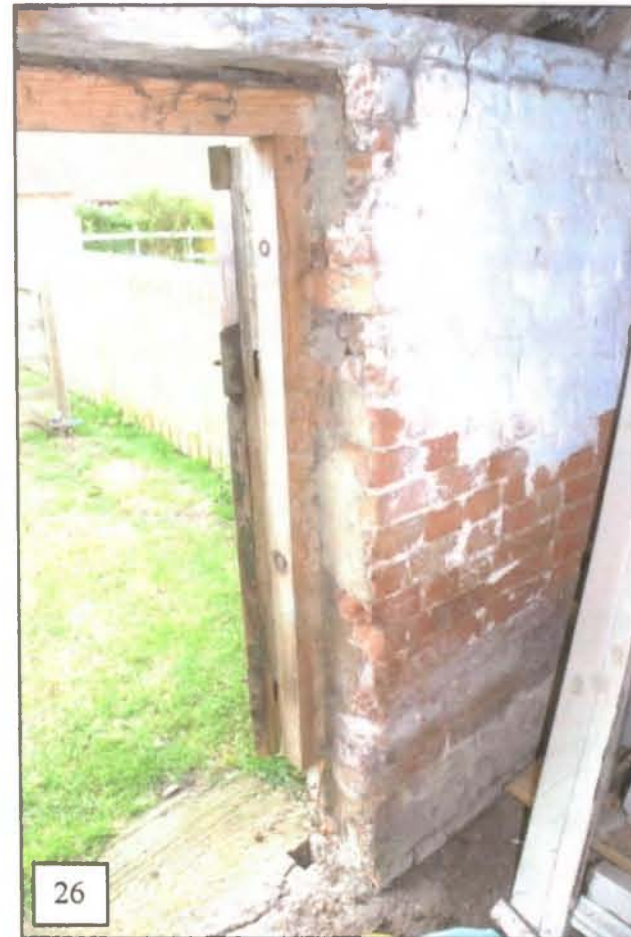
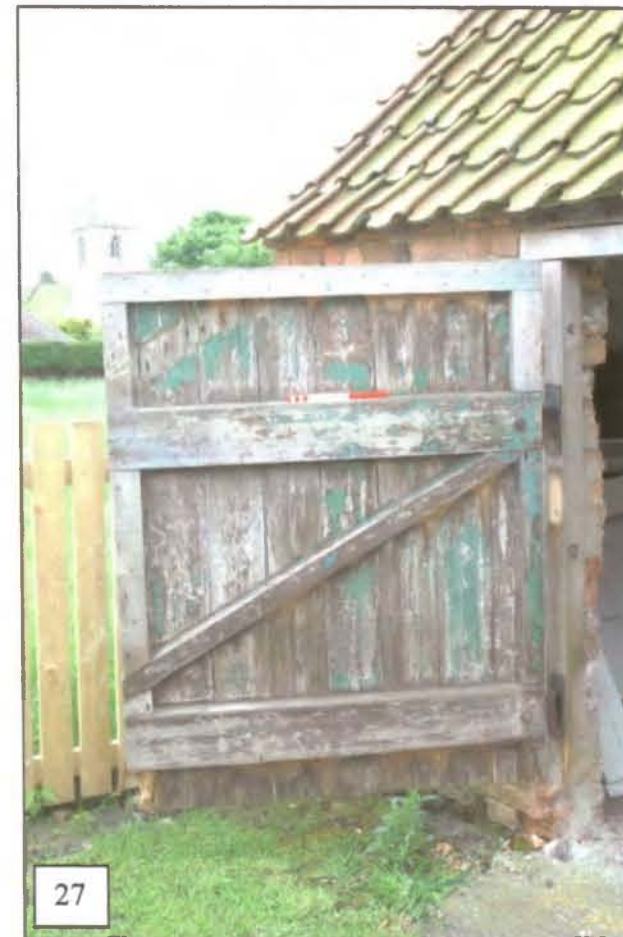
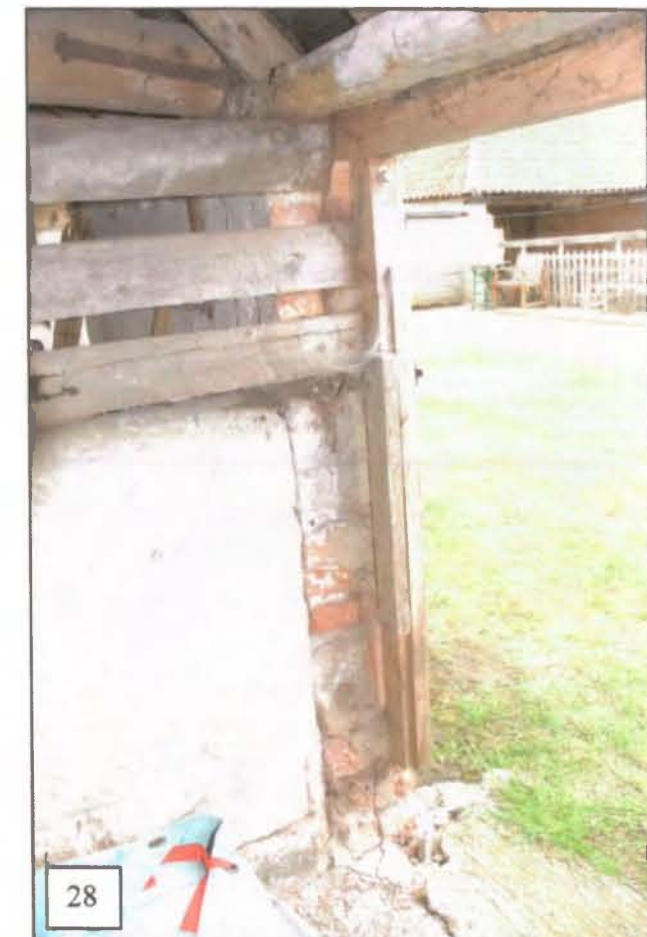
The floor of Room 1 was of poured concrete: this was heavily worn in places, and 2½" in thickness. A more modern concrete ramp led from the door.

The door opening itself has clearly been broken through: it seems likely that the building was open-fronted originally. The brick-built part of the structure had a clear, straight vertical joint with the block-built part, 9" to the west of the present opening.

The door of was of framed, ledged and diagonally braced (chamfered timbers) 5½" tongue and grooved plank construction. This was probably a re-used lower stable door, now re-hung approximately 1ft off the ground.

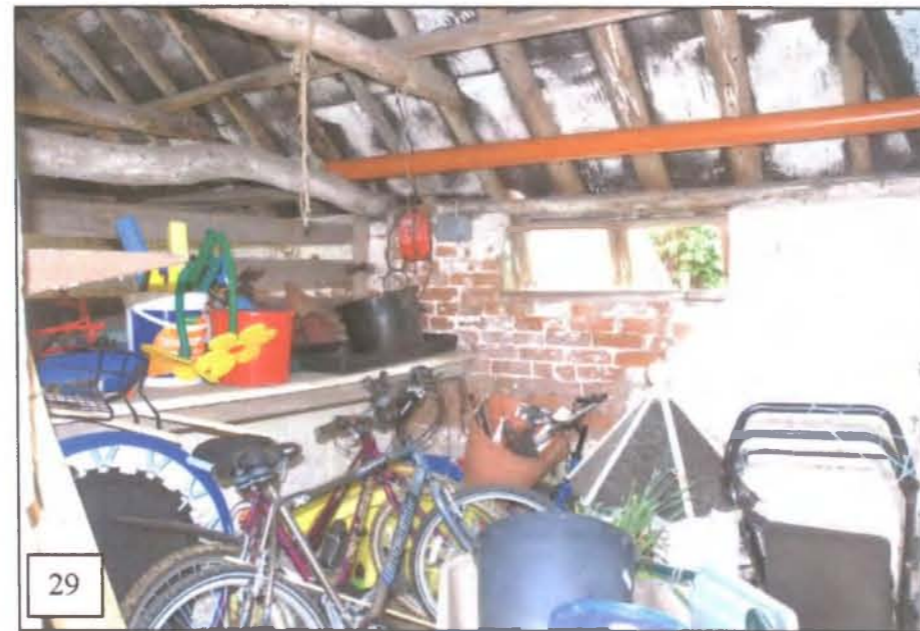
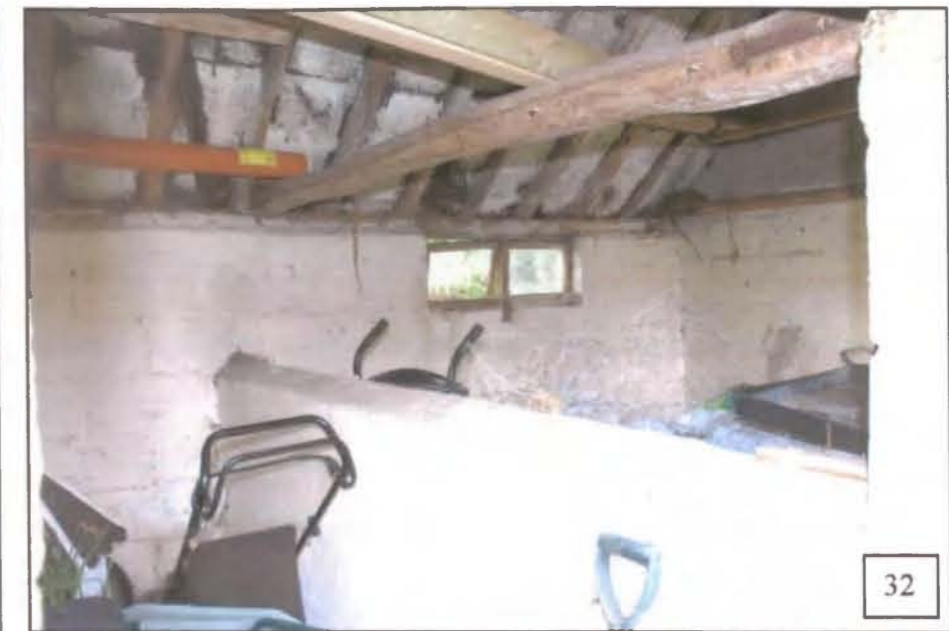
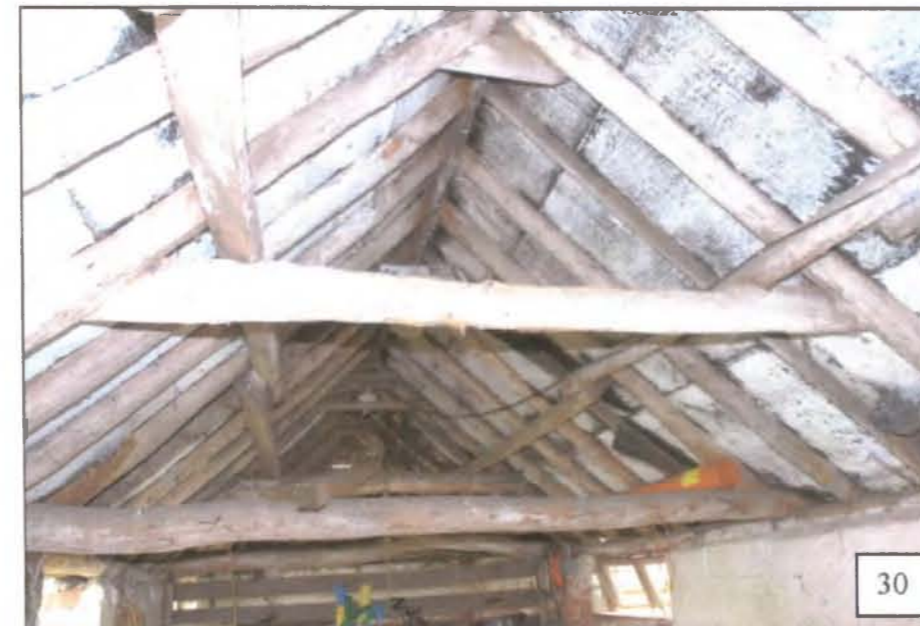
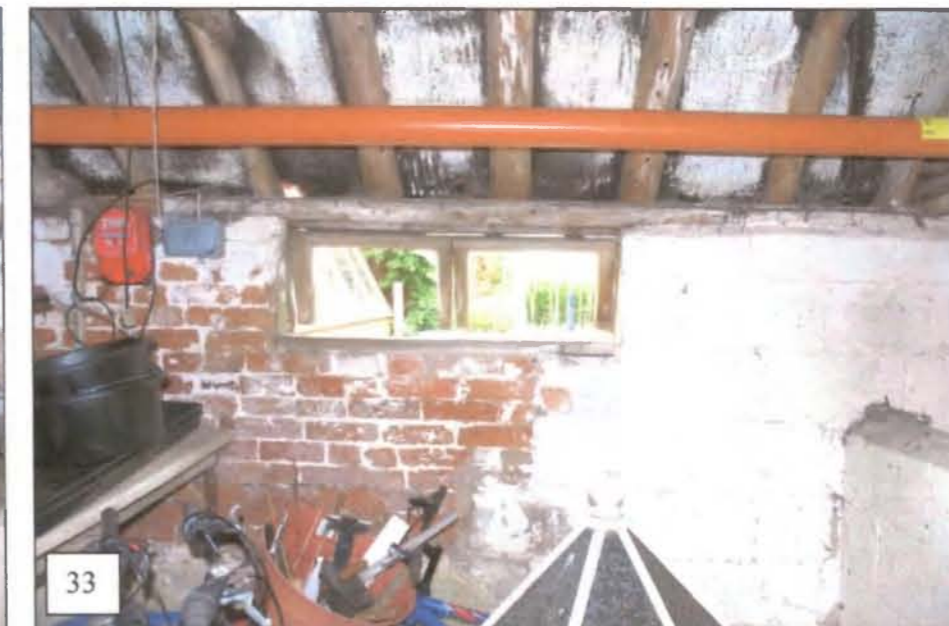
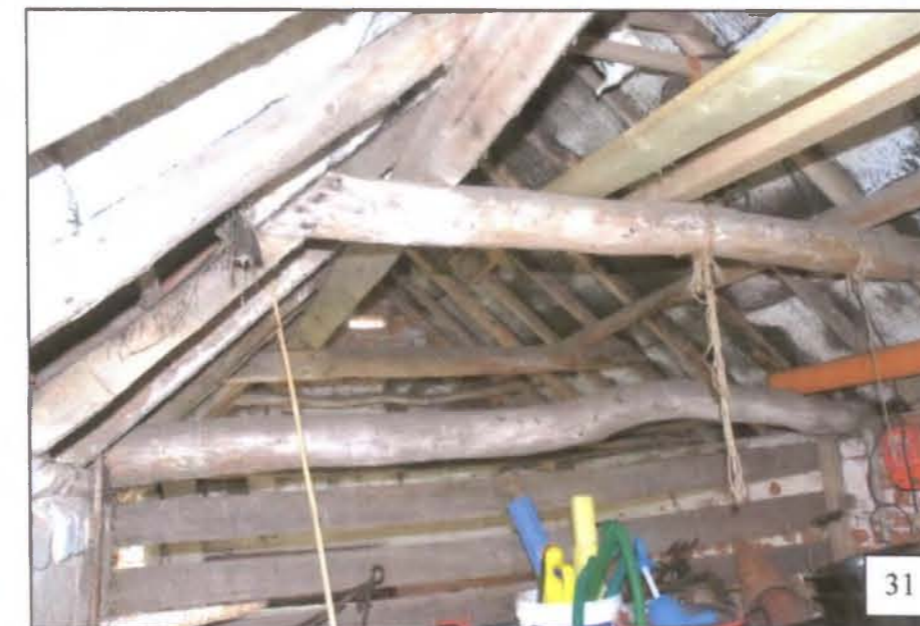
**Room 2**

Room 2 was generally of concrete block construction. In the south wall, the brickwork changed to blocks approximately half-way below the window.

The concrete-block partition wall dividing this room from Room 3 on the west side was similar to that on the east side, dividing it from Room 1 (see Room 1), but no timber partition was present above it. All of the block-built walls here were whitewashed. The remains of modern Dexion shelving were present on the north wall, along with a modern re-used kitchen surface used as a bench on the east side, attesting to the building's most recent use as a garden store.

The roof, as described in Room 1, continued through this room and was of exactly similar construction to Room 1. A completely roundwood 6" diameter tie-beam was present on the east side, just west of the timber partition from Room 1.

The floor was of poured concrete throughout, 2½" in thickness.

This room had no exterior door, and even a frame was no longer present in the opening in the block-built north wall. However, rectangular gaps at each side of the concrete threshold to this room attest to a doorframe having been present when the floor was poured.

A window of two top-hung casements was present in a 43" wide and 16" high opening in the south wall, let in immediately below the wall plate. The casements had 2½" beaded-edged frames, which were clearly reused, and had been turned through 90° from their original orientation when they were positioned. They were hung from a timber lintel, but the timber 'sill' simply acted as a stop on the inside: on the exterior, a cement sill was present, sloping to the exterior face.

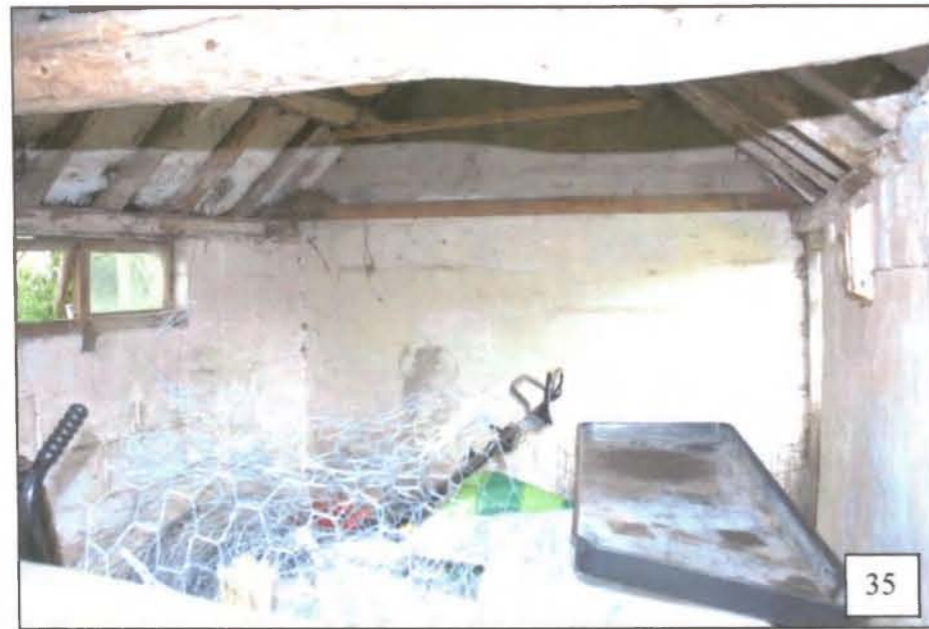
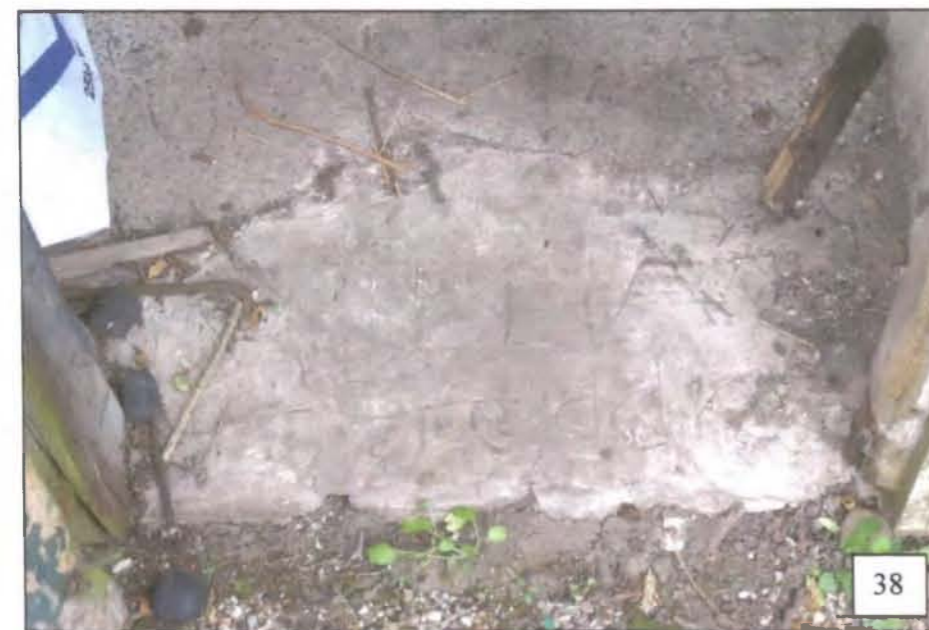
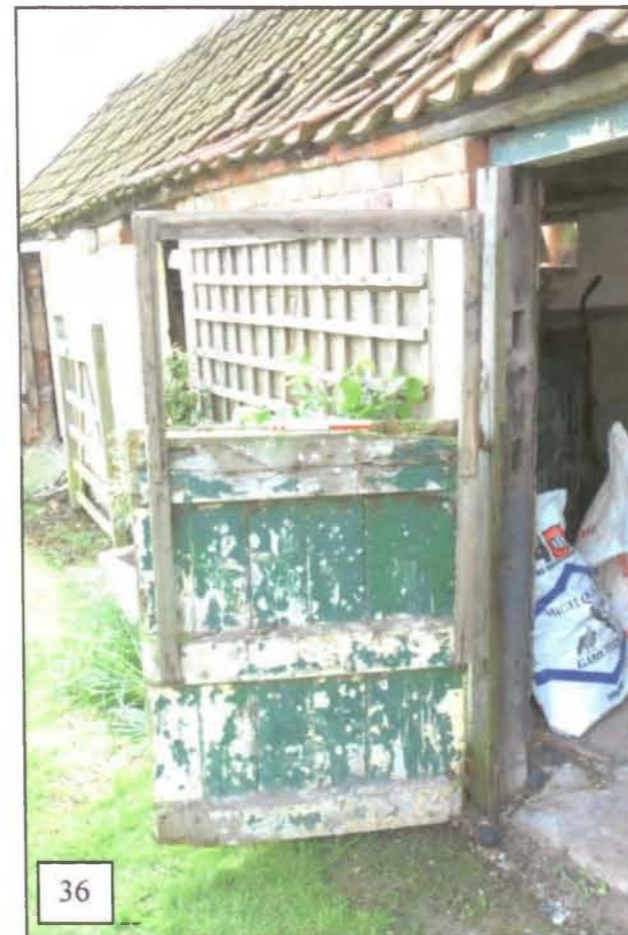
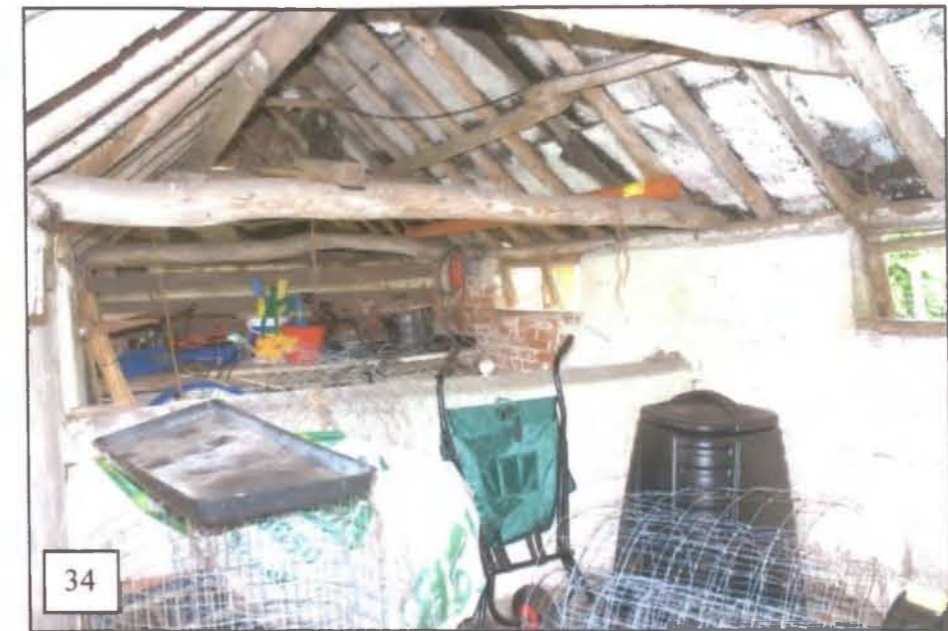
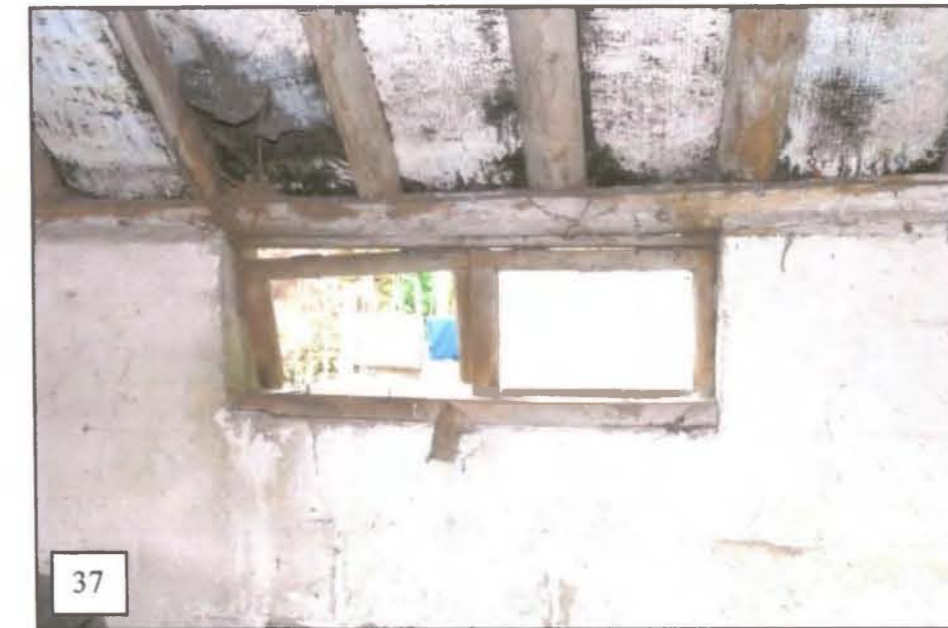
**Room 3**

The walls of Room 3 were constructed entirely of concrete blocks in stretcher bond. The north wall had two courses of brick headers making up the space between the blocks and wall plate (brick size: 9" x 4½" x 3"). As in the other rooms, all of the walls were whitewashed.

The roof, of identical construction to that described previously, continued here; however, it is uncertain if the roof has been reconstructed at this end. The west (block-built) gable had 4 ½" x 3" supports for the shortened purlins, in modern circular-sawn timber, and the west tie-beam was also of circular-sawn wood. A roundwood tie-beam was present just inside the east partition wall.

The floor was of poured concrete throughout, 2 ½" in thickness. The floor was ramped down inside doorway – this being a more recent patch, with an inscription – 'WILLIAM + Freddie'.

The window in the south wall was virtually identical to that of Room 2, but 1" narrower.

The door of Room 3 was a 3-ledged (chamfered timbers), 5" beaded tongue and grooved plank lower stable door. Its frame was of 4 ½" x 3" chamfered timber. The post on the east side of the doorframe appears have been re-used; it had three 3 ½" x 1 ¾" mortices in its upper half.
