*RESULTS OF ARCHAEOLOGICAL PHOTOGRAPHIC RECORDING ADJACENT TO THE
GRANGE, MARRIOTS GATE, LUTTON, SPALDING, LINCOLNSHIRE*

PLANNING APPLICATION REFERENCE:

H12/1129/04/FULL

Site Code: MGLS07

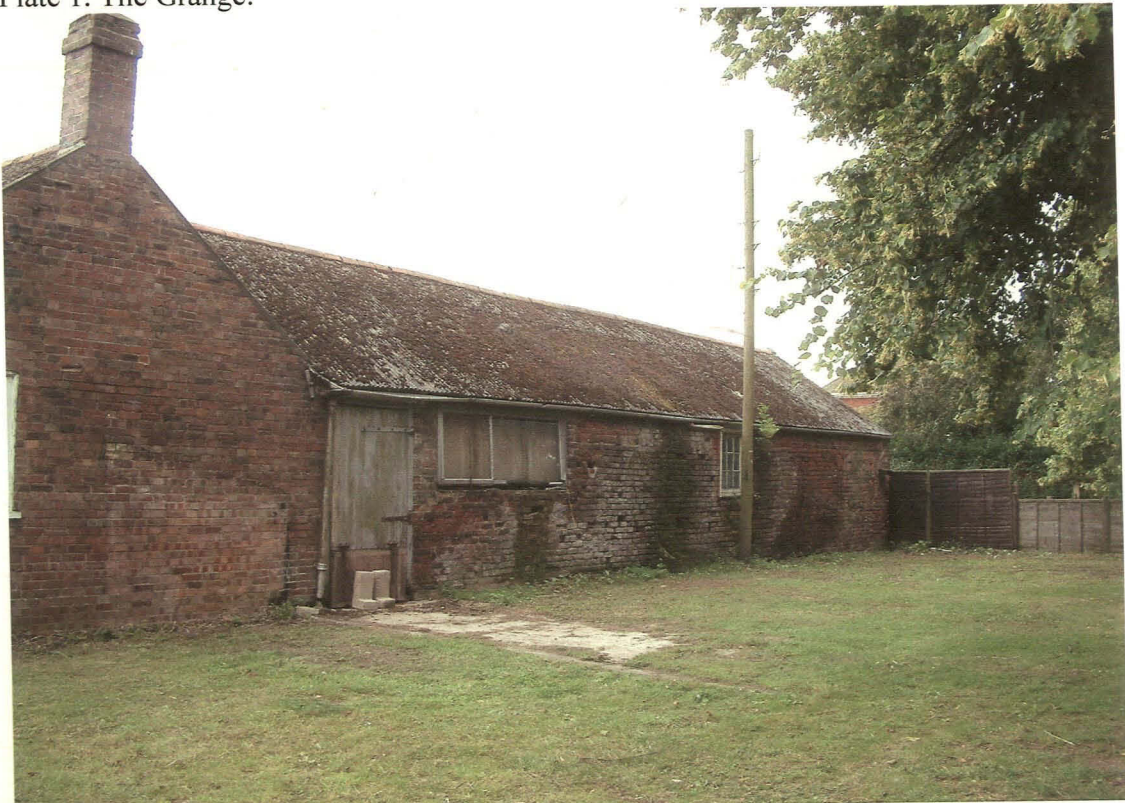
Outbuilding 1 (Plates 2, 7, 8, 9 & 10) is built using Flemish Garden Wall bond with signs of the inner yard stable door and openings being bricked up in the 20th centuries. The roof is built with modern timbers and corrugated iron (Plate 8 & 9). The construction date is a mix of original late 19th century with rebuilding and changes made in the 20th century. The original use of this range of buildings would have been mainly storage or animal housing. The insertion of 20th century sliding garage doors suggests more recent use was large machinery or vehicle storage.

Plate 2. Outbuilding 1 looking south west.

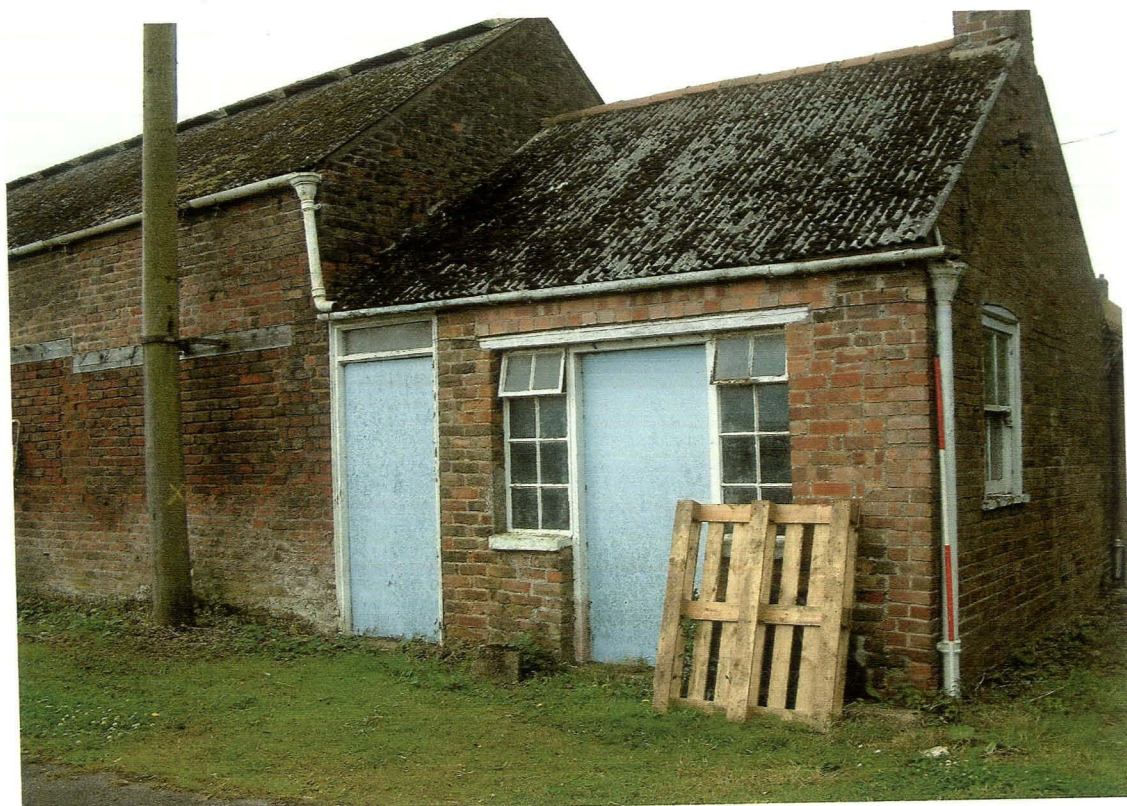
- 6.7 A small office exists at the northern end of this building with a central entrance door (on the east face) and adjoining windows which were added in the twentieth century. The small staff office is original use but all that remains of any interior features is a cast iron fireplace (Plate 11). It occupies one room.

Plate 3. Small staff cottage on northern end of outbuilding 2.

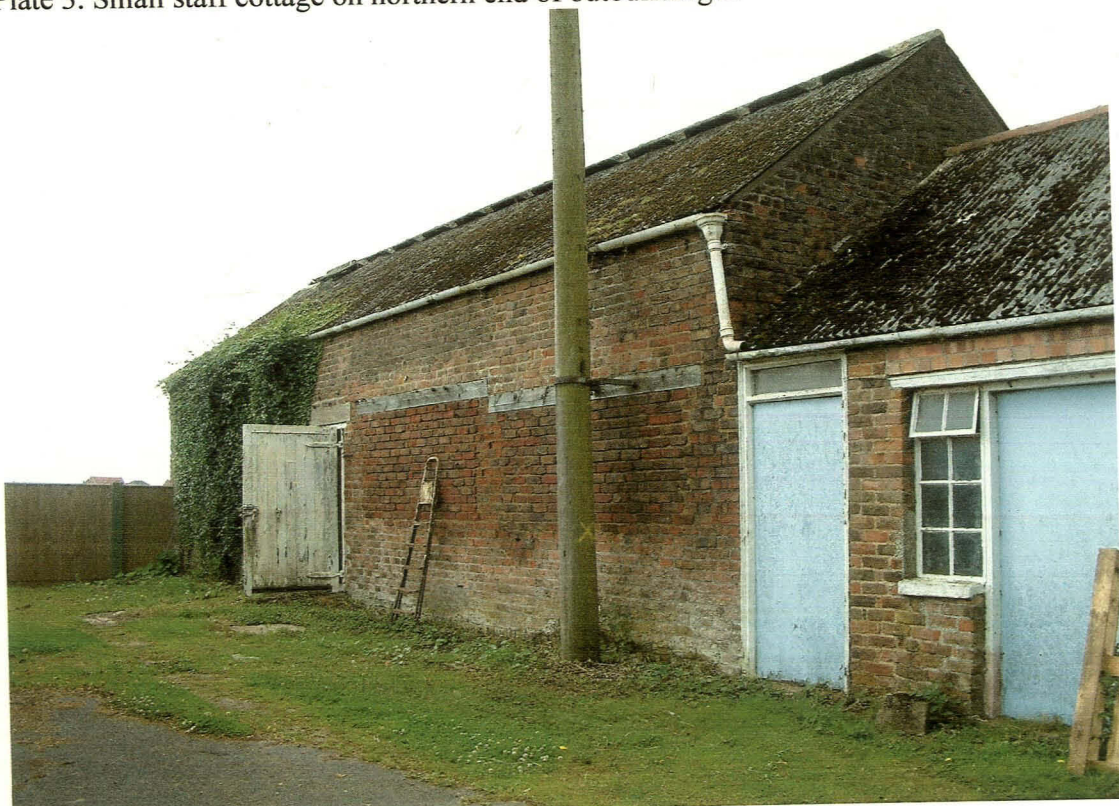
- 6.8 Two further original blocked up large window openings are seen on this same eastern face (Plate 4) and the southern gable end (Plate 5). The blocked up openings shown on Plate 4 are made with 19th century brick perhaps re-used from elsewhere on site. The door opening is 20th century in date with a concrete lintel over. Plate 5 shows an upper opening (possibly original) which is blocked off with re-used late 19th century brick and an opening at ground level which appears to have been made in the 20th century. The opening and joist holes at the first floor level of the southern face suggests there was originally a first floor. At the southern end of the eastern face, the building is covered in ivy and on internal inspection, a blocked window of 20th century date is seen (Plate 14).

Plate 4. Outbuilding 2 looking south.

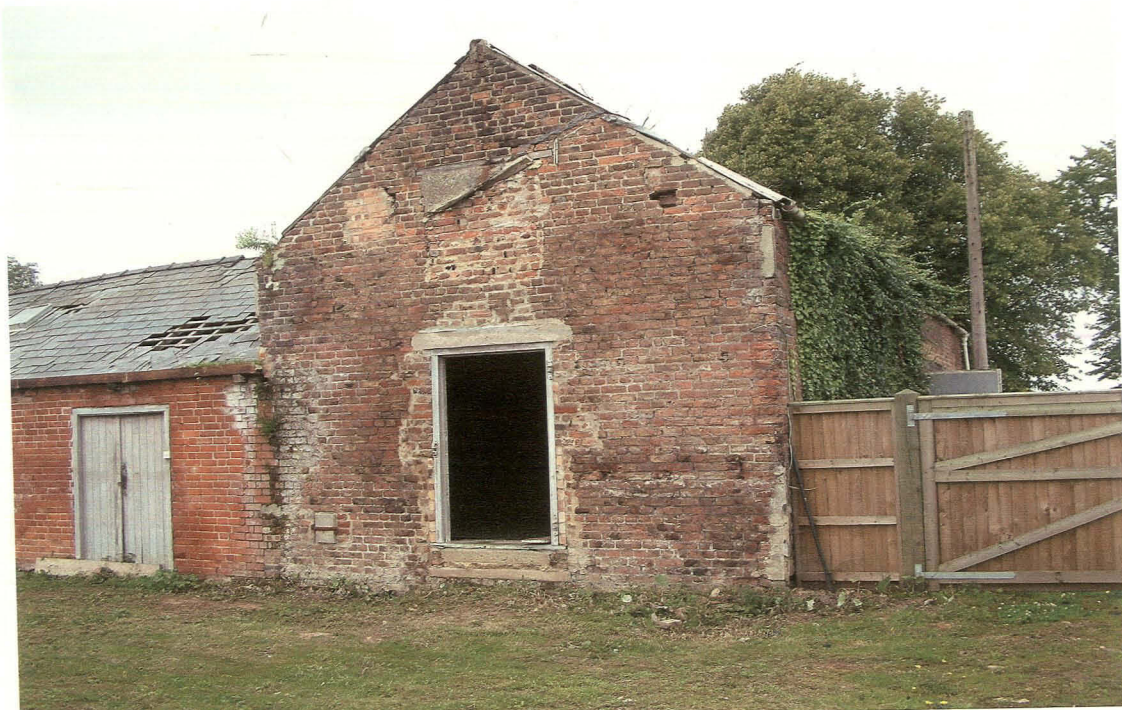
Plate 5. Gable end of outbuilding 2 looking north.

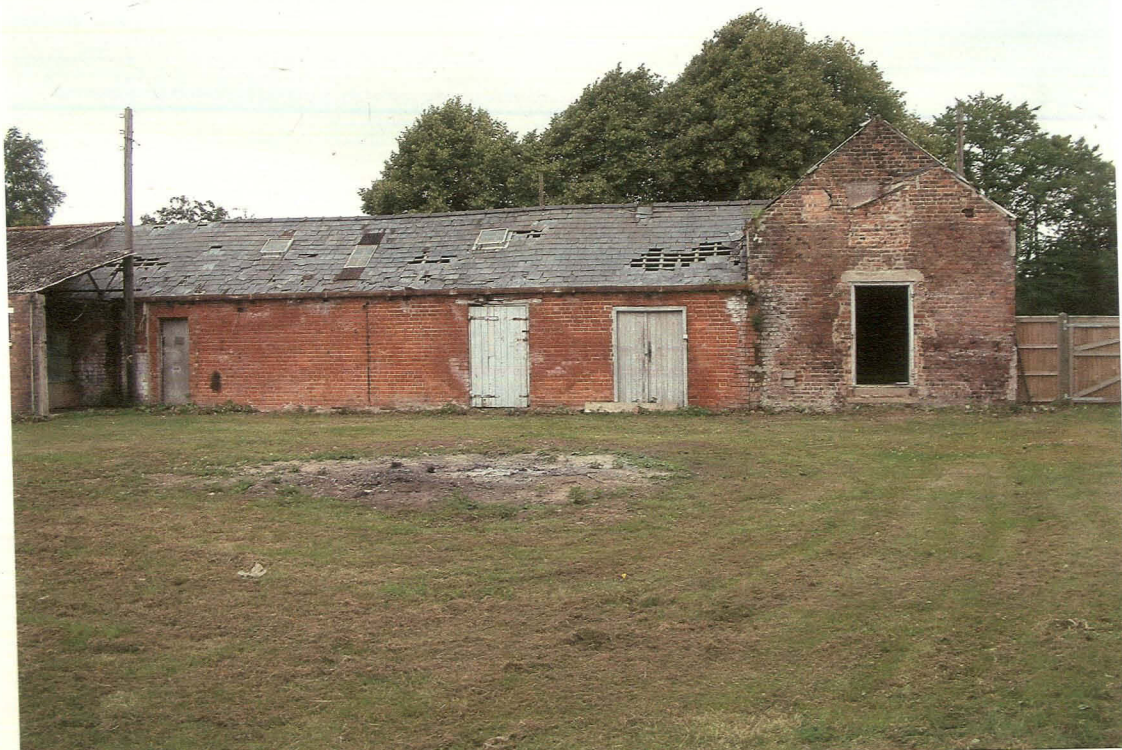
- 6.10 Outbuilding 3 (Plates 6 & 9) is of early 20th century date, built of brick using Flemish Garden Wall bond, with a slate roof. The original use of this building appears to have been some stabling and mainly large machine storage with openings into the yard and into the field to the south. The lintel over the central door is wood. The floor is concrete.

Plate 6. Outbuilding 3 ends at telegraph pole looking north west.

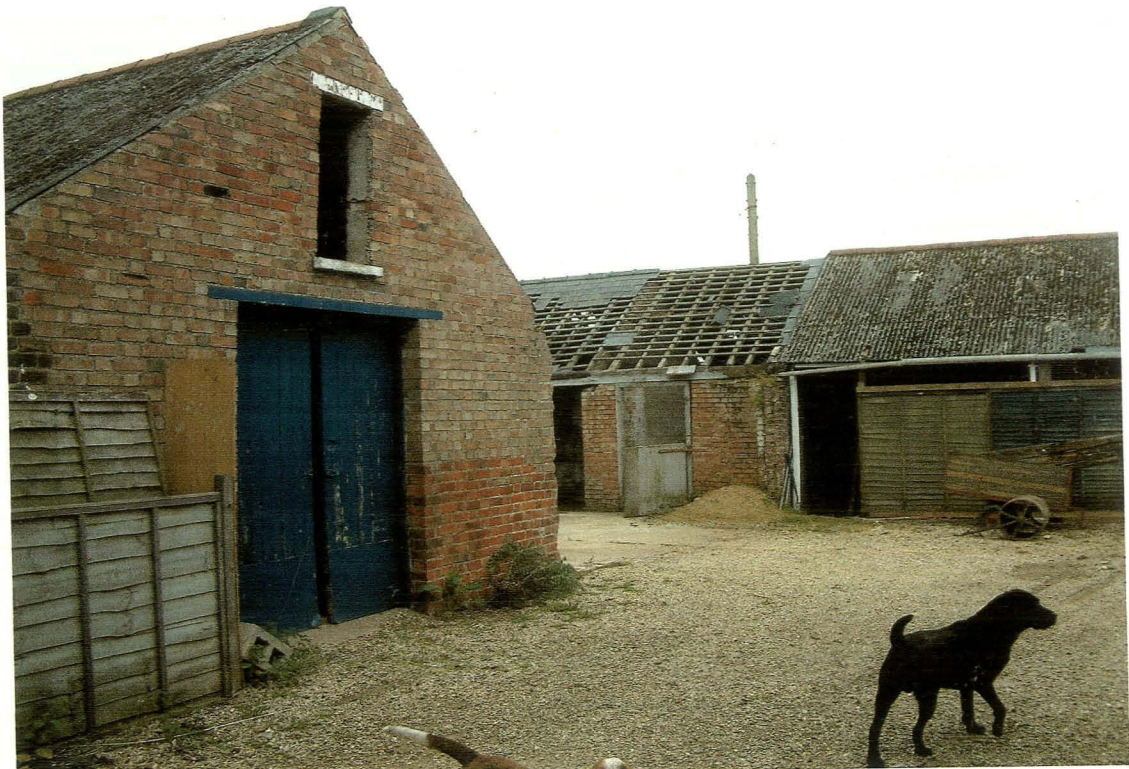
Plate 7. Gable end of outbuilding 1 looking south.

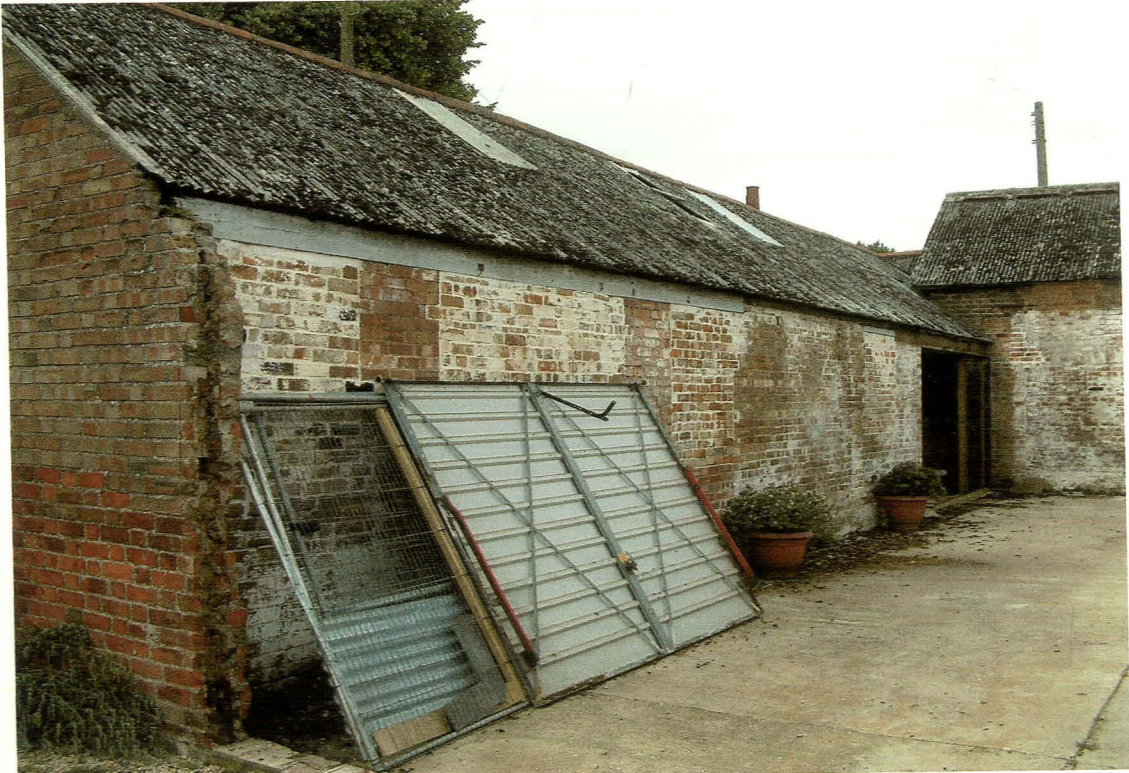
Plate 8. Outbuilding 1 looking east.

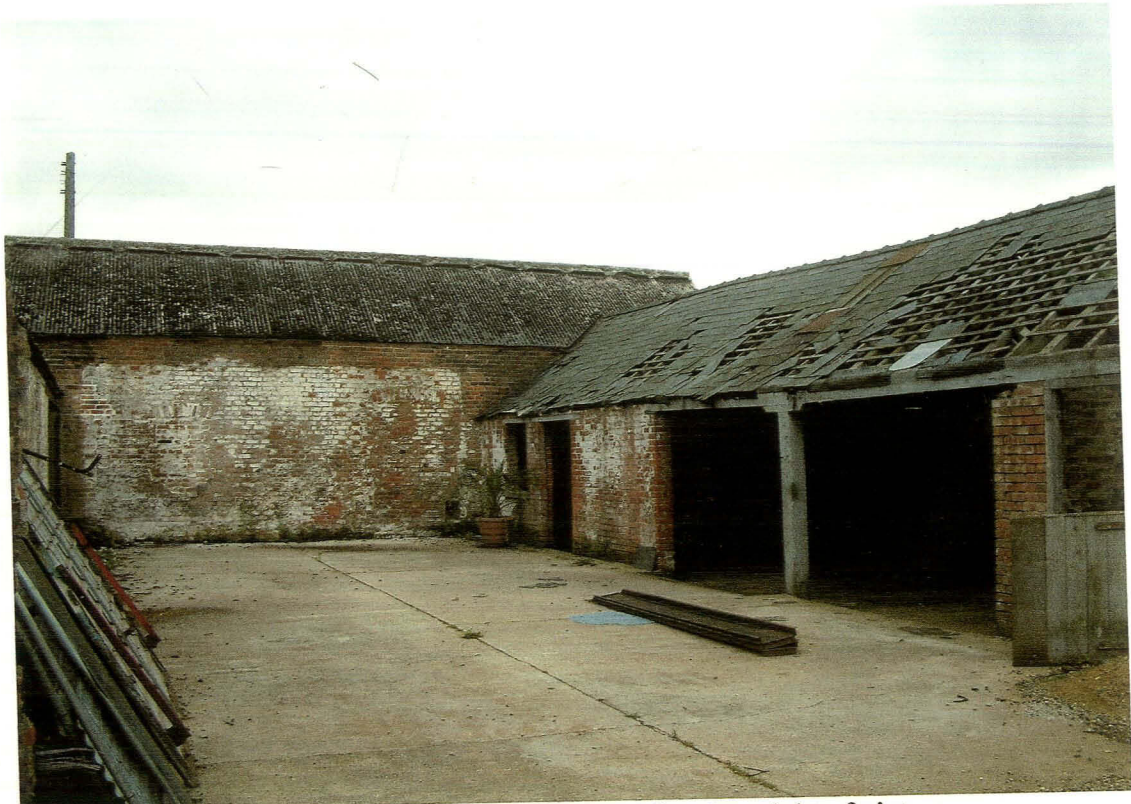
Plate 9. Outbuildings 2 and 3 looking east, outbuilding 3 to right of picture.

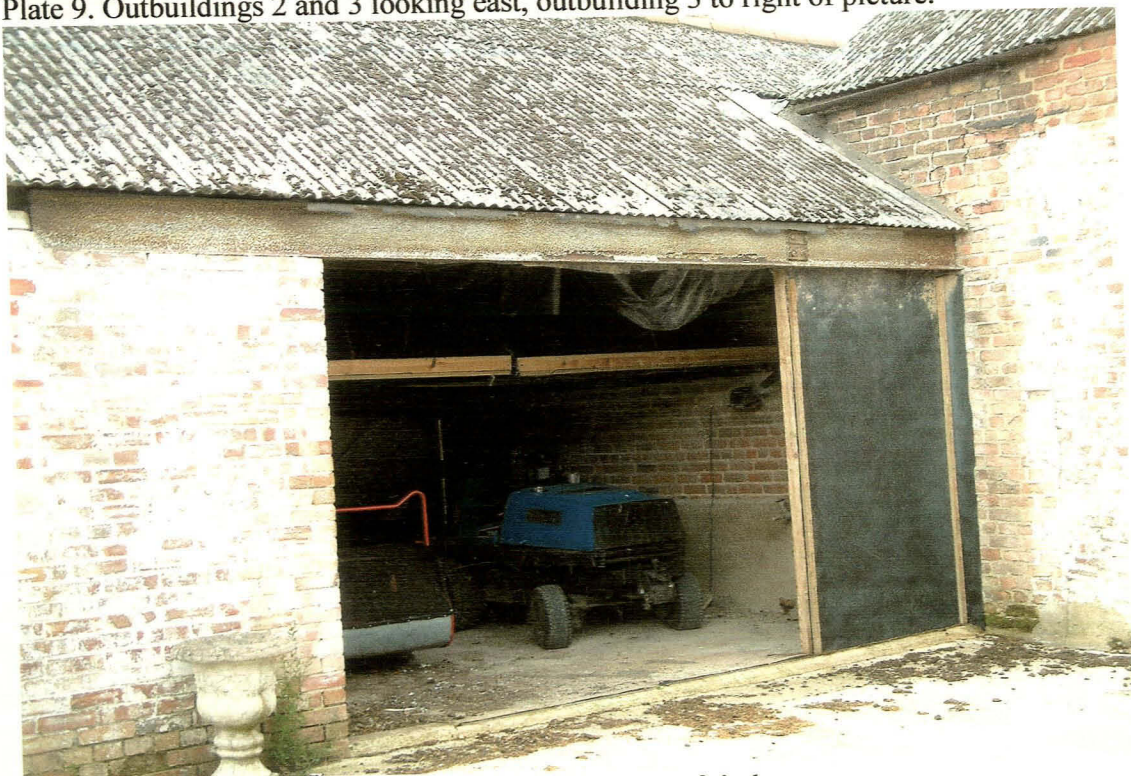
Plate 10. Shot of inside of building 1 with modern roof timbers.

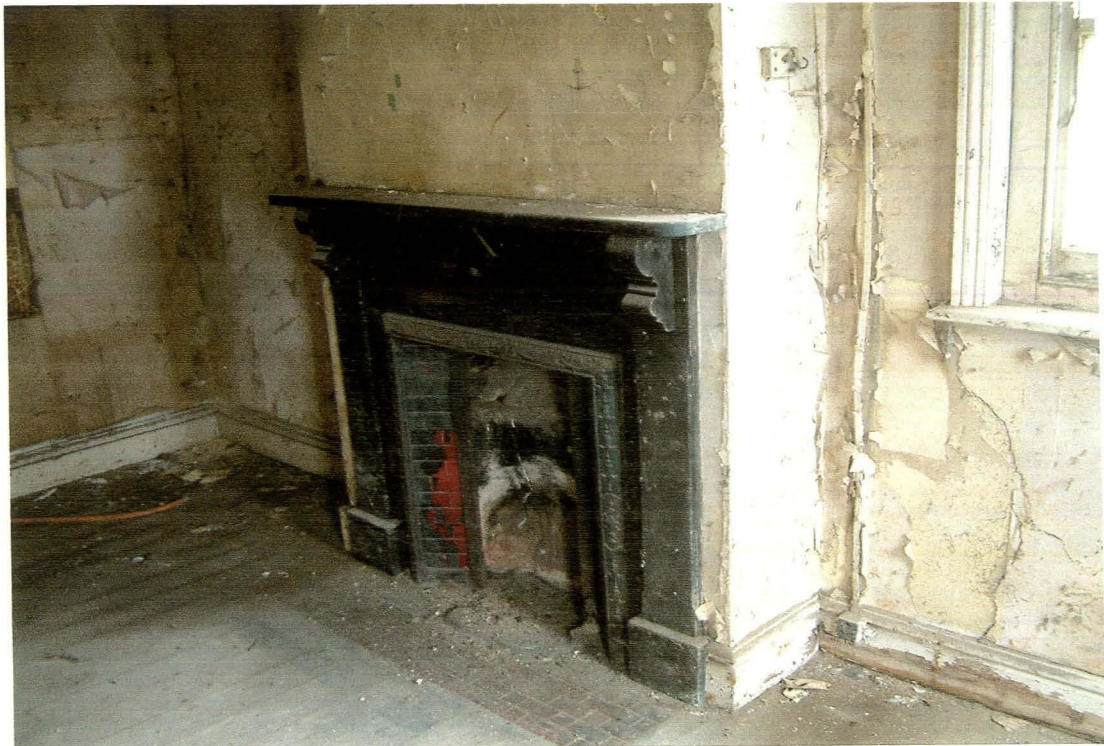
- 6.4 The report (and archive) shall provide a visual record of the existing fabric and architectural features. A photographic record was made of all external and internal elevations using 35mm format colour film and digital camera. No items of particular architectural interest were encountered. An iron Victorian fireplace was encountered in one room.

Plate 11. Shot of interior of small office in outbuilding 2

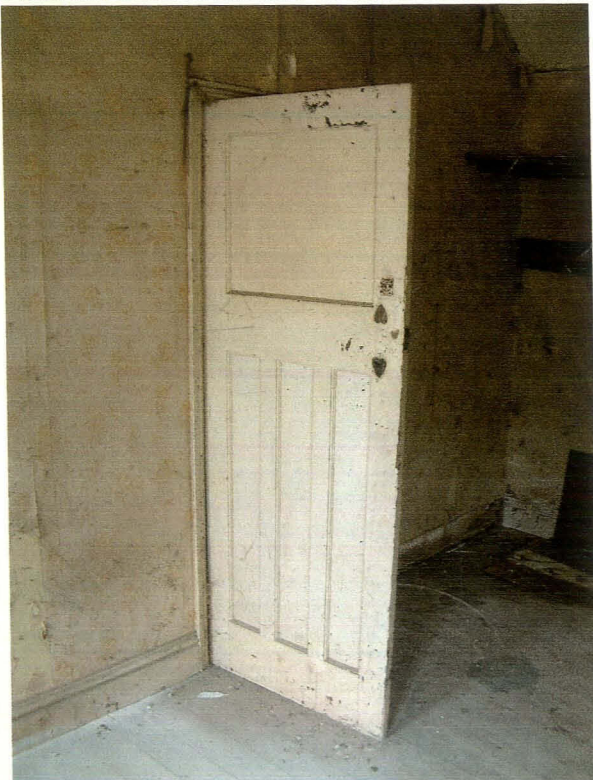
Plate 12. Internal décor, original door and condition of office.

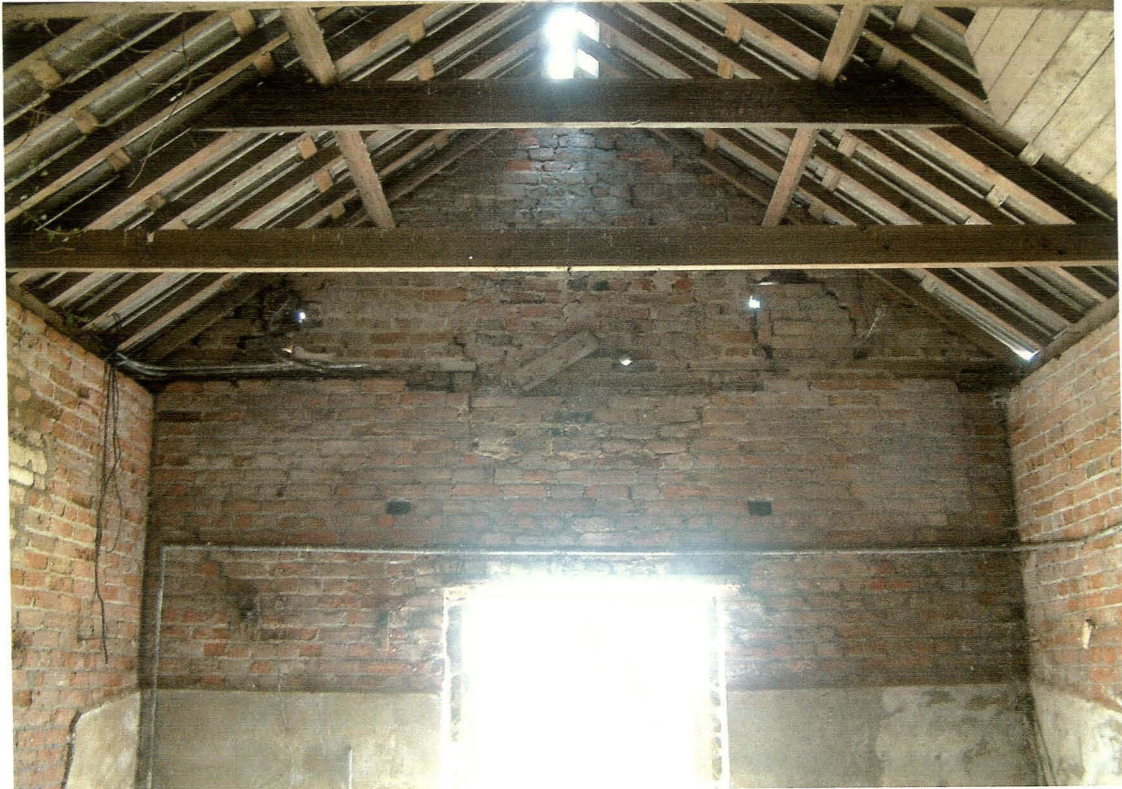
- 6.6 Outbuilding 2 (Plates 3, 4, 5, 9, 11-16) also dates from the 19th century with 20th century additions or alterations. The building is built using English Garden Wall bond and has a corrugated iron roof with modern wooden roof trusses (Plate 13). Its original use may have been storage. It is divided by original brick partitioning into three rooms.

Plate 13. Showing internal details of outbuilding 2.

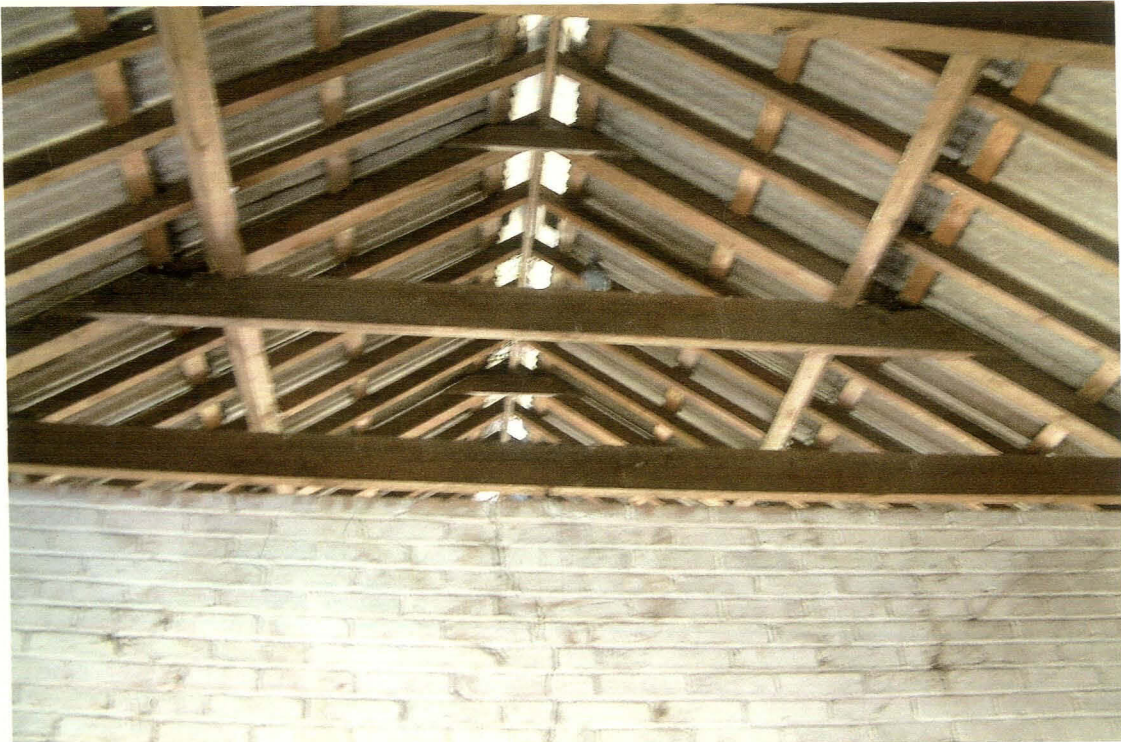
Plate 14. Showing modern timbers and corrugated roof of outbuilding 2.

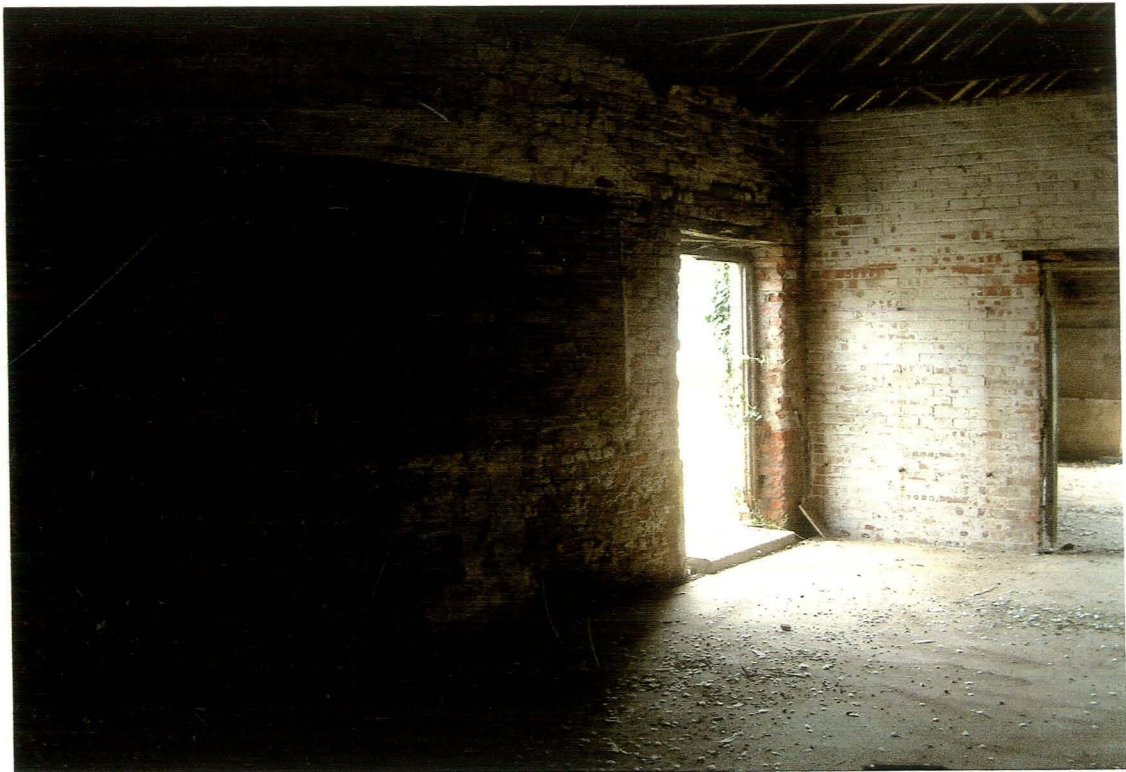
- 6.9 The floor of the barn is concrete throughout (Plate 15). The western face looks onto the courtyard and has two openings, a doorway and a window which have been bricked up the 19th century bricks (Plate 16).

Plate 15. Interior of Outbuilding 2 showing concrete floor, internal division, bricked opening.

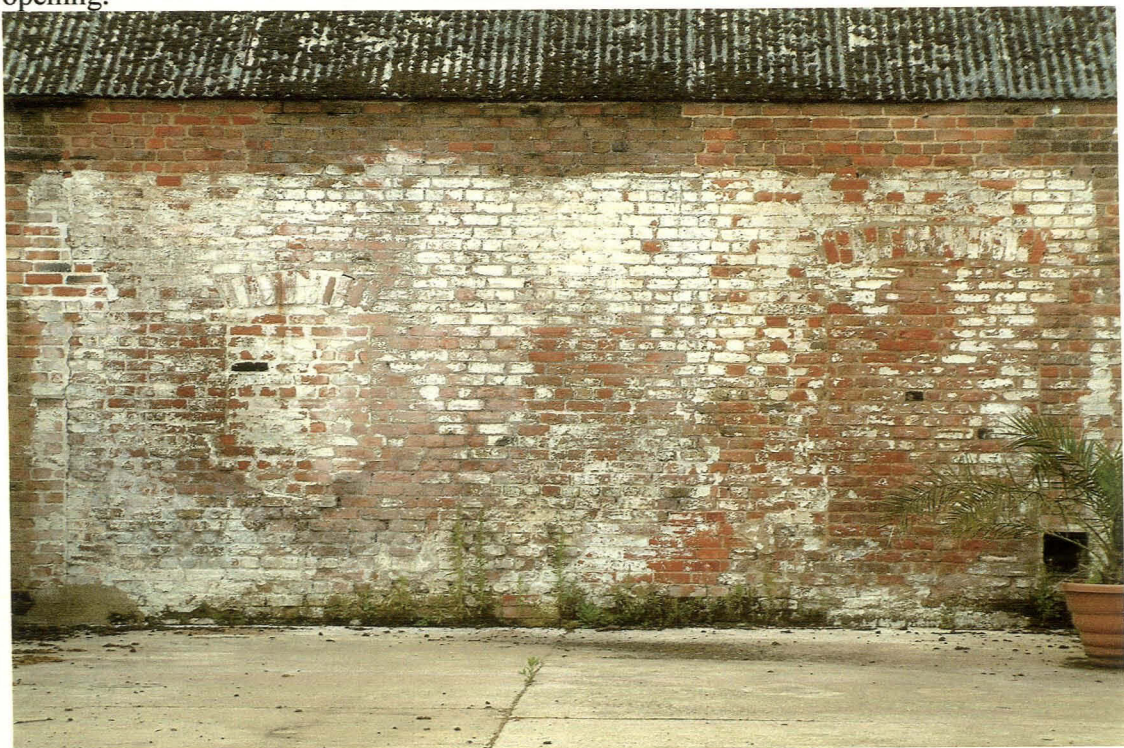
Plate 16. The western face looking onto the courtyard showing two bricked up openings, a doorway and a window.
