PINGLEY CAMP, BRIGG, LINCOLNSHIRE

PHOTOGRAPHIC BUILDING SURVEY

Report prepared for Barford Builders by S. A. Savage

Site Code: PPCB 08
Planning ref: 119946
NGR: TA 0178 0680
LCNCC acc. no. 2008.189
PCA job no.:08-515

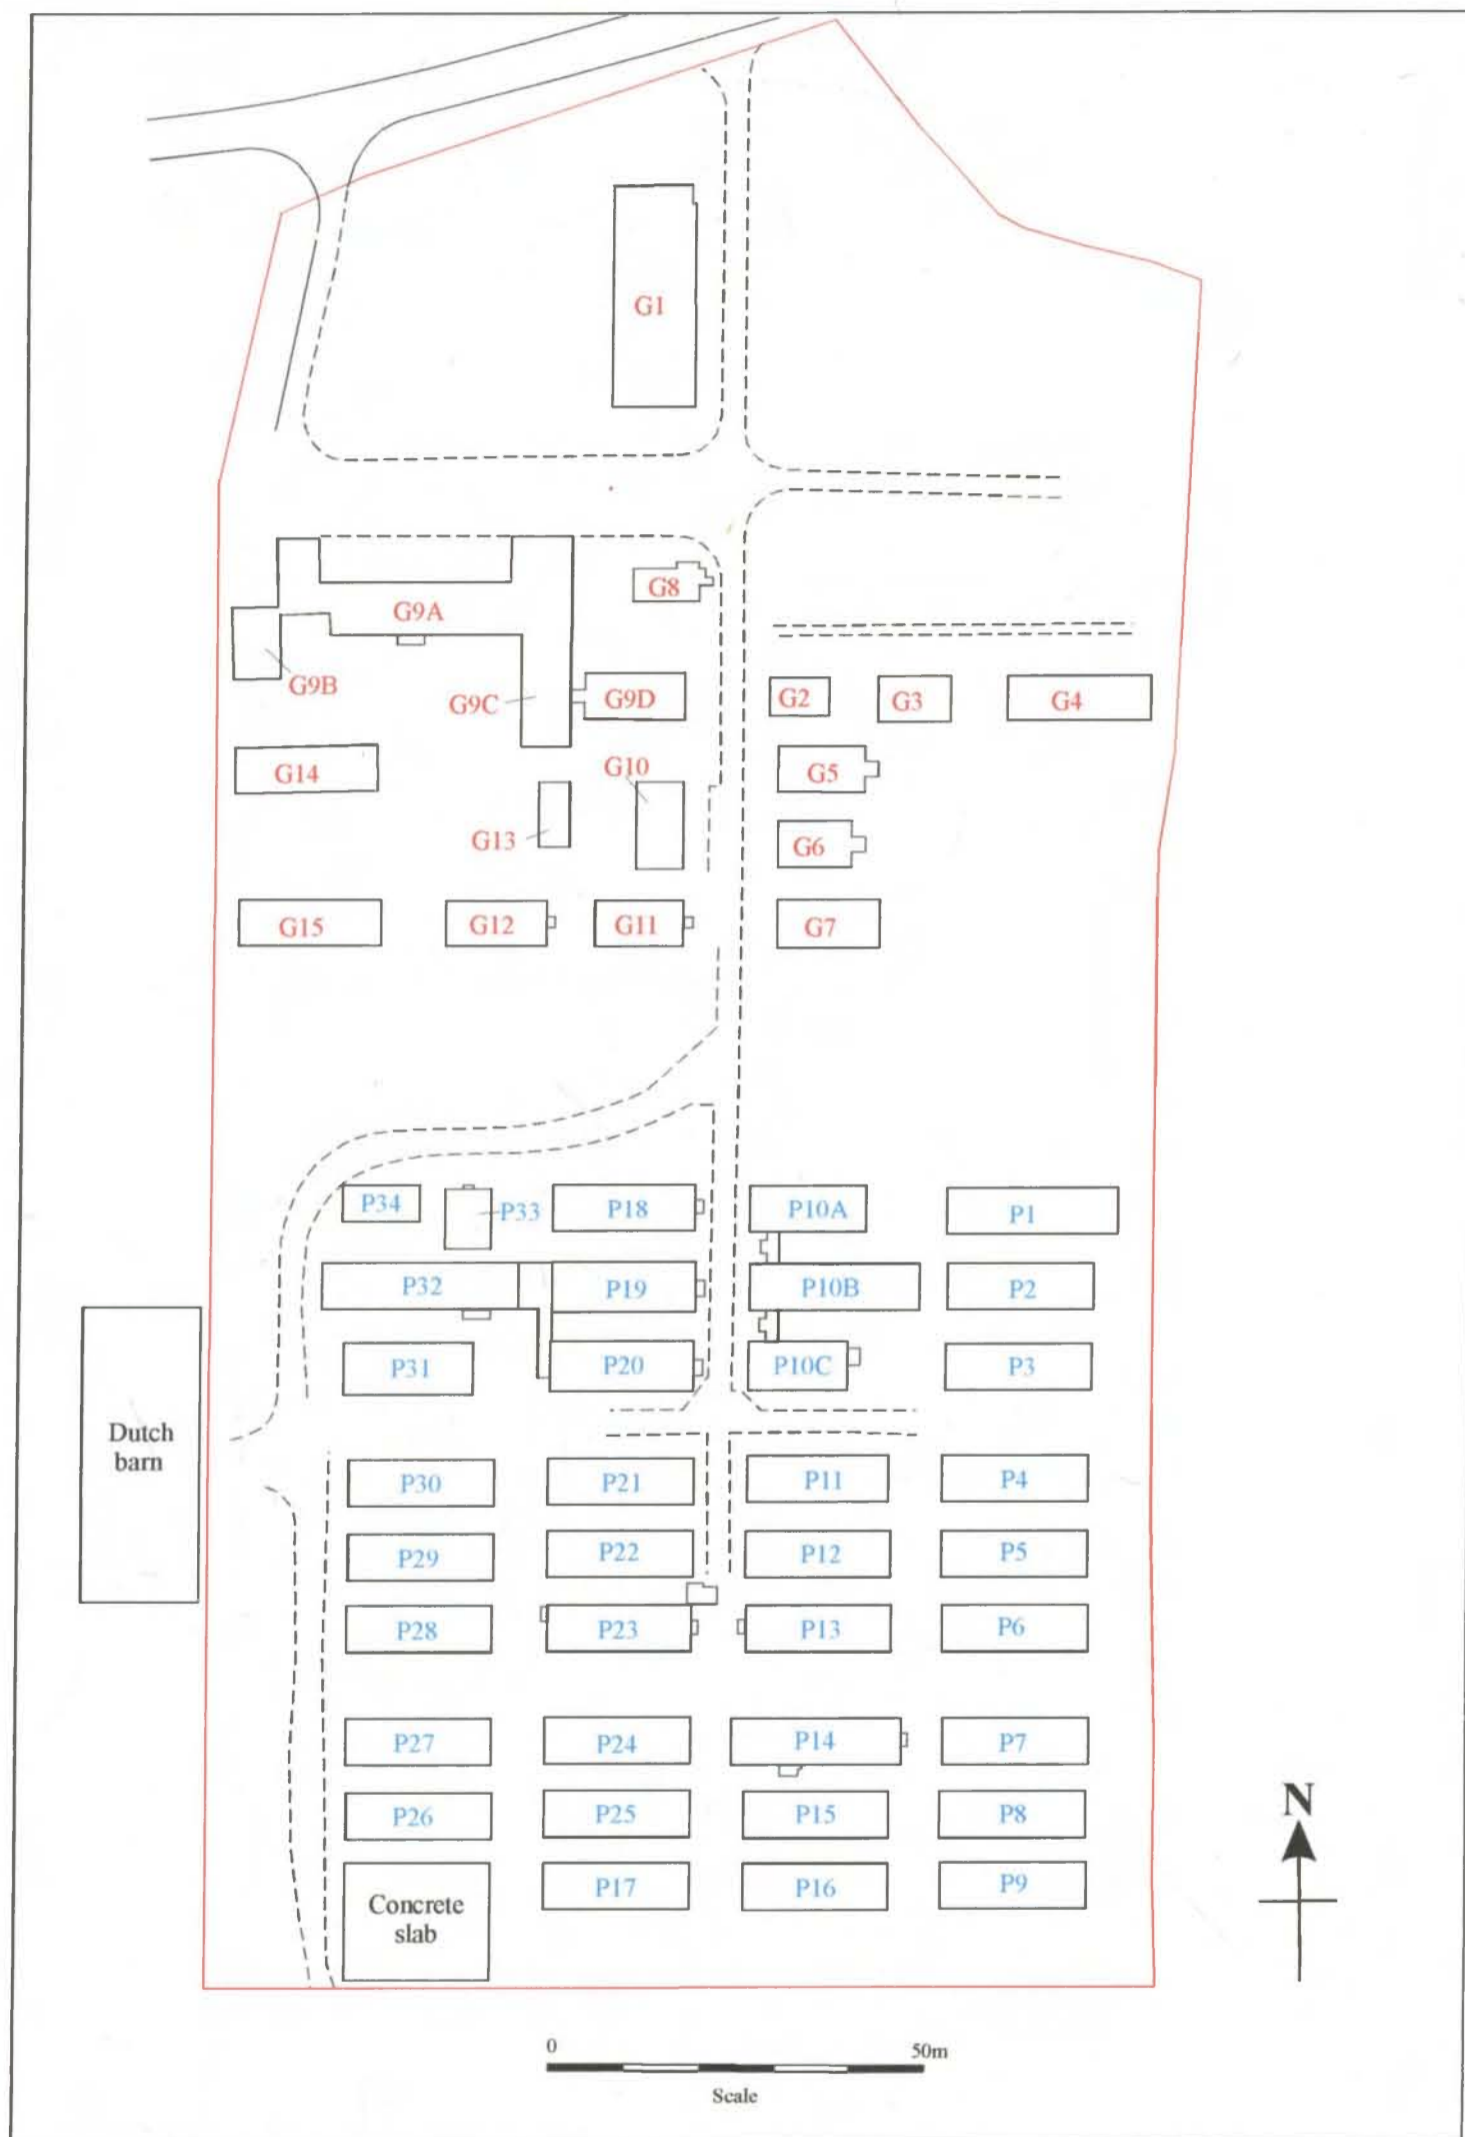
Fig. 2: Site Layout Plan of the development Site at Pingley Farm Camp, showing the building numbers used in this report. The Buildings of the Guards' Compound are shown in red, while those of the prison camp are shown in blue. Scale 1: 1000,

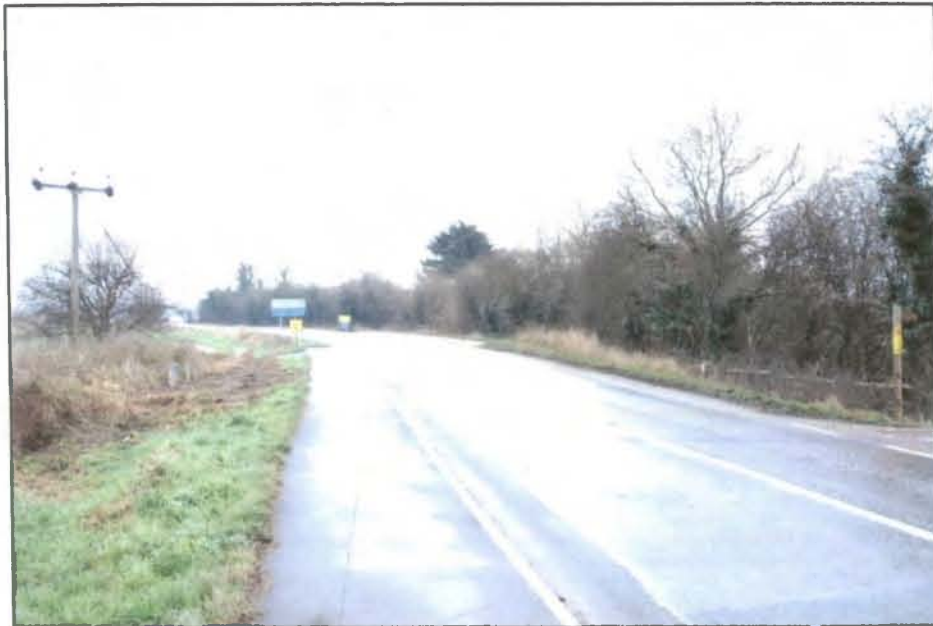
General view, looking east along Bigby High Road: the entrance to the camp is in the middle distance.

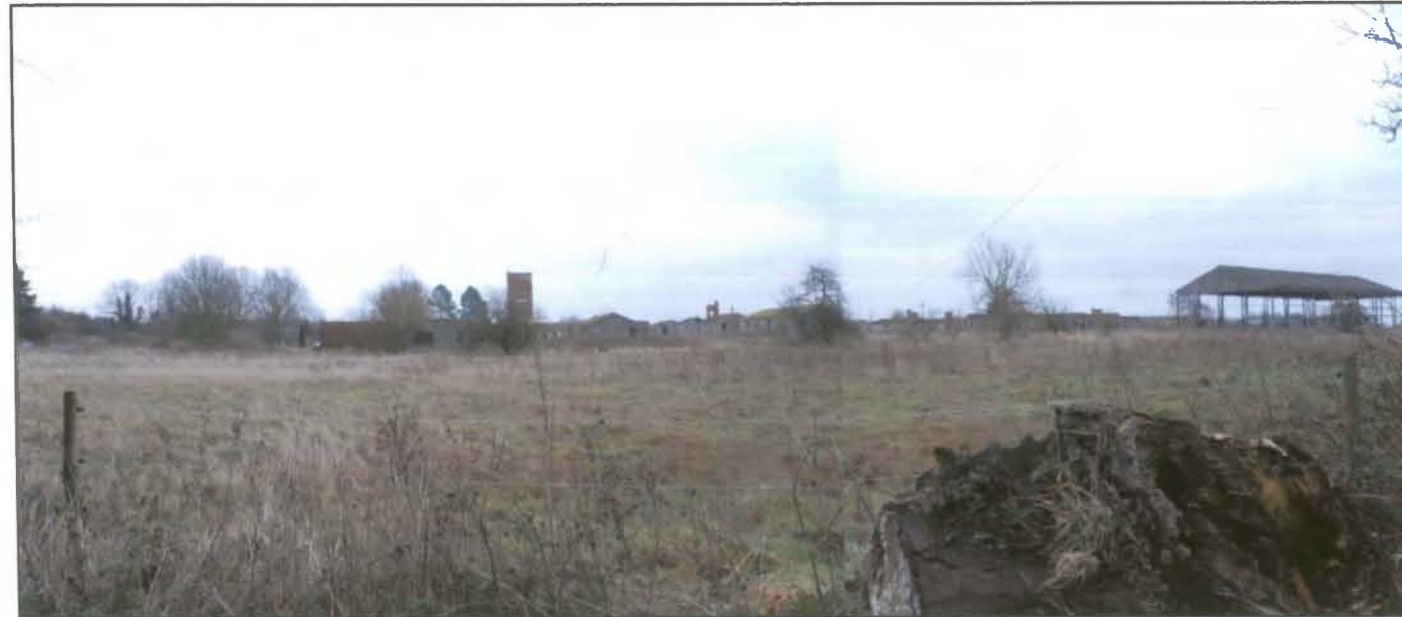
Panoramic view of the camp, from the bridleway to the west, looking east.

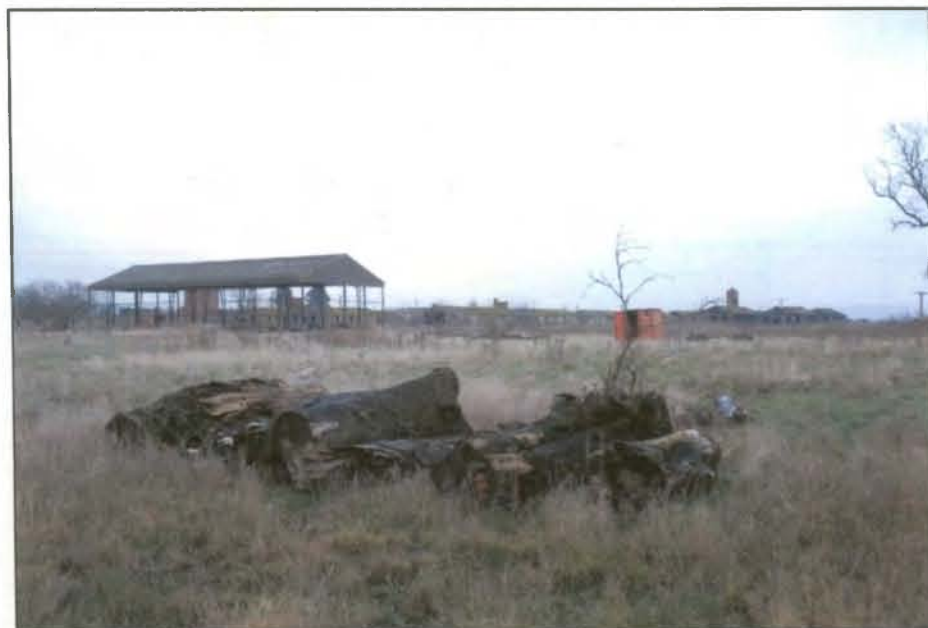
General view of the camp looking northeast from the bridleway junction.

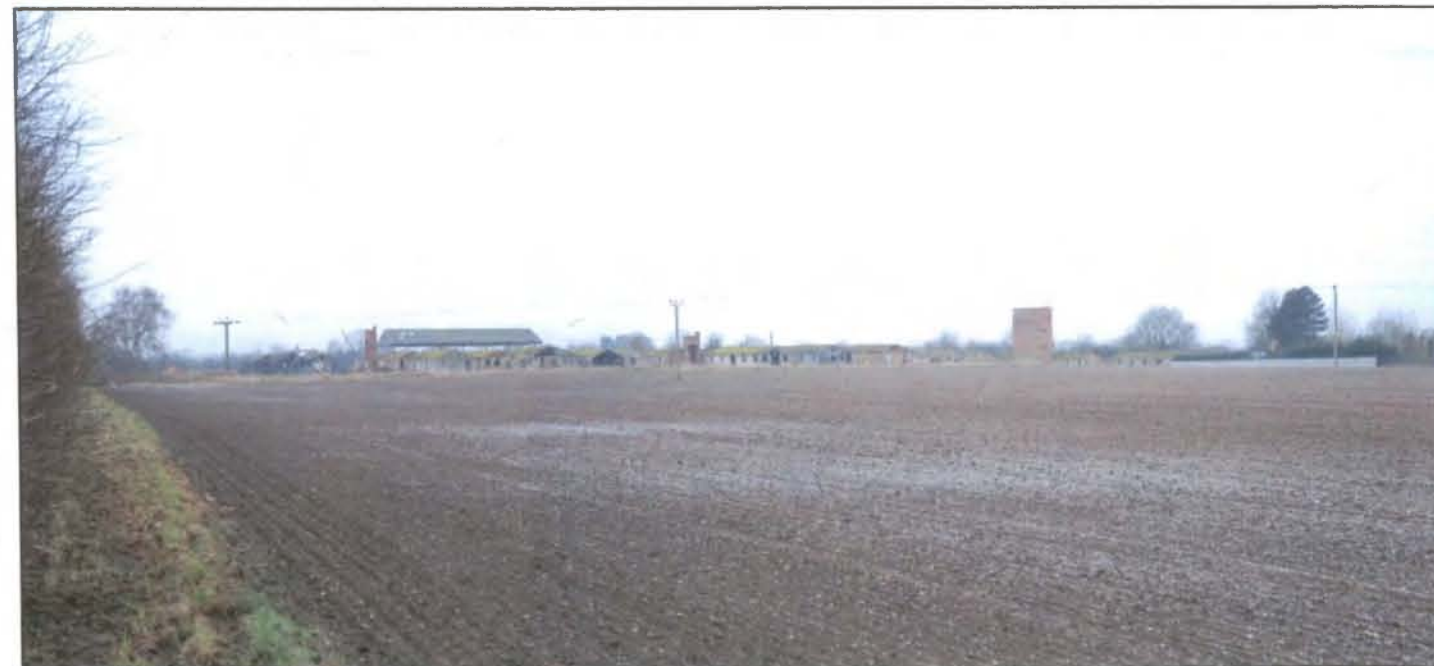
Panoramic view of the camp, looking northwest.

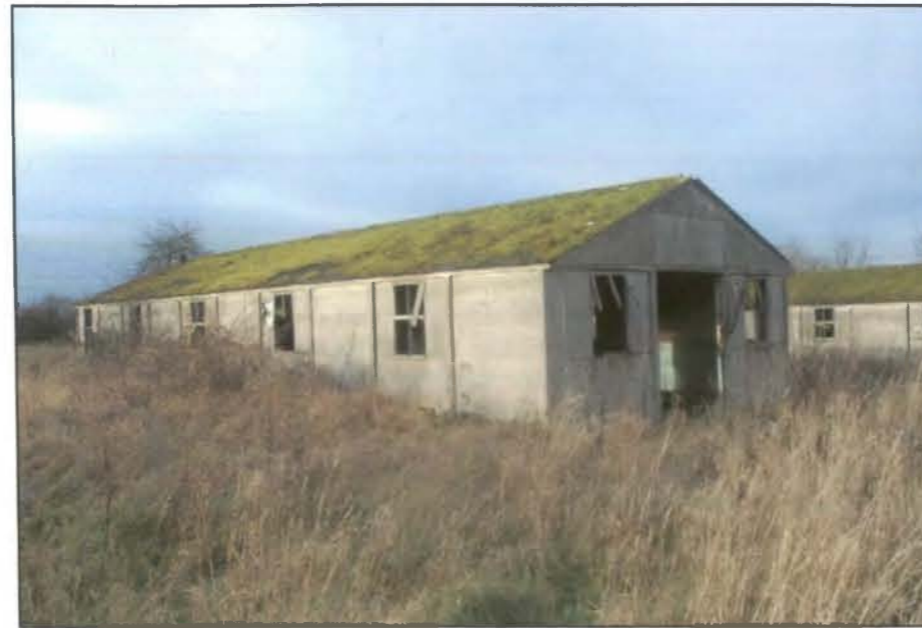
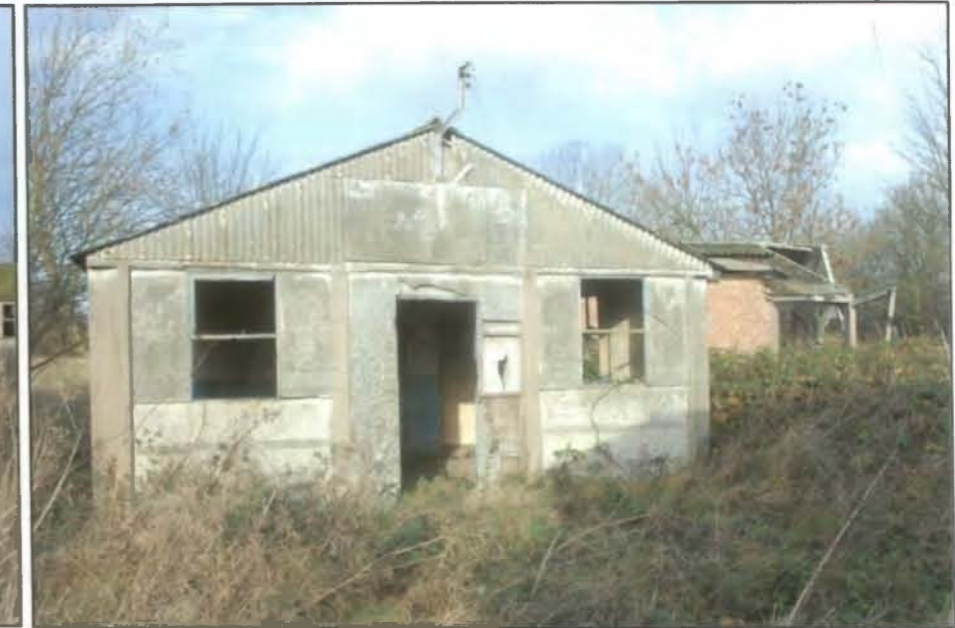
Although both of the MoWP type huts have the same prefabricated reinforced concrete frame, the type used for accommodation had prefabricated concrete panels filling the concrete frame. These concrete infill panels were 68" in length, 15" high and 5" in thickness. Six were used to create blind bays, while three were used in those with windows.

Most of the huts of this type were 60ft or ten bays in length.

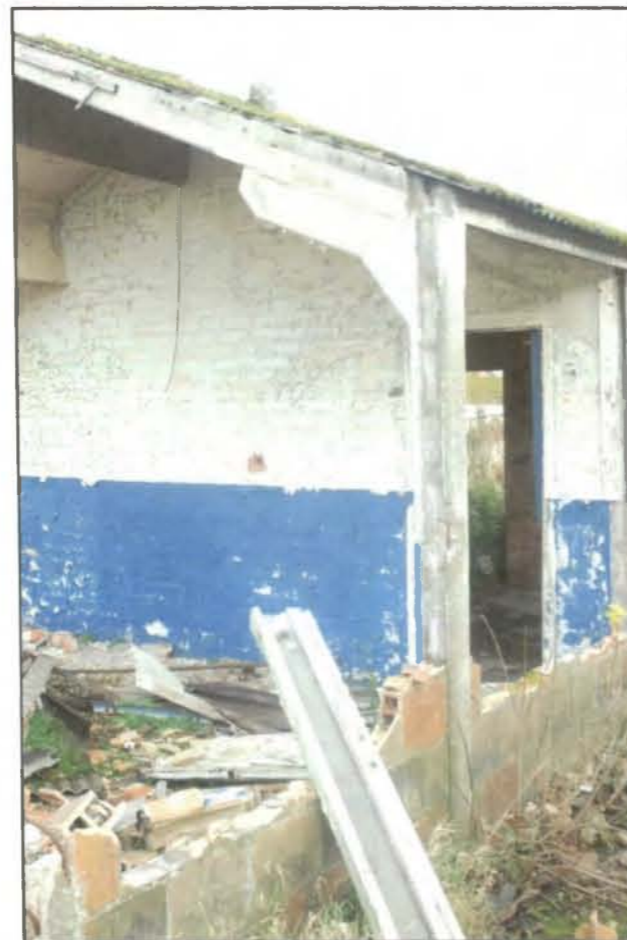
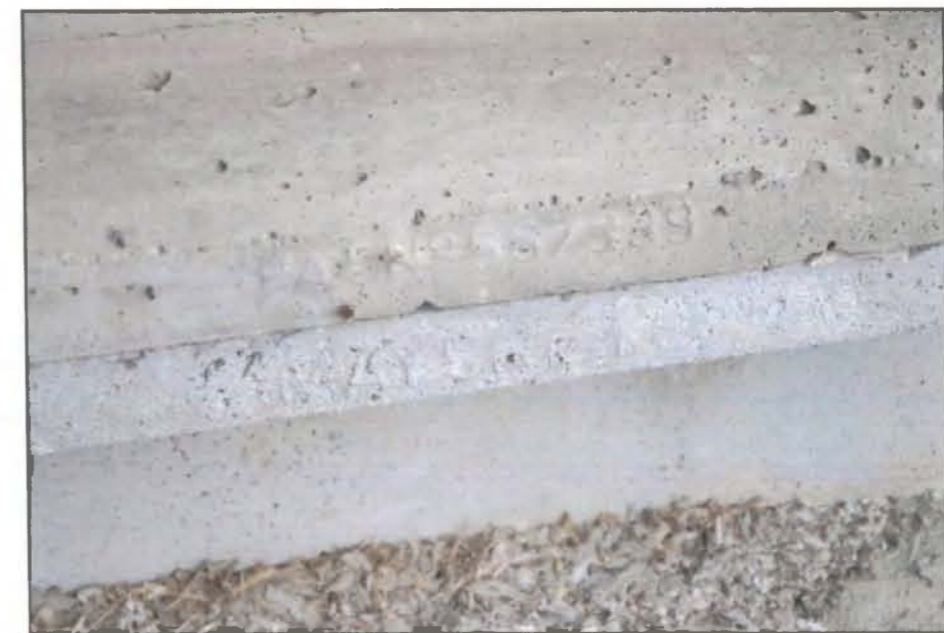
The MoWP type huts which were not of the above category used hollow bricks as infill within the concrete frame. These bricks were 11½" x 8¾" x 4" in size. This type of construction was generally used for communal buildings at the site, within both the guards' compound and the prison area. It is not clear exactly why these structures employed these materials; however, it is the case that many of these buildings were subdivided into rooms and corridors, and in many cases, the hollow bricks were also used in the construction of the partitions within these buildings. Although this design allowed for partition walls to have bonded corners, the rare occurrence of partition walls occurring in the middle of infill panels, rather than at the uprights of the concrete framing, where it only abuts the vertical concrete members, does not appear to justify the use of this considerably more labour-intensive construction method.

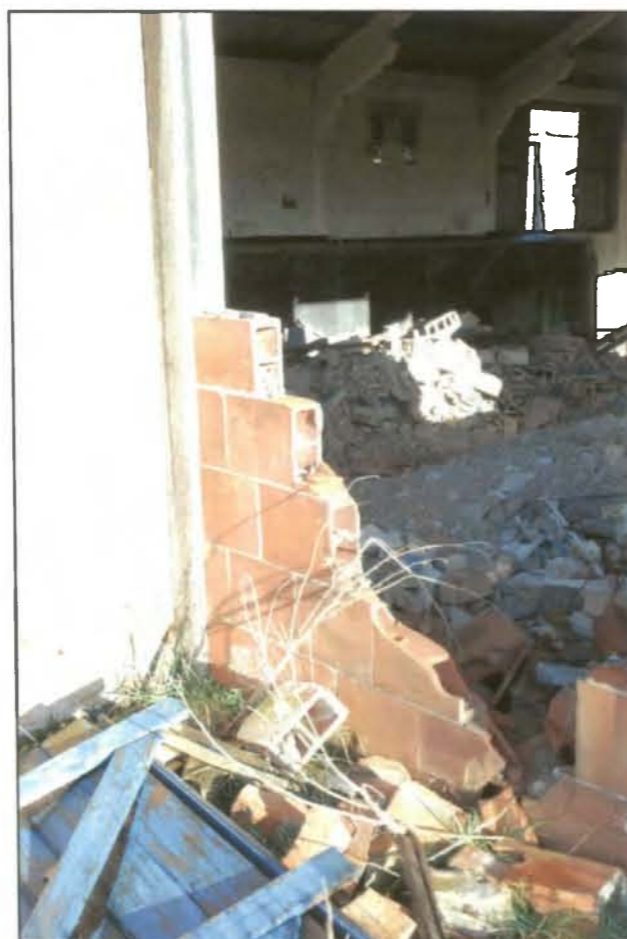
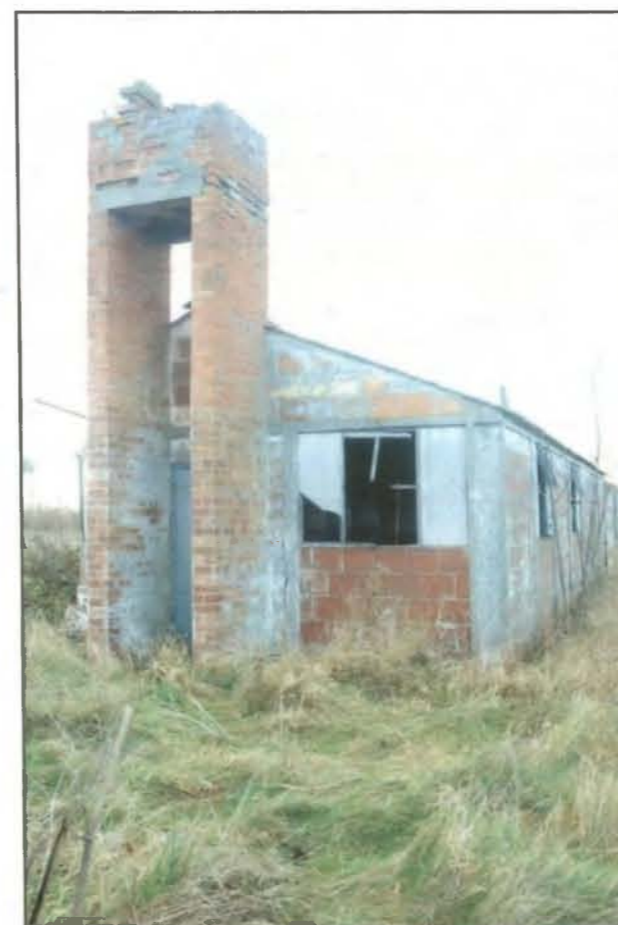
The buildings of this type comprised all of the MoWP huts in the guards compound, with the exception of the guards' sleeping huts (G14 and 15) and the communal buildings in the prison area (the CRS, the cookhouse, the local produce stall, the tailor's shop, the recreation huts, the ablutions and shower blocks).

The glaring exception is the detention block in the guards' compound, which was entirely constructed of conventional brickwork within the MoWP concrete frame.

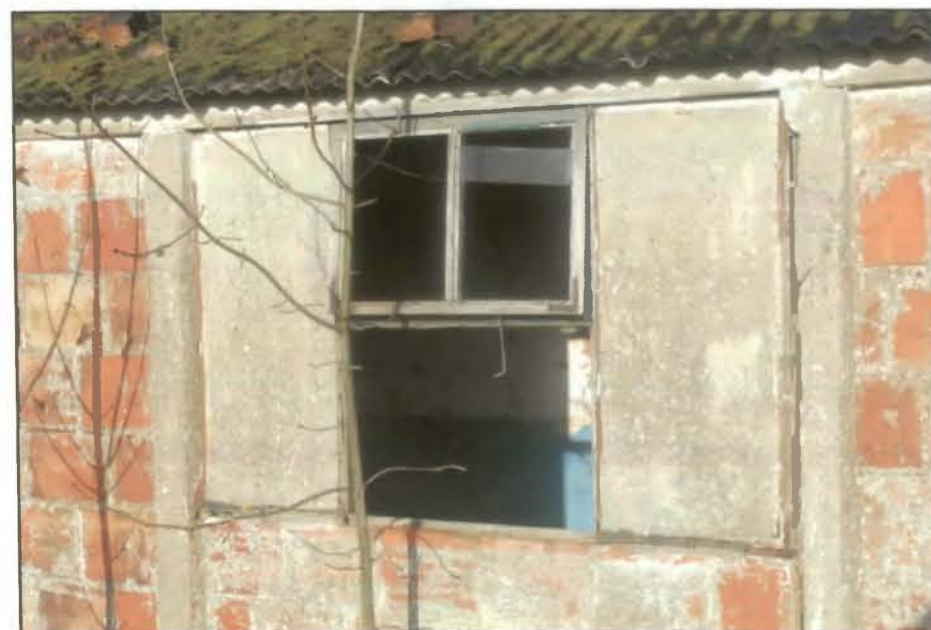
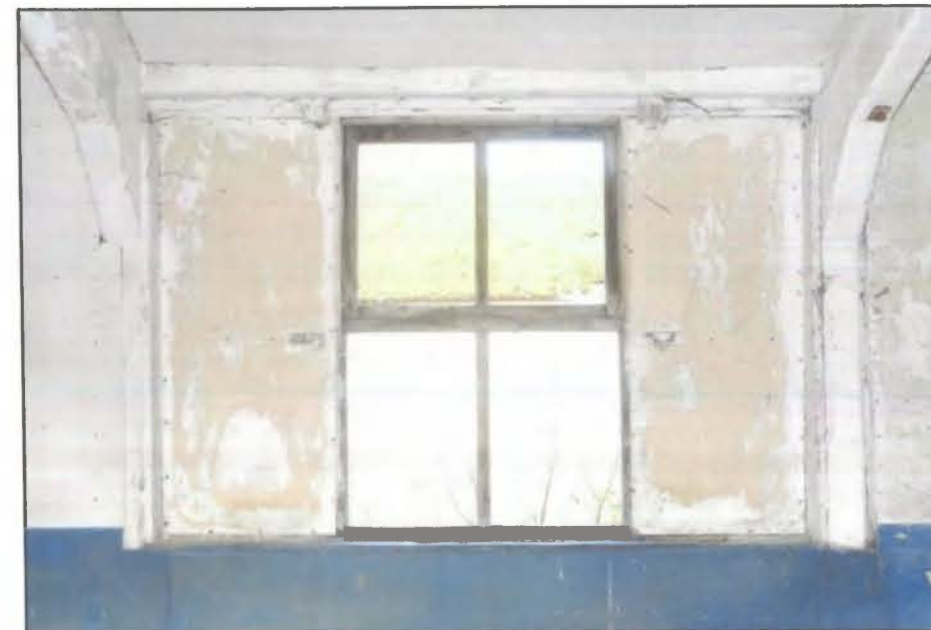
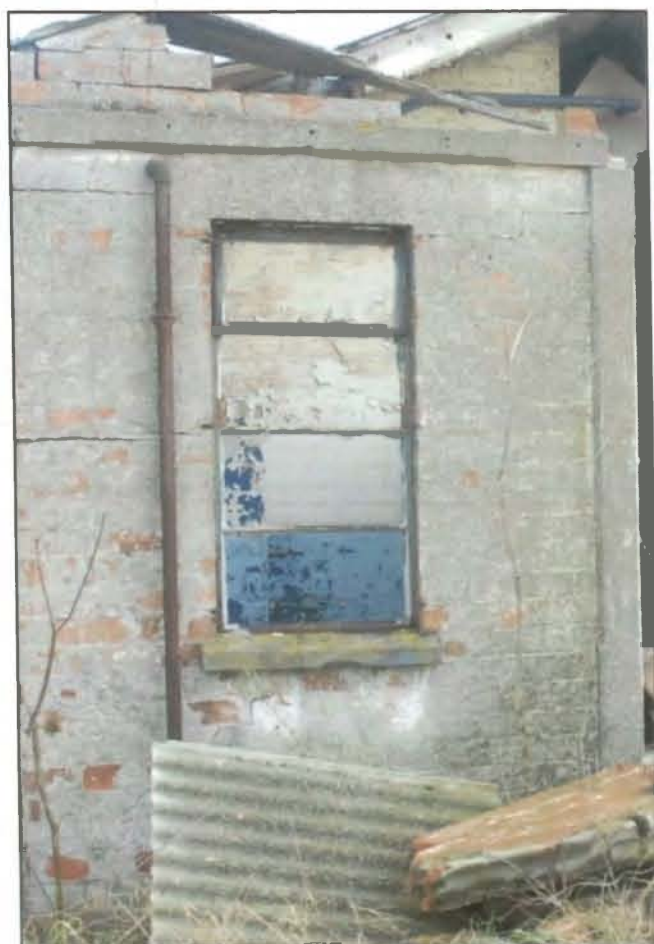
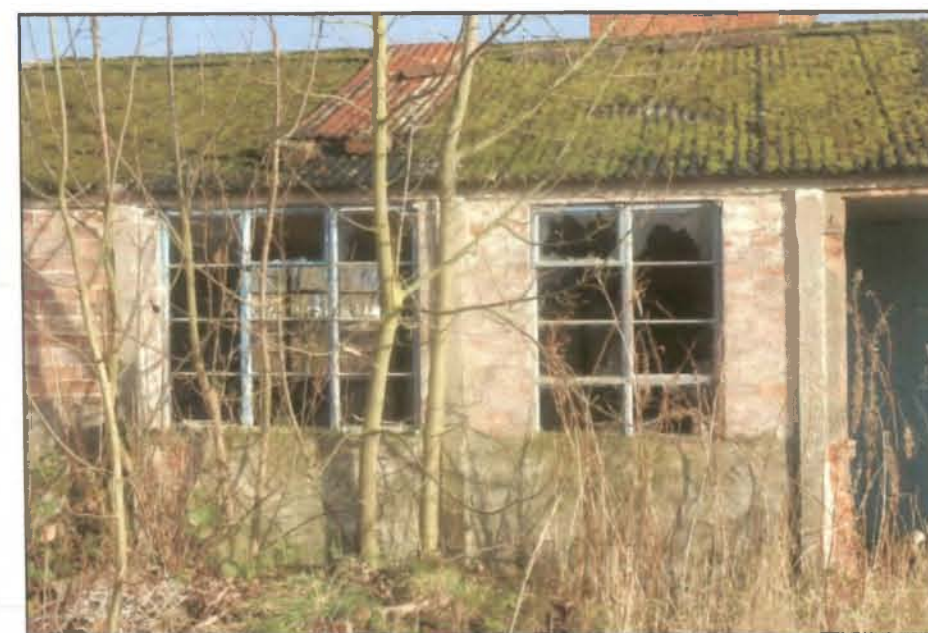
The MoWP huts (of both types) generally employed a standard window type, whereby the entire length of the bay was framed out in 2¼" x ¾" timber, with a 30" x 43" four-light window constructed in the middle, with a top-hung casement in its upper half. This window construction was present in all of the MoWP type huts, regardless of function, with the exception of some windows in the cookhouse, in which the entire length of the bay was glazed, and the detention block and camp reception station, where metal-framed windows were used.

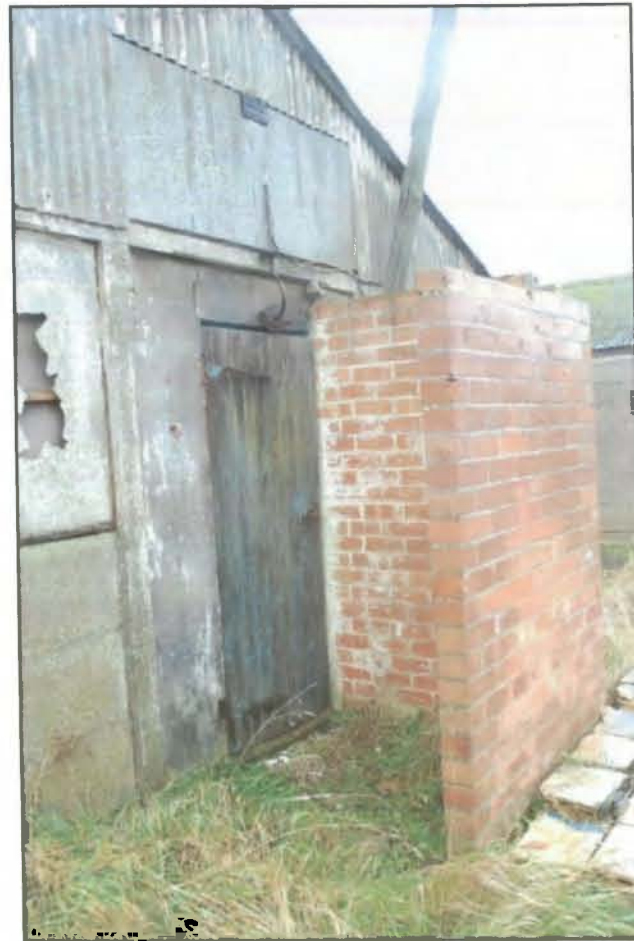
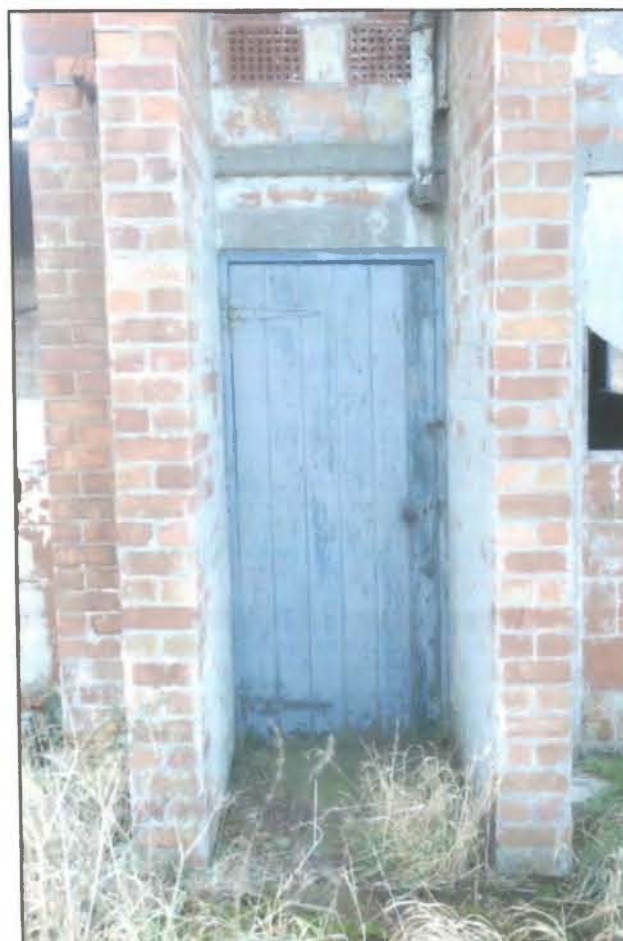
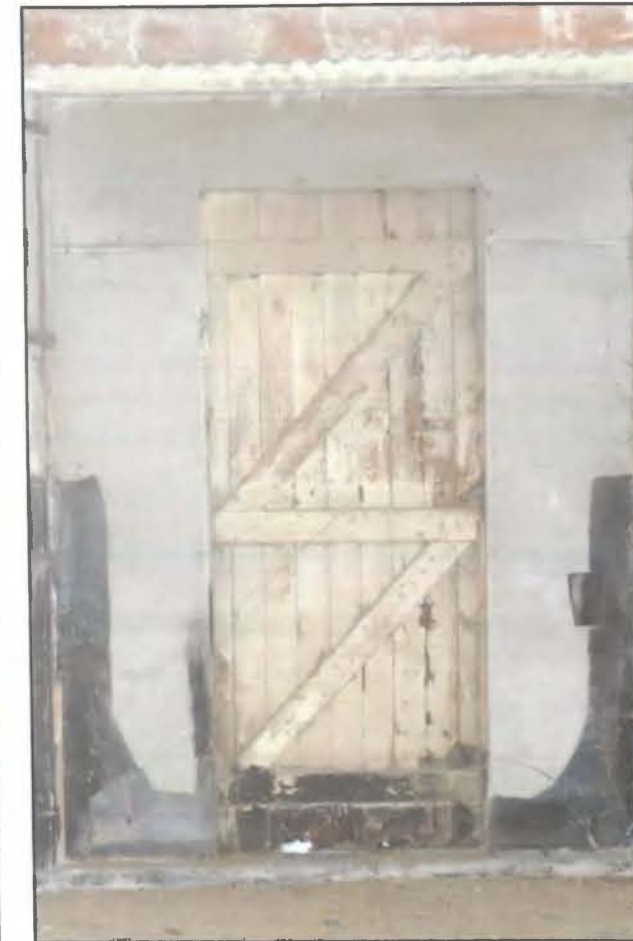
Where original exterior doors were still present, they comprised ledged and diagonally braced 3½" chamfer-edged plank doors, hinged to open outwards.

Many of the huts exhibited a brick porch structure, either on the exterior, where it sometimes had a flat concrete roof, but also occasionally on the interior. The most likely interpretation for these structures was as light baffles, to prevent light escaping from the huts during the blackout.

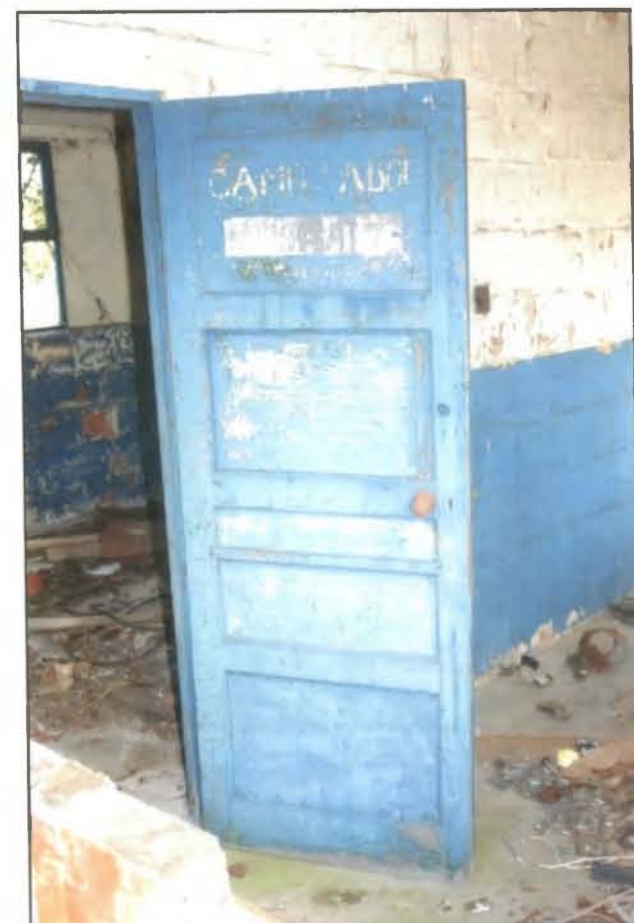
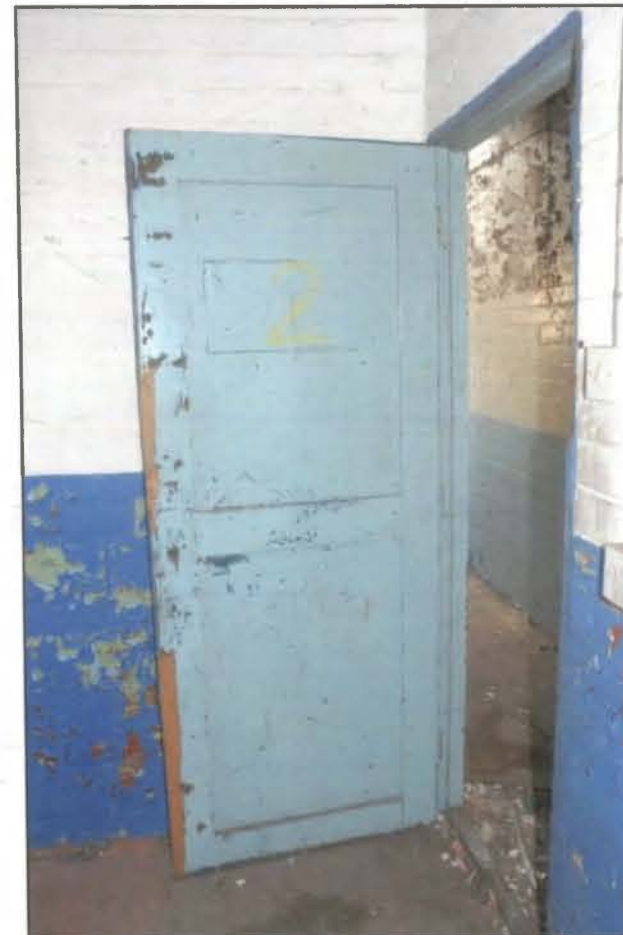
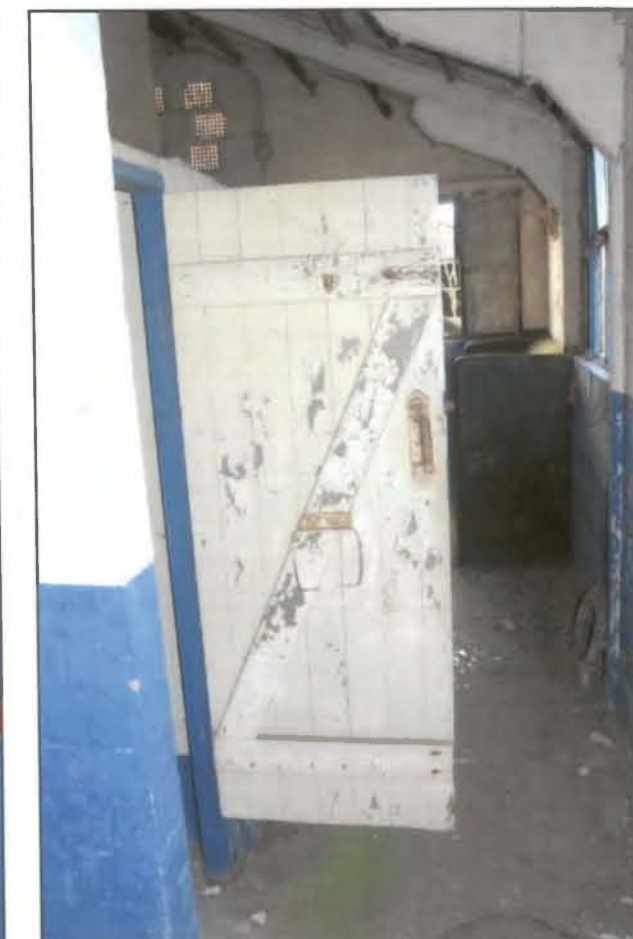
Several types of interior doors were encountered, the most prevalent being a four-panel door.

However, two-panel doors were also present within the detention block, and smaller ledged and diagonally braced 4" plank doors were used on the cubicles in the guards' latrine/ablutions hut (G12).

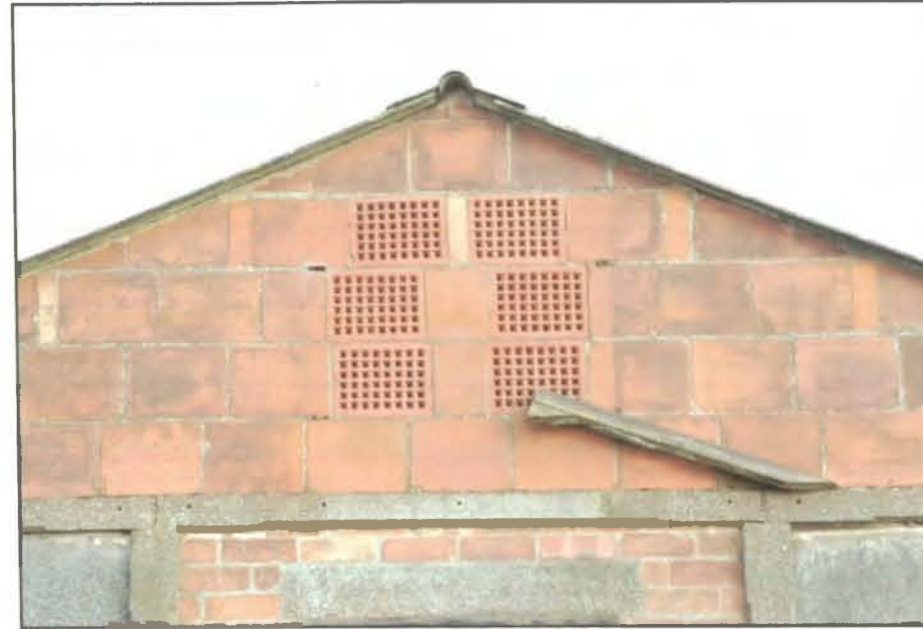
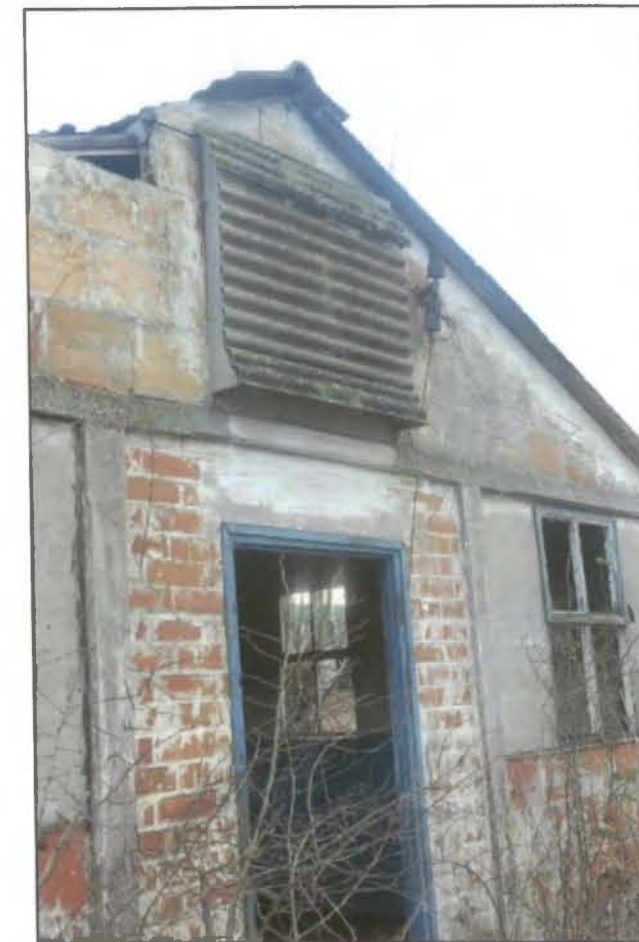
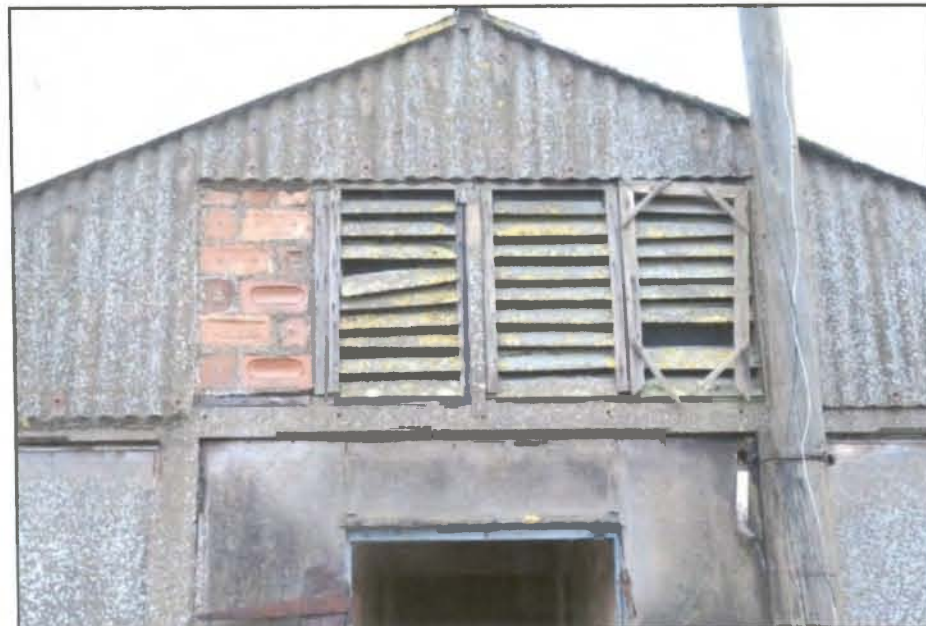
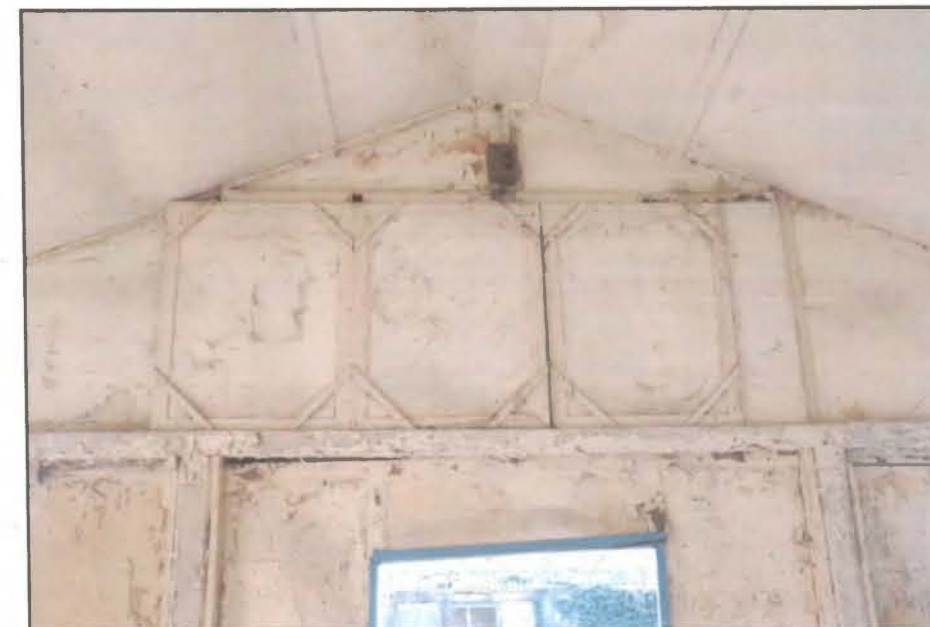
Gable Ventilators

A further difference noted between the MoWP hut types was in the forms of the ventilators employed in the gables of the huts. The hollow brick infill type hut generally employed six airbricks; these were often concealed behind a corrugated asbestos panel.

The concrete infill type huts more often employed timber slatted panels, generally four in number.

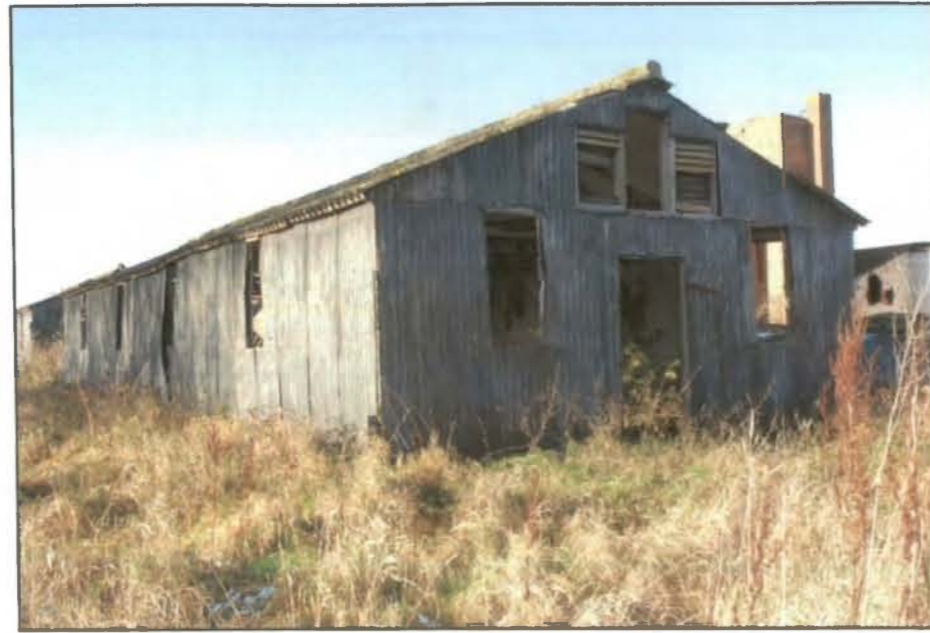
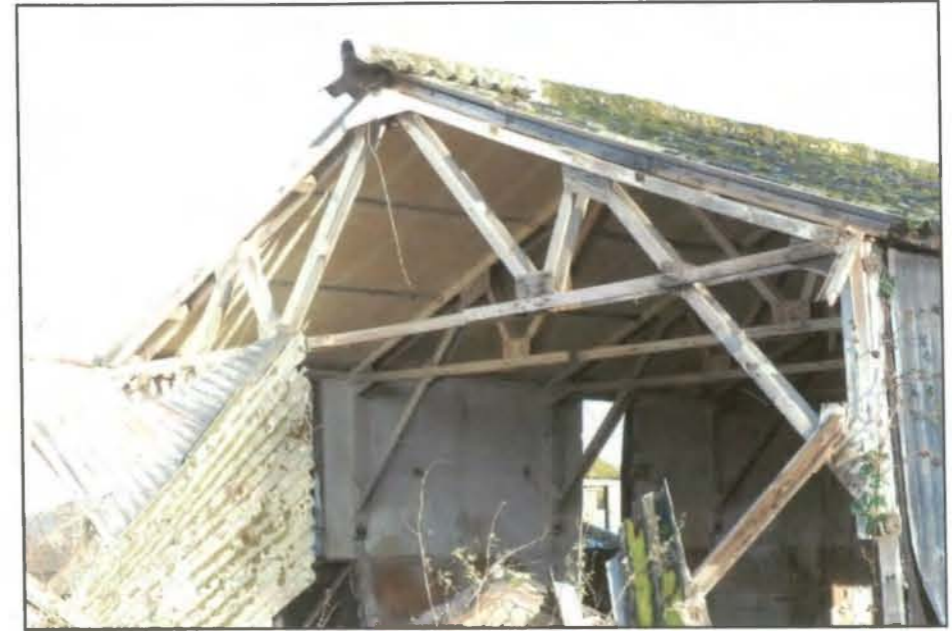
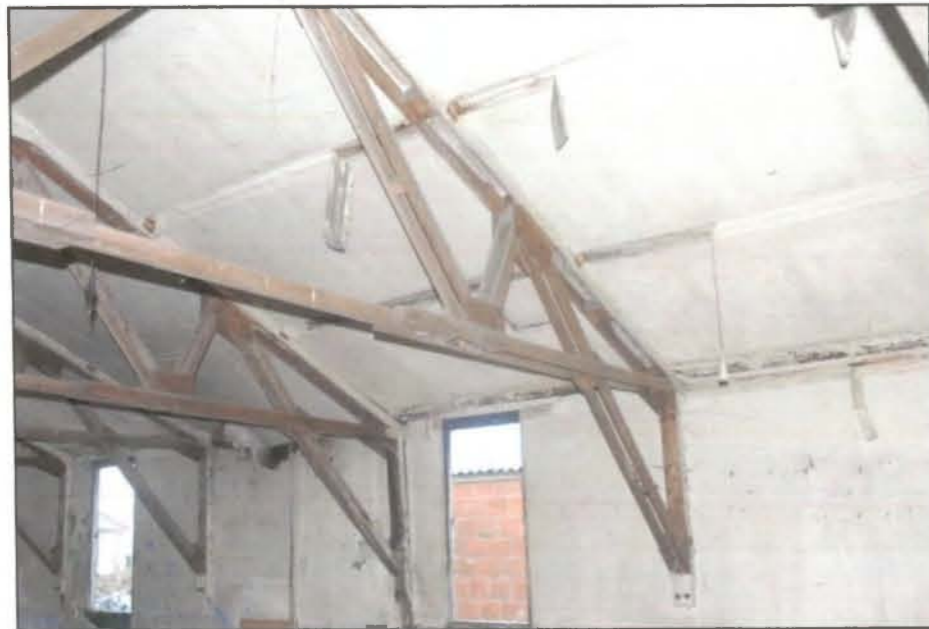
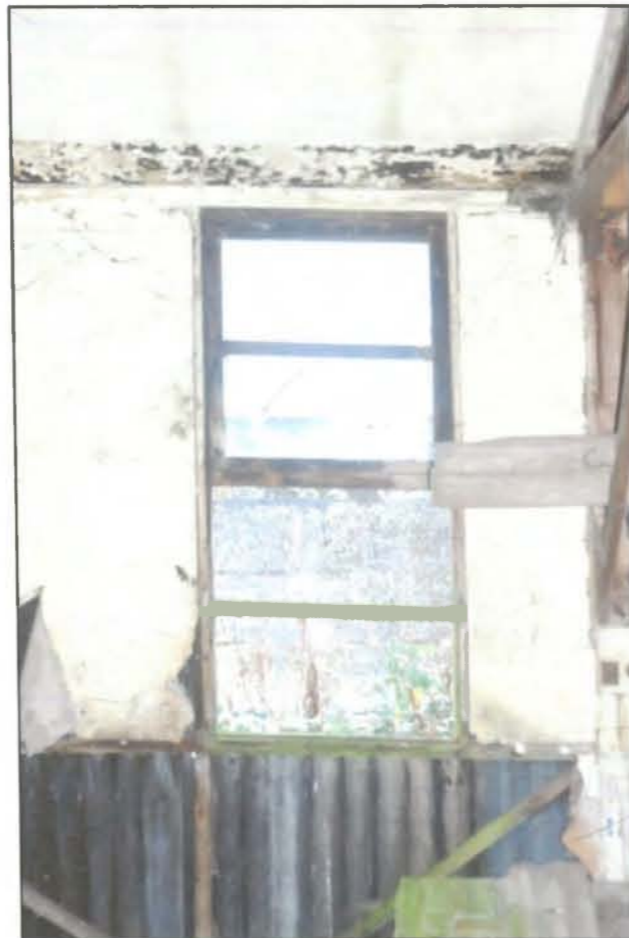
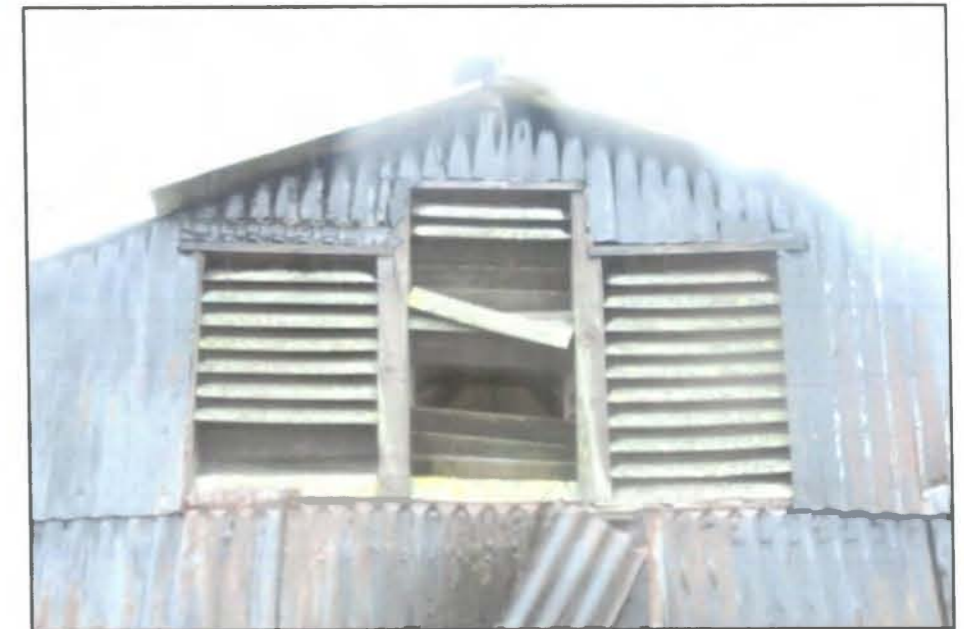
Laing Type Huts

Initially the huts of this type were clad in weatherboard, which has since been replaced in corrugated metal sheeting and treated with a bituminised paint. They were ten bays (60ft) in length and had five windows in each side, which are 46" in height and 23" wide; these were of four lights, the upper pair forming a top-hung casement. The windows in the sides of the hut occupied alternating bays, but were offset from the centre of the bays.

The corrugated asbestos sheet pitched roofs were supported by composite timber roof trusses. These were of 2 3/4" x 7/8" timber, doubled up in most of the truss, using 2" x 2" spacers, with 1/4" plywood reinforcement at the joints.

The Laing huts also had a distinctive slatted gable ventilator composed of three panels.

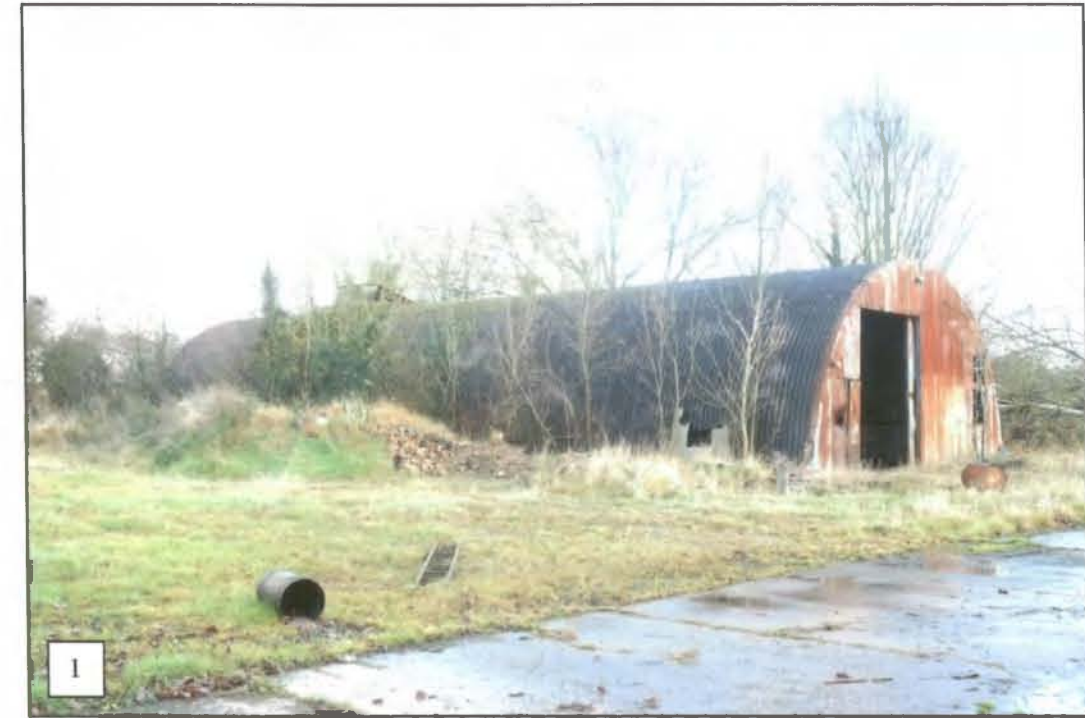
The southern gable was constructed of corrugated metal sheeting and was dominated by a large opening in the west half of the gable. This could be closed with a large sliding door, also of corrugated metal, on a 2" angle-iron cross-braced frame. To the west a smaller door for personnel access was present: this was of two plain metal sheets on a 1½" angle-iron frame.
