PINGLEY CAMP, BRIGG, LINCOLNSHIRE

PHOTOGRAPHIC BUILDING SURVEY

Report prepared for Barford Builders by S. A. Savage

Site Code: PPCB 08
Planning ref: 119946
NGR: TA 0178 0680
LCNCC acc. no. 2008.189
PCA job no.:08-515

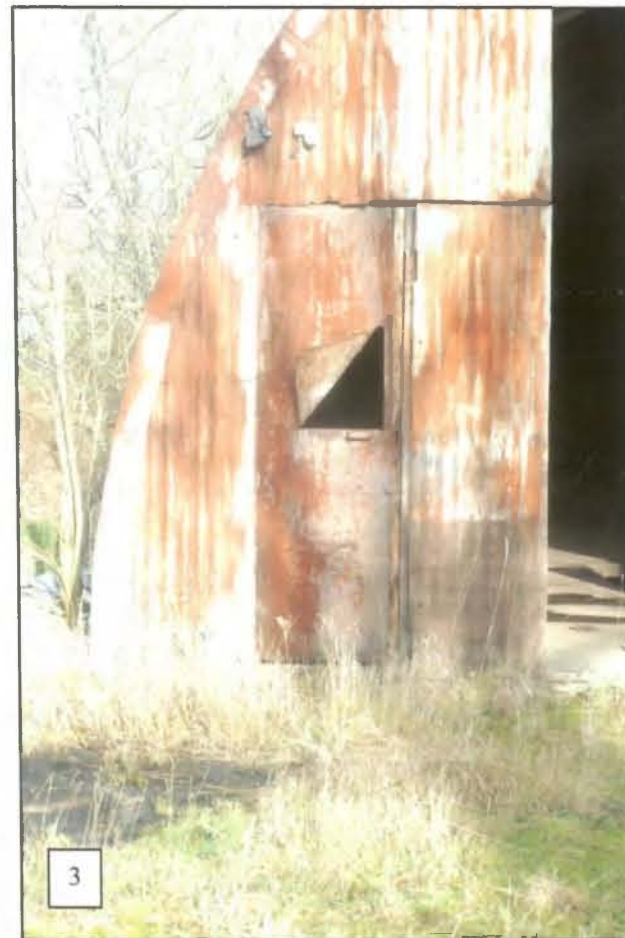
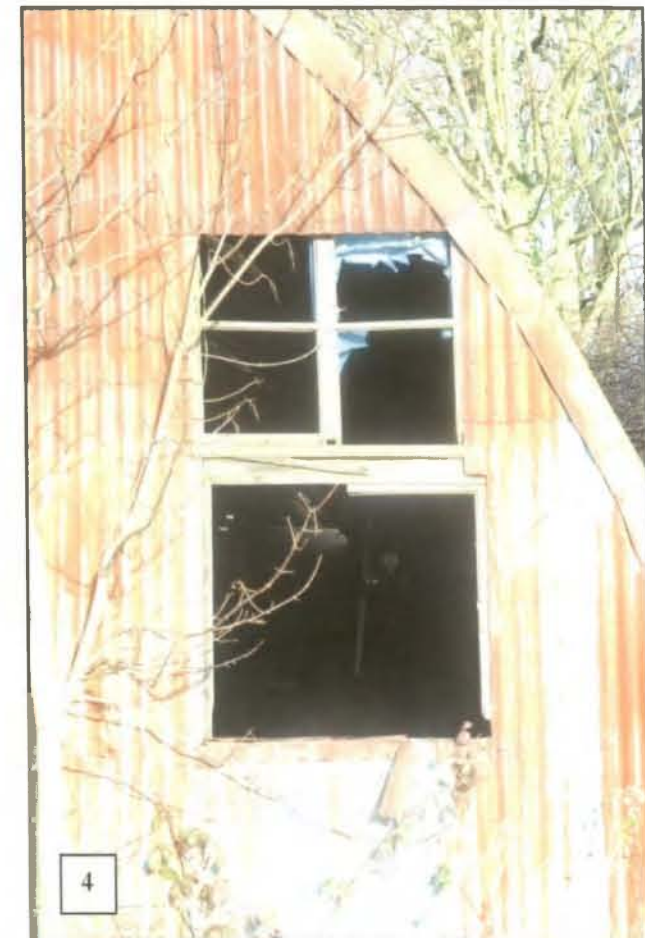
In the eastern part of the south gable, a window was present. This window was constructed in 3" x 1¼" timber and the upper half comprised a pair of side-hung casements, each of two panes. The lower half of this window was missing.

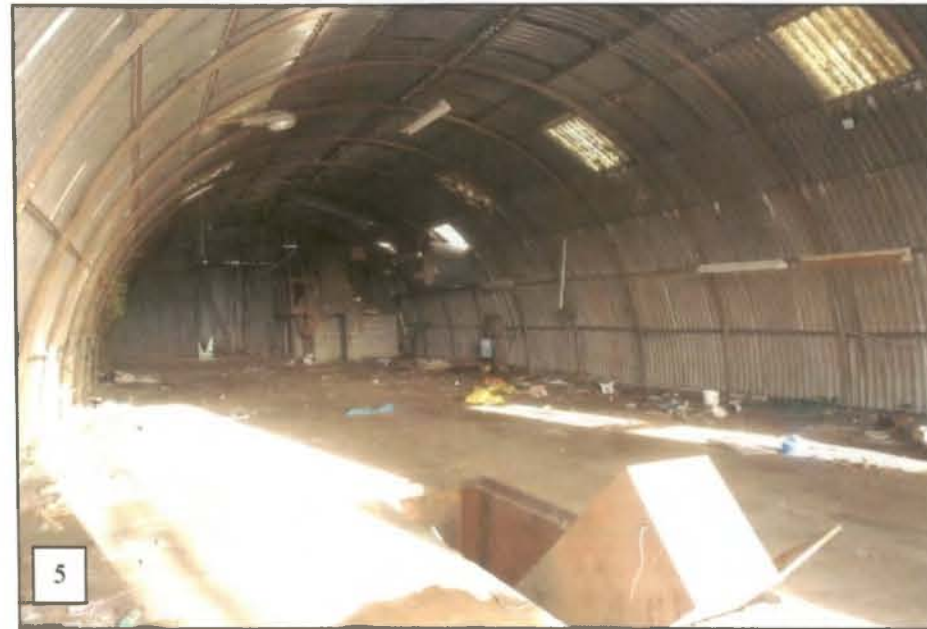
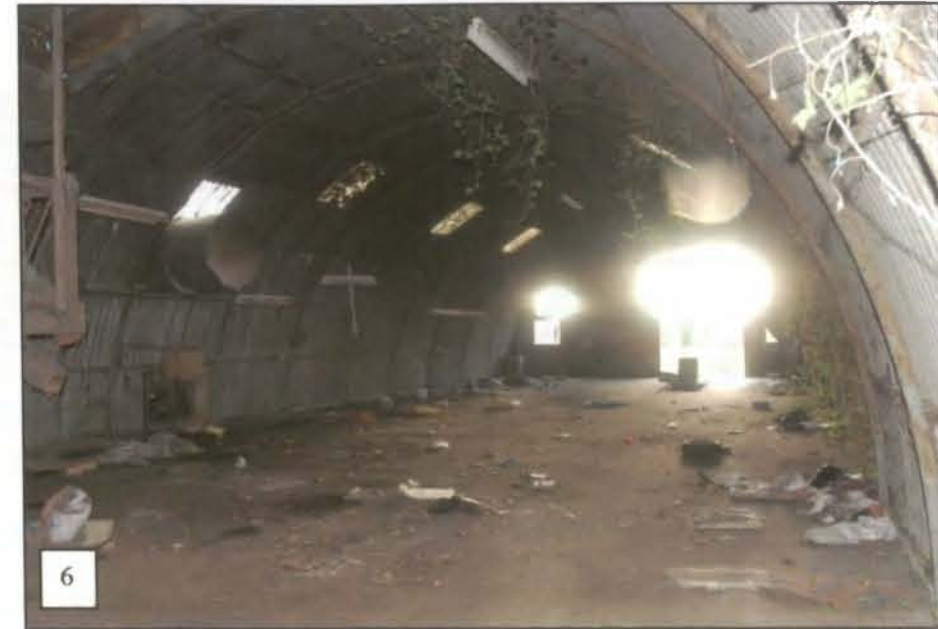
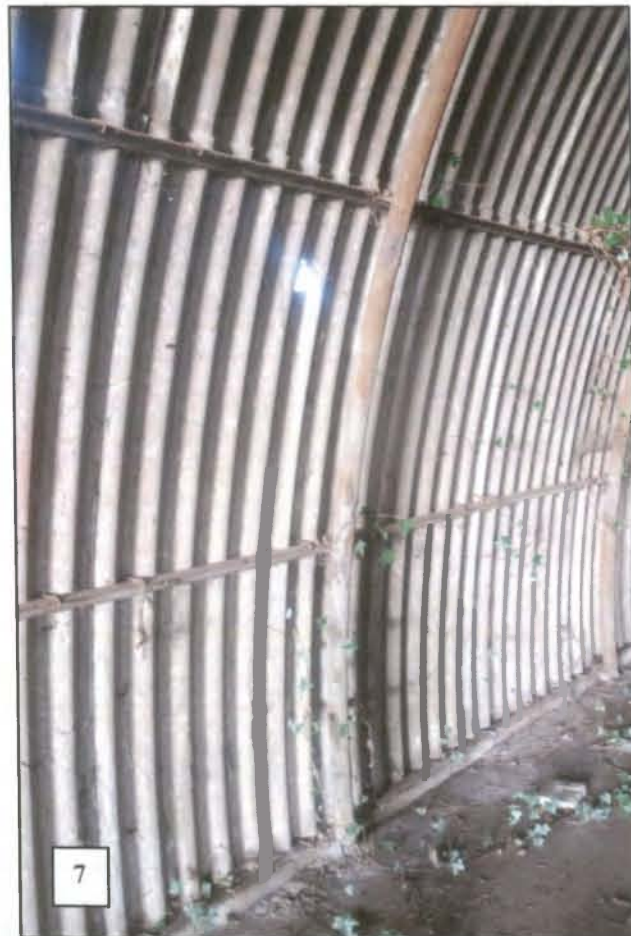
The structure of the building was clearly visible on the interior. This comprised a series of metal arches made up of four prefabricated sections of curved 3" diameter steel pipe sections with flanges to which the horizontal 1 3/4" angle-iron frame was attached. The corrugated asbestos cladding was attached to the angle-iron framework on threaded brackets, which hooked over the horizontal angle-iron frame on the inside.

The northeastern corner of the building had been more recently altered. A large grain-blower had been constructed here, on a breeze block base, with a grain hopper occupying the north east corner itself, with a pair of timber plank doors inserted in a brick extension giving access to the hopper.

Further changes had been affected in the roof where a corrugated asbestos clerestory had been inserted in the third bay from the north and a large bore pipe had been inserted two bays further south.

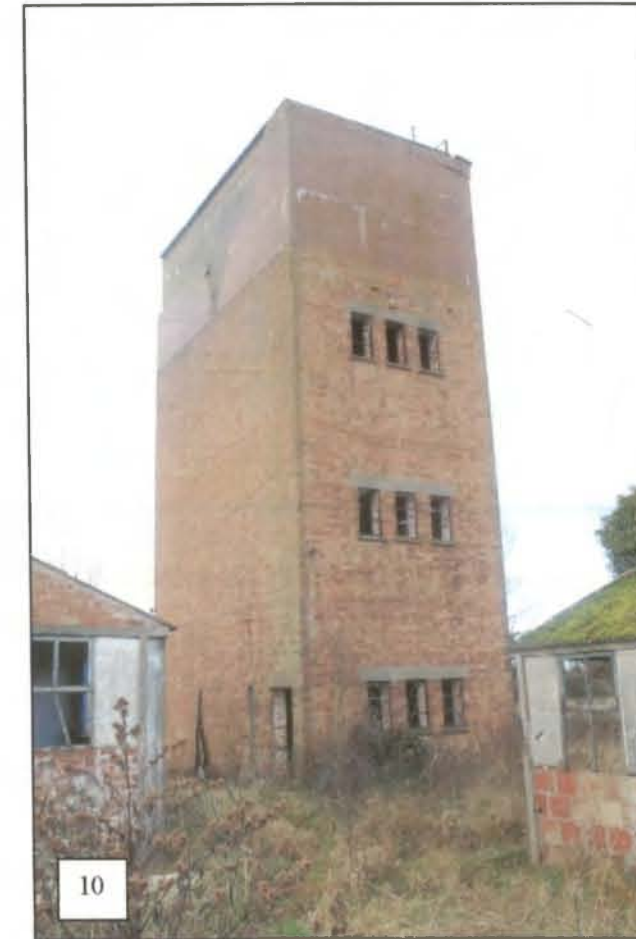
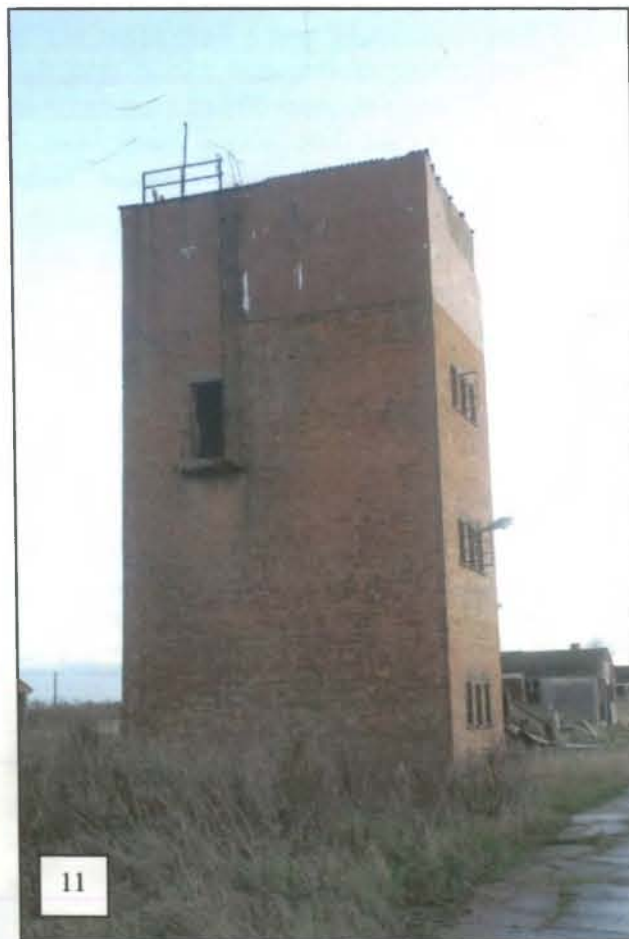
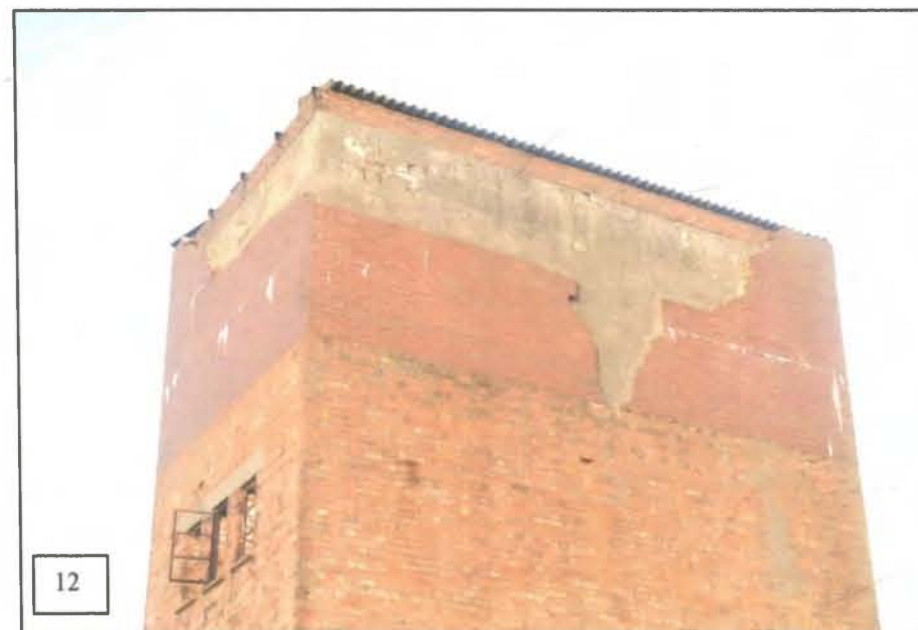
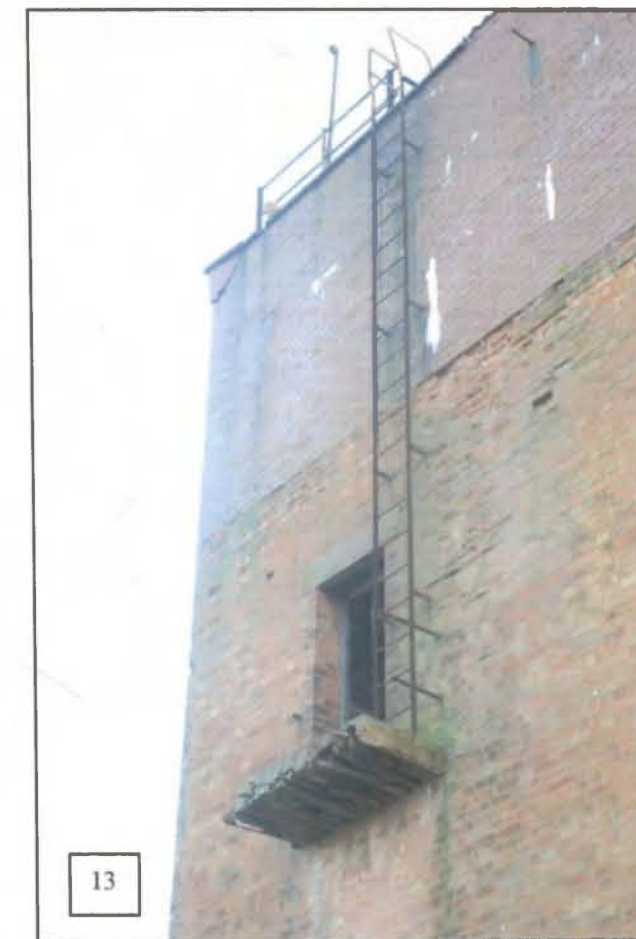
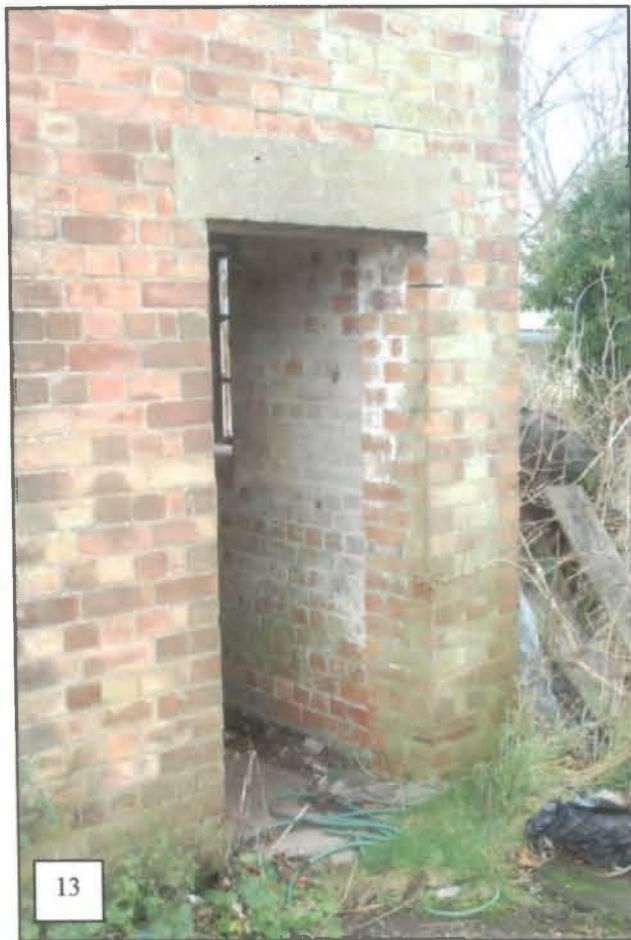
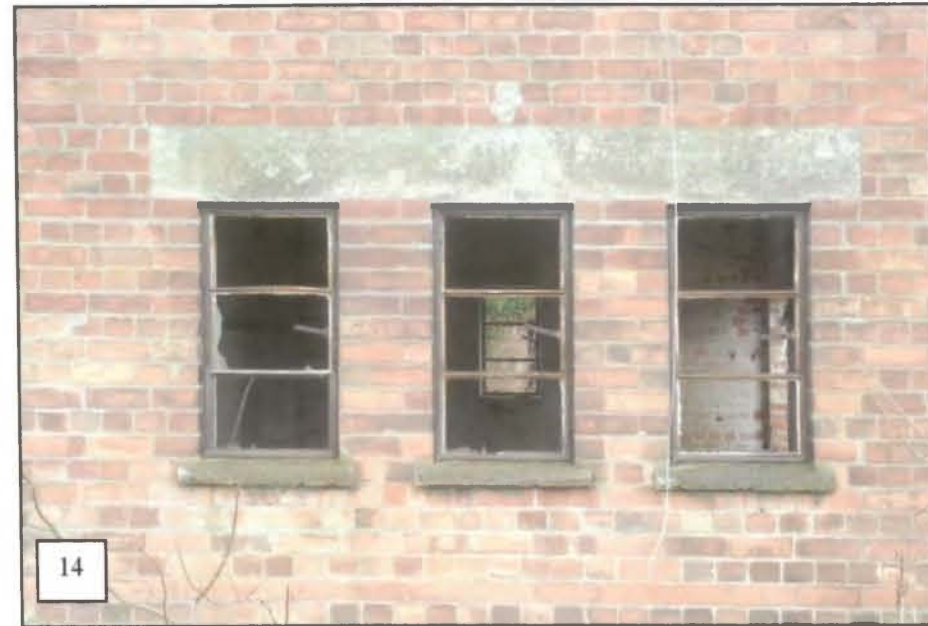
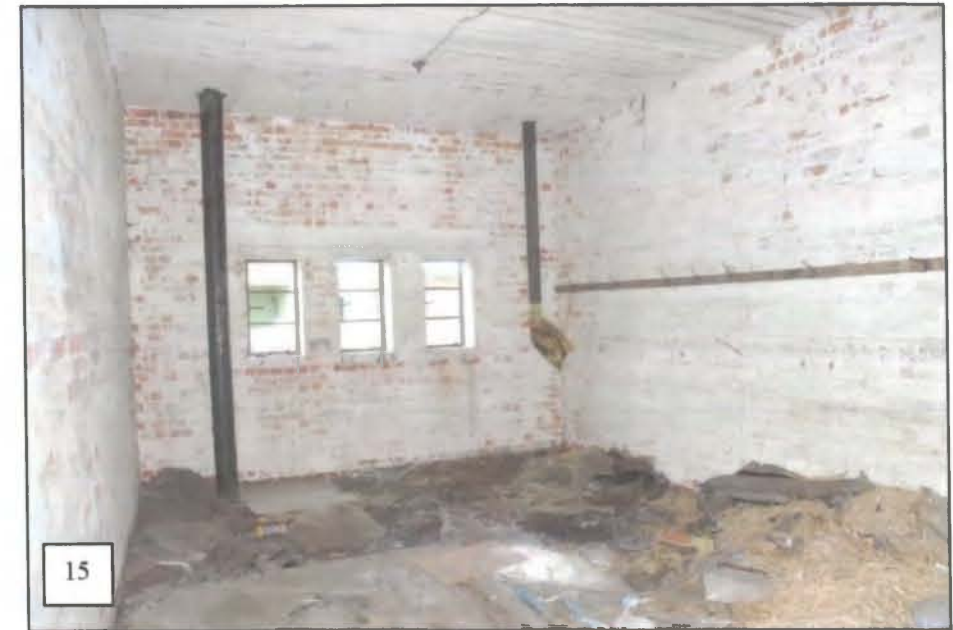
Building G2 – Water Tower

This was the most imposing structure on the site. It comprised a four-storey building of brick, with the concrete water tank occupying the fourth floor.

It was constructed of brick (9" x 4¼" x 2¾") in English bond, the walls being 13¾" in thickness. Each floor below the water tank had a group of three metal-framed windows in the east and west elevations, with a common concrete lintel and concrete sills. The floors within the structure were all of poured concrete. Access was provided to the first and second floors up a metal ladder in the northeast corner; at second floor level, access to the roof comprised a reinforced concrete platform on the north side of the building and an exterior metal ladder.

The concrete water tank was clad in a single skin of glazed bricks, giving it a redder colour than the rest of the brickwork. This brick skin had partially fallen away on the south and west sides of the building, but some remedial work had been undertaken in cement to prevent further water penetration.

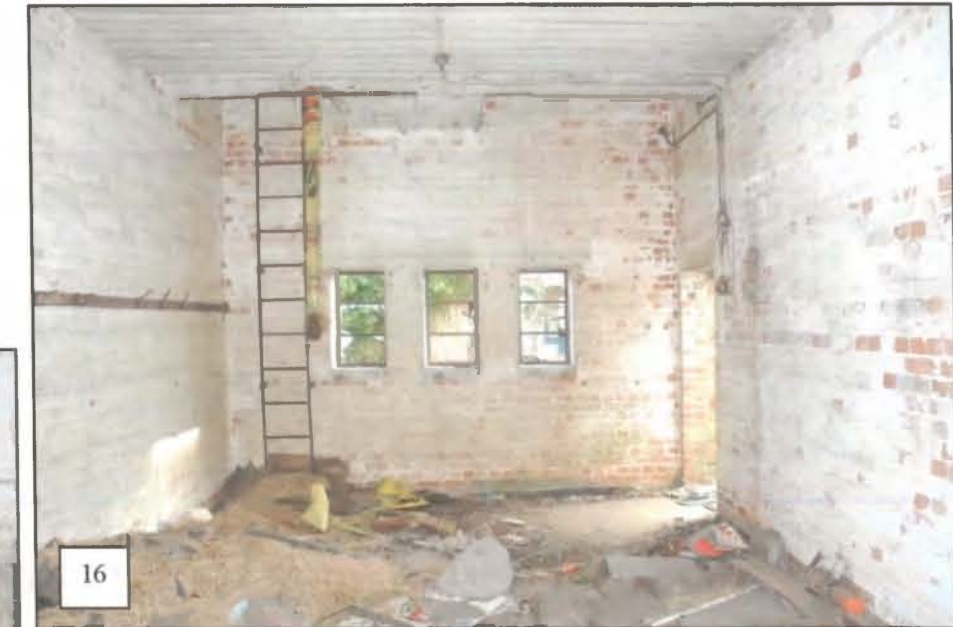
For safety reasons, only the ground floor of the water tower was accessed. The building was accessed through a door opening at the east corner of the south side. The interior was completely whitewashed. It was dominated by three vertical steel pipes: in the northwest and northeast corners these were 3 1/2 " in diameter and did not reach the ground, while the pipe in the southwest corner was 6 1/2 " in diameter and had the words 'Release Valve' painted on it with a downward pointing arrow.

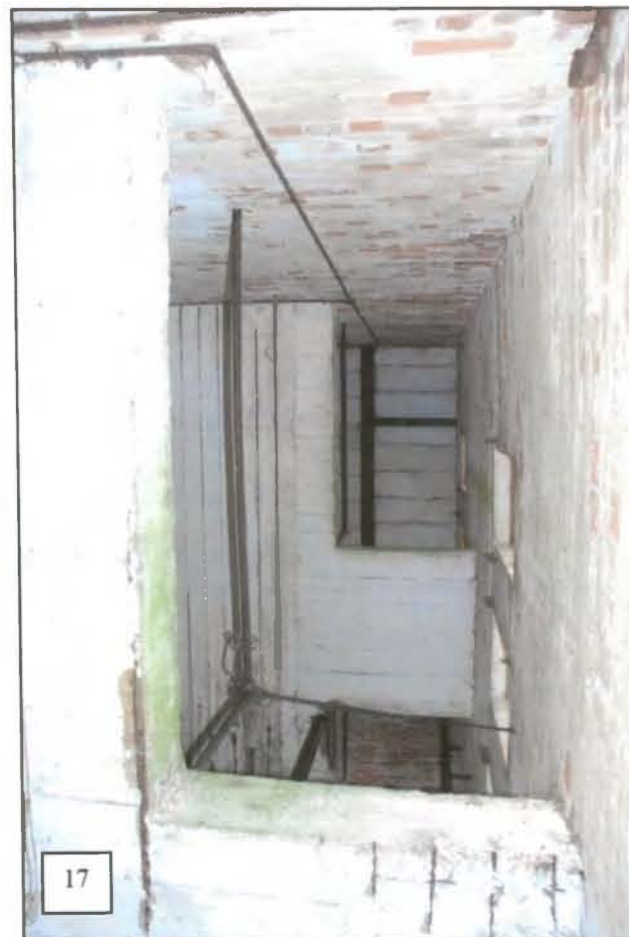
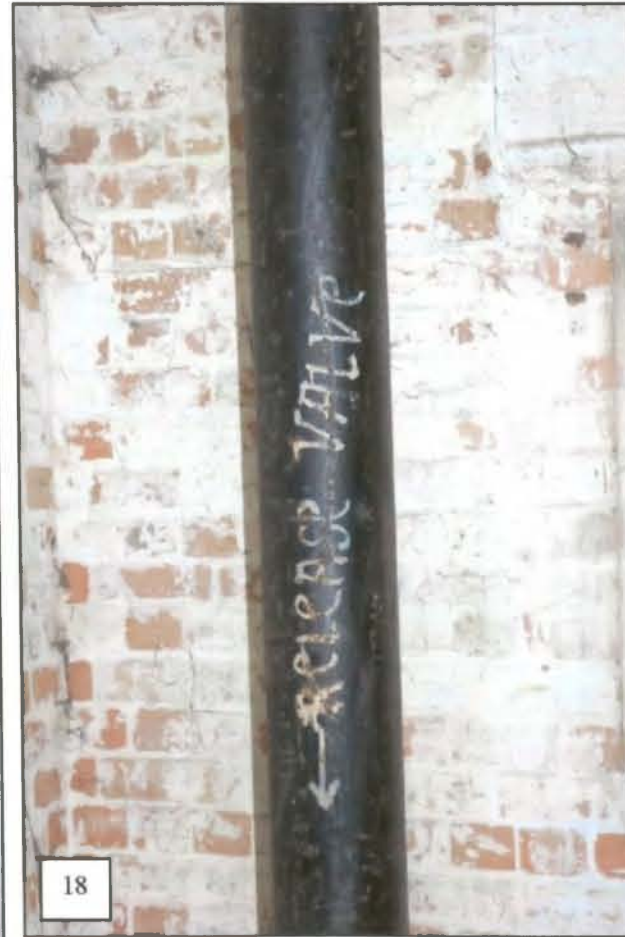
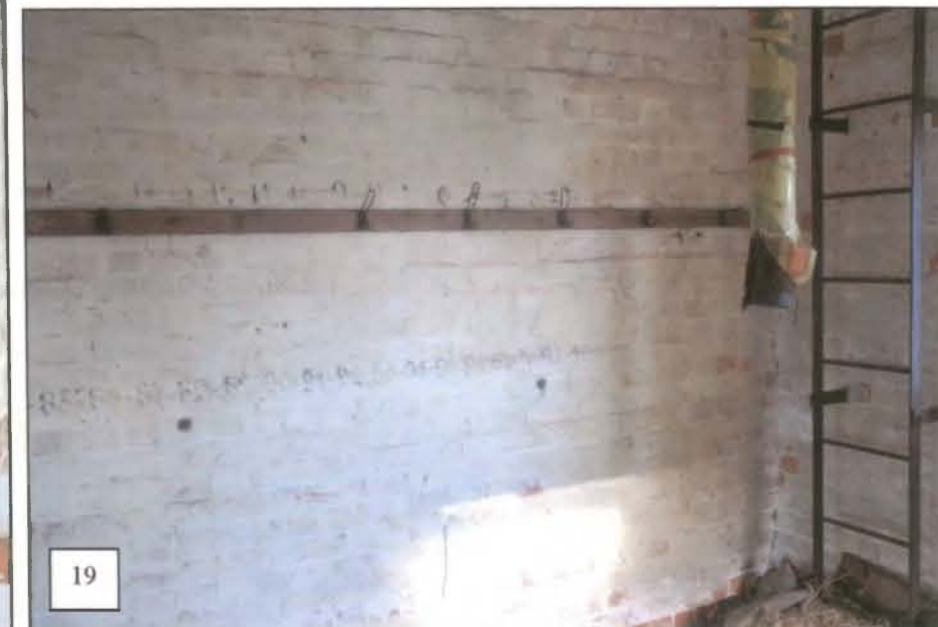
On the north wall a row of metal wire coat hooks was present and the numbers 1 to 100 were painted in two rows above and below these hooks, suggesting that equipment had been stored here in a very ordered way. The numbers ran from 1-50 in the upper row from right to left, while the lower row comprised the numbers 51-100 from left to right.

Apart from the opening through the first and second floors in the northeast corner to permit access up the metal ladder, these floors also had an opening in the southeast corner, with a safety rail of 1 1/2" pipe. This opening was located immediately inside the exterior door and would have allowed equipment to be hoisted onto these floors for storage.

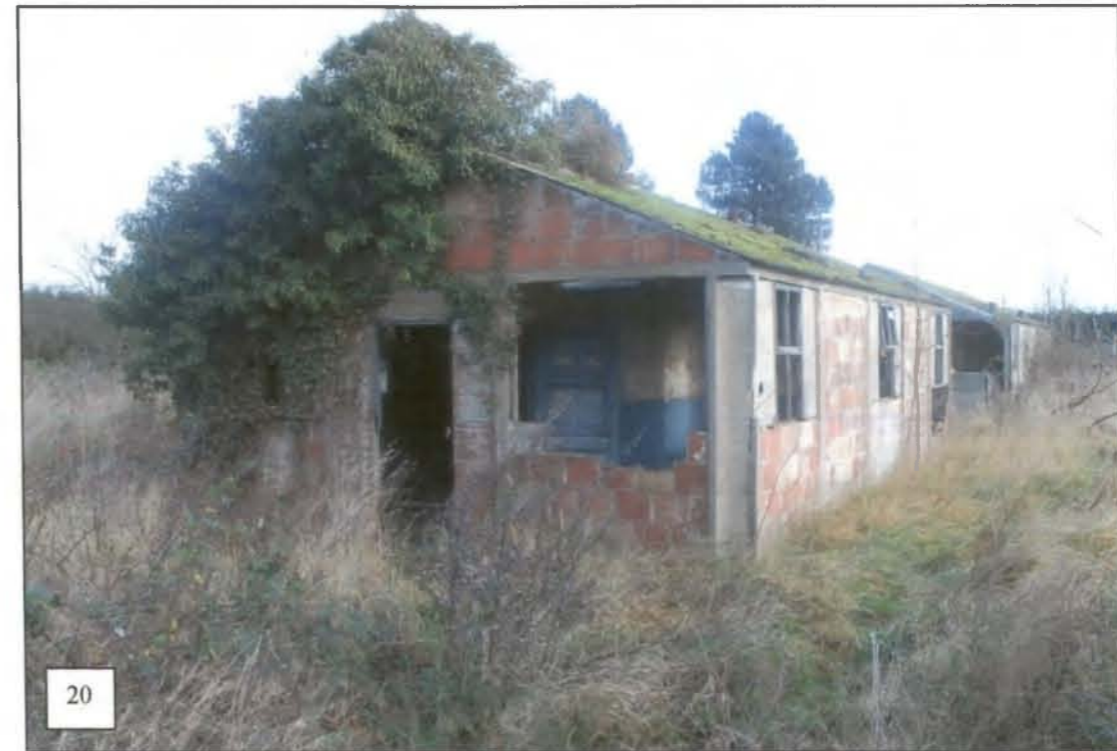
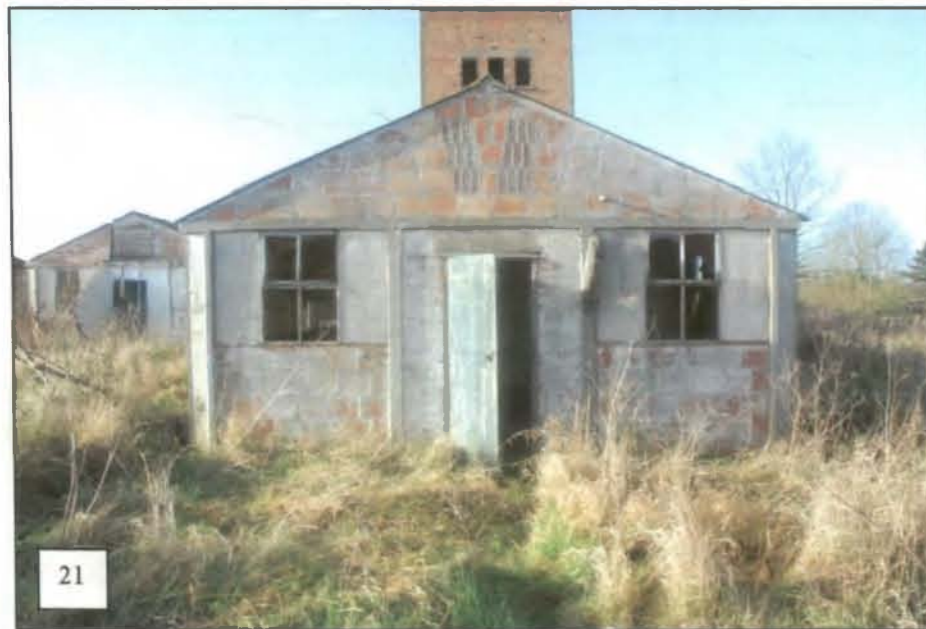
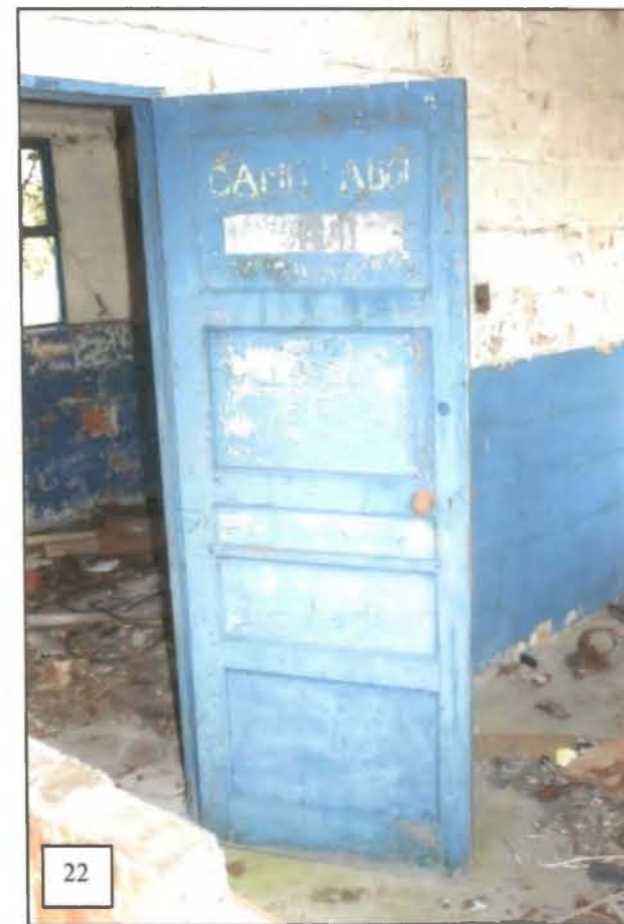
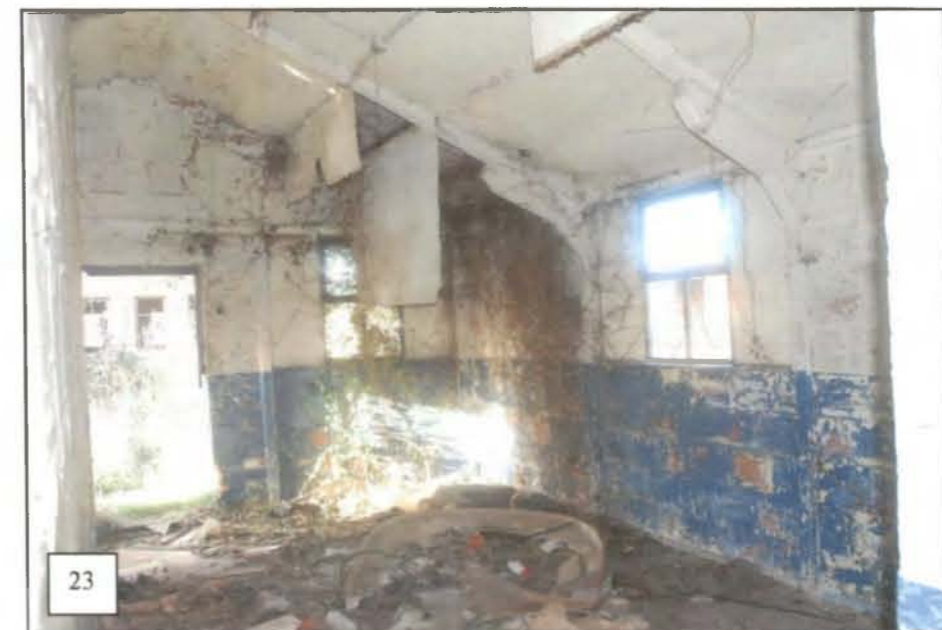
Hut G3

This building was located immediately to the east of the water tower, and comprised a MoWP type hut, with a concrete frame of five bays, infilled with hollow bricks. The interior was divided into four rooms with hollow brick partition walls.

The building was decorated with light blue lower walls, with the upper part white, and blue windows. This paint scheme appeared to be peeling off an earlier scheme with dark blue lower walls, which in a few places was peeling to reveal an original colour scheme of light green lower walls, with cream upper walls. The division between the colours was at window sill level.

This was clearly an administration building, and is described on the wartime plan of the camp as 'Tool shed and M A Officer'. No likely interpretation for the abbreviation 'M A' could be found.

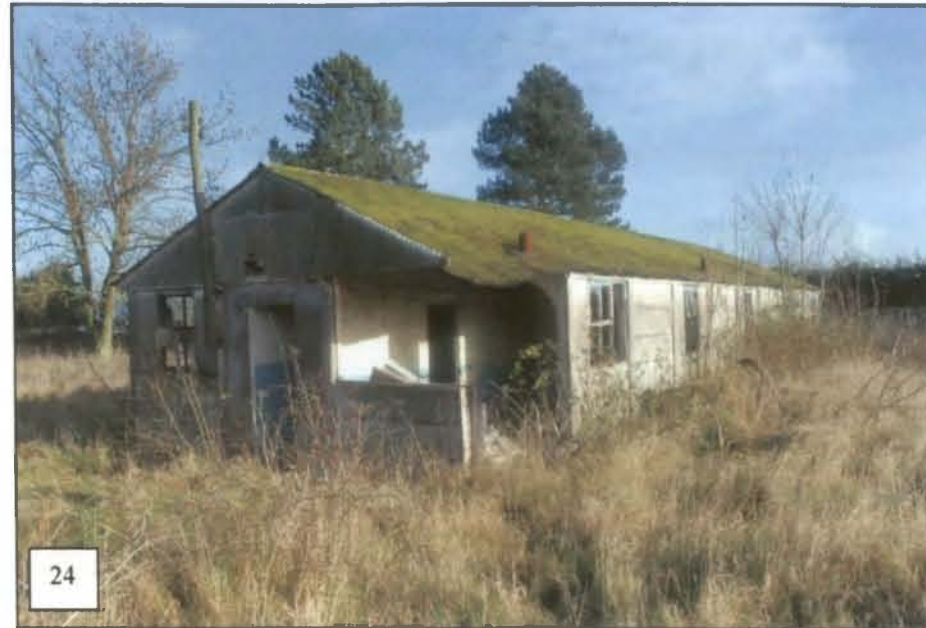
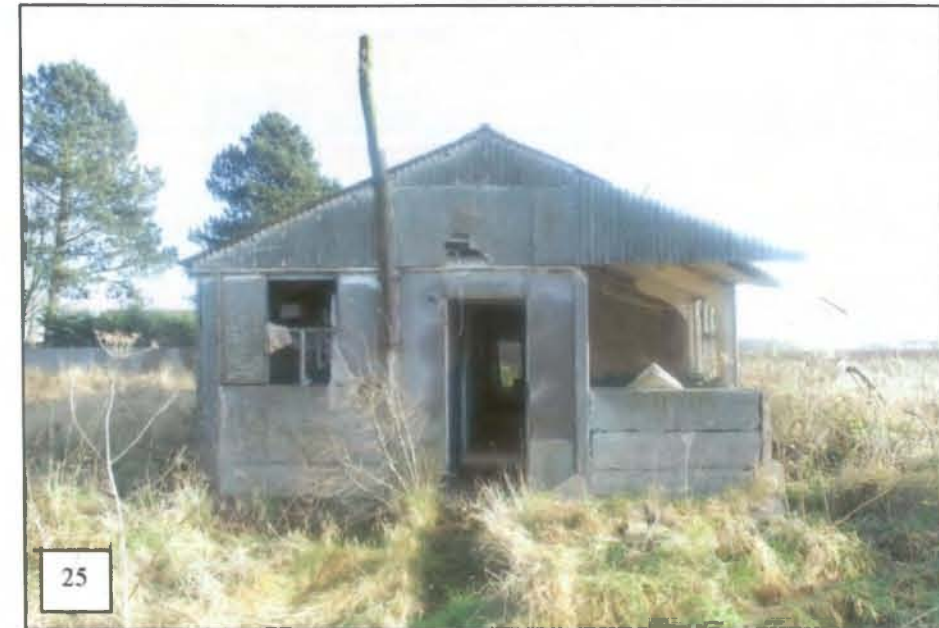
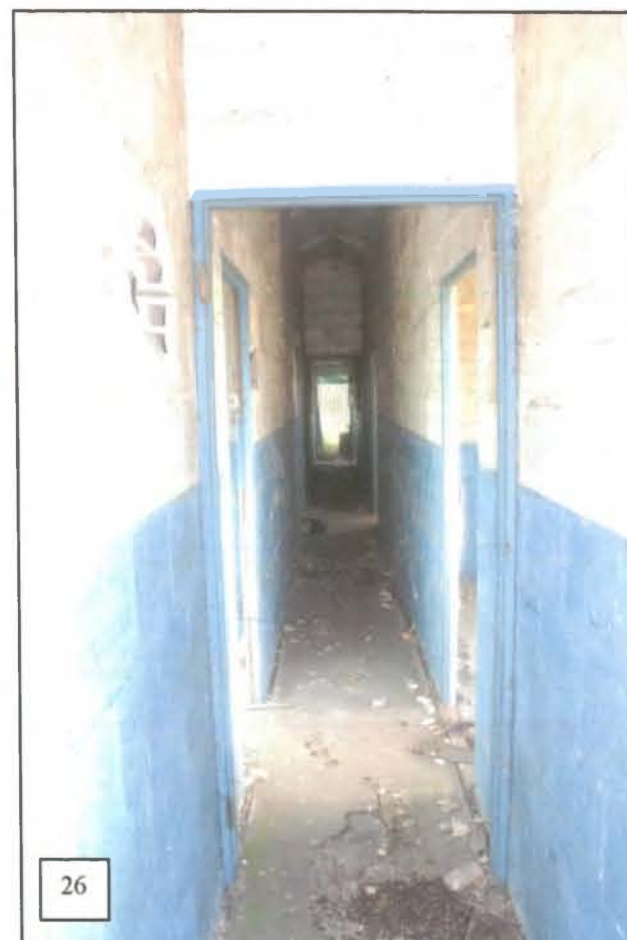
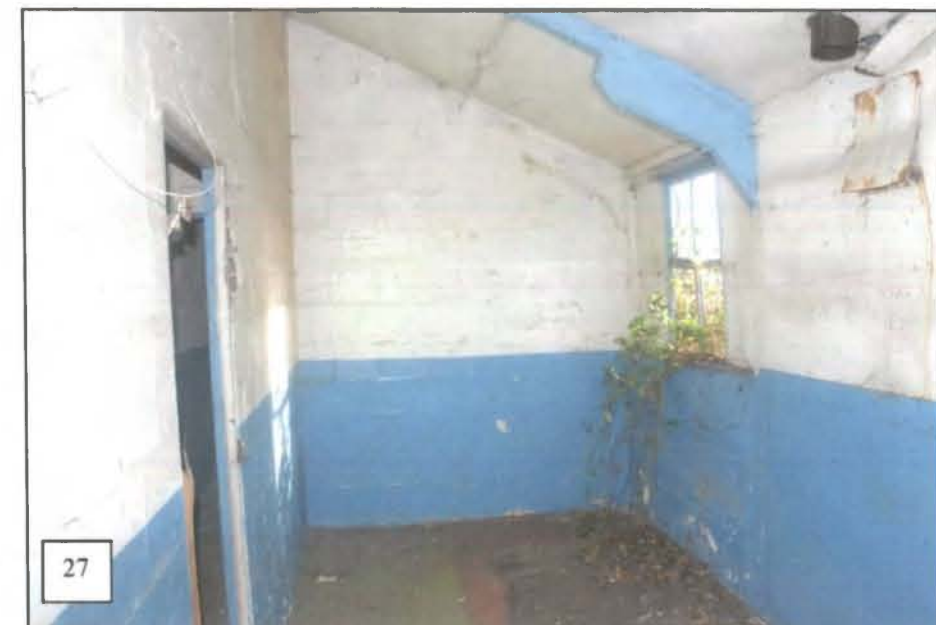
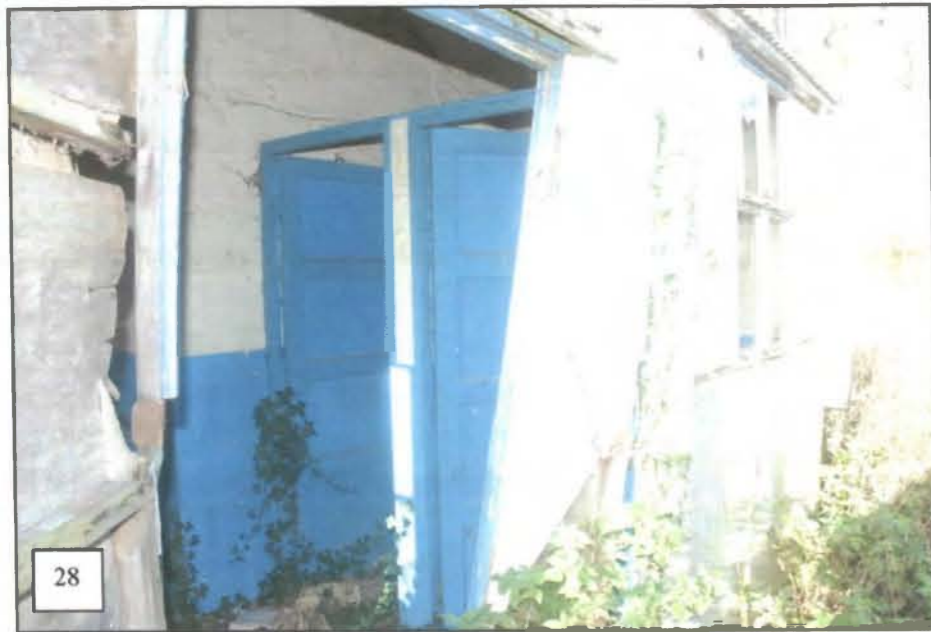
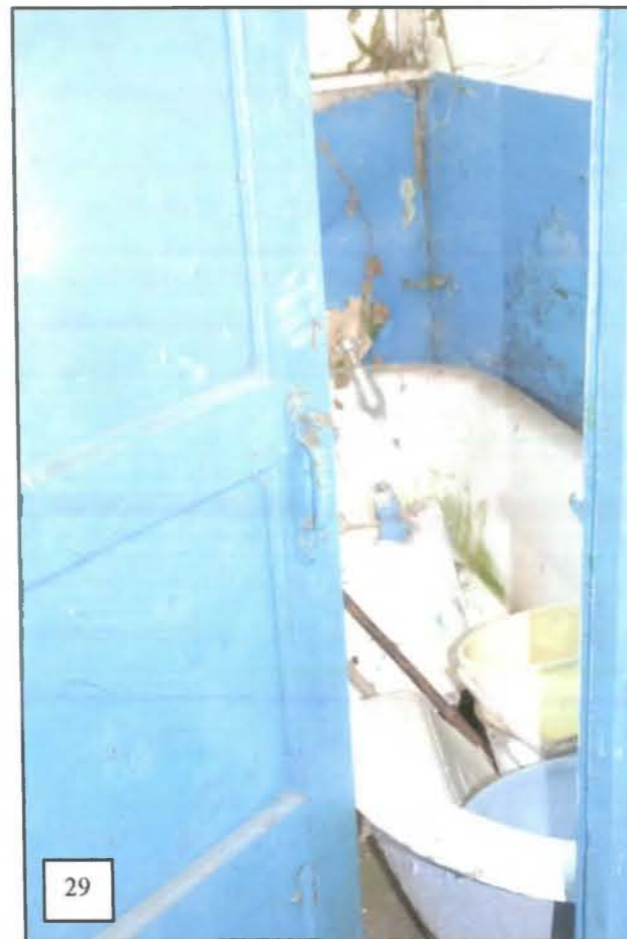
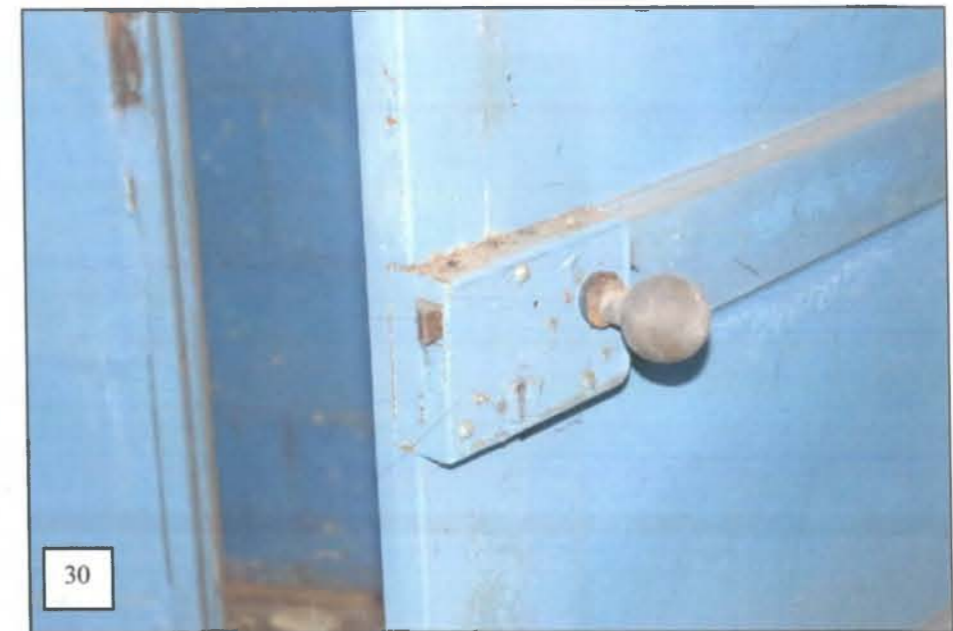
Hut G4

This building was located to the east of Hut G3, and comprised a MoWP type hut, oriented east-west, with a concrete frame of ten bays, infilled with pre-cast concrete panels. The roof and gables were of corrugated asbestos panels and the gable ventilators were of four slatted panels, covered by sheets of plain asbestos.

The interior was divided with hollow brick partition walls and comprised a central corridor flanked on each side by three rooms, each three bays in length. At the east end the corridor opened up to the full width of the central bay, and the eastern bay was occupied by two toilet cubicles on the north side and a bathroom to the south.

This building was an accommodation block, and is described on the wartime plan of the camp as 'Officers' living huts and latrines'.

It was mostly decorated in a lower mid-blue/upper white colour scheme, with the dividing line at windowsill level; however, it had clearly been occupied more recently and some rooms displayed a more modern colour scheme, including light green and mauve.

The toilet cisterns and baths appeared original and although the exterior doors were missing, some interior four-panel doors were present, and some rooms retained furniture possibly of a wartime date.

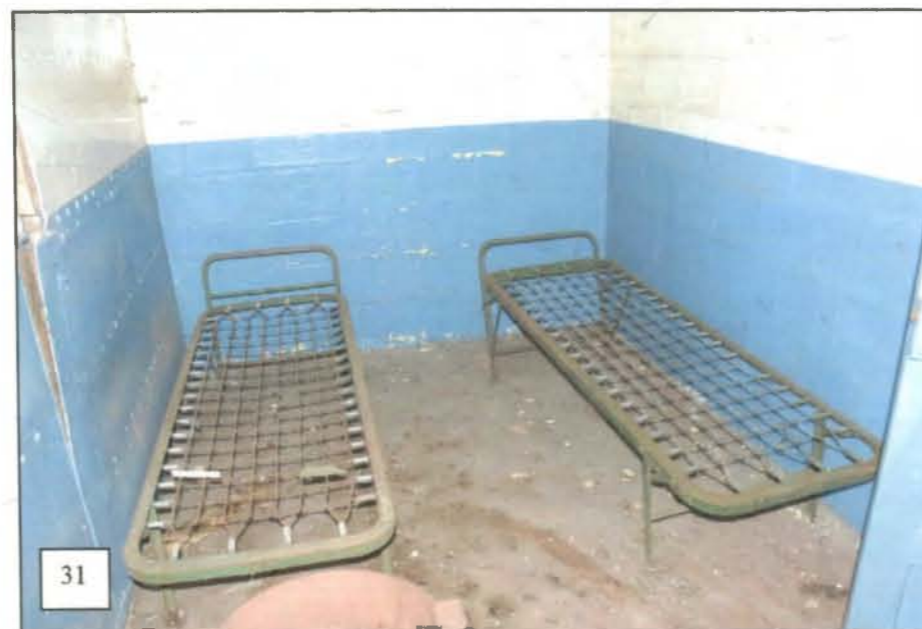
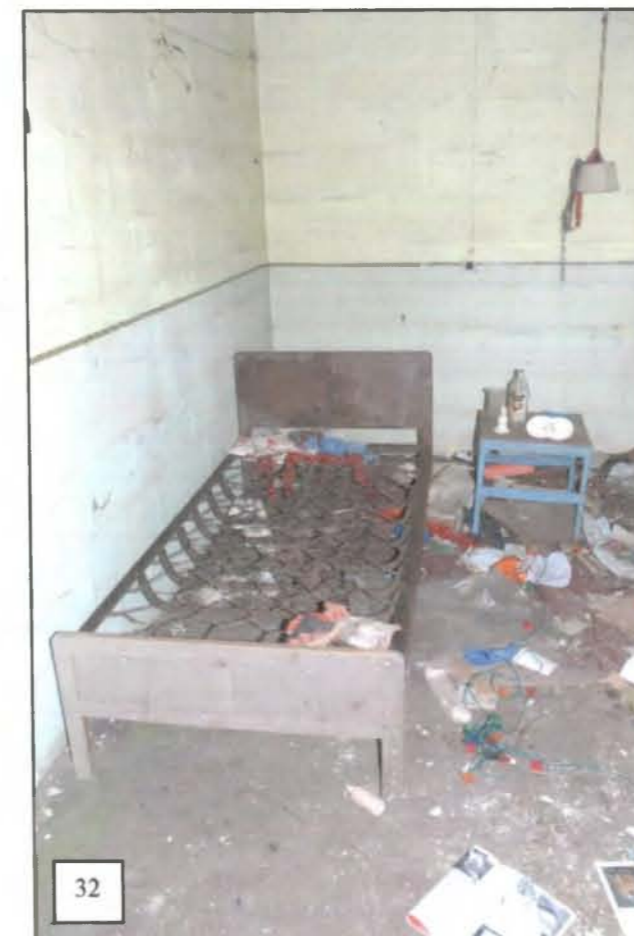
The eastern four rooms each had a stovepipe exit near to the eaves in the roof, indicative of pot-bellied stoves, although these holes were not present in the eastern two rooms.

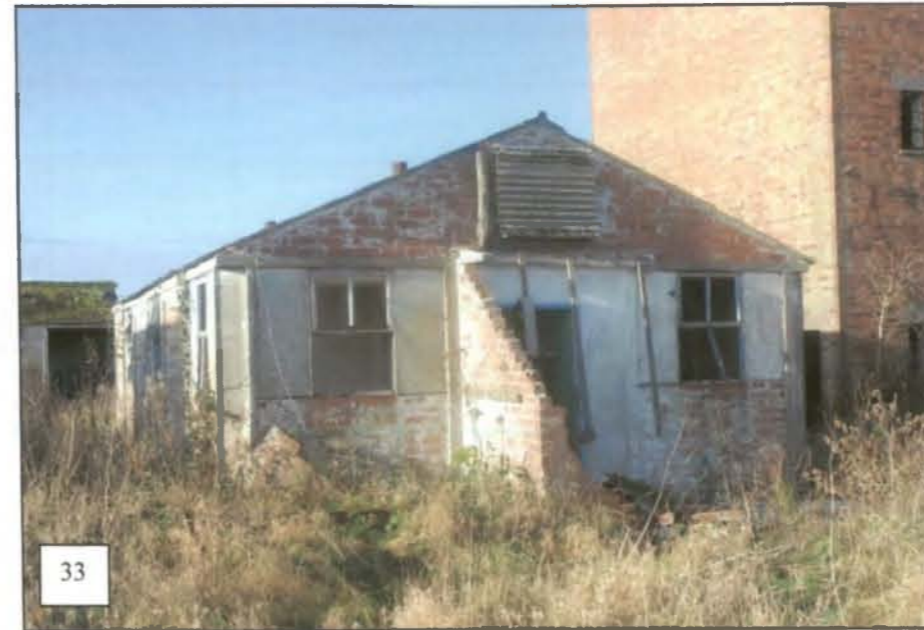
This hut was partially demolished, with the western two bays damaged; the interior had been stripped and the eastern porch structure was also demolished.

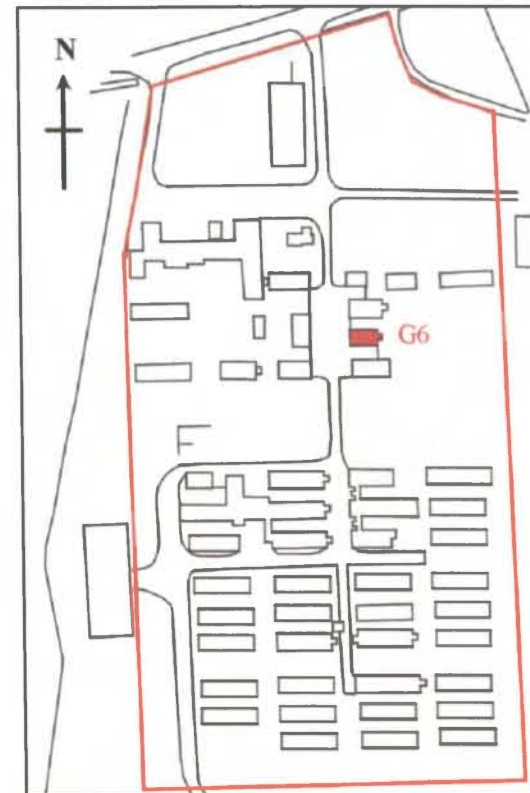
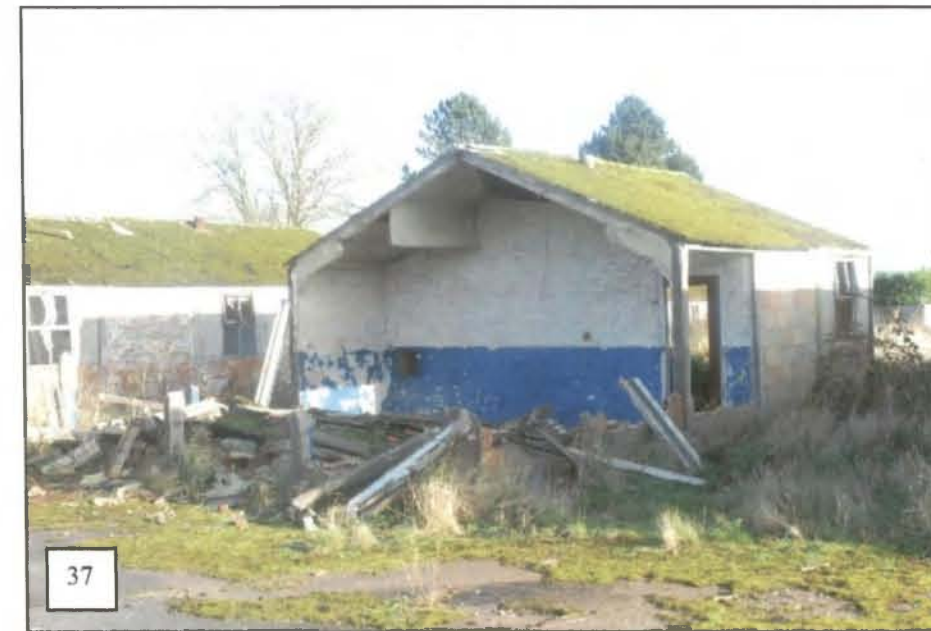
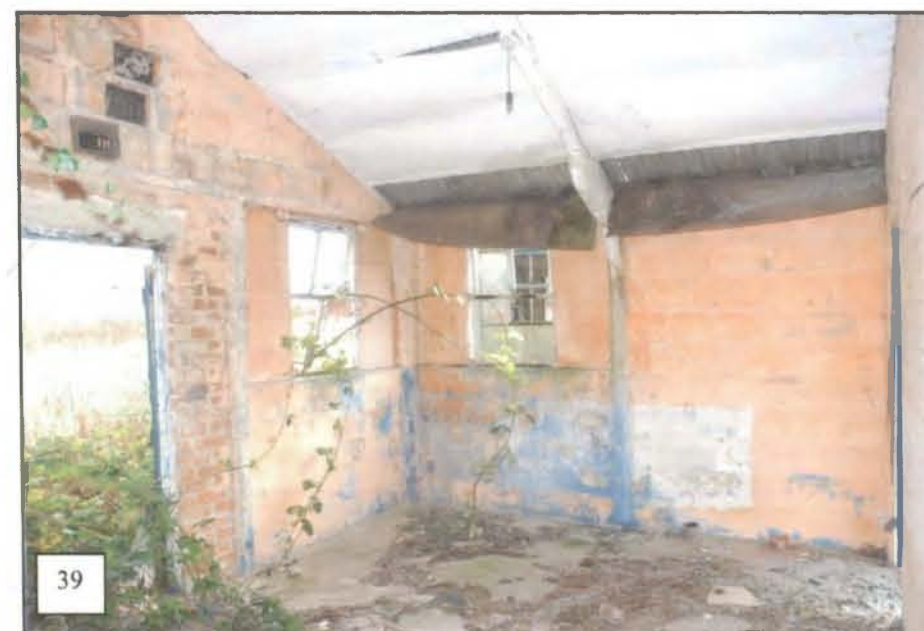
The west two bays of the structure had been completely demolished, but the eastern gable remained intact and retained an original exterior door.
