PINGLEY CAMP, BRIGG, LINCOLNSHIRE

PHOTOGRAPHIC BUILDING SURVEY

Report prepared for Barford Builders by S. A. Savage

Site Code: PPCB 08
Planning ref: 119946
NGR: TA 0178 0680
LCNCC acc. no. 2008.189
PCA job no.:08-515

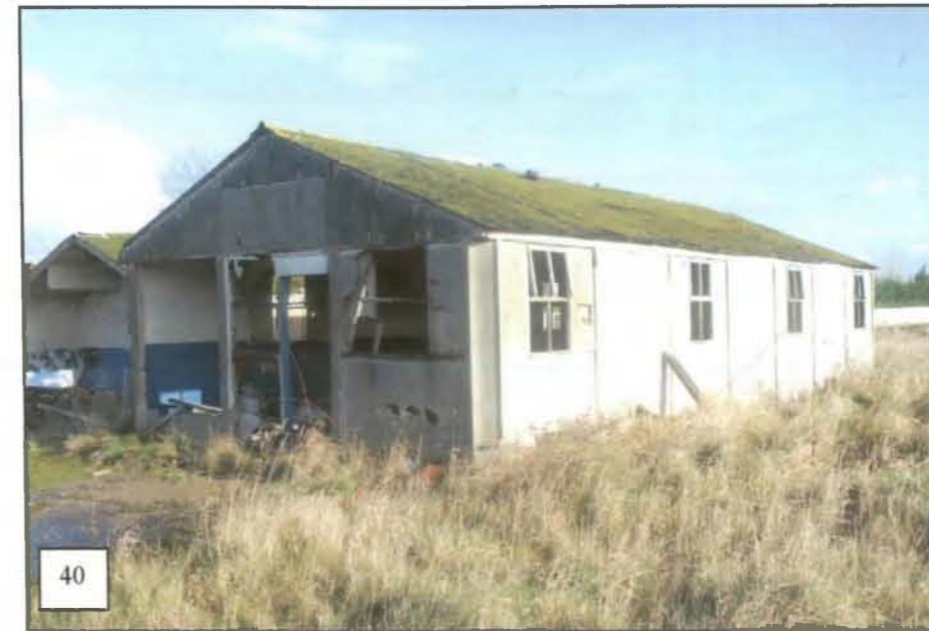
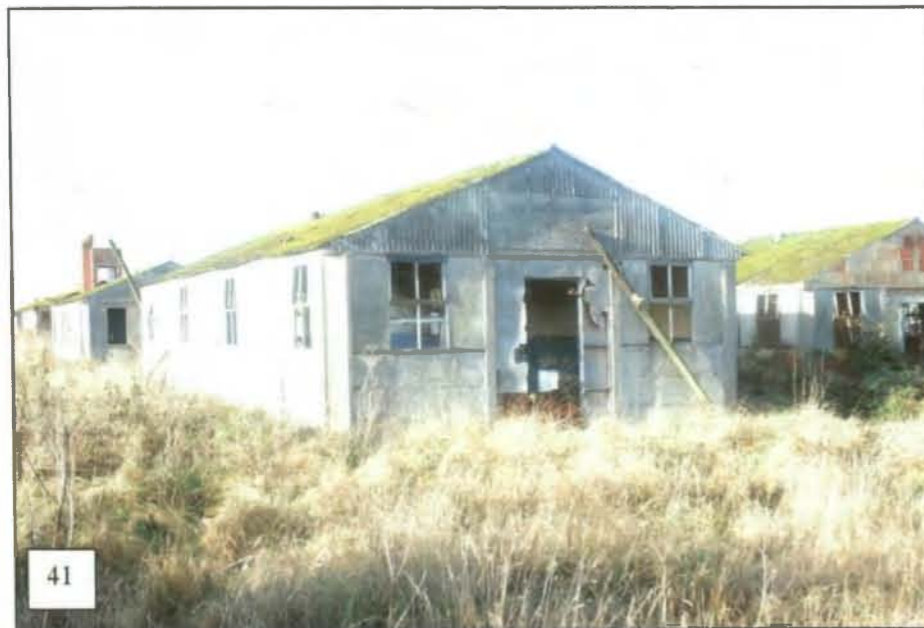
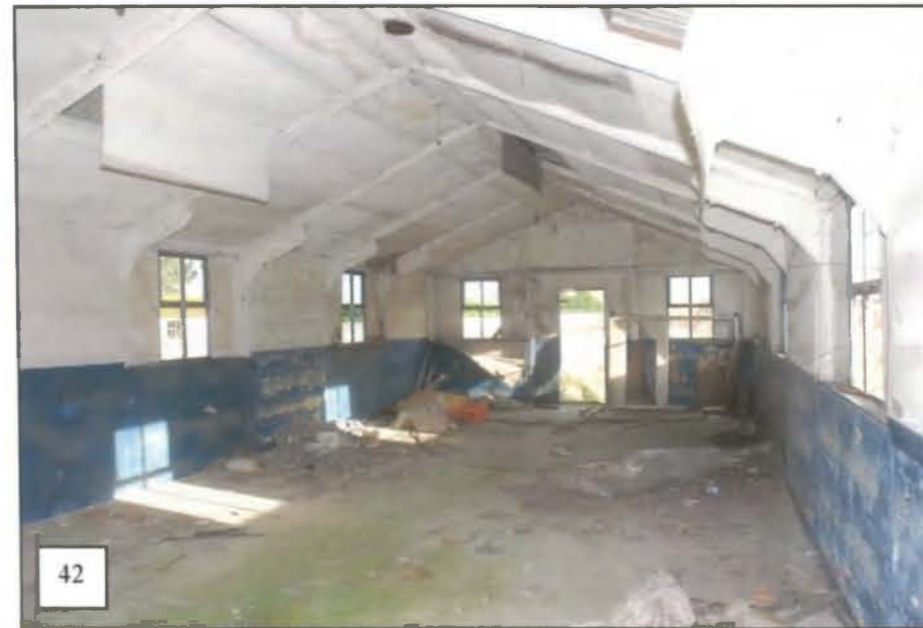
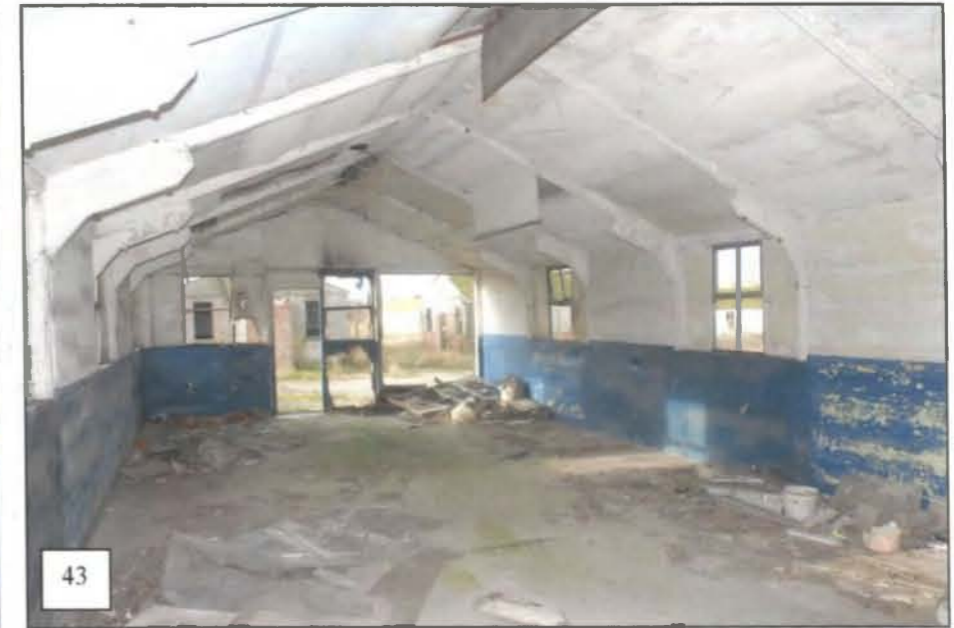
This building was located to the south of Hut G6, and comprised a MoWP type hut, oriented east-west, with a concrete frame of seven bays, infilled with pre-cast concrete panels. The roof and gables were of corrugated asbestos panels and the gable ventilators were of four slatted panels, covered by sheets of plain asbestos. It had four windows in the south side, and three in the north side.

The interior comprised a single room, and was decorated with lower mid-blue/upper white walls. Some marks on the floor may indicate that the building was once sub-divided, and the location of the stovepipe exits (with two near the eaves in the second bay from the east, and a single one near the ridge in the third bay from the west) tends to support this.

Although its most recent use was clearly as light agricultural storage, it is recorded on the original wartime plan of the camp as the 'Commandant's Office'.

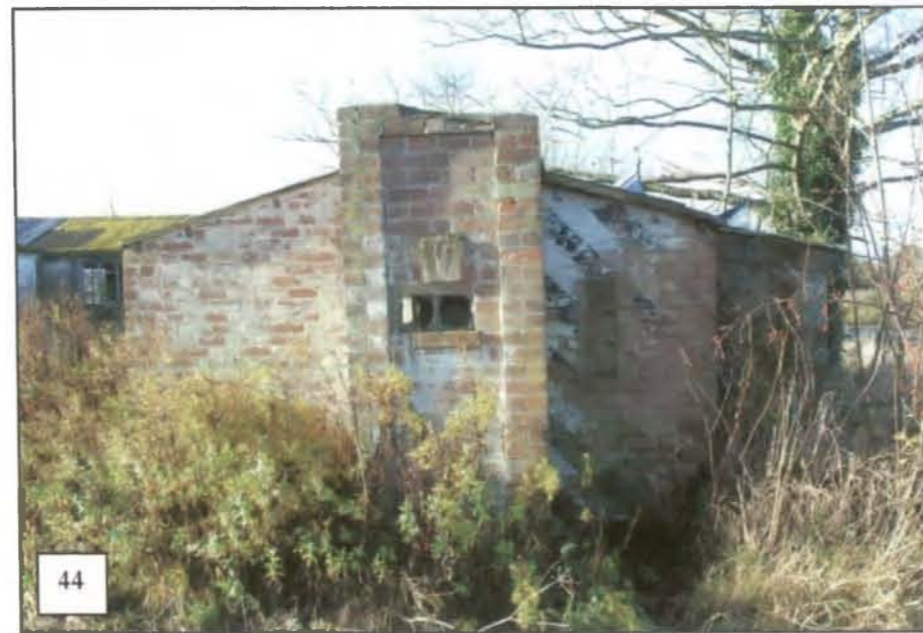
The room to the west of this retained an original exterior door in its southwest corner, with a four-light window to the east.

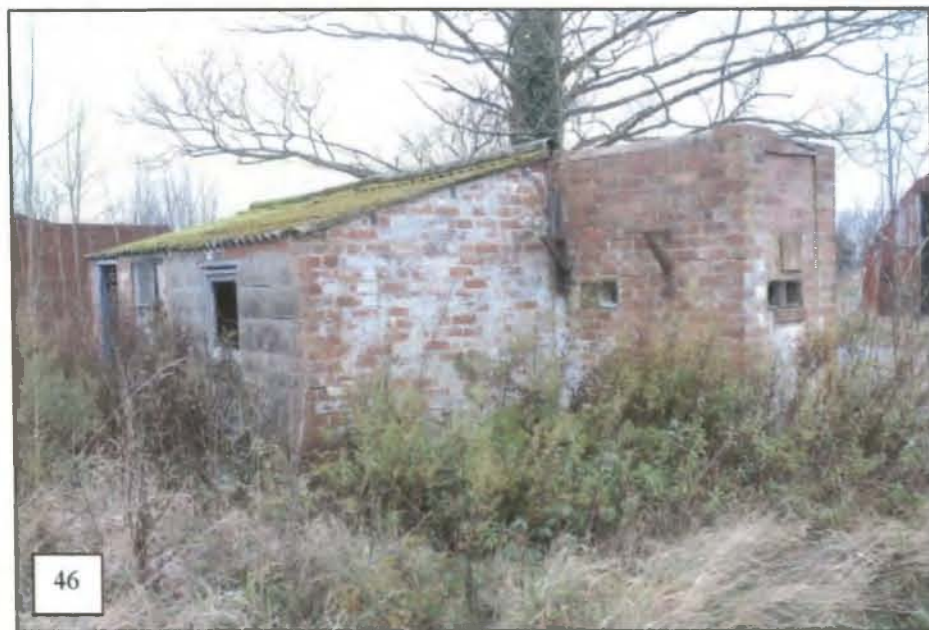
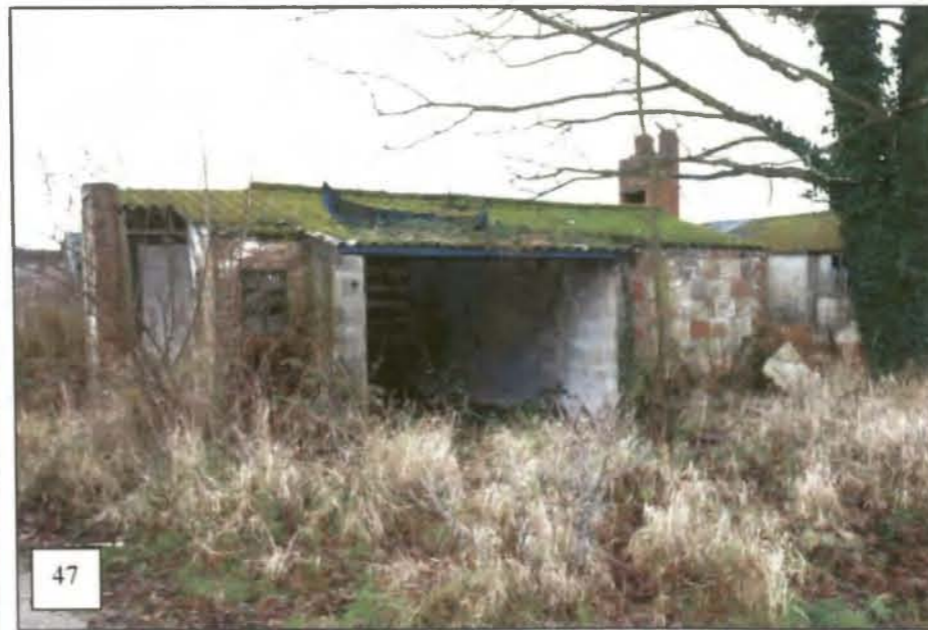
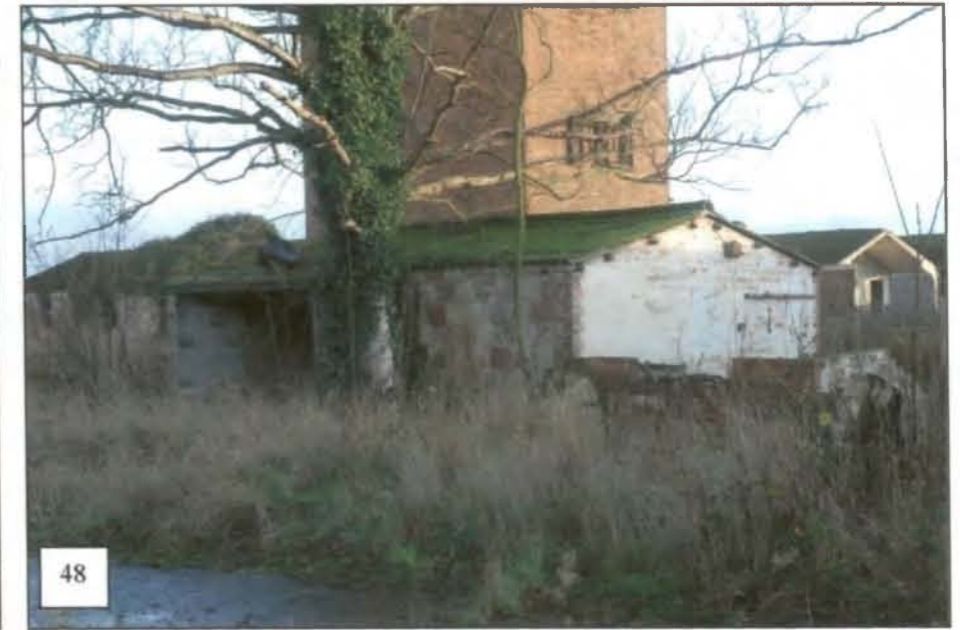
The interior of the building was entirely whitewashed. The sentry post retained an original fitted desk in the northern bay, and had its original framed, ledged and diagonally braced exterior door of 4½" chamfered planks.

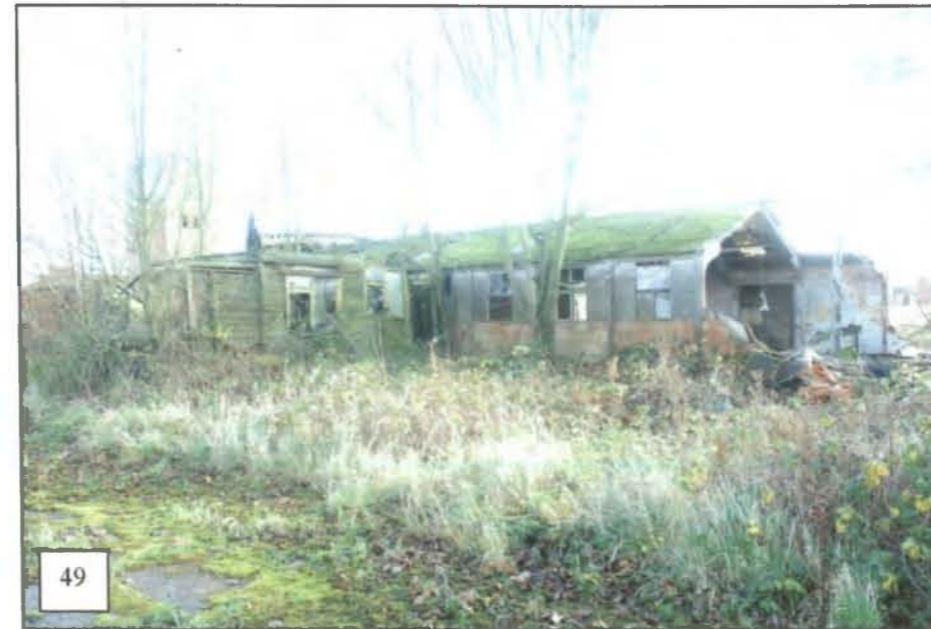
This complex of buildings occupied a position in the northwest part of the guards' compound and comprised several interconnecting elements, derived from MoWP huts.

According to the wartime plan, when constructed this complex comprised four separate elements, apparently linked by external corridors, but later additions have amalgamated them into a single complex.

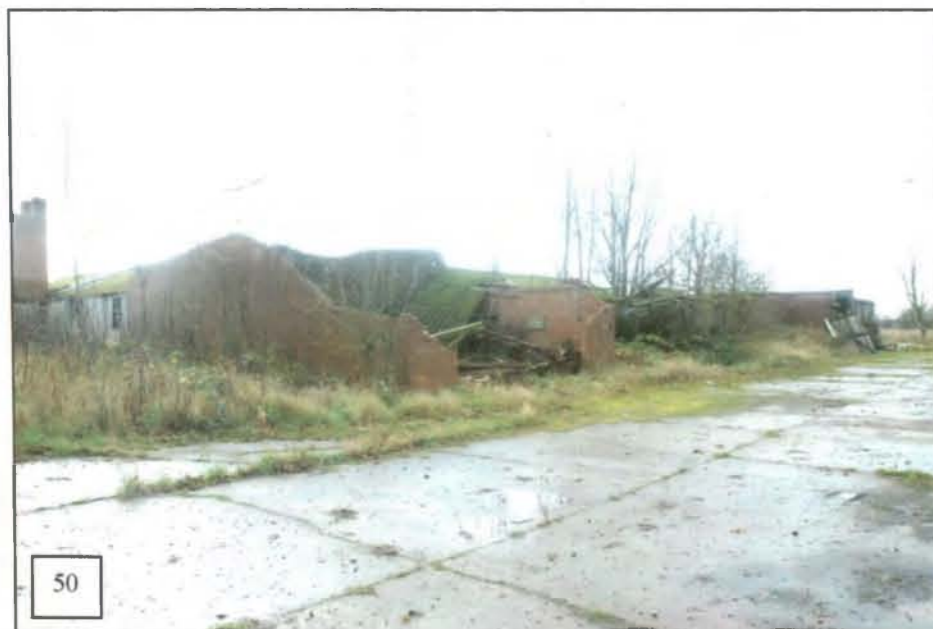
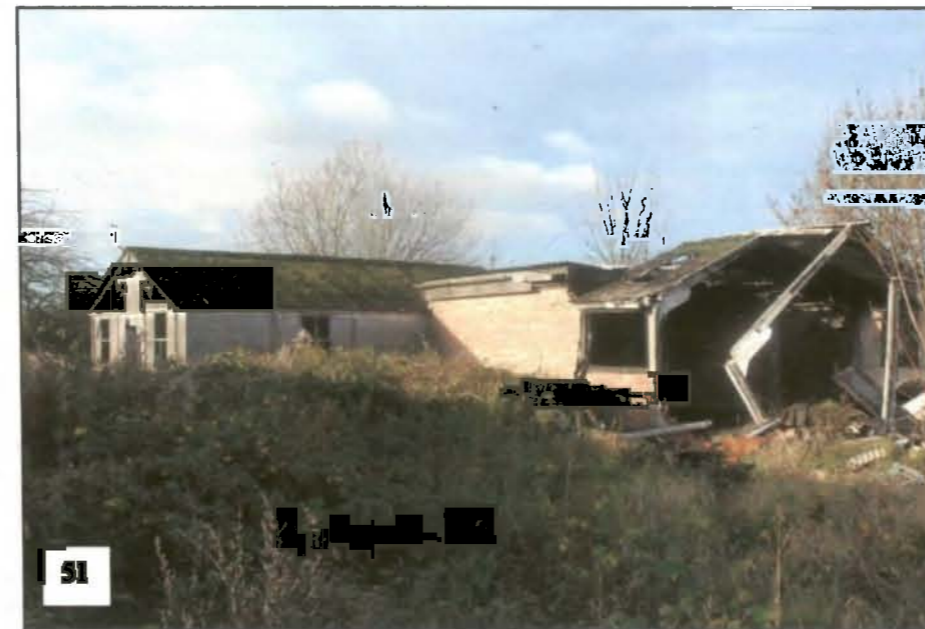
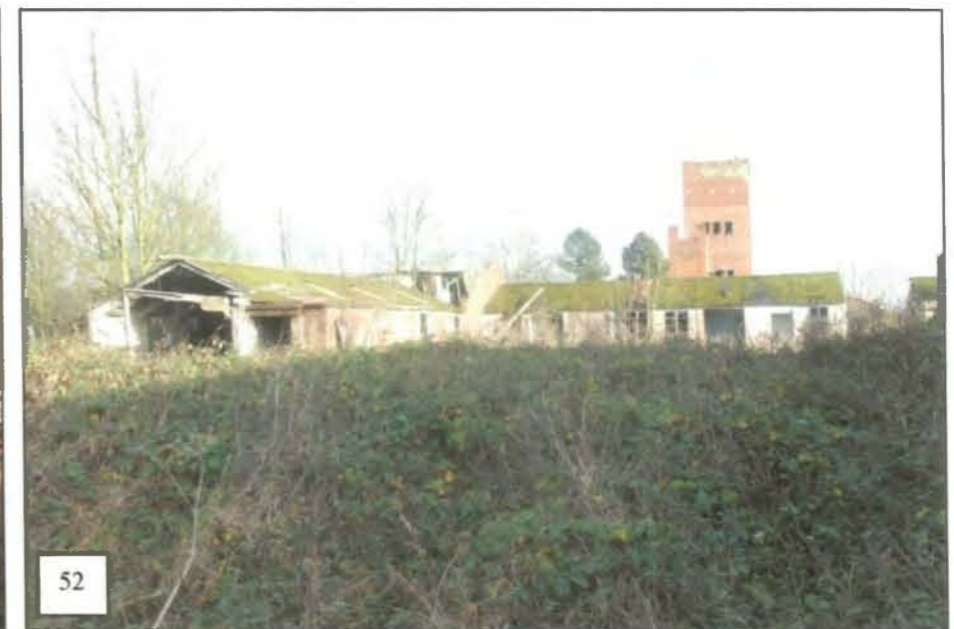
The north side of the building had a window in each bay, while windows conformed to the normal alternating bays on the south side. The building was accessed through double doors in a conventional brick porch structure with a concrete roof on the south side.

The interior appears not to have been subdivided, but a recent fire has heavily damaged the western two-thirds of the structure, making closer observation hazardous.

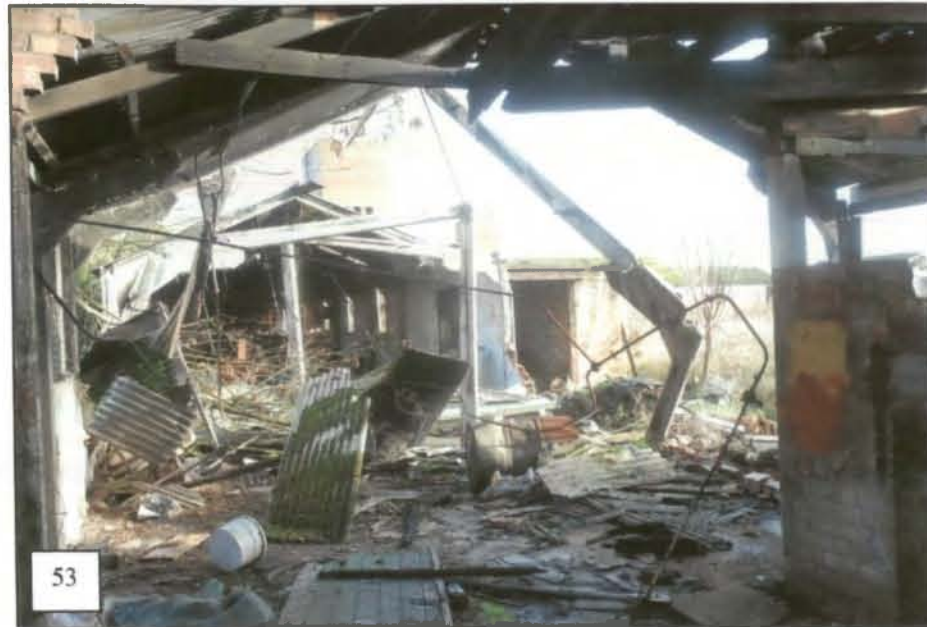
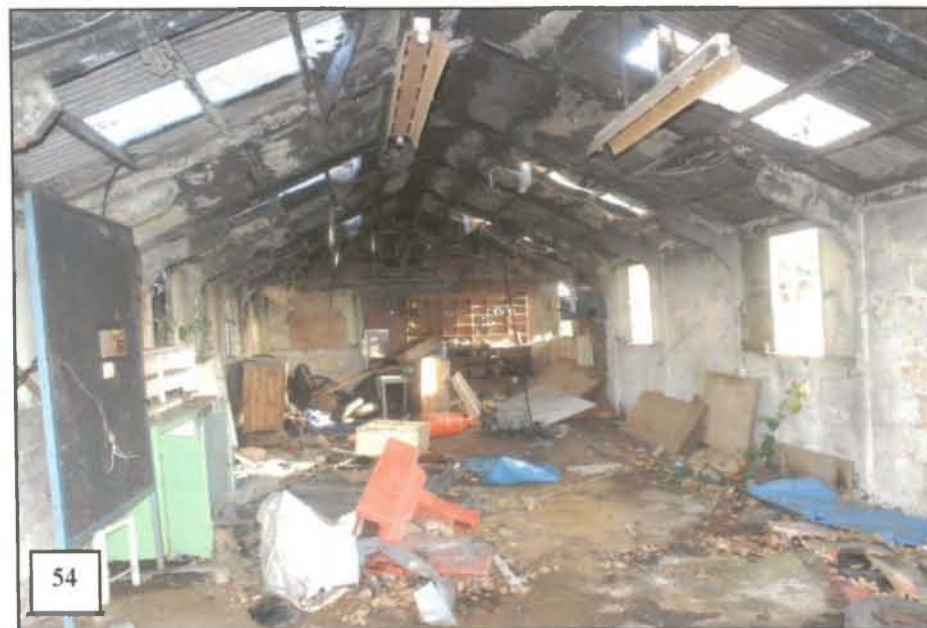
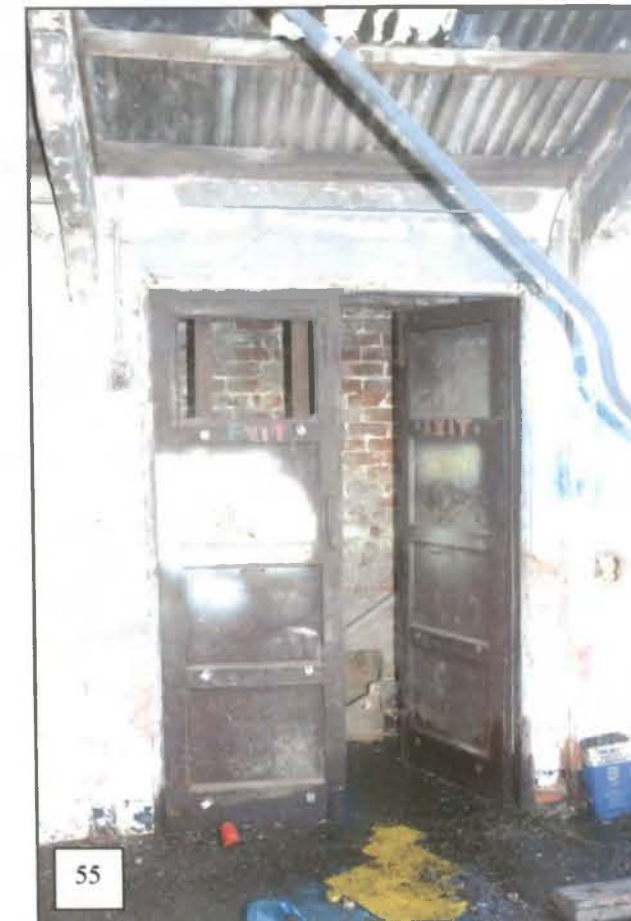
The building appeared to have been a mechanical workshop in its most recent use, and retained very few original fixtures, apart from the original four-panel double doors in the south wall, the uppermost panel of which was glazed. Corrugated Perspex panels had been inserted into the roof to allow more light into the interior, and modern striplights had been installed throughout.

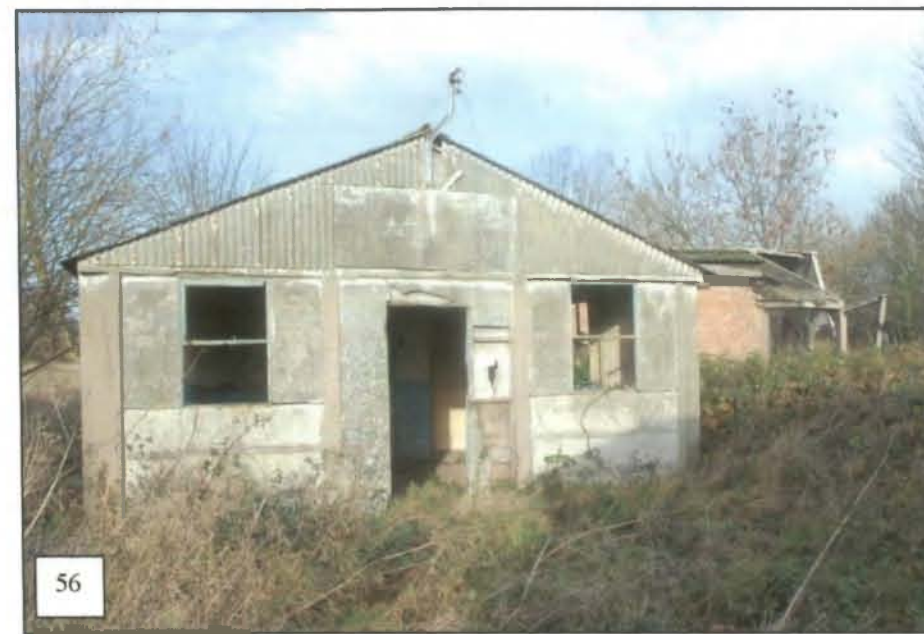
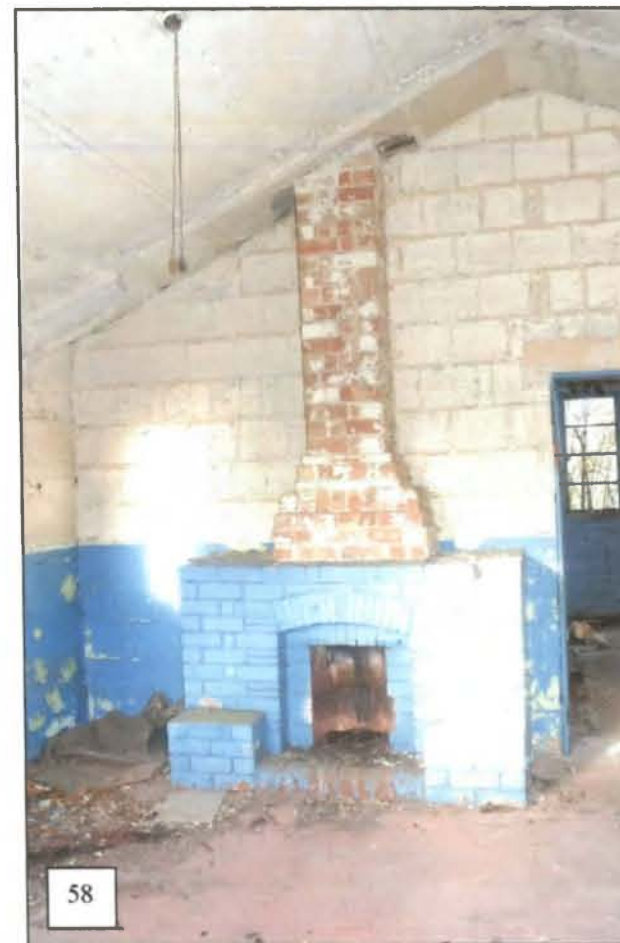
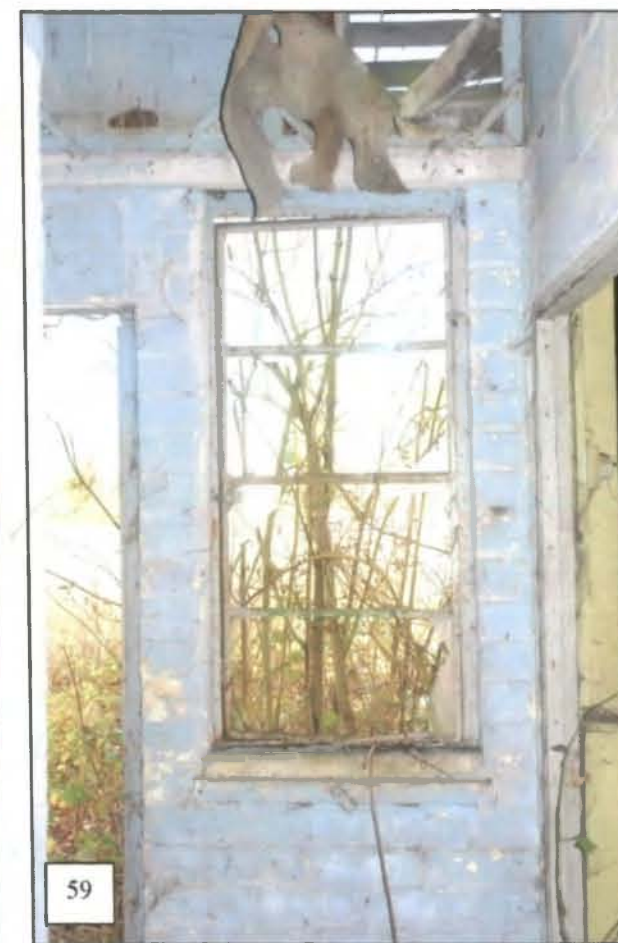
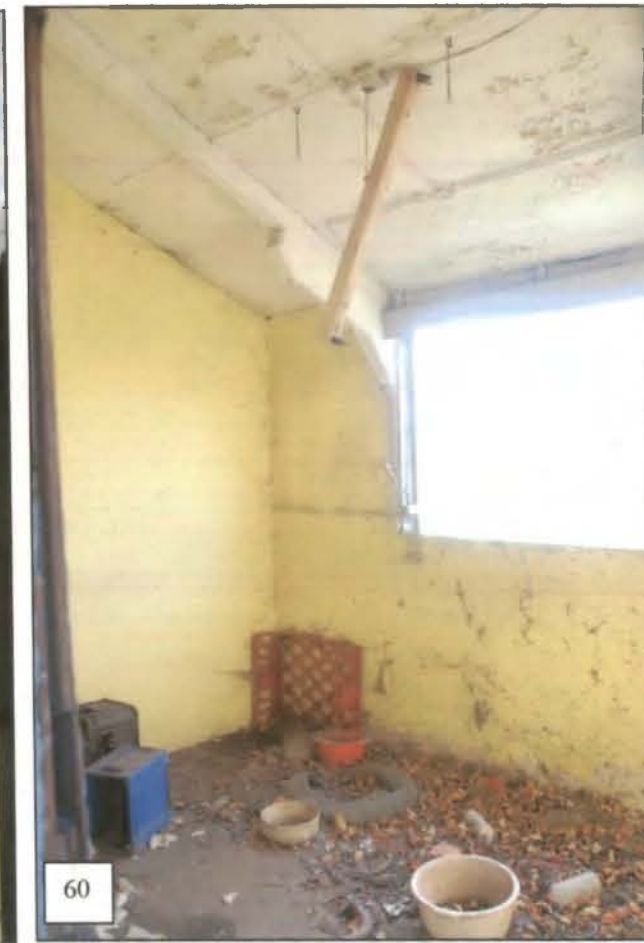
This building was located immediately to the west of Hut G9A, and comprised a MoWP type hut, oriented north-south, with a concrete frame of five bays, infilled with pre-cast concrete panels. The roof and gables were of corrugated asbestos panels and the gable ventilators were of four panels of timber slats, covered by sheets of plain asbestos. It had two windows in the east and west sides, unusually occurring within the same bays.

The interior was divided into six rooms with hollow brick partition walls. A single room, accessed through the north gable door, occupied the northern 2½ bays, while a corridor led off to the southern gable door flanked to east and west by two rooms, each two bays in length. The rooms occupying the northeast and northwest corners were toilet cubicles.

The northern room had a brick fireplace and chimney, apparently a later addition, and a small storeroom was accessed through a door in the north wall. The remaining two rooms, accessed from the central corridor, were unremarkable, having been repainted, and contained no original fixtures.

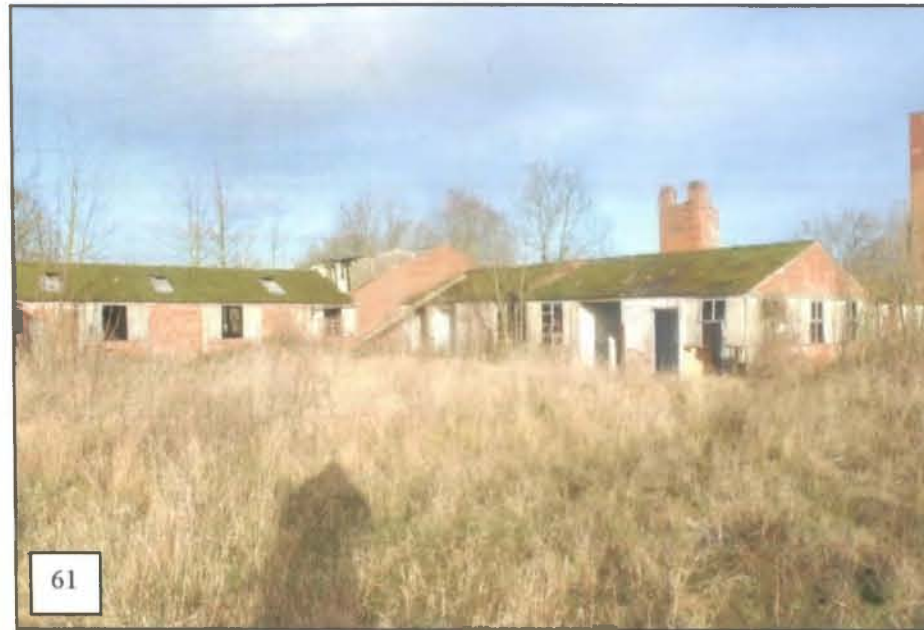
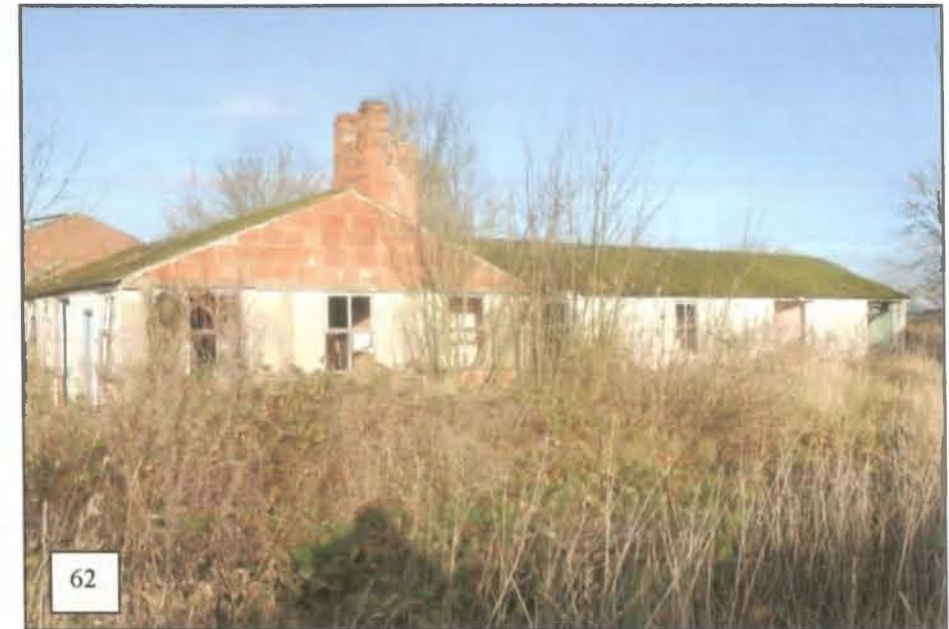
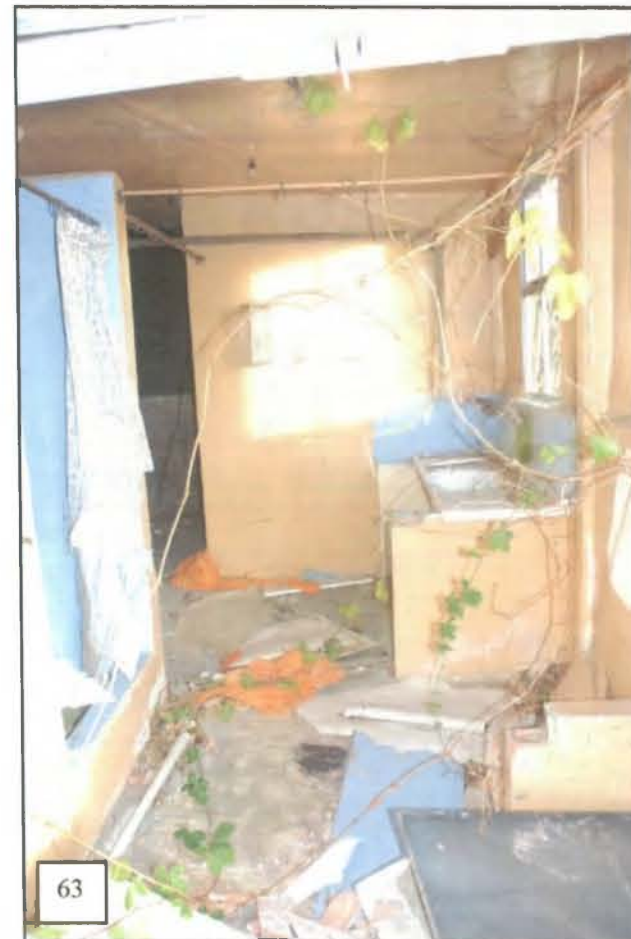
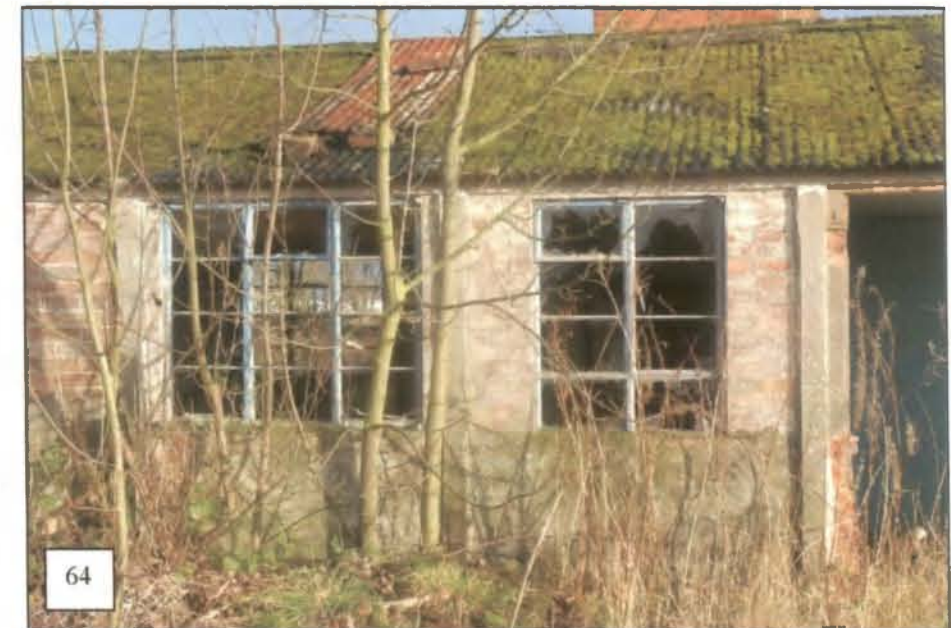
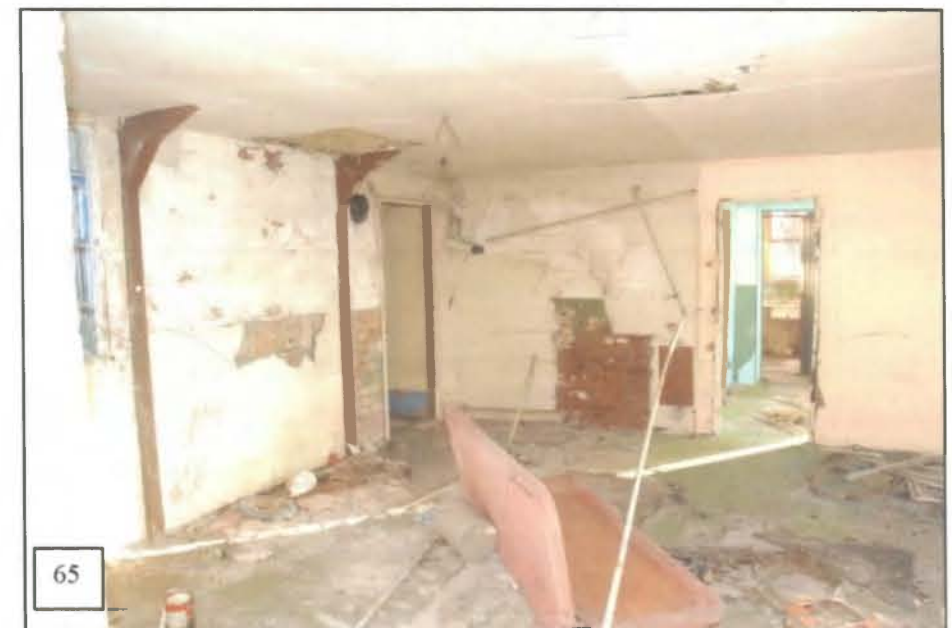
This building was located immediately to the west of Hut G9A, and comprised a MoWP type hut, oriented north-south, with a concrete frame of eight bays, infilled in hollow brick. The roof was of corrugated asbestos panels and the gable ventilators were of airbricks. It had three windows in the east side, three windows in the southern gable and six windows in its west wall, the central two of which were metal-framed.

The interior was divided into seven rooms with hollow brick partition walls. The southern part of the hut was occupied by a toilet to the east and washroom to the west with a shower, while the room to the southwest of the linking corridor to the neighbouring hut, Hut G9D, housed a boiler. A single room occupied the central three bays of this building, and probably originally housed cooking facilities (large metal-framed windows are found in this context elsewhere in the camp). The rooms occupying the northern part of the hut were probably storage.

This building was recently occupied and generally had a modern pale pink colour scheme; however, the room to the north of the washroom retained its original decoration, with the lower walls painted mid green while the upper walls were cream.

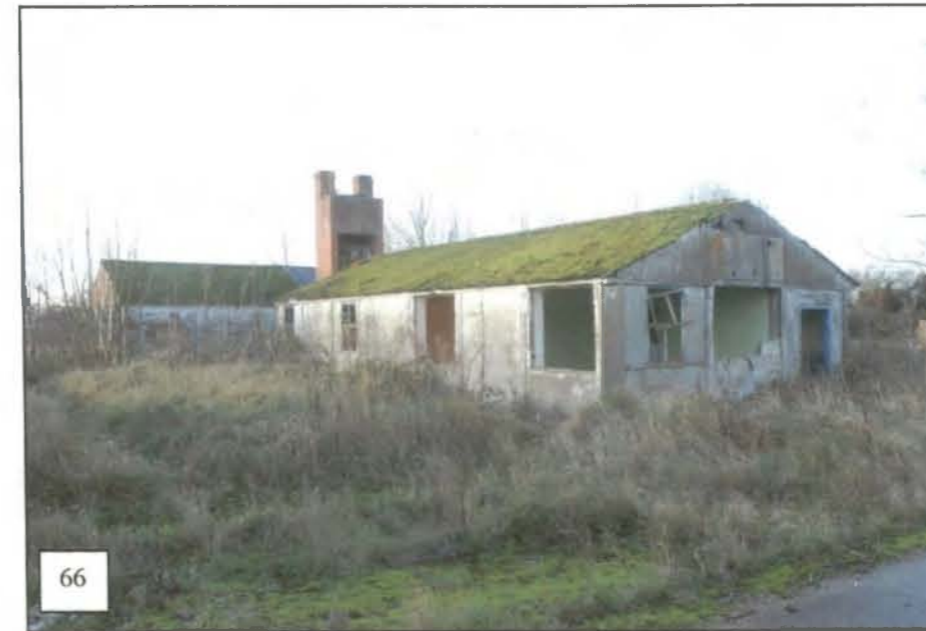
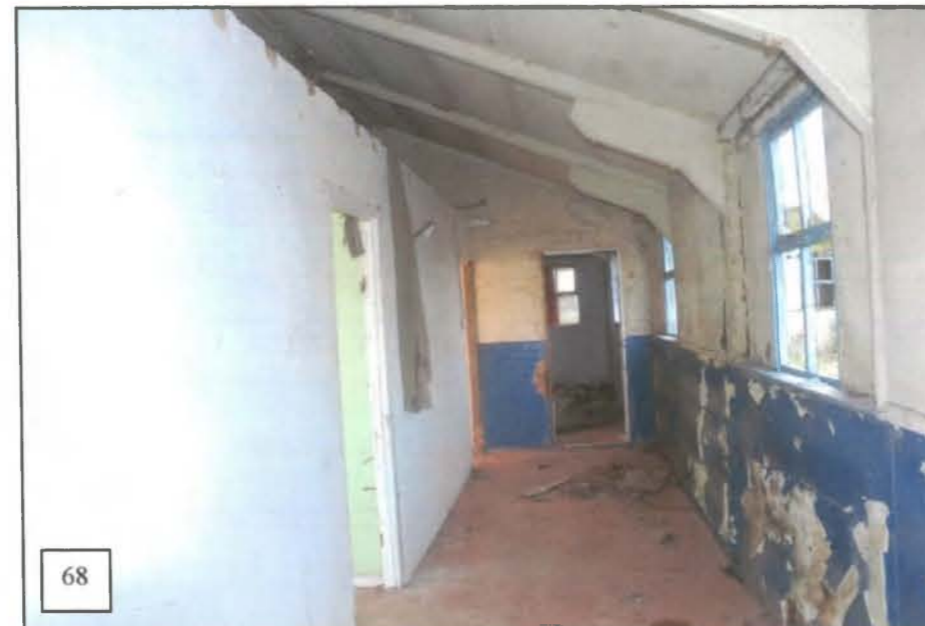
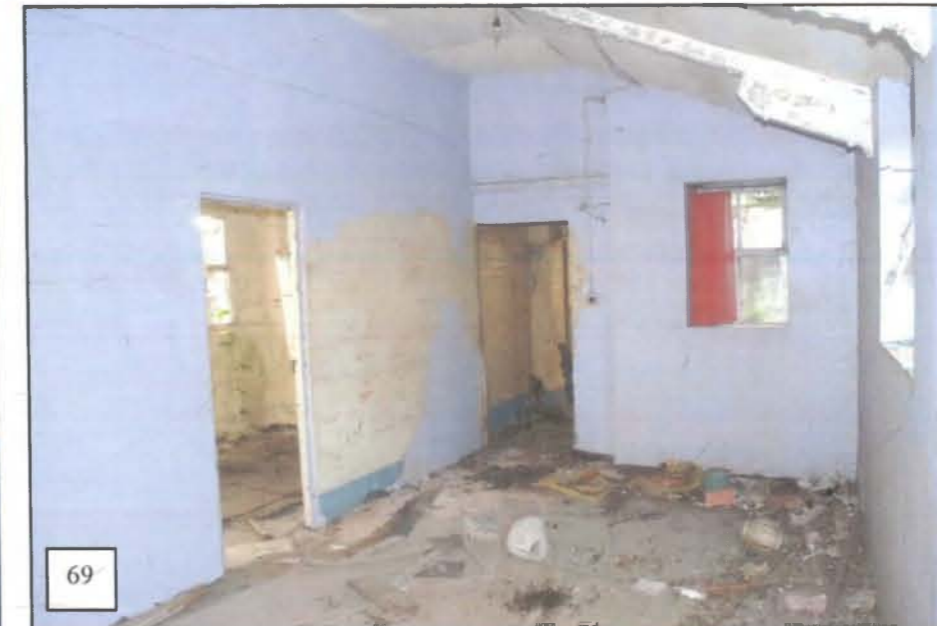
This building was located immediately to the east of Hut G9C, and comprised a MoWP type hut, oriented east-west, with a concrete frame of seven bays, infilled with pre-cast concrete panels. It had four windows in the south wall and three in the north wall. The roof and eastern gable were of corrugated asbestos panels and the gable ventilators were of four panels of timber slats, covered by sheets of plain asbestos.

The interior was originally divided into three rooms with a mixture of hollow brick and conventional brick partition walls. A single room, which originally occupied the eastern four bays of the hut, had been recently partitioned in modern studwork, to provide two rooms on the south side accessed from a corridor to the north. These modern rooms were decorated in modern emulsion paint, while the northern corridor had the now familiar lower mid blue/upper white colour scheme.

The original central door opening in the east gable had been blocked with breeze blocks and a new exterior door opening had been forced through the east gable on the line of the new northern corridor. The western part of the hut was subdivided with an east-west partition in hollow brick, with a central communicating door opening.

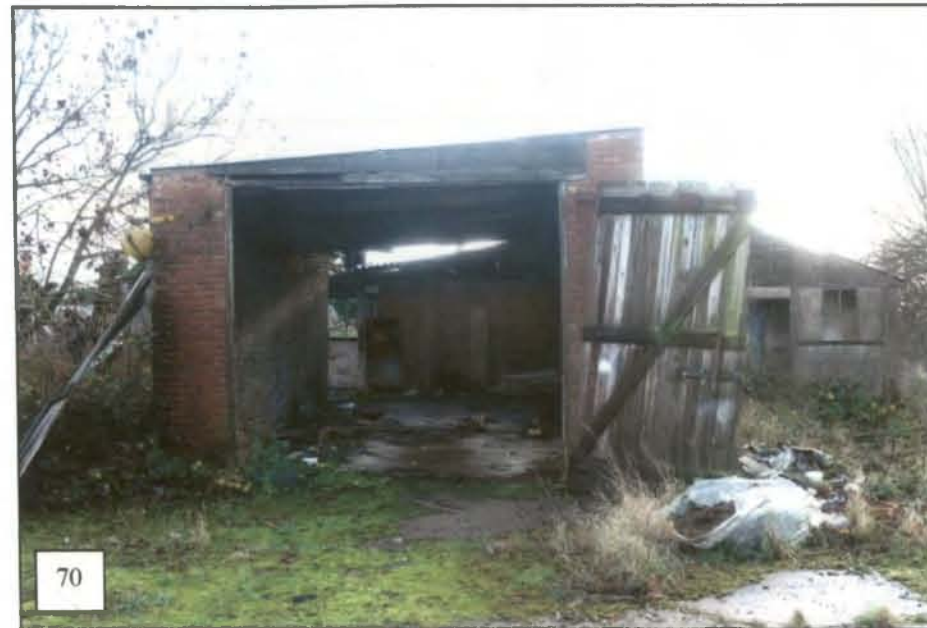
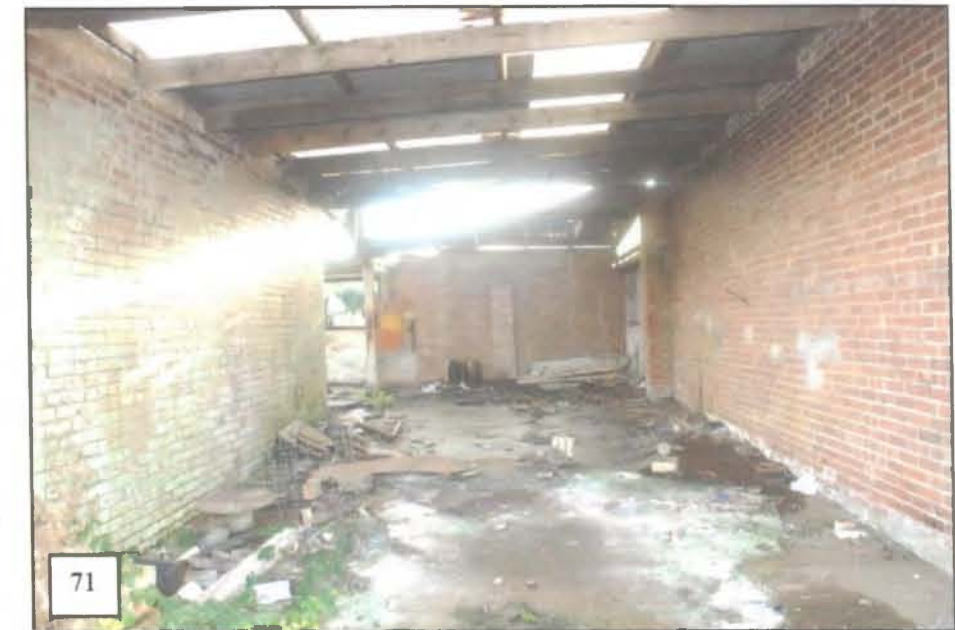
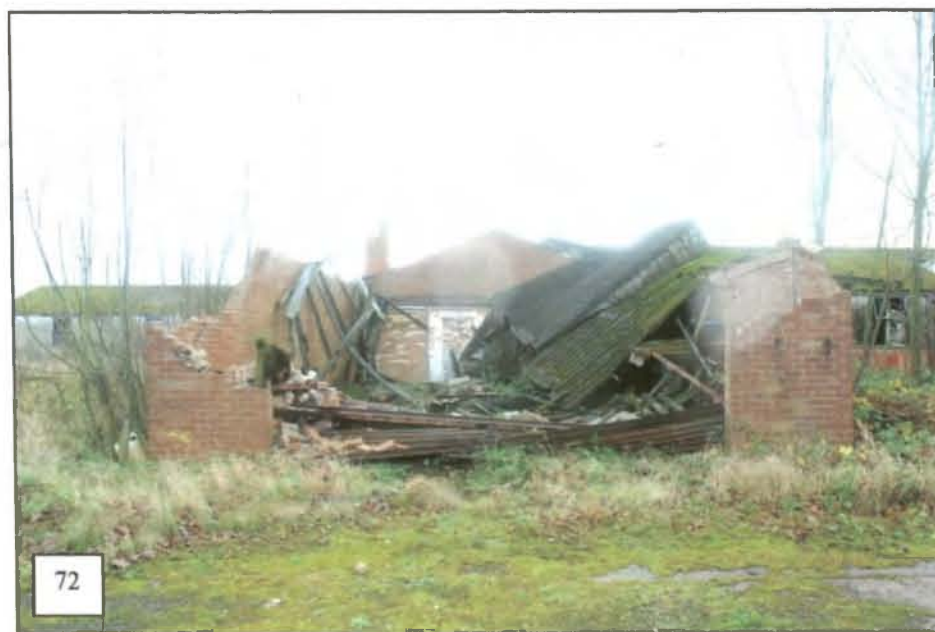
It had a pair of large ledged and diagonally braced doors on the north side, only the western of which remained, and was badly fire damaged.

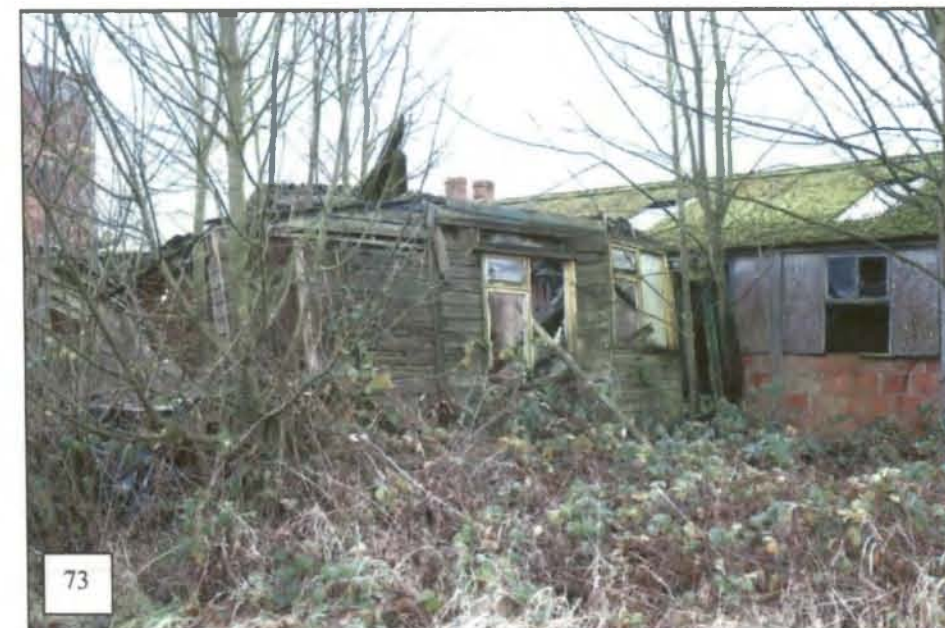
The eastern of the garage structures was partially demolished, and occupied the area to the north of Hut G9C, at the east end of Hut G9A. It appeared of similar construction to the western garage building, but had a pitched roof, while the large door opening on the north side was occupied by a roller shutter door.

On the north side of Hut G9A, a free-standing timber shed of two rooms had been constructed. It was of shiplap panels with modern casement windows. It had almost completely collapsed, but probably acted as a reception building when the camp was being used as foreign student accommodation.
