PINGLEY CAMP, BRIGG, LINCOLNSHIRE

PHOTOGRAPHIC BUILDING SURVEY

Report prepared for Barford Builders by S. A. Savage

Site Code: PPCB 08
Planning ref: 119946
NGR: TA 0178 0680
LCNCC acc. no. 2008.189
PCA job no.:08-515

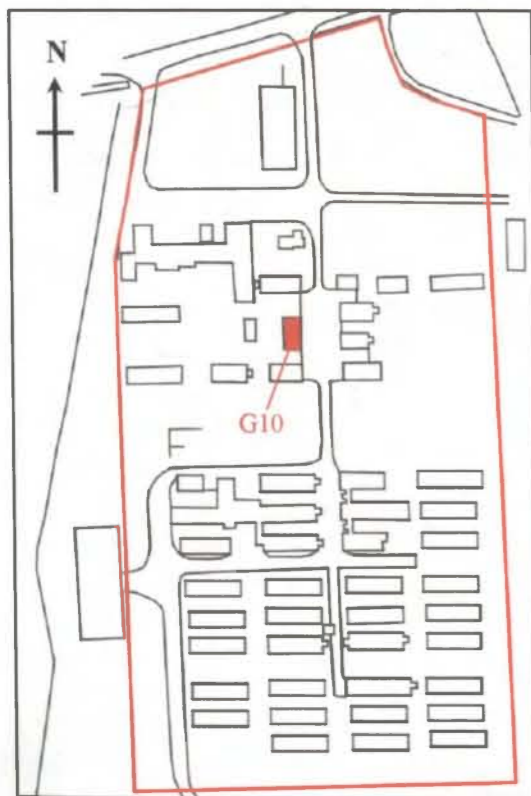
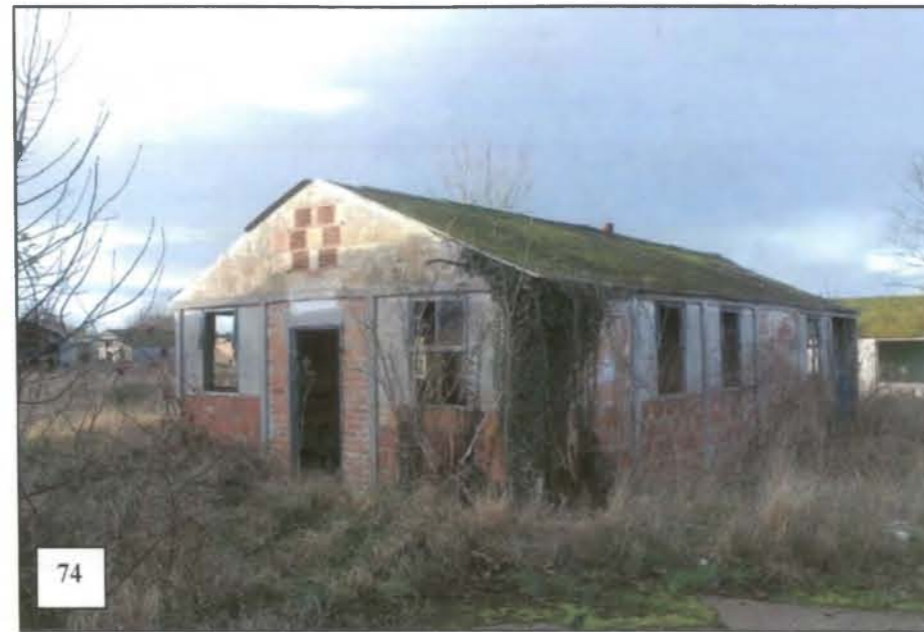
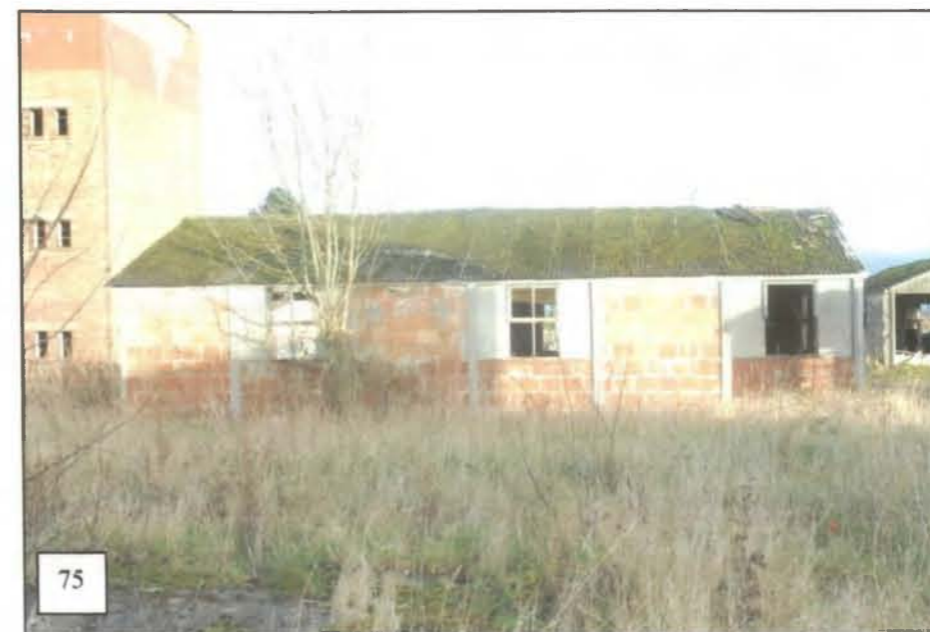
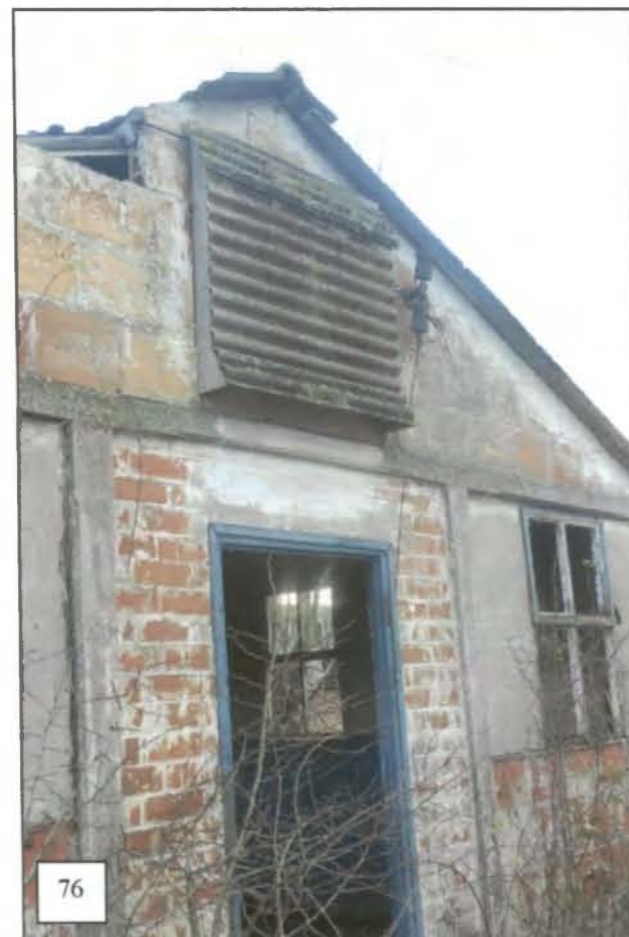
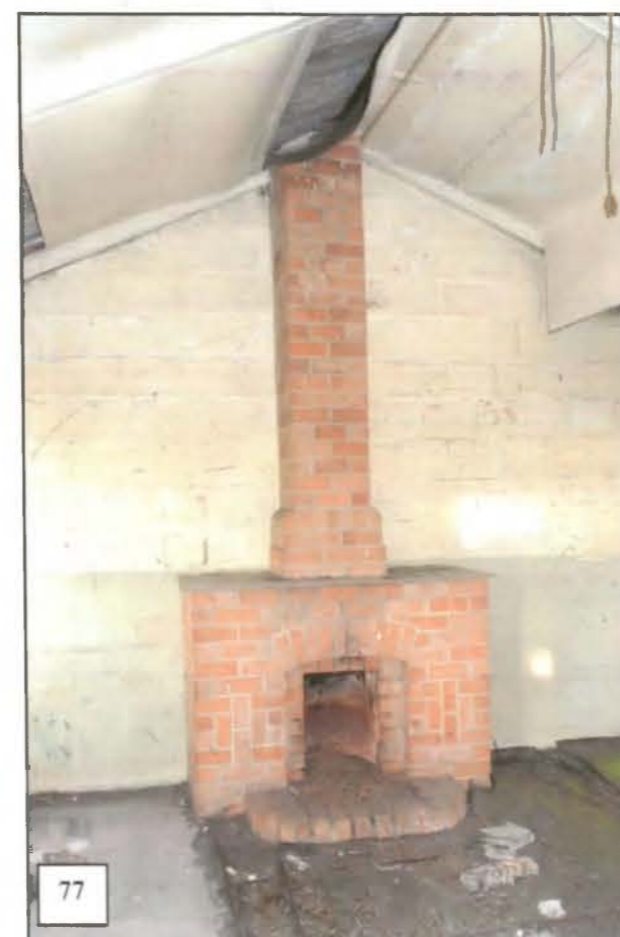
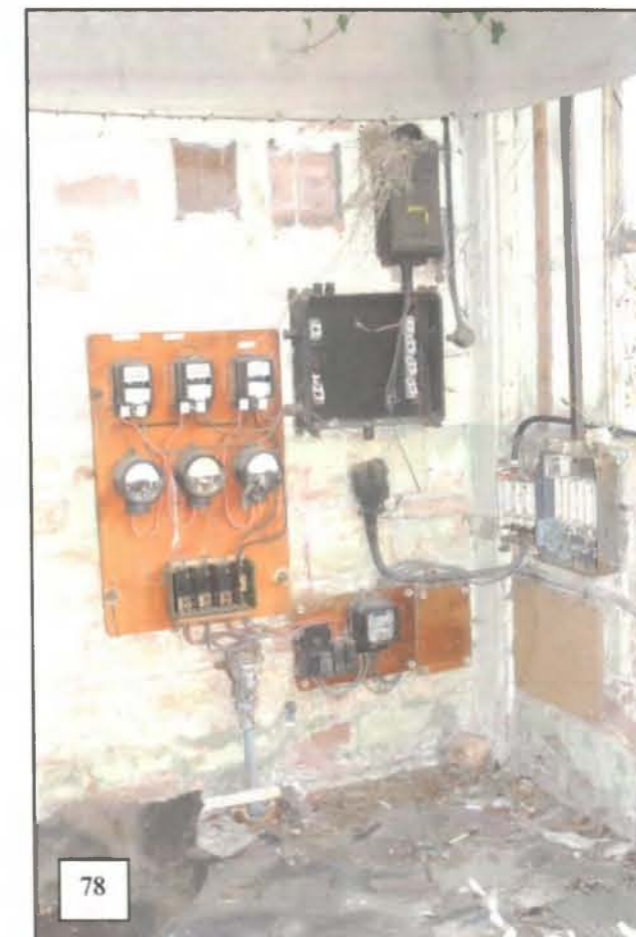
The interior was divided into two rooms by a central hollow brick partition wall, with no communicating door. The northern room was of three bays, decorated in a lower light green/upper cream colour scheme, while the southern had a lower mid blue/upper white colour scheme. The northern room had a modern brick fireplace and chimney in the middle of the partition wall, with a slate mantel. The southeast corner of this hut was occupied by a antiquated electrical switchgear

The wartime plan of the camp records this building as the 'Guard Hut and S.A.A. [Small Arms and Ammunition] Store'.

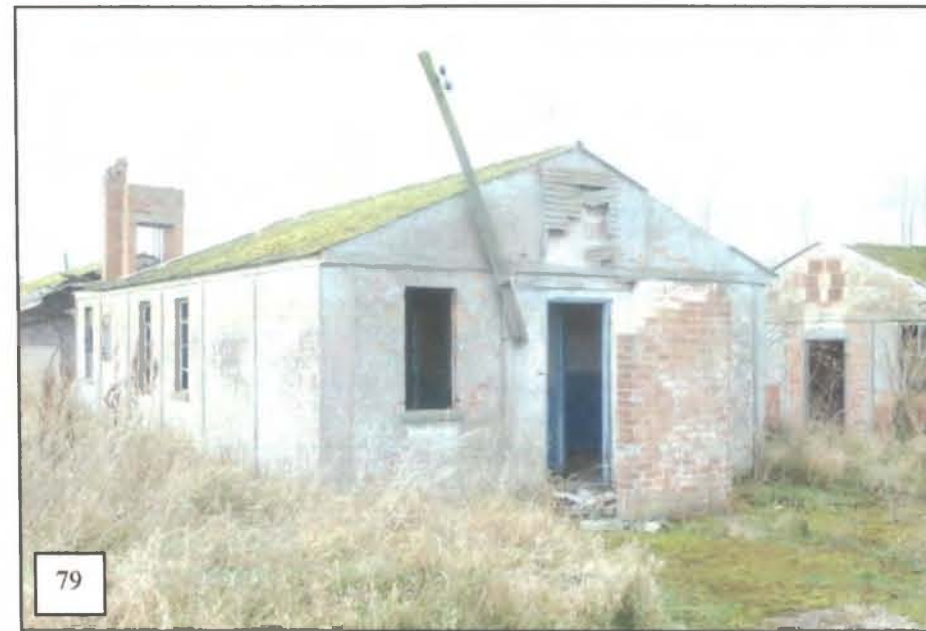
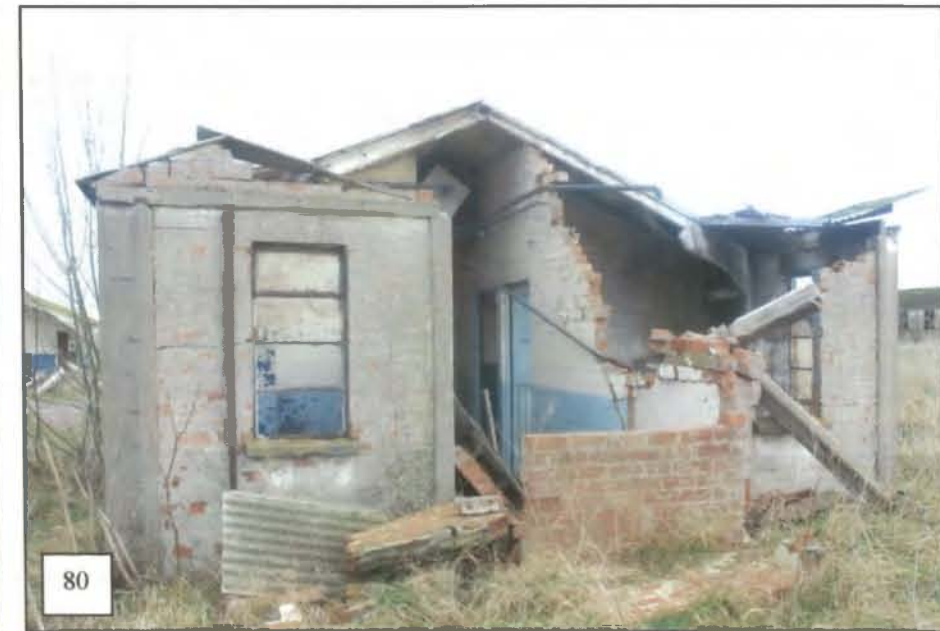
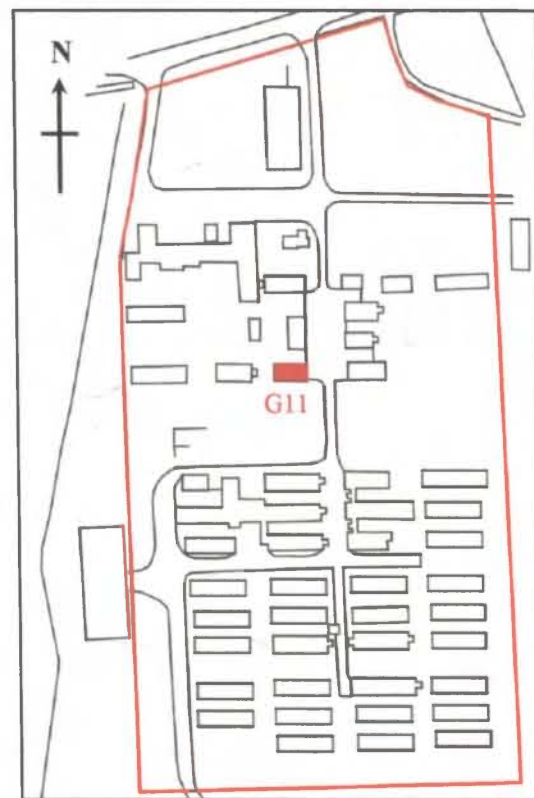
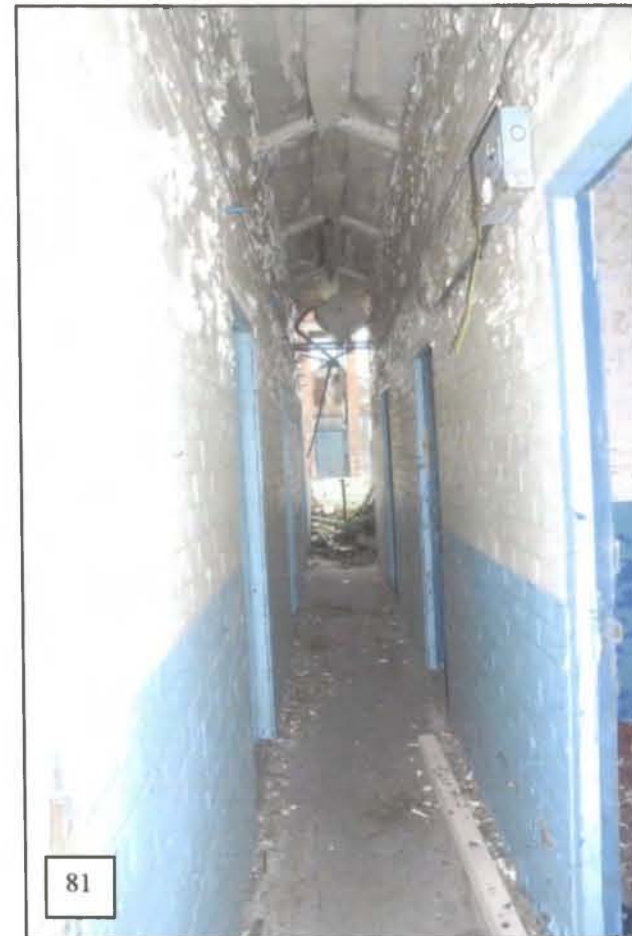
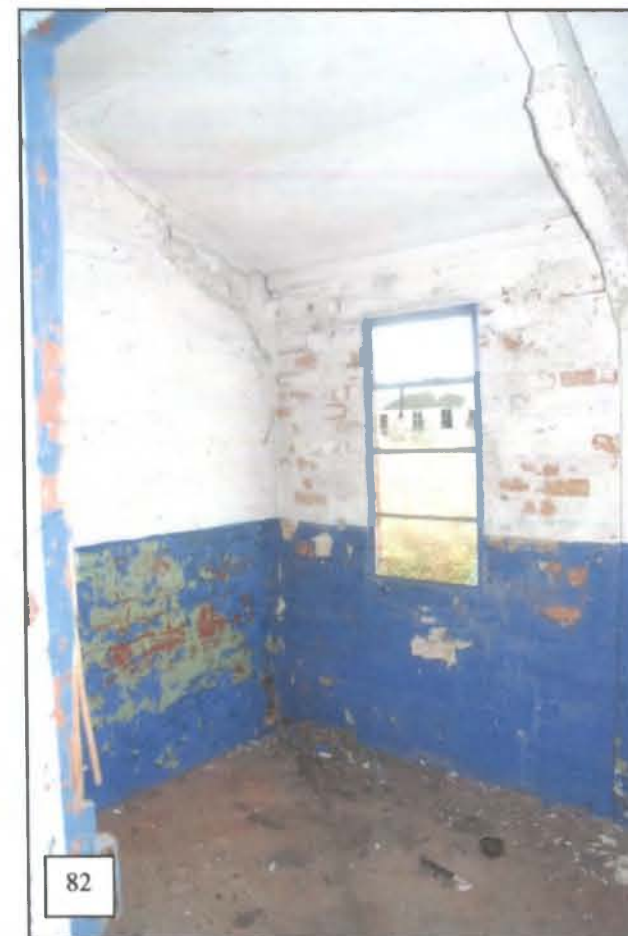
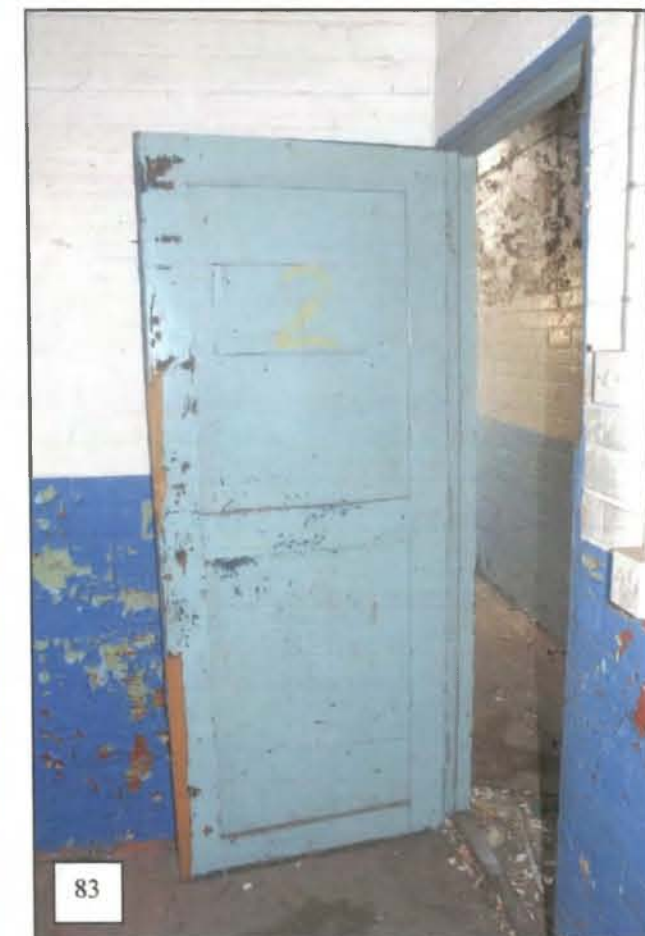
This building was located to the south of Hut G10, and comprised a MoWP type hut, oriented east-west, with a concrete frame of six bays, infilled with conventional brickwork. The roof was of corrugated asbestos panels and the gable ventilators were of airbricks, with a corrugated asbestos cover. The window openings had concrete lintels and sills, and the exterior was cement rendered.

The interior was divided with conventional brick partition walls and comprised a central corridor flanked on each side by three rooms, each 1½ bays in length. At the west end the corridor opened up to the full width of the central bay, and the southwestern bay was occupied by a boiler room, while a toilet cubicle and urinal occupied the bay on the opposite side.

All of the windows in this building were metal framed, of four lights, the uppermost a top-hung casement. The rooms retained their doors, each of which was of two-panel construction; these originally had a small observation window in the upper panel, all of which have since been covered. The door to the boiler room was of the four-panel type seen elsewhere throughout the camp. The western bay of the building was partially demolished.

The wartime plan of the camp describes this building as the 'Detention Block'.

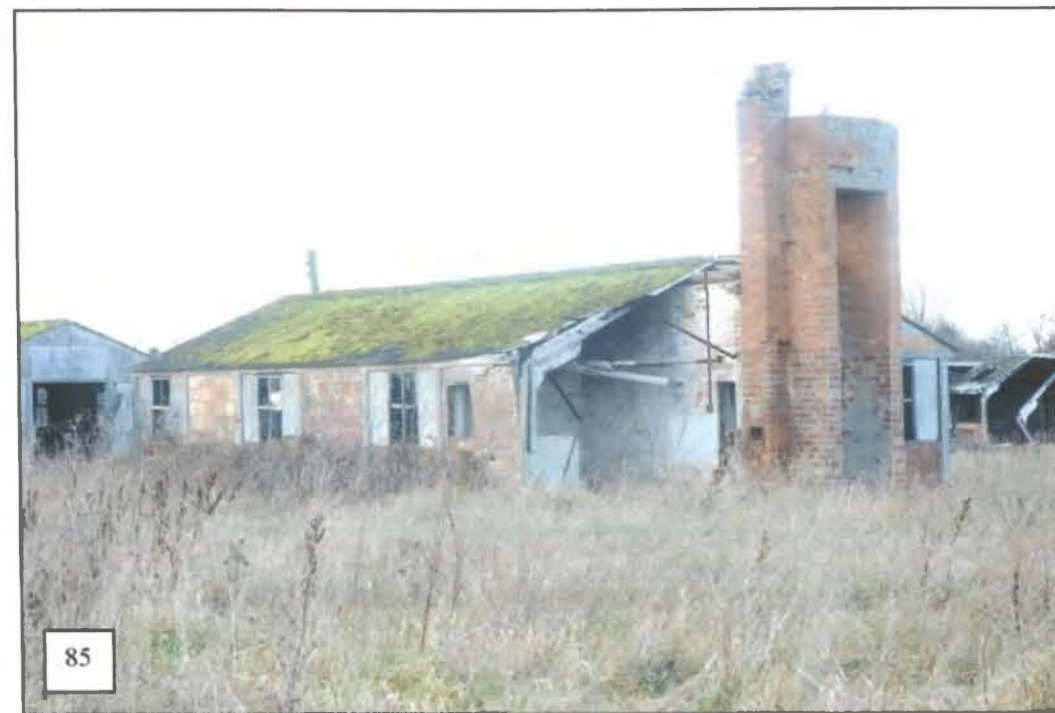
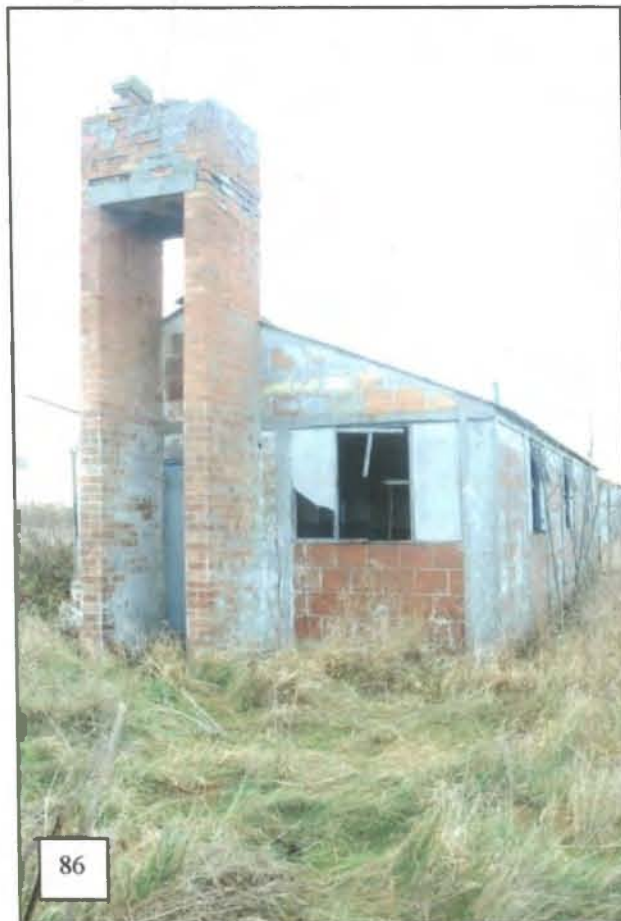
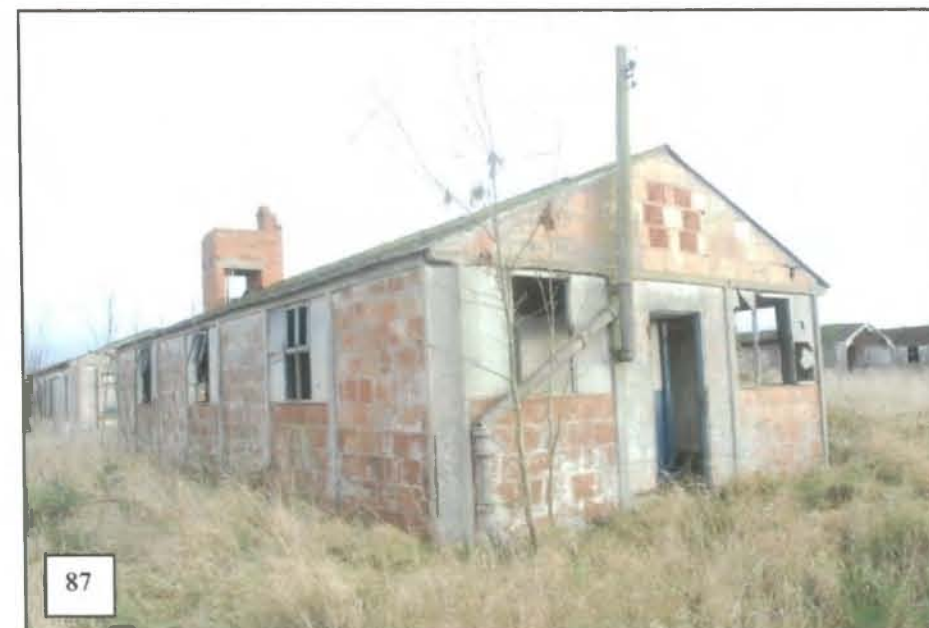
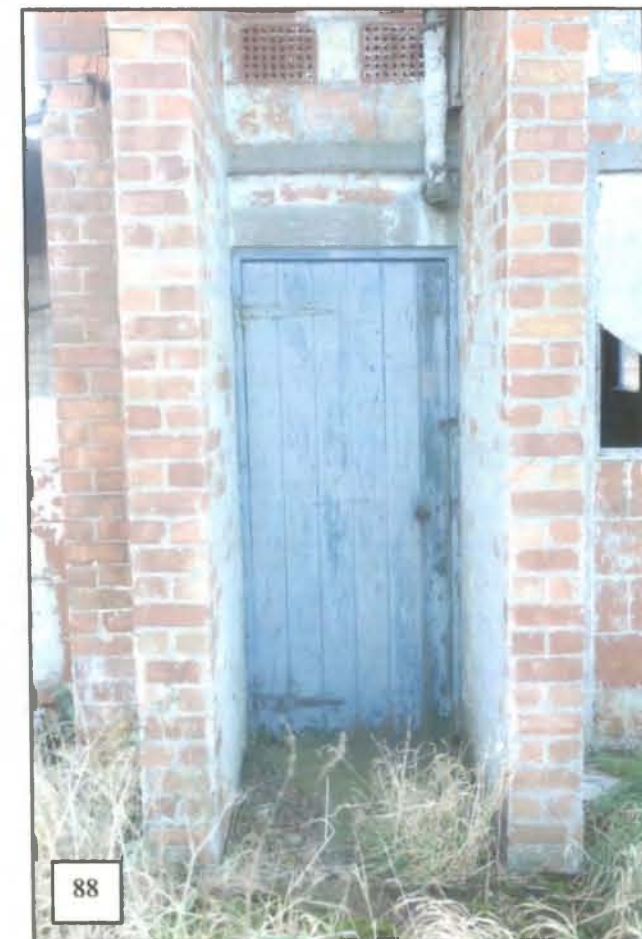
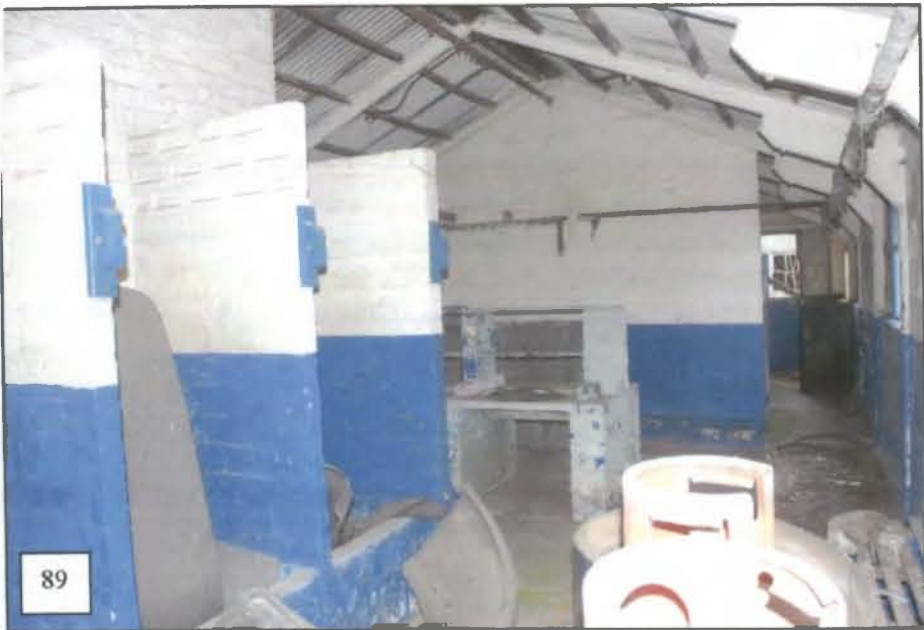
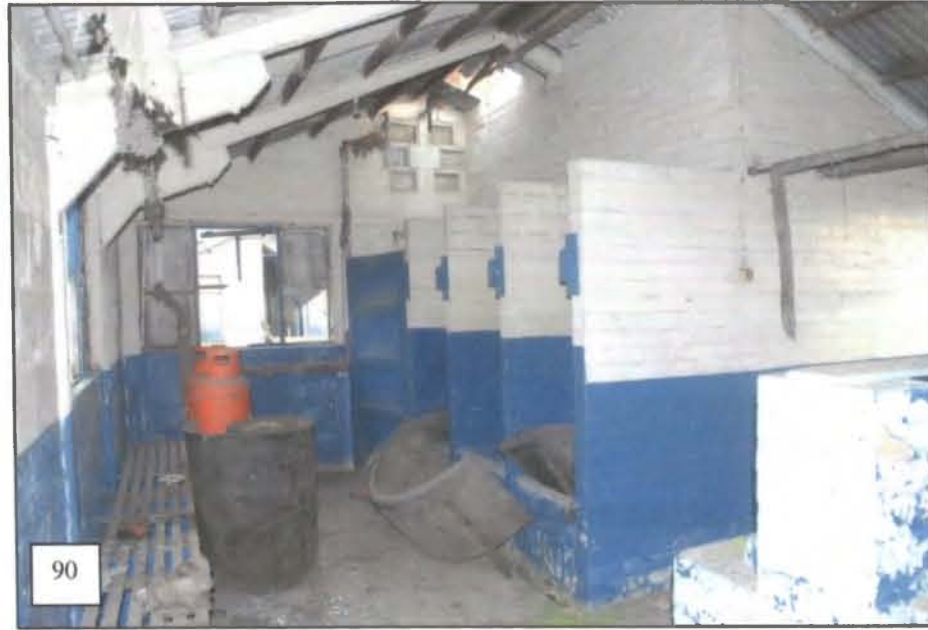
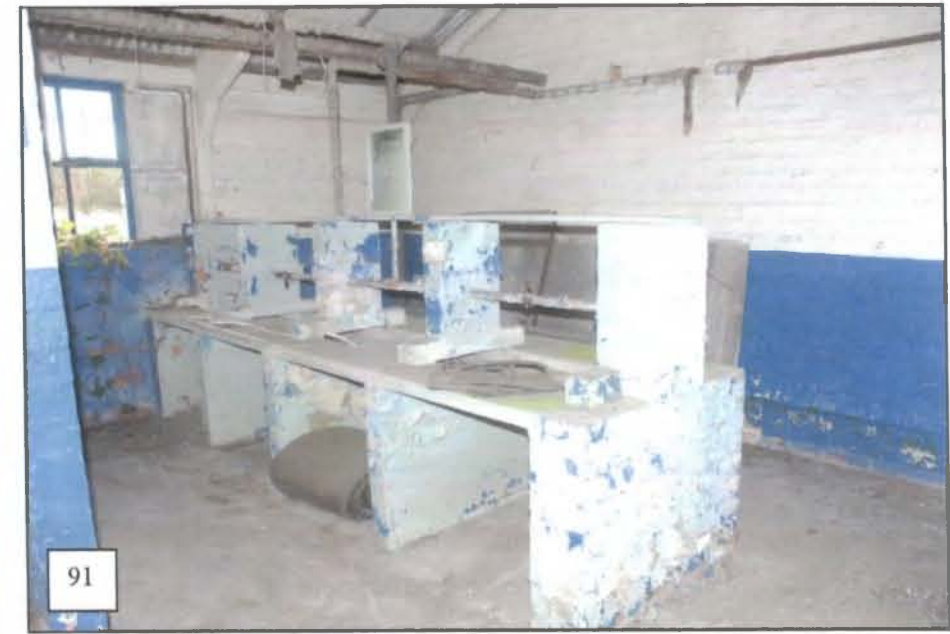
Hut G12

This hut was located immediately to the west of Hut G11, and comprised a MoWP type hut, oriented east-west, with a concrete frame of six bays, infilled with hollow bricks. It had three windows in both the north and south walls. The roof was of corrugated asbestos panels and the gable ventilators were of airbricks.

The eastern gable was dominated by an elevated water tank supported on 9" brick pillars, which also formed the flue for the adjacent boiler room. The eastern gable door was accessed between the walls of this structure.

The interior was divided into five rooms with conventional brick partition walls. As mentioned above, the southeast corner was occupied by a boiler room, with a coal hatch in the south wall.

The eastern part of the building was a large open room, with four shower cubicles built against the partition wall from the boiler room. Opposite the shower cubicles, a bench of timber slats was located on the north wall, supported on 9" brick piers. The western part of this area was dominated by a communal sink, composed of a central asbestos trough flanked with plain asbestos sheet drainers, supported on a mixture of 9" and 4" brick piers, which continued above the level of the sink to support the pipes for the taps and a central raised sheet asbestos shelf.

The western part of the hut was occupied with a row of toilet cubicles, which retained their ledged and diagonally braced 3½" chamfered plank doors, built against the western partition wall. In the northwest corner a urinal was present, while the room in the southwest corner of the hut was a drying room, occupied by a metal framework of drying rails which retained many of their heavy wire clothes hooks.

The wartime plan of the camp describes this building as the 'Guards' Ablution, Latrine and Drying Rm'.

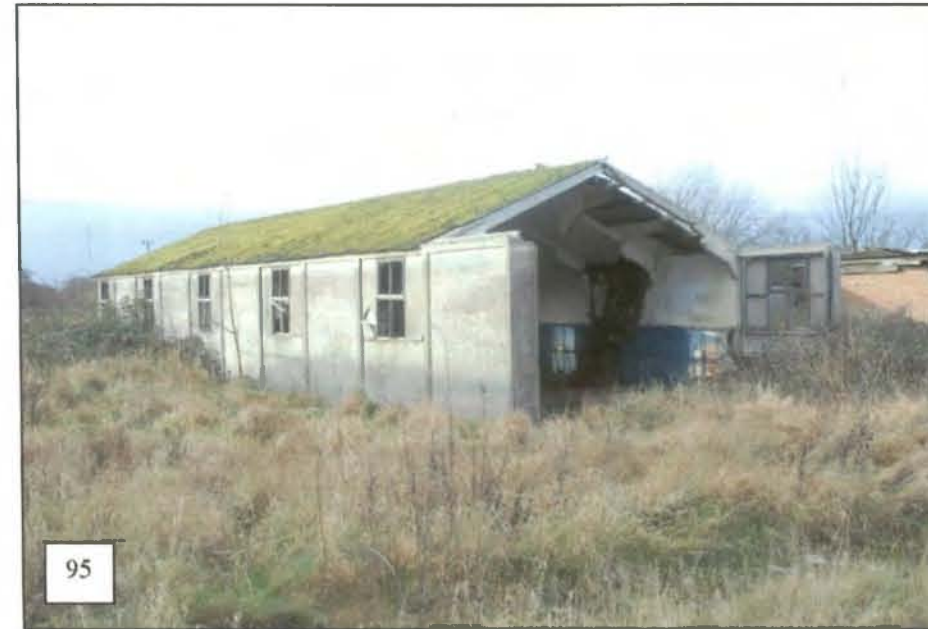
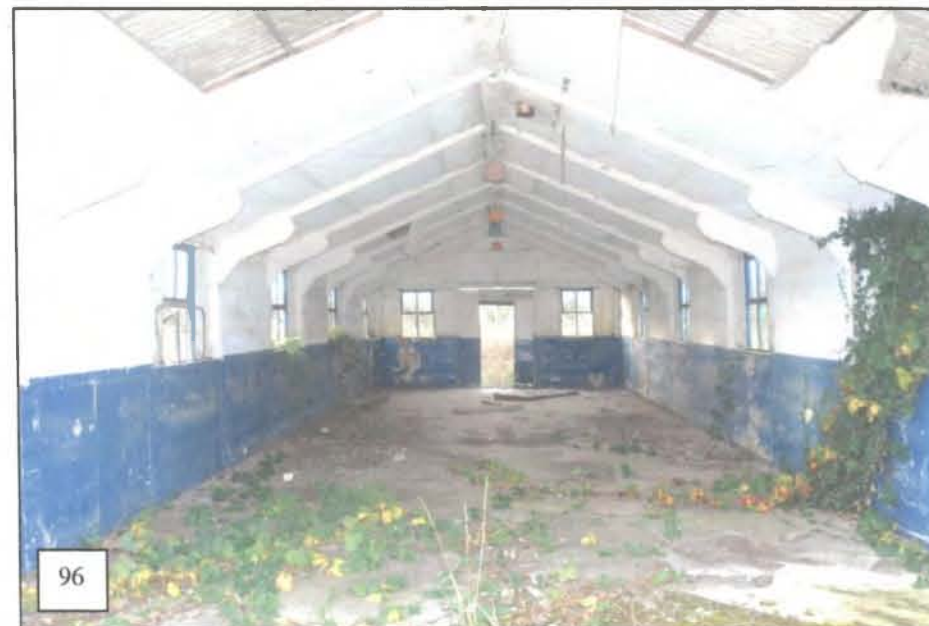
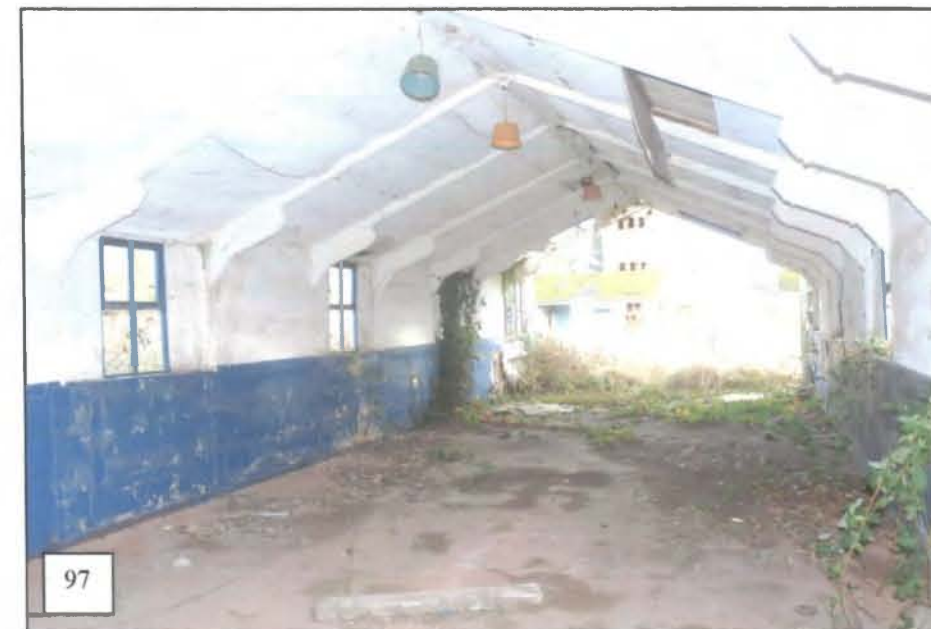
Hut G14

This building was located between Hut G9B to the north and Hut G15 to the south, close to the western perimeter of the camp. It comprised a MoWP type hut, oriented east-west, with a concrete frame of ten bays, infilled with pre-cast concrete panels. The roof and gables were of corrugated asbestos panels and the gable ventilators were of four slatted panels, covered by sheets of plain asbestos.

A single stovepipe exit was present to the north of the ridge in the fourth bay from the eastern gable. The eastern gable itself had been removed.

The wartime plan of the camp describes this building with Hut G15 to the south as the 'Guards' Living Huts'.

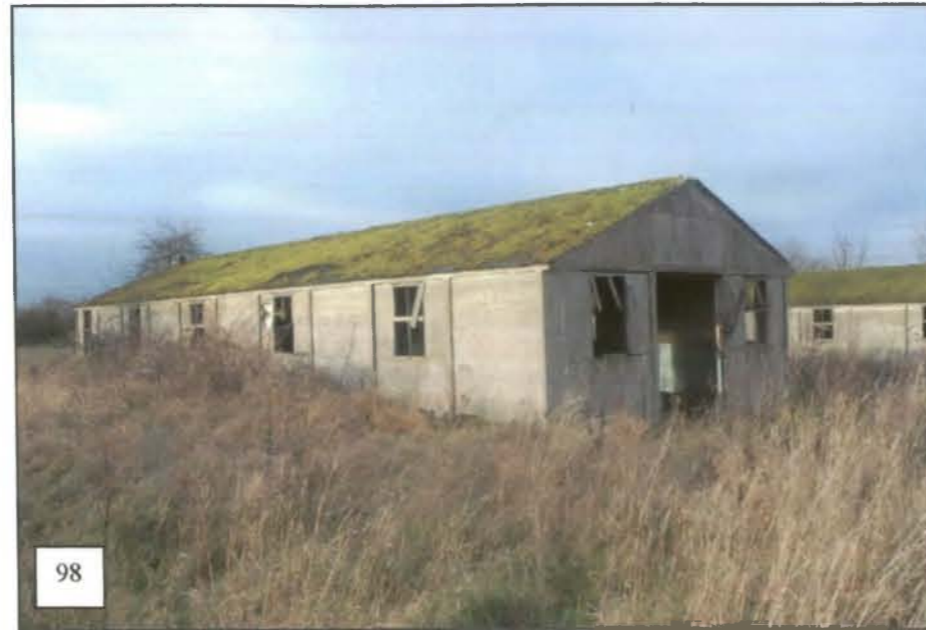
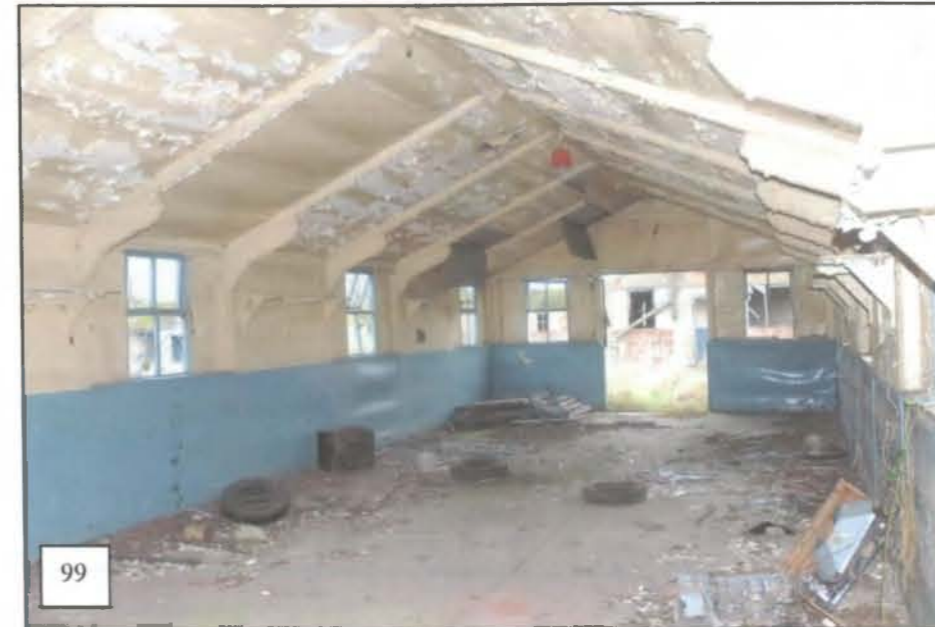
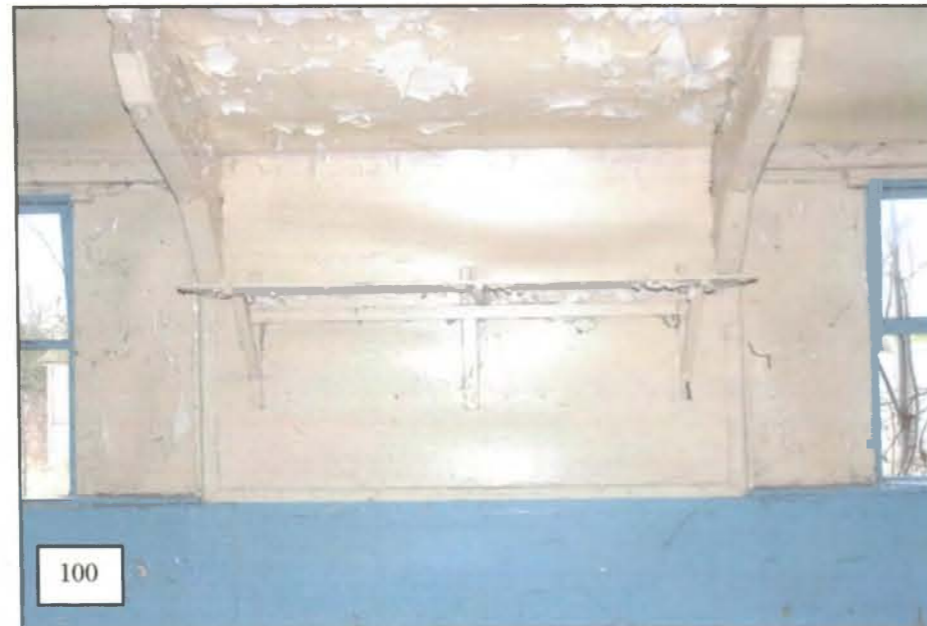
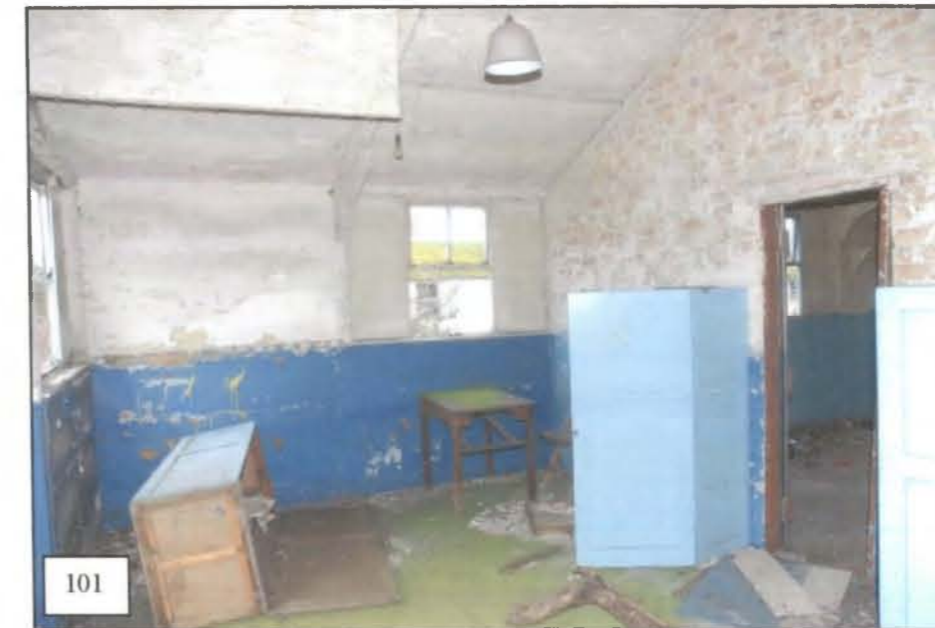
Hut G15

This building was located to the south of Hut G14, in the southwest corner of the guards' compound. It comprised a MoWP type hut, oriented east-west, with a concrete frame of ten bays, infilled with pre-cast concrete panels. The roof and gables were of corrugated asbestos panels and the gable ventilators were of four slatted panels, covered by sheets of plain asbestos.

The western two bays were separated from the rest of the hut with a 4" conventional brick partition wall with a central door opening which retained its original ledged and diagonally braced plank door. The main room was decorated in the lower light blue/upper white colour scheme, while the blue in the smaller room was darker.

In the main room, a single stovepipe exit was present to the north of the ridge in the fourth bay from the eastern gable.

A shelf was present between the windows on both sides of the main room, while the western room had a central stovepipe exit, and retained some furniture, including two lockers which may have been original.

The wartime plan of the camp describes this building with Hut G14 to the north as the 'Guards' Living Huts'. It seems likely that the smaller room in this hut housed one or two NCOs.

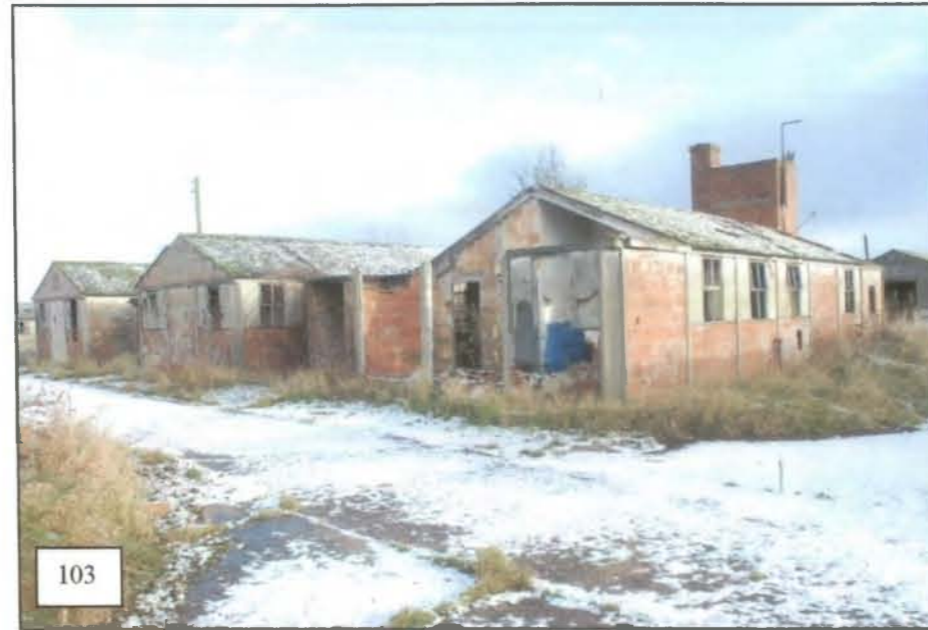
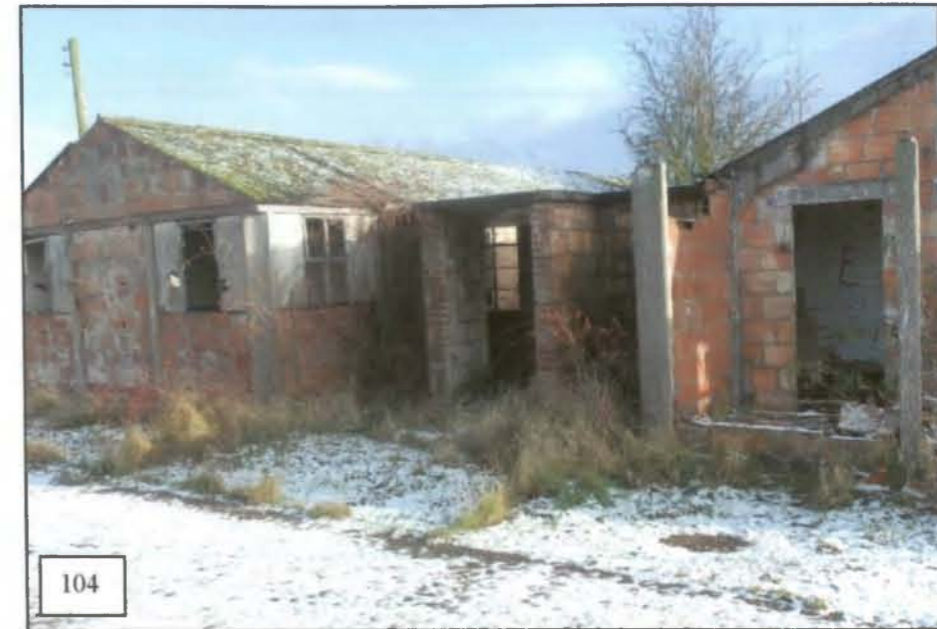
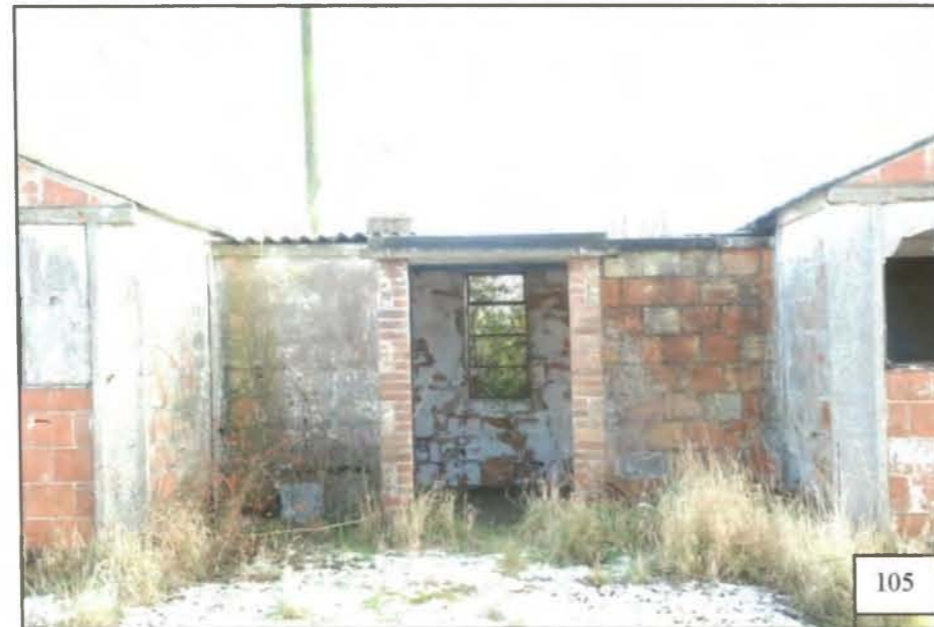
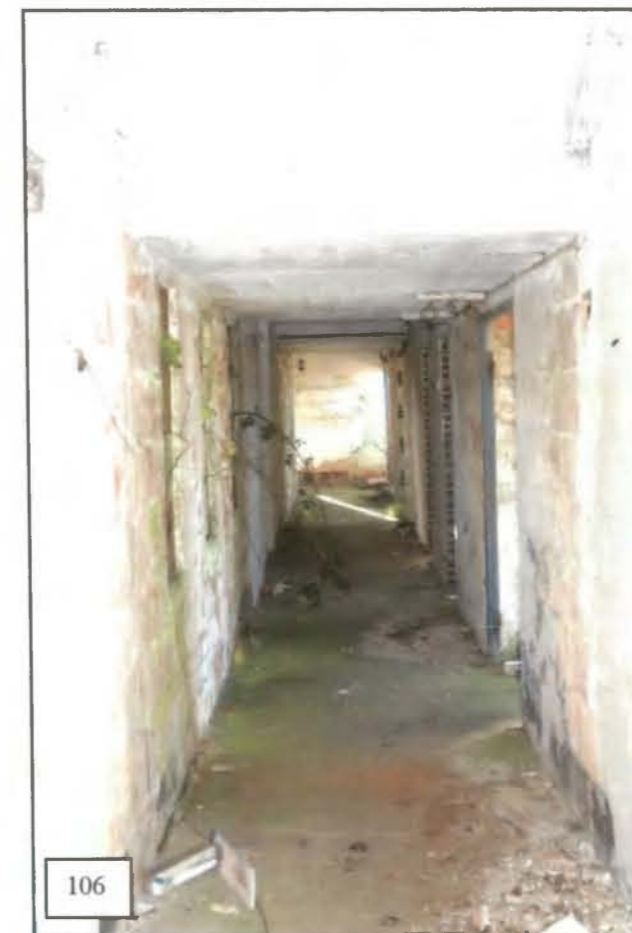
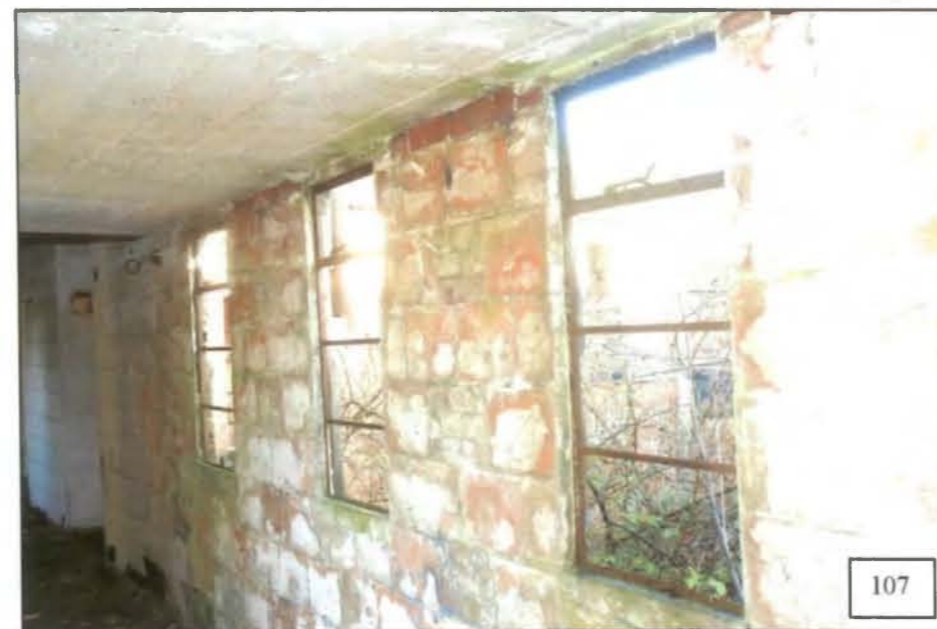
Complex P10 – Camp Reception Station (CRS)

This complex of buildings comprised three MoWP huts joined by a brick-built corridor. It occupied the northernmost block of three huts, to the east of the central spine road. It functioned as the camp medical facility.

The linking corridor was constructed of hollow bricks, with a shallow single-pitched roof of corrugated asbestos panels. It comprised two sections, the northern one linking Huts P10a and P10b, while the southern one connected Huts P10b and P10c. Each of these sections had a central porch, of conventional bricks, with a flat concrete roof.

Within each of these porch structures, a pair of double doors (no longer extant) gave access to the linking corridor. On the opposite side of the corridor, a group of three metal-framed four-light windows, the uppermost a top-hung casement, lit the corridor.
