PINGLEY CAMP, BRIGG, LINCOLNSHIRE

PHOTOGRAPHIC BUILDING SURVEY

Report prepared for Barford Builders by S. A. Savage

Site Code: PPCB 08
Planning ref: 119946
NGR: TA 0178 0680
LCNCC acc. no. 2008.189
PCA job no.:08-515

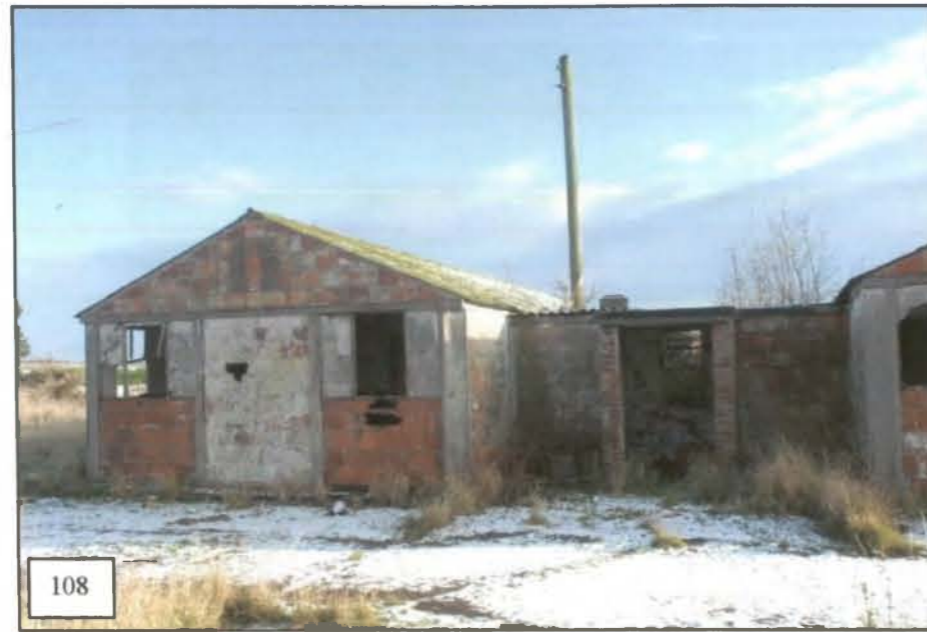
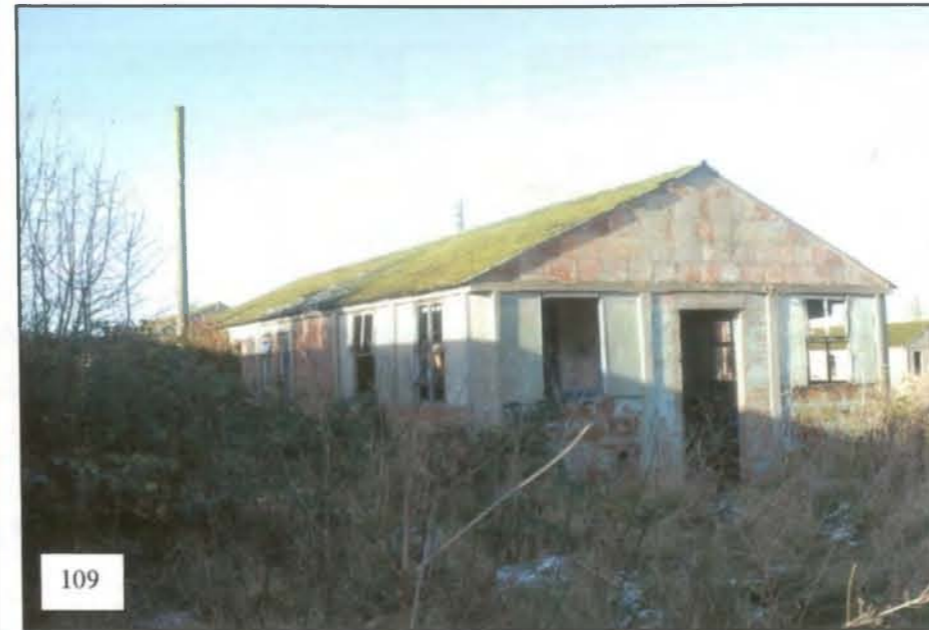
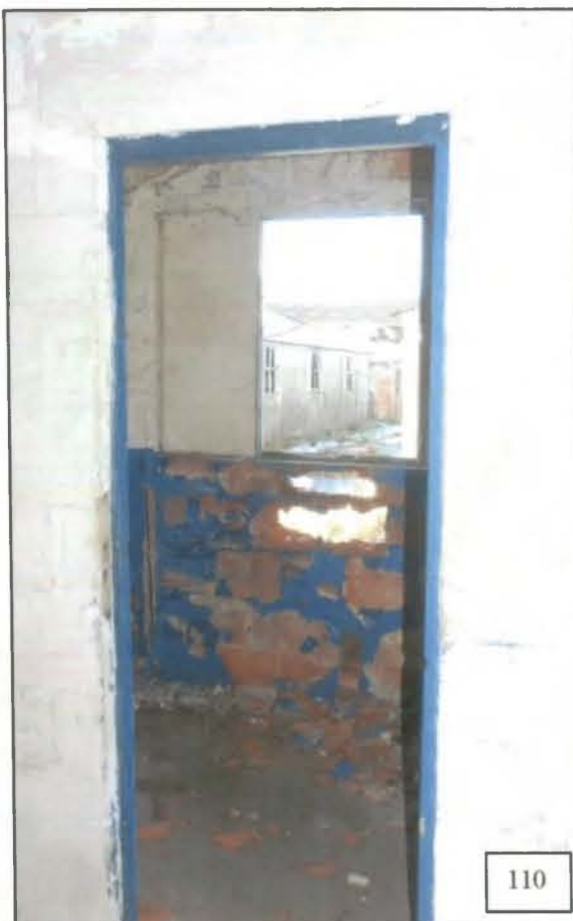
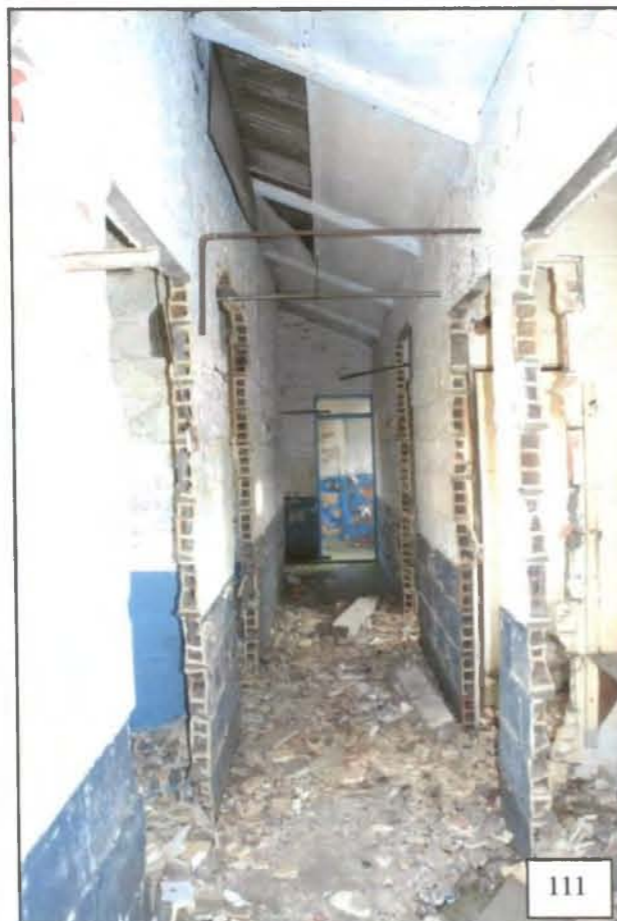
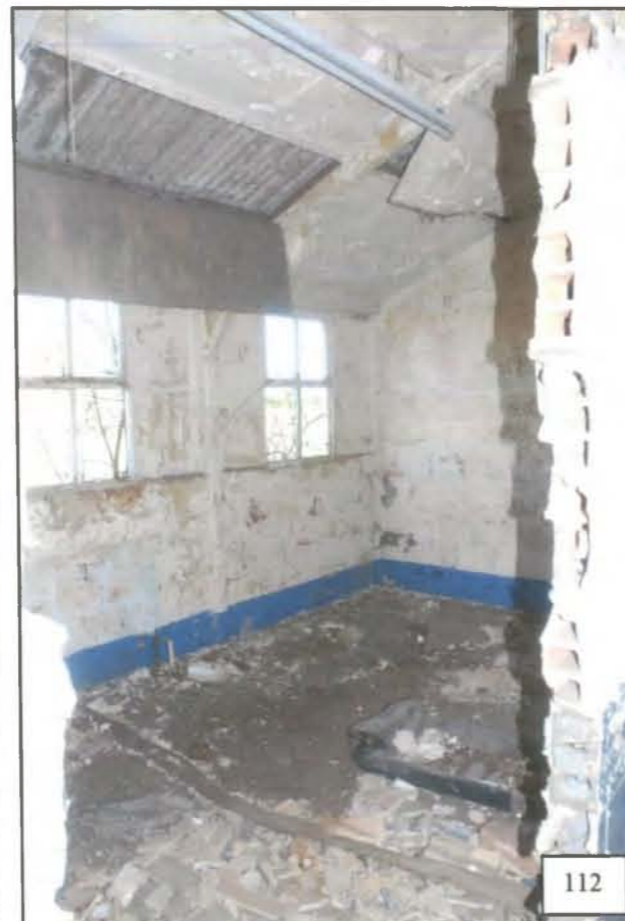
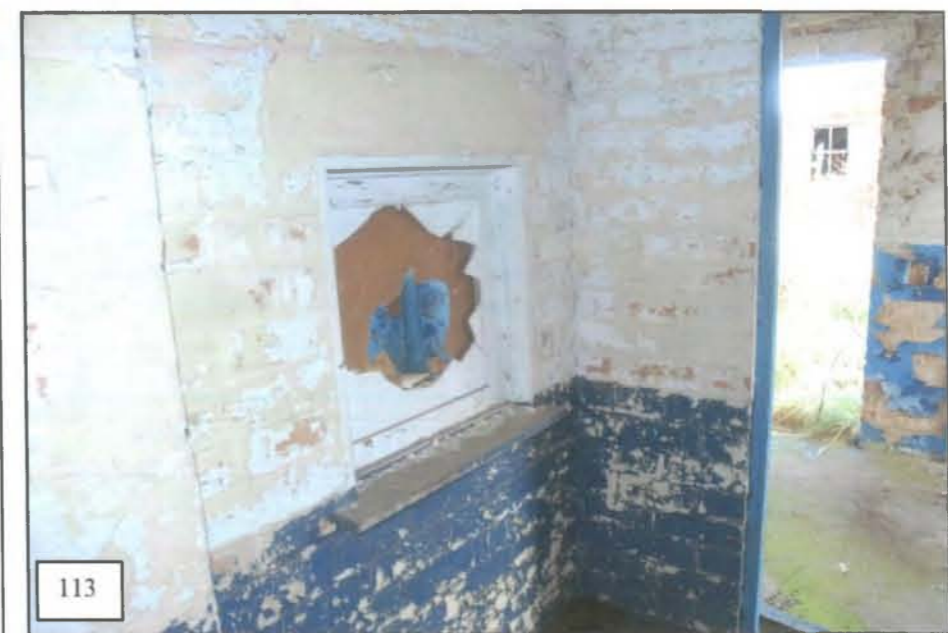
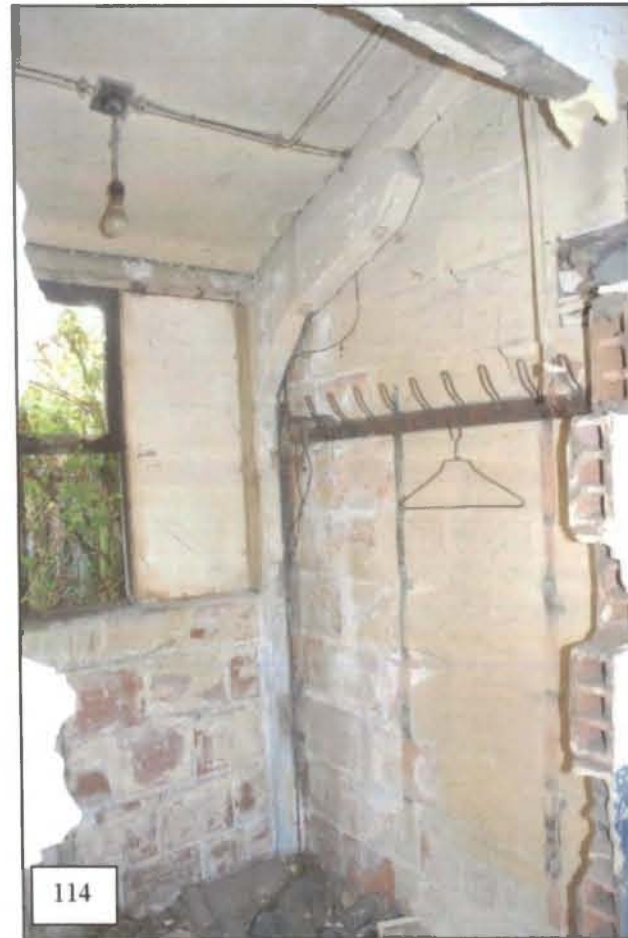
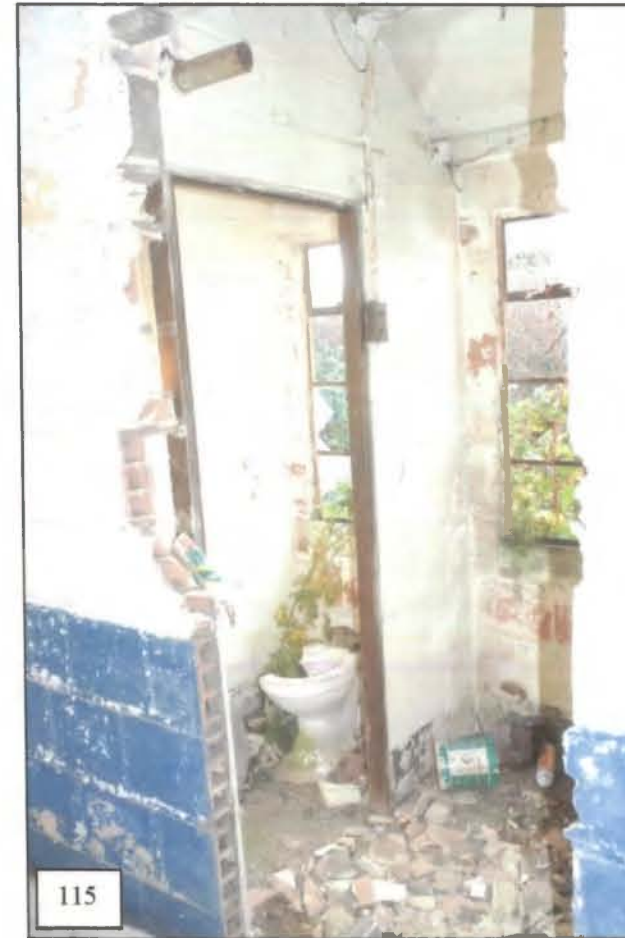
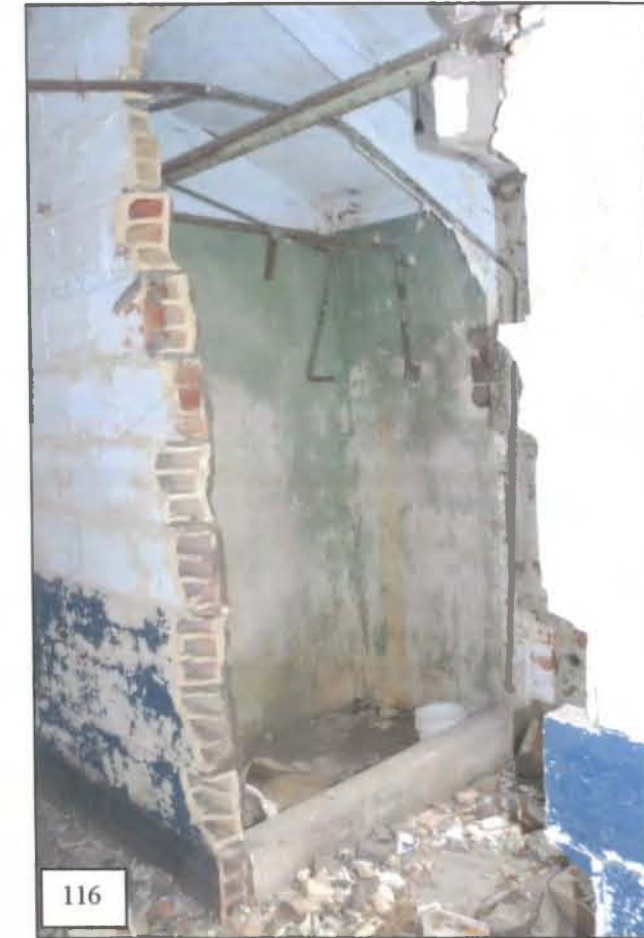
This was the northernmost of the three interlinked huts. It comprised a MoWP type hut, with a concrete frame of seven bays, infilled with hollow bricks. The gable ventilators were airbricks.

The interior was divided into nine rooms with hollow brick partition walls. The building had been stripped, and the function of the rooms was in many cases not immediately apparent. However, this building was visited in 2006 by Roger Thomas of English Heritage and at this time, the rooms retained their doors on which their function was written in Italian.

The southern room in the west gable was the orderly room, while the room to the north was the medical officer's office. Working east down the north side of the corridor, this was followed by the medical officer's store and the dental surgery. The large room occupying the eastern gable was the medical orderly's quarters. This had a hatch into the corridor, and so probably doubled as a dispensary.

The rooms along the south side of the corridor in Hut P10A were (from east to west) a shower room, a lavatory and a store.

The rooms throughout the CRS were decorated with the lower parts of the walls mid or dark blue; in the dental surgery this was only a band 20" high, and the upper walls were white.

Although this hut had conventional four-pane timber-framed windows, metal-framed windows were present in the third and fourth bays from the west in both the north and south walls.

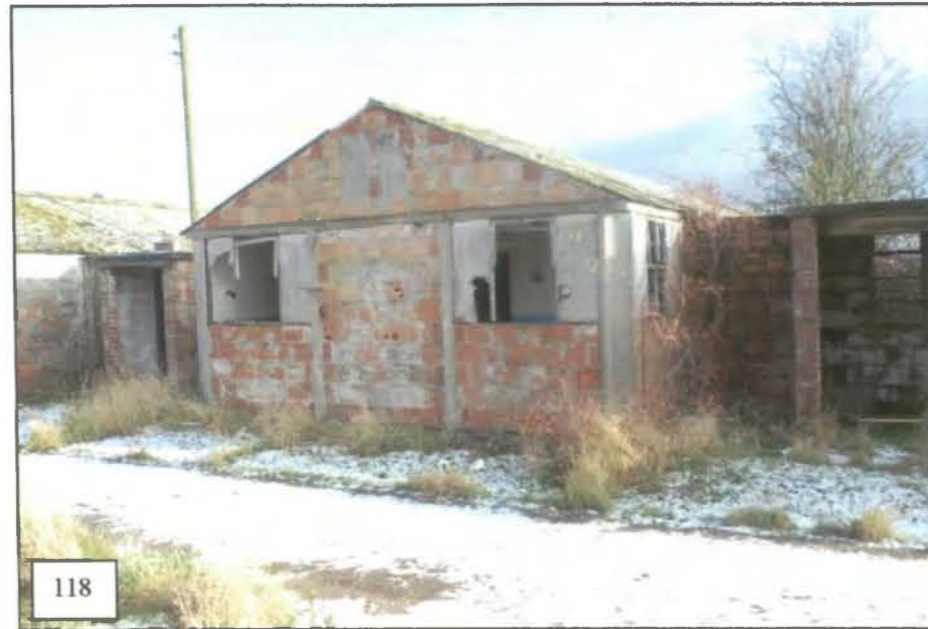
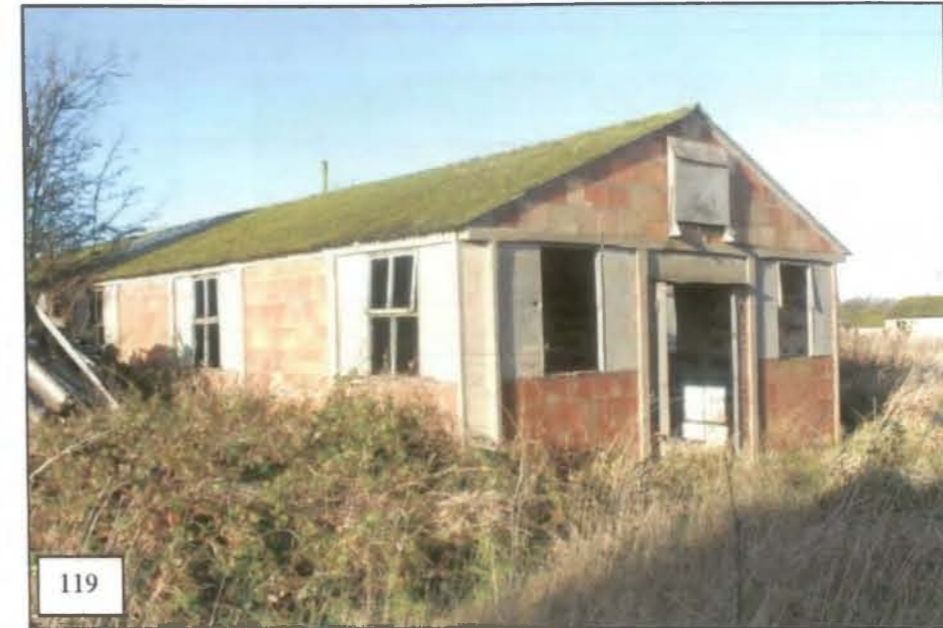
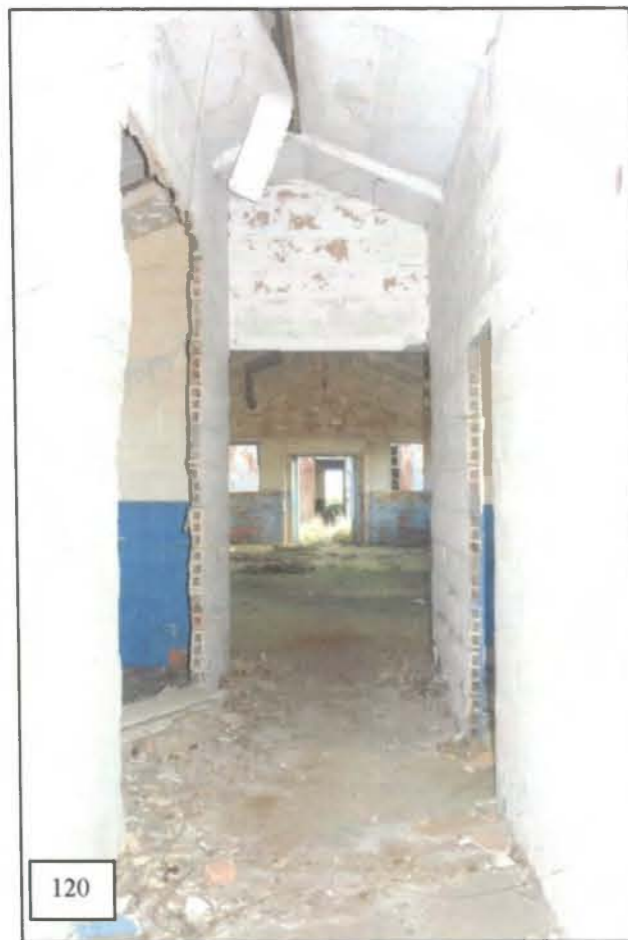
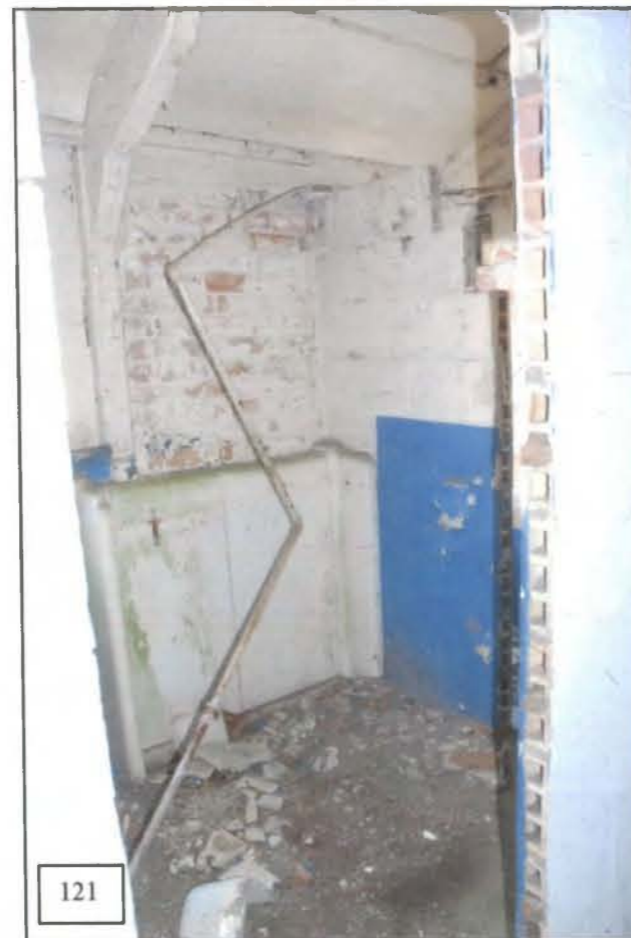
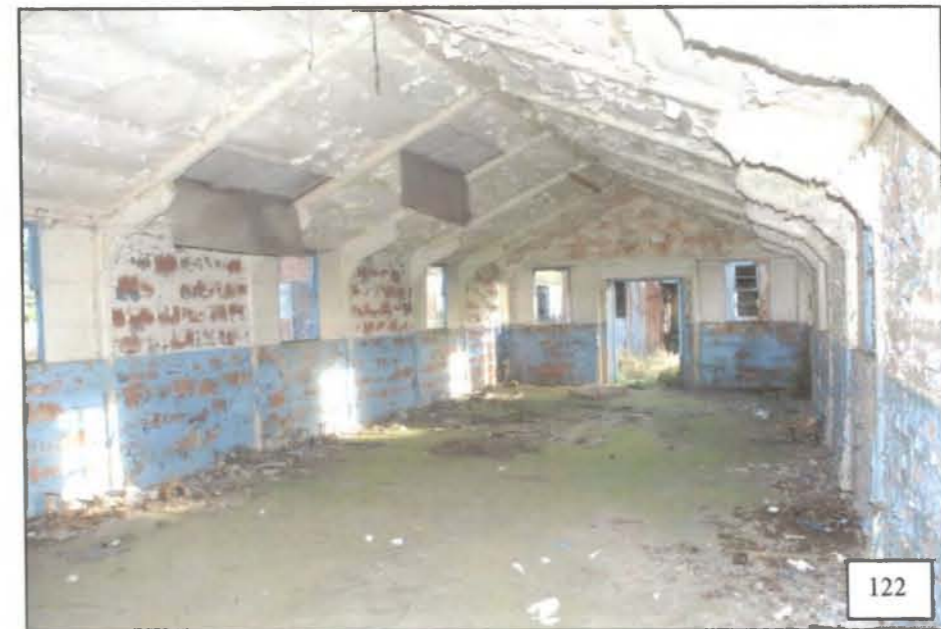
This was the central of the three interlinked huts. It again comprised a MoWP type hut, with a concrete frame of twelve bays, infilled with hollow bricks. The gable ventilators were airbricks.

The northern of the two rooms in the west gable was a bathroom; the southern room's function was unclear. To the east of the linking corridor, a central corridor led east past an isolation ward to the north and a patients' lavatory to the south. The eastern 7½ bays of this hut comprised the main ward of the medical centre.

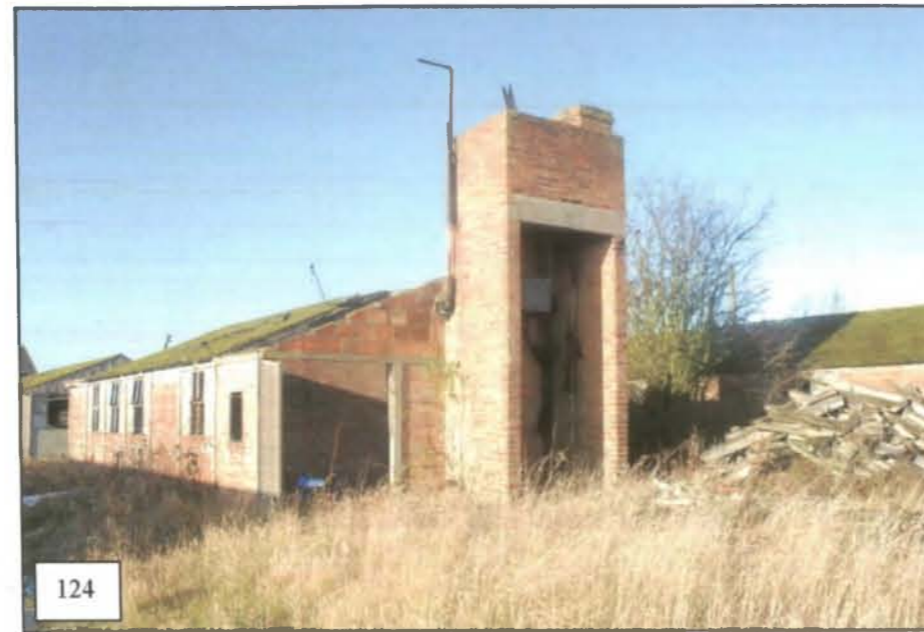
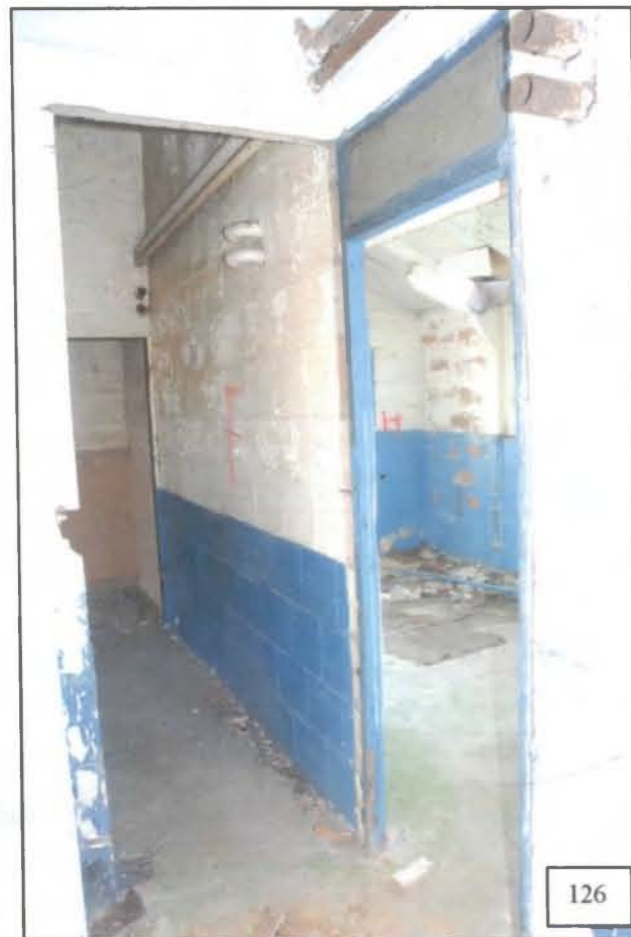
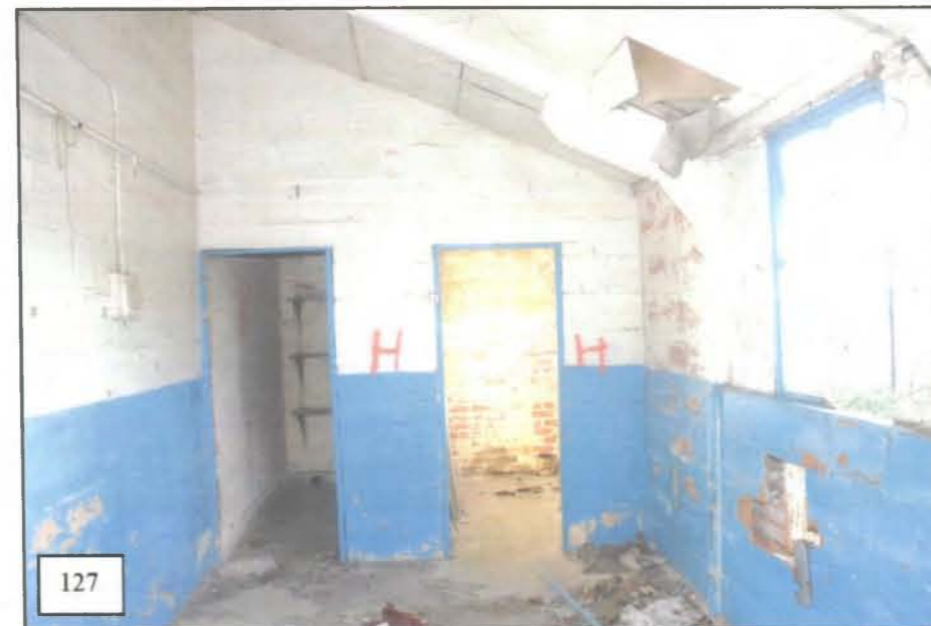
Building P10C

This was the southern of the three interlinked huts. It comprised a MoWP type hut, with a concrete frame of seven bays, infilled with hollow bricks. The gable ventilators were airbricks.

The western two bays of this hut were occupied by the boiler room, which had an elevated water tank/chimney structure at the east end.

The southern of the two rooms in the west gable was the medical officer's quarters, while the northern room had collapsed. The room occupying the remainder of the south side of the hut was the kitchen, with storage rooms at the east end. On the north side, the medical officer's lavatory was present, followed by a room labelled 'sluice', beyond which a door in the north wall gave exterior access.

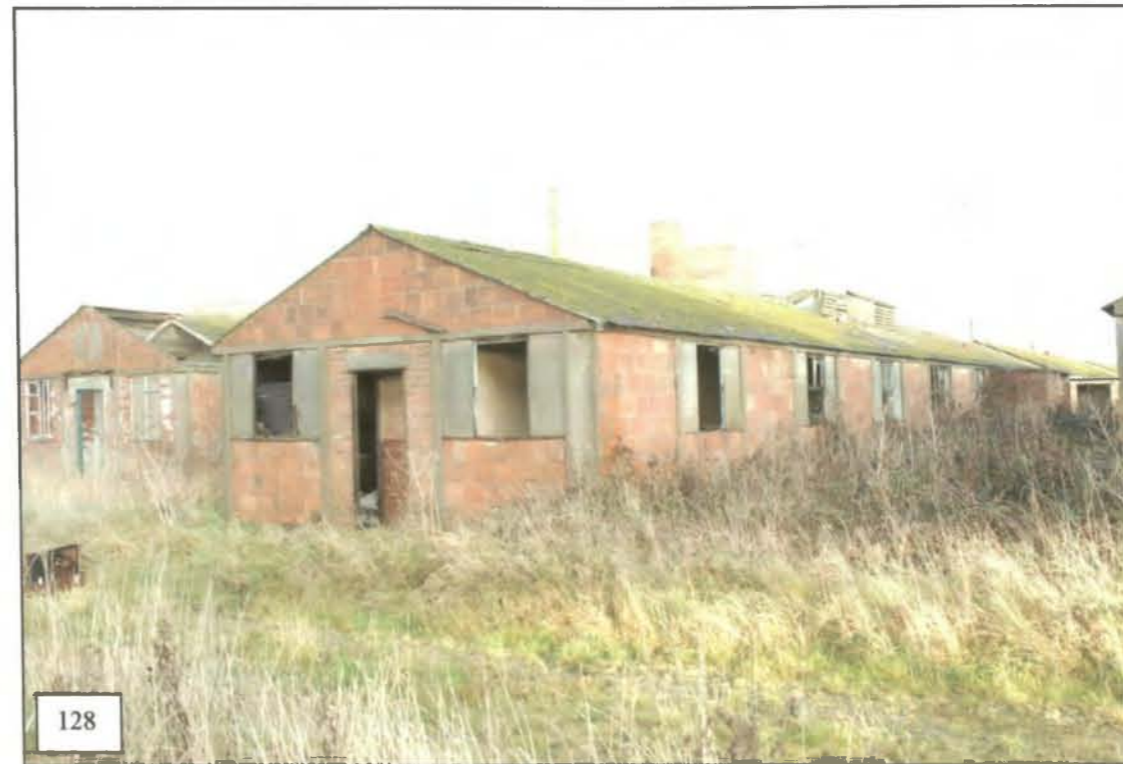
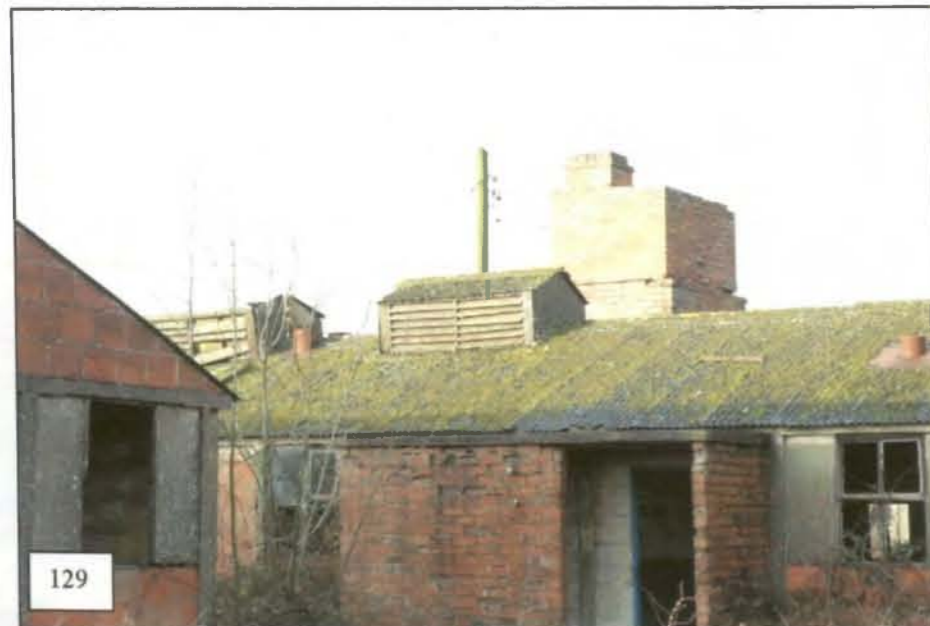
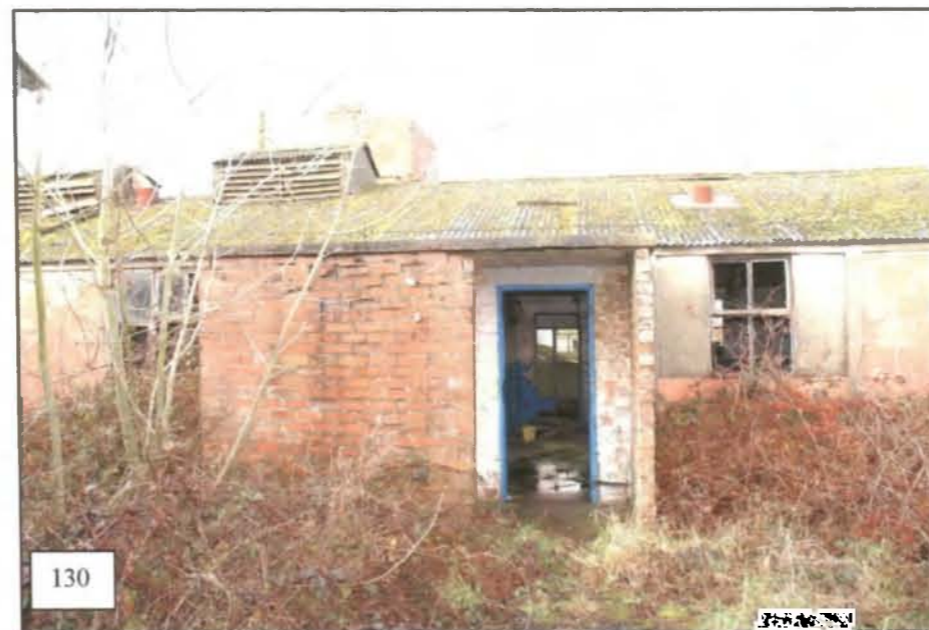
Hut P32 was a MoWP type hut, on an east-west alignment with a concrete frame of fourteen bays, infilled with hollow bricks. The gable ventilators were airbricks, but these were supplemented by slatted timber clerestories.

The main entrance to Hut P32 was at the eastern end of the southern wall of the building where an exterior porch of conventional 4" brick with a flat concrete roof gave access through two doors either into the easternmost room, where food was probably served, or the central room, where the cooking took place.

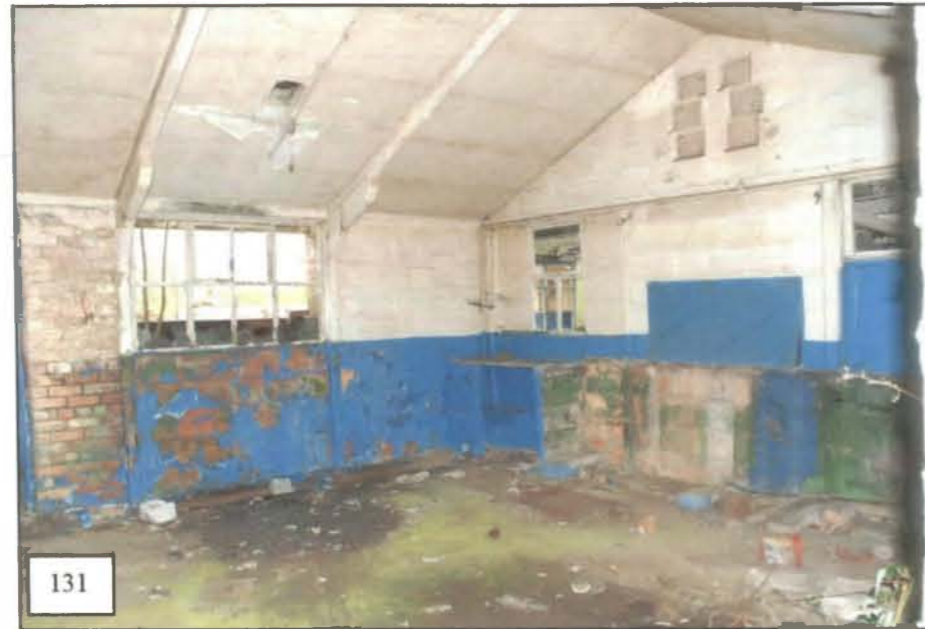
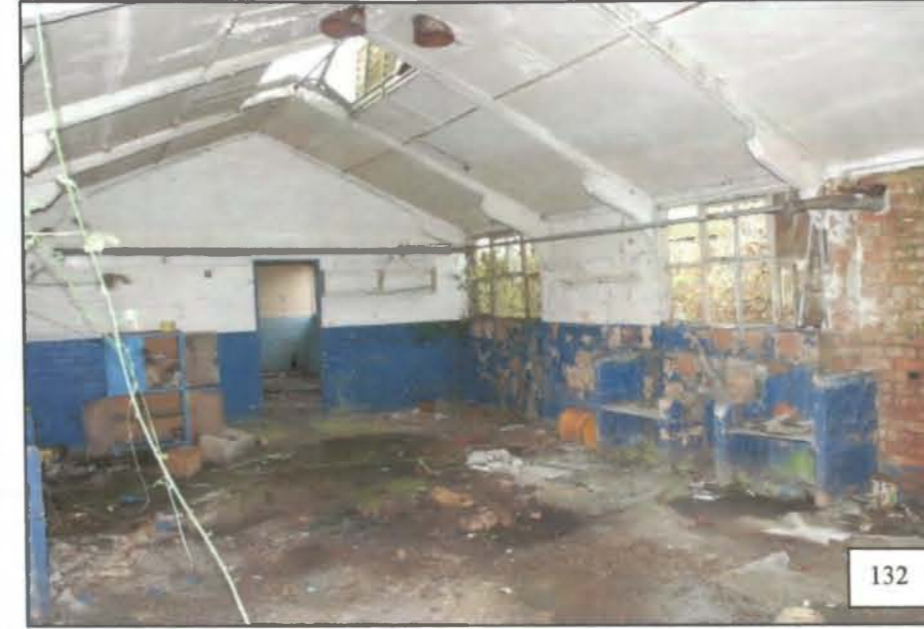
The easternmost room of Hut P32 occupied the eastern three bays of the building and was probably where food was served during the wartime period. It has since been extensively altered: the central panel of the gable has been blocked and a serving hatch installed, while a further serving hatch has been inserted in the lower part of the southern gable window. The window on the north side is of eight lights, and a door opposite the one in the south wall gave further access.

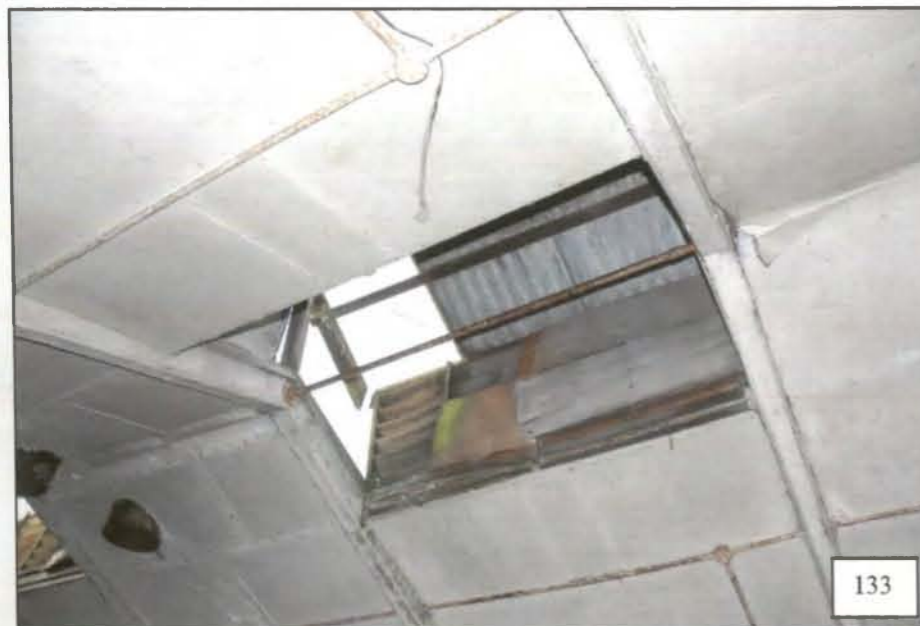
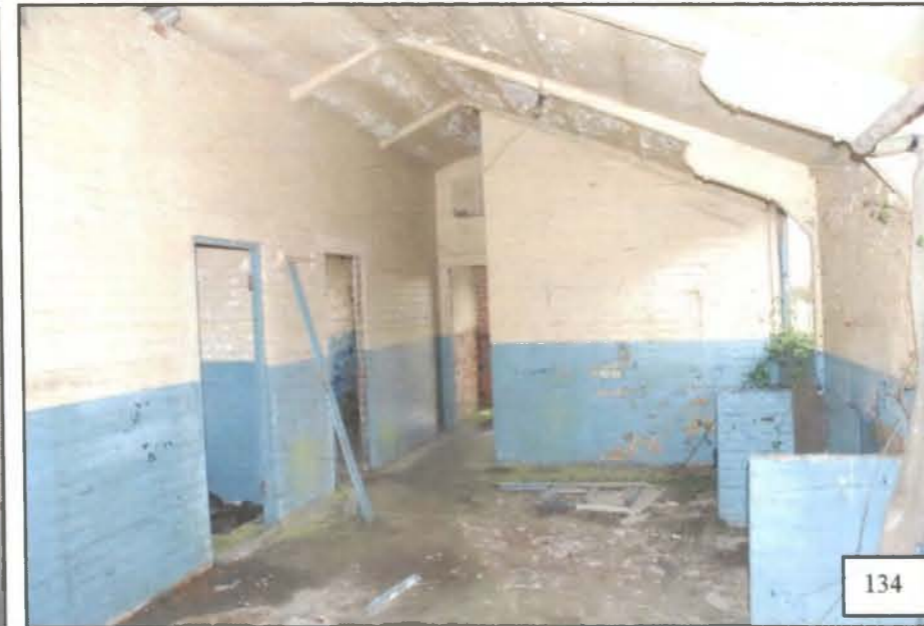
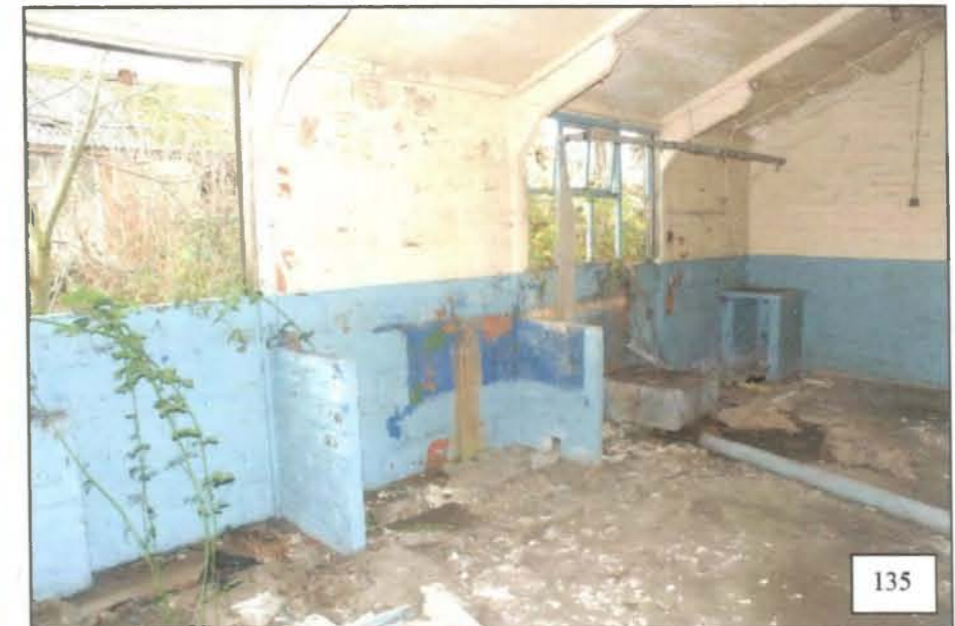
The central five bays of this hut comprised the kitchen itself, where a large pile of rust in the middle of the floor coupled with two large stovepipes in the roof (between the clerestory ventilators) gave evidence for the location of the cookers. This room also had eight-light windows, on both north and south sides, in front of which brick supports and drainage gullies in the floor attest to the presence of at least two sinks on each side.

The western five bays of this hut were divided into four rooms; in the northwest corner a coal store and boiler room were present, while the two rooms along the south side appeared to represent storage, as the scars from shelving were evident on the walls. The larger room had two eight-light windows in the north wall, and similar evidence to that seen in the central room for sinks was also present here. The central and eastern rooms of the building were decorated with dark blue lower/white upper walls, while in the western rooms, the blue was a lighter shade.

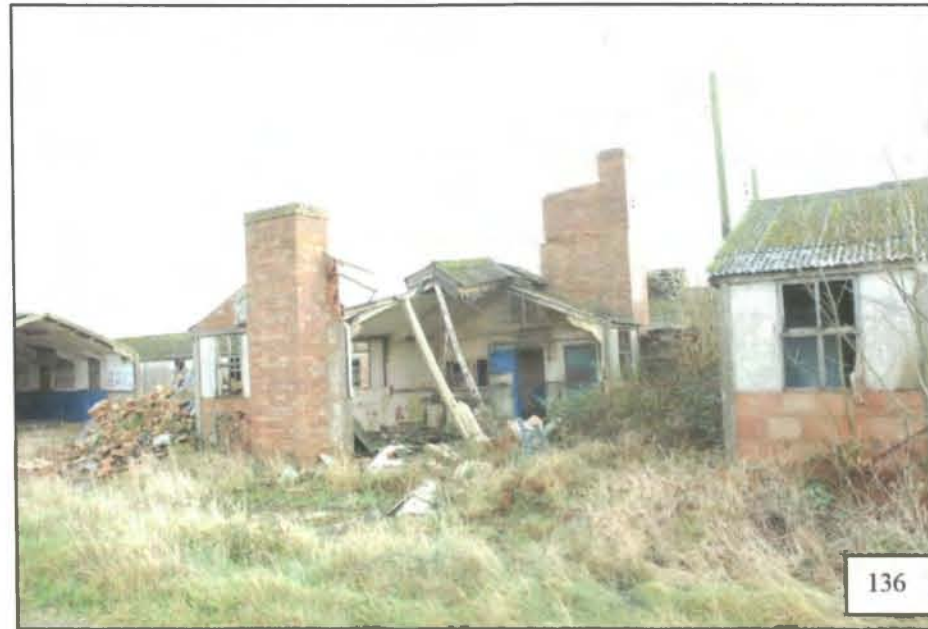
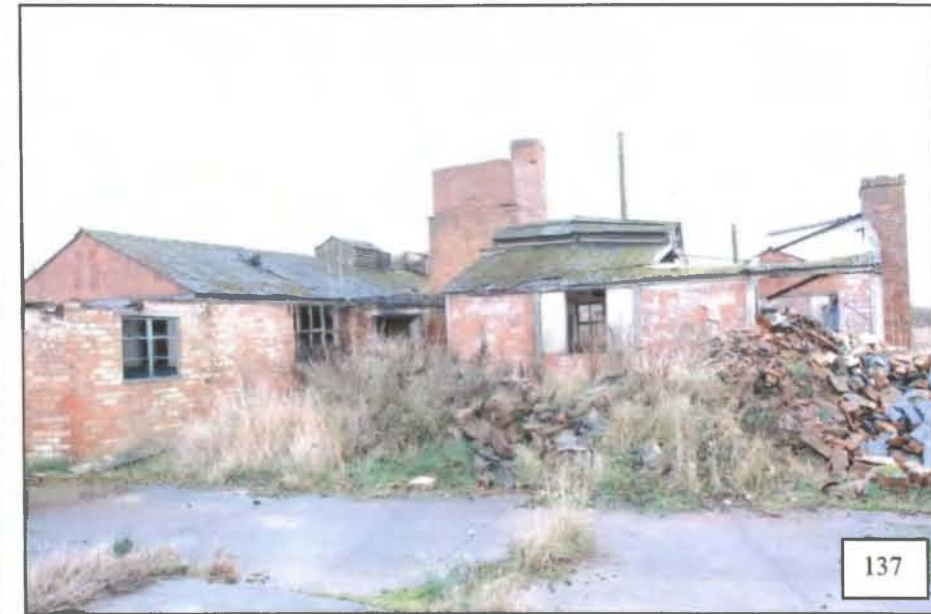
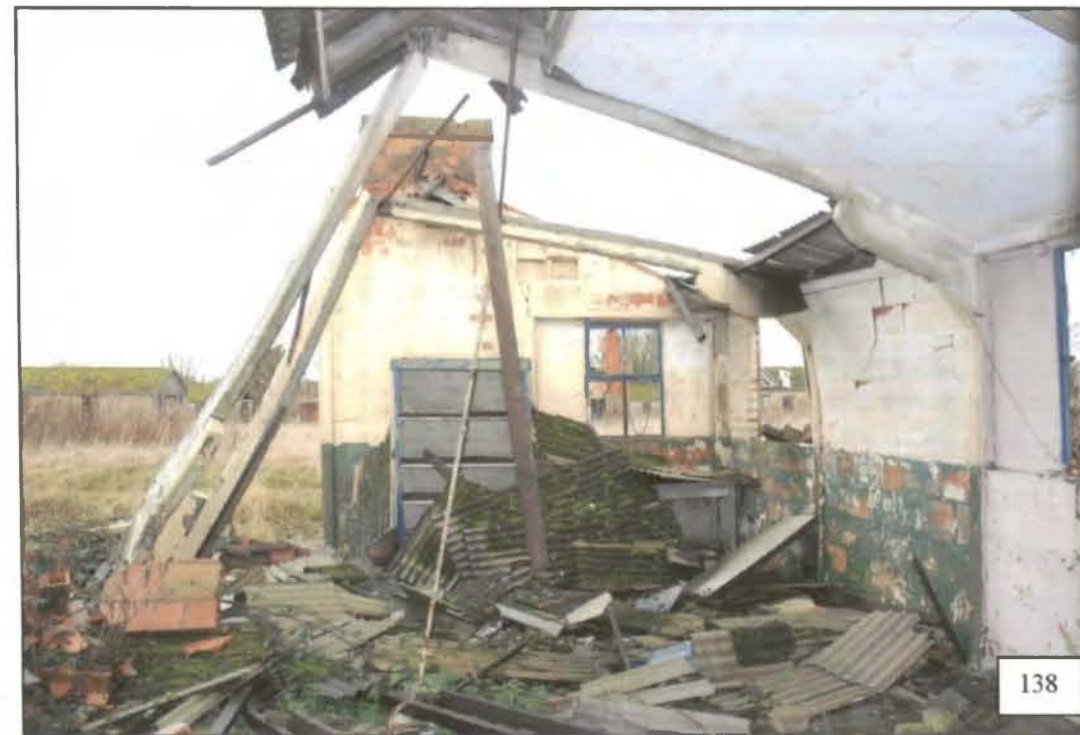
Hut P34 – cookhouse extension.

This hut probably represented the bakery part of the cookhouse, attested by the large chimney in the northern gable; however, it had almost completely collapsed. It comprised a MoWP type hut, on a north-south alignment with a concrete frame of four bays, infilled with hollow bricks. The gable ventilators were airbricks: three on each side of the chimney stack.

The roof was of asbestos panels and had a clerestory ventilator which ran the length of the building.

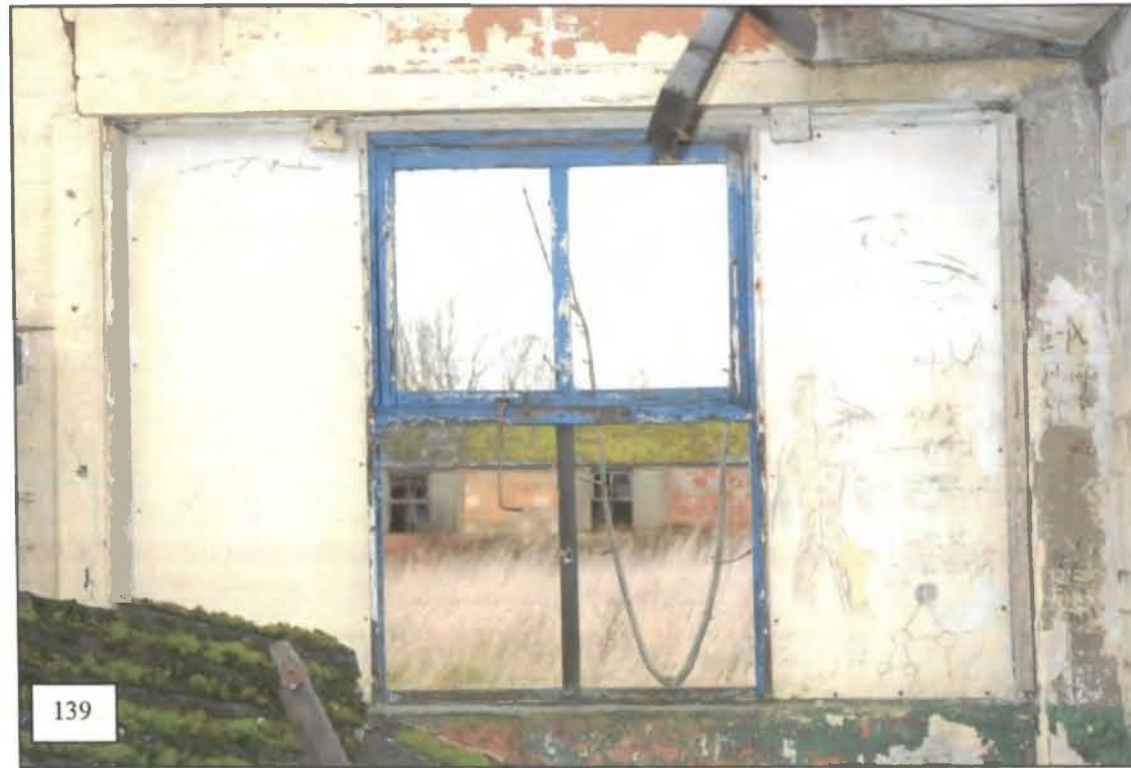
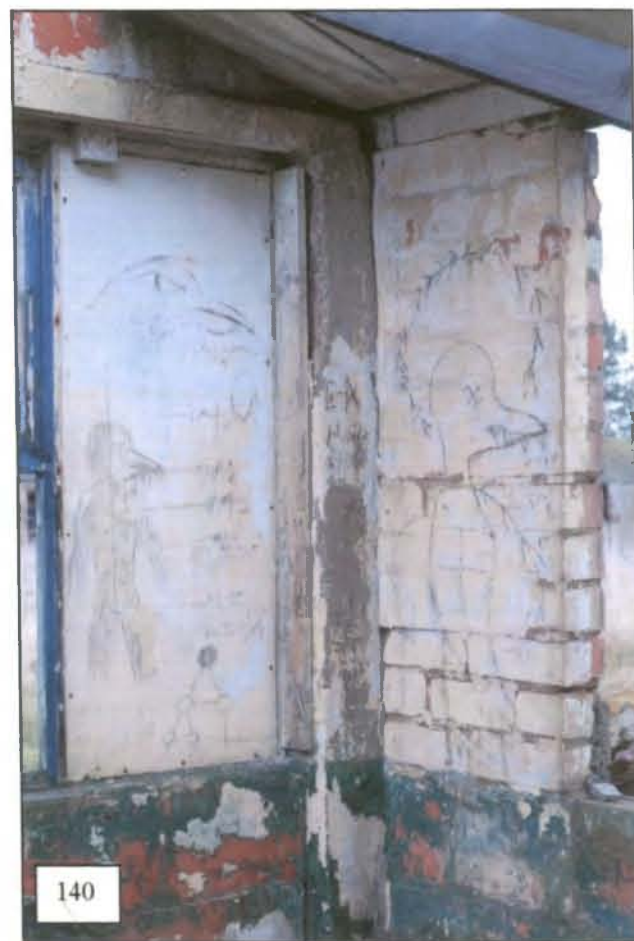
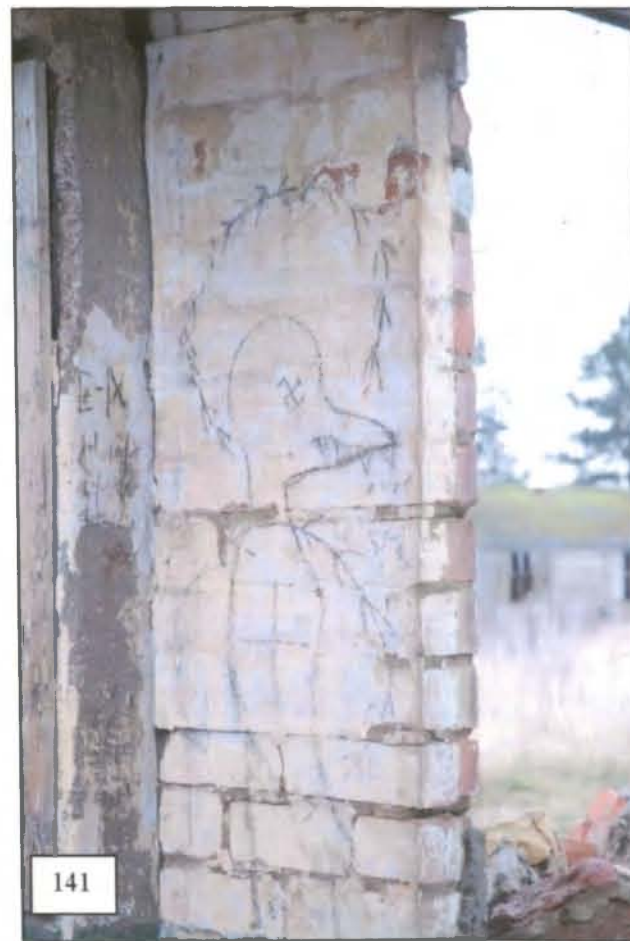
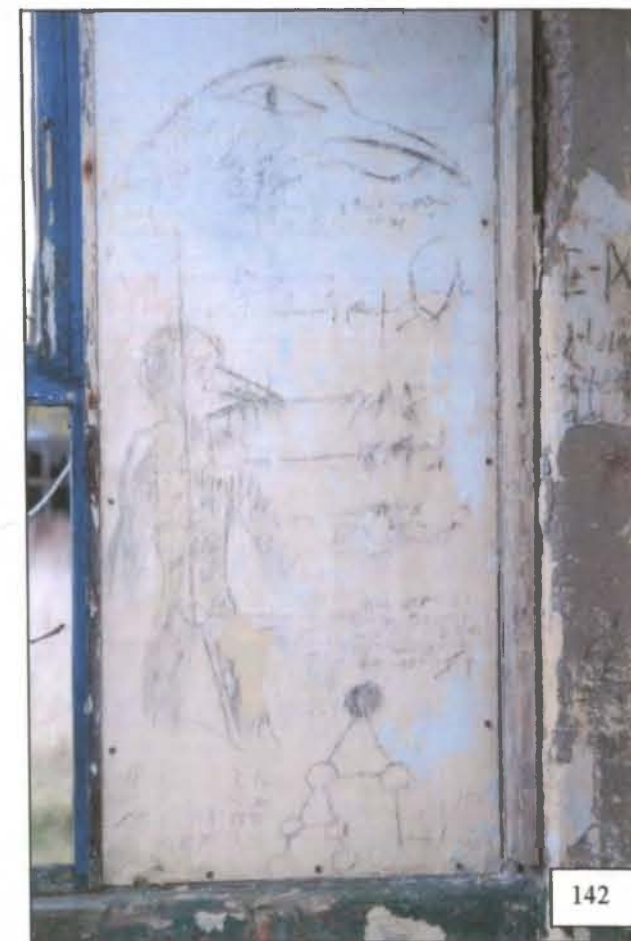
This building had been decorated with dark green lower walls and white upper walls, although the window frames were painted mid-blue.

Two examples of graffiti were evident in the northeast corner of the structure. Both of the panels flanking the east window in the north gable had graffiti, but only the eastern panel could be clearly made out. Graffiti here comprised a large bird head, a figure, geometric shapes and some indecipherable writing.

Further graffiti was evident on the brick panel to the north of the northern window in the east side. This comprised a further bird-like figure with a swastika and some writing on the concrete frame separating the two panels. The graffiti appears to have been executed in a very soft pencil or crayon. It is highly unlikely that this represents art from the wartime period, as the brick infill panel is a later repair to the structure; also, the swastika is not the Nazi-style reversed swastika, but a clockwise-rotating 'fylfot' type, indicating that the artist was ignorant of the difference.
