PINGLEY CAMP, BRIGG, LINCOLNSHIRE

PHOTOGRAPHIC BUILDING SURVEY

Report prepared for Barford Builders by S. A. Savage

Site Code: PPCB 08
Planning ref: 119946
NGR: TA 0178 0680
LCNCC acc. no. 2008.189
PCA job no.:08-515

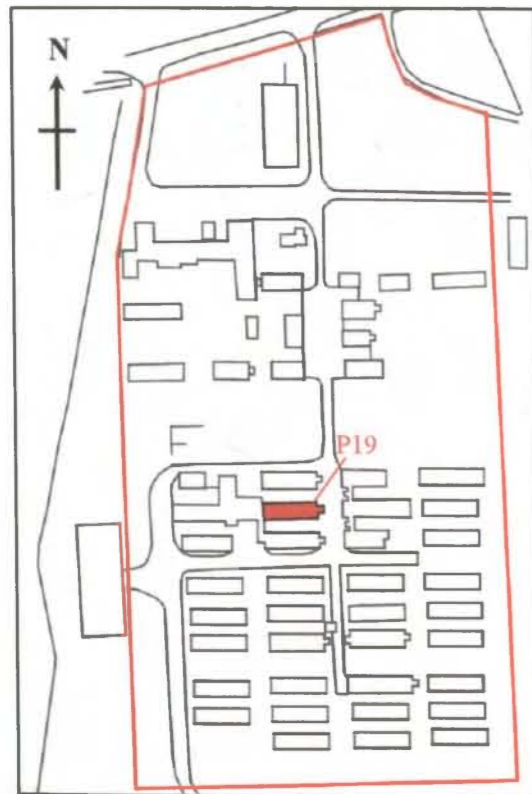
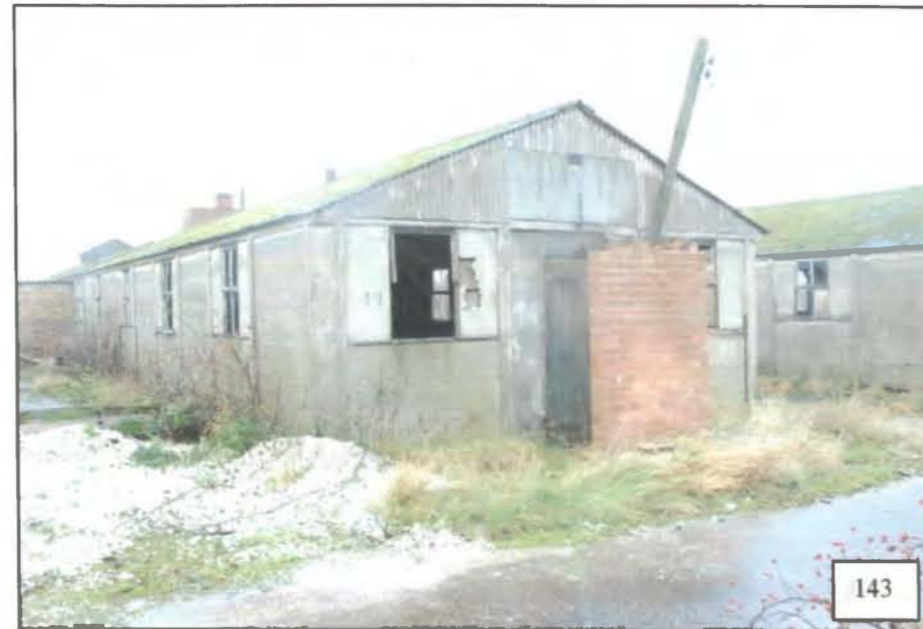
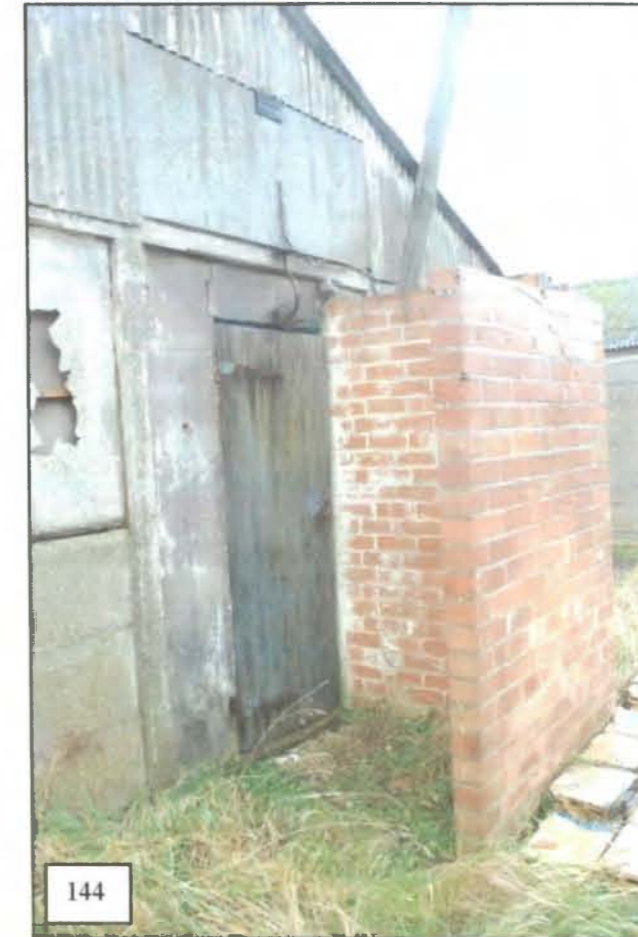
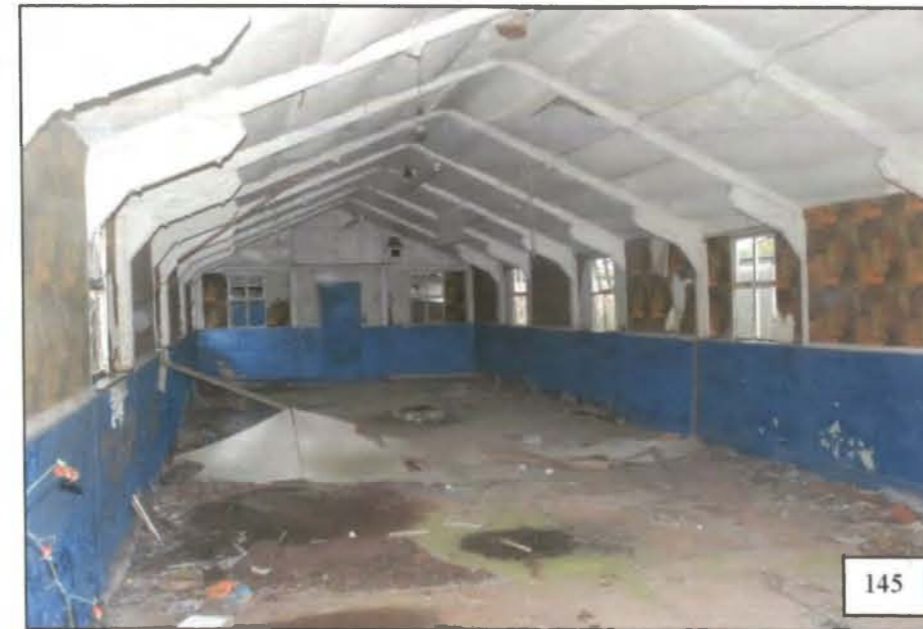
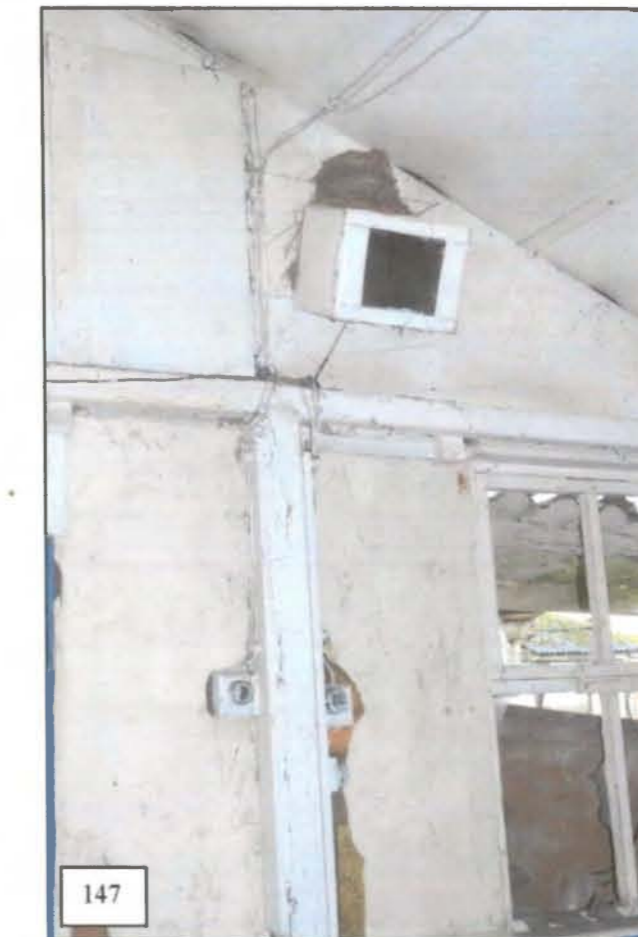
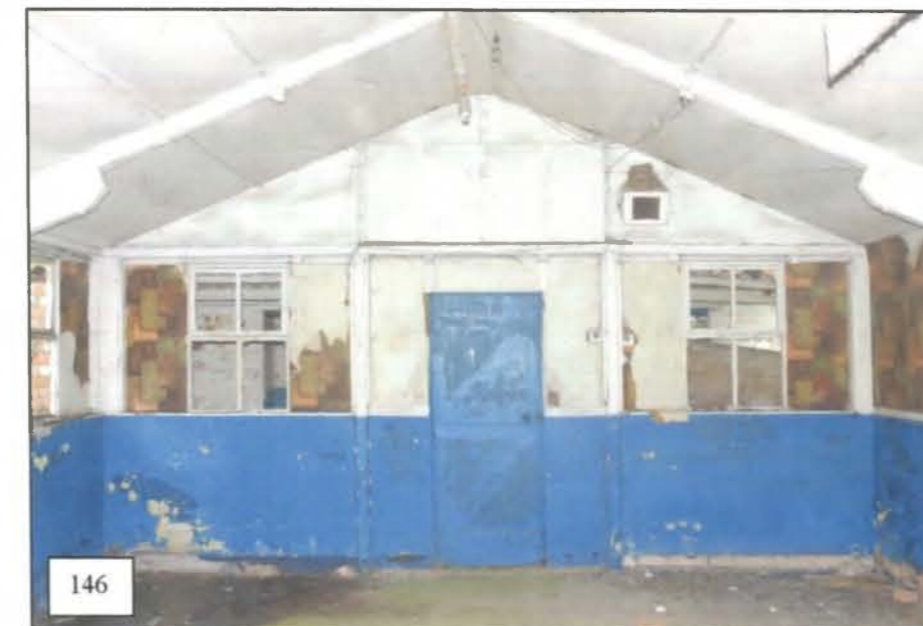
Hut P19 – Dining Hut

This building was located immediately to the east of the cookhouse (Hut P32), and comprised a MoWP type hut, oriented east-west, with a concrete frame of ten bays, infilled with pre-cast concrete panels. The roof and gables were of corrugated asbestos panels and the gable ventilators were of four slatted panels, covered by sheets of plain asbestos. It had a brick porch structure at its east end and retained its exterior doors.

The interior of this hut was a single room, decorated below windowsill level in dark blue, and white above. The walls above sill level had been wallpapered in a brown 1970s style paper. Stovepipe exits were present in the roof to the north of the ridge in the fourth bay from the west and to the south of the ridge in the fourth bay from the east. A radio speaker was also present on the western gable wall.

This hut was recorded on the wartime plan as a 'dining hut', which purpose it appears to have served until the end of the 'Concordia' period, when the camp accommodated foreign students.

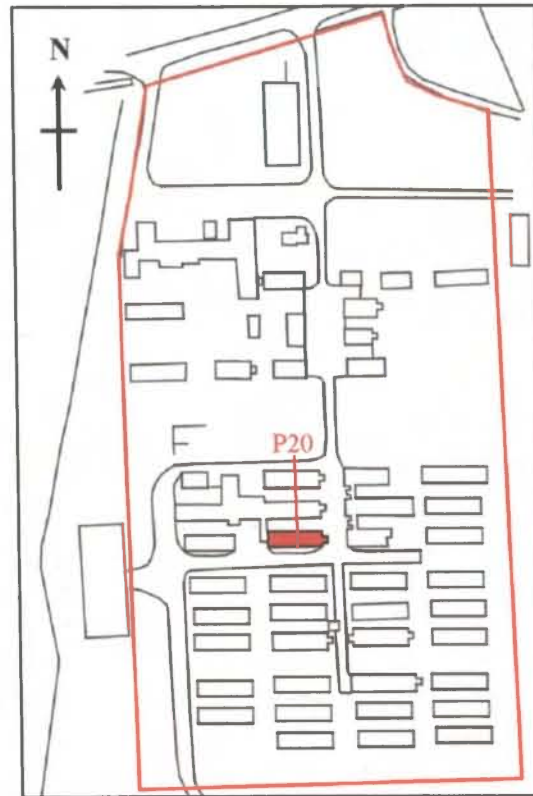
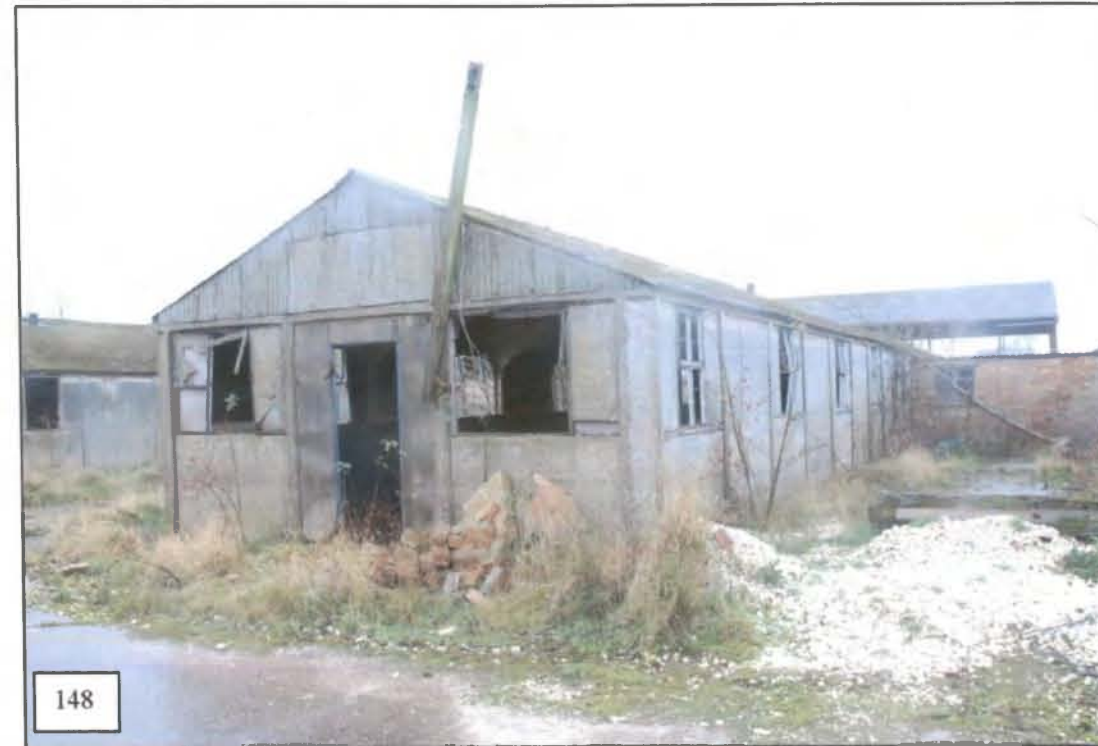
Hut P20 – Dining Hut

This building was located immediately to the south of dining hut P19. It comprised a MoWP type hut, oriented east-west, with a concrete frame of ten bays, infilled with pre-cast concrete panels. The roof and gables were of corrugated asbestos panels and the gable ventilators were of four slatted panels, covered by sheets of plain asbestos.

The interior of this hut was a single room, decorated below windowsill level in dark blue, and white above. The walls above sill level had been wallpapered in a purple 1970s style paper. Stovepipe exits were present in the roof to the north of the ridge in the fourth bay from the west and to the south of the ridge in the fourth bay from the east.

This hut was also recorded on the wartime plan as a 'dining hut', and like Hut P19, it continued in this function until the end of the 'Concordia' period, when the camp accommodated foreign students.

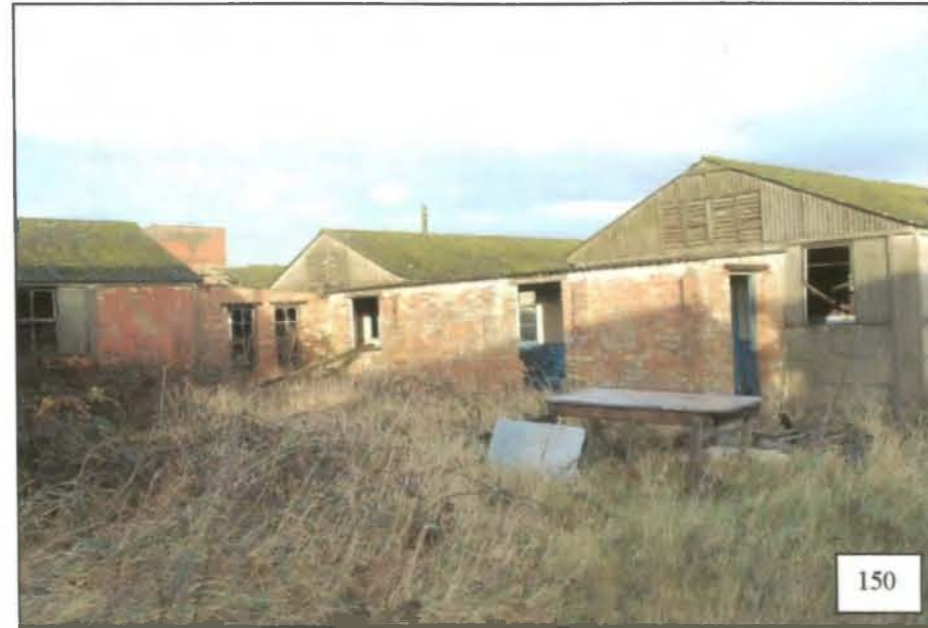
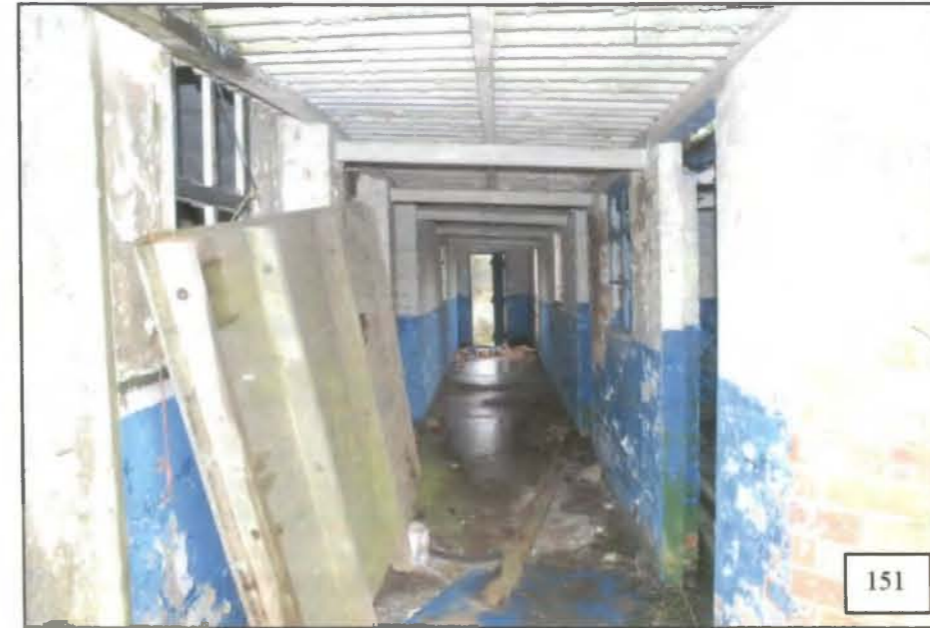
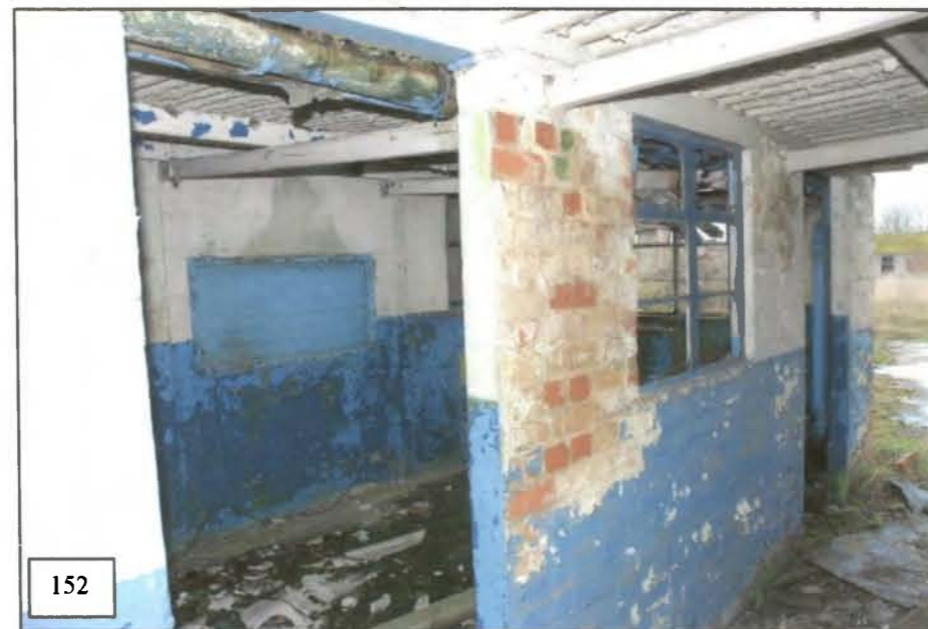
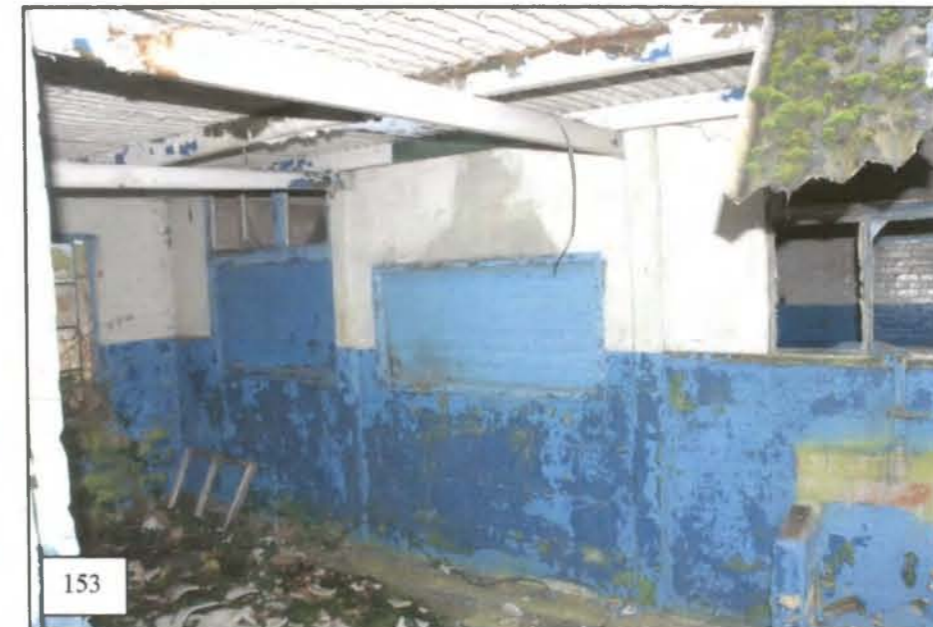
Servery

The area between the dining huts (Huts P19 and P20) and the cookhouse (Hut P32) was enclosed with a roof of corrugated asbestos panels, supported on a central 4" brick wall which extended to the south as far as the west gable door of Hut P20. This area represented the conversion of this space into a servery – serving hatches were let into the gable of the cookhouse – and allowed meals to be transported to the dining huts protected from the elements.

This structure is not shown on the wartime plan of the camp, which demonstrates that it is not an original feature: it was probably added while the camp was in use as an agricultural hostel, rather than during its wartime use as a PoW camp.

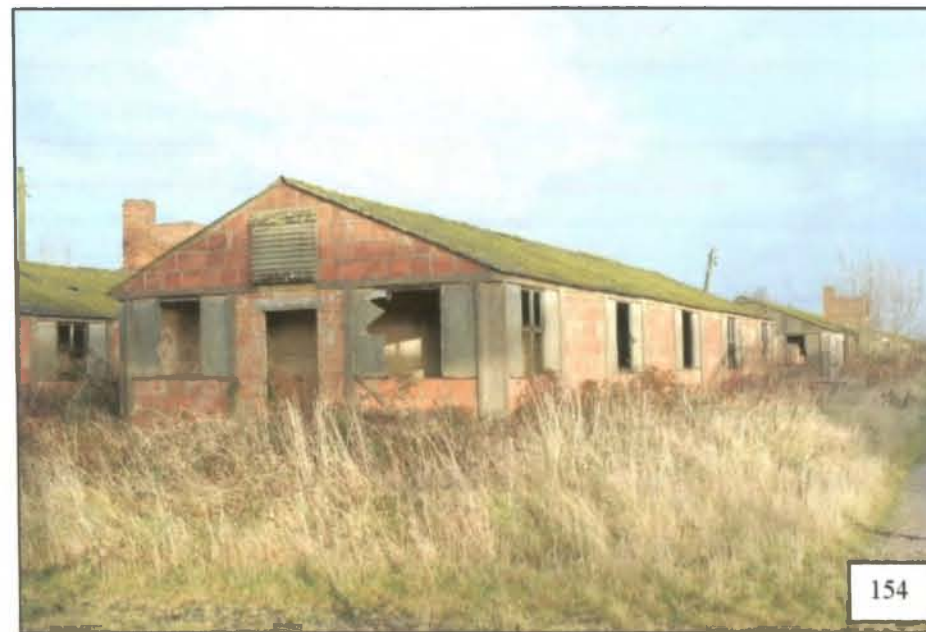
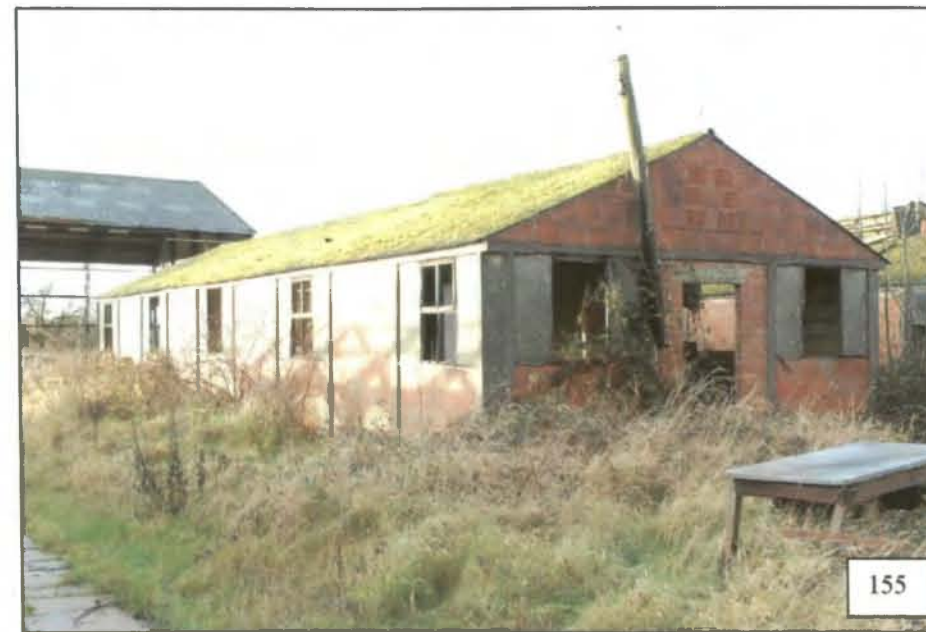
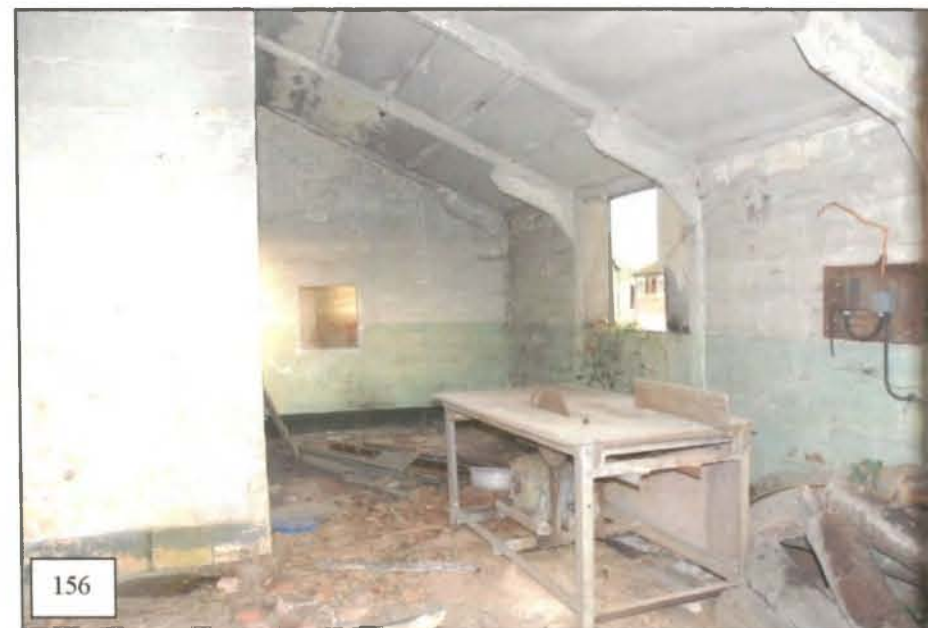
Hut P31 – Grocery and Local Produce Store

This building was located immediately to the south of the cookhouse (Hut P32), and comprised a MoWP type hut, aligned east-west, with a concrete frame of nine bays, infilled with hollow bricks. The roof was of corrugated asbestos panels and the gable ventilators were of airbricks, the western ventilator retained its corrugated asbestos cover.

The interior was divided into five rooms with a mixture of hollow brick and conventional brick 4" partition walls. A large room occupied the western four bays of this building; this in turn contained a smaller room of two bays in length in its north eastern corner. A communicating hatch was present between this and the central part of the building.

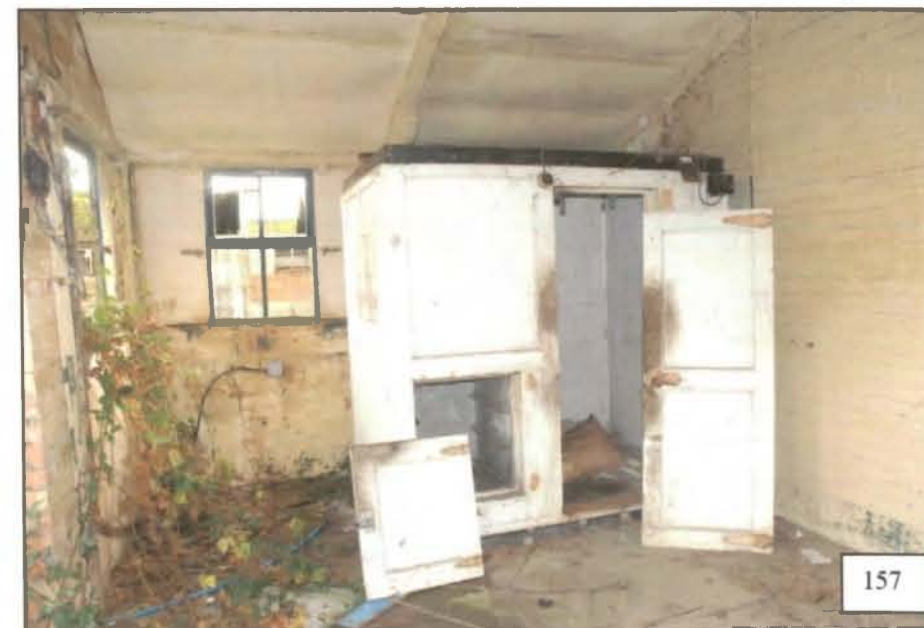
The rooms in the western part of the building were decorated with a 10" high dark green band at the base of the walls; the lower part of the walls was light green and the upper part white.

In the eastern part of the hut, the eastern two bays were divided from the central section and contained a large refrigerator, which may have been an original fixture. A central opening in the partition wall gave access to the central three bays of the building.

The central part of the building was again subdivided, with a 42" high x 28" wide counter with an asbestos sheet surface and shelving below. Behind this counter, the area had contained shelving and a door gave access to a storage room in the southeast corner of the area. This storage room contained rails for hanging meat.

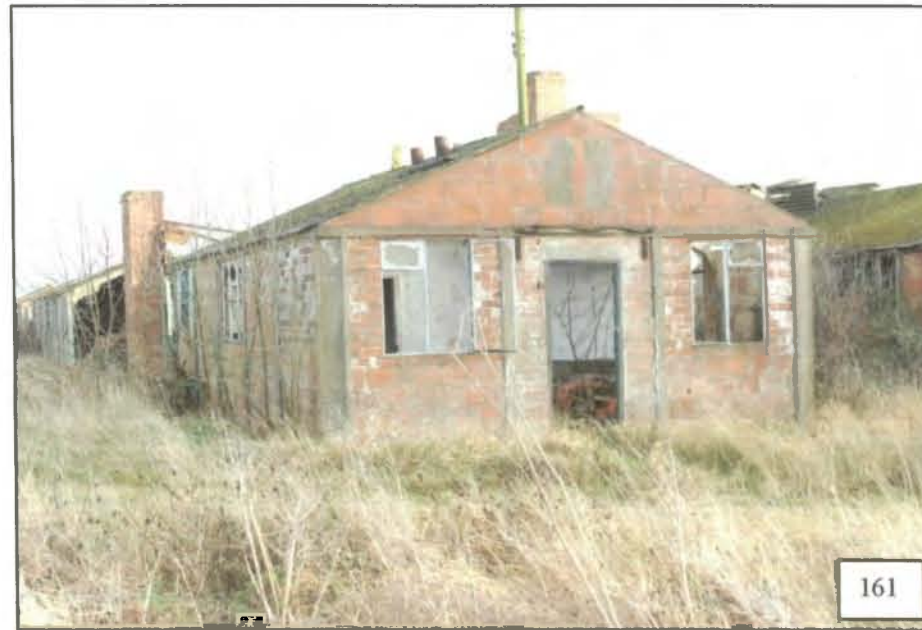
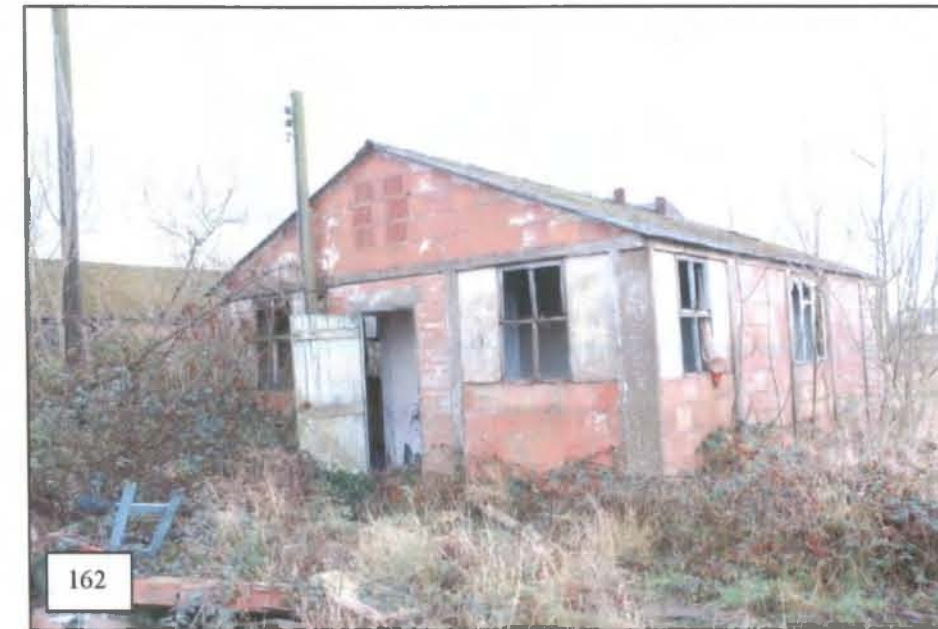
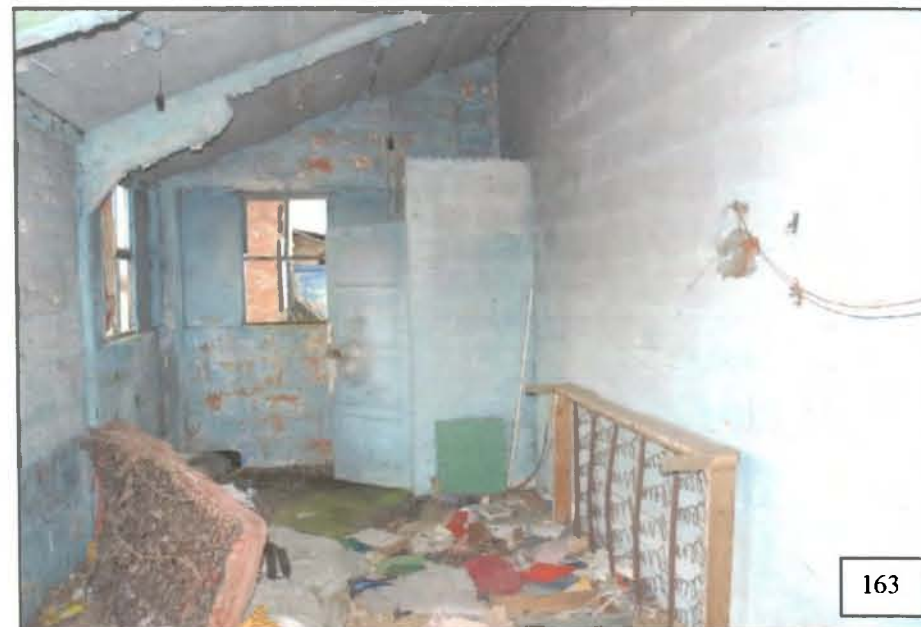
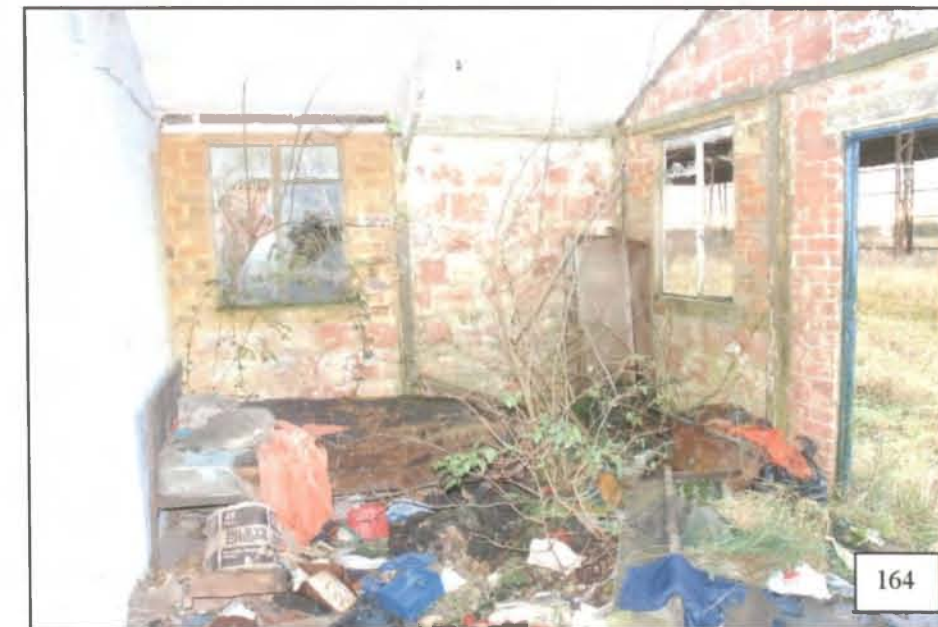
Hut P33 – Tradesmen’s Shops

This building was located immediately to the north of the cookhouse (Hut P32) in the northwest corner of the prison compound. It comprised a MoWP type hut, aligned east-west, with a concrete frame of five bays, infilled with hollow bricks. The roof was of corrugated asbestos panels and the gable ventilators were of airbricks.

The interior was divided into three rooms with hollow brick partition walls.

A large room occupied the western two bays, and the windows of this room had been replaced with modern metal casements. This room was also largely undecorated.

Two smaller rooms divided along the ridgeline of the building occupied the eastern part of the hut. This hut had been recently occupied and decorated.

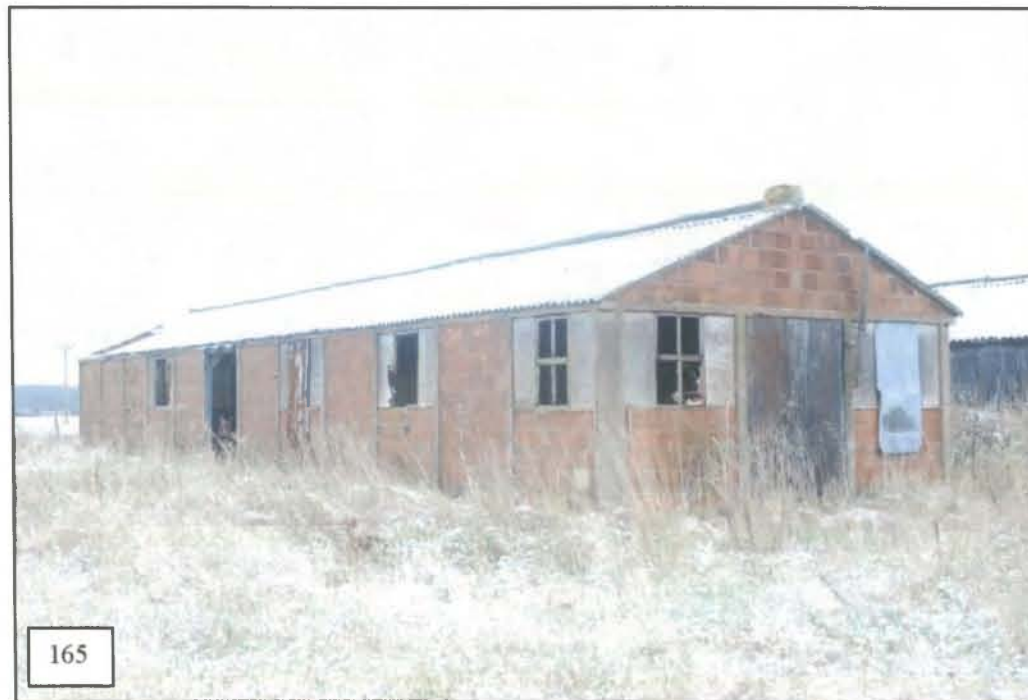
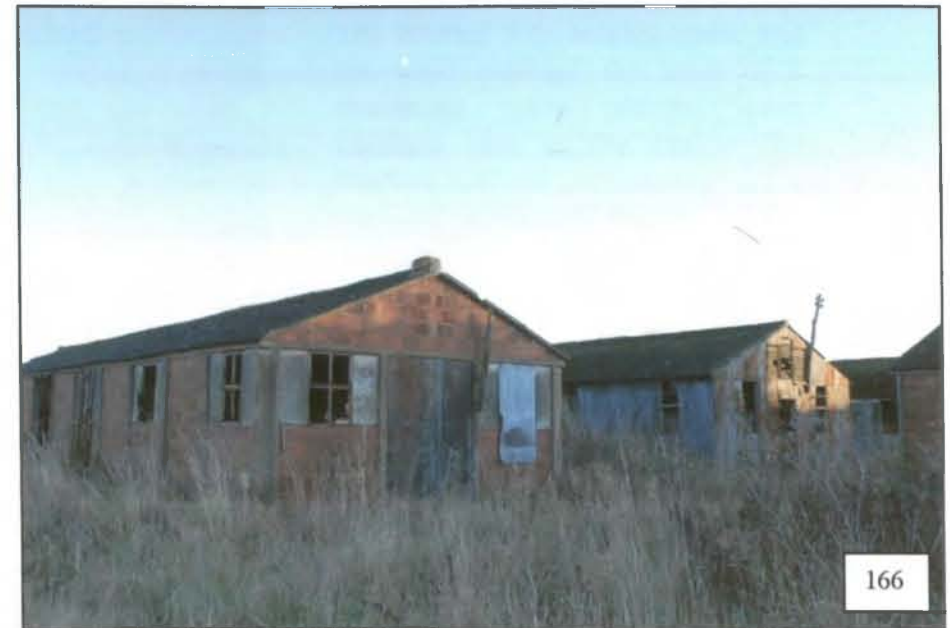
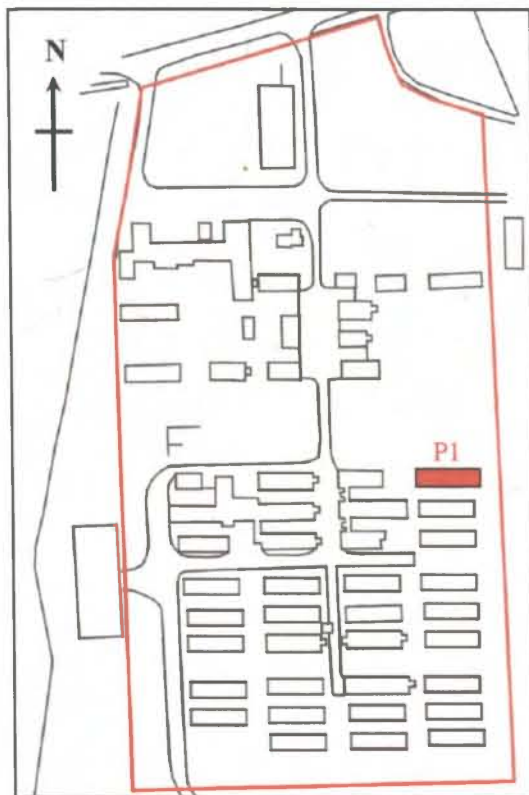
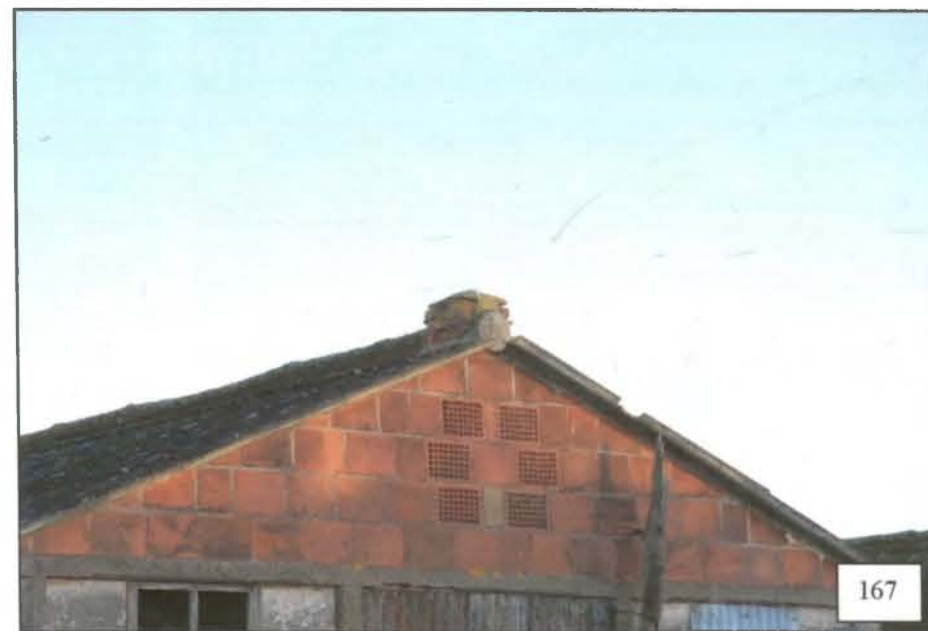
Hut P1 - Chapel

This building was located to the east of CRS, in the northeast corner of the prison compound. It comprised a MoWP type hut, east-west aligned, with a concrete frame of twelve bays, infilled with hollow bricks. It had a roof of corrugated asbestos panels and the gable ventilators were of airbricks. This was the prison chapel.

It had the usual west gable door, but the east end was entirely closed, and the sixth bay from the east end was open in both the north and south walls of the structure. On the north side a concrete step outside the open bay suggested that it had contained double-doors.

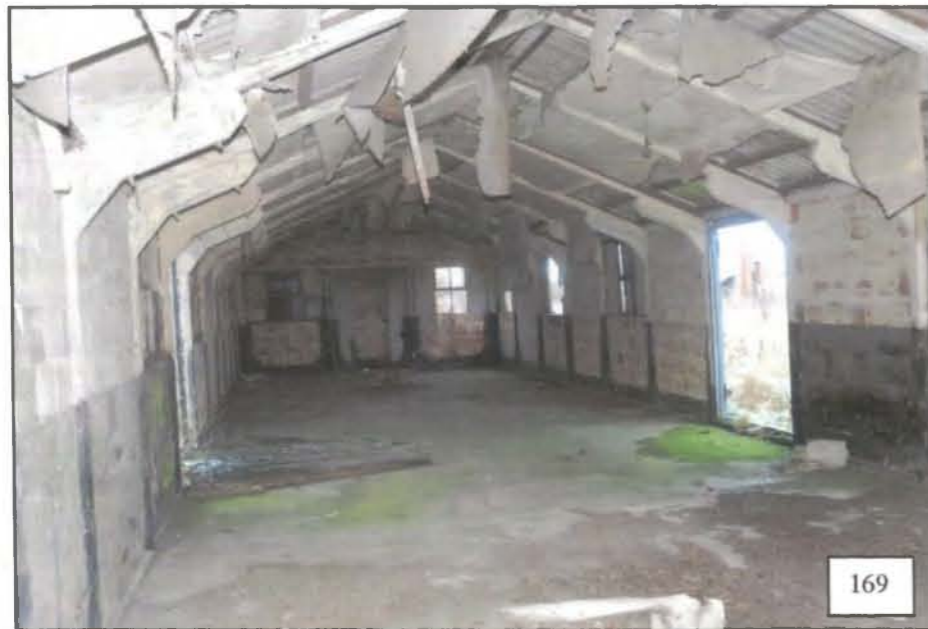
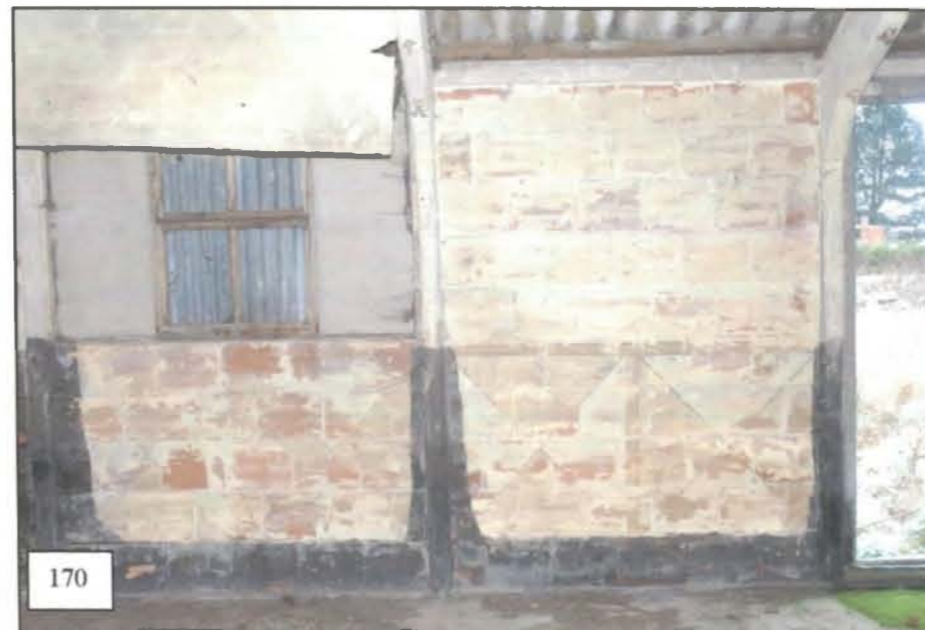
A small pile of bricks at the apex of the west gable probably indicated the former position of a cross.

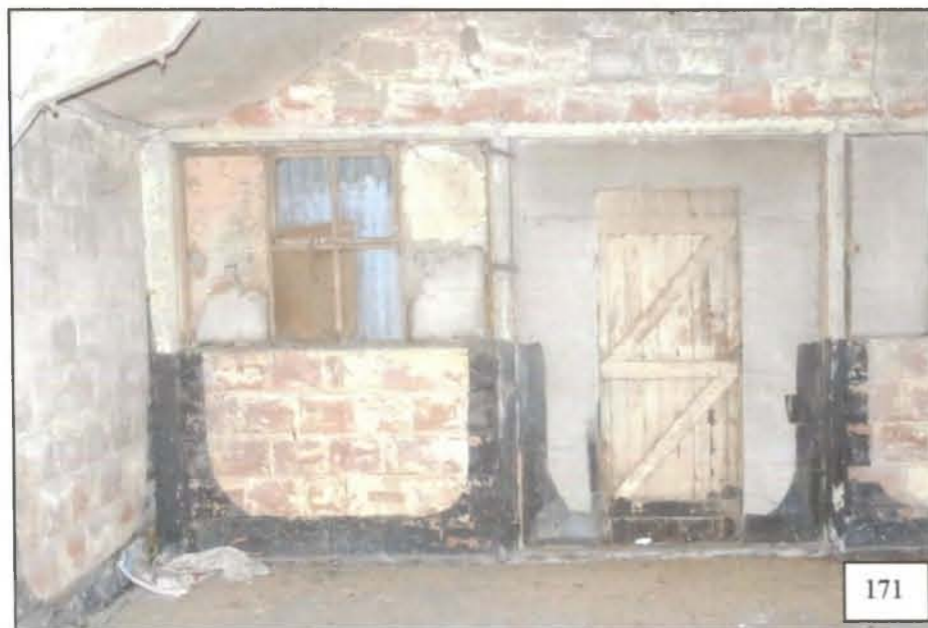
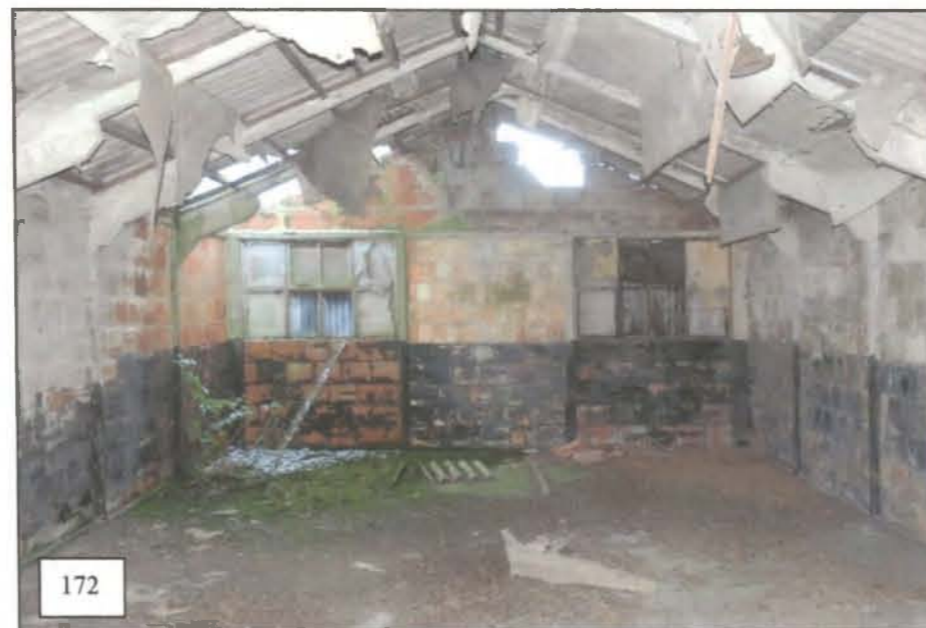
The interior was entirely open, and the walls retained the trace of a decorative paint scheme seen nowhere else at the camp. The western part of the building had a repeated geometric pattern in the lower part of each bay, separated by vertical black elements at each concrete upright of the frame. A 10" high black skirting band was also present. Above the geometric pattern at windowsill level, the walls were painted cream, but the concrete members of the frame were unpainted.

The east end was painted black to windowsill level, although no windows were present in the eastern three bays. An ornate shelf bracket still survived in the second bay from the east on the north wall.

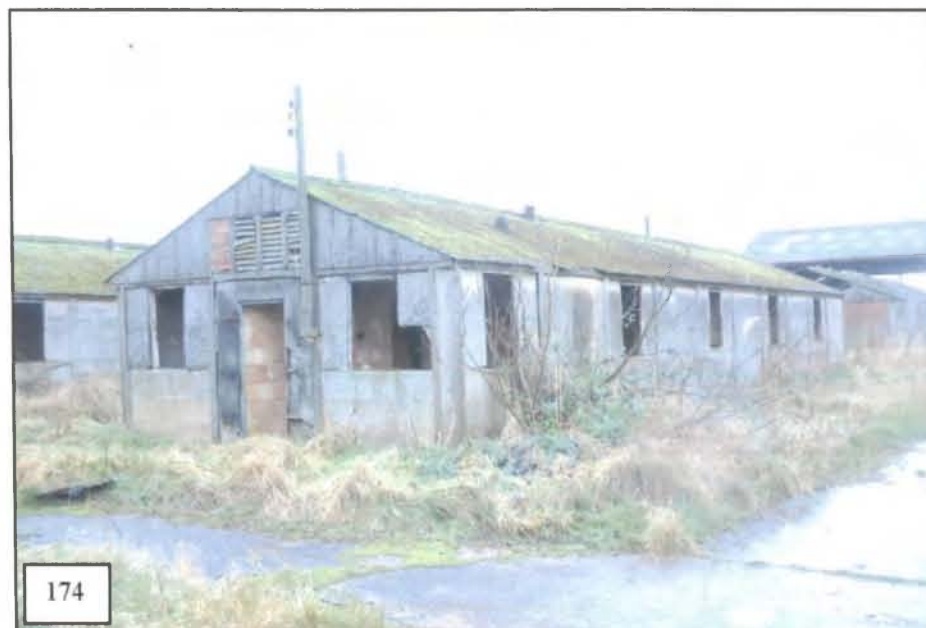
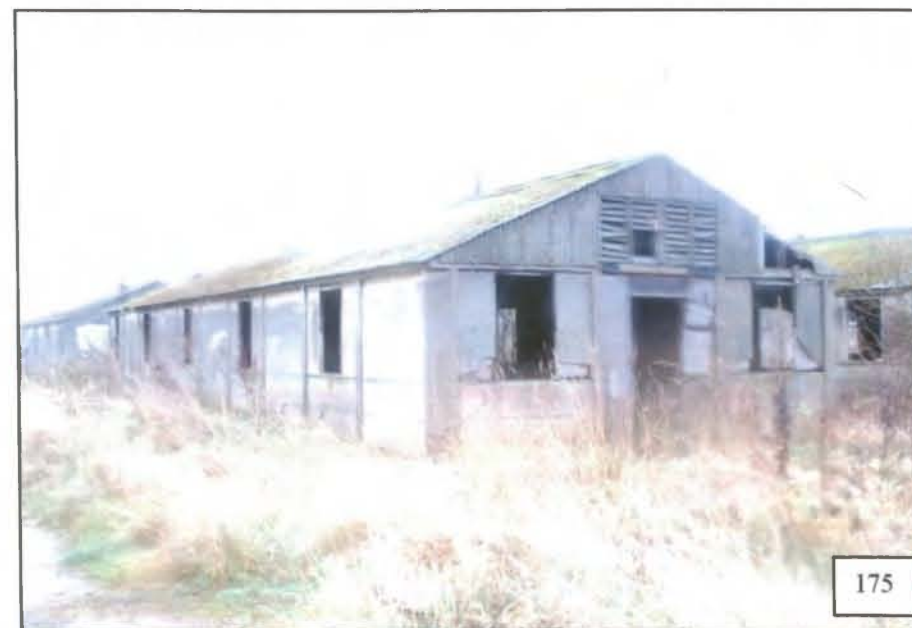
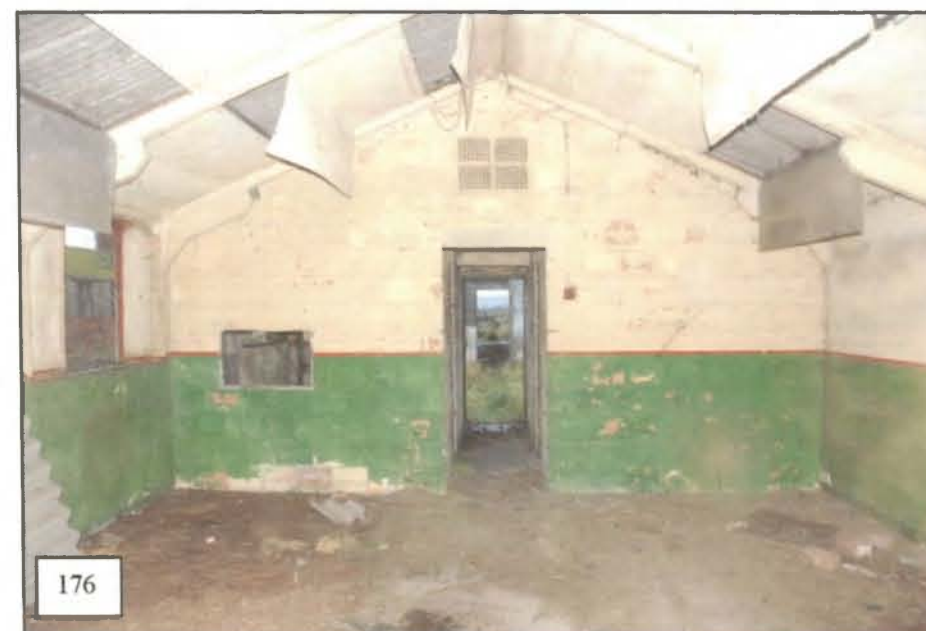
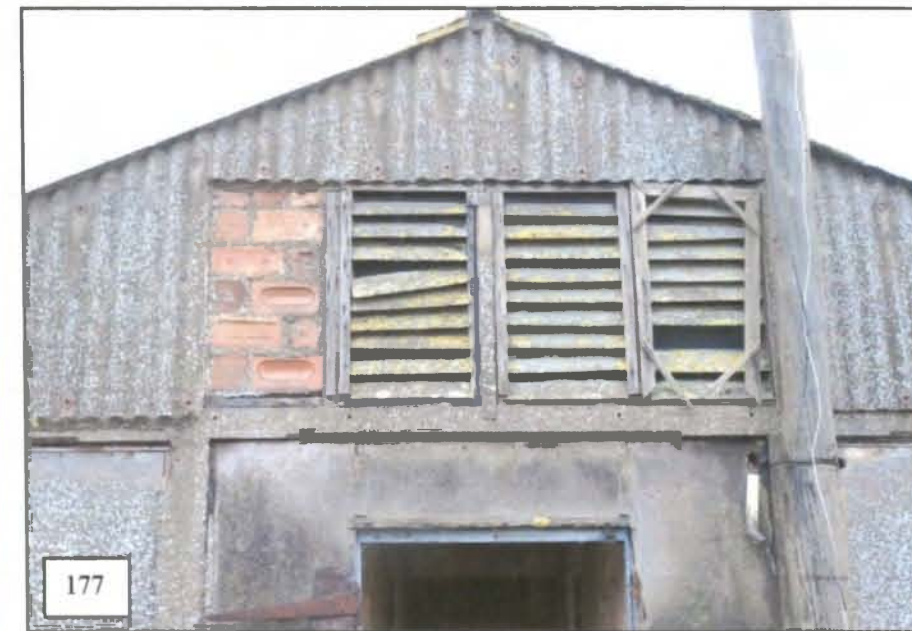
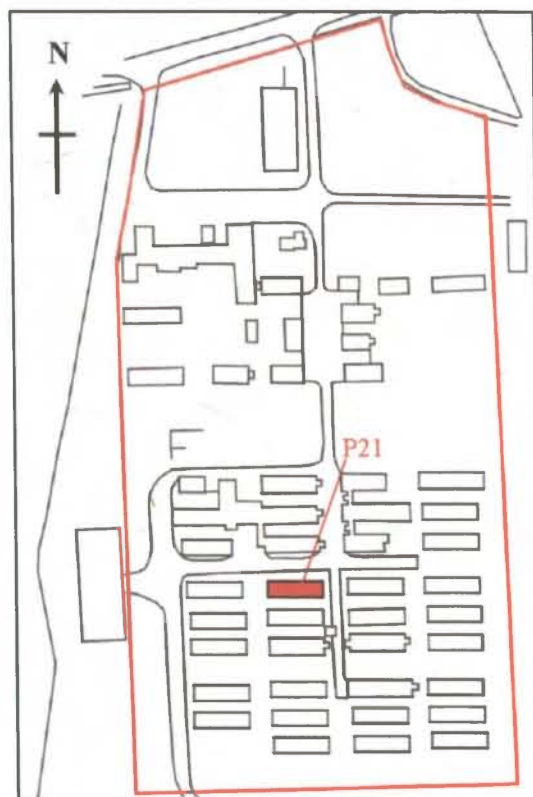
Hut P21

This building was located to the south of Dining Hut P20, and comprised a MoWP type hut, oriented east-west, with a concrete frame of ten bays, infilled with pre-cast concrete panels. The roof and gables were of corrugated asbestos panels and the gable ventilators were of four panels of timber slats.

The interior was divided into four rooms with hollow brick and conventional brick partition walls. The east gable door gave access onto a short corridor, two bays in length and flanked by a room to north and south. The corridor led into a central room three bays in length, which was separated from the western room by a further partition wall with a central door.

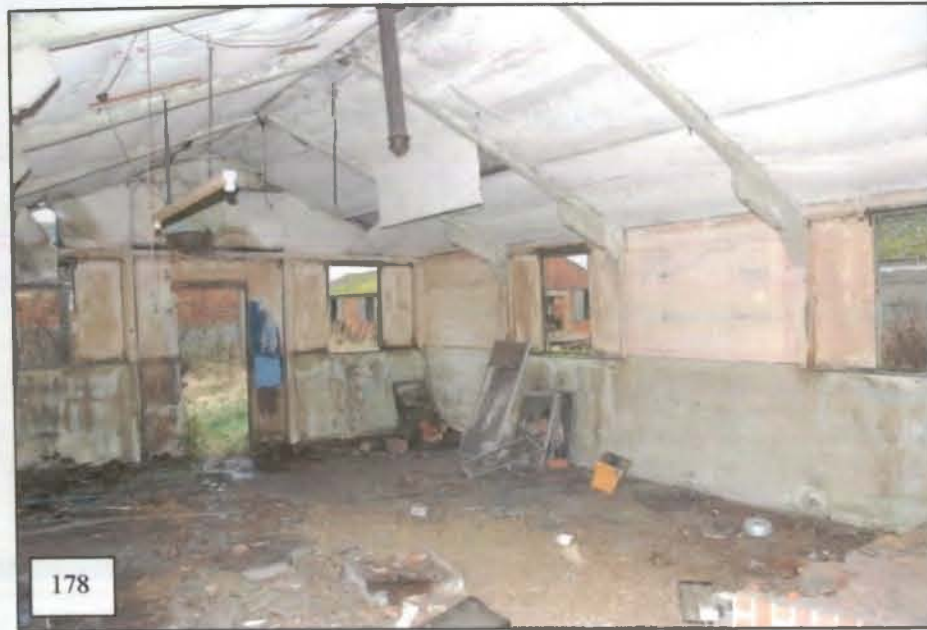
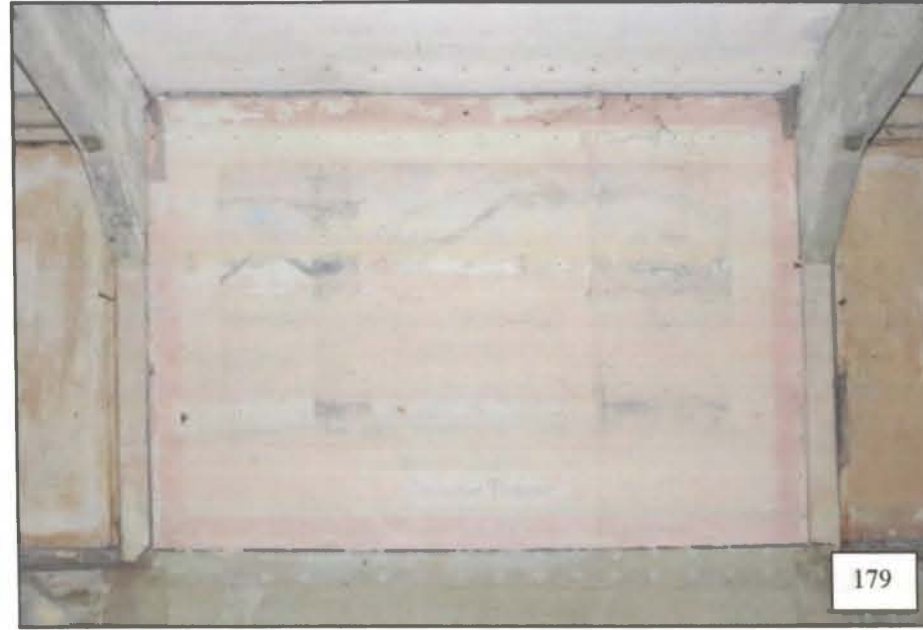
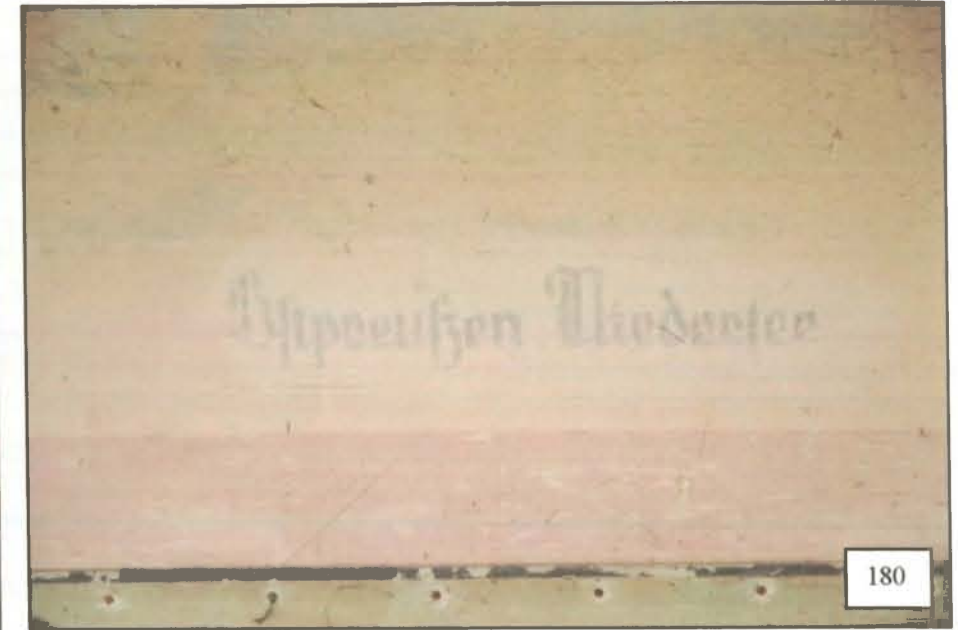
The two small rooms at the east end, the corridor and the room at the west side all shared the same decorative scheme, with the lower part of the walls painted light green and the upper part painted cream. The central room was painted in a darker shade of green with a black pinstripe separating this from the cream colour above.

The western room in Hut P21 contained painted panels, probably landscapes, which had almost completely washed out. These landscape panels had a pink border, and were titled in German *Fraktur* script. The landscape panel on the north wall was located in the third bay from the west end of the hut, the subject was indiscernible, but it was titled 'Ostpreussen Niedersee' which translates as 'the Niedersee (lower lake) in East Prussia'.
