PINGLEY CAMP, BRIGG, LINCOLNSHIRE

PHOTOGRAPHIC BUILDING SURVEY

Report prepared for Barford Builders by S. A. Savage

Site Code: PPCB 08
Planning ref: 119946
NGR: TA 0178 0680
LCNCC acc. no. 2008.189
PCA job no.:08-515

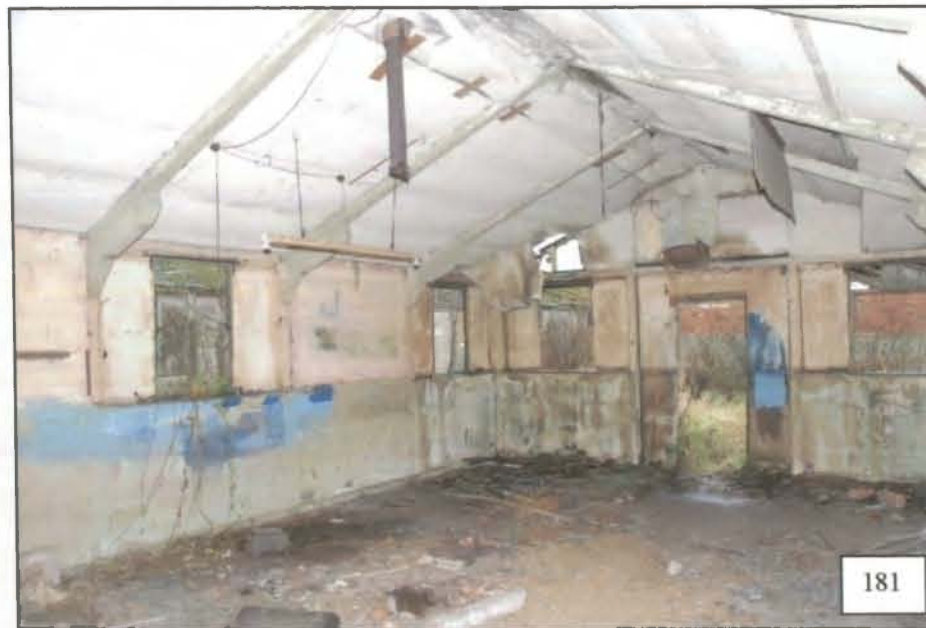
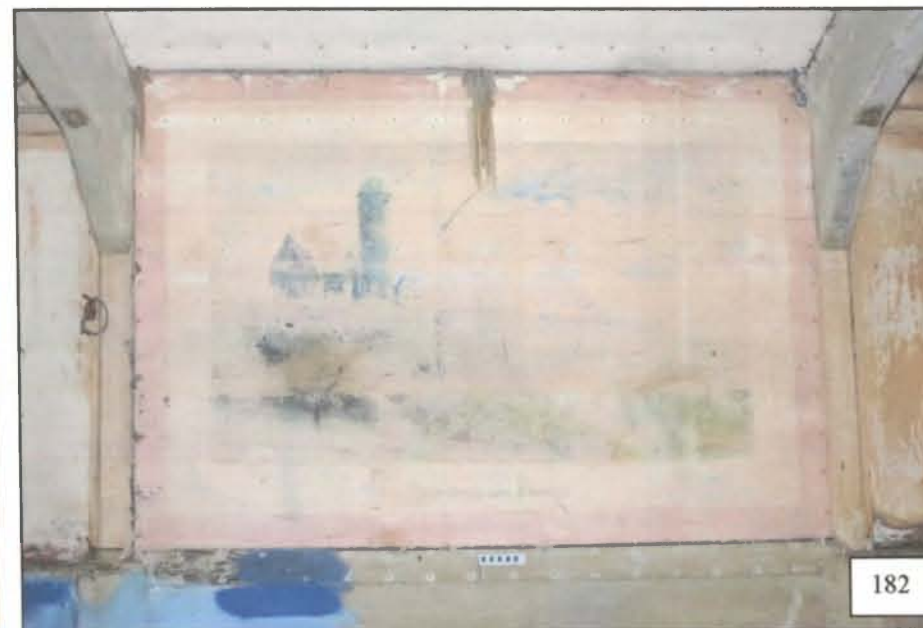
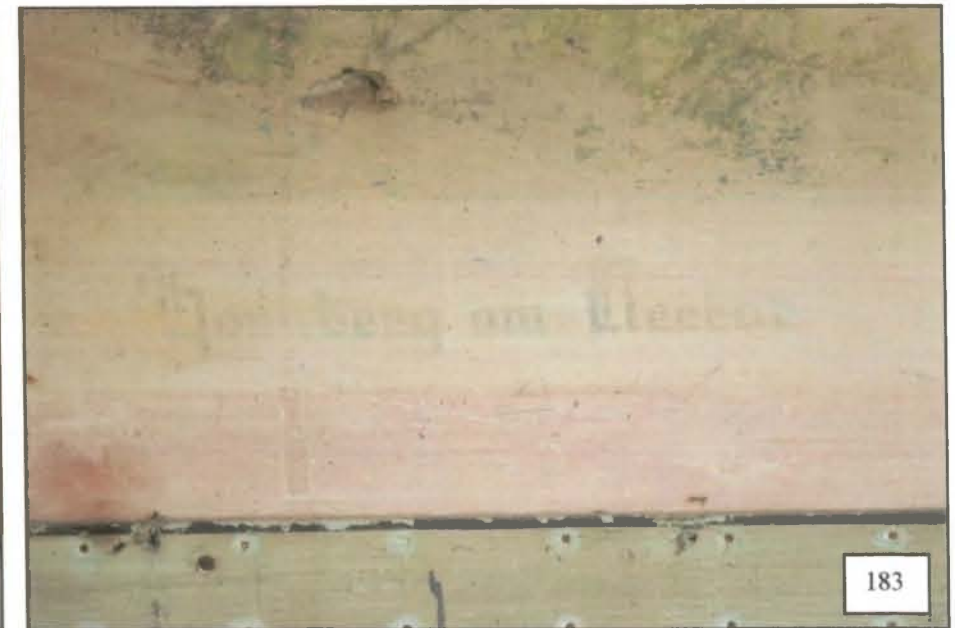
The landscape panel on the south wall was located in the second bay from the west end of the hut. Although the subject was unclear, it appeared to be of a castle, and bore the title 'Hornberg am Neckar', a place name on the Neckar River in Baden-Wurttemberg.

A further panel, located in the northeast bay of this room, had a pink border, but showed no sign of a painting or a title.

This hut had a modern brick arcade against the east wall, and two low herringbone brick walls had clearly been pushed over at the eastern side of the room. It seems likely that its most recent use was as some sort of bar.

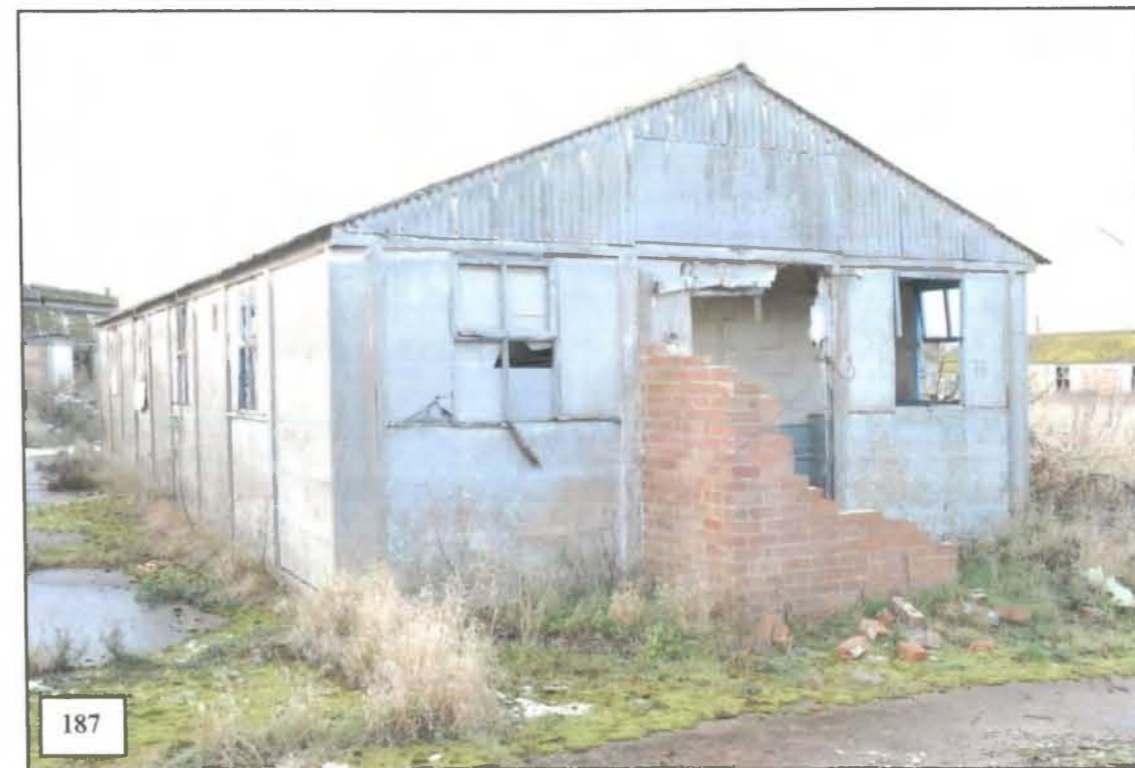
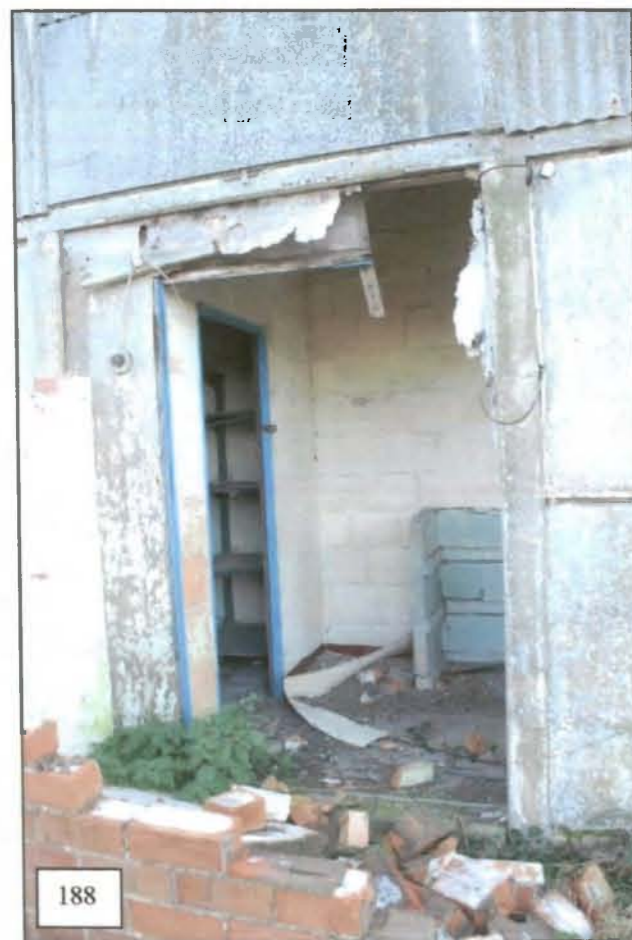
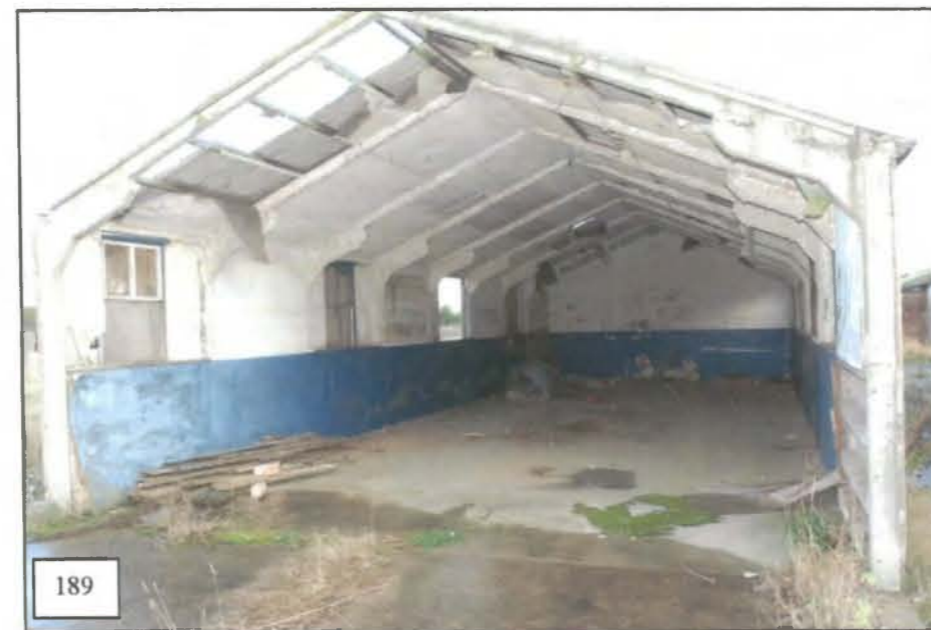
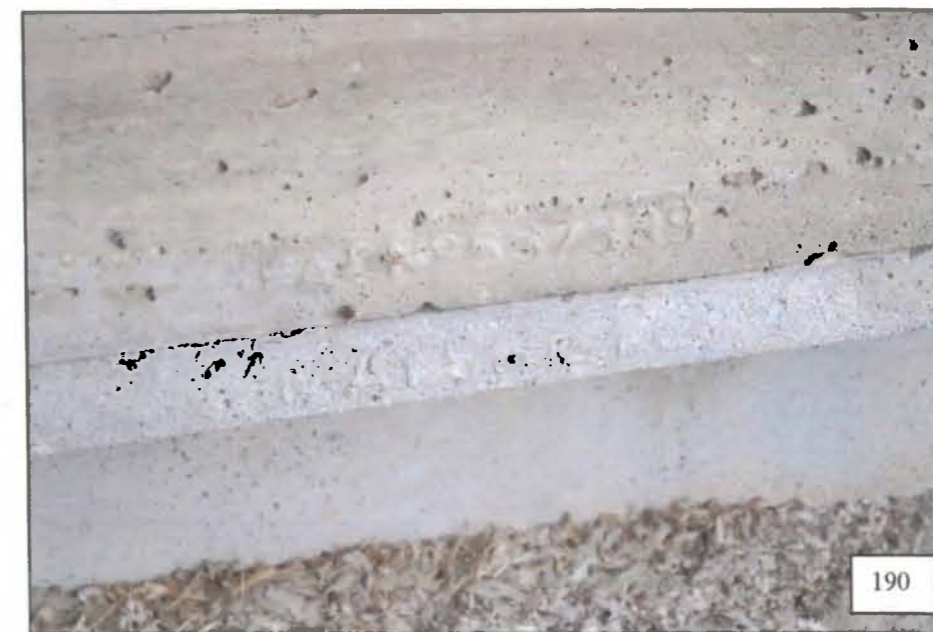
This building was located immediately to the north of Dining Hut P19, and comprised a MoWP type hut, oriented north-south, with a concrete frame of ten bays, infilled with pre-cast concrete panels. The roof and gables were of corrugated asbestos panels and the gable ventilators were of four panels of timber slats, covered by sheets of plain asbestos.

The interior was divided into three rooms with hollow brick partition walls. Two of these rooms occupied the eastern bay of the hut, and could only be accessed through the eastern gable door. These rooms appeared to be storage of some kind as they both contained the remains of built-in shelving.

The remainder of Hut P18 was a single room, decorated with the lower walls painted dark blue, the upper walls white.

The hut had lost its western gable and westernmost bay, probably to allow vehicular access for agricultural storage.

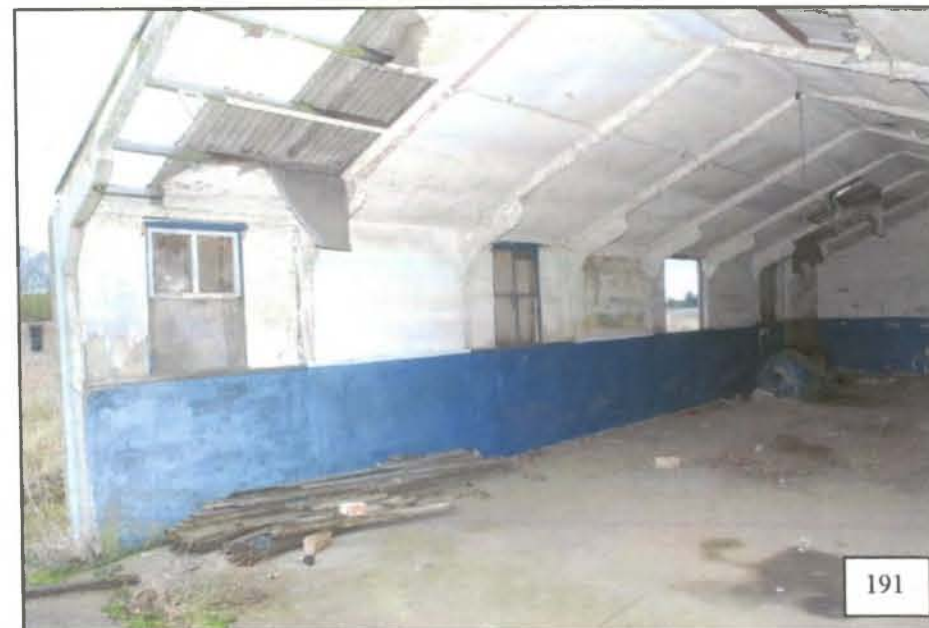
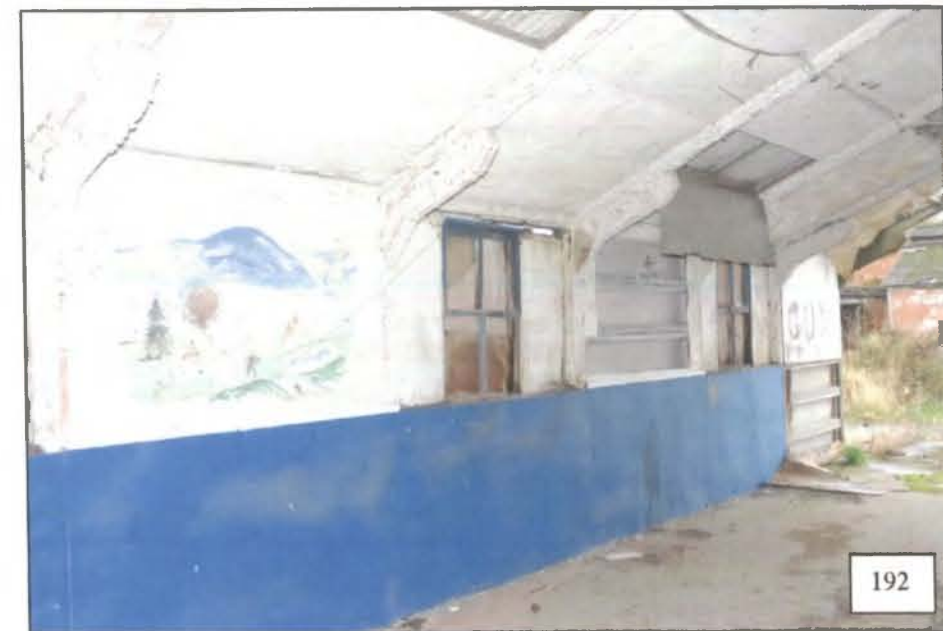
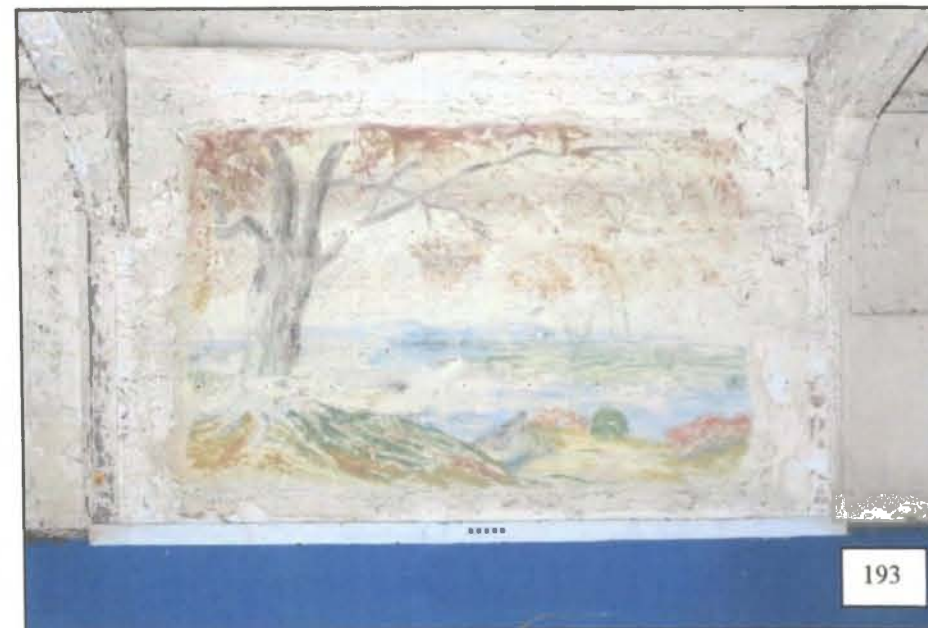
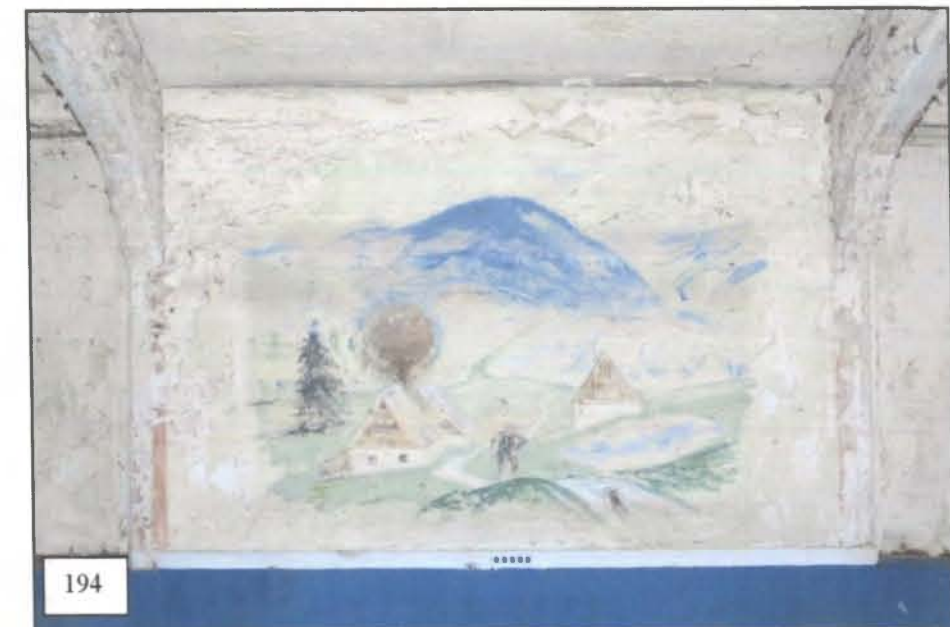
Both of these paintings were executed in bright colours, although the paint was peeling badly from the panels.

A missing panel to the east of the southern landscape attests to the removal of a further painting.

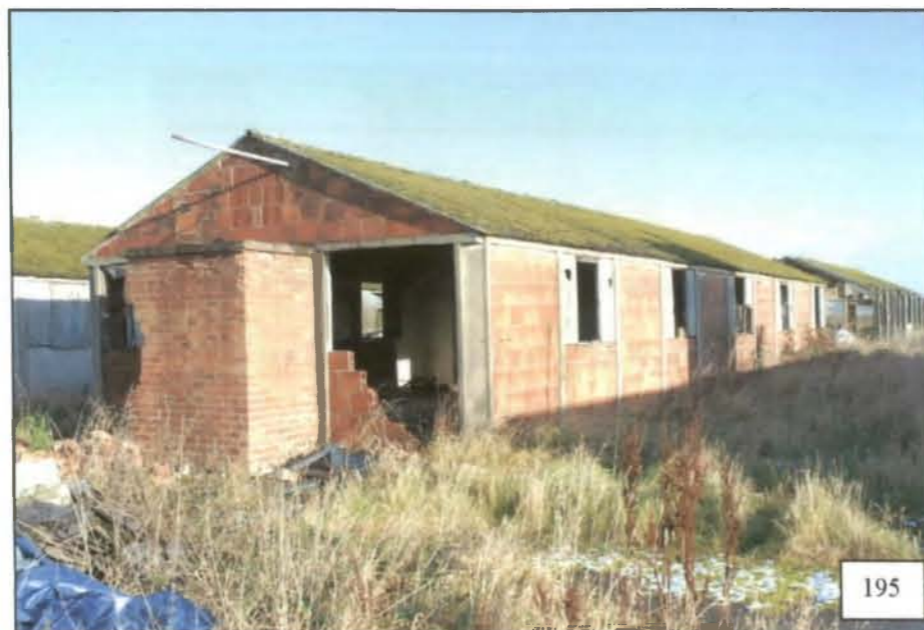
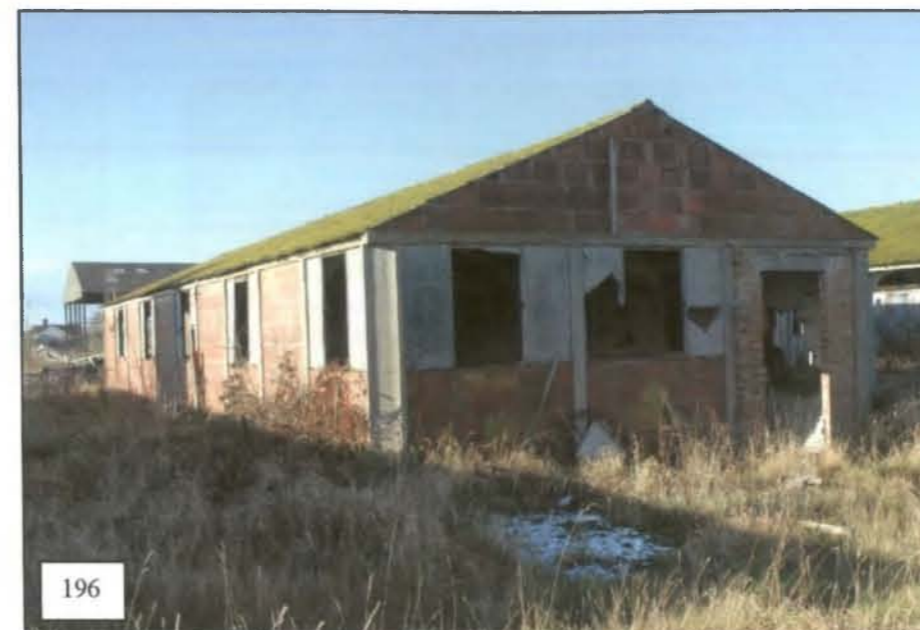
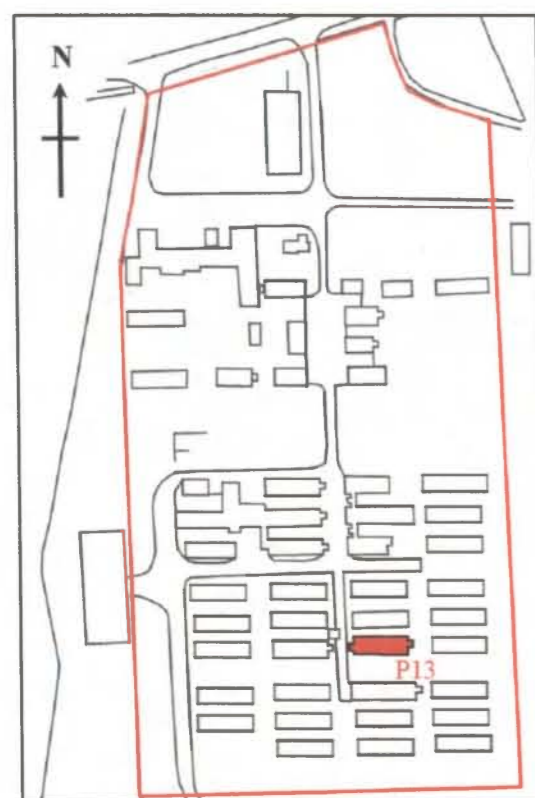
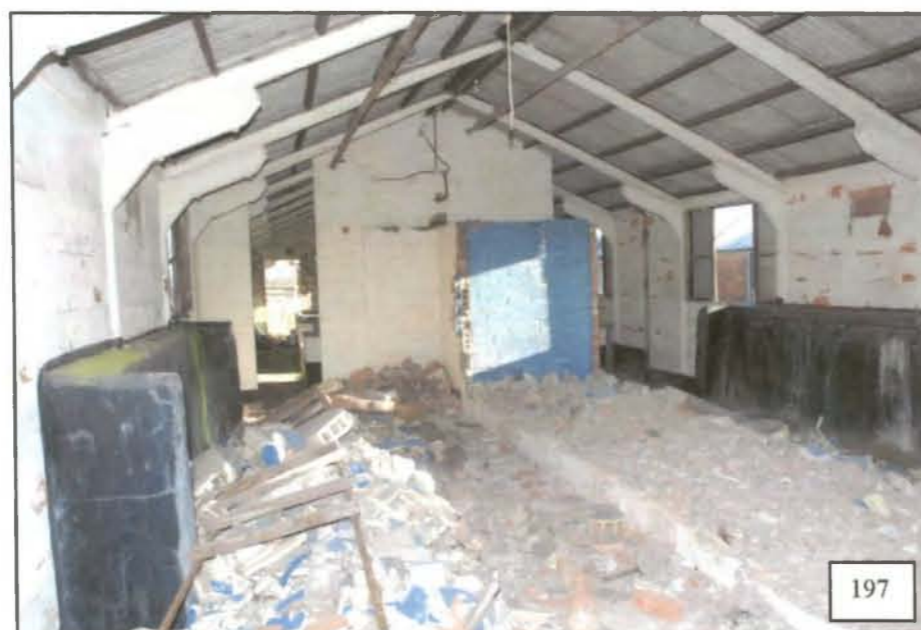
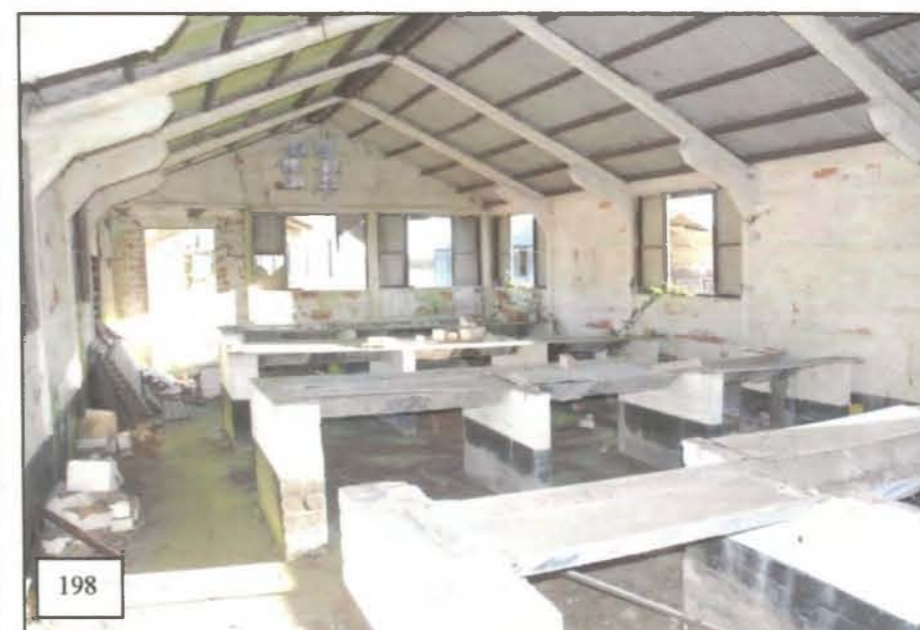
This building was located immediately to the south of accommodation hut P12, and comprised a MoWP type hut, on an east-west alignment, with a concrete frame of ten bays, infilled with hollow bricks. The roof was of corrugated asbestos panels and the gable ventilators were of airbricks. The eastern gable had a door in the northern bay, while the west gable had a brick porch structure.

Apart from whitewashed walls with a black band at floor level, the building was completely undecorated, lacking even a roof lining.

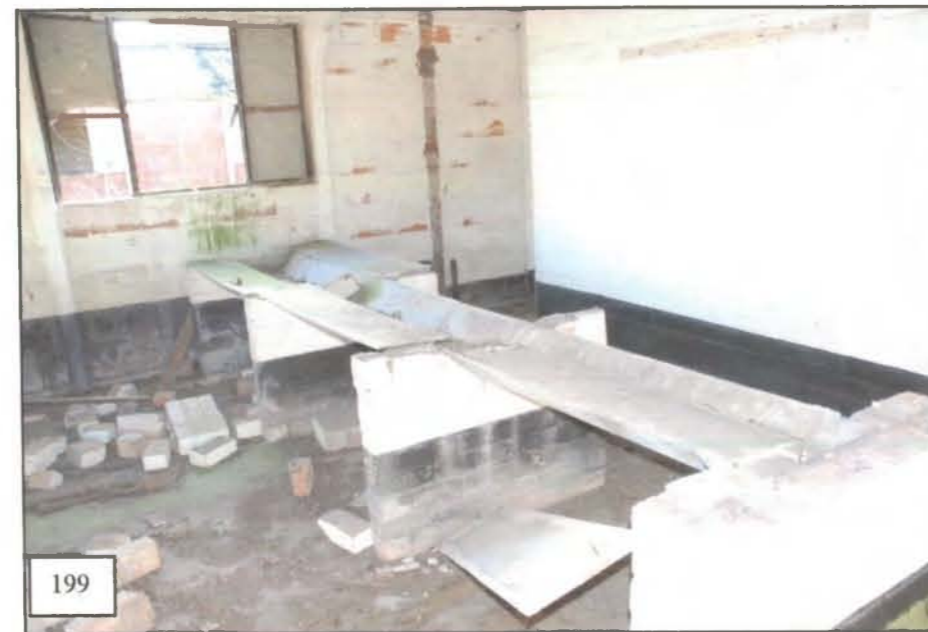
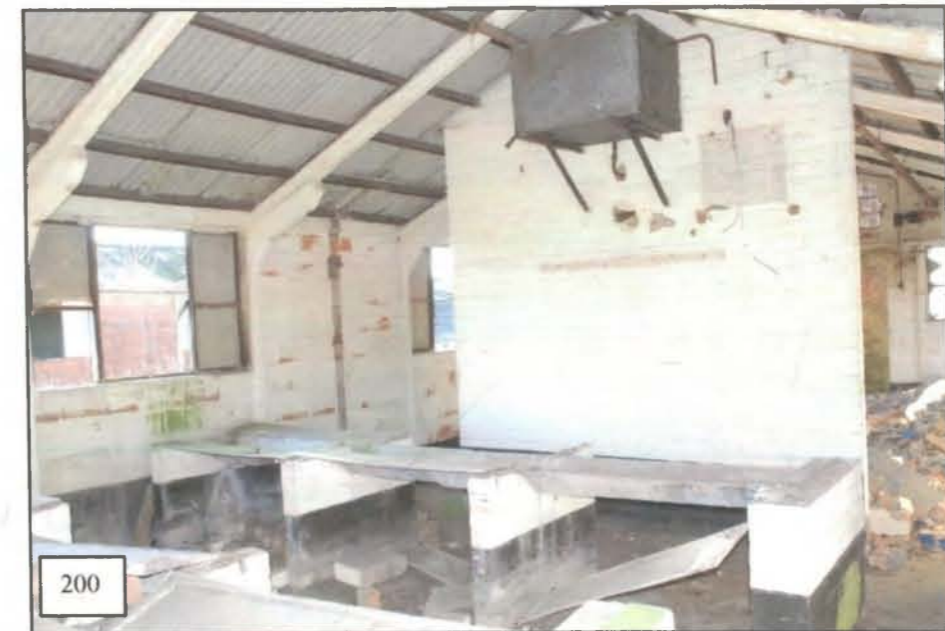
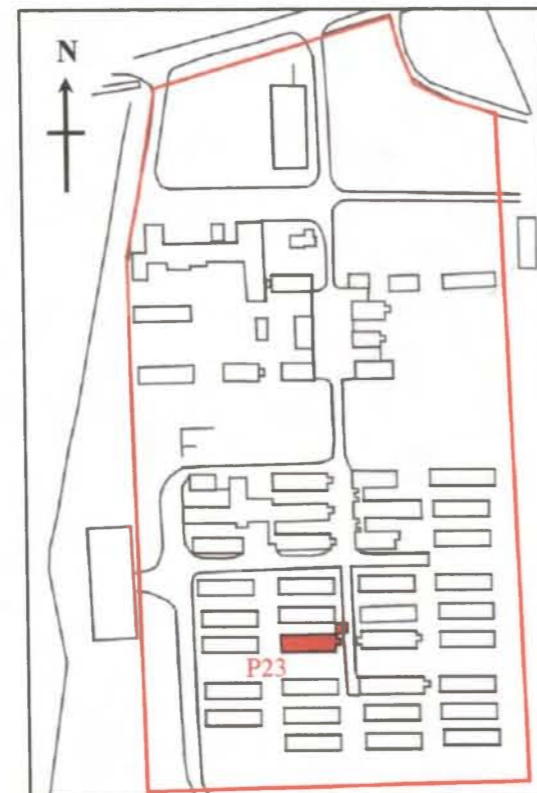
The interior was divided into two rooms with a conventional brick partition. The western room, of 4½ bays, had functioned as a latrine. Urinals were still present on the north and south walls; however, the double row of brick toilet cubicles, which had occupied the centre of this room, was almost completely demolished.

The eastern room was occupied by four of the communal sinks, similar to those seen previously in Hut G12; these were not so well preserved however, lacking the brick and asbestos superstructure seen in Hut G12. A large water tank remained attached to the partition wall near to the roof.

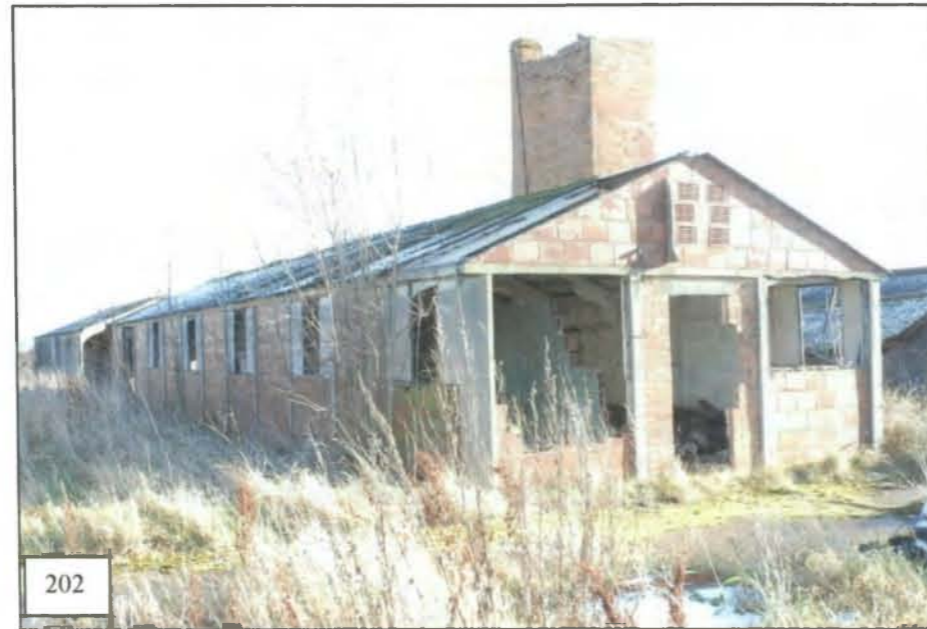
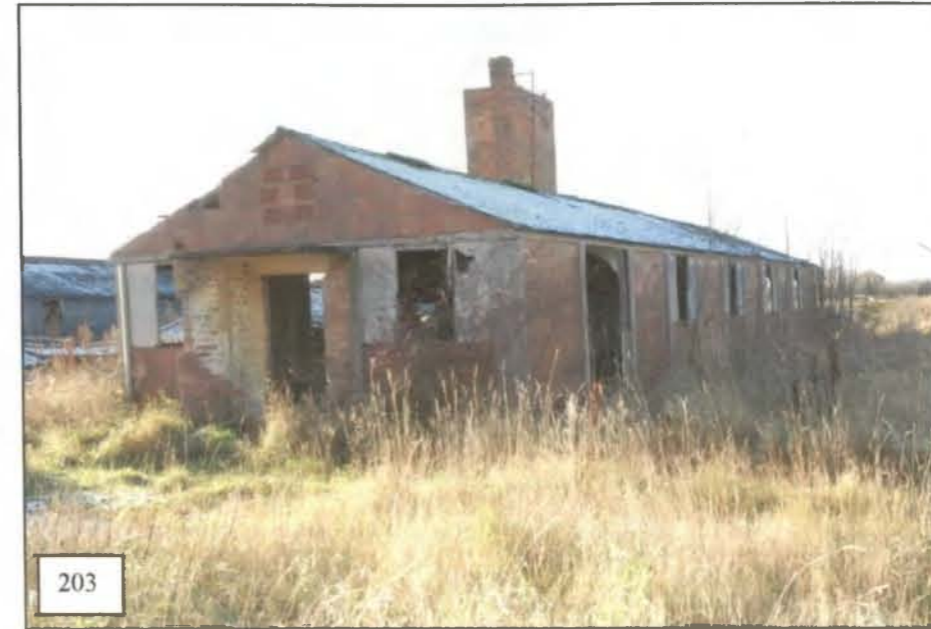
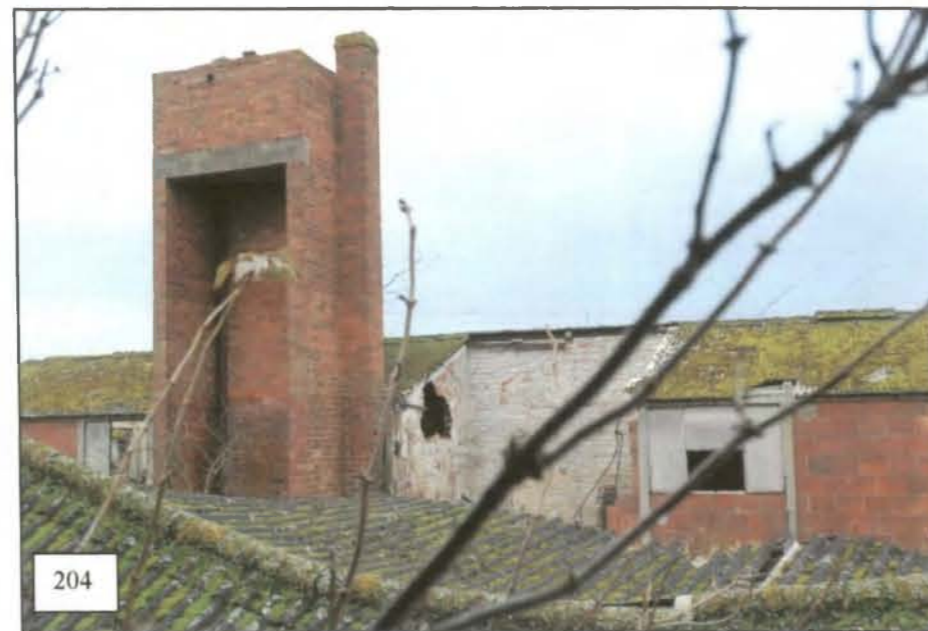
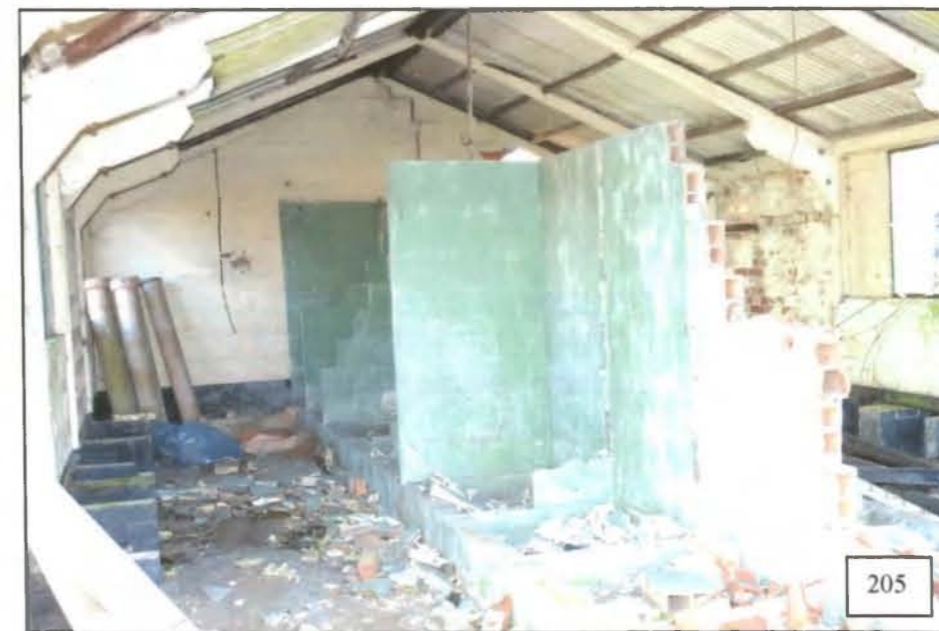
Hut P14 - Shower and Drying Room

This building was located to the south of Hut P13, and comprised a MoWP type hut, on an east-west alignment, with a concrete frame of twelve bays, infilled with hollow bricks. The roof was of corrugated asbestos panels and the gable ventilators were of airbricks. The eastern gable had a brick porch structure, which had retained its concrete roof.

Like Hut P13, apart from whitewashed walls with a black band at floor level, the building was completely undecorated, lacking even a roof lining.

The hut was divided in half with a hollow brick partition, and the western half housed a double row of nine back-to-back shower cubicles; these were painted green and ran down the centre of the room. Along the sides, the black-painted brick supports of changing benches similar to that seen in Hut G12 were also present. The western room was empty, but had clearly functioned as a drying room, as the mounting points of six radiators were present below the windows. The western room was further subdivided, as the boiler room occupied the central two bays on the south side of the building, with a large elevated water tank/flue structure abutting the south side of the hut to the east. As the neighbouring hut had collapsed, it was not possible to gain access to this room.

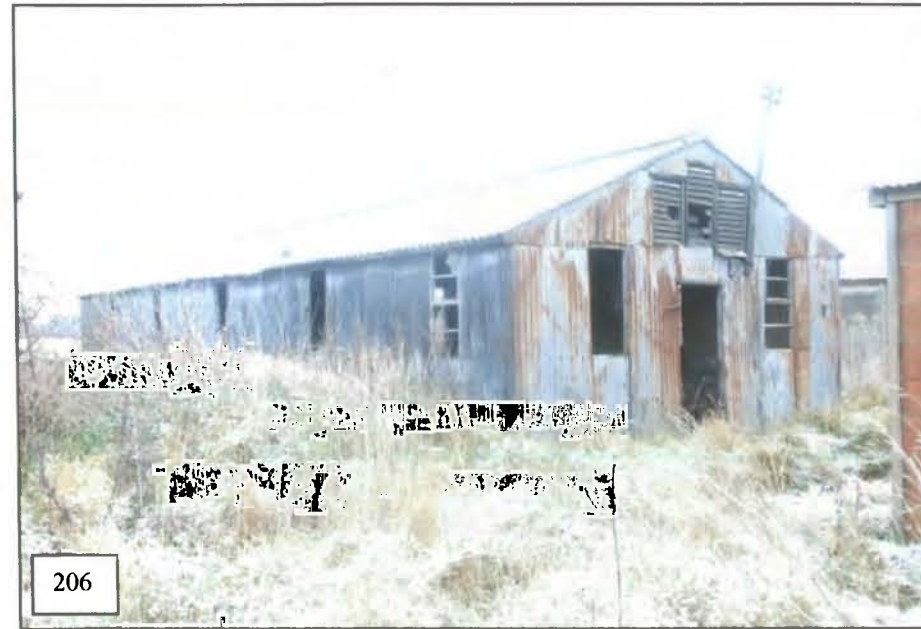
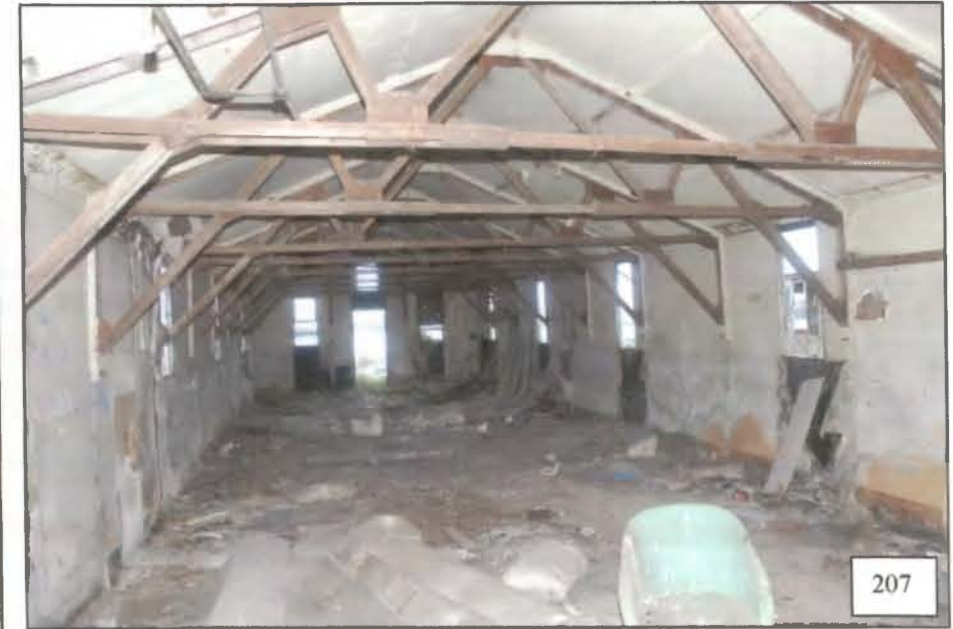
This hut was located to the south of the chapel, Hut P1. It was of Laing timber-framed construction, with a pitched roof of corrugated sheet asbestos. Initially the huts of this type were clad in weatherboard, which has since been replaced in corrugated metal sheeting and treated with a bituminised paint. It had five windows in each side, which are 46" in height and 23" wide; they were of four lights, the upper pair forming a top-hung casement. The windows in the sides of the hut occupied alternating bays, and were offset from the centre of the bays.

The interior of this hut comprised a single room, dominated by the exposed composite timber roof trusses. These were of 2 3/4" x 7/8" timber, doubled up in most of the truss, using 2" x 2" spacers, with 1/4" plywood reinforcement at the joints.

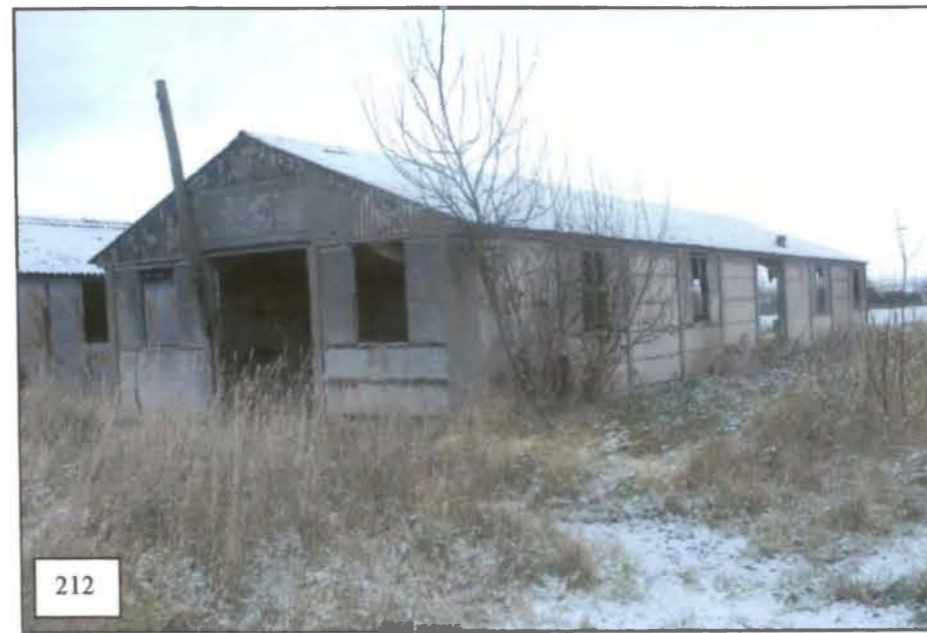
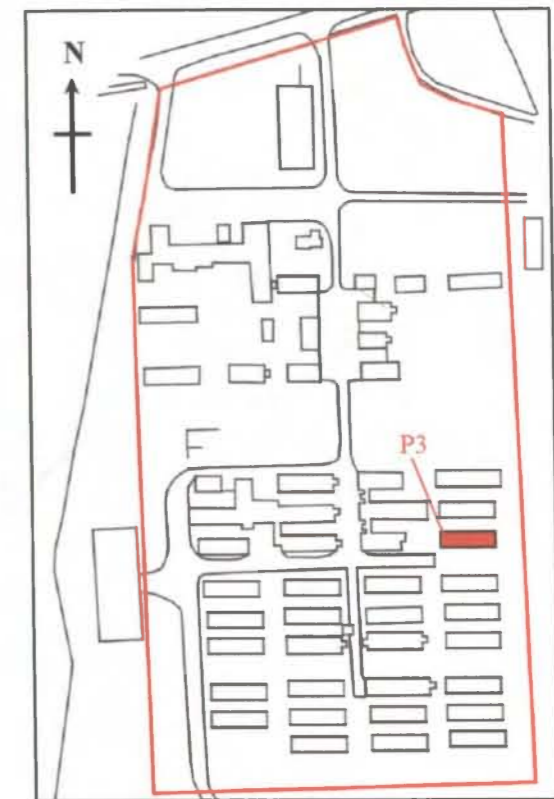
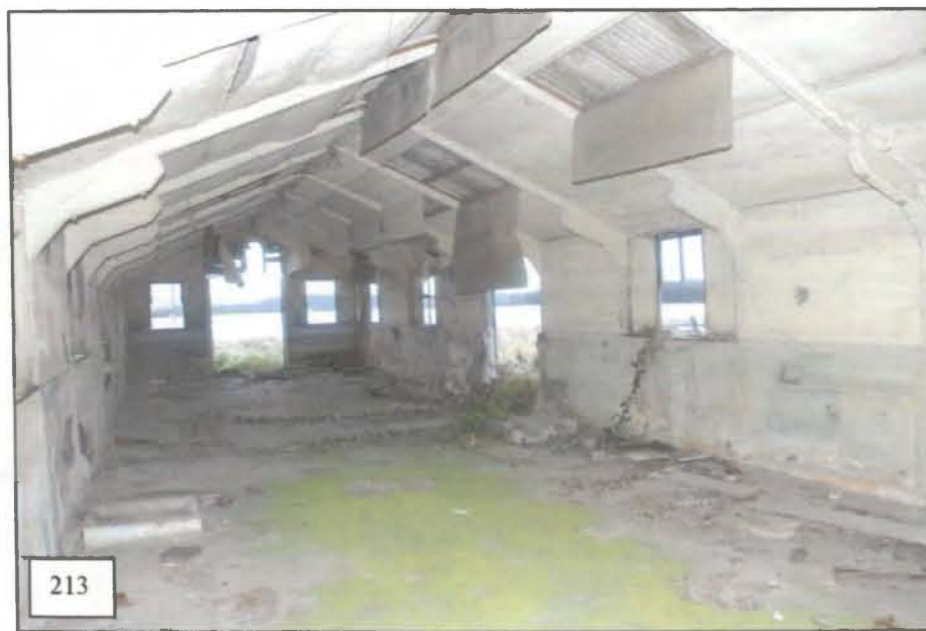
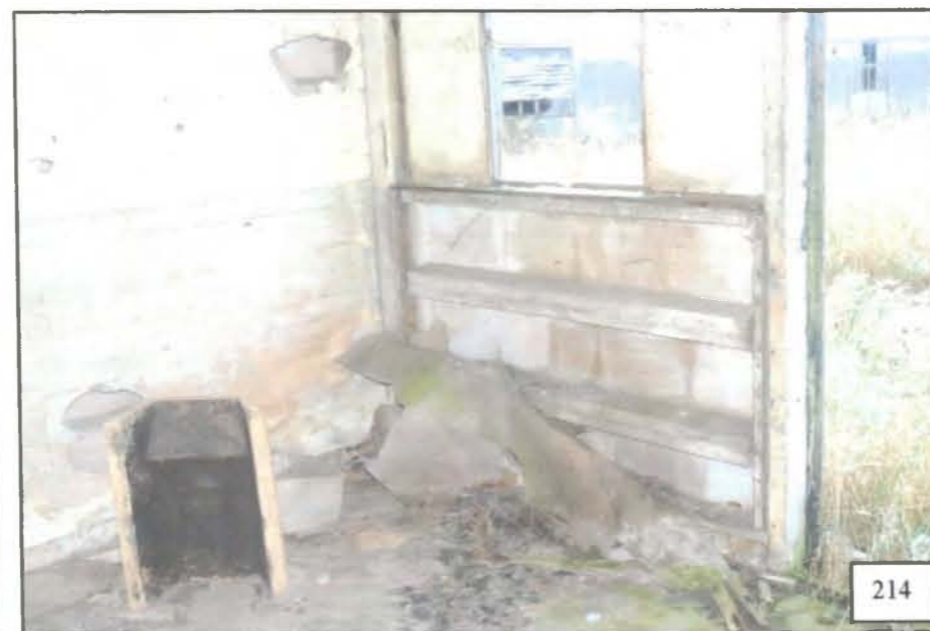
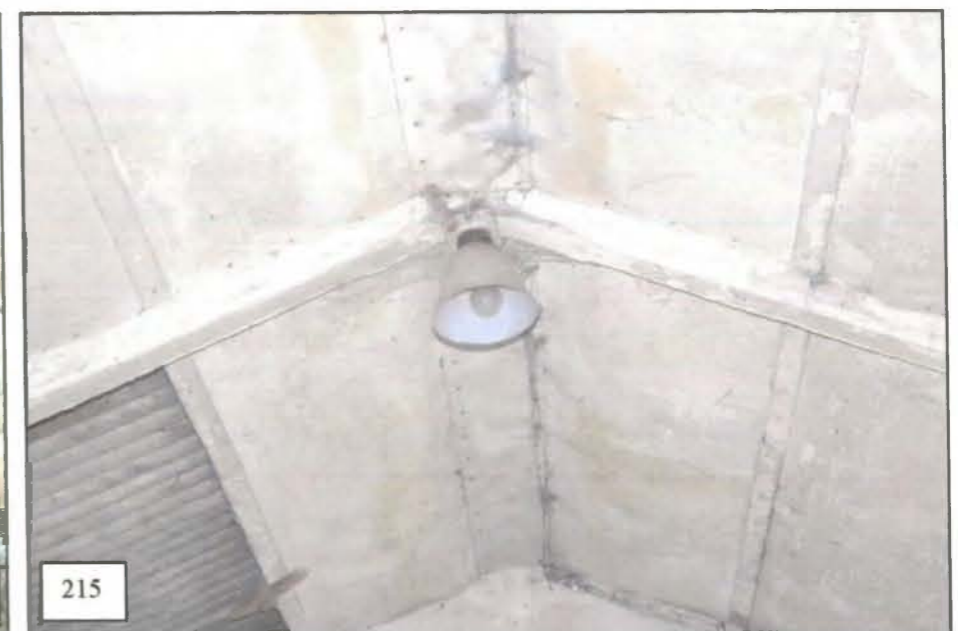
Hut P3

This hut was located to the south of Hut P2; it was a typical MoWP accommodation block, oriented east-west, with a concrete frame of ten bays, infilled with pre-cast concrete panels. The roof and gables were of corrugated asbestos panels and the gable ventilators were of four panels of timber slats, covered by sheets of plain asbestos.

The interior comprised a single room, the walls and roof were lined in a cardboard ply, and this building retained a few of its original light fittings. It also retained the concrete bases of two pot-bellied stoves.

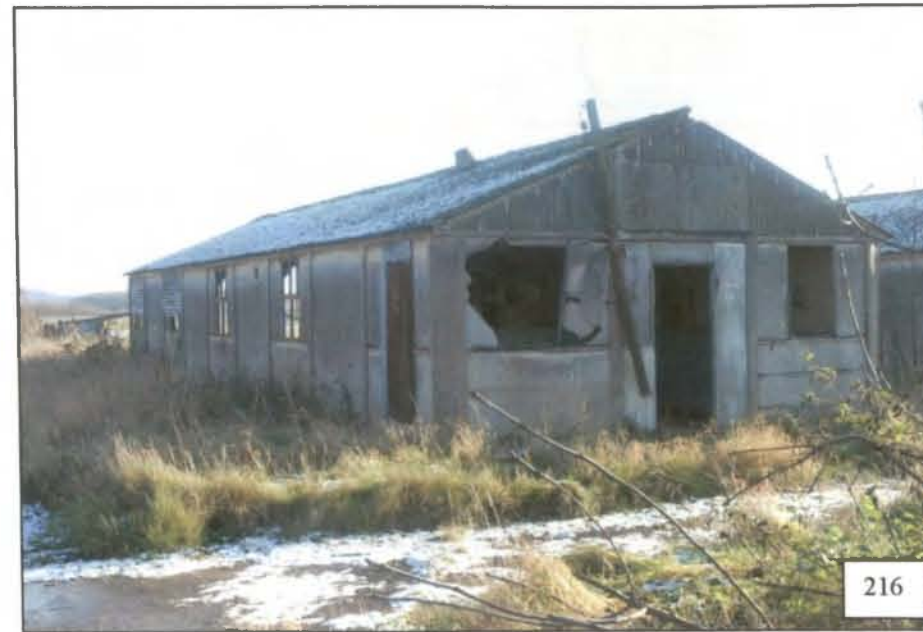
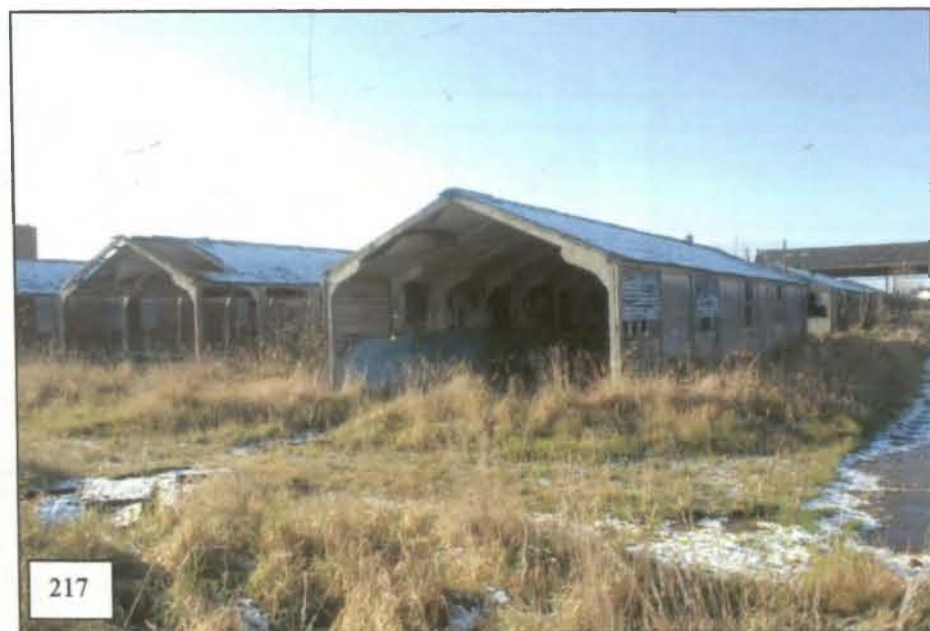
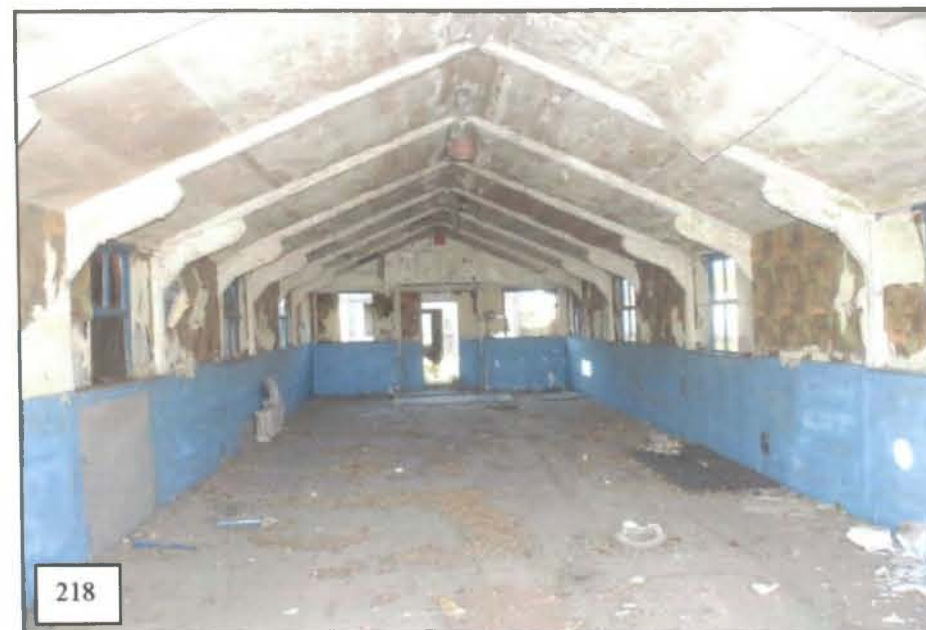
Hut P11

This was a typical MoWP accommodation hut, located to the immediate south of the CRS Hut 10C.

It had lost its eastern gable wall, and the easternmost bay, probably to allow vehicular access for agricultural storage.
