PINGLEY CAMP, BRIGG, LINCOLNSHIRE

PHOTOGRAPHIC BUILDING SURVEY

Report prepared for Barford Builders by S. A. Savage

Site Code: PPCB 08
Planning ref: 119946
NGR: TA 0178 0680
LCNCC acc. no. 2008.189
PCA job no.:08-515

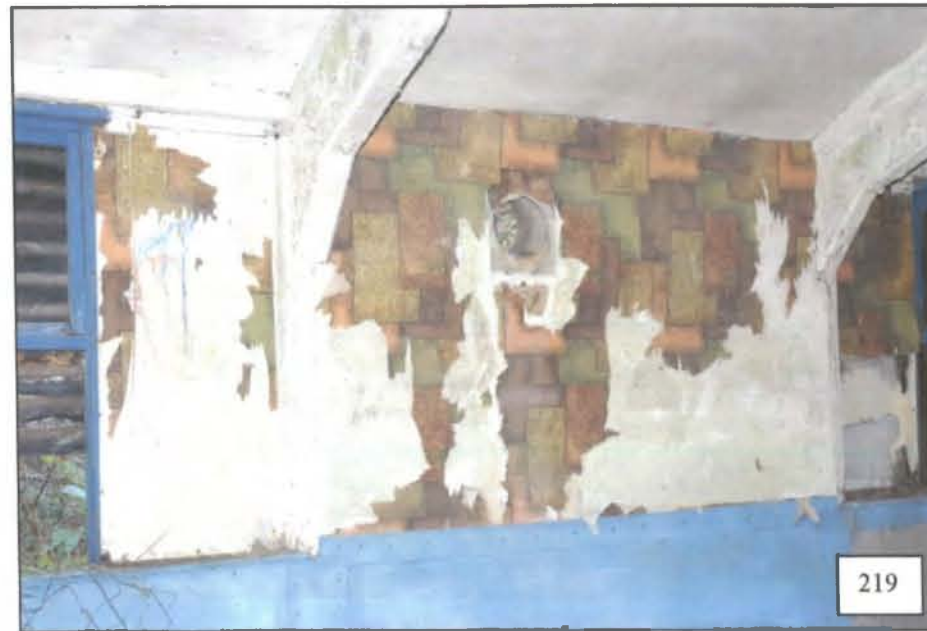
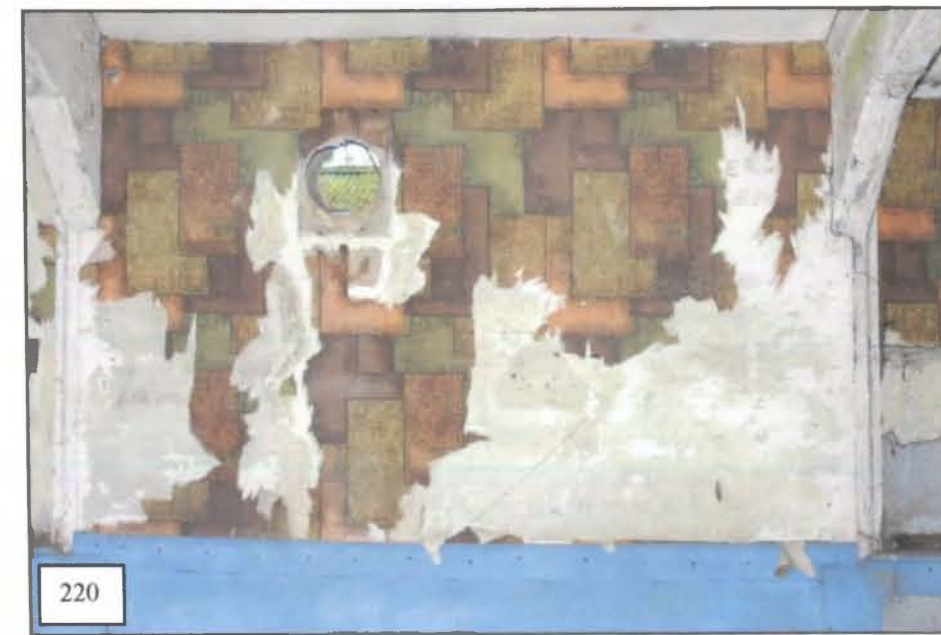
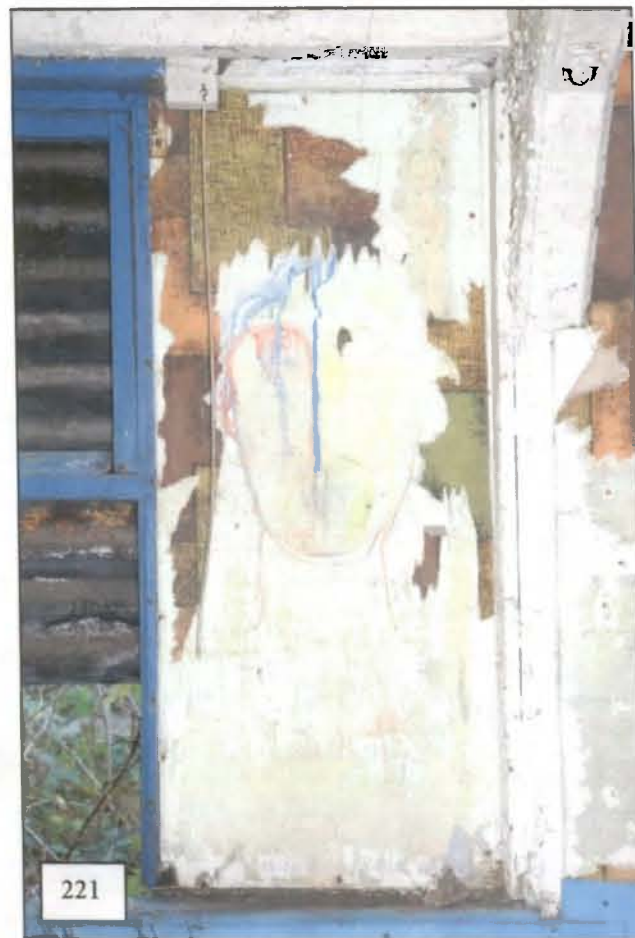
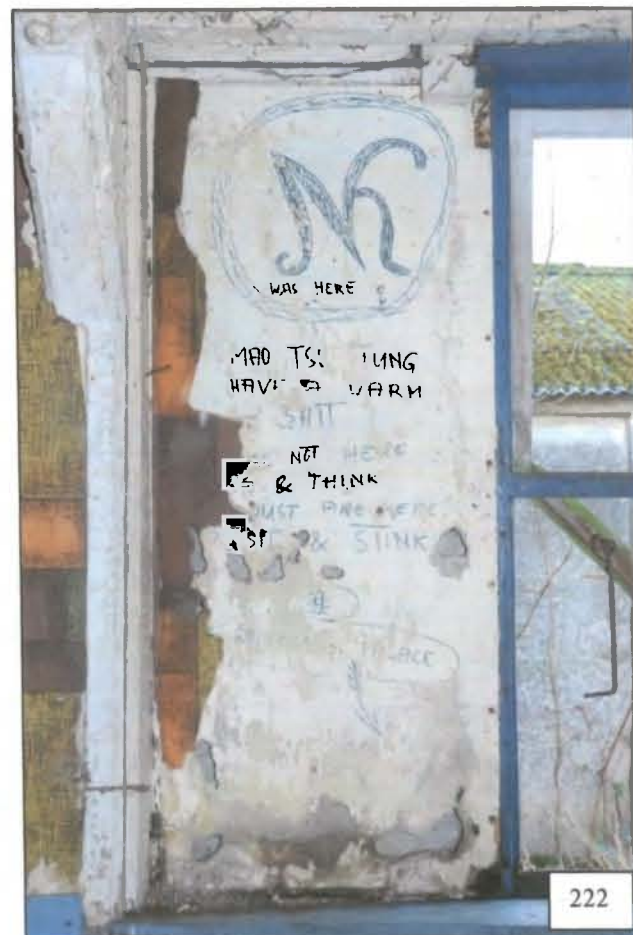
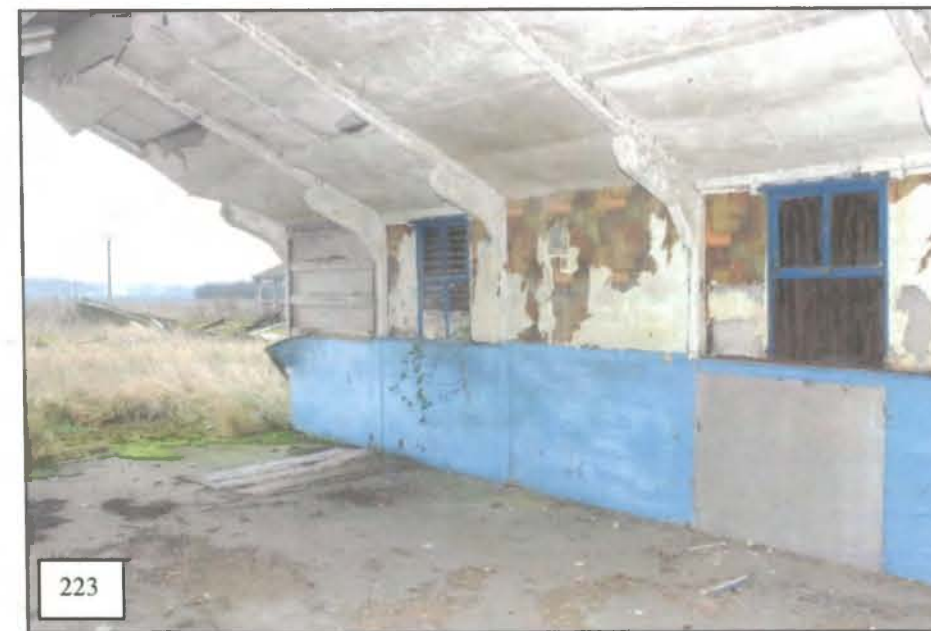
This hut contained several pieces of graffiti, which although probably not of wartime date, certainly predated the 1970s wallpaper from behind which portions of it could be seen. A coloured face could be made out behind the wallpaper on the western flanking panel of the easternmost window in the south wall. Behind the wallpaper of the blind panel adjacent to this, the feet and lower legs of a cartoon of a man could be made out in a patch of peeled wallpaper.

A ribald poem and a monogram were also present on the eastern flanking panel of the westernmost window on the south side. Although initially discounted as being recent, closer inspection proved that this too lay beneath the wallpaper.

The graffiti behind the wallpaper in Hut 11, which does not date to the period of the site's use as a prisoner of war camp, is damaged in one case, fragmentary in another and obscene in the case of the third. It is proposed that this too, has been adequately recorded as part of this survey.

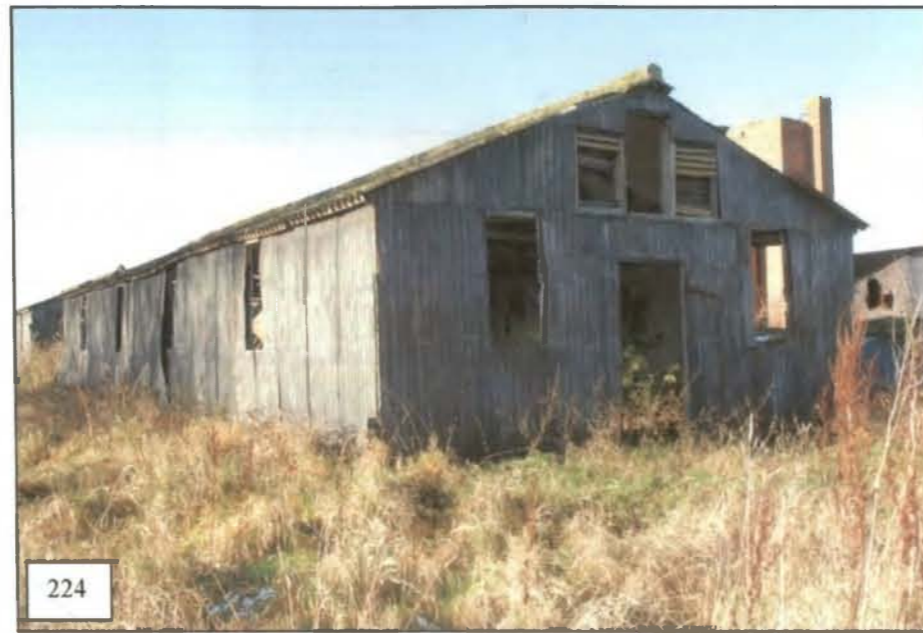
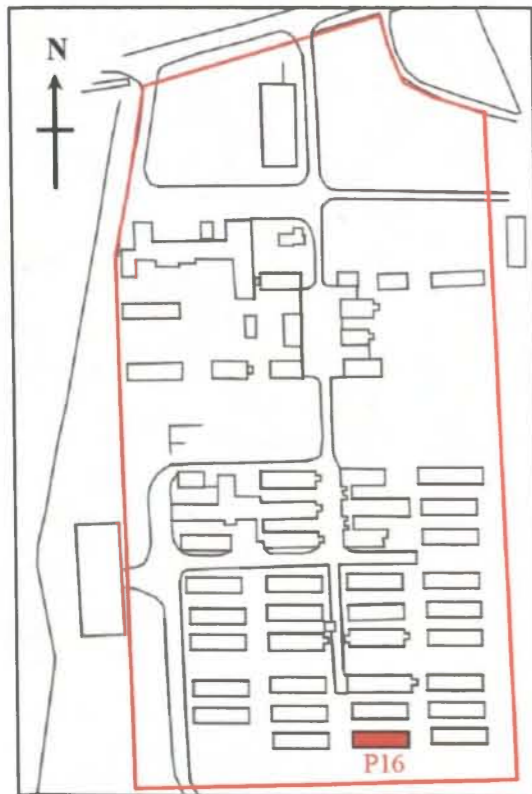
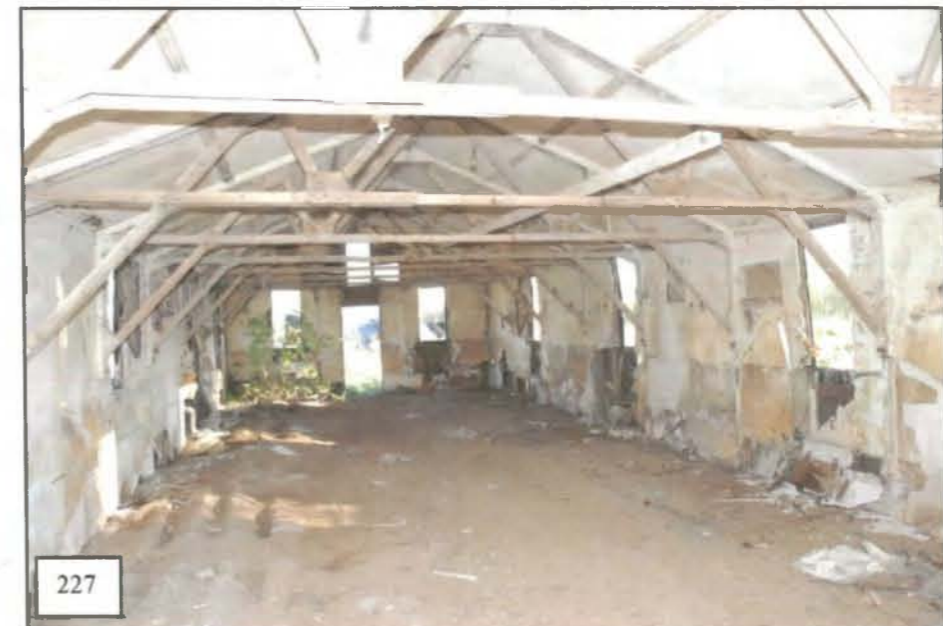
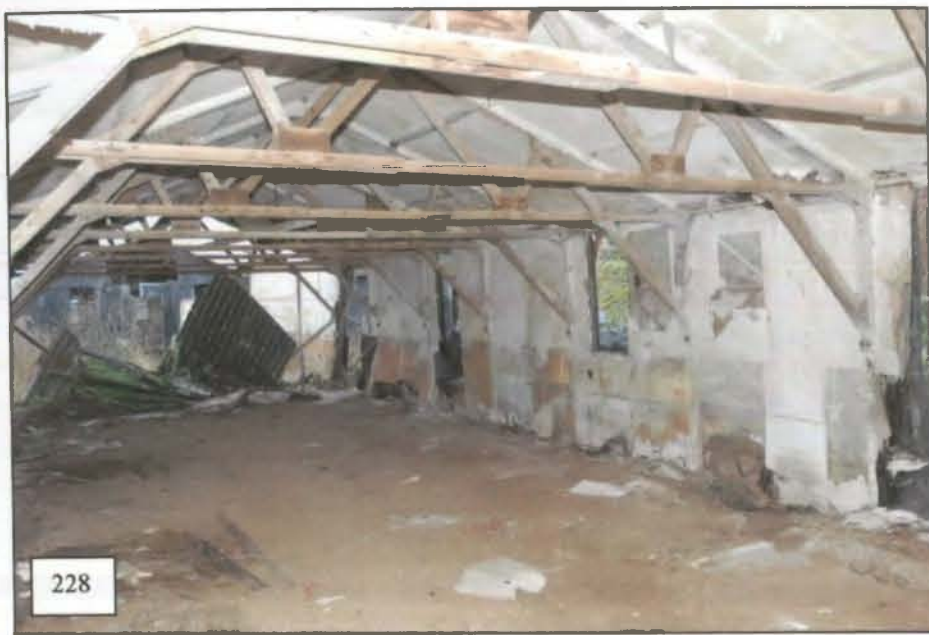
This hut was in a precarious state, and the western gable had already collapsed.

This hut has proved to be the location of a quantity of prisoner-of war art: this is witnessed by the many pieces of missing plasterboard on its walls.

Only two pieces of art are now recognisable in this hut. On the north wall, in the fifth bay from the west end of the hut, a drawing of the Walt Disney cartoon character 'Goofy' was present. Unfortunately, this is now badly damaged and barely recognisable.

The remaining art comprises the Walt Disney cartoon characters in Hut P16. The 'Goofy' character on the north wall is so badly damaged that it is no longer recognisable. The small Mickey Mouse and Minnie Mouse cartoons on the south wall of Hut P16 are of some quality of execution, are small, and could be detached from their location. These may represent articles which could be conserved and displayed.

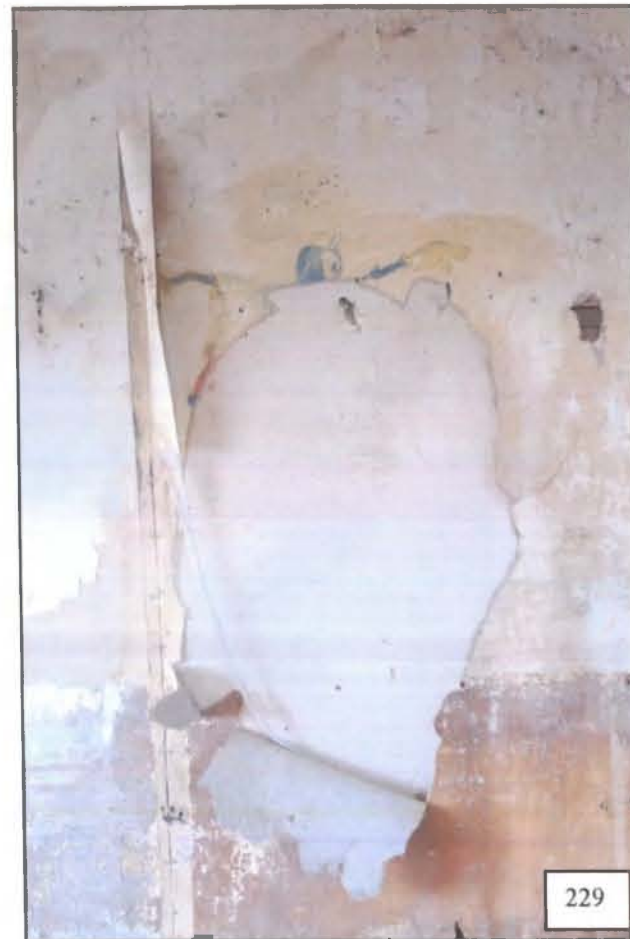
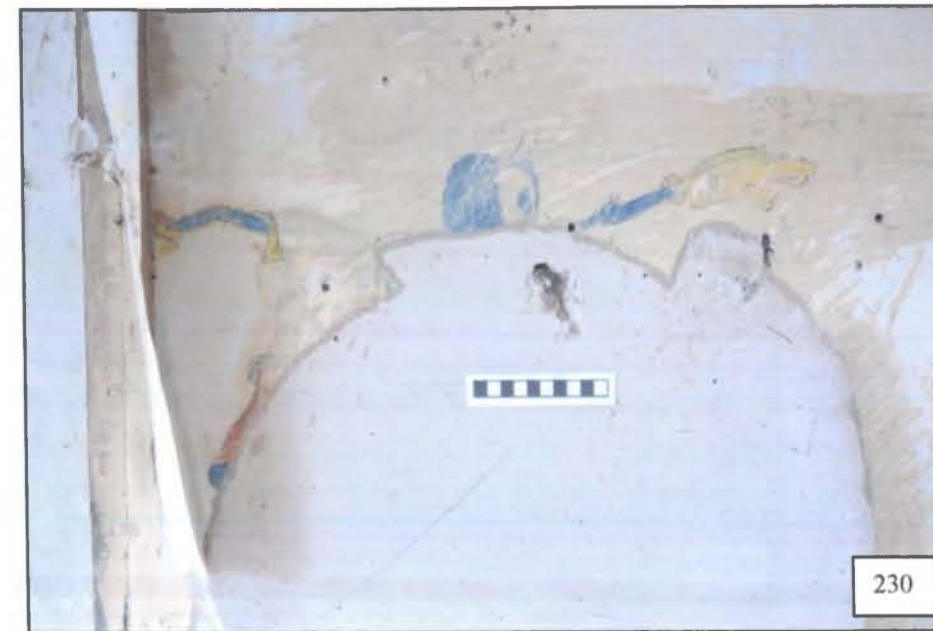
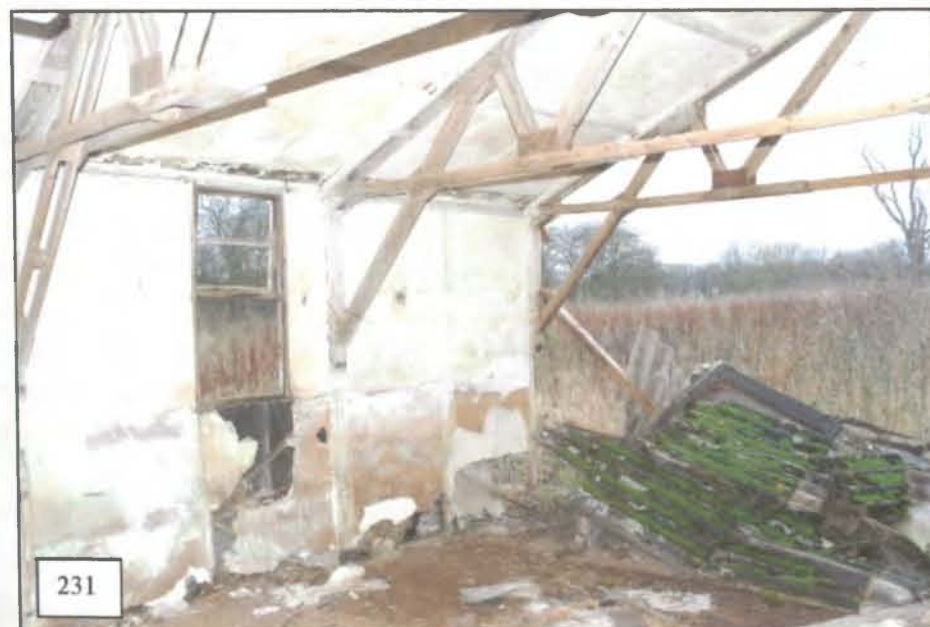
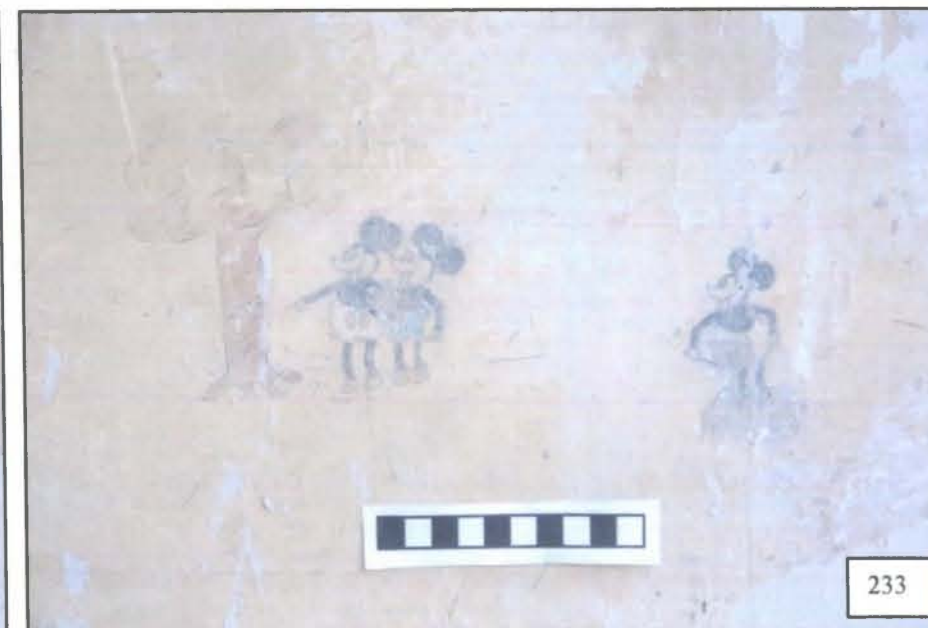
At the west end of the hut, on the south side, two small cartoons of Mickey and Minnie Mouse are present on the last intact wall panel. These figures are very small, only 70mm in height. They are drawn in wax pencil on the surface of the lining paper, and are only visible because the whitewash, which had been painted over them, has flaked off in the increasingly damp conditions.

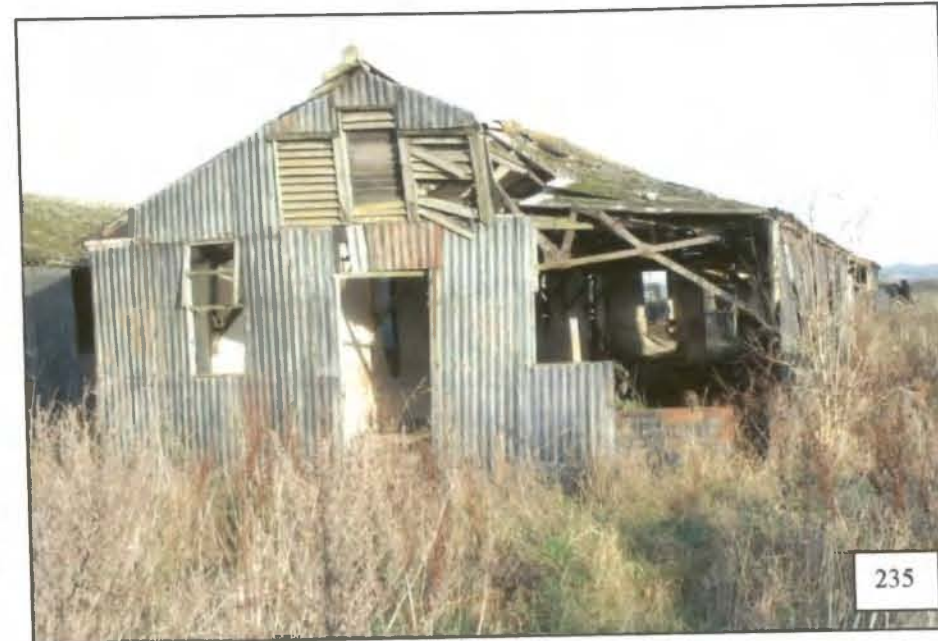
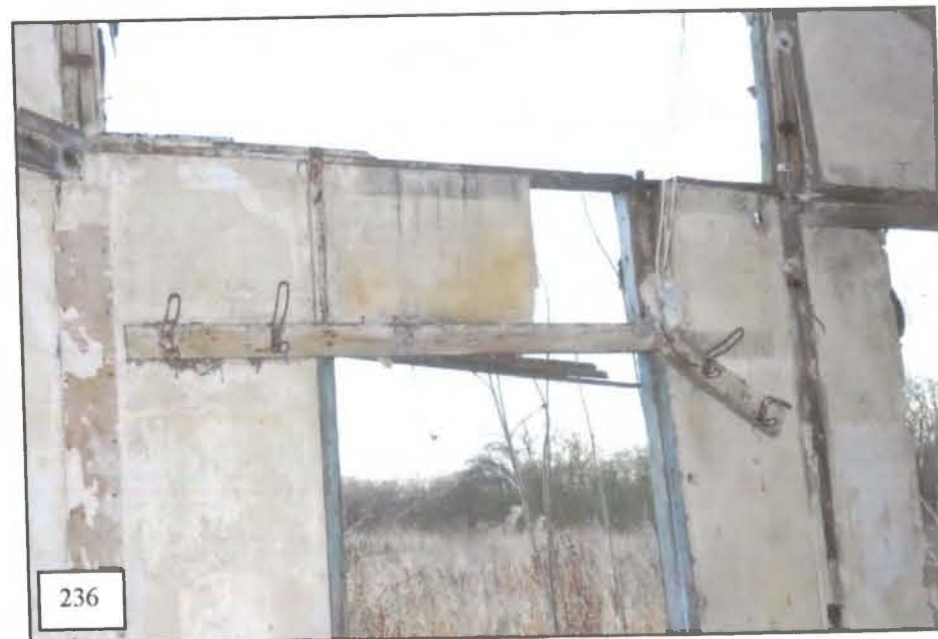
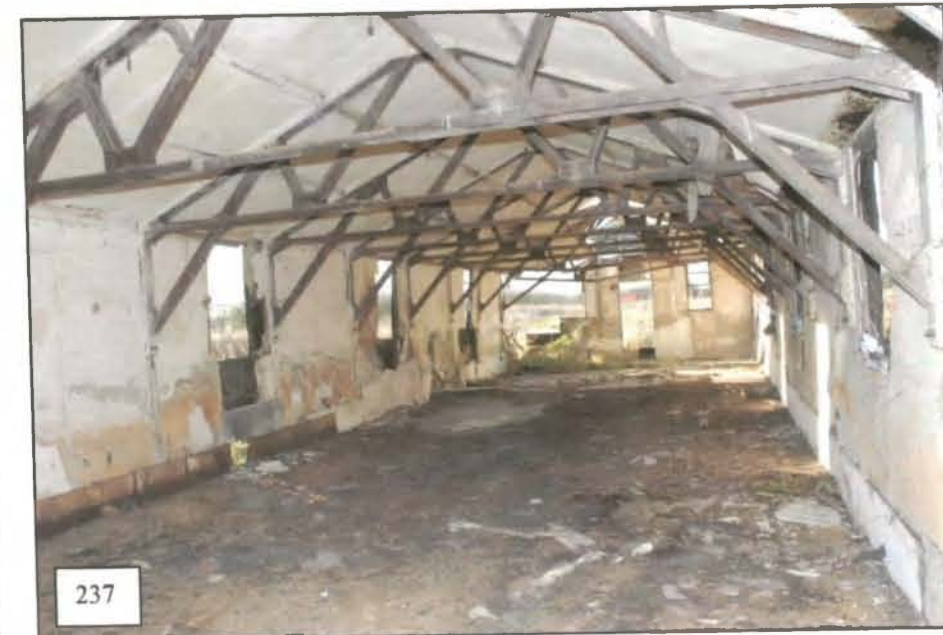
Hut P17

This was a typical Laing timber-framed accommodation hut, located in the southernmost row of huts, immediately to the west of the spine road.

Lying on the floor of this hut, apparently torn from the wall, a piece of the lining paper with a pencil drawing of three female figures, and a man in a suit and hat was discovered.

In the case of the pencil drawings of three female figures and a man in a suit and hat, which were lying on the floor of Hut 17, further assessment into the condition of the piece by an expert conservator is necessary to determine its condition and conservation requirements.

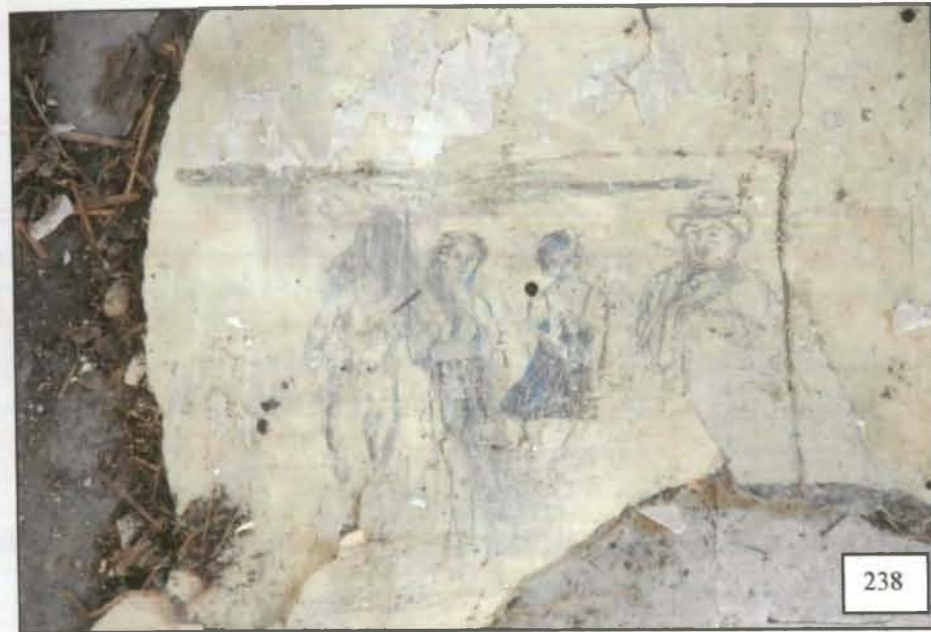
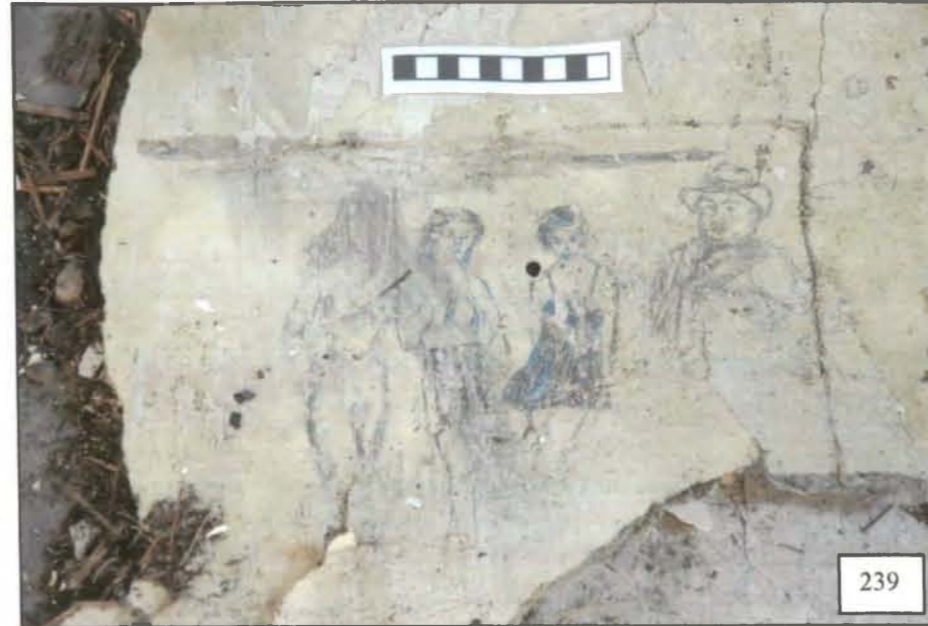
Matching the torn edges proved that this had been removed from the south wall of the hut.

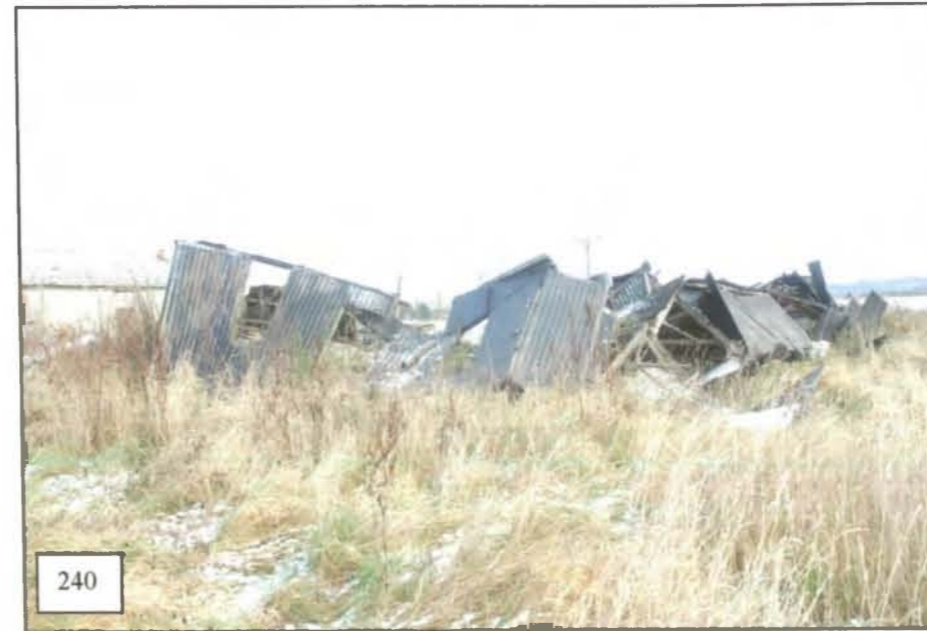
This was a prisoners' living hut located to the south of Hut P4 and had also been demolished.

It comprised a Laing timber-framed type hut of ten bays, oriented east-west. The roof and gables were of corrugated asbestos panels. It had been clad in corrugated metal panels and lined with plasterboard.

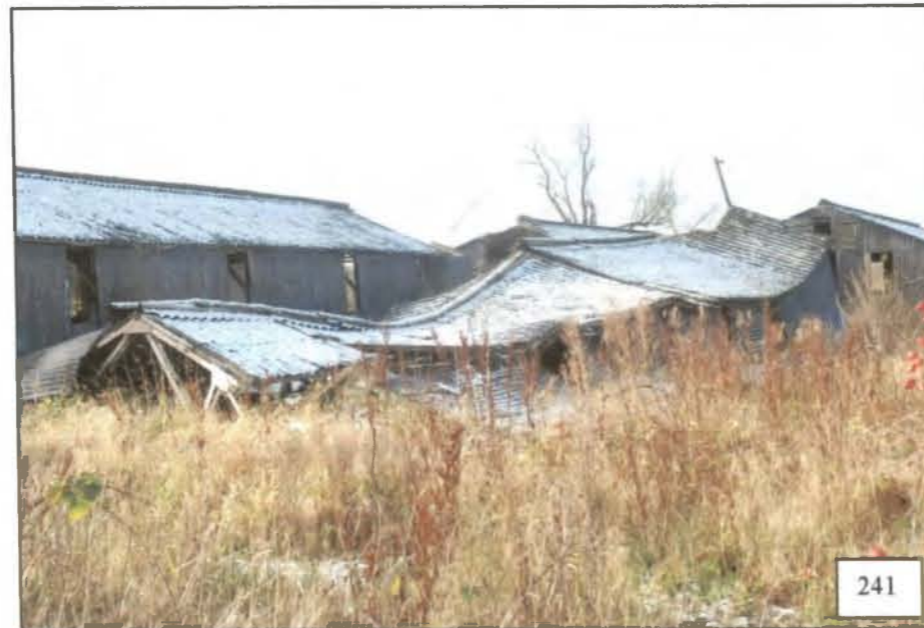
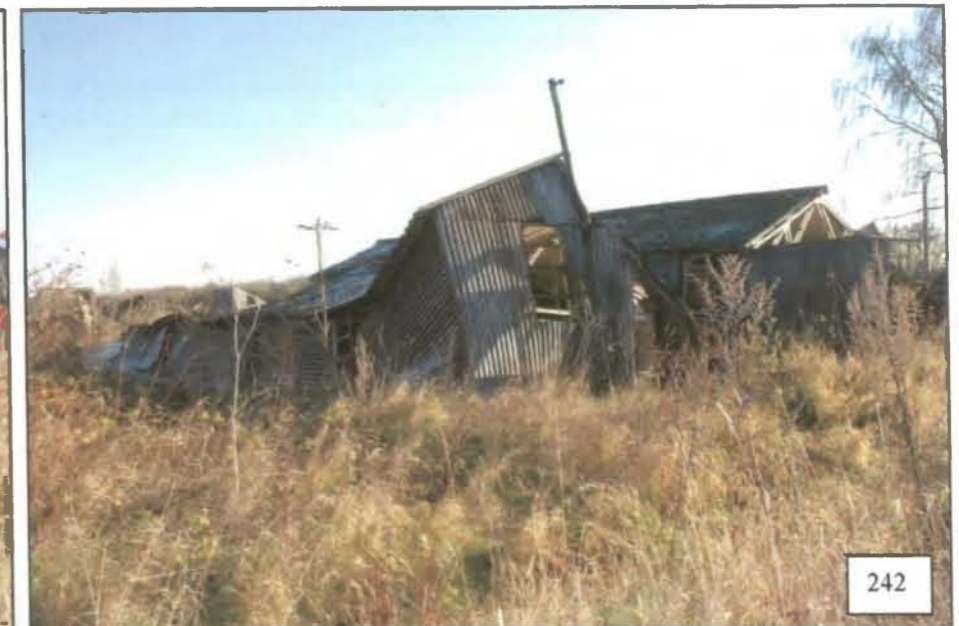
Hut P15

This was a prisoners' living hut located to the south of Hut P14 and had collapsed.

It comprised a Laing timber-framed type hut of ten bays, oriented east-west. The roof and gables were of corrugated asbestos panels. It had been clad in corrugated metal panels and lined with plasterboard.

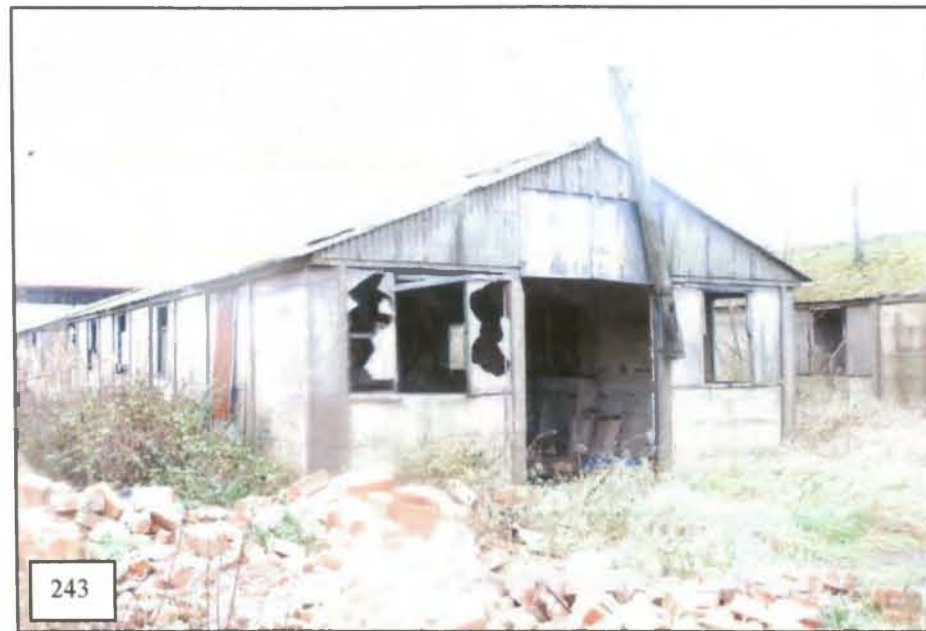
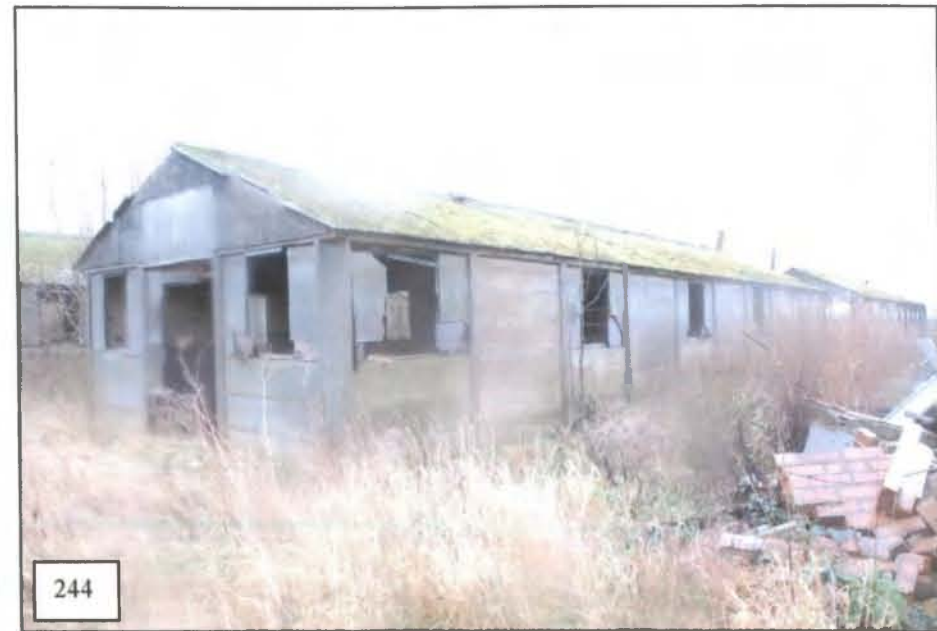
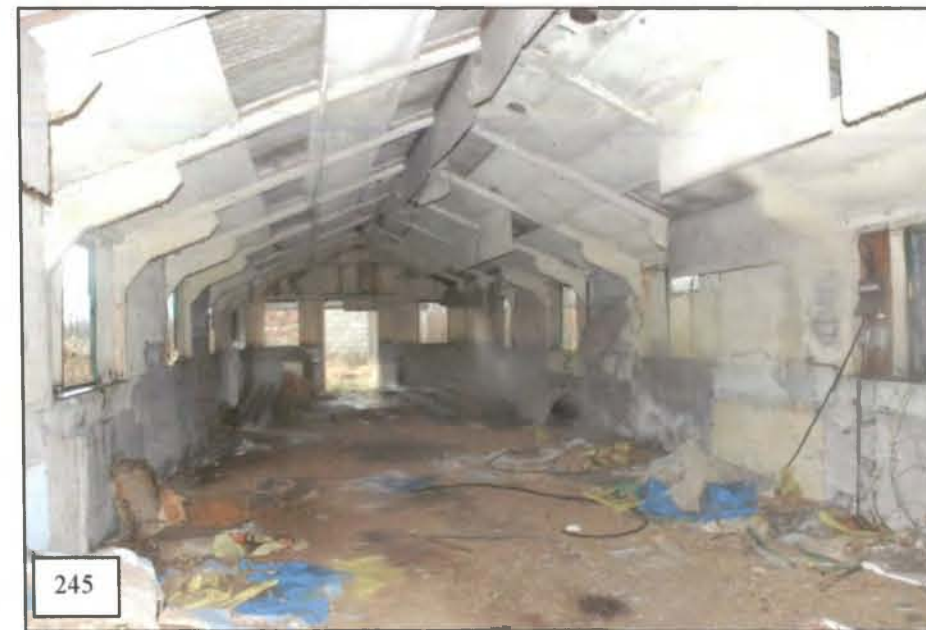
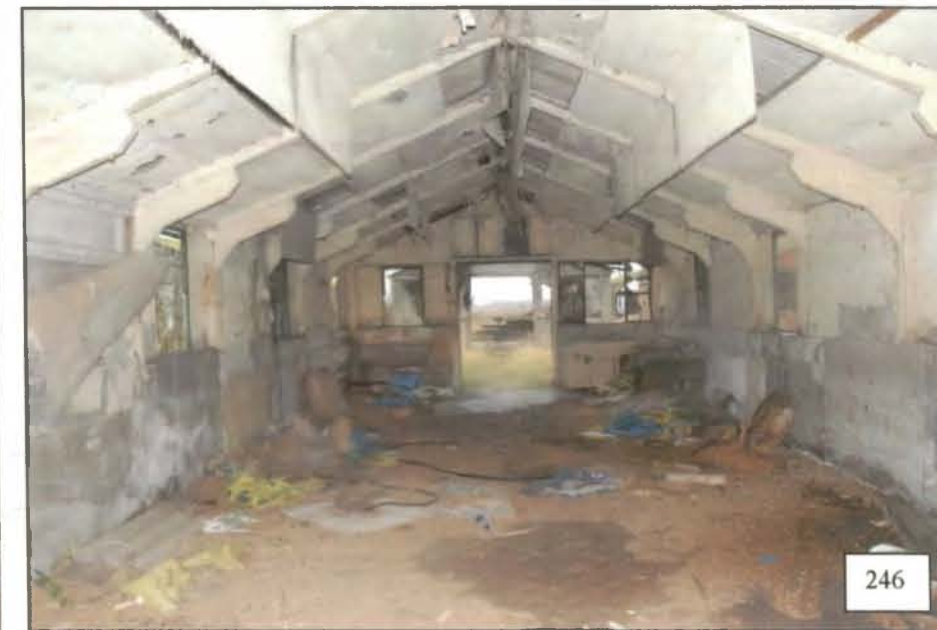
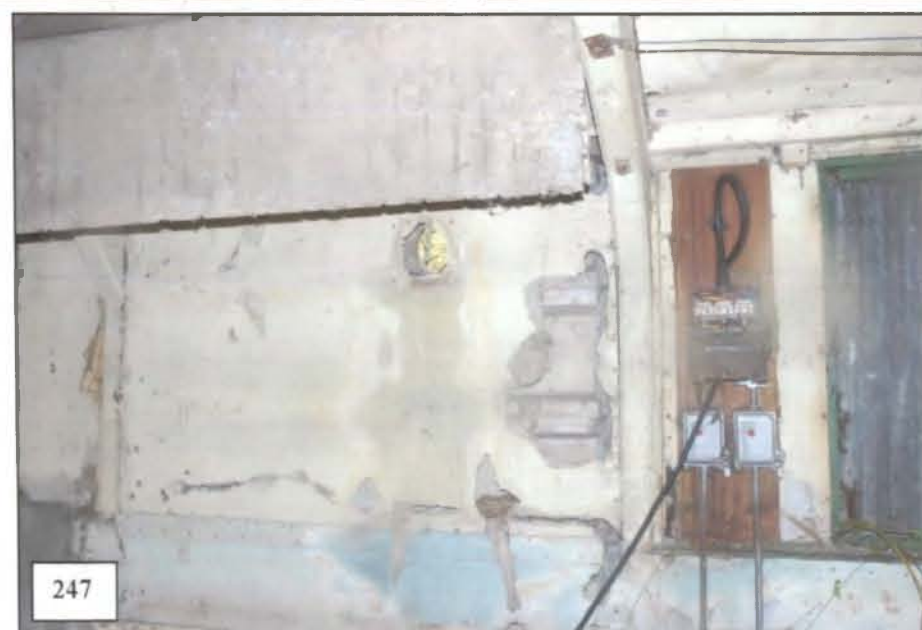
Hut P22 was a typical hut of the MoWP Type, located to the immediate south of the Camp Leader's Hut P21.

It was a fairly complete example of its type, unusually with the stovepipe exits from pot-bellied stoves exiting through the walls rather than the roof. It had most recently been used as a feed store for the chickens housed in huts P16, P17 and P25.

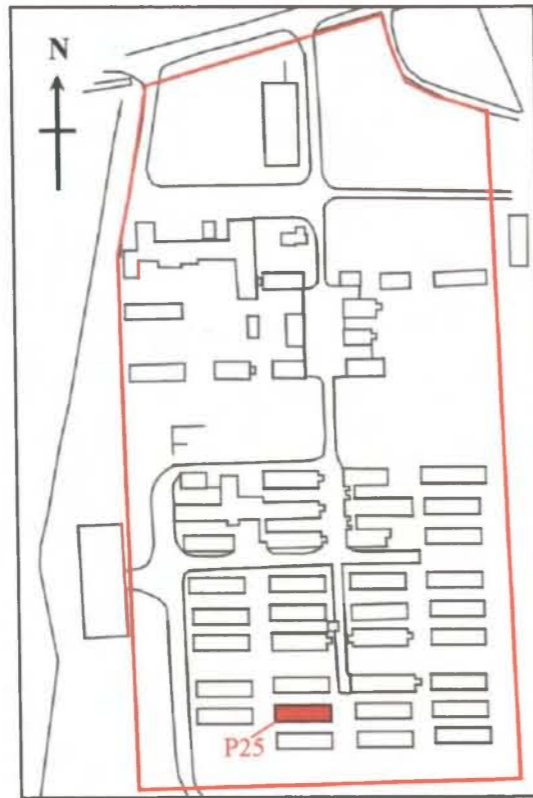
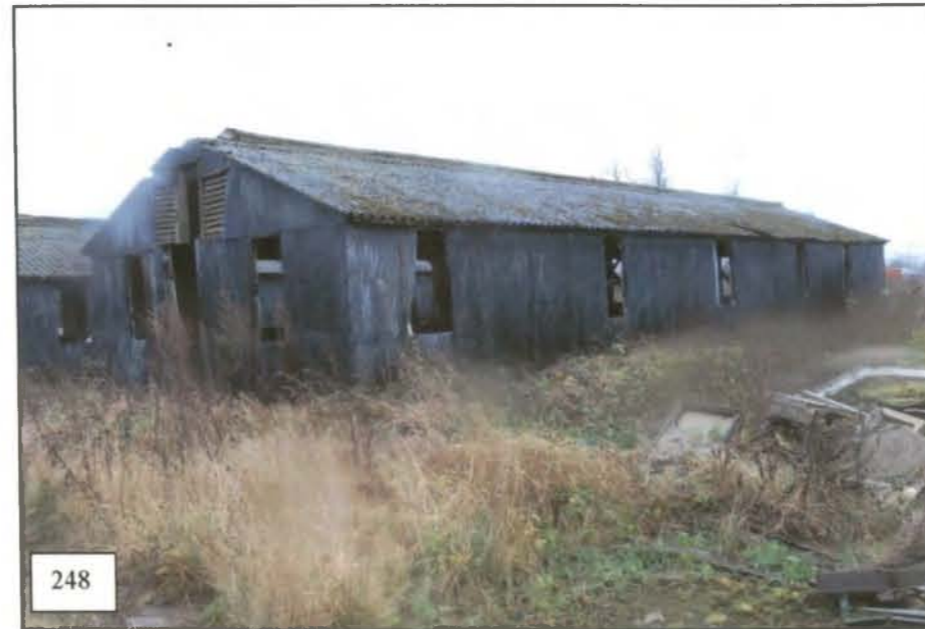
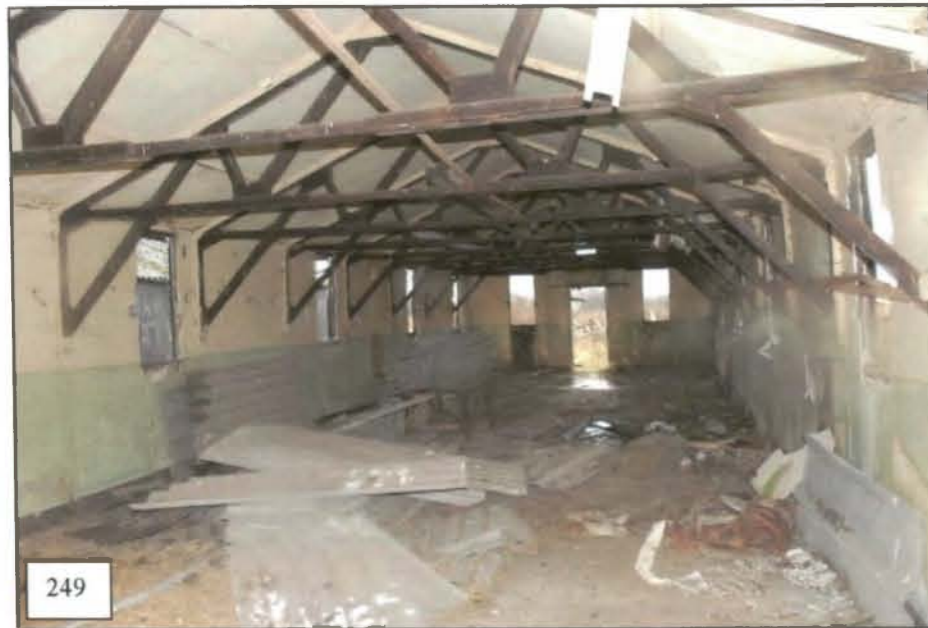
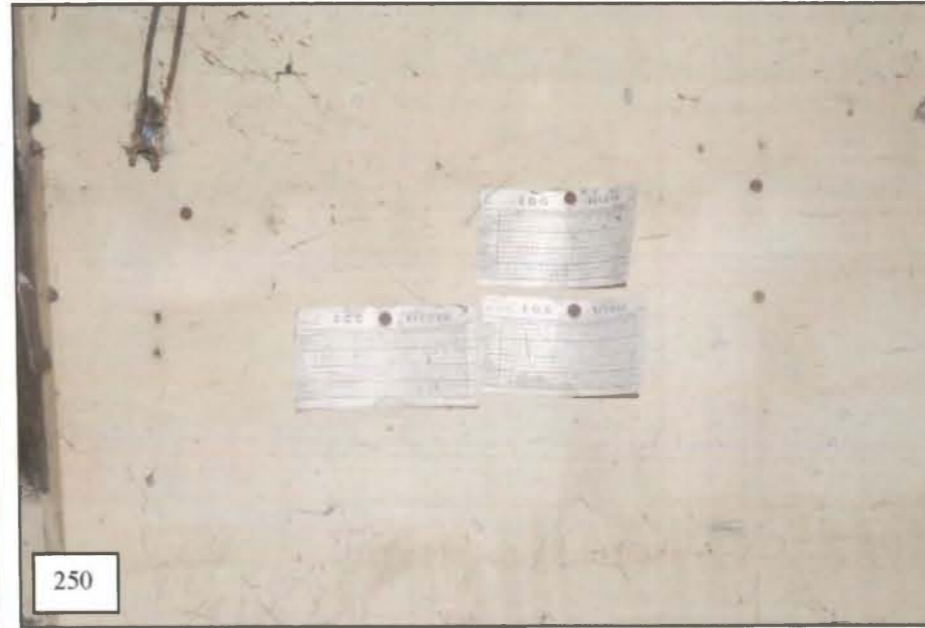
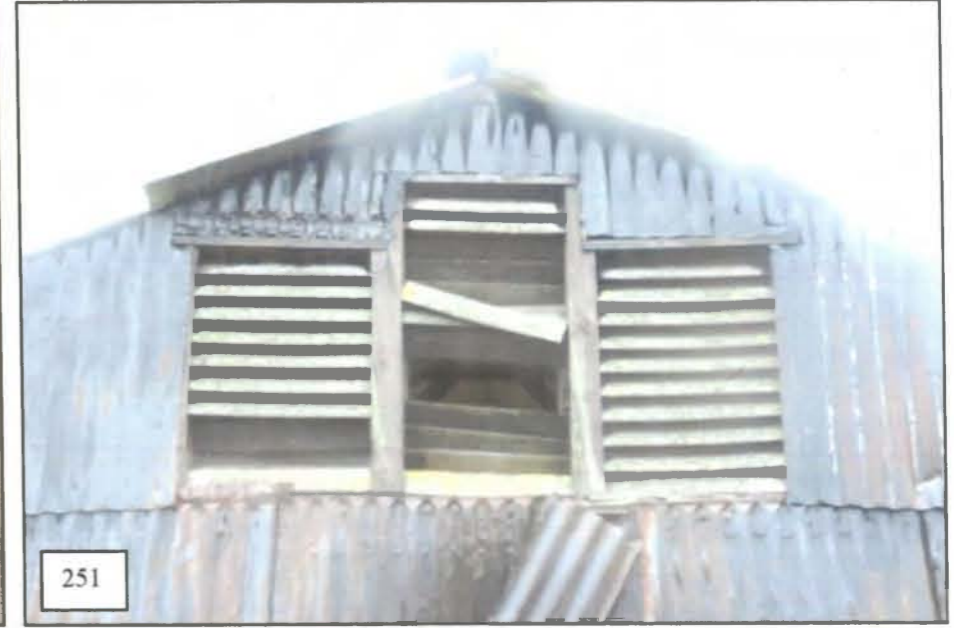
Hut P25

This was a typical Laing timber-framed accommodation hut, located to the immediate north of Hut P17, immediately to the west of the spine road. Like Huts 16, 17 and 25, this hut had most recently housed chickens, as witnessed by the egg records pinned to the wall.

This hut also had the most complete example of the three slatted panel gable ventilator employed in this type of hut.

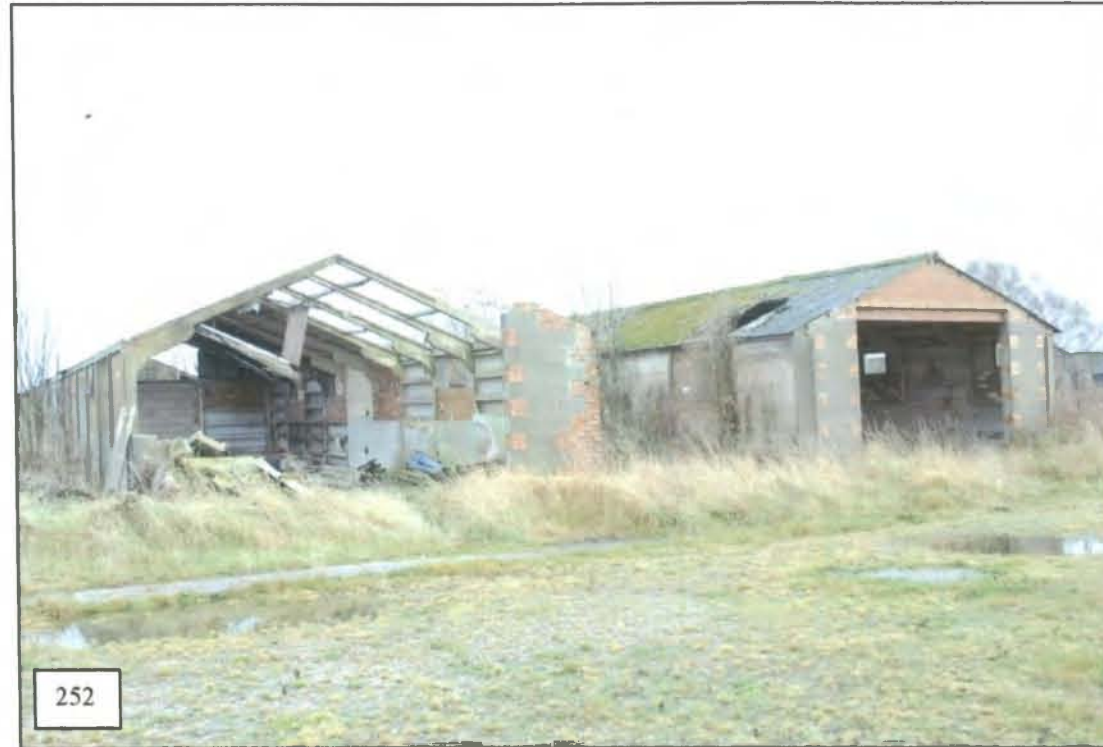
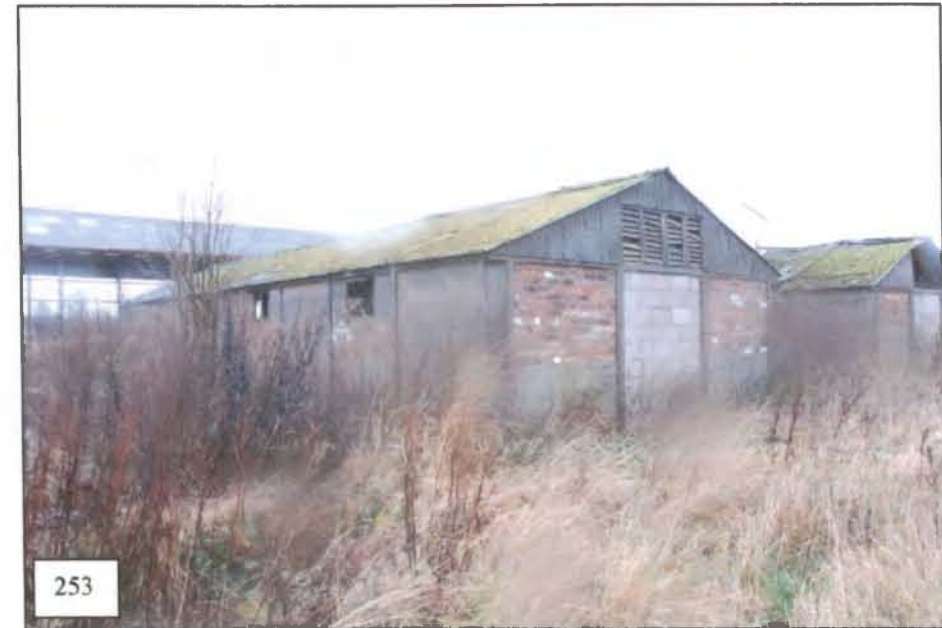
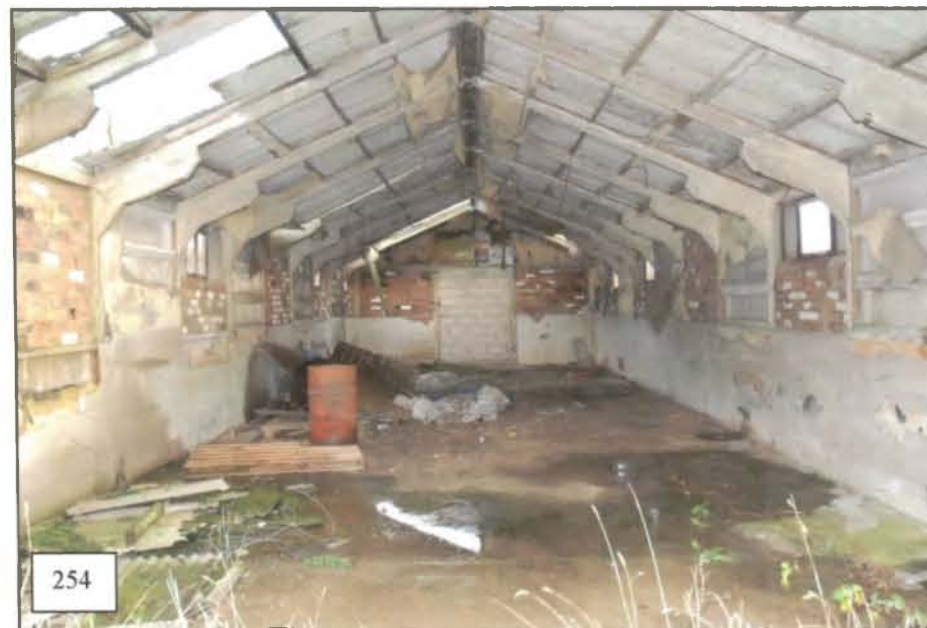
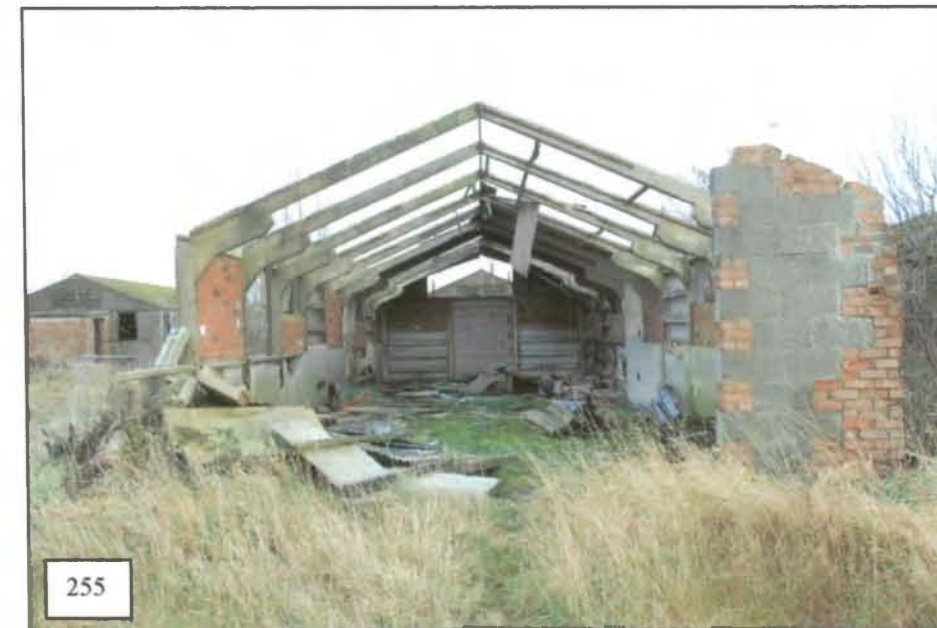
Huts P29 & P30

These were originally prisoners' living huts located to the south of Hut P31 and had been most recently converted to a garage function.

They both comprised MoWP type huts, oriented east-west, with concrete frames of ten bays, infilled with pre-cast concrete panels. They retained their original roof and eastern gable, which were of corrugated asbestos panels and the east gables retained their four panel slatted timber ventilators.

The recent conversion into a garage/storage function has completely altered the appearance of these structures.

The west gable of Hut 29 was altered in re-used modern brick and breezeblocks to produce a large door opening with a heavy I-beam steel lintel. All of the original windowed bays in the sides of the building were filled in with re-used 4" brickwork and had small two-light windows constructed below the eaves. In the eastern gable, the window panels were completely bricked up and the central panel was entirely blocked in breezeblocks.

Hut P30 had been converted in exactly the same fashion as Hut P29, but it has since been fire damaged and retained little of its roof, while the western end had partially collapsed.
