PINGLEY CAMP, BRIGG, LINCOLNSHIRE

PHOTOGRAPHIC BUILDING SURVEY

Report prepared for Barford Builders by S. A. Savage

Site Code: PPCB 08
Planning ref: 119946
NGR: TA 0178 0680
LCNCC acc. no. 2008.189
PCA job no.:08-515

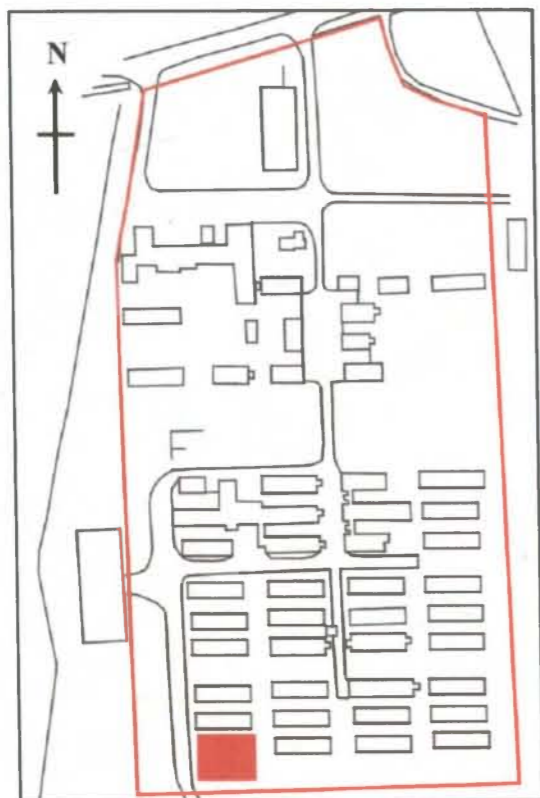
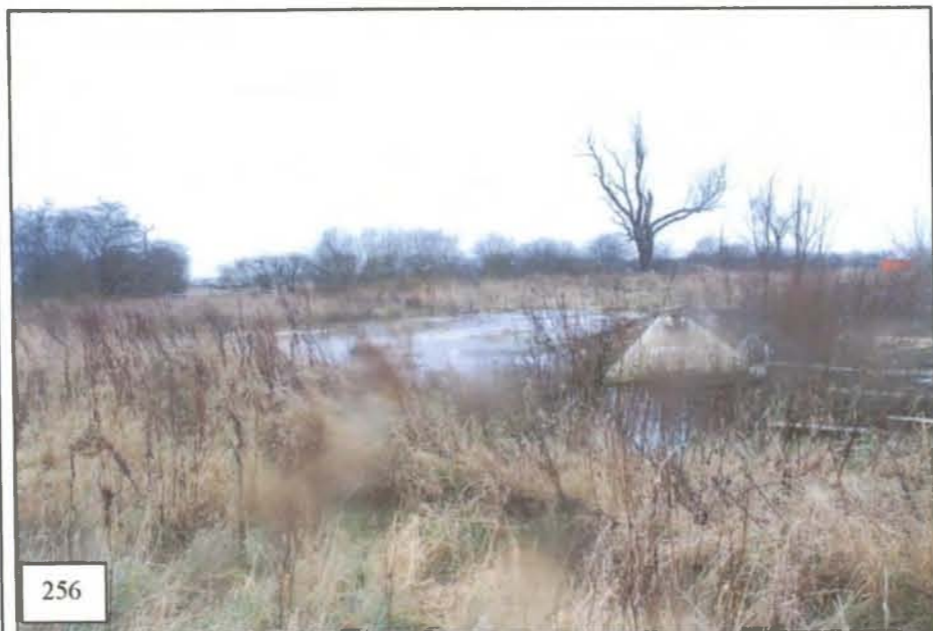
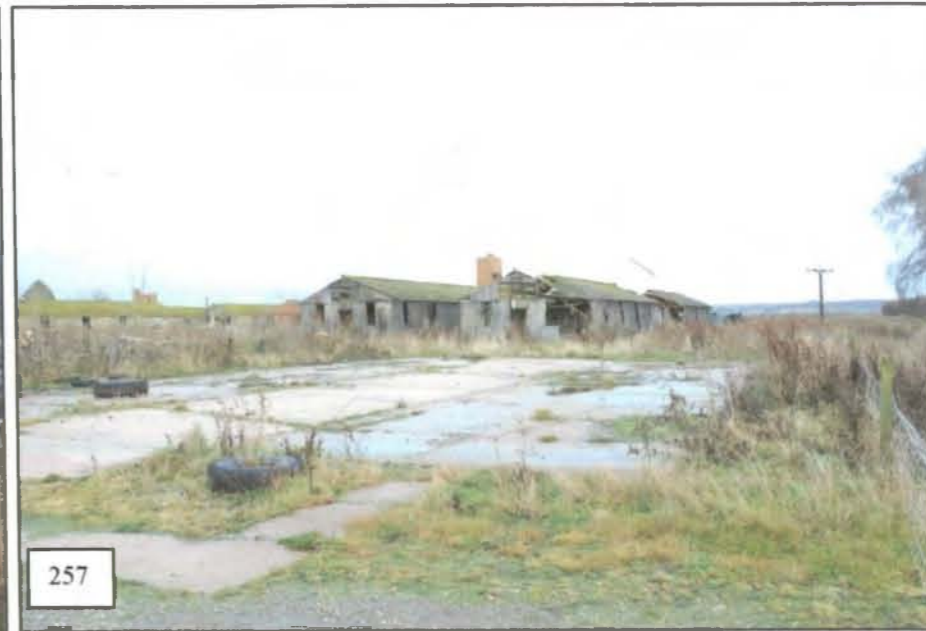
SW Corner

The hut in the southwest corner of the prisoner compound was demolished and a new building was constructed here. This building has also now gone, leaving behind only the poured concrete floor slab.

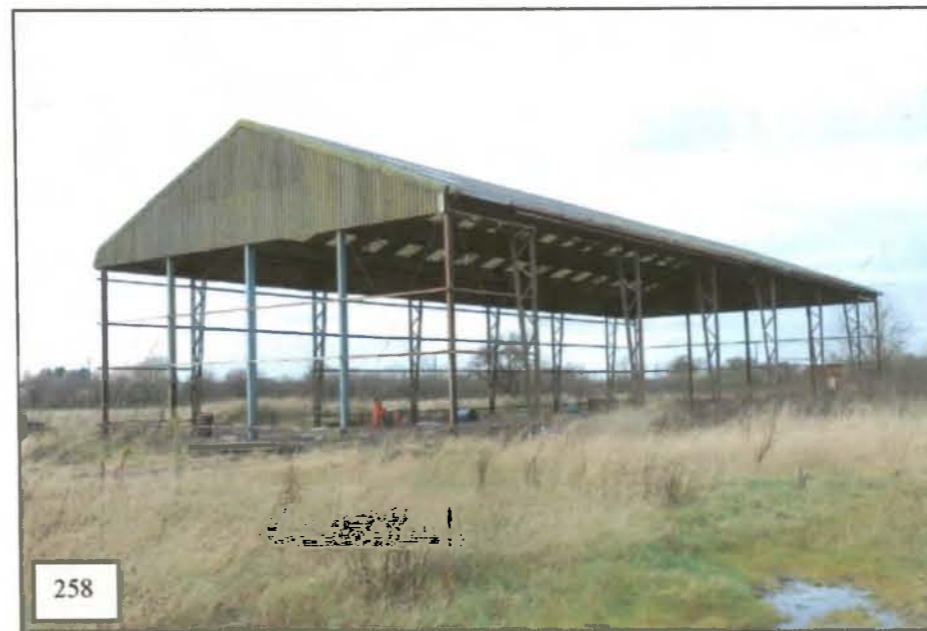
Dutch Barn

This structure lies to the immediate west of the proposed development area, and dominates the site. It is not considered contemporary with the prisoner of war camp; it is more likely to be associated with the use of the site as a hostel for agricultural workers.

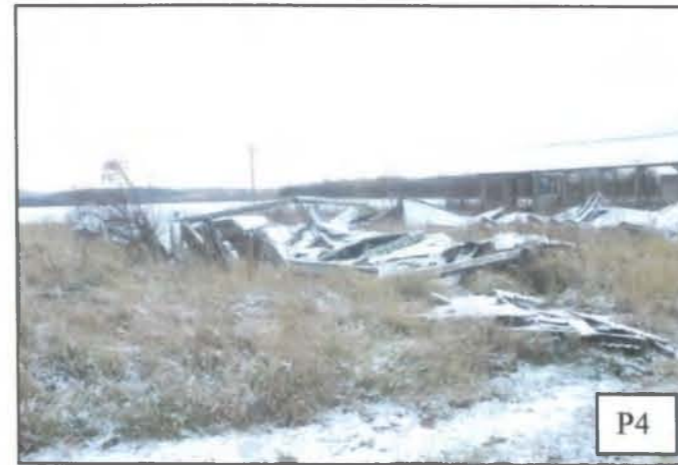
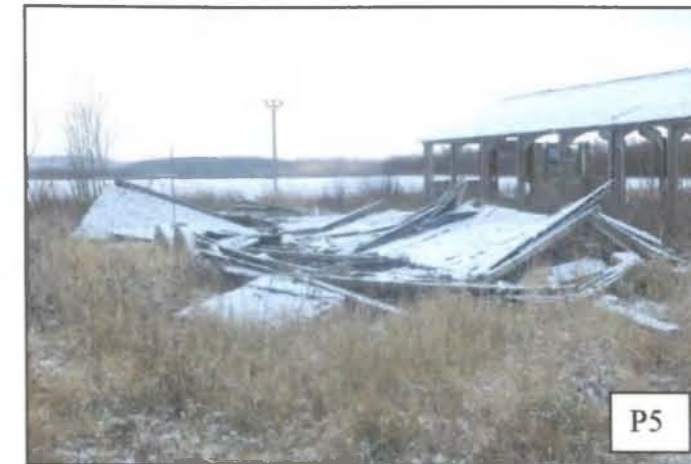
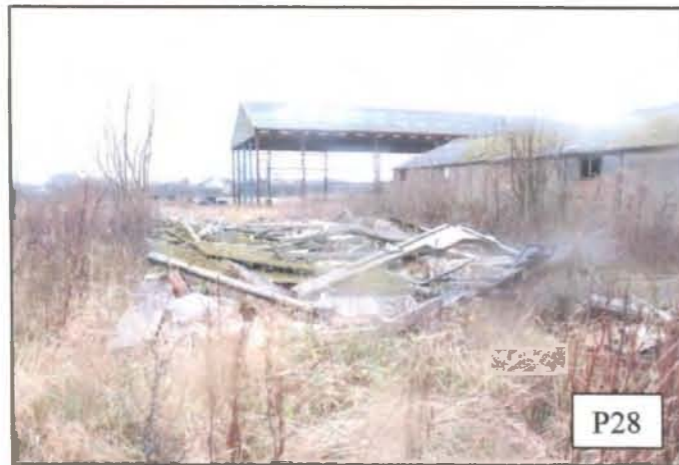
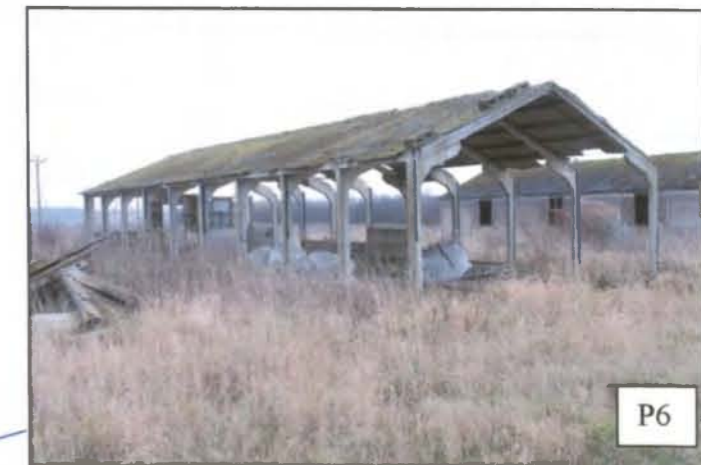
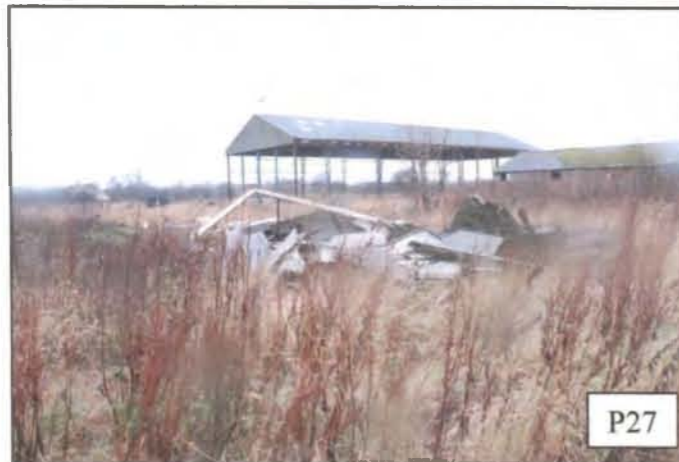
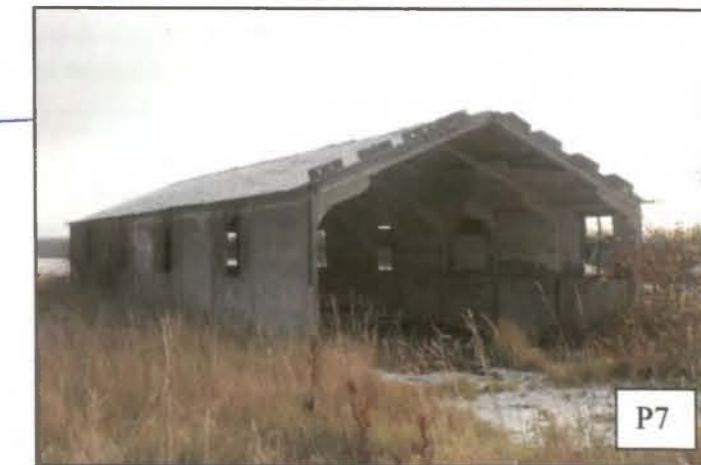
Damaged and demolished living huts – MoWP type

Several of the living huts have been heavily damaged or demolished.

These were MoWP type huts, all were oriented east-west, with a concrete frame of ten bays, infilled with pre-cast concrete panels. Their roofs and gables were of corrugated asbestos panels.

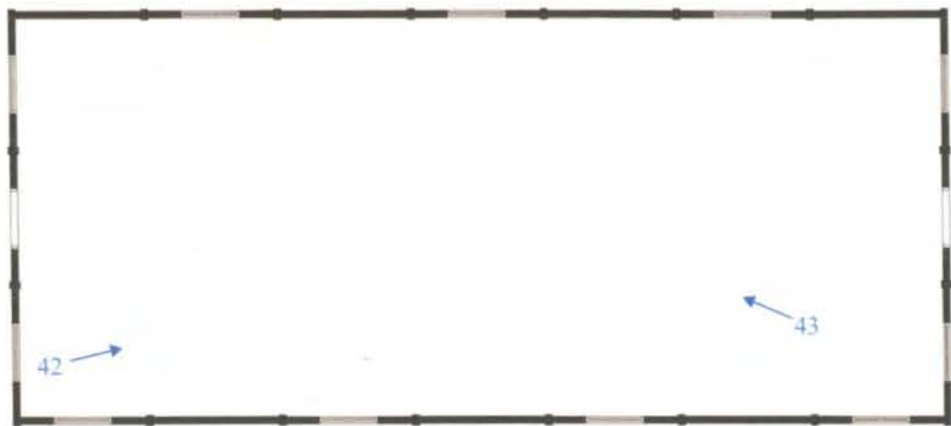
HUT G7

Plan showing the locations and directions of photographs taken of Hut G7(left). Scale 1:100.

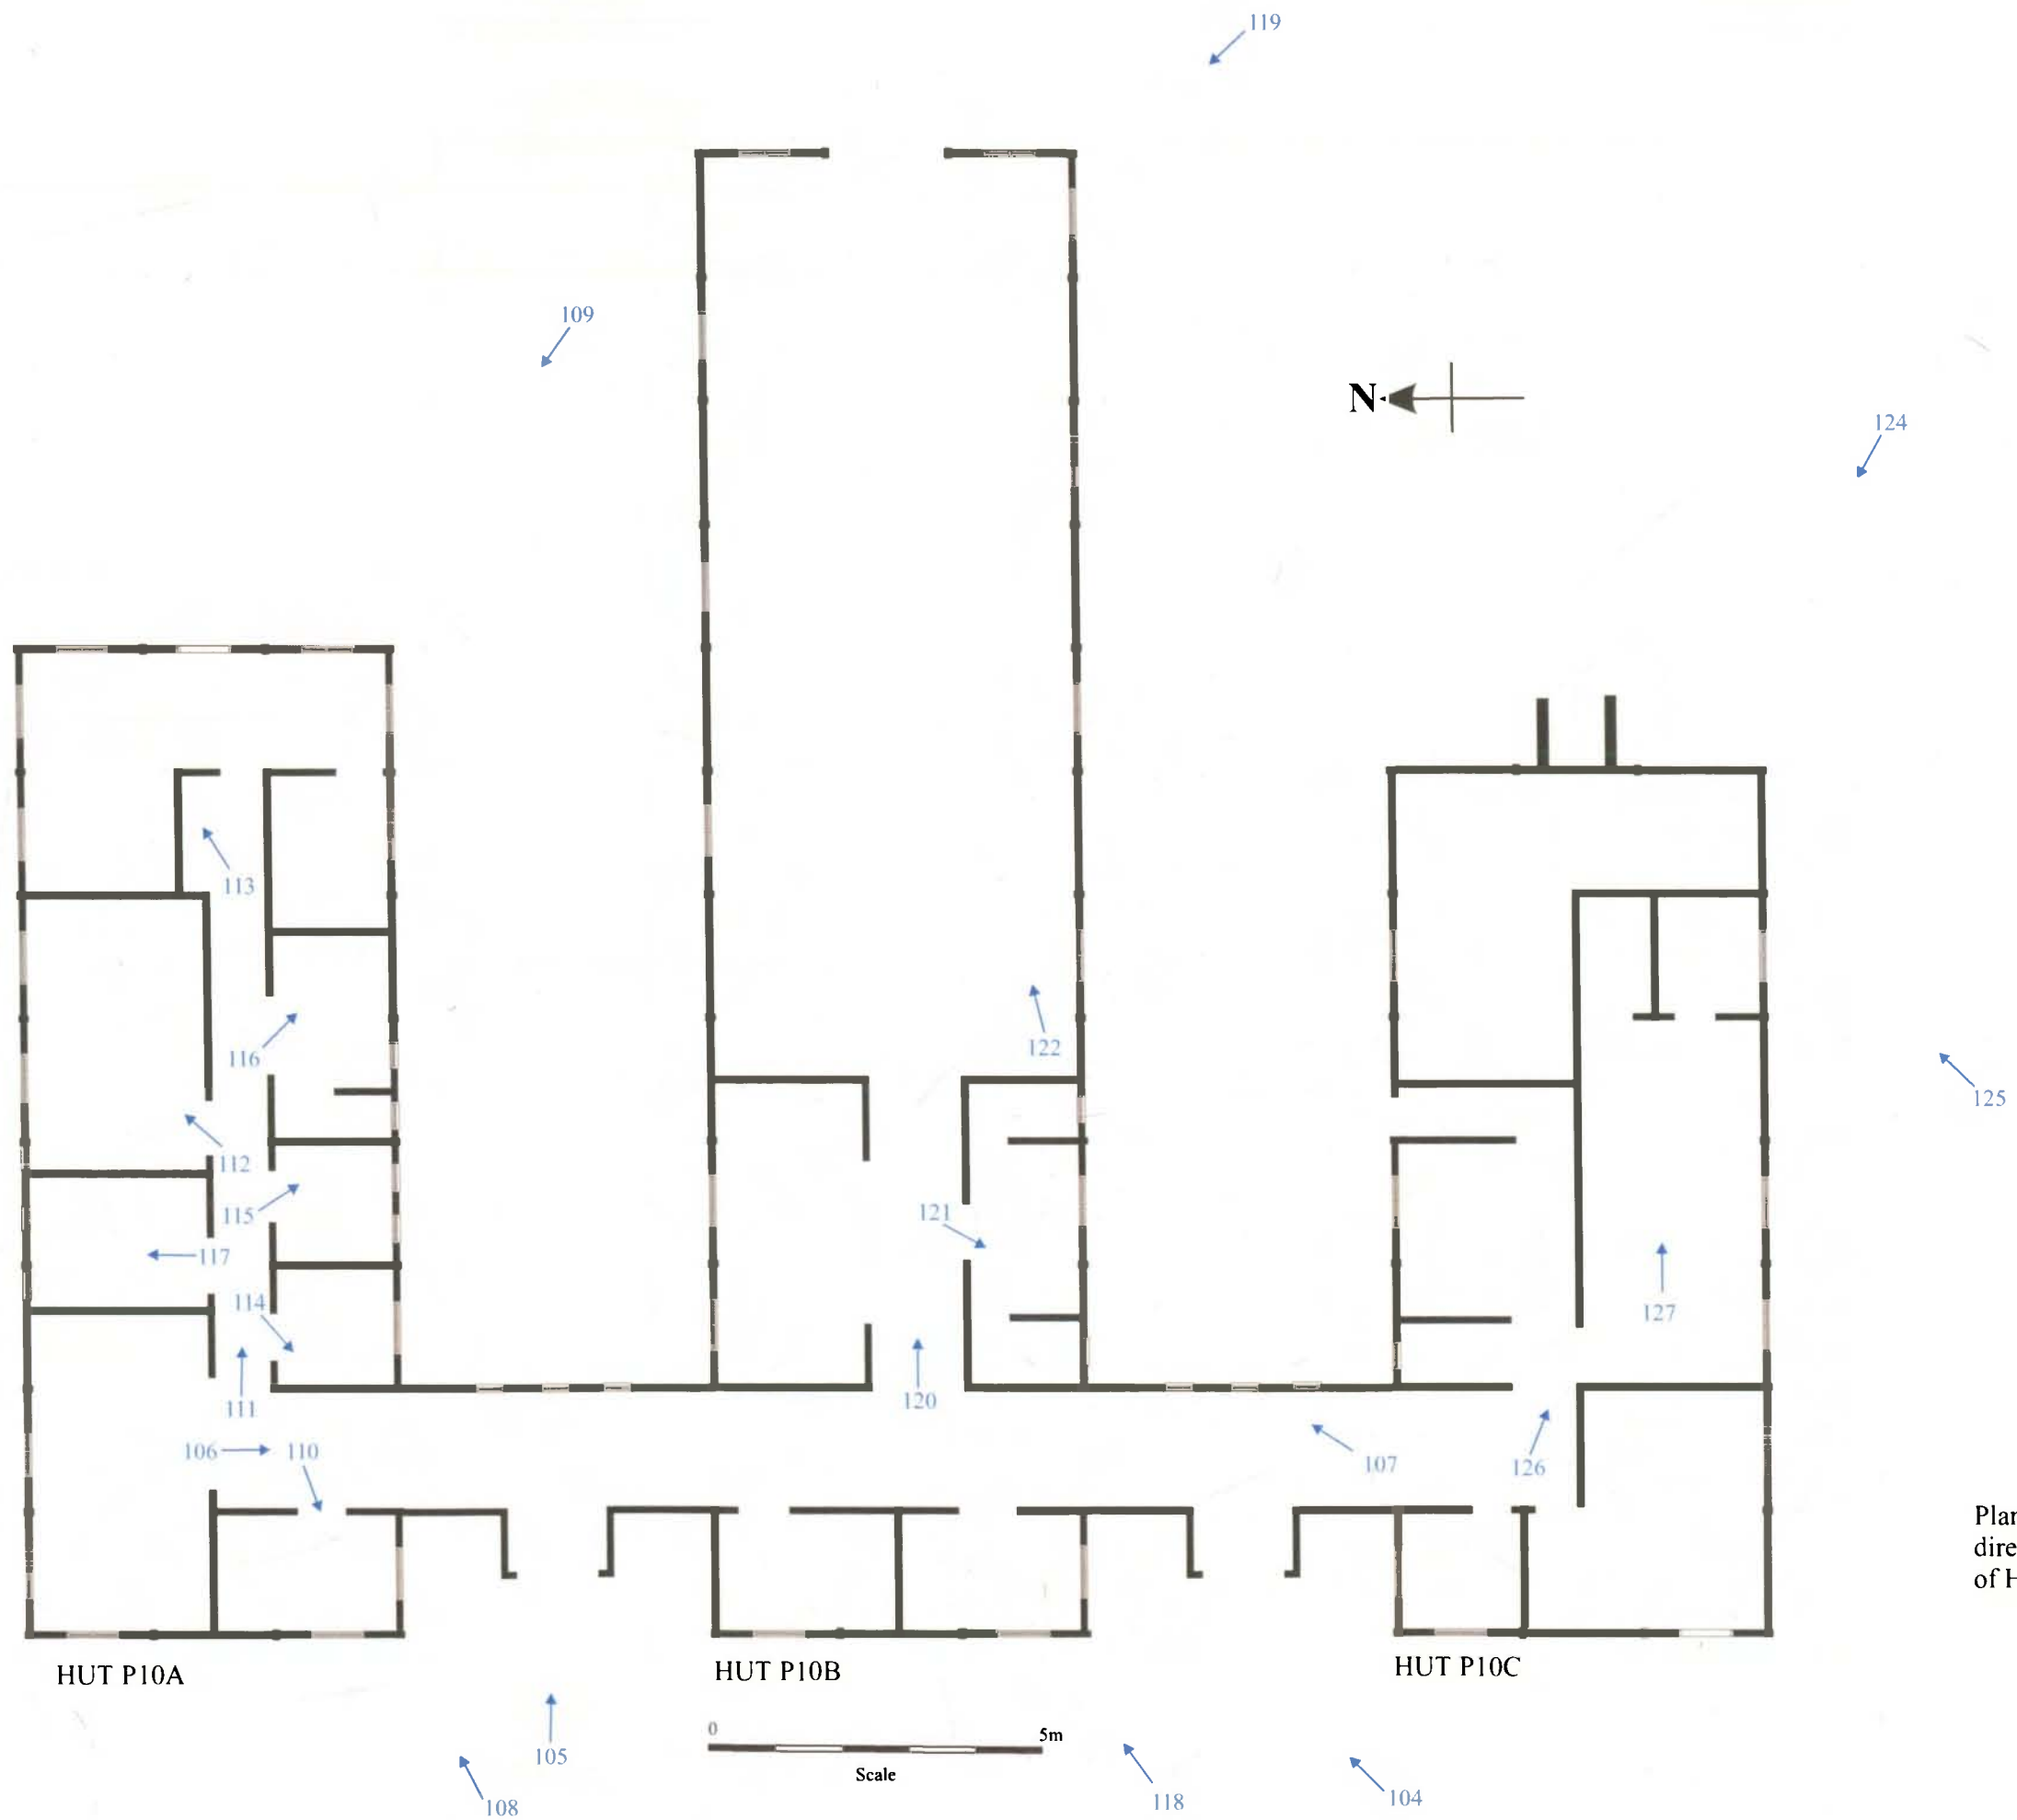
HUT G12

Plans showing the locations and directions of photographs taken of Huts G10, G11 and G12. Scale 1:100.

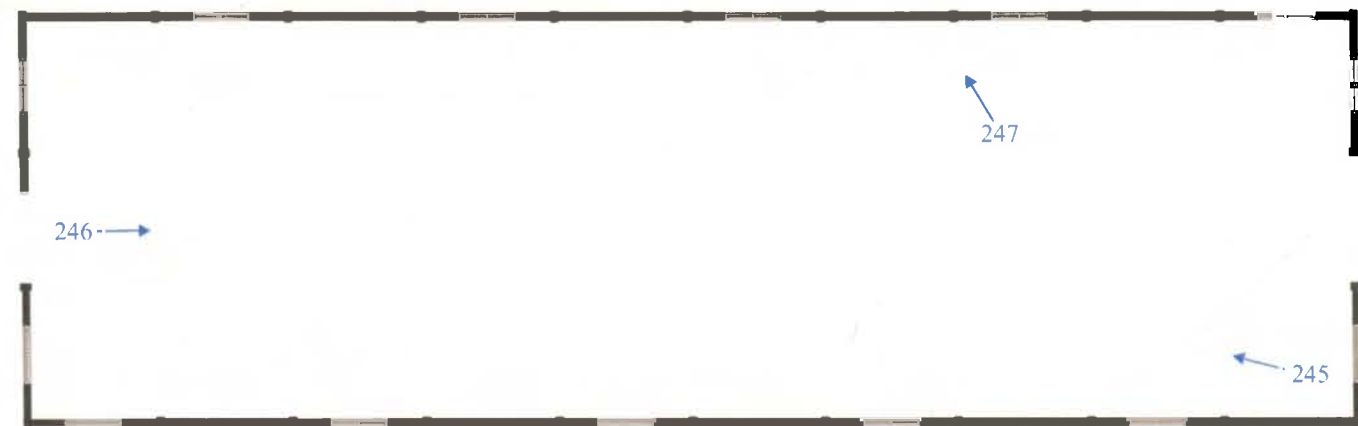
Plan showing the locations and directions of exterior photographs taken of Huts P9, P15, P29 and P30. Scale 1:500.
