**ARCHAEOLOGICAL SCHEME OF WORKS:
PHOTOGRAPHIC SURVEY AND TRIAL TRENCHING AT
THE OLD CORNMILL, SOUTH STREET, BOURNE, LINCOLNSHIRE**

NGR: TF 0964 2002
Planning Ref: S06/1625/121
LCCM Accession Number: 2007.134
AAA Site Code: BOSS07

by Chris Clay
August 2007

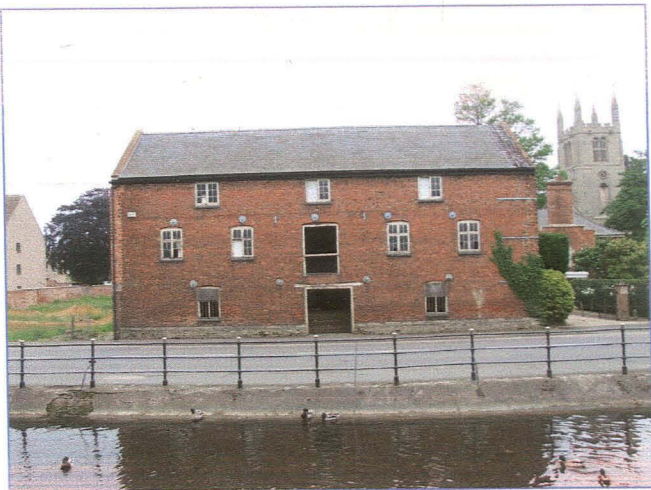
Plate 2: West elevation, looking east.

- 7.2 The lower courses of the west elevation are in stone, the remainder being built in Flemish Bond brickwork, considered to be the most decorative bond, used in this instance on the frontage facing South Street. There is a large double door at street level, with a smaller door directly above, which has a segmental arch of a brick soldier course. There are nine windows in this elevation, two at ground floor level, four on the first floor and three on the second floor. They all have sills of black engineering bricks, and the ground and first floor windows each have a segmental arch of a brick soldier course. The windows on the second storey are set immediately below the roof line.

- 7.3 The south end of this elevation has a series of metal ties inserted, which appear to have been necessitated by subsidence of the south gable end. There has also been extensive rebuilding at the north corner of this elevation, probably occasioned by the demolition of the formerly adjacent warehouse building. There are a number of circular steel plates along the elevation indicating the position of tie rods.

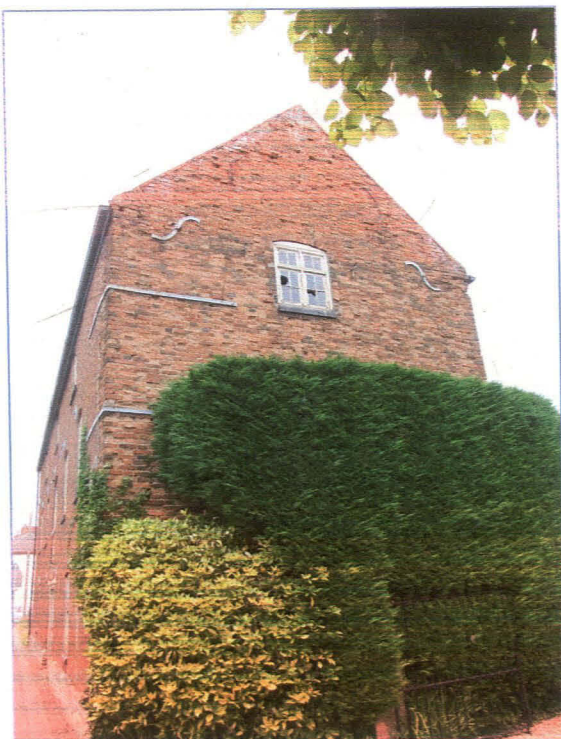
Plate 3: South elevation, looking north-north-east

- 7.4 The south elevation is largely obscured by a conifer hedge. There is a single window visible at second storey level, which has the same design as the windows in the east elevation and is probably contemporary. There is a single course of brick coping stones along the roof gable with decorative tumbling at the bottom of the roof line.

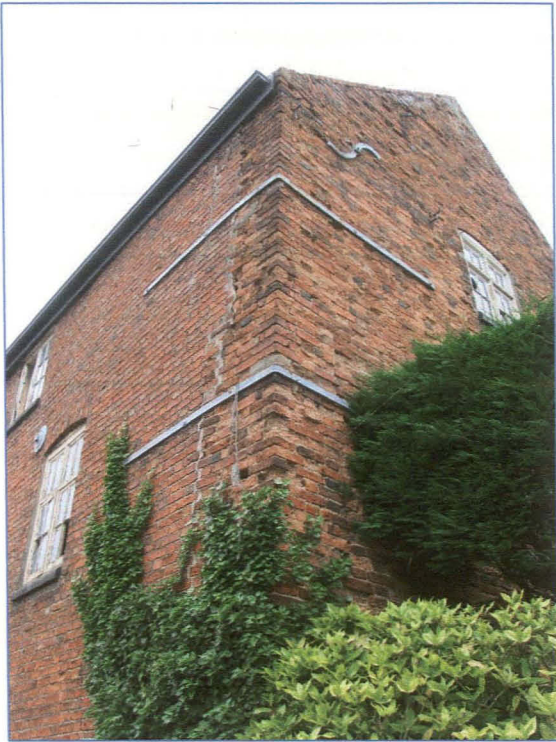
Plate 4: Detail of south-west corner, showing steel ties and the cracking and subsidence of the wall. Looking north-east

- 7.13 In the south wall of the building, there is slight evidence that the building has been increased in height at some time, as evidenced by a possible roof scar flanking the window in the south elevation. There is however no matching roof scar on the exterior of this elevation, and it may merely be a crack caused by subsidence of the wall, already noted externally, where metal ties have been used to hold the south wall to the west wall.

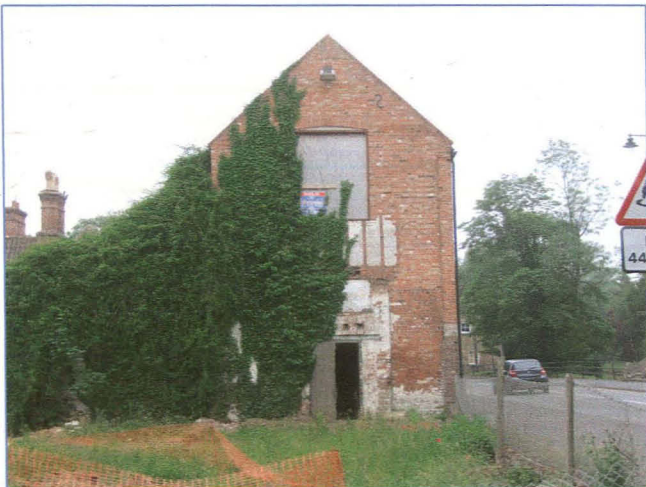
Plate 5: North elevation, looking south

- 7.6 The north elevation was also partially obscured by vegetation. It had a single door at ground floor level, and a set of double doors at second storey level. Areas of white washing and occasional small gaps in the brickwork indicate structural features related to the warehouse building formerly attached to this elevation.

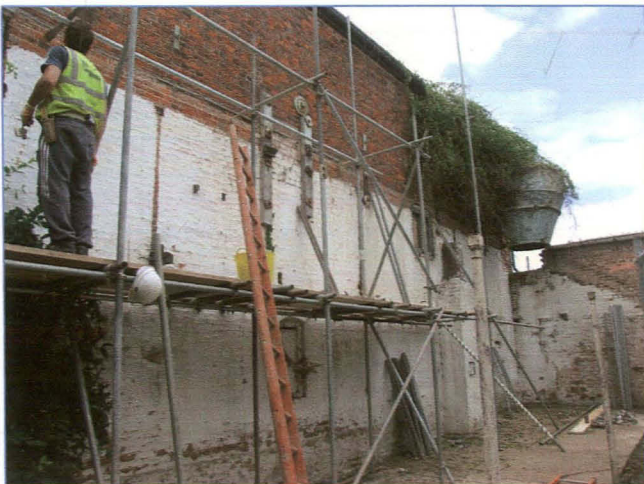
Plate 6: East elevation, looking north-north-west. Note the small chimney and the metal funnel at the north end of the elevation.

- 7.5 At the time of the photographic survey, the east elevation was largely obscured by vegetation and a lean-to structure. The vegetation and lean-to were later removed, allowing further photographs to be taken of the east elevation during the trial trenching. This elevation, like the west elevation, was built of coursed stonework at its base and brickwork above. There are two small windows evident, one at ground floor level (which has been blocked), and one on the first floor. This elevation also displays a small brick chimney with a metal hatch, and an adjacent steel hopper or chute. There were no corresponding internal features associated with these structures. The chimney was probably related to the use of steam powered machinery in the corn mill, while the hopper appears to be a later addition, the exact function of which was unclear.

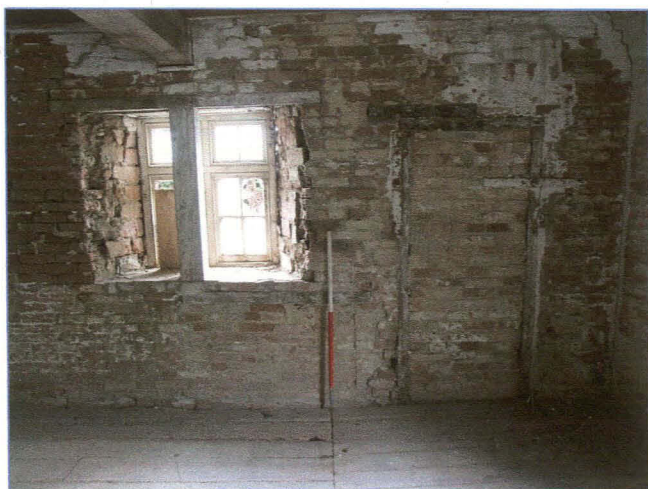
Plate 11: South wall of the first floor, showing the window and blocked doorway, looking south.

- 7.10 The brickwork in the south wall is in a poor state, with a number of cracks evident. The opening for the window is recessed into the wall and supported by a wooden beam with a wooden lintel over. To the west of the window is a blocked doorway, the wooden frame of which has been left in situ.

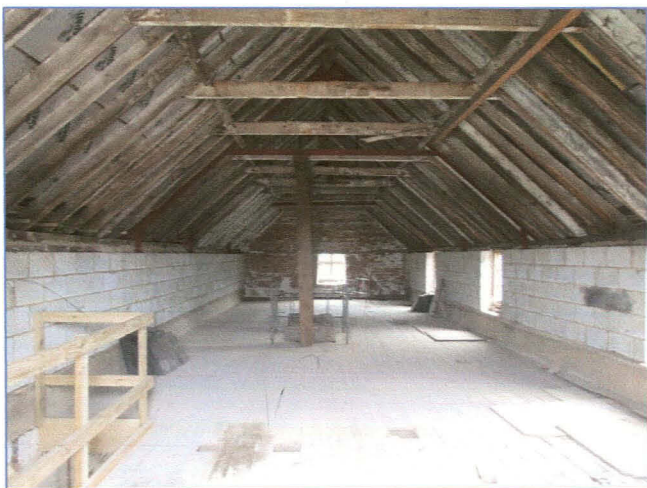
Plate 12: Second floor, looking south

- 7.12 The most extensive evidence of recent repairs is visible on the second storey. Breeze block walls have been added along the north, east and west elevations, and the building has a new roof with asbestos insulation.

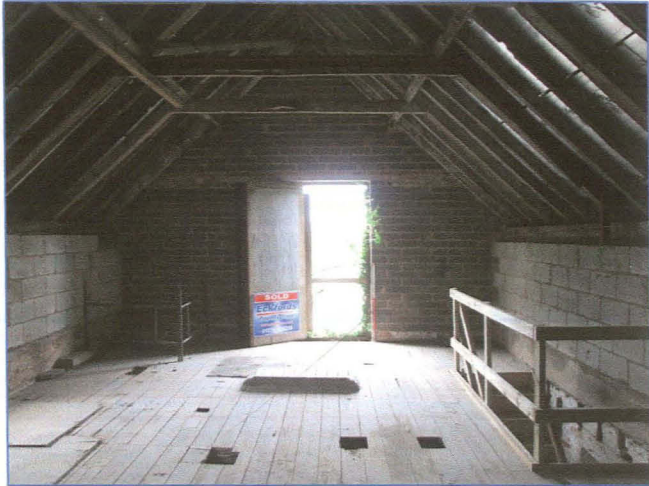
Plate 13: North end of the second floor, looking north to the door and repaired north wall.

- 7.11 The north wall on this floor also exhibits a recent breeze block repair, again likely to have been occasioned by the demolition of the adjacent building, and reflected by an external brickwork repair.

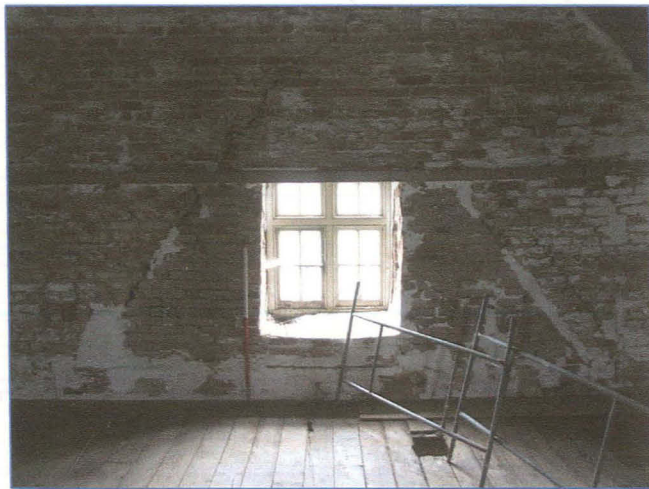
Plate 14: Window at the south end of the second floor, showing the cracks evidencing the subsidence of the south wall. Looking south.

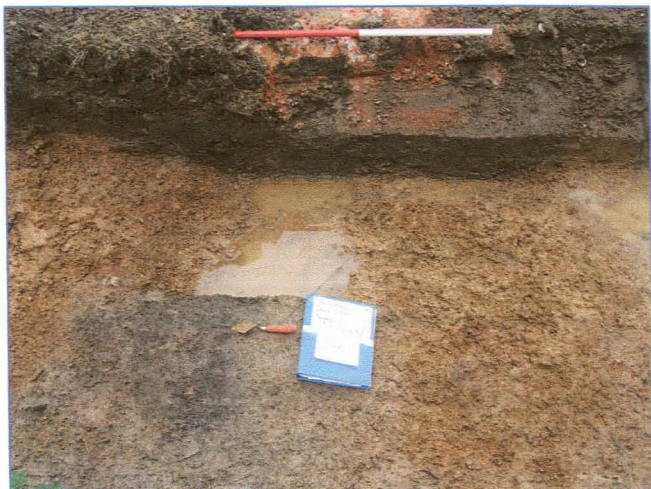
Plate 4: Curvilinear gully 103, Trench 1, looking east.

- 8.1.3 Towards the south end of the trench were two curvilinear features, 103 and 108. Both ran eastwards from the western limit of excavation and then turned southwards. 103 contained a primary natural silting deposit, 104, and a much darker secondary fill which may represent a dump of domestic waste. Ditch 108 contained a single natural silting deposit, 109. Both features were undated, although 103 produced two fragments of animal bone.

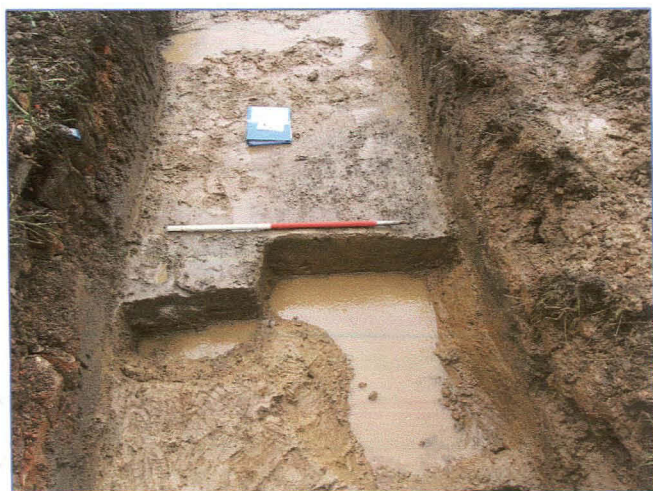
Plate 5: Curvilinear ditch 108, Trench 2, looking north.

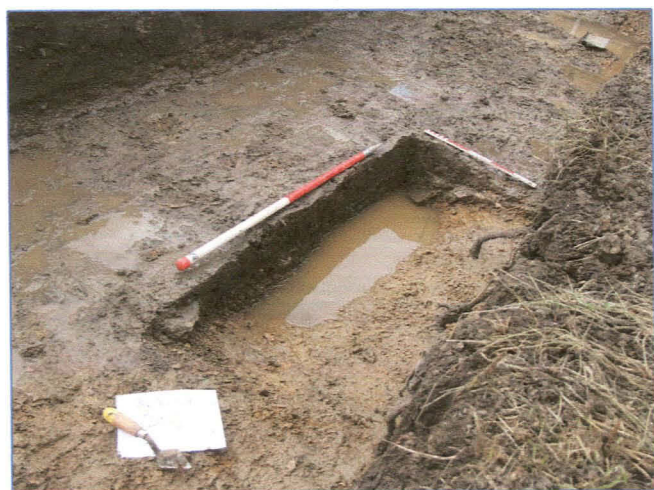
Plate 6: Slot through large pit 203, Trench 2, looking south-west.

- 8.2.1 Trench 2 contained an identical stratigraphic sequence to Trench 1, comprising topsoil 200, subsoil 201 and the natural geology 202. A single large pit was exposed in the centre of the trench. The north edge of the pit was exposed, with the remainder being beyond the southern limit of excavation. The area exposed was 6.8m wide and had a moderately shallow profile and a flat base. The pit was filled by a dark brown/grey clayey silt with occasional charcoal flecks and limestone fragments. Dating evidence from the feature comprised a glazed tile fragment of 15th to 17th century date, and four Bourne Ware sherds and a sherd of a Cistercian Ware cup that were dated to the 15th to 16th century.
