# ARCHAEOLOGICAL WATCHING BRIEF AND BUILDING RECORDING AT 37 HIGH STREET, ROPSLEY, LINCOLNSHIRE (HSR 01)

> > Work Undertaken For Mr R. Cooper

> > > November 2004

APS Report No. 158/04

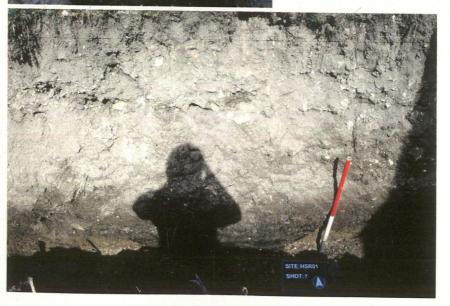
Located west of the barns and cut into the subsoil (017) was a sub-circular feature (019). This measured 1.4m wide by 0.32m deep (Fig. 4, Section 4). This pit contained a single fill of black silty clay with charcoal (018) and had evidence for burning along the edges.

Plate 3 - Section 4, looking north

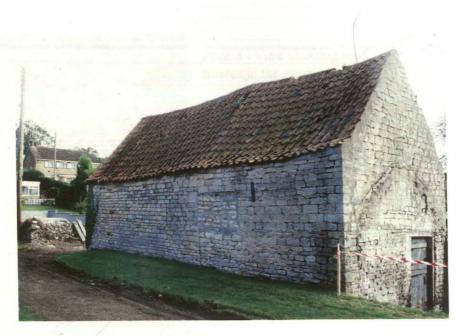
Externally the structure is two-storeys high and comprises two linked buildings of coursed limestone rubble with a red pantile roof (Plates 4 and 5). A straight join between the two buildings is apparent on the north and south sides. Quoins are evident at each corner of the eastern building but there are only a few quoins at the west end of the western building and none on its easterly side. There is no break in the roof line, though there is a slight ridge in the apex where it crosses the dividing wall.

The northern elevation is lower than the other three as it is set into a bank, formed by a causeway track leading from the High Street, on the east, westward to the church. Immediately west of the straight join between the two buildings is a blocked entry with a timber lintel. This opening, like a window in size, is in the upper storey. Approximately 1.2m east of the straight join is a further, partial, straight join. There is no obvious matching pair to this. Toward the eastern end of the elevation is a low section where the masonry steps back slightly.

Plate 4 - View showing the barns from the northwest, showing the join between the two and the scar outline of a further outhouse

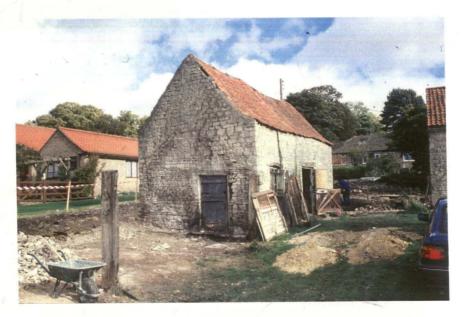
Plate 5 - View of the barns from the southwest

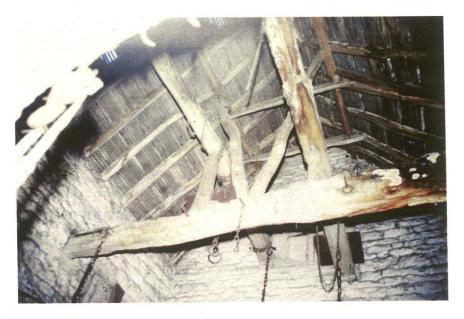
A north-south beam crosses the room about 0.35-0.4m below the eaves. This beam has joist sockets in its west side, but not its eastern face. This beam supports a V-shaped arrangement of diagonal timber struts and, either side of this, two short studs (Fig. 8). Both of the diagonal struts rise to the upper parts of the purlins. The stud on the south of the V-shaped struts supports a plank, while that to the north carries a rounded beam, both of these members running east-west across the room.

Collars are present intermittently connecting the common rafters, and the purlins are clasped.

Plate 7 - View showing the roof trusses in the western barn
