**ARCHAEOLOGICAL WATCHING BRIEF
AND BUILDING ASSESSMENT OF
BEDE ALMSHOUSES,
SLEAFORD ROAD,
TATTERSHALL,
LINCOLNSHIRE
(TBA 95)**

Work Undertaken For
Meldrum Lee and Gillatt

February 1997

A.P.S. Report No. 4/97

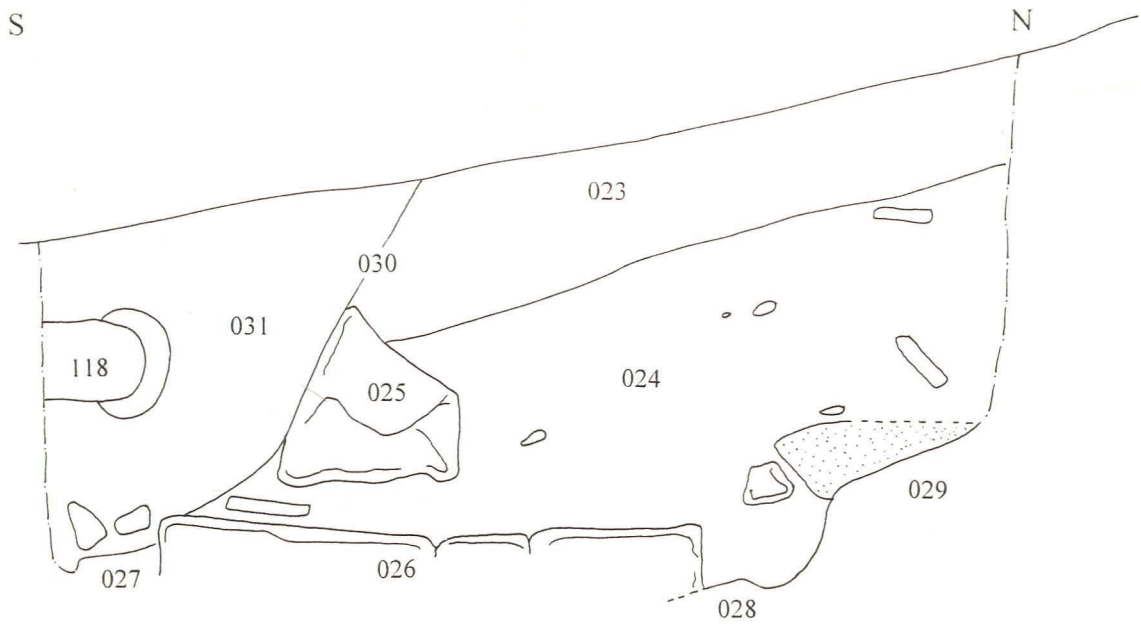
Figure 6 - Section 7

Section 7, showing demolition and recent deposits above wall 026

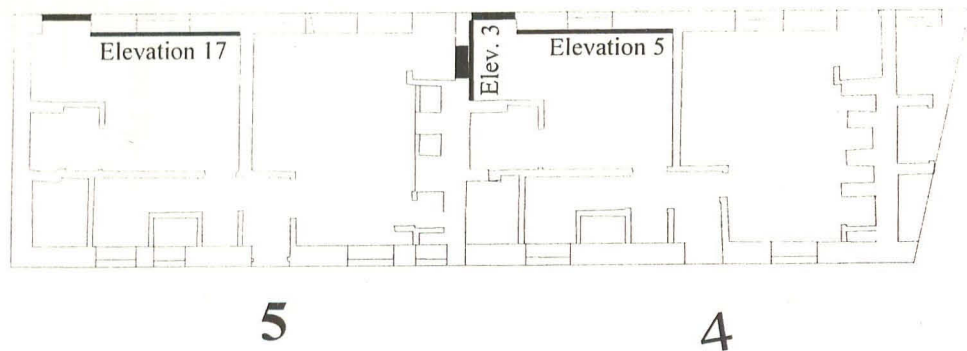
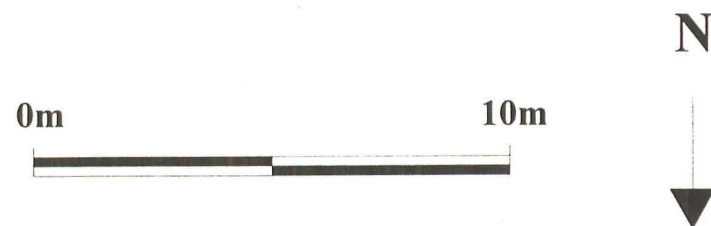
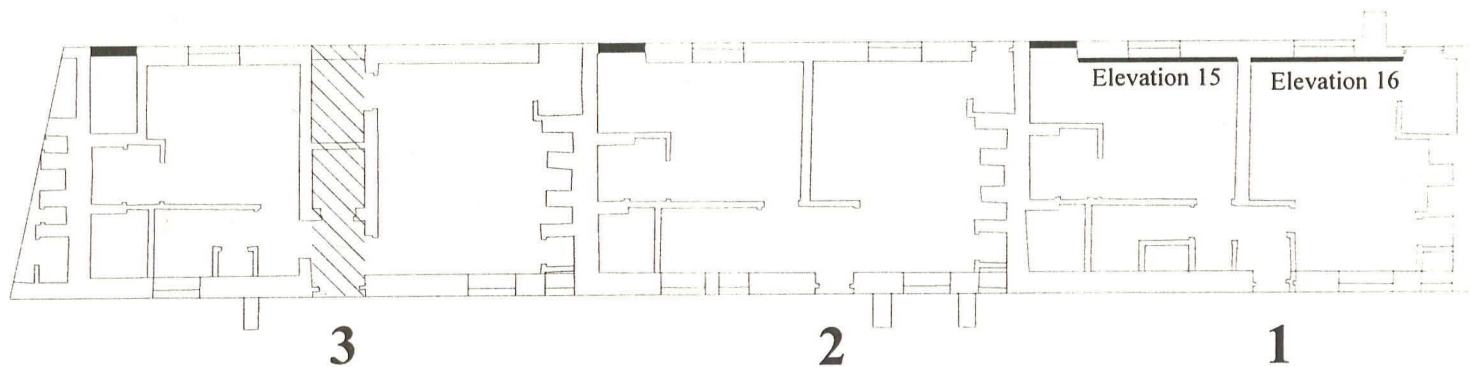
Figure 7 - Ground Plan of the Almshouses

- Blocked Doorway
- Former Passage

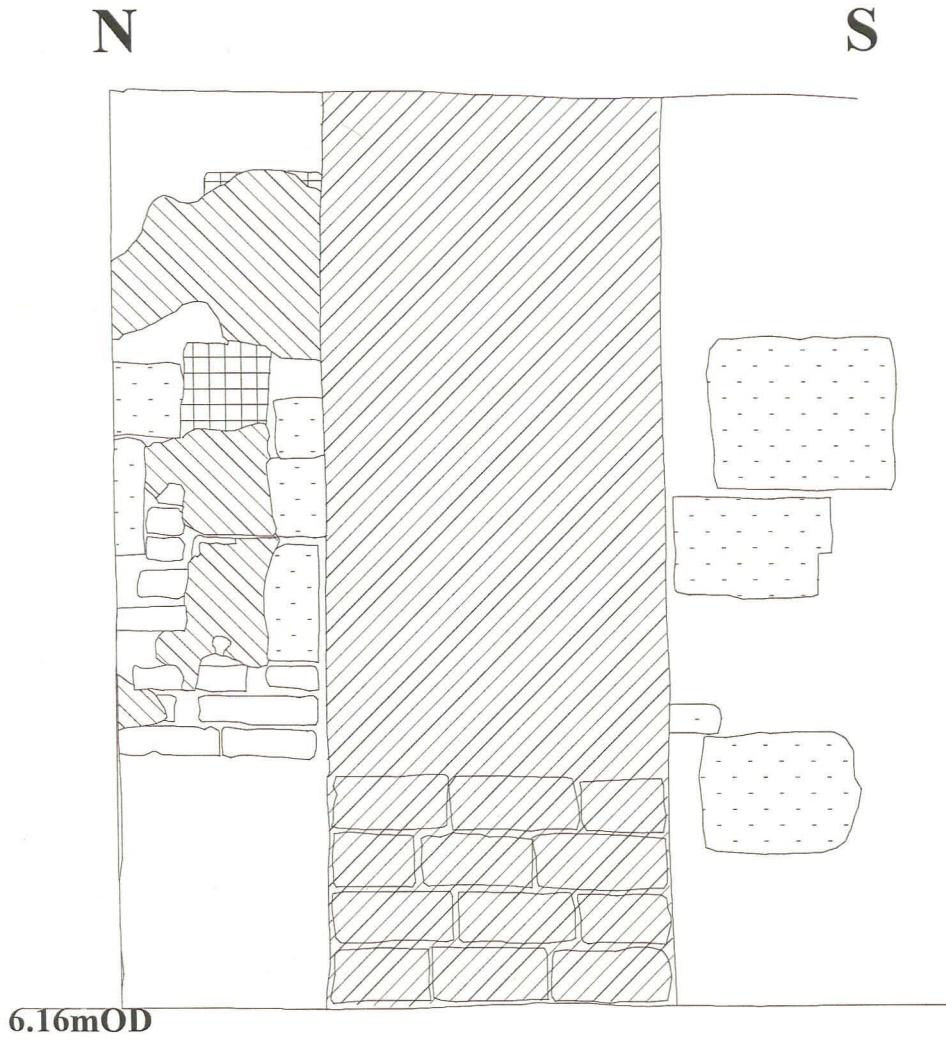
Elevation 3, showing blocked doorway between No. 4 and No. 5.

Interior; Walls are composed of reused limestone masonry, usually the lower courses, and red brick in English 'type' bond. Former doorways to the front are revealed as recesses boarded up with window set above these. Elevation 3 (Fig. 8) shows a blocked doorway between two dwellings of recent brick, a feature that may have existed in all dwellings. Recent repairs show the use of breeze blocks and modern brick. The former central passage through this structure has been utilised as cupboard space for Dwelling 3.

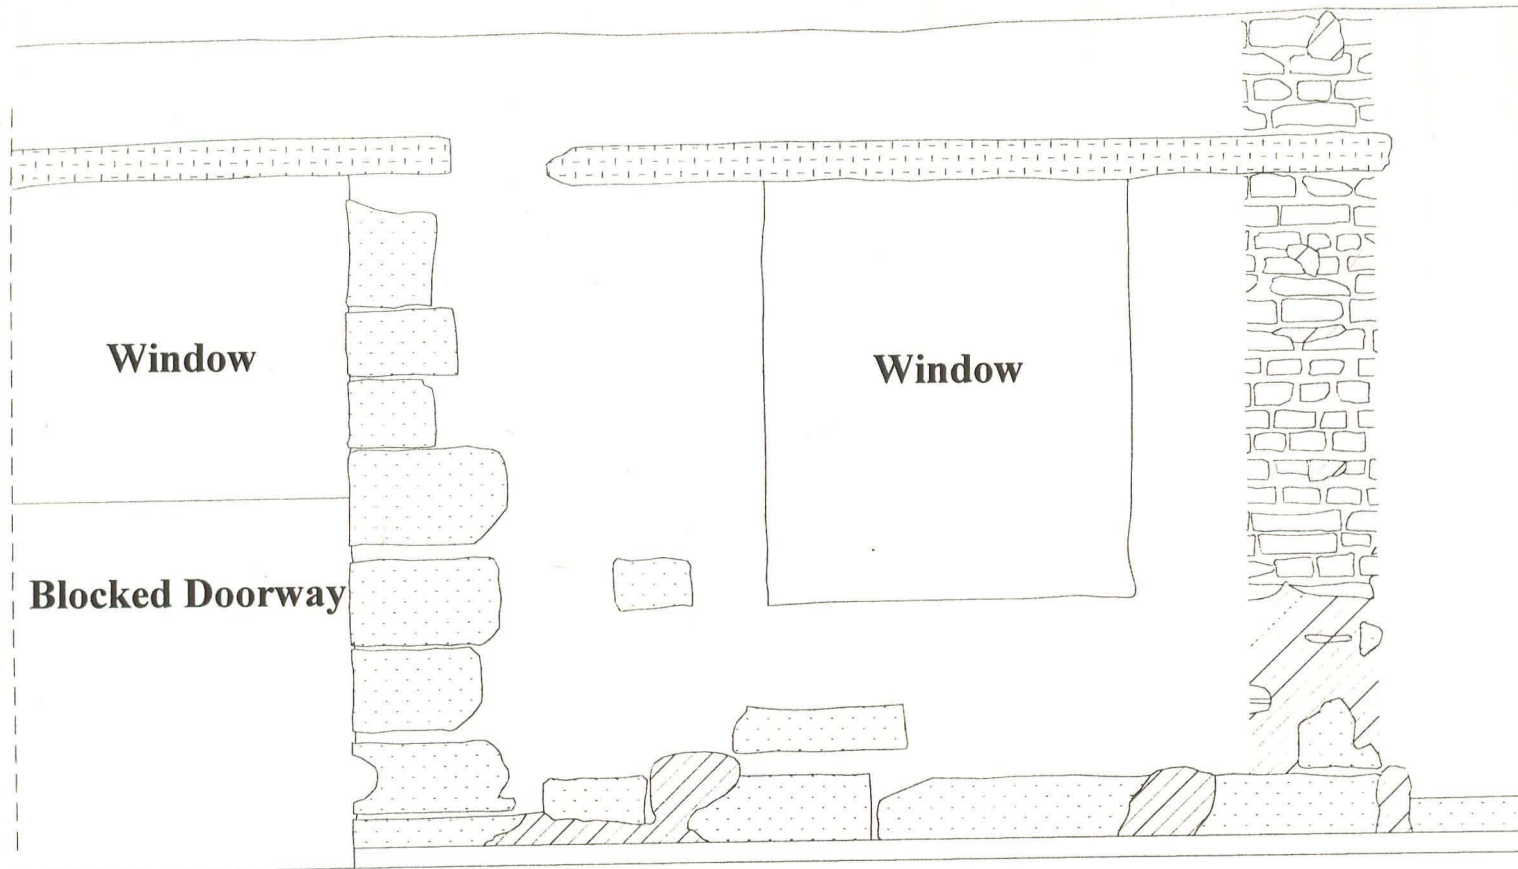
Figure 9 - Elevation 15 *see replacement figure in rear pocket*

Elevation 15

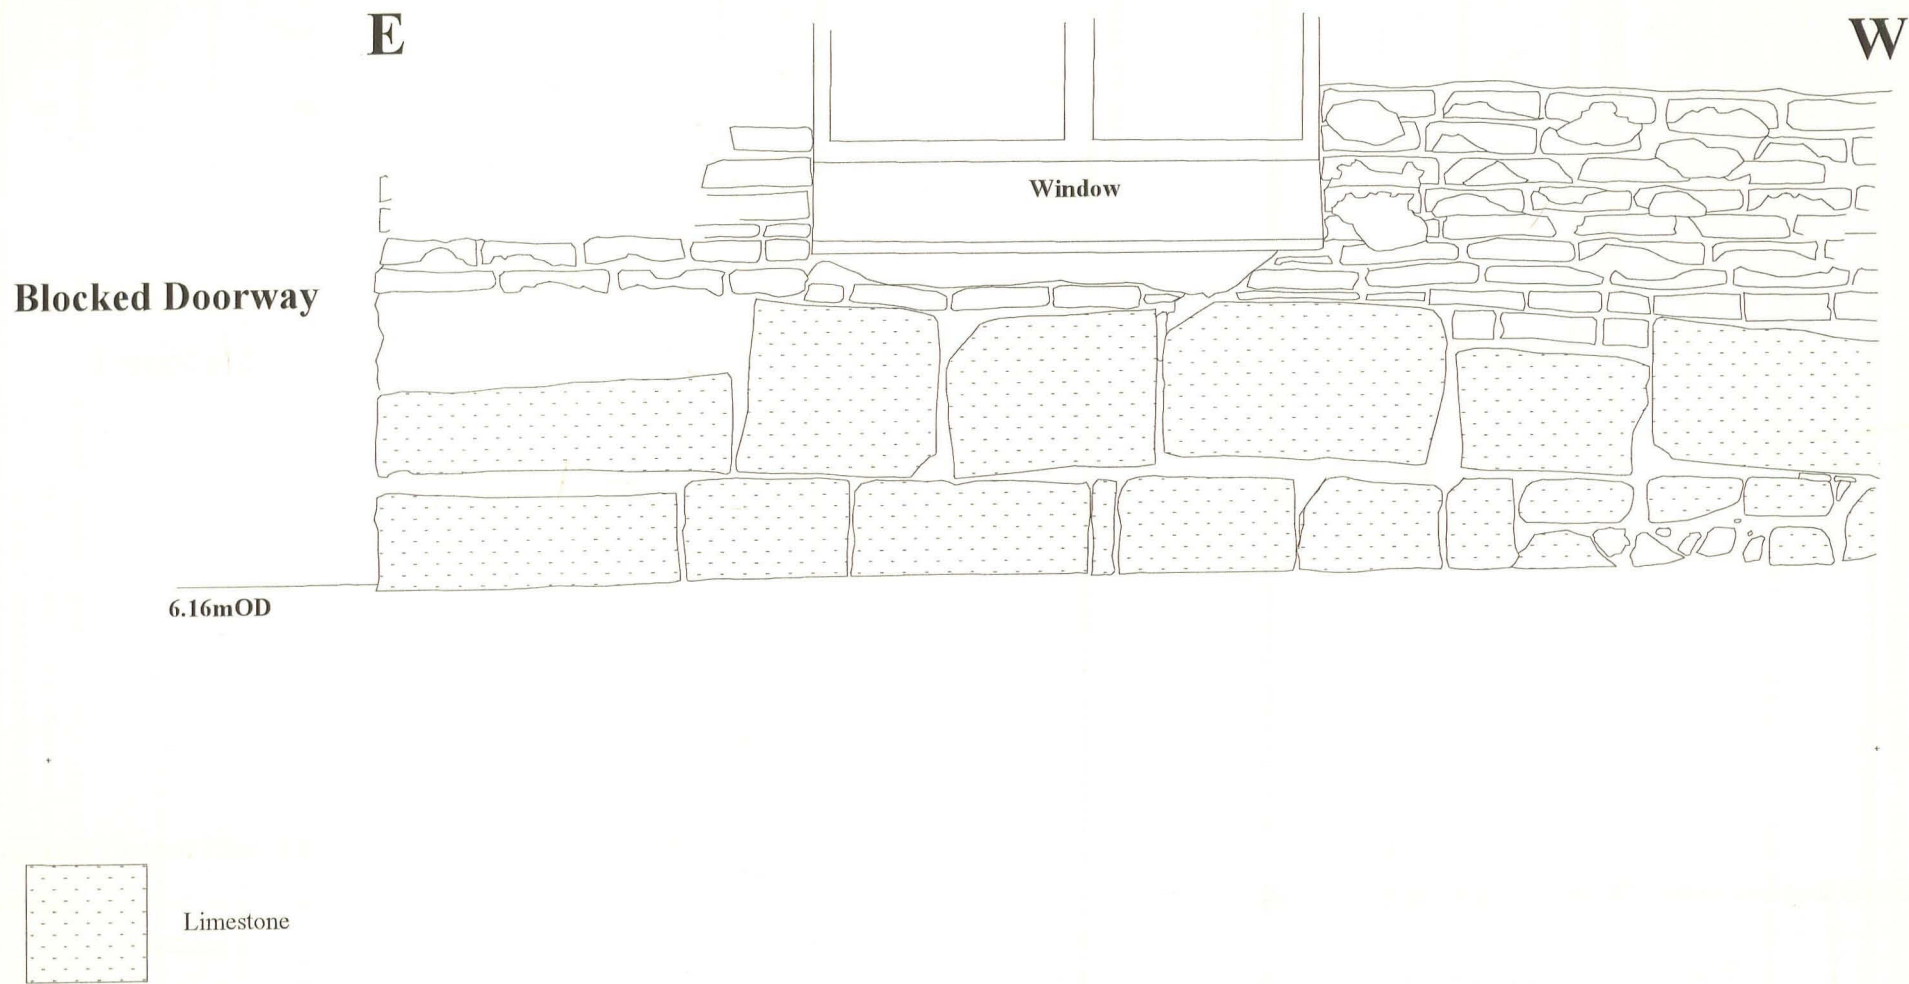
Figure 10 - Elevation 17 *see replacement figure in rear pocket*

Elevation 17, showing reused masonry

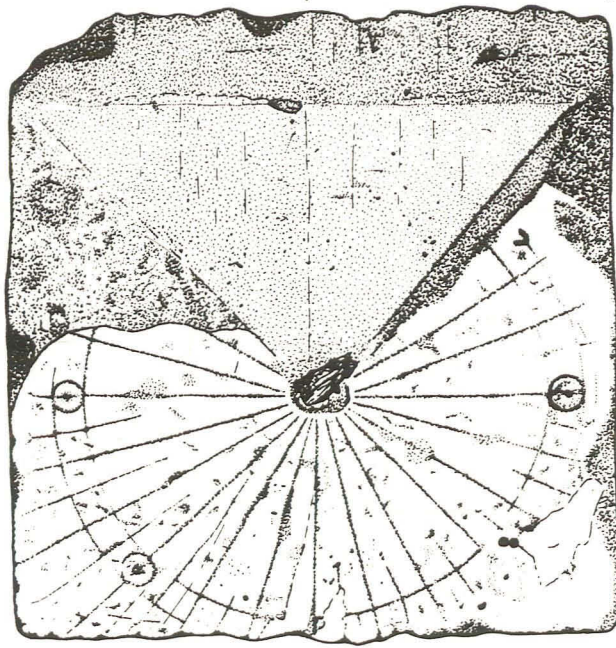
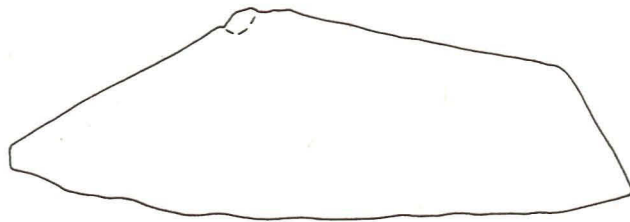
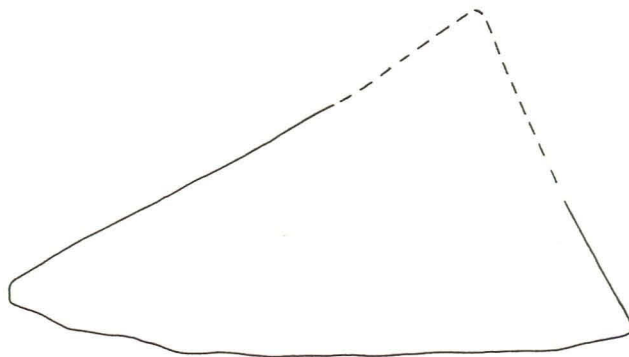
Figure 13 - Stone Sundial (001)

No.	Description	Form	From	Dimensions
1	Rectangular block, with sloping upper surface. Central iron remnant with 21 striations radiating outwards.	Sundial	001	310mm x 340mm x 130mm
2	Corner piece, with projected triangular moulding. Broken	Fireplace Surround	001	360mm x 260mm x 190mm
3	Roughly rectangular piece with curving upper surface. Central slot 15mm wide with a single deeper recess, 50mm deep.	Window moulding	002	250mm x 190mm x 70mm
4	Corner piece, with curving inner portion. Central V-shaped slot. Triangular recesses moulding.	Window moulding	+	300mm x 250mm x 270mm
5	Rectangular slab, worked on three sides only	Ashlar block	+	420mm x 370mm x 110mm
6	Rectangular block with flat upper face and triangular section cut off 1 corner. Small rebate below slope with rectangular recess.	Door jamb	+	280mm x 270mm x 120mm

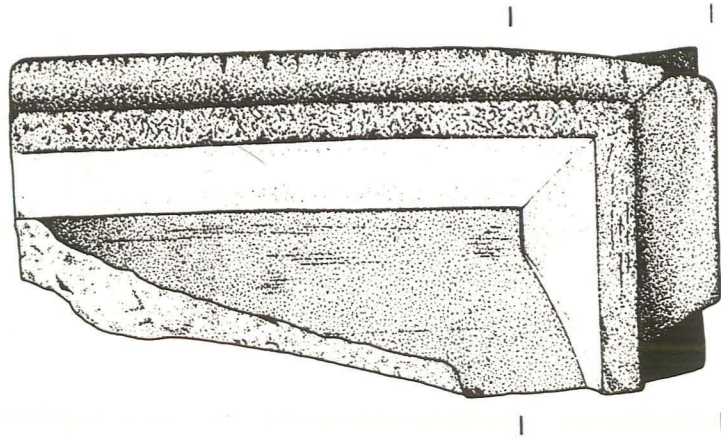
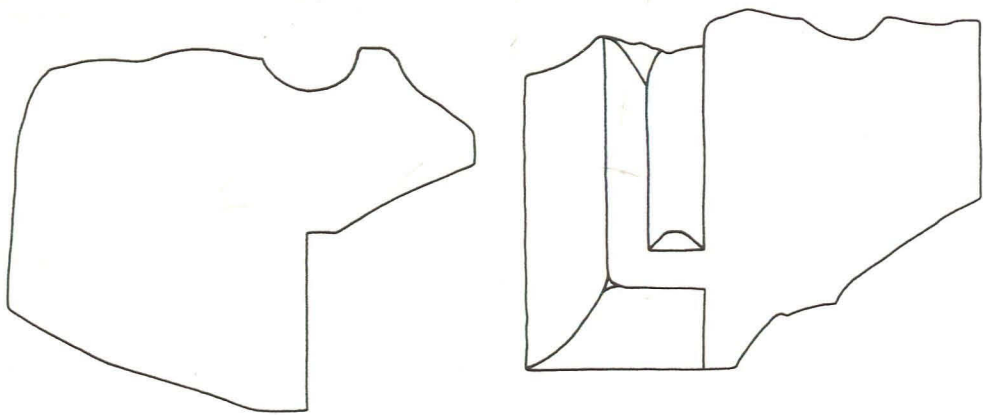
Figure 14 - Decorative Fire Surround

Most of the fragments are from external fittings and bear the appropriate evidence of weathering. The one internal feature is probably part of a fireplace surround. This lacks the weathered appearance of the external fittings, as might be expected. Reddening of the fractured end of the piece bears witness to the effects of heat and supports the interpretation as a fragment of decorative fire surround.

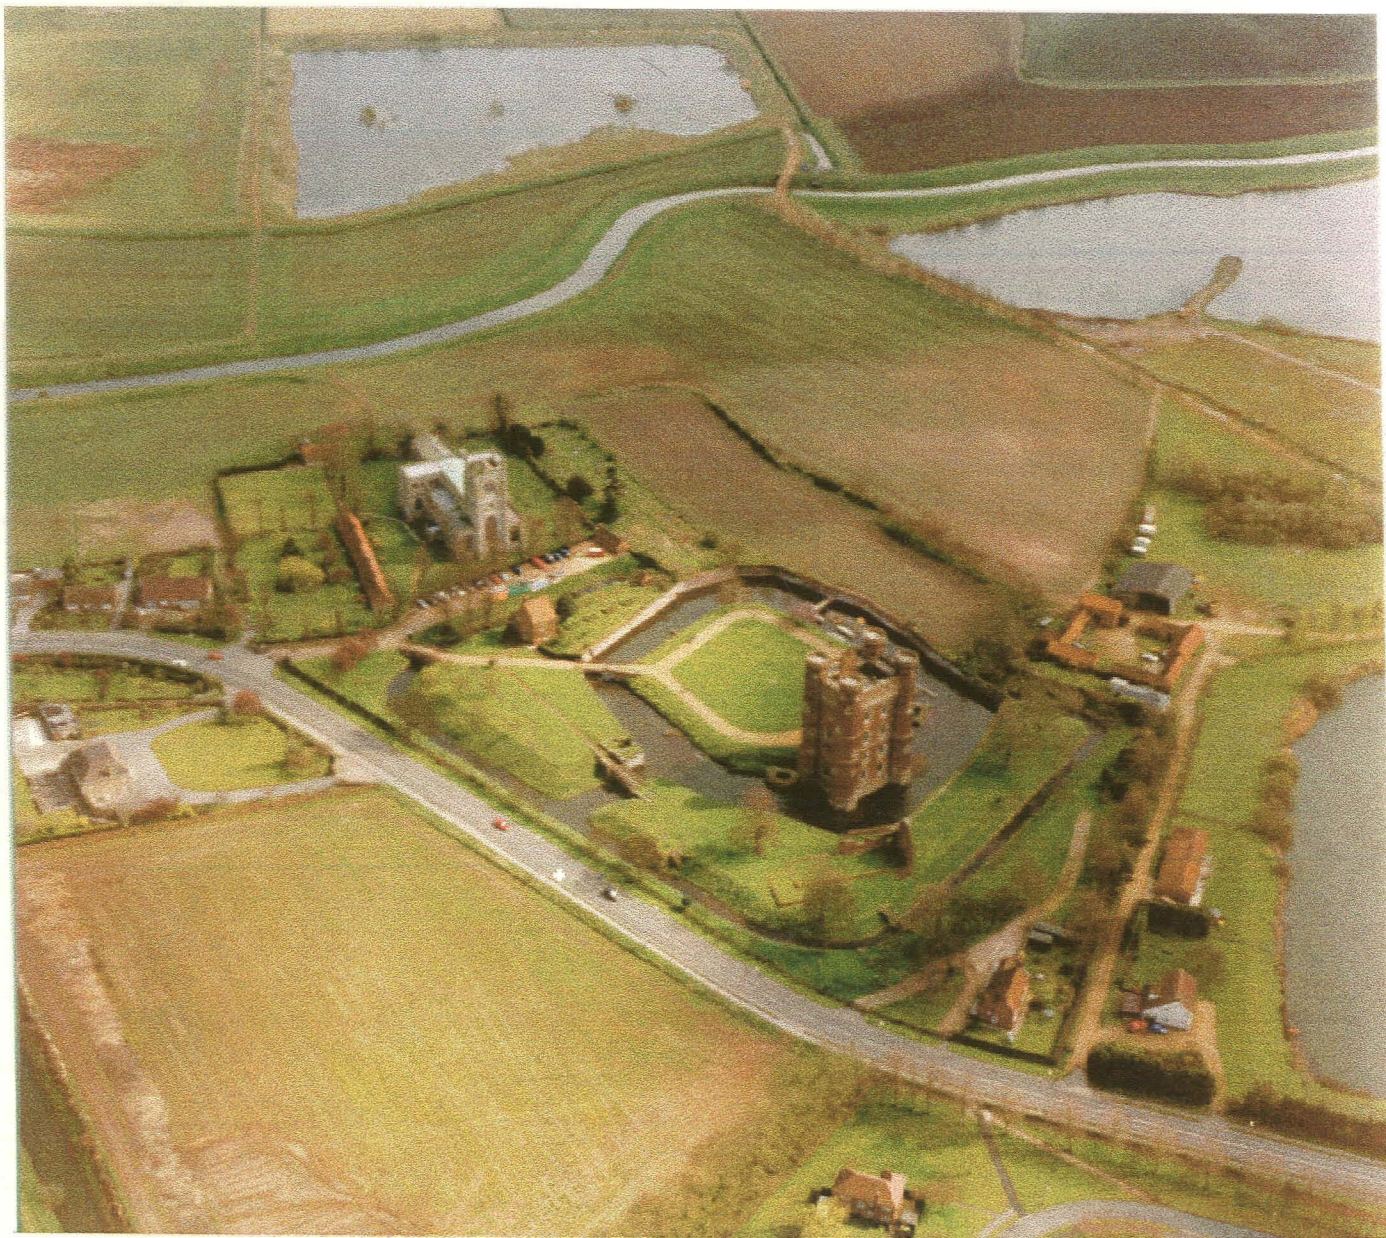
Plate 1 - Aerial View of the Investigation Area

The Bede Almshouses are located to the left (north) of the Collegiate Church. Above this is the modern bowling green where excavations revealed the site of the gatehouse to Tattershall College. This is overlooked by the Keep of Tattershall Castle, set within a double moat. (Photo D.Start)

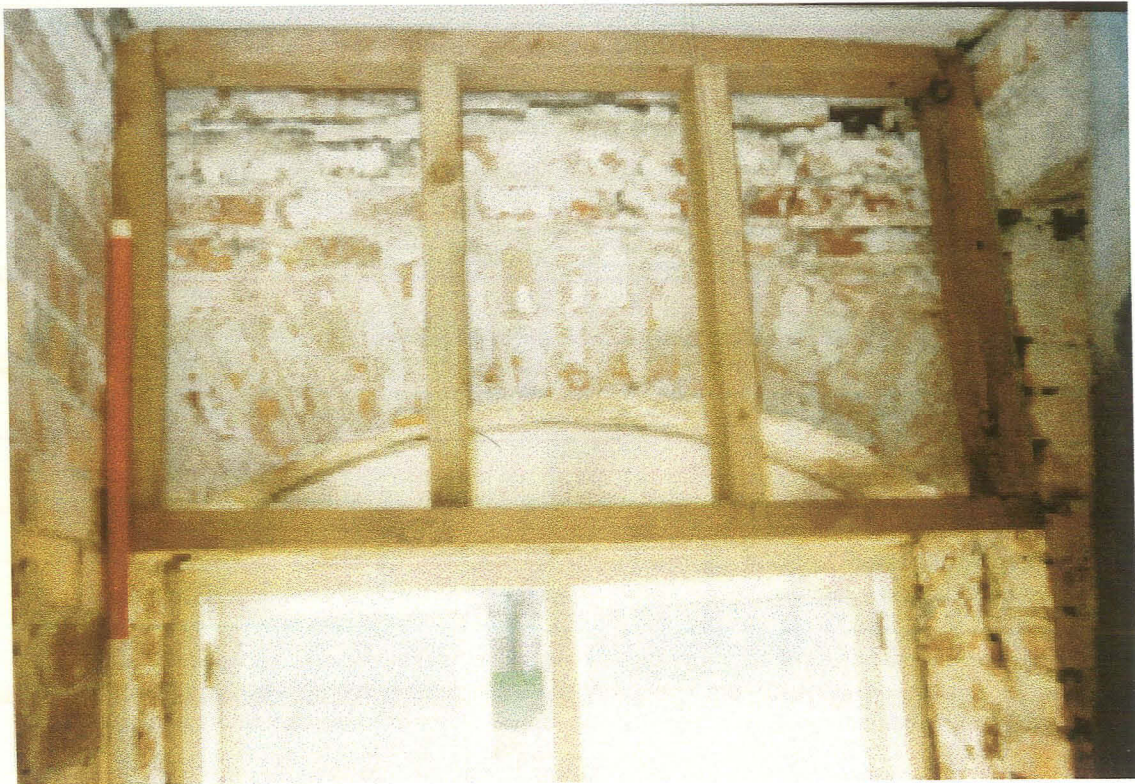
Plate 2 - Brick Arch of the Central Passageway, located in the centre of cottage No. 3.

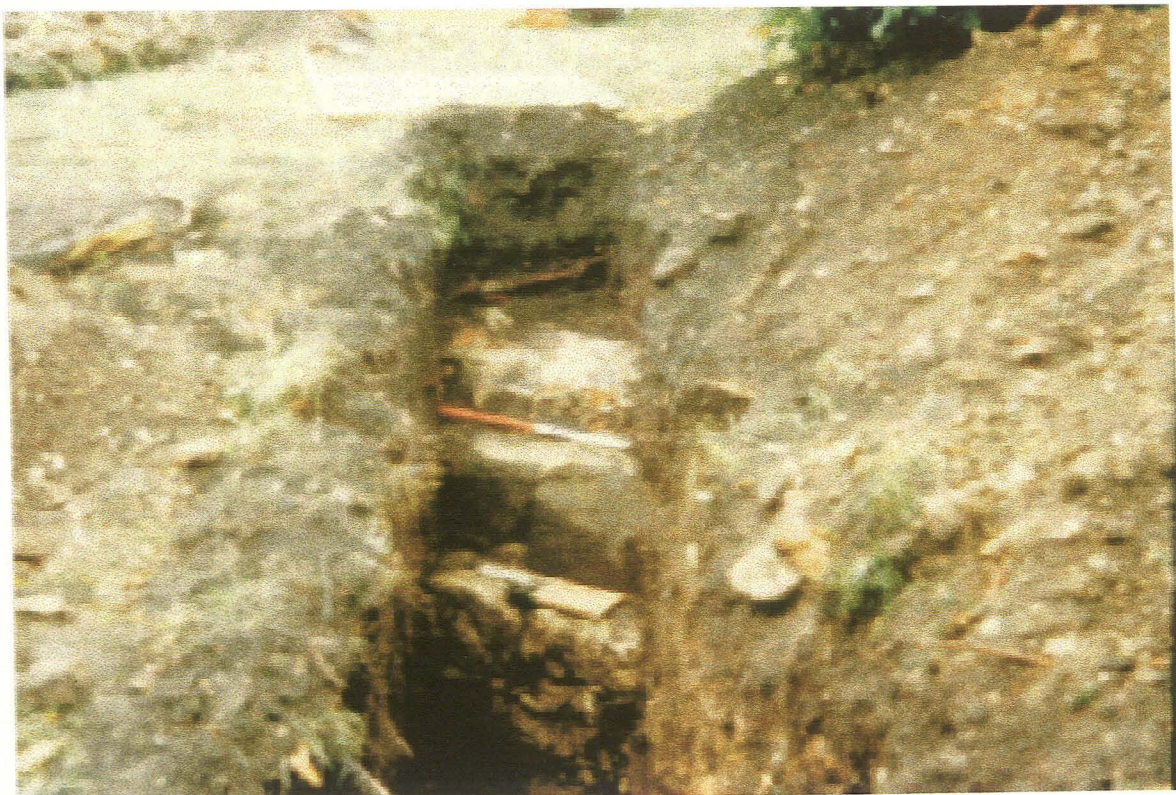
Plate 3 - Limestone Wall with Brick Upper Course (032, 033 and 034), looking North.

Situated to the north of this second fireplace, a short stretch of wall was revealed in the northeastern soakaway trench. This wall was composed of three elements, these being a limestone rubble foundation (033), a limestone ashlar course (034) upon which a brick wall had been constructed (035). Together these three contexts are 1.15m high and aligned east to west.

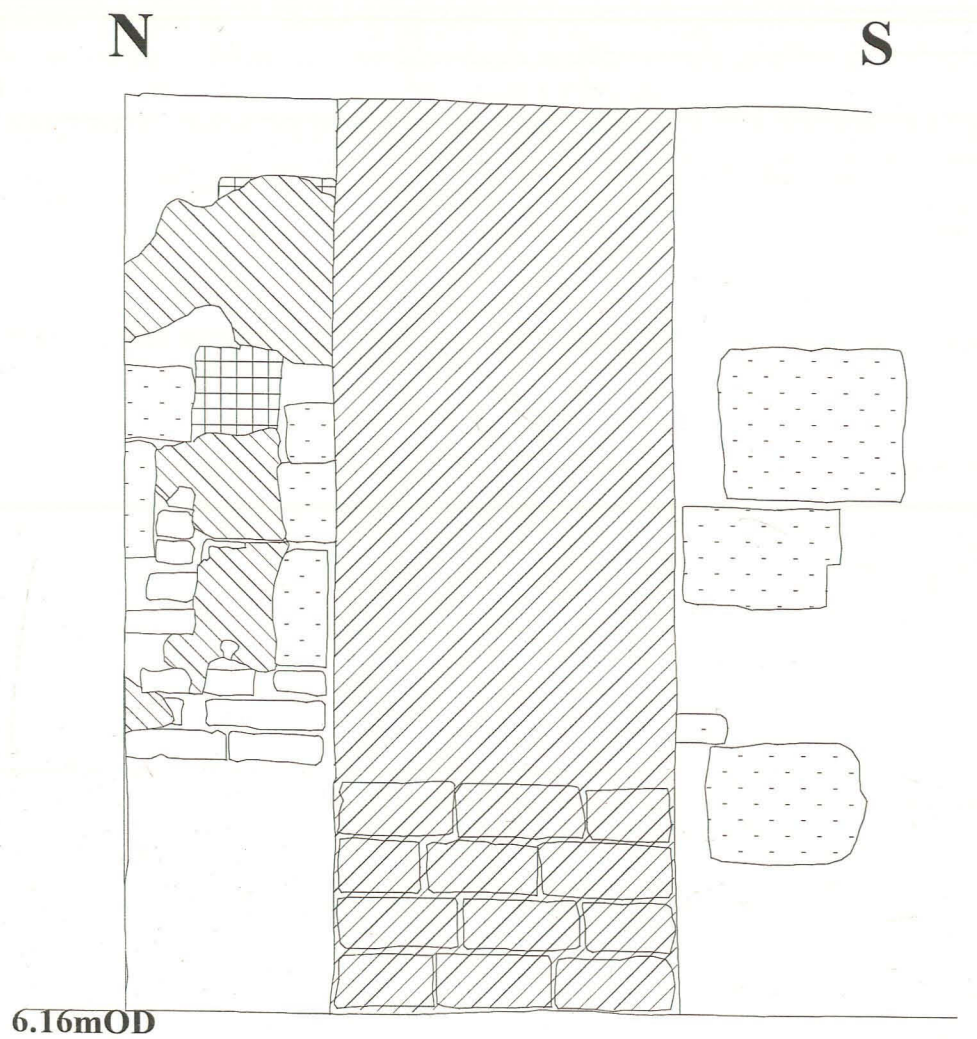
Figure 8 - Elevation 3

Elevation 3, showing blocked doorway between No. 4 and No. 5.

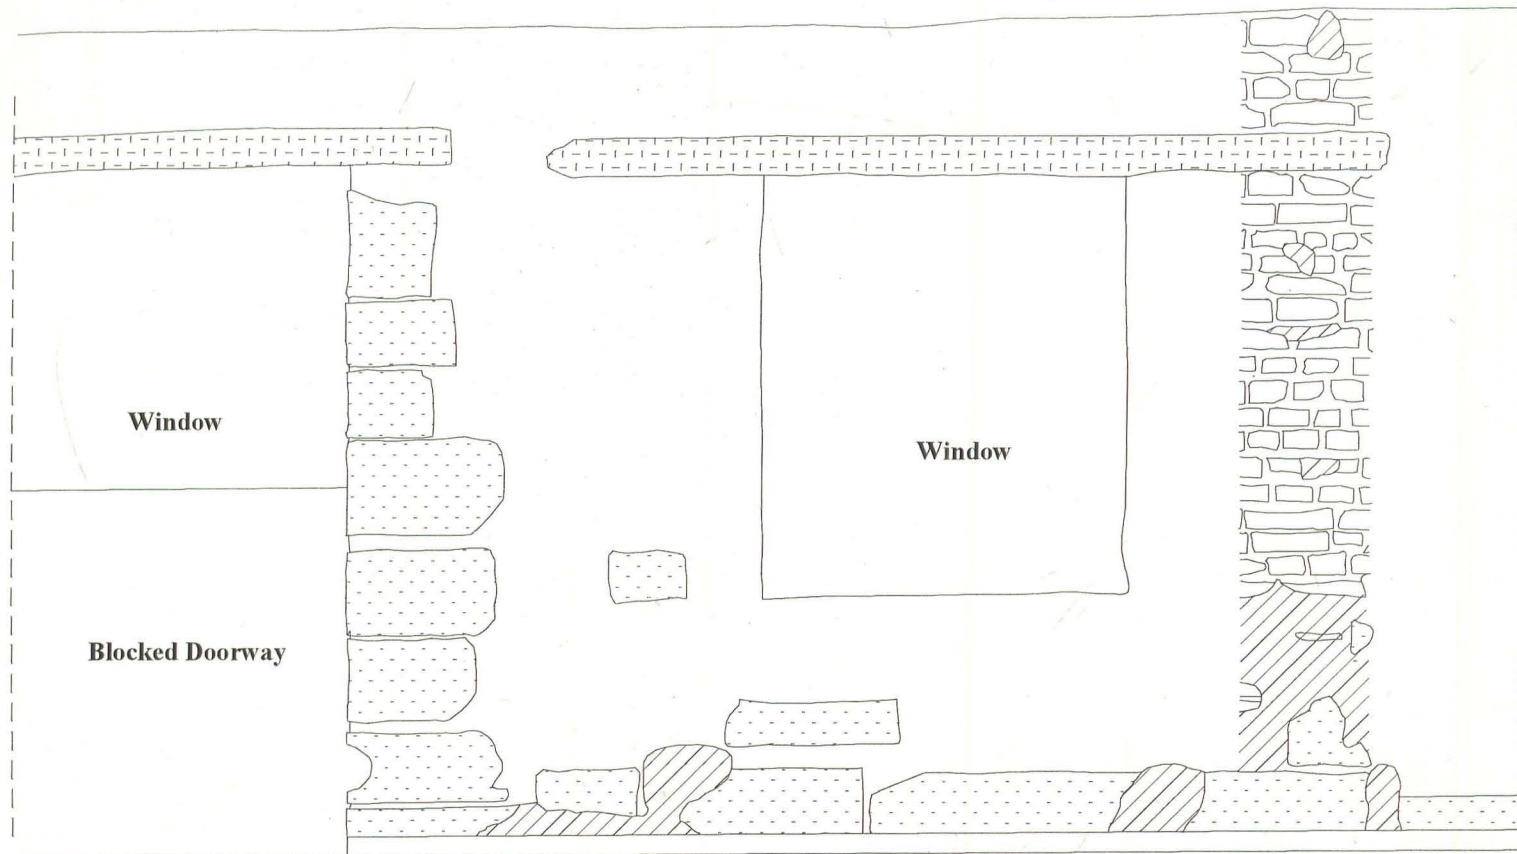
Figure 9 - Elevation 15

Elevation 15, showing brickwork and reused masonry.

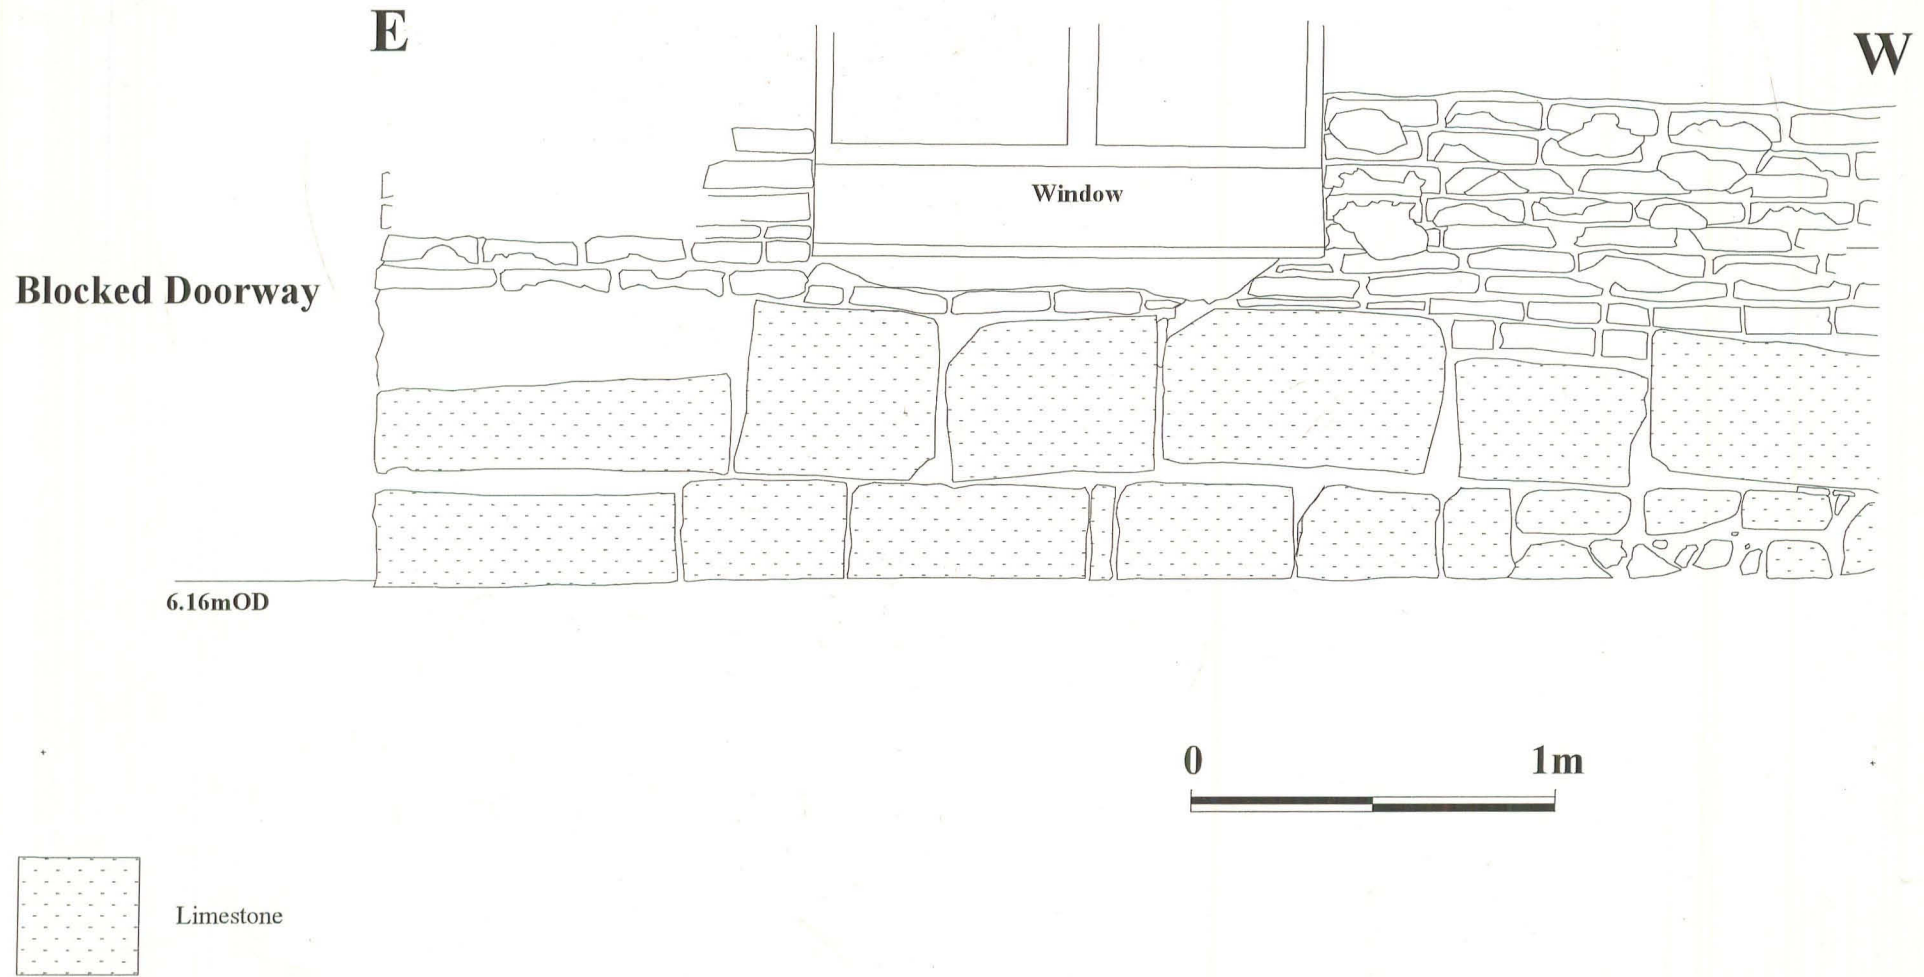
Figure 10 - Elevation 17

Elevation 17, showing reused masonry
