**SURVEY AND PETROLOGICAL ANALYSIS AT  
SS PETER AND PAUL'S CHURCH,  
BOURNE,  
LINCOLNSHIRE  
(BPPC08 and BPPC09)**

Work Undertaken For  
**Matthew Thomas, Architect**  
On behalf of the  
**Parochial Church Council**

APS Report No. **51/09**

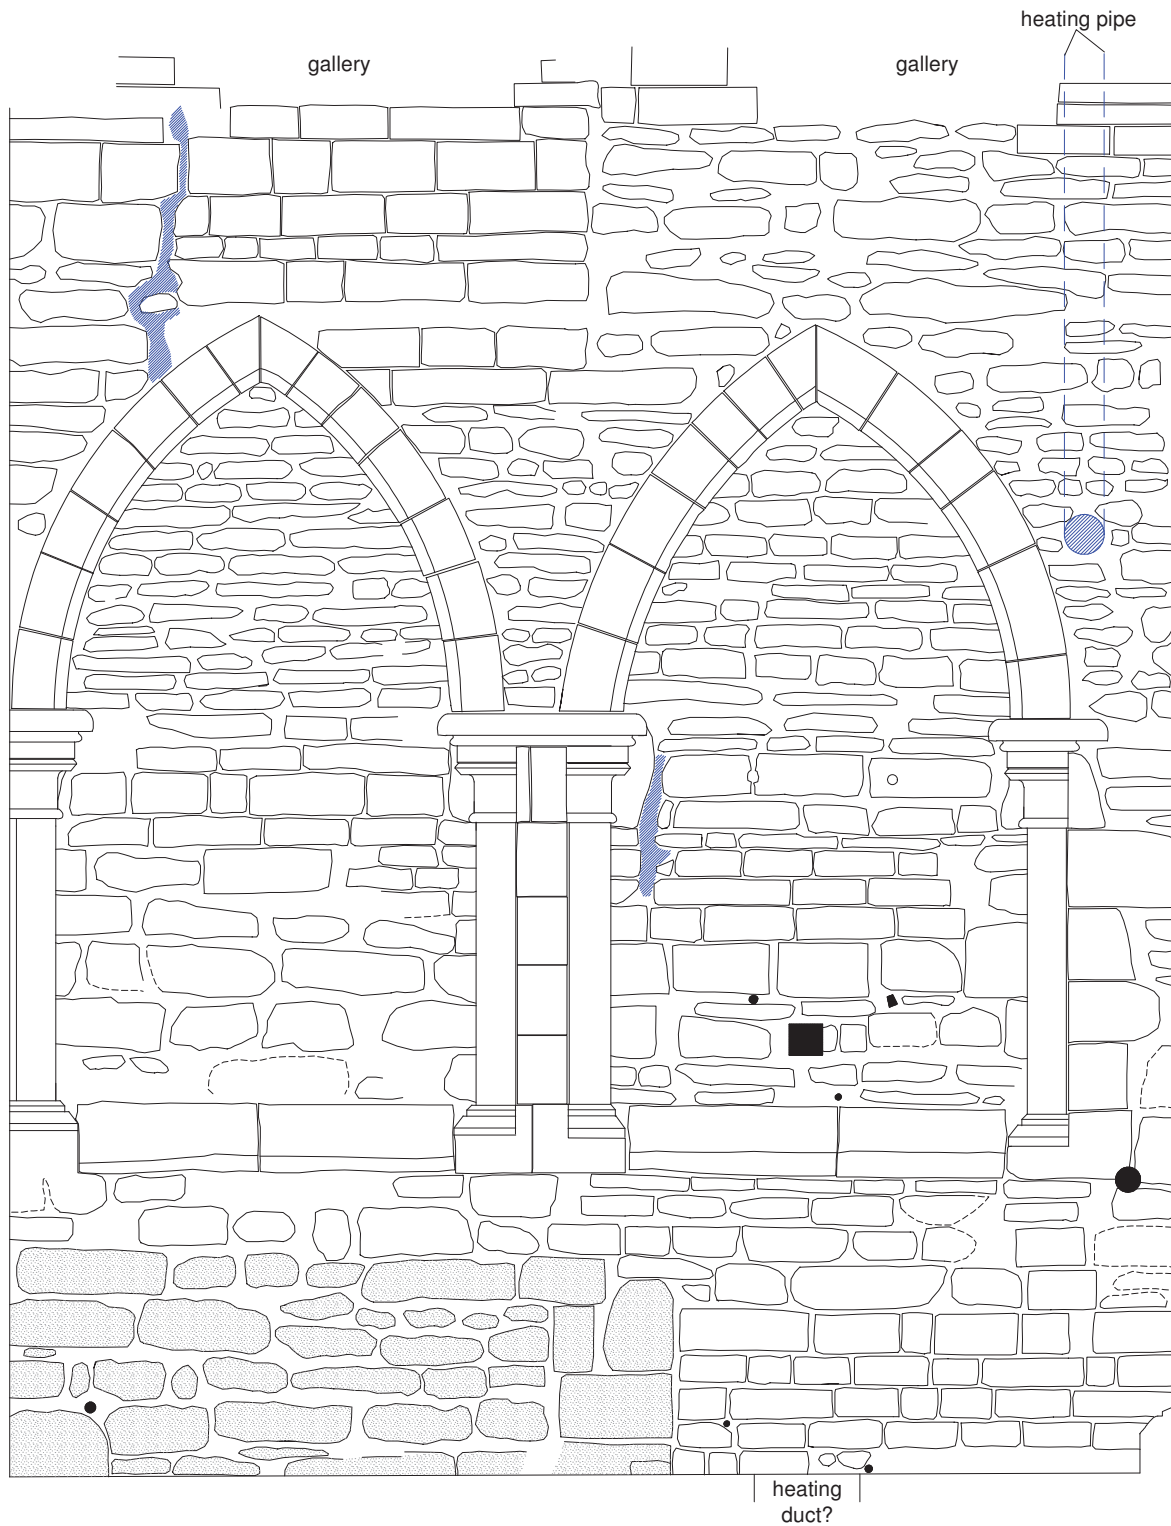
There are two blind arches in the north wall in limestone ashlar. In the fabric surrounding the arches there are at least six distinct styles of masonry, and the mortar bedding is thick and irregular (Fig. 6, Plate 1). This is in marked contrast to the west and south walls of the nave, where the arcades incorporate, and are surrounded by, coursed ashlar blocks set with narrow and even mortar beds (Plate 2).

There is a variation in the lower stone courses below the arches, the western part (shaded grey in Fig. 6) comprising poorly coursed limestone pieces of differing sizes while that to the east is neatly coursed blocks. This change is defined by three stone forming a vertical straight join 0.62m high (Plate 3). Above the height of the straight join the individual stones, and their coursing, are much less regular. Some of the stone is not flush with the wall and a stone beneath the central columns which has a semi-circular profile is possible evidence for re-use.

The column shafts appear to be of sandstone, suggesting that they are replacements. Infill between the two arches is sawn ashlar blocks, likely to be of recent origin. In addition, the sills are chamfered and overlap the column bases (Plate 3), whereas in the arcades in the west and south wall of the church the sills are flat slabs set beneath the column bases (Plate 2). Therefore, the chamfered sills

The upper infill of the arches, and between them at the same level, is an area of coursed smaller stone. Above the western (left) arch, up to the gallery, is a repair in coursed ashlar blocks. There is a straight join at the eastern end of this and to the east, above the right hand arch, is an area of mixed rubble.

A vertical straight join below the west side of the eastern arch indicates an opening at this point, though there is no matching face to the east. Blocking of this opening is represented by an area of coursed ashlar to the east of the straight join. The upper parts of this potential opening, and its blocking, were probably removed during

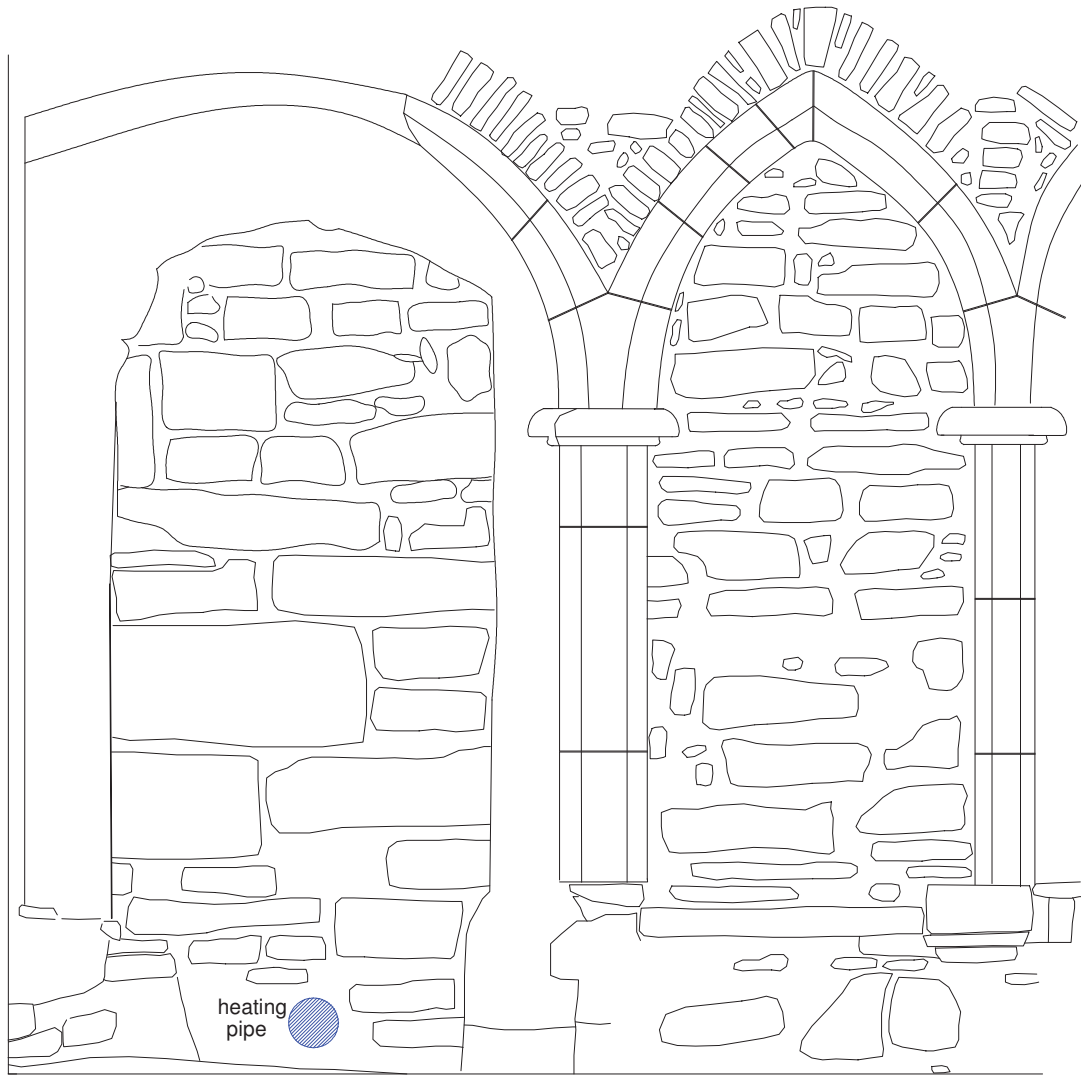
The surveyed section of wall comprises the easternmost two arches of a 13<sup>th</sup> century blind arcade within the boiler room.

The most easterly arch is incomplete due to the insertion of a recess which extends to about 1.07m behind the line of the wall (Fig. 8, Plate 4). This recess is lined and fronted with brick, except for the rear wall which is constructed from large and medium ashlar. Several of the pieces of masonry are set to meet the edges of the recess. The recess does not have parallel sides. While the western wall is straight, the lower part of the eastern wall curves to the west at its southern end. Moreover, the rear wall of the alcove is not square to the sides.

The recorded blind arcade retains much of its medieval character though the stonework is occasionally masked by later pointing. The stonework above the arches may be later, dating from the rebuilding of the north tower. Each arch of the arcade has a ledge sill, presumably a seat. The stonework below this level is generally in a poor condition.

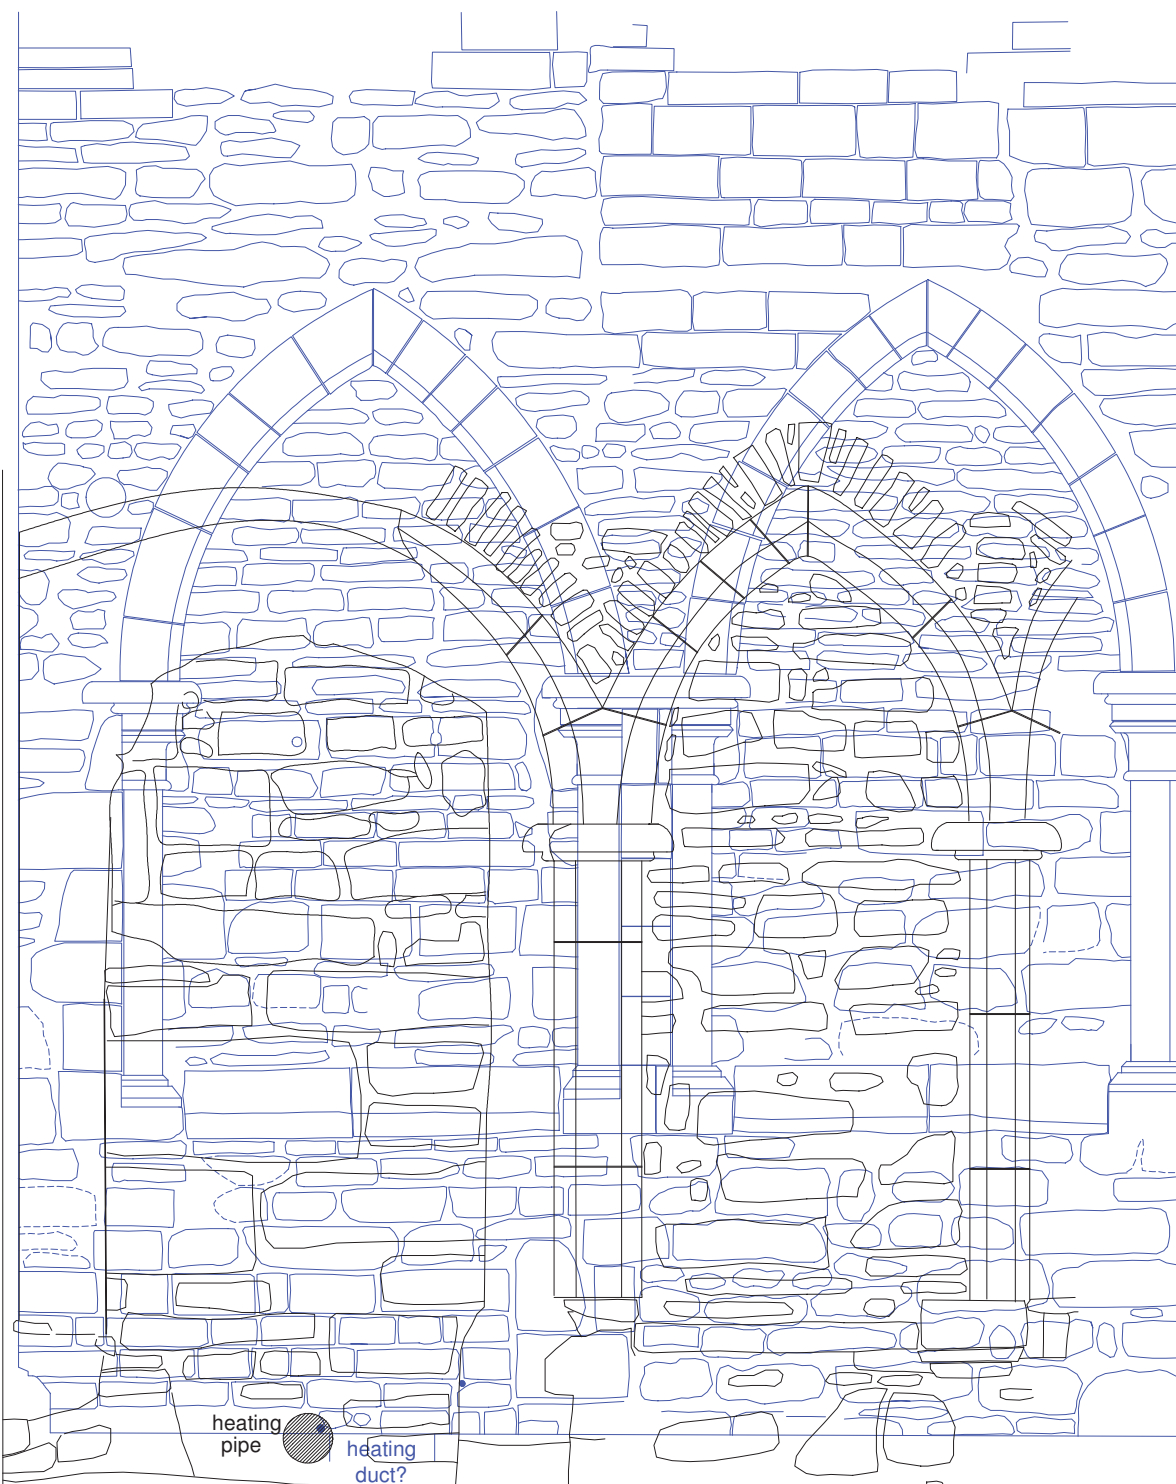
Figure 10 - Superimposed elevations looking south

Overlaying both elevations shows that the floor in the boiler room is some 0.15m below that within the north tower area. Also, the arches of the boiler room arcade are lower than those within the church (Figs. 9 and 10).

Superimposing the elevation drawings shows the arcades overlapping. While this would seem to argue against an entry through the arcades, this overlapping is due to the recess being angled, and not square, to the walls (Figs. 5 and 3).

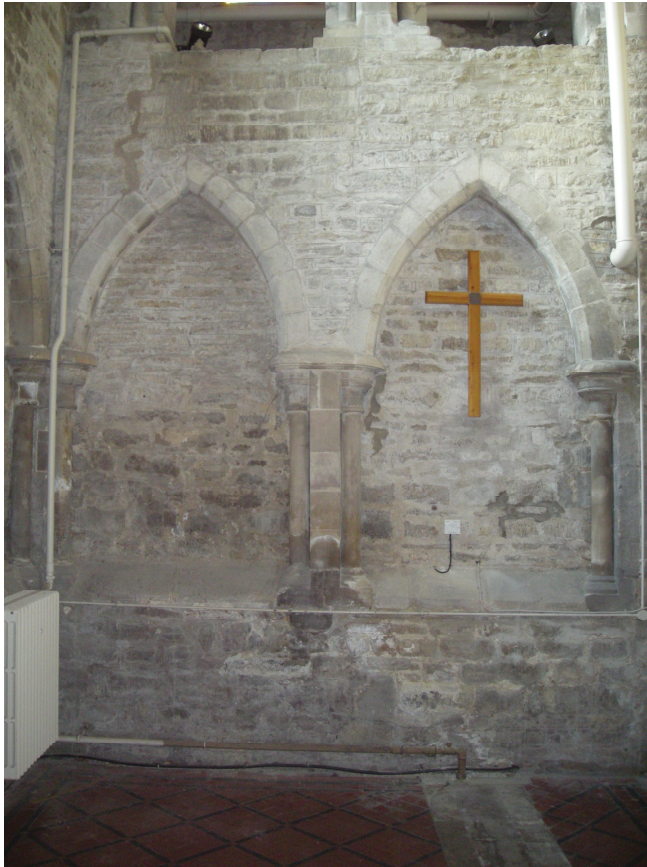
Plate 1 Blind arcade in north wall of tower

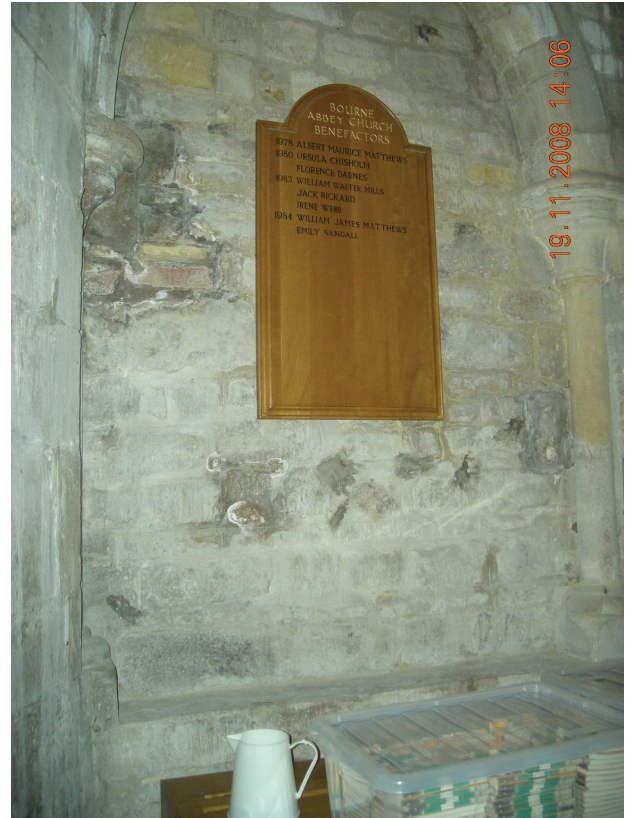
In both arches of the north internal wall there is a sloping sill. The blind arches south of the west door to the north tower have no sloping sill, instead having a shelf composed of either one or more ashlar blocks.

Plate 2 Blind arch located beneath the southwest tower, showing squared shelf of ashlar and different stonework for comparison

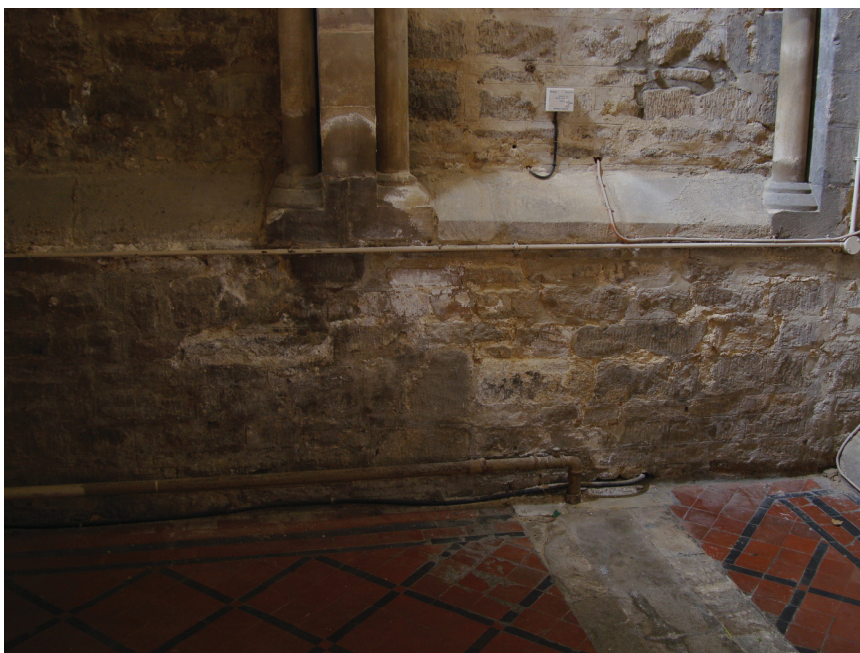
Plate 3 Detail of lower part of arcade, showing inserted chamfered sill and straight join

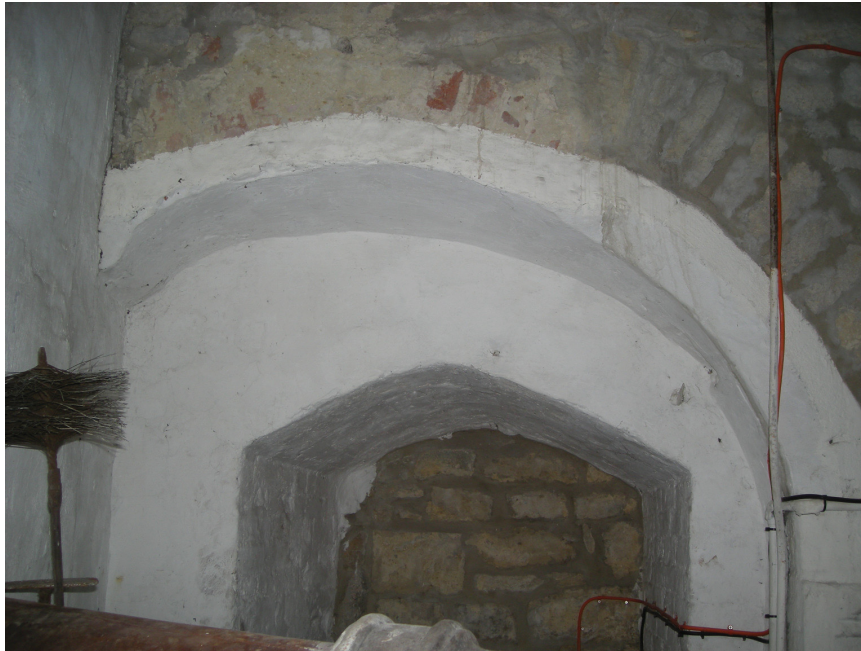
Further indications of an opening through the wall are provided by the inserted niche in the boiler room. This is clearly not original as it is lined with brick, cuts through the medieval blind arcade and still retains wall core at its base. Additionally, several of the stones in the back wall meet the sides of the niche. This implies that these stones are blocking and that the niche previously extended further to the south.

Plate 4 Recess cut through arcade in boiler room

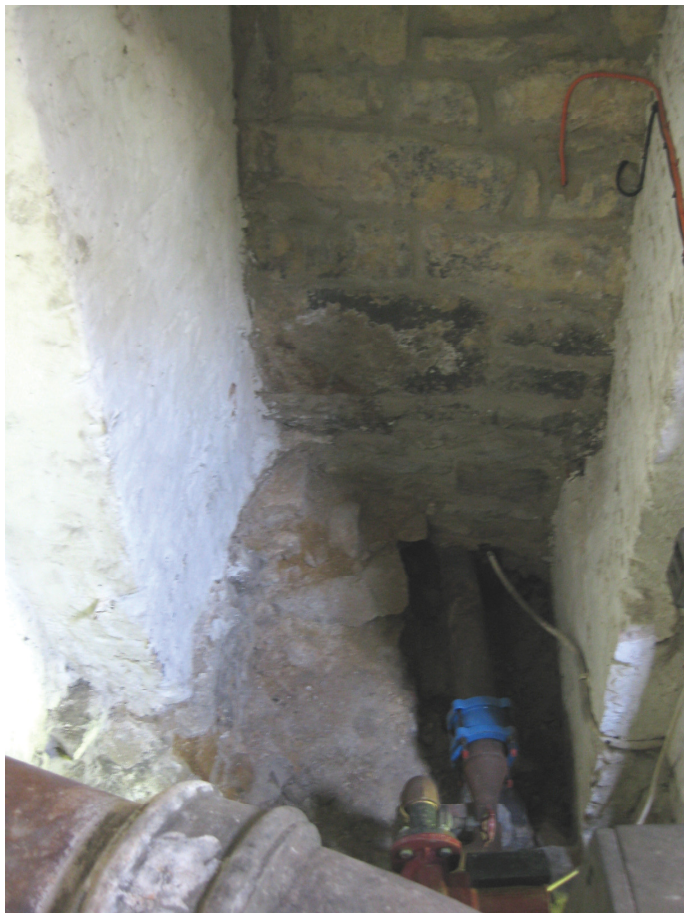
At the base of the recess are surviving remnants of wall core (Plate 5), indicating that the original medieval wall had no passage through it.

Plate 5 Detail of recess base, showing original wall core cut through by pipe duct

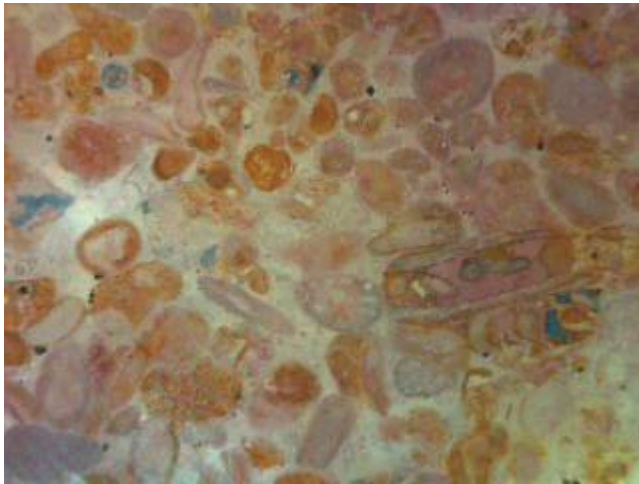
Figure 1

Rock 1: Samples 1-2, 4-8 and 10-11 are all very similar in appearance. They are all peloidal limestone with rare punctate brachiopod shells, sparse bivalve shells and sparse oolitic brown iron-rich pellets. Thin-sections were made of four examples (samples 1, 2, 8 and 10).

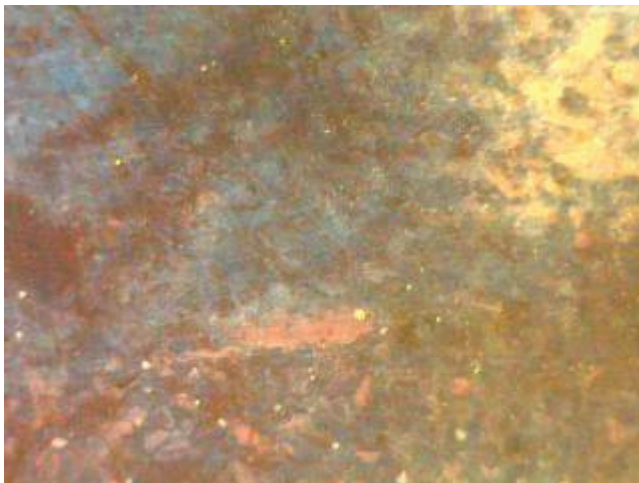
Figure 2

Rock 2: Sample 3 is much finer in texture than any of the other samples. It is suggested here that it comes from an earlier phase and was reused alongside roughly finished infill. None of the other stonework in the wall has such a fine texture, even the *in situ* carved stones (which all appear to be Rock 1).

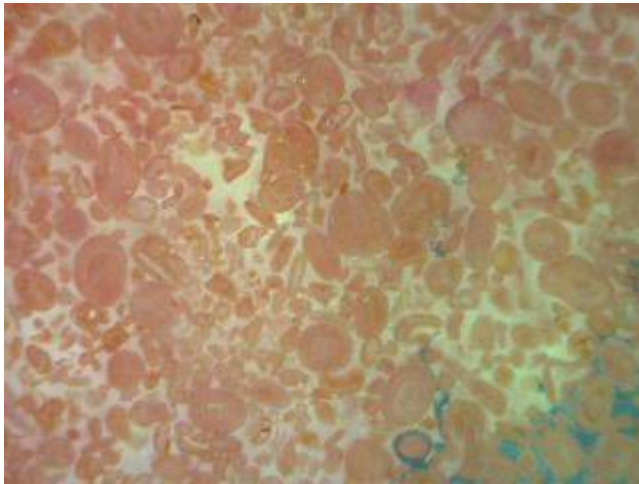
*Figure 3*

Rock 3: Sample 9 is of similar texture to the major group (Rock 1) but lacks the shell and iron-rich oolitic grains. It is more similar visually to material used in definite 19<sup>th</sup> century work.

Ooliths. Up to four layers of oolite built up over various cores, mostly biological in origin (e.g. shell). All grains less than 0.5mm across.

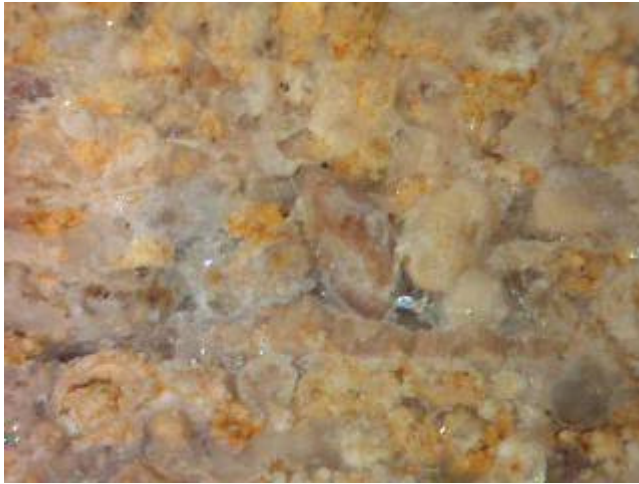
1. Taken from the right hand (i.e. more easterly) block of stonework below a chamfer course.

*Figure 4 (sent for TS, sample V5154). Field of view for this and other macro-photos = c.3.4mm wide.*

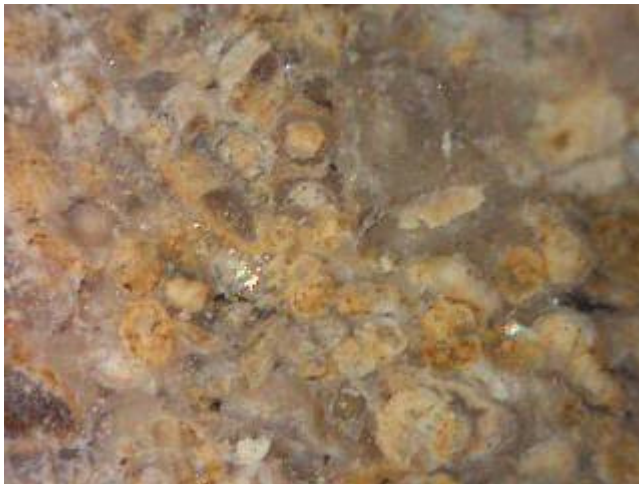
2. Taken from the left hand block of stonework below the chamfer course.

*Figure 5 (sent for TS, sample V5155)*

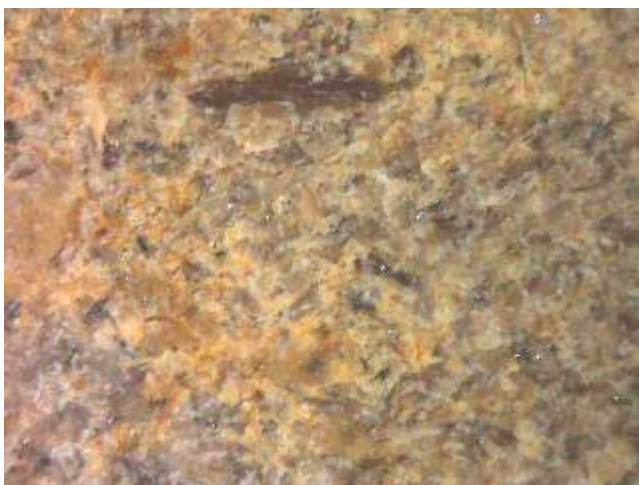
3. Taken from a block of stonework interpreted by the architects as the faced stonework forming the left hand side of a blocked doorway.

*Figure 6 (sent for TS, sample V5156)*

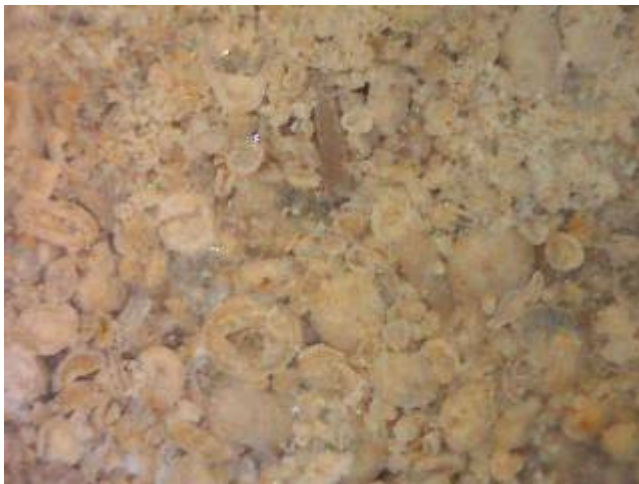
9. Taken from a patch of more regular-shaped stonework below the more westerly window and gallery opening. This appears to be a repair patch inserted into the wall, and cutting areas 10 and 11.

*Figure 12 (sent for TS, sample V5158)*
