Burnhervie, Inverurie, AB51 5JA  
Report on soil strip for minimum offtake  
connection

Cameron Archaeology  
10 June 2011

# **Burnhervie, Inverurie, AB51 5JA**

## **Report on soil strip for minimum offtake connection**

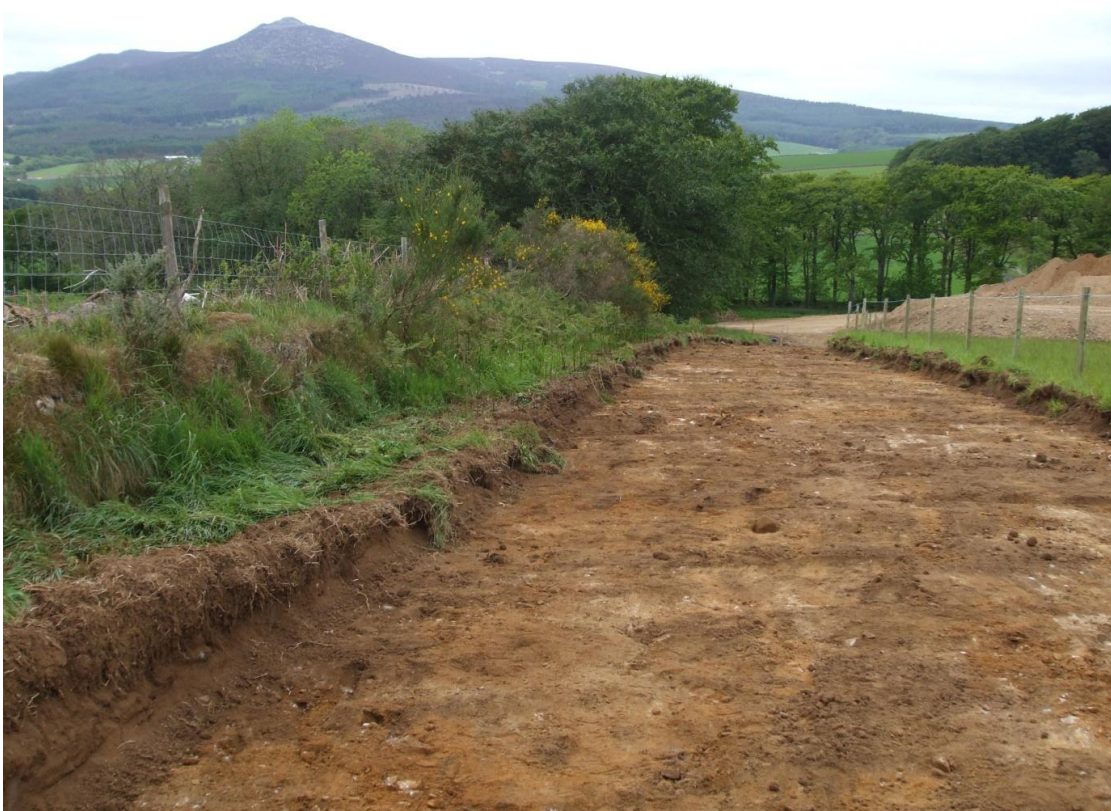
Ill 3 Area 1 facing WNW

This is the area north of drystone dyke (F1) and is a cultivated field with up to 0.2m of topsoil on clayey gravel natural subsoil. No features were recorded in this area.

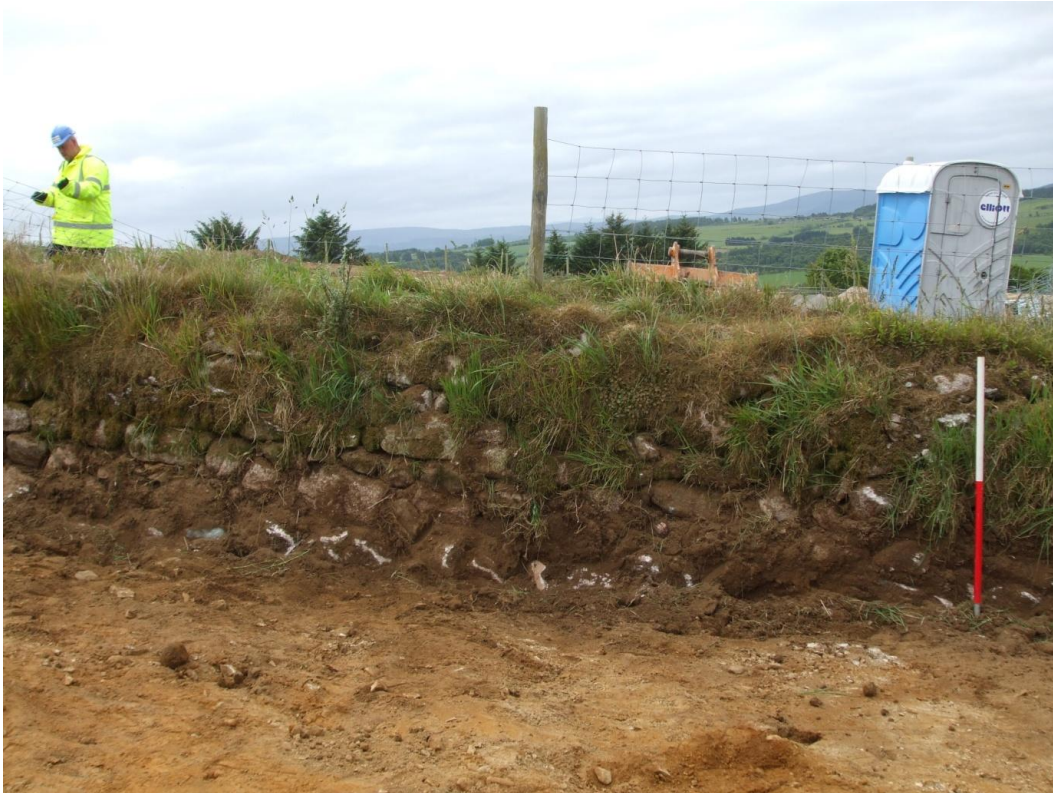
III 4 Area 1 Feature F1 facing south

A drystone dyke was a maximum of 1m high and 0.6m wide at the base. It was removed in the area of the soil strip and will be reinstated after the work is completed.

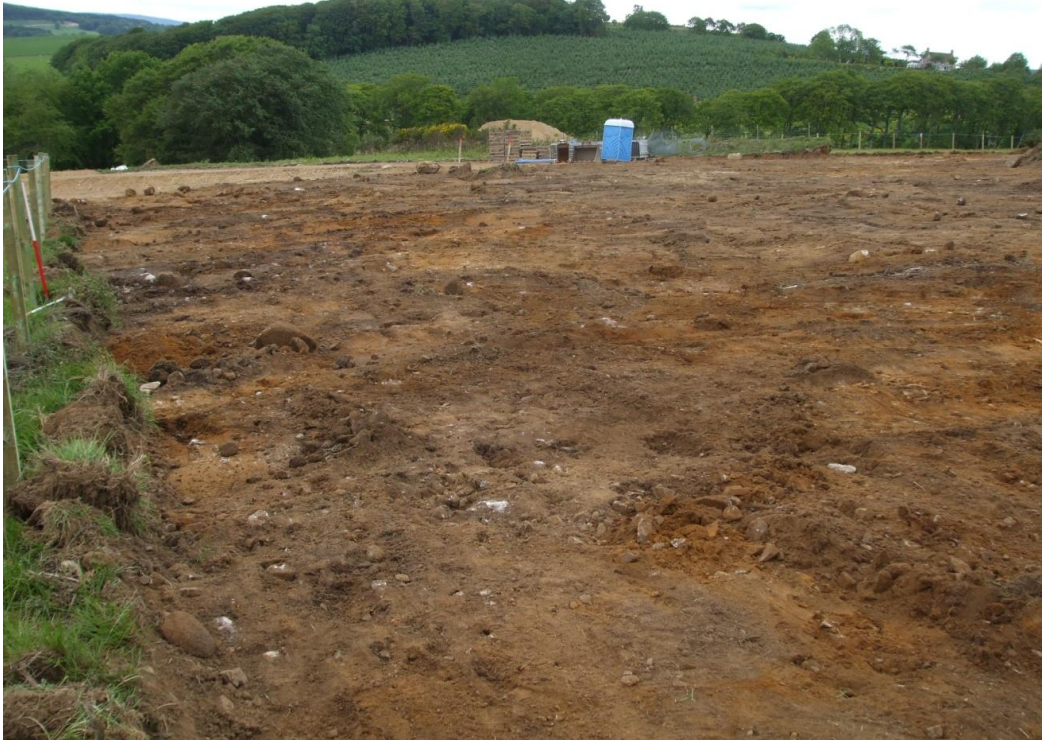
III 6 Area 2 west end facing NW

This area south of drystone wall F1 had been cleared of gorse prior to this watching brief. The soil was very shallow (up to 0.1m) and the subsoil as very disturbed by burnt and unburnt roots, dumps of stone and soil as well as two areas of deep plough marks (F2 and F3), probably dating to the 19th or 20th century. The area is shown partly tree covered on the First Edition Ordnance Survey

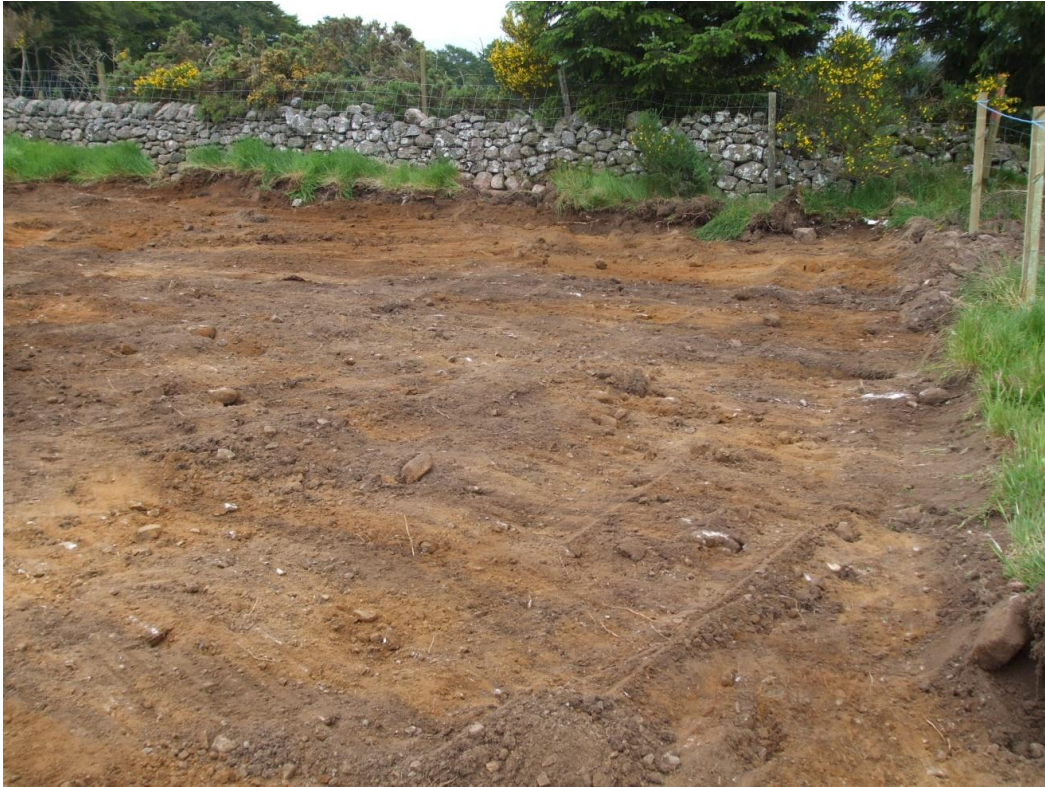
III 7 Area 2 plough marks (F2) extreme south of site, facing south

A small number of finds from around the plough marks include fragments of china and small fragments of ceramic roof tile suggesting a 19th or early 20th-century date for these features.
