**Report on the archaeological evaluation
Silverburn Phase 2, Corunna Road, Bridge of Don,
Aberdeen, AB23 8DA**

Cameron Archaeology Ltd

7 November 2011

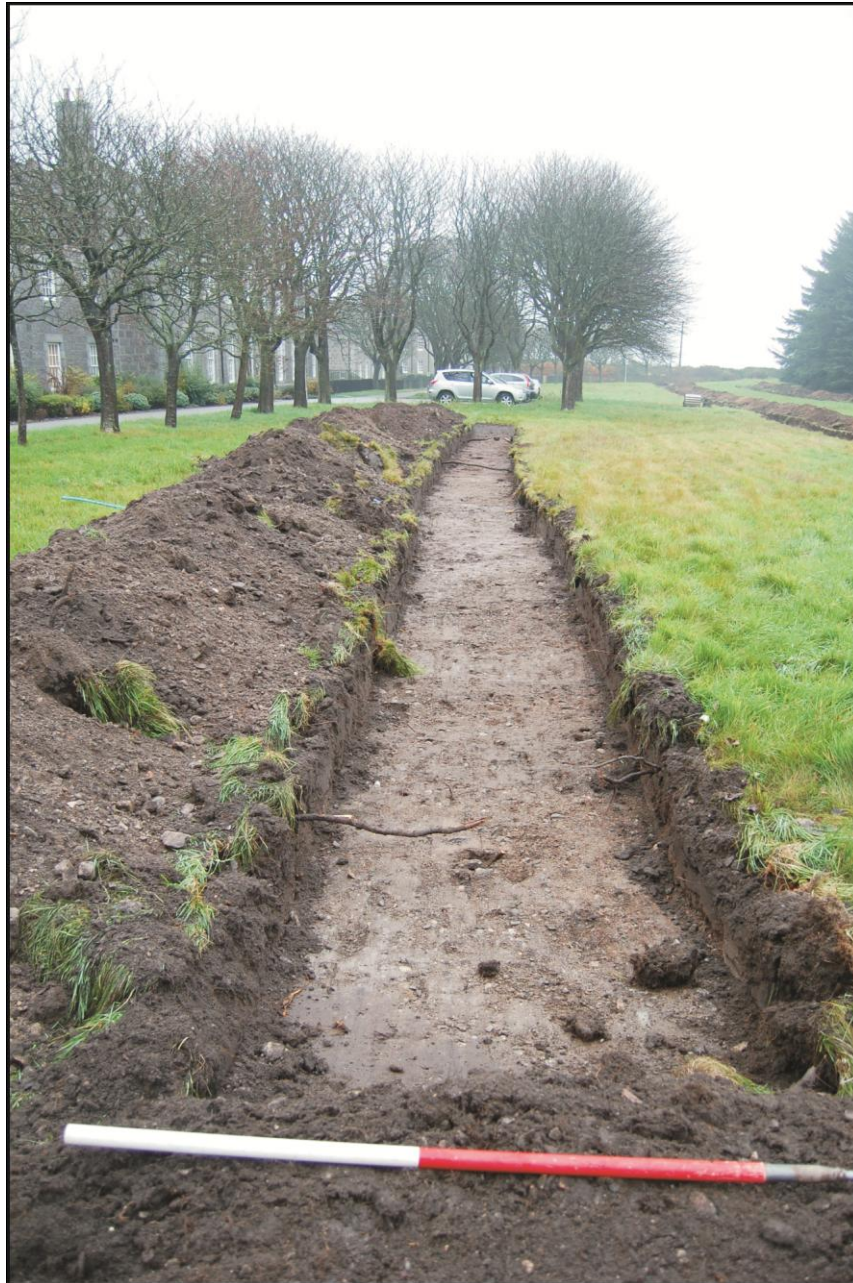
Cover Trench 1 facing east

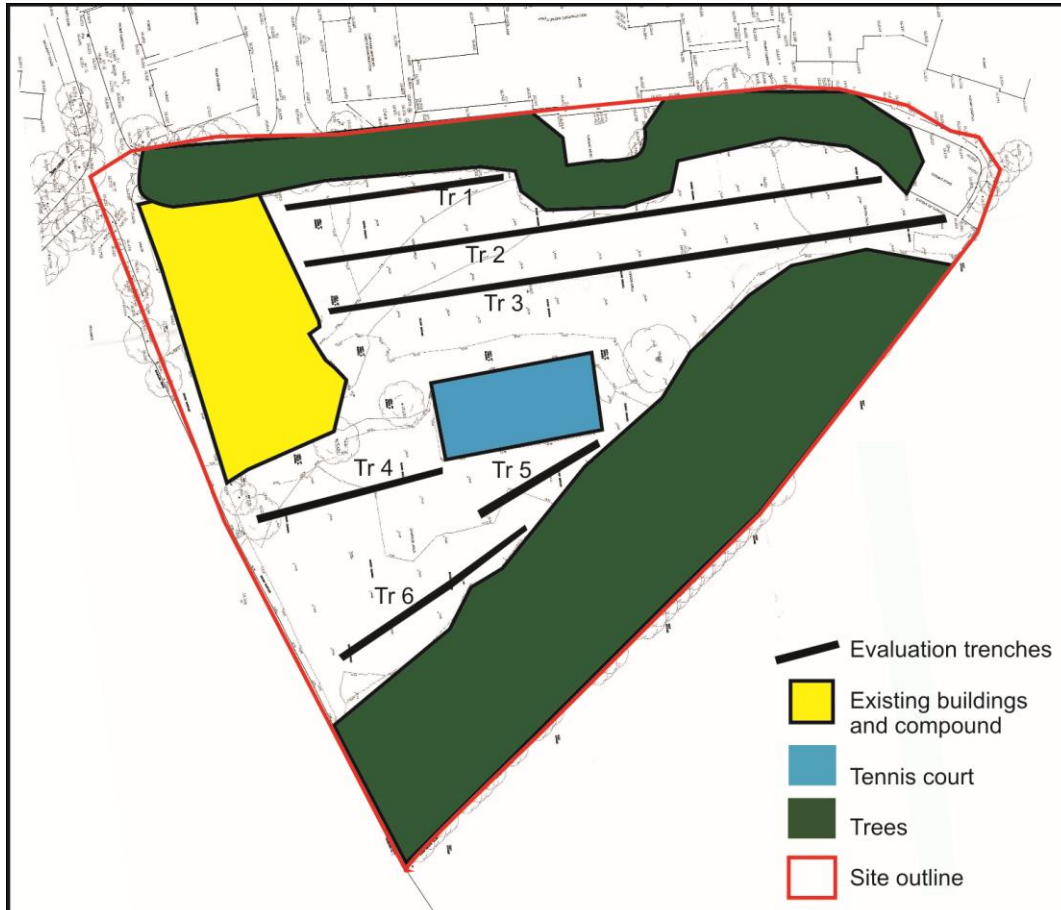
Ill 3 Existing layout with evaluation trenches

The archaeological evaluation took place on 3-4 November 2011. Six trenches (totaling 7% of the available area) were excavated with a tracked machine with 1.5m ditching bucket.

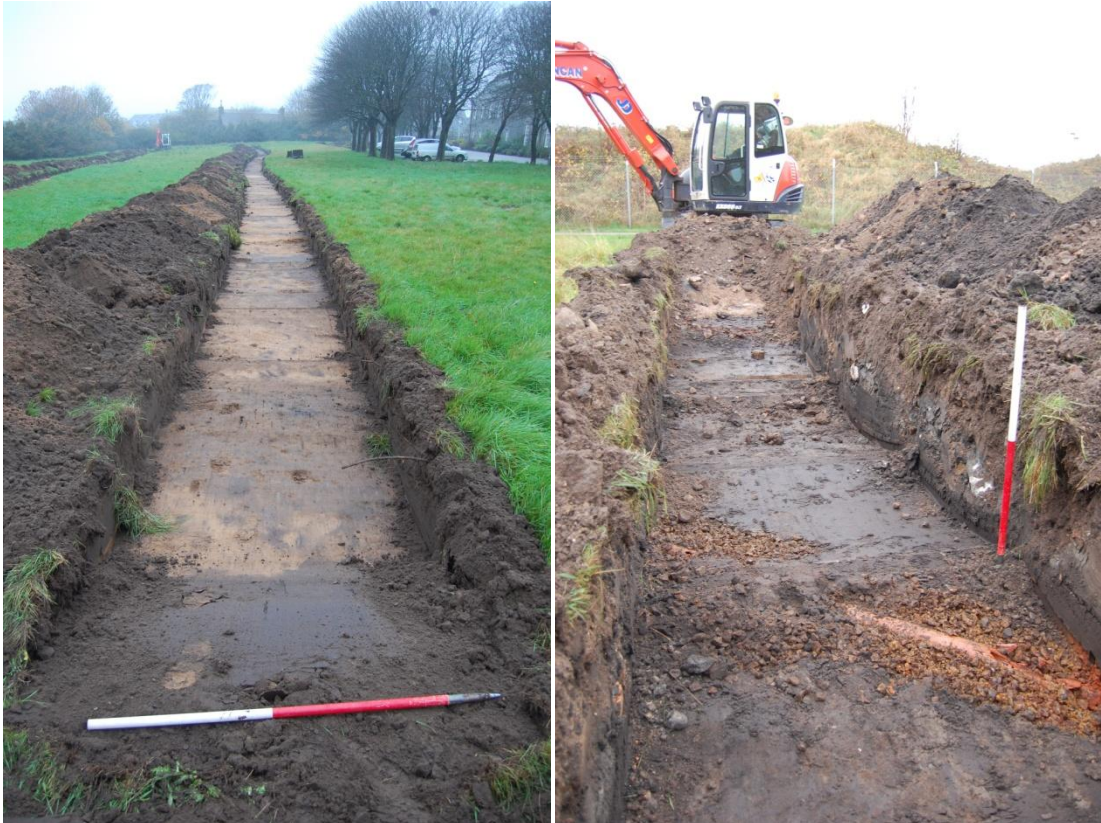
Ill 5 Trench 2 showing sand natural (left; facing W), Trench 4 showing ceramic land drain F3 (right; facing W)

Trenches 4-6 were excavated in the southern part of the site adjacent to a former tennis court. The ground appeared to have been disturbed, was hummocky and overgrown with nettles. The trenches revealed that up to 1m of modern building rubble (sewer pipe, stone, brick, plastic and wood) had been dumped in this area (Ill 4); in places the plough soil had been completely removed and the rubble dumped on the natural sand. In other places some plough soil remained; it was up to 20cm deep and waterlogged. Several land drains were identified including two ceramic drains in 0.5m wide trenches filled with small angular stones. Details of all features appear in archive.
