Land at Wellington Road, Aberdeen,  
AB12 3WH  
Archaeological Evaluation Report

Cat Peters  
Cameron Archaeology  
24 January 2012

# Land at Wellington Road, Aberdeen Archaeological Evaluation Report

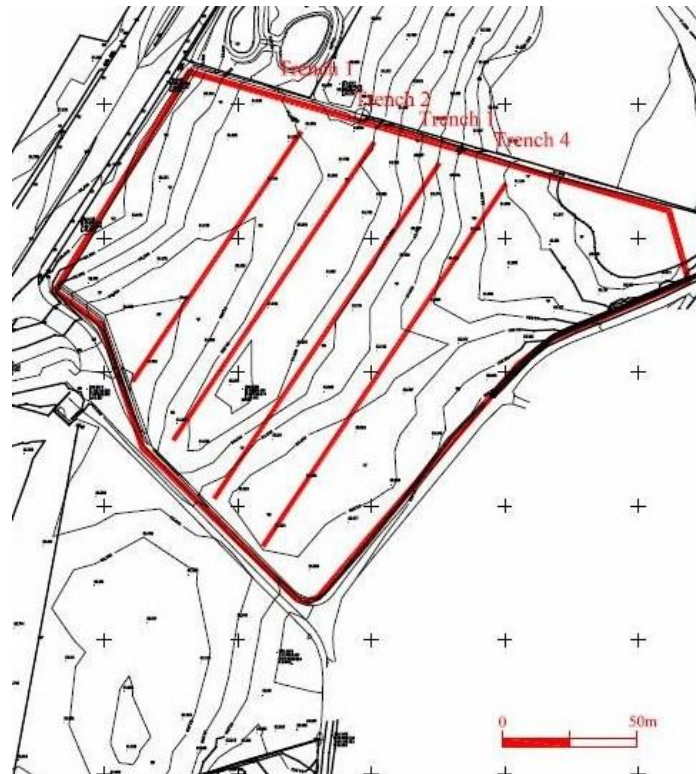
**Illus 4 Location of evaluation trenches within Area 2**

Area 2 was located in the north-eastern part of the development site and consisted of one field. The presence of overhead electricity cables meant that the western part of the field was not evaluated. Four linear trenches were excavated within Area 2 on a north-east south-west alignment (Ill 4).

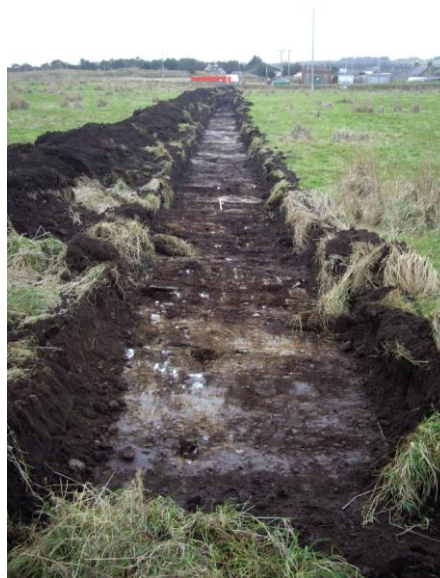
**Illus 5 Trench 1 upon completion, facing south-west**

Trench 1 was 113m by 1.8m and revealed a loose dark brown silty topsoil between 0.3 and 0.4m in depth with small stone (up to 0.15m diameter) inclusions overlying a loose orange-brown silty sand natural with some patches of yellow-grey sand. Two south-east north-west aligned stone drains were encountered within the southern half of the trench.

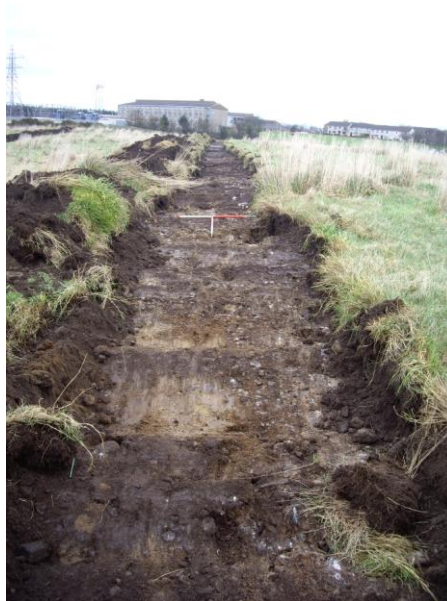
**Illus 6 Trench 2 upon completion, facing north-east**

Trench 2 was located 25m to the east of Trench 1. It was 1.8m by 135m. A loose dark brown silty topsoil between 0.3m and 0.5m depth lay above a loose orange-brown silty sand. No features were encountered within Trench 2.

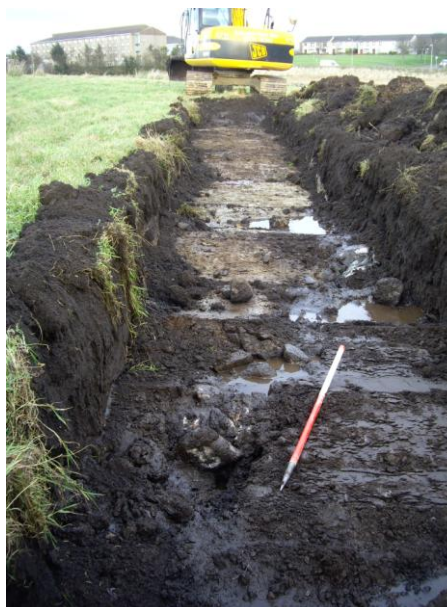
**Illus 7 Drain encountered in Trench 3, facing north-east**

Trench 3 was excavated 25m to the east of Trench 2 and revealed a loose dark brown silty topsoil between 0.5 and 0.7m depth on top of an orange silty sand with areas of brown silty sand. The trench measured 1.8m by 151m. One north-east south-west aligned stone drain was encountered in the northern part of the trench (Ill 7). No further features were encountered in Trench 3.

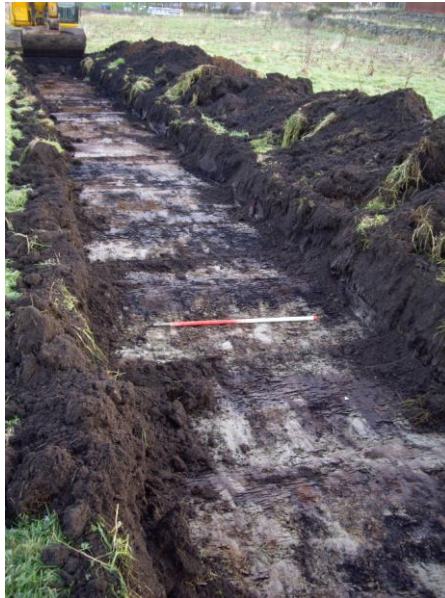
**Illus 8 Rig and Furrow marks in south-western extent of Trench 4, facing north-east**

Trench 4 was sited to the east of Trench 3, 25m to the east, and was 1.8m wide and 163m in length. It consisted of 0.3m to 0.6m depth of loose dark brown silty

topsoil overlying an orange-brown silty sand. The north-eastern 20m extent contained a yellow-grey clay-like sand. A total of six stone drains, four running north-east to south-west and two running east to west, as well as some probable rig and furrow marks (Ill 8). A fragment of pottery, white with blue patterning, suggests a 19<sup>th</sup> century date, which ties in with known land usage of the area as being extensively ploughed in the 19<sup>th</sup> and 20<sup>th</sup> centuries (Cameron 2011b, 6).

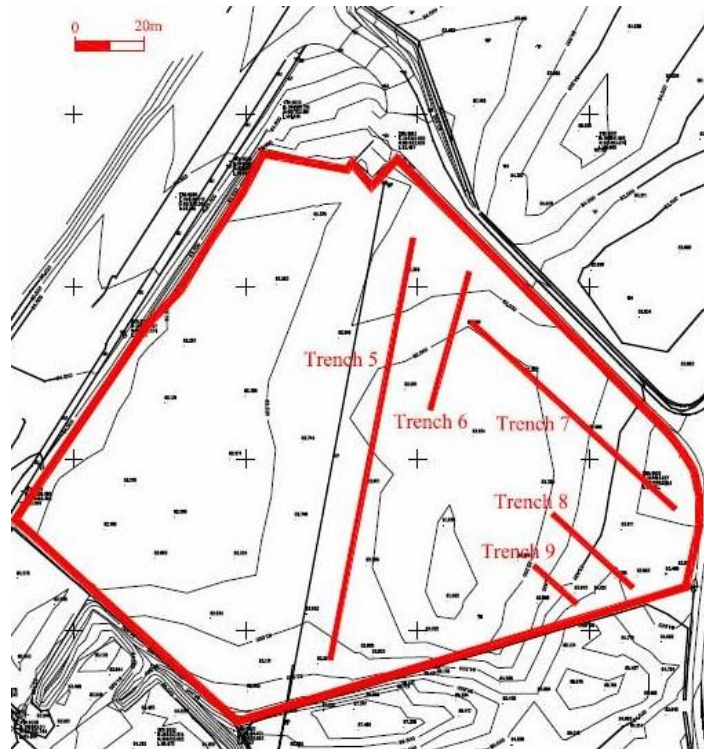
**Illus 9 Location of evaluation trenches within Area 3**

Area 3 consists of one field. Area 3 contained a large area of bog, which was unsafe to excavate in due to the rising water levels and the difficulty in backfilling. The presence of overhead electricity cables also ruled out the western part of Area 3. A total of five trenches (Trenches 5-9) were excavated within Area 3 (Ill 8).

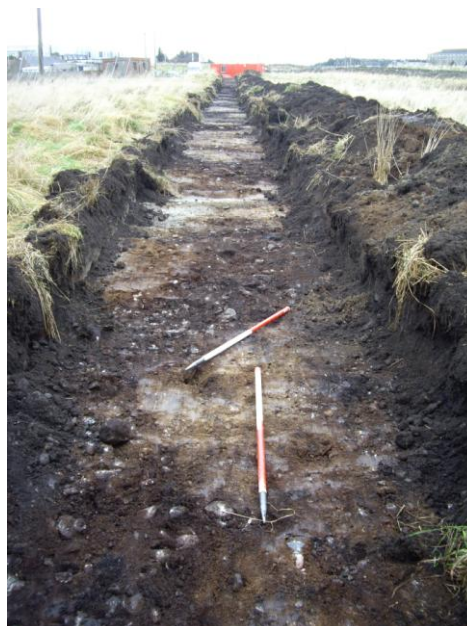
**Illus 10 Southernmost stone drain in Trench 5, facing north**

Trench 5 was excavated on a north to south alignment to an extent of 1.8m in width and 125m in length. A loose dark brown silty topsoil 0.3m to 0.7m in depth with occasional boulders up to 0.6m diameter. This overlay an orange-brown silty sand. A total of seven stone drains were encountered within the trench, four on a north-east to south-west alignment, and three on a north-west to south-east alignment (Ill 9). No further features were encountered.

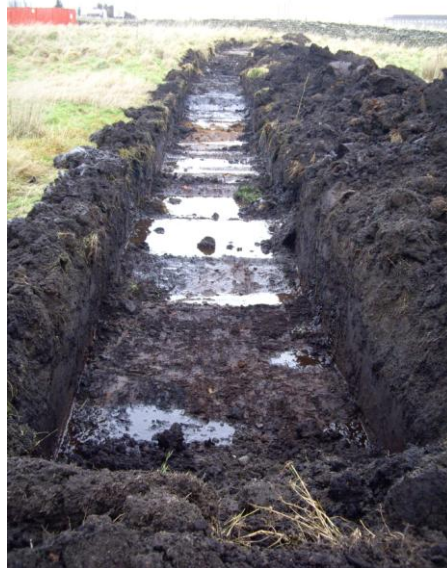
**Illus 11 Trench 6 upon completion, facing north**

Trench 6 was located to the east of Trench 5 and measured 1.8m by 42m. It was curtailed due to the boggy ground (Ill 10). In the northern part of the trench a loose dark brown silty topsoil of between 0.3m and 0.6m depth overlay an orange brown silty sand. The southern part of the trench encountered a very wet and dark peat with boulders. A maximum depth of 0.75m in the peat was reached, but the boggy nature of the ground, and the damaged stone drains encountered, made backfilling almost impossible, so the trench was stopped.

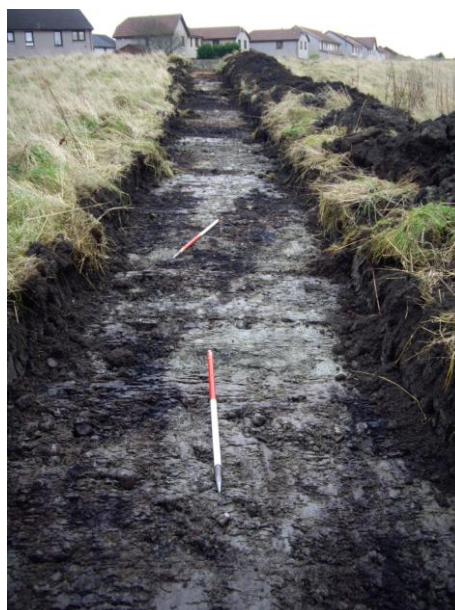
**Illus 12 Easternmost drain in Trench 7, facing south-east**

Trench 7 was excavated on a north-west to south-east alignment measuring 1.8m by 81m. It revealed a loose dark brown silty topsoil of between 0.35 and 0.55m depth above a yellow-grey clay-like sand. Two stone drains were found in Trench 7, both within the western half, the western one aligned north-east to south-west, and the easternmost aligned north-west to south-east (Ill 11).

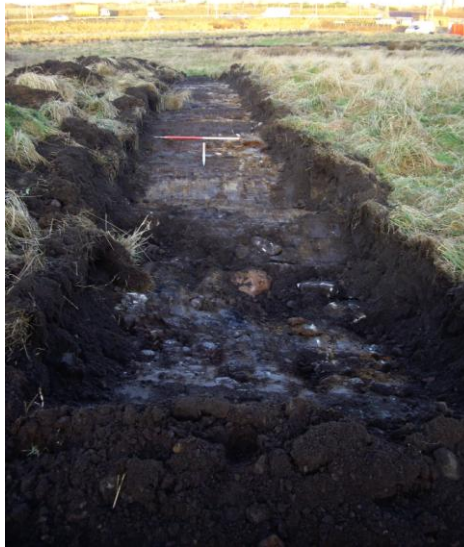
**Illus 13 Drain in south-eastern part of Trench 8, facing north-west**

Trench 8 was on the same alignment as Trench 7, and to the south. It measured 1.8m by 32m. It revealed a loose very dark brown silty topsoil overlay a loose orange silty sand. One stone drain was encountered within the trench, on a north-east to south-west alignment (Ill 13). No further features were observed.

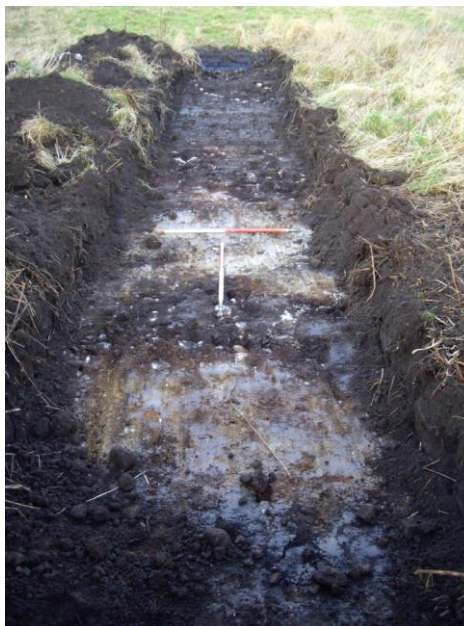
**Illus 14 Trench 9 showing stone drains, facing north-west**

Trench 9 was excavated to the south of Trench 8 and was 1.8m in width and 17m in length. It encountered a loose very dark brown silty topsoil of between 0.3 to 0.5m in thickness which directly overlay a loose orange silty sand. Three stone drains were observed within the trench, all on a north-east south-west alignment.

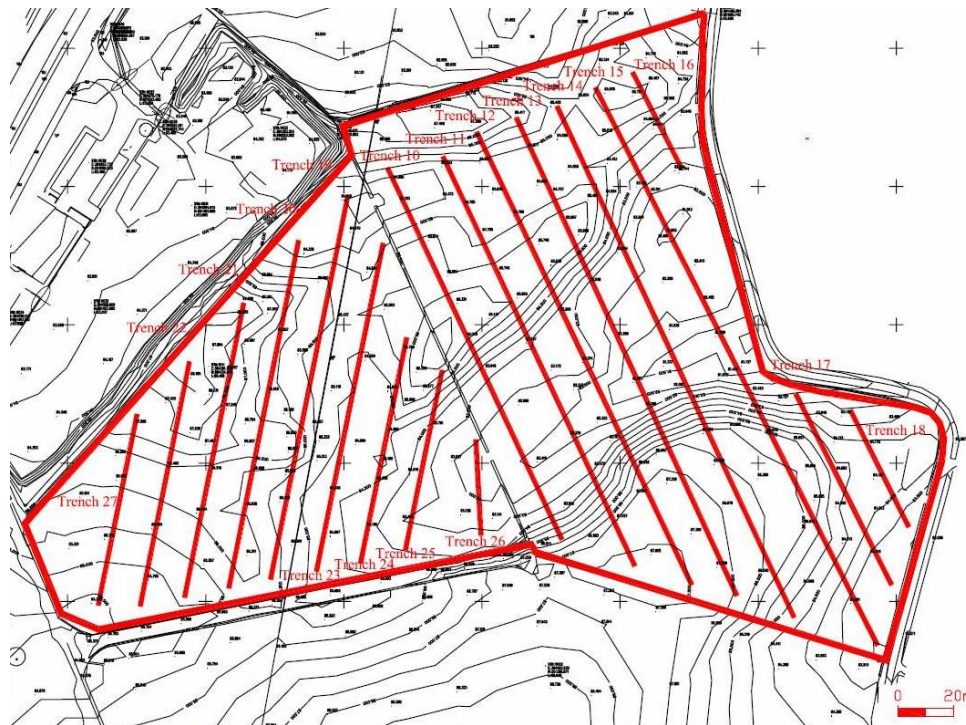
**Illus 15**      **Location of evaluation trenches within Area 5**

Area 5 consisted of two fields and formed the southernmost part of the development area. The consumption dyke formed its southernmost boundary on the western side. A total of 18 trenches were excavated within Area 5 (Trenches 10-27).

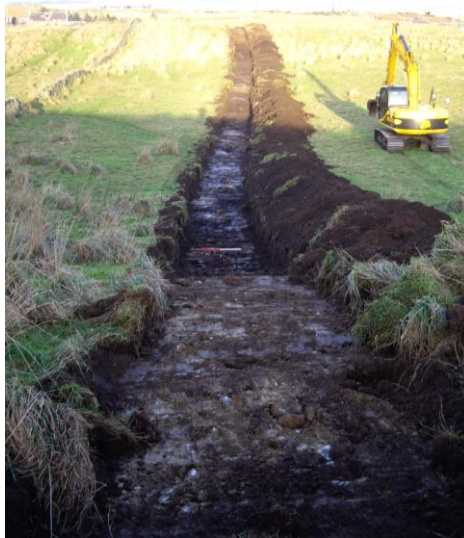
**Illus 16 Trench 10 upon completion, facing north-west**

Trench 10 was excavated at the western extent of the eastern field in Area 5, on a north-west south-east alignment following the field boundary. It measured 1.8m by 147m and revealed a loose dark brown silty soil between 0.2 and 0.7m thickness directly overlaying a loose orange silty sand. No features were encountered within Trench 10 (Ill 15).

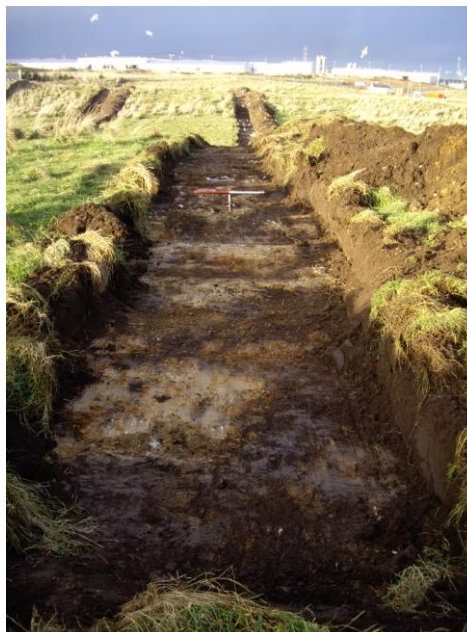
**Illus 17 Trench 11 upon completion, facing north-west**

Trench 11 was located 20m to the east of Trench 10 and measured 1.8m in width by 164m in length and was excavated on a north-west to south-east alignment. It revealed a loose dark brown silty soil of between 0.3 and 0.9m in depth which overlies a loose orange silty sand. No features were observed within Trench 11 (Ill 1).

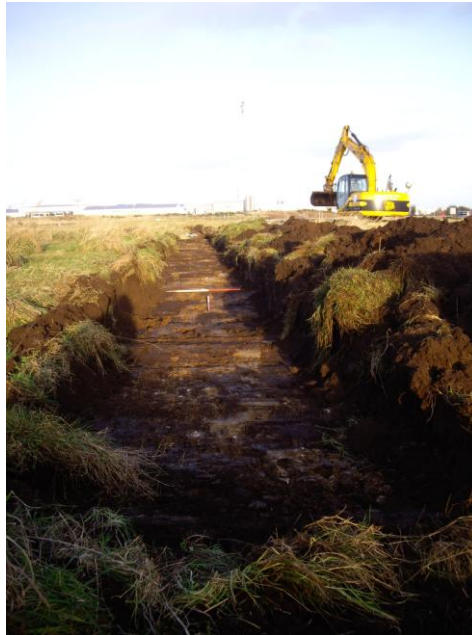
**Illus 18 Trench 12 upon completion facing north-west**

Trench 12 was located to the east of Trench 11 on a north-west south-east alignment, 15m to the east of Trench 11. It was 1.8m wide and 182m long. It consisted of a loose dark brown silty soil between 0.2m and 0.8m depth overlying a loose orange silty sand. There was an area of gravel at the top of one of the

undulations, and also an area of rocky natural, but no archaeological features were encountered (Ill 18).

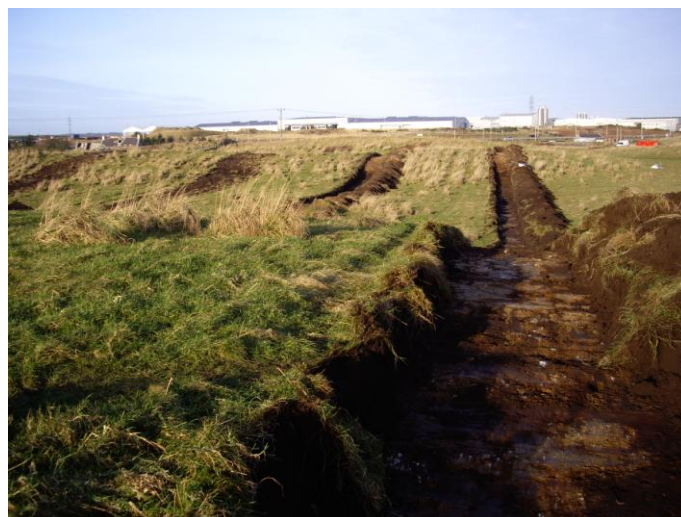
**Illus 19 Trench 13 under excavation, facing north-west**

Trench 13 measured 1.8m in width and 190m in length and was located 15m to the east of Trench 12 on the same alignment. A loose dark brown silty topsoil of between 0.15 and 0.75m thickness overlay a loose orange sandy natural (Ill 19). An area of boulders was encountered on the cusp of the first area of high ground and an area of gravel formed the natural ground at the top of the second rise, as the trench was excavated south-westwards. No features were observed.

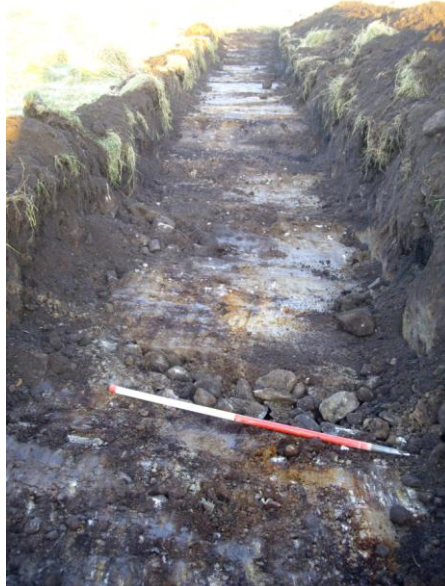
**Illus 20 Stone drain in Trench 14, facing north-west**

Trench 14 was excavated to the east of Trench 13 to a width of 1.8m in width and 203m in length. The topsoil was a loose dark brown silty soil between 0.2 and 0.75m thickness overlay a loose orange sandy natural silt. A ceramic jar was found in the topsoil of Trench 14 (front cover). The backstamp at its base was in

an oval pattern, inscribed, 'Doulton & Co Limited, Lambeth' with the number '40' at its centre, a probable pattern number. The Lambeth pottery of Doulton opened in 1854, and Doulton adopted 'Royal' at the turn of the century. In addition, the fact that it is oval, and the number 40, suggests a 1869-72 date. This ties in neatly with known 19<sup>th</sup> and 20<sup>th</sup> century farming activity in the area. The jar was chipped, and was not retained. An east-west aligned stone drain was observed towards the north-western end of Trench 14 (Ill 20). No other features were encountered within Trench 14.

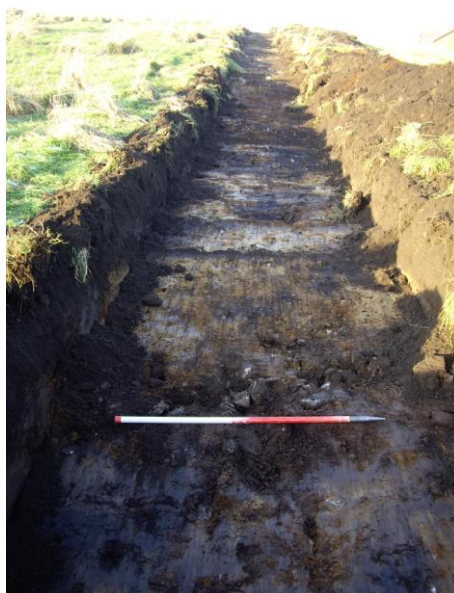
**Illus 21 Stone drain in Trench 15, facing north-west**

Trench 15 was located 15m to the east of Trench 14 and was 1.8m by 226m. It contained a loose dark brown silty topsoil of between 0.2 and 0.75m depth and which included some boulders at the base of the northernmost area of higher ground, and this overlay a loose soft orange silty sand. A stone drain was observed close to the south-eastern extent of the trench (Ill 21).

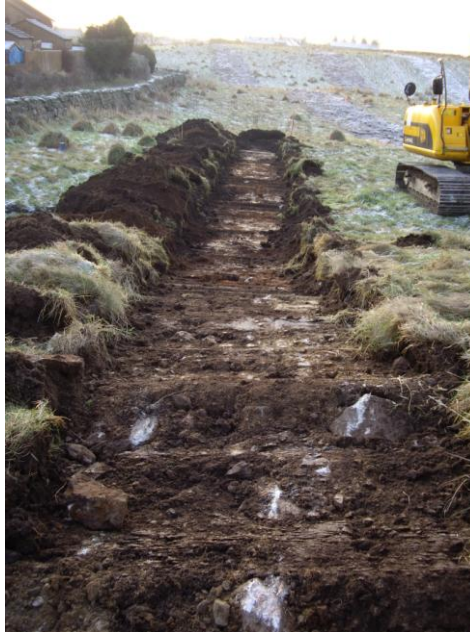
**Illus 22 Trench 16 upon completion, facing south-east**

Trench 16 was a shorter trench excavated on a north-west south-east alignment to the east of Trench 15 and measured 1.8m wide and 38m long. A loose dark brown silty topsoil between 0.2 and 0.65m depth overlay a loose soft orange silty sand (Ill 22). No features were encountered within the trench.

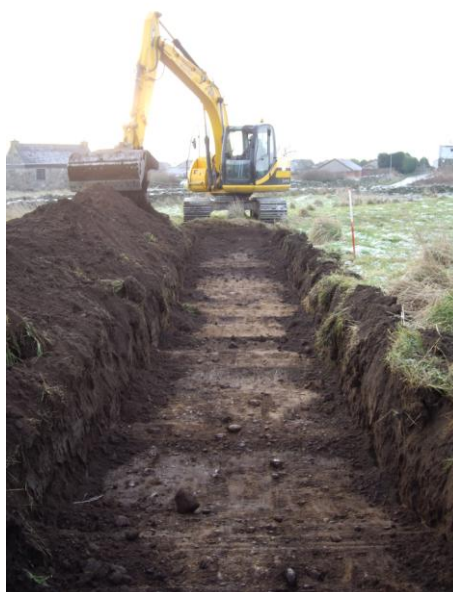
**Illus 23 Trench 17 under excavation facing south-east**

Trench 17 was excavated within the south-eastern corner of Area 5, on a north-west to south-east alignment and measured 1.8m in width and 77.5m in length. A loose dark brown silty topsoil of between 0.25m and 0.8m thickness was encountered overlying a loose soft orange silty sand (Ill 23). No features were observed within Trench 17.

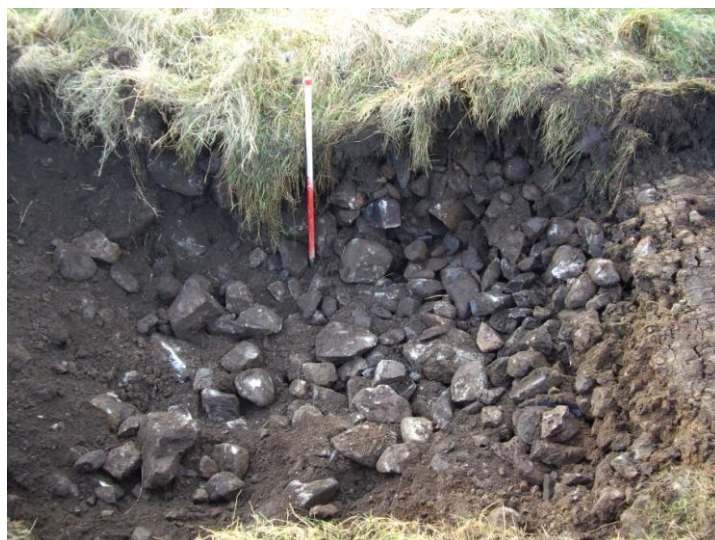
**Illus 24 Stone dump within Trench 18, facing east**

Trench 18 was located to the east of Trench 17, measuring 1.8m by 47m and revealing a loose dark brown silty topsoil of between 0.35 and 0.6m thickness above a loose soft orange silty sand. An area of loose individual stones was encountered at the centre of the trench within the topsoil, close to a nearby line of stones which may have once been an old field boundary wall, so this could represent a dump of stones from the wall (Ill 24).

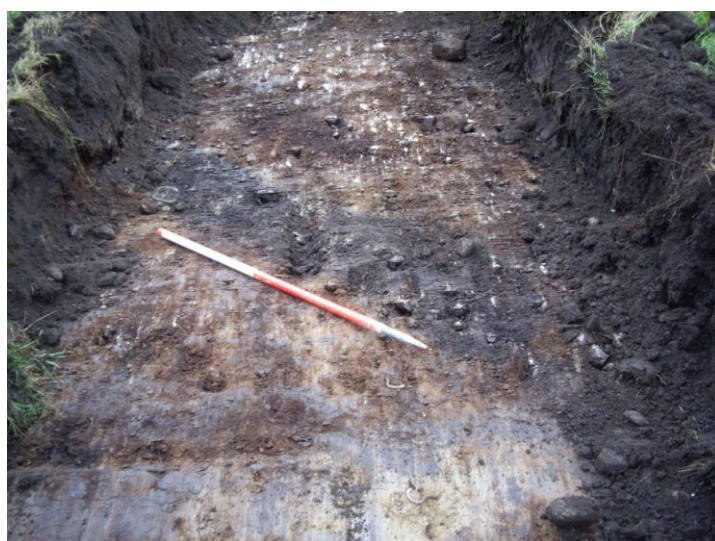
**Illus 25 Southernmost stone drain in Trench 19, facing north-west**

Trench 19 was the first trench to be excavated within the western part of Area 5 and was on a north-east south-west alignment, measuring 1.8m by 142m. It consisted of a loose dark brown silty topsoil between 0.25 and 0.55m deep overlying an orange soft silty sand. Two stone drains were encountered within the north-eastern part of the trench on a north-west south-east alignment (Ill 25).

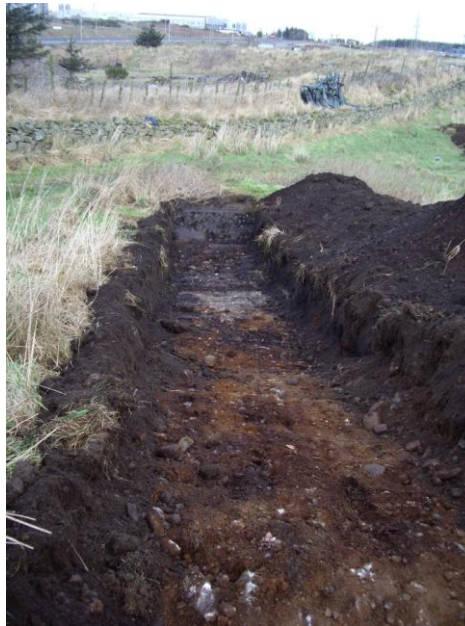
**Illus 26 Peat-like deposit at north-eastern extent of Trench 20, facing north-east**

Trench 20 was located 15m to the west of Trench 19. It was 1.8m wide and 128.5m long. A dark brown peaty deposit was encountered with a depth of 0.9m

at the far north-eastern extent of the trench (Ill 26). The rest of the trench consisted of a loose dark brown silty topsoil above a loose orange soft silty sand. One stone drain was encountered at the centre of the trench's length on a south-east north-west alignment.

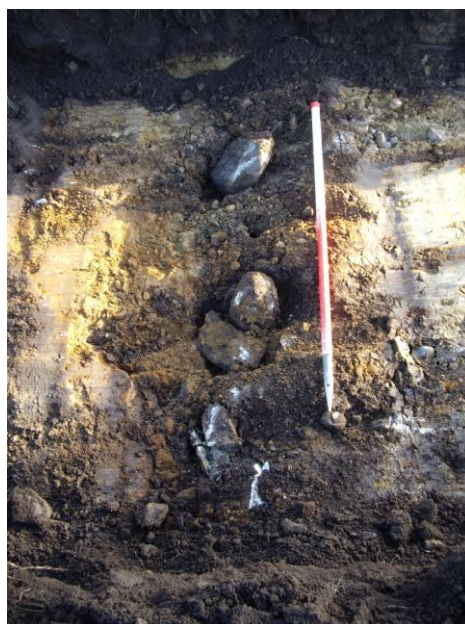
**Illus 27 Stone drain in Trench 21, facing south-east**

Trench 21 was located 15m to the west of Trench 20 and measured 1.8m by 110m. It revealed a loose dark brown silty topsoil varying between 0.2m and 0.6m in thickness, which overlay an orange loose soft silty sand. The natural was more gravel-like within the north-eastern half of the trench. One stone drain was encountered which was south-east north-west aligned (Ill 27).

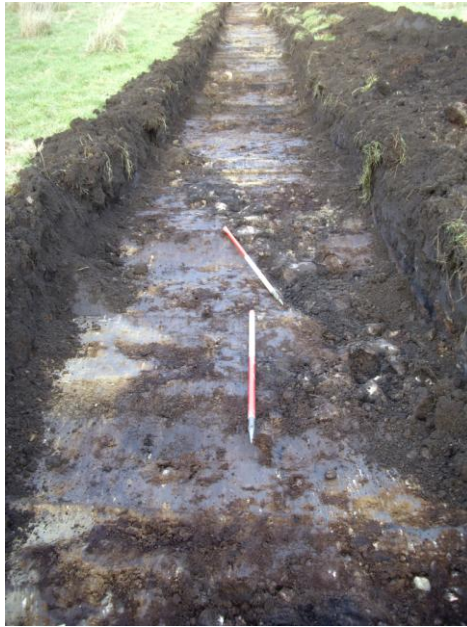
**Illus 28 Stone drain in Trench 22, facing north-east**

Trench 22 was 1.8m wide and 90m long and was located 15m to the west of Trench 21. It contained between 0.3m and 0.5m of loose dark brown silty topsoil which lay upon an orange loose silty sand. One stone drain was observed in Trench 22, on a north-south alignment towards the south-western extent of the trench (Ill 28).

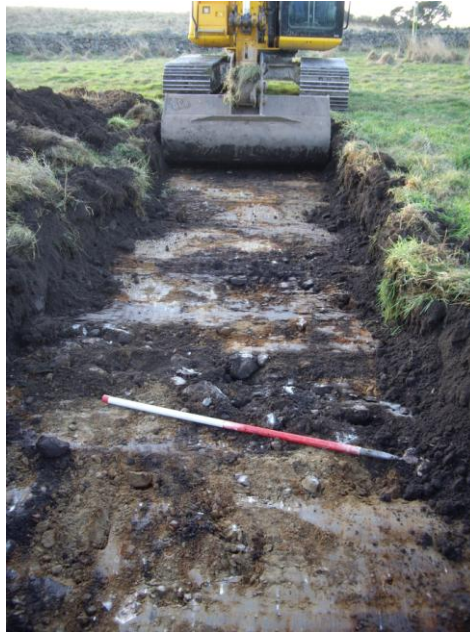
**Illus 29 Southernmost stone drain in Trench 23, facing south-west**

Trench 23 was located in the eastern part of the western of the two fields forming Area 5. It was on a north-east south-west alignment and was 1.8m by 121m. It consisted of a loose dark brown silty topsoil of between 0.3 and 0.6m depth which was on a soft orange silty sand. An area of gravelly natural was encountered towards the middle of the trench. Four stone drains were noted from this trench, all on a north-west south-east alignment and all located towards the middle stretch of the trench (Ill 29).

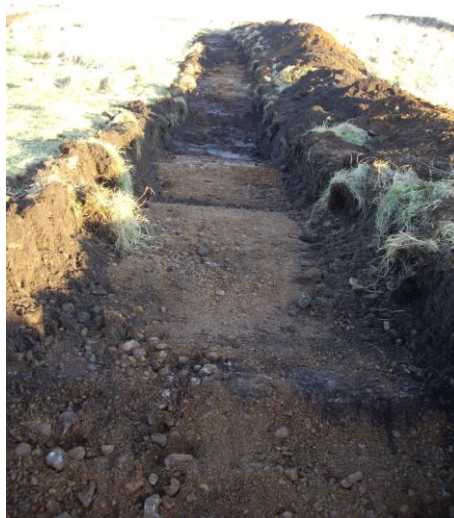
**Illus 30 Gravel encountered in Trench 24, facing north-east**

Trench 24 measured 1.8m by 84m and was located 15m to the east of Trench 23. It revealed a loose dark brown silty topsoil above a loose soft orange sand. An area of naturally occurring gravel was encountered towards the north-eastern half of the trench (Ill 30). Two stone drains were encountered towards the centre of the trench.

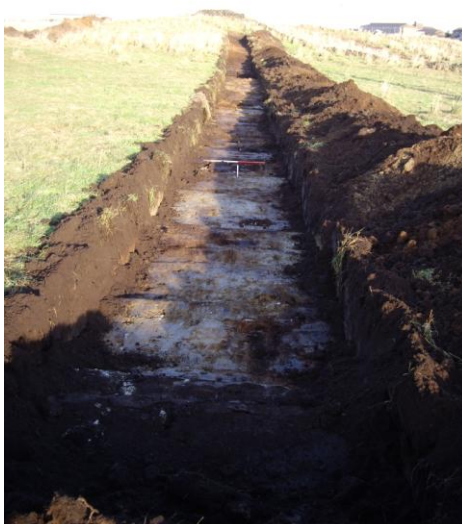
**Illus 31 Trench 25 upon completion facing north-east**

Trench 25 was located to the east of Trench 24 and was 1.8m wide and 69m long. It consisted of a loose dark brown silty topsoil between 0.3 and 0.75m deep above a loose soft orange silty sand, and contained a gravel area in its north-eastern part, and four north-west south-east aligned stone drains (Ill 31).

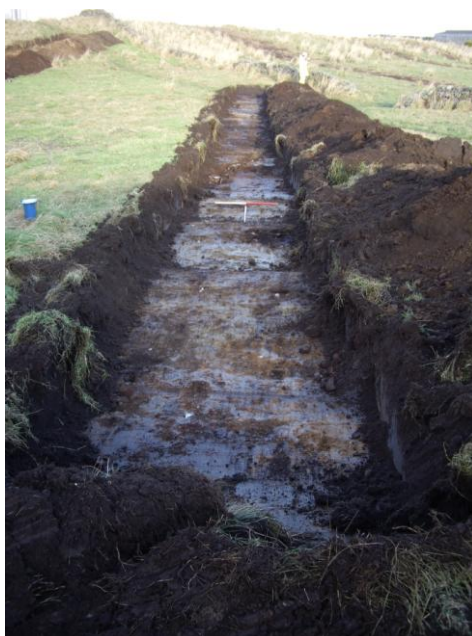
**Illus 32 Trench 26 upon completion, facing north-east**

Trench 26 was the smallest trench in the western part of Area 5, measuring 1.8m in width and 40m in length. It was located to the east of Trench 25 and revealed a loose dark brown silty topsoil of between 0.3 and 0.65m in depth above a loose soft orange silty sand (Ill 32). Two stone drains were recorded in this trench, the northernmost on a north-west south-east alignment and the southernmost on a north-east south-west alignment. No other features were observed in this trench.

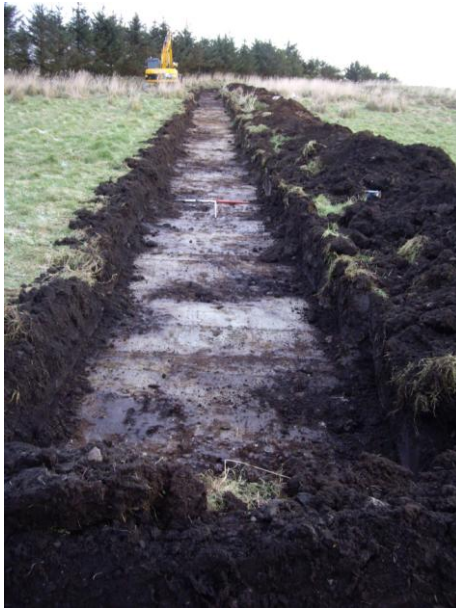
**Illus 33 Trench 27 upon completion, facing north-east**

Trench 27 was the final trench to be excavated and was 1.8m wide and 62m long and was located to the west of Trench 22 in the far western side of Area 5. It contained a loose dark brown silty topsoil varying in depth from 0.3 and 0.5m, and

which overlay a soft loose orange silty sand. No features were encountered in this trench (Ill 33).
