Land at Airyhall Road, Aberdeen, AB15 7TF

Alison Cameron
Cameron Archaeology
15 January 2012

SUMMARY

Ten trenches were excavated on 12-13 January 2012 during a 7% archaeological evaluation of this 1 hectare plot which has planning permission for residential accommodation (P110020). Three quarry pits were recorded which had probably been dug to extract building materials for the construction of Airyhall House but no other significant archaeological remains were uncovered. It is recommended that no further archaeological work is required prior to this development.

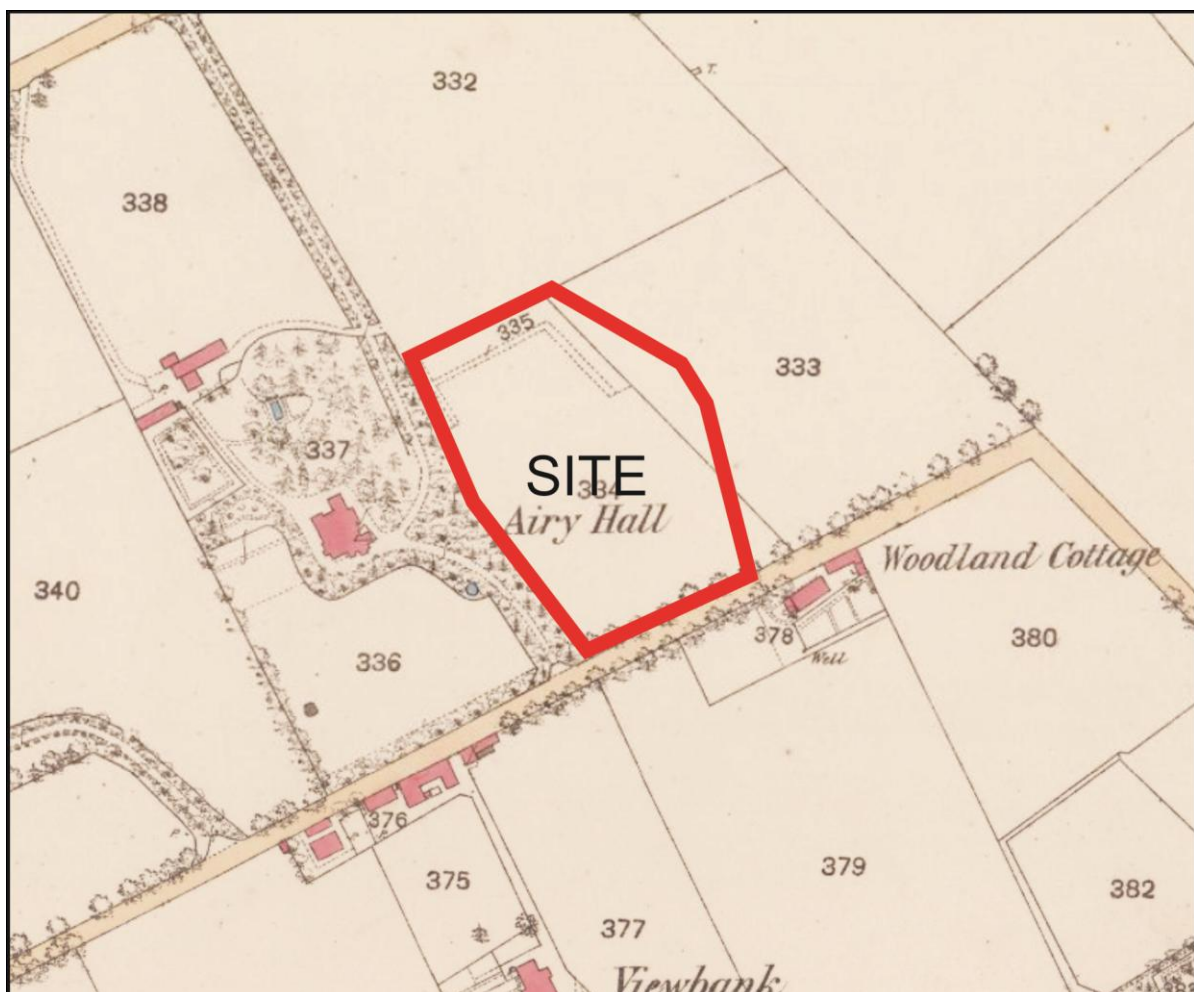
Illus 3 Site outline on First Edition Ordnance Survey (copyright National Libraries of Scotland)

- 2.1 There are no known archaeological sites within the proposed development area. The First (III 3), Second and Third Ordnance Survey maps indicate that the site was fields in the 19th or early 20th century. No buildings or other features are recorded on the site although a track is shown on the First Edition at the north of the area.
- 2.2 A number of finds have been recovered from the surrounding area. A flint blade was found in a garden in Gordon Road, Mannofield (NJ90SW 20), a barbed and tanged arrowhead in Gaitside Terrace (NJ90SW 19) and several flints including a flint scraper, barbed and tanged arrowhead and flint knife at Deeside Gardens (NJ90SW 51).
- 2.3 The site lies just to the south of the Freedom Lands of Aberdeen (Cruickshank and Gunn 1929, 36).

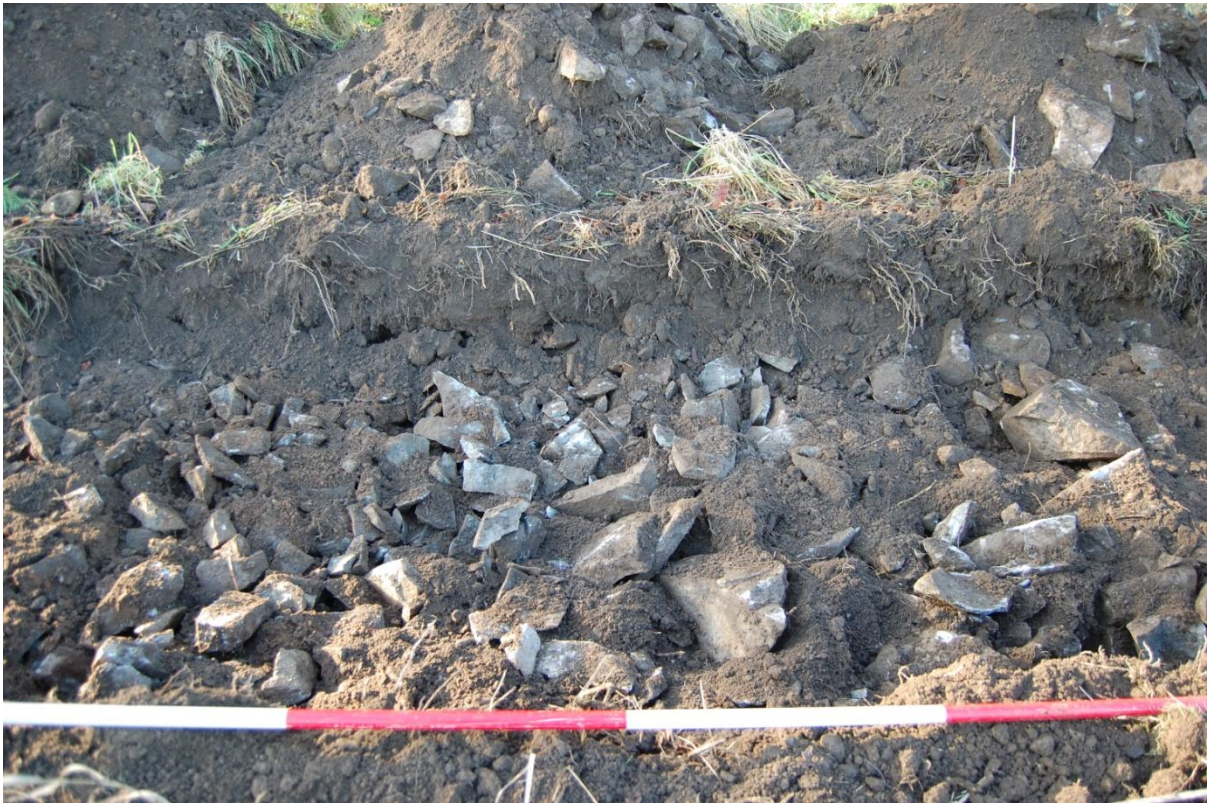
Illus 6 Quarry pit F12 facing west

- 3.2 13 features (Illus 5) were recorded including stone and ceramic drains; details of these appear in archive. Three pits (F10, F12, F13) were filled with angular quarry waste; they were 6-10m in diameter. A small number of 19th-century pottery sherds were found in association with these features. These are probably small quarry pits possibly dug to remove building stone for the construction of Airyhall House and then backfilled with stone waste. Several small quarries are recorded on the late 19th-century Ordnance Survey maps but none in the vicinity of Airyhall House.

Feature no	Trench	Description	Direction
F1	1	Ceramic drain in 0.5m wide trench	N-S
F2	1	Stone drain 1m wide trench	SW-NE
F3	1	Trench filled with pea gravel, stone and redeposited natural subsoil; probably = F5 lead pipe trench	E-W
F4	2	Trench filled with stones 1m wide; stone drain?	N-S
F5	2	Trench filled with stones 2m wide; lead pipe in top of trench	E-W
F6	3	Lead pipe in 0.3m wide trench	N-S
F7	3	1m wide stone drain	SE-NW
F8	3	0.4m wide trench; lead pipe in part of length	SSE-NNW
F9	4	Trench 1m wide filled with loose stones; just north of quarry pit F10	E-W
F10	4	Pit 10m long at least 2m deep filled with small and large angular quarry waste. Quarry pit used for construction of Airyhall House? IUnfilled with waste. Sherds of 19th-century china	
F11	4	0.4m wide trench filled with soil	SSE-NNW
F12	5	Pit 6m long at least 1m deep filled with small and large angular quarry waste. Quarry pit used for construction of Airyhall House? IUnfilled with waste. Sherds of 19th-century china
