# Land at Stoneywood, Aberdeen, AB21 9LA

Cameron Archaeology  
January 2012

A 7% archaeological evaluation, standing building survey and walkover surveys were carried out on 12.43 hectares at Stoneywood, Aberdeen between 19 December 2011 and 4 January 2012. The Aberdeenshire Canal was recorded in Area S1b and its line and size were recorded. No other significant archaeological remains are to be destroyed by this development. It is recommended that when the soil is being stripped in area S1B an archaeologist is present to record further details of the canal.

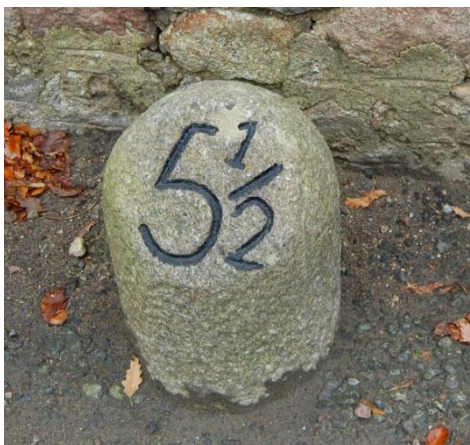
Figure 6 Canal milestone 5.5 in lane north of Stoneywood Terrace (NJ81SE 45.01)

A number of the canal milestones and half-milestones survive although not in their original positions. The milestones began their counting at zero from Aberdeen harbour and one milestone (5.5 miles; NJ81SE 45.01) survives adjacent to the current site (Fig 2). The canal was closed and the land used for the construction of the Aberdeen to Inverness railway line. In many places the railway has destroyed the canal remains but in places, such as the area of the current site, the railway took a diverging course. A site adjacent to the current site is currently being redeveloped by Scotia Homes; an archaeological evaluation on that site failed to record any remains of the canal (Buchanan 2007). Excavations at 476 Great Northern Road (Cameron 2001, 7), New BP offices, Stoneywood Road (Buchanan 2005) and McIntosh of Dyce, Victoria Road, Dyce (NJ81SE 173, Cameron 2006) have all revealed remains of the base of the cut for the canal.

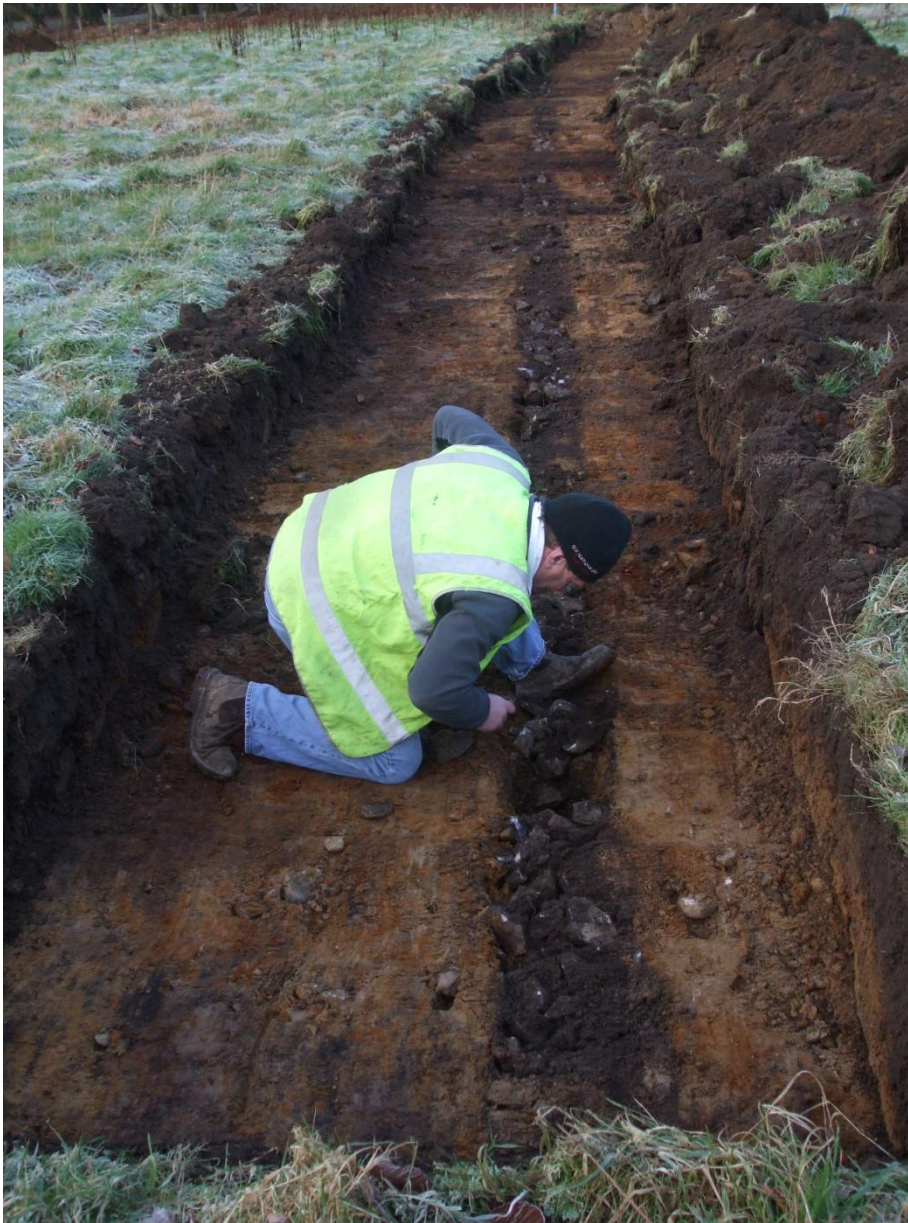
Figure 9 Area S1A Trench 2 stone drain F2 facing W

Six trenches were excavated in this area totalling 1278 m<sup>2</sup>. Much of the area had been waterlogged and there were several land drains including 0.2m wide stone-filled trenches and 0.4m wide stone and clay-filled trenches. An E-W bank (F23) 1.5m wide and 0.1m high was cut through in Trench 7; the feature is a low soil bund, probably the remains of a fence line.

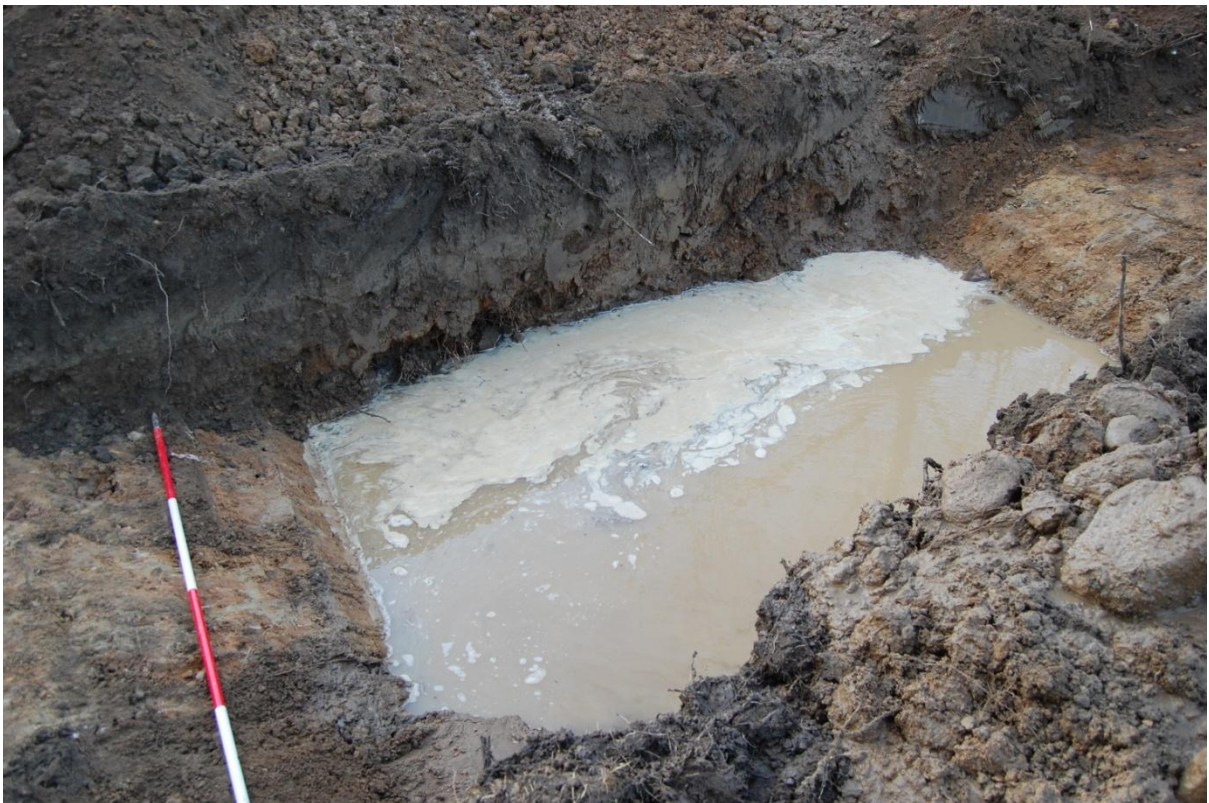
Figure 11 Area S1b canal F27 facing SW

When the canal was first constructed it was 17ft (c 5.6m) wide and 3 ft (c 1m) deep. Within the first six years it was increased to a maximum of 23 ft (c 7.6m) and 3ft 10in (c 1.3m) over much of its distance (Graham 1967-8, 171). Pearson (1986, 298) described a section of the canal he saw drained in the area of Tait's (now Stoneywood) Paper Mill as 'The eastern bank is supported by a dry stone wall at least 3 feet high, with the bed of the waterway sloping steeply from the base of the wall to the lowest part of the channel. The western bank is supported by a dry stone wall about 1 foot high, its top being at the same level as the top of the wall at the eastern bank.

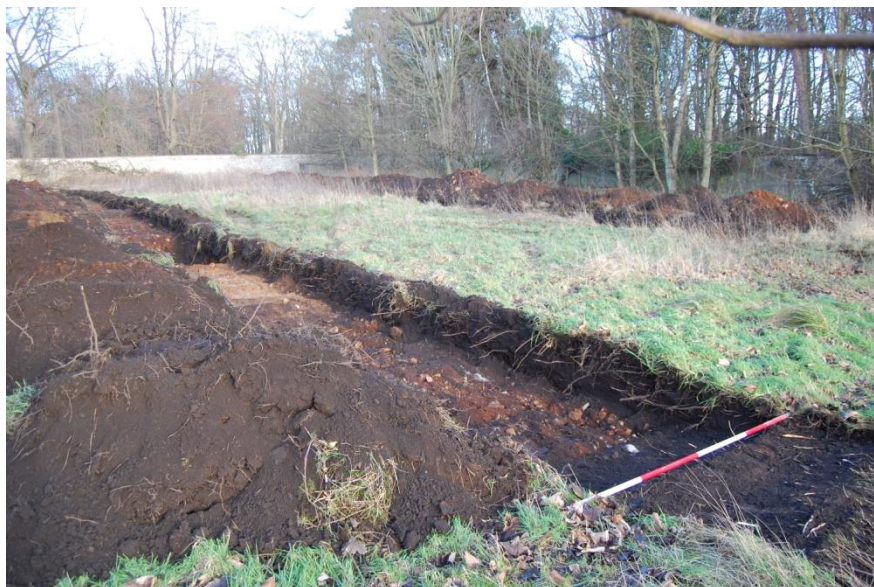
Figure 15 S3, Trench 12 (foreground) in walled garden

S3 is 0.47 hectares within the former walled garden of Waterton House. The garden is divided into two halves. Two trenches were excavated in each area and a small number of garden features recorded. A clinker and waterwashed pebble path (F32) was 0.3m below the current ground level which ran across the centre of the garden from west to east. A lead pipe (F36) ran along the northern edge of the path. A 1m square mortared stone feature built into the base of the north wall was a possible well (F38).

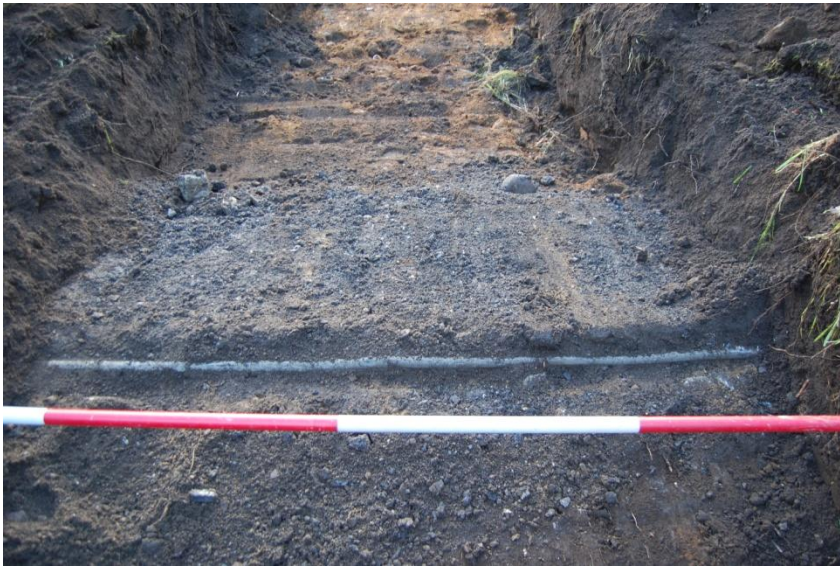
Figure 16 S3 Trench 14 path F32 and lead pipe F36

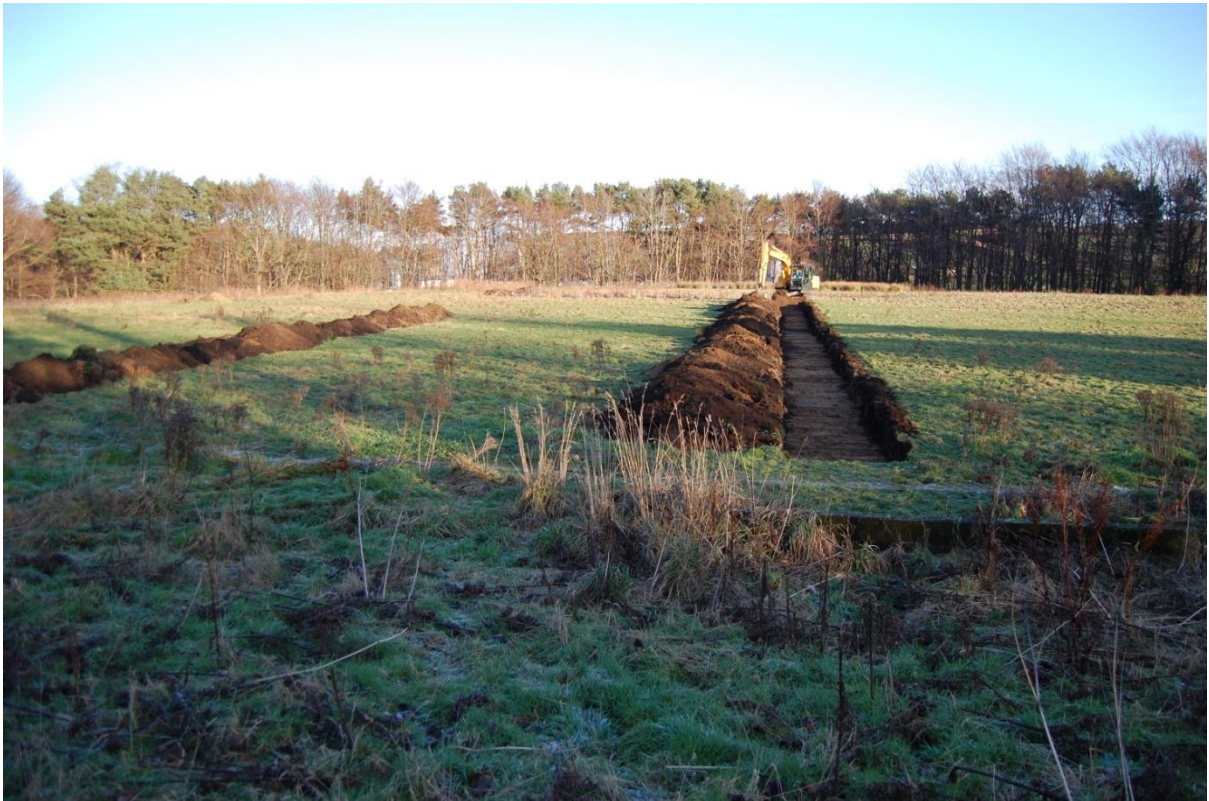
Figure 20 Area S6 Trench 32 (right) Trench 31 (left) facing NE

Area S6 is 2.04 hectares in size. The north and east of the area are made-up ground consisting of brick, stone, concrete, tar, sand and soil. This is presumably demolition material from the Paper Works to the north (Fig 18). The west and central areas have been levelled and the topsoil replaced; this may have been preparation for playing pitches. The area to the south is probably the original ground level; 0.4-0.9m of topsoil survives on natural subsoil; one stone land drain (F49) was recorded.

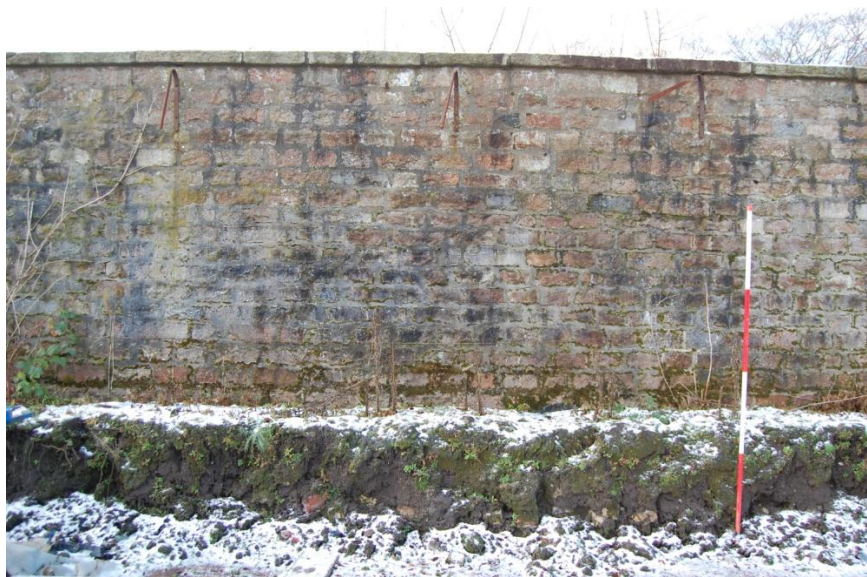
Figure 21 N2 walled garden wall F62 showing section through topsoil previously stripped and mounded

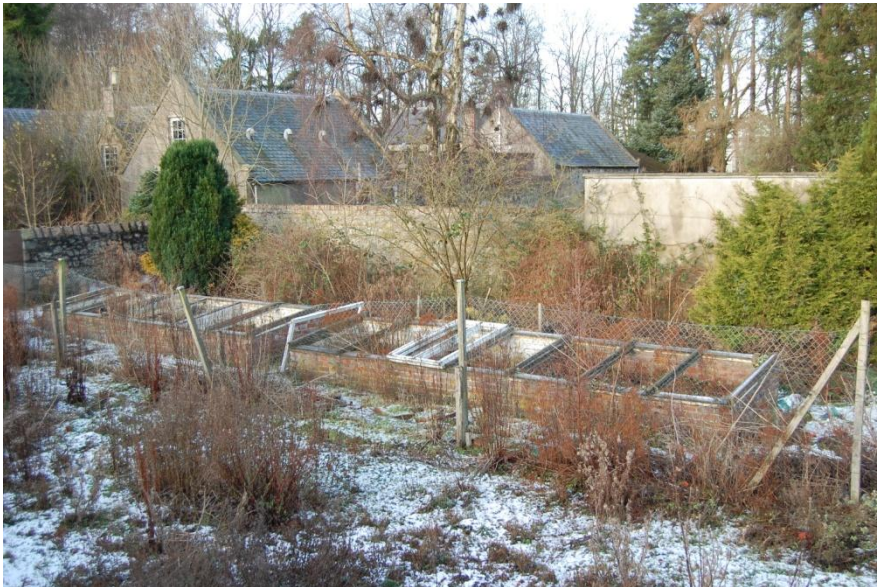
Figure 23 B2 garden F69 showing disturbance from trees and cloches

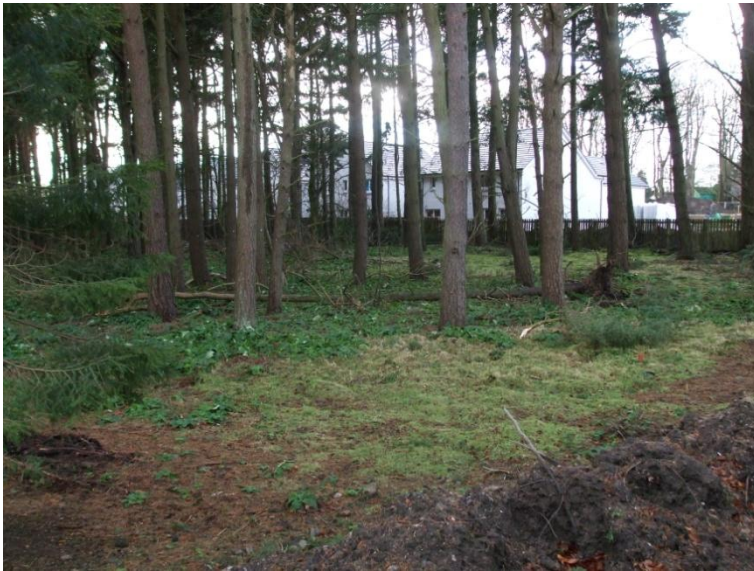
Figure 27 Area N3 showing BANCON site in background

Area N3 is 0.37 hectares (area W10, Stoneywood Tree Survey) mainly Scots Pine around 80 years old. This was open land at the First Edition Ordnance Survey (surveyed 1864) but wooded by the Second Edition (surveyed 1896). No archaeological features were recorded during this walkover.

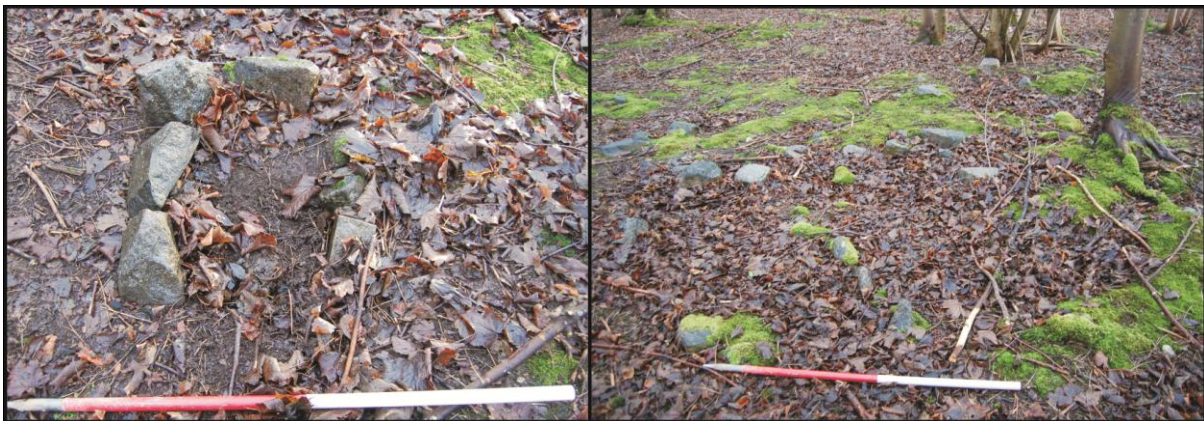
Figure 28 Stone settings F73 (left) and F74 (right)

Area S2 is 1.72 hectares (area W11, Stoneywood Tree Survey) comprising mainly 20-30 year old sycamore. This was open land at the First Edition Ordnance Survey (surveyed 1864). Two stone features were identified: F73 is a rectangular stone setting 0.5 x 0.3m in size and F74 is oval 1.5 x 1m in size. Both are modern in date: the area was a field until the late 19th century, the stone of the settings appear to have been recently sited and are not covered in lichen (as is most of the woodland floor) and the settings are close to a small car parking area. These settings are likely to be pet burials of 20th-century date. No archaeological features of any antiquity were recorded in S2.

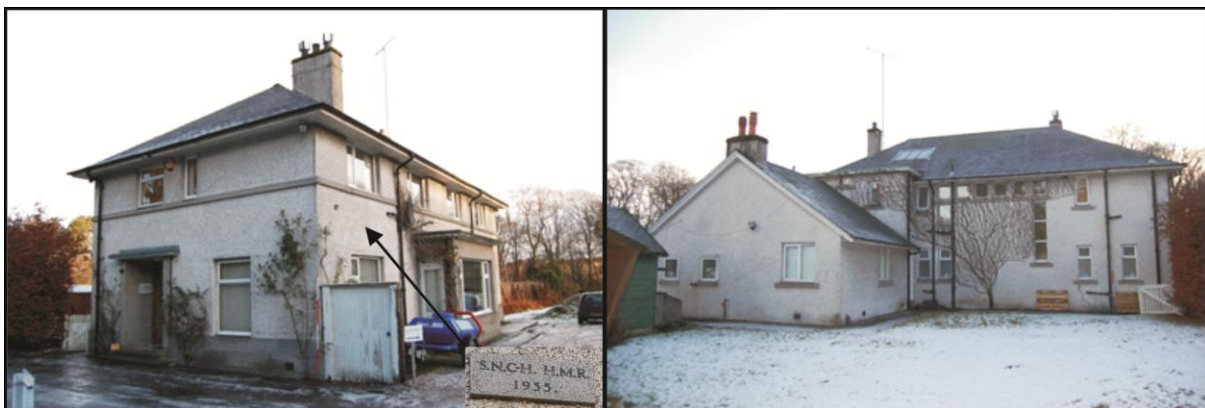
Moir House is a 1955 'garden house' built adjacent to the walled gardens within former woodland; it is being demolished. A plaque on the south facade reads 'S.N.C-H H.M.R./1955'.

Figure 30 Area N2 Moir House (F63) from SW (left) from N (right)

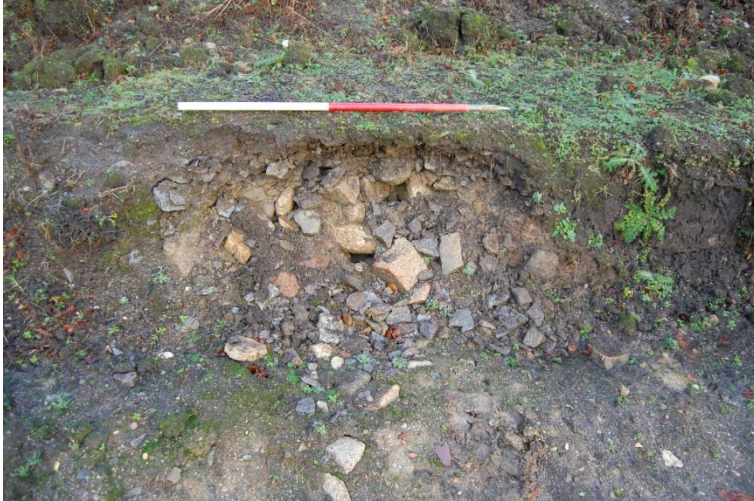
Figure 31 Area N2 Section through path F71; facing north

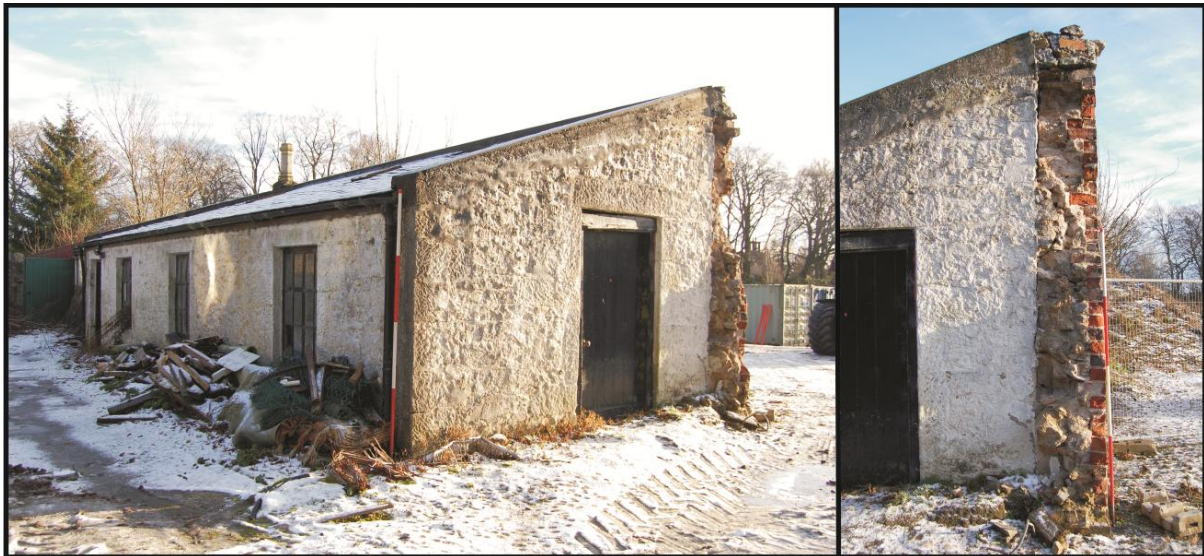
The stone walls of the garden are 3.5m high and c 0.5m wide at the base; they are faced on the inner surface with brick. Stone lean-to F59 is attached to the north side of the north garden wall F61; it is 18m long and 3m wide. There was originally another building (F60) which has since been demolished and the scar can be seen on the garden wall.

Figure 32 Area N2 Gardeners lean-to F59 (left) and detail of attachment to N garden wall F61 (right)

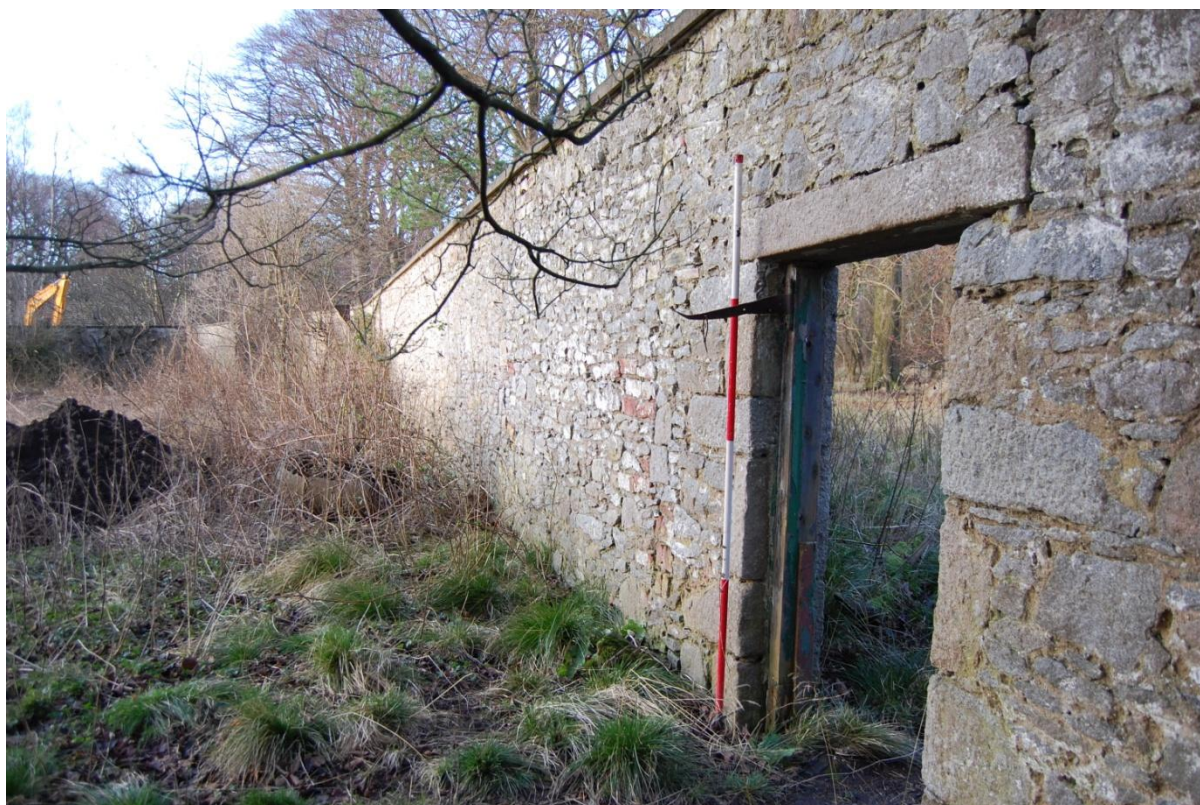
Figure 34 Area S3 walled garden, gate F40 facing WNW

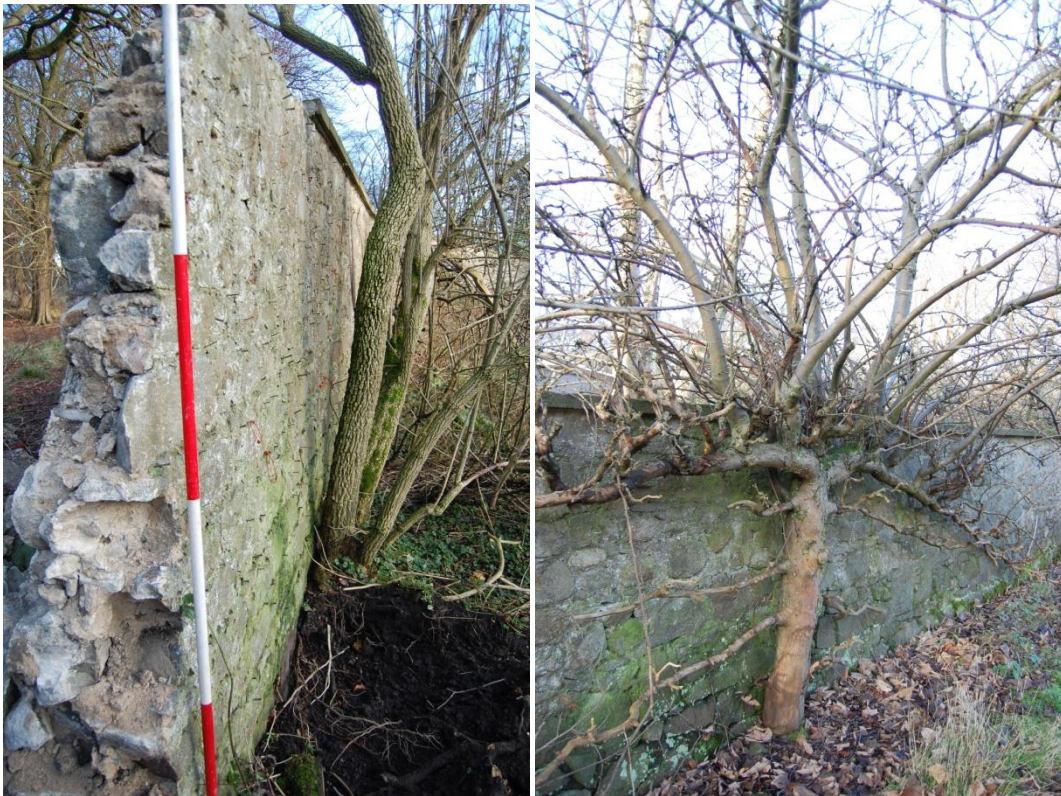
Figure 35 Area S3 North wall F30 showing nails for espalier of fruit trees (left) and remains of horizontal espalier (right)

linked to a tap. Nails survive on all internal wall surfaces indicating espaliered fruit trees were grown on all walls.

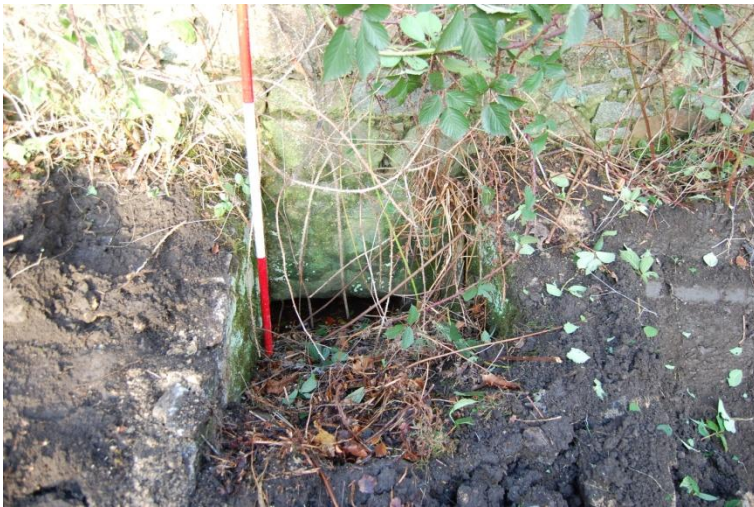
Figure 36 Area S3 F38 possible well
