Land at House of Dun, Montrose, Angus,
AB45 3ES
Archaeological Watching Brief Report

Cat Peters
Cameron Archaeology
27 February 2012

Archaeological Watching Brief

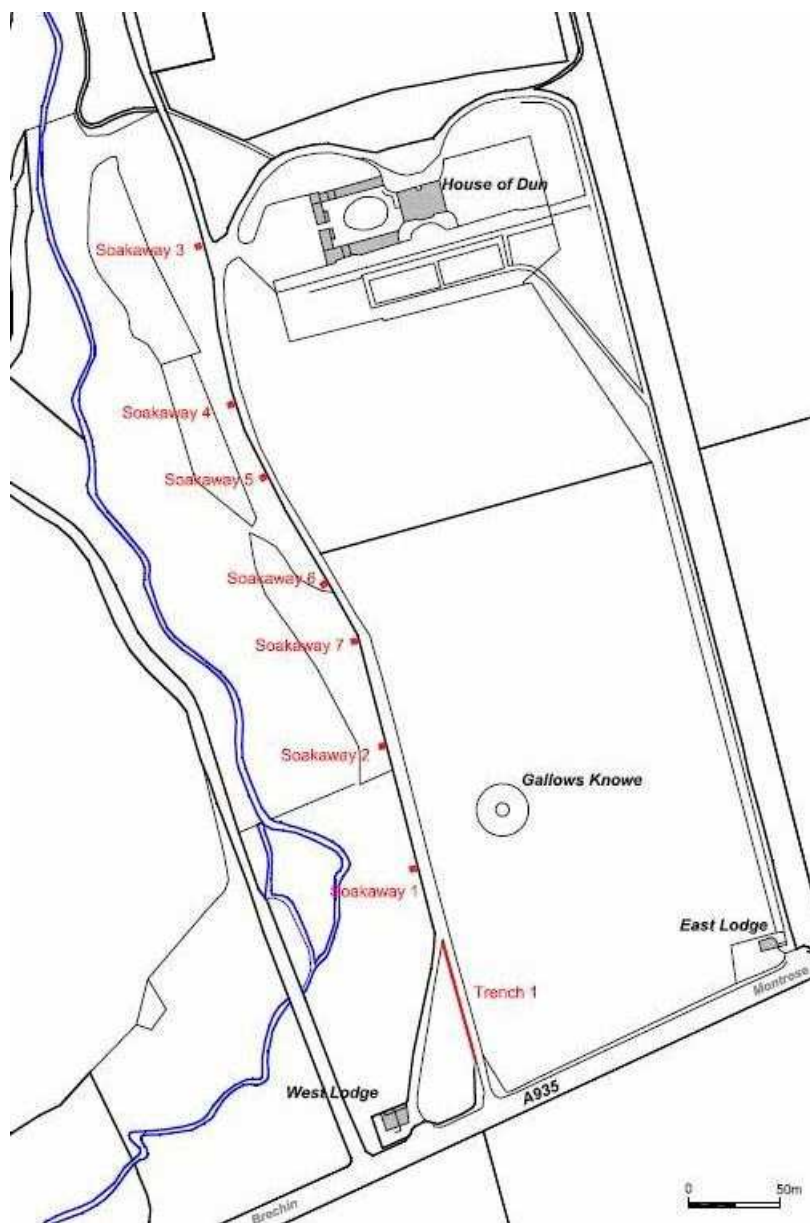
Illus 3 Location Plan of Trench and Soakaways

The watching brief took place between the 25th January and 6th February 2012. It monitored the excavation of a linear trench, at the southern extent of the entrance track (Trench 1; Illus 3) and 7 soakaway pits, located at intervals to the western side of the entrance drive (Soakaways 1-7, Illus 3).

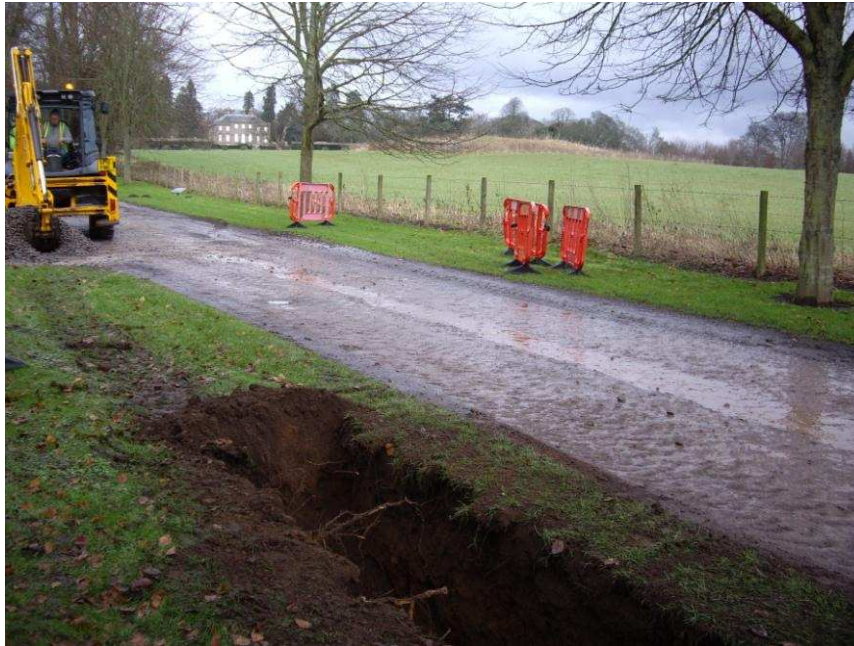
Illus 4 Trench 1 under excavation

Trench 1 measured 61m in length and was 1.2m wide and was excavated to a maximum depth of 0.9m. The southernmost 2m of the trench revealed a mid brown loose granite deposit indicating made-up ground, suggesting the entrance drive was once wider than at present. A north-west south-east aligned plastic pipe ran across the trench at a depth of 0.3m within the made-up ground deposit. The rest of the trench revealed a topsoil of between 0.18 and 0.5m depth overlying an

orange-brown sandy silt (Illus 4). No finds or features of archaeological interest were revealed in Trench 1.

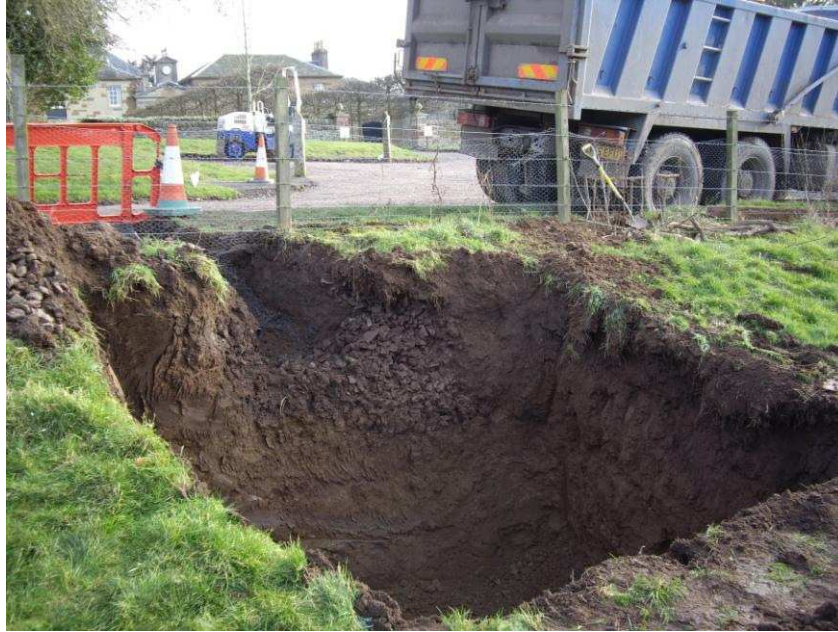
Illus 5 Soakaway 3- final depth

A total of 7 soakaways were excavated for the new drainage channels to be inserted across the entrance drive. These were excavated to the west of the entrance drive. Soakaway 1 was the southernmost, was located 42m to the north-west of Trench 1, and was the closest to Gallows Knowe, which lay 44m to the north-east. Soakaway 2 was located 66m north-west of Saokaway 1; Soakaway 7 56m north-west of Soakaway 2; Soakaway 6 32m north-west of Soakaway 7; Soakaway 5, 64m north-west of Soakaway 6' Soakaway 4 40m north-west of Soakaway 5 and Soakaway 3 was located 85m to the north-west of Soakaway 4 and 65m west of the House of Dun courtyard wall (Illus 5). Each soakaway measured 3m by 3m and was excavated to a maximum depth of 2.4m In each, a dark-brown loose topsoil up to 1m deep was encountered above an orange sandy natural. No finds or features of archaeological interest were revealed during the soakaway excavations.
