City Centre District Heating Phase 1 Report on Archaeological Watching Brief

Cameron Archaeology
3 May 2012

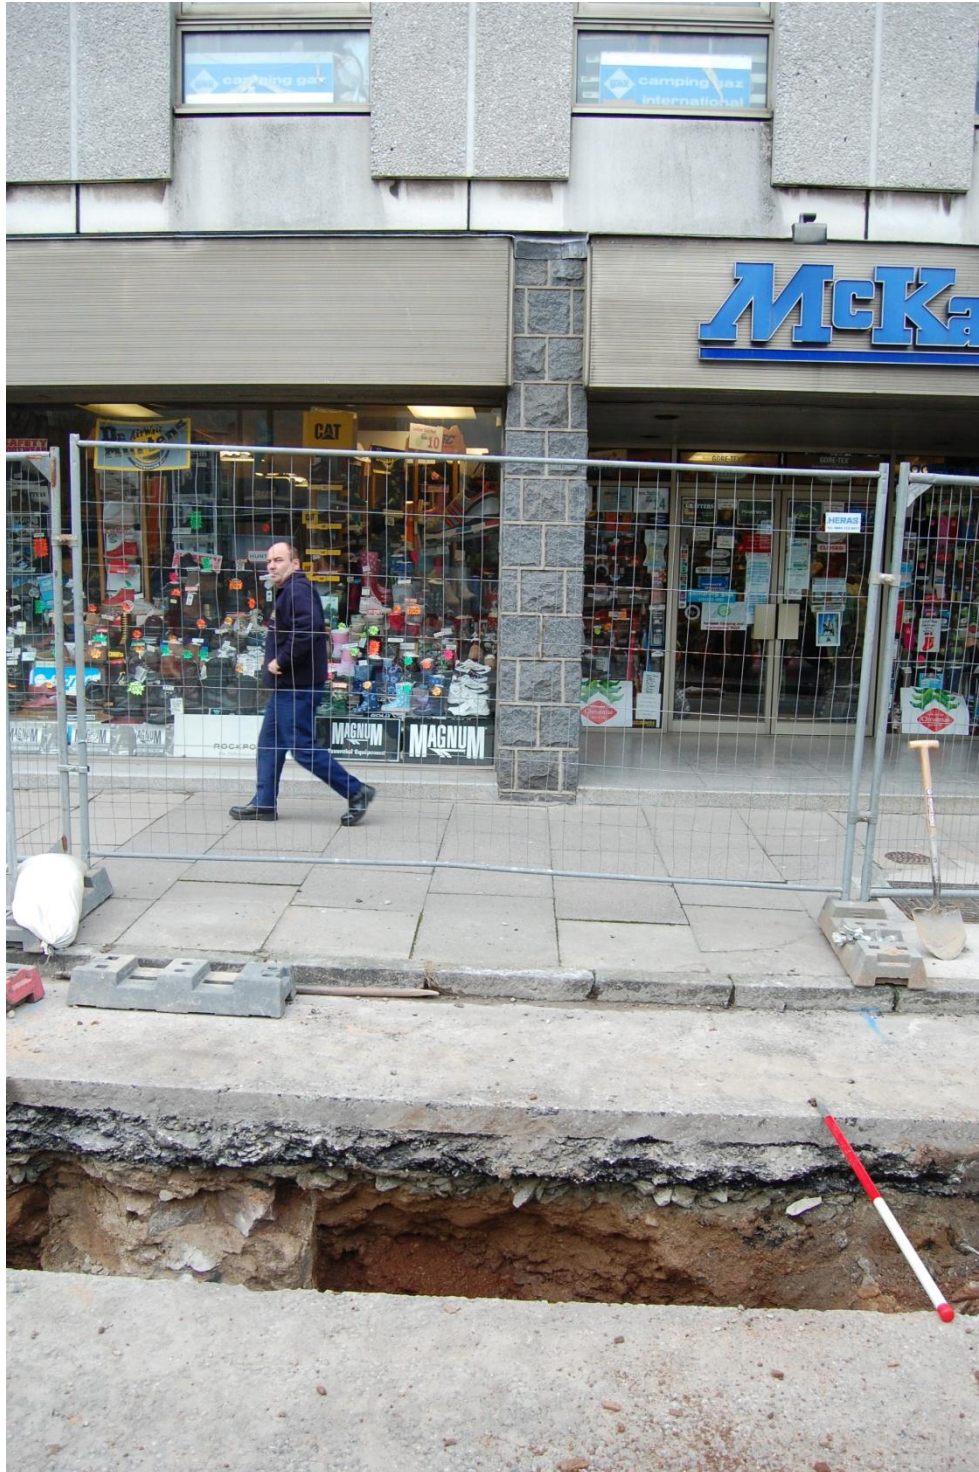
Cover: 29-31 Queen Street showing wall foundation *in situ* (left) and natural sand (right)

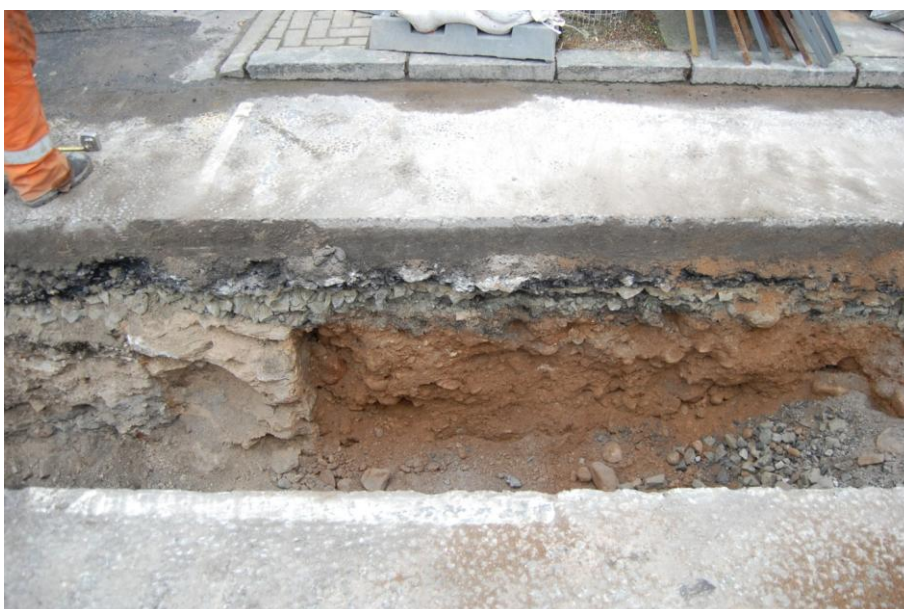
Remains of 19th-century wall foundations were recorded in Queen Street (Illus 6; Illus 7); details are available in archive. The level of the natural sand was recorded immediately below the current road and pavement surfaces and no earlier features were encountered during this work.

Illus 6 Queen St: wall foundation (left) cut into natural sand (right)

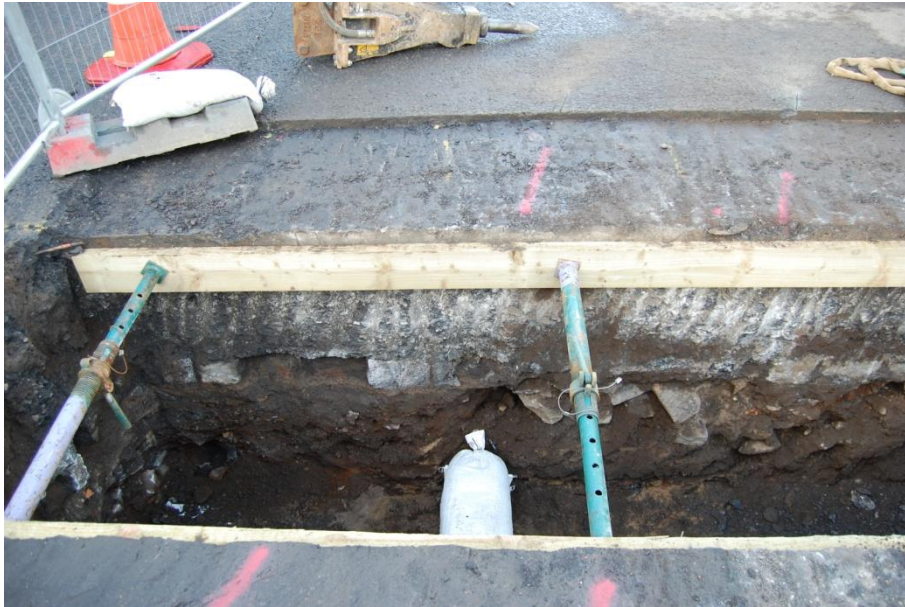
100% of trenching in West North Street was monitored; a previous cobbled surface was recorded but all other layers recorded were make-up for previous roads or service trenches.

Illus 7 West North Street section showing previous road surface (cassies/granite cobbles)

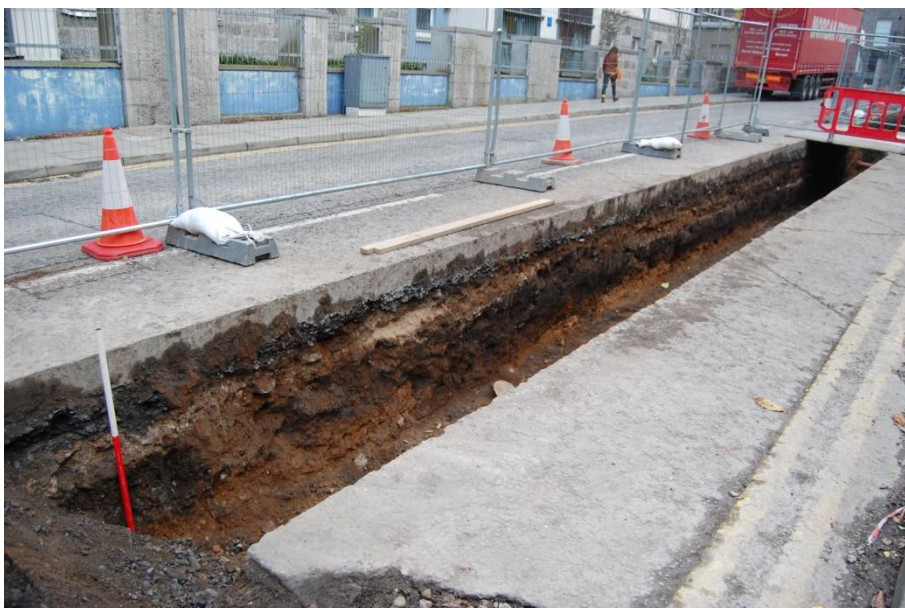
100% of trenching in Mealmarket Street was monitored. The natural gravels were up to 1m below the current road surface and above this garden soils survived *in situ* at the west end of the street whereas at the east the ground had been made up using soil and sand infill. This infill probably dates to the 19th century when the level of this area was raised to create King Street.

Illus 8 Mealmarket Street showing natural gravels with garden soil above

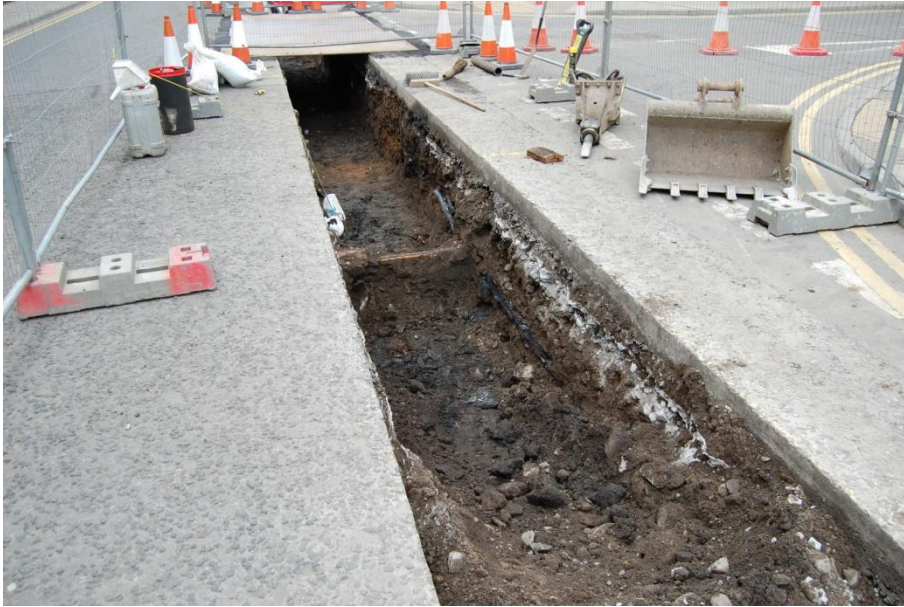
25% of trenching in Constitution Street was monitored; all layers under the current road surface were infill including many service trenches. No archaeologically significant contexts were recorded.

Illus 9 Constitution Street trench

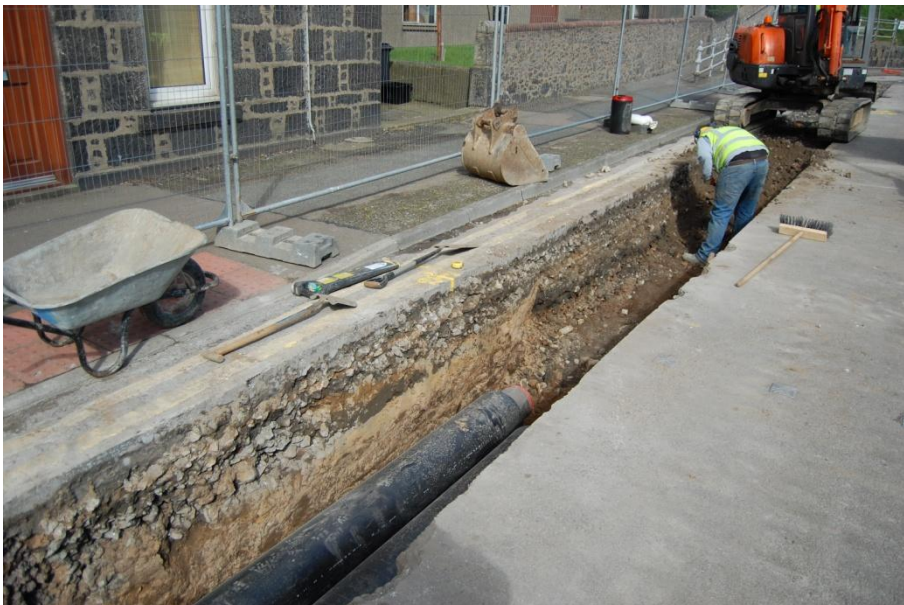
25% of trenching in Links Road was monitored; natural sand deposits were recorded immediately below the current pavement and no archaeologically significant layers or features were recorded.

Illus 10 Links Road trench showing natural sand below current road

It is recommended that no further archaeological work is required during this current development.
