REPORT ON ARCHAEOLOGICAL MONITORING AT PROVOST SKENE'S HOUSE, GUESTROW, ABERDEEN.

NGR NJ 94198 06385

11 May 2012

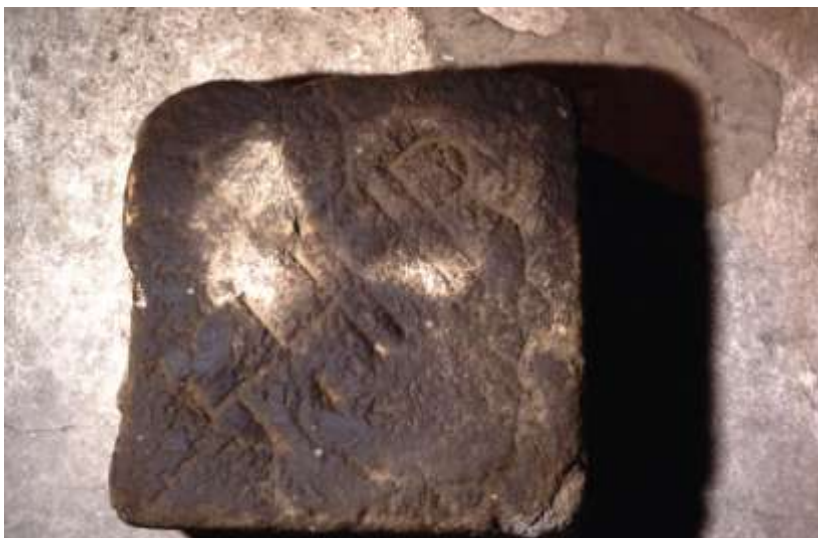
2.2.4 The area is rich in archaeological remains including scatters of Mesolithic and later flints at several neighbouring sites including Queen Street and Broad St (Dent 1982, 26-34) and 16-18 Netherkirkgate (Cameron and Stones 2001, 28-39). Substantial well-preserved medieval remains were also found at these two sites as well as at 43-57 Upperkirkgate/Flourmill Brae (Stones 2001, 50-58) just north of the current site and at Marischal College on the opposite of Broad Street (Cameron forthcoming). Small watching briefs have taken place both outside and inside the house on previous occasions; nothing has been recovered from the external trenches. During repair work to central heating pipes, part of the stone floor of the old kitchen was uplifted within the 17th-century part of the house. No archaeological deposits were found, but a stone incised with the letters 'THHR' was discovered. It had been part of the floor and after being recorded, was replaced (Cameron 1991, 24).

Illus 2 Stone inscribed 'THHR' found on floor of Provost Skene's House kitchen

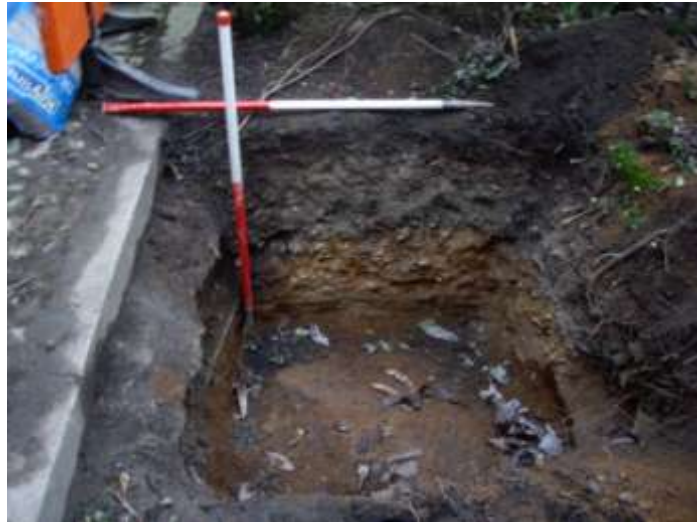
3.2.1 **Trench 1:** Trench 1 was excavated to incorporate cabling for a new security camera to be installed at Provost Skene's House. It was located at the north eastern corner of the building on the south-eastern side (Illus 3). It was L-shaped, measuring 3m in length and 1.2m in width at its south-easternmost extent. It was deepest at its south-eastern extent, where it was excavated to a depth of 0.7m (Illus 4). This revealed a 0.35m deposit of mid grey-brown topsoil overlaying an orange sandy natural.

Illus 4: South-eastern extent of Trench 1, facing south-east

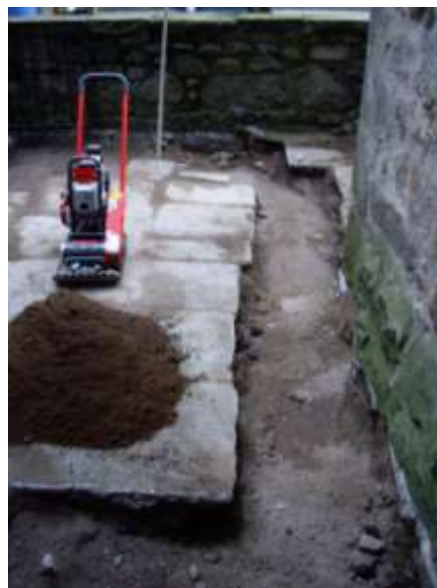
3.2.2 **Trench 2:** Trench 2 was excavated to incorporate cabling for a new security camera to be installed at Provost Skene's House. It was located at the north eastern corner of the building on the south-eastern side (Illus 3). Unfortunately, upon arrival on-site, this trench had already been both excavated and backfilled (Illus 5). Apparently it had been excavated to a depth of about 3 feet (0.9mish), and within the north-western half, an "original slate floor" was observed at its base (Excavators, *pers. comm.*). This was left *in-situ*.

Illus 5: Backfilled Trench 2, facing south-east

3.2.3 First Edition Ordnance Survey mapping of the area, dating to 1867 (Illus 8) shows that this trench may have been within what was once part of the Provost Skene's House Building, so the appearance of the "floor" may suggest that traces of this part of the building, or subsequent abutting building, since demolished, still survive sub-surface. Unfortunately it had not been subjected to archaeological monitoring, but does indicate the high potential for earlier remains to survive in the area, and the importance of

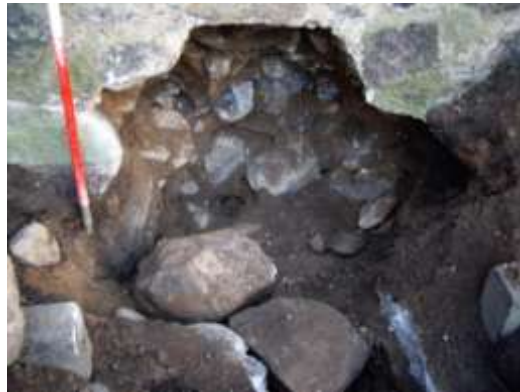
- 3.2.4 **Trench 3:** Trench 3 was excavated to provide a new water main to Provost Skene's House. It was located to the north-west of the building (Illus 3). It began with a drill hole through the wall of the building itself, at the north-eastern extent of the trench (Illus 6), followed by a curvilinear trench, 0.5m in width and running across a distance of 22.5m, the majority of the length being 4.12m to the north west of the building (Illus 2).

Illus 6: Drill hole through wall at north-western extent of Trench 3

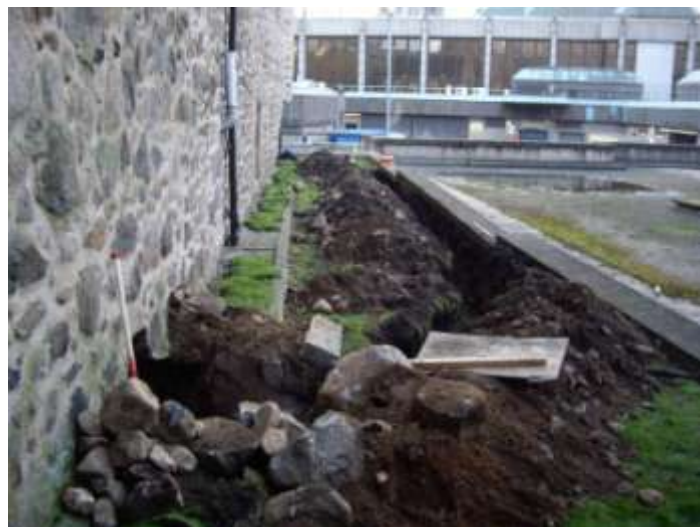
- 3.2.5 The northern side of a manhole was encountered 3m south-west of the north-eastern extent of the trench. Otherwise, a dark-brown topsoil ranging from between 0.3m and 0.35m overlying an orange-brown silty soil was all that was observed from Trench 3. The depth at the north-eastern end was 0.6m and the trench gradually got deeper to a maximum of 0.8m in depth at its south-western extent (Illus 7).

Illus 7: Trench 3 facing south-west
