FYVIE CASTLE, AB53 8JS

Watching brief on lightning trenches

Alison Cameron
27 January 2012

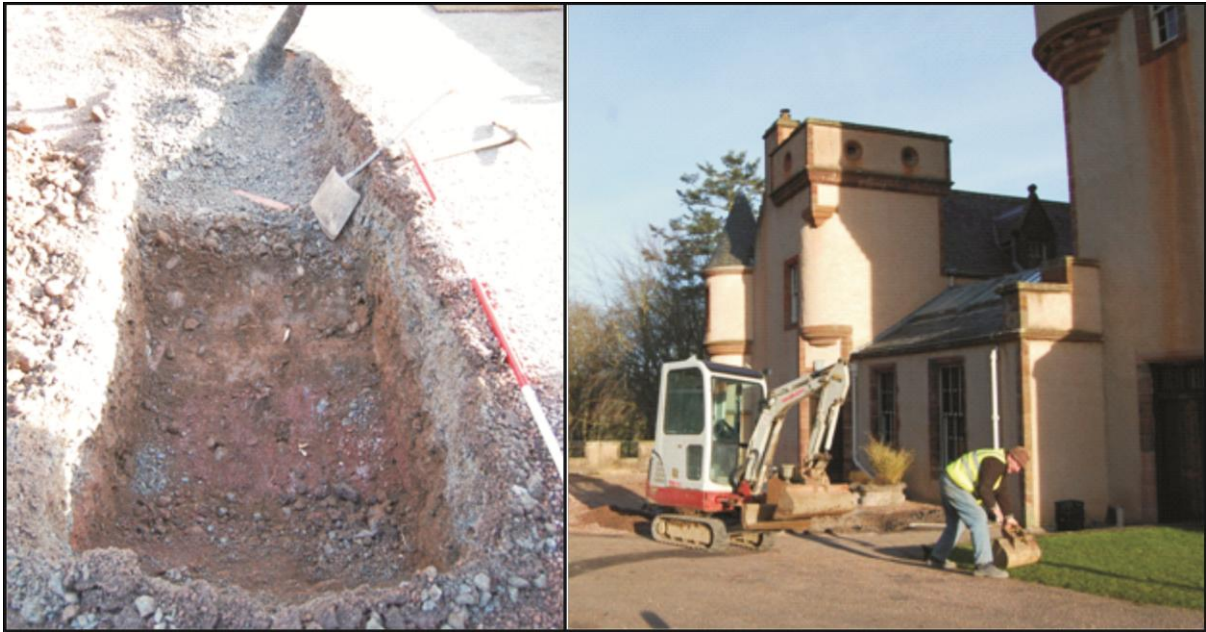
Illus 3 Trench 1 Left: trench facing east; Right: location facing north east

Trench 1 was excavated to the north of the cafe door in the Leith Tower. Modern drains were encountered and all material removed was very modern. No archaeological features or finds were identified.

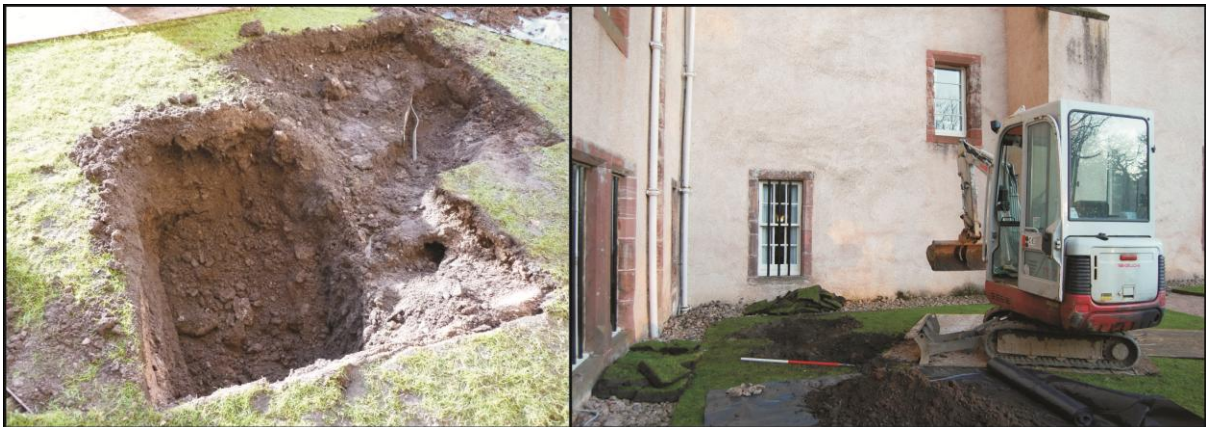
Illus 4 Trench 2 Left: Right:

A trench maximum 1.5 x 1.5m in size was excavated in the south east corner of the Leith Tower. The fill was dark brown loam with few small stones in a trench dug to bury the existing lightning conductor. No archaeological features or finds were identified.

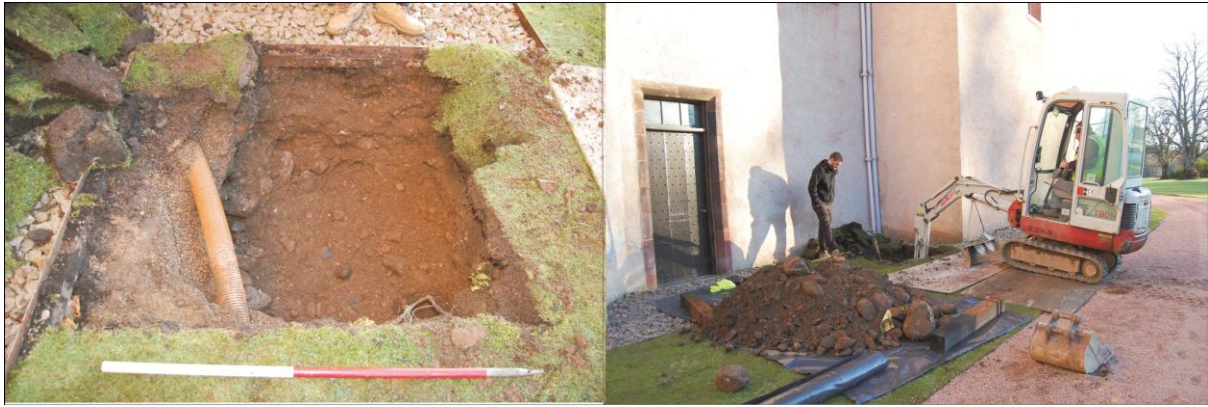
Illus 5 Trench 3 Left: trench facing south; Right: location facing south-east

Trench 3 was 1.2 x 1.2m in size and located near the north west corner of the Meldrum Tower. It was filled with a brown loam with many stones in a trench dug to bury the existing lightning conductor. A modern plastic pipe was cut through the east edge of the trench and a modern electric cable along the north of the trench. No archaeological features or finds were identified.

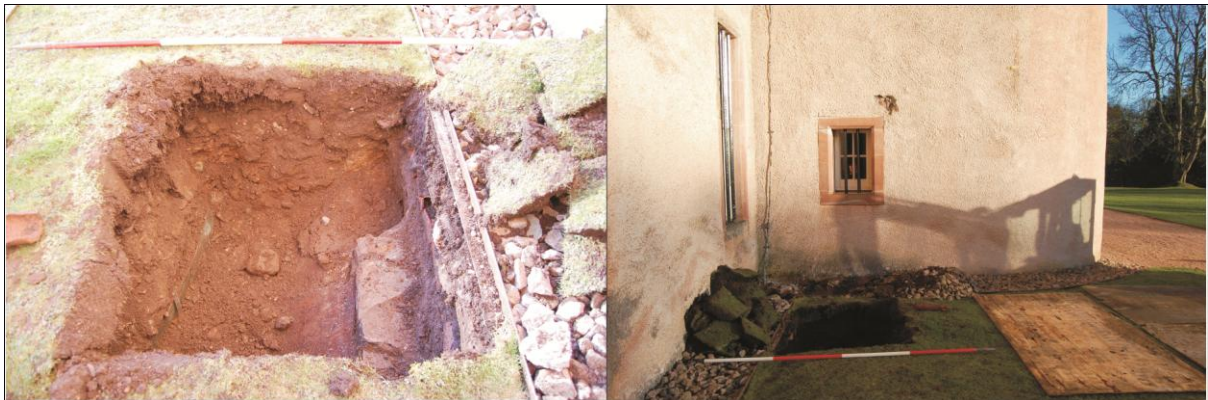
Trench 4 was located on the west side of the Seton Tower on the south facade of the castle. Modern services included a sewer pipe running across the south east corner of the trench and a ceramic water pipe along the north edge. A mortared stone feature (F3; Illus 6, 7) in the north of the trench under the ceramic water pipe may pre-date these services. F3 was constructed of mortared stone and slate but its date or interpretation were not possible to ascertain during this work.

Illus 6 Trench 4 Left: F3 (right) facing west; Right: location facing east

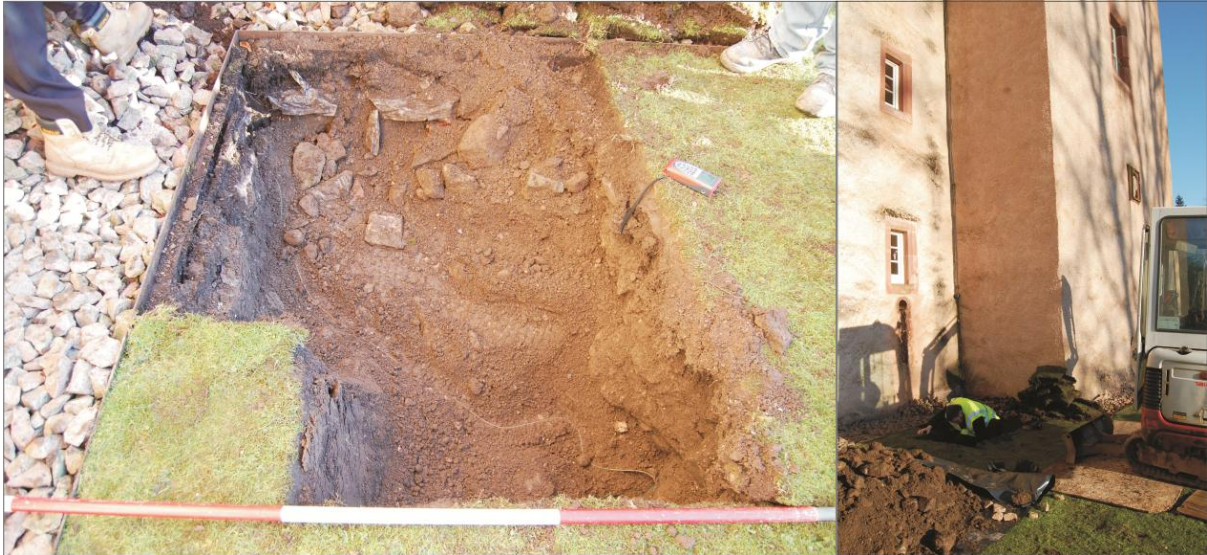
Illus 8 Trench 5 Left: trench facing east; Right: location facing north-east

Trench 5 was located on the west side of the Preston Tower on the south facade of the castle. It was filled with a brown loam with many stones in a trench dug to bury the existing lightning conductor. No archaeological features or finds were identified.

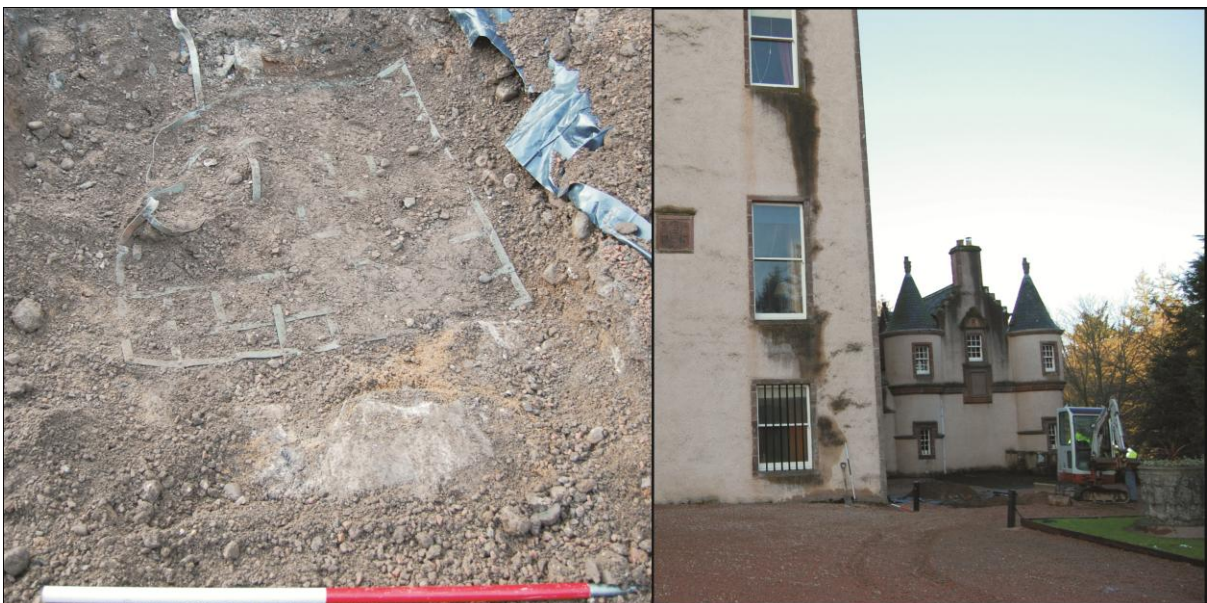
Trench 1 was 1.5 x 1.5m in size and was excavated east of the Butler's flat north of Leith Tower. A lightning mat consisting of copper alloy tapes pinned into a rectangular mesh was uncovered (Illus 9); it was hand-made (Best Contractors staff, pers comm) and at least 25 years old. At the north of the trench one mortared stone (F1; Illus 9, 10) may have been the remains of a structure. Adjacent to Trench 6 were three stones which may be the remains of an old wall foundation. These were photographed (Illus 11) and will be studied at a later date.

Illus 9 Trench 6 Left: Lightning mat with Stone F1 (foreground) facing south; Right: location facing west

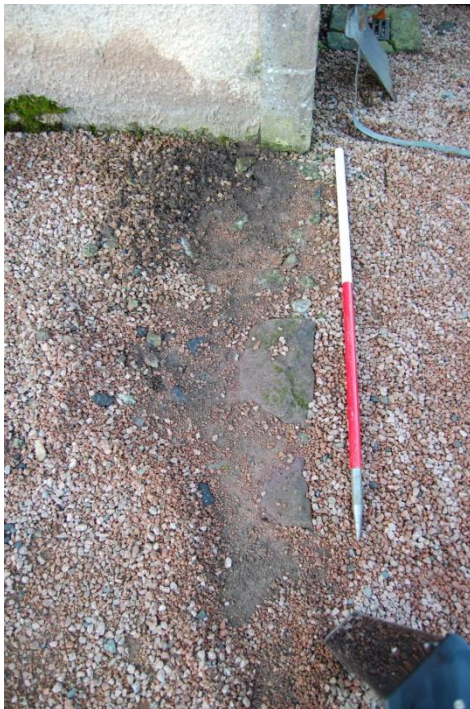
Illus 11 Remains of possible wall foundation F1

On 23th-24th January 2012 six trenches were excavated using mini digger for the improvement of lightning conductors. Two possible features were recorded in the trenches but all the soil removed had been disturbed in the recent past and no significant remains were disturbed. Feature F1 adjacent to Trench 6 will be studied further at a later date as part of a larger project (Fraser, Cameron and Addyman forthcoming).
