**Report on the standing building survey
54-60 Frederick Street, Aberdeen, AB24 5HY
(The Granary Building)
Aberdeen Community Health Care Village**

**Alison Cameron
Cameron Archaeology Ltd
7 April 2012**

Report on the standing building survey 54-60 Frederick Street, Aberdeen, AB24 5HY Aberdeen Community Health Care Village

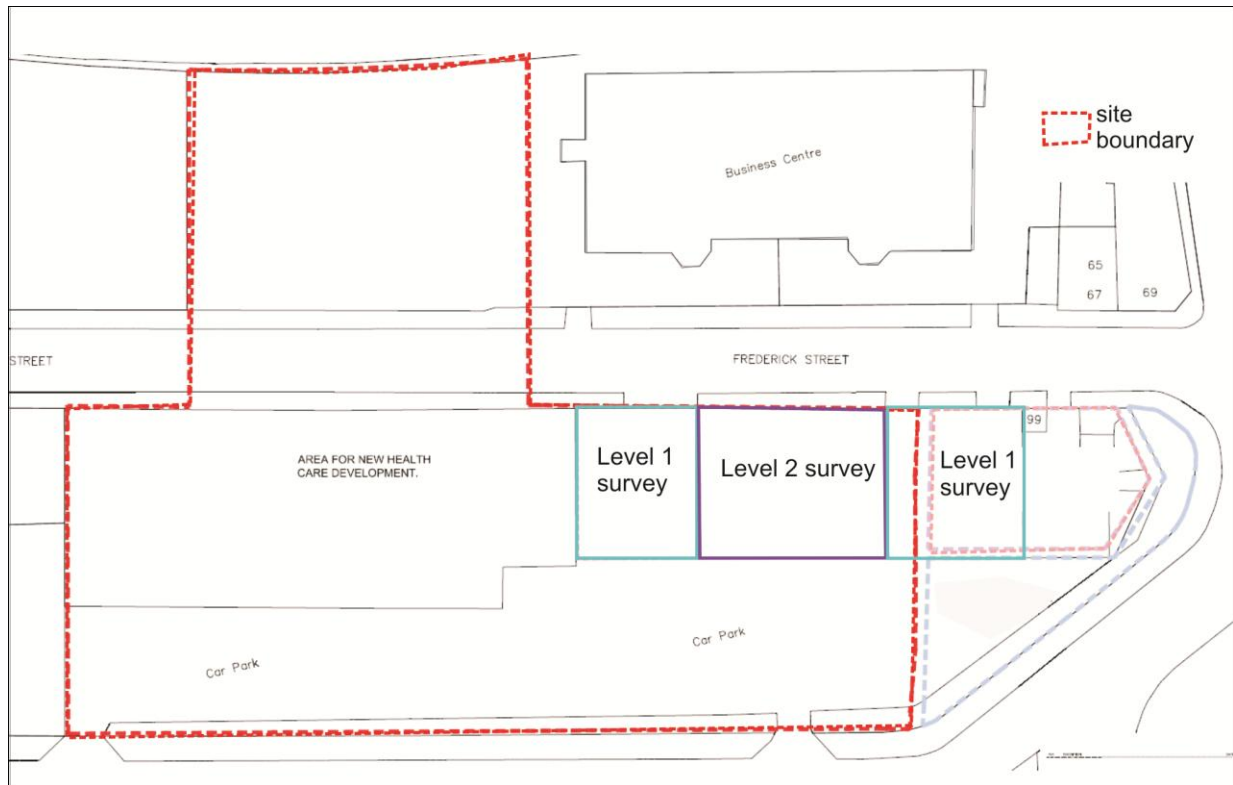
Illus 4 Plan showing outline of development and Level 1 and Level 2 survey areas

A Level 1 survey was carried out on (Illus 1) the one storey extensions on the east and west sides of the former granary warehouse, 60 Frederick Street and a Level 2 survey was carried out on the warehouse building itself. The survey took place between 23 March - 3 April 2012.

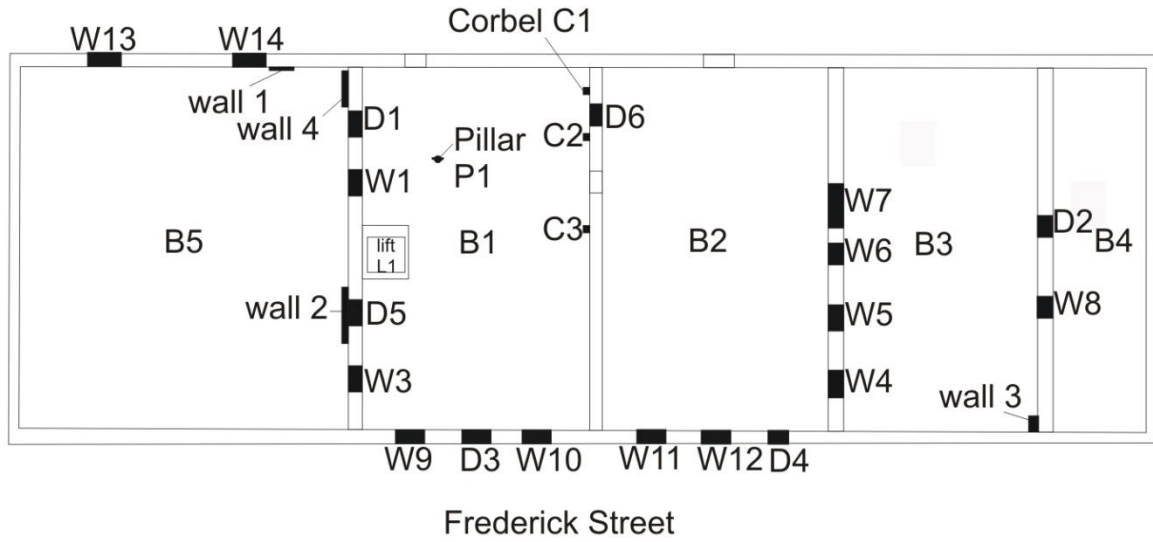
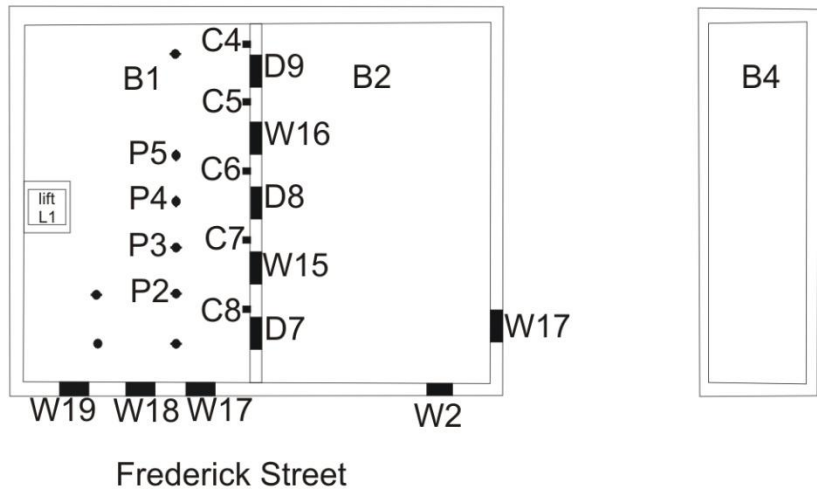
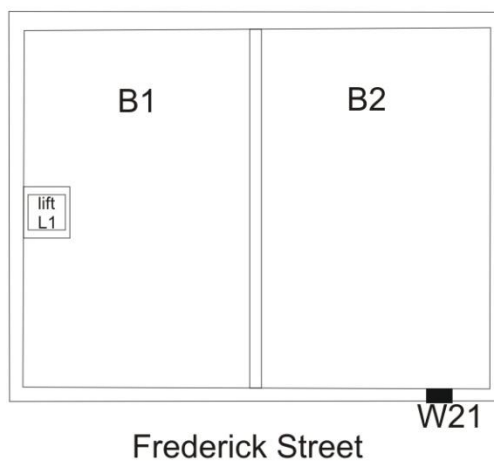
Illus 5 Floor plans with features numbered

Building B1/B2 ('The Granary'; Illus 5; Illus 6-12) has been converted to offices and stores with the addition of an internal staircase at the west side and internal partition. Original door and windows were recorded (Illus 5) as well as an original lift and cast iron pillars. These allowed the granary rooms to be subdivided with metal partitions. These pillars are mainly boxed in but examples on the first floor of Building B1 have been uncovered and these are recorded in Illus 11 showing the possible room divisions.

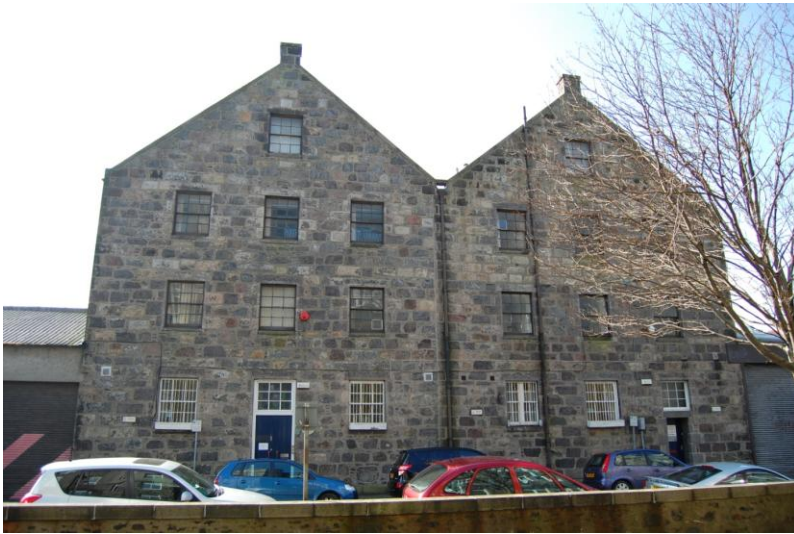
Illus 6 B1/B2 North facade

The granary building is Listed Category B (NJ90NW 1802; NJ 9455 0657). It is a mid 19th century, 3-storey and attic, tall, M-gabled former granary (commercial premises 2006) with principal elevation to Frederick Street at the north. It is constructed of sneaked, coursed granite rubble with regularly spaced rectangular window openings, some infilled. There are 20th century extensions to east and west. It has predominantly 12-pane timber sash and case windows to street elevation, replacement windows to rear. It has grey slates and cast-iron rainwater pipes. The interior has an original floor-plan largely extant. The interior of the building has retained its timber flooring and original cast-iron columns. The flanges to the columns would have allowed partitions to be slotted between each column, creating smaller spaces for easier grain storage. The lift and lift shaft to the east have metal concertina doors.

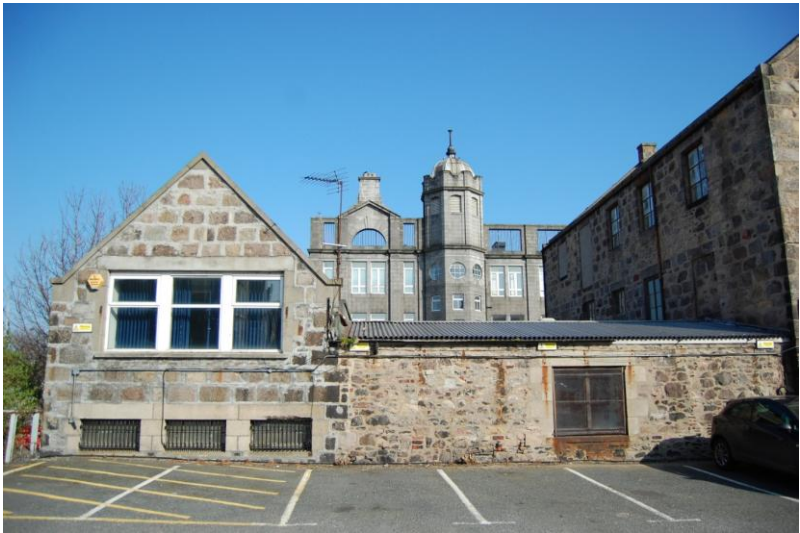
Illus 9 B4/B3 West extension, south wall

Buildings B3 and B4 to the west of the granary consist of a granite garage B3 and two-storey office building B4. They have been substantially converted but original features include windows W4-W7 which formed the original exterior walls of B2.

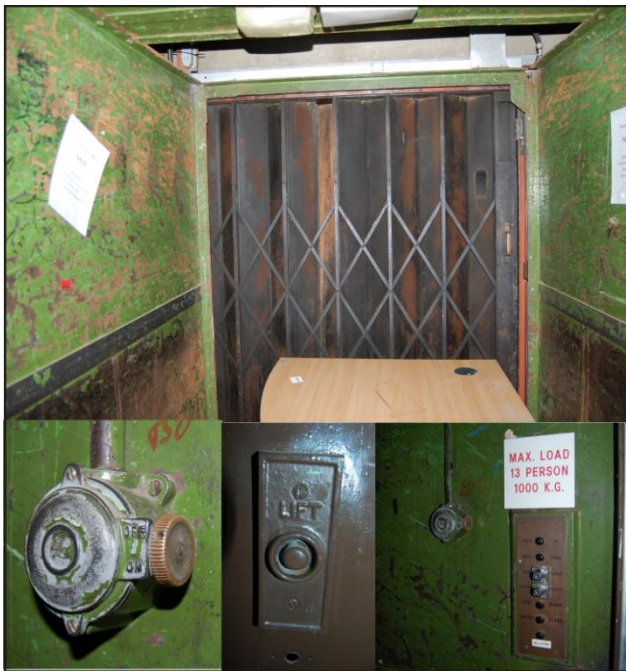
Illus 12 lift L1 (above) and lift controls (below)

An original metal lined lift with concertina doors (L1; Illus 11, 12) survives at the east end of B1.
